Request for Determination of Applicability – 11 Hunt Road

Proposed Septic System Repair

Wetland Border Report

Site Locus: 11 Hunt Road, Sudbury MA Prepared for: Connorstone Engineering, Inc.

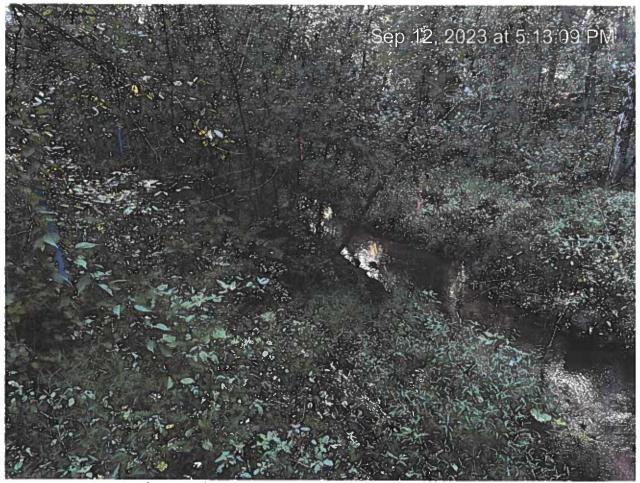
Photo 1. View of wetland and stream at rear of the locus site.

Additionally, the bank of a stream internal to the BVW system was flagged with series GCS1-20. This stream is identified on the USGS map of the area as being intermittent.

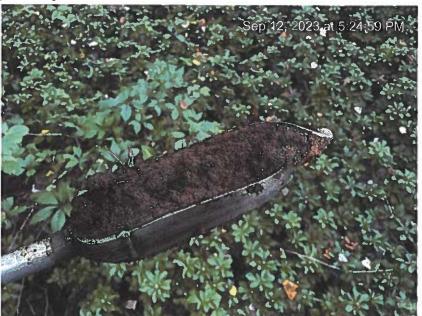
Photo 2. Upland soil sample pulled upgradient of flag GCA5.

Soils identified on the property include sandy loams. In the wetland soil sample, fine sandy loam (FSL) with matrix color 10YR2/1 was found from 0-16", and FSL (10YR5/1) was found from 16-24". In the upland soil sample, FSL (10YR2/2) was found from 0-2", FSL (10YR3/4) was found from 2-8", and FSL (10YR5/6) was found from 8-24". More detailed information about soils is included in the attached NRCS Soil Map and the DEP Bordering Vegetated Wetland Determination Forms.

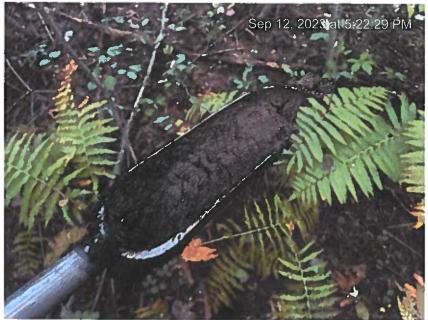
Photo 3. Wetland soil sample pulled downgradient of flag GCA5.
