**Environmental Monitor Construction Site Inspection Report
MassDOT Project #608164 Construction Contract # 119678
EM Report #1**

Project Description: Bruce Freeman Rail Trail Right-of-Way
Permit Description(s): Order of Condition (MGL Chapter 131, Section 40 and 310 CMR 10.00, Mass DEP File No. 301-1362); 2022 EPA NPDES General Permit for Discharges from Construction Areas ; U.S. Army Corps of Engineers Permit No NAE-2021-01975.

Project Name:	Bruce Freeman Rail Trail Right-of-Way
Date of Inspections:	5/8/2024
Bi Weekly/ Monthly Period Covered:	May Weekly Inspection #1
Inspector's Name(s):	Douglas Beach
Inspectors' Contact Information:	dbeach@beta-inc.com

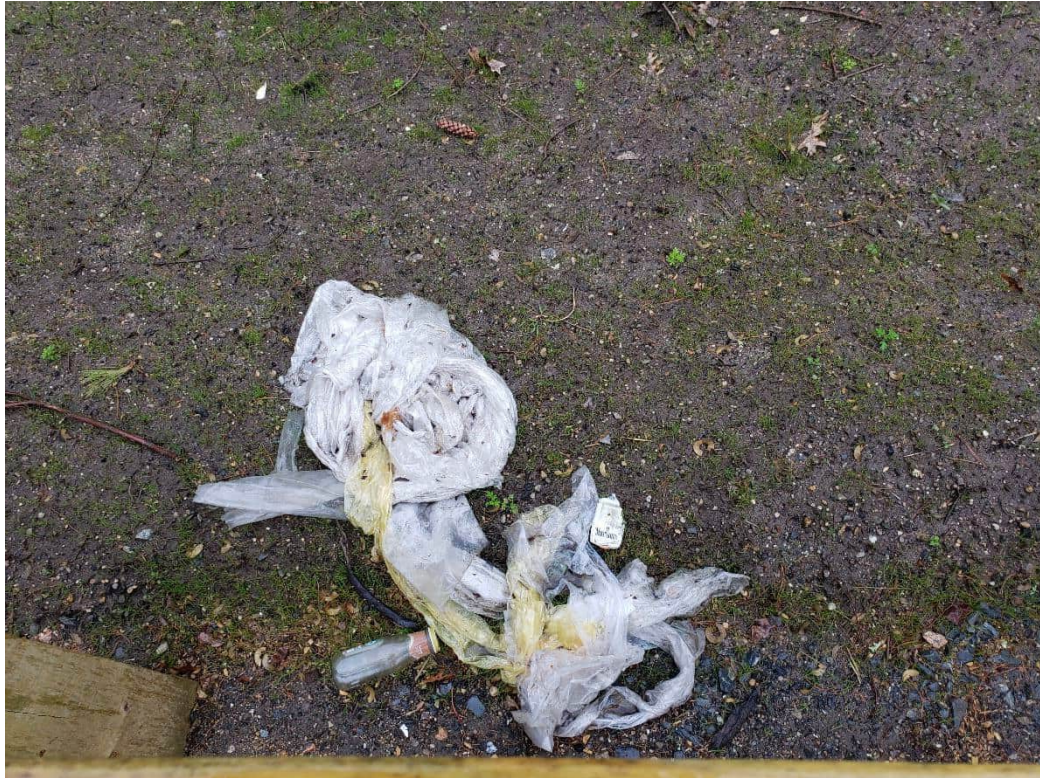
Photo No. 1 **Date:**
5/8/2024

View of debris near Station 125+50 per Compliance Action Item 1.

Item	Location/ Description	Observation Date	Resolution Due Date	Recommended Resolution / Resolution Date	Comments/Updates
1	Trash and concrete improperly disposed of around Stations 125+50 through 126+00 Priority: Low	5/8/2024	5/15/2024	Pick up loose trash and remove concrete pile from the area in accordance with the SWPPP.	
2	Concrete pile requiring disposal at Station 143+50 Priority: Low	5/8/2024	5/15/2024	Remove concrete pile from the area.	
3	Sediment washout over the slope and existing erosion controls at Stations 155+00 to 162+50 Priority: Low	5/8/2024	5/15/2024	Replace decomposed and damaged compost filter tubes in the areas necessary to contain sediment washout until stabilization measures are completed.	
4	Concrete pile improperly disposed of at Station 163+00 Priority: Low	5/8/2024	5/15/2024	Remove concrete pile from the area.	
5	Turbid water in swale at Stations 167+00 through 172+00 Priority: High	5/8/2024	5/15/2024	Stabilize all contributing areas to the swale and implement stabilization measures over exposed soils within the swale itself once water recedes. It is recommended that the contractor coordinate with MassDOT on stabilization within the swale, which may require jute netting and seed.

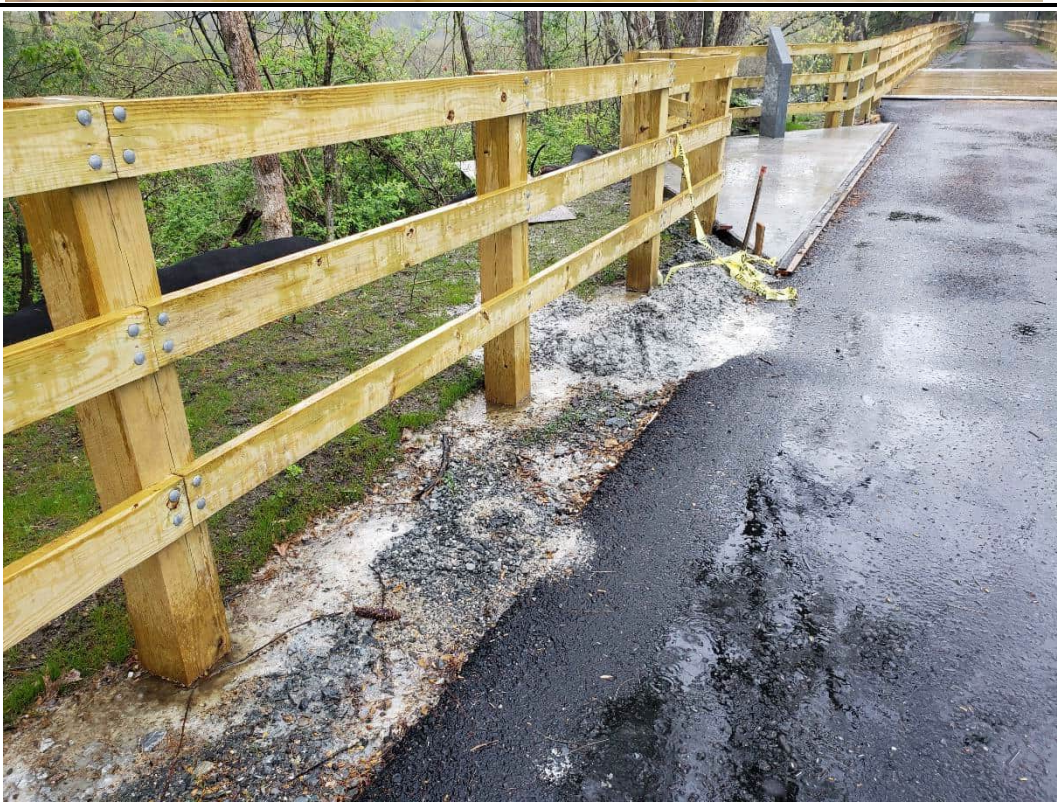
Photo No. 2 **Date:**
5/8/2024

View of dried concrete and cement washout at Station 125+50 per Compliance Action Items 1, 2, 4, 7, 8, 10, 11, 24, 25, and 28.

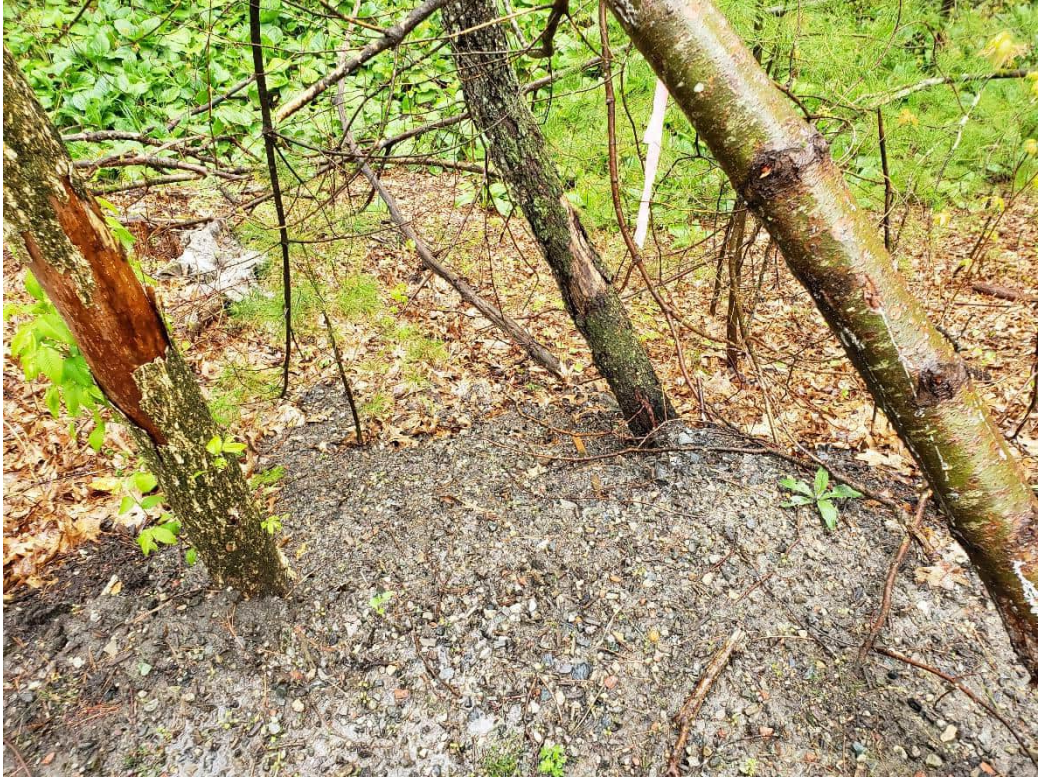
Site Location		BETA Project No. 24.10326.23
Photo No. 3	Date: 5/8/2024

Direction Photo Taken: Toward the West		
Description: Typical view of washout between Stations 155+00 through 162+00 per Compliance Action Item 3.		
Photo No. 4	Date: 5/8/2024

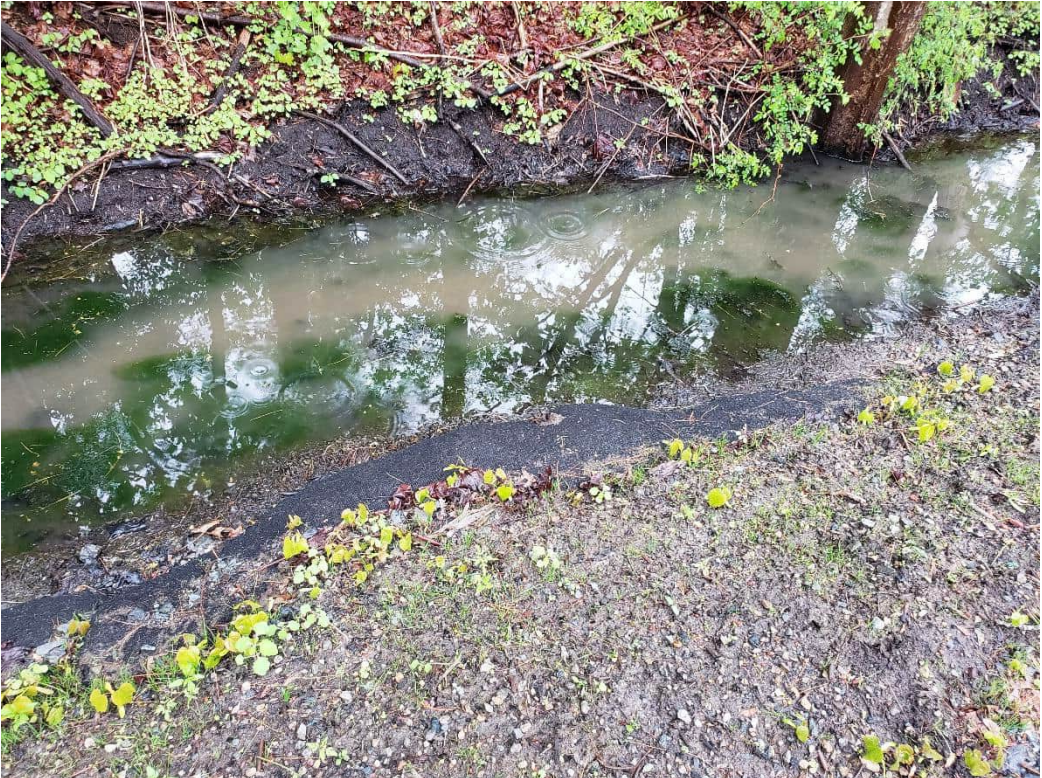
Direction Photo Taken: Toward the West		
Description: View of turbid water within a channel near Stations 167+00 through 172+00 per Compliance Action Item 5.

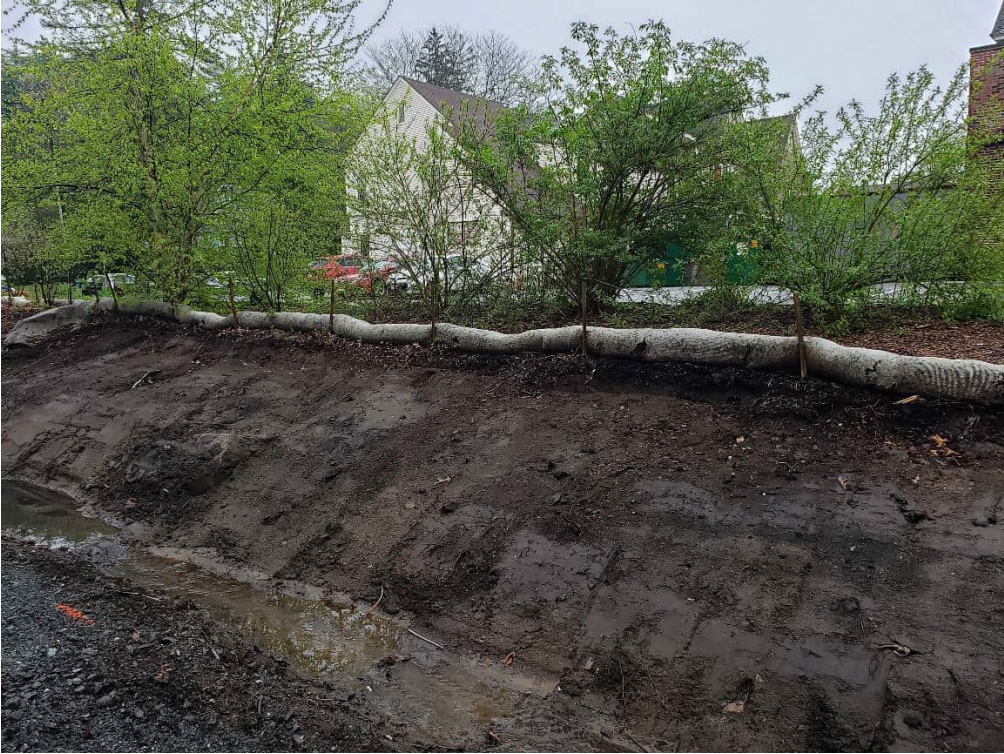
Site Location		BETA Project No. 24.10326.23
Photo No. 5	Date: 5/8/2024

Direction Photo Taken: Toward the Northeast		
Description: View of exposed soils requiring stabilization along the east side of trail near Stations 172+00 through to 175+00 per Compliance Action Item 6.		
Photo No. 6	Date: 5/8/2024

6	Exposed sediment slope at Station 172+00 to 175+00 Priority: High	5/8/2024	5/15/2024	Install temporary sediment controls along the slope such as jute netting and/or straw following the application of seed.	
7	Concrete pile improperly disposed of at Station 181+50 Priority: Low	5/8/2024	5/15/2024	Remove concrete pile from the area.	
8	Concrete pile improperly disposed of at Station 184+50 Priority: Low	5/8/2024	5/15/2024	Remove concrete pile from the area.	
9	Rill erosion resulting in offsite sediment migration at Station 1003+00 Priority: Low	5/8/2024	5/15/2024	Fill in rills and apply seed to stabilize the area. Temporary stabilization measures such as straw and/or jute netting may be required.

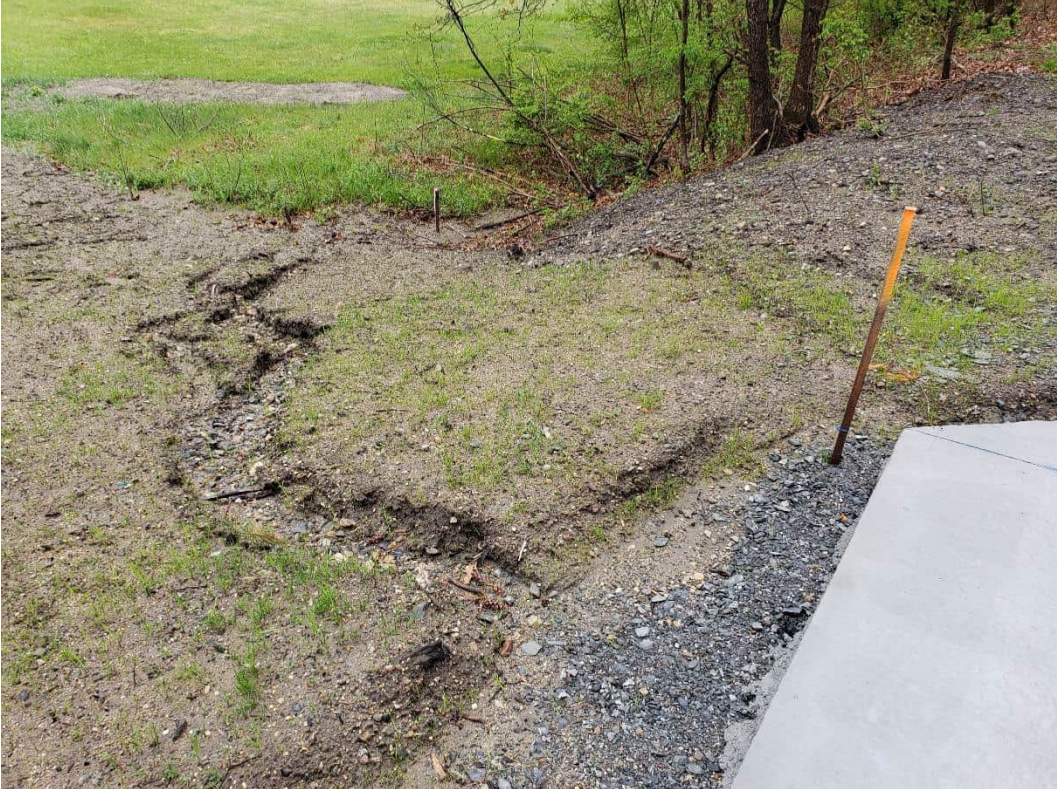
Direction Photo Taken: Toward the Northwest		
Description: View of rill erosion along a slope at the intersection of Stations 184+50 and 1003+00 per Compliance Action Item 9.

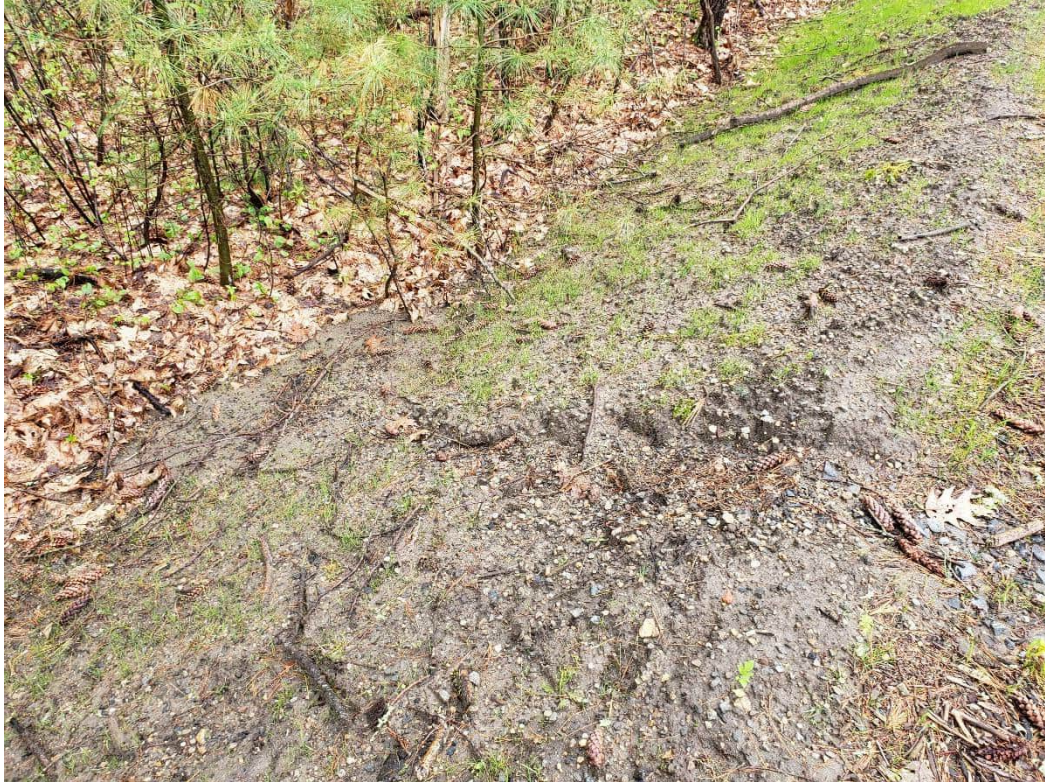
<p>Site Location</p>		<p>BETA Project No. 24.10326.23</p>
<p>Photo No. 7</p>	<p>Date: 5/8/2024</p>

<p>Direction Photo Taken:</p> <p>Toward the West</p>		
<p>Description:</p> <p>View of typical rill erosion and sediment runoff along the west side of the trail from Stations 201+00 through 204+00 per Compliance Action Item 13.</p>		
<p>Photo No. 8</p>	<p>Date: 5/8/2024</p>

10	Concrete pile improperly disposed of at Station 1001+00 Priority: Low	5/8/2024	5/15/2024	Remove concrete pile from the area.	
11	Concrete pile improperly disposed of at Station 185+00 Priority: Low	5/8/2024	5/15/2024	Remove concrete pile from the area.	
12	Concrete pile improperly disposed of and rill erosion behind concrete pad at Station 201+50 Priority: Low	5/8/2024	5/15/2024	Remove concrete and fill in rills/stabilize area with seed. Temporary stabilization measures such as straw and/or jute netting may be required.	
13	Rill erosion is occurring along the west side of the trail at Stations 201+50 to 204+00 Priority: Low	5/8/2024	5/15/2024	Fill in rills and apply seed to stabilize the area. Temporary stabilization measures such as straw and/or jute netting may be required.	
14	Sediment-laden runoff is being discharged into a stream from the new parking lot at Station 216+50 Priority: High	5/8/2024	5/15/2024	Replace compost filter tubes around the stream and develop a method of redirecting runoff from the parking lot at the source.

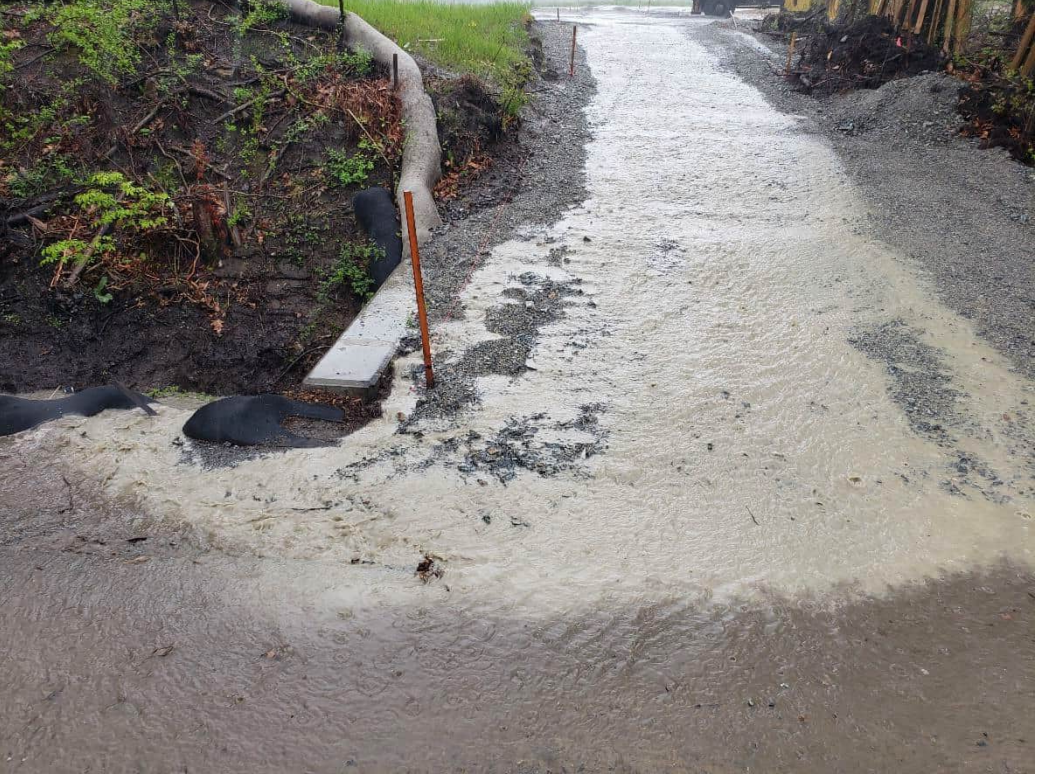
<p>Direction Photo Taken:</p> <p>Toward the East</p>		
<p>Description:</p> <p>View of sediment laden runoff being discharged from the parking lot into the stream at Station 216+50 per Compliance Action Item 14.</p>

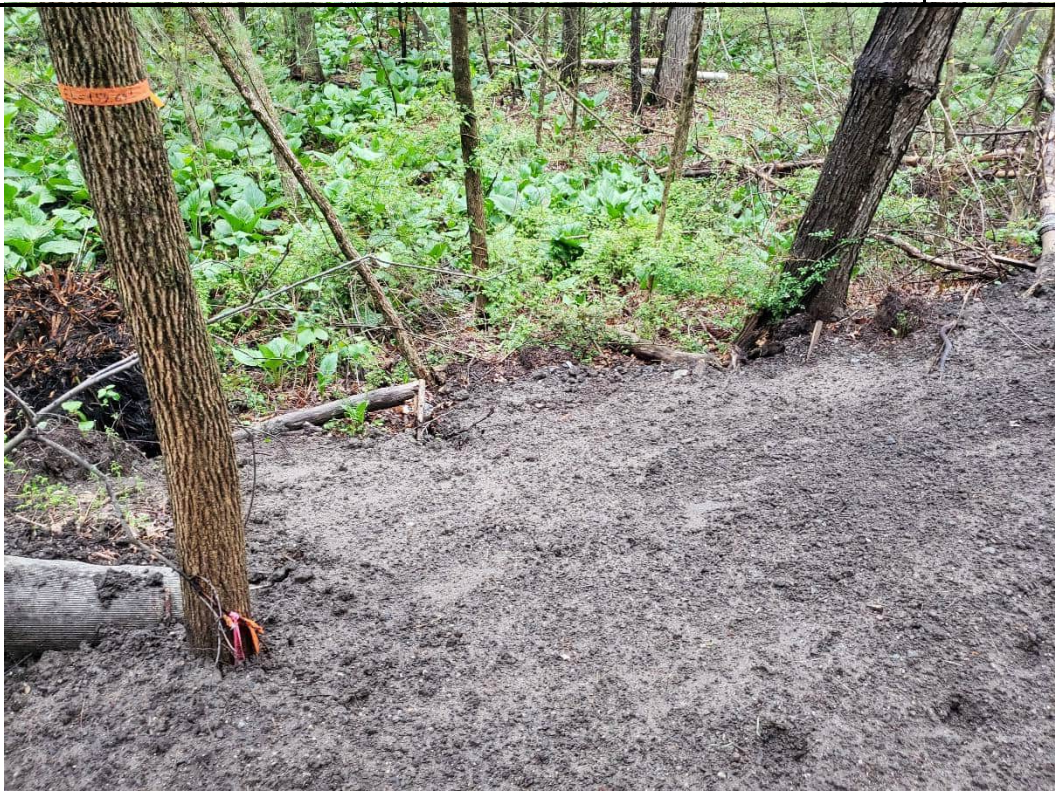
<p>Site Location</p>		<p>BETA Project No. 24.10326.23</p>
<p>Photo No. 9</p>	<p>Date: 5/8/2024</p>

<p>Direction Photo Taken:</p> <p>Toward the West</p>		
<p>Description:</p> <p>View of washout overtopping compost filter tubes at Station 221+50 per Compliance Action Item 15.</p>		
<p>Photo No. 10</p>	<p>Date: 5/8/2024</p>

15	Sediment migration off of the trail and into wetlands at Station 221+50 Priority: High	5/8/2024	5/15/2024	Replace damaged compost filter tubes and remove accumulated sediment from areas beyond the limits of work. Once any grading work is completed, apply seed to the slope and stabilize it with jute netting, straw, etc.	
16	Sediment migration beyond the limits of work at Stations 231+00 to 232+00 Priority: Medium	5/8/2024	5/15/2024	Remove accumulated sediment from areas beyond the limits of work and replace compost filter tubes. Once any grading work is completed, apply seed to the slope and stabilize it with jute netting, straw, etc.	
17	Sediment migration beyond the limits of work at Stations 236+00 to 238+00 Priority: High	5/8/2024	5/15/2024	Remove accumulated sediment from areas beyond the limits of work and replace compost filter tubes. Once any grading work is completed, apply seed to the slope and stabilize it with jute netting, straw, etc.

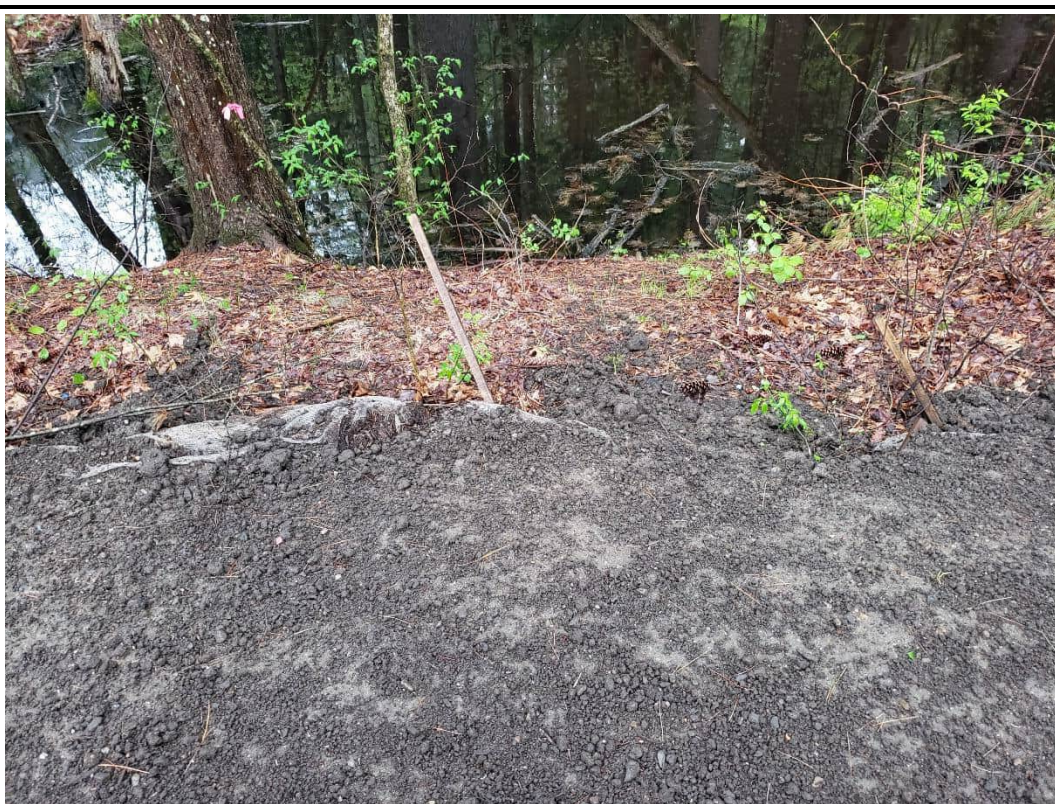
<p>Direction Photo Taken:</p> <p>Toward the West</p>		
<p>Description:</p> <p>View of washout overtopping compost filter tubes at Station 231+00 per Compliance Action Item 16.</p>

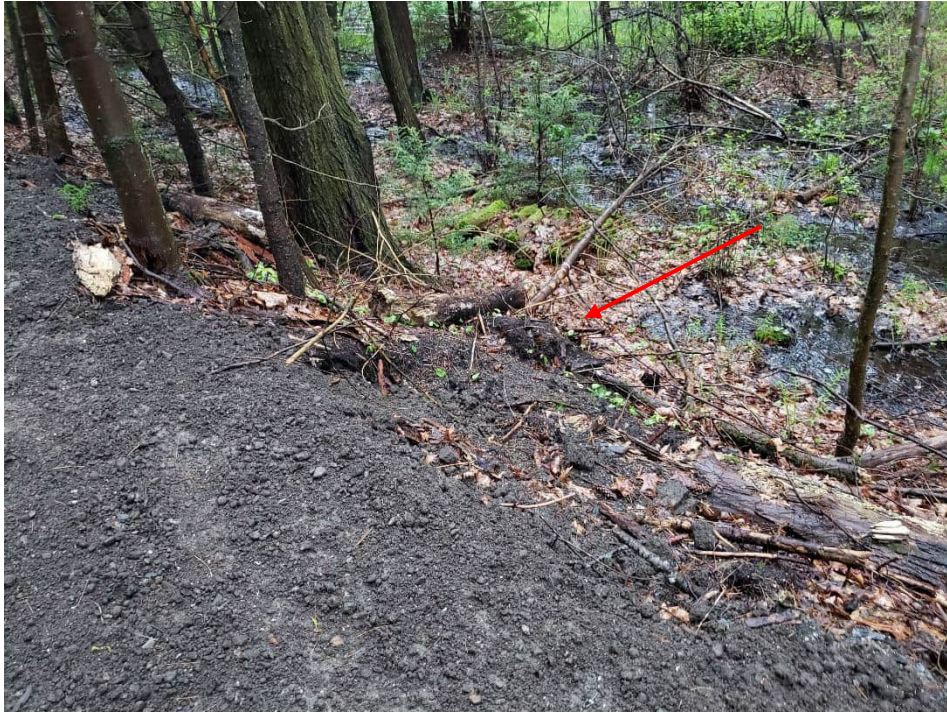
Site Location		BETA Project No. 24.10326.23
Photo No. 11	Date: 5/8/2024

Direction Photo Taken: Toward the Northeast		
Description: View of washout overtopping compost filter tubes resulting in sediment/soil accumulation within the wetland along the east side of the trail between Stations 236+00 and 238+00 per Compliance Action Item 17.		
Photo No. 12	Date: 5/8/2024

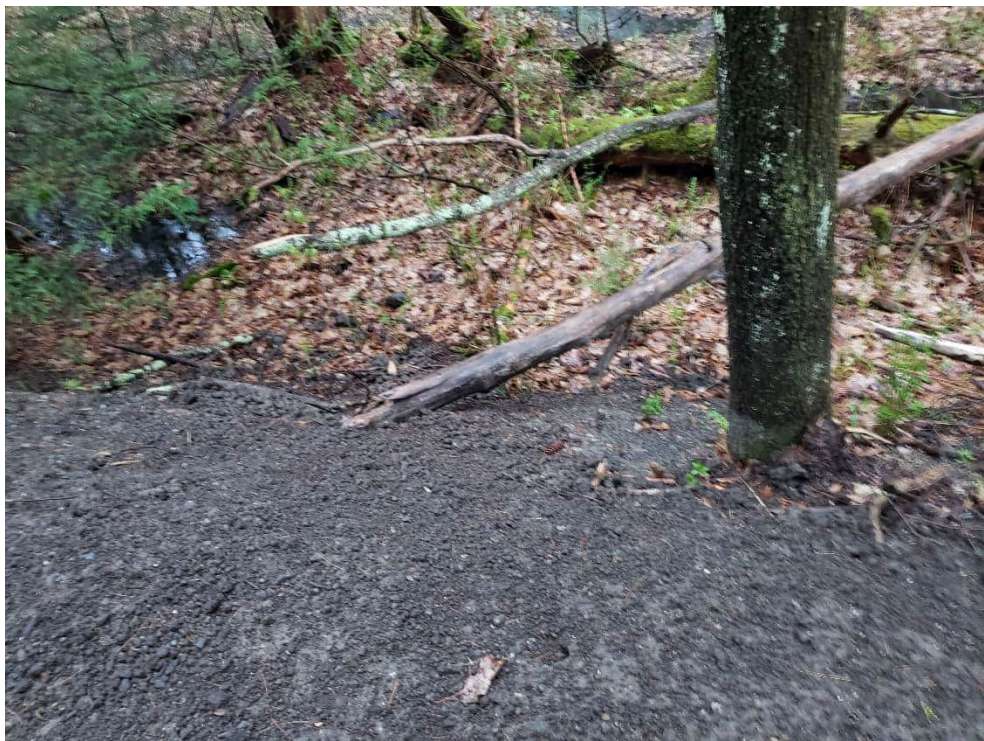
Direction Photo Taken: Toward the West		
Description: View of washout overtopping compost filter tubes near Stations 238+00 and 241+00 per Compliance Action Item 18.

18	Sediment migration beyond the limits of work at Stations 238+00 to 241+00 Priority: Medium	5/8/2024	5/15/2024	Stabilize steep slopes with jute netting or compost filter tubes to prevent additional land movement and erosion.	
19	Sediment migration into the stream at Station 247+00 Priority: High	5/8/2024	5/15/2024	Install compost filter tubes to prevent further sedimentation of the stream. If dry conditions are present, evaluate whether sediment removal is feasible.	
20	Rill erosion moving offsite on the West side of the trail at Stations 252+00 to 253+00 Priority: Low	5/8/2024	5/15/2024	Add or replace compost filter tubes or straw wattles to stabilize the immediate area until grass grows in.	
21	Washout and erosion issues on the east side of trail at Stations 255+50 to 256+00 Priority: Low	5/8/2024	5/15/2024	Remove material that has eroded offsite and add additional erosion control such as straw wattles, jute netting, or compost filter tubes.

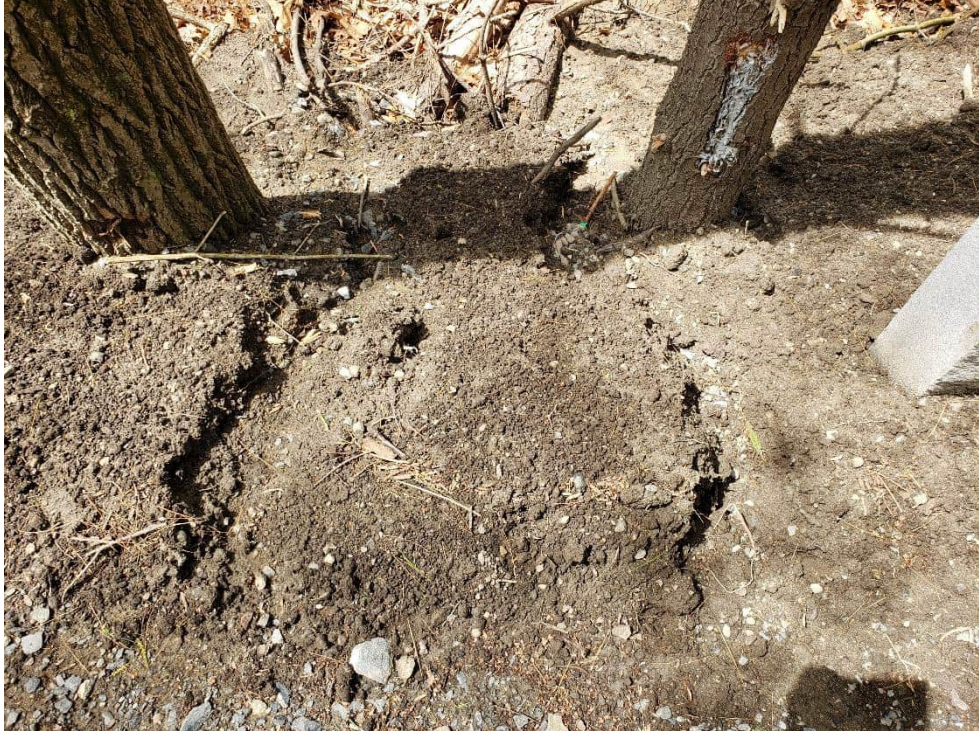
Site Location		BETA Project No. 24.10326.23
Photo No. 13	Date: 5/8/2024

Direction Photo Taken: Toward the West		
Description: View of rill erosion along exposed soils near Station 252+00 per Compliance Action Item 20.		
Photo No. 14	Date: 5/8/2024

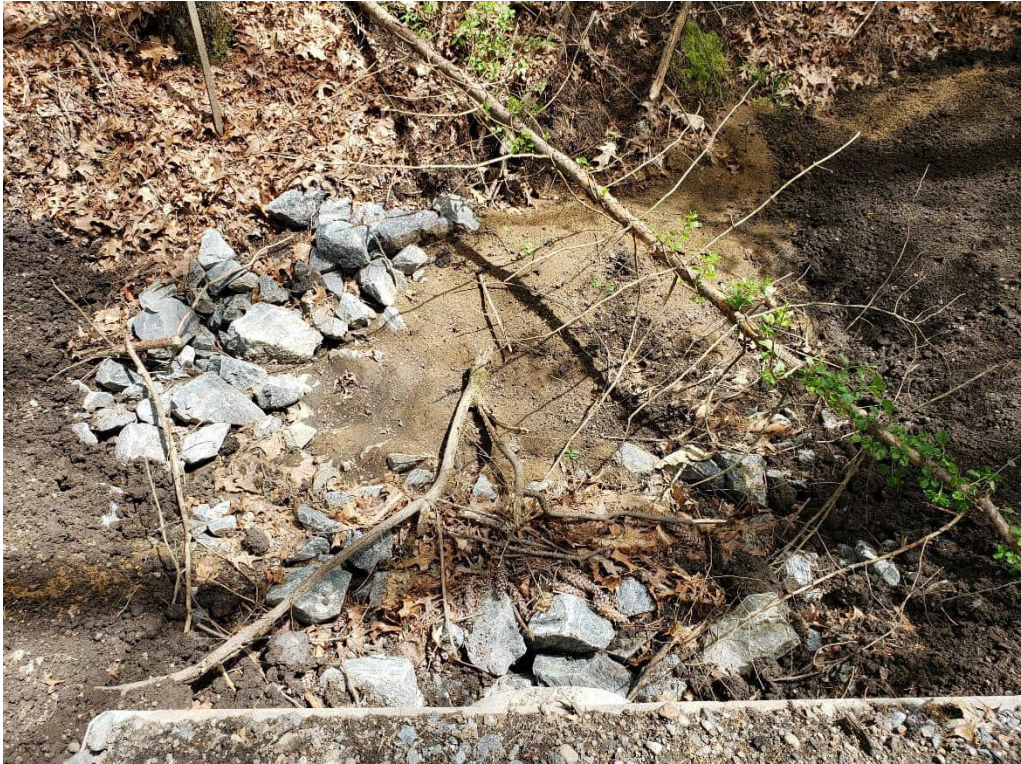
Direction Photo Taken: Toward the East		
Description: View of stone with pipe ends with accumulated sediment at Station 257+00 per Compliance Action Item 22.

22	Sand and silt accumulation observed at and beyond the stone for pipe ends at Station 257+00 Priority: High	5/8/2024	5/15/2024	Remove accumulated sand and silt within and beyond the stone for pipe ends. Consider expanding stone apron if required to accommodate flows.
