Environmental Monitor Construction Site Inspection Report
MassDOT Project #608164 Construction Contract # 119678
EM Report #3

Project Description: Bruce Freeman Rail Trail Right-of-Way
 Permit Description(s): Order of Conditions (MGL Chapter 131, Section 40 and 310 CMR 10.00, Mass DEP File No. 301-1362); 2022 EPA NPDES General Permit for Discharges from Construction Areas; U.S. Army Corps of Engineers Permit No NAE-2021-01975.

Project Name: Bruce Freeman Rail Trail - Phase 2d - Sudbury
 Date of Inspections: 5/21/2024
 Bi Weekly/ Monthly Period Covered: May Weekly Inspection #3
 Inspector's Name(s): Douglas Beach
 Inspectors' Contact Information: dbeach@beta-inc.com

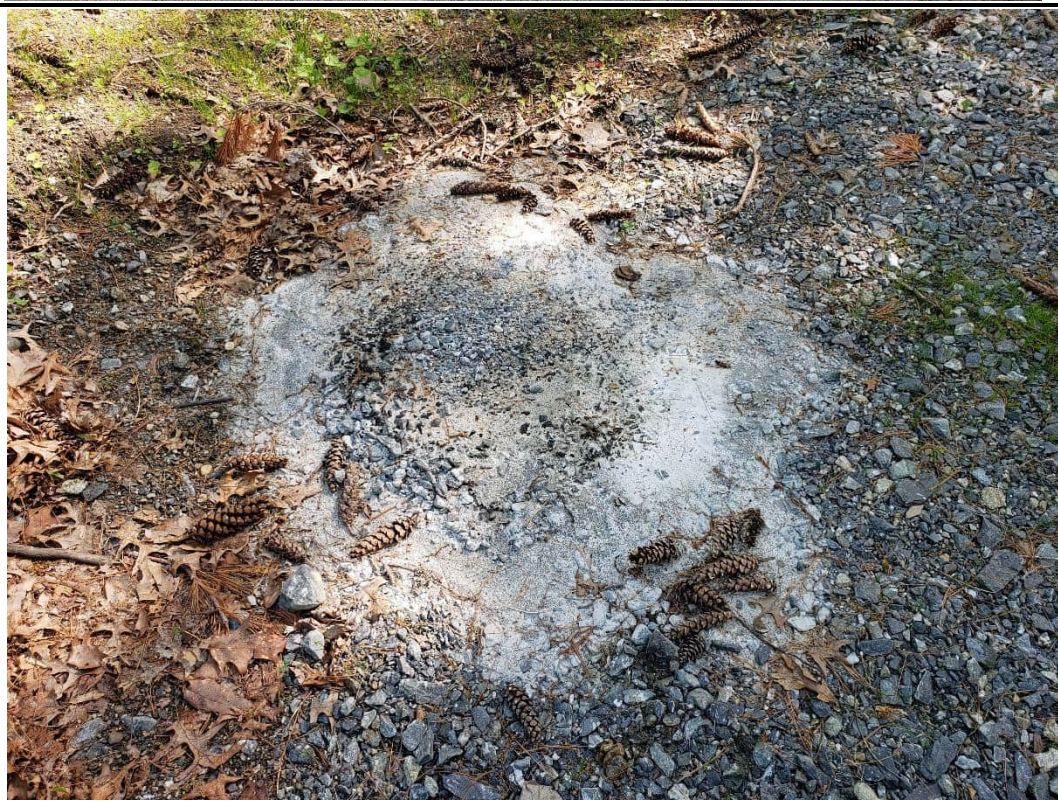
Photo No. 2 **Date:**
5/21/2024

Typical view of dried concrete and cement washout at Station 143+50 per Compliance Action Items 1, 2, 4, 7, 11, 28, and 30.

30	Concrete pile improperly disposed of at Station 101+00 Priority: Low	5/16/2024	5/23/2024	Remove concrete pile from the area.	5/21/2024 - Observation remains.
29	Trash has been left on the rest area pad at Station 101+00 Priority: Low	5/16/2024	5/23/2024	Remove the trash in a proper manner.	5/21/2024 - Observation remains.
1	Trash and concrete improperly disposed of around Stations 125+50 through 126+00 Priority: Low	5/8/2024	5/15/2024	Pick up loose trash and remove concrete pile from the area in accordance with the SWPPP.	5/16/2024 - Observation remains. 5/21/2024 - Observation remains.
2	Concrete pile requiring disposal at Station 143+50 Priority: Low	5/8/2024	5/15/2024	Remove concrete pile from the area.	5/16/2024 - Observation remains. 5/21/2024 - Observation remains.
3	Sediment washout over the slope and existing erosion controls at Stations 155+00 to 162+50 Priority: Low	5/8/2024	5/15/2024	Replace decomposed and damaged compost filter tubes in the areas necessary to contain sediment washout until stabilization measures are completed.	5/16/2024 - Observation remains. 5/21/2024 - Observation remains.

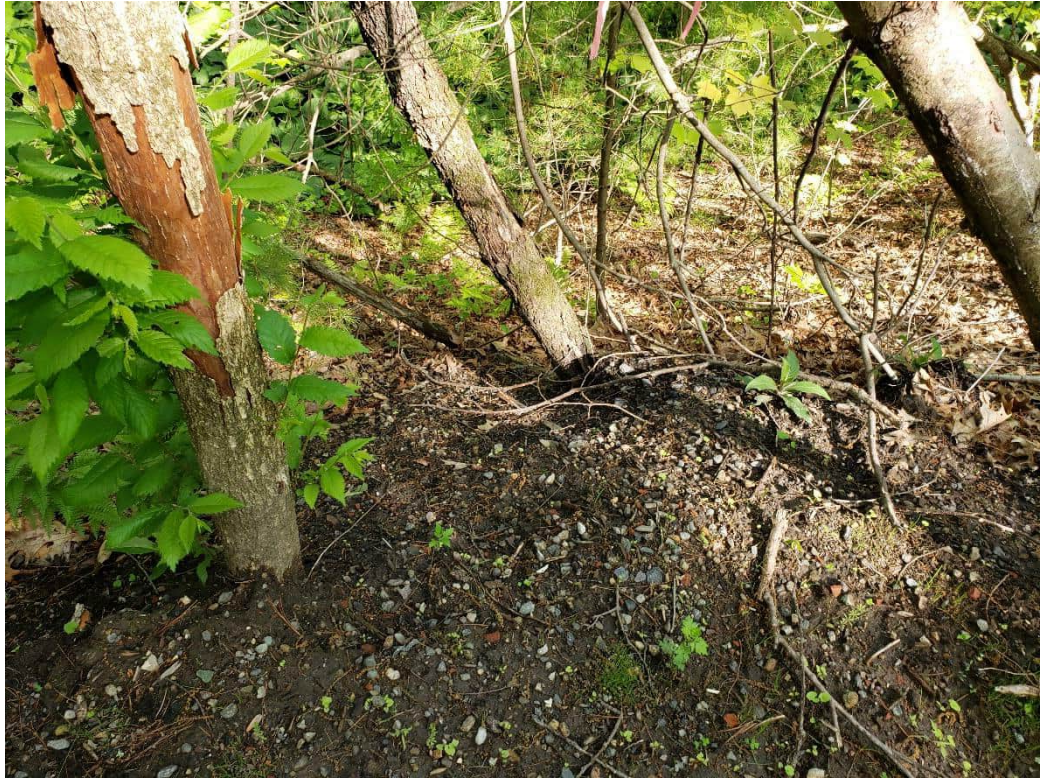
Photo No. 3	Date: 5/21/2024
--------------------	---------------------------

Description: Typical view of washout between Stations 155+00 through 162+00 per Compliance Action Item 3.

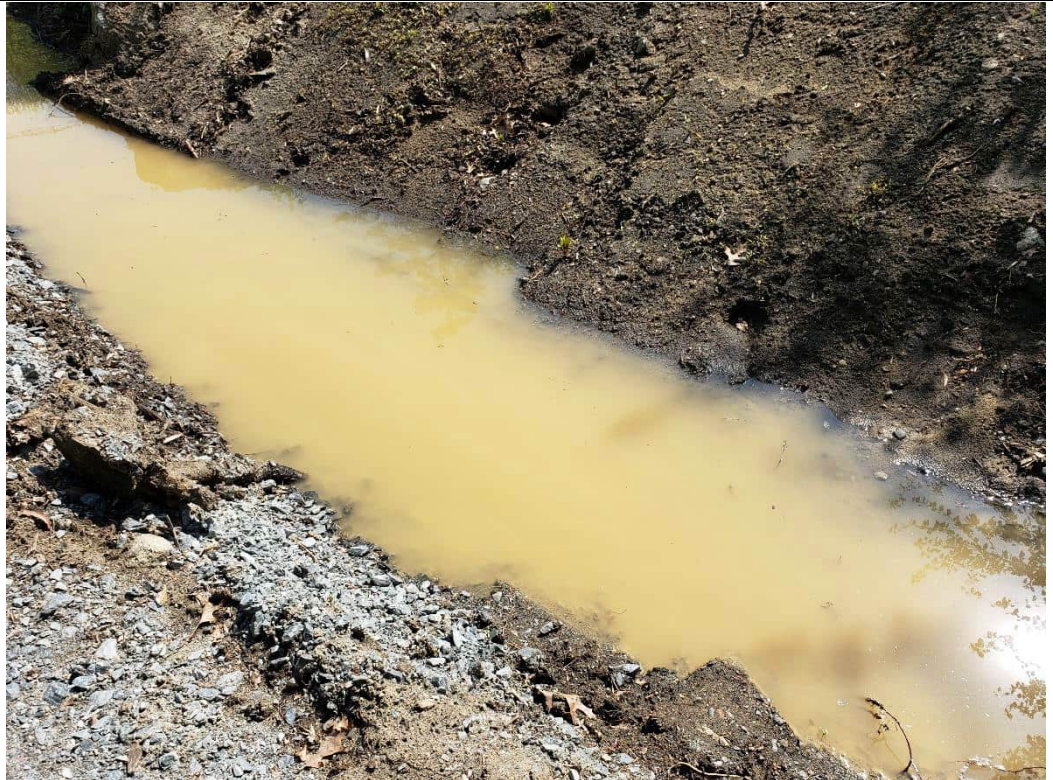
Photo No. 4	Date: 5/21/2024
--------------------	---------------------------

Description: View of turbid water within a channel near Stations 167+00 through 172+00 per Compliance Action Item 5.
--

5	Turbid water in swale at Stations 167+00 through 172+00 Priority: High	5/8/2024	5/15/2024	Stabilize all contributing areas to the swale and implement stabilization measures over exposed soils within the swale itself once water recedes. It is recommended that the contractor coordinate with MassDOT on stabilization within the swale, which may require jute netting and seed.	5/16/2024 - Observation remains. 5/21/2024 - Observation remains.
6	Exposed sediment slope at Station 172+00 to 175+00 Priority: High	5/8/2024	5/15/2024	Install temporary sediment controls along the slope such as jute netting and/or straw following the application of seed.	5/16/2024 - Observation remains. 5/21/2024 - Observation remains.
7	Concrete pile improperly disposed of at Station 181+50 Priority: Low	5/8/2024	5/15/2024	Remove concrete pile from the area.	5/16/2024 - Observation remains. 5/21/2024 - Observation remains.

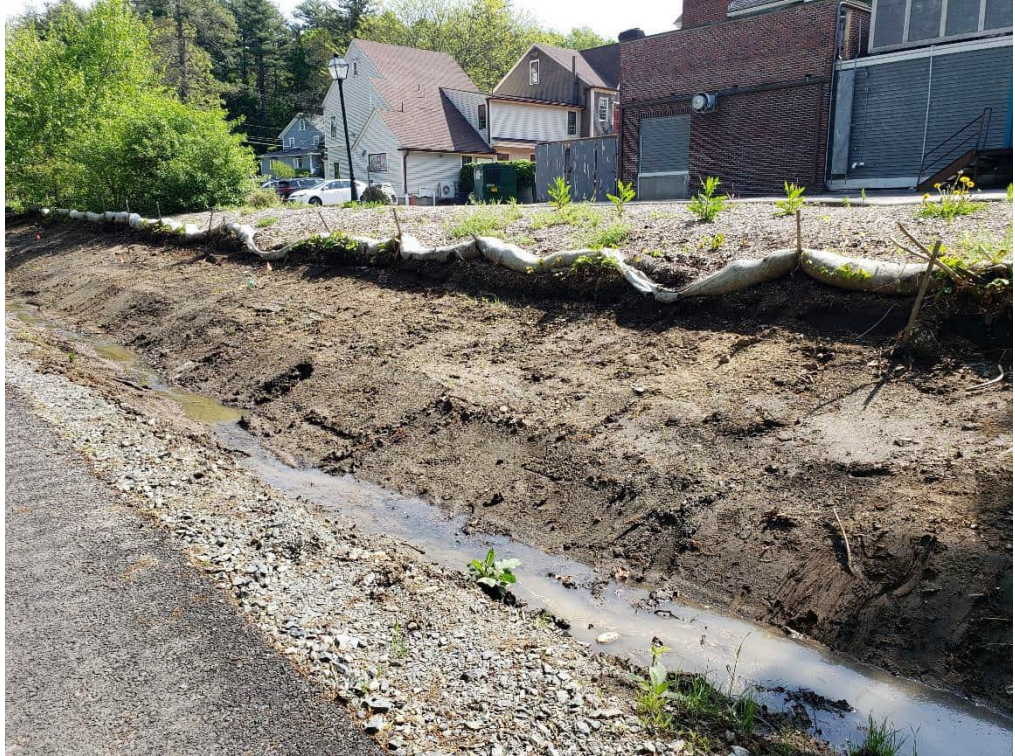
Photo No. 5 **Date:**
5/21/2024

View of exposed soils requiring stabilization along the east side of trail near Stations 172+00 through to 175+00 per Compliance Action Item 6.

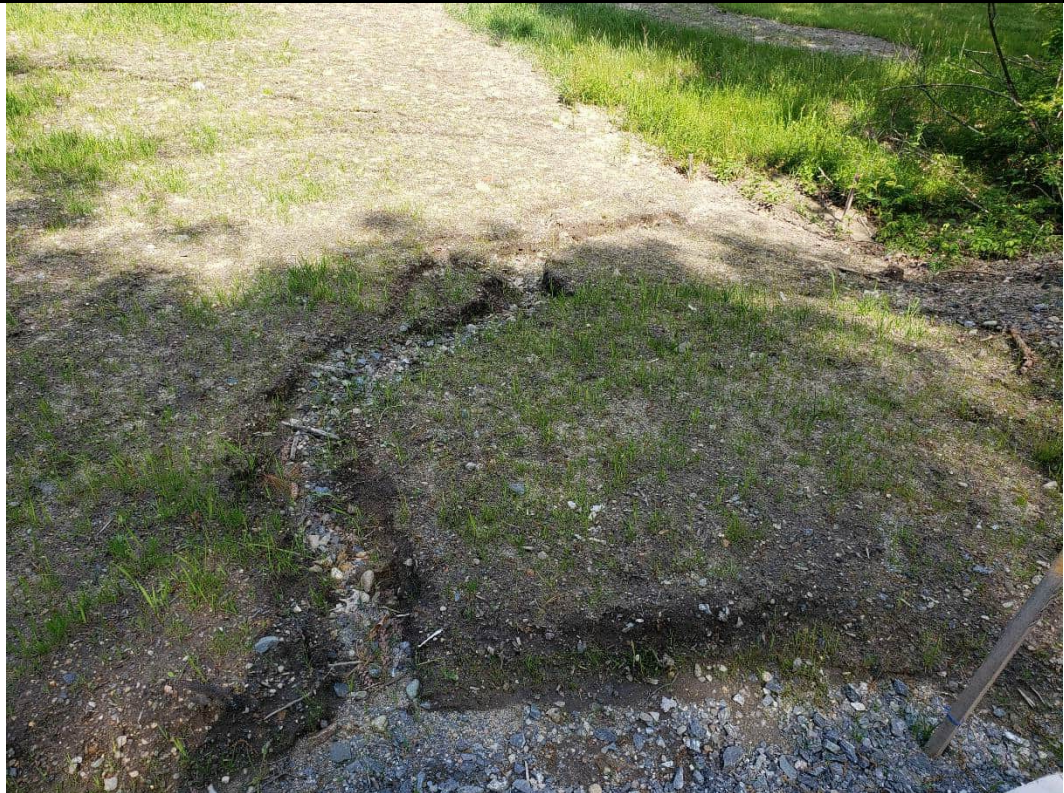
Photo No. 6 **Date:**
5/21/2024

View of rill erosion along a slope at the intersection of Stations 184+50 and 1003+00 per Compliance Action Item 9.

9	Rill erosion resulting in offsite sediment migration at Station 1003+00 Priority: Low	5/8/2024	5/15/2024	Fill in rills and apply seed to stabilize the area. Temporary stabilization measures such as straw and/or jute netting may be required.	5/16/2024 - Observation remains. 5/21/2024 - Observation remains.
11	Concrete pile improperly disposed of at Station 185+00 Priority: Low	5/8/2024	5/15/2024	Remove concrete pile from the area.	5/16/2024 - Observation remains. 5/21/2024 - Observation remains.
13	Rill erosion is occurring along the west side of the trail at Stations 201+50 to 204+00 Priority: Low	5/8/2024	5/15/2024	Fill in rills and apply seed to stabilize the area. Temporary stabilization measures such as straw and/or jute netting may be required.	5/16/2024 - Observation remains. 5/21/2024 - Observation remains.
14	Sediment-laden runoff is being discharged into a stream from the new parking lot at Station 216+50 Priority: High	5/8/2024	5/15/2024	Replace compost filter tubes around the stream and develop a method of redirecting runoff from the parking lot at the source.	5/16/2024 - New compost filter tubes have been installed but were observed to be undermined. In addition, a new earthen slope was observed to be constructed in this area and requires stabilization. 5/21/2024 - No turbidity was observed due to no rain preceding this inspection. However, additional erosion controls should be explored at this location to prevent future discharges.

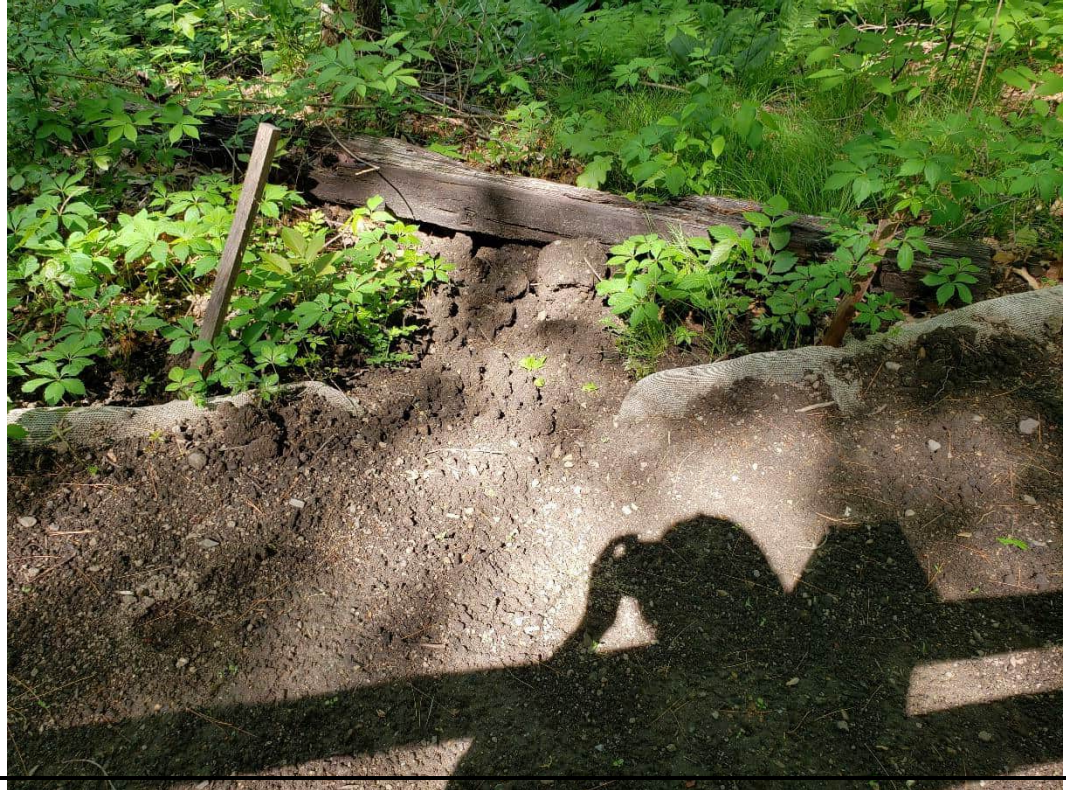
Photo No. 11	Date: 5/21/2024
---------------------	---------------------------

Description: View of washout overtopping compost filter tubes at Station 231+00 per Compliance Action Item 16.
--

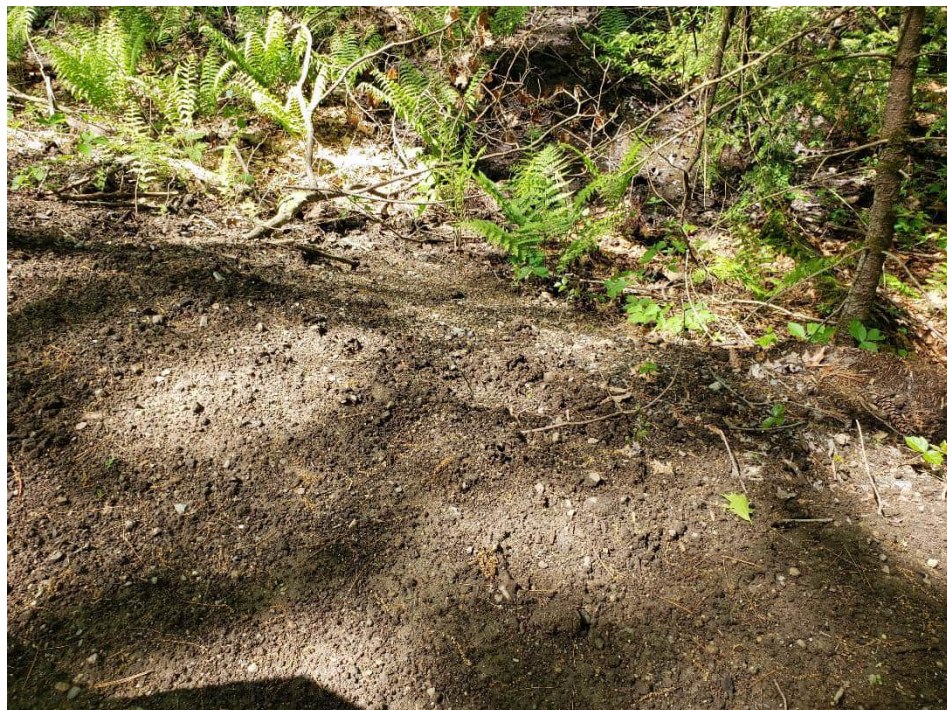
Photo No. 12	Date: 5/21/2024
---------------------	---------------------------

Description: View of washout overtopping compost filter tubes resulting in sediment/soil accumulation within the wetland along the east side of the trail between Stations 236+00 and 238+00 per Compliance Action Item 17.

17	Sediment migration beyond the limits of work at Stations 236+00 to 238+00 Priority: High	5/8/2024	5/15/2024	Remove accumulated sediment from areas beyond the limits of work and replace compost filter tubes. Once any grading work is completed, apply seed to the slope and stabilize it with jute netting, straw, etc.	5/16/2024 - Observation remains. 5/21/2024 - Observation remains.
18	Sediment migration beyond the limits of work at Stations 238+00 to 241+00 Priority: Medium	5/8/2024	5/15/2024	Stabilize steep slopes with jute netting or compost filter tubes to prevent additional land movement and erosion.	5/16/2024 - Observation remains. 5/21/2024 - Observation remains.
19	Sediment migration into the stream at Station 247+00 Priority: High	5/8/2024	5/15/2024	Install compost filter tubes to prevent further sedimentation of the stream. If dry conditions are present, evaluate whether sediment removal is feasible.	5/16/2024 - Observation remains. 5/21/2024 - Observation remains.

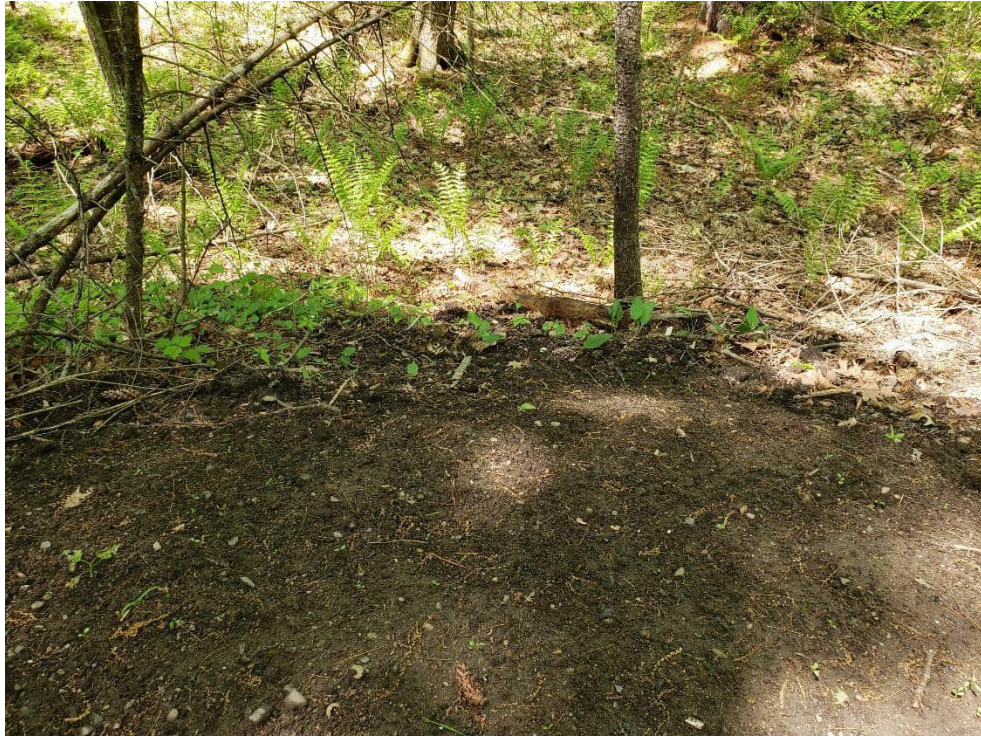
Photo No. 13	Date: 5/21/2024
---------------------	---------------------------

Description: View of washout overtopping compost filter tubes near Stations 238+00 and 241+00 per Compliance Action Item 18.
--

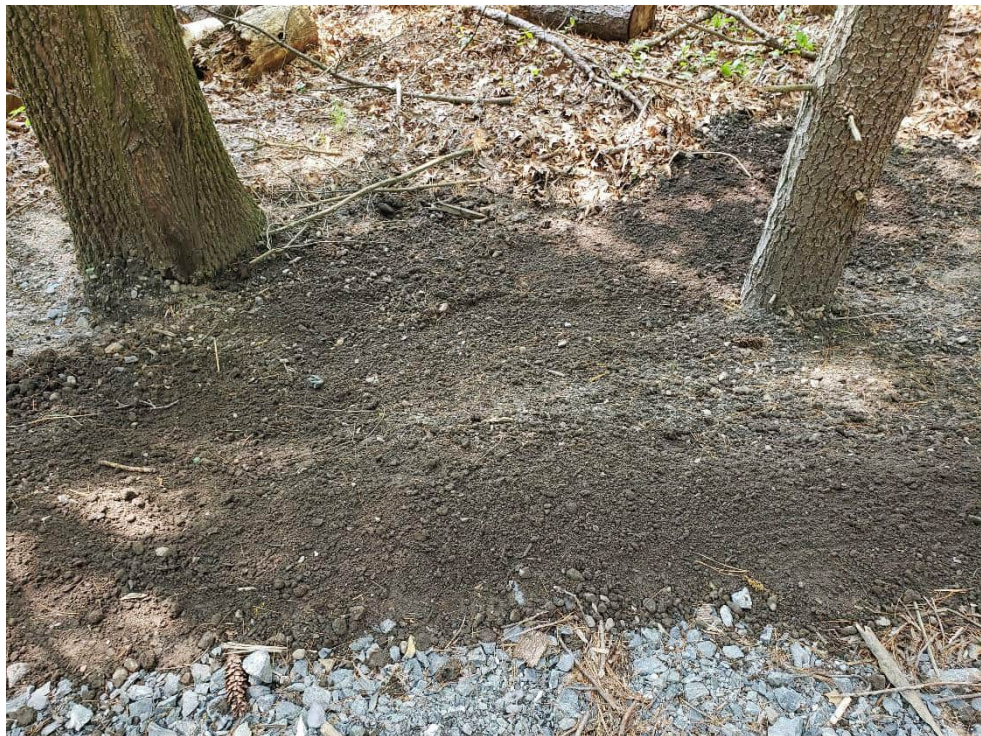
Photo No. 14	Date: 5/21/2024
---------------------	---------------------------

Description: View of loam that has been raked over to eliminate rill erosion at Station 252+00 per Compliance Action Item 20.

20	Rill erosion moving offsite on the West side of the trail at Stations 252+00 to 253+00 Priority: Low	5/8/2024	5/15/2024	Add or replace compost filter tubes or straw wattles to stabilize the immediate area until grass grows in.	5/16/2024 - Observation remains. 5/21/2024 - Rills have been raked over; however, the downgradient erosion and sediment controls require maintenance and the area requires stabilization.
21	Washout and erosion issues on the east side of trail at Stations 255+50 to 256+00 Priority: Low	5/8/2024	5/15/2024	Remove material that has eroded offsite and add additional erosion control such as straw wattles, jute netting, or compost filter tubes.	5/16/2024 - Observation remains. 5/21/2024 - All rill erosion locations have been raked over eliminating channels, but eroded material must be removed from overwashed erosion controls and location must be stabilized.
23	Sediment has accumulated within the cattle crossing at Station 258+00 and is migrating towards adjacent wetlands Priority: High	5/8/2024	5/15/2024	Remove all accumulated sediment and address the sediment release at the source through additional erosion controls and stabilization measures.	5/16/2024 - Observation remains. 5/21/2024 - Partial sediment removal has been completed. It appears that this accumulation of sediment may be occurring due to offsite inputs and may require coordination with MassDOT.
