## FIELD NOTES SUMMARY

**Customer:** Hop Brook Protection Association

**Waterbody:** Stearns Mill Pond

**Date:** 9/8/22, 12:00 PM

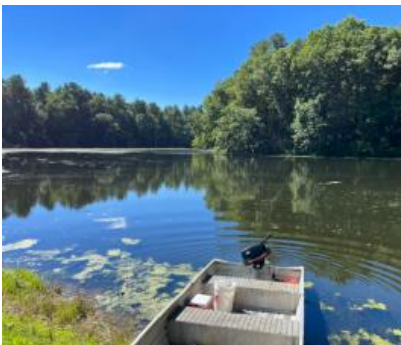
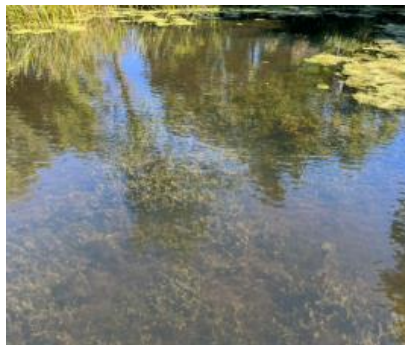
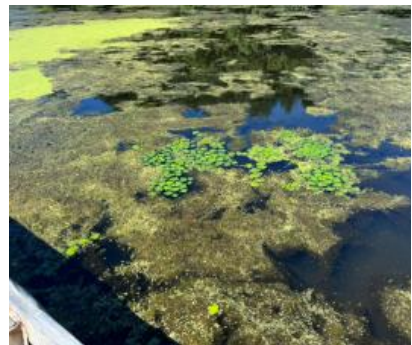
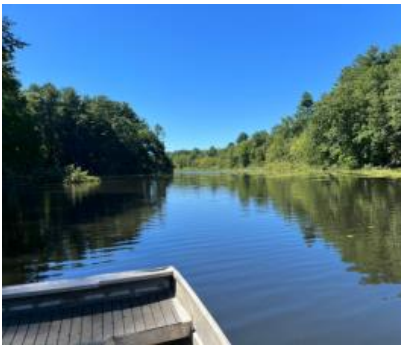
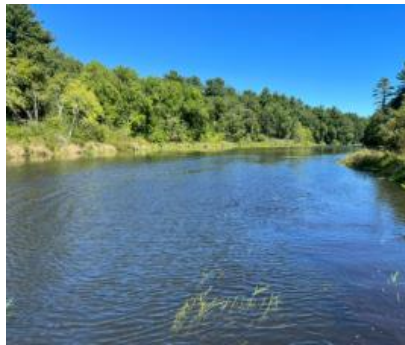
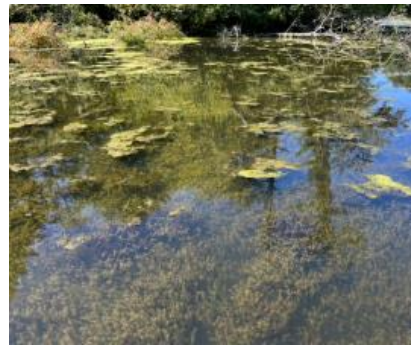
### Photos

Upon arrival, a survey was conducted using visual observation paired with a standard throw-rake and handheld GPS/ArcGIS Field Maps, as applicable. The overall health and conditions of Stearns Mill Pond had improved drastically since the first treatment. The Pond looked great as the treatments worked very well. Trace densities of water chestnut were observed, along the southeastern shoreline; in our estimation less than 20 plants remained in the Pond. Also noted during the survey were waterlilies, curly-leaf pondweed (invasive), elodea, coontail, duckweed, and watermeal. Elodea was the densest species documented. Filamentous algae was also noted in trace to sparse densities, both on the surface and on the bottom. There was a significant amount of open water documented, which was much improved from the pre-treatment conditions. The boat was properly cleaned and inspected prior to launching and upon demobilization.

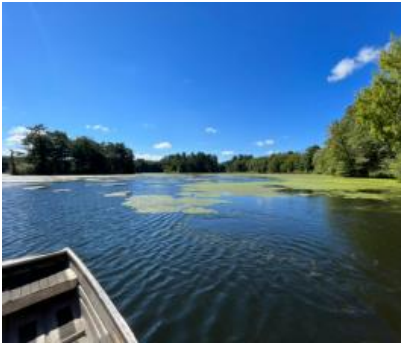
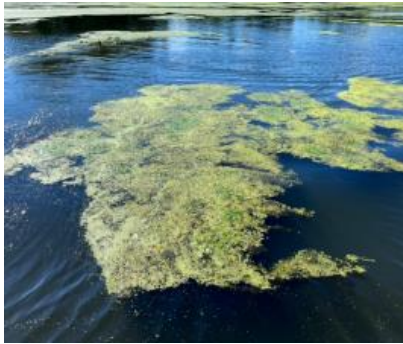
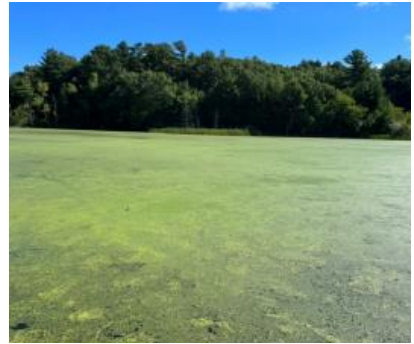
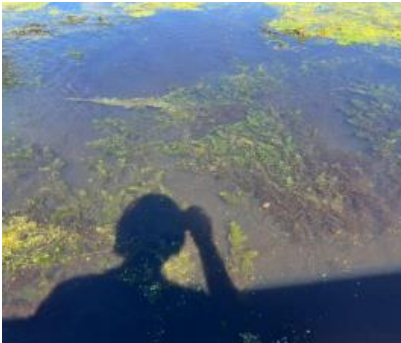
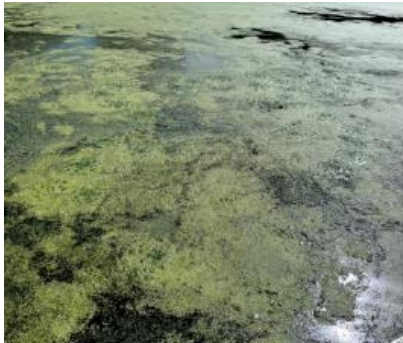
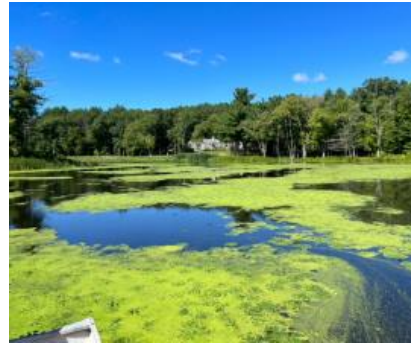
## Photos

Upon arrival, a survey was conducted using visual observation paired with a standard throw-rake and handheld GPS/ArcGIS Field Maps, as applicable. The water chestnut has significantly decreased in densities since the series of treatments performed over the summer. While eradication is never possible, a high percentage of control was achieved. Unfortunately, a large portion of the surface of the Pond is covered with native watermeal and duckweed, best seen in photos 3 and 6, with a closeup in photo 5. As noted above, water chestnut was greatly reduced but low densities were observed scattered around the Pond, largely in trace to sparse densities compared to moderate to dense prior to management. Chestnut was documented around the island, and along the western and eastern shorelines. An occasional trace to sparse patch of chestnut was found towards the middle of the Pond. This is where individual plants to very small, isolated patches were located. The southern coves significantly improved from the previous pre-treatment conditions. As noted above, a large portion of the Pond is covered with watermeal/duckweed, which is not impacted by the Clearcast herbicide, nor is a target for treatments. There were however a few areas of open water, including portions of the northwestern corner, middle/eastern-middle of the Pond, and within the southwestern coves. Other species notes included waterlilies, coontail, elodea, thin-leaf pondweed, and cattails, all native species. The most prominent species throughout the Pond included watermeal, duckweed, and coontail as these species were documented at moderate to dense densities. The coontail made traveling throughout the Pond very difficult as it was surfacing throughout the majority of the waterbody. Elodea, waterlilies, and thin-leaf pondweed were documented at trace densities. The southwestern coves were extremely shallow. Filamentous algae and epiphytic algae were noted, with filamentous algae being the primary algae documented. Filamentous algae was observed scattered on the surface mixed throughout the vegetation. It was primarily found on the surface, but occasionally documented on the bottom. Epiphytic algae was noted on a small percentage of the vegetation, which indicates that the plant is

dying/decaying. The gate was closed and locked while leaving the site. Prior to launching the jon boat and removing the jon boat, the boat was washed using a battery powered pressurized sprayer. It was also inspected prior to launching and demobilizing from the site.

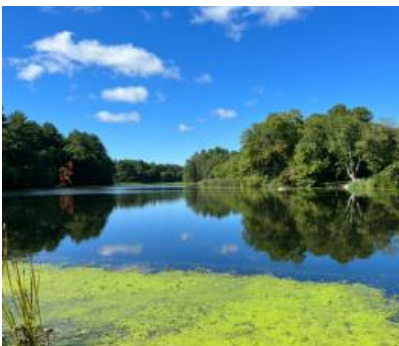
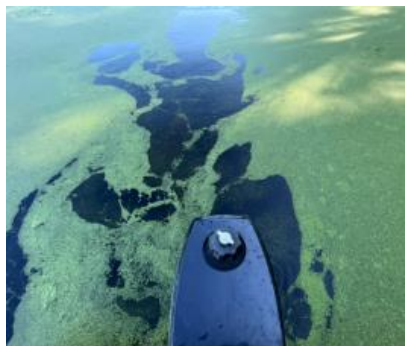
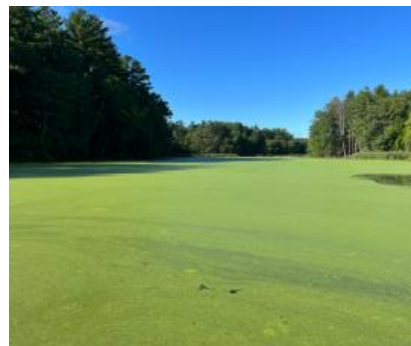
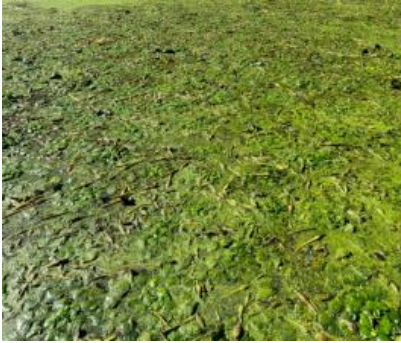
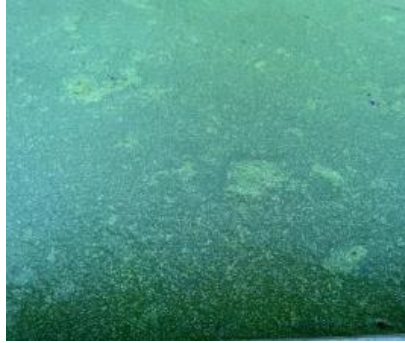
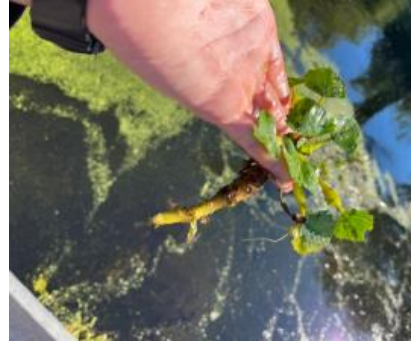
## Photos

Upon arrival, a survey was conducted using visual observation paired with a standard throw-rake and handheld GPS/ArcGIS Field Maps, as applicable. Overall, the Pond has greatly improved since the series of treatments. The water chestnut population has significantly decreased as great control was achieved. Water chestnut was still documented, but at trace to sparse densities scattered around the Pond. Water chestnut was primarily documented against the shoreline, with a few small patches scattered throughout the middle of the western half of the Pond. The majority of the eastern half of the Pond was open water. A large percentage of the small areas of remaining water chestnut did not appear healthy looking, as the plants were no longer rooted (seen in photo 6), discolored in appearance, or covered in epiphytic/filamentous algae. Epiphytic algae on vegetation indicates that the plant is dying/decaying. Filamentous algae was primarily found in the western half of the Pond, in the proximity of dead water chestnut and dense watermeal/duckweed. This was typically found on the surface, although benthic filamentous algae was noted throughout the Pond, but primarily contained within the western point of the Pond. Other native species noted include Elodea, coontail, duckweed, watermeal, and ribbon-leaf pondweed. Duckweed and watermeal were the most prevalent and dominant species documented throughout the Pond. Duckweed and watermeal were observed as very dense throughout the western 2/3 of the Pond. This is best seen in photo 3. In photo 4, you will see some scattered water chestnut mixed within the duckweed/watermeal cover. In the eastern half, the duckweed/watermeal was more scattered at trace to sparse densities. Cattails were noted scattered around the perimeter of the Pond in sparse to dense densities. Also documented throughout the survey was floating fragments of water chestnut plants. The gate was shut and tied closed with the rope while leaving the site.
