## FIELD NOTES SUMMARY

**Customer:** Hop Brook Protection Association

**Pond Name:** Stearns Millpond

**Date:** 7/17/23

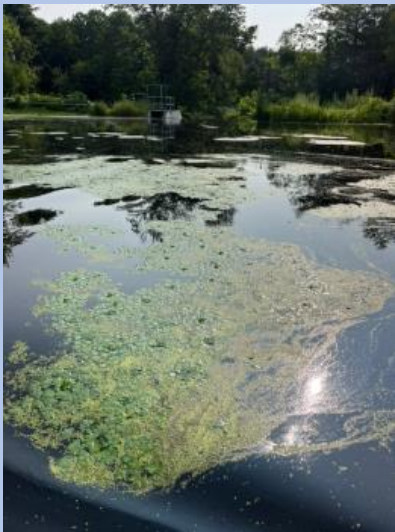
**Photo 1**

The treatment targeted the growth of water chestnut (which was the second treatment performed in 2023). The majority of the water chestnut was scattered in trace to sparse densities, occasionally found in moderate densities in a small number of areas. The densest areas of water chestnut included the eastern cove and one area within the middle of the Pond. Other than those areas, the plants were more scattered. It is important not to confuse native growth at the surface with water chestnut growth, as it can be easily mistaken from looking at a distance. Seeds were noted just starting to form on the water chestnut plants, with portions of the population not yet forming seeds. The water level was slightly higher than average due to the previous heavy rainfall, which did not affect the treatment as the water chestnut was on the surface. A handful of water chestnut plants were documented growing within the water column. Based on our observations, we've scheduled a kayak survey for 7/27 to document the success of the program thus far. Based on this survey, we will determine if a third treatment may be necessary to gain the desired level of control. If this is needed, it will be scheduled for early August, prior to seeds dropping, and will be conducted at no additional cost.
