**Re: Sudbury to Hudson Reliability Project Invasive Species Management Year End Summary
2024 / SWCA Project Nos. 63499 and 67104**

NSTAR Electric Company d/b/a Eversource Energy (Eversource) is building an approximately 9-mile-long 115-kilovolt underground transmission line between Eversource's existing Sudbury substation in Sudbury, Massachusetts, and the Hudson Light & Power Company's substation in Hudson, Massachusetts. The new underground transmission line traverses the municipalities of Sudbury, Hudson, Stow, and Marlborough, Massachusetts. Approximately 7.5 miles of the new transmission line has been installed within an inactive Massachusetts Bay Transportation Authority (MBTA) railroad right-of-way (ROW). Eversource has coordinated with the Massachusetts Department of Conservation and Recreation (DCR) to develop a two-phased project in which a portion of the Massachusetts Central Rail Trail (MCRT) will be co-located with the new transmission line. Phase I (currently underway) is the responsibility of Eversource and includes the installation of the underground transmission line, all major earthwork, installation of the stormwater management system, construction of a 14-foot

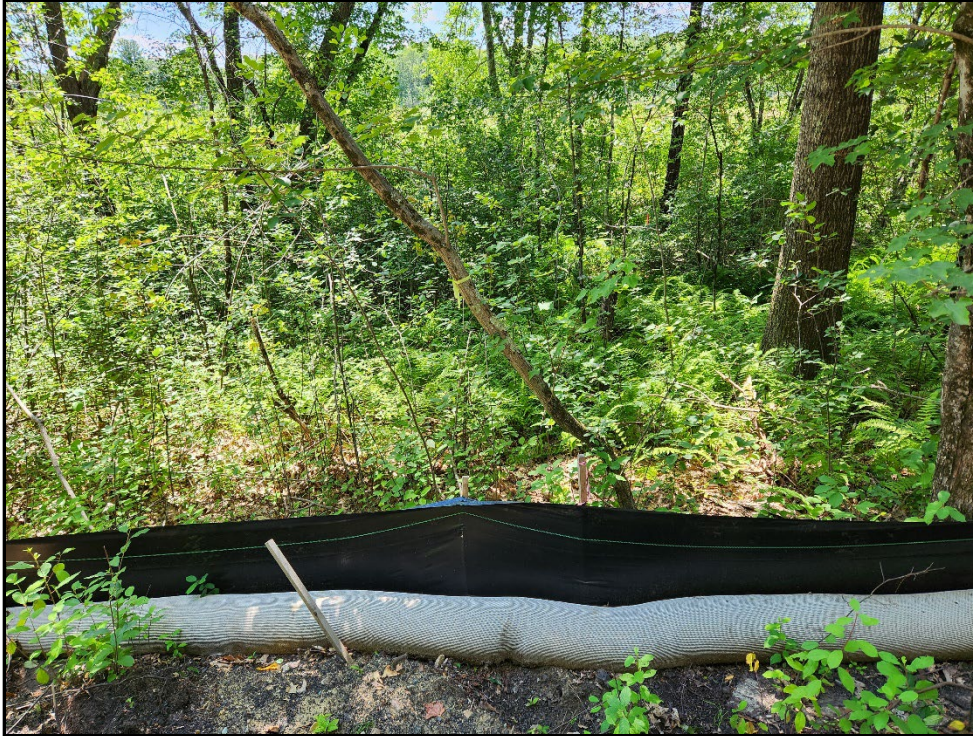
Photo 1. Mitigation area conditions at approximately STA 738+00 (Segment 14) facing south prior to invasive species management. Photo taken May 2023.

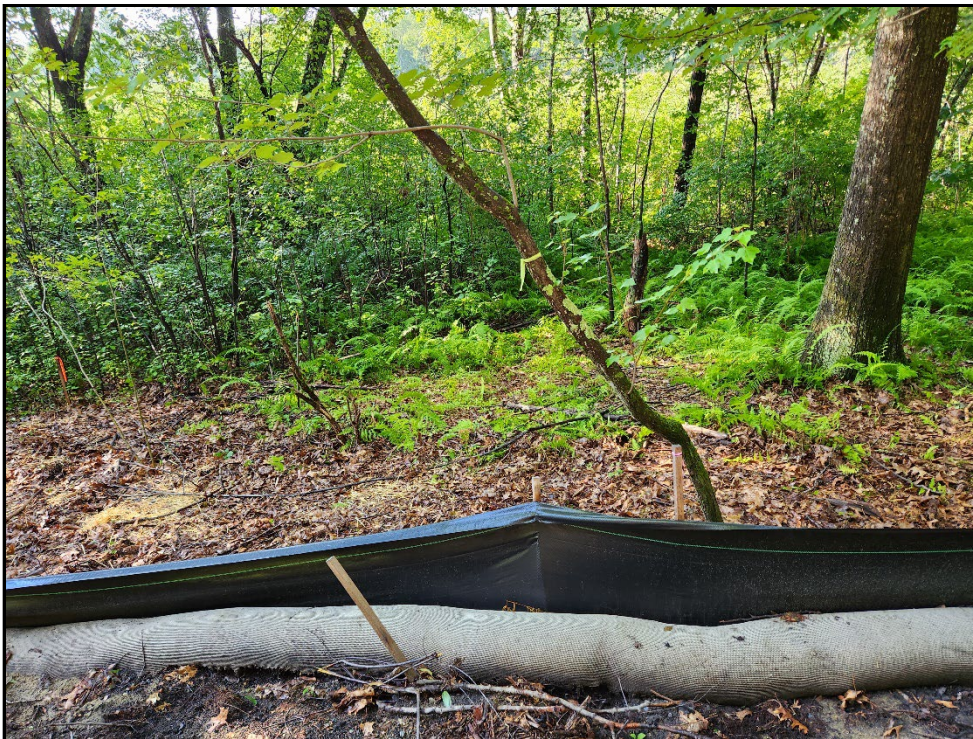
Photo 2. Mitigation area conditions at approximately STA 738+00 (Segment 14) facing south after invasive species management. Photos 1 and 2 show invasive management that was performed by hand in 2023.

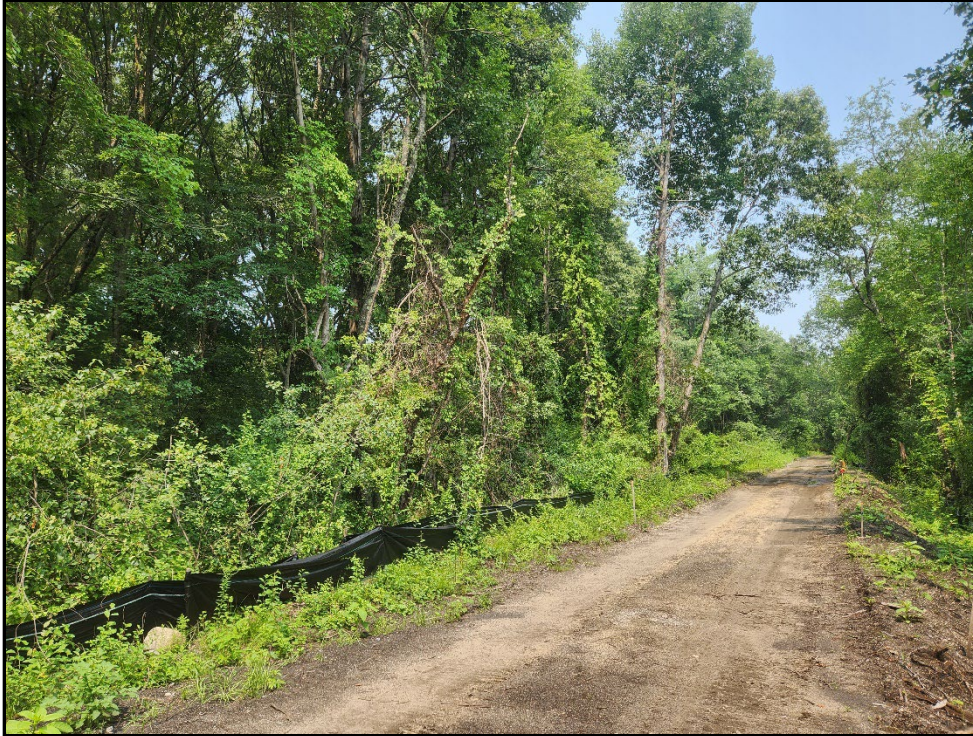
Photo 3. Mitigation area conditions at approximately STA 739+00 (Segment 14) facing northeast prior to invasive species management. Photo taken May 2023.

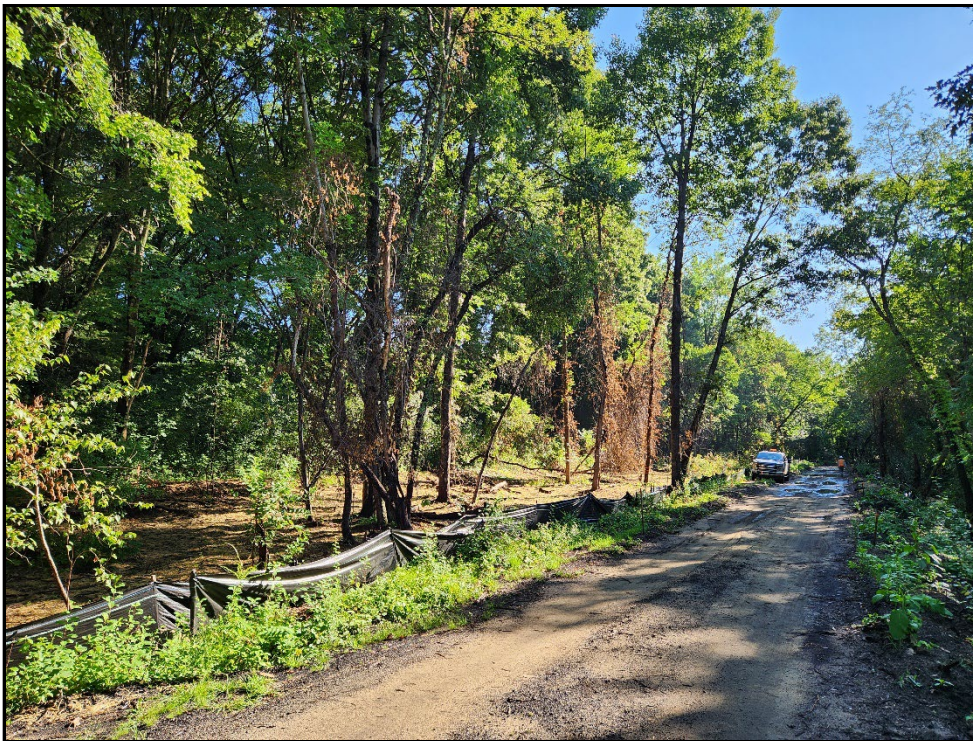
Photo 4. Mitigation area conditions at approximately STA 739+00 (Segment 14) facing northeast after invasive species management. Photos 3 and 4 show invasive management that was done using a mini excavator in 2023.

A mini excavator was used to remove invasive species in mitigation areas with a high density of invasive trees, shrubs and vines. Areas for excavation were selected based on invasive species density and

accessibility. A mini excavator was used in Segment 14 between approximately station (STA) 734+00 and 743+00, Segment 11 between approximately STA 556+00 and 560+00, in Segment 10 between approximately STA 551+50 and 555+75 and in Segment 9 between approximately STA 513+00 and 517+00.

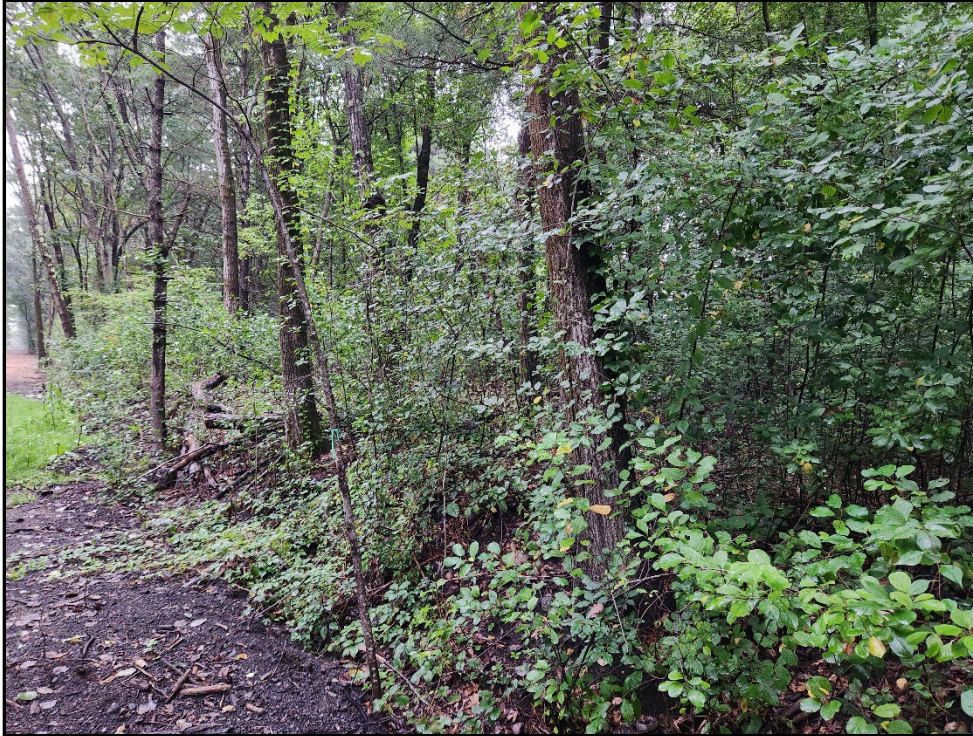
Photo 5. Mitigation area conditions at approximately STA 516+00 (Segment 9) facing northwest prior to invasive species management. Photo taken June 2023.

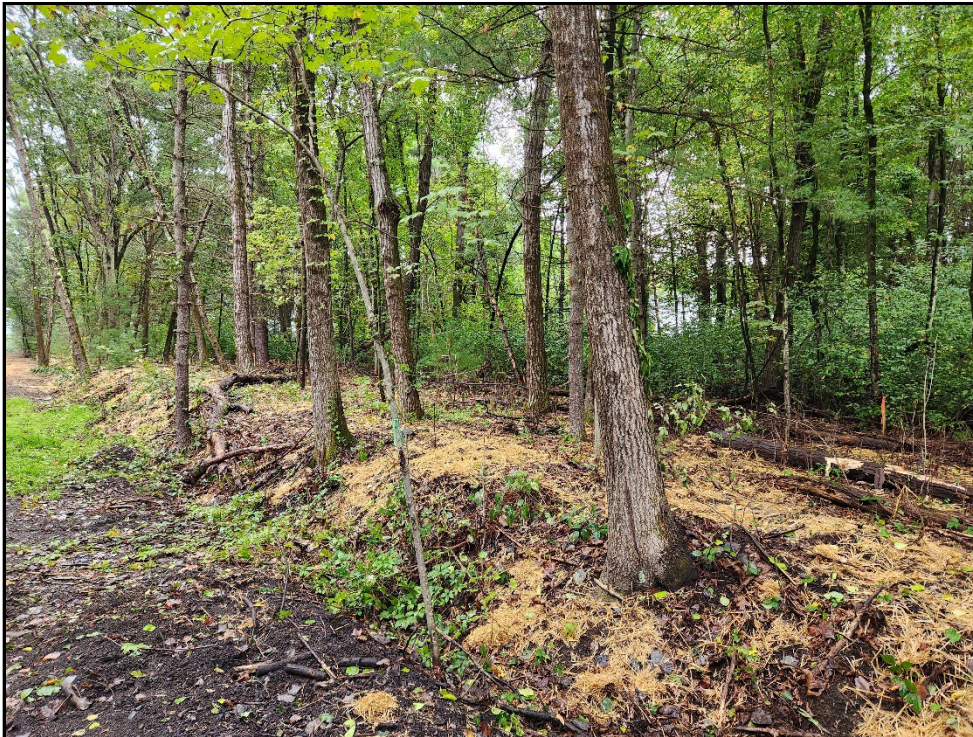
Photo 6. Mitigation area conditions at approximately STA 516+00 (Segment 9) facing northwest after invasive species management. Photos 5 and 6 show invasive management that was done using a mini excavator in 2023.

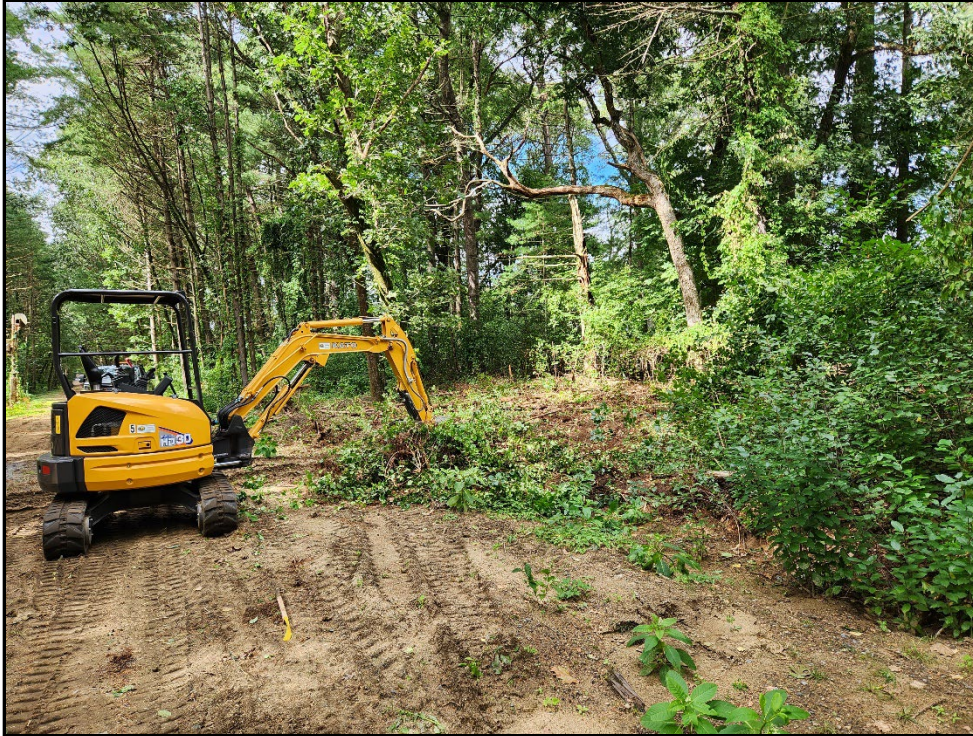
Photo 7. A mini excavator is shown removing invasive plants in Segment 10 in 2023. A dense patch of glossy buckthorn is visible to the right.

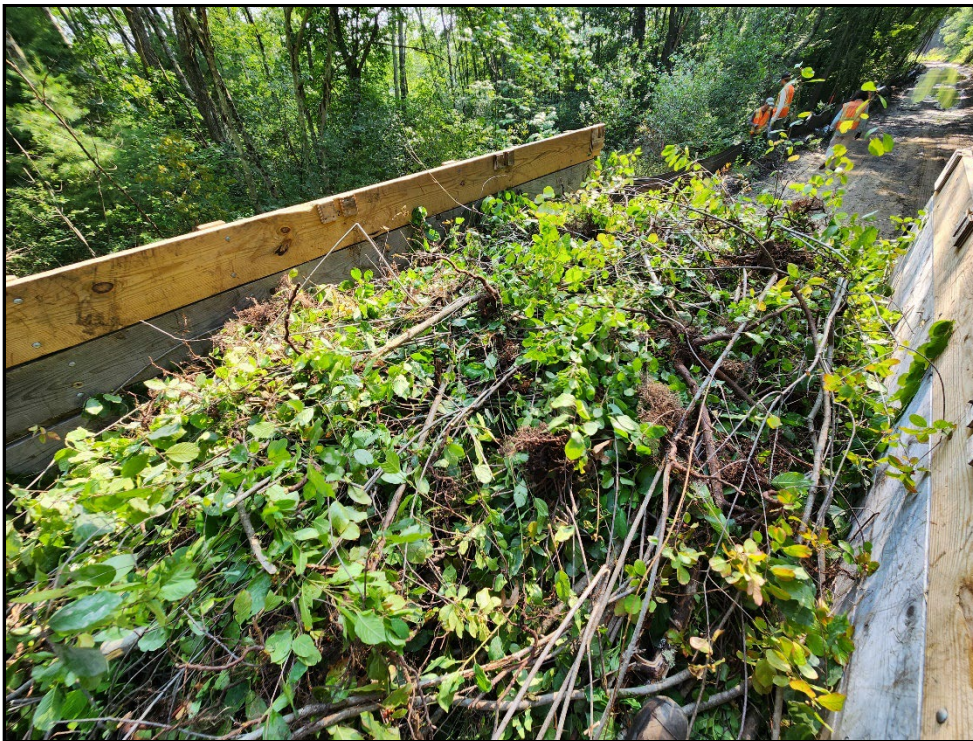
Photo 8. Glossy buckthorn and other woody invasive plants collected for removal in 2023.

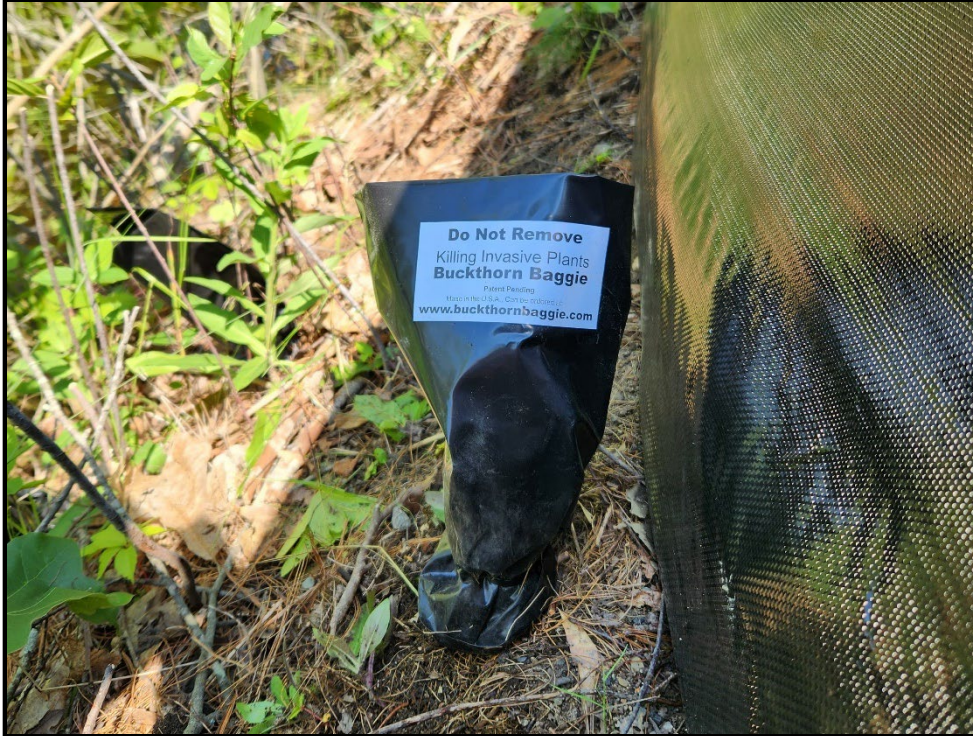
Photo 9. A Buckthorn Baggie placed over a buckthorn stump in Segment 14 in 2023.

Glossy buckthorn greater than 2 inches in diameter and Norway maples 1 to 4 inches in diameter that could not be removed manually were controlled using Buckthorn Baggies. These are small, black, 12 × 12-inch contractor-type bags that are placed over a living stump and zip tied to the stump. Successful management occurs when the stump resprouts inside the bag where there is no light or oxygen, causing the plant to die. The bags should remain in place for 1-2 complete growing seasons before being removed.

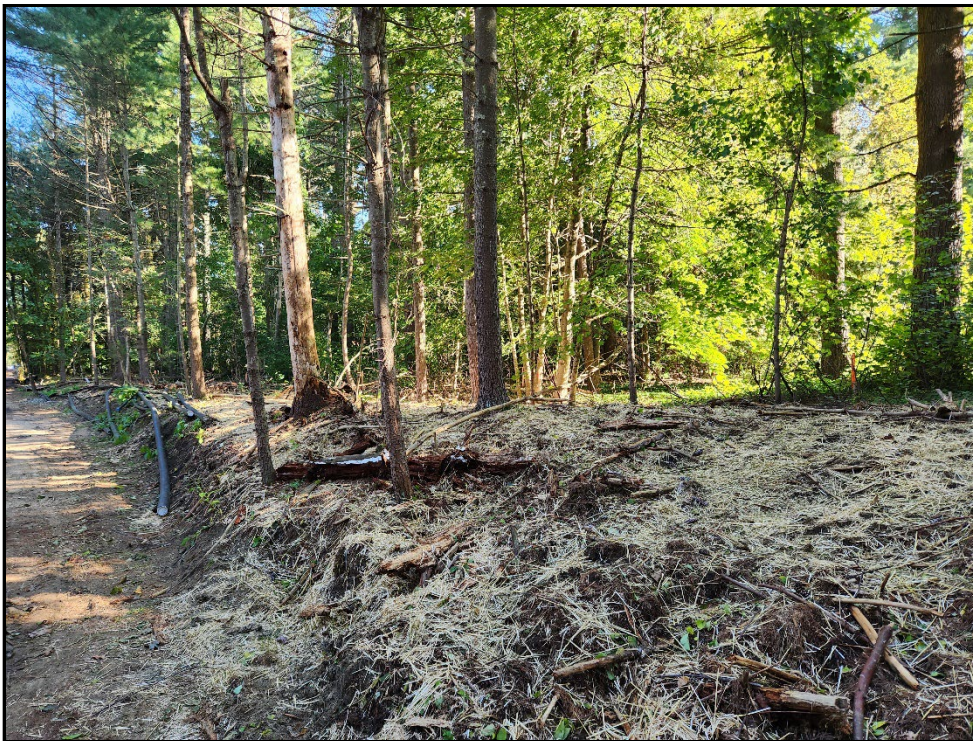
Photo 10. Soil disturbance caused by invasive species removal was seeded and mulched using straw in 2023.

All other woody invasive plant material was removed using hand tools. Areas where invasive plant management resulted in exposed or heavily disturbed soil were seeded using an approved native seed mix. Straw mulch was spread over seeded areas.

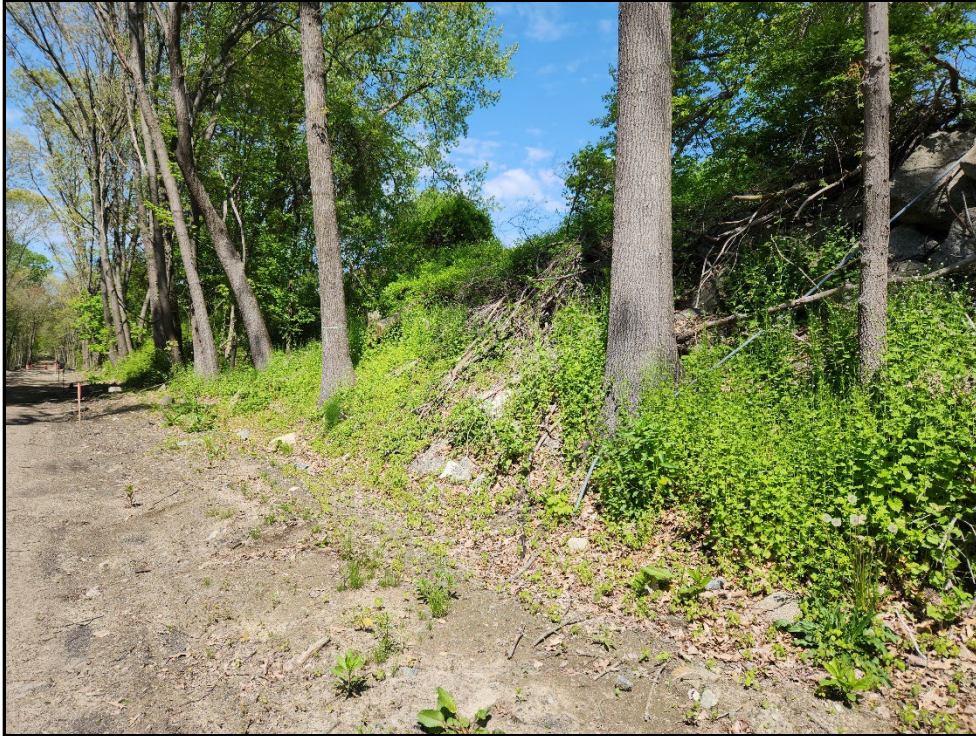
Photo 111. Before removing garlic mustard near STA 757 in Segment 14 in May 2024.

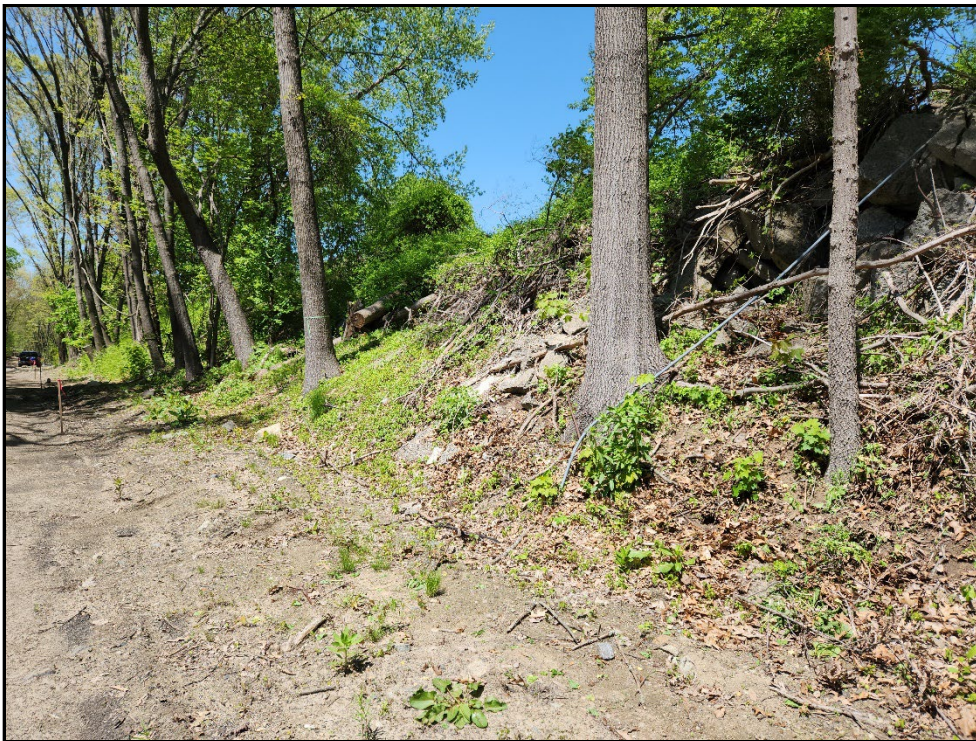
Photo 112. After removing garlic mustard near STA 757 in Segment 14 in May 2024.

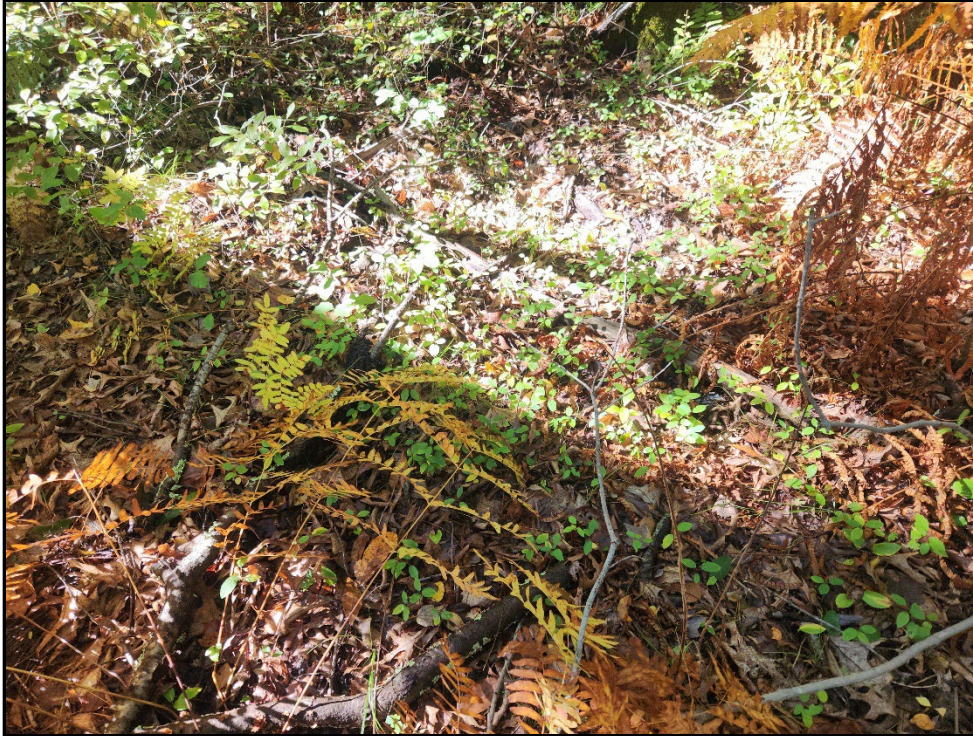
Photo 113. A roughly 10 foot by 10 foot area in Segment 8 containing several hundred glossy buckthorn seedlings in 2024.

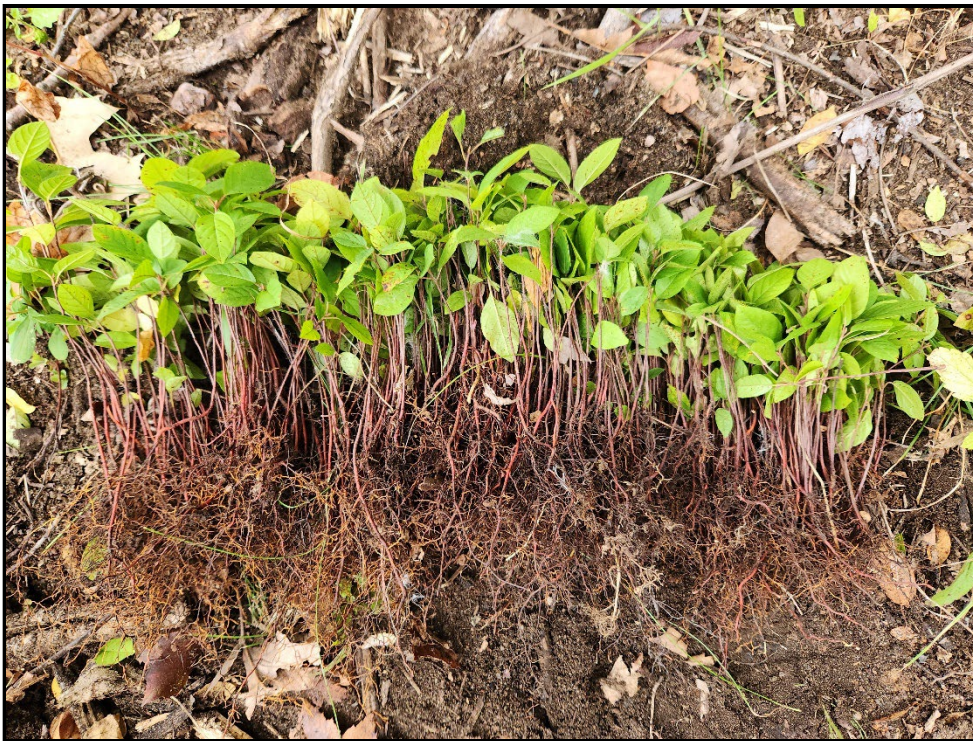
Photo 114. Hundreds of glossy buckthorn seedlings removed from the area pictured in photo 3. Material was bagged and disposed of off-site.

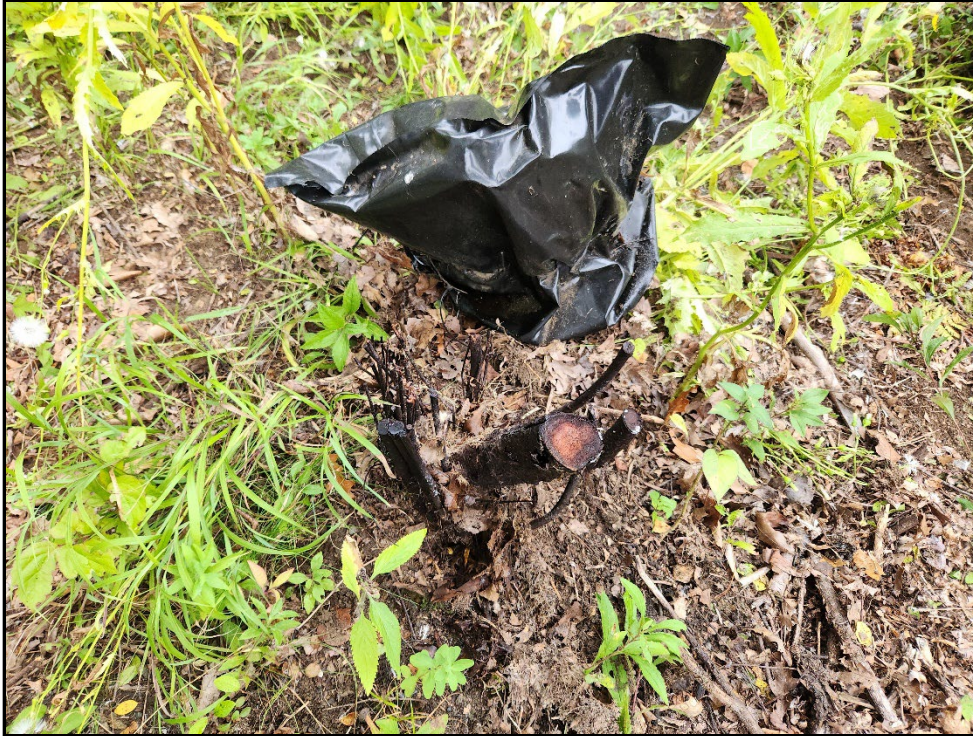
Photo 115. A Buckthorn Baggie removed, revealing a dead buckthorn stump in 2024.

Glossy buckthorn greater than 2 inches in diameter and Norway maples 1 to 4 inches in diameter that could not be removed manually during initial efforts in 2023 were controlled using Buckthorn Baggies. SWCA invasive species technicians inspected the previously installed Buckthorn Baggies to document if management was successful. Many of these were successful in killing the buckthorn; however, some stumps were able to resprout from below the bag and grow suckering stems outside of the bag. When encountered, these individuals were re-bagged, with their suckering stems added to the existing or replacement bag to receive another year of smothering treatment. When successful management was observed, the bag was removed from the deceased plant and taken off-site.

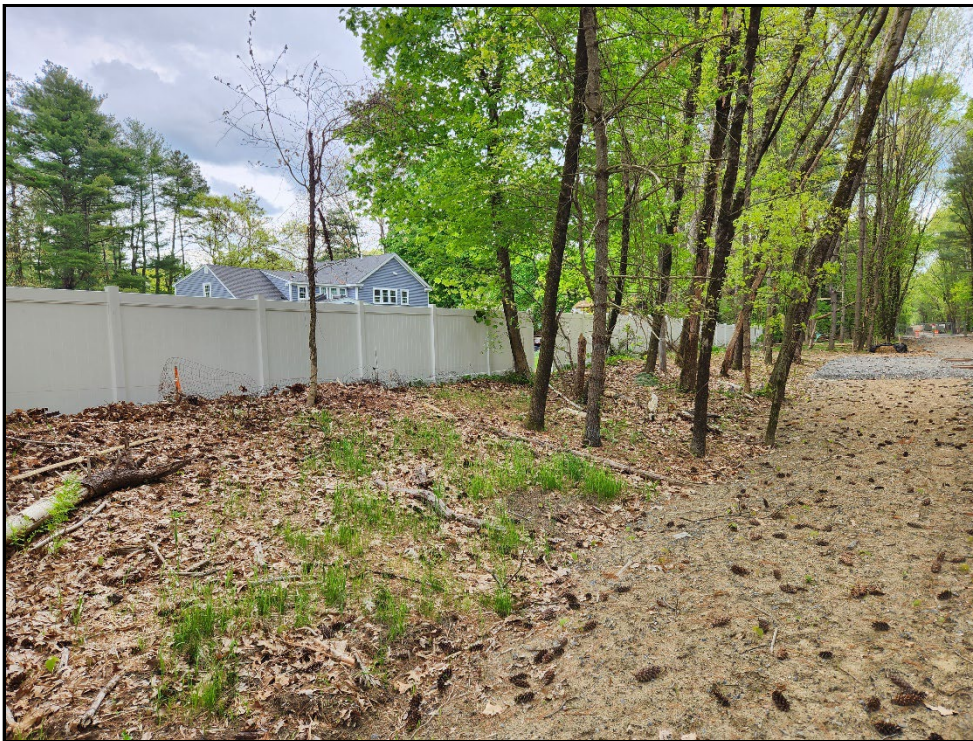
Photo 116. A mitigation area at STA 552 in Segment 10 after completing management in 2024.

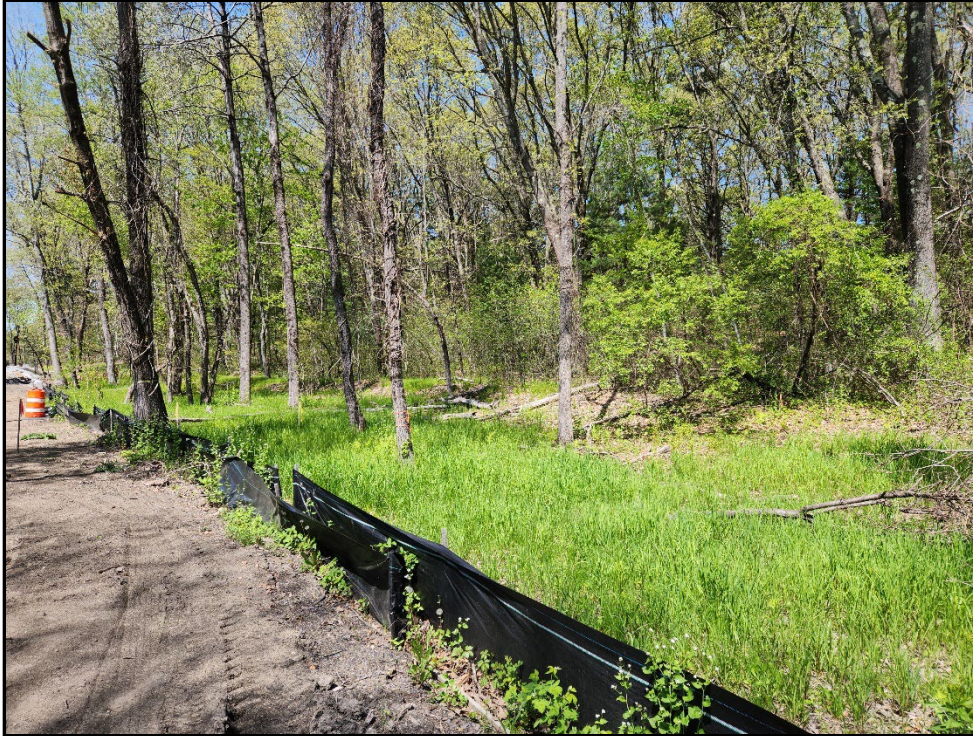
Photo 117. Native seed mix emerging densely in a large mitigation area. This photo was taken in Segment 14 at STA 740+50 facing west in 2024.

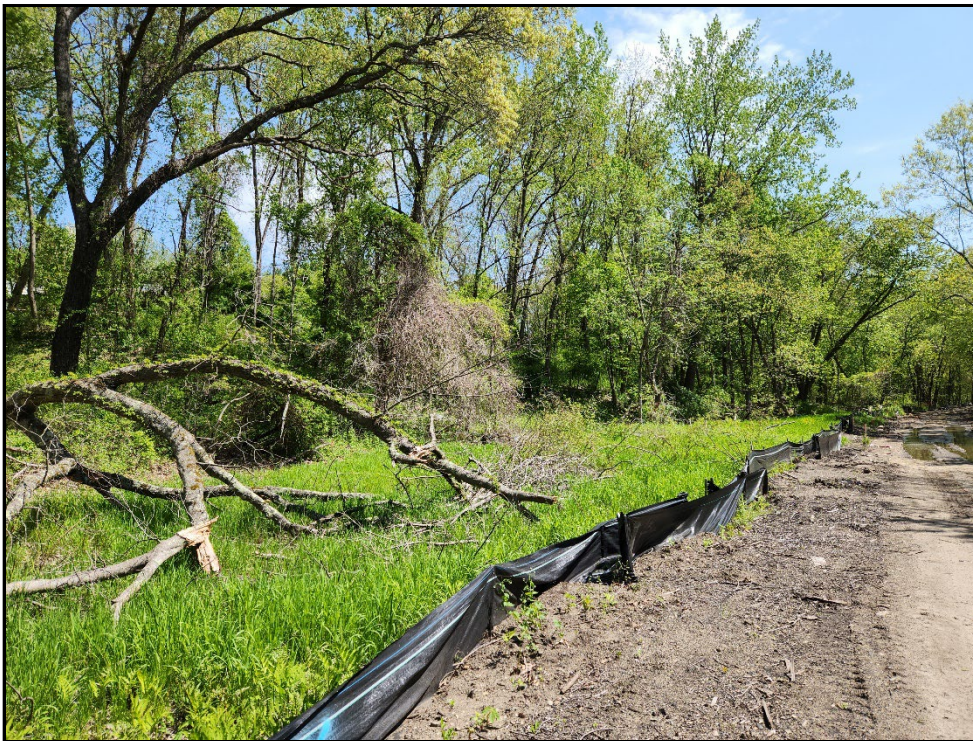
Photo 118. Native seed mix emerging densely in a large mitigation area. This photo was taken in Segment 14 at STA 740+50 facing east in 2024.

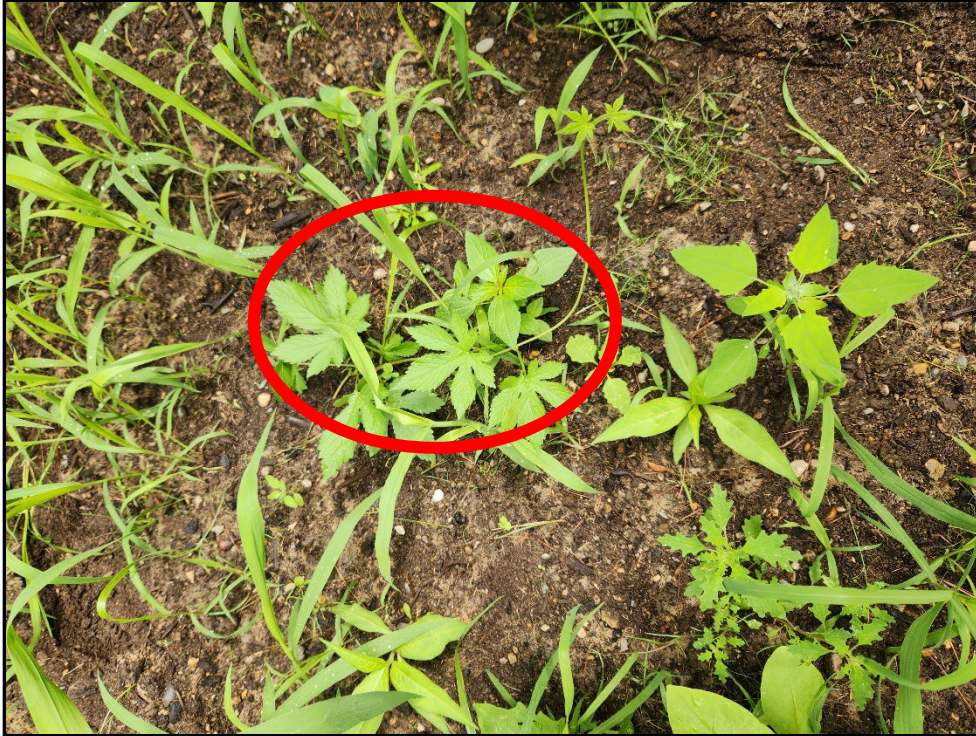
Photo 119. Japanese hops in the LOW in Segment 9.

On August 7, 2024, SWCA found Japanese hops in a newly created stormwater retention basin within the LOW in the western end of Segment 9. Following this initial sighting, SWCA swept the entire LOW to survey for and remove any Japanese hops. During this survey, Japanese hops was found in topsoil in all segments in Sudbury except Segments 7 and 8. All observations of Japanese hops were restricted to the topsoil that was used along the margins of the LOW. All Japanese hops were removed from the site and disposed of in landfill waste.

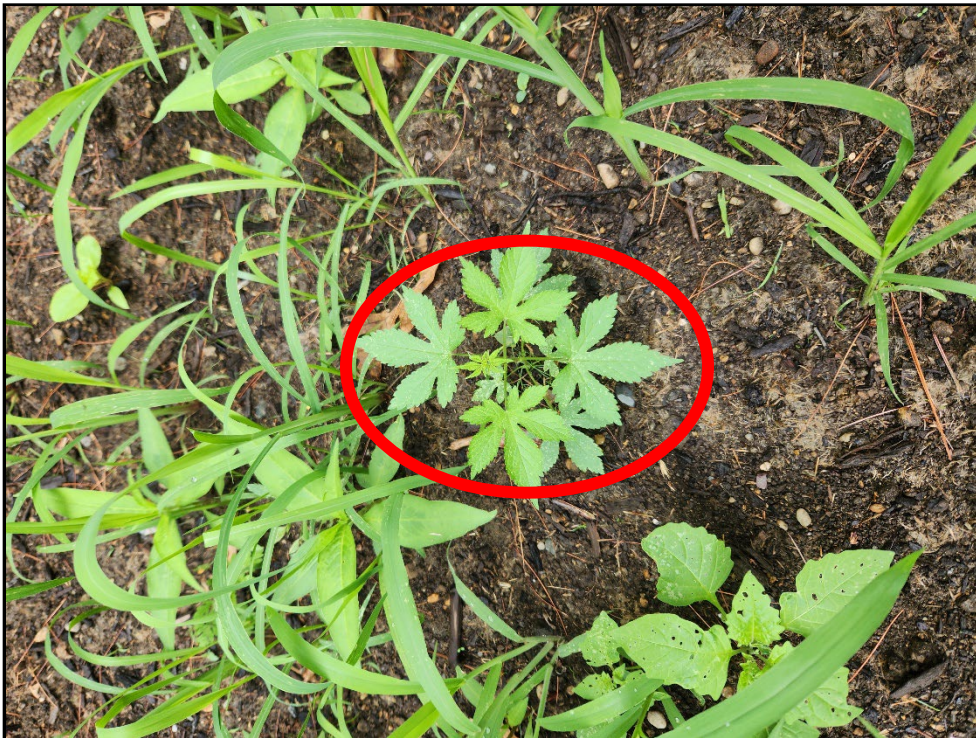
Photo 200. Japanese hops in the LOW in Segment 11.

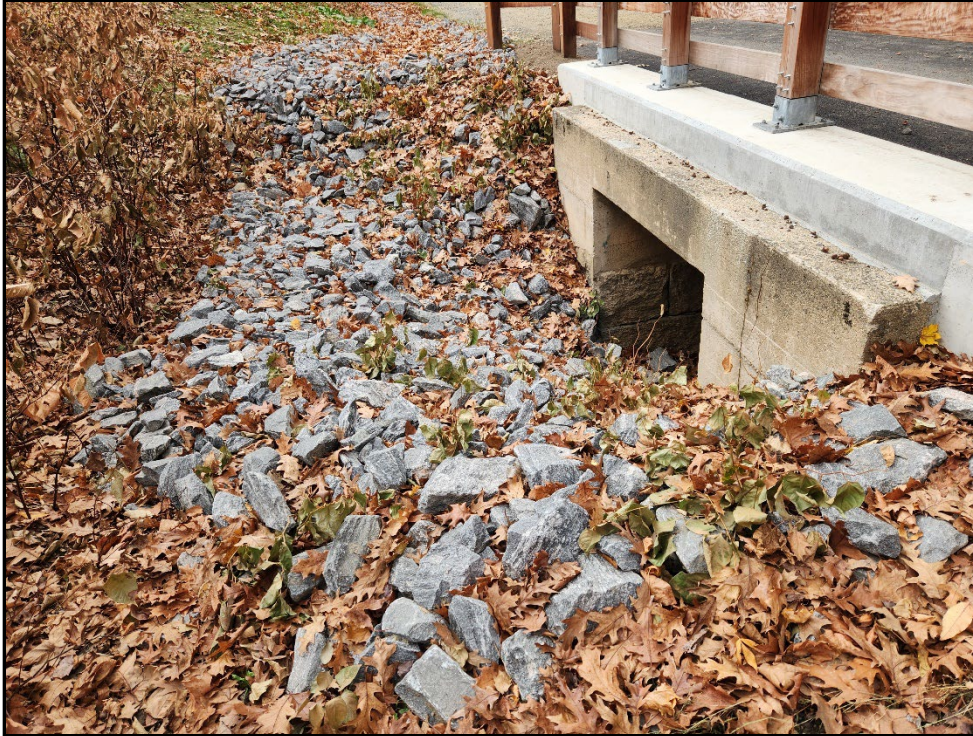
Additionally, Japanese knotweed was found emerging from the rip rap used to stabilize the slopes leading into a stone culvert at approximately STA 119+70. As detailed in Attachment B, Japanese knotweed existed in this location prior to site construction. A constructed swale leading into this rip rap also contained Japanese knotweed. Photographs of Japanese knotweed populations in Segments 1 and 2 can be found in Attachment A.

Photo 21. Japanese knotweed growing through rip rap near STA 119+50 in Segment 1. This photo was taken in fall of 2024.

All invasive plant species along the ROW will be monitored in 2025. Specific attention should be given to the Japanese knotweed in Segments 1 and 2, particularly where it is growing within newly established infrastructure. Japanese hops will also be closely monitored throughout the entire Project LOW and removed to ensure that it does not become established along the ROW.

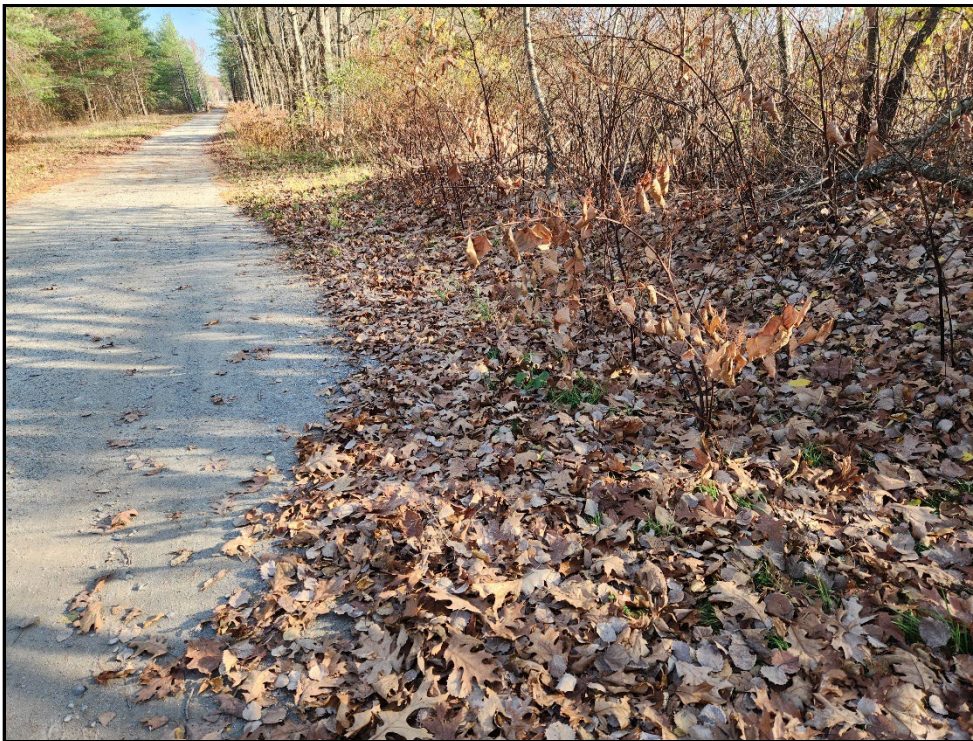
While conducting invasive removal within the LOW in November, SWCA observed that Japanese knotweed populations in Segments 1 and 2 had changed from their previous mapped distribution. These populations were mapped in 2021 prior to beginning construction. Figures 1 through 3 (Attachment B) show Japanese knotweed distribution preconstruction and as observed in November 2024. While some populations have reduced their footprint, particularly where they were present in the center of the LOW, these populations have also moved or expanded slightly to occupy adjacent areas of the LOW.

Photo 22. Japanese knotweed in the LOW near STA 135 in Segment 2. This photo was taken in fall of 2024.

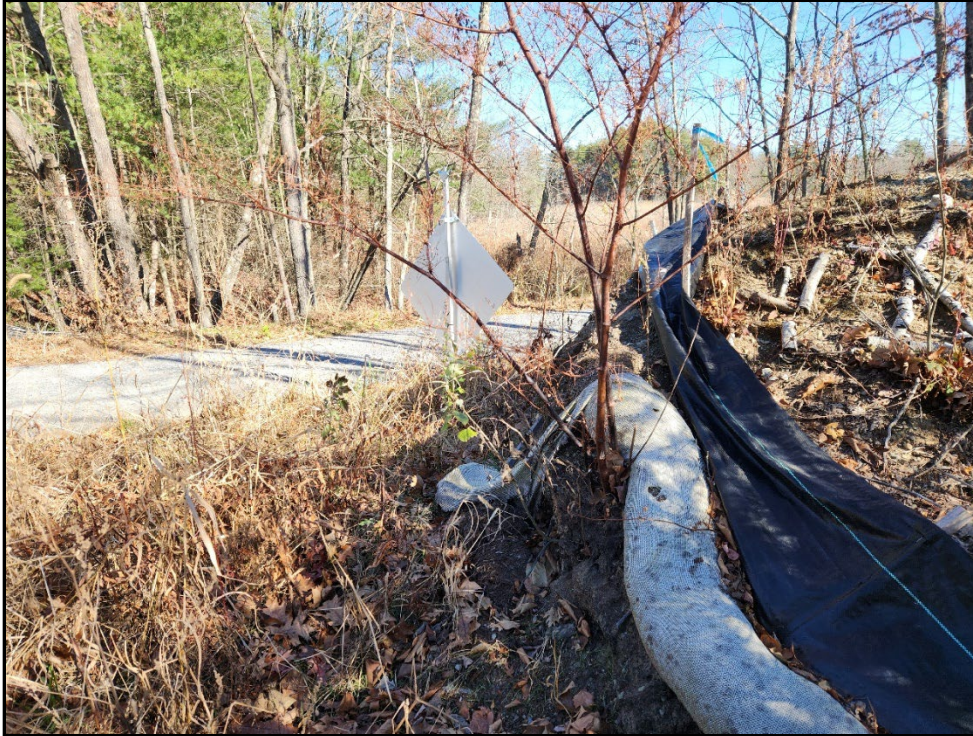
Photo 23. Japanese knotweed growing in the LOW near STA 142+50 in Segment 2. This photo was taken in fall of 2024.

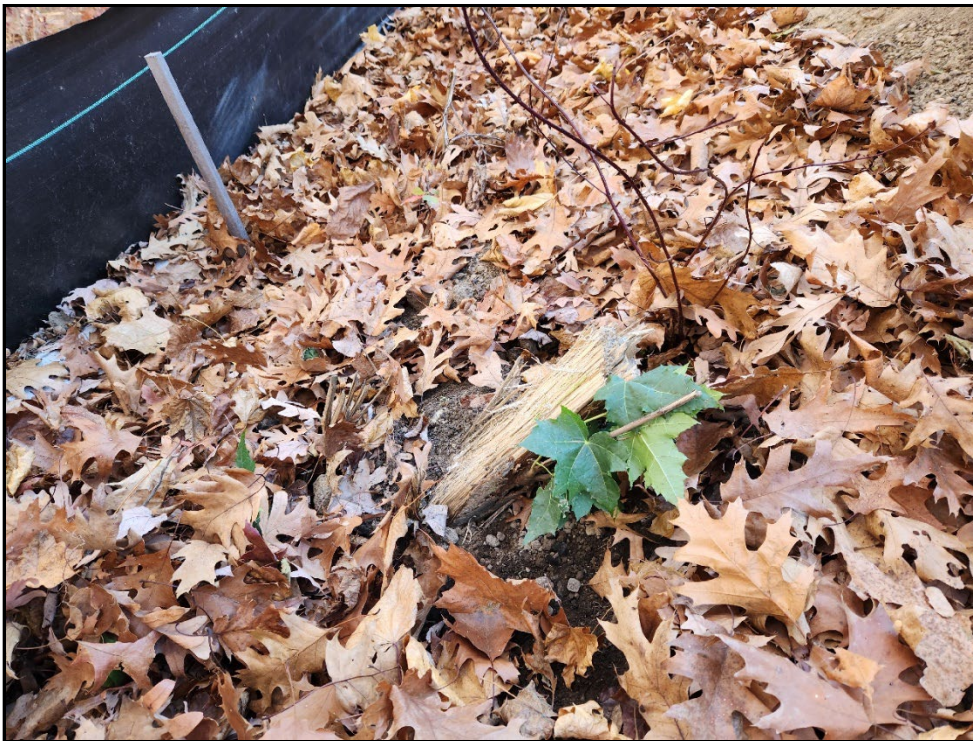
While conducting invasive species management in the LOW in Segment 1, SWCA found a Norway maple in a native planting area near STA 121+00 on the north side of the ROW. This tree was approximately 8 inches in diameter and could not be removed manually or controlled using Buckthorn Baggies. The stump appeared damaged as if a machine had attempted to remove it in the past, possibly while clearing or grading the area in preparation for planting. Due to the size of this tree stump, alternative methods of management might be necessary to ensure this tree is managed. A potential alternative is girdling of the tree stump; however, this is not very likely to be successful as the tree was already impacted vegetatively through machine work. The other potential management method would be a targeted application of herbicides to the cut surface of the tree.

Photo 24. A Norway maple stump in a native planting area near STA 121+30 in Segment 1. This photo was taken in fall of 2024.

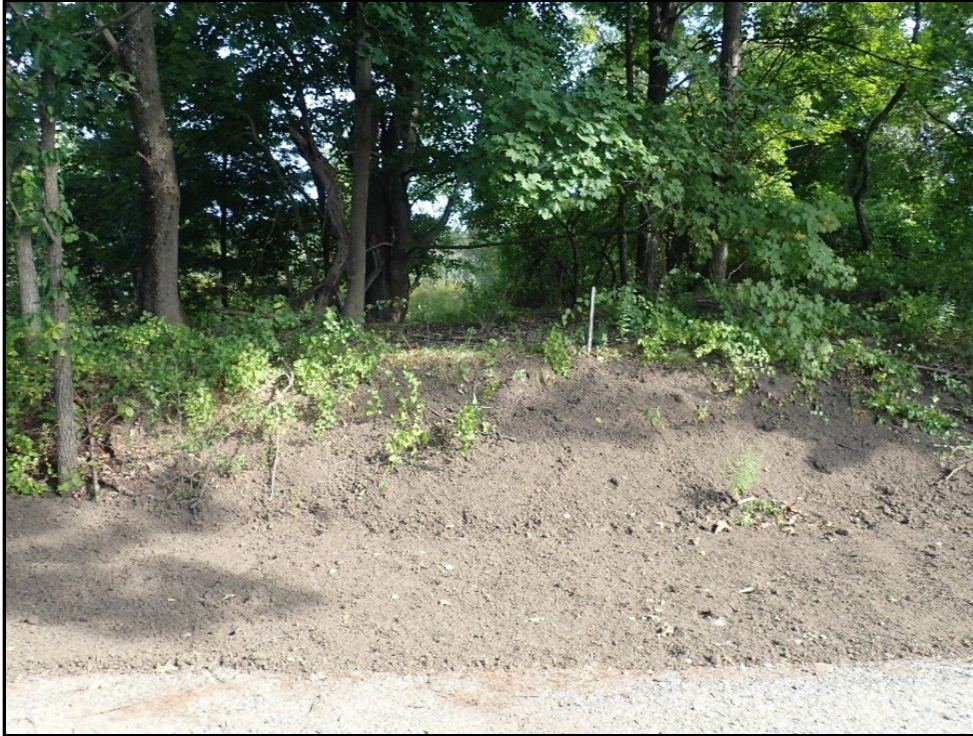
During the supplementary mitigation review on August 27, 2024, with the Sudbury Conservation Agent, Lori Capone, an area dominated by Asiatic bittersweet that was not included in the invasive plant management mitigation management area was identified along the Project route and selected for invasive plant management as supplementary mitigation required to meet the regulatory needs of the Project. Specifically, the area is in Segment 14 near STA 762+00 on the north side of the Project LOW about 400 feet west of the Sudbury Substation driveway. The area is approximately 2,860 square feet of upland located between the recently installed project landscape plantings and the easement line. The area appeared to be historically disturbed and contained a variety of invasive plant species: Asiatic bittersweet, Japanese barberry, multiflora rose, and glossy buckthorn. Please refer to the Environmental Resource Map (Attachment D) identifying the location of the area.

Photo 255. Segment 14 supplemental invasive management area at approximately STA 762+00 facing north before invasive species removal.

On October 18, 2024, the SWCA Invasive Species Management Team removed all the invasive plant species listed above by hand from the identified additional supplementary mitigation area. The removed invasive plants were bagged, sealed, removed off site, and disposed of appropriately. Please refer to the attached photograph pages (see Attachment A) for view of the site before and after restoration.

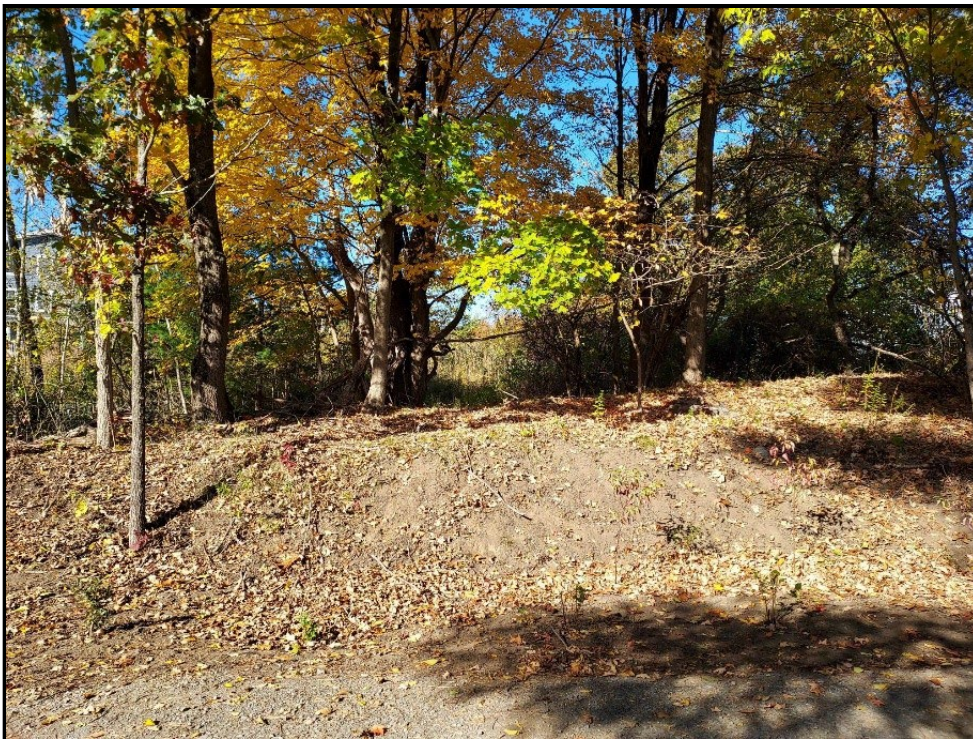
Photo 266. Segment 14 supplemental invasive management area at approximately STA 762+00 facing north after invasive species removal.
