**Re: Sudbury to Hudson Reliability Project Invasive Species Management Year End Summary
2024 / SWCA Project Nos. 63499 and 67104**

NSTAR Electric Company d/b/a Eversource Energy (Eversource) is building an approximately 9-mile-long 115-kilovolt underground transmission line between Eversource's existing Sudbury substation in Sudbury, Massachusetts, and the Hudson Light & Power Company's substation in Hudson, Massachusetts. The new underground transmission line traverses the municipalities of Sudbury, Hudson, Stow, and Marlborough, Massachusetts. Approximately 7.5 miles of the new transmission line has been installed within an inactive Massachusetts Bay Transportation Authority (MBTA) railroad right-of-way (ROW). Eversource has coordinated with the Massachusetts Department of Conservation and Recreation (DCR) to develop a two-phased project in which a portion of the Massachusetts Central Rail Trail (MCRT) will be co-located with the new transmission line. Phase I (currently underway) is the responsibility of Eversource and includes the installation of the underground transmission line, all major earthwork, installation of the stormwater management system, construction of a 14-foot

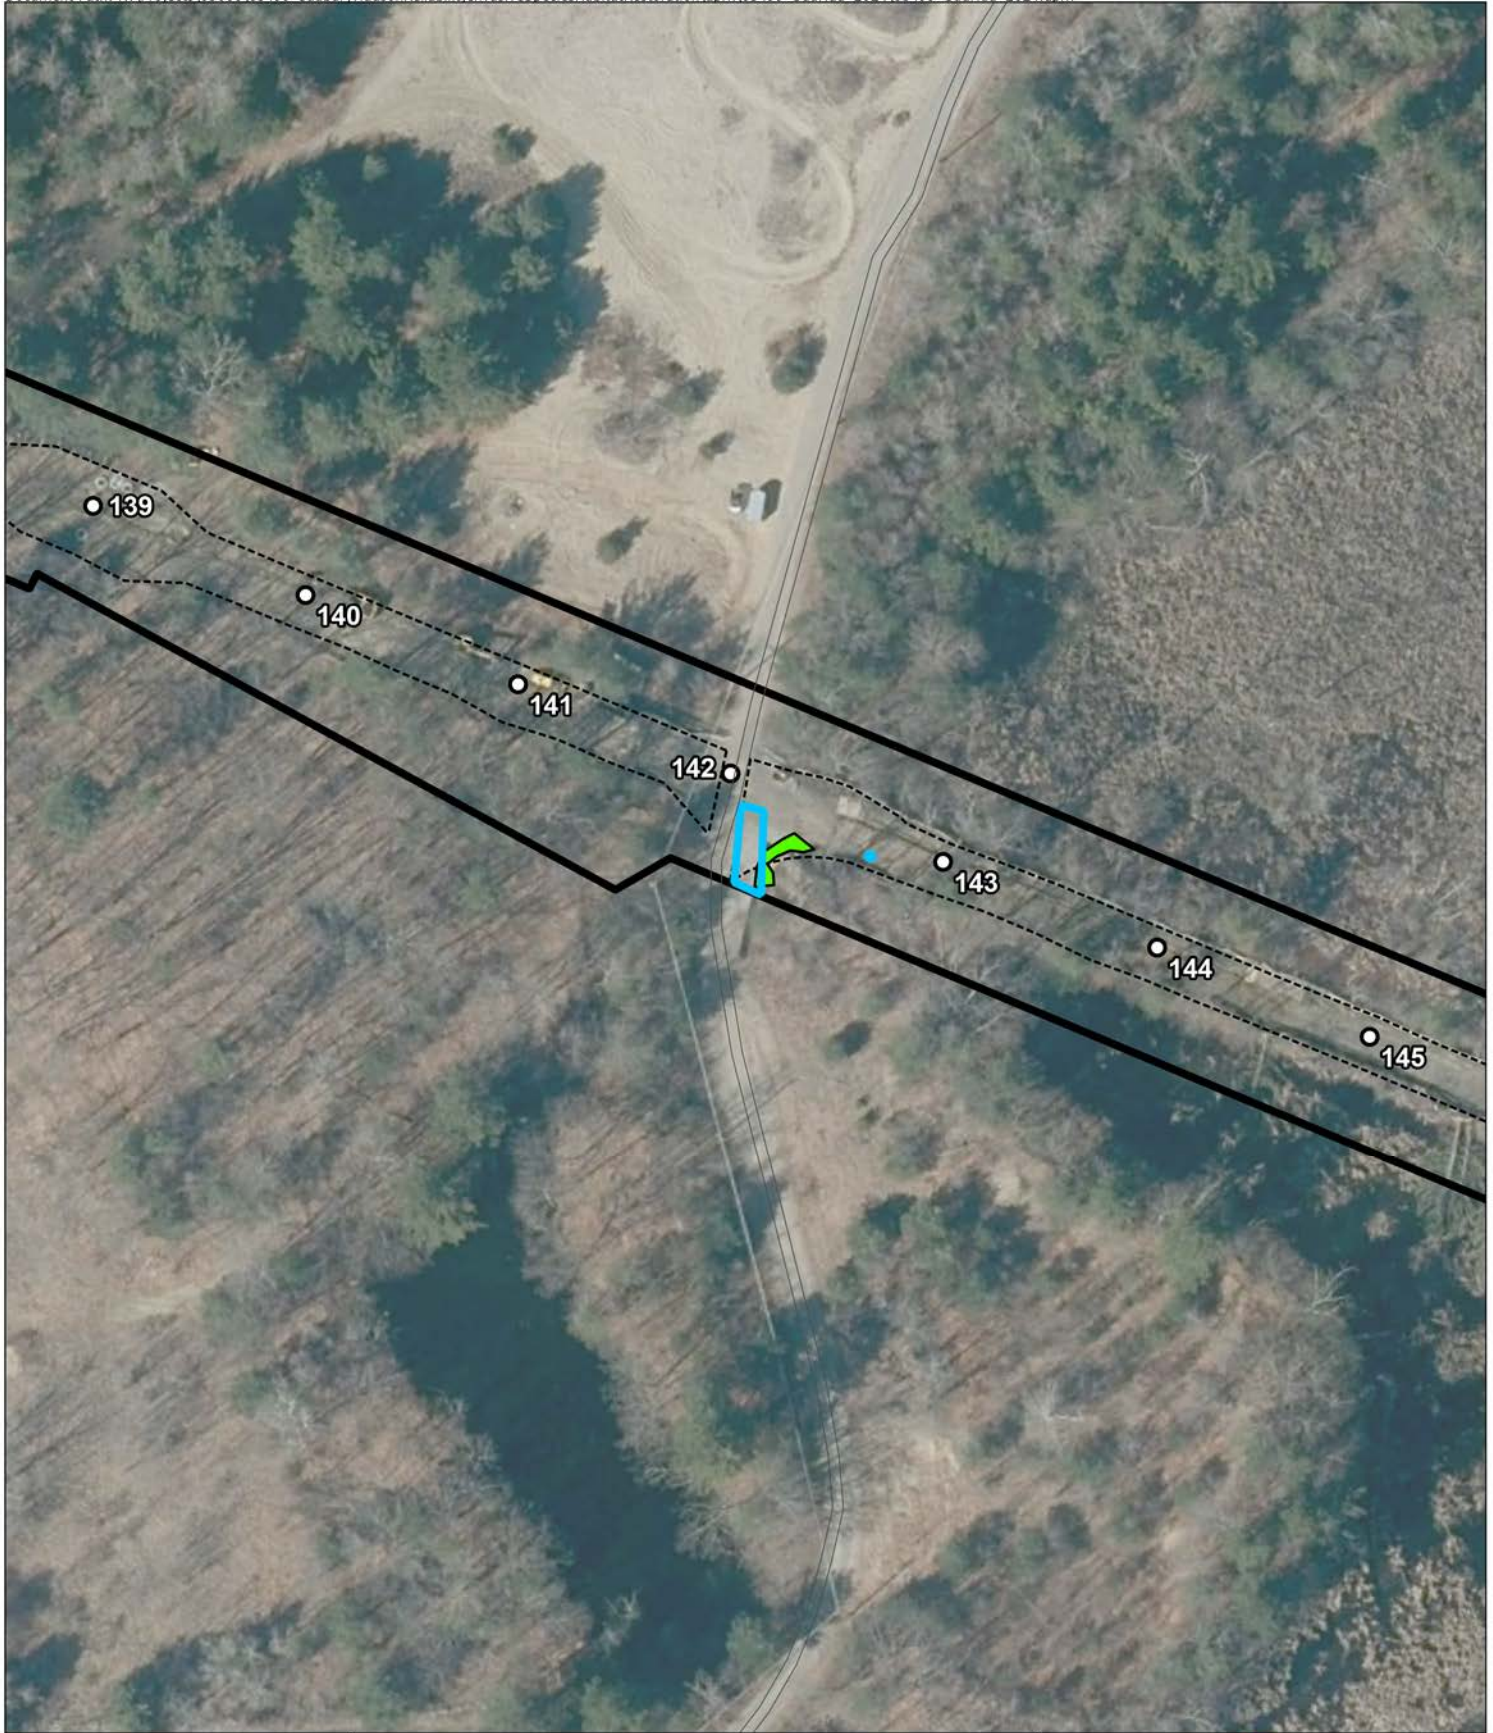
While conducting invasive removal within the LOW in November, SWCA observed that Japanese knotweed populations in Segments 1 and 2 had changed from their previous mapped distribution. These populations were mapped in 2021 prior to beginning construction. Figures 1 through 3 (Attachment B) show Japanese knotweed distribution preconstruction and as observed in November 2024. While some populations have reduced their footprint, particularly where they were present in the center of the LOW, these populations have also moved or expanded slightly to occupy adjacent areas of the LOW.

Figure 3. Japanese Knotweed in Segment 2 LOW (East) Sudbury to Hudson Reliability Project, Hudson, MA

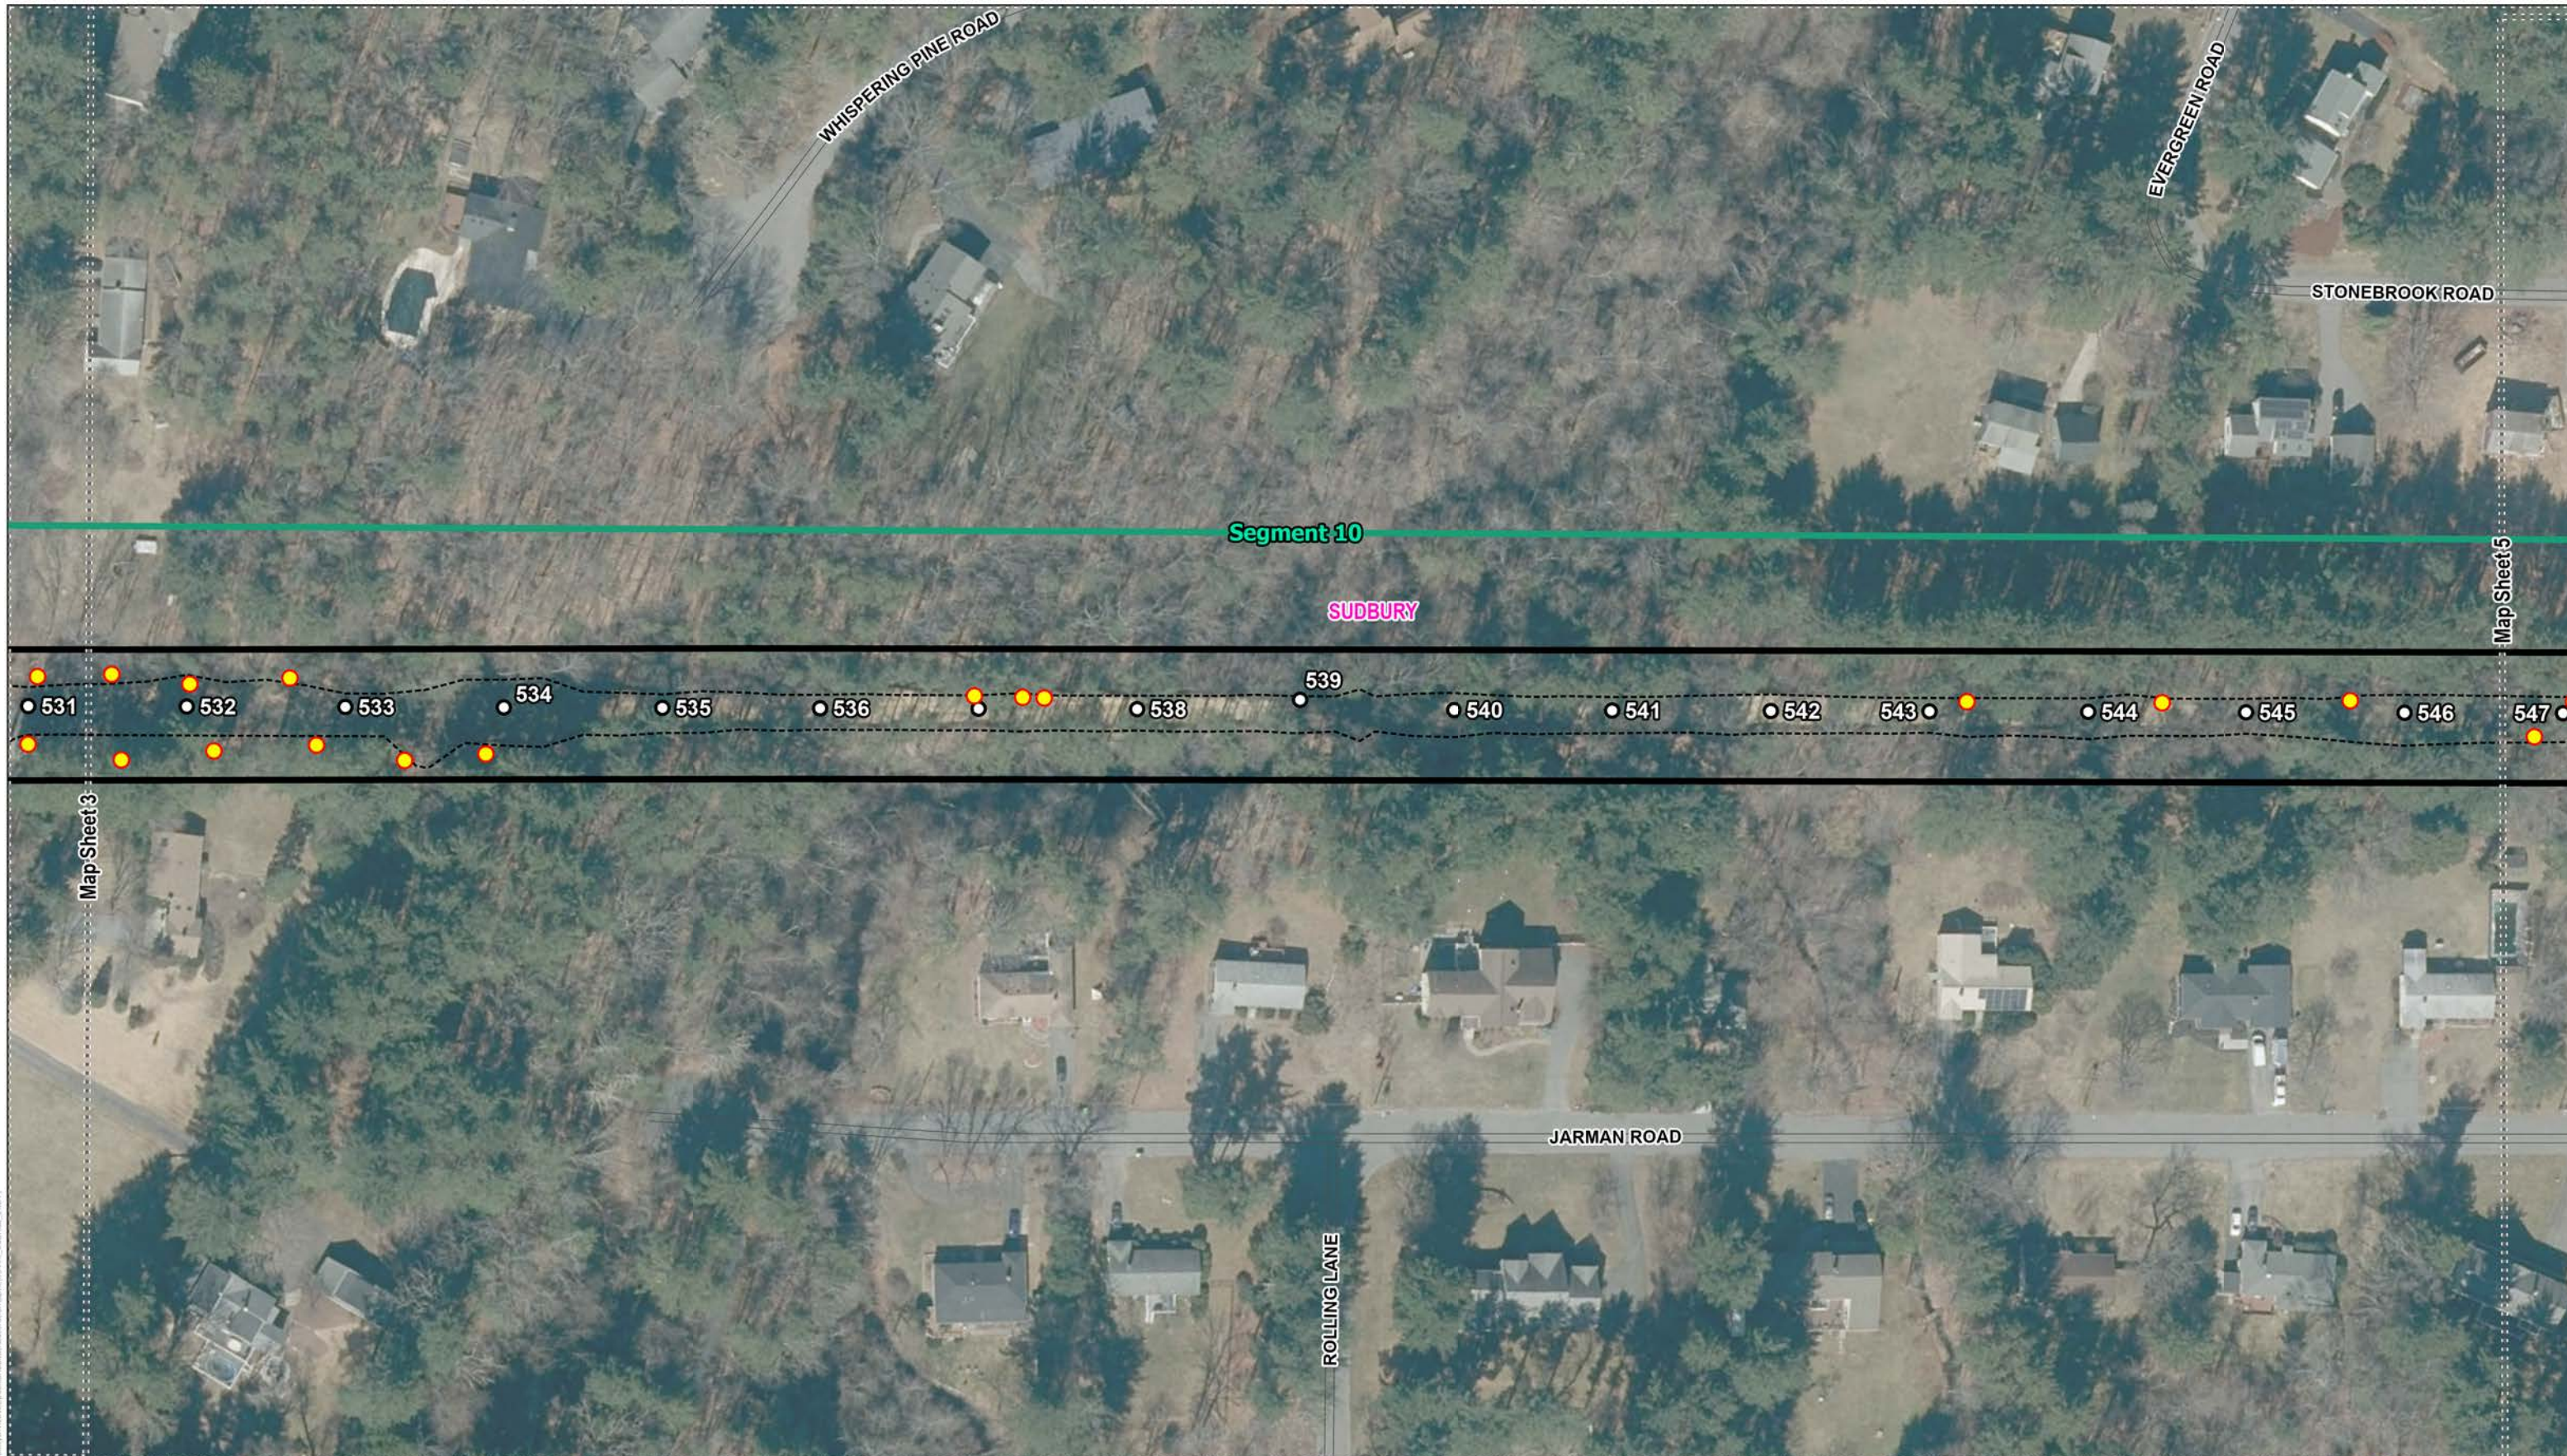
On August 7, 2024, SWCA found Japanese hops in a newly created stormwater retention basin within the LOW in the western end of Segment 9. Following this initial sighting, SWCA swept the entire LOW to survey for and remove any Japanese hops. During this survey, Japanese hops was found in topsoil in all segments in Sudbury except Segments 7 and 8. All observations of Japanese hops were restricted to the topsoil that was used along the margins of the LOW. All Japanese hops were removed from the site and disposed of in landfill waste.

Following this initial sweep, additional Japanese hops were found by SWCA staff during invasive species management visits, as well as by SWCA and AECOM construction monitors during routine, daily inspections. All individual Japanese hops sightings were reported to SWCA with approximate station number locations. The distribution of Japanese hops can be seen in Attachment C of this report.

A total of 165 Japanese hops were removed from the LOW in Sudbury and Hudson. The vast majority of these were found in Sudbury with only 6% (10 plants) found in Hudson. This distribution is organized by segment and station number in Table 1 (see Attachment C).
