PROJECT SUBMISSION FORM

TOWN CLOCK - CLOCK DIAL RESTORATION AND RE-GILDING AT FIRST PARISH CHURCH, SUDBURY MA

The Steeple First Parish of Sudbury

A Photographic Essay
Stephen Gabeler

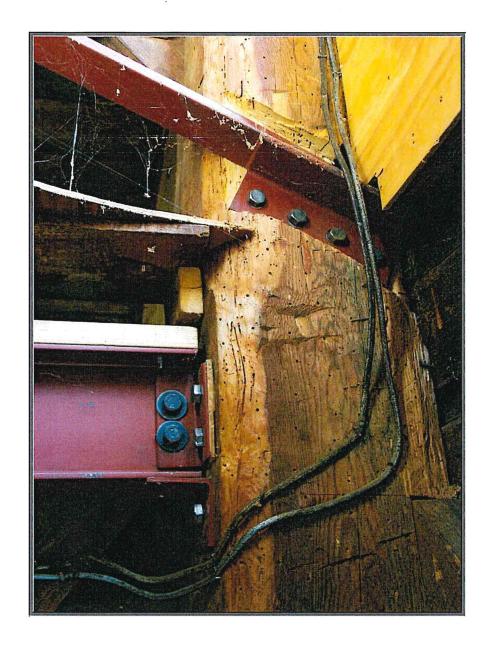
After traversing the shelf, we come to the Southeast timber post of the steeple. The four lower posts are quite large and are part of the original 1842 addition. The numerous holes are the result of an infestation of powder post beetles that were discovered and treated in the 1960s. Each of these vertical timbers is the entire trunk of a large, mature white pine tree. These trees were likely seedlings before the founding of the town 203 years before. The floor at the next level and the inside wall around the arched window are much newer construction using plywood. The red steel beams were added in 1997 as part of a major restoration and preservation effort. We will continue to see this steelwork to the top.

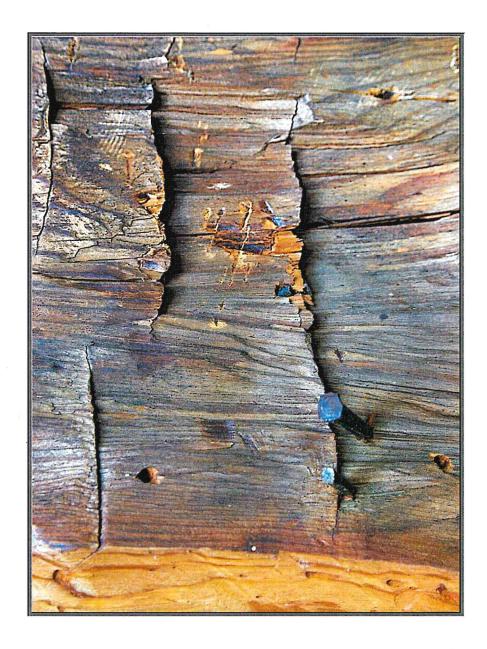
The timbers in the original post and beam construction show the marks of being hewn square with an adze (an axe like tool with a horizontal blade like a hoe). Square cut nails also indicate an earlier age. Hudson's History of Sudbury indicates that there was a nail mill on Hop Brook at one time. Perhaps some of these came from there. There was a time when this was the new addition to the second Meetinghouse of the congregation. The first had been built 100 years before and that is 268 years before today. Thirteen generations of families have come to this place and made it theirs.

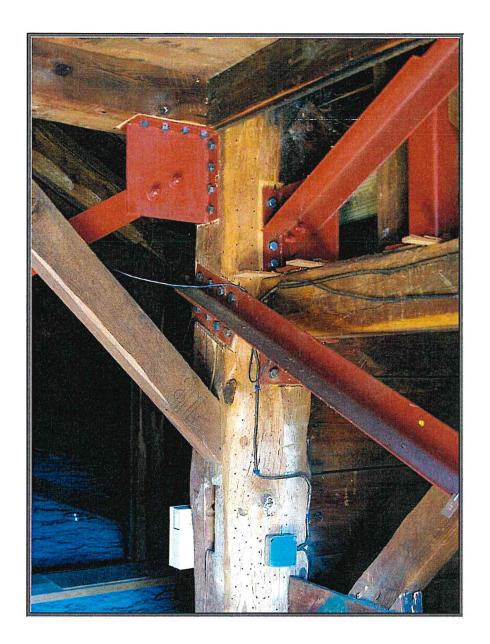
We are now on that plywood floor at the level of the arched window seen at the front of the Church. This is the Northeast post showing reinforcement efforts from several eras. The hand hewn timbers are probably all original 1842 construction and have wooden pegged mortise and tenon joints. The wooden diagonal braces are more precisely saw cut oak and perhaps more recent. The steel is 1997 as mentioned before. Some of the electrical wiring looks around vintage 1950's or so and may have been added when the clock was electrified. The space above the Sanctuary ceiling is seen off in the dark with the insulation added in 2008 (did you notice that the ice dams and megacicles were not so bad the last two winters?). Each generation has taken responsibility for stewardship of these spaces.

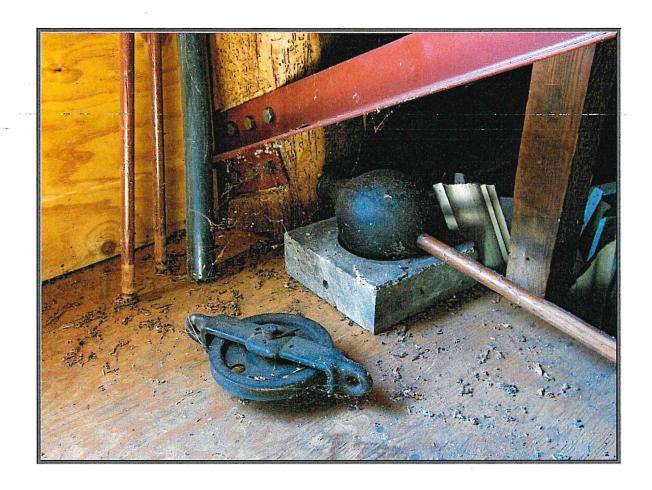
At the base of the stairs to the clock level, by the Southwest post, is the pendulum that was removed from the clock when it was electrified. That heavy cast iron ball and wooden shaft kept time for the Town for about 70 to 80 years before it was set to rest not far from its partner. The pulley next to it was part of a mechanism of weights, cables and pulleys that were cranked up every week to power the clock.

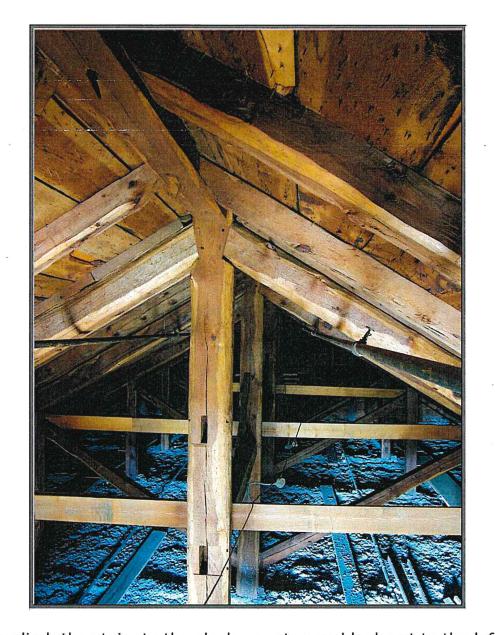
As we climb the stairs to the clock, we stop and look out to the left for an open view of the whole structure above the Sanctuary. The truss structure with center posts, side posts, diagonal braces and rafter beams give the roof the strength required to be able to span the entire width of the building and support the roof, bearing only on the outer walls. The completely open space in our Sanctuary without any posts is a tribute to what is above the ceiling. Most of what we see here is the original 1797 construction using the pegged mortise and tenon joinery (no nails!). The empty mortises and peg holes suggest modifications for the 1842 addition of the foyer and steeple. The horizontal bracing boards look newer and the much more recent 1997 re-roofing with plywood can be seen through gaps in the original roofing boards where sections have broken out (look at their width!). The notched joints along the ridge are especially beautiful.

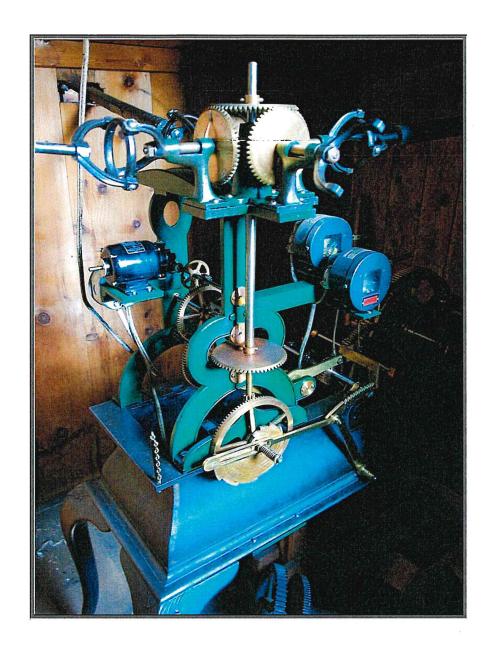
We see in the light coming from the window on the North face of the steeple a beautiful piece of 19th century machinery. The massive cast iron base is decorated with cabriole legs more like a piece of living room furniture. This is an E. Howard #2 Flatbed Striker Tower Clock and was a gift to the Town by the Sudbury school children in 1873. It is nearly identical to the one in Clock Tower Place in Maynard (installed 1892) except for electrification. The pendulum has been removed and replaced by the motor seen here. A second larger motor is in the base to drive the bell striker part of the mechanism. The gears, cranks and cables to the weights have also been removed and can be seen on the floor. Three universal joints and shafts drive the East, South and West clock faces on the steeple. Those children are the age of my great grandparents.

The Town of Sudbury clock is located in the clock/bell tower of the First Parish Church at 227 Concord Road. The clock itself is an historically significant E. Howard #2 Flatbed Striker Tower Clock, and was a gift to the Town by the Sudbury school children in 1873. More on the history of the clock is included in the attached: A Photo Essay of the Structure, History, and Views of Our Steeple, by Steve Gabeler.

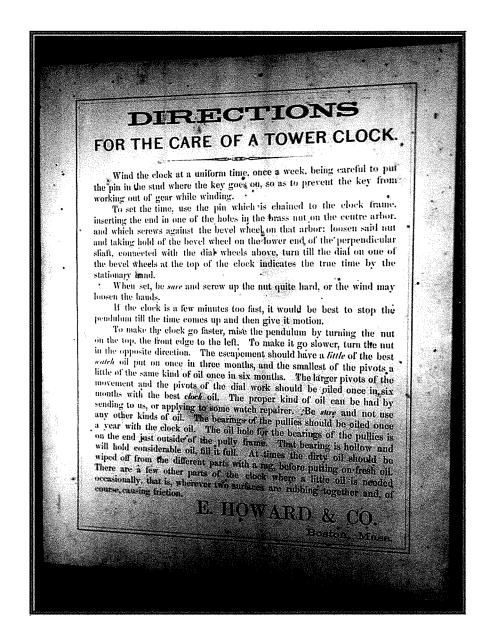
How many times have you lost the users manual to something? This one has been glued to the wall for over 135 years! Judging by the vintage of the electric motors, the change to motor drive probably occurred in the 1940s or 1950s. Prior to that, someone climbed the steeple every week to wind the clock and the striker. Edward Howard was one of the earliest timepiece makers in America and was also one of the founders of the Waltham Watch Company.

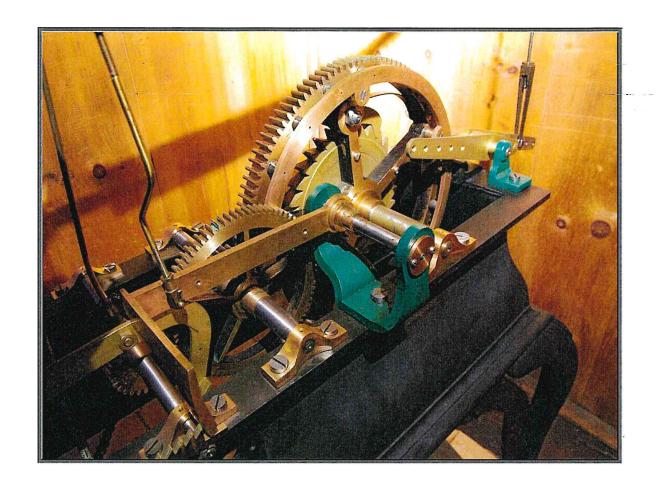
It is too dark to see the right hand side of the clock mechanism so we will turn on a work light (being certain to turn it off when we are done). This is the bell striker mechanism that sounds on the hour. It seems to be much more massive than we might expect in a clock. The reason will become more apparent when we get to the bell and striker. The rod on the far right goes all the way up to the striker. Being a gift to the Town of Sudbury, it remains town property and is maintained by the town. You may have noticed that it looks a lot cleaner and brighter than it's 137 year age. In May of 2003 the Selectmen voted to accept \$1800 from the Sudbury Foundation and \$1200 from First Parish for major repair and cleaning.

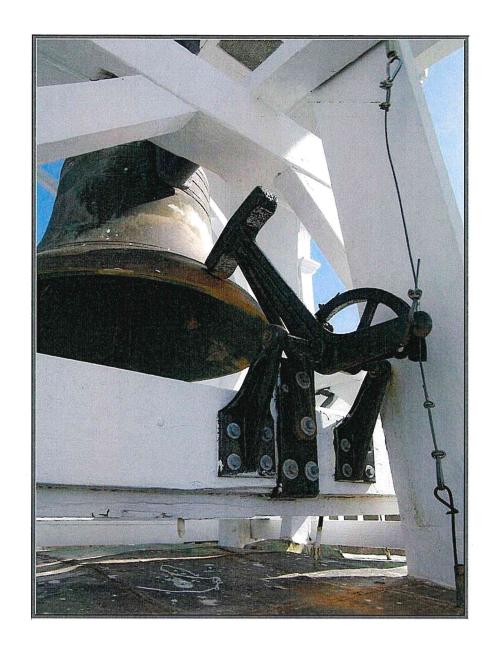
We are greeted by a contraption with a head on it as big as a good sized sledge hammer. This is the striker that is pulled down by the clock with rods and cables and released to strike the bell. The bell carriage has 4 inch square timbers and is well cross braced. Most of us think of bells as having this shape and fairly thin walls. This one is solid bronze with walls that are several inches thick. I believe it weighs over a ton. It must have been fun getting it up there with horses and ropes.

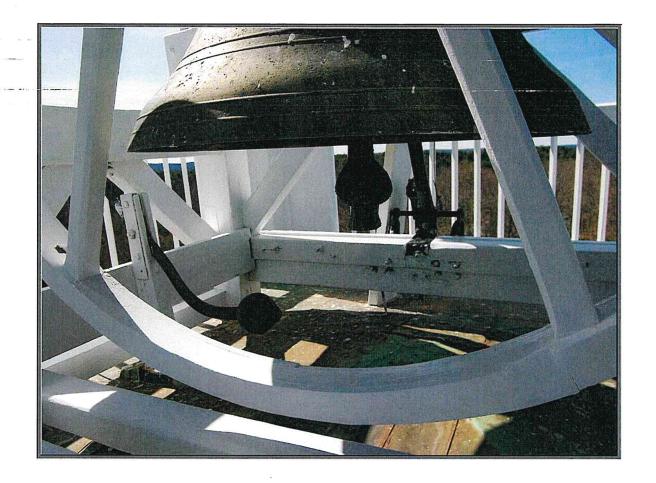
Climbing around to the other side of the carriage, we can look down and see the three ways of ringing the bell. On the far side is the clock striker we just looked at. To the left is a round cast iron ball on the end of a curved lever. This is what strikes the bell when it is tolled (remember the small rope we passed when we first entered the steeple?). The large diameter wooden wheel has the pealing rope attached to it (the one that hangs from the ceiling in the Foyer). The clapper hanging in the center of the bell strikes it when the entire bell is swung. Pealing the bell has a different sound because it is moving when ringing and the mouth of the bell is facing outwards over the carriage when struck. It is heard for greater distances as a result. The engineer in me can't help this so hold on – if the clock only rings from 6AM to Midnight, that's 141 times a day – 365 days a year is 51,465 – 137 years is over 7 million times that this bell has sounded the hour since the clock was installed. Then there is the tolling and pealing ...

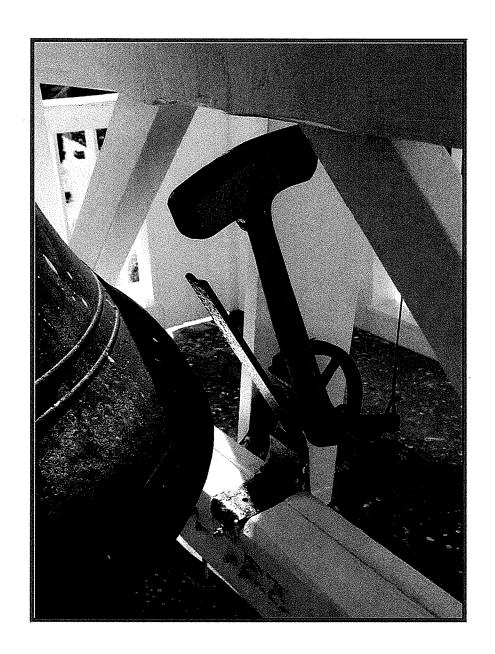
Coming around to the hatch we see the clock striker is pulled back ready to sound one o'clock. Knowing how loud that is from this distance, I move a little quicker. Climbing carefully onto the narrow stairs, I slide the hatch cover back into position over my head making sure that it is fully seated. We just beat the clock. What a sound! I have read that part of the art of casting these bells is to get them to sound a perfectly tuned chord and not just a single note. I can't imagine how they did it so well. The clock and the bell bring so many metaphors to mind that I don't know where to begin – so I won't. I will leave you to imagine them for yourself.
