FORM A - AREA

Town/City: Sudbury

Name of Area: Central Massachusetts Railroad Corridor
(Boston & Maine Railroad Corridor)

Recorded by: Stacy E. Spies

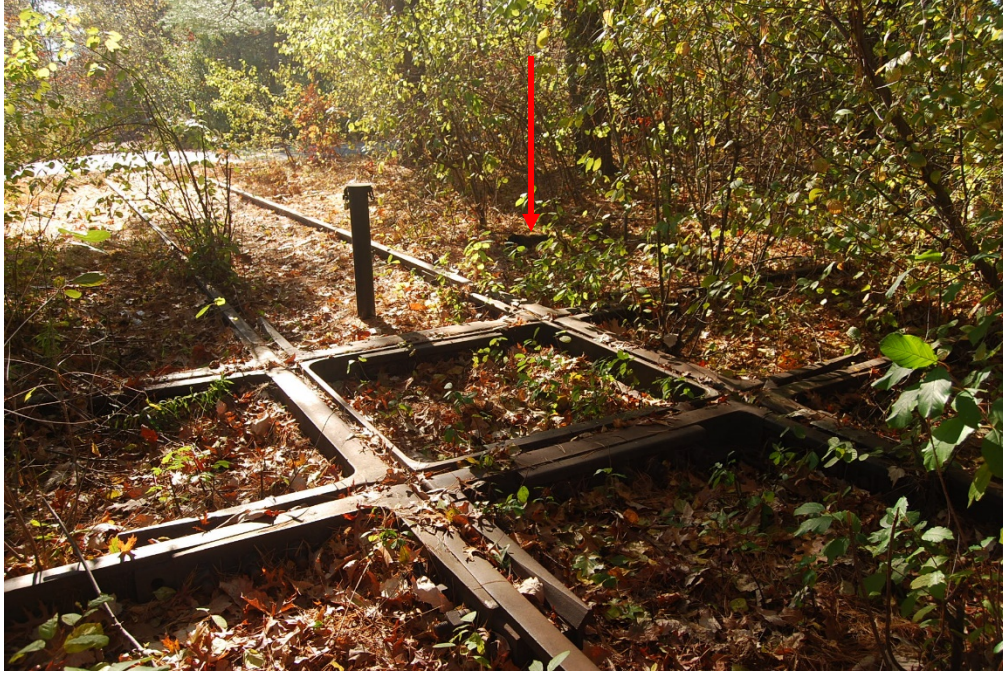
Diamond intersection. View looking SW. Fallen wood post at red arrow.

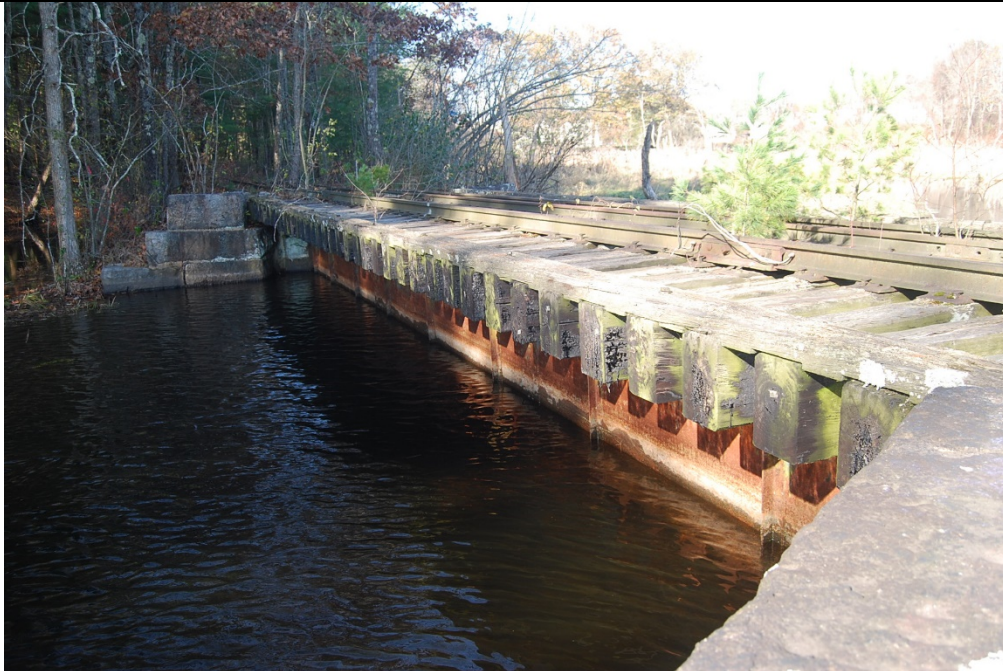
Bridge 127. (SUD.901) South elevation. View looking NW.

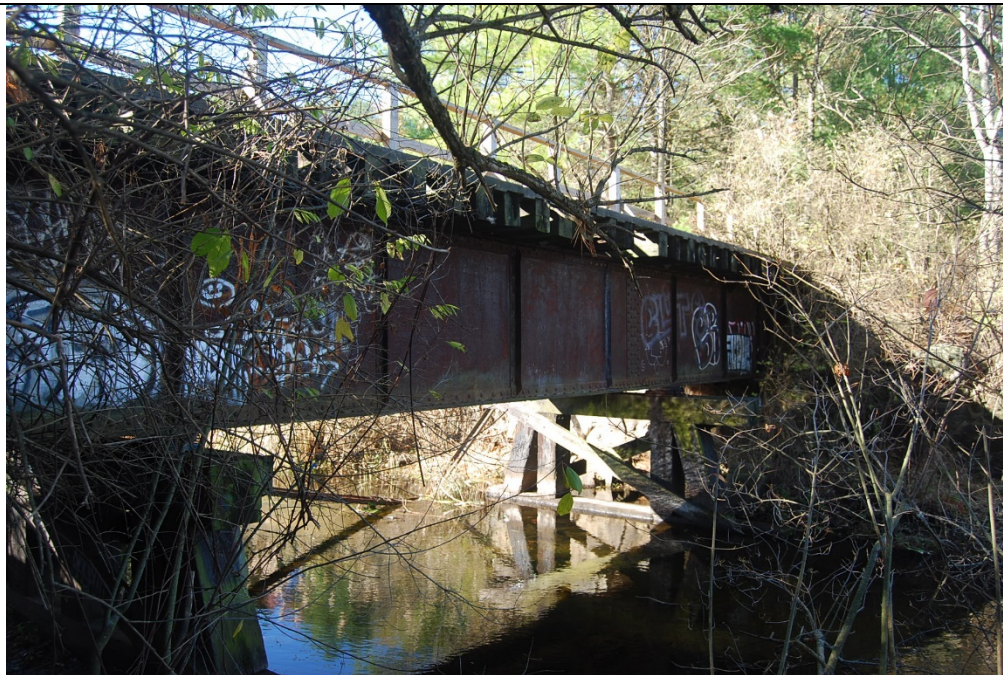
Bridge 128. (SUD.900) North elevation. View looking SW.

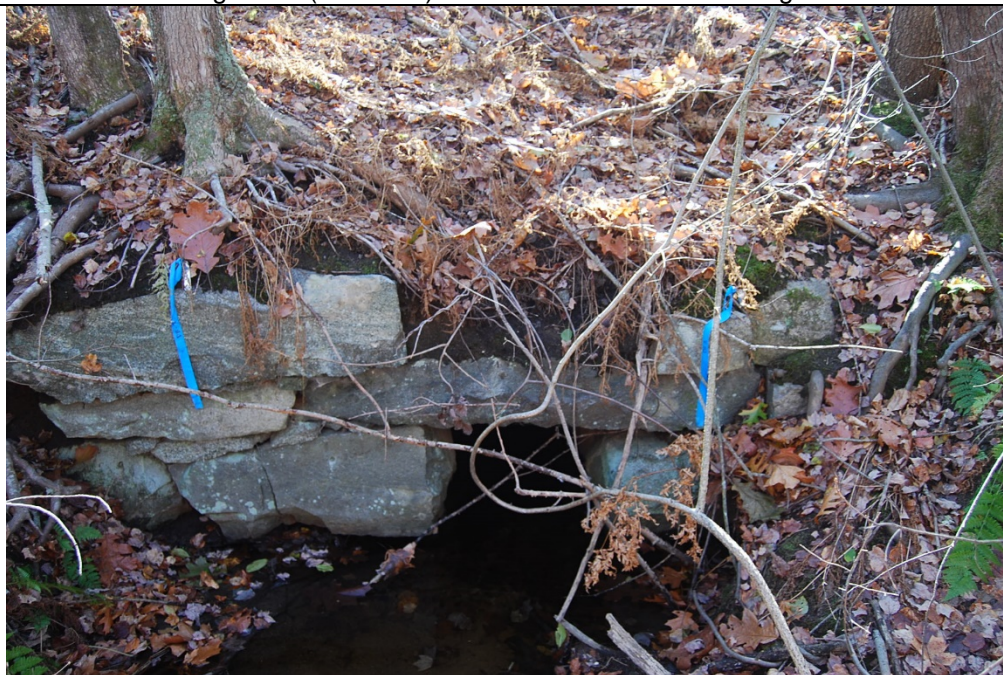
Culvert 126B (MP 19.06) is a 2' x 2½' box culvert constructed of large cut stone sidewalls capped with two courses of rectangular stones. An approximately 4' rectangular stone serves as a lintel. Earthen wingwalls extend from the opening. The culvert is located at a depth of 10 feet below the rail bed. The culvert retains a high level of integrity. The culvert's condition is good at the south elevation and fair at the north elevation due to loss of the top stone and encroaching tree roots.

Culvert 126B. North elevation. View looking S.

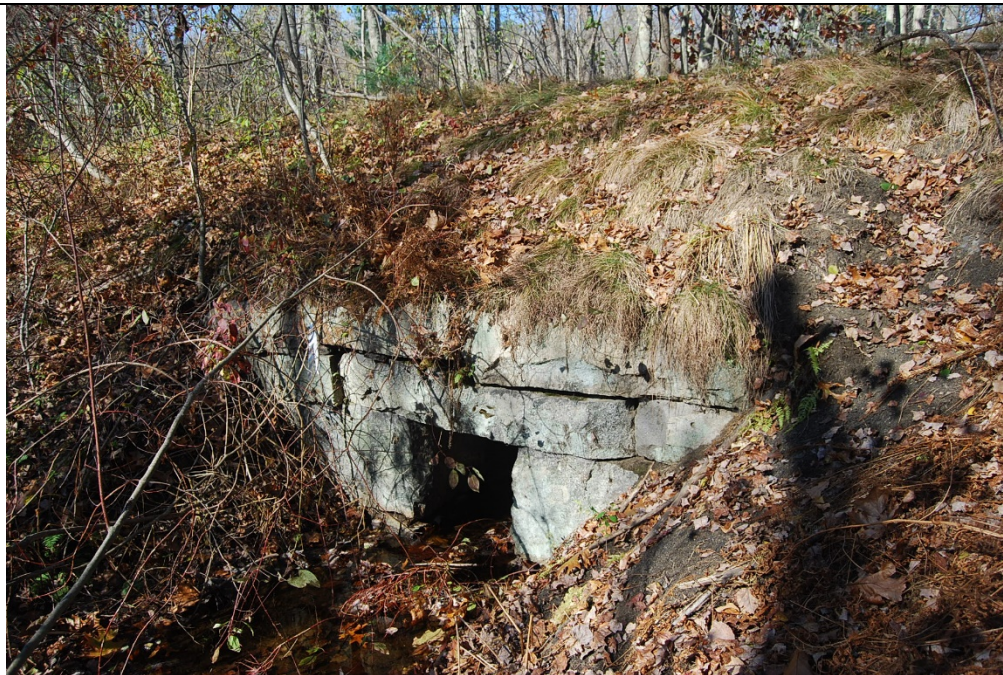
Culvert 126B. South elevation. View looking NW.

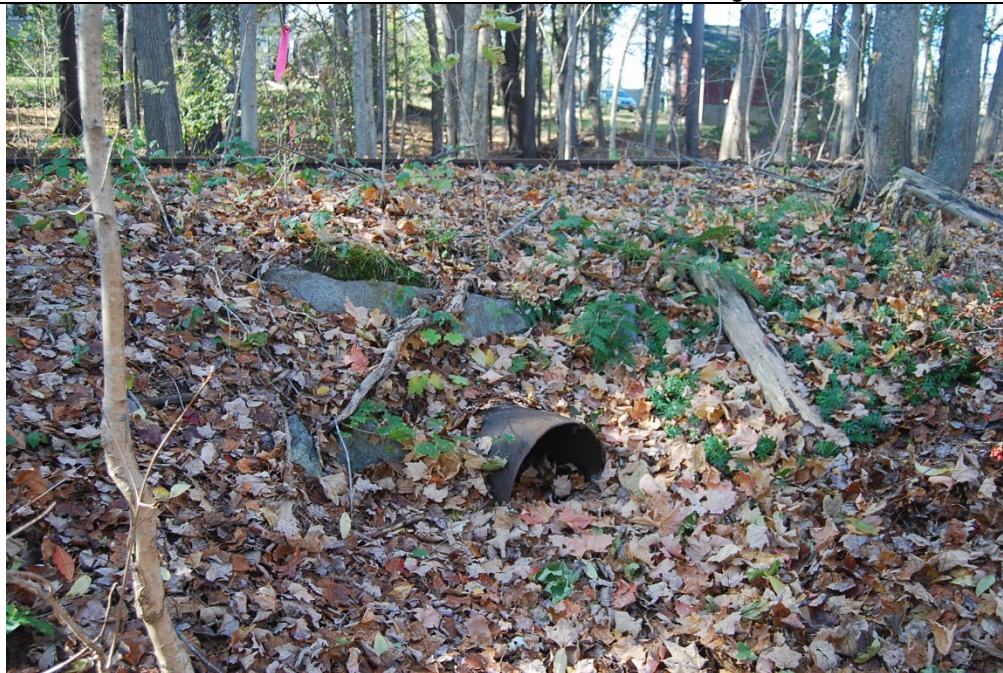
Culvert 127A (MP 19.70) is 24"-diameter cast iron pipe set into a dressed stone box. Earthen wingwalls, now largely collapsed, flank the opening. The opening has been largely infilled with dirt, obscuring the opening. The south lip of the pipe is broken, but the piece remains *in situ*. The culvert is located at a depth of 5 feet below the rail bed. The culvert retains a moderate level of historic integrity and is in fair condition. The culvert's condition and historic integrity could be reassessed if it is unearthed at a future date.

Culvert 127A. North elevation. View looking SW.

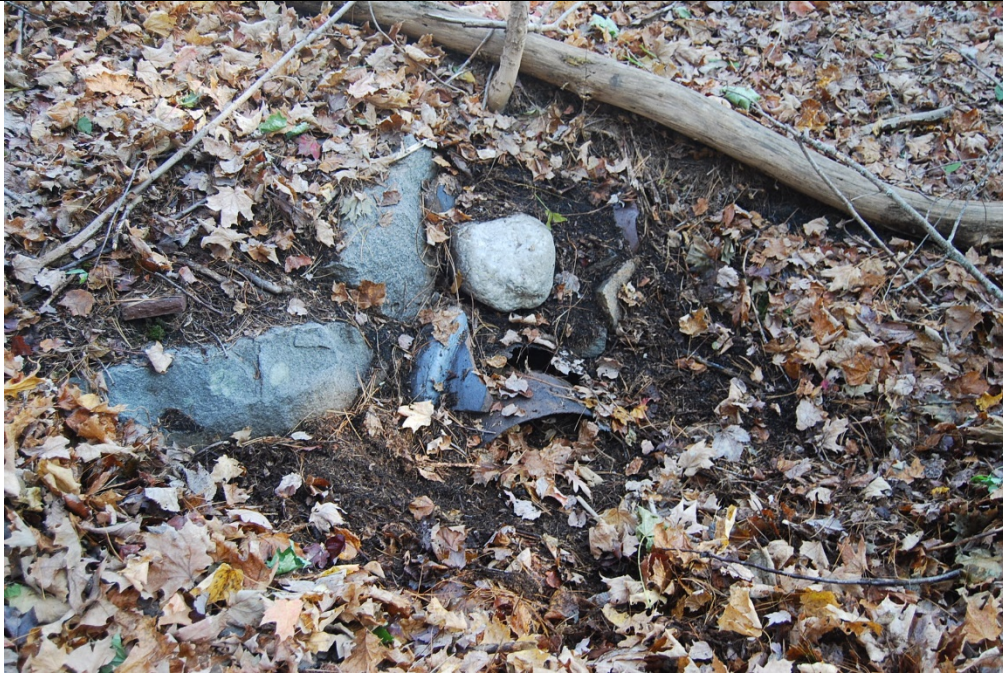
Culvert 127A. South elevation. View looking N. Although culvert has begun to fill in, stone box and cast iron pipe still visible.

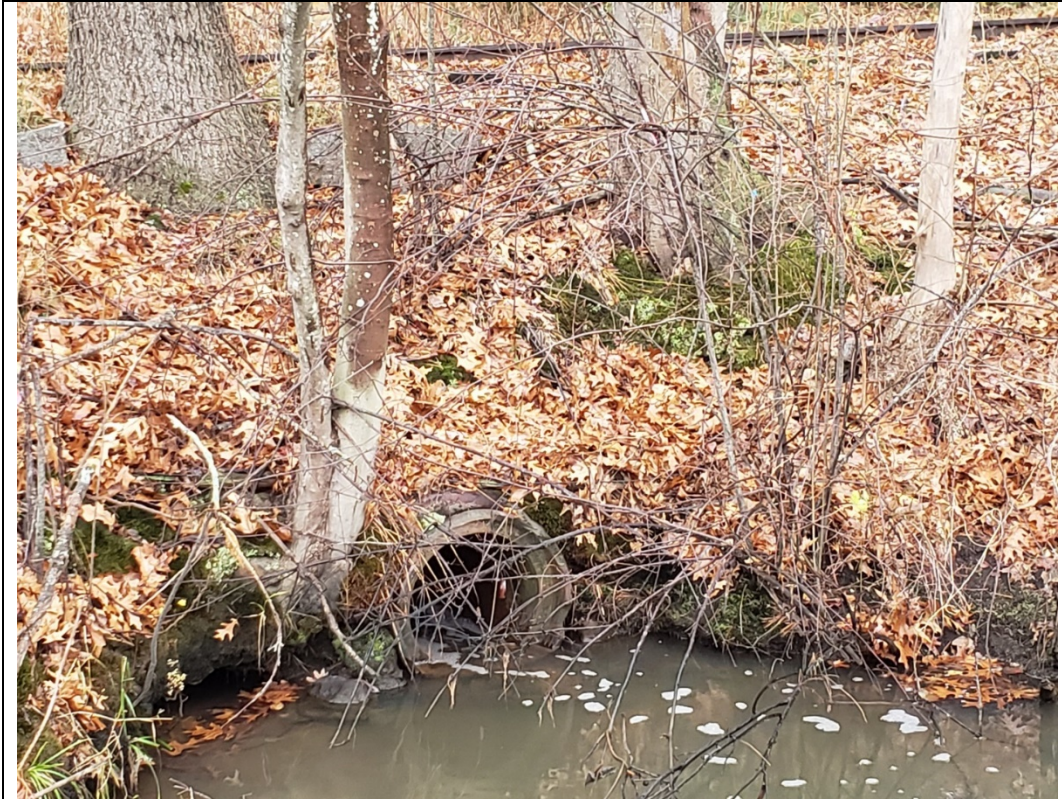
Culvert 127B (MP 19.87) is a 24"-diameter cast iron pipe set into a 2½' x 1½' stone box with earthen wingwalls. The opening has been largely infilled with dirt, obscuring the stonework. The culvert is located at a depth of 5 feet below the rail bed. The culvert appears to retain a high level of historic integrity and is in fair condition, largely due to the encroaching tree roots.

Culvert 127B. North elevation. View looking S.

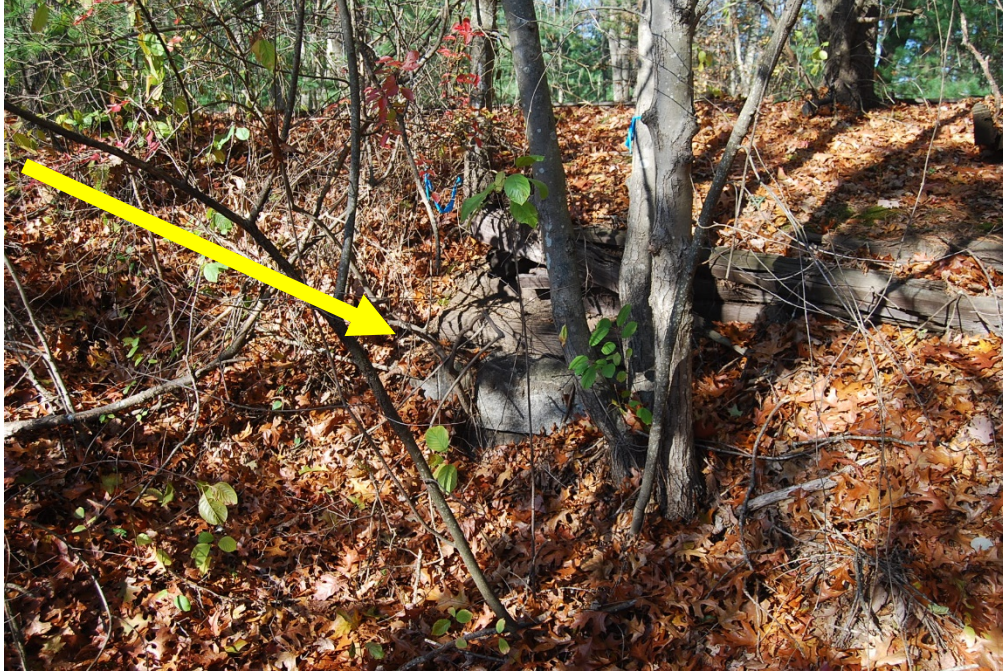
Culvert 127C (MP 20.14) is a 1' x 2' stone box culvert. The openings at both elevations have been infilled with dirt, obscuring the structure. The culvert is located at a depth of 10 feet below the rail bed. The culvert retains a moderate level of historic integrity and is in fair condition, from what can be seen. The culvert's condition and historic integrity could be reassessed if it is unearthed at a future date.

Culvert 127C. North elevation. View looking SE. Stone blocks visible at center photo.

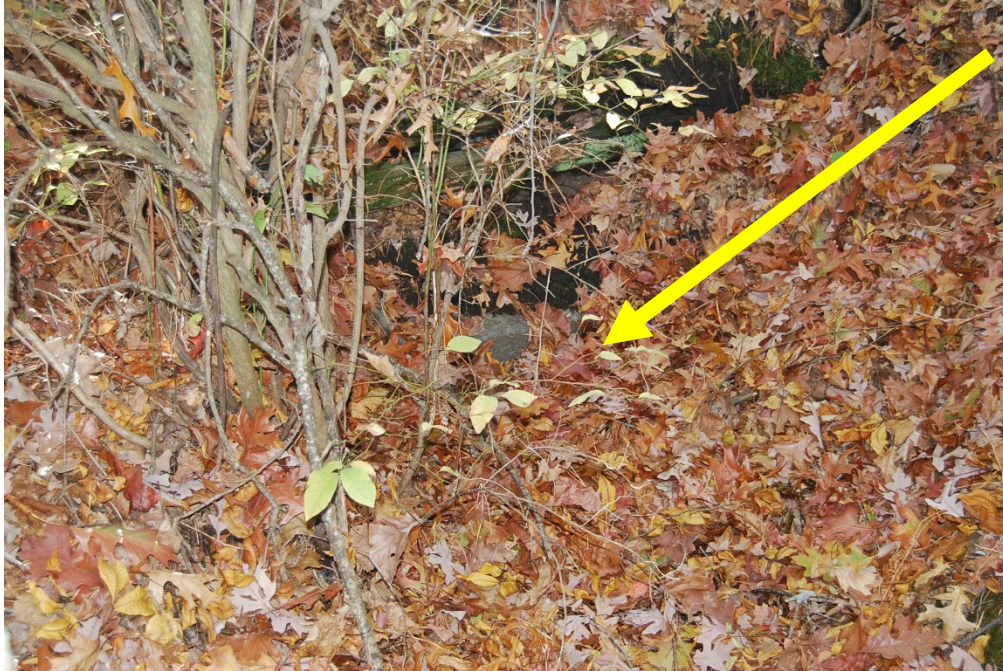
Culvert 127C. South elevation. View looking NW. Stone blocks visible at center photo.

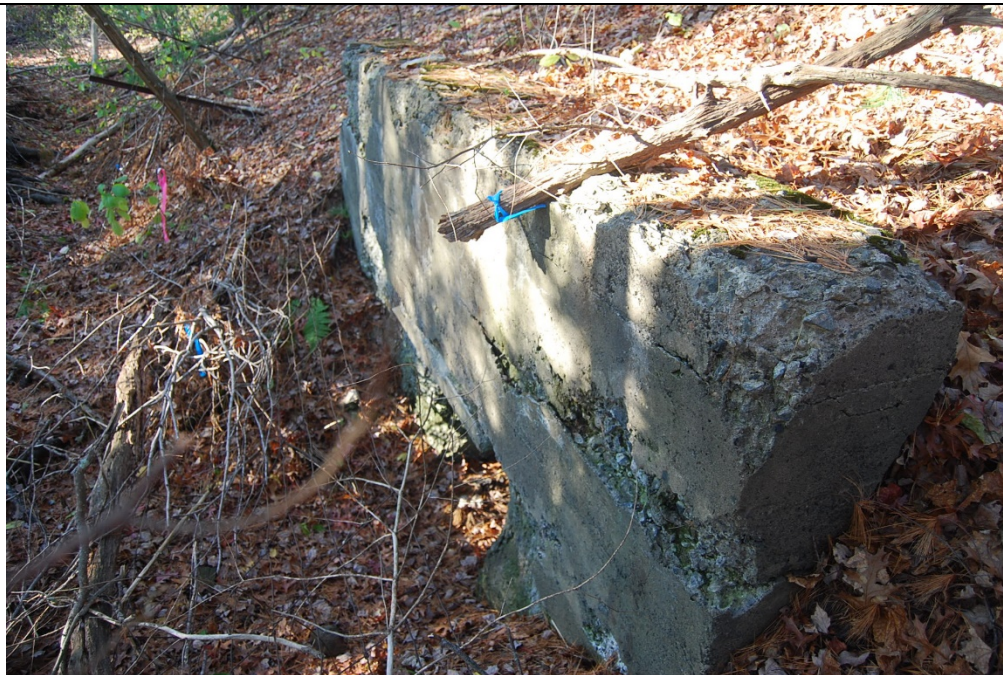
Culvert 127E (MP 20.75) is 2' x 2' poured concrete box culvert with rectangular stone lintels. The north elevation demonstrates wear with exposed aggregate and the loss of the finish coat at the corners and in some locations. The south elevation has lost the finish coat over its entire face, as well as some of the structural concrete. The culvert is located at a depth of 8 feet below the rail bed. The culvert retains a high level of historic integrity and is in fair condition.

Culvert 127E. North elevation. View looking SE.

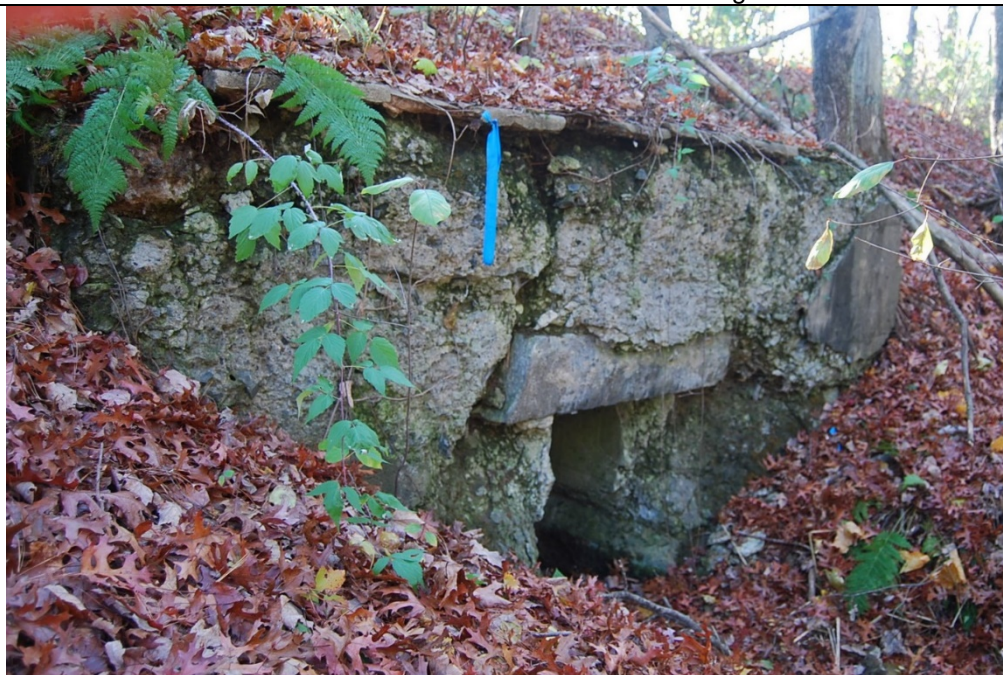
Culvert 127E. South elevation. View looking NE.

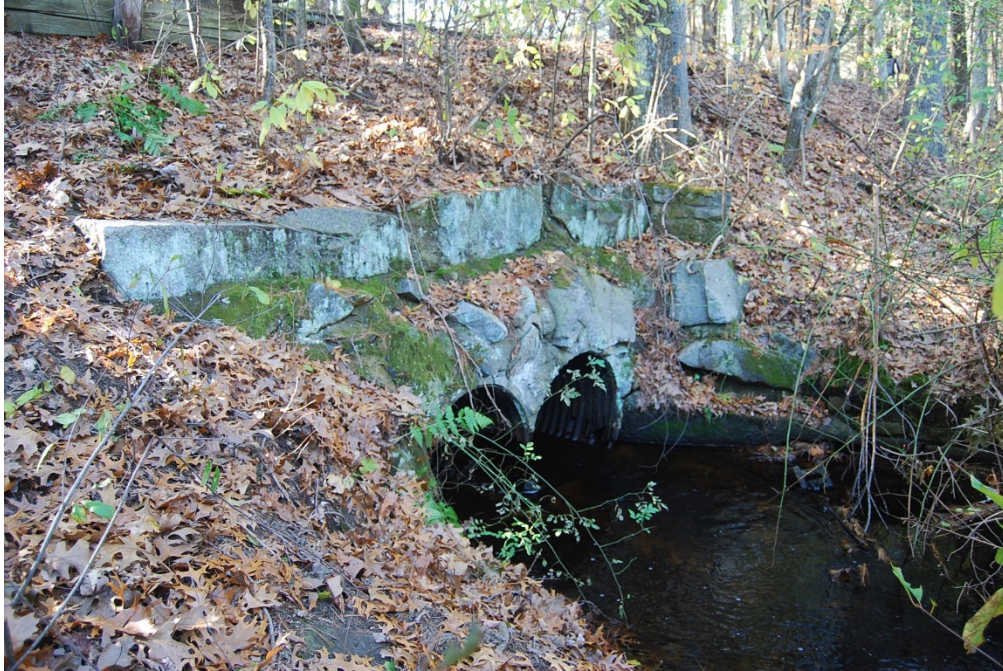
Culvert 127F (MP 21.18) is a large 3' x 3' stone box culvert altered with two corrugated metal pipes set with poured concrete. Stone wingwalls extend from the openings. The culvert is located at a depth of 13 feet below the rail bed. The culvert retains a high level of integrity and is in fair condition; The south elevation has begun to collapse.

Culvert 127F. North elevation. View looking SW.

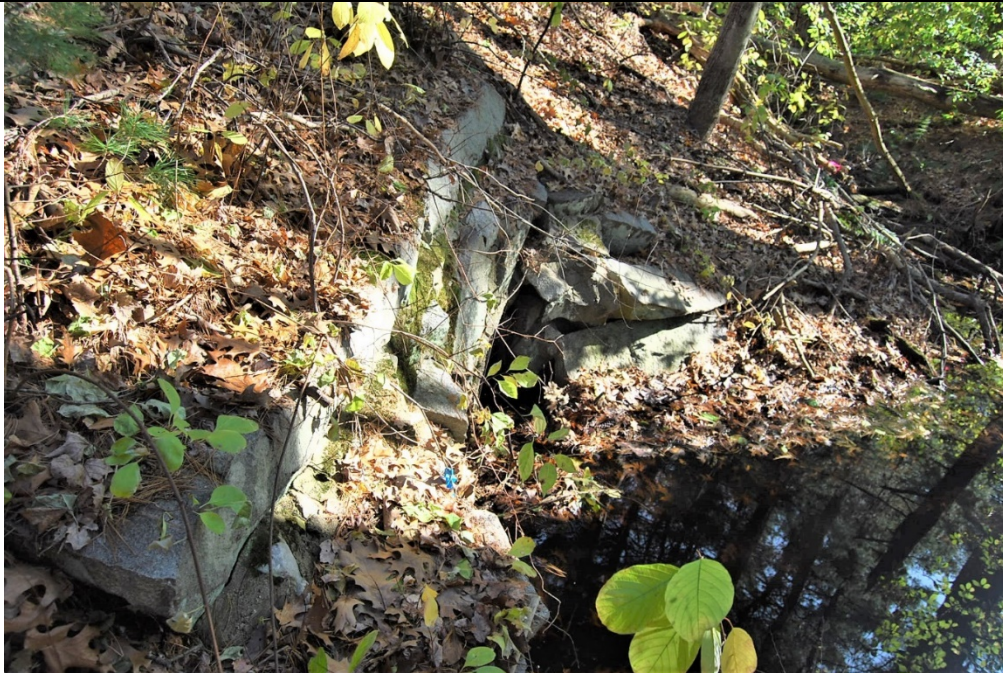
Culvert 127F. South elevation. View looking NE.

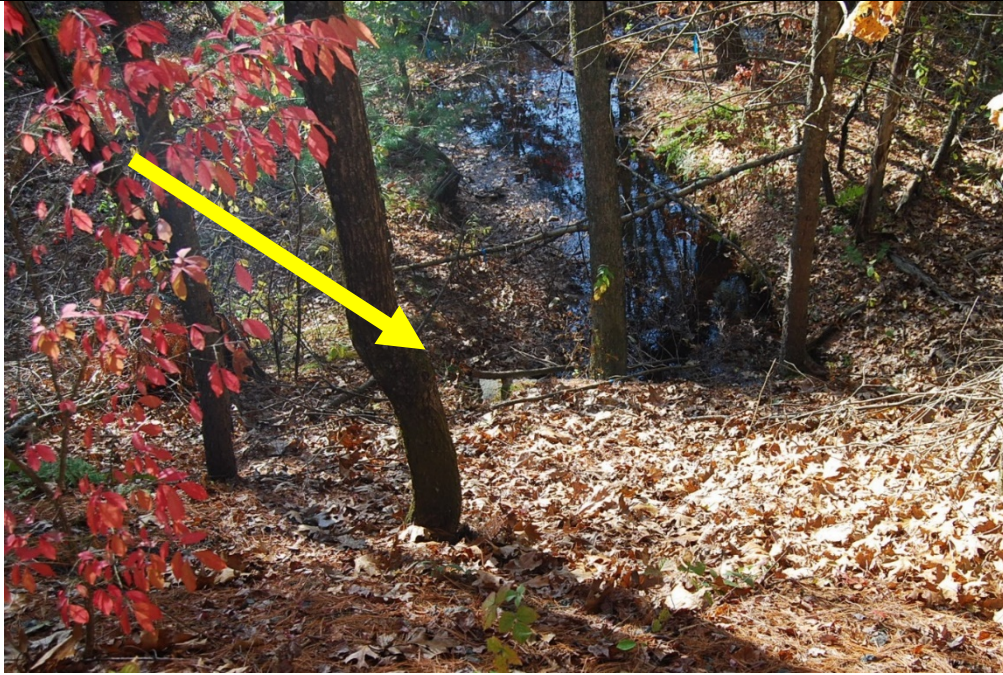
Culvert 127H (MP 21.51) is a 2½ x 3' stone box culvert constructed of cut stone sidewalls capped with two courses of rectangular stones. An approximately 4' rectangular stone serves as a lintel. Earthen wingwalls extend at oblique angles from the opening. The culvert retains a high level of integrity. The culvert's condition is good; encroaching tree roots endanger the structure.

Culvert 127H. North elevation as seen from rail bed. View looking N.

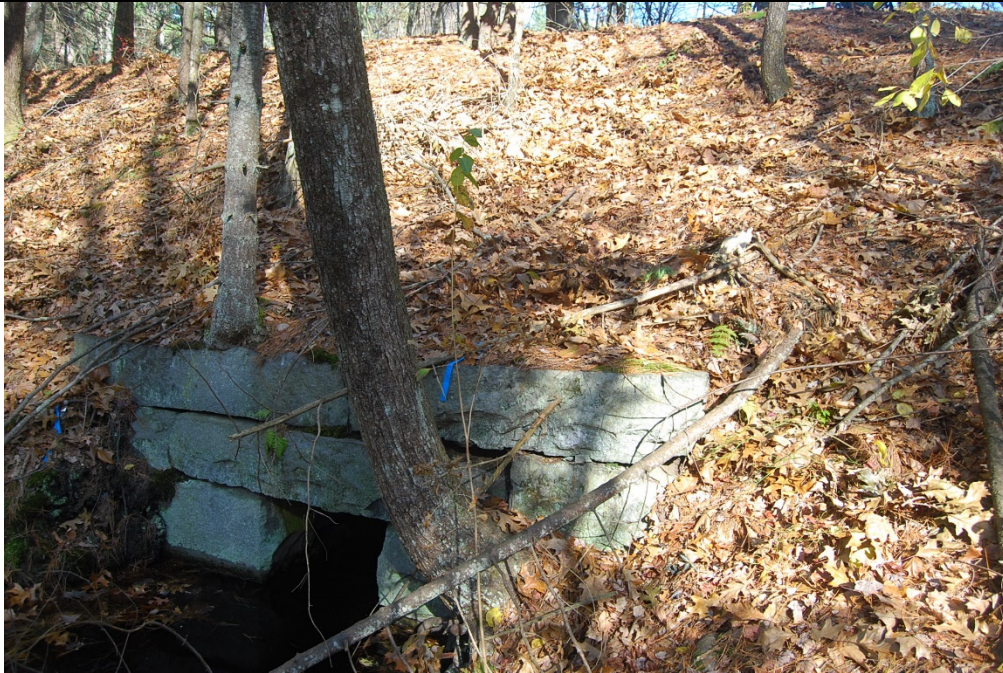
Culvert 127H. South elevation. View looking NW.

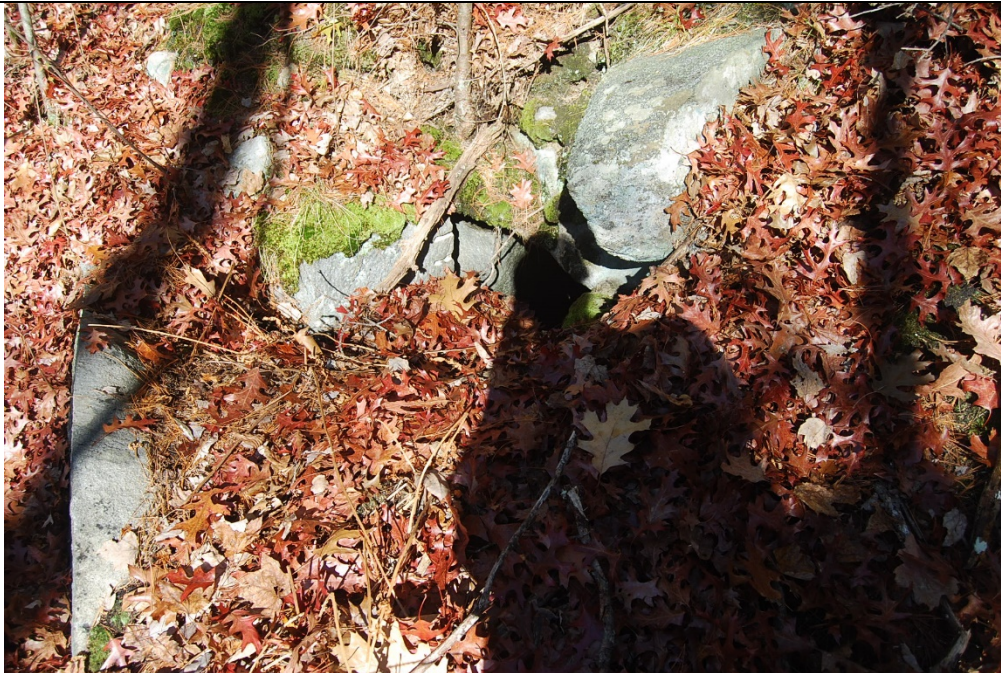
Culvert 127J (MP 22.05) is a 2'x2' cut stone box culvert constructed of large cut stone sidewalls capped with two courses of rectangular stones. The culvert has collapsed at the south elevation; the north elevation is inaccessible. The culvert retains a high level of integrity, as it does not appear to have undergone alterations. The culvert's condition, however, is poor given the collapse.

Culvert 127J. South elevation. View looking N.

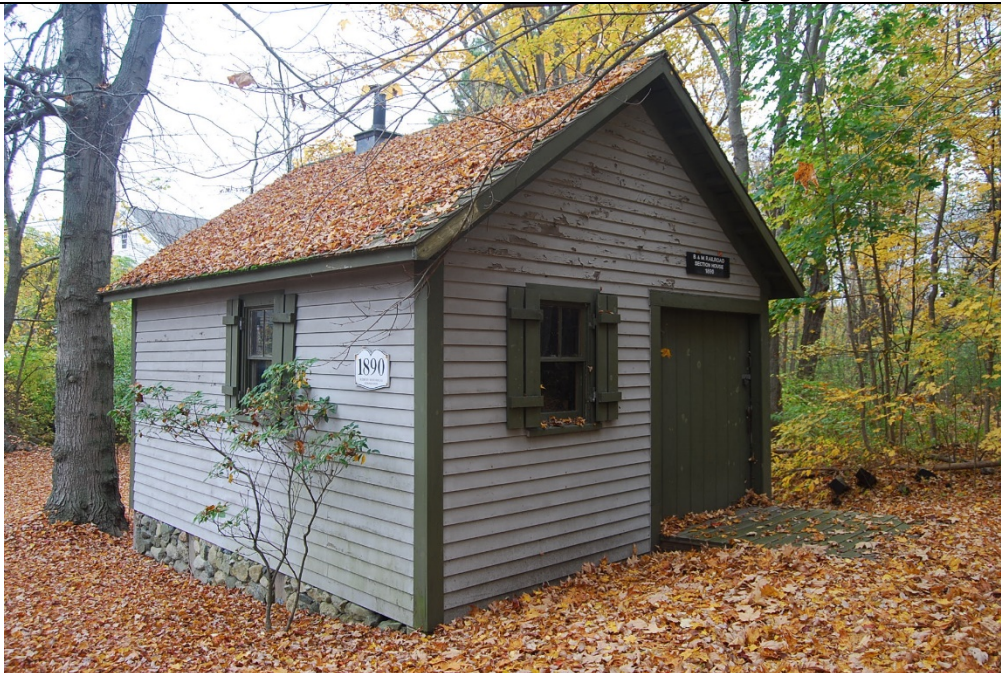
Section Tool House. West and South (trackside) elevations. View looking NE.

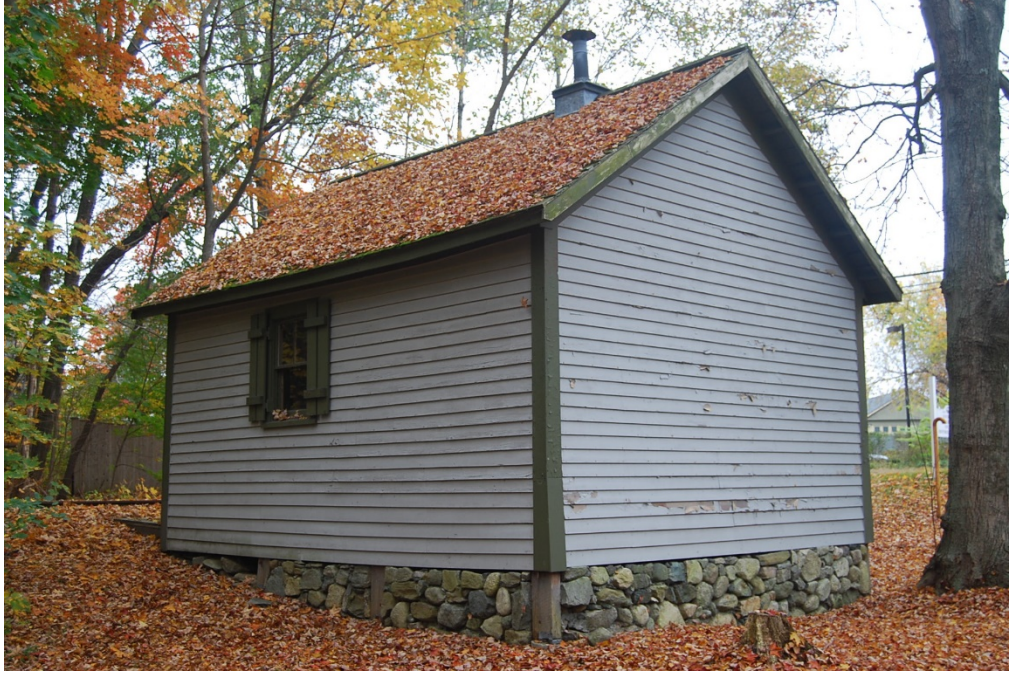
Section Tool House. East and North elevations. View looking SW.

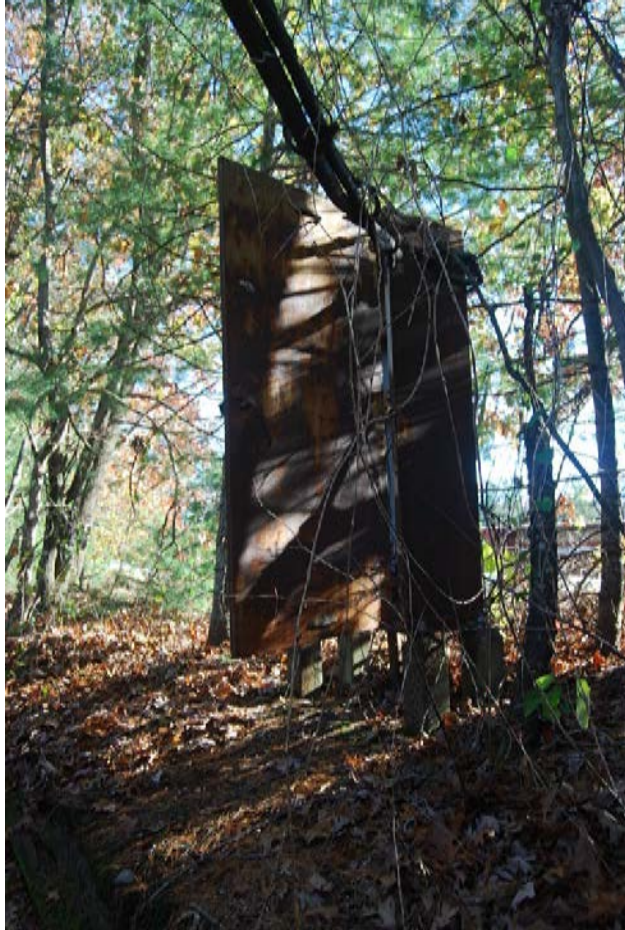
Relay Box at MP 20.59. South side of tracks. View looking SE. Box rests on four cast concrete piers.

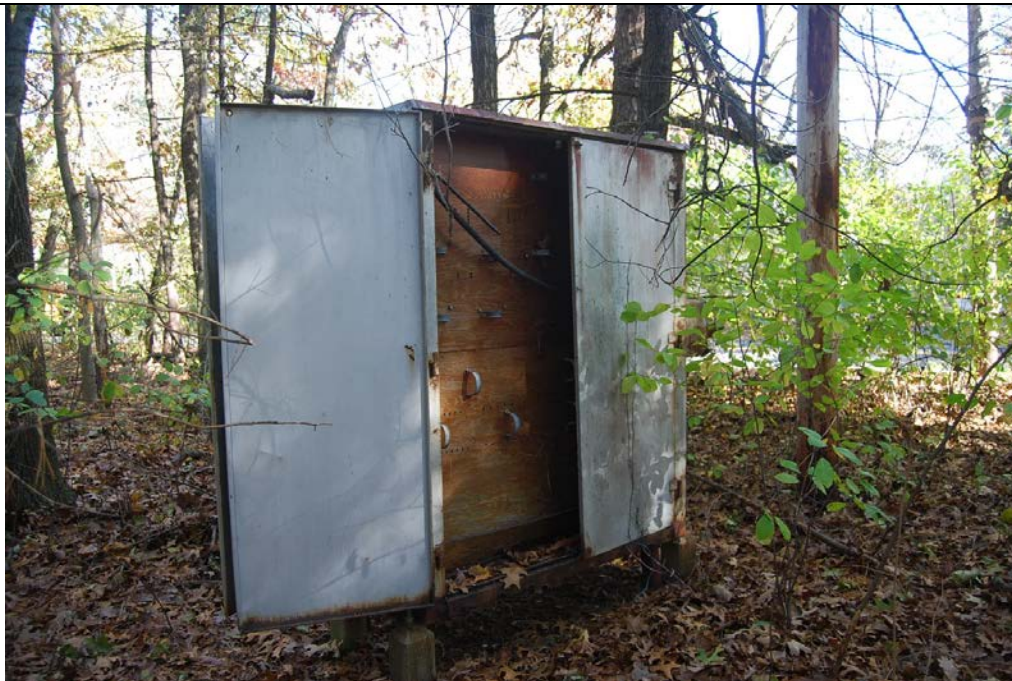
Relay Box at MP 20.79. Horse Pond Road visible through foliage. North side of tracks. View looking northeast. Box rests on four cast concrete piers.

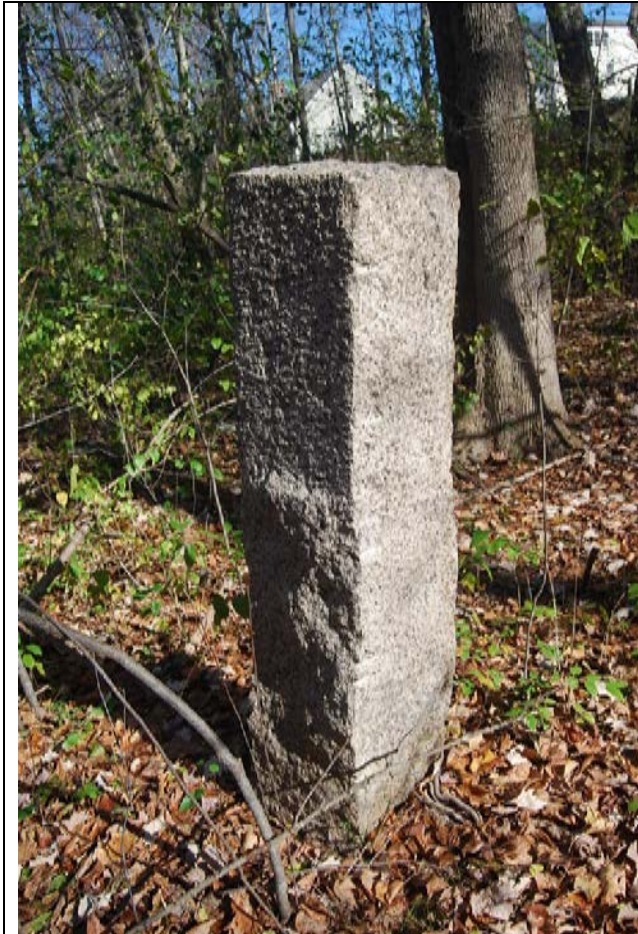
Four granite mileposts are located in the ROW. All are located on the north side of the tracks. The upright rectangular posts are roughly hewn with a more carefully dressed, bush-hammered, section at the tops of the east and west elevations that were to be painted. The posts have flat tops and are approximately 12 inches square and approximately 8 feet tall, with 4 feet set underground. Mileposts 20.0, 21.0, and 22.0 have been painted as they would have been by the B&MRR. The mileposts retain a high level of integrity and are in good condition.

Milepost 19.0. West and south elevations. View looking NE. Notice smoother dressed area at top, where it would have been painted.

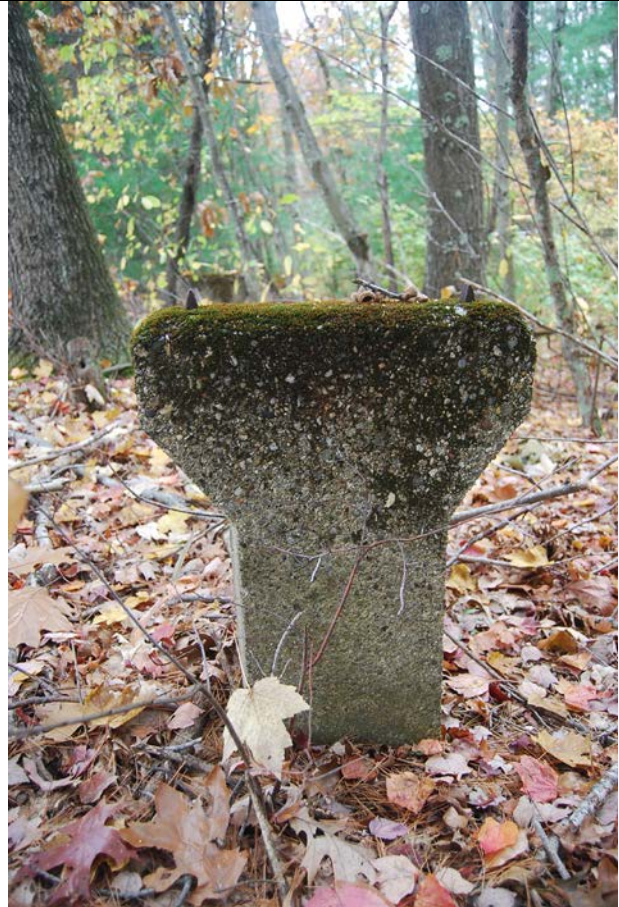
Four sets of rail rests, typical of the B&MRR, have been located in the corridor. The existing circa 1929-1930 rail rests replaced earlier rail rests in the same locations. The rail rests, also called rail racks, are constructed to store spare rails at convenient intervals in order to make repairs easier. Storing the rails off the ground prevents them from being covered with snow or frozen to the ground when needed. Rail rests typically keep the rails at least 18 inches from the ground and could be construction of a number materials, although concrete was a popular choice due to ease of maintenance and longevity. In this corridor, rail rests are located on the engineer's side, outbound movement, and as near as possible to the mile posts, as per B&MRR specifications.

Rail Rest at MP 20.09. Detail, East post. Note inverted spikes at top used to contain rails.

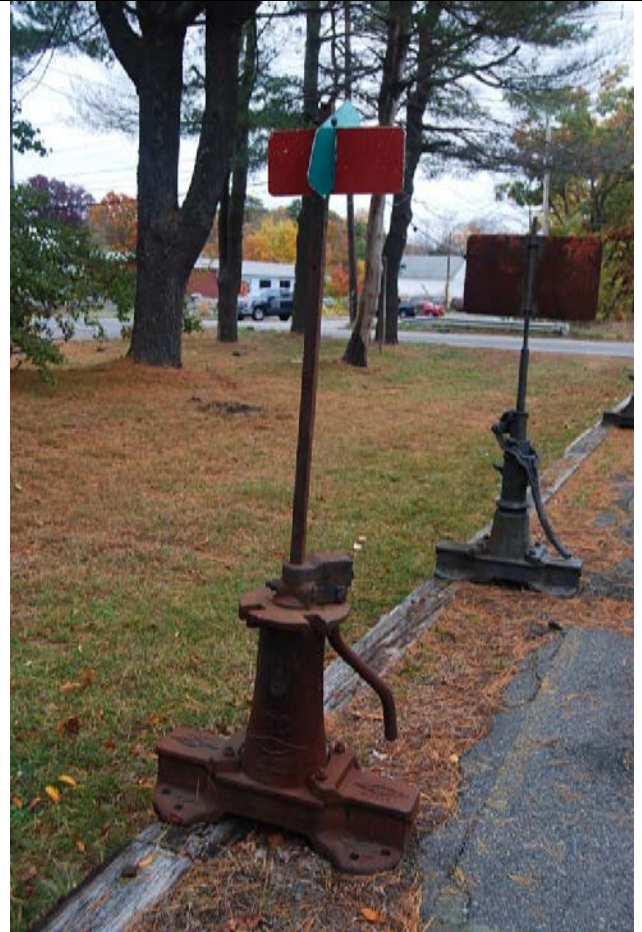
Switchstands. Center stand is B&MRR Ramapo-Ajax Stand No. 17. Stand in foreground is typical of period but not from this railroad.

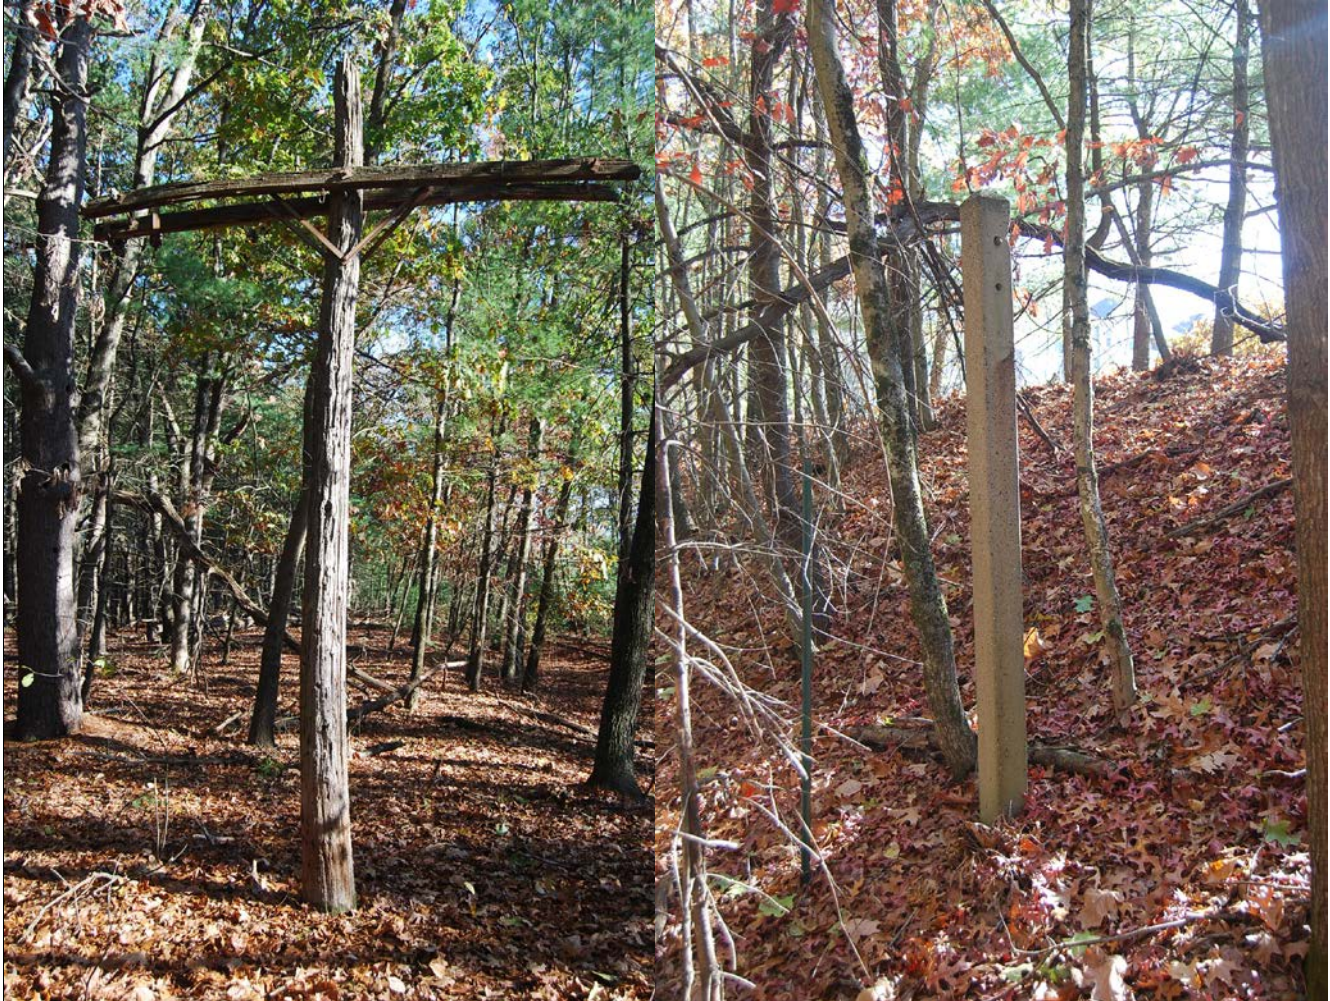
two horizontal cross-posts near the top. Some of the telegraph poles retain glass insulators. The telegraph poles retain a fair or poor level of integrity and are in poor condition.

Typical telegraph pole. View looking E.
