PRELIMINARY STRUCTURES REPORT

Bruce Freeman Rail Trail Project

Bridge No. S-31-007(XXX)
Proposed Bikepath over Hop Brook
Sudbury, Massachusetts

**Bruce Freeman Rail Trail Project
Abandoned Railroad Bridge over Hop Brook
PRELIMINARY STRUCTURES REPORT**

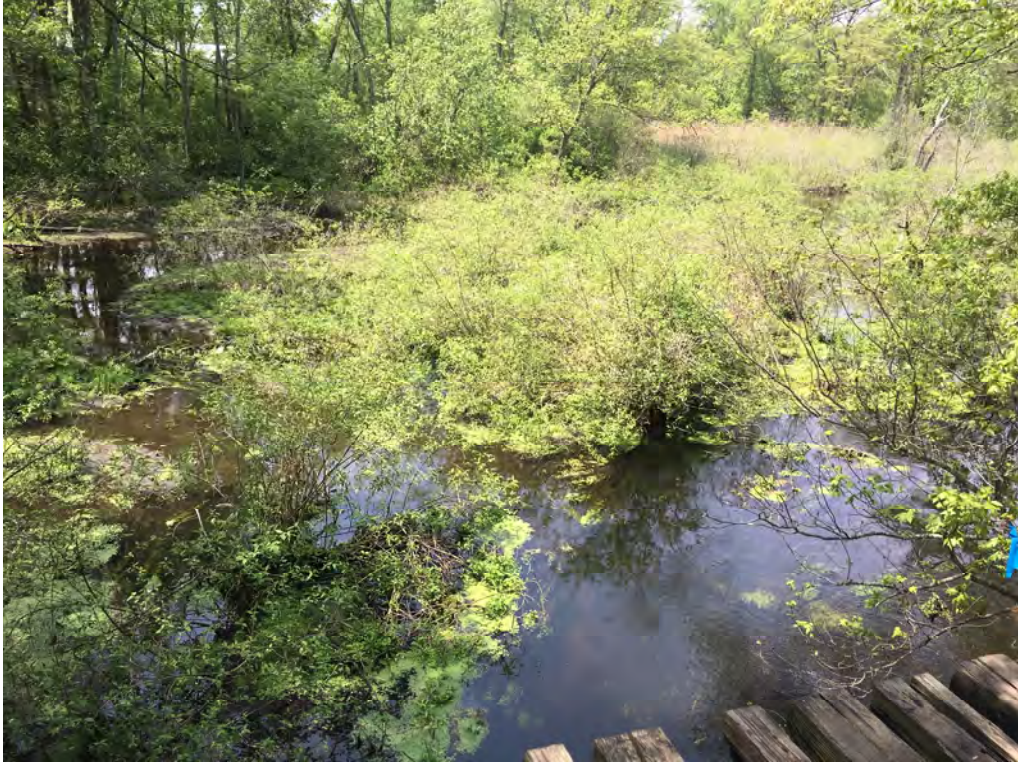
Photo 3: Channel (Looking West of the Bridge)

The channel alignment is poor, however there are no obvious signs of settlement at the abutments. There is a possible scour hole in the northwest corner of the channel, but no other signs of scour. The channel velocity is slow to moderate and there is moderate amounts of debris in the channel. There are some silt deposits in the northeast and southwest corners due to the alignment.

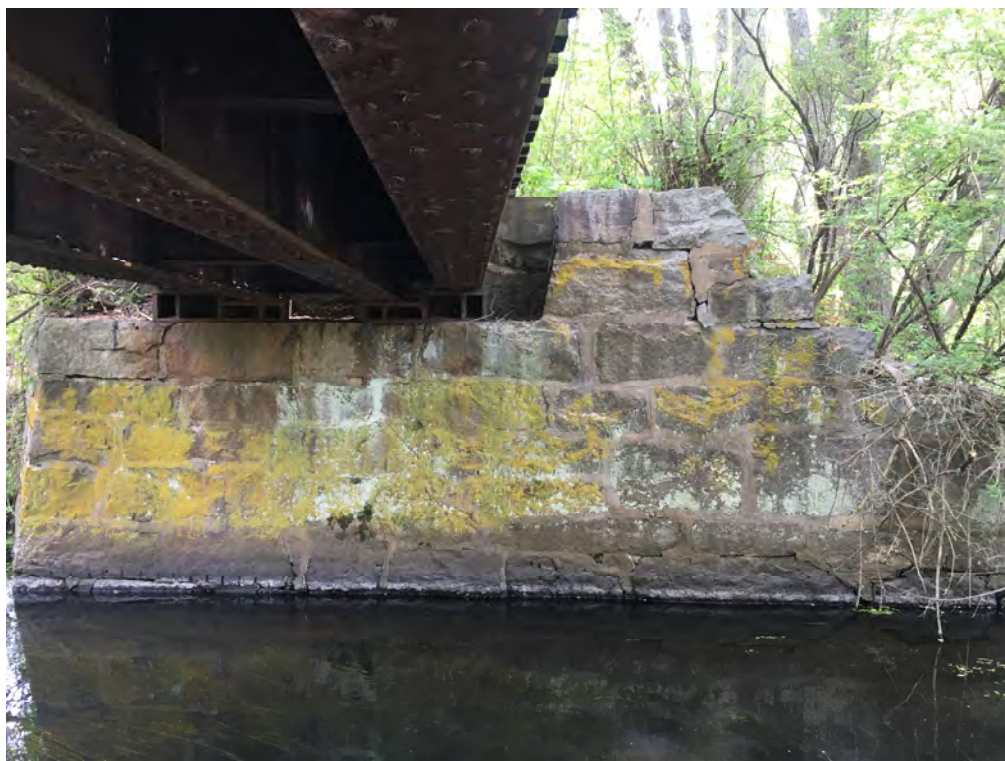
Photo 5: South Abutment

Both abutments are in satisfactory condition. Some of the pointing is missing on the abutment faces and wingwalls, mostly near the waterline. There are no obvious signs of settlement.

- Clean and Repoint stone masonry missing joints at abutments and wingwalls.
- Monitor abutments for potential scour

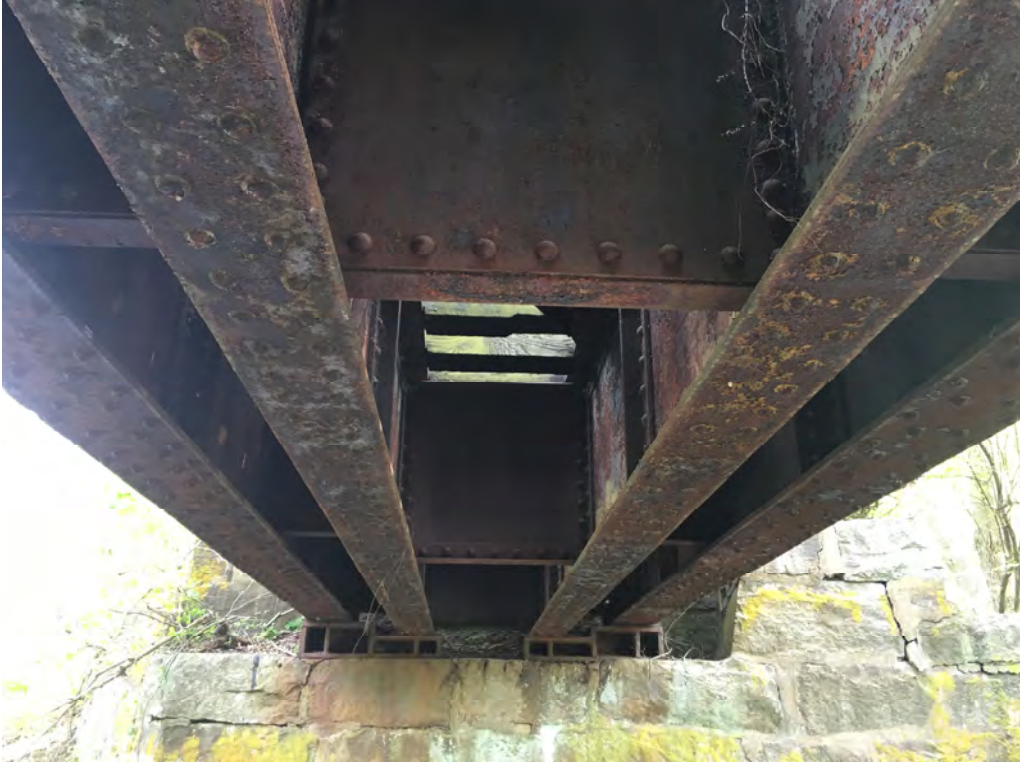
Photo 9: Typical Framing

The existing structure is a riveted steel deck plate girder superstructure supported on granite block stone masonry abutments. The structure is comprised of four steel built up girders, nested in two groups. The girders are spaced at 2'-0", 3'-0", and 2'-0" from west to east respectively. There are built up channel diaphragms at 1/3 points along the bridge along with lateral bracing of the top flange. The existing

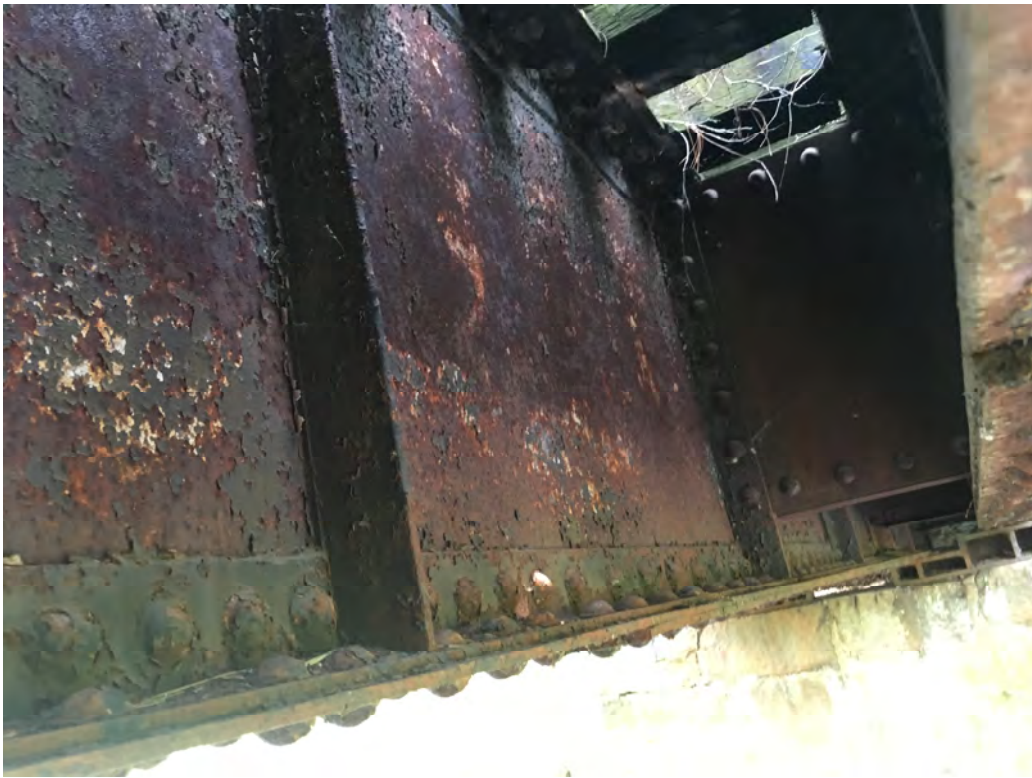
Photo 10: Typical Steel Condition

The built up girders are in satisfactory condition, with only surface rusting and minor pitting. The paint system has completely failed, and only minor flakes remain. The bracing and rivet heads are also in satisfactory condition with less than 5% loss. Although the timber ties and rails were not evaluated during the site visit as they will be removed for the rehabilitation of the bridge, it is noted that the ties were moderately rotted, some more than half the way through. There is no noted collision damage to the superstructure.

- Remove all railroad ties and track.
- Remove all existing paint.
- Paint all steel elements.
- Jack superstructure for horizontal shift for proposed path alignment and replace bearings.

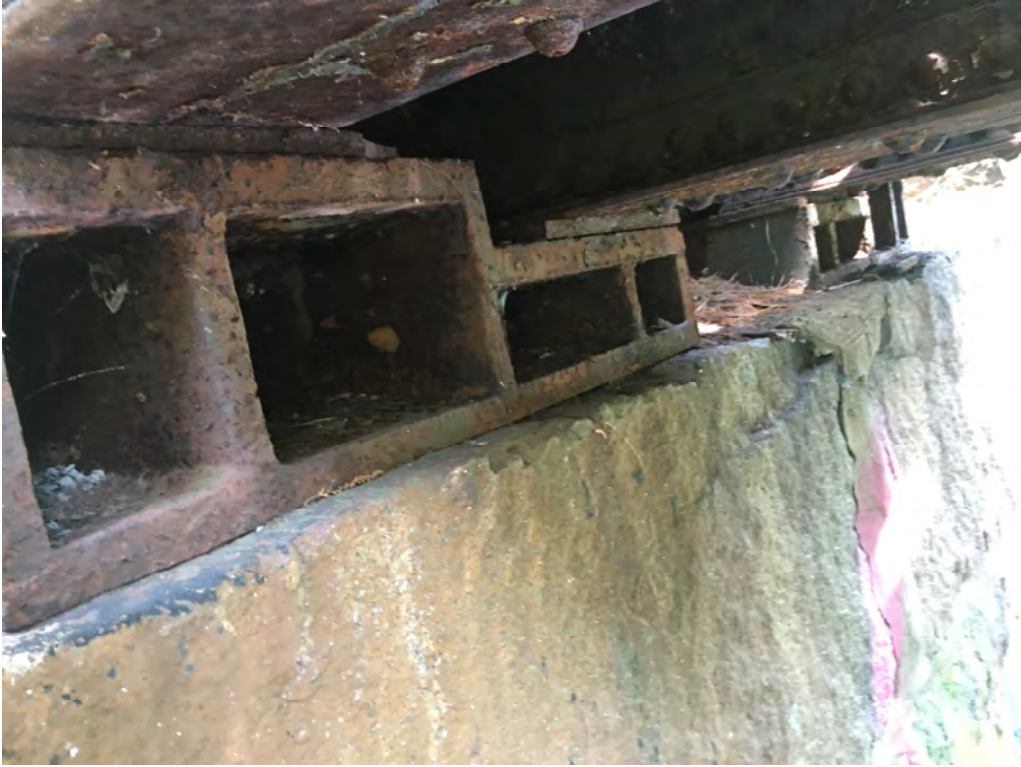
Photo 11: Typical Bearing Assemblies

The bearings at both abutments appear to be in generally satisfactory condition with minor rust and debris present and do not need to be replaced. The bearings sit directly on steel built up bolsters which sit on the stone bridge seats.
