Feasibility Study for the Bruce Freeman Rail Phase 3 Extension

Prepared for the Town of Sudbury

June 2023

Fuss & O'Neill has completed a feasibility study which includes preliminary data collection, conceptual design, and cost analysis for the extension of the Bruce Freeman Rail Trail (BFRT) Phase 3 in Sudbury, MA.

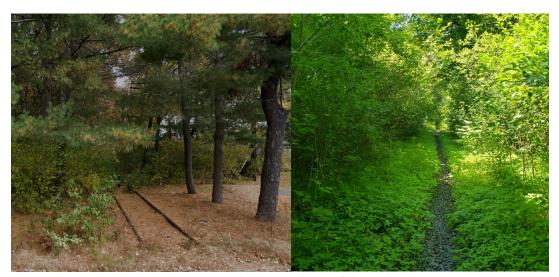
Image 1: Existing condition of the trail

The rail trail is proposed to follow the inactive Framingham and Lowell Railroad line which was abandoned in the 1980's. Because of this, the proposed build area is overgrown with trees and vegetation and remnants of the old railroad infrastructure are evident in the project area.

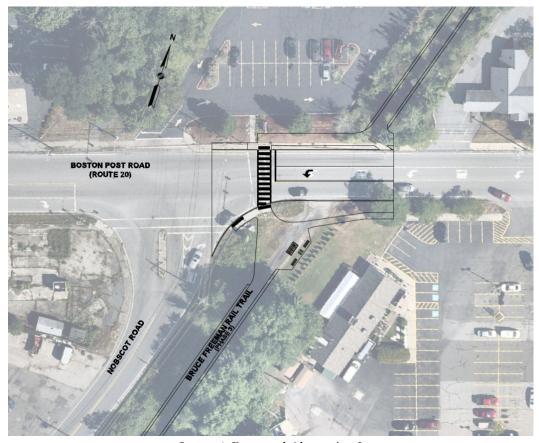
Image 4: Proposed Alternative 2

The second alternative would align trail users with the existing signalized crosswalk location and allow them to cross the road under the protection of pedestrian signal phase (See Image 4 below). Supplemental signage and pavement markings for both trail users and drivers would be implemented to direct all intersection users on how to safely navigate this intersection. This alternative would maintain the existing roadway geometry, pavement markings, and signal infrastructure. Minor upgrades to signal phasing, push buttons, pedestrian count-down timers, curb ramps, and signage to meet ADA standards would be necessary, but generally the intersection configuration and assets would remain unchanged.

The preferred alternative is alternative 2, which includes leaving the existing intersection signalized and only upgrading features like pedestrian curb ramps, sidewalks around the intersection, and the signal timings. No changes in roadway geometry are recommended because at the current stage, this is a rail trail project and a full intersection reconstruction is not deemed necessary to accommodate the trail.

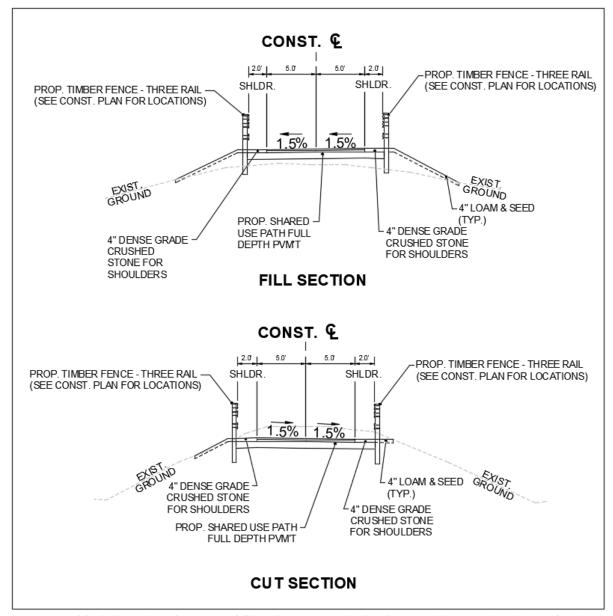
Image 12: Typical sections for areas of fill and cut, respectively, shown with protective timber fencing.

the trail will have fencing to protect trail users from either wetlands or steep side slopes which can be seen in Image 12 below.

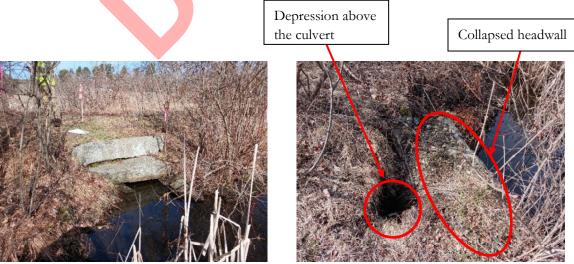
The western headwall appears to have collapsed which allowed for very limited access to examine the interior of the culvert. The eastern headwall appears in working condition. A major concern is the existing ground above the trail near the western headwall. Near this headwall, depressions in the ground were observed causing concern for potential erosion or even a full collapse of the culvert.

Western entrance and wingwalls

Collapsed headwall at the eastern entrance

Recommendations: High water levels and low headwalls prohibited the examination of the inside of the culvert so further examination during a dryer period is recommended. However, given the observed conditions, a replacement of this culvert and reconstruction of headwalls is likely needed.

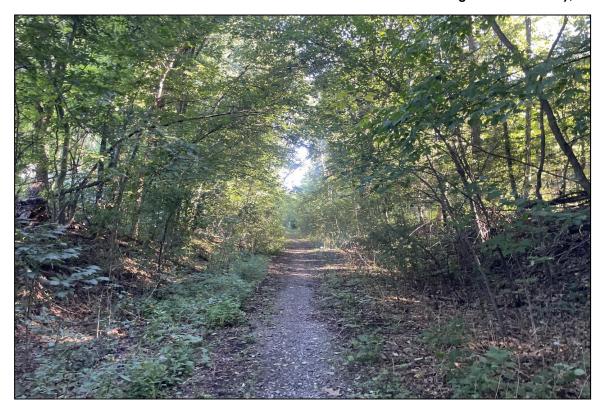
Photo 1: Overview of rail trail from the entrance near Eaton Road W in Framingham, MA (9/14/22).

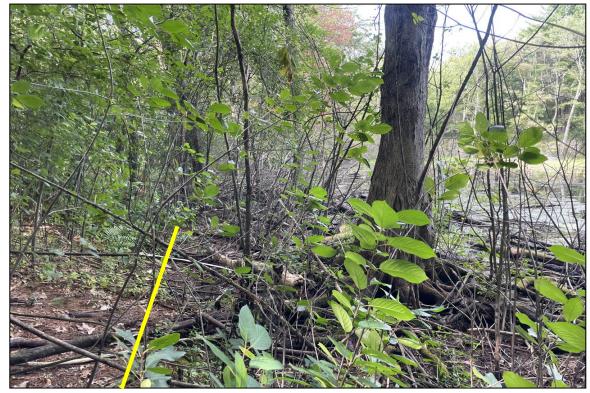
Photo 8: View of Bank 5A of the unnamed pond. Yellow line approximates delineated Bank (9/14/22).

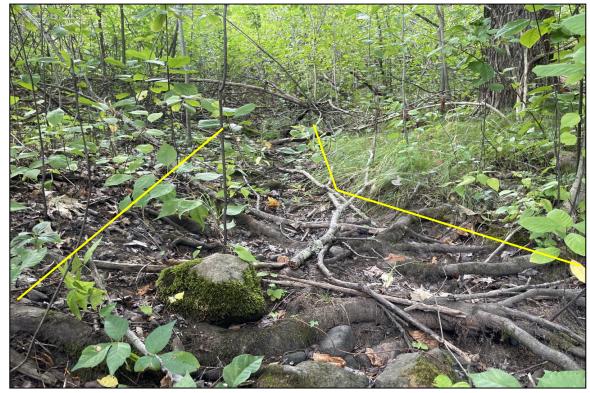
Photo 10: View of Banks 5B/C defined by a break in slope and change in vegetation (9/14/22).

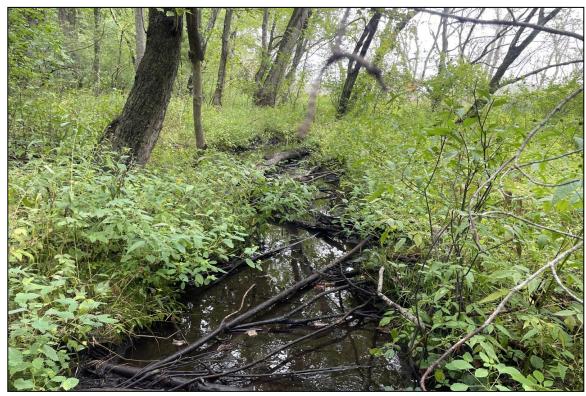
Photo 18: View of Banks 6D/E from flag 6D-1. This stream is classified as intermitted under MAWPA and perennial under the Sudbury Wetlands Bylaw (9/20/22)

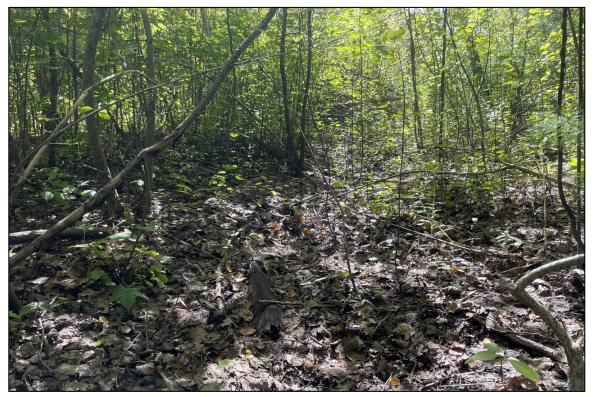
Photo 24: View of the diffuse Bank 11B which is not jurisdictional under MAWPA and considered an intermittent stream under the Sudbury Wetlands Bylaw (9/28/22).
