Camp Sewataro — Buildings

Town of Sudbury ADA Transition Plan

January 2021

Institute for Human Centered Design

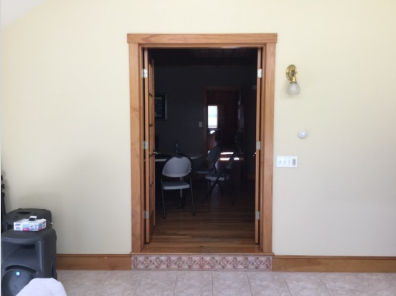
ID	Location	Floor	Room	Element	Type	Photo	Issues	Current Measure	Recommendations	Quantity	Price	Cost Estimation
1	Building 1 - Door Between Rear Office and Sun Room	1

Note: From the sun room entrance, if the public is allowed to access the rest of the house, a lift or 17' ramp will need to be installed in this location.	1	-	\$0
2	Building 1 - Parking	Ext.		Off-Street Parking Lot or Garage	Employee

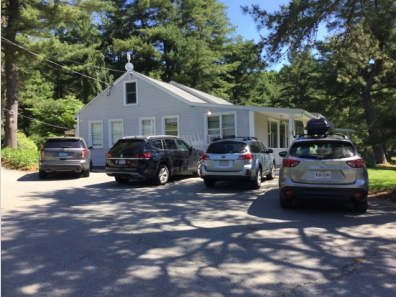
Total # of parking Total # of designated accessible parking spaces Total # of designated van accessible spaces	5 0 0	Provide one van accessible parking space.	1	1850	\$1850
3	Building 1 - Route to Entrance	Ext.		Entrance	Main Entrance

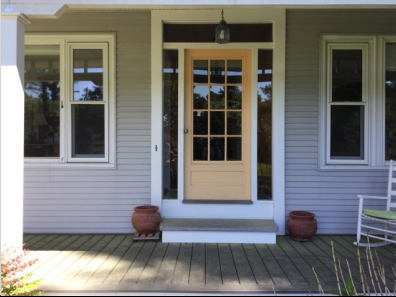
Entrance not on an accessible route Directional sign to accessible entrance not provided	27.25" -	Provide a directional sign indicating the location of the nearest accessible entrance.	1	346	\$346
4	Building 1 - Side Patio	1		Entrance	Secondary Entrance

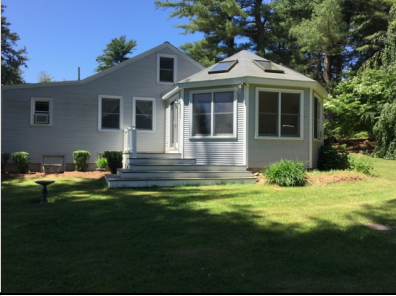
Entrance not on an accessible route	-	Provide a 35' long ramp to this entrance with compliant landings. (Cost estimate for a pressure treated wood dogleg ramp to address a 35" change in level.)	1	8566	\$8566

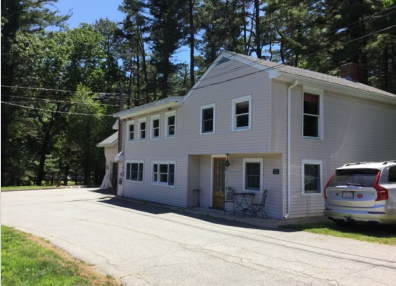
5	Building 2	Ext.		Off-Street Parking Lot or Garage	Visitor

Total # of parking Total # of designated van accessible spaces	5 est. 0	Provide one van accessible space.	1	1850	\$1850

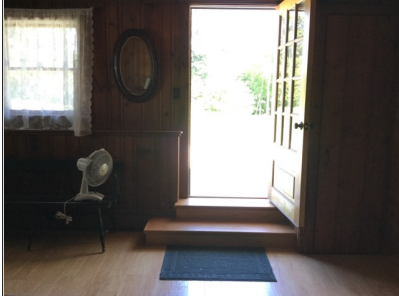
ID	Location	Floor	Room	Element	Type	Photo	Issues	Current Measure	Recommendations	Quantity	Price	Cost Estimation
6	Building 2 - Main Entrance	1		Interior Access Route	N/A

Level changes > 1/4"	12.5"	Provide a compliant wood ramp to address the 12.5" change in level. (Cost estimate for a wood dogleg ramp.)	1	5027	\$5027
7	Building 2 - Main Entrance	Ext.		Entrance	Main Entrance

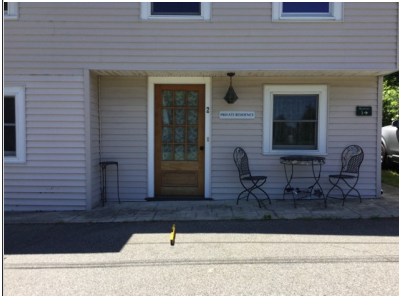
Entrance not on an accessible route Hardware not operable with a closed fist	3.25" -	Provide a compliant sloped walkway to the entrance and a level platform at the entrance that provides door maneuvering clearance. Provide hardware that can be operable with one hand and not require tight grasping, pinching, or twisting of the wrist. (Cost estimate for door hardware and a 15' long by 4' wide concrete route.)	1	1864	\$1864
8	Building 4 - Parking	1		Off-Street Parking Lot or Garage	N/A

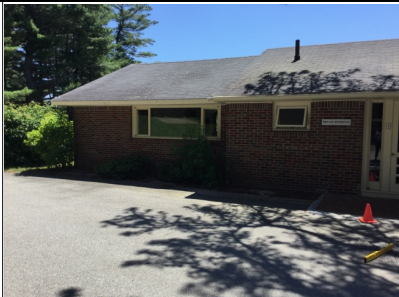
Total # of parking Total # of designated van accessible spaces	5 0	Provide one van accessible space.	1	1850	\$1850

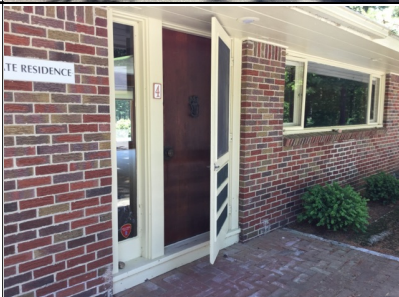
9	Building 4 - Main Entrance	1		Exterior Access Route	Exterior

Accessible route not provided	6.25"	Ensure an accessible route is provided. Provide a 6' long ramp with compliant platforms at the top and bottom. (Cost estimate for a straight concrete ramp with a 6" rise.)	1	7080	\$7080
10	Building 4 - Main Entrance	1		Entrance	Main Entrance

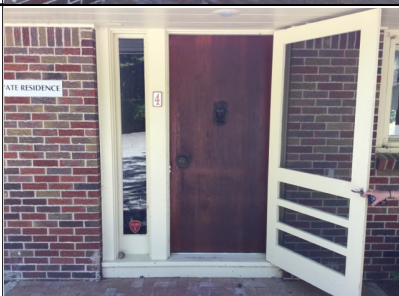
Hardware not operable with a closed fist	-	Provide hardware that can be operable with one hand and not require tight grasping, pinching, or twisting of the wrist.	1	484	\$484

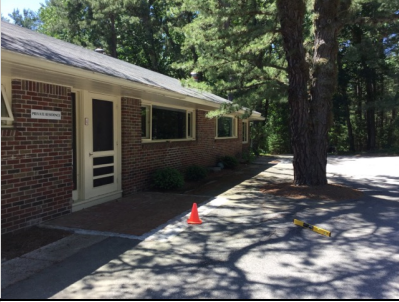
ID	Location	Floor	Room	Element	Type	Photo	Issues	Current Measure	Recommendations	Quantity	Price	Cost Estimation
11	Building 4 - Route to Entrance	1		Exterior Access Route	Exterior

Running slope > 1:20 (5%)	11.4%	Reduce running slope to be no steeper than 1:20 (5%). Route by entrance has an excessive slope due to tree roots. Address issues when designing ramp at entrance.	1	-	\$0
12	Building 6 - Barn Entrance	Ext.		Entrance	Main Entrance

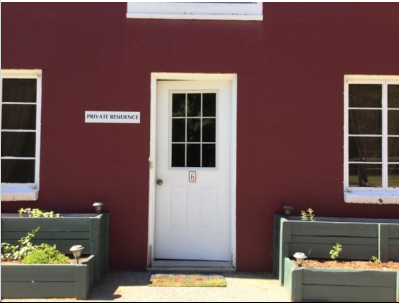
Threshold > 1/2" high Hardware not operable with a closed fist	2", 1" -	Alter threshold to be 1/2" high max. Provide hardware that can be operable with one hand and not require tight grasping, pinching, or twisting of the wrist.	1	534	\$534
13	Building 6 - Route to Horse Stable Barn	Ext.		Off-Street Parking Lot or Garage	Visitor

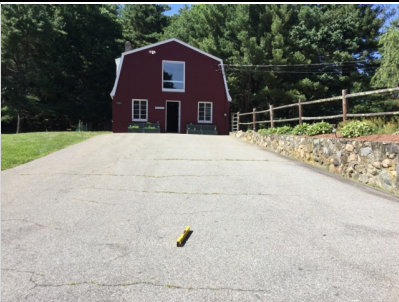
Total # of designated van accessible spaces Total # of parking	5 est. 0	Provide one van accessible space.	1	1850	\$1850
