Heritage Park

Town of Sudbury ADA Transition Plan

January 2021

**Town of Sudbury
Heritage Park**

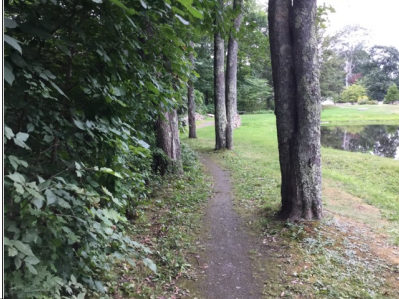
ID	Location	Floor	Room	Element	Type	Photo	Issues	Current Measure	Recommendations	Quantity	Price	Cost Estimation
Approach and Entrance												
Exterior Access Route												
1	Walkway South of Pond	Ext.		Exterior Access Route	Exterior

Exterior route < 48" wide	17"	Ensure that a clear width of 48" min. is maintained at the accessible route. (Cost estimate for labor and 20' long 4' wide stone dust route.)	1	Labor 640	\$640
2	Dogwood Path	Ext.		Exterior Access Route	Exterior

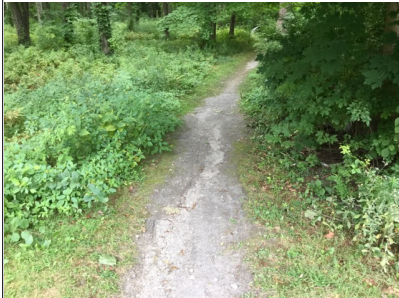
Exterior route < 48" wide Cross slope > 1:50 (2.00%) Running slope > 1:20 (5%)	20"-30" 3.4% 9.1%-17%	Ensure that a clear width of 48" min. is maintained at the accessible route. Reduce cross slope to be no steeper than 1:50 (2.00%). Reduce running slope to be no steeper than 1:20 (5%). (Cost estimate for a 530' long, 4' wide stone dust path.)	1	16960	\$16960
3	9/11 Memorial	Ext.		Exterior Access Route	Walkway

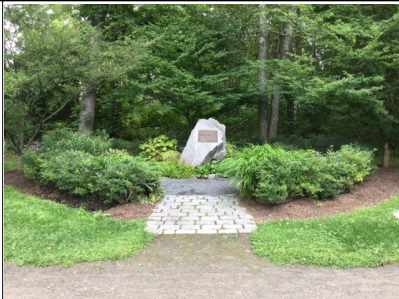
Surface openings > 1/2" Running slope > 1:20 (5%)	1.5" 10.1%	Ensure that surface has openings that are 1/2" max. and the long opening dimension is perpendicular to the dominant direction of travel. Reduce running slope to be no steeper than 1:20 (5%). (Cost estimate for a 14' long 4' wide stone dust route.)	1	560	\$560

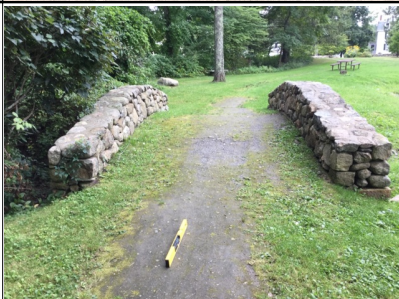
4	Walkway South of Pond	Ext.		Exterior Access Route	Walkway

Running slope > 1:20 (5%)	7.3%	Reduce running slope to be no steeper than 1:20 (5%). (Cost estimate for a 6' long 4' wide stone dust area.)	1	240	\$240
5	Walkway South of Pond	Ext.		Exterior Access Route	Walkway

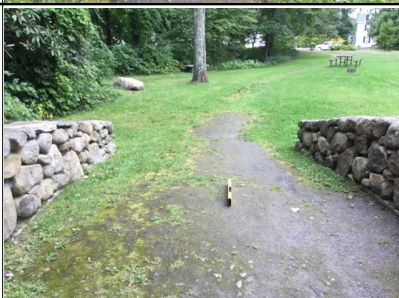
Running slope > 1:20 (5%)	9.7%	Reduce running slope to be no steeper than 1:20 (5%). (Cost estimate for a 12' long 4' wide stone dust area.)	1	480	\$480

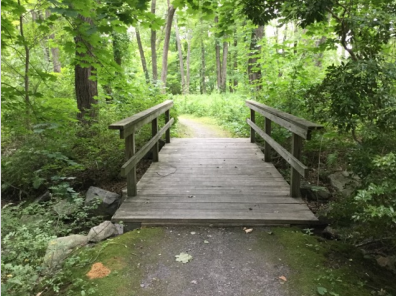
ID	Location	Floor	Room	Element	Type	Photo	Issues	Current Measure	Recommendations	Quantity	Price	Cost Estimation
6	Dogwood Path	Ext.		Exterior Access Route	Walkway

Level changes > 1/4"	3"	Alter change in level to be 1/4" high max. (Cost estimate for providing a 12' by 4' stone dust area.)	1	480	\$480
7	Dogwood Path Bridge	Ext.		Exterior Access Route	Walkway

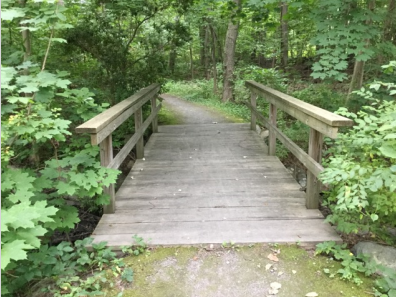
Level changes > 1/4"	1.25"	Alter change in level to be 1/4" high max. (Cost estimate for providing a 4' by 4' stone dust area.)	1	160	\$160
8	Walkway from Pond to Concord Road	Ext.		Exterior Access Route	Walkway

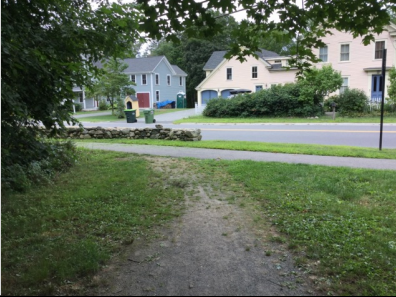
Route not maintained in operable working condition Vertical clearance < 80" above ground	- 74"	Ensure the accessible route is maintained in operable working condition. Trim low hanging tree branches. (Cost estimate for a 20' long 4' wide stone dust route.)	1	840	\$840
9	Cricket Pond	Ext.		Exterior Access Route	Exterior

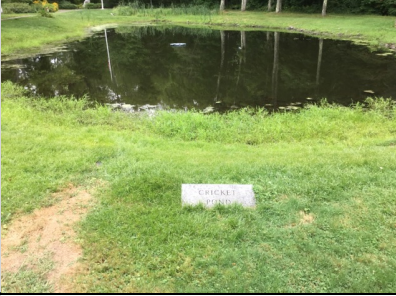
Accessible route not provided	-	Locate sign identifying pond on an accessible route.	1	Labor	\$0

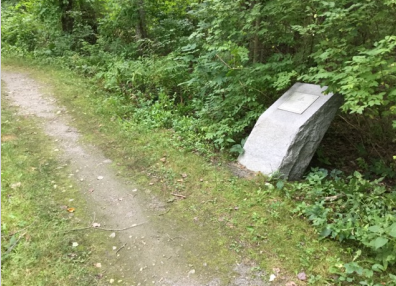
10	Dogwood Path Plaque	Ext.		Exterior Access Route	Exterior

Accessible route not provided	-	Ensure an accessible route is provided to the plaque. (Cost estimate for a 6' long by 4' wide stone dust walkway.)	1	192	\$192

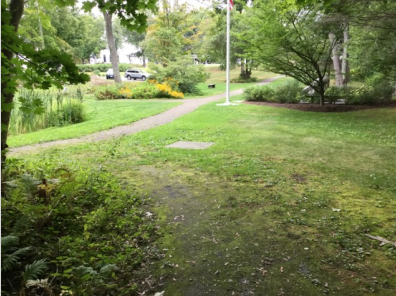
ID	Location	Floor	Room	Element	Type	Photo	Issues	Current Measure	Recommendations	Quantity	Price	Cost Estimation
11	Entrance from Dogwood Path to 9/11 Memorial	Ext.		Exterior Access Route	Exterior

Accessible route not provided		Ensure an accessible route is provided between the dogwood path and the 9/11 Memorial path. (Cost estimate for a 20' long by 4' wide stone dust walkway.)	1	640	\$640
12	Near Stairs to Old Sudbury Road	Ext.		Exterior Access Route	Exterior

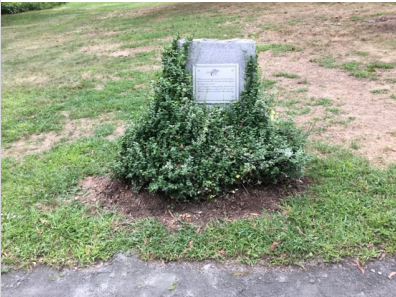
Accessible route not provided	-	Ensure an accessible route is provided. (Cost estimate for a 6' long by 4' wide stone dust walkway.)	1	192	\$192
13	Plaque Along Walkway by Pond and 9/11 Memorial	Ext.		Exterior Access Route	Exterior

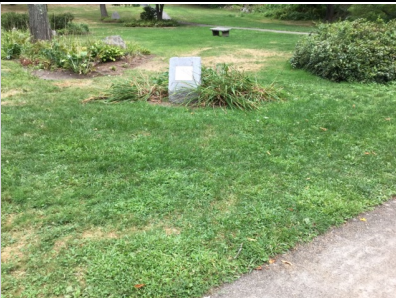
Accessible route not provided	-	Ensure an accessible route is provided. (Cost estimate for a 10' long by 4' wide stone dust walkway.)	1	320	\$320
14	Walkway from Pond to Concord Road	Ext.		Exterior Access Route	Exterior

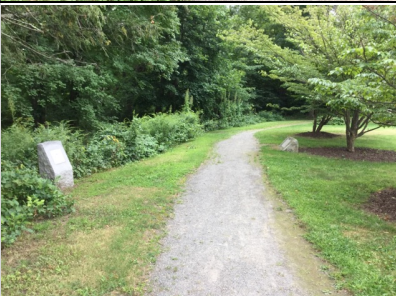
Accessible route not provided	-	Ensure an accessible route is provided to each plaque. (Cost estimate for a 6' long by 4' wide stone dust walkway.)	2	192	\$384

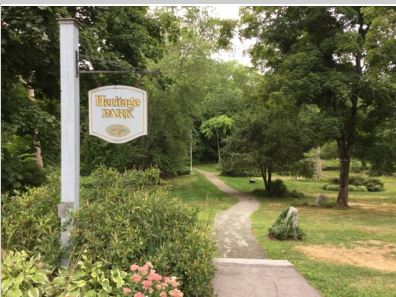
Entrance												
15	Main Entrance from Old Sudbury Road	Ext.		Entrance	Main Entrance

Entrance not on an accessible route		Provide a directional sign indicating the location of the nearest accessible entrance.	1	346	\$346
Access to Goods and Services

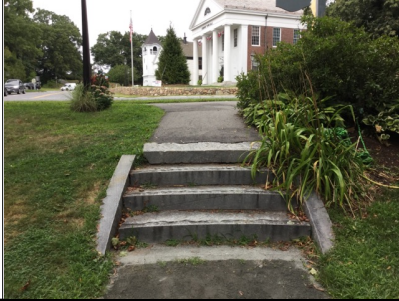
ID	Location	Floor	Room	Element	Type	Photo	Issues	Current Measure	Recommendations	Quantity	Price	Cost Estimation
Stairways												
16	Main Entrance from Old Sudbury Road	Ext.		Stairways	Exterior

Handrails not provided	-	Provide handrails. (Cost estimate for 20' of metal handrail.)	1	1480	\$1480
Picnic Tables												
17	Near Old Sudbury Road Entrance	Ext.		Picnic Tables	N/A

Accessibility issues include lack of handrails at stairs.

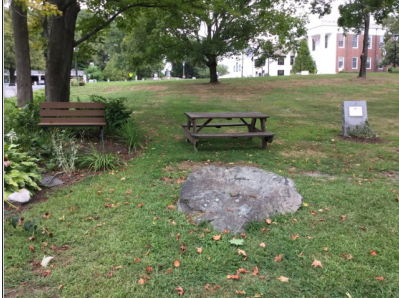
Toe or knee clearance at table not provided Picnic table not on an accessible route	- -	Provide at least one picnic table with top between 28"- 34" above the ground and 27" clear height underneath. Ensure that the dining surface is connected to an accessible route. (Cost for an accessible picnic table.)	1	1400	\$1400
18	Walkway South of Pond	Ext.		Picnic Tables	N/A

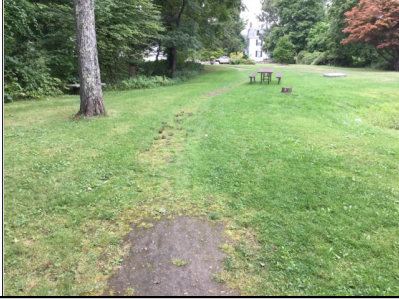
Toe or knee clearance at table not provided Picnic table not on an accessible route	14.75" deep -	Provide at least one picnic table with top between 28"- 34" above the ground and 27" clear height underneath. Ensure that the dining surface is connected to an accessible route. (Cost estimate for 20' long 4' wide stone dust walkway and a new accessible picnic table.)	1	2040	\$2040

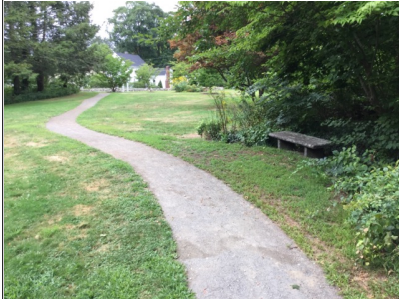
Benches												
19	Along Walkway by Pond	Ext.		Benches	N/A

No accessible route to one bench in this area		Provide an accessible route to at least one bench in this area. (Cost estimate for a 10' long by 4' wide stone dust walkway.)	1	320	\$320
20	Dogwood Path Bench After Bridge by 9/11 Memorial	Ext.		Benches	N/A

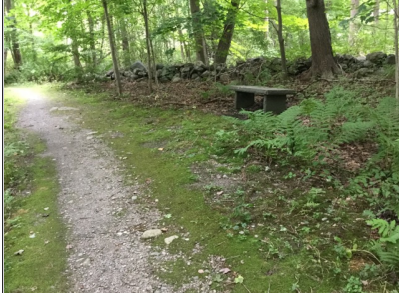
No accessible route to one bench in this area		Provide an accessible route to at least one bench in this area. (Cost estimate for a 10 long by 4' wide stone dust walkway.)	1	320	\$320

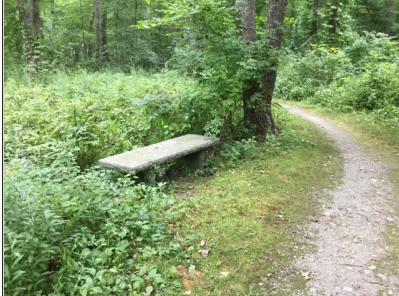
ID	Location	Floor	Room	Element	Type	Photo	Issues	Current Measure	Recommendations	Quantity	Price	Cost Estimation
21	Dogwood Path Bench Before Bridge by Concord Road	Ext.		Benches	N/A

No accessible route to one bench in this area	-	Provide an accessible route to at least one bench in this area. (Cost estimate for a 6' long by 4' wide stone dust walkway.)	1	192	\$192
22	Walkway from 9/11 Memorial to Pond	Ext.		Benches	N/A

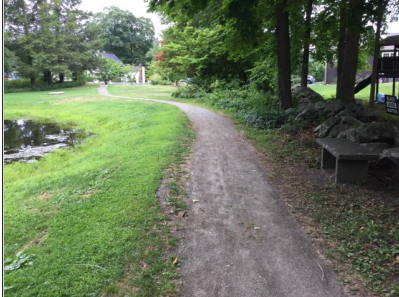
No accessible route to one bench in this area	-	Provide an accessible route to at least one bench in this area. (Cost estimate for a 6' long by 4' wide stone dust walkway.)	1	192	\$192
23	Walkway from Old Sudbury Road to 9/11 Memorial	Ext.		Benches	N/A

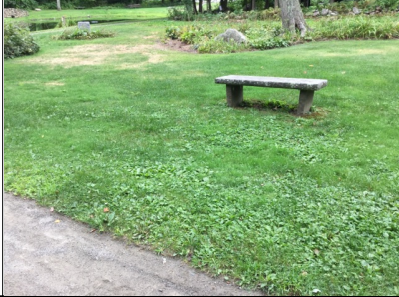
No accessible route to one bench in this area		Provide an accessible route to at least one bench in this area. (Cost estimate for a 10' long by 4' wide stone dust walkway.)	1	320	\$320
24	Walkway South of Pond	Ext.		Benches	N/A

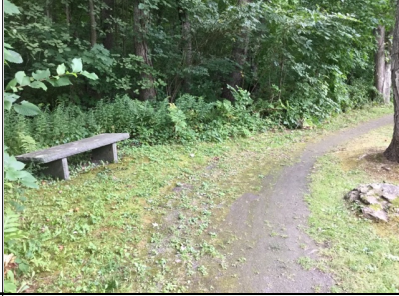
No accessible route to one bench in this area		Provide an accessible route to at least one bench in this area. (Cost estimate for a 6' long by 4' wide stone dust walkway.)	1	192	\$192

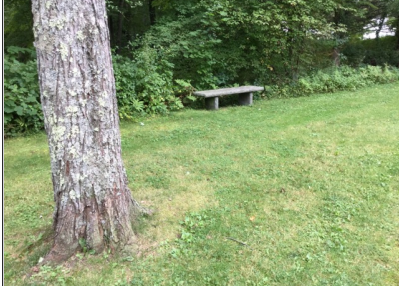
25	Walkway South of Pond	Ext.		Benches	N/A

No accessible route to one bench in this area		Provide an accessible route to at least one bench in this area. (Cost estimate for 10' long 4' wide stone dust walkway.)	1	320	\$320

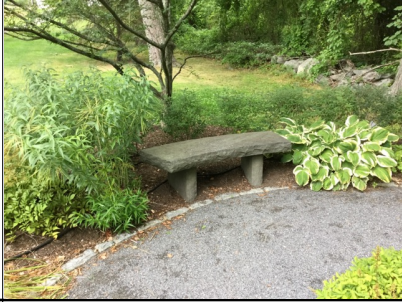
ID	Location	Floor	Room	Element	Type	Photo	Issues	Current Measure	Recommendations	Quantity	Price	Cost Estimation
26	9/11 Memorial	Ext.

Recommend providing space alongside one bench in each area for a wheelchair user to sit shoulder to shoulder with a person seated on the bench.	1	-	\$0
27	Main Entrance from Old Sudbury Road	Ext.

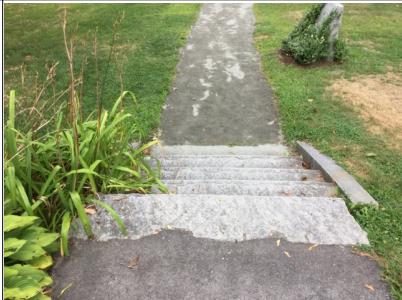
Recommend providing visual contrast strips at stair for safety and increased visibility.	1	-	\$0
28	Main Entrance from Old Sudbury Road	Ext.

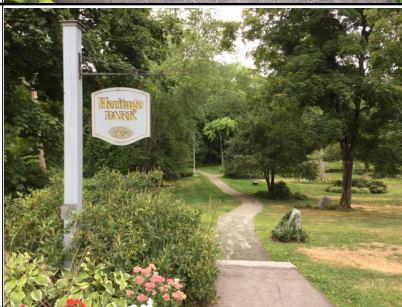
Recommend providing an accessible entrance to the park at this point if possible.	1	-	\$0
29	Near Pond	Ext.

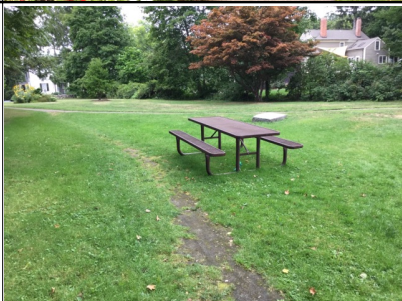
Recommend providing a 48" wide route around all sides of one picnic table in each area.	1	-	\$0
