**Weekly Environmental Compliance Summary**

**Sudbury to Hudson Transmission Reliability Project (USEPA Tracking # MAR1003UW)**

Sudbury, Hudson, and Stow, MA

Week of: February 27 to March 3, 2023

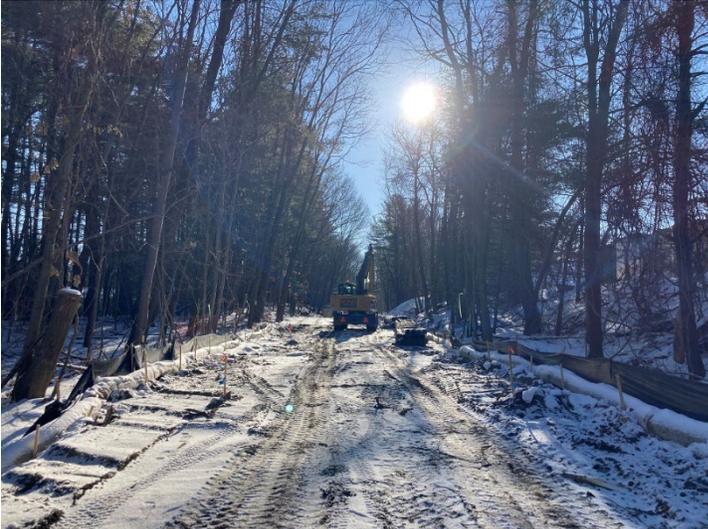
<p align="center"><b>PHOTOGRAPHIC LOG</b></p>	
<p><b>Client Name:</b> Eversource</p>		<p><b>Site Location:</b> Sudbury to Hudson Transmission Reliability Project</p>	<p><b>Town:</b> Hudson</p>
<p><b>Photo No.:</b> 2</p>	<p><b>Date:</b> 2/27/2023</p>

<p><b>Description:</b> View of Bond performing conduit work in segment 3. Facing east.</p>

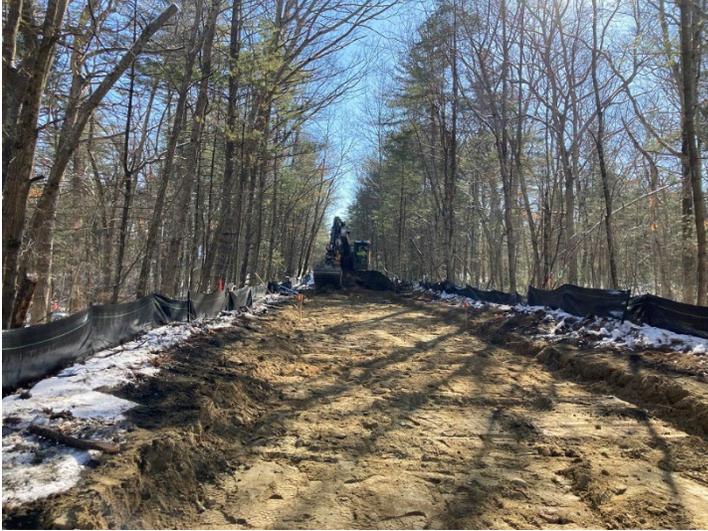
<b>PHOTOGRAPHIC LOG</b>	
<b>Client Name:</b> Eversource		<b>Site Location:</b> Sudbury to Hudson Transmission Reliability Project	<b>Town:</b> Sudbury
<b>Photo No.:</b> 3	<b>Date:</b> 2/27/2023

<b>Description:</b> View of ET&L performing cut & fill activities in segment 8. Facing east.

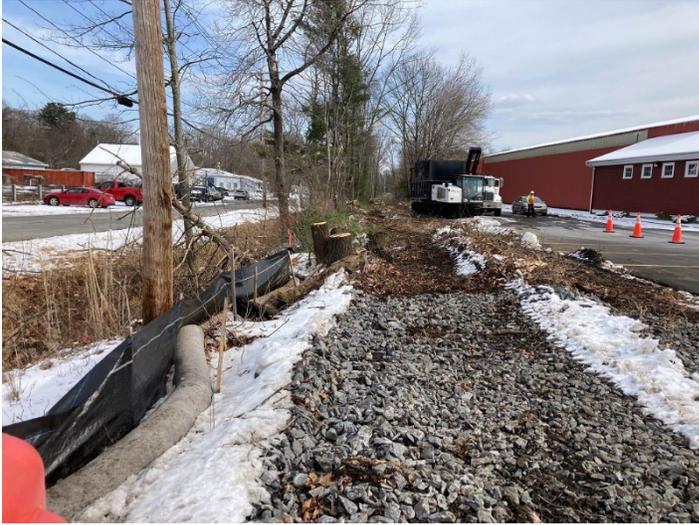
<p><b>PHOTOGRAPHIC LOG</b></p>	
<p><b>Client Name:</b> Eversource</p>		<p><b>Site Location:</b> Sudbury to Hudson Transmission Reliability Project</p>	<p><b>Town:</b> Sudbury</p>
<p><b>Photo No.:</b> 6</p>	<p><b>Date:</b> 2/27/2023</p>

<p><b>Description:</b>                  View of Moosehead performing chipping activities in segment 12. Facing east.</p>

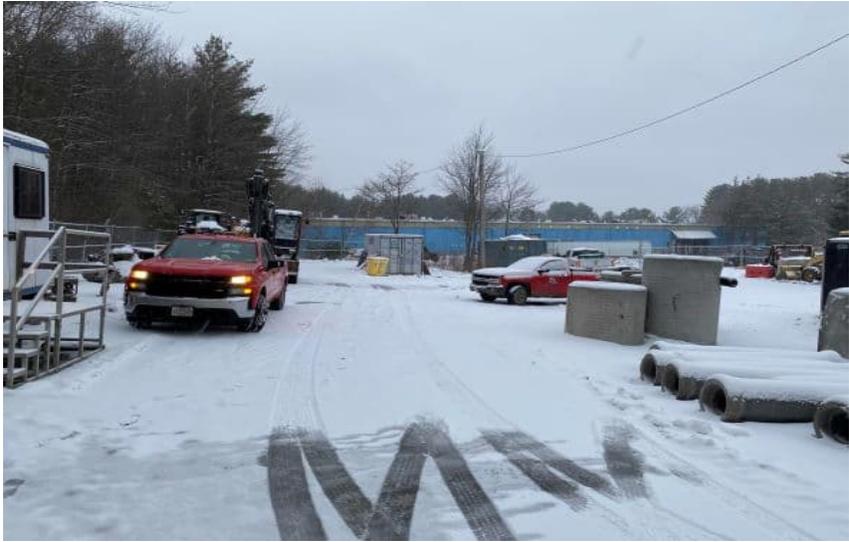
<p>PHOTOGRAPHIC LOG</p>	
<p>Client Name: Eversource</p>		<p>Site Location: Sudbury to Hudson Transmission Reliability Project</p>	<p>Town: Hudson</p>
<p>Photo No.: 1</p>	<p>Date: 2-28-23</p>

<p>Description:</p> <p>Laydown yard at 555 Main Street, looking westward.</p>

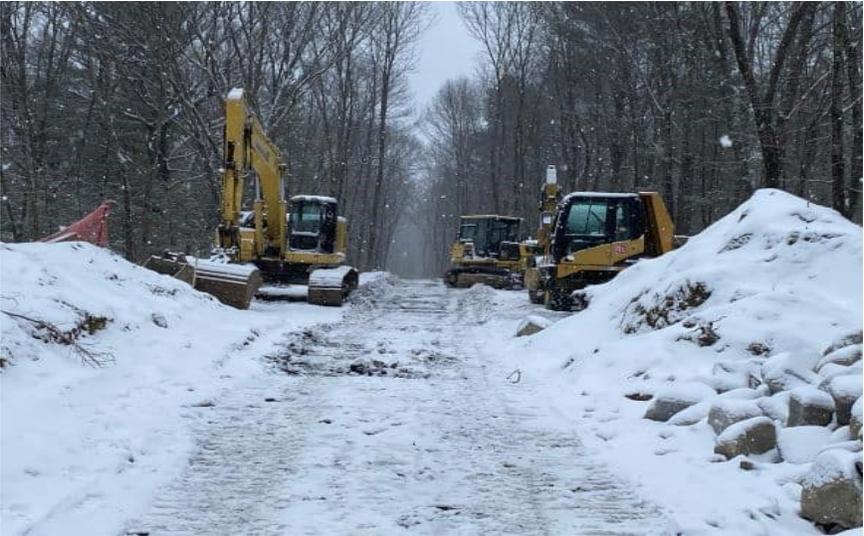
<p>PHOTOGRAPHIC LOG</p>	
<p>Client Name: Eversource</p>		<p>Site Location: Sudbury to Hudson Transmission Reliability Project</p>	<p>Town: Hudson</p>
<p>Photo No.: 3</p>	<p>Date: 2-28-23</p>

<p>Description:</p> <p>ET&amp;L mobilizing off Wilkins for headwall work in Stow, looking eastward.</p>

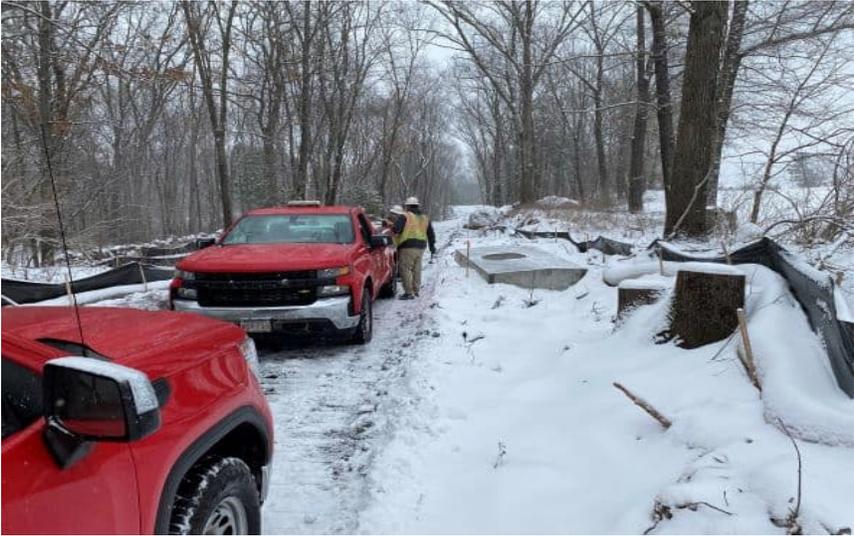
<p>PHOTOGRAPHIC LOG</p>	
<p>Client Name: Eversource</p>		<p>Site Location: Sudbury to Hudson Transmission Reliability Project</p>	<p>Town: Stow</p>
<p>Photo No.: 4</p>	<p>Date: 2-28-23</p>

<p>Description:</p> <p>ET&amp;L preparing (survey) for headwall work in Stow (Segment 1 at approximate Sta# 127+00, looking eastward.</p>

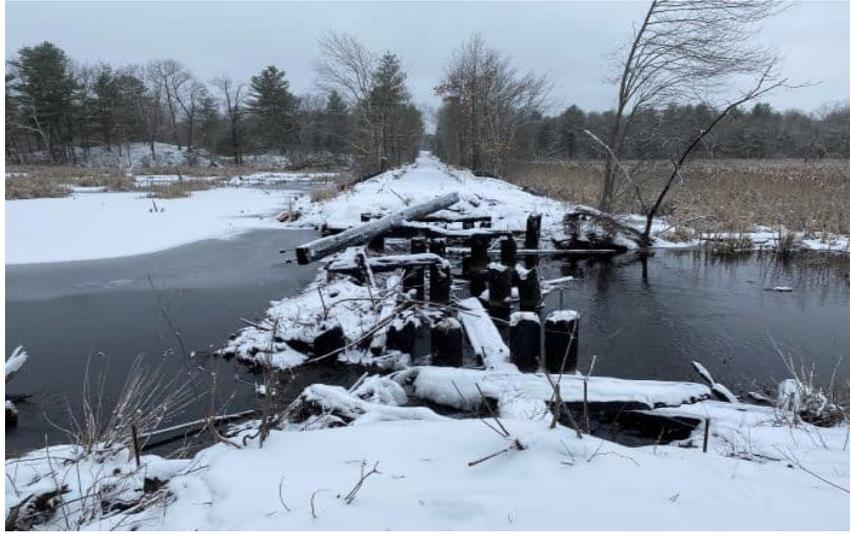
<p>PHOTOGRAPHIC LOG</p>	
<p>Client Name: Eversource</p>		<p>Site Location: Sudbury to Hudson Transmission Reliability Project</p>	<p>Town: Hudson</p>
<p>Photo No.: 6</p>	<p>Date: 2-28-23</p>

<p>Description:                  Bridge 130, looking westward.</p>

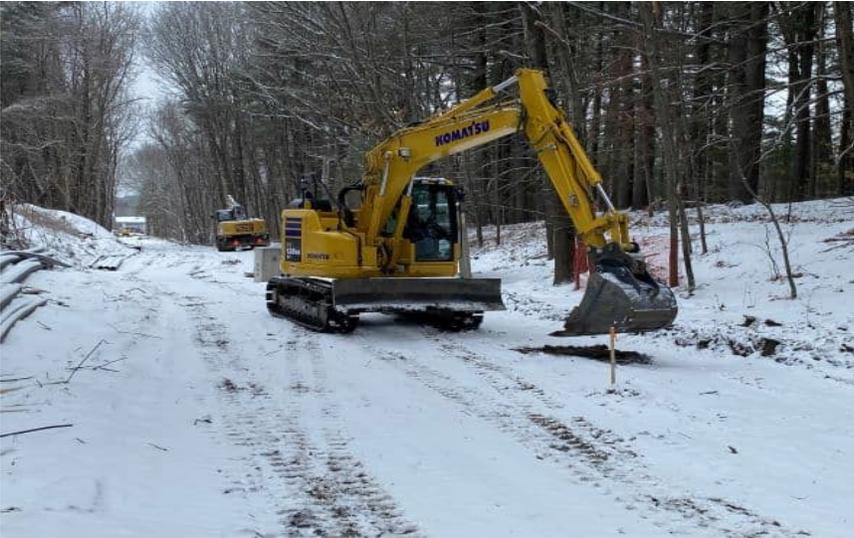
<p>PHOTOGRAPHIC LOG</p>	
<p>Client Name: Eversource</p>		<p>Site Location: Sudbury to Hudson Transmission Reliability Project</p>	<p>Town: Hudson</p>
<p>Photo No.: 7</p>	<p>Date: 2-28-23</p>

<p>Description:</p> <p>Bond conducting site work within Segment 4 at approximate Sta#166+50, looking westward.</p>

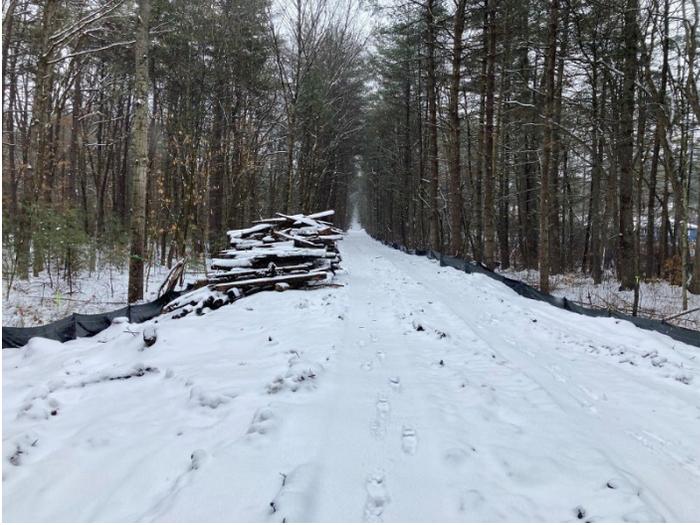
<p align="center"><b>PHOTOGRAPHIC LOG</b></p>	
<p><b>Client Name:</b> Eversource</p>		<p><b>Site Location:</b> Sudbury to Hudson Transmission Reliability Project</p>	<p><b>Town:</b> Sudbury</p>
<p><b>Photo No.:</b> 1</p>	<p><b>Date:</b> 2/28/2023</p>

<p><b>Description:</b> View of segment 10 off Peakham Rd. Facing east.</p>

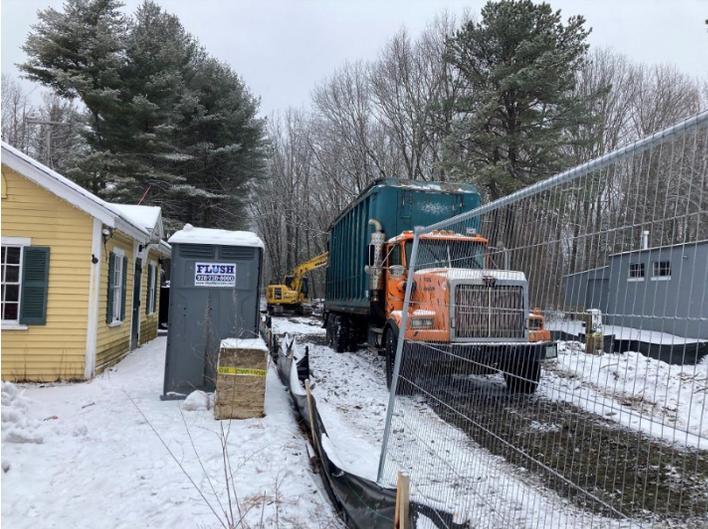
<p align="center"><b>PHOTOGRAPHIC LOG</b></p>	
<p><b>Client Name:</b> Eversource</p>		<p><b>Site Location:</b> Sudbury to Hudson Transmission Reliability Project</p>	<p><b>Town:</b> Sudbury</p>
<p><b>Photo No.:</b> 2</p>	<p><b>Date:</b> 2/28/2023</p>

<p><b>Description:</b> View of Moosehead performing rail and tie removal in segment 11 off Union Ave. Facing west.</p>

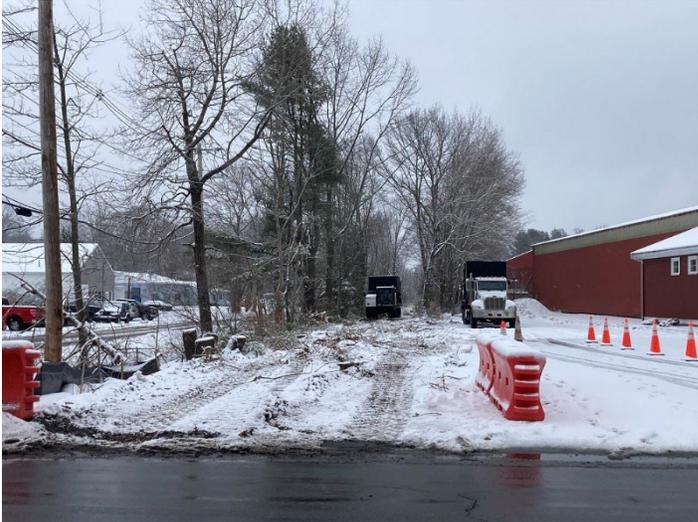
<p><b>PHOTOGRAPHIC LOG</b></p>	
<p><b>Client Name:</b> Eversource</p>		<p><b>Site Location:</b> Sudbury to Hudson Transmission Reliability Project</p>	<p><b>Town:</b> Sudbury</p>
<p><b>Photo No.:</b> 4</p>	<p><b>Date:</b> 2/28/2023</p>

<p><b>Description:</b> View of Moosehead performing chipping activities in segment 12. Facing east.</p>

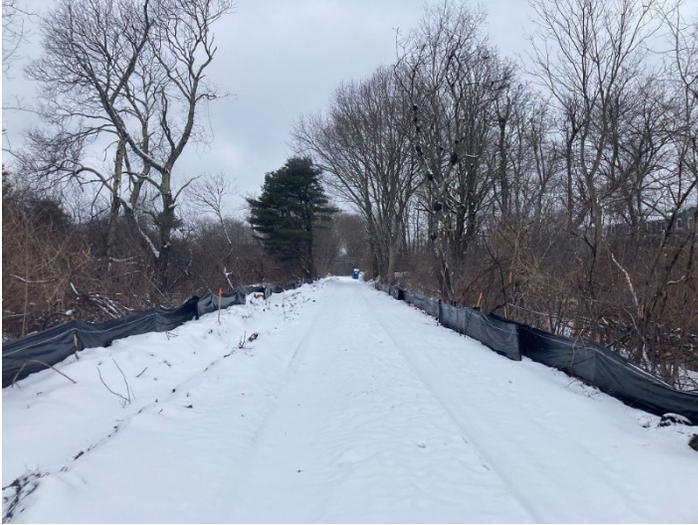
<b>PHOTOGRAPHIC LOG</b>	
<b>Client Name:</b> Eversource		<b>Site Location:</b> Sudbury to Hudson Transmission Reliability Project	<b>Town:</b> Sudbury
<b>Photo No.:</b> 5	<b>Date:</b> 2/28/2023

<b>Description:</b> View of segment 14. Facing west.

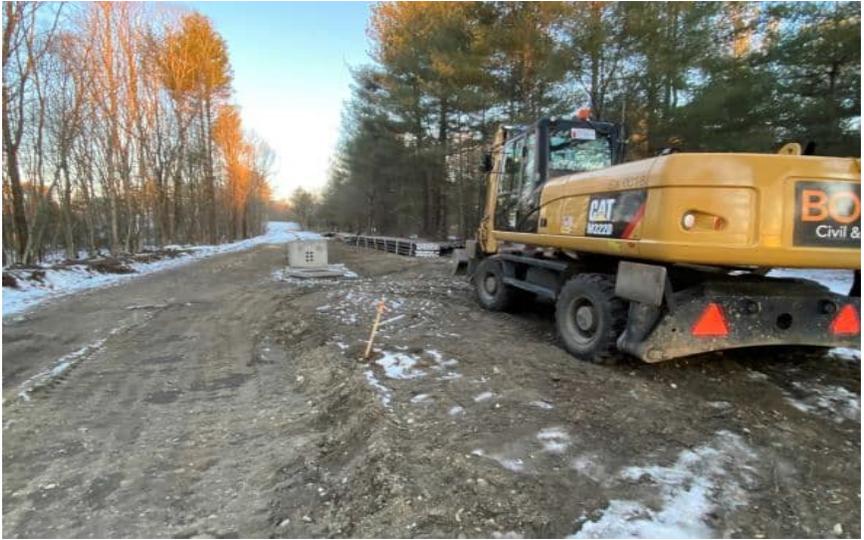
<p>PHOTOGRAPHIC LOG</p>	
<p>Client Name: Eversource</p>		<p>Site Location: Sudbury to Hudson Transmission Reliability Project</p>	<p>Town: Hudson</p>
<p>Photo No.: 1</p>	<p>Date: 3-3-23</p>

<p>Description:</p> <p>MH#7 within Segment 2 at approximate Sta#139+00, looking westward.</p>

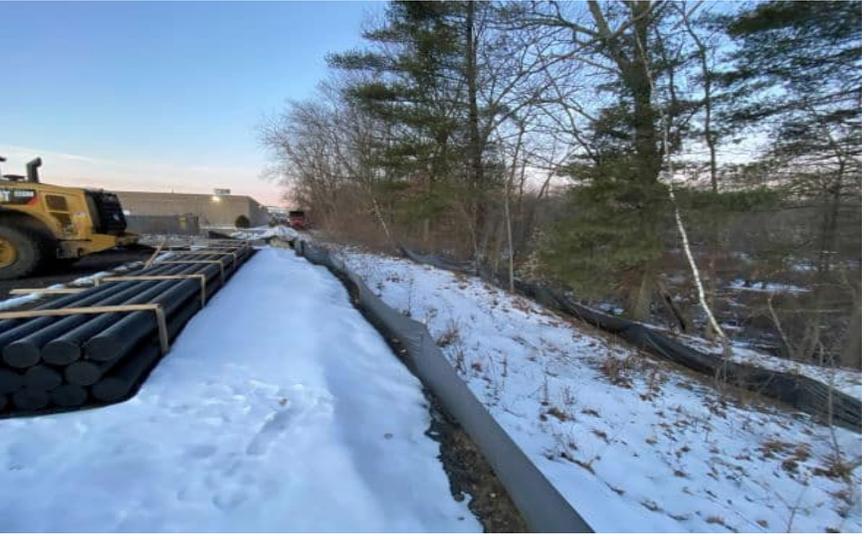
<p>PHOTOGRAPHIC LOG</p>	
<p>Client Name: Eversource</p>		<p>Site Location: Sudbury to Hudson Transmission Reliability Project</p>	<p>Town: Hudson</p>
<p>Photo No.: 2</p>	<p>Date: 3-3-23</p>

<p>Description:</p> <p>New silt fencing north side of Bonazzoli laydown yard, looking westward.</p>

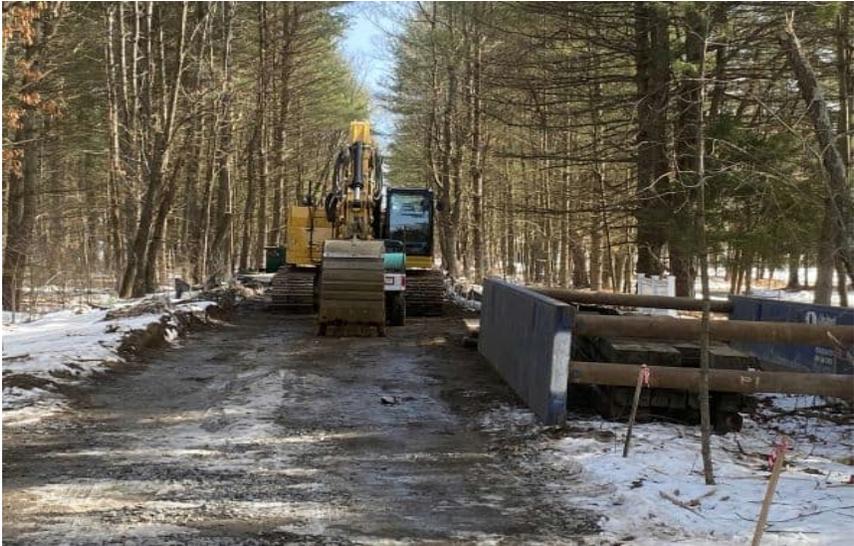
<p>PHOTOGRAPHIC LOG</p>	
<p>Client Name: Eversource</p>		<p>Site Location: Sudbury to Hudson Transmission Reliability Project</p>	<p>Town: Hudson</p>
<p>Photo No.: 3</p>	<p>Date: 3-3-23</p>

<p>Description:                  Equipment staged at MH#11, within Segment 5 at approximate Sta# 300+25, looking eastward.</p>

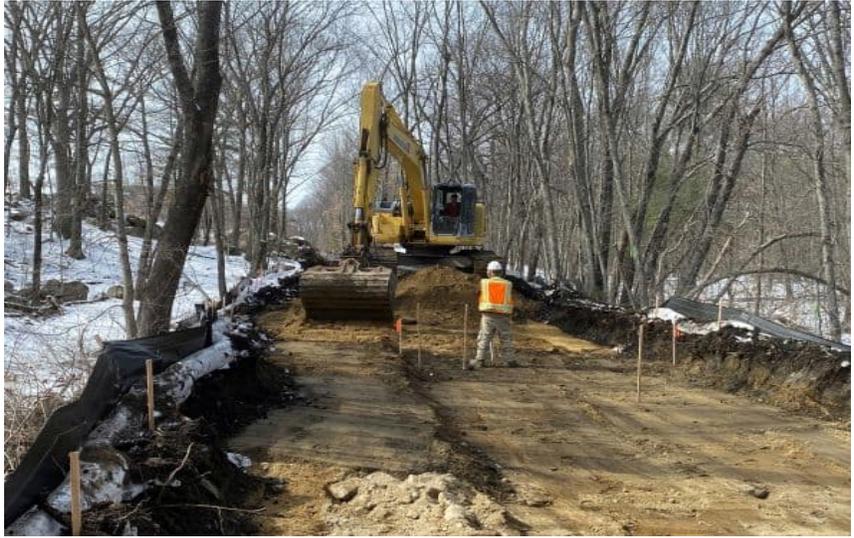
<p>PHOTOGRAPHIC LOG</p>	
<p>Client Name: Eversource</p>		<p>Site Location: Sudbury to Hudson Transmission Reliability Project</p>	<p>Town: Hudson</p>
<p>Photo No.: 4</p>	<p>Date: 3-3-23</p>

<p>Description:                  ET&amp;L grading within Segment 1 at approximate Sta# 131+00, looking westward.</p>

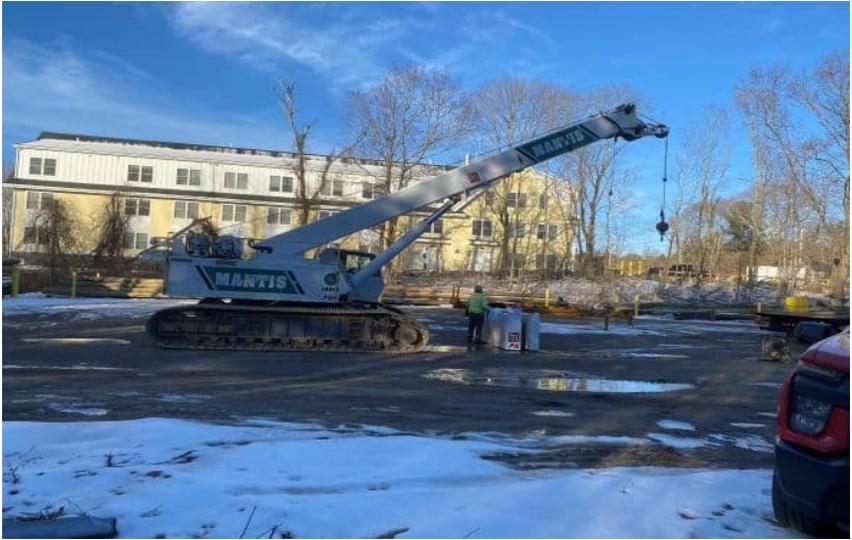
<p>PHOTOGRAPHIC LOG</p>	
<p>Client Name: Eversource</p>		<p>Site Location: Sudbury to Hudson Transmission Reliability Project</p>	<p>Town: Sudbury</p>
<p>Photo No.: 5</p>	<p>Date: 3-3-23</p>

<p>Description:</p> <p>Crane at Sudbury substation, to be used within Segment 14 at approximate Sta#737+50 for sheeting installation, looking westward.</p>

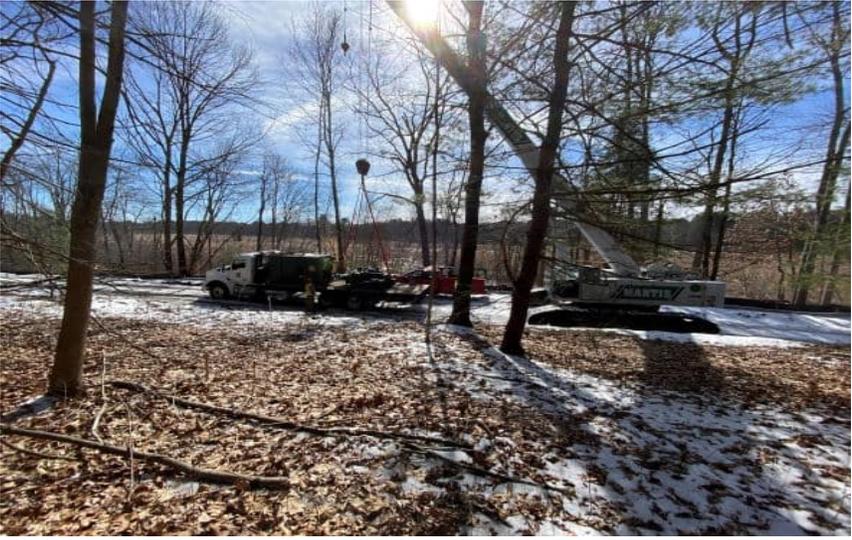
<p>PHOTOGRAPHIC LOG</p>	
<p>Client Name: Eversource</p>		<p>Site Location: Sudbury to Hudson Transmission Reliability Project</p>	<p>Town: Sudbury</p>
<p>Photo No.: 6</p>	<p>Date: 3-3-23</p>

<p>Description:</p> <p>Staged equipment (crane, power pack &amp; vibratory hammer) within Segment 14 at approximate Sta# 737+50, looking southward.</p>

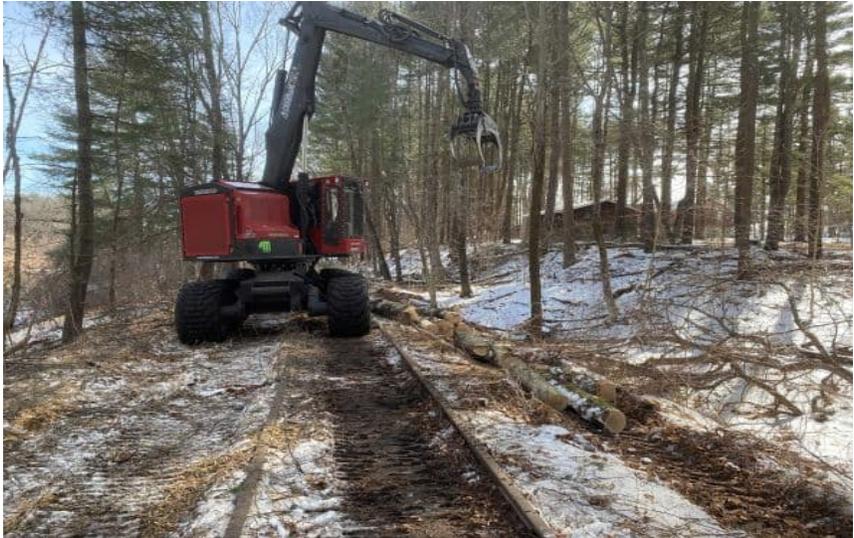
<p>PHOTOGRAPHIC LOG</p>	
<p>Client Name: Eversource</p>		<p>Site Location: Sudbury to Hudson Transmission Reliability Project</p>	<p>Town: Sudbury</p>
<p>Photo No.: 7</p>	<p>Date: 3-3-23</p>

<p>Description:</p> <p>Log removal within Segment 13 at approximate Sta# 719+50, looking westward.</p>

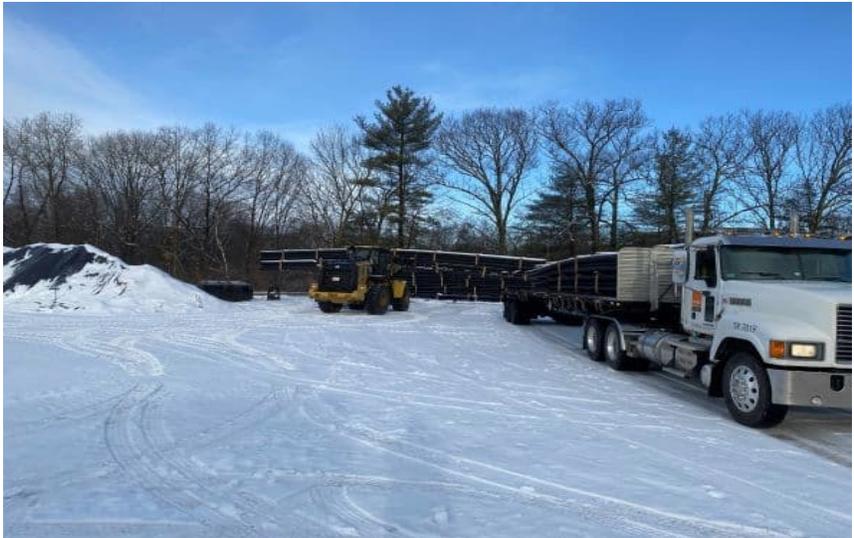
<b>PHOTOGRAPHIC LOG</b>	
Client Name: Eversource		Site Location: Sudbury to Hudson Transmission Reliability Project	Town: Hudson
Photo No.: 2	Date: 3-1-23

Description:  Bonazzoli laydown yard, Bond loading conduit bundles for staging within Segment 3, looking northward.

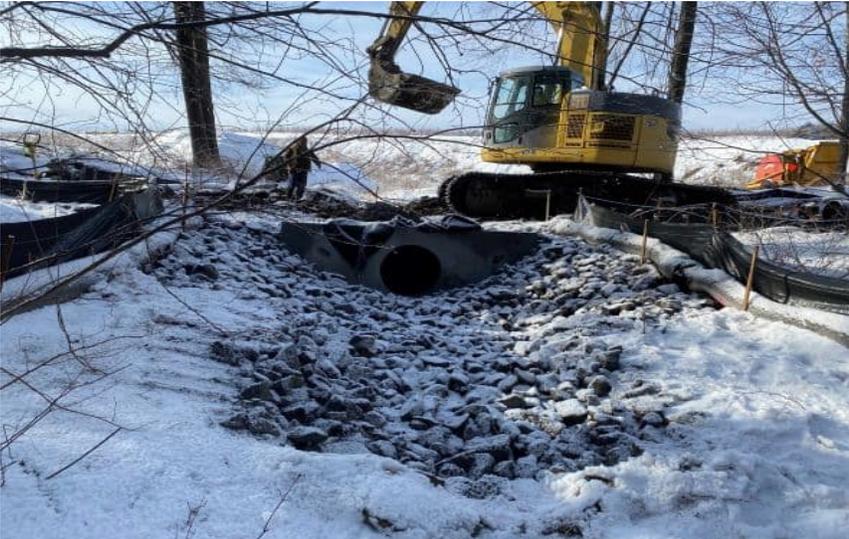
<b>PHOTOGRAPHIC LOG</b>	
Client Name: Eversource		Site Location: Sudbury to Hudson Transmission Reliability Project	Town: Stow
Photo No.: 3	Date: 3-1-23

Description:  ET&L installing new headwall within Segment 1 at approximate Sta# 127+00, looking westward.

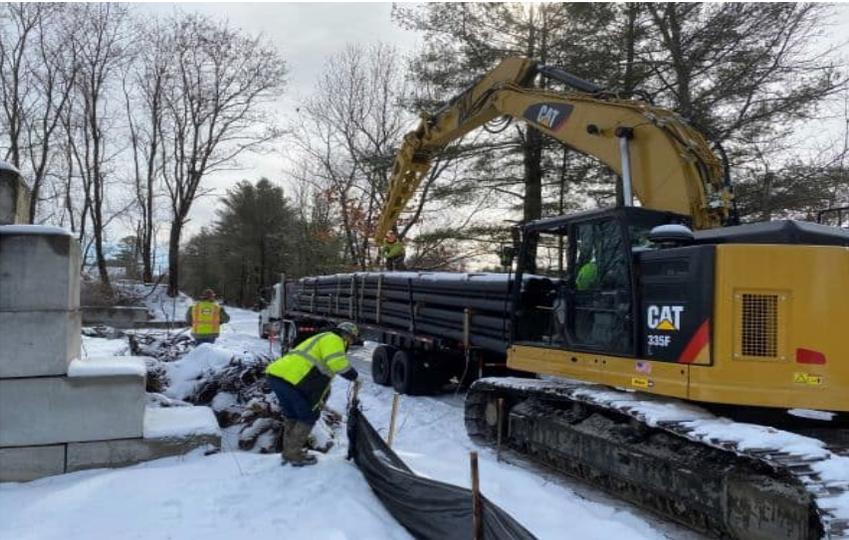
<b>PHOTOGRAPHIC LOG</b>	
Client Name: Eversource		Site Location: Sudbury to Hudson Transmission Reliability Project	Town: Hudson
Photo No.: 4	Date: 3-1-23

Description:  Staging of conduit within Segment 3 at approximate Sta# 154+00, looking eastward.

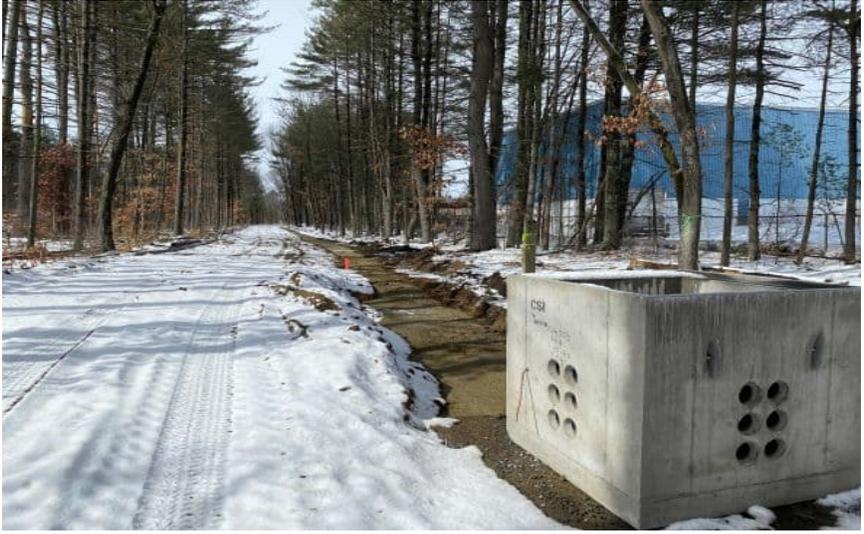
<b>PHOTOGRAPHIC LOG</b>	
Client Name: Eversource		Site Location: Sudbury to Hudson Transmission Reliability Project	Town: Hudson
Photo No.: 5	Date: 3-1-23

Description:  MH#10 within Segment 4 at approximate Sta# 196+00 (conduit backfill in background), looking westward.

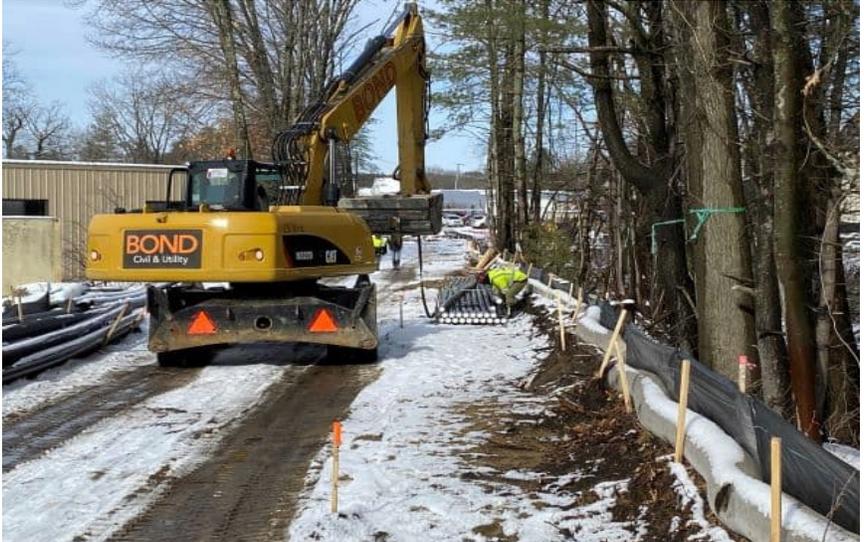
<b>PHOTOGRAPHIC LOG</b>	
Client Name: Eversource		Site Location: Sudbury to Hudson Transmission Reliability Project	Town: Hudson
Photo No.: 6	Date: 3-1-23

Description:  Staging of conduit within Segment 3 at approximate Sta# 177+00, looking westward.

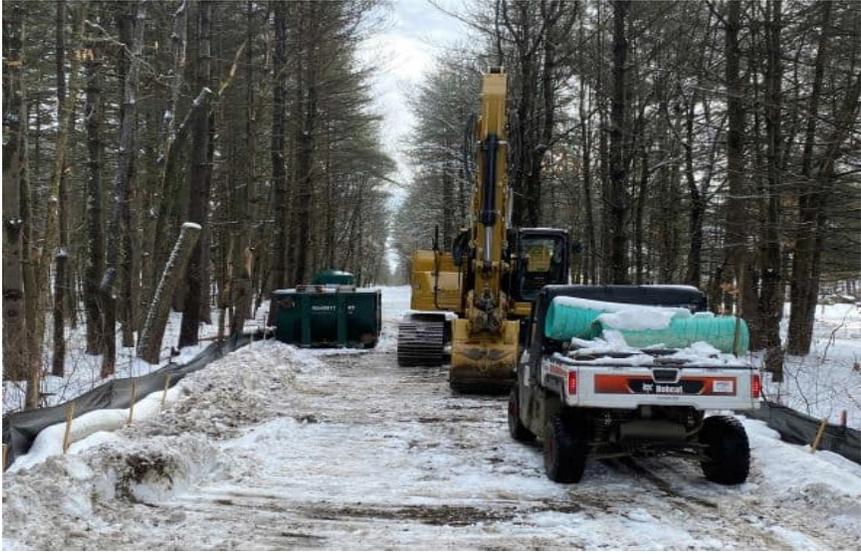
<b>PHOTOGRAPHIC LOG</b>	
Client Name: Eversource		Site Location: Sudbury to Hudson Transmission Reliability Project	Town: Hudson
Photo No.: 7	Date: 3-1-23

Description:  Staging at MH#11 within Segment 5 at approximate Sta# 300+25, looking eastward.

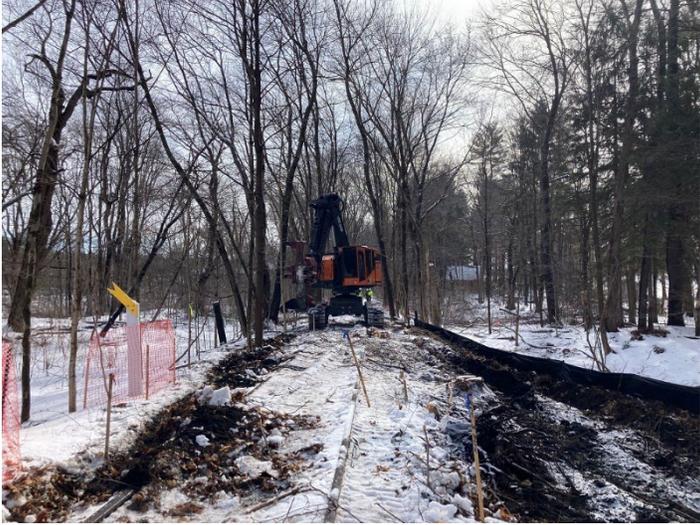
<b>PHOTOGRAPHIC LOG</b>	
<b>Client Name:</b> Eversource		<b>Site Location:</b> Sudbury to Hudson Transmission Reliability Project	<b>Town:</b> Sudbury
<b>Photo No.:</b> 3	<b>Date:</b> 3-01-2023

<b>Description:</b> View of Moosehead performing tree cutting activities in segment 13 off of Boston Post Rd. Facing east.

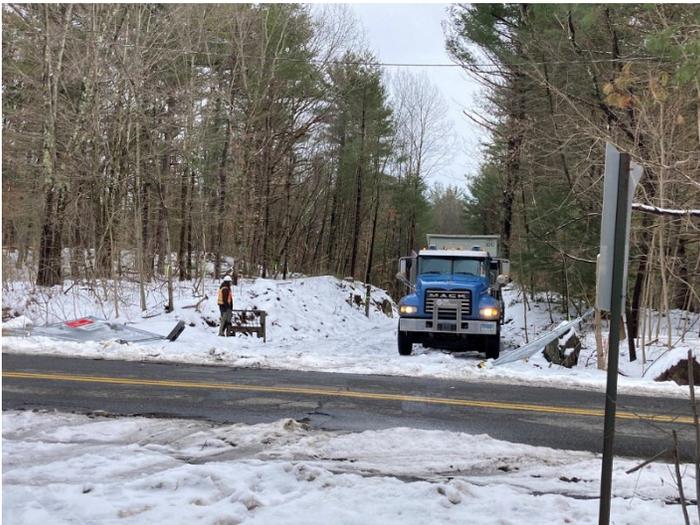
<b>Epsilon</b> ASSOCIATES INC.		<b>PHOTOGRAPHIC LOG</b>	
Client Name: Eversource		Site Location: Sudbury to Hudson Transmission Reliability Project	Town: Sudbury
Photo No.: 6	Date: 3-01-2023

<b>Description:</b> View of Frank Hoey (SWCA) performing biological monitoring in segment 10 off of Peakham Rd. Facing east.

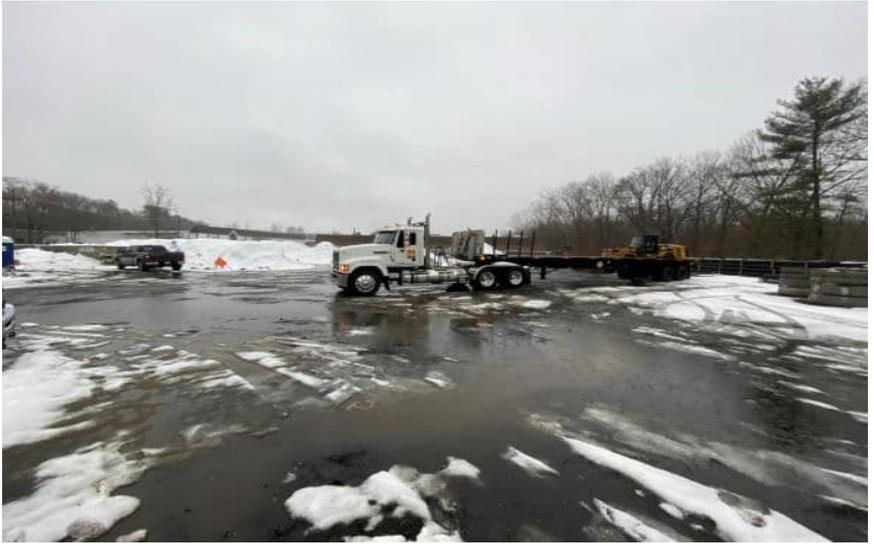
<b>PHOTOGRAPHIC LOG</b>	
Client Name: Eversource		Site Location: Sudbury to Hudson Transmission Reliability Project	
		Town: Hudson	
Photo No.: 1	Date: 3-2-23

Description:  Bonazzoli laydown yard, Bond loading conduit bundles for staging within Segment 3, looking westward.

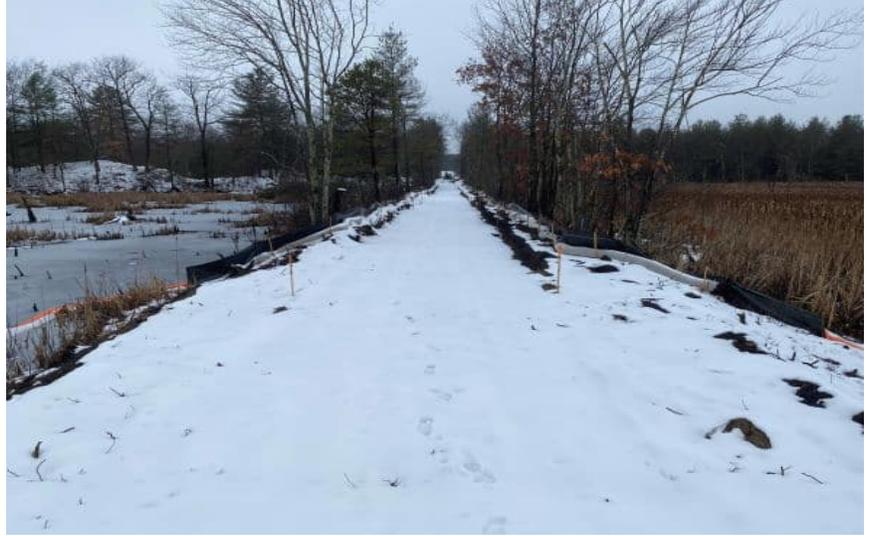
<b>PHOTOGRAPHIC LOG</b>	
Client Name: Eversource		Site Location: Sudbury to Hudson Transmission Reliability Project	
		Town: Hudson	
Photo No.: 2	Date: 3-2-23

Description:  Right-of-way at Bridge 130 to water supply road within Segment 2 at approximate Sta# 148+50, looking westward.

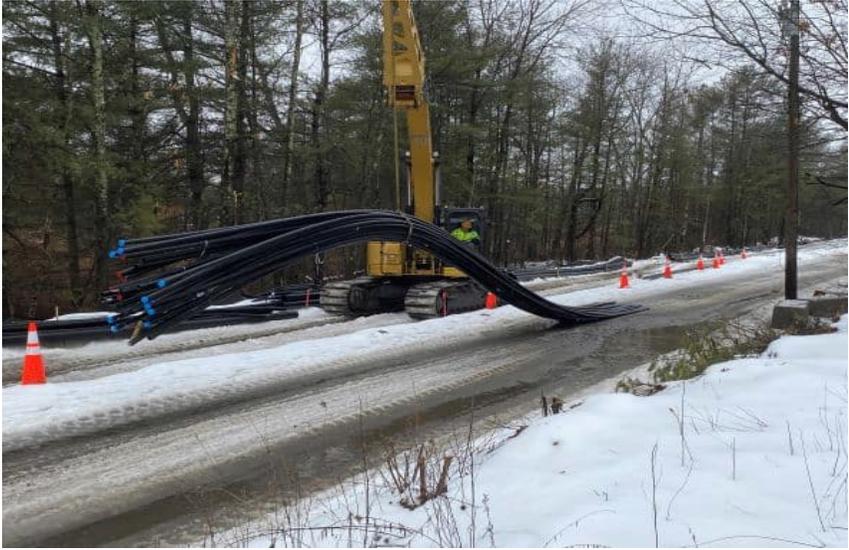
<b>PHOTOGRAPHIC LOG</b>	
Client Name: Eversource		Site Location: Sudbury to Hudson Transmission Reliability Project	Town: Hudson
Photo No.: 3	Date: 3-2-23

Description:  Bond conducting conduit staging within Segment 3 at approximate Sta# 162+00, looking westward.

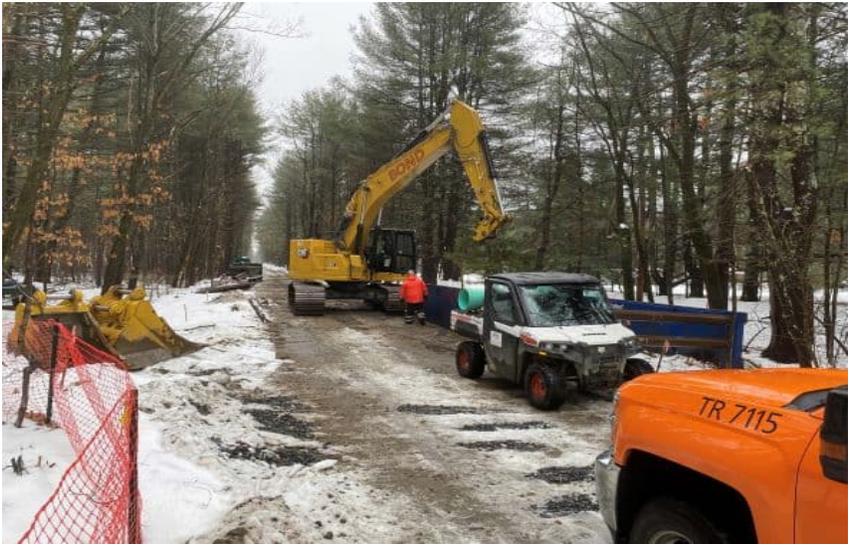
<b>PHOTOGRAPHIC LOG</b>	
Client Name: Eversource		Site Location: Sudbury to Hudson Transmission Reliability Project	Town: Hudson
Photo No.: 4	Date: 3-2-23

Description:  Staging at MH#11 within Segment 5 at approximate Sta# 300+25, looking eastward.

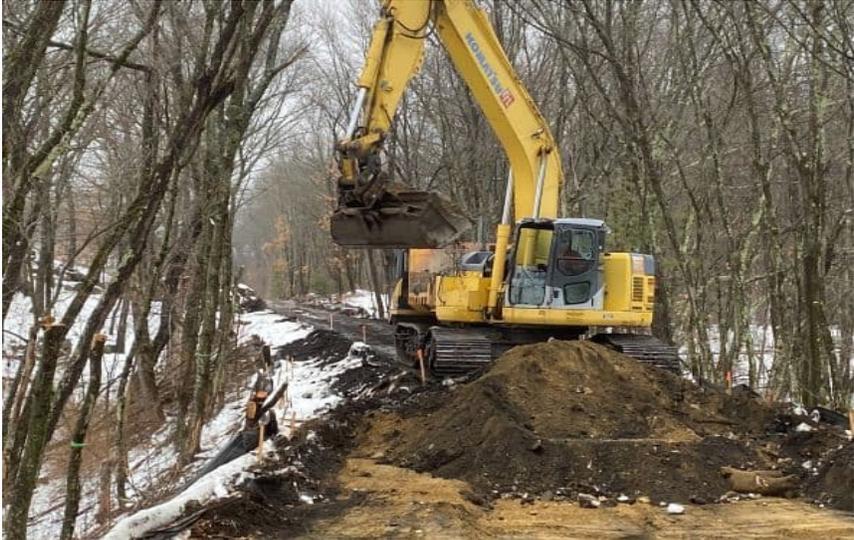
<b>PHOTOGRAPHIC LOG</b>	
Client Name: Eversource		Site Location: Sudbury to Hudson Transmission Reliability Project	Town: Hudson
Photo No.: 5	Date: 3-2-23

Description:  ET&L conducting grading within Segment 1 at approximate Sta# 131+00, looking westward.

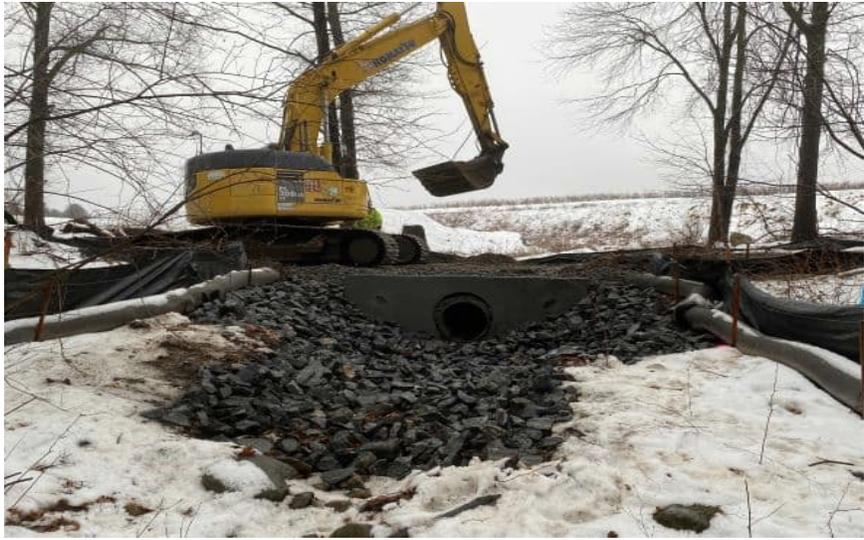
<b>PHOTOGRAPHIC LOG</b>	
Client Name: Eversource		Site Location: Sudbury to Hudson Transmission Reliability Project	Town: Stow
Photo No.: 6	Date: 3-2-23

Description:  ET&L installing new headwall within Segment 1 at approximate Sta# 127+00, looking westward.

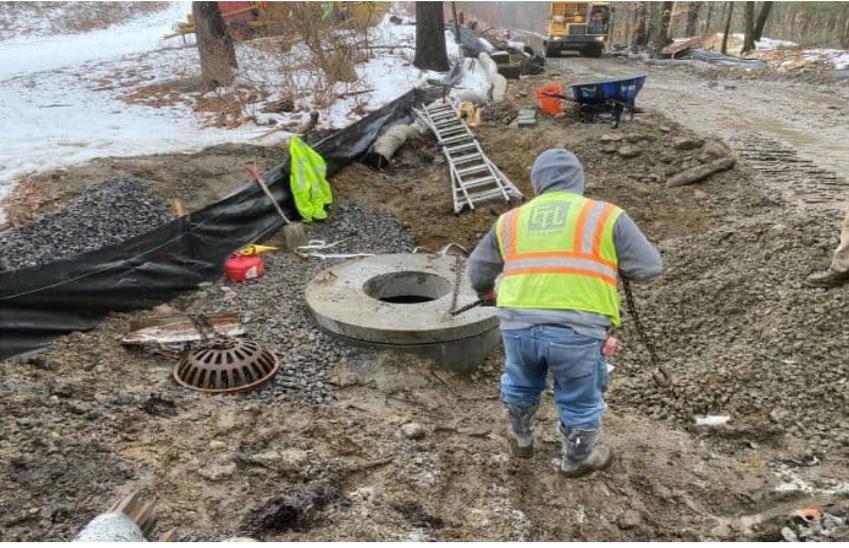
<b>PHOTOGRAPHIC LOG</b>	
Client Name: Eversource		Site Location: Sudbury to Hudson Transmission Reliability Project	Town: Stow
Photo No.: 7	Date: 3-2-23

Description:  ET&L installing new drainage structure within Segment 1 at approximate Sta# 127+00, looking westward

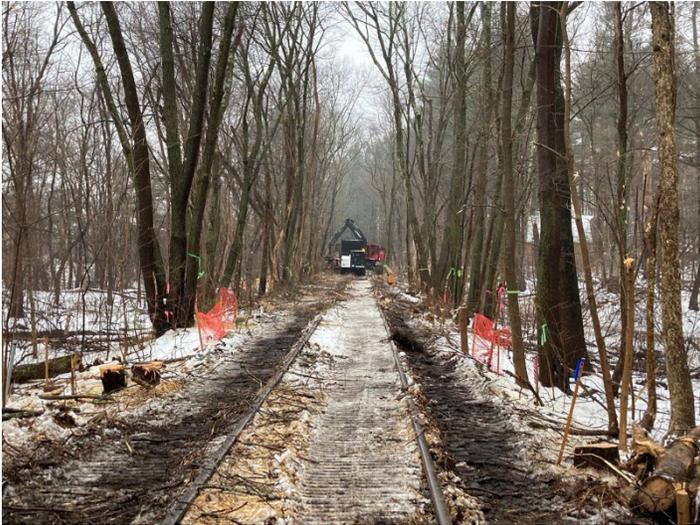
<b>PHOTOGRAPHIC LOG</b>	
<b>Client Name:</b> Eversource		<b>Site Location:</b> Sudbury to Hudson Transmission Reliability Project	<b>Town:</b> Sudbury
<b>Photo No.:</b> 4	<b>Date:</b> 3-02-2023

<b>Description:</b> View of Moosehead performing chipping activities in segment 13 off Boston Post Rd. Facing east.
