**Weekly Environmental Compliance Summary**

**Sudbury to Hudson Transmission Reliability Project (USEPA Tracking # MAR1003UW)**

Week of: March 6 to March 10, 2023

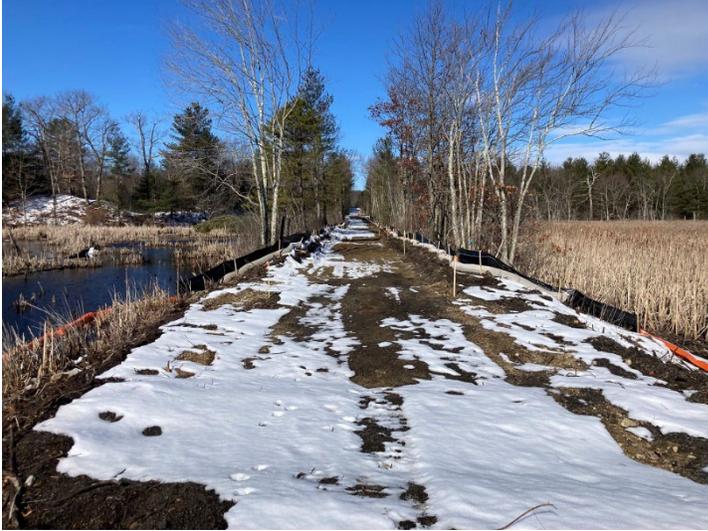
<p align="center"><b>PHOTOGRAPHIC LOG</b></p>	
<p><b>Client Name:</b> Eversource</p>		<p><b>Site Location:</b> Sudbury to Hudson Transmission Reliability Project</p>	
<p><b>Photo No.:</b> 3     <b>Date:</b> 3/07/2023</p>

<p><b>Description:</b> View of segment 2 from bridge 130. Facing west.</p>

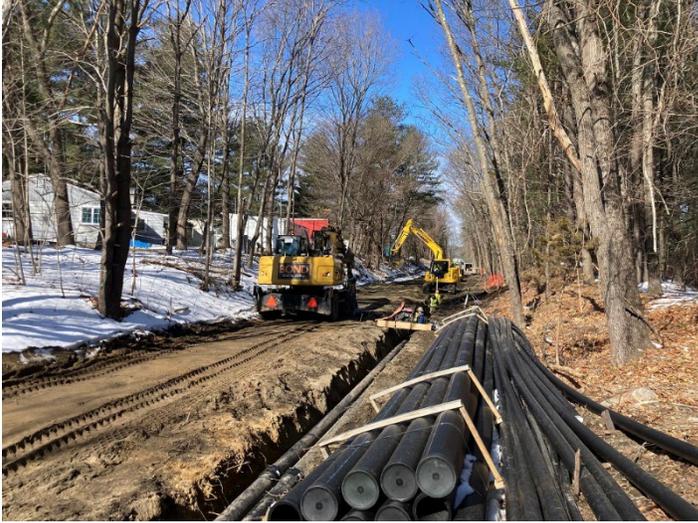
<p align="center"><b>PHOTOGRAPHIC LOG</b></p>	
<p><b>Client Name:</b> Eversource</p>		<p><b>Site Location:</b> Sudbury to Hudson Transmission Reliability Project</p>	
<p><b>Photo No.:</b> 4     <b>Date:</b> 3/07/2023</p>

<p><b>Description:</b> View of Bond performing conduit installation in segment 3 off Main St. Facing west.</p>

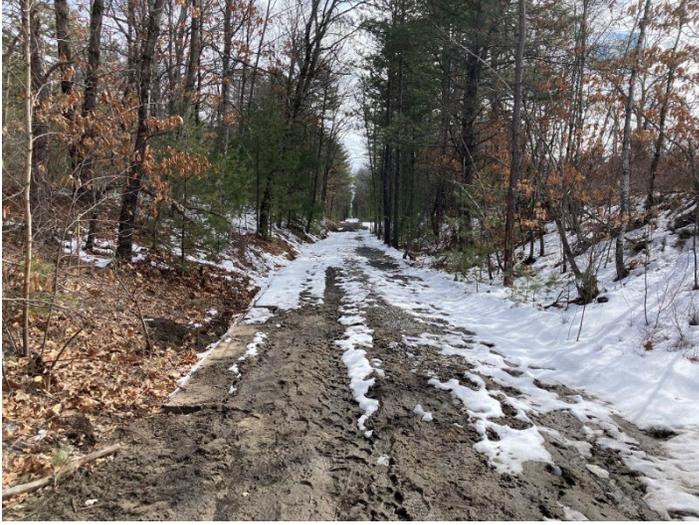
<p align="right"><b>PHOTOGRAPHIC LOG</b></p>	
<p><b>Client Name:</b> Eversource</p>		<p><b>Site Location:</b> Sudbury to Hudson Transmission Reliability Project</p>	<p><b>Town:</b> Sudbury</p>
<p><b>Photo No.:</b> 6</p>	<p><b>Date:</b> 3/07/2023</p>

<p><b>Description:</b> View of 200' Black Racer time of year restricted area with stone access. Facing east.</p>

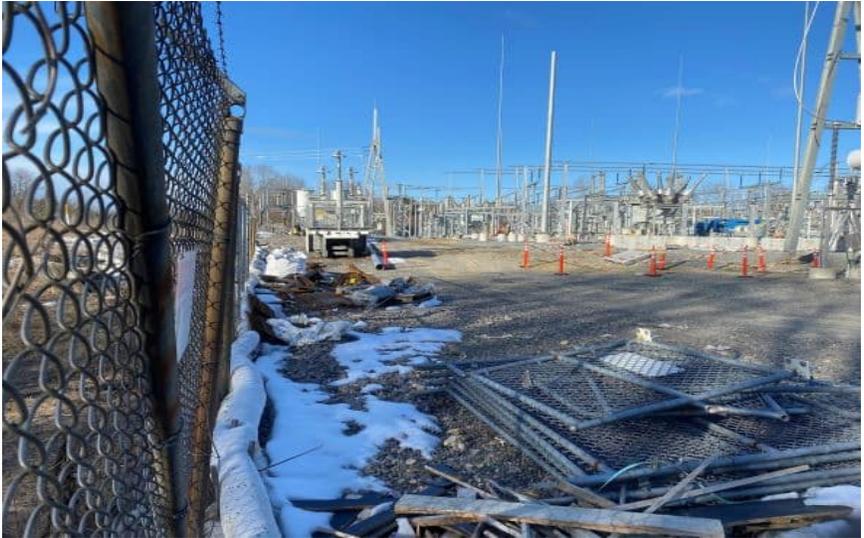
<p>PHOTOGRAPHIC LOG</p>	
<p>Client Name: Eversource</p>		<p>Site Location: Sudbury to Hudson Transmission Reliability Project</p>	<p>Town: Sudbury</p>
<p>Photo No.: 1</p>	<p>Date: 3-7-23</p>

<p>Description:</p> <p>Compost filter tubes at substation, looking westward.</p>

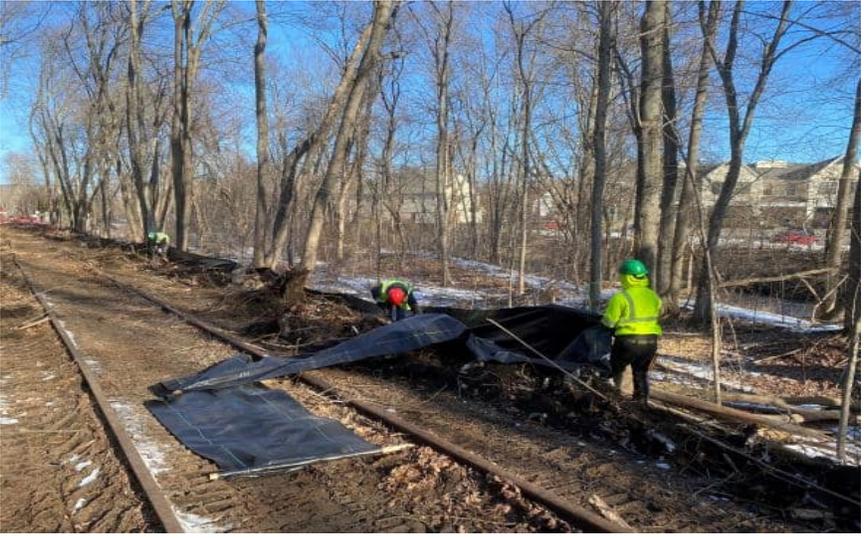
<p>PHOTOGRAPHIC LOG</p>	
<p>Client Name: Eversource</p>		<p>Site Location: Sudbury to Hudson Transmission Reliability Project</p>	<p>Town: Sudbury</p>
<p>Photo No.: 2</p>	<p>Date: 3-7-23</p>

<p>Description:</p> <p>MON adding erosion control within Segment 13 at approximate Sta# 720+00, looking westward.</p>

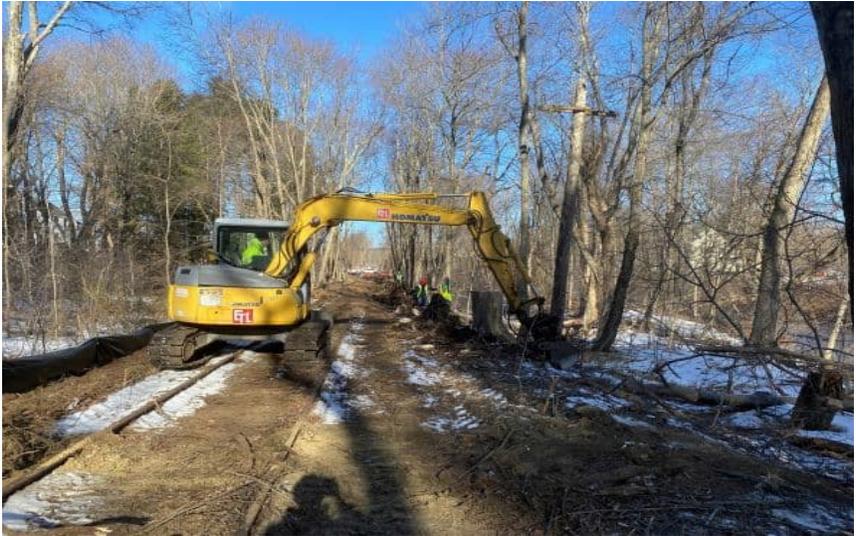
<p>PHOTOGRAPHIC LOG</p>	
<p>Client Name: Eversource</p>		<p>Site Location: Sudbury to Hudson Transmission Reliability Project</p>	<p>Town: Sudbury</p>
<p>Photo No.: 3</p>	<p>Date: 3-7-23</p>

<p>Description:</p> <p>ETL assisting in erosion control installation within Segment 13 at approximate Sta# 720+00, looking westward.</p>

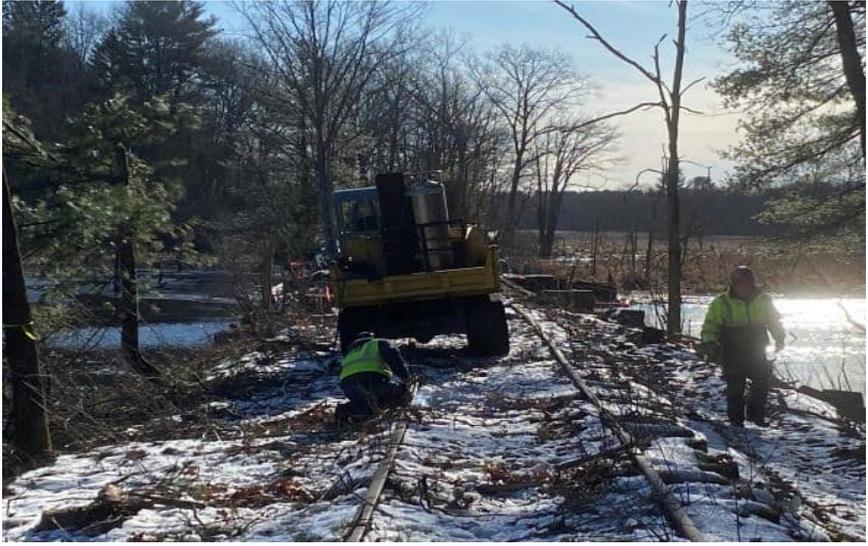
<p>PHOTOGRAPHIC LOG</p>	
<p>Client Name: Eversource</p>		<p>Site Location: Sudbury to Hudson Transmission Reliability Project</p>	<p>Town: Sudbury</p>
<p>Photo No.: 4</p>	<p>Date: 3-7-23</p>

<p>Description:</p> <p>Moosehead cutting rail within Segment 13 at Bridge 127, looking eastward.</p>

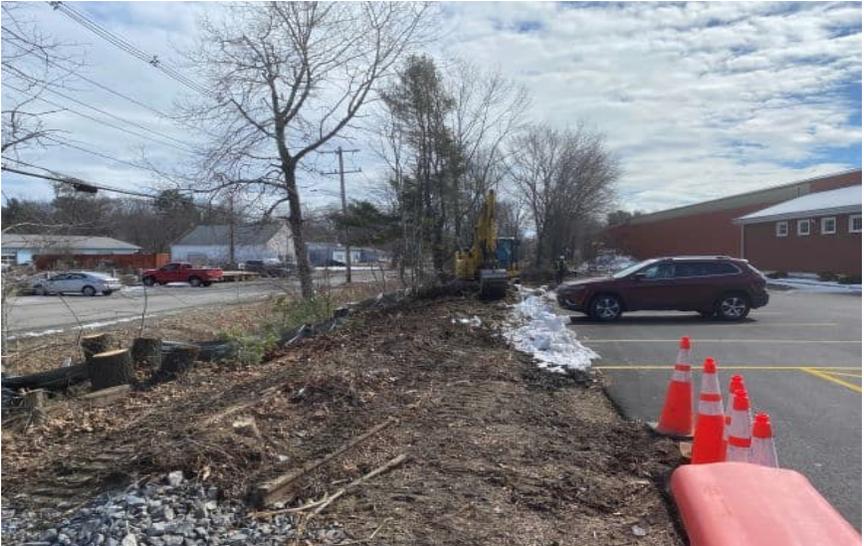
<p>PHOTOGRAPHIC LOG</p>	
<p>Client Name: Eversource</p>		<p>Site Location: Sudbury to Hudson Transmission Reliability Project</p>	<p>Town: Sudbury</p>
<p>Photo No.: 5</p>	<p>Date: 3-7-23</p>

<p>Description:</p> <p>Rail/tie removal by Moosehead within Segment 12 just off Union Street, looking eastward.</p>

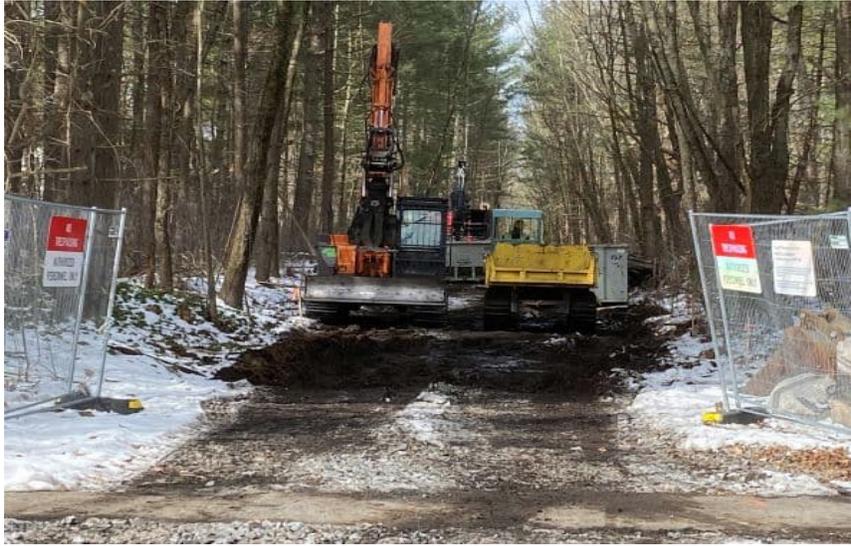
<p>PHOTOGRAPHIC LOG</p>	
<p>Client Name: Eversource</p>		<p>Site Location: Sudbury to Hudson Transmission Reliability Project</p>	<p>Town: Sudbury</p>
<p>Photo No.: 6</p>	<p>Date: 3-7-23</p>

<p>Description:</p> <p>Moosehead conducting cleanup activities within Segment 10 just off Horsepond Road, looking westward.</p>

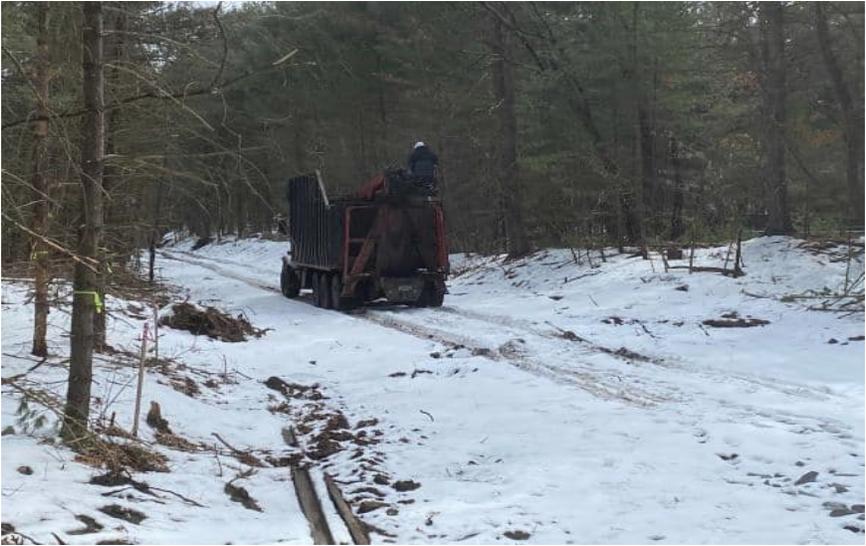
<p>PHOTOGRAPHIC LOG</p>	
<p>Client Name: Eversource</p>		<p>Site Location: Sudbury to Hudson Transmission Reliability Project</p>	<p>Town: Sudbury</p>
<p>Photo No.: 7</p>	<p>Date: 3-7-23</p>

<p>Description:</p> <p>Moosehead removing debris within Segment 9 just off Peakham Road, looking eastward.</p>

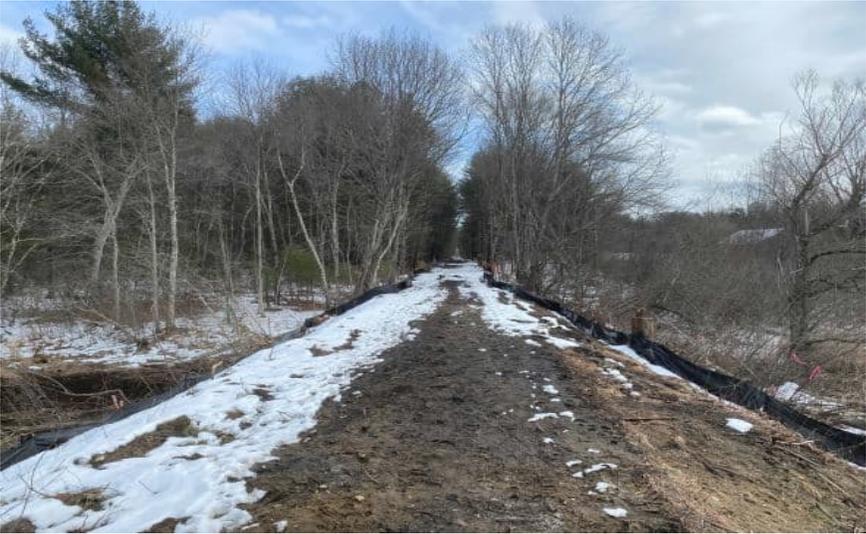
<p>PHOTOGRAPHIC LOG</p>	
<p>Client Name: Eversource</p>		<p>Site Location: Sudbury to Hudson Transmission Reliability Project</p>	<p>Town: Sudbury</p>
<p>Photo No.: 8</p>	<p>Date: 3-7-23</p>

<p>Description:</p> <p>Right-of-way within Segment 8 from Bridge 128, looking eastward.</p>

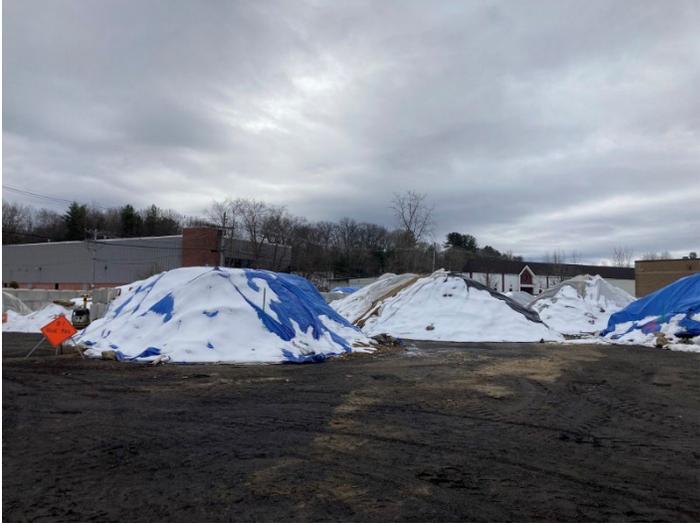
<b>PHOTOGRAPHIC LOG</b>	
<b>Client Name:</b> Eversource		<b>Site Location:</b> Sudbury to Hudson Transmission Reliability Project	<b>Town:</b> Hudson
<b>Photo No.:</b> 1	<b>Date:</b> 3/08/2023

<b>Description:</b> View of laydown yard at Robert Bonazzoli Ave. Facing southwest.

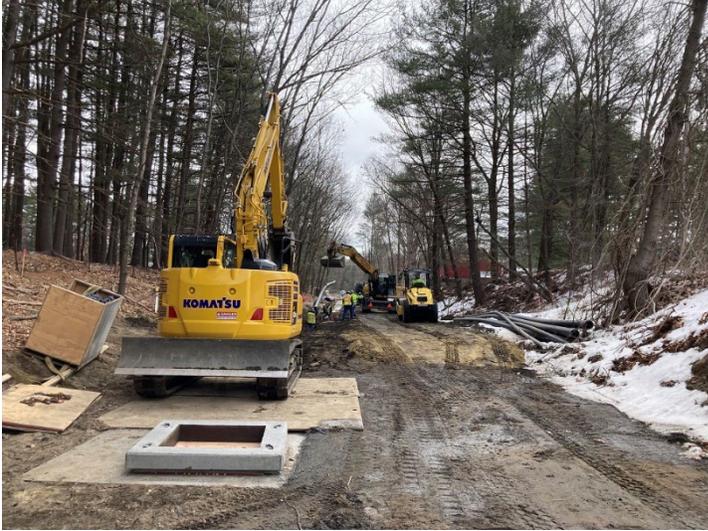
<p align="right"><b>PHOTOGRAPHIC LOG</b></p>	
<p><b>Client Name:</b> Eversource</p>		<p><b>Site Location:</b> Sudbury to Hudson Transmission Reliability Project</p>	
<p><b>Photo No.:</b> 3     <b>Date:</b> 3/08/2023</p>

<p><b>Description:</b> View of Bond performing conduit installation in segment 3 off Main St. Facing east.</p>

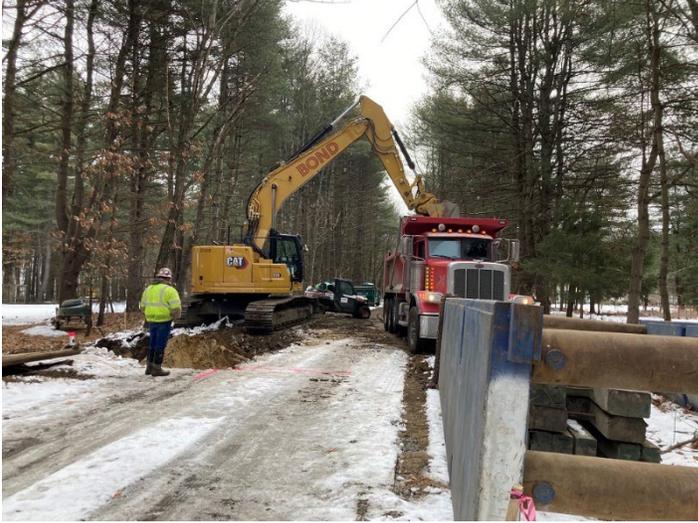
<p align="right"><b>PHOTOGRAPHIC LOG</b></p>	
<p><b>Client Name:</b> Eversource</p>		<p><b>Site Location:</b> Sudbury to Hudson Transmission Reliability Project</p>	
<p><b>Photo No.:</b> 4     <b>Date:</b> 3/08/2023</p>

<p><b>Description:</b> View of Bond excavating for MH #11 in segment 5. Facing east.</p>

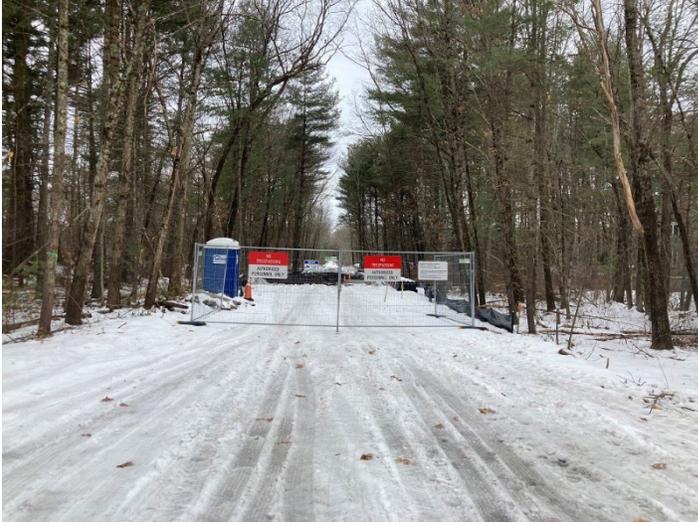
<p><b>PHOTOGRAPHIC LOG</b></p>	
<p><b>Client Name:</b> Eversource</p>		<p><b>Site Location:</b> Sudbury to Hudson Transmission Reliability Project</p>	<p><b>Town:</b> Hudson</p>
<p><b>Photo No.:</b> 5</p>	<p><b>Date:</b> 3/08/2023</p>

<p><b>Description:</b> View of entrance to segment 5 at White Pond Rd where hand hole installation occurred on 3/07/2023. No activity noted in area. Facing west.</p>

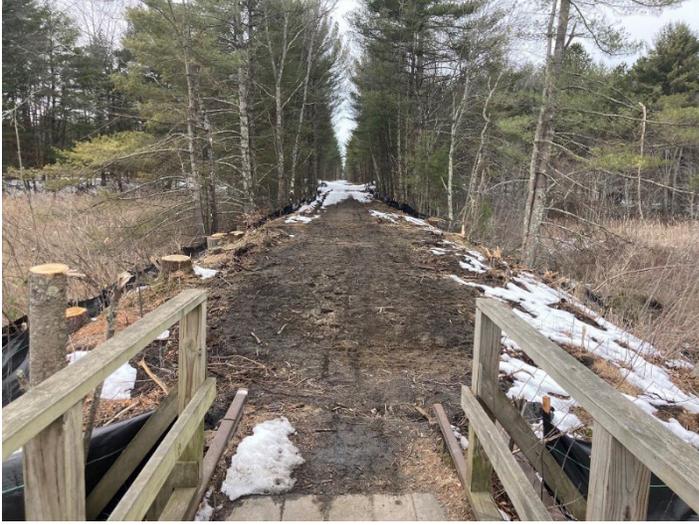
<p><b>PHOTOGRAPHIC LOG</b></p>	
<p><b>Client Name:</b> Eversource</p>		<p><b>Site Location:</b> Sudbury to Hudson Transmission Reliability Project</p>	<p><b>Town:</b> Sudbury</p>
<p><b>Photo No.:</b> 6</p>	<p><b>Date:</b> 3/08/2023</p>

<p><b>Description:</b> View of segment 7 from bridge 128. Facing west.</p>

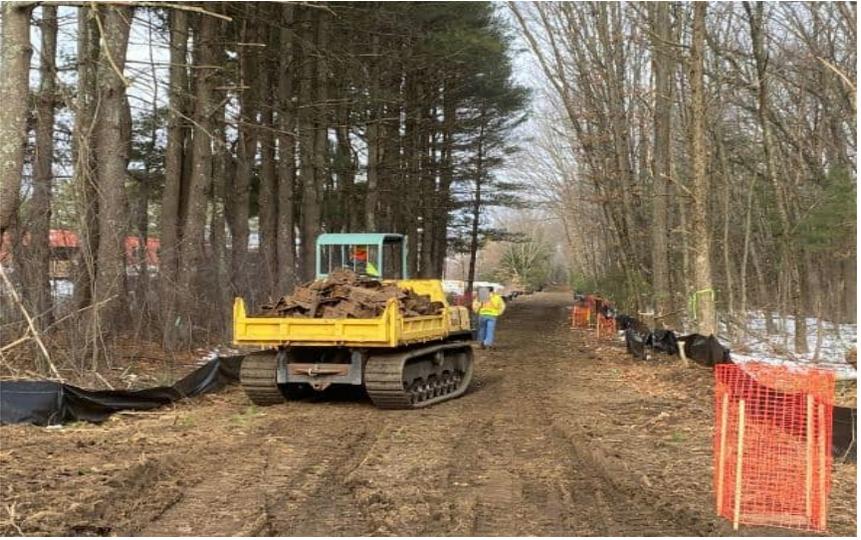
<p>PHOTOGRAPHIC LOG</p>	
<p>Client Name: Eversource</p>		<p>Site Location: Sudbury to Hudson Transmission Reliability Project</p>	<p>Town: Sudbury</p>
<p>Photo No.: 1</p>	<p>Date: 3-8-23</p>

<p>Description:</p> <p>Moosehead conducting cleanup activities, preceded by biological monitor, within Segment 11 just off Union Avenue, looking westward.</p>

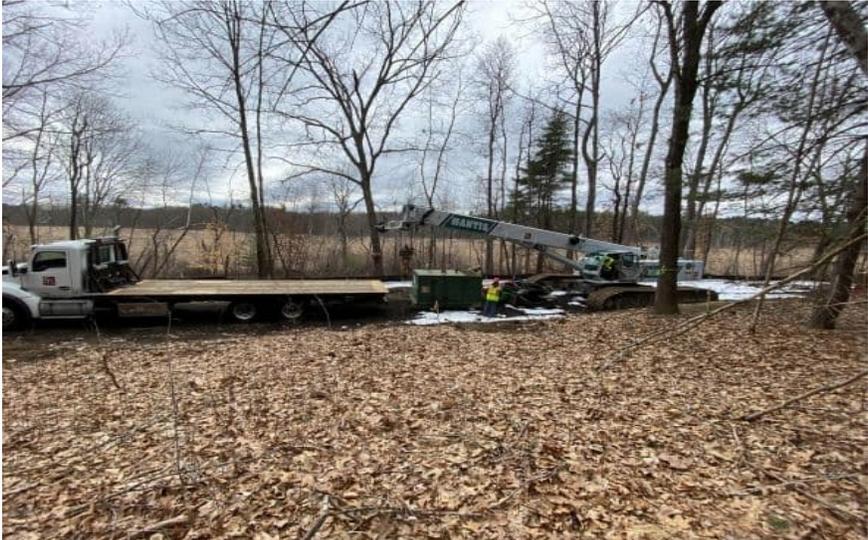
<p>PHOTOGRAPHIC LOG</p>	
<p>Client Name: Eversource</p>		<p>Site Location: Sudbury to Hudson Transmission Reliability Project</p>	<p>Town: Sudbury</p>
<p>Photo No.: 2</p>	<p>Date: 3-8-23</p>

<p>Description:</p> <p>Crane removal from Segment 14 at approximate Sta# 737+00, looking southward.</p>

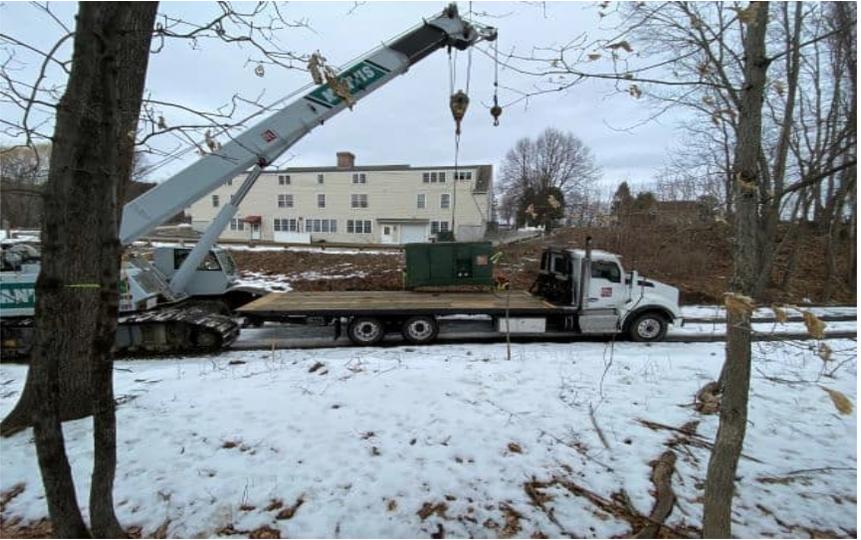
<p>PHOTOGRAPHIC LOG</p>	
<p>Client Name: Eversource</p>		<p>Site Location: Sudbury to Hudson Transmission Reliability Project</p>	<p>Town: Sudbury</p>
<p>Photo No.: 3</p>	<p>Date: 3-8-23</p>

<p>Description:</p> <p>Crane placement within Segment 14 at approximate Sta# 753+50, looking northward.</p>

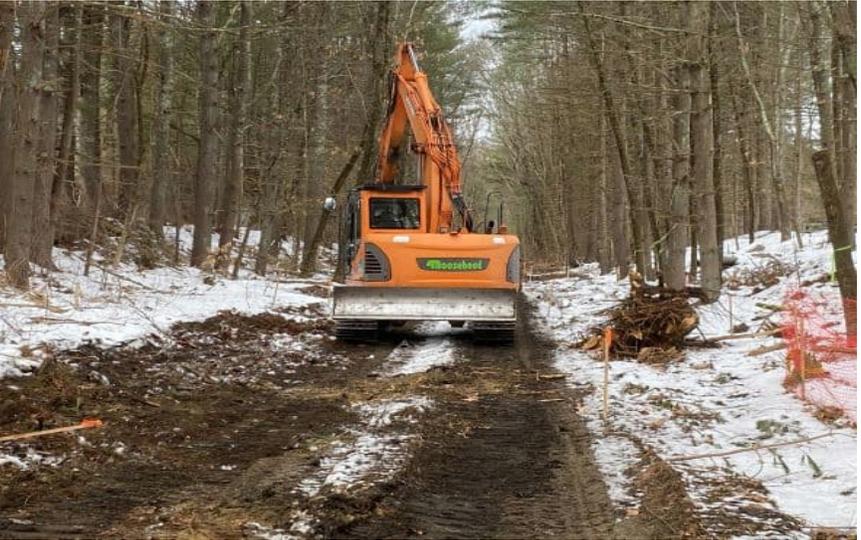
<p>PHOTOGRAPHIC LOG</p>	
<p>Client Name: Eversource</p>		<p>Site Location: Sudbury to Hudson Transmission Reliability Project</p>	<p>Town: Sudbury</p>
<p>Photo No.: 4</p>	<p>Date: 3-8-23</p>

<p>Description:</p> <p>Moosehead conducting debris removal within Segment 10 at approximate Sta# 545+00, looking westward.</p>

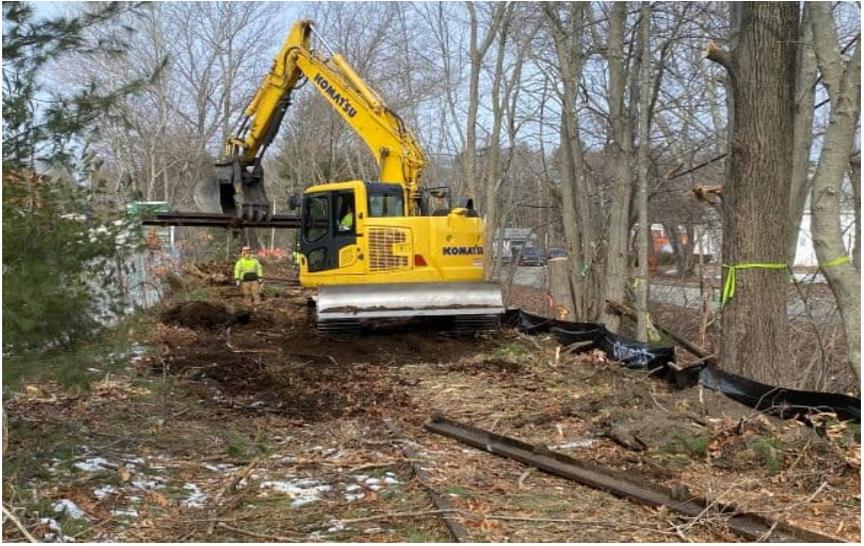
<p>PHOTOGRAPHIC LOG</p>	
<p>Client Name: Eversource</p>		<p>Site Location: Sudbury to Hudson Transmission Reliability Project</p>	<p>Town: Sudbury</p>
<p>Photo No.: 5</p>	<p>Date: 3-8-23</p>

<p>Description:</p> <p>Rail/tie removal by Moosehead, within Segment 12, over culvert between Boston Post Road &amp; Union Avenue, looking westward.</p>

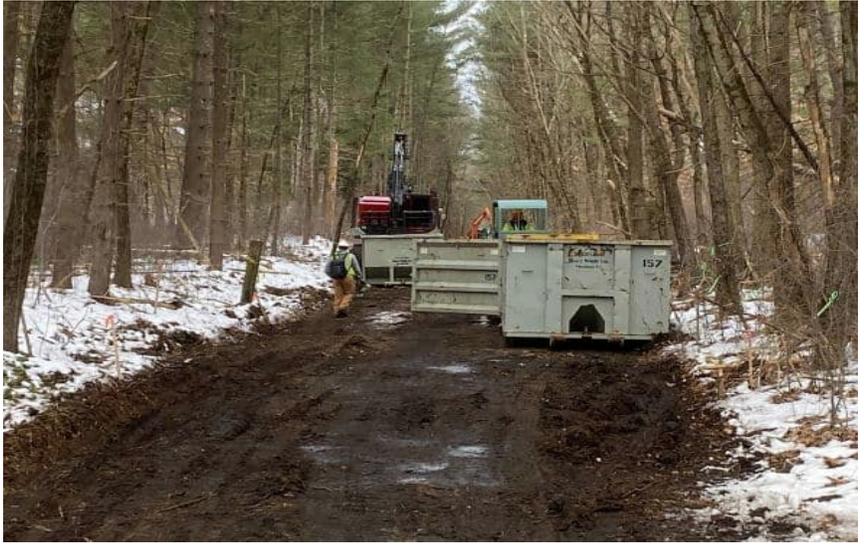
<p>PHOTOGRAPHIC LOG</p>	
<p>Client Name: Eversource</p>		<p>Site Location: Sudbury to Hudson Transmission Reliability Project</p>	<p>Town: Sudbury</p>
<p>Photo No.: 6</p>	<p>Date: 3-8-23</p>

<p>Description:</p> <p>Moosehead conducting cleanup activities within Segment 10 just off Horsepond Road, looking westward.</p>

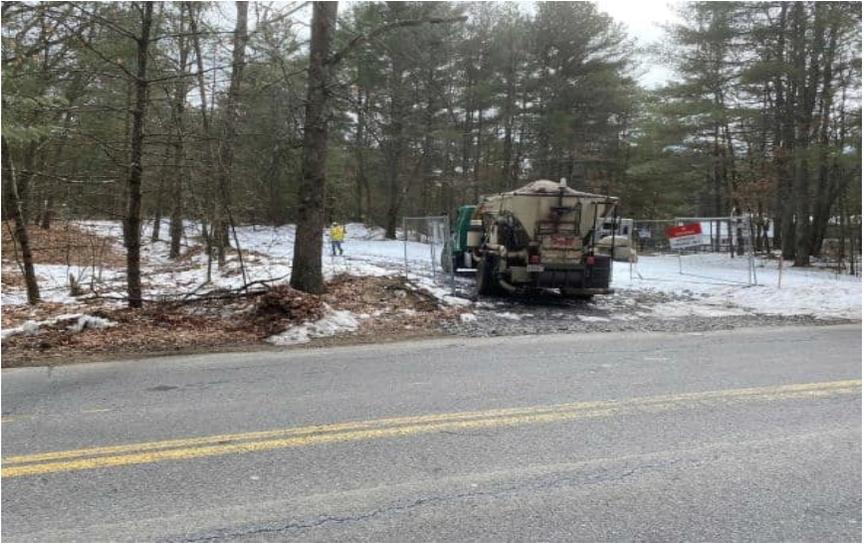
<p>PHOTOGRAPHIC LOG</p>	
<p>Client Name: Eversource</p>		<p>Site Location: Sudbury to Hudson Transmission Reliability Project</p>	<p>Town: Sudbury</p>
<p>Photo No.: 7</p>	<p>Date: 3-8-23</p>

<p>Description:</p> <p>MON entering Segment 9 to install compost filter tubes, preceded by biological monitor, just off Peakham Road, looking eastward.</p>

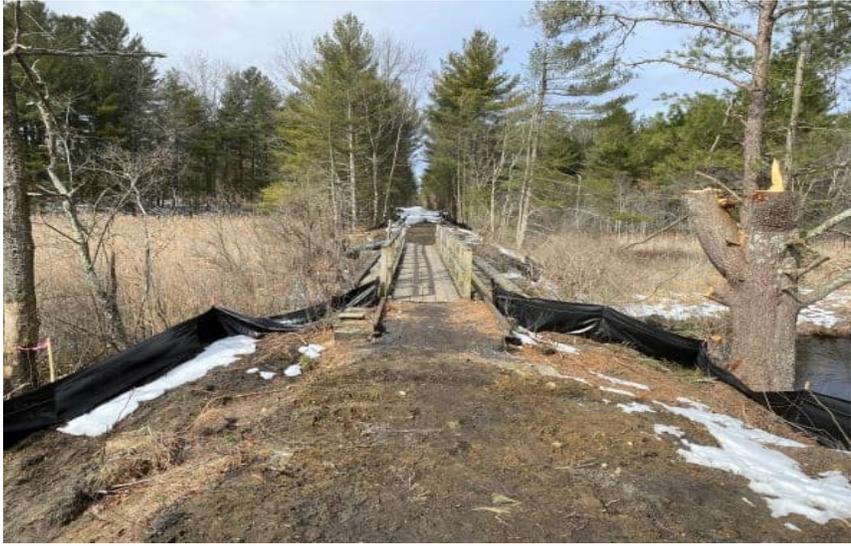
<p>PHOTOGRAPHIC LOG</p>	
<p>Client Name: Eversource</p>		<p>Site Location: Sudbury to Hudson Transmission Reliability Project</p>	<p>Town: Sudbury</p>
<p>Photo No.: 8</p>	<p>Date: 3-8-23</p>

<p>Description:</p> <p>Right-of-way within Segment 8 at Bridge 128, looking westward.</p>

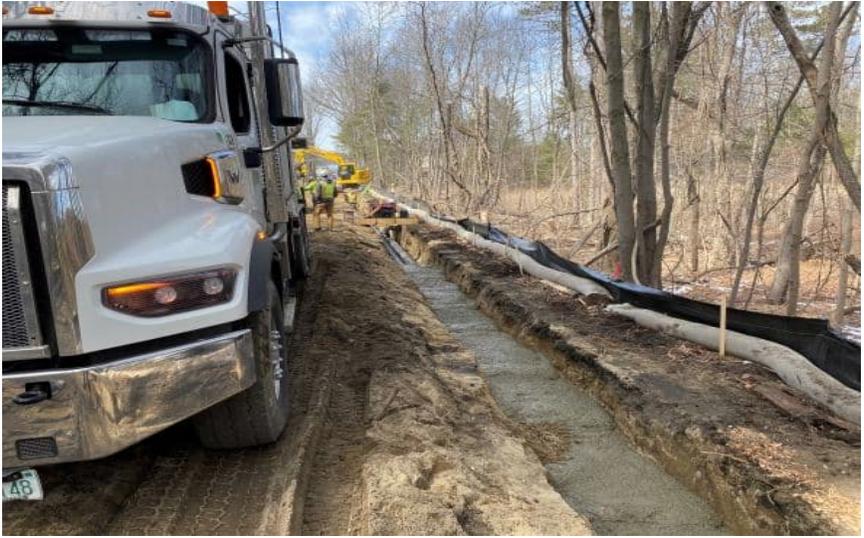
<p><b>PHOTOGRAPHIC LOG</b></p>		
<p>Client Name: Eversource</p>		<p>Site Location: Sudbury to Hudson Transmission Reliability Project</p>		<p>Town: Hudson</p>
<p>Photo No.: 1</p>	<p>Date: 3-10-23</p>

<p>Description:</p> <p>Conduit installment (backfilling) within Segment 3 at approximate Sta# 174+00, looking westward.</p>

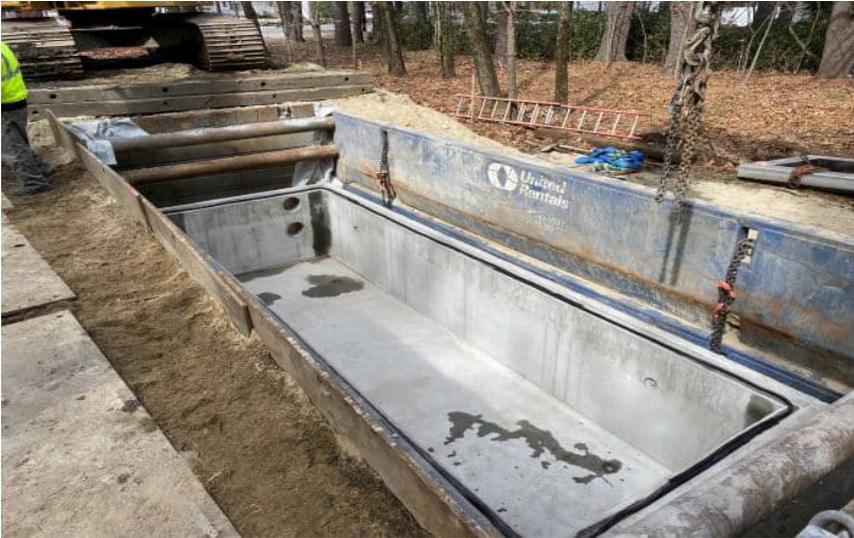
<p>PHOTOGRAPHIC LOG</p>	
<p>Client Name: Eversource</p>		<p>Site Location: Sudbury to Hudson Transmission Reliability Project</p>	<p>Town: Hudson</p>
<p>Photo No.: 3</p>	<p>Date: 3-10-23</p>

<p>Description:</p> <p>Newly installed (lower half) at MH#11, within Segment 5 at approximate Sta# 300+25, looking westward.</p>

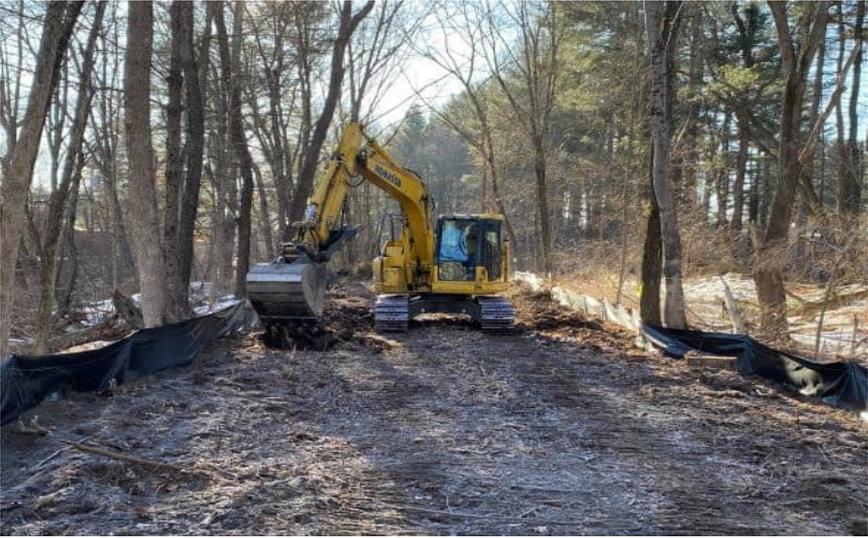
<p>PHOTOGRAPHIC LOG</p>	
<p>Client Name: Eversource</p>		<p>Site Location: Sudbury to Hudson Transmission Reliability Project</p>	<p>Town: Sudbury</p>
<p>Photo No.: 4</p>	<p>Date: 3-10-23</p>

<p>Description:</p> <p>Moosehead clearing debris within Segment 13 at approximate Sta# 716+00, looking westward.</p>

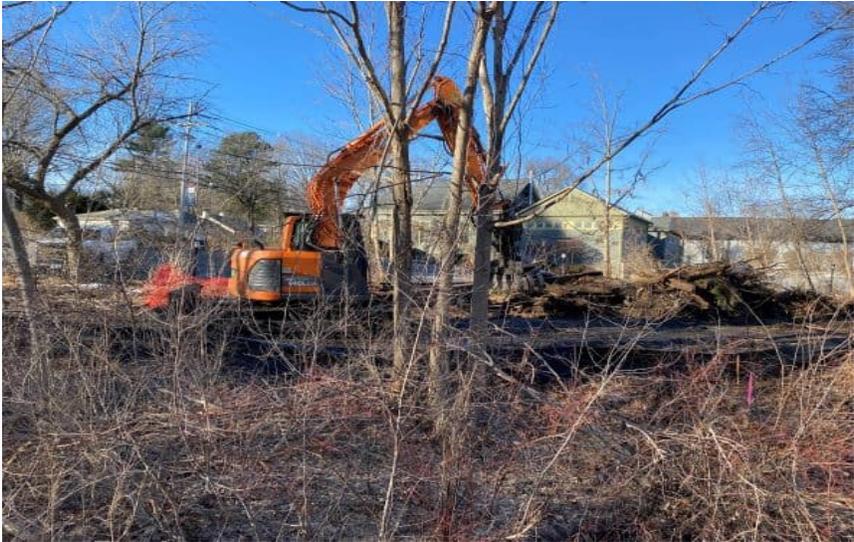
<p>PHOTOGRAPHIC LOG</p>	
<p>Client Name: Eversource</p>		<p>Site Location: Sudbury to Hudson Transmission Reliability Project</p>	<p>Town: Sudbury</p>
<p>Photo No.: 5</p>	<p>Date: 3-10-23</p>

<p>Description:                  Moosehead clearing debris within Segment 12 at approximate Sta# 711+00, looking westward.</p>

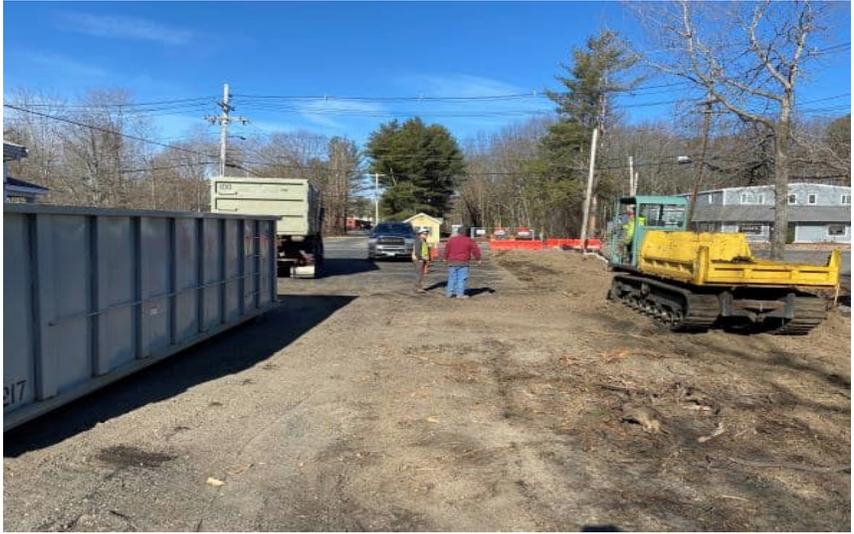
<p>PHOTOGRAPHIC LOG</p>	
<p>Client Name: Eversource</p>		<p>Site Location: Sudbury to Hudson Transmission Reliability Project</p>	<p>Town: Sudbury</p>
<p>Photo No.: 6</p>	<p>Date: 3-10-23</p>

<p>Description:                  Cleanup (dumpsters) at Union Avenue, looking westward.</p>

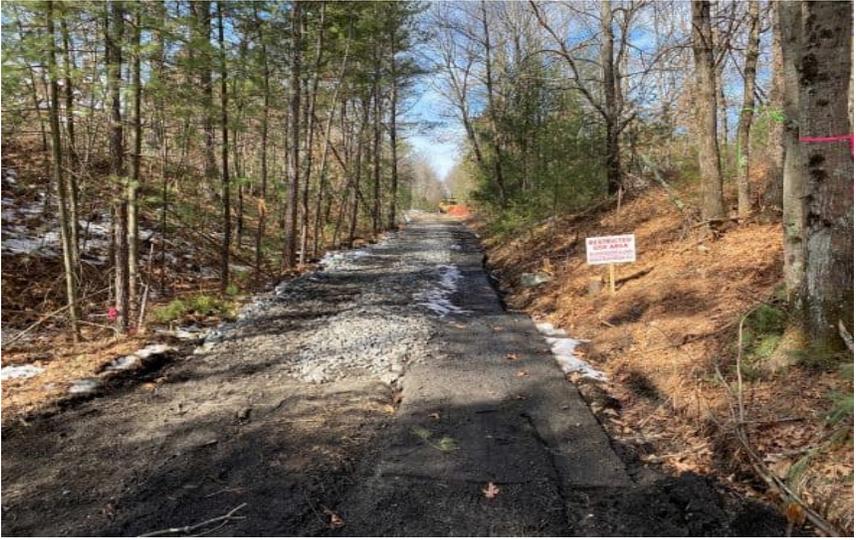
<p>PHOTOGRAPHIC LOG</p>	
<p>Client Name: Eversource</p>		<p>Site Location: Sudbury to Hudson Transmission Reliability Project</p>	<p>Town: Sudbury</p>
<p>Photo No.: 8</p>	<p>Date: 3-10-23</p>

<p>Description:</p> <p>Black Racer restrictive area (current condition), looking westward.</p>

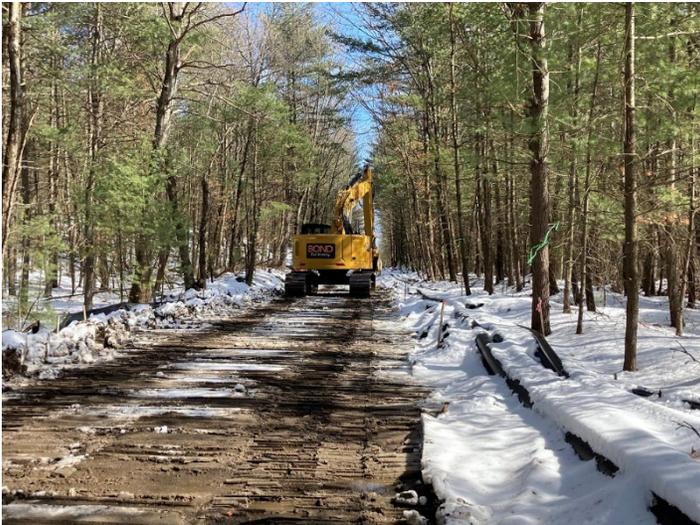
<b>Epsilon</b> ASSOCIATES INC.		<b>PHOTOGRAPHIC LOG</b>	
Client Name: Eversource		Site Location: Sudbury to Hudson Transmission Reliability Project	Town: Hudson
Photo No.: 5	Date: 3-06-2023

<b>Description:</b> View of Bond preparing for MH #11 installation in segment 5 off Parmenter Rd. Facing east.

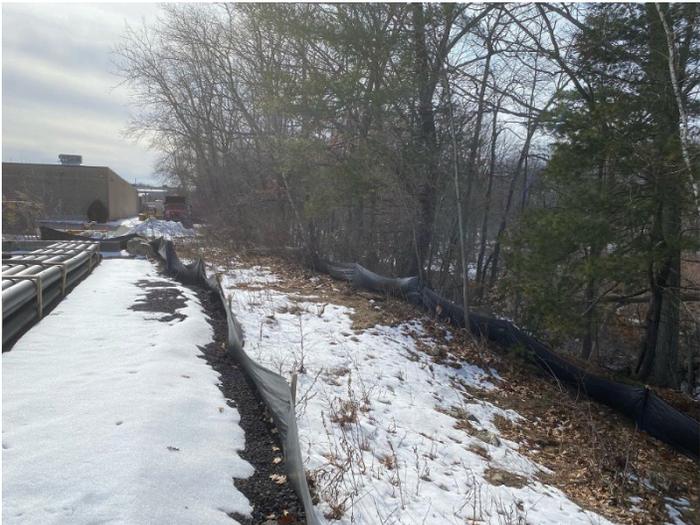
<b>Epsilon</b> ASSOCIATES INC.		<b>PHOTOGRAPHIC LOG</b>	
Client Name: Eversource		Site Location: Sudbury to Hudson Transmission Reliability Project	Town: Hudson
Photo No.: 8	Date: 3-06-2023

<b>Description:</b> View of silt fence at laydown yard on Robert Bonazzoli Ave. Facing southwest.

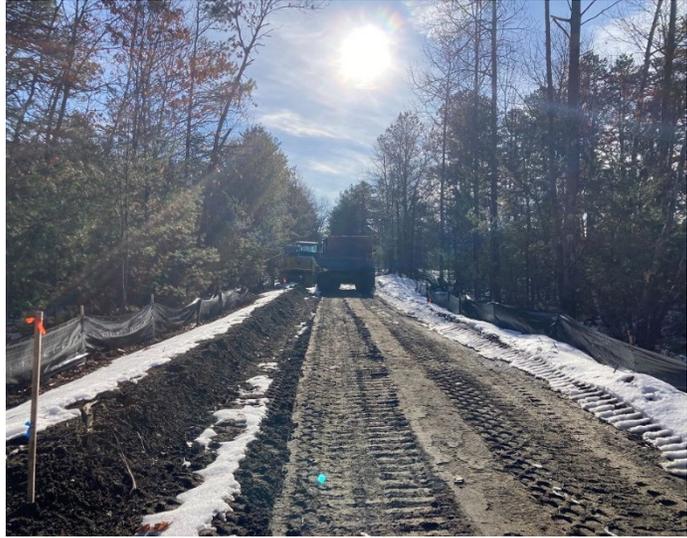
<b>PHOTOGRAPHIC LOG</b>	
<b>Client Name:</b> Eversource		<b>Site Location:</b> Sudbury to Hudson Transmission Reliability Project	<b>Town:</b> Hudson
<b>Photo No.:</b> 1	<b>Date:</b> 3-09-2023

<b>Description:</b> View of ET&L staging equipment at east end of segment 6. Facing east.

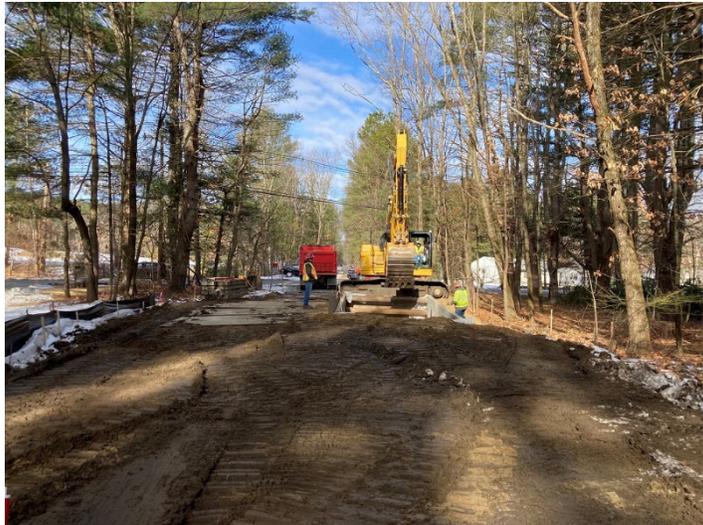
<b>PHOTOGRAPHIC LOG</b>	
<b>Client Name:</b> Eversource		<b>Site Location:</b> Sudbury to Hudson Transmission Reliability Project	<b>Town:</b> Hudson
<b>Photo No.:</b> 2	<b>Date:</b> 3-09-2023

<b>Description:</b> View of Bond performing excavation at MH #11 in segment 5. Facing west.

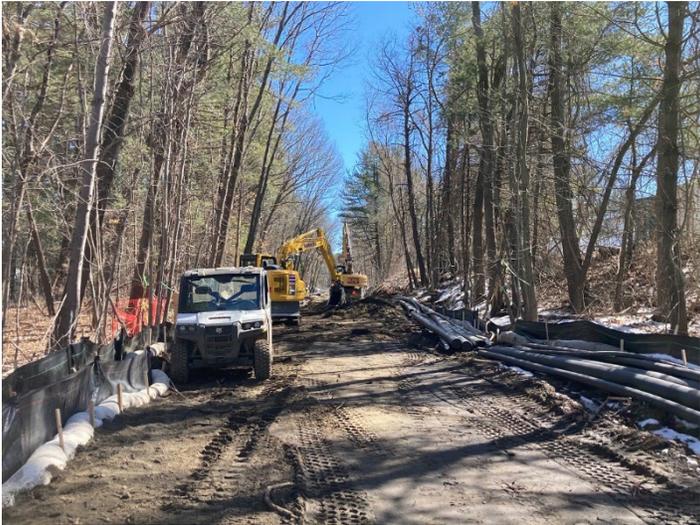
<b>PHOTOGRAPHIC LOG</b>	
<b>Client Name:</b> Eversource		<b>Site Location:</b> Sudbury to Hudson Transmission Reliability Project	<b>Town:</b> Hudson
<b>Photo No.:</b> 4	<b>Date:</b> 3-09-2023

<b>Description:</b> View of Bond performing conduit installation in segment 3. Facing east.

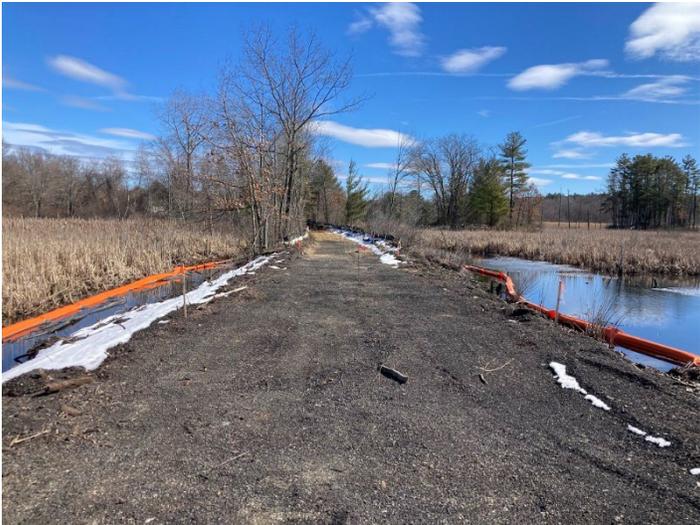
<b>Epsilon</b> ASSOCIATES INC.		<b>PHOTOGRAPHIC LOG</b>	
<b>Client Name:</b> Eversource		<b>Site Location:</b> Sudbury to Hudson Transmission Reliability Project	<b>Town:</b> Hudson
<b>Photo No.:</b> 5	<b>Date:</b> 3-09-2023

<b>Description:</b> View of E&S controls in segment 3 from bridge 130. Facing east.

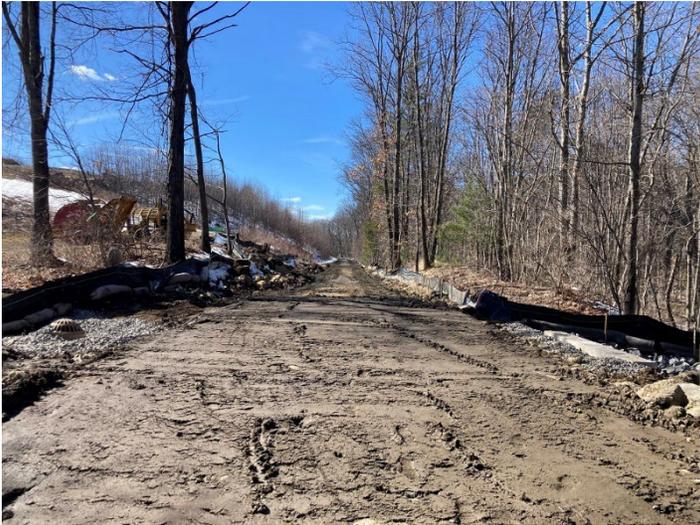
<b>Epsilon</b> ASSOCIATES INC.		<b>PHOTOGRAPHIC LOG</b>	
<b>Client Name:</b> Eversource		<b>Site Location:</b> Sudbury to Hudson Transmission Reliability Project	<b>Town:</b> Stow
<b>Photo No.:</b> 6	<b>Date:</b> 3-09-2023

<b>Description:</b> View of Stow portion of project in segment 1. Facing west.

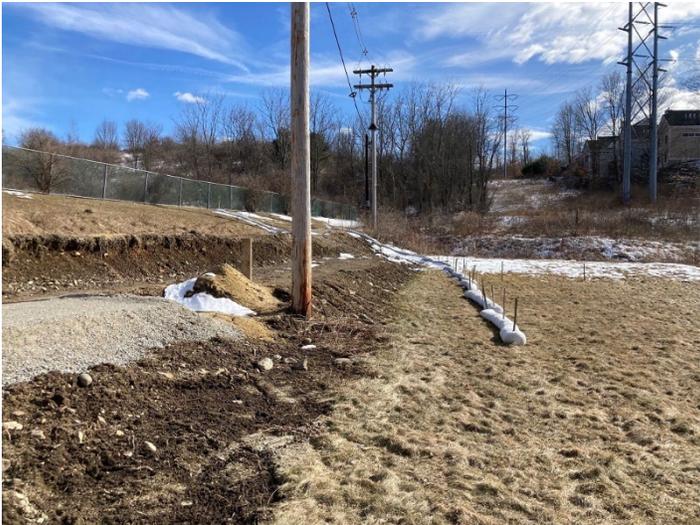
<b>Epsilon</b> ASSOCIATES INC.		<b>PHOTOGRAPHIC LOG</b>	
<b>Client Name:</b> Eversource		<b>Site Location:</b> Sudbury to Hudson Transmission Reliability Project	<b>Town:</b> Hudson
<b>Photo No.:</b> 7	<b>Date:</b> 3-09-2023

<b>Description:</b> View of filter tubes at MH#1 area. Facing south.

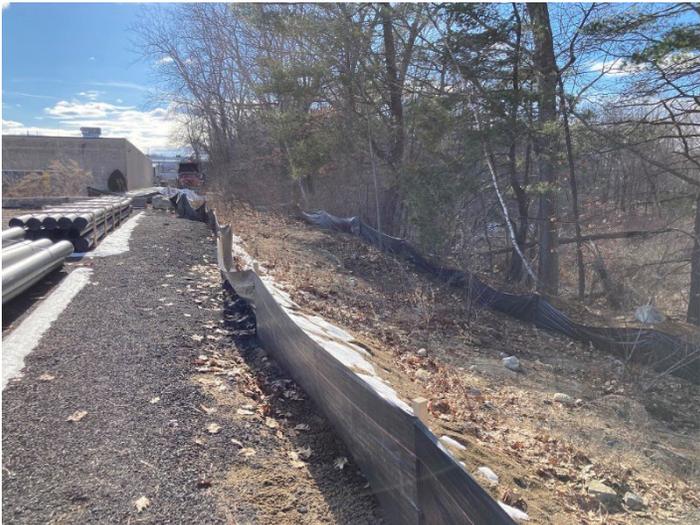
<b>Epsilon</b> ASSOCIATES INC.		<b>PHOTOGRAPHIC LOG</b>	
<b>Client Name:</b> Eversource		<b>Site Location:</b> Sudbury to Hudson Transmission Reliability Project	<b>Town:</b> Hudson
<b>Photo No.:</b> 8	<b>Date:</b> 3-09-2023

<b>Description:</b> View of silt fence at laydown yard on Robert Bonazzoli Ave. Facing southwest.

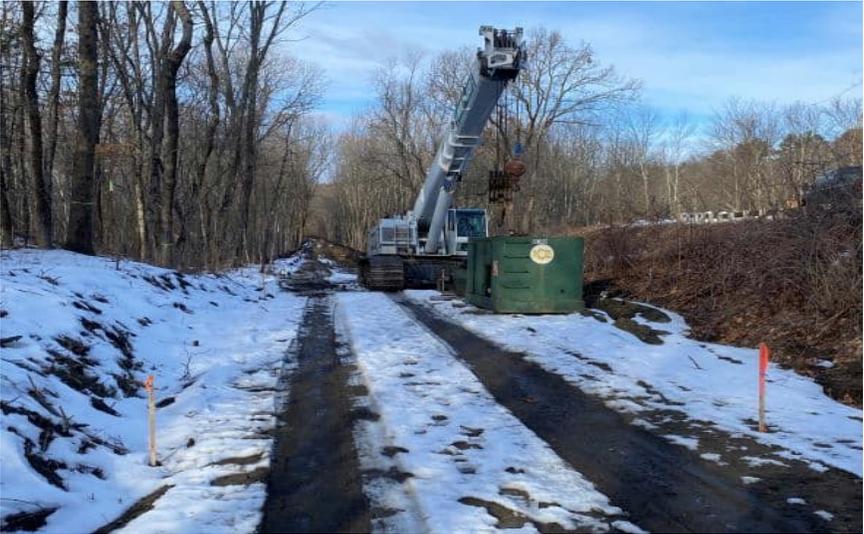
<b>PHOTOGRAPHIC LOG</b>	
Client Name: Eversource		Site Location: Sudbury to Hudson Transmission Reliability Project	Town: Sudbury
Photo No.: 1	Date: 3-9-23

Description:  Staged crane, powerpack & vibratory hammer within Segment 14 at approximate Sta# 753+00, looking westward.

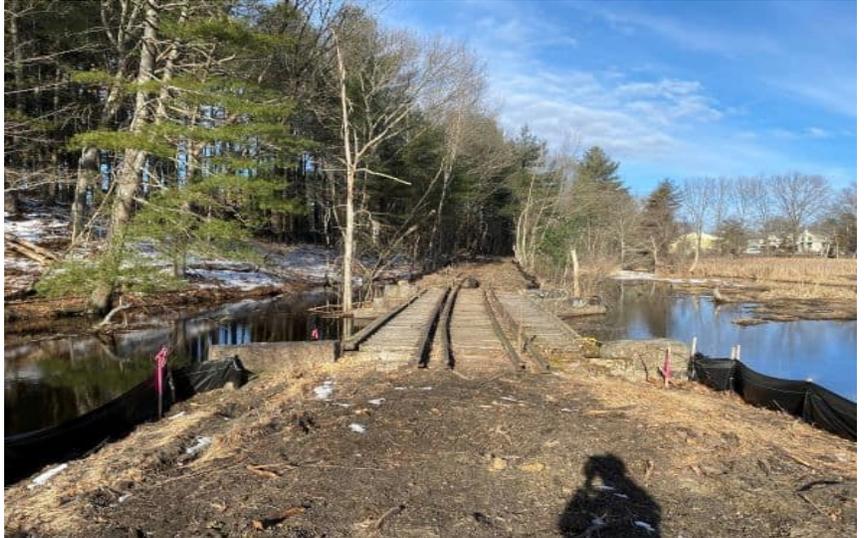
<b>PHOTOGRAPHIC LOG</b>	
Client Name: Eversource		Site Location: Sudbury to Hudson Transmission Reliability Project	Town: Sudbury
Photo No.: 2	Date: 3-9-23

Description:  Right-of-way at Bridge 127, looking westward.

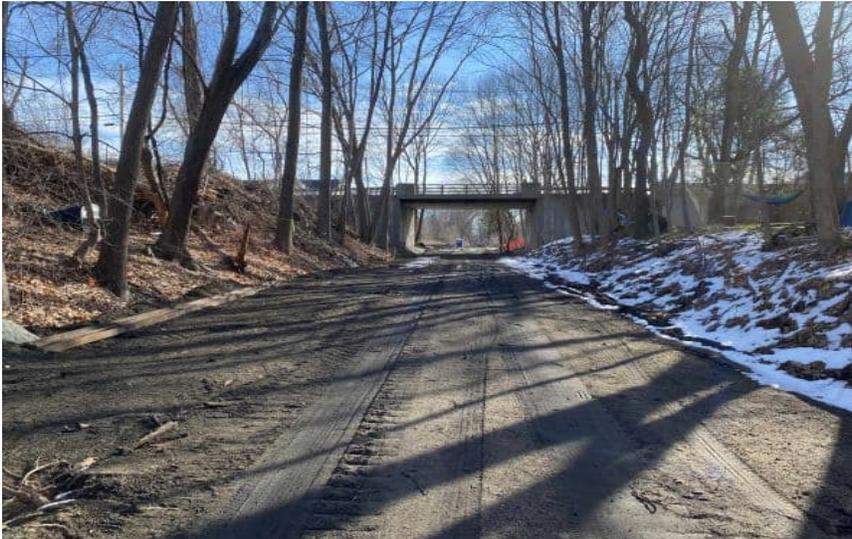
<b>PHOTOGRAPHIC LOG</b>	
Client Name: Eversource		Site Location: Sudbury to Hudson Transmission Reliability Project	Town: Sudbury
Photo No.: 3	Date: 3-9-23

Description:  ROW within Segment 14 at Landham overpass, looking eastward.

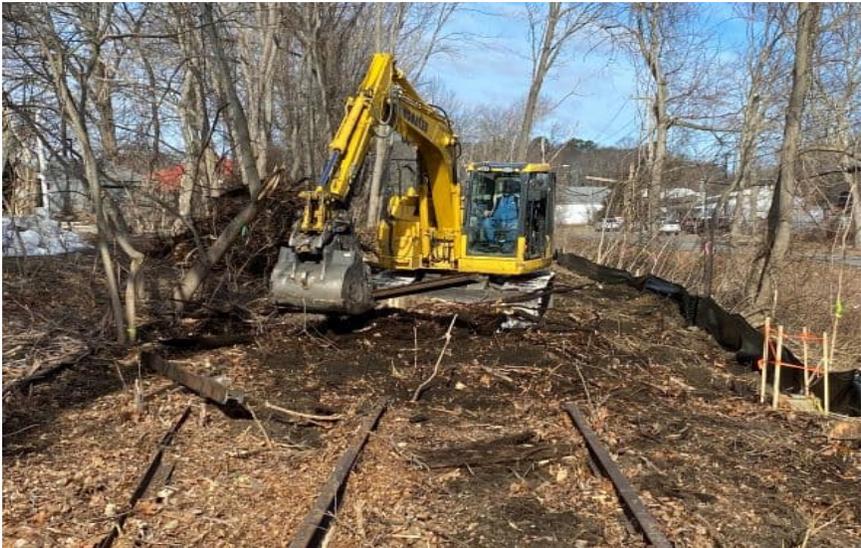
<b>PHOTOGRAPHIC LOG</b>	
Client Name: Eversource		Site Location: Sudbury to Hudson Transmission Reliability Project	Town: Sudbury
Photo No.: 4	Date: 3-9-23

Description:  Moosehead removing rail/ties within Segment 12 at approximate Sta# 709+00, looking westward.

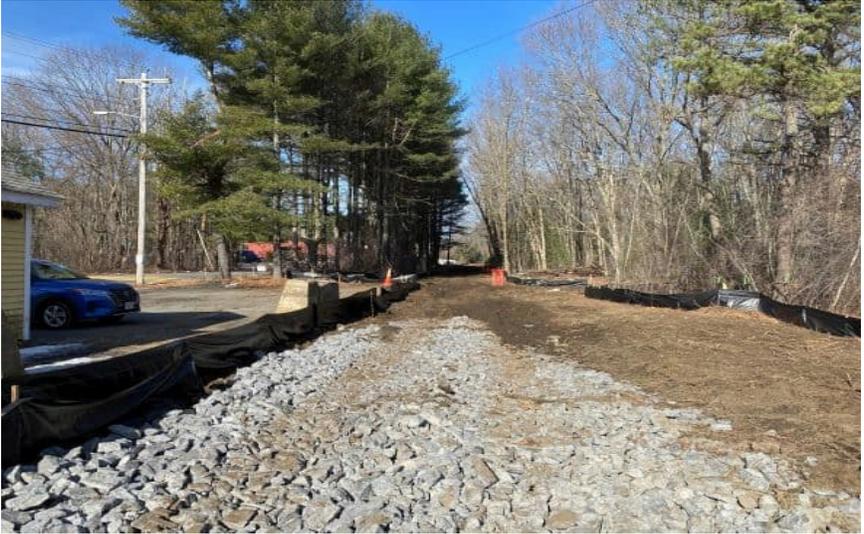
<b>PHOTOGRAPHIC LOG</b>	
Client Name: Eversource		Site Location: Sudbury to Hudson Transmission Reliability Project	Town: Sudbury
Photo No.: 5	Date: 3-9-23

Description:  ROW off Union Avenue, looking westward.
