**Weekly Environmental Compliance Summary**

**Sudbury to Hudson Transmission Reliability Project (USEPA Tracking # MAR1003UW)**

Week of: March 6 to March 10, 2023

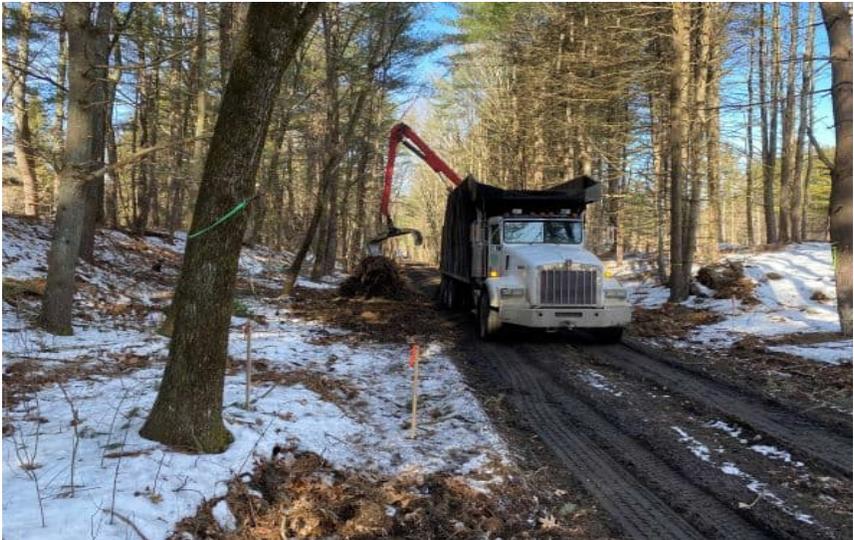
<b>PHOTOGRAPHIC LOG</b>	
Client Name: Eversource		Site Location: Sudbury to Hudson Transmission Reliability Project	Town: Sudbury
Photo No.: 6	Date: 3-9-23

Description:  Moosehead removing debris within Segment 10 at approximate Sta# 548+00, looking westward.

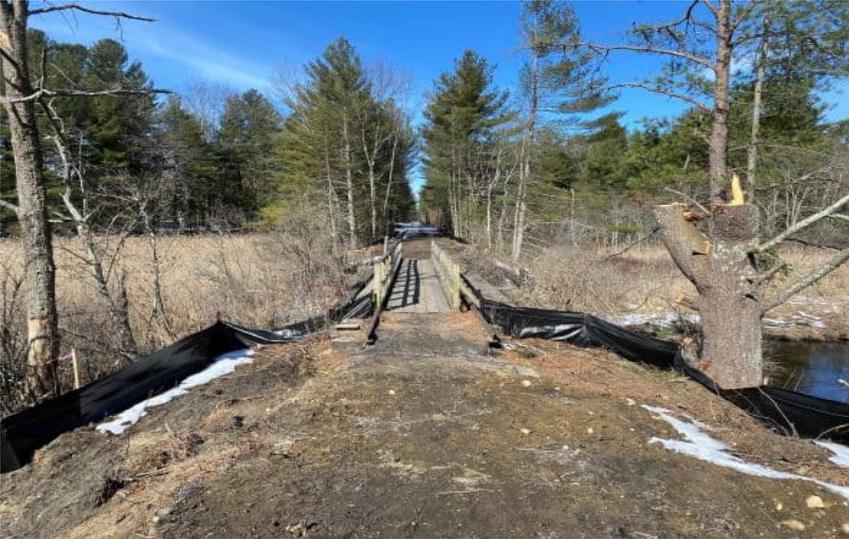
<b>PHOTOGRAPHIC LOG</b>	
Client Name: Eversource		Site Location: Sudbury to Hudson Transmission Reliability Project	Town: Sudbury
Photo No.: 7	Date: 3-9-23

Description:  Bridge 128 within Segment 8, looking westward.

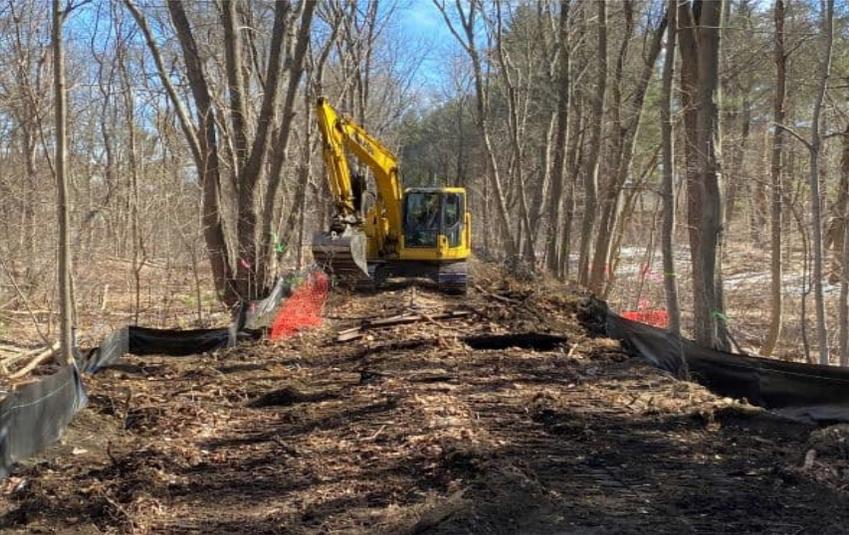
<b>PHOTOGRAPHIC LOG</b>	
Client Name: Eversource		Site Location: Sudbury to Hudson Transmission Reliability Project	Town: Sudbury
Photo No.: 8	Date: 3-9-23

Description:  Rail/tie removal within Segment 13, looking eastward.
