## Weekly Environmental Compliance Summary

**Sudbury to Hudson Transmission Reliability Project (USEPA Tracking # MAR1003UW)**

Week of: May 8 to May 12, 2023

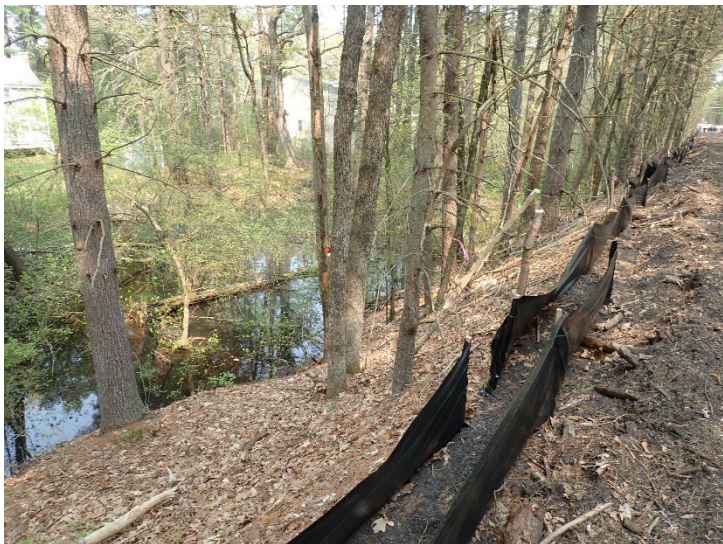
<b>PHOTOGRAPHIC LOG</b>	
<b>Client Name:</b> Eversource		<b>Site Location:</b> Sudbury to Hudson Transmission Reliability Project	
<b>Town:</b> Sudbury			
<b>Photo No.:</b> 5	<b>Date:</b> 5-11-23

<b>Description:</b>  View of existing erosion controls within Segment 9, looking eastward.

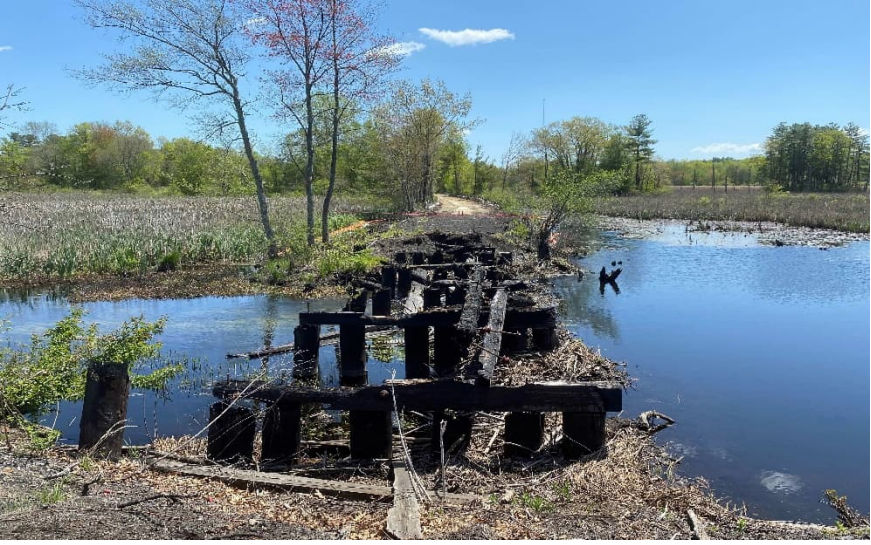
<b>PHOTOGRAPHIC LOG</b>	
Client Name: Eversource		Site Location: Sudbury to Hudson Transmission Reliability Project	
Photo No.: 4		Date: 5-12-23	
Description:  Bridge 130 at segment 2/3 boundary looking into segment 2, existing erosion control, looking westward.

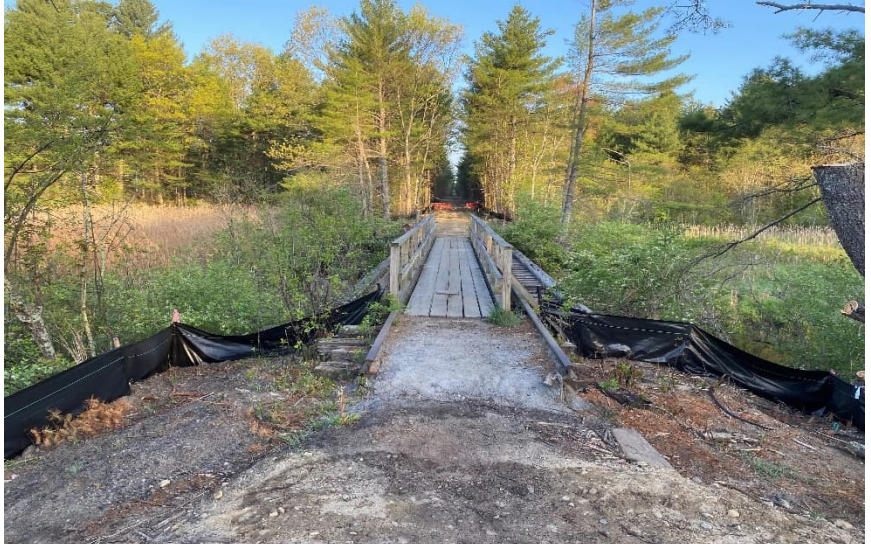
<b>PHOTOGRAPHIC LOG</b>	
Client Name: Eversource		Site Location: Sudbury to Hudson Transmission Reliability Project	
Photo No.: 6		Date: 5-12-23	
Description:  Bridge 128 at segment 7/8 boundary looking into segment 7, existing erosion control, looking westward.

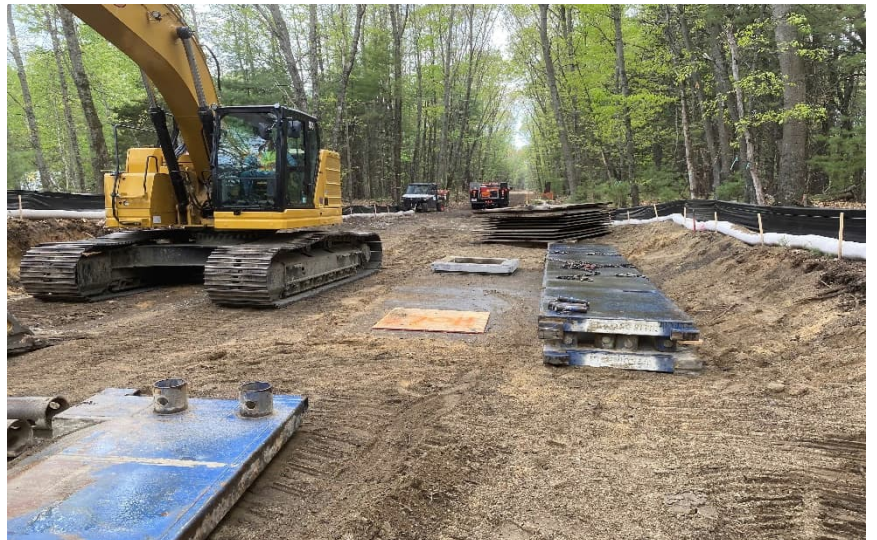
<b>PHOTOGRAPHIC LOG</b>	
Client Name: Eversource		Site Location: Sudbury to Hudson Transmission Reliability Project	
Photo No.: 8		Date: 5-12-23	
Description:  Recently installed manhole #23, Segment 11, existing erosion control, looking westward.

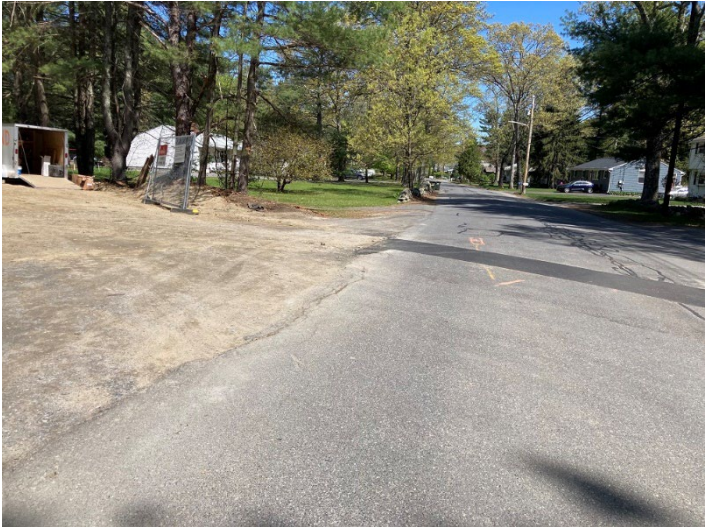
<b>PHOTOGRAPHIC LOG</b>	
<b>Client Name:</b> Eversource		<b>Site Location:</b> Sudbury to Hudson Transmission Reliability Project	
<b>Town:</b> Hudson			
<b>Photo No.:</b> 5	<b>Date:</b> 5-08-2023

<b>Description:</b> View of entrance to segment 4 at Parmenter Rd. Fresh stone should be applied to tracking pad (routine maintenance). Facing north.

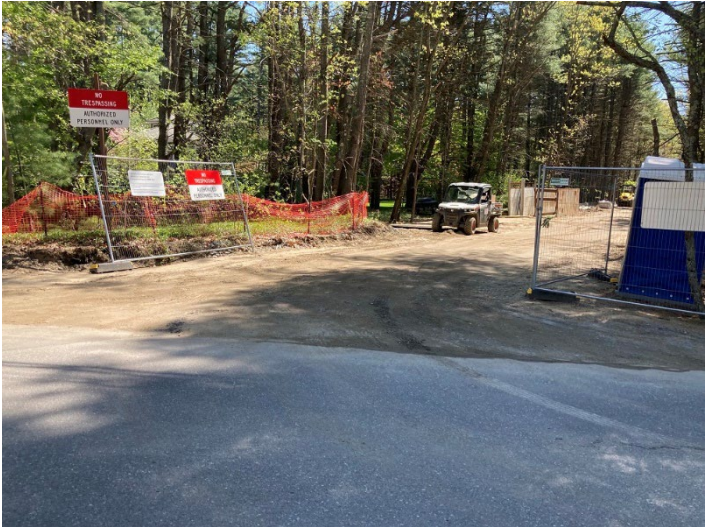
<b>PHOTOGRAPHIC LOG</b>	
<b>Client Name:</b> Eversource		<b>Site Location:</b> Sudbury to Hudson Transmission Reliability Project	
<b>Town:</b> Hudson			
<b>Photo No.:</b> 6	<b>Date:</b> 5-08-2023

<b>Description:</b> View of entrance to segment 5 at Parmenter Rd. Fresh stone should be applied to tracking pad (routine maintenance). Facing northeast.

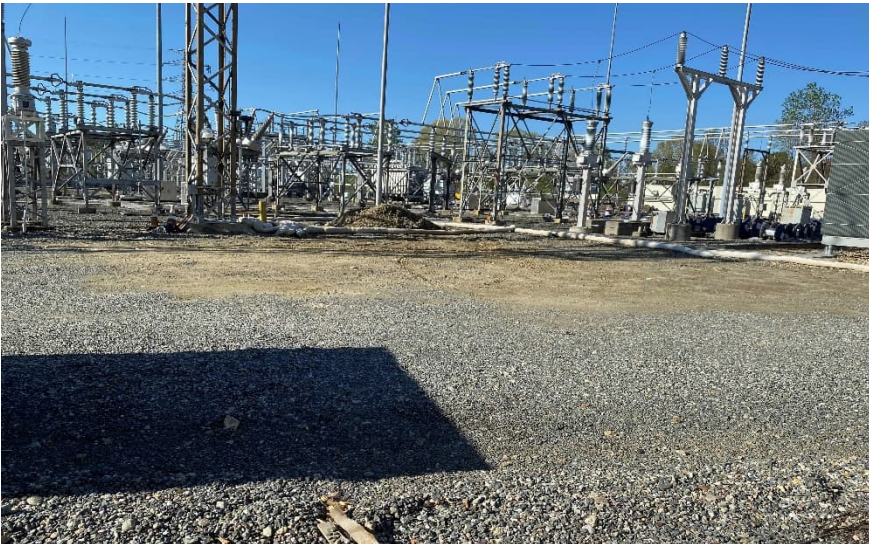
<b>PHOTOGRAPHIC LOG</b>	
Client Name: Eversource		Site Location: Sudbury to Hudson Transmission Reliability Project	
Photo No.: 1      Date: 5-8-23		Town: Sudbury	
Description:  Sudbury Substation, new spoil pile, looking southward.

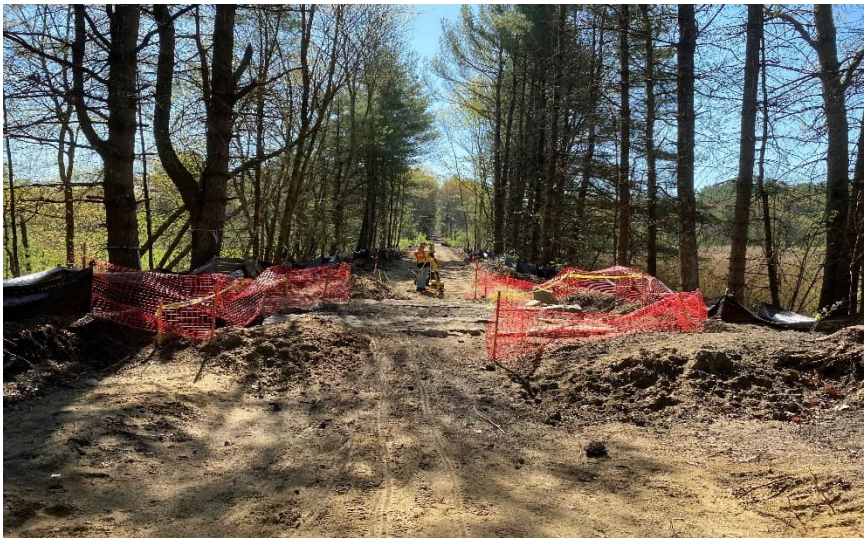
<b>PHOTOGRAPHIC LOG</b>	
Client Name: Eversource		Site Location: Sudbury to Hudson Transmission Reliability Project	
Photo No.: 5      Date: 5-8-23		Town: Sudbury	
Description:  Survey activities within Segment 7, existing erosion control, looking eastward.

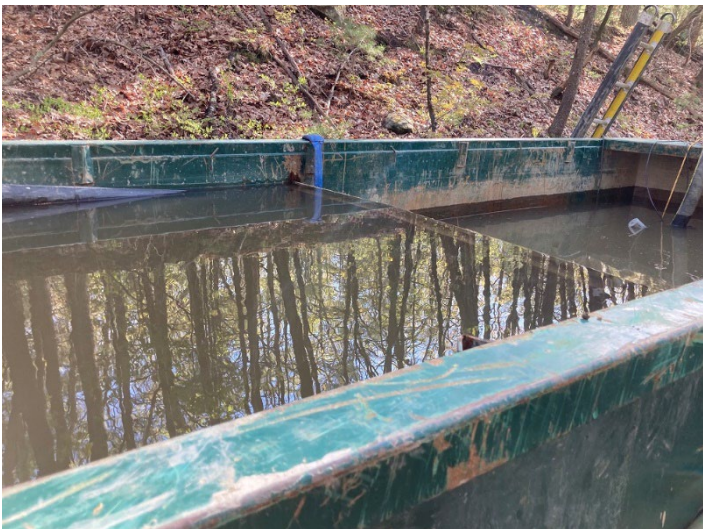
<b>PHOTOGRAPHIC LOG</b>	
<b>Client Name:</b> Eversource		<b>Site Location:</b> Sudbury to Hudson Transmission Reliability Project	<b>Town:</b> Hudson
<b>Photo No.:</b> 2	<b>Date:</b> 5/08/2023

<b>Description:</b> View of dewatering water in frac tank. Water appeared slightly turbid. Facing northeast.

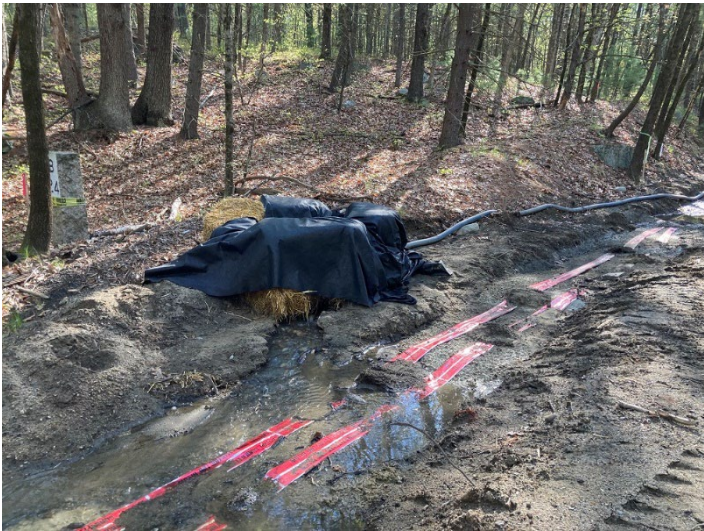
<b>PHOTOGRAPHIC LOG</b>	
<b>Client Name:</b> Eversource		<b>Site Location:</b> Sudbury to Hudson Transmission Reliability Project	
<b>Town:</b> Hudson			
<b>Photo No.:</b> 4	<b>Date:</b> 5/08/2023

<b>Description:</b> View of dewatering controls (straw bale corral with filter fabric and silt bag) and discharge below controls. Facing northeast.

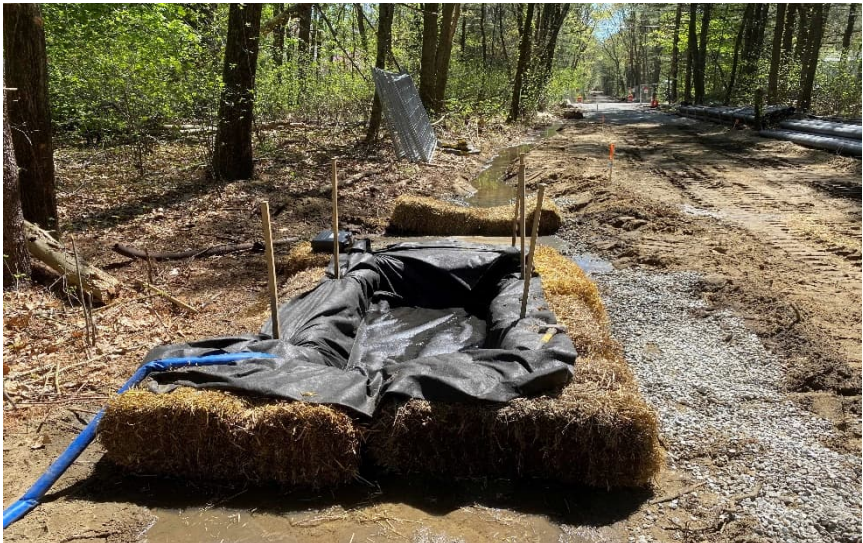
<b>PHOTOGRAPHIC LOG</b>	
Client Name: Eversource		Site Location: Sudbury to Hudson Transmission Reliability Project	
Photo No.: 4		Date: 5/8/2023	
Description: Segment 10 near MH#21. View of discharge bag/bales, looking eastward. Water appeared to be clear.

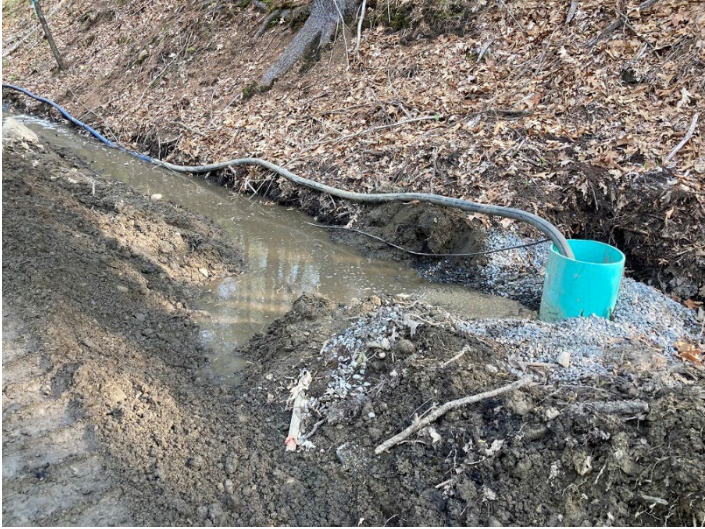
<b>PHOTOGRAPHIC LOG</b>	
<b>Client Name:</b> Eversource		<b>Site Location:</b> Sudbury to Hudson Transmission Reliability Project	<b>Town:</b> Hudson
<b>Photo No.:</b> 1	<b>Date:</b> 5/09/2023

<b>Description:</b> View of dewatering operation in segment 5. Water appeared turbid prior to treatment. Facing northwest.

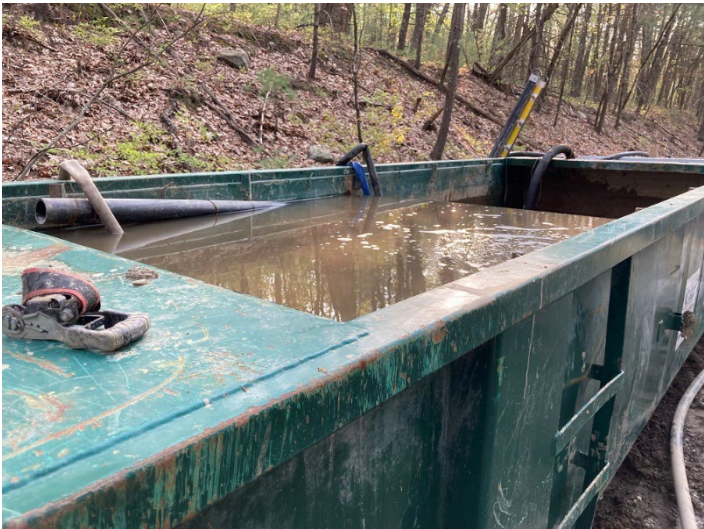
<b>PHOTOGRAPHIC LOG</b>	
<b>Client Name:</b> Eversource		<b>Site Location:</b> Sudbury to Hudson Transmission Reliability Project	<b>Town:</b> Hudson
<b>Photo No.:</b> 2	<b>Date:</b> 5/09/2023

<b>Description:</b> View of dewatering water in frac tank. Water appeared turbid. Facing northeast.

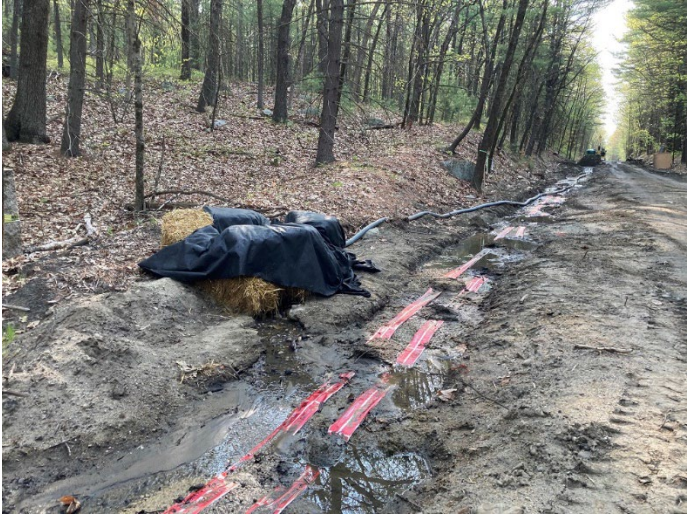
<b>PHOTOGRAPHIC LOG</b>	
<b>Client Name:</b> Eversource		<b>Site Location:</b> Sudbury to Hudson Transmission Reliability Project	
<b>Town:</b> Hudson			
<b>Photo No.:</b> 3	<b>Date:</b> 5/09/2023

<b>Description:</b> View of dewatering controls (straw bale corral with filter fabric and silt bag). Facing northeast.

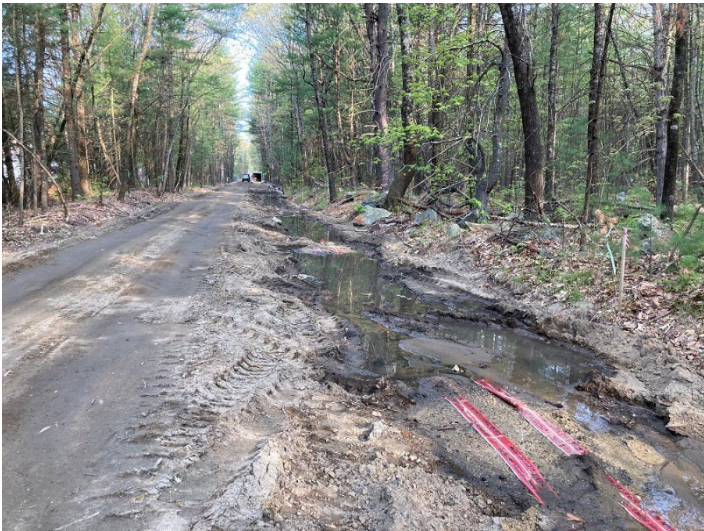
<b>PHOTOGRAPHIC LOG</b>	
<b>Client Name:</b> Eversource		<b>Site Location:</b> Sudbury to Hudson Transmission Reliability Project	
<b>Town:</b> Hudson			
<b>Photo No.:</b> 4	<b>Date:</b> 5/09/2023

<b>Description:</b> View of discharge below controls. Facing west.

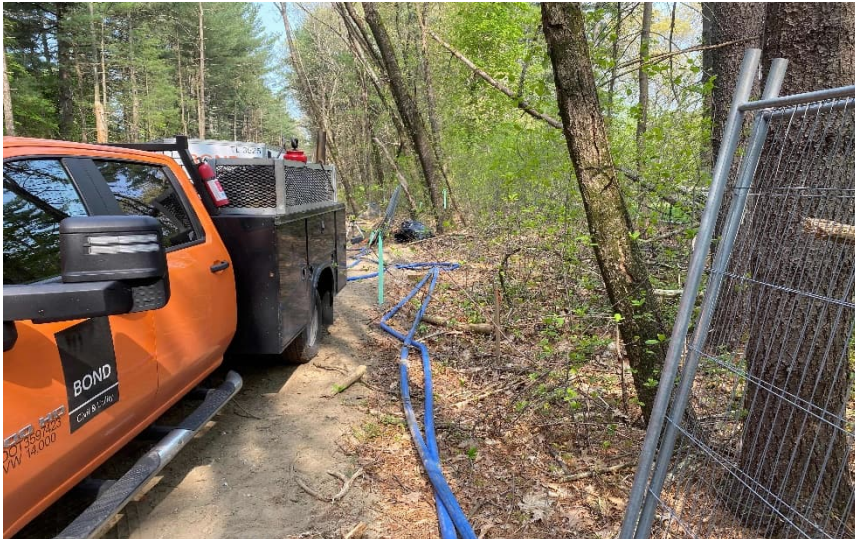
<b>PHOTOGRAPHIC LOG</b>	
Client Name: Eversource		Site Location: Sudbury to Hudson Transmission Reliability Project	
Photo No.: 3		Date: 5/9/2023	
Description: Segment 10 at MH#21. View of dewatering operation, looking westward.

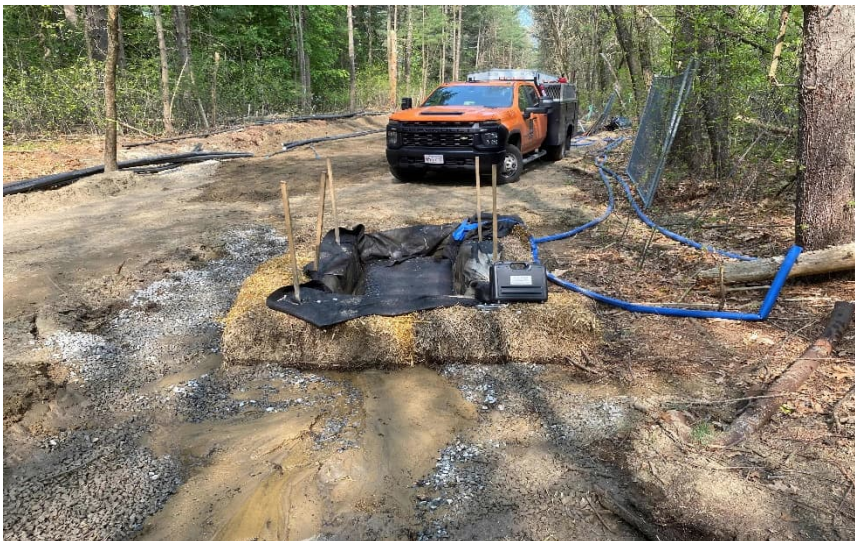
<b>PHOTOGRAPHIC LOG</b>	
Client Name: Eversource		Site Location: Sudbury to Hudson Transmission Reliability Project	
Photo No.: 4		Date: 5/9/2023	
Description: Segment 10 near MH#21. View of discharge bag/bales, looking westward. Water appeared to be clear.

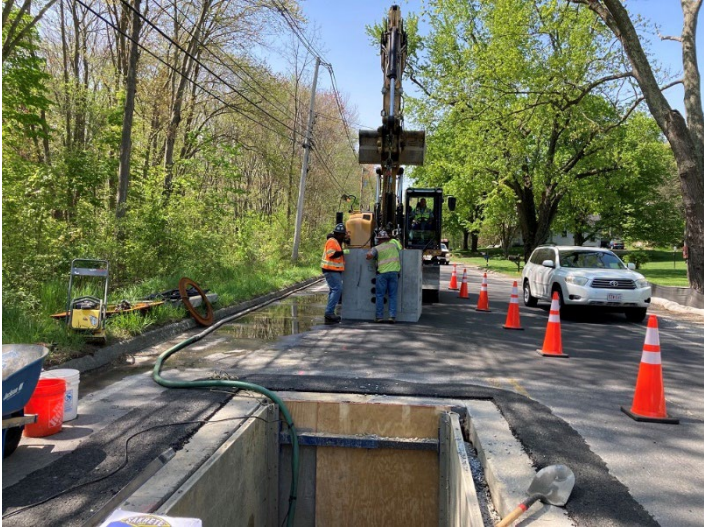
<b>PHOTOGRAPHIC LOG</b>	
<b>Client Name:</b> Eversource		<b>Site Location:</b> Sudbury to Hudson Transmission Reliability Project	
<b>Town:</b> Hudson			
<b>Photo No.:</b> 1	<b>Date:</b> 5/10/2023

<b>Description:</b> View of Bond working at MH #4/HH #4 where dewatering operation is occurring. Facing southwest.

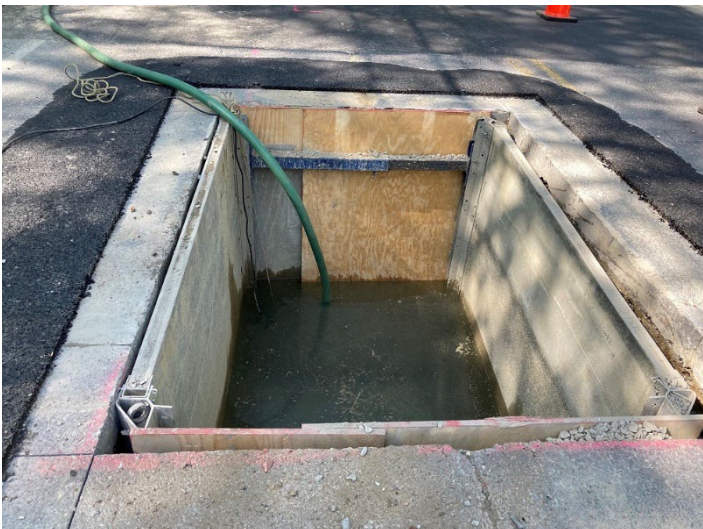
<b>PHOTOGRAPHIC LOG</b>	
<b>Client Name:</b> Eversource		<b>Site Location:</b> Sudbury to Hudson Transmission Reliability Project	
<b>Town:</b> Hudson			
<b>Photo No.:</b> 2	<b>Date:</b> 5/10/2023

<b>Description:</b> View of dewatering operation. Water appeared turbid prior to treatment. Facing southwest.

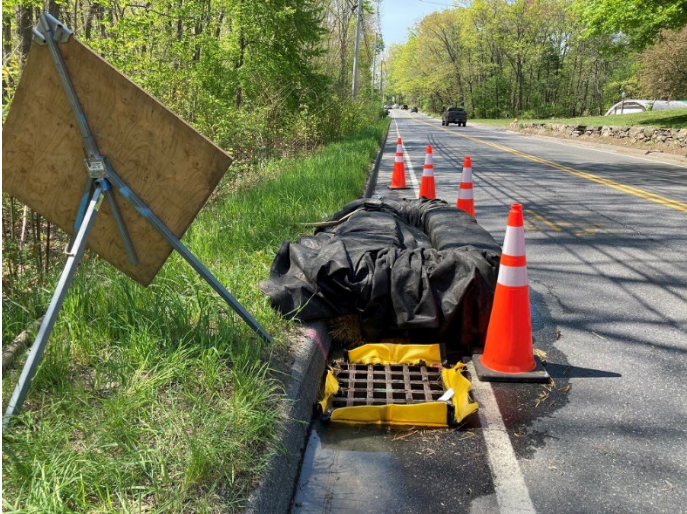
<b>PHOTOGRAPHIC LOG</b>	
<b>Client Name:</b> Eversource		<b>Site Location:</b> Sudbury to Hudson Transmission Reliability Project	
<b>Town:</b> Hudson			
<b>Photo No.:</b> 3	<b>Date:</b> 5/10/2023

<b>Description:</b> View of dewatering controls (straw bale corral with filter fabric and silt bag along with silt sack inlet protection in catch basin). Facing southwest.

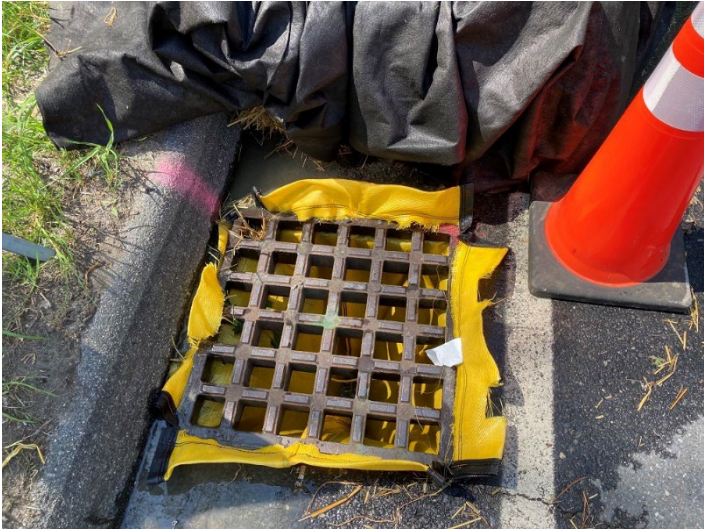
<b>PHOTOGRAPHIC LOG</b>	
<b>Client Name:</b> Eversource		<b>Site Location:</b> Sudbury to Hudson Transmission Reliability Project	
<b>Town:</b> Hudson			
<b>Photo No.:</b> 4	<b>Date:</b> 5/10/2023

<b>Description:</b> View of discharge point from project.

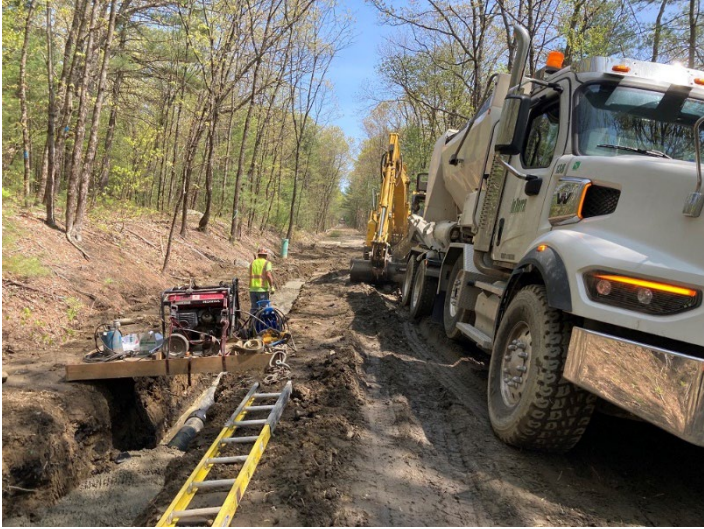
<b>PHOTOGRAPHIC LOG</b>	
<b>Client Name:</b> Eversource		<b>Site Location:</b> Sudbury to Hudson Transmission Reliability Project	
<b>Town:</b> Hudson			
<b>Photo No.:</b> 1	<b>Date:</b> 5/10/2023

<b>Description:</b> View of Bond performing conduit work in segment 5 where dewatering operation is occurring. Facing east.

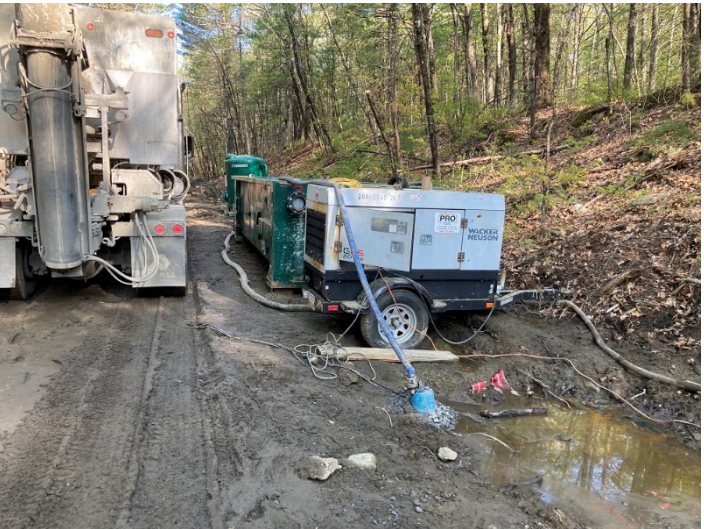
<b>PHOTOGRAPHIC LOG</b>	
<b>Client Name:</b> Eversource		<b>Site Location:</b> Sudbury to Hudson Transmission Reliability Project	
<b>Town:</b> Hudson			
<b>Photo No.:</b> 2	<b>Date:</b> 5/10/2023

<b>Description:</b> View of dewatering operation in segment 5. Water appeared turbid prior to treatment. Facing west.

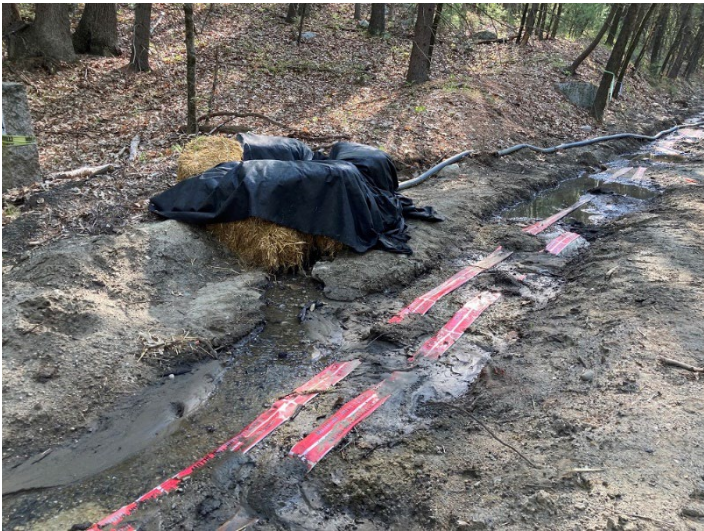
<b>PHOTOGRAPHIC LOG</b>	
<b>Client Name:</b> Eversource		<b>Site Location:</b> Sudbury to Hudson Transmission Reliability Project	
<b>Town:</b> Hudson			
<b>Photo No.:</b> 4	<b>Date:</b> 5/10/2023

<b>Description:</b> View of dewatering controls and discharge below controls. Water appeared clear. Facing northeast.

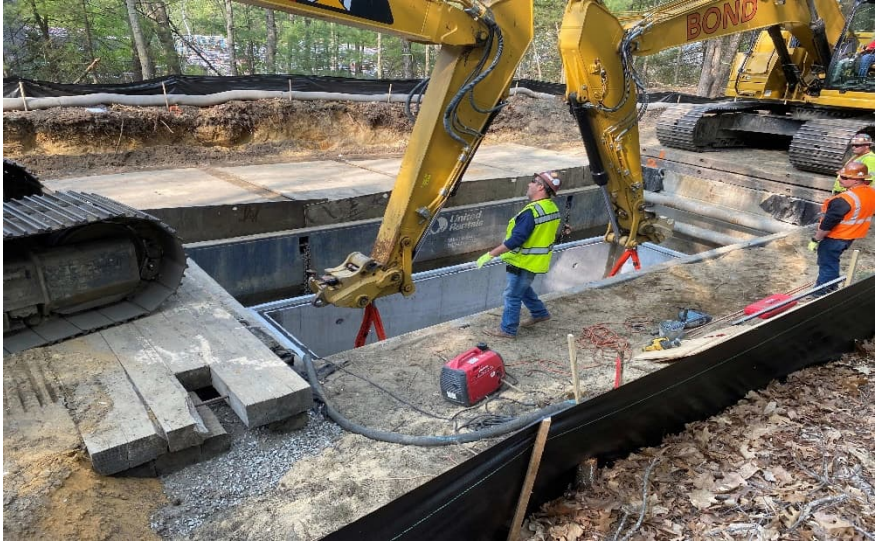
<b>PHOTOGRAPHIC LOG</b>	
Client Name: Eversource		Site Location: Sudbury to Hudson Transmission Reliability Project	
Photo No.: 1		Date: 5/11/2023	
Description: View of area being pumped at work operation within Segment 11 next to MH#23, off Union Avenue. Water appeared clear.

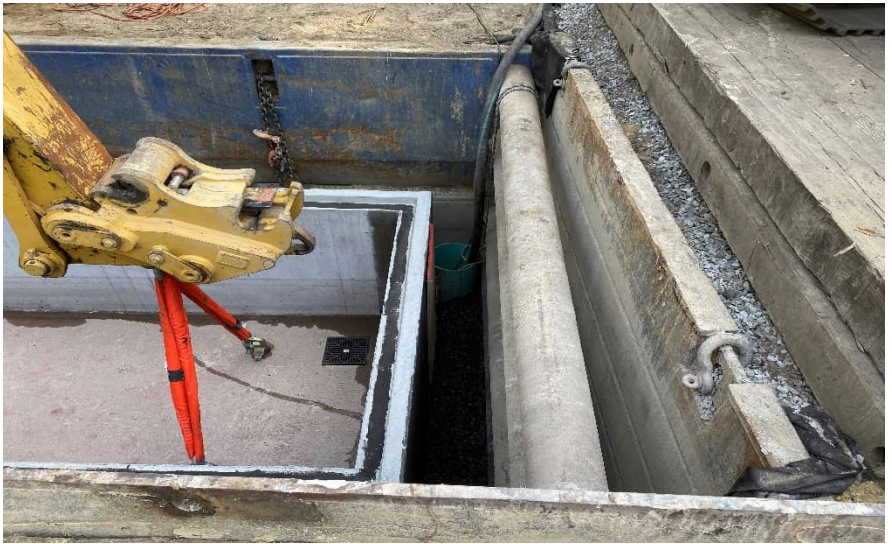
<b>PHOTOGRAPHIC LOG</b>	
Client Name: Eversource		Site Location: Sudbury to Hudson Transmission Reliability Project	
Photo No.: 2		Date: 5/11/2023	
Description: View of pumping operation within Segment 11 at MH#23, looking eastward.

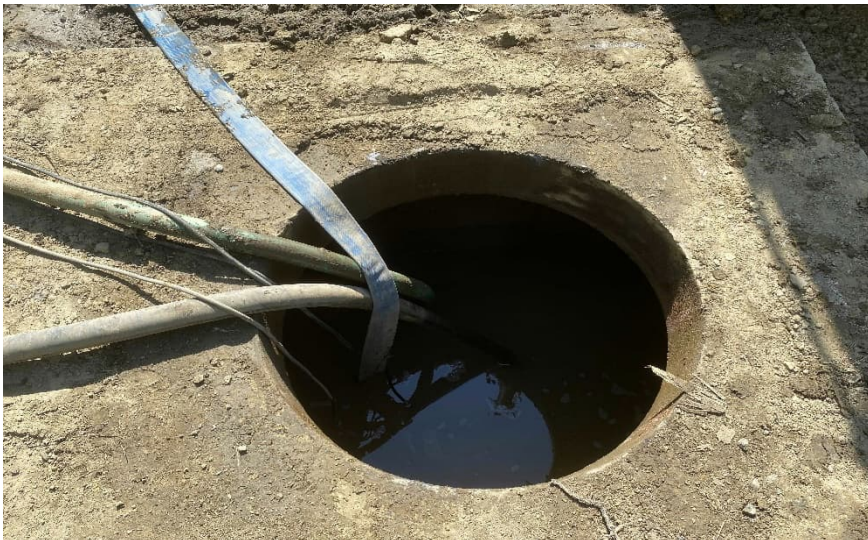
<b>PHOTOGRAPHIC LOG</b>	
Client Name: Eversource		Site Location: Sudbury to Hudson Transmission Reliability Project	
Photo No.: 1		Date: 5/12/2023	
Description: View of area being pumped at work operation within Segment 5 at MH#12 (accumulated water in manhole). Water appeared slightly turbid.

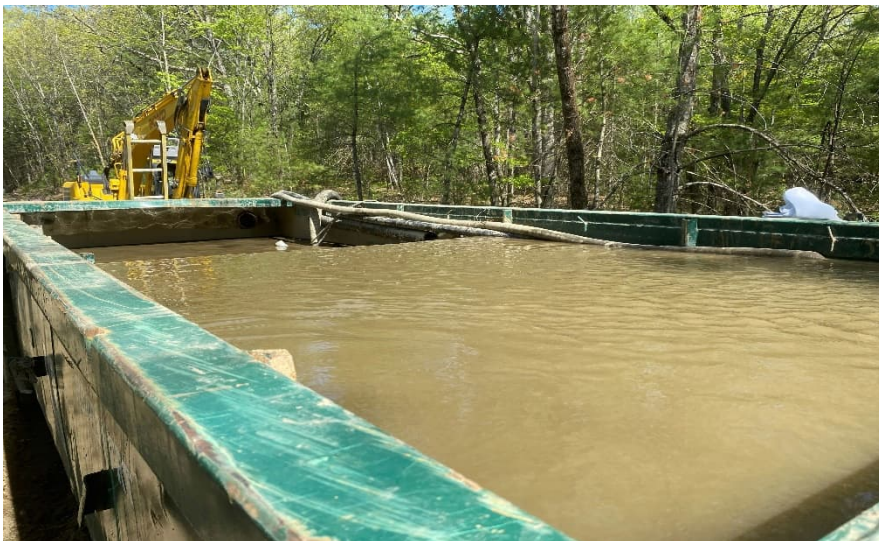
<b>PHOTOGRAPHIC LOG</b>	
Client Name: Eversource		Site Location: Sudbury to Hudson Transmission Reliability Project	
Photo No.: 2		Date: 5/12/2023	
Description: View of pumping operation at Segment 5 at MH#12 (frac tank to filtration system to dewatering bag within bale corral), looking westward.

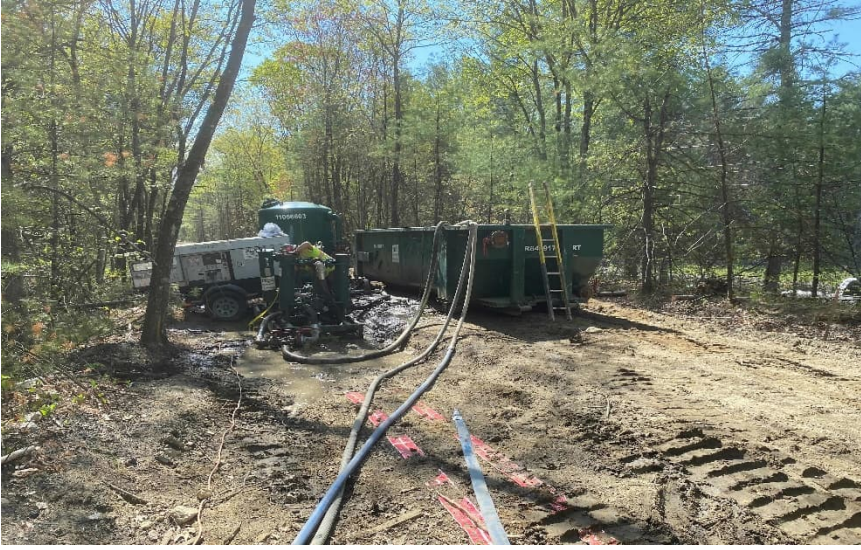
<b>PHOTOGRAPHIC LOG</b>	
Client Name: Eversource		Site Location: Sudbury to Hudson Transmission Reliability Project	
Photo No.: 3		Date: 5/12/2023	
Description: Segment 5 at MH#12. View of dewatering operation, looking eastward.

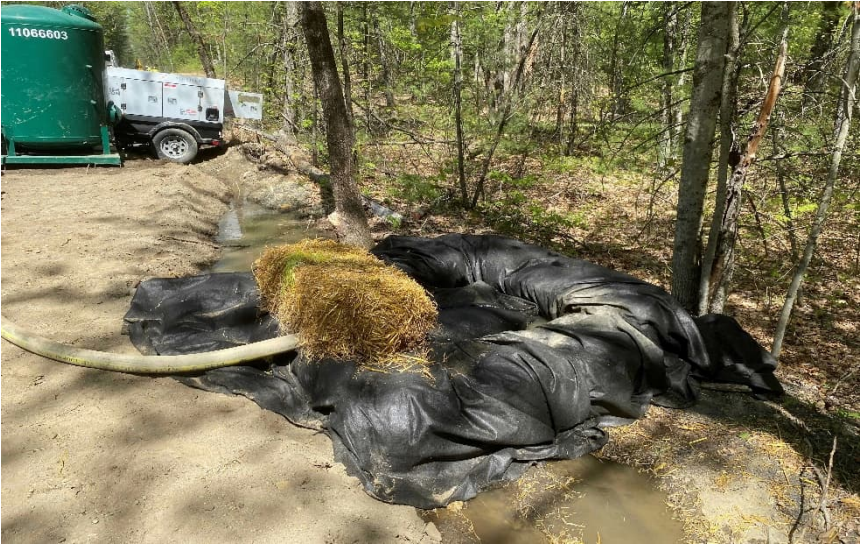
<b>PHOTOGRAPHIC LOG</b>	
Client Name: Eversource		Site Location: Sudbury to Hudson Transmission Reliability Project	
Photo No.: 4		Date: 5/12/2023	
Description: Segment 5 at approximate MH#12. View of discharge bag/bales, looking westward. Water appeared to be turbid.
