**Weekly Environmental Compliance Summary**

**Sudbury to Hudson Transmission Reliability Project (USEPA Tracking # MAR1003UW)**

Sudbury, Hudson, and Stow, MA

Week of: July 10 to July 14, 2023

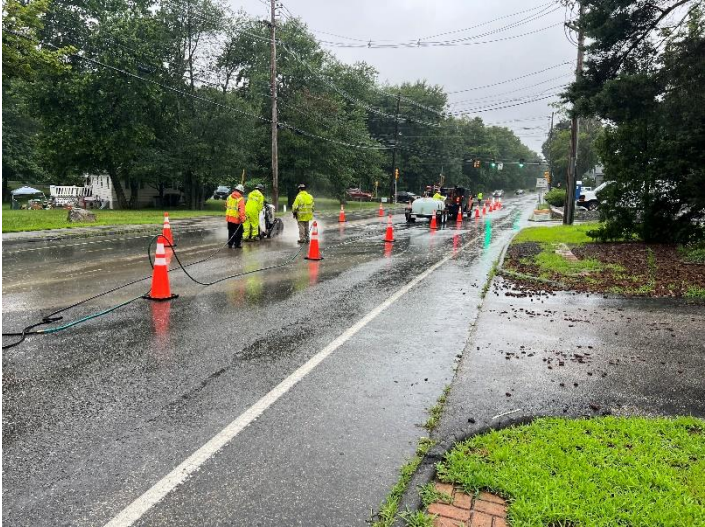
<b>PHOTOGRAPHIC LOG</b>	
<b>Client Name:</b> Eversource		<b>Site Location:</b> Sudbury to Hudson Transmission Reliability Project	
<b>Town:</b> Hudson			
<b>Photo No.:</b> 1	<b>Date:</b> 7/10/2023

<b>Description:</b> View of Bond working near MH #2 on Forest Ave. Facing southwest.

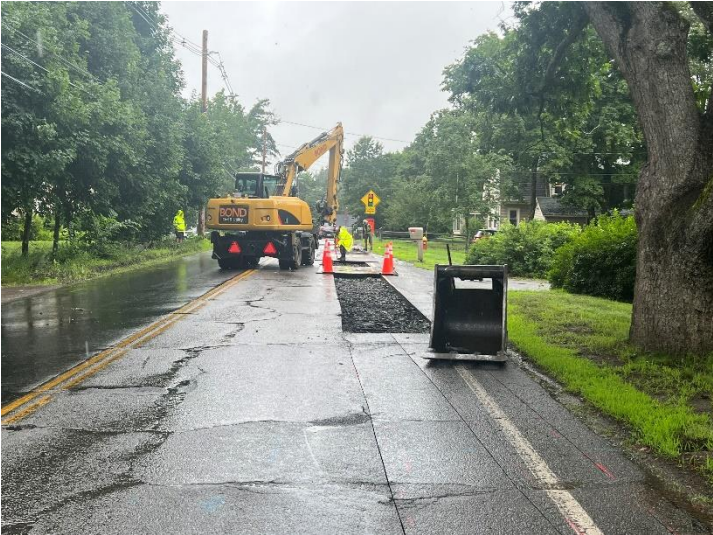
<b>PHOTOGRAPHIC LOG</b>	
<b>Client Name:</b> Eversource		<b>Site Location:</b> Sudbury to Hudson Transmission Reliability Project	
<b>Town:</b> Hudson			
<b>Photo No.:</b> 2	<b>Date:</b> 7/10/2023

<b>Description:</b> View of Bond working on Wilkins St. Facing southwest.

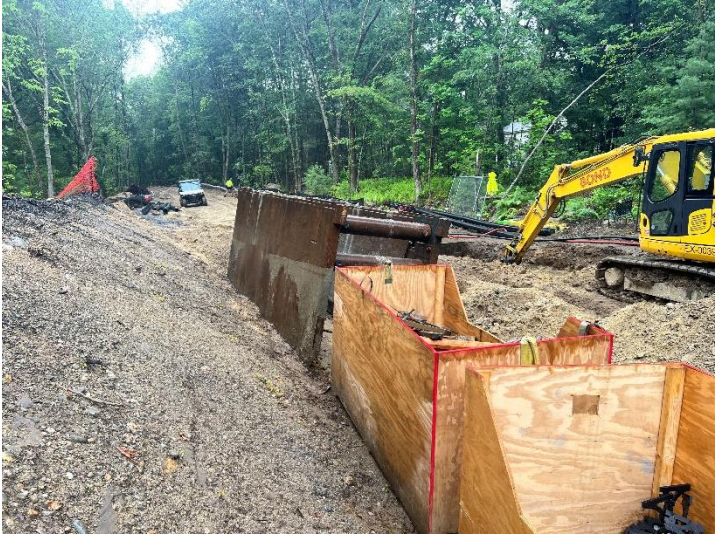
<b>PHOTOGRAPHIC LOG</b>	
<b>Client Name:</b> Eversource		<b>Site Location:</b> Sudbury to Hudson Transmission Reliability Project	
<b>Town:</b> Hudson			
<b>Photo No.:</b> 3	<b>Date:</b> 7/10/2023

<b>Description:</b> View of the excavation near the construction entrance off of Wilkins Street in segment 1. Facing northeast.

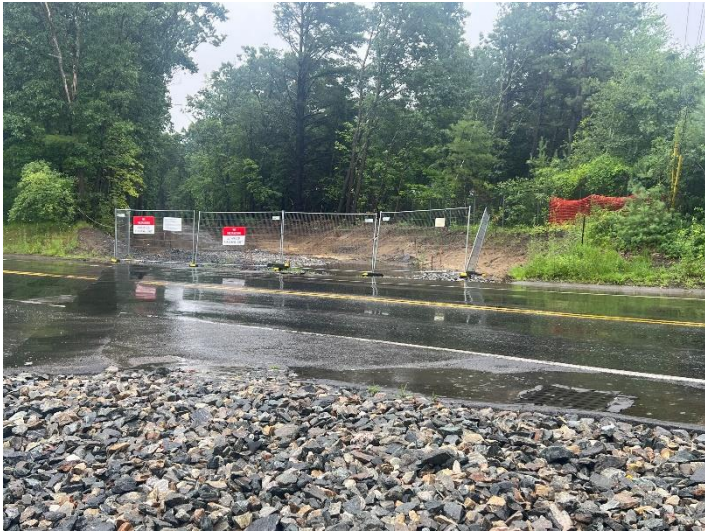
<b>PHOTOGRAPHIC LOG</b>	
<b>Client Name:</b> Eversource		<b>Site Location:</b> Sudbury to Hudson Transmission Reliability Project	
<b>Town:</b> Hudson			
<b>Photo No.:</b> 6	<b>Date:</b> 7/10/2023

<b>Description:</b> View of construction entrance to segment 4 at Main Street. Facing east.

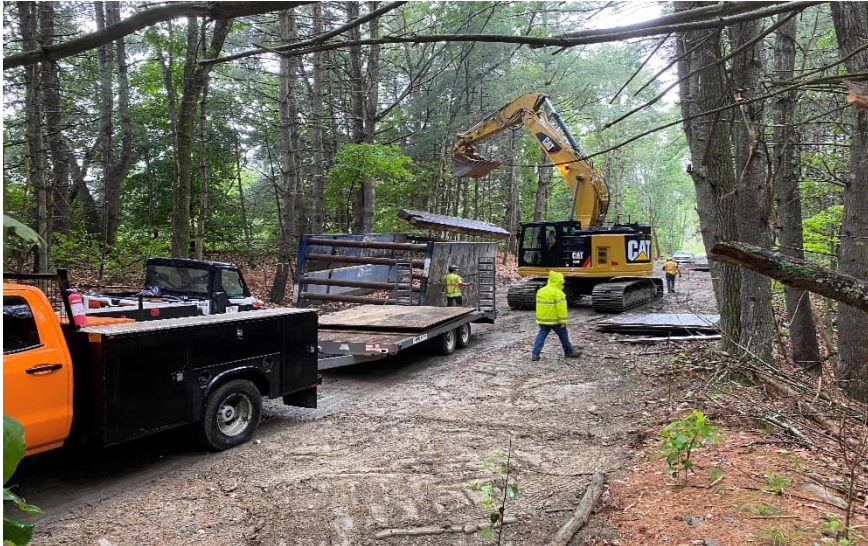
<b>PHOTOGRAPHIC LOG</b>	
Client Name: Eversource		Site Location: Sudbury to Hudson Transmission Reliability Project	
Town: Sudbury			
Photo No.: 1	Date: 7-10-23

Description:  Manhole work within segment 8, manhole #17, looking westward.

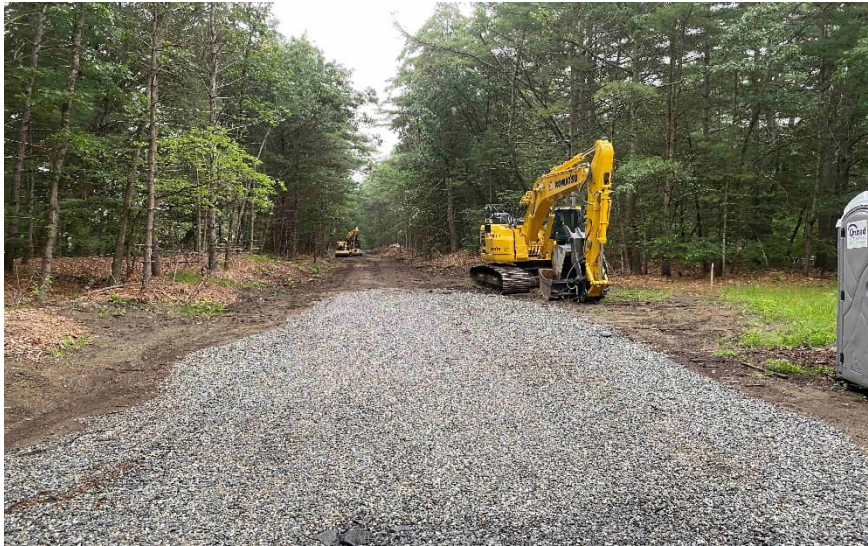
<b>PHOTOGRAPHIC LOG</b>	
Client Name: Eversource		Site Location: Sudbury to Hudson Transmission Reliability Project	
Town: Sudbury			
Photo No.: 2	Date: 7-10-23

Description:  Work area within segment 9, looking eastward.

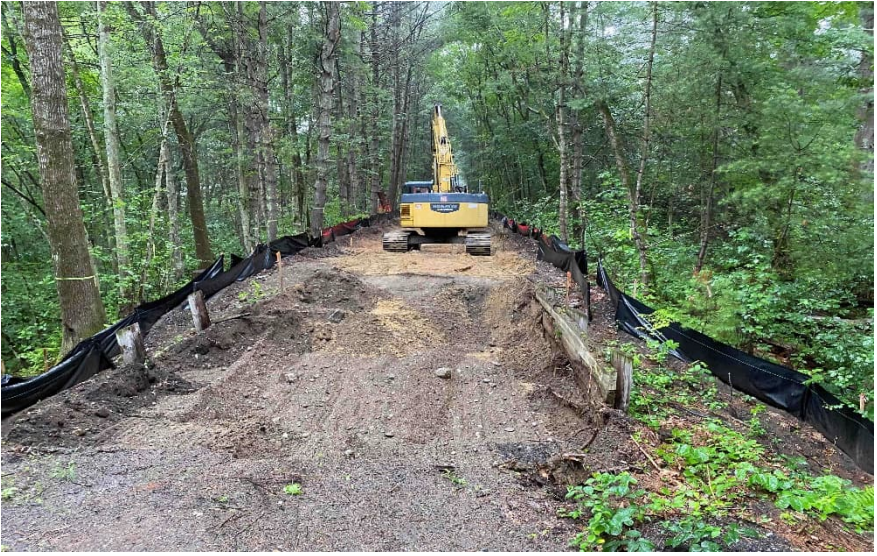
<b>PHOTOGRAPHIC LOG</b>	
Client Name: Eversource		Site Location: Sudbury to Hudson Transmission Reliability Project	
Town: Sudbury			
Photo No.: 3	Date: 7-10-23

Description:  Grading work within segment 10 over Dudley Brook culvert, looking eastward.

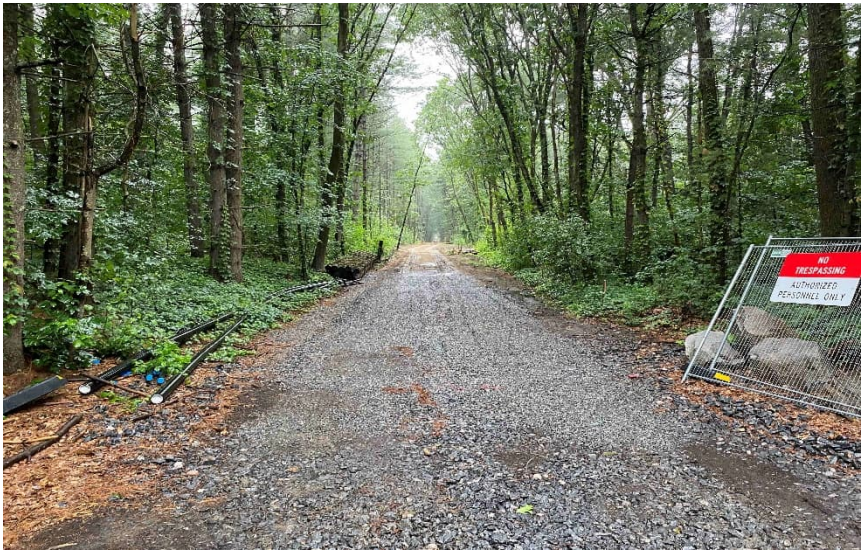
<b>PHOTOGRAPHIC LOG</b>	
Client Name: Eversource		Site Location: Sudbury to Hudson Transmission Reliability Project	
Town: Sudbury			
Photo No.: 4	Date: 7-10-23

Description:  Work area within segment 10, looking westward.

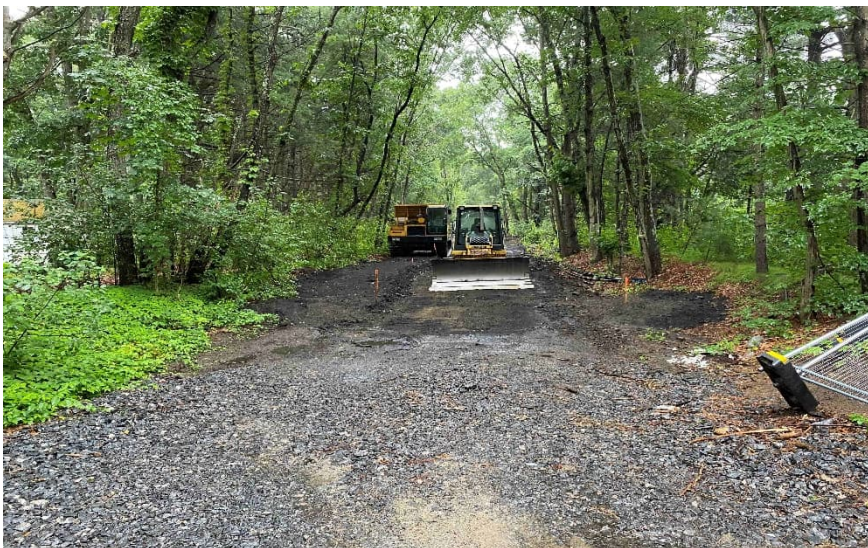
<b>PHOTOGRAPHIC LOG</b>	
Client Name: Eversource		Site Location: Sudbury to Hudson Transmission Reliability Project	
Photo No.: 5      Date: 7-10-23		Town: Sudbury	
Description:  Work area within segment 11, existing erosion control, looking eastward.

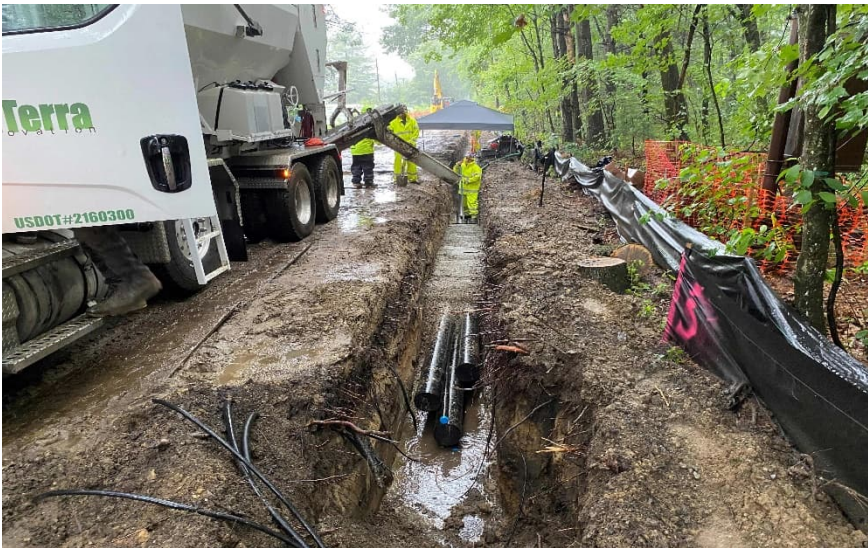
<b>PHOTOGRAPHIC LOG</b>	
Client Name: Eversource		Site Location: Sudbury to Hudson Transmission Reliability Project	
Photo No.: 6      Date: 7-10-23		Town: Sudbury	
Description:  Work area within segment 11 (conduit work), existing erosion control, looking westward.

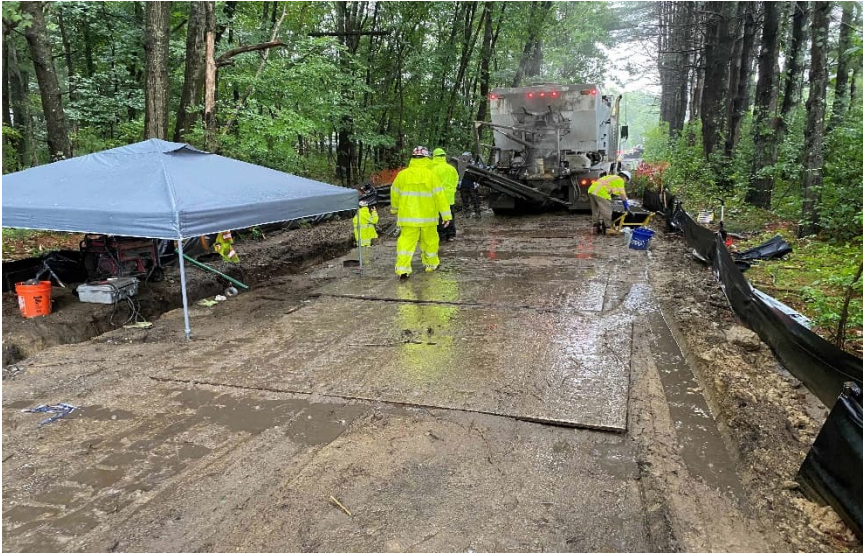
<b>PHOTOGRAPHIC LOG</b>	
Client Name: Eversource		Site Location: Sudbury to Hudson Transmission Reliability Project	
Town: Sudbury			
Photo No.: 7	Date: 7-10-23

Description:  Work area within Segment 11, backfilling, looking westward.

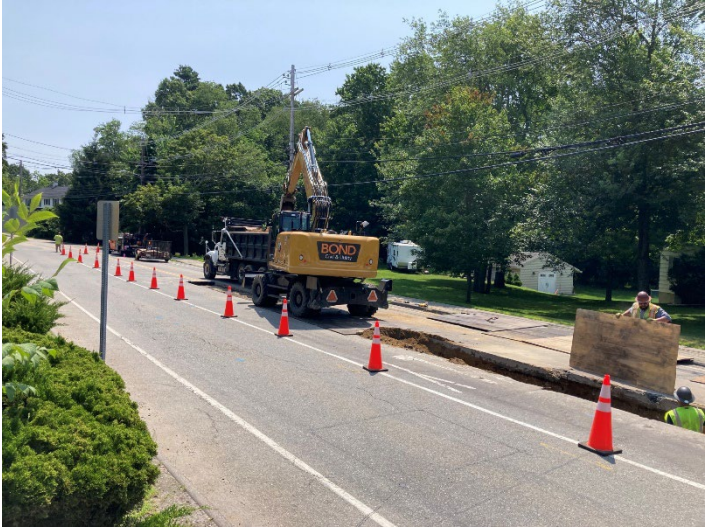
<b>PHOTOGRAPHIC LOG</b>	
<b>Client Name:</b> Eversource		<b>Site Location:</b> Sudbury to Hudson Transmission Reliability Project	
<b>Town:</b> Hudson			
<b>Photo No.:</b> 1	<b>Date:</b> 7/12/2023

<b>Description:</b> View of Bond working near MH #2 on Forest Ave. Facing southeast.

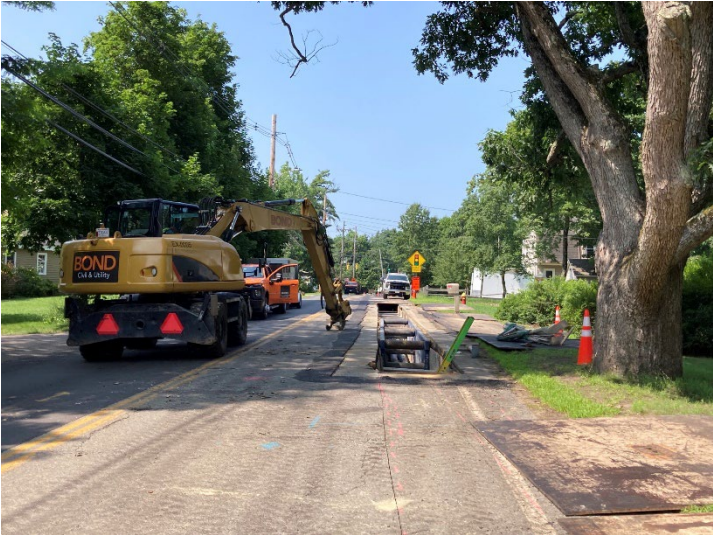
<b>PHOTOGRAPHIC LOG</b>	
<b>Client Name:</b> Eversource		<b>Site Location:</b> Sudbury to Hudson Transmission Reliability Project	
<b>Town:</b> Hudson			
<b>Photo No.:</b> 2	<b>Date:</b> 7/12/2023

<b>Description:</b> View of Bond working on Wilkins St. Facing south.

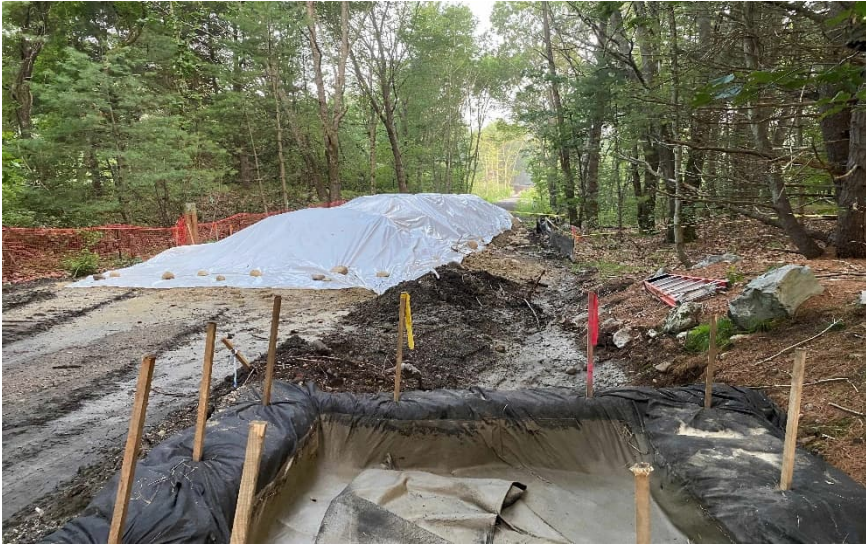
<b>PHOTOGRAPHIC LOG</b>	
Client Name: Eversource		Site Location: Sudbury to Hudson Transmission Reliability Project	
Town: Sudbury			
Photo No.: 1	Date: 7-12-23

Description:  Manhole work within segment 8, manhole #17, spoil piles covered prior to removal, looking westward.

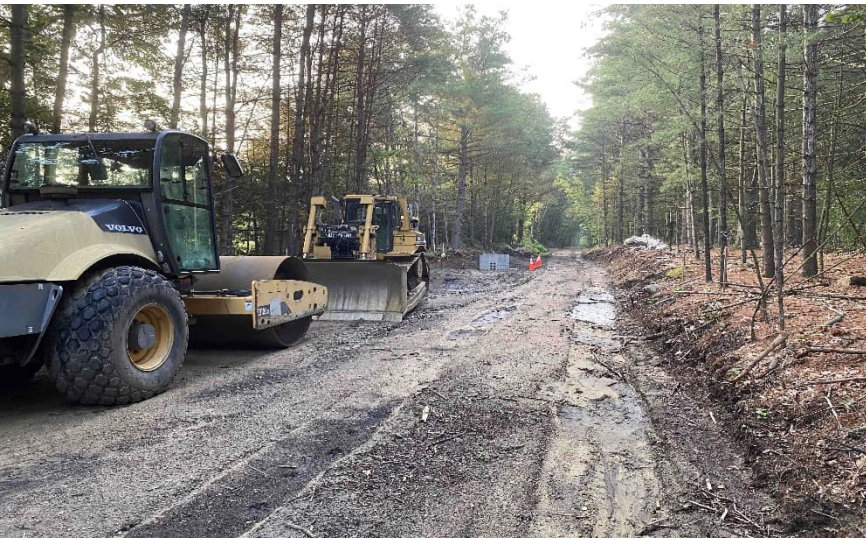
<b>PHOTOGRAPHIC LOG</b>	
Client Name: Eversource		Site Location: Sudbury to Hudson Transmission Reliability Project	
Town: Sudbury			
Photo No.: 2	Date: 7-12-23

Description:  Work area within segment 9, manhole 18 area, looking eastward.

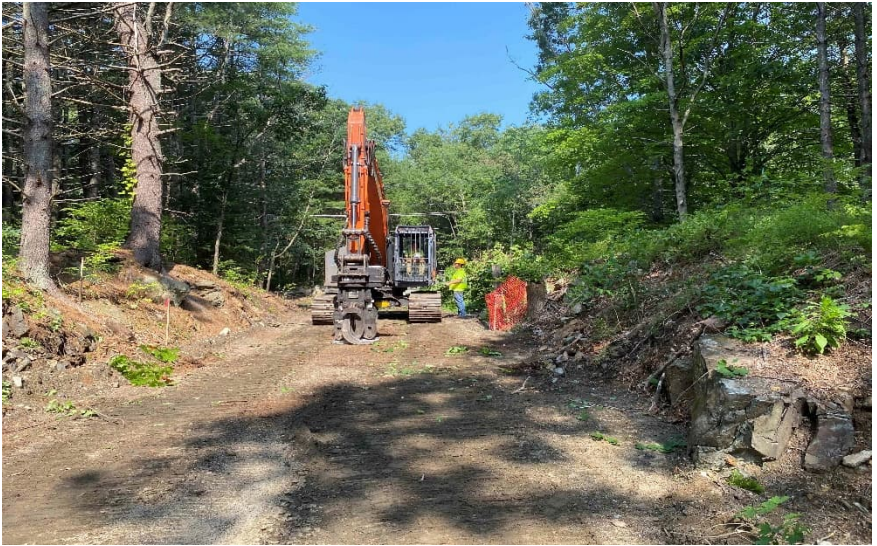
<b>PHOTOGRAPHIC LOG</b>	
Client Name: Eversource		Site Location: Sudbury to Hudson Transmission Reliability Project	
Town: Sudbury			
Photo No.: 3	Date: 7-12-23

Description:  Invasive species removal work within segment 10 (Moosehead), looking westward.

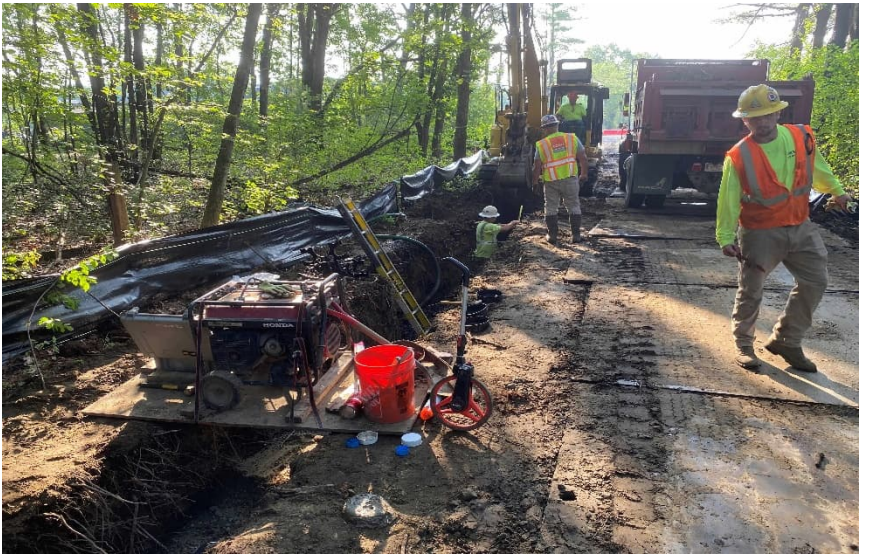
<b>PHOTOGRAPHIC LOG</b>	
Client Name: Eversource		Site Location: Sudbury to Hudson Transmission Reliability Project	
Town: Sudbury			
Photo No.: 4	Date: 7-12-23

Description:  Work area within segment 11, conduit work, existing erosion control, looking eastward.

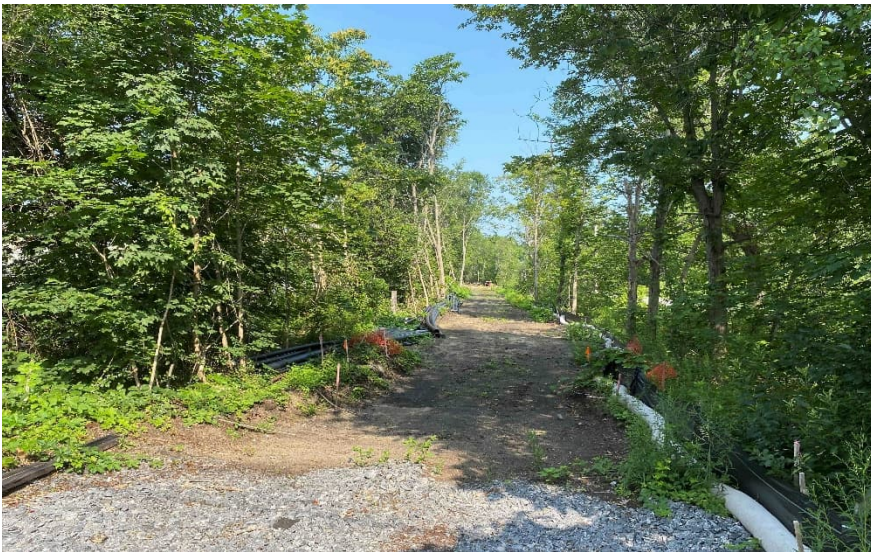
<b>PHOTOGRAPHIC LOG</b>	
Client Name: Eversource		Site Location: Sudbury to Hudson Transmission Reliability Project	
Town: Sudbury			
Photo No.: 5	Date: 7-12-23

Description:  Work area within segment 12, existing erosion control, looking westward.

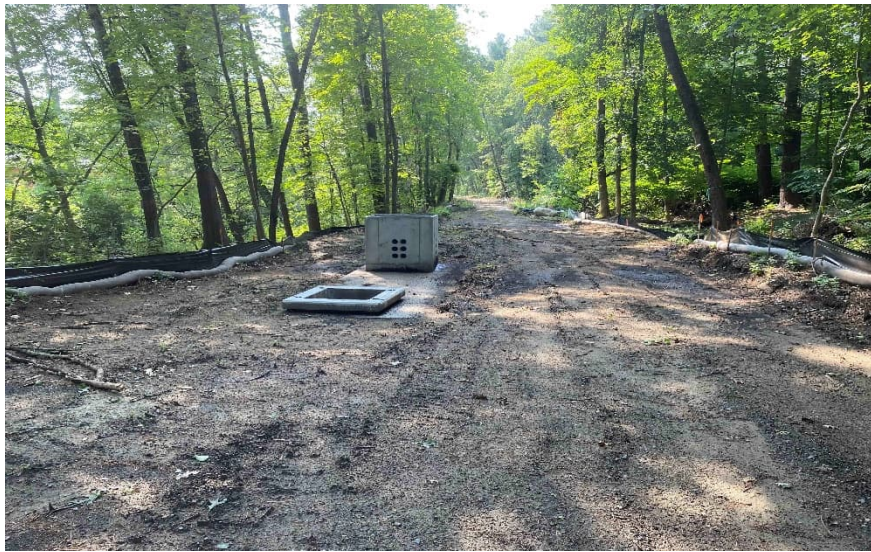
<b>PHOTOGRAPHIC LOG</b>	
Client Name: Eversource		Site Location: Sudbury to Hudson Transmission Reliability Project	
Town: Sudbury			
Photo No.: 6	Date: 7-12-23

Description:  Work area within segment 13, manhole 25, existing erosion control, looking eastward.

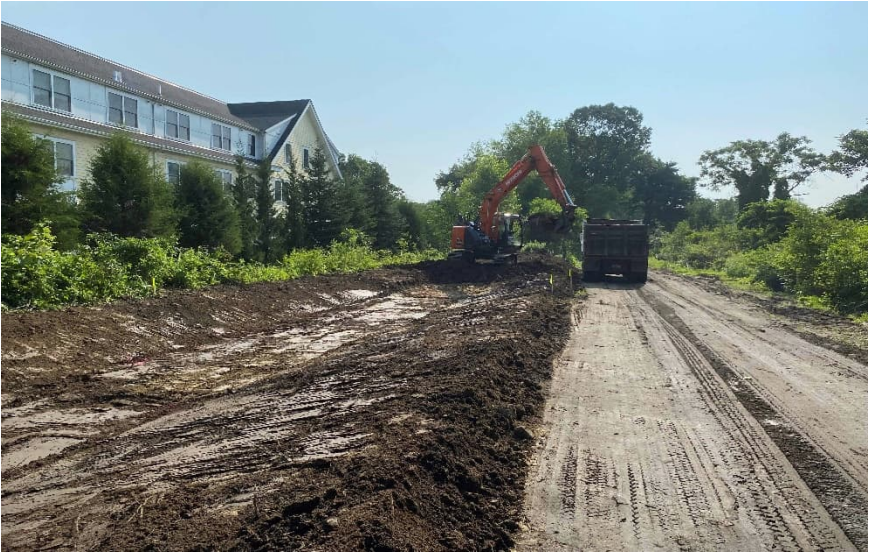
<b>PHOTOGRAPHIC LOG</b>	
Client Name: Eversource		Site Location: Sudbury to Hudson Transmission Reliability Project	
Photo No.: 7		Date: 7-12-23	
Description:  ET&L creating basin within Segment 14, looking eastward.

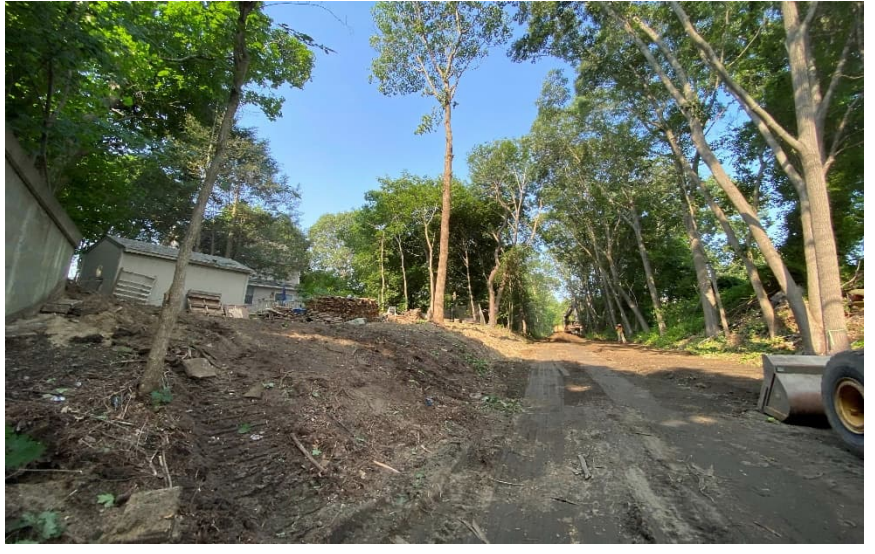
<b>PHOTOGRAPHIC LOG</b>	
Client Name: Eversource		Site Location: Sudbury to Hudson Transmission Reliability Project	
Photo No.: 8		Date: 7-12-23	
Description:  Invasive species (Norway maple) removed from area within segment 14, looking westward.

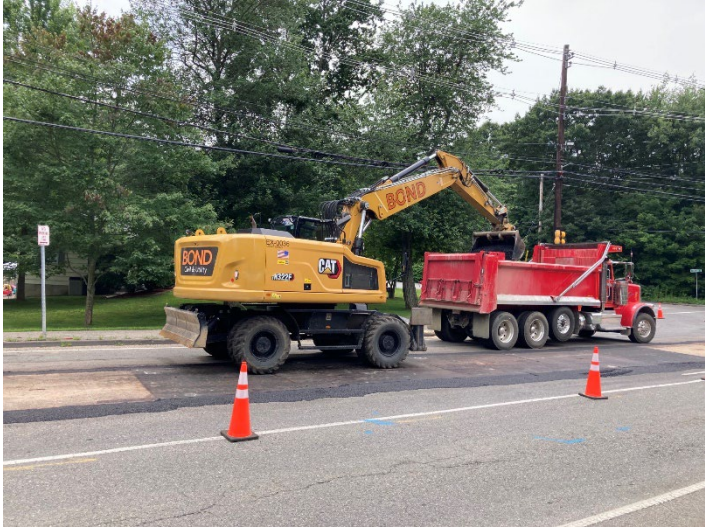
<b>PHOTOGRAPHIC LOG</b>	
<b>Client Name:</b> Eversource		<b>Site Location:</b> Sudbury to Hudson Transmission Reliability Project	
<b>Town:</b> Hudson			
<b>Photo No.:</b> 1	<b>Date:</b> 7/13/2023

<b>Description:</b> View of Bond working near MH #2 on Forest Ave. Facing southeast.

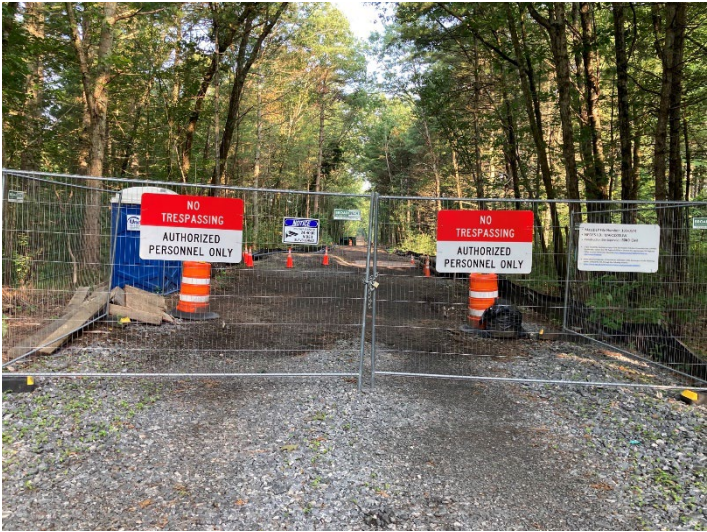
<b>PHOTOGRAPHIC LOG</b>	
<b>Client Name:</b> Eversource		<b>Site Location:</b> Sudbury to Hudson Transmission Reliability Project	
<b>Town:</b> Hudson			
<b>Photo No.:</b> 6	<b>Date:</b> 7/13/2023

<b>Description:</b> View of construction entrance to segment 5 at White Pond Rd. Facing west.

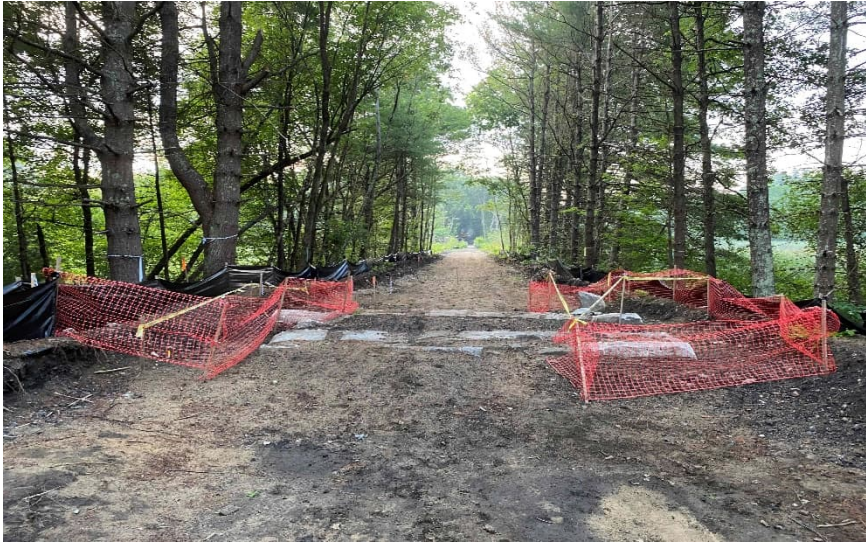
<b>PHOTOGRAPHIC LOG</b>	
Client Name: Eversource		Site Location: Sudbury to Hudson Transmission Reliability Project	
Town: Sudbury			
Photo No.: 1	Date: 7-13-23

Description:  Work area within segment 7, historic cattle crossing, existing erosion control, looking eastward.

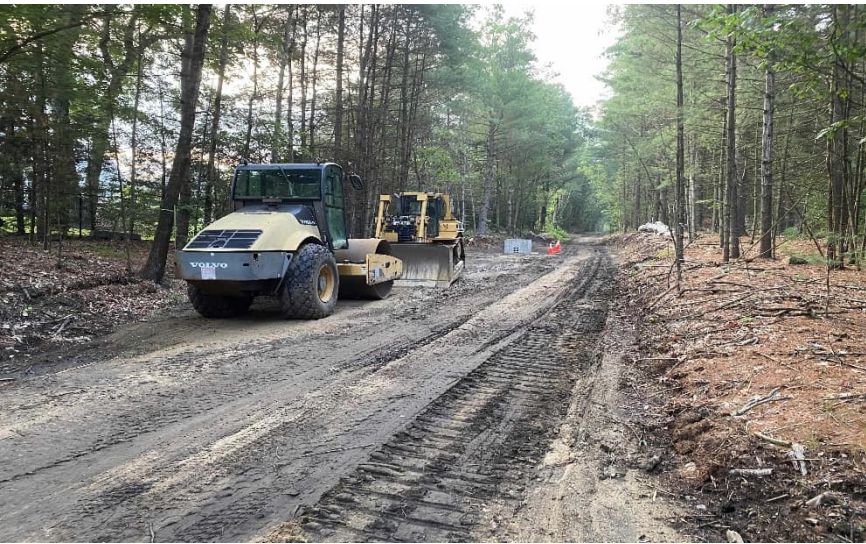
<b>PHOTOGRAPHIC LOG</b>	
Client Name: Eversource		Site Location: Sudbury to Hudson Transmission Reliability Project	
Town: Sudbury			
Photo No.: 2	Date: 7-13-23

Description:  Work area within segment 9, manhole 18 area, looking eastward.

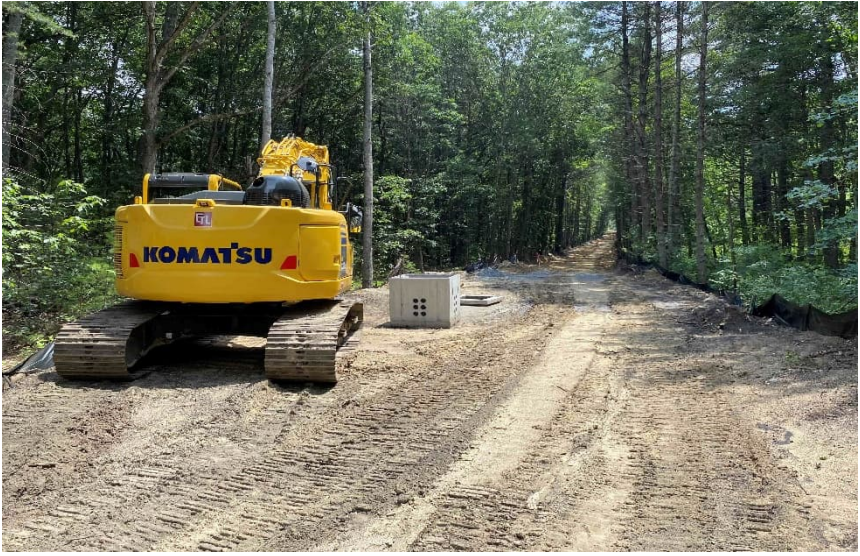
<b>PHOTOGRAPHIC LOG</b>	
Client Name: Eversource		Site Location: Sudbury to Hudson Transmission Reliability Project	
Town: Sudbury			
Photo No.: 3	Date: 7-13-23

Description:  Work area within segment 10, manhole #19, existing erosion control, looking eastward.

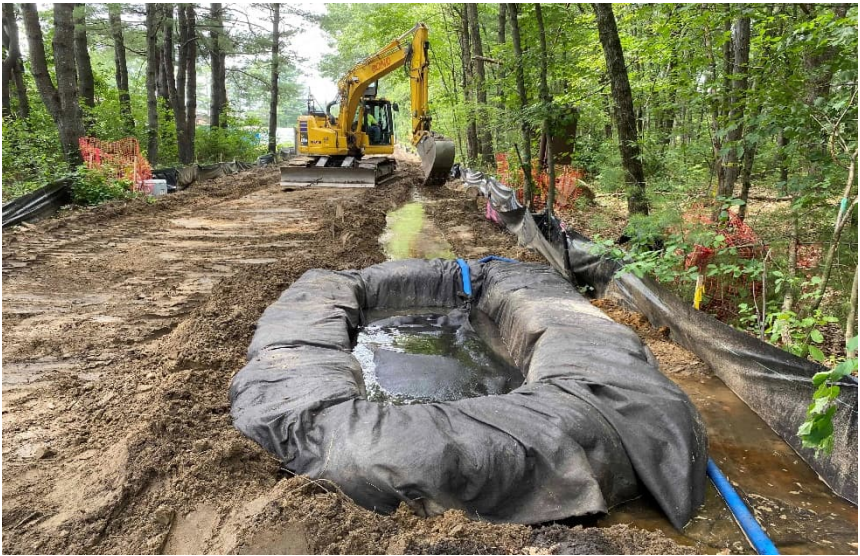
<b>PHOTOGRAPHIC LOG</b>	
Client Name: Eversource		Site Location: Sudbury to Hudson Transmission Reliability Project	
Town: Sudbury			
Photo No.: 4	Date: 7-13-23

Description:  Work area within segment 11, conduit work, existing erosion control, dewatering operation, looking westward.

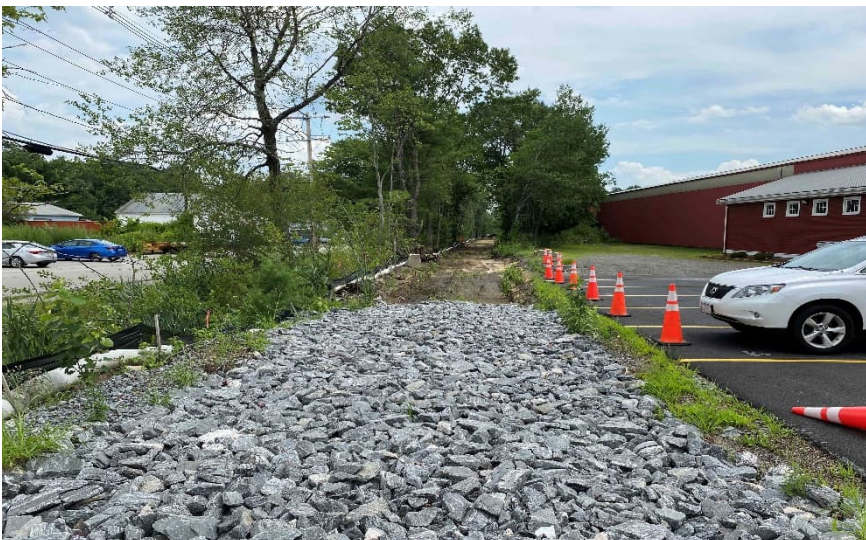
<b>PHOTOGRAPHIC LOG</b>	
Client Name: Eversource		Site Location: Sudbury to Hudson Transmission Reliability Project	
Photo No.: 5      Date: 7-13-23		Town: Sudbury	
Description:  Work area within segment 12, existing erosion control, looking eastward.

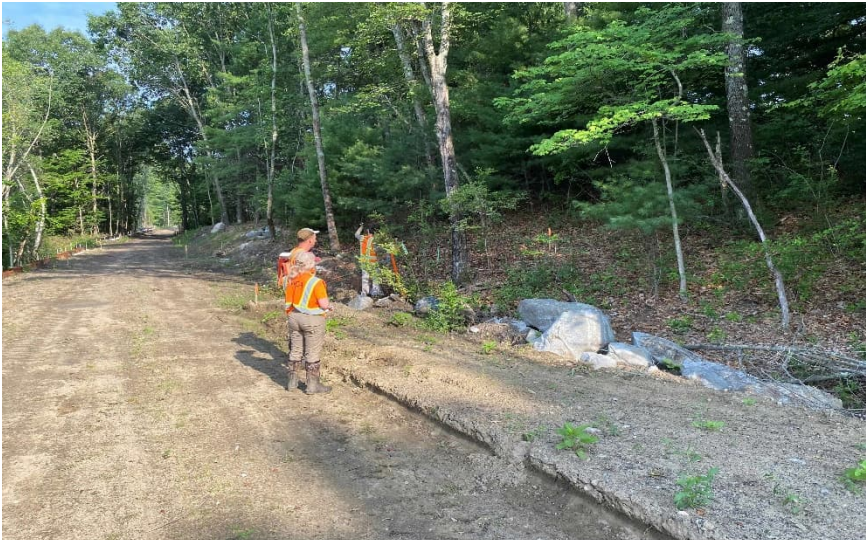
<b>PHOTOGRAPHIC LOG</b>	
Client Name: Eversource		Site Location: Sudbury to Hudson Transmission Reliability Project	
Photo No.: 6      Date: 7-13-23		Town: Sudbury	
Description:  Invasive species removal work within segment 14, looking westward.

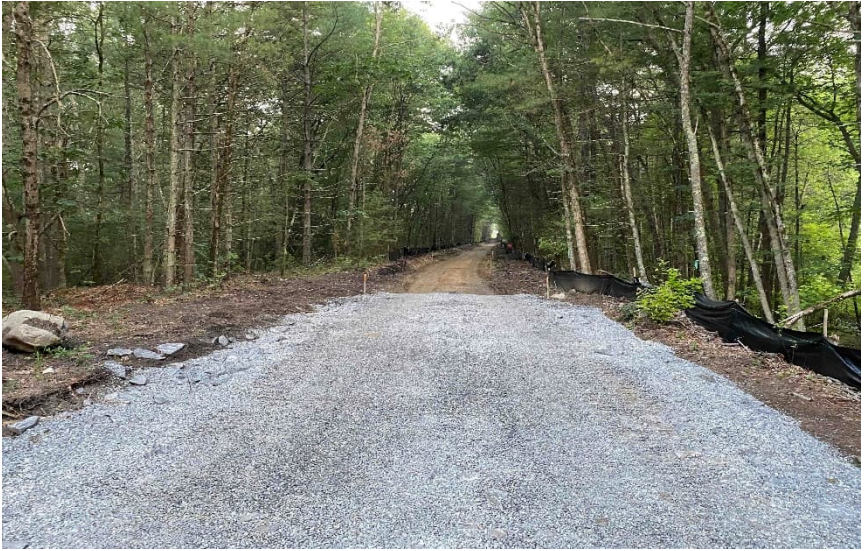
<b>PHOTOGRAPHIC LOG</b>	
Client Name: Eversource		Site Location: Sudbury to Hudson Transmission Reliability Project	
Town: Sudbury			
Photo No.: 7	Date: 7-13-23

Description:  Work area within segment 8, existing erosion control, looking westward.

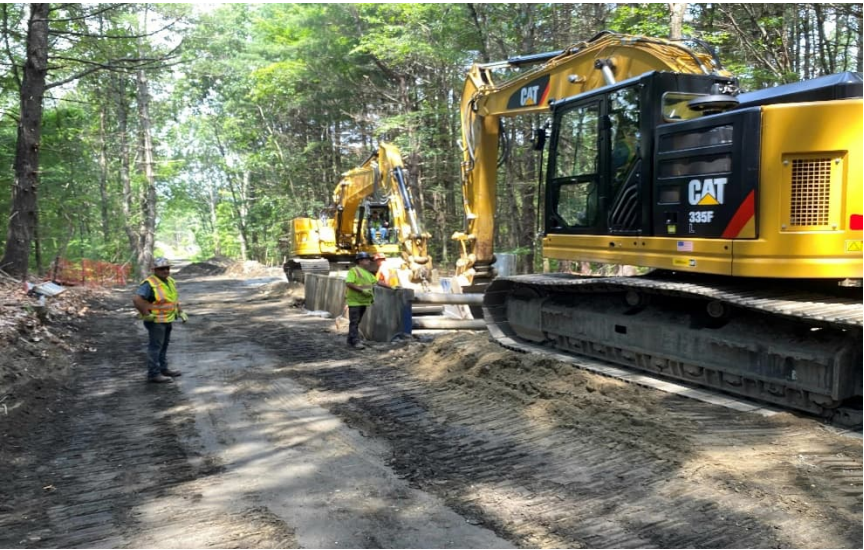
<b>PHOTOGRAPHIC LOG</b>	
Client Name: Eversource		Site Location: Sudbury to Hudson Transmission Reliability Project	
Town: Sudbury			
Photo No.: 8	Date: 7-13-23

Description:  Work area within segment 8, manhole #17, looking westward.

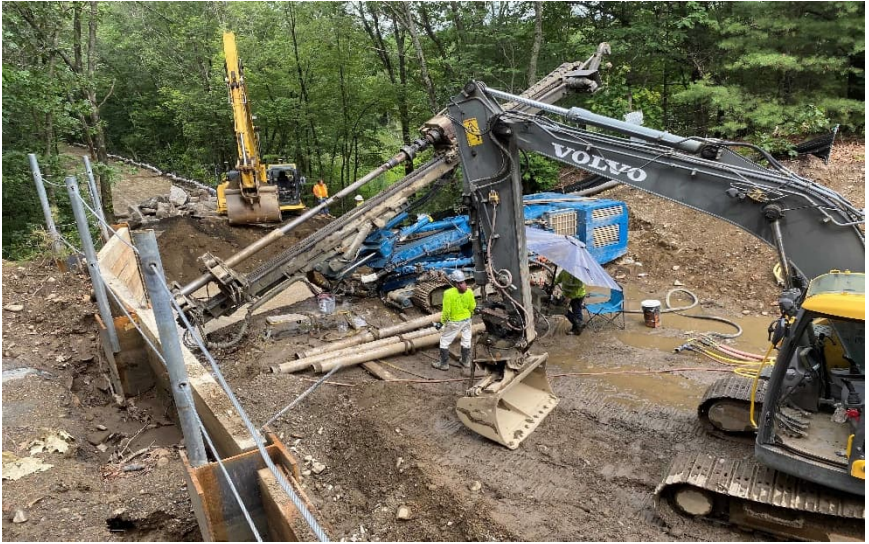
<b>PHOTOGRAPHIC LOG</b>	
Client Name: Eversource		Site Location: Sudbury to Hudson Transmission Reliability Project	
Photo No.: 1		Date: 7-14-23	
Description:  Chestnut Street crossing, toward segment 1, looking westward.

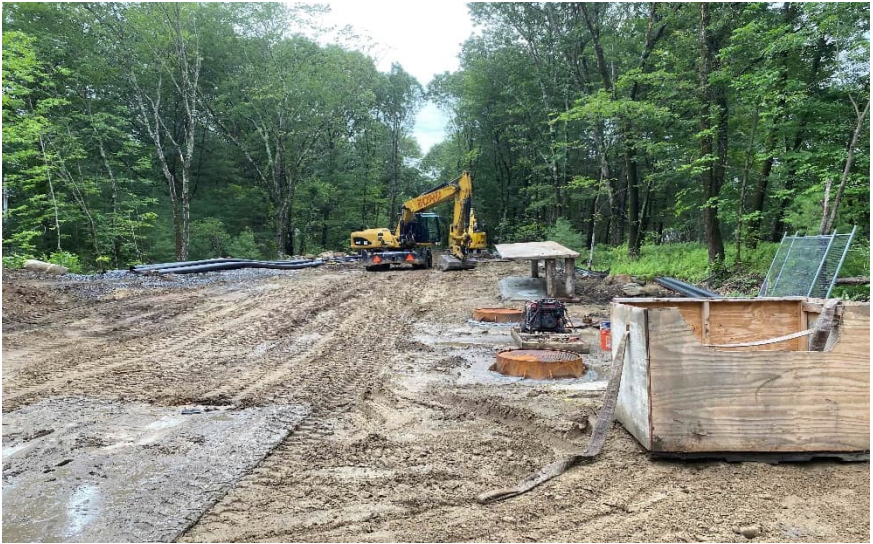
<b>PHOTOGRAPHIC LOG</b>	
Client Name: Eversource		Site Location: Sudbury to Hudson Transmission Reliability Project	
Photo No.: 2		Date: 7-14-23	
Description:  Work area within segment 1, manhole #5, existing erosion control, looking eastward.

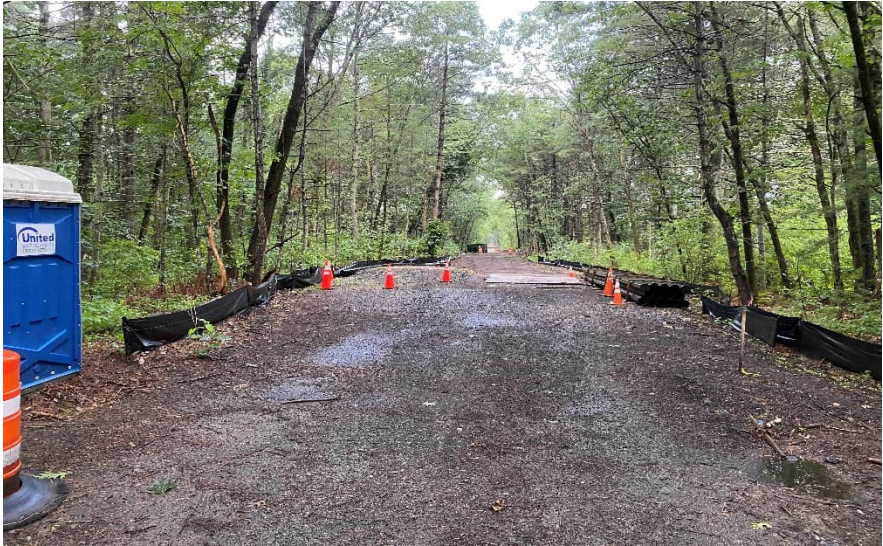
<b>PHOTOGRAPHIC LOG</b>	
Client Name: Eversource		Site Location: Sudbury to Hudson Transmission Reliability Project	
Photo No.: 3		Date: 7-14-23	
Description:  Work area within segment 5, existing erosion control, looking westward.

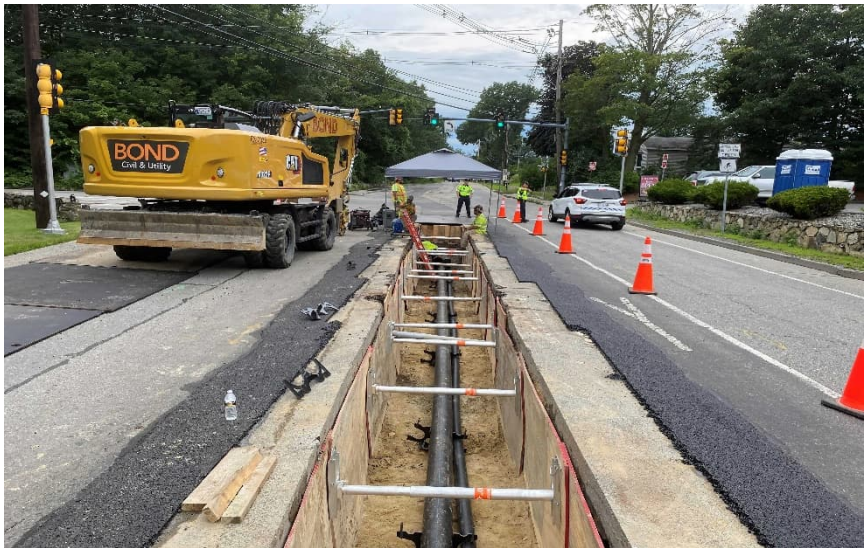
<b>PHOTOGRAPHIC LOG</b>	
Client Name: Eversource		Site Location: Sudbury to Hudson Transmission Reliability Project	
Photo No.: 4		Date: 7-14-23	
Description:  Work area within Forest Avenue, conduit work, looking southward.

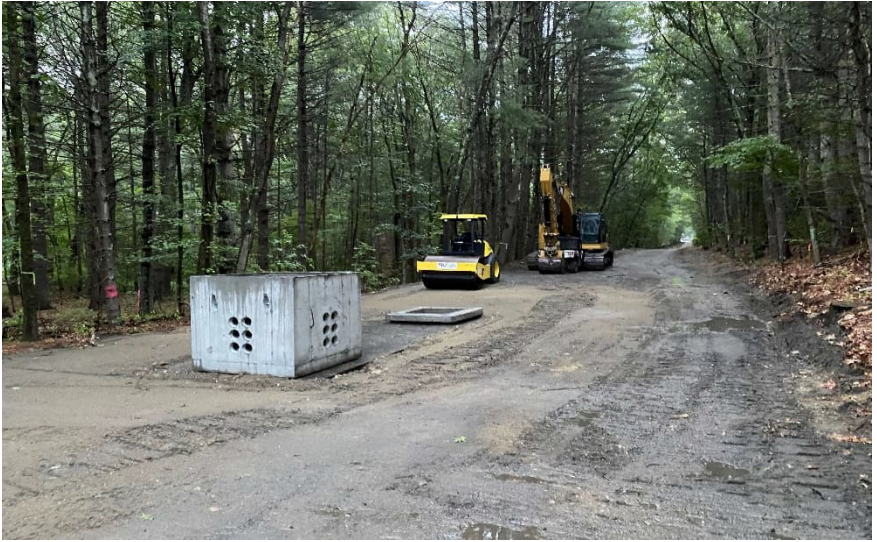
<b>PHOTOGRAPHIC LOG</b>	
Client Name: Eversource		Site Location: Sudbury to Hudson Transmission Reliability Project	
Photo No.: 5		Date: 7-14-23	
Description:  Work area within segment 8, manhole #17, looking eastward.

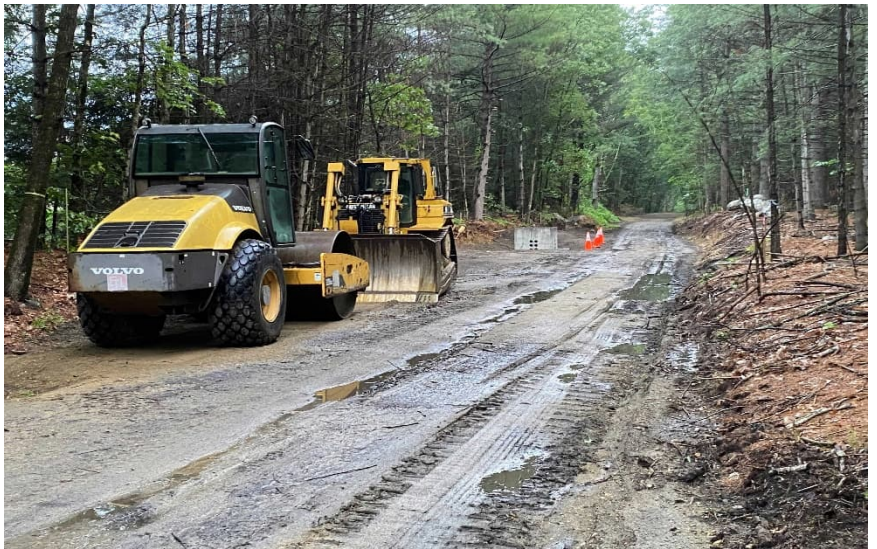
<b>PHOTOGRAPHIC LOG</b>	
Client Name: Eversource		Site Location: Sudbury to Hudson Transmission Reliability Project	
Photo No.: 6		Date: 7-14-23	
Description:  Work area within segment 9, manhole 18, looking eastward.

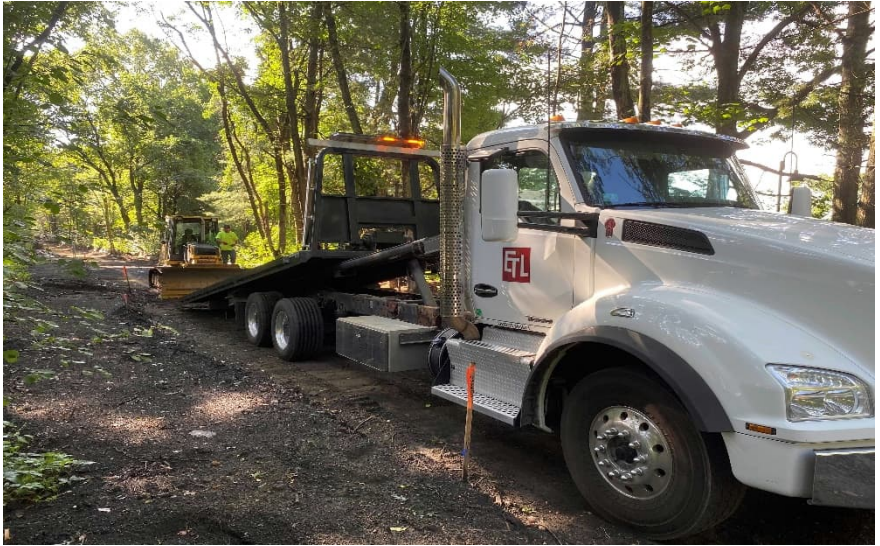
<b>PHOTOGRAPHIC LOG</b>	
Client Name: Eversource		Site Location: Sudbury to Hudson Transmission Reliability Project	
Photo No.: 7		Date: 7-14-23	
Description:  Unloading equipment within Segment 11, existing erosion control, looking eastward.

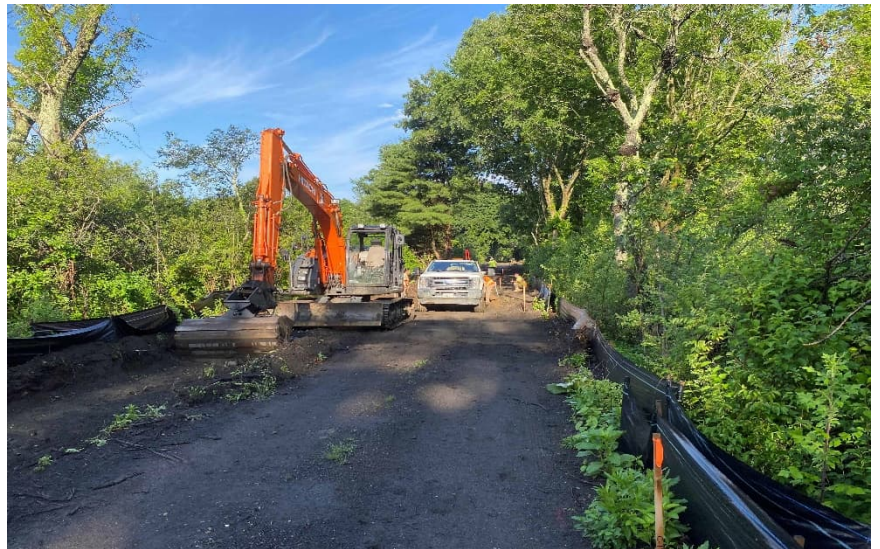
<b>PHOTOGRAPHIC LOG</b>	
Client Name: Eversource		Site Location: Sudbury to Hudson Transmission Reliability Project	
Photo No.: 8		Date: 7-14-23	
Description:  Work area within segment 14, work over culvert, existing erosion control, looking westward.

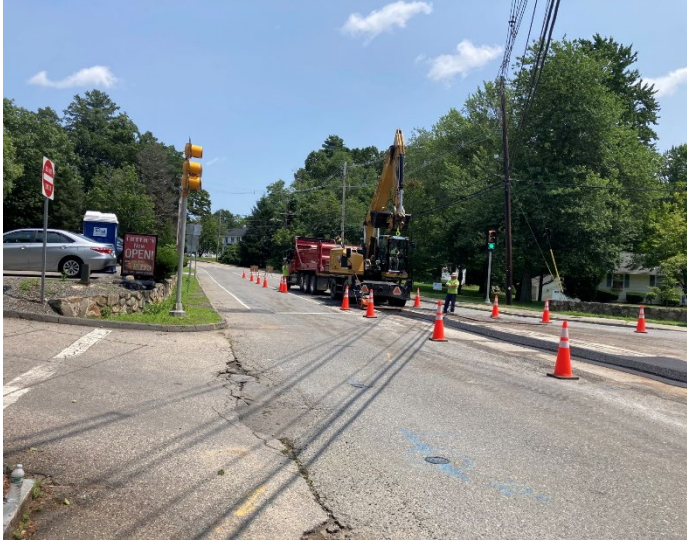
<b>PHOTOGRAPHIC LOG</b>	
<b>Client Name:</b> Eversource		<b>Site Location:</b> Sudbury to Hudson Transmission Reliability Project	
<b>Town:</b> Hudson			
<b>Photo No.:</b> 1	<b>Date:</b> 7-11-2023

<b>Description:</b> View of Bond working near MH #2 on Forest Ave. Facing southeast.

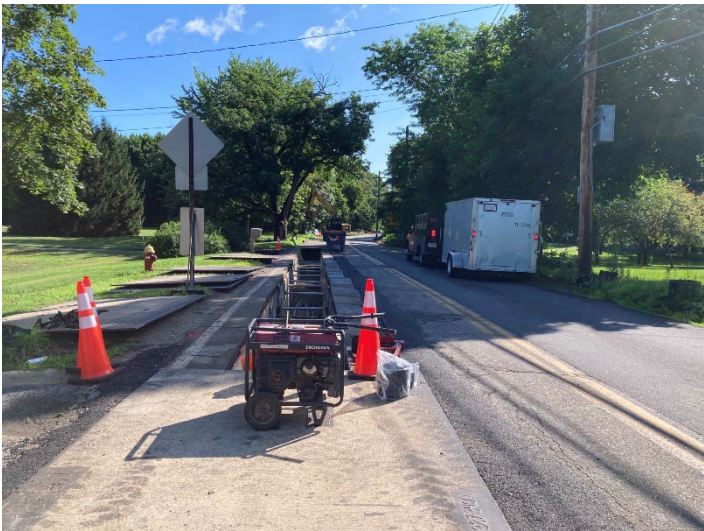
<b>PHOTOGRAPHIC LOG</b>	
<b>Client Name:</b> Eversource		<b>Site Location:</b> Sudbury to Hudson Transmission Reliability Project	
<b>Town:</b> Hudson			
<b>Photo No.:</b> 2	<b>Date:</b> 7-11-2023

<b>Description:</b> View of Bond working on Wilkins St. Facing north.

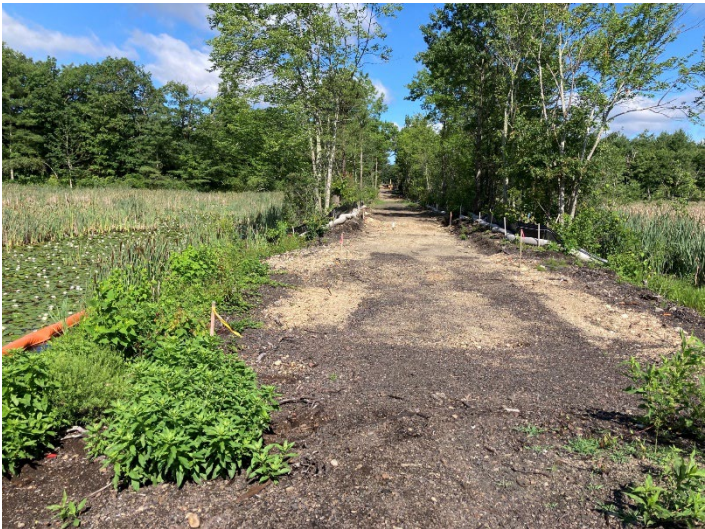
<b>PHOTOGRAPHIC LOG</b>	
<b>Client Name:</b> Eversource		<b>Site Location:</b> Sudbury to Hudson Transmission Reliability Project	
<b>Town:</b> Hudson			
<b>Photo No.:</b> 5	<b>Date:</b> 7-11-2023

<b>Description:</b> View of segment 2 from Bridge 130. Facing west.

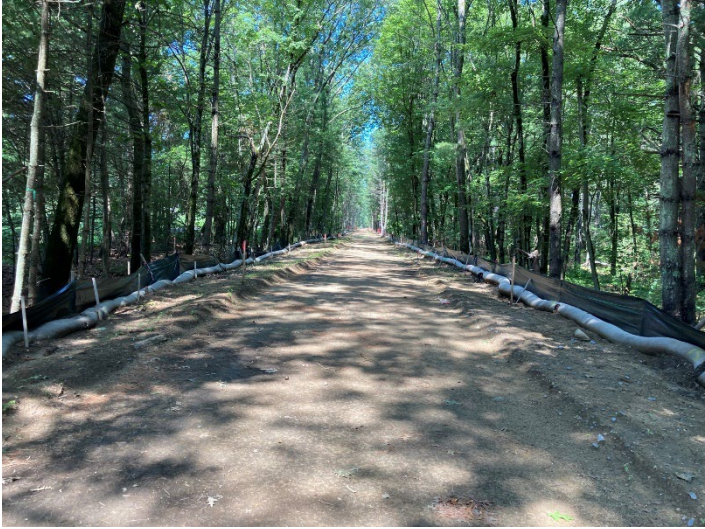
<b>PHOTOGRAPHIC LOG</b>	
<b>Client Name:</b> Eversource		<b>Site Location:</b> Sudbury to Hudson Transmission Reliability Project	
<b>Town:</b> Hudson			
<b>Photo No.:</b> 7	<b>Date:</b> 7-11-2023

<b>Description:</b> View of Type A E&S controls in segment 4. Controls are operating properly. Facing west.

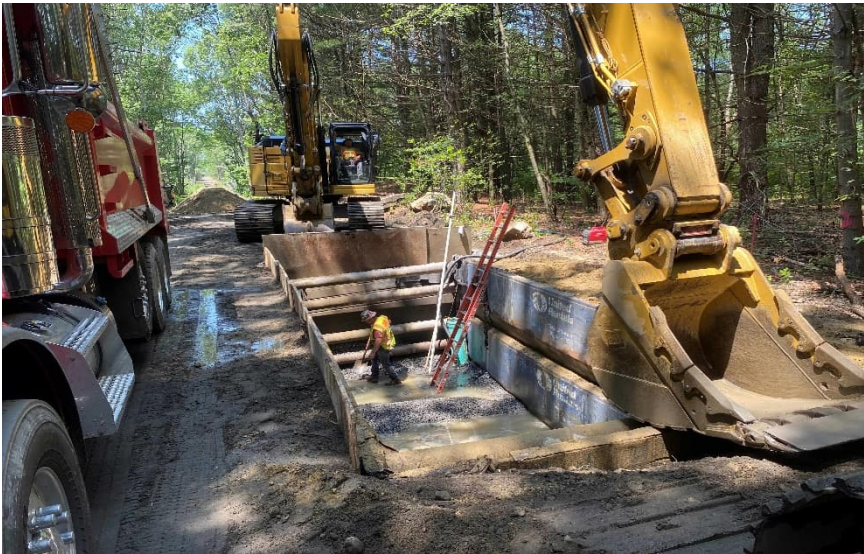
<b>PHOTOGRAPHIC LOG</b>	
Client Name: Eversource		Site Location: Sudbury to Hudson Transmission Reliability Project	
Photo No.: 1      Date: 7-11-23		Town: Sudbury	
Description:  Work area within Segment 8, Bond conducting manhole #17 work, looking westward.
