**Weekly Environmental Compliance Summary**

**Sudbury to Hudson Transmission Reliability Project (USEPA Tracking # MAR1003UW)**

Sudbury, Hudson, and Stow, MA

Week of: July 10 to July 14, 2023

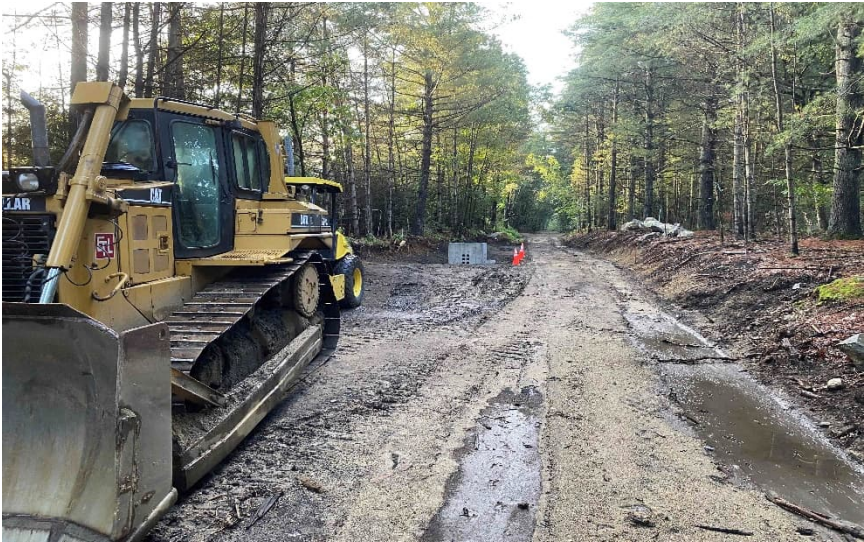
<b>PHOTOGRAPHIC LOG</b>	
Client Name: Eversource		Site Location: Sudbury to Hudson Transmission Reliability Project	
Photo No.: 2      Date: 7-11-23		Town: Sudbury	
Description:  Work area within Segment 9, manhole #18, looking eastward.

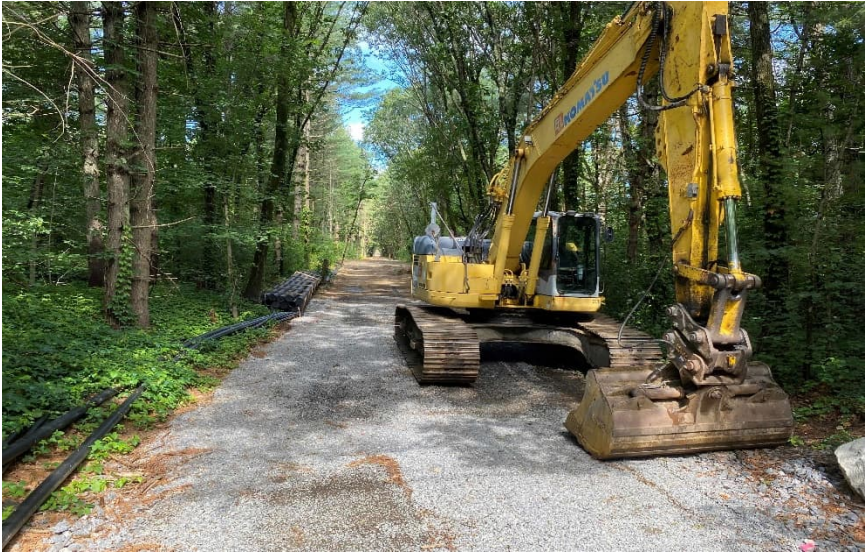
<b>PHOTOGRAPHIC LOG</b>	
Client Name: Eversource		Site Location: Sudbury to Hudson Transmission Reliability Project	
Town: Sudbury			
Photo No.: 3	Date: 7-11-23

Description:  Work area within segment 10, looking westward.

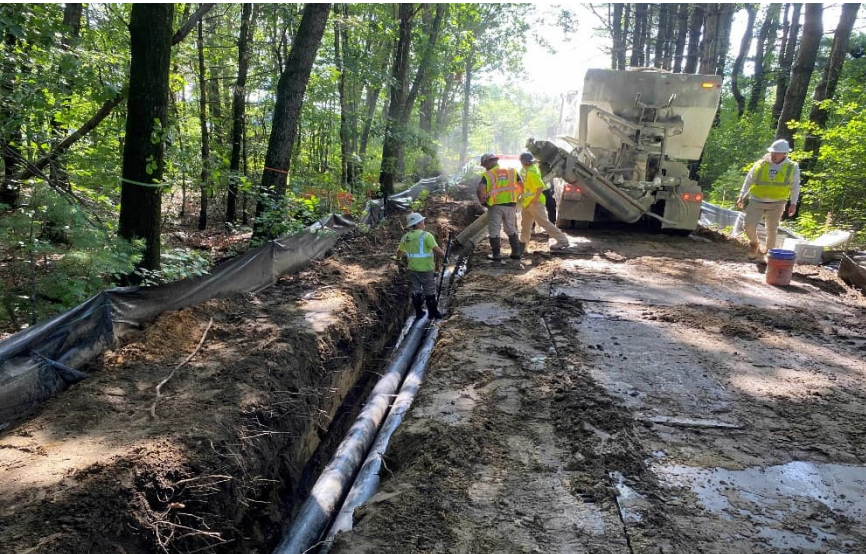
<b>PHOTOGRAPHIC LOG</b>	
Client Name: Eversource		Site Location: Sudbury to Hudson Transmission Reliability Project	
Town: Sudbury			
Photo No.: 4	Date: 7-11-23

Description:  Work area within segment 11, conduit work, existing erosion control, looking eastward.

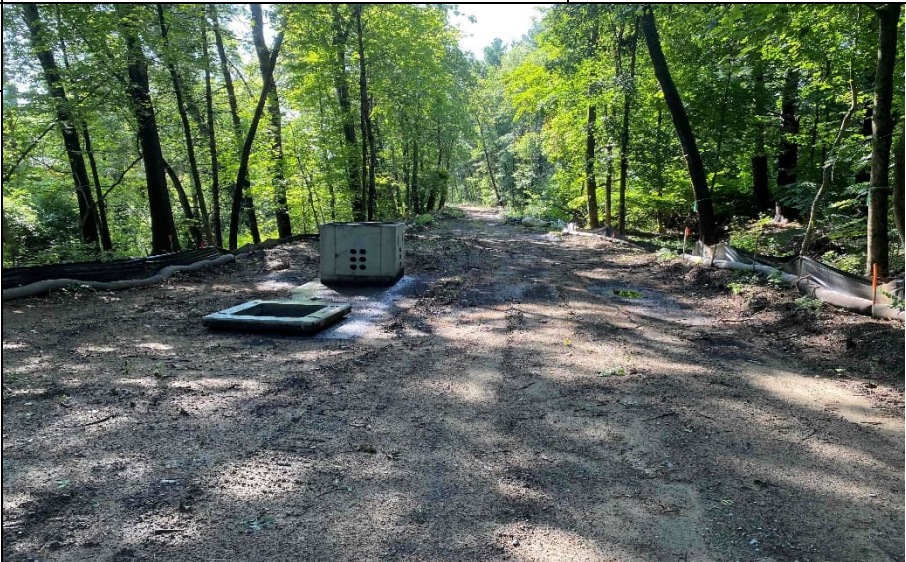
<b>PHOTOGRAPHIC LOG</b>	
Client Name: Eversource		Site Location: Sudbury to Hudson Transmission Reliability Project	
Photo No.: 5      Date: 7-11-23		Town: Sudbury	
Description:  Work area within segment 13, manhole 25 area, existing erosion control, looking eastward.

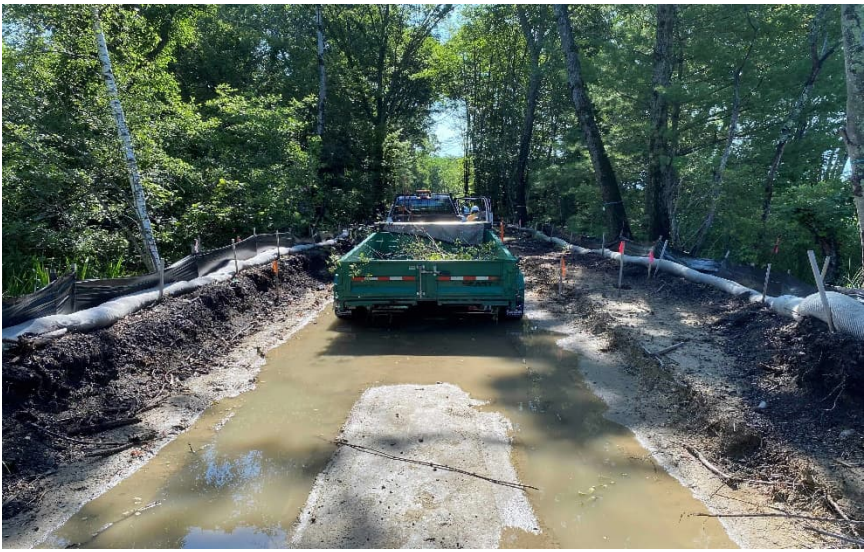
<b>PHOTOGRAPHIC LOG</b>	
Client Name: Eversource		Site Location: Sudbury to Hudson Transmission Reliability Project	
Photo No.: 6      Date: 7-11-23		Town: Sudbury	
Description:  Work area within segment 14, invasive species removal (buckthorn), existing erosion control, looking eastward.

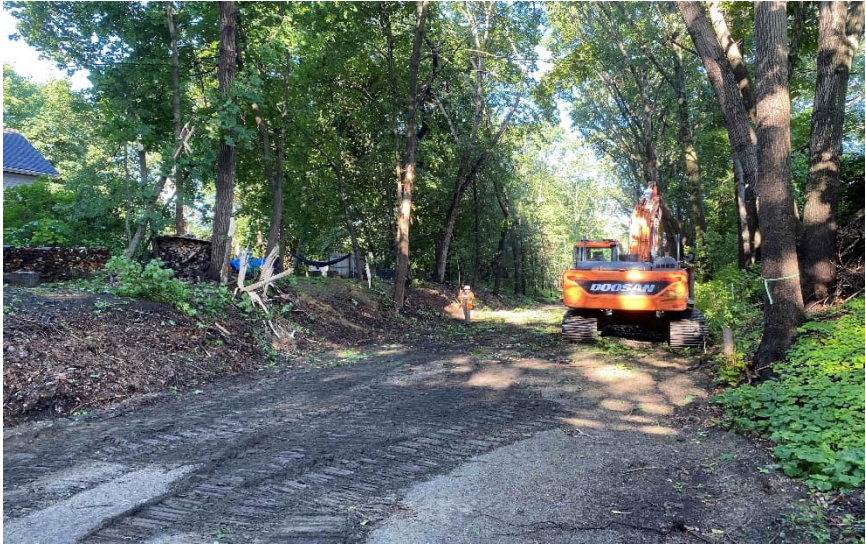
<b>PHOTOGRAPHIC LOG</b>	
Client Name: Eversource		Site Location: Sudbury to Hudson Transmission Reliability Project	
Town: Sudbury			
Photo No.: 7	Date: 7-11-23

Description:  Work area within segment 14, invasive species removal (Norway maple), existing erosion control, looking westward.

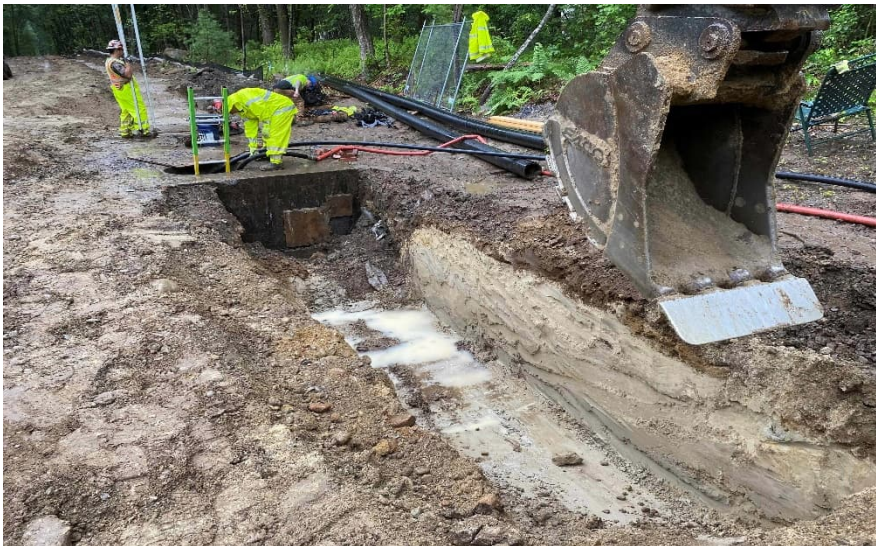
<b>PHOTOGRAPHIC LOG</b>	
Client Name: Eversource		Site Location: Sudbury to Hudson Transmission Reliability Project	
Photo No.: 1		Town: Hudson	
Date: 7/10/2023			
Description: View of area being pumped at work operation at Segment 1, off Wilkins Avenue, looking westward.

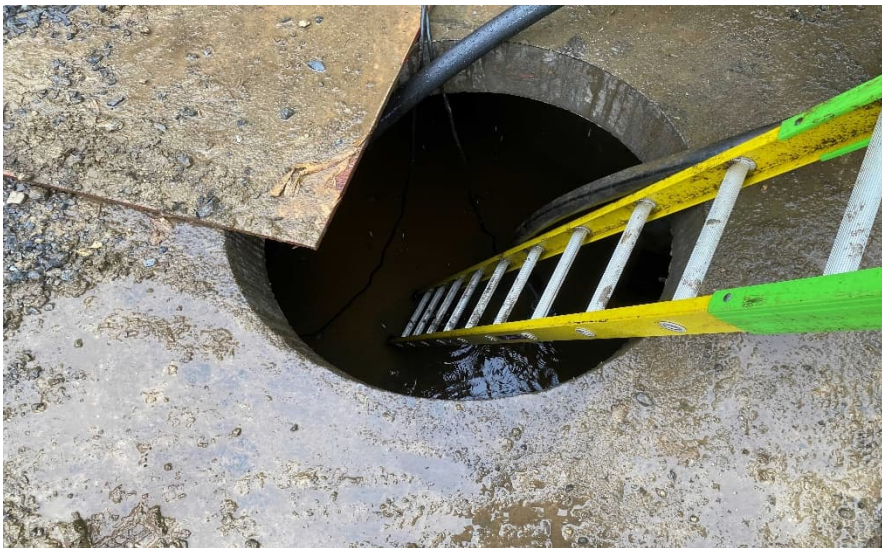
<b>PHOTOGRAPHIC LOG</b>	
Client Name: Eversource		Site Location: Sudbury to Hudson Transmission Reliability Project	
Photo No.: 2		Town: Hudson	
Date: 7/10/2023			
Description: View of pumping operation at Segment 1. This is the location of dewatering water prior to treatment. Water appeared to be slightly turbid.

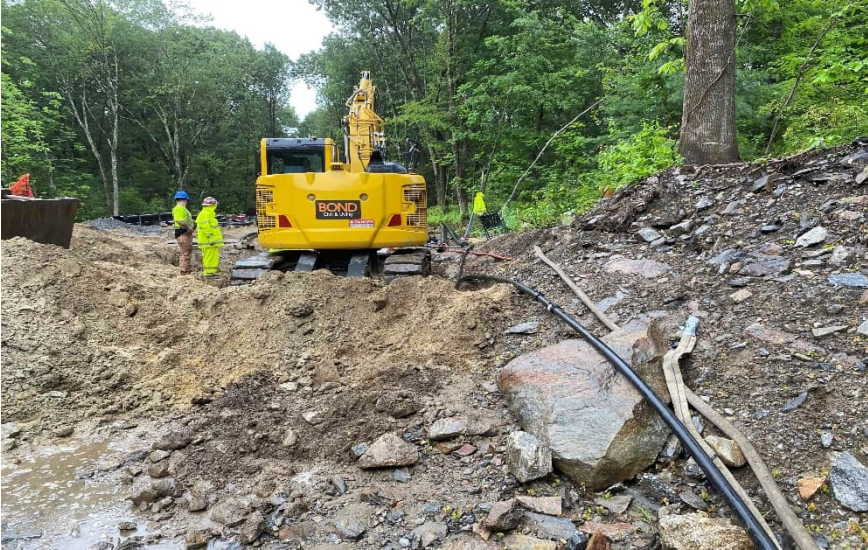
<b>PHOTOGRAPHIC LOG</b>	
Client Name: Eversource		Site Location: Sudbury to Hudson Transmission Reliability Project	
Photo No.: 3		Date: 7/10/2023	
Description: Segment 1. View of dewatering operation, looking westward.

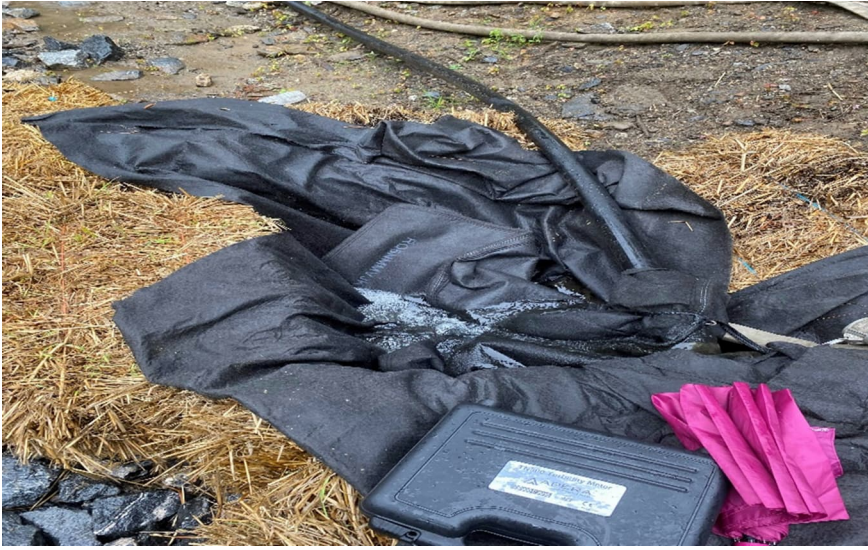
<b>PHOTOGRAPHIC LOG</b>	
Client Name: Eversource		Site Location: Sudbury to Hudson Transmission Reliability Project	
Photo No.: 4		Date: 7/10/2023	
Description: Segment 1. View of discharge bag/bales, looking westward. Water discharge to bag intermittent and appeared to be slightly turbid.

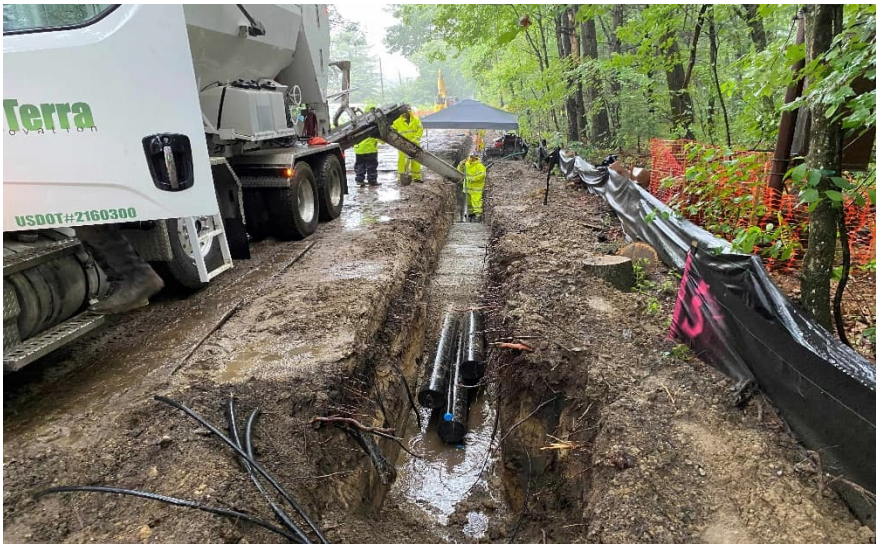
<b>PHOTOGRAPHIC LOG</b>	
Client Name: Eversource		Site Location: Sudbury to Hudson Transmission Reliability Project	
Photo No.: 1		Town: Sudbury	
Date: 7/10/2023

Description: View of area being pumped at work operation at Segment 11, off Union Avenue, looking westward.

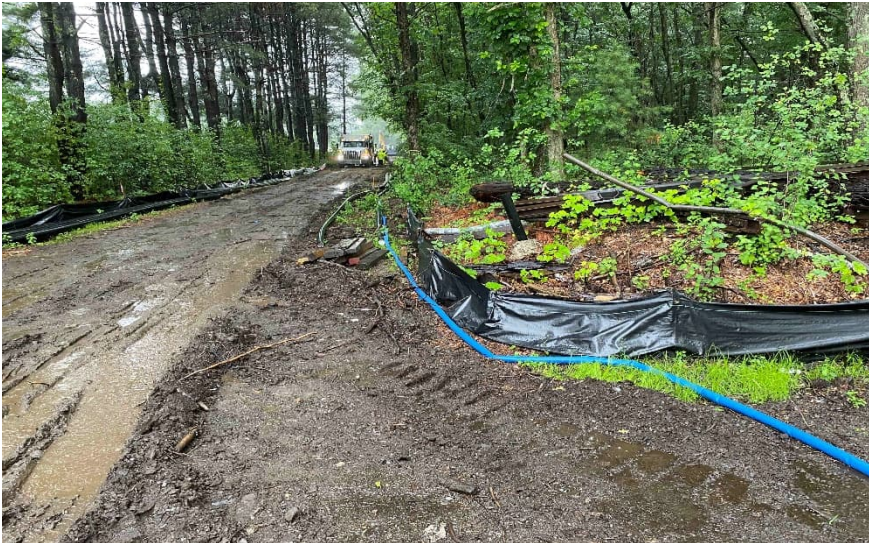
<b>PHOTOGRAPHIC LOG</b>	
Client Name: Eversource		Site Location: Sudbury to Hudson Transmission Reliability Project	
Photo No.: 3		Town: Sudbury	
Date: 7/10/2023

Description: Segment 11. View of dewatering operation, looking westward.

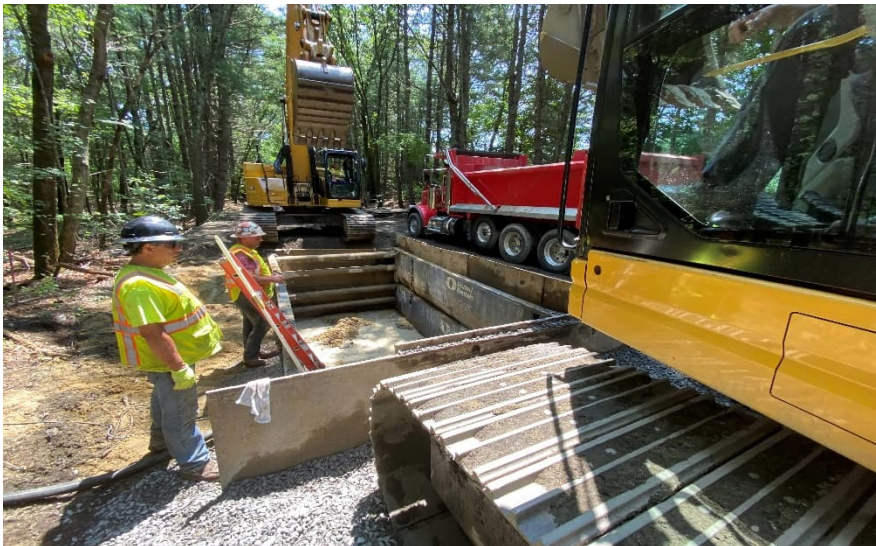
<b>PHOTOGRAPHIC LOG</b>	
Client Name: Eversource		Site Location: Sudbury to Hudson Transmission Reliability Project	
Photo No.: 1		Town: Sudbury	
Date: 7/11/2023

Description: View of area being pumped at work operation at Segment 8, looking eastward.

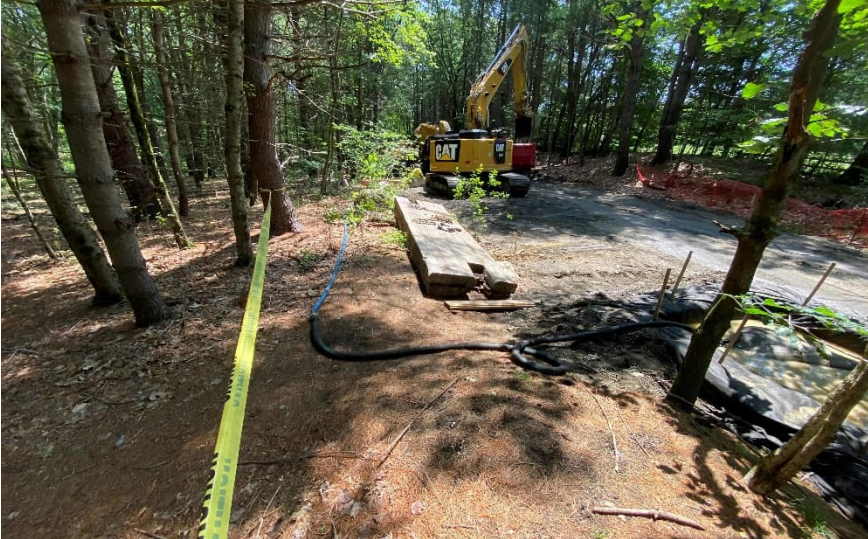
<b>PHOTOGRAPHIC LOG</b>	
Client Name: Eversource		Site Location: Sudbury to Hudson Transmission Reliability Project	
Photo No.: 3		Town: Sudbury	
Date: 7/11/2023

Description: Segment 8. View of dewatering operation, looking eastward.

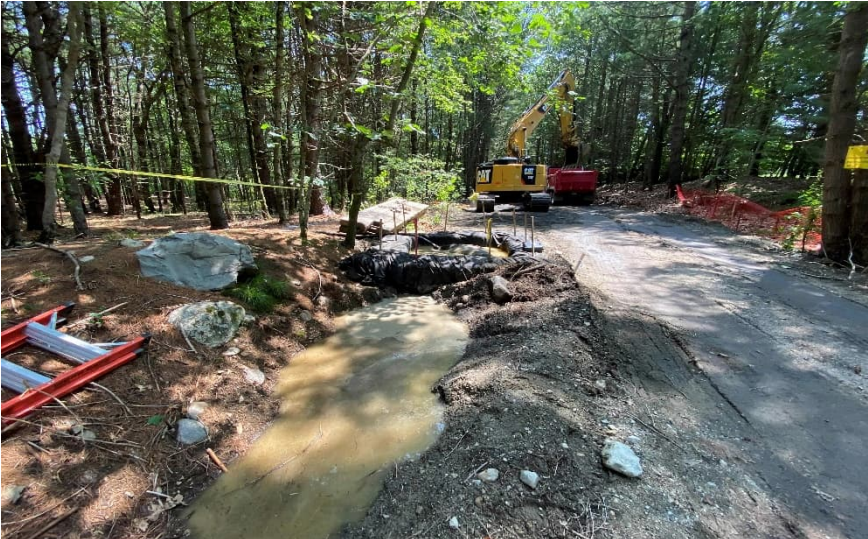
<b>PHOTOGRAPHIC LOG</b>	
Client Name: Eversource		Site Location: Sudbury to Hudson Transmission Reliability Project	
Photo No.: 4		Town: Sudbury	
Date: 7/11/2023

Description: Segment 8. View of discharge bag/bales, looking eastward. Water discharge to bag intermittent and appeared to be slightly turbid.

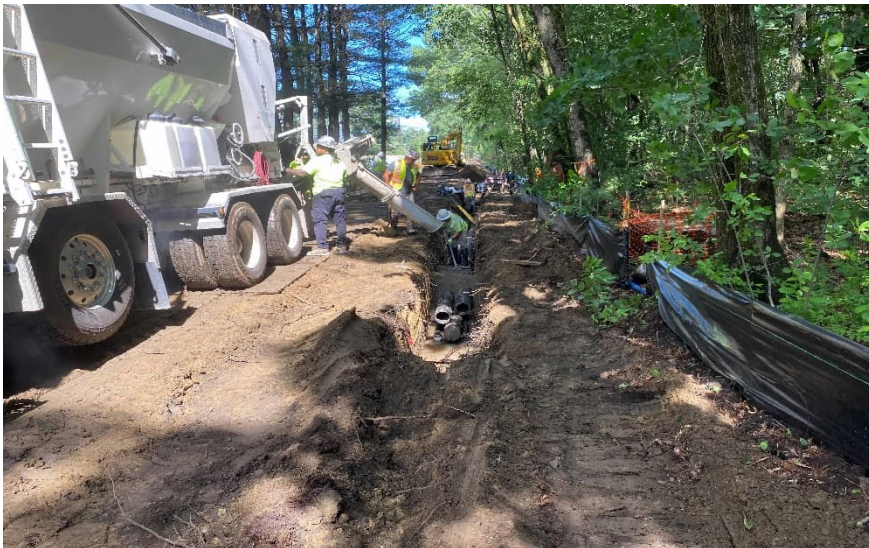
<b>PHOTOGRAPHIC LOG</b>	
Client Name: Eversource		Site Location: Sudbury to Hudson Transmission Reliability Project	
Photo No.: 1		Date: 7/11/2023	
Description: View of area being pumped at work operation at Segment 11, off Union Avenue, looking westward.

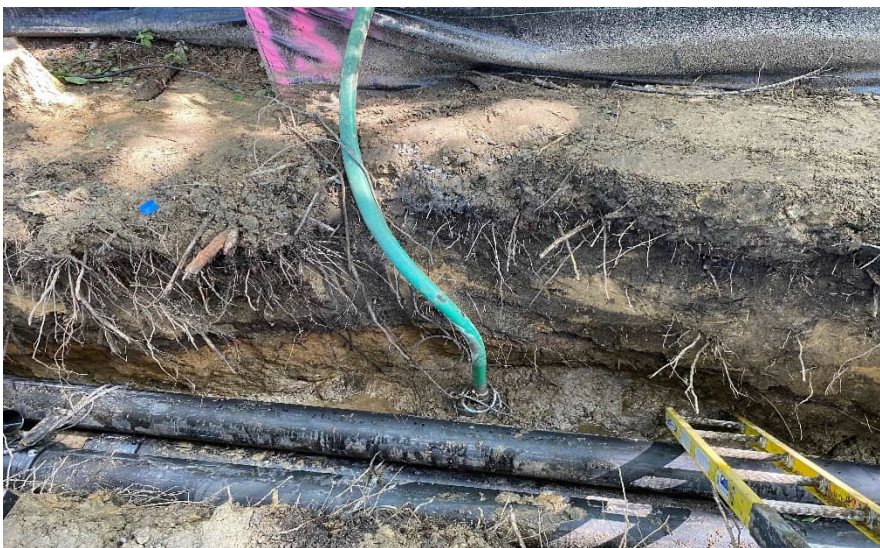
<b>PHOTOGRAPHIC LOG</b>	
Client Name: Eversource		Site Location: Sudbury to Hudson Transmission Reliability Project	
Photo No.: 2		Date: 7/11/2023	
Description: View of pumping operation at Segment 11. This is the location of dewatering water prior to treatment. Water appeared to be slightly turbid.

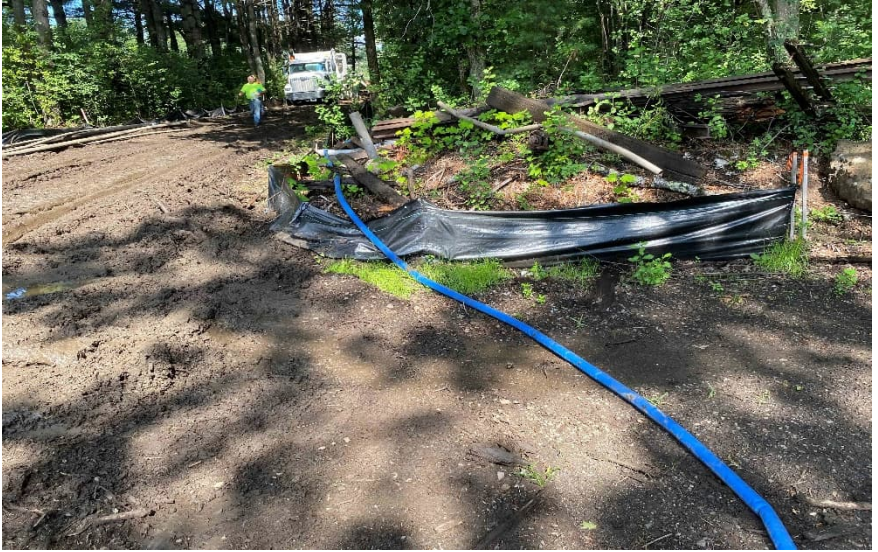
<b>PHOTOGRAPHIC LOG</b>	
Client Name: Eversource		Site Location: Sudbury to Hudson Transmission Reliability Project	
Town: Sudbury			
Photo No.: 3	Date: 7/11/2023

Description: Segment 11. View of dewatering operation, looking westward.

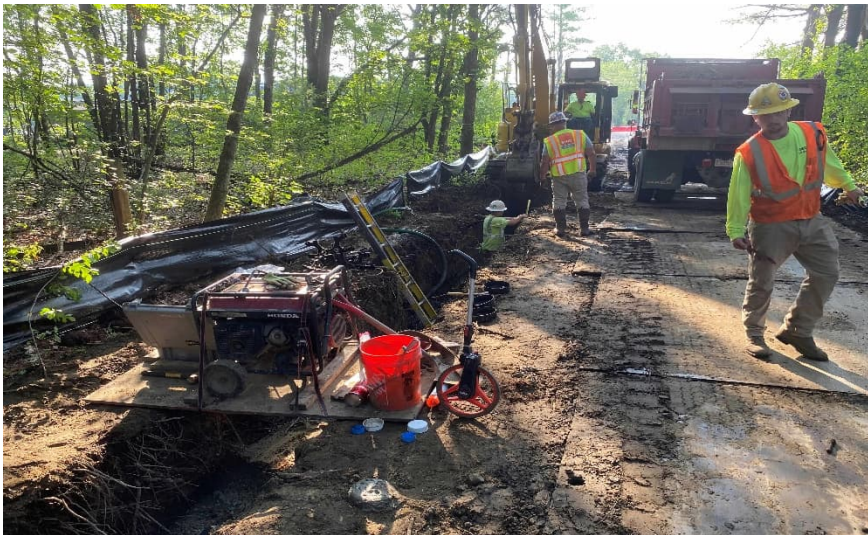
<b>PHOTOGRAPHIC LOG</b>	
Client Name: Eversource		Site Location: Sudbury to Hudson Transmission Reliability Project	
Town: Sudbury			
Photo No.: 1	Date: 7/12/2023

Description: View of area being pumped at work operation at Segment 11, off Union Avenue, looking westward.

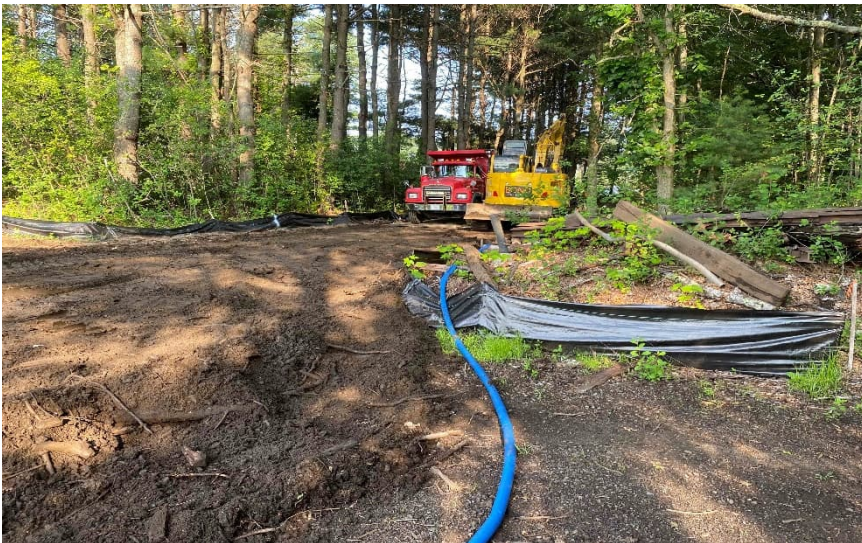
<b>PHOTOGRAPHIC LOG</b>	
Client Name: Eversource		Site Location: Sudbury to Hudson Transmission Reliability Project	
Photo No.: 3		Date: 7/12/2023	
Description: Segment 11. View of dewatering operation, looking westward.

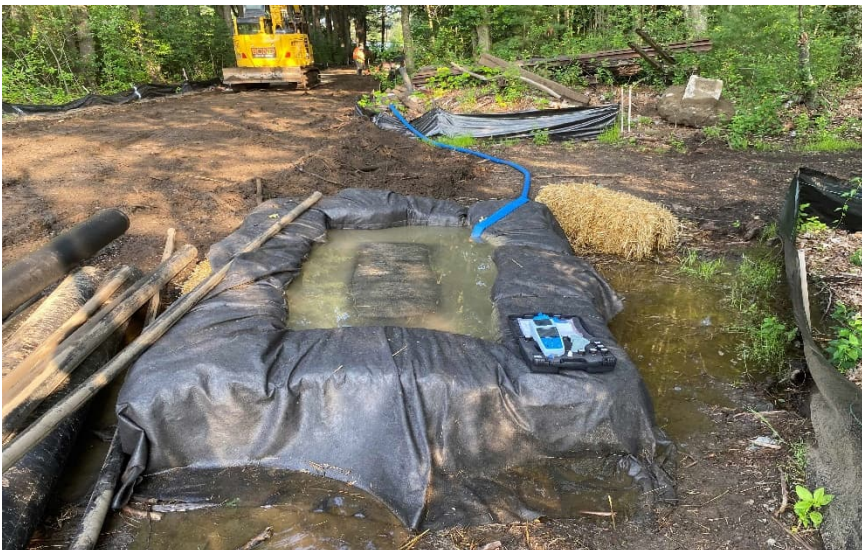
<b>PHOTOGRAPHIC LOG</b>	
Client Name: Eversource		Site Location: Sudbury to Hudson Transmission Reliability Project	
Photo No.: 4		Date: 7/12/2023	
Description: Segment 11. View of discharge bag/bales, looking westward. Water discharge to bag intermittent and appeared to be slightly turbid.

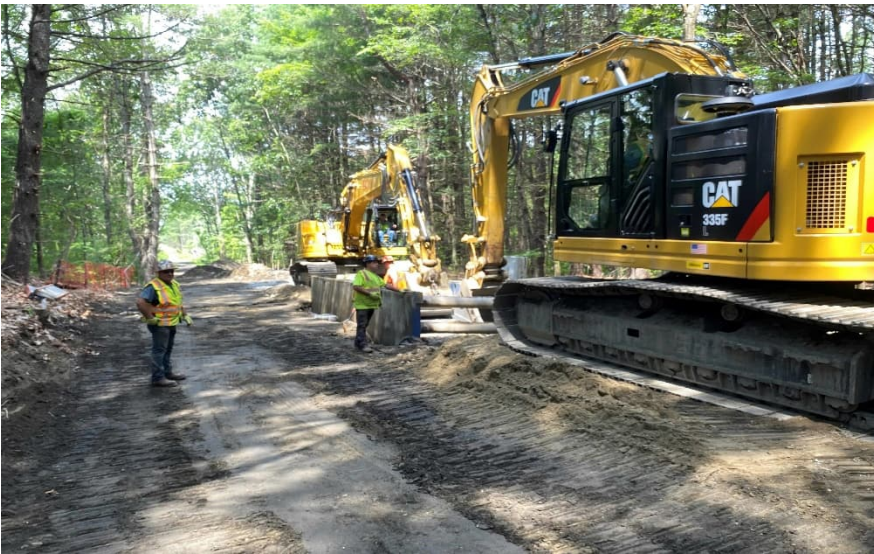
<b>PHOTOGRAPHIC LOG</b>	
Client Name: Eversource		Site Location: Sudbury to Hudson Transmission Reliability Project	
Photo No.: 1		Date: 7/13/2023	
Description: View of area being pumped at work operation at Segment 8, looking westward.

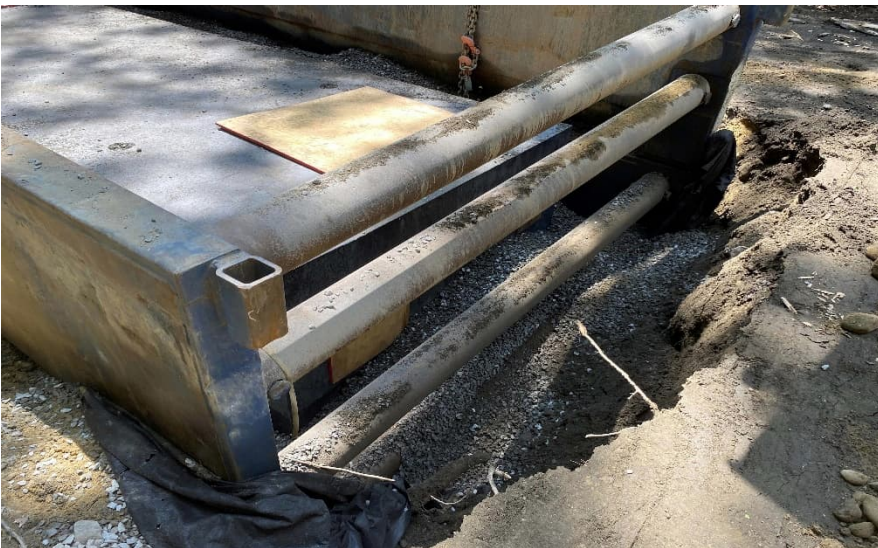
<b>PHOTOGRAPHIC LOG</b>	
Client Name: Eversource		Site Location: Sudbury to Hudson Transmission Reliability Project	
Photo No.: 2		Date: 7/13/2023	
Description: View of pumping area at Segment 8. This is the location of dewatering water prior to treatment.

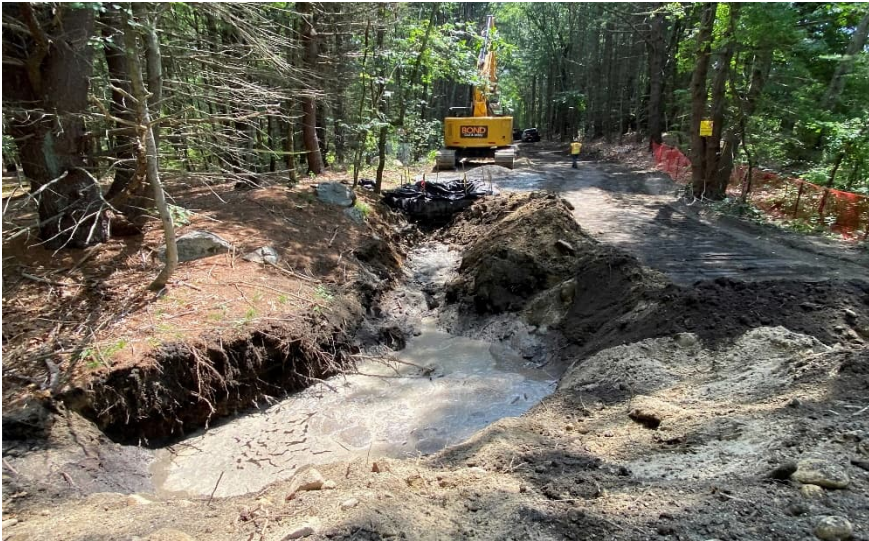
<b>PHOTOGRAPHIC LOG</b>	
Client Name: Eversource		Site Location: Sudbury to Hudson Transmission Reliability Project	
Photo No.: 3		Date: 7/13/2023	
Description: Segment 8. View of dewatering operation, plunge pool area west of discharge corral, looking eastward.

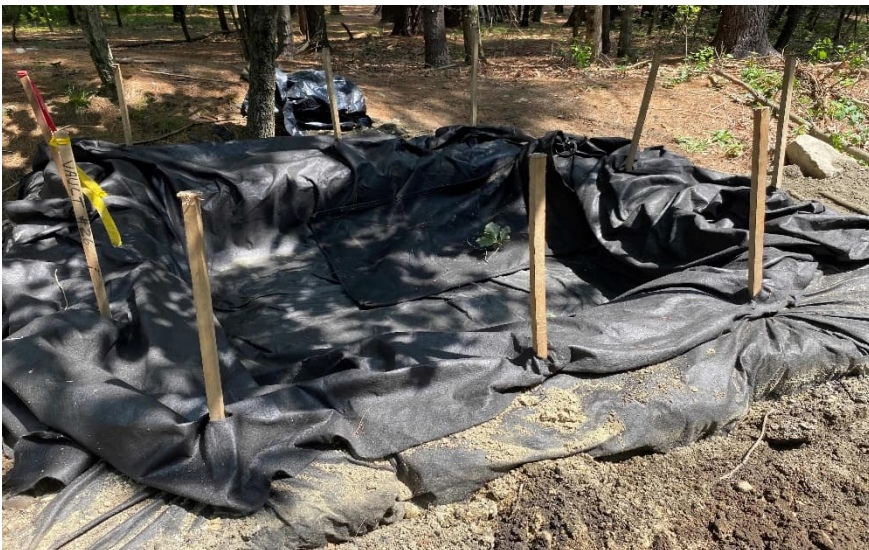
<b>PHOTOGRAPHIC LOG</b>	
Client Name: Eversource		Site Location: Sudbury to Hudson Transmission Reliability Project	
Photo No.: 4		Date: 7/13/2023	
Description: Segment 8. View of discharge bag/bales, looking eastward. Water discharge to bag intermittent and appeared to be slightly turbid.

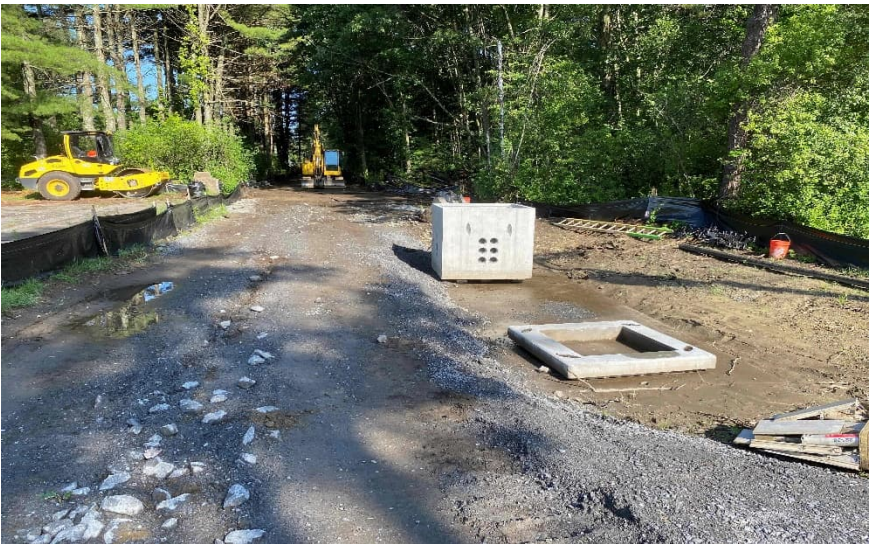
<b>PHOTOGRAPHIC LOG</b>	
Client Name: Eversource		Site Location: Sudbury to Hudson Transmission Reliability Project	
Photo No.: 1		Date: 7/13/2023	
Description: View of area being pumped at Segment 11, Manhole #24, off Union Avenue, looking westward.

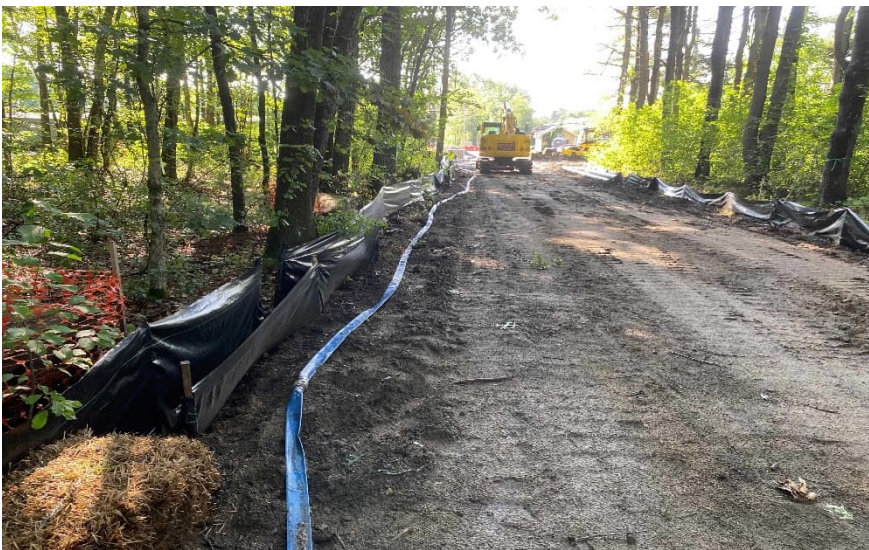
<b>PHOTOGRAPHIC LOG</b>	
Client Name: Eversource		Site Location: Sudbury to Hudson Transmission Reliability Project	
Photo No.: 2		Date: 7/13/2023	
Description: Segment 11. View of dewatering operation, looking westward.
