Weekly Environmental Compliance Summary

Sudbury to Hudson Transmission Reliability Project (USEPA Tracking # MAR1003UW)

Week of: August 28 to September 1, 2023

CONSTRUCTION MONITORING REPORT

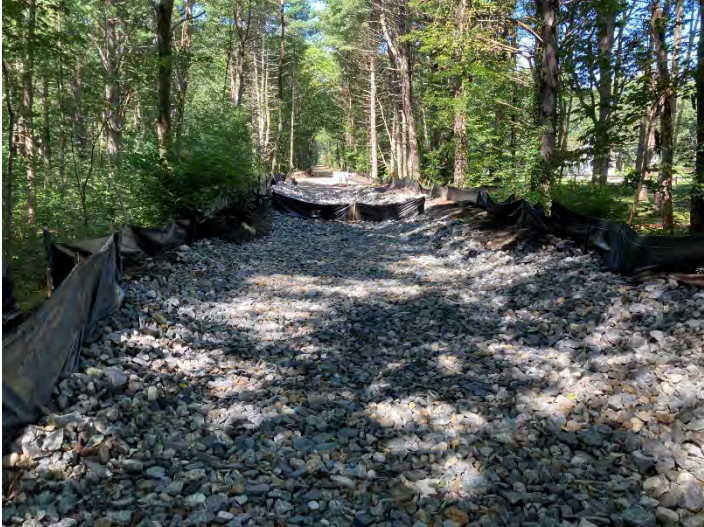
Epsilon ASSOCIATES INC.		PHOTOGRAPHIC LOG	
Client Name: Eversource		Site Location: Sudbury to Hudson Transmission Reliability Project	Town: Sudbury
Photo No.: 1	Date: 8/29/2023

Description: View of area above collapsed culvert in segment 9. Facing west.

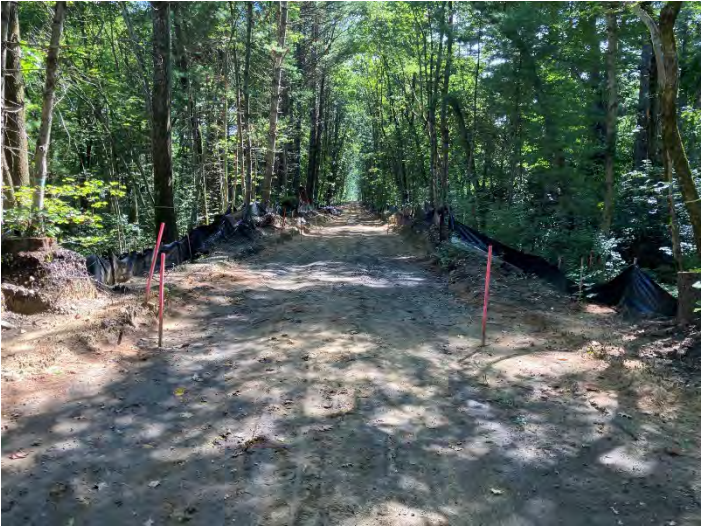
Epsilon ASSOCIATES INC.		PHOTOGRAPHIC LOG	
Client Name: Eversource		Site Location: Sudbury to Hudson Transmission Reliability Project	Town: Sudbury
Photo No.: 2	Date: 8/29/2023

Description: View of Dudley Brook culvert area in segment 10. Facing west.

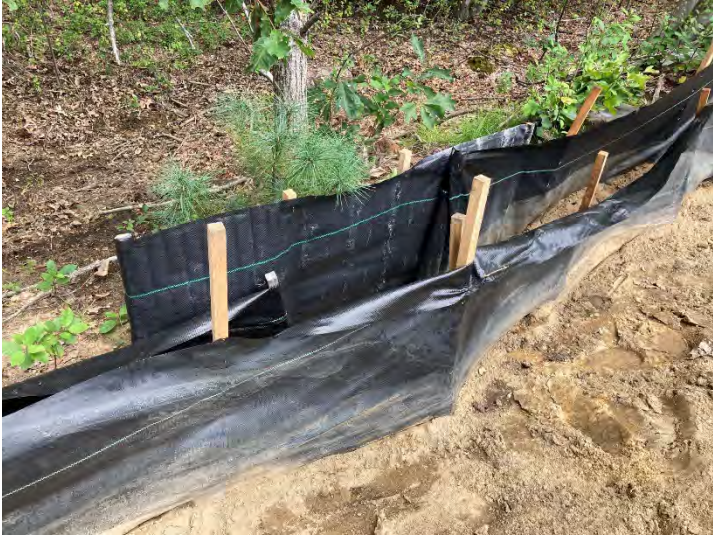
PHOTOGRAPHIC LOG	
Client Name: Eversource		Site Location: Sudbury to Hudson Transmission Reliability Project	
Town: Sudbury			
Photo No.: 3	Date: 8/29/2023

Description: View of Sta. #575 in segment 11. Deposited sediment has been removed and gap in syncopated silt fence has been closed (with approval from Sudbury CC agent). Facing northeast.

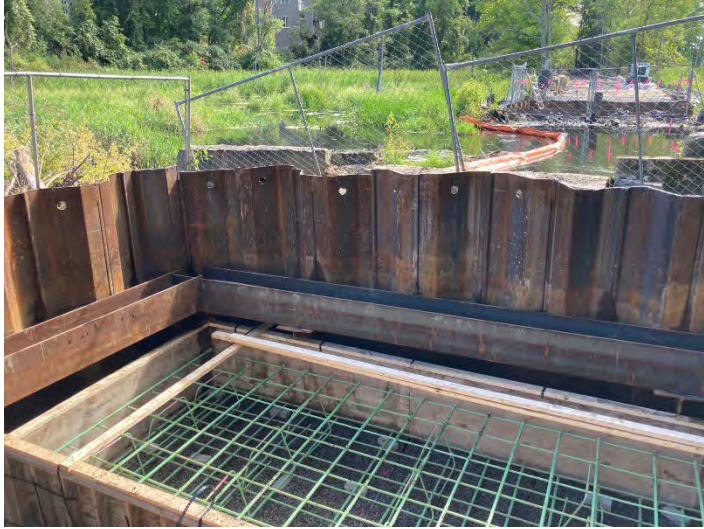
PHOTOGRAPHIC LOG	
Client Name: Eversource		Site Location: Sudbury to Hudson Transmission Reliability Project	
Town: Sudbury			
Photo No.: 5	Date: 8/29/2023

Description: View of bridge 127 work area. See additional dewatering inspection report. Facing west.

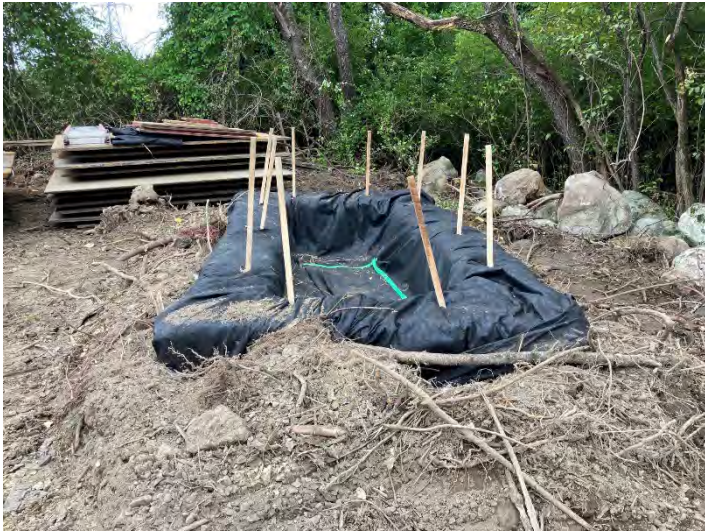
PHOTOGRAPHIC LOG	
Client Name: Eversource		Site Location: Sudbury to Hudson Transmission Reliability Project	
Town: Sudbury			
Photo No.: 6	Date: 8/29/2023

Description: View of dewatering corral that has been installed near future MH #28 location. Corral was inspected and approved by Lori Capone (Sudbury CC). Facing south.

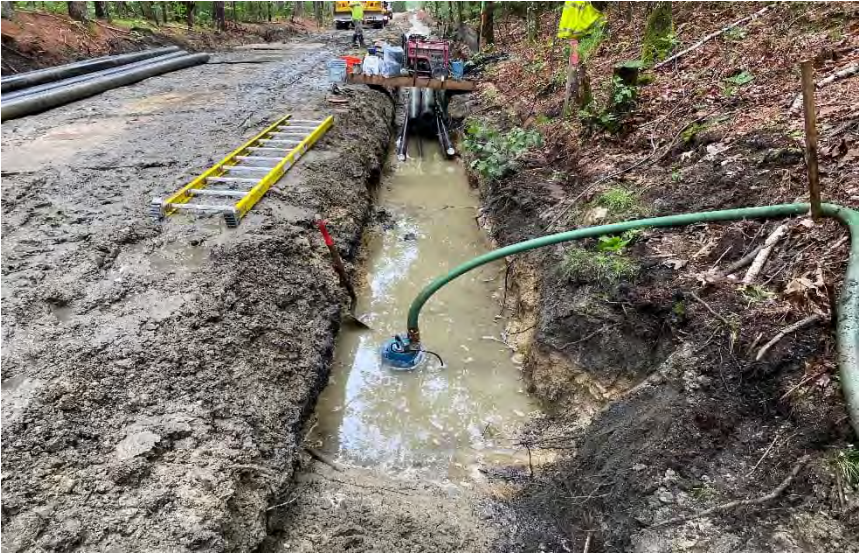
PHOTOGRAPHIC LOG	
Client Name: Eversource		Site Location: Sudbury to Hudson Transmission Reliability Project	
Town: Sudbury			
Photo No.: 3	Date: 8-30-23

Description: Conduit work area within segment 7, dewatering of trench, looking westward.

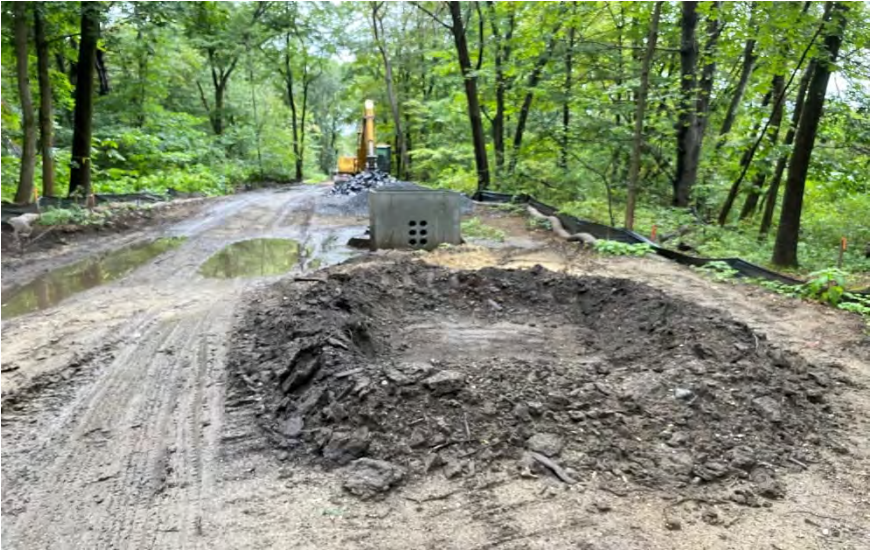
PHOTOGRAPHIC LOG	
Client Name: Eversource		Site Location: Sudbury to Hudson Transmission Reliability Project	
Town: Sudbury			
Photo No.: 7	Date: 8-30-23

Description: Work area within segment 13, concrete washout area, bridge 127 work, existing erosion control, looking westward.

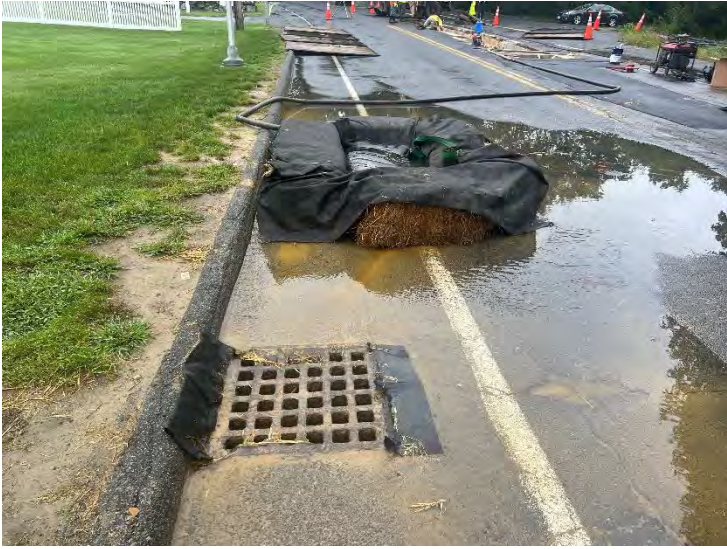
PHOTOGRAPHIC LOG	
Client Name: Eversource		Site Location: Sudbury to Hudson Transmission Reliability Project	
Town: Hudson			
Photo No.: 3	Date: 8-30-23

Description: Overview of the dewatering corral setup along Forest Ave. Facing East.

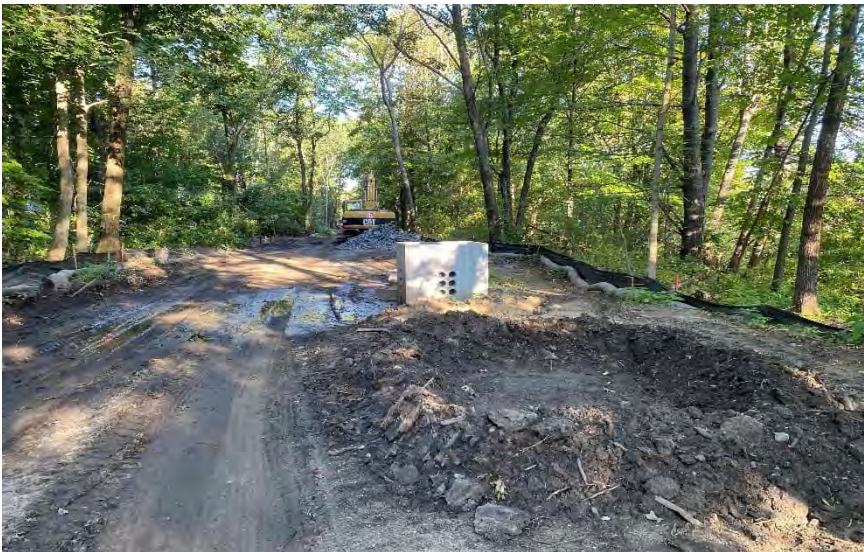
PHOTOGRAPHIC LOG	
Client Name: Eversource		Site Location: Sudbury to Hudson Transmission Reliability Project	
Town: Sudbury			
Photo No.: 5	Date: 9-1-23

Description: Work area within segment 13, existing erosion control, looking westward.

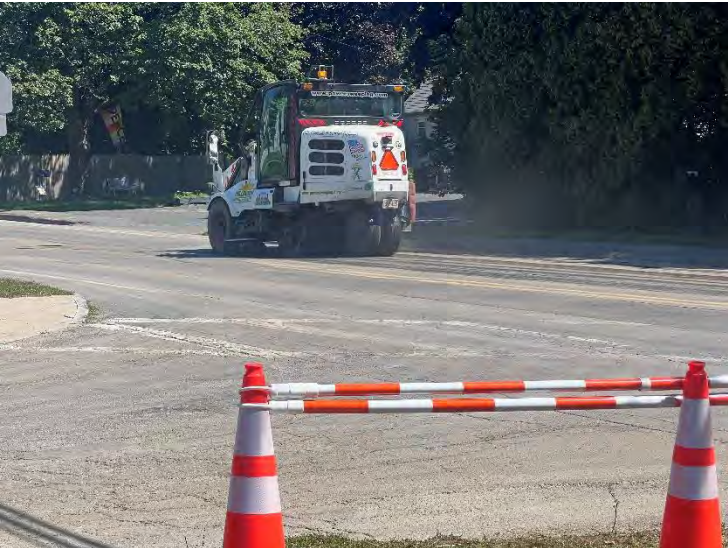
PHOTOGRAPHIC LOG	
Client Name: Eversource		Site Location: Sudbury to Hudson Transmission Reliability Project	
Photo No.: 2 Date: 9-01-23		Town: Hudson	
Description: View of street sweeping along Forest Ave. Facing South.

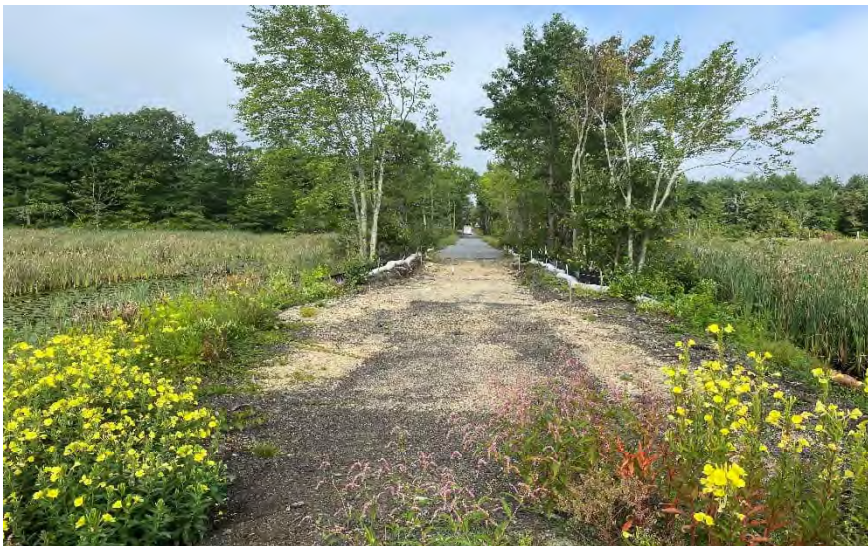
PHOTOGRAPHIC LOG	
Client Name: Eversource		Site Location: Sudbury to Hudson Transmission Reliability Project	
Town: Hudson			
Photo No.: 1	Date: 8-28-23

Description: Work area within segment 2 from bridge 130, existing erosion control, looking westward.

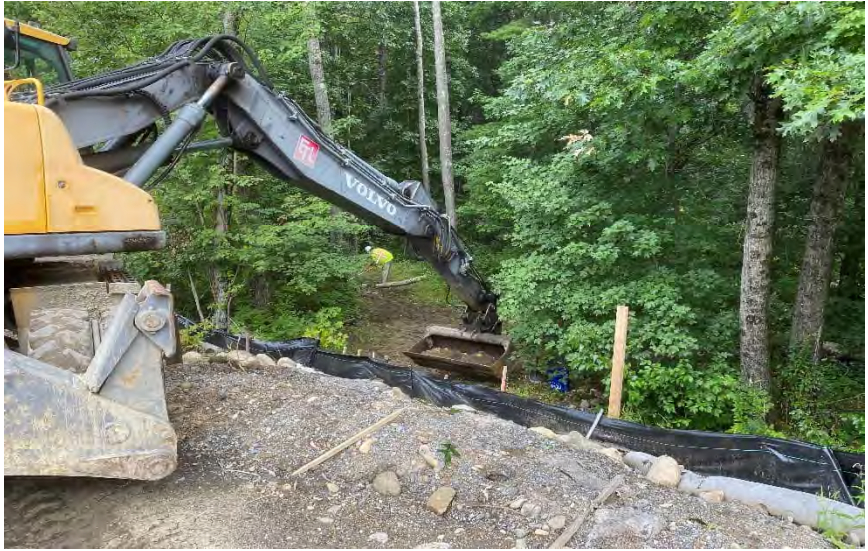
PHOTOGRAPHIC LOG	
Client Name: Eversource		Site Location: Sudbury to Hudson Transmission Reliability Project	
Town: Hudson			
Photo No.: 3	Date: 8-28-23

Description: Work area within segment 1, erosion control cleanup, looking northward.

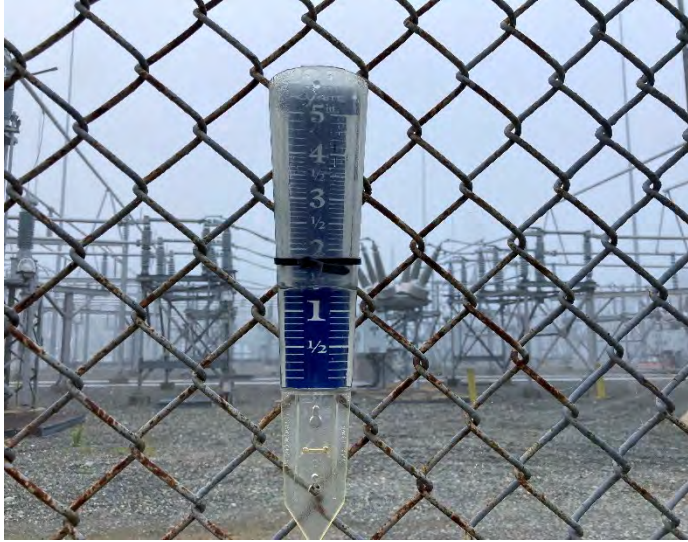
PHOTOGRAPHIC LOG	
Client Name: Eversource		Site Location: Sudbury to Hudson Transmission Reliability Project	
Town: Sudbury			
Photo No.: 1	Date: 8-28-2023

Description: View of rain gauge at Sudbury Substation. 1.40" observed in gauge at approximately 8:00am. Facing south.

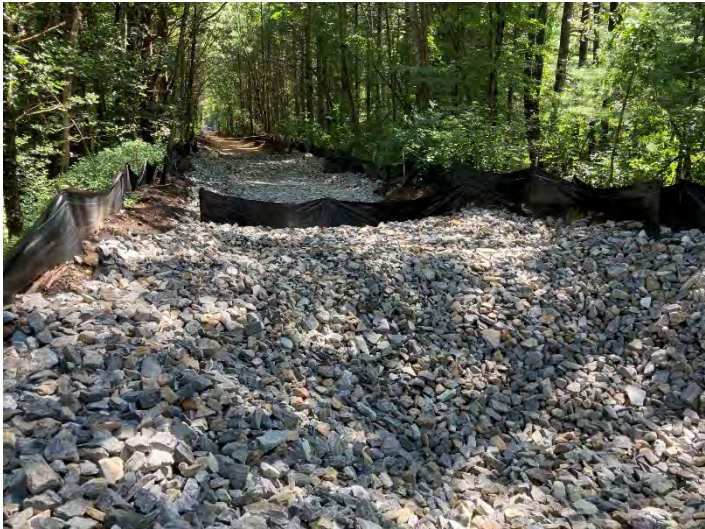
PHOTOGRAPHIC LOG	
Client Name: Eversource		Site Location: Sudbury to Hudson Transmission Reliability Project	
Town: Sudbury			
Photo No.: 2	Date: 8-28-2023

Description: View of area above collapsed culvert in segment 9. Facing east.

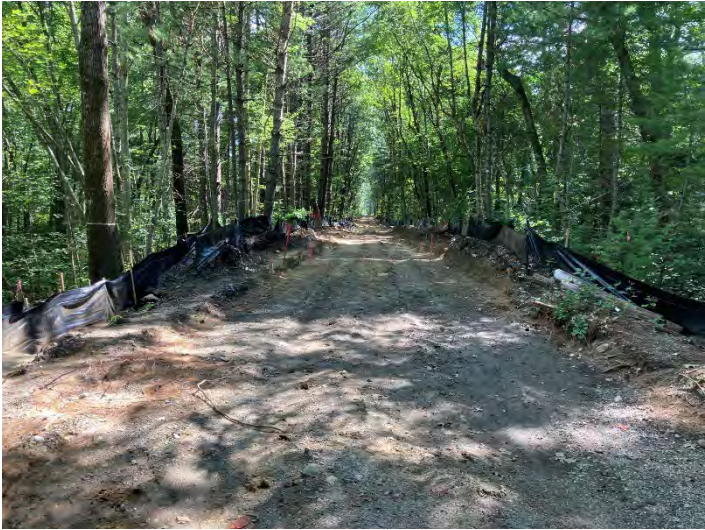
PHOTOGRAPHIC LOG	
Client Name: Eversource		Site Location: Sudbury to Hudson Transmission Reliability Project	
Town: Sudbury			
Photo No.: 3	Date: 8-28-2023

Description: View of syncopated silt fence in segment 10. Facing east.

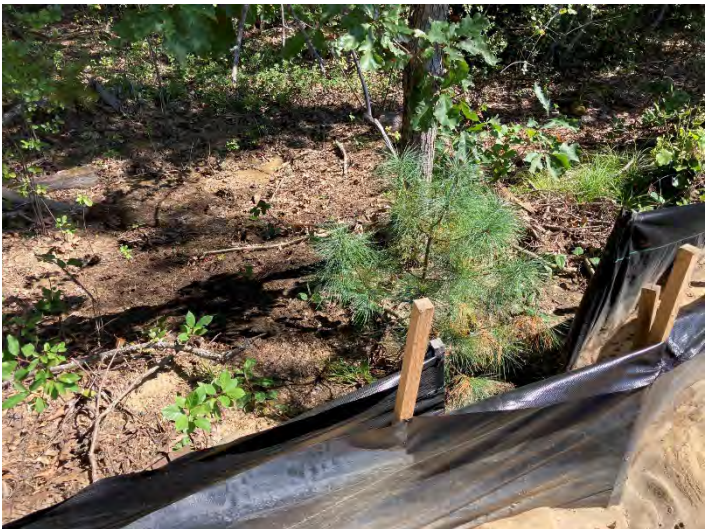
PHOTOGRAPHIC LOG	
Client Name: Eversource		Site Location: Sudbury to Hudson Transmission Reliability Project	
Town: Sudbury			
Photo No.: 4	Date: 8-28-2023

Description: View of Sta. #575 in segment 11. A small amount of sediment has migrated through the syncopated silt fence. Lori Capone (Sudbury CC) has given permission for gap to be closed in silt fence in this location. Facing northeast.

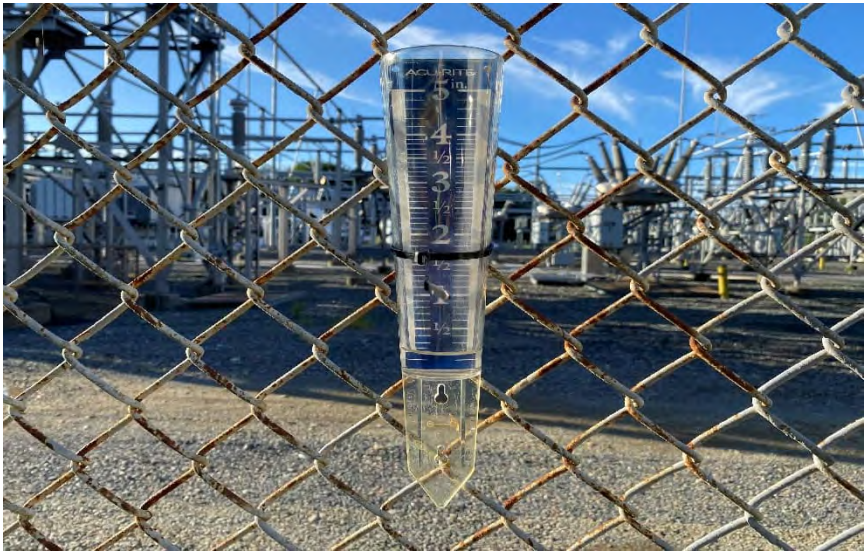
PHOTOGRAPHIC LOG	
Client Name: Eversource		Site Location: Sudbury to Hudson Transmission Reliability Project	
Town: Sudbury			
Photo No.: 1	Date: 8-31-23

Description: Rain gauge at substation, with 0.25" of rainfall, looking southward.

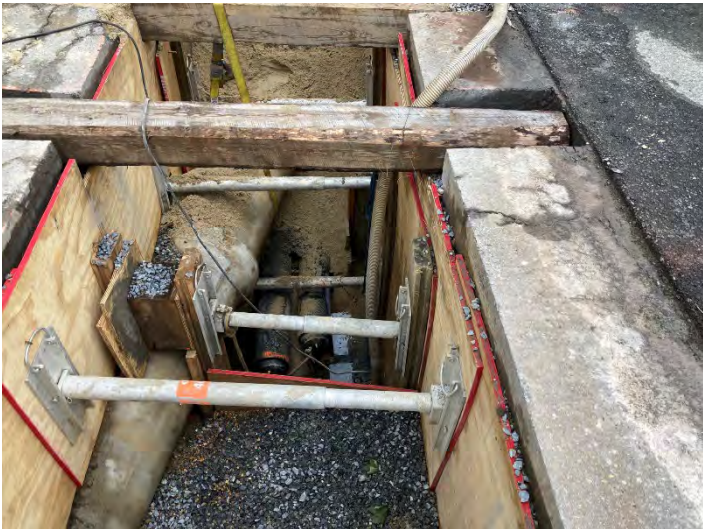
PHOTOGRAPHIC LOG	
Client Name: Eversource		Site Location: Sudbury to Hudson Transmission Reliability Project	
Photo No.: 2		Town: Hudson	
Date: 8/26/2023

Description: View of trench and water prior to treatment. Water appeared slightly turbid. Facing south.

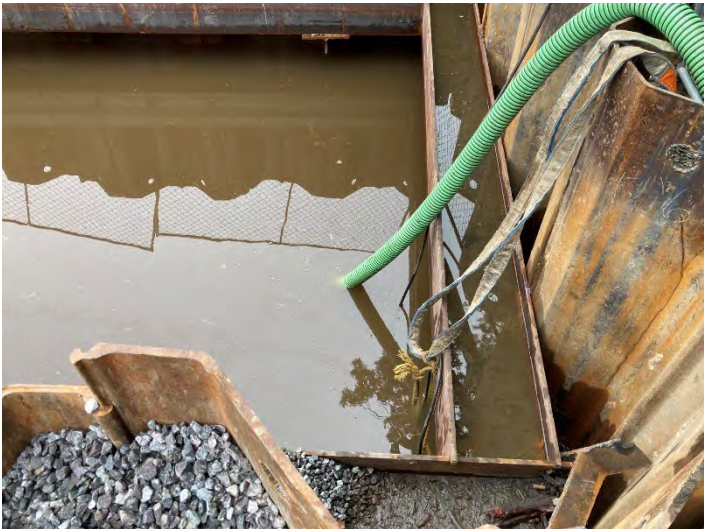
PHOTOGRAPHIC LOG	
Client Name: Eversource		Site Location: Sudbury to Hudson Transmission Reliability Project	
Town: Sudbury			
Photo No.: 2	Date: 8/28/2023

Description: View of water prior to treatment. Water appeared to be slightly turbid.

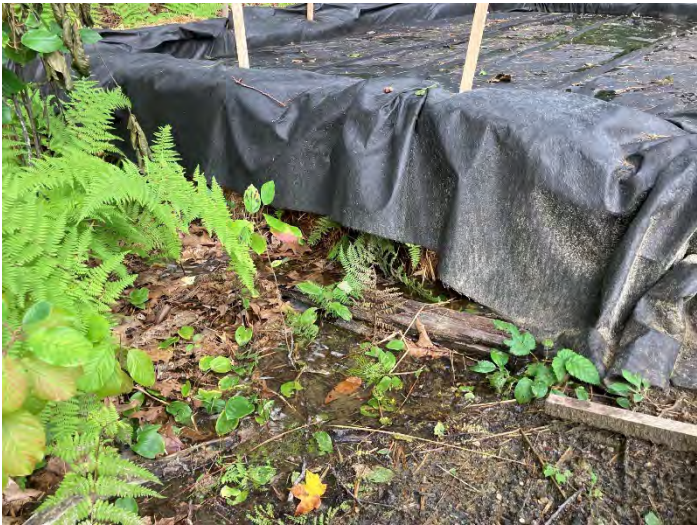
PHOTOGRAPHIC LOG	
Client Name: Eversource		Site Location: Sudbury to Hudson Transmission Reliability Project	
Town: Sudbury			
Photo No.: 4	Date: 8/28/2023

Description: View of discharge from corral. Discharge traveled east outside of the silt fence but did not reach any jurisdictional areas. Discharge appeared clear. Turbidity reading was less than 50 NTUs. Facing southwest.

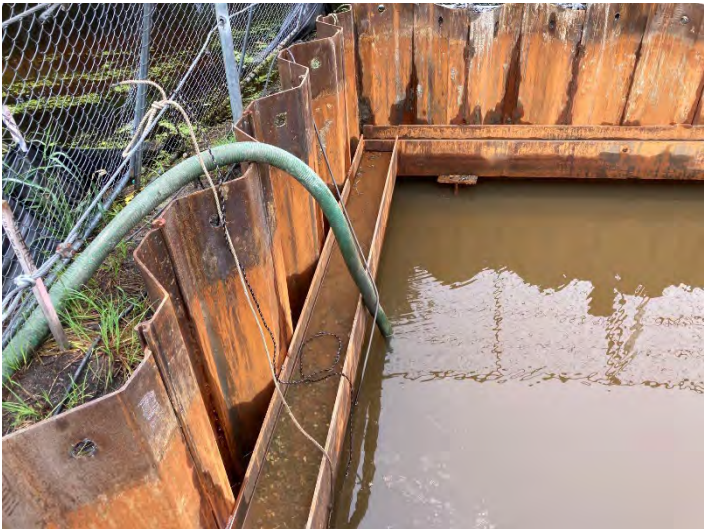
PHOTOGRAPHIC LOG	
Client Name: Eversource		Site Location: Sudbury to Hudson Transmission Reliability Project	
Photo No.: 2		Date: 8/28/2023	
Description: View of water prior to treatment. Water appeared slightly turbid.

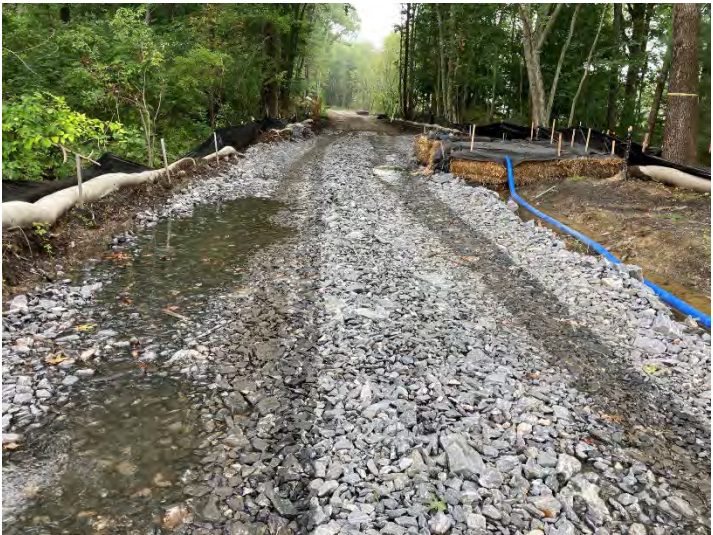
PHOTOGRAPHIC LOG	
Client Name: Eversource		Site Location: Sudbury to Hudson Transmission Reliability Project	
Town: Sudbury			
Photo No.: 4	Date: 8/28/2023

Description: View of discharge from controls. Discharge appeared to be leaving the work area and reaching wetlands. Discharge appeared clear. Turbidity reading was less than 50 NTUs. Facing east.

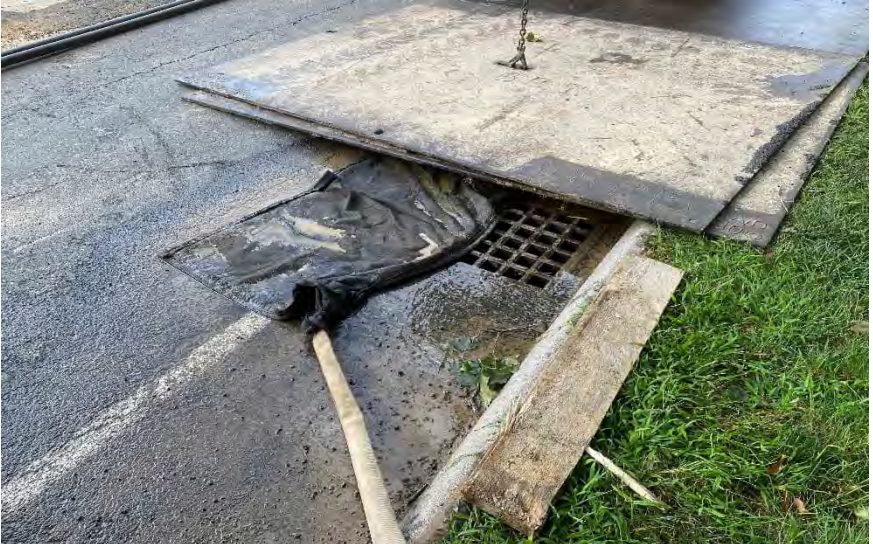
PHOTOGRAPHIC LOG	
Client Name: Eversource		Site Location: Sudbury to Hudson Transmission Reliability Project	
Photo No.: 4 Date: 8/29/2023		Town: Hudson	
Description: Forest Avenue. View of dewatering operation (corral/bag), looking southward.

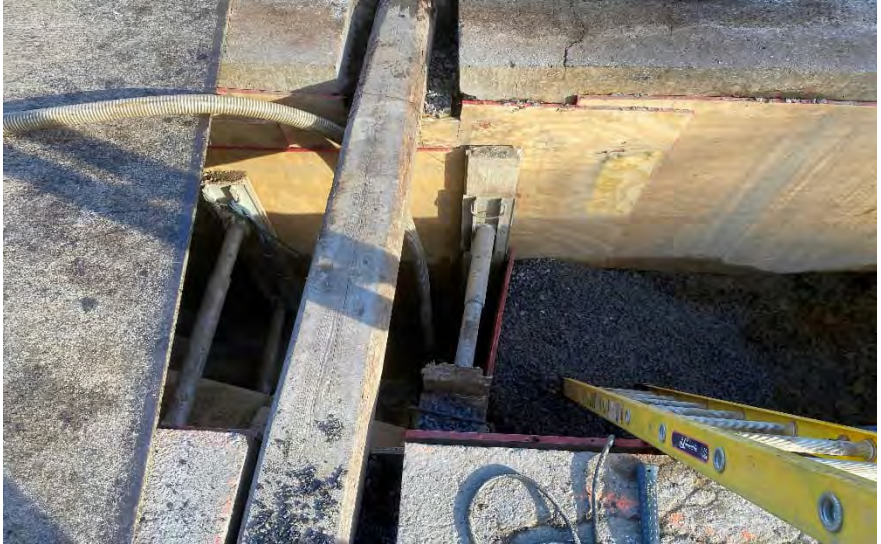
PHOTOGRAPHIC LOG	
Client Name: Eversource		Site Location: Sudbury to Hudson Transmission Reliability Project	
Town: Hudson			
Photo No.: 1	Date: 8/29/2023

Description: View of area being pumped at Forest Avenue (area in conduit trench).

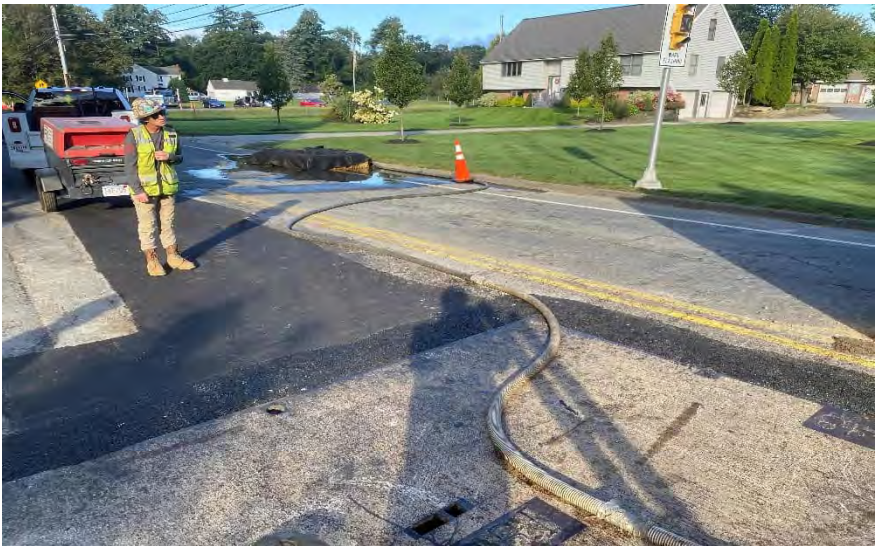
PHOTOGRAPHIC LOG	
Client Name: Eversource		Site Location: Sudbury to Hudson Transmission Reliability Project	
Town: Hudson			
Photo No.: 2	Date: 8/29/2023

Description: Forest Avenue. View of dewatering operation, looking southward.

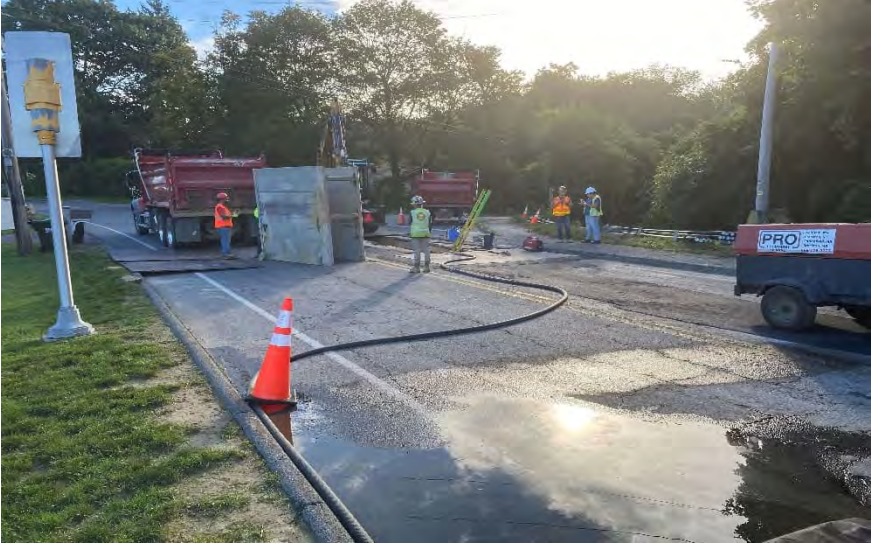
PHOTOGRAPHIC LOG	
Client Name: Eversource		Site Location: Sudbury to Hudson Transmission Reliability Project	
Town: Hudson			
Photo No.: 3	Date: 8/29/2023

Description: Forest Avenue. View of dewatering operation (pumping at far end of area), looking northward.

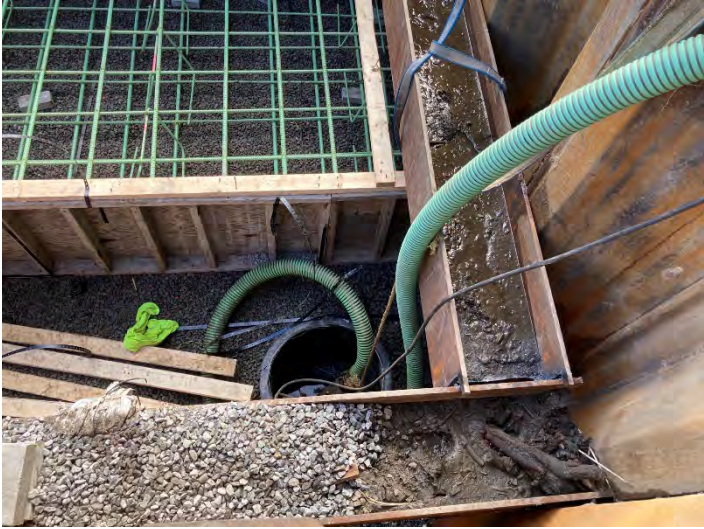
PHOTOGRAPHIC LOG	
Client Name: Eversource		Site Location: Sudbury to Hudson Transmission Reliability Project	
Town: Sudbury			
Photo No.: 1	Date: 8/29/2023

Description: View of pumping operation at Bridge 127 work at Hop Brook. Water prior to treatment appeared to be slightly turbid.

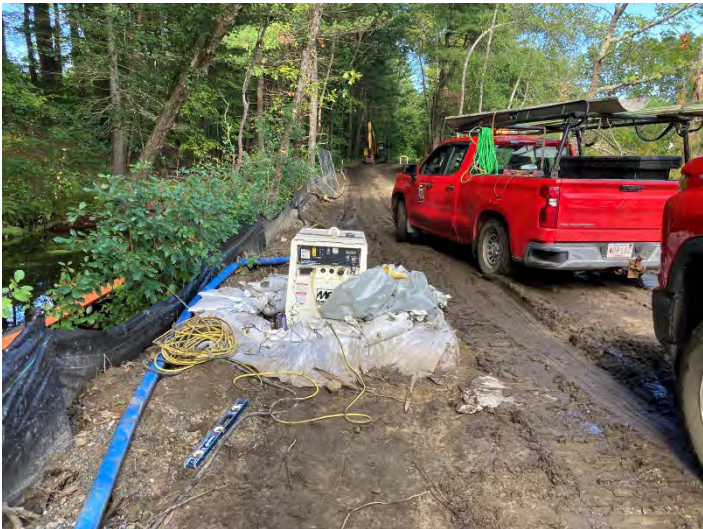
PHOTOGRAPHIC LOG	
Client Name: Eversource		Site Location: Sudbury to Hudson Transmission Reliability Project	
Town: Sudbury			
Photo No.: 2	Date: 8/29/2023

Description: View of generator being used for pumping operation. Generator has been placed in lined pit for spill prevention. Facing west.

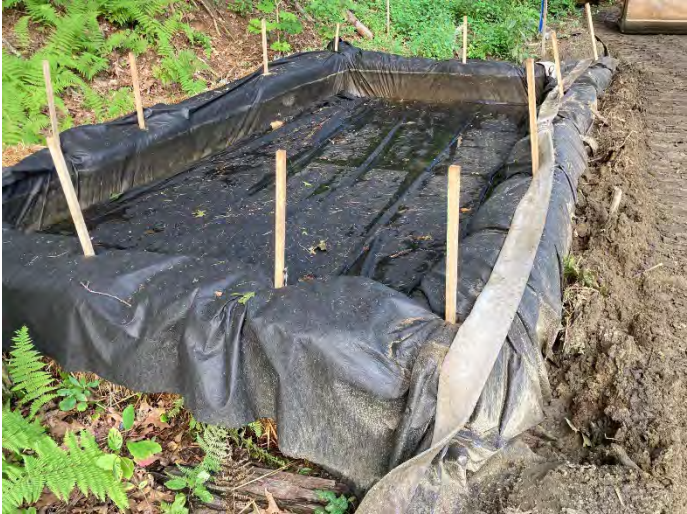
PHOTOGRAPHIC LOG	
Client Name: Eversource		Site Location: Sudbury to Hudson Transmission Reliability Project	
Town: Sudbury			
Photo No.: 3	Date: 8/29/2023

Description: View of dewatering controls (straw bale corral with filter fabric, stone, and silt bag). Facing west.

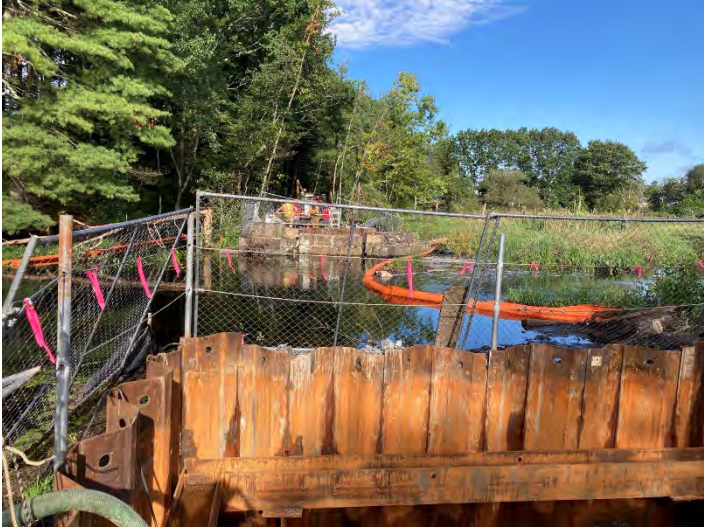
PHOTOGRAPHIC LOG	
Client Name: Eversource		Site Location: Sudbury to Hudson Transmission Reliability Project	
Photo No.: 1		Date: 8/29/2023	
Description: View of work area and pumping operation at cofferdam at Bridge 127 work at Hop Brook. Facing west.

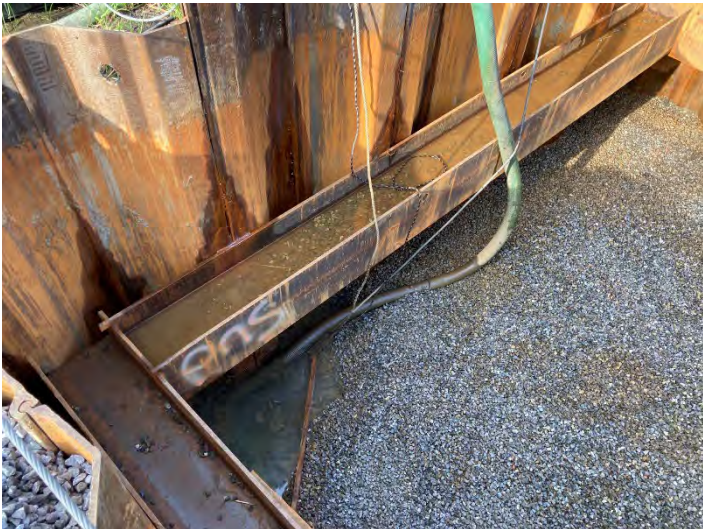
PHOTOGRAPHIC LOG	
Client Name: Eversource		Site Location: Sudbury to Hudson Transmission Reliability Project	
Photo No.: 2		Date: 8/29/2023	
Description: View of water prior to treatment. Water appeared slightly turbid.

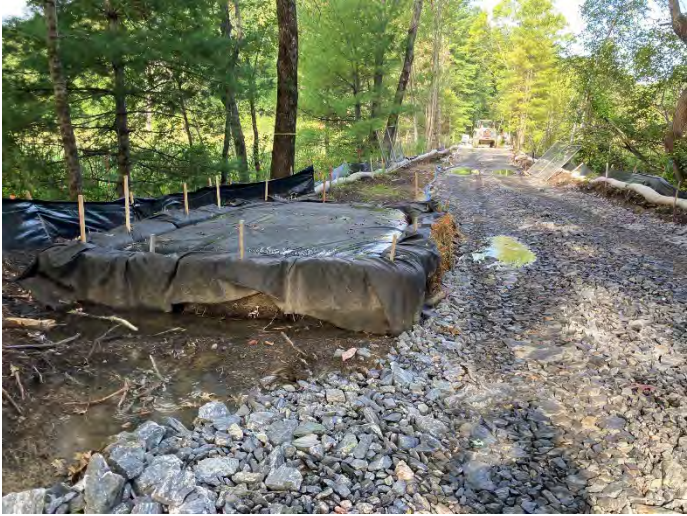
PHOTOGRAPHIC LOG	
Client Name: Eversource		Site Location: Sudbury to Hudson Transmission Reliability Project	Town: Sudbury
Photo No.: 3	Date: 8/29/2023

Description: View of dewatering controls (straw bale corral with filter fabric, stone, and silt bag). Facing west.

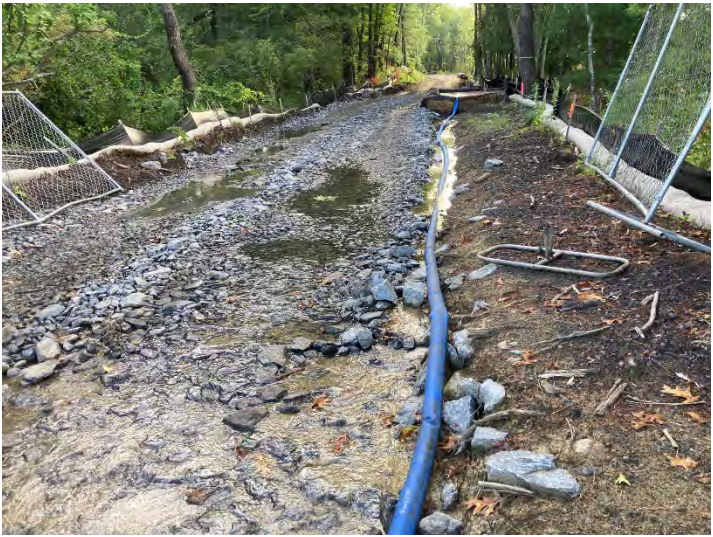
PHOTOGRAPHIC LOG	
Client Name: Eversource		Site Location: Sudbury to Hudson Transmission Reliability Project	Town: Sudbury
Photo No.: 4	Date: 8/29/2023

Description: View of discharge from controls. Discharge appeared to be leaving the work area and reaching wetlands. Discharge appeared clear. Turbidity reading was less than 50 NTUs. Facing east.

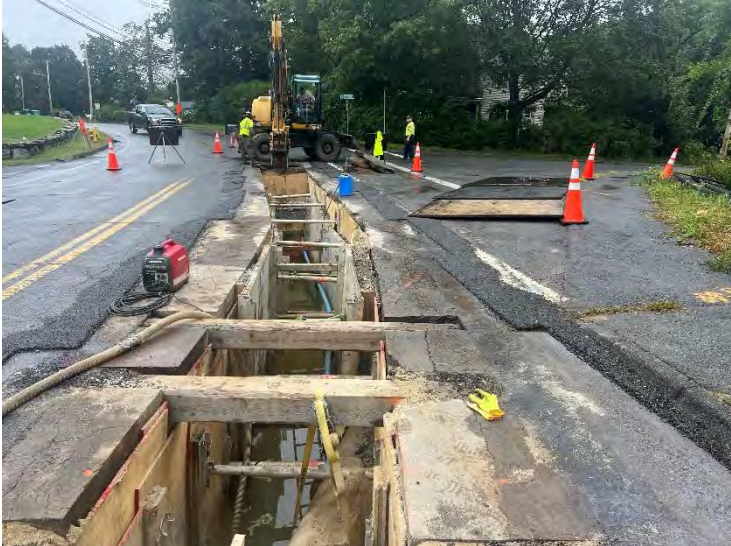
PHOTOGRAPHIC LOG	
Client Name: Eversource		Site Location: Sudbury to Hudson Transmission Reliability Project	
Photo No.: 1 Date: 8/30/2023		Town: Hudson	
Description: View of area being pumped at Forest Avenue (area in conduit trench).

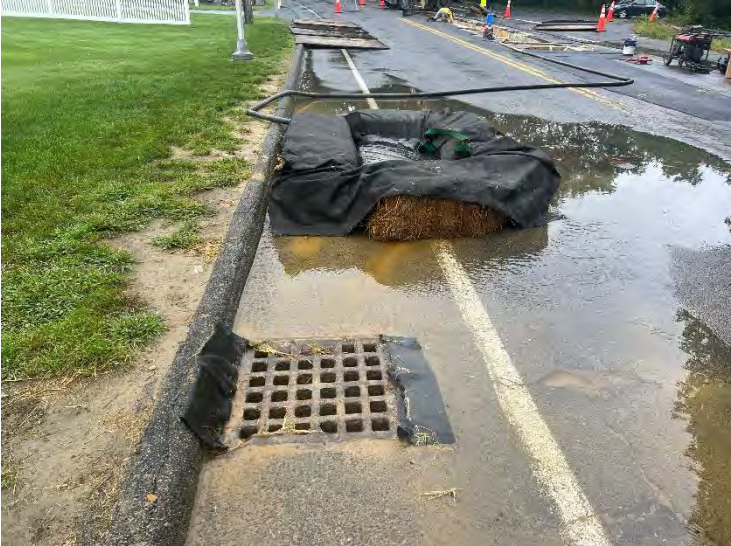
PHOTOGRAPHIC LOG	
Client Name: Eversource		Site Location: Sudbury to Hudson Transmission Reliability Project	
Town: Hudson			
Photo No.: 4	Date: 8/30/2023

Description: Forest Avenue. View of the water discharging to a nearby catch basin with proper inlet protection. Facing East.

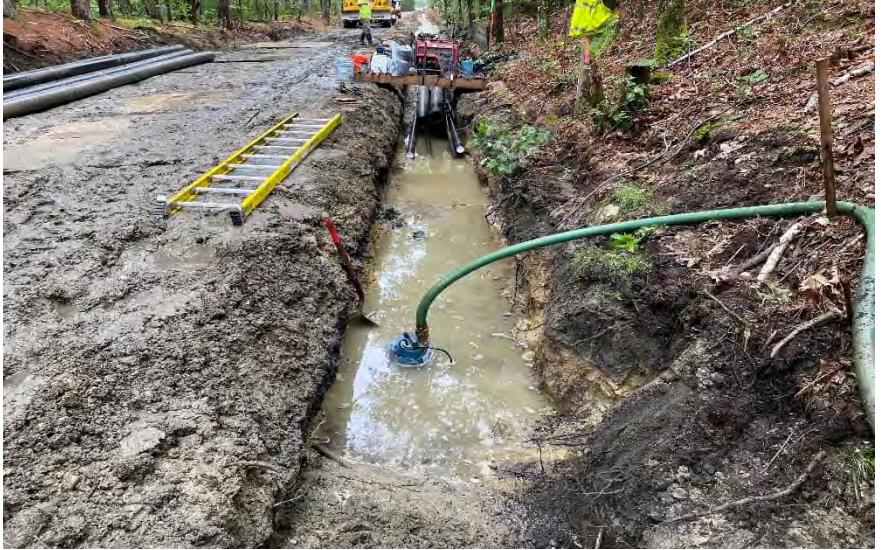
PHOTOGRAPHIC LOG	
Client Name: Eversource		Site Location: Sudbury to Hudson Transmission Reliability Project	
Town: Sudbury			
Photo No.: 1	Date: 8/30/2023

Description: View of area being pumped at Segment 7, east of Manhole #15, looking westward.

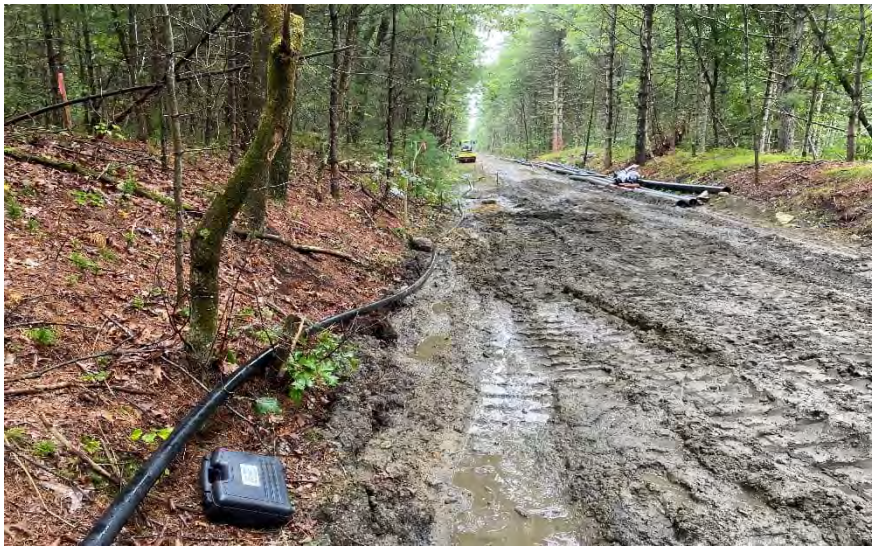
PHOTOGRAPHIC LOG	
Client Name: Eversource		Site Location: Sudbury to Hudson Transmission Reliability Project	
Town: Sudbury			
Photo No.: 2	Date: 8/30/2023

Description: Segment 7. View of dewatering operation, looking eastward.

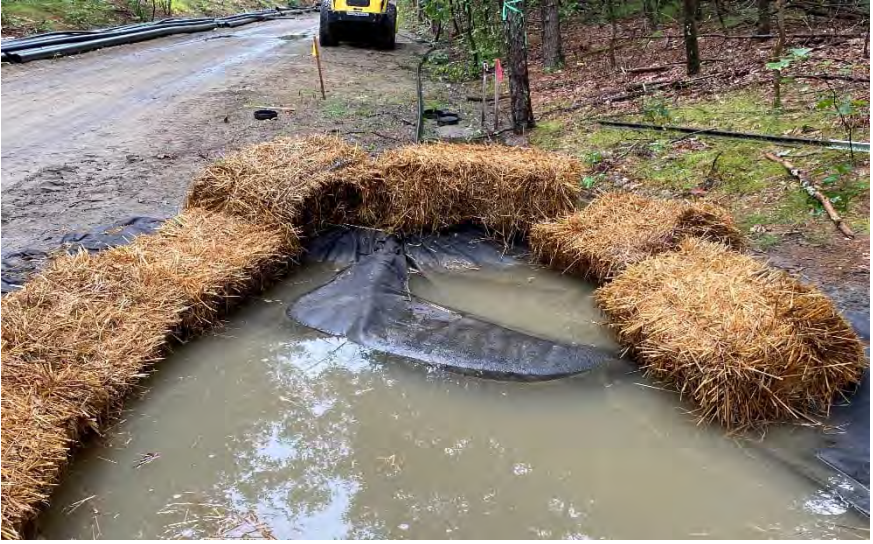
Description: Segment 7. View of discharge bag/bales, looking eastward. Water discharge to bag intermittent and appeared to be slightly turbid.

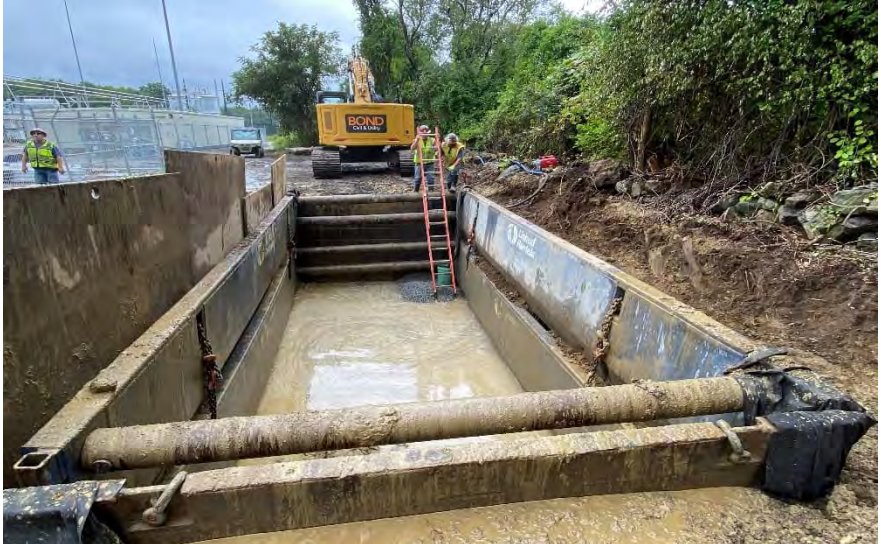
PHOTOGRAPHIC LOG	
Client Name: Eversource		Site Location: Sudbury to Hudson Transmission Reliability Project	
Town: Sudbury			
Photo No.: 1	Date: 8/30/2023

Description: View of area being pumped at Manhole #28, looking southward.

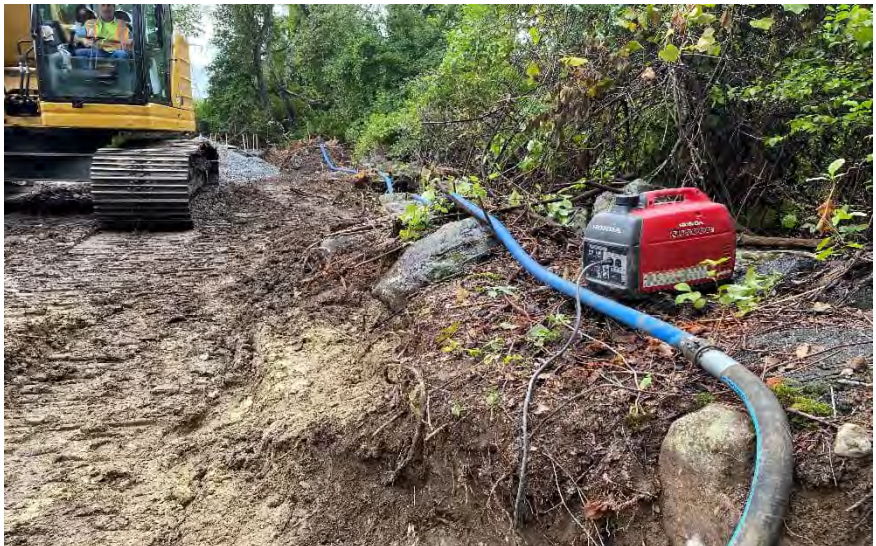
PHOTOGRAPHIC LOG	
Client Name: Eversource		Site Location: Sudbury to Hudson Transmission Reliability Project	
Town: Sudbury			
Photo No.: 2	Date: 8/30/2023

Description: Manhole #28. View of dewatering operation, looking southward.

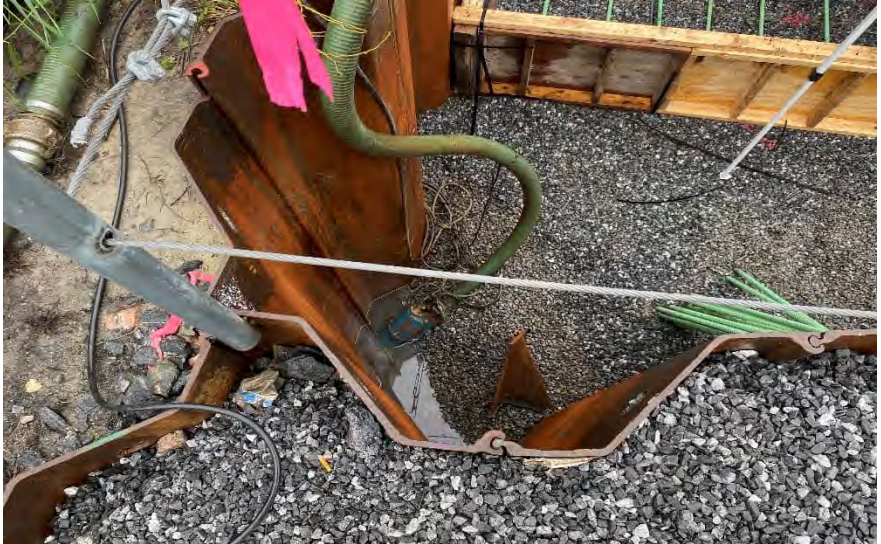
PHOTOGRAPHIC LOG	
Client Name: Eversource		Site Location: Sudbury to Hudson Transmission Reliability Project	
Town: Sudbury			
Photo No.: 1	Date: 8/30/2023

Description: View of area being pumped at Hop Brook (area in cofferdam), looking westward.

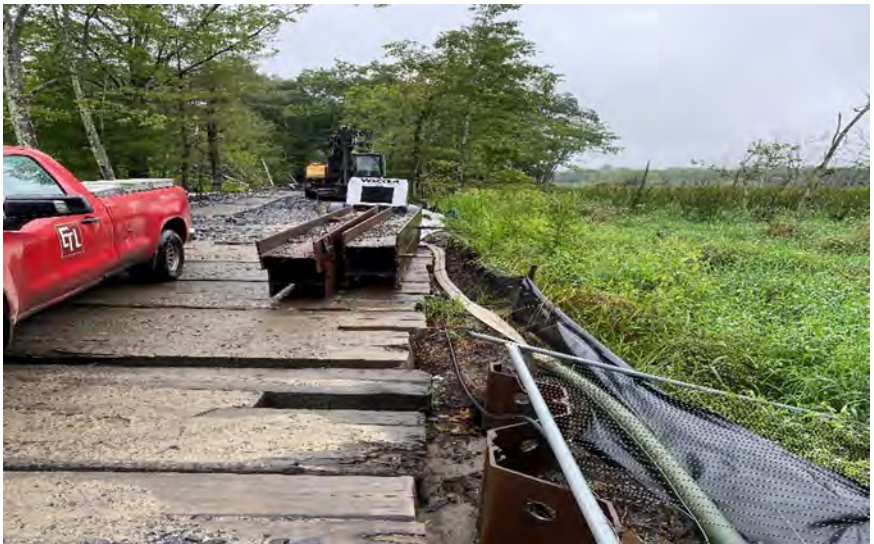
PHOTOGRAPHIC LOG	
Client Name: Eversource		Site Location: Sudbury to Hudson Transmission Reliability Project	
Town: Sudbury			
Photo No.: 2	Date: 8/30/2023

Description: Segment 14. View of dewatering operation (pumping at far end of area), looking westward.

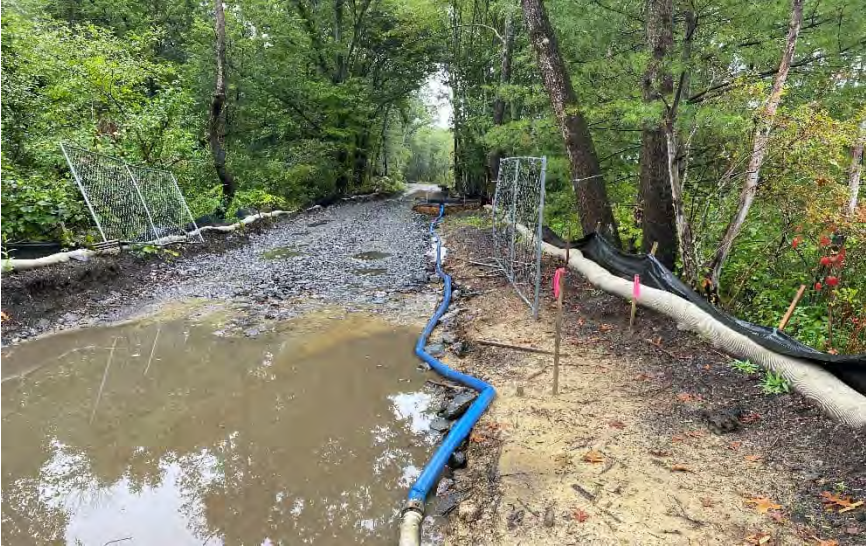
PHOTOGRAPHIC LOG	
Client Name: Eversource		Site Location: Sudbury to Hudson Transmission Reliability Project	
Photo No.: 3 Date: 8/30/2023		Town: Sudbury	
Description: Segment 14. View of dewatering operation (pumping at far end of area), looking eastward.

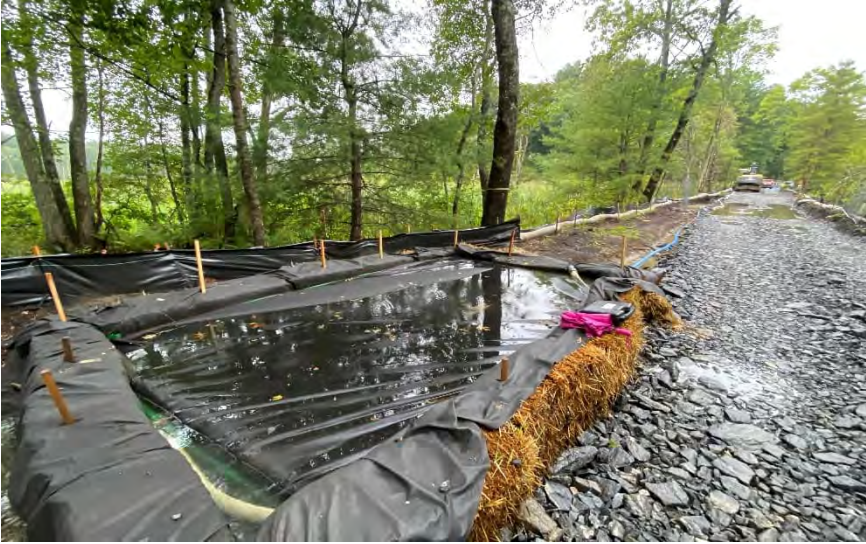
PHOTOGRAPHIC LOG	
Client Name: Eversource		Site Location: Sudbury to Hudson Transmission Reliability Project	
Photo No.: 4 Date: 8/30/2023		Town: Sudbury	
Description: Segment 14. View of dewatering operation (pumping at far end of area), looking westward.

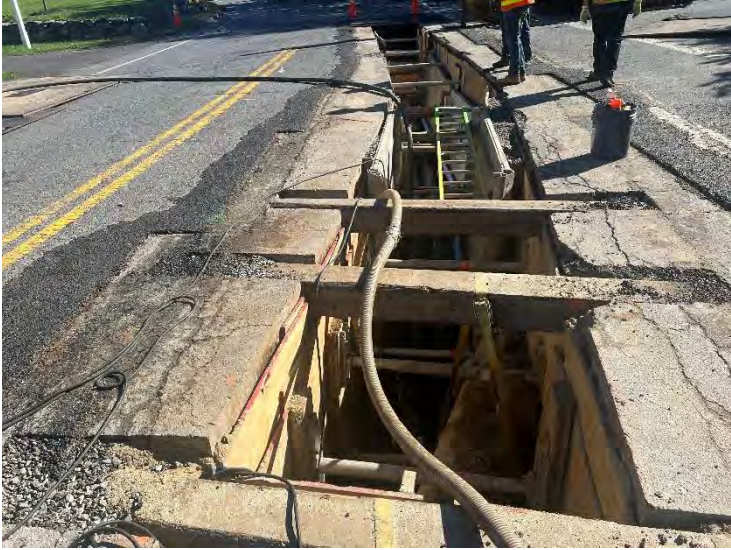
PHOTOGRAPHIC LOG	
Client Name: Eversource		Site Location: Sudbury to Hudson Transmission Reliability Project	
Photo No.: 1		Date: 8/31/2023	
Description: View of area being pumped at Forest Avenue (area in conduit trench).

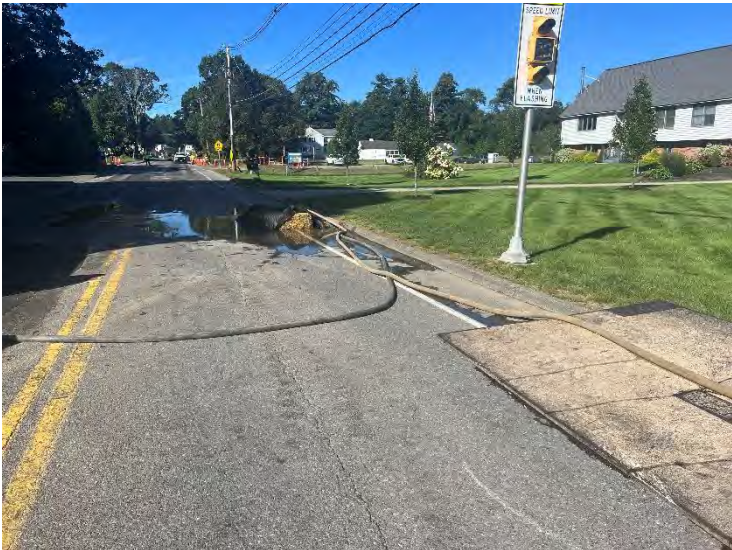
PHOTOGRAPHIC LOG	
Client Name: Eversource		Site Location: Sudbury to Hudson Transmission Reliability Project	
Photo No.: 2		Date: 8/31/2023	
Description: Forest Avenue. View of dewatering operation. Facing West.
