Weekly Environmental Compliance Summary

Sudbury to Hudson Transmission Reliability Project (USEPA Tracking # MAR1003UW)

Week of: August 28 to September 1, 2023

CONSTRUCTION MONITORING REPORT

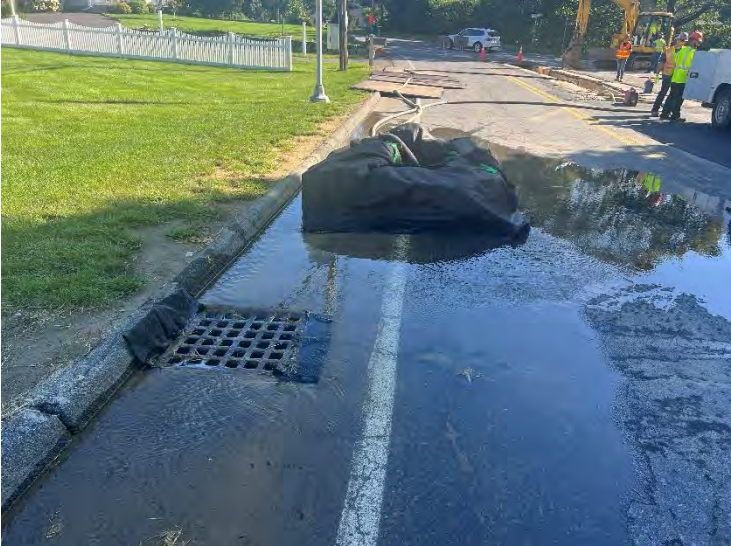
PHOTOGRAPHIC LOG	
Client Name: Eversource		Site Location: Sudbury to Hudson Transmission Reliability Project	
Town: Hudson			
Photo No.: 4	Date: 8/31/2023

Description: Forest Avenue. View of the water discharging to a nearby catch basin with proper inlet protection. Facing East.

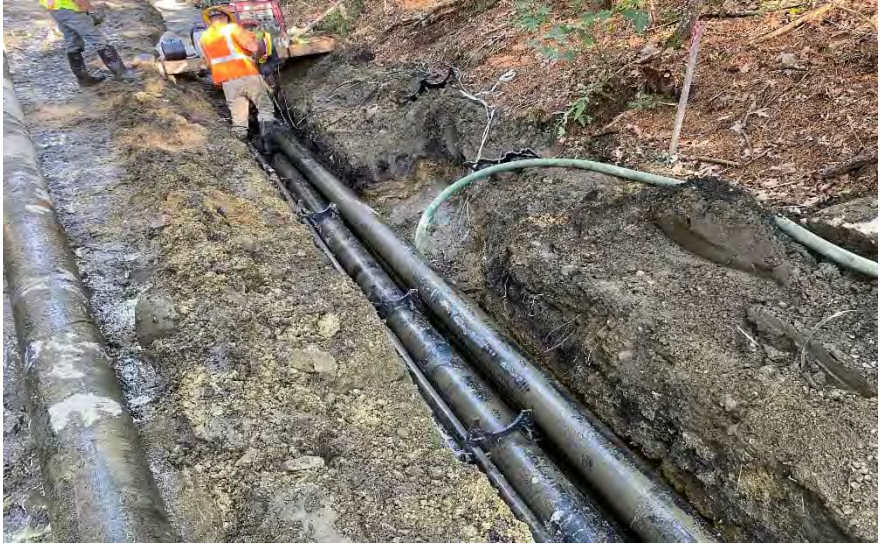
PHOTOGRAPHIC LOG	
Client Name: Eversource		Site Location: Sudbury to Hudson Transmission Reliability Project	
Town: Sudbury			
Photo No.: 1	Date: 8/31/2023

Description: View of area being pumped at Segment 7, east of Manhole #15, looking westward.

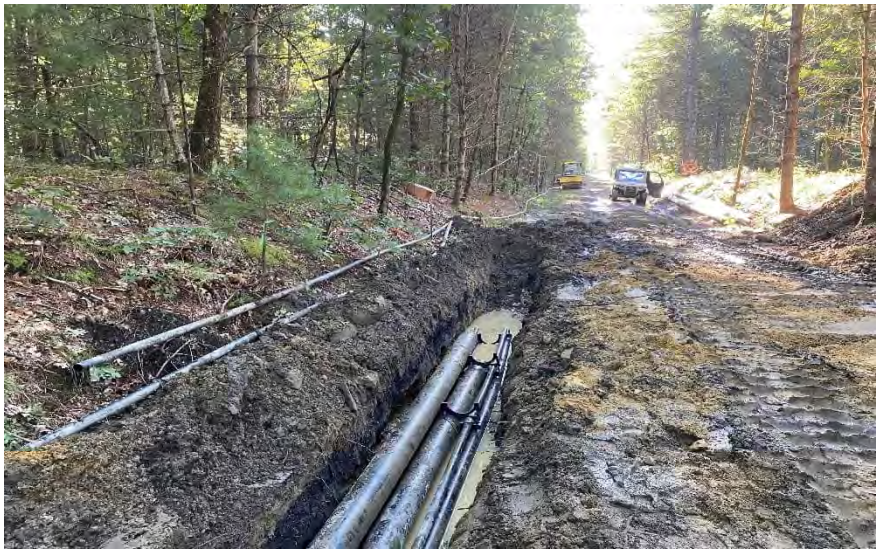
PHOTOGRAPHIC LOG	
Client Name: Eversource		Site Location: Sudbury to Hudson Transmission Reliability Project	
Town: Sudbury			
Photo No.: 2	Date: 8/31/2023

Description: Segment 7. View of dewatering operation, looking eastward.

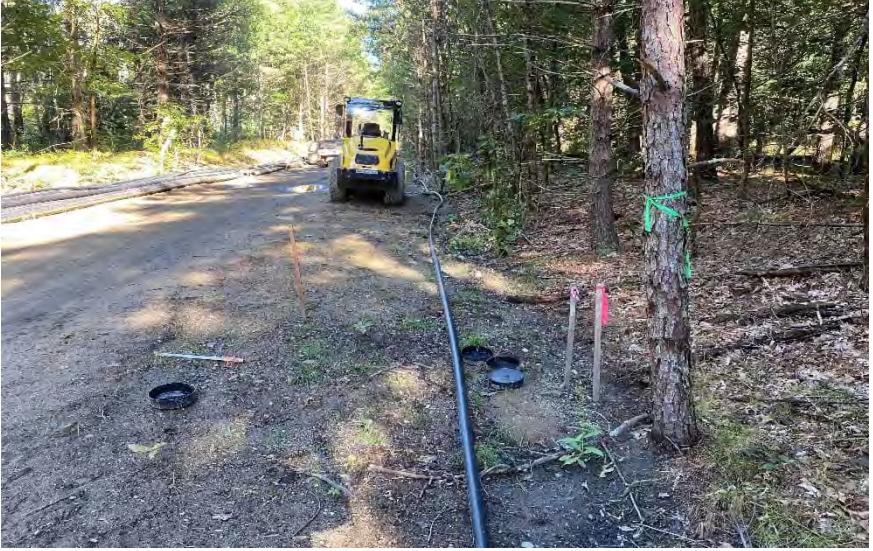
PHOTOGRAPHIC LOG	
Client Name: Eversource		Site Location: Sudbury to Hudson Transmission Reliability Project	
Town: Sudbury			
Photo No.: 3	Date: 8/31/2023

Description: Segment 7. View of dewatering operation, looking westward.

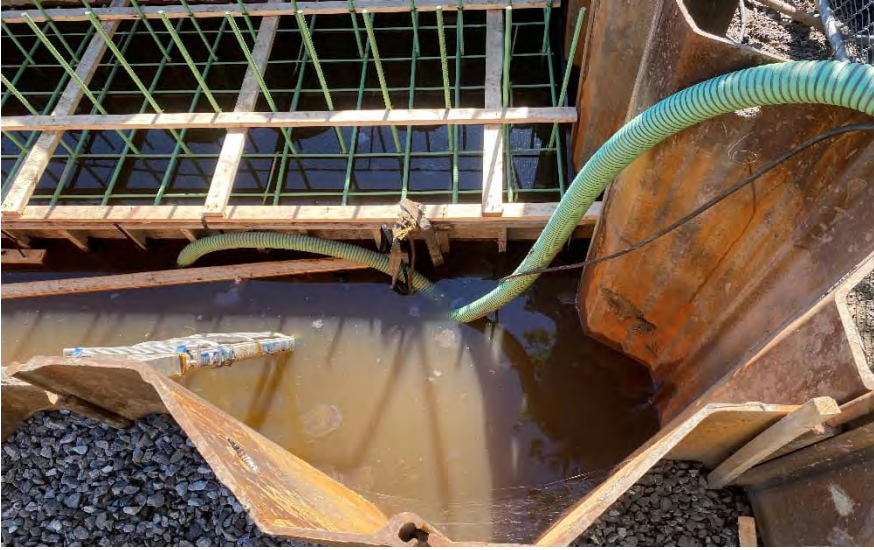
PHOTOGRAPHIC LOG	
Client Name: Eversource		Site Location: Sudbury to Hudson Transmission Reliability Project	
Town: Sudbury			
Photo No.: 1	Date: 8/31/2023

Description: View of area being pumped at Hop Brook (area in cofferdam), looking westward.

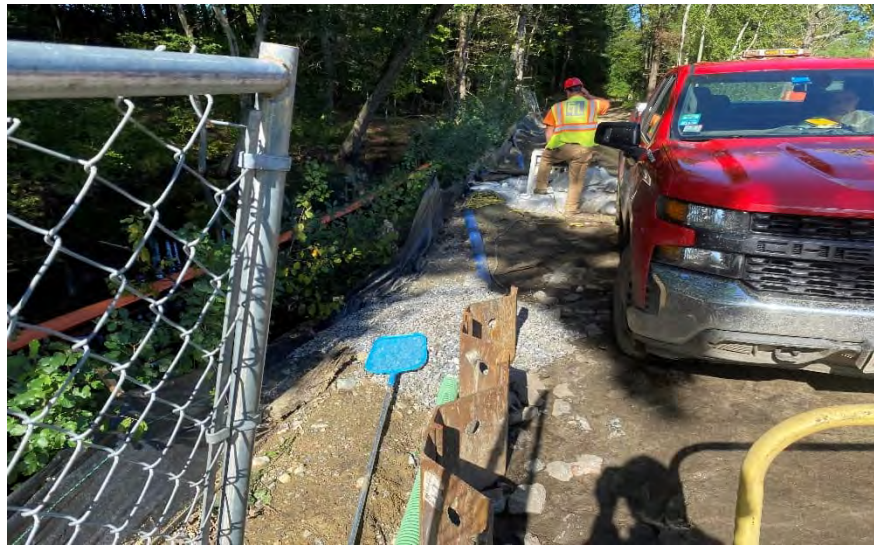
PHOTOGRAPHIC LOG	
Client Name: Eversource		Site Location: Sudbury to Hudson Transmission Reliability Project	
Town: Sudbury			
Photo No.: 2	Date: 8/31/2023

Description: Segment 13. View of dewatering operation (pumping at far end of area), looking westward.

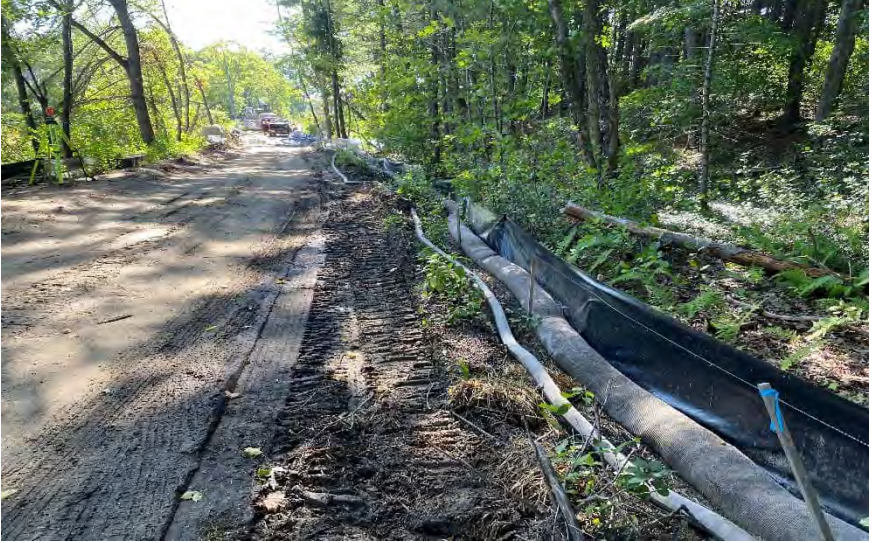
PHOTOGRAPHIC LOG	
Client Name: Eversource		Site Location: Sudbury to Hudson Transmission Reliability Project	
Photo No.: 3 Date: 8/31/2023		Town: Sudbury	
Description: Segment 13. View of dewatering operation (pumping at far end of area), looking eastward.

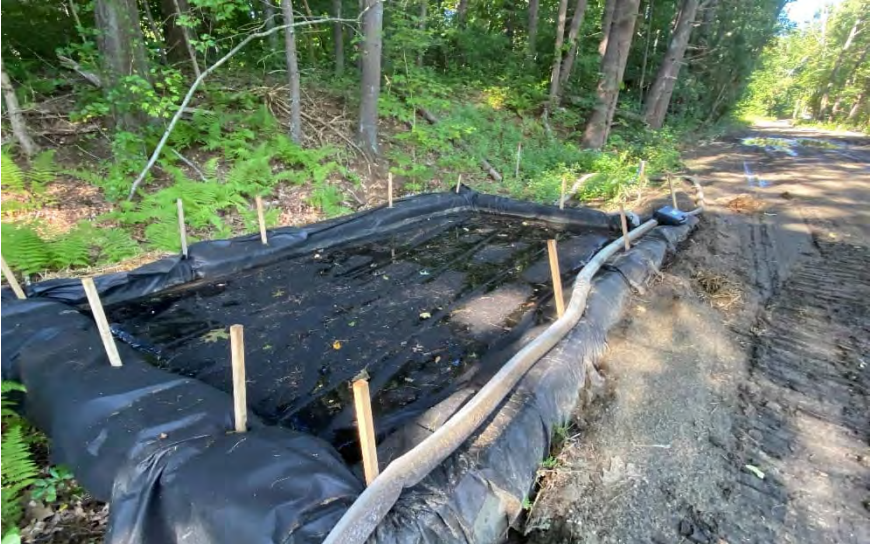
PHOTOGRAPHIC LOG	
Client Name: Eversource		Site Location: Sudbury to Hudson Transmission Reliability Project	
Photo No.: 4 Date: 8/31/2023		Town: Sudbury	
Description: Segment 13. View of dewatering operation (pumping at far end of area), looking westward.

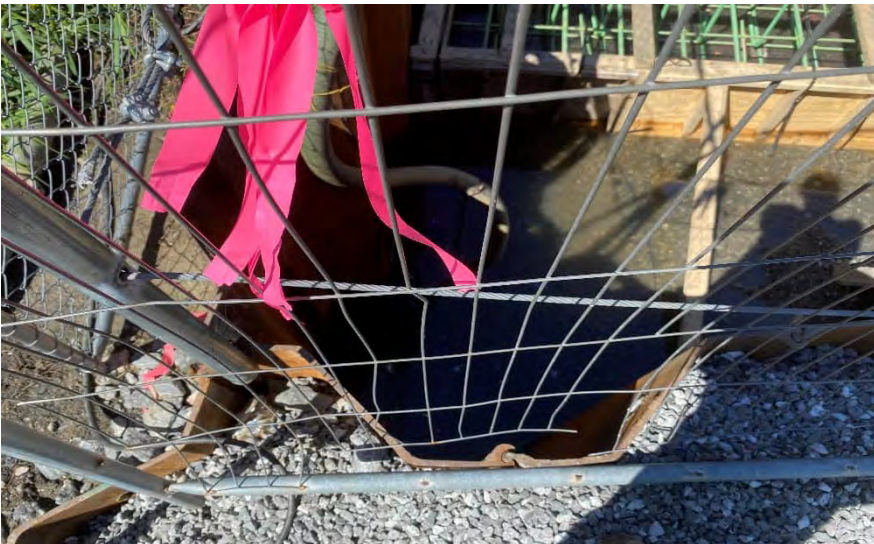
PHOTOGRAPHIC LOG	
Client Name: Eversource		Site Location: Sudbury to Hudson Transmission Reliability Project	Town: Sudbury
Photo No.: 1	Date: 8/31/2023

Description: View of area being pumped at Hop Brook (area in cofferdam), looking westward.

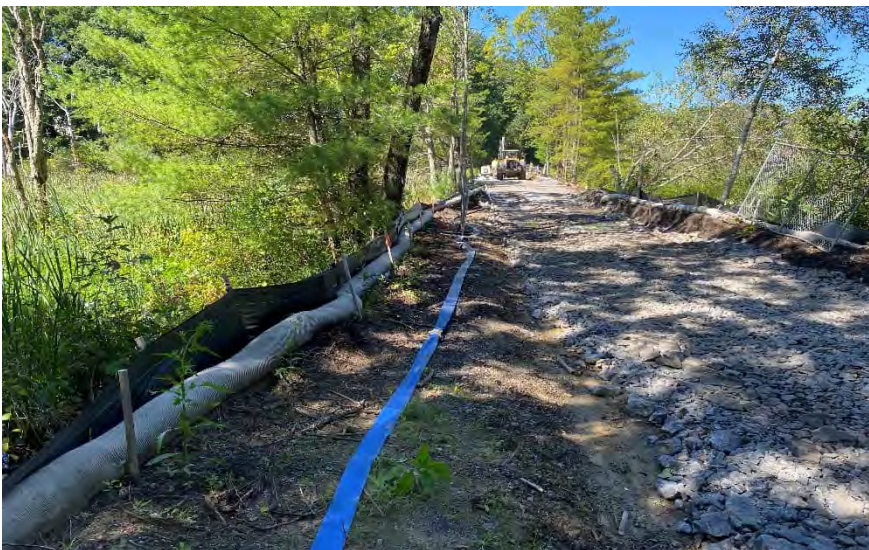
PHOTOGRAPHIC LOG	
Client Name: Eversource		Site Location: Sudbury to Hudson Transmission Reliability Project	Town: Sudbury
Photo No.: 2	Date: 8/31/2023

Description: Segment 14. View of dewatering operation (pumping at far end of area), looking westward.

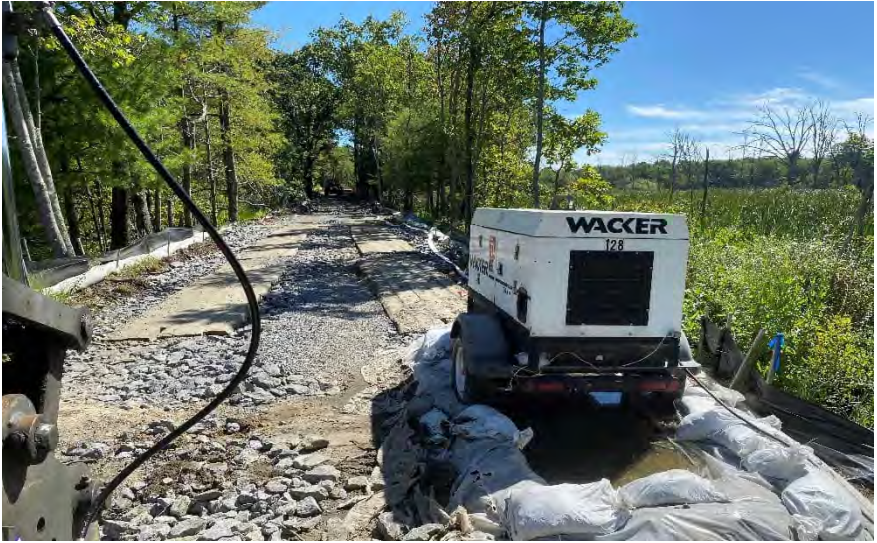
PHOTOGRAPHIC LOG	
Client Name: Eversource		Site Location: Sudbury to Hudson Transmission Reliability Project	Town: Sudbury
Photo No.: 3	Date: 8/31/2023

Description: Segment 14. View of dewatering operation (pumping at far end of area), looking eastward.

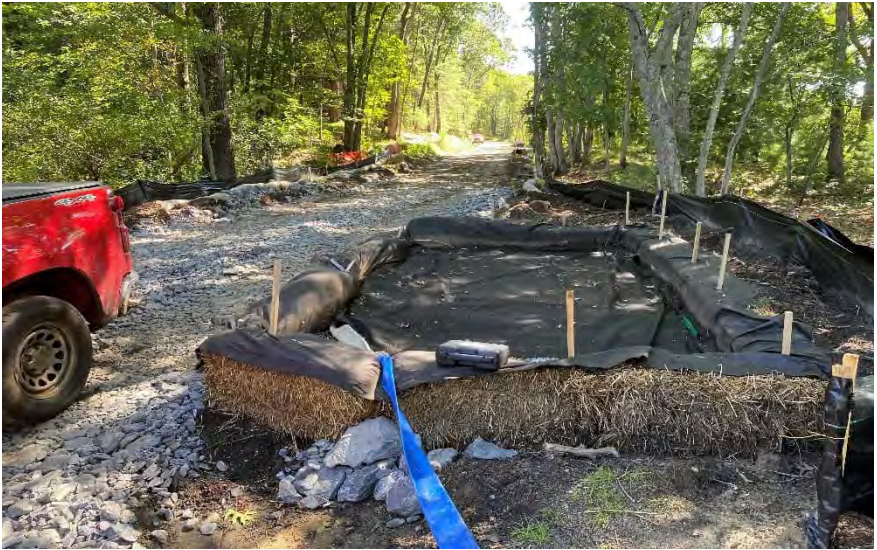
PHOTOGRAPHIC LOG	
Client Name: Eversource		Site Location: Sudbury to Hudson Transmission Reliability Project	Town: Sudbury
Photo No.: 4	Date: 8/31/2023

Description: Segment 14. View of dewatering operation (pumping at far end of area), looking eastward.

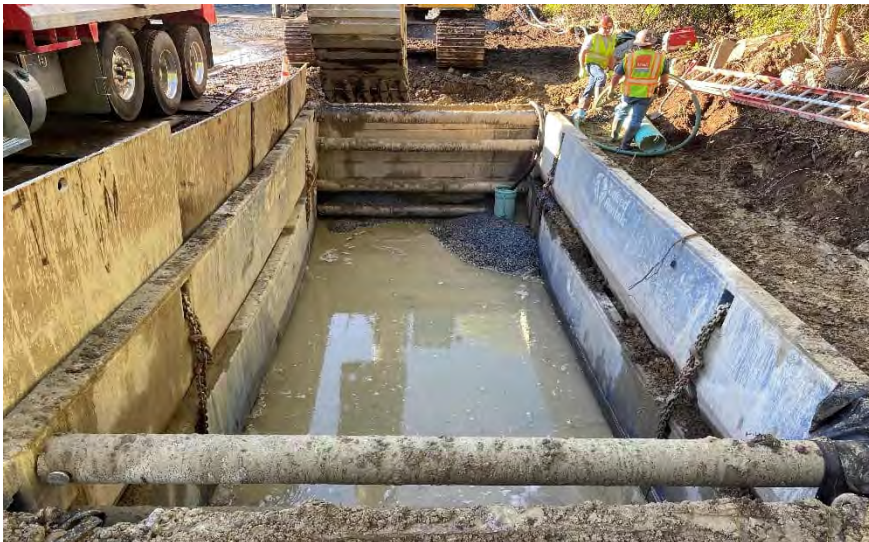
PHOTOGRAPHIC LOG	
Client Name: Eversource		Site Location: Sudbury to Hudson Transmission Reliability Project	
Town: Sudbury			
Photo No.: 1	Date: 8/31/2023

Description: View of area being pumped at Manhole #28, looking eastward.

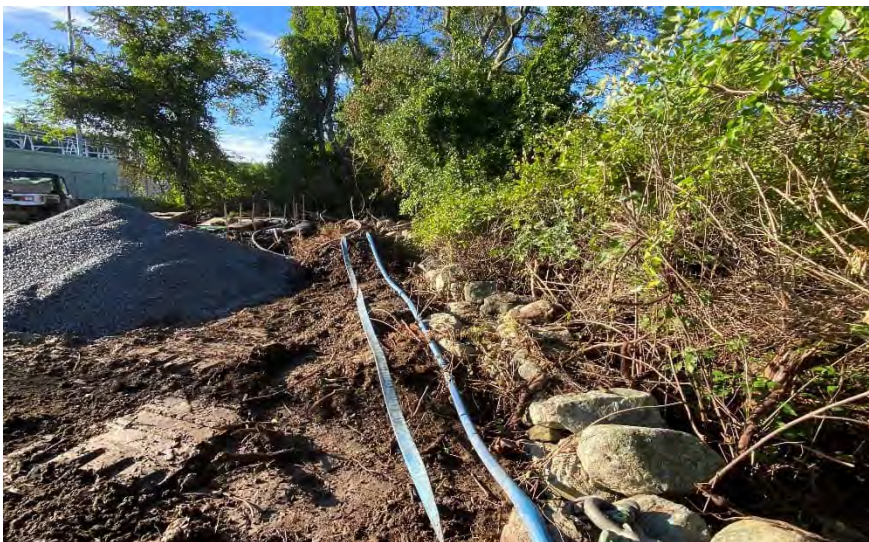
PHOTOGRAPHIC LOG	
Client Name: Eversource		Site Location: Sudbury to Hudson Transmission Reliability Project	
Town: Sudbury			
Photo No.: 2	Date: 8/31/2023

Description: Manhole #28. View of dewatering operation, looking southward.

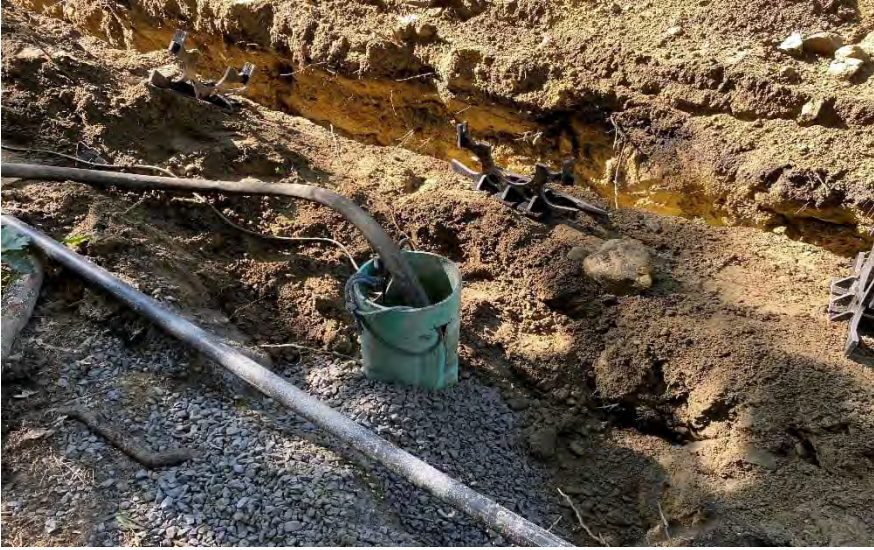
PHOTOGRAPHIC LOG	
Client Name: Eversource		Site Location: Sudbury to Hudson Transmission Reliability Project	Town: Sudbury
Photo No.: 1	Date: 9/1/2023

Description: View of area being pumped at Segment 7, east of Manhole #15, looking westward.

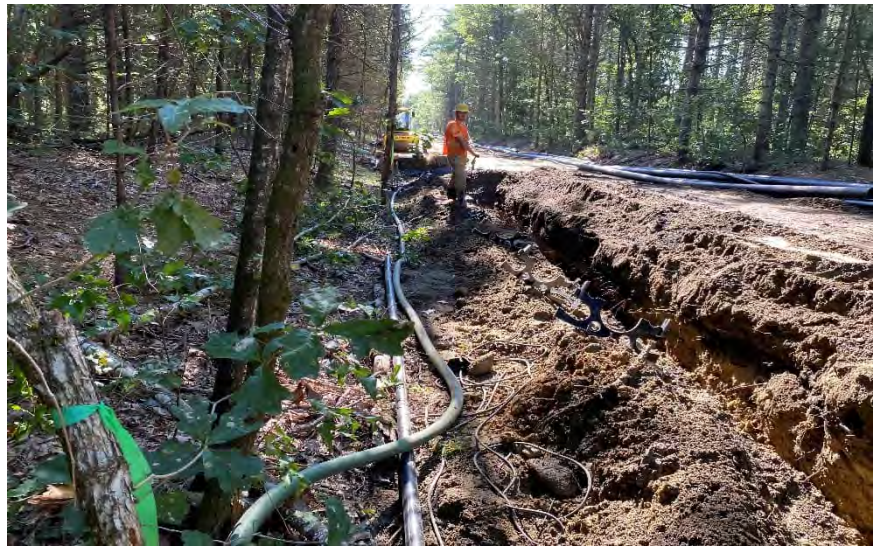
PHOTOGRAPHIC LOG	
Client Name: Eversource		Site Location: Sudbury to Hudson Transmission Reliability Project	Town: Sudbury
Photo No.: 2	Date: 9/1/2023

Description: Segment 7. View of dewatering operation, looking eastward.

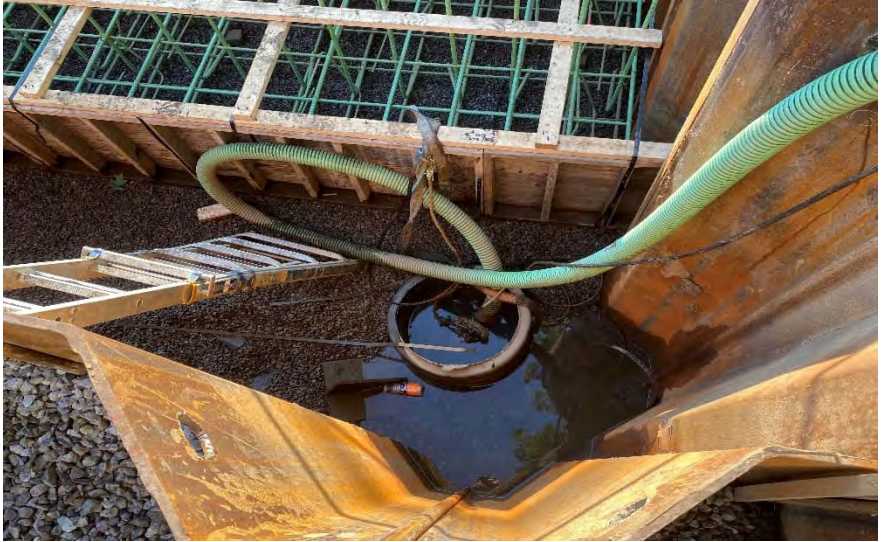
PHOTOGRAPHIC LOG	
Client Name: Eversource		Site Location: Sudbury to Hudson Transmission Reliability Project	Town: Sudbury
Photo No.: 1	Date: 9/1/2023

Description: View of area being pumped at Hop Brook (area in cofferdam), looking westward.

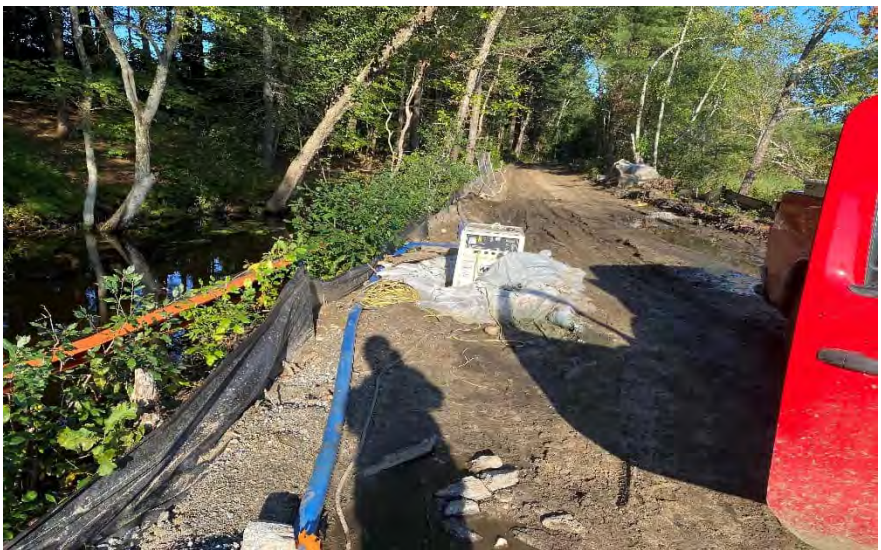
PHOTOGRAPHIC LOG	
Client Name: Eversource		Site Location: Sudbury to Hudson Transmission Reliability Project	Town: Sudbury
Photo No.: 2	Date: 9/1/2023

Description: Segment 13. View of dewatering operation (pumping at far end of area), looking westward.

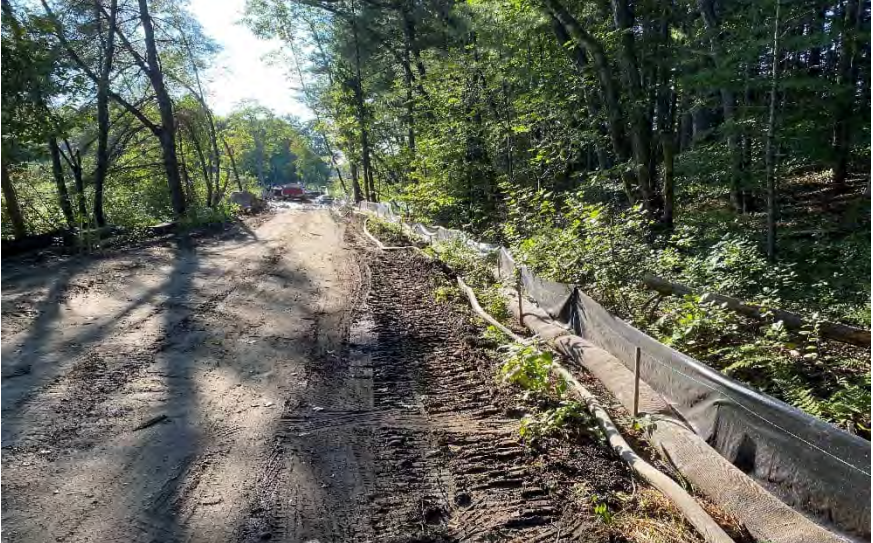
PHOTOGRAPHIC LOG	
Client Name: Eversource		Site Location: Sudbury to Hudson Transmission Reliability Project	
Photo No.: 3 Date: 9/1/2023

Description: Segment 13. View of dewatering operation (pumping at far end of area), looking eastward.

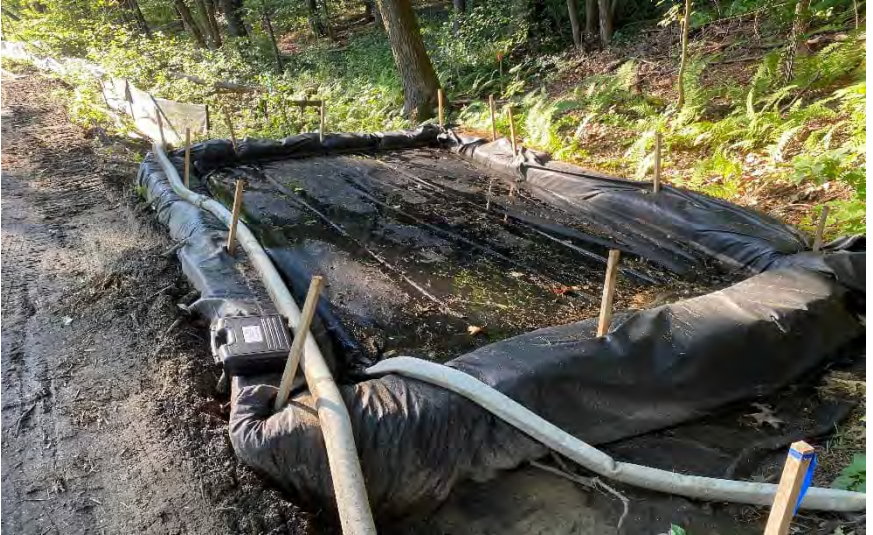
PHOTOGRAPHIC LOG	
Client Name: Eversource		Site Location: Sudbury to Hudson Transmission Reliability Project	
Photo No.: 4 Date: 9/1/2023

Description: Segment 13. View of dewatering operation (pumping at far end of area), looking eastward.

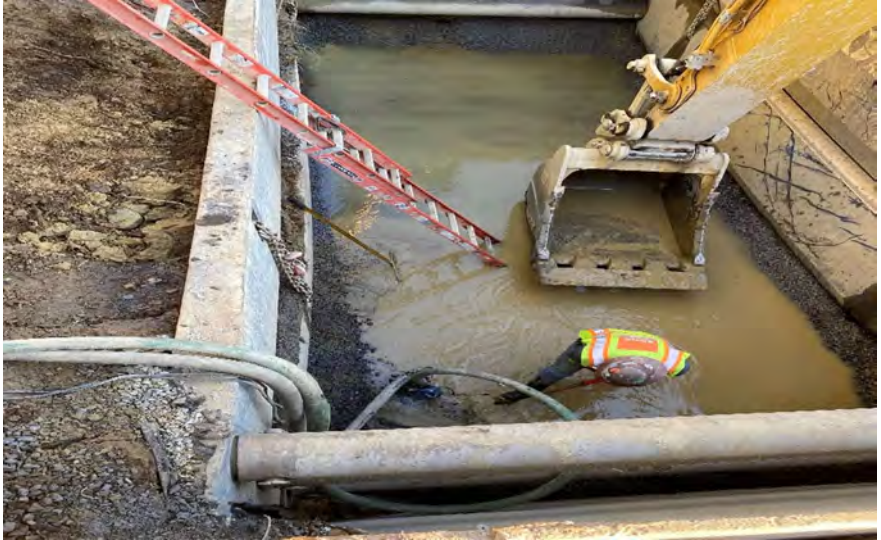
PHOTOGRAPHIC LOG	
Client Name: Eversource		Site Location: Sudbury to Hudson Transmission Reliability Project	
Town: Sudbury			
Photo No.: 1	Date: 9/1/2023

Description: View of area being pumped at Manhole #28, looking eastward.

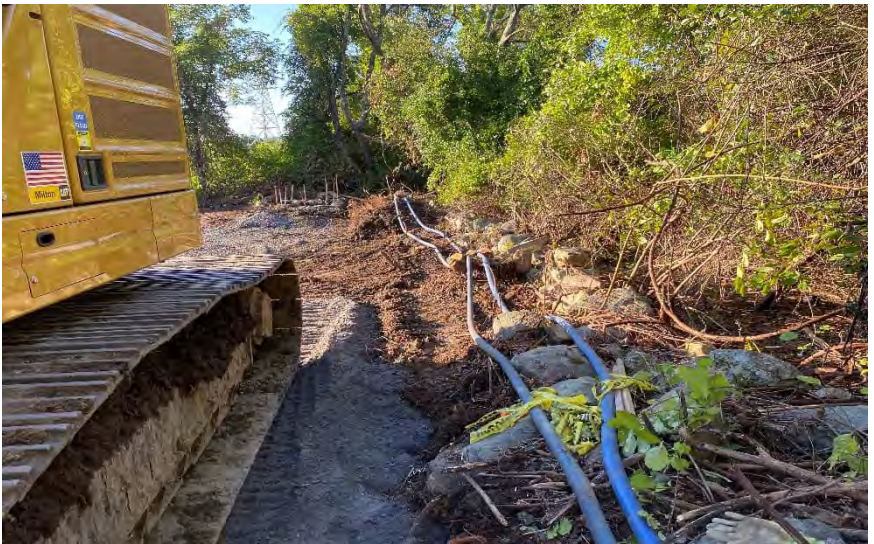
PHOTOGRAPHIC LOG	
Client Name: Eversource		Site Location: Sudbury to Hudson Transmission Reliability Project	
Town: Sudbury			
Photo No.: 2	Date: 9/1/2023

Description: Manhole #28. View of dewatering operation, looking southward.
