Weekly Environmental Compliance Summary

Sudbury to Hudson Transmission Reliability Project (USEPA Tracking # MAR1003UW)

Week of: October 2, 2023 to October 6, 2023

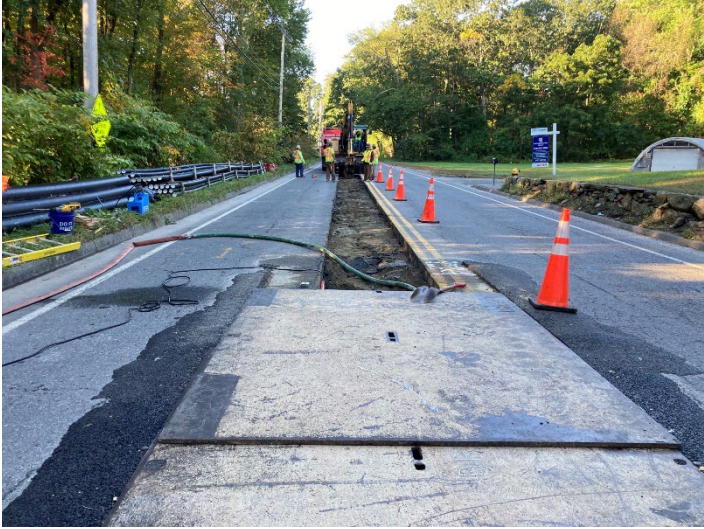
| Photo No.: 1 | Date: 10/03/2023 | | |

| Description: View of Oscar's Crew (Bond) working on Forest Ave. See additional dewatering inspection report. Facing south. | | | |

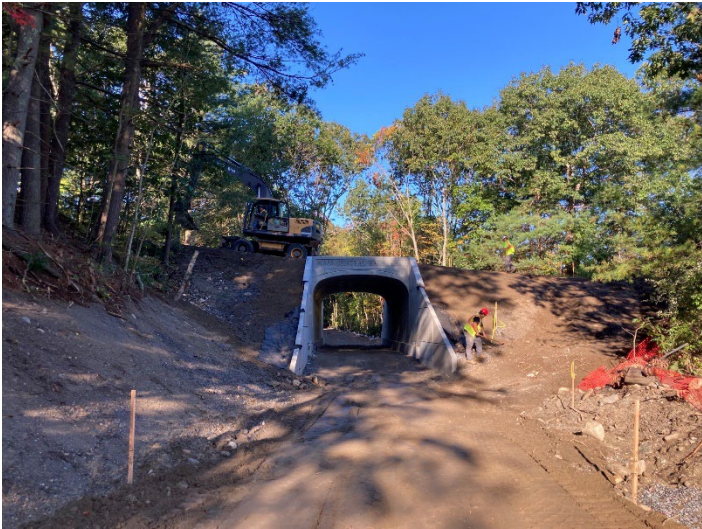
| Photo No.: 4 | Date: 10/03/2023 | | |

| Description: View of work at Chestnut St tunnel. Facing west. | | | |

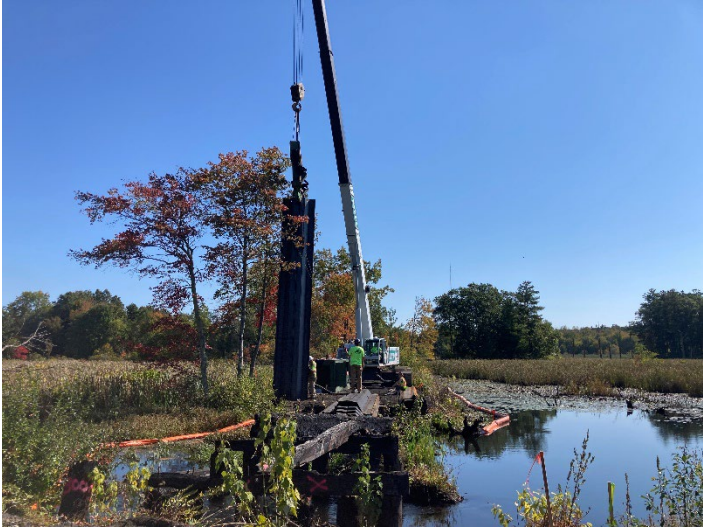
| Photo No.: 5 | Date: 10/03/2023 | | |

| Description: View of ET&L driving sheets at Bridge 130. Facing east. | | | |

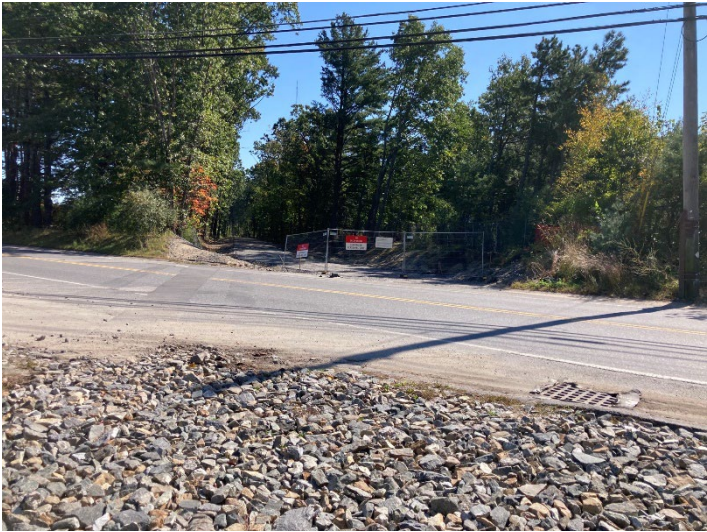
| Photo No.: 6 | Date: 10/03/2023 | | |

| Description: View of entrance to segment 4 of Main St. Facing east. | | | |

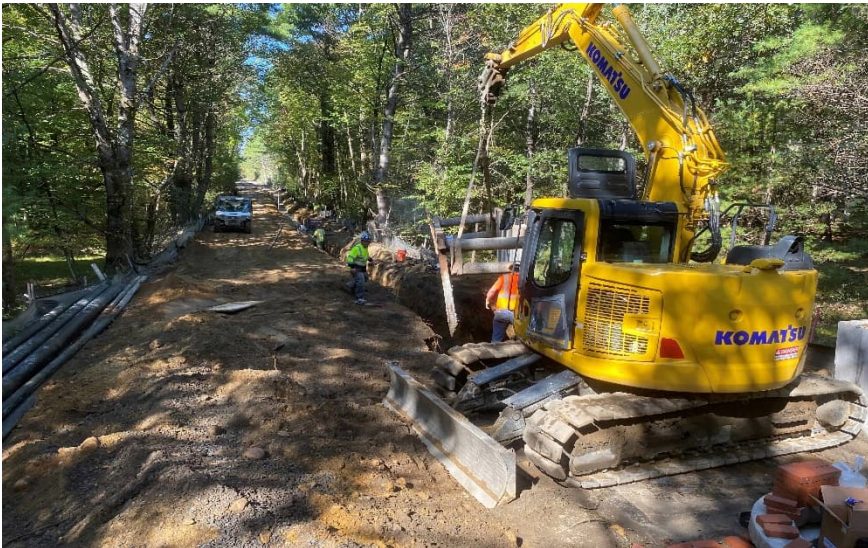
| Photo No.: 1 Date: 10-3-23 | | Town: Sudbury | |

| Description: Conduit work area within segment 7, looking westward. | | | |

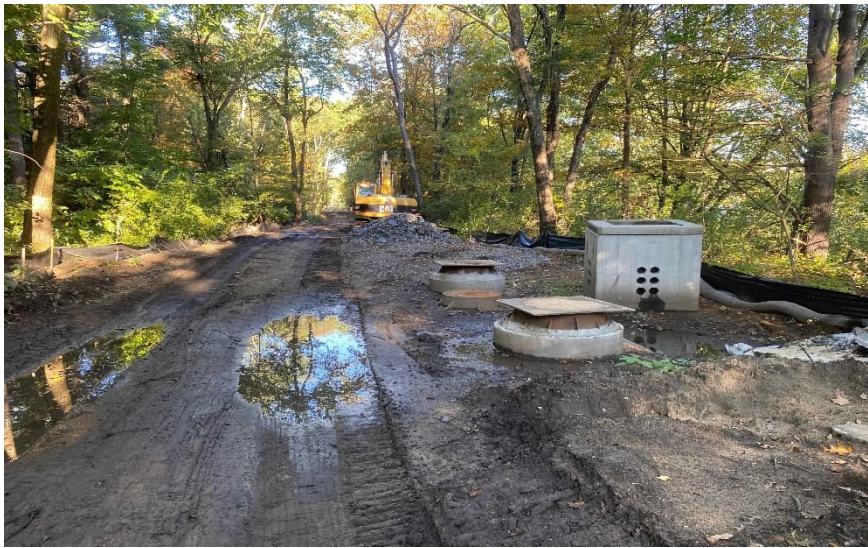
| Photo No.: 2 Date: 10-3-23 | | Town: Sudbury | |

| Description: Work area within segment 13, existing erosion control, looking westward. | | | |

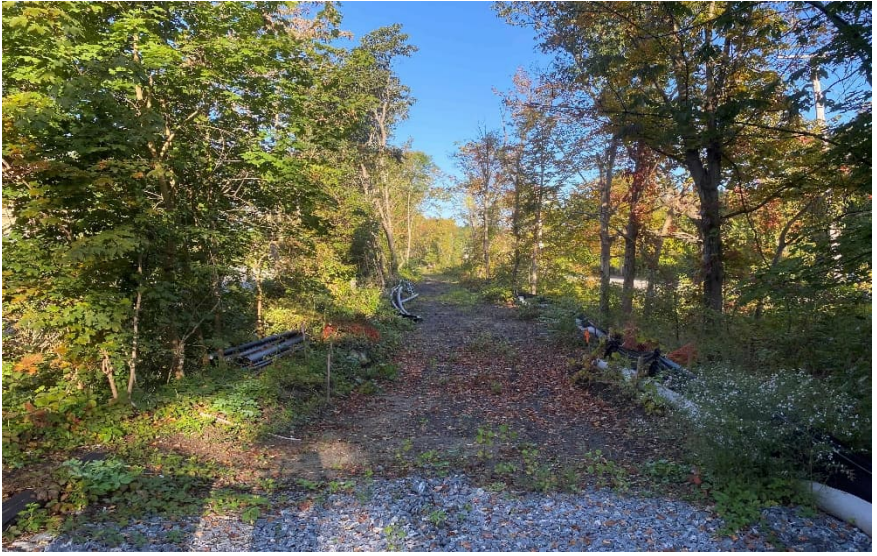
| Photo No.: 3 | Date: 10-3-23 | | |

| Description: Work area within segment 12, existing erosion control, looking westward. | | | |

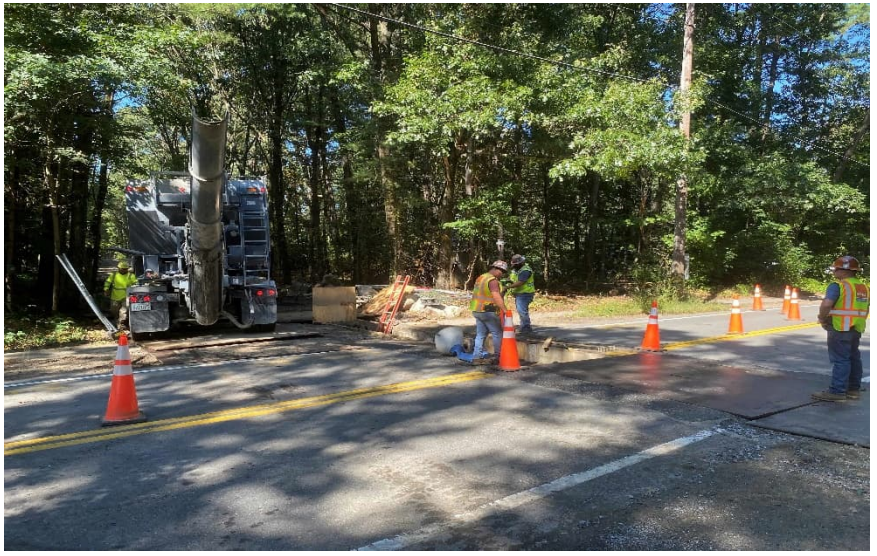
| Photo No.: 4 | Date: 10-3-23 | | |

| Description: Work area within Horse Pond Road, trenching (west side of road), looking westward. | | | |

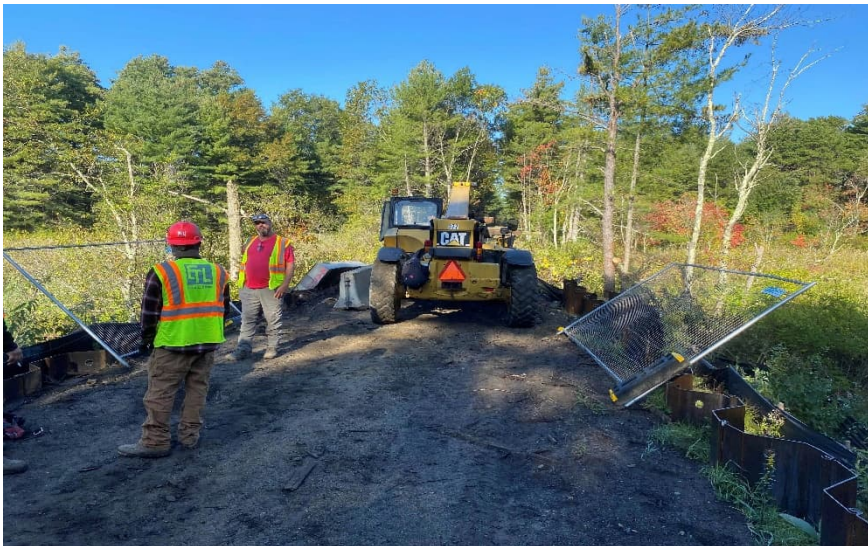
| Photo No.: 5 | Date: 10-3-23 | | |

| Description: Work area within segment 8, removal of materials from area, looking westward. | | | |

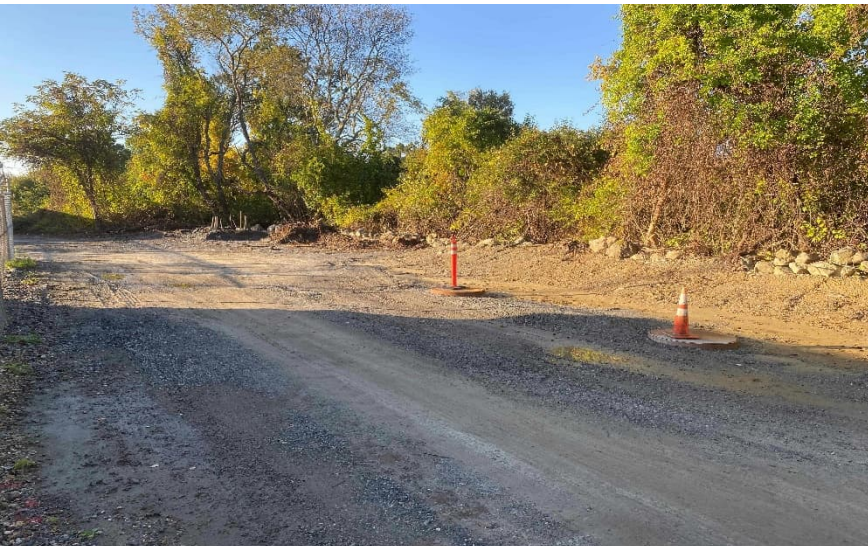
| Photo No.: 6 | Date: 10-3-23 | | |

| Description: Work area at manhole 28 near Sudbury substation, looking southward. | | | |

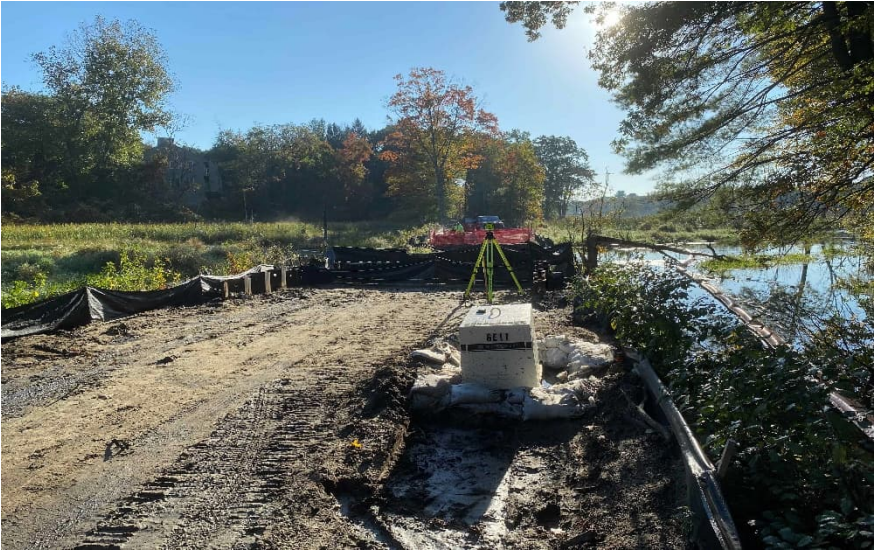
| Photo No.: 7 | Date: 10-3-23 | | |

| Description: Work area within segment 13 -> 14, bridge 127 work area, existing erosion control, looking eastward. | | | |

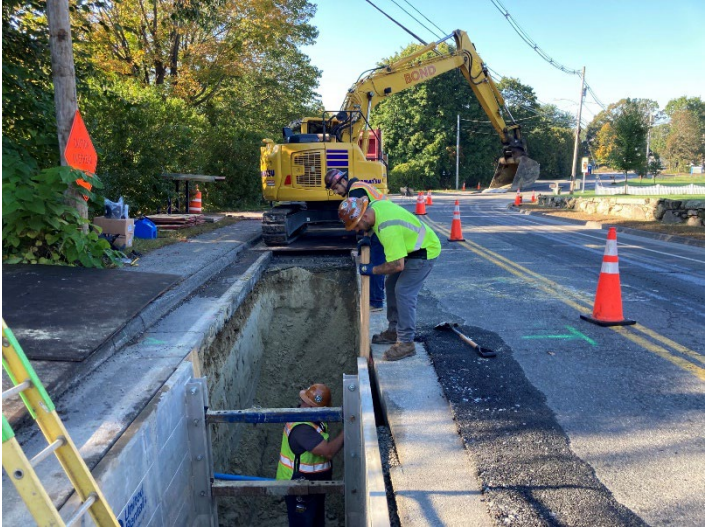
| Photo No.: 1 | Date: 10/04/2023 | | |

| Description: View of Jim's crew (Bond) working in roadway on Forest Ave. Facing south. | | | |

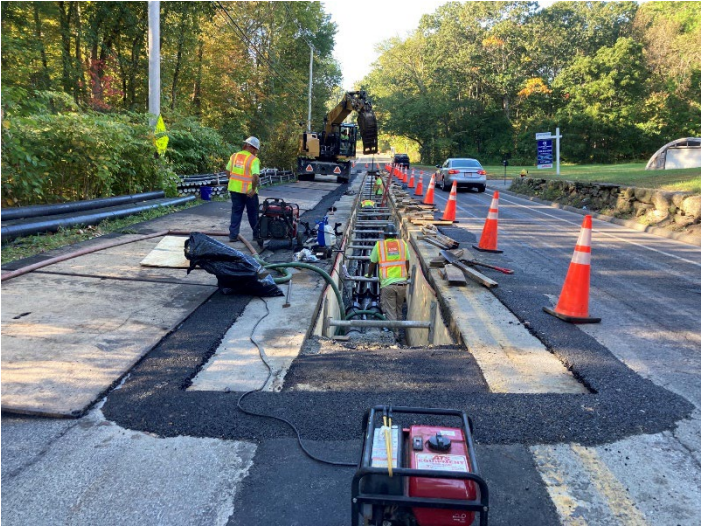
| Photo No.: 2 | Date: 10/04/2023 | | |

| Description: View of Oscar's Crew (Bond) working on Forest Ave. See additional dewatering inspection report. Facing south. | | | |

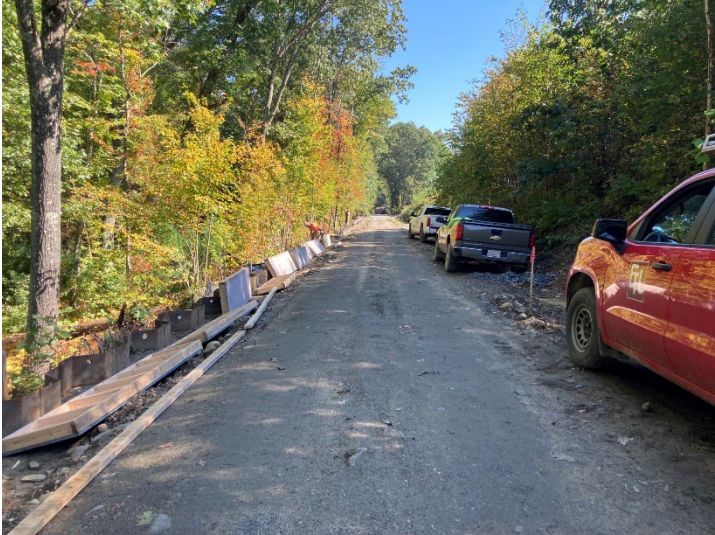
| Photo No.: 3 | Date: 10/04/2023 | | |

| Description: View of ET&L working at walls 1 and 2 in segment 1. Facing east. | | | |

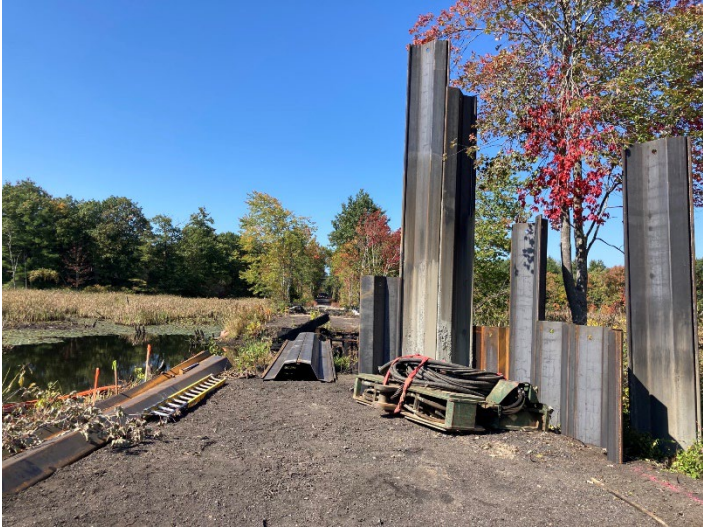
| Photo No.: 5 | Date: 10/04/2023 | | |

| Description: View of sheets that have been driven at Bridge 130. No work was conducted at the bridge today. Facing west. | | | |

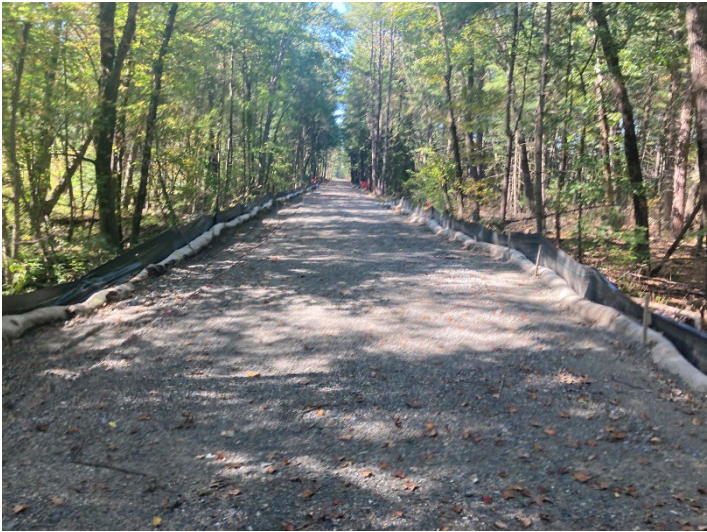
| Photo No.: 6 | Date: 10/04/2023 | | |

| Description: View of E&S controls in segment 4. Facing west. | | | |

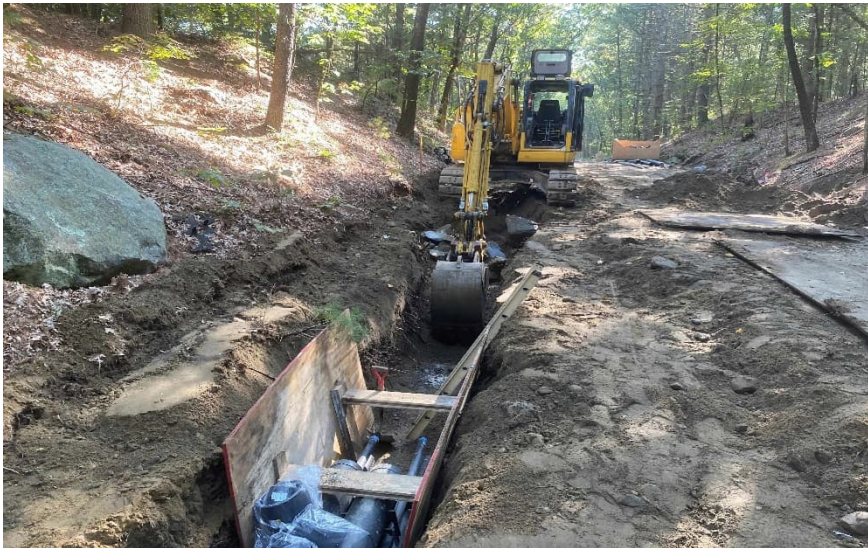
| Photo No.: 1 | Date: 10-4-23 | | |

| Description: Conduit work area within segment 9, looking eastward. | | | |

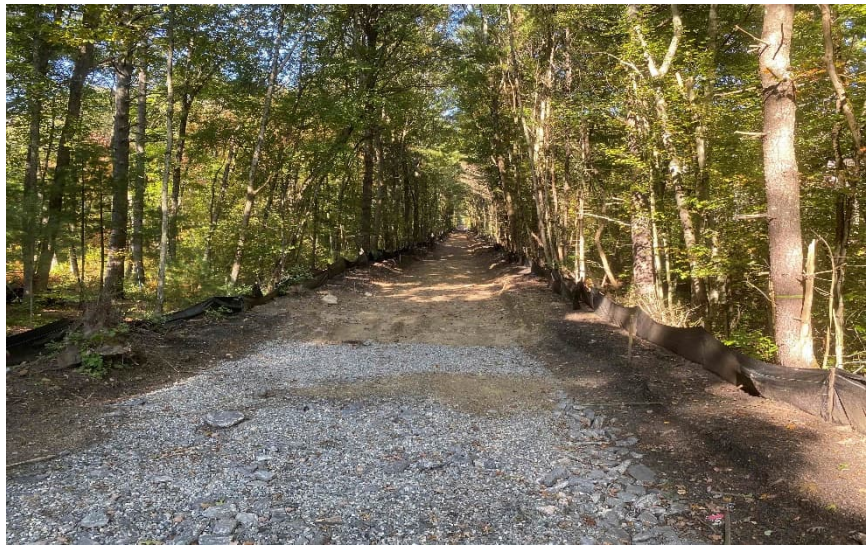
| Photo No.: 2 | Date: 10-4-23 | | |

| Description: Work area within segment 9, existing erosion control, looking westward. | | | |

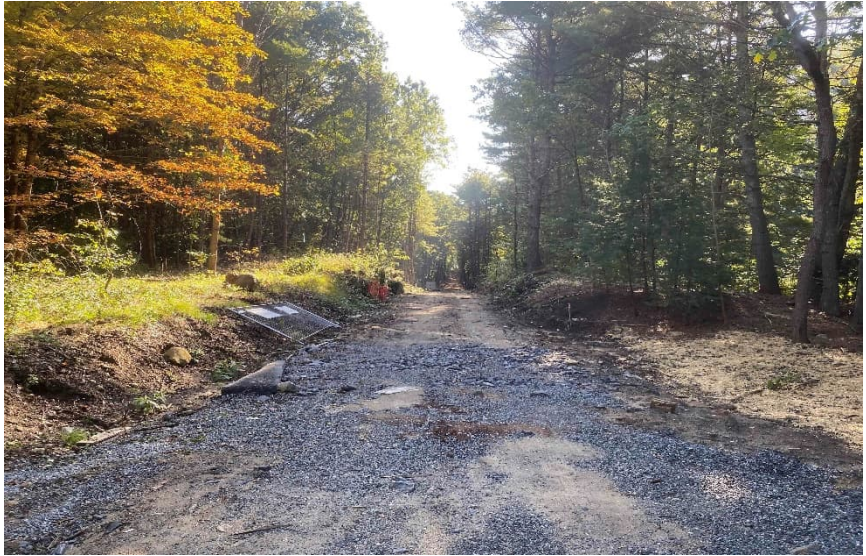
| Photo No.: 3 | Date: 10-4-23 | | |

| Description: Work area within segment 10, existing erosion control, looking eastward. | | | |

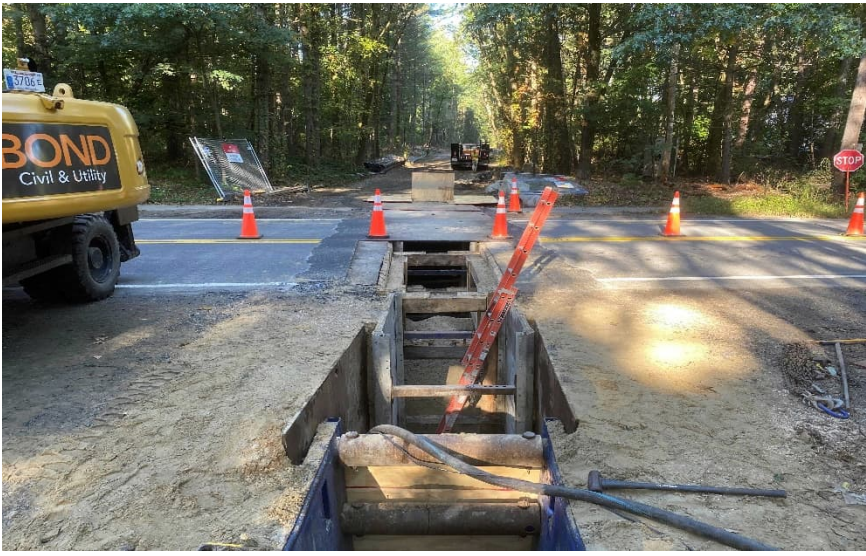
| Photo No.: 4 | Date: 10-4-23 | | |

| Description: Work area within Horse Pond Road, trenching (east side of road), looking westward. | | | |

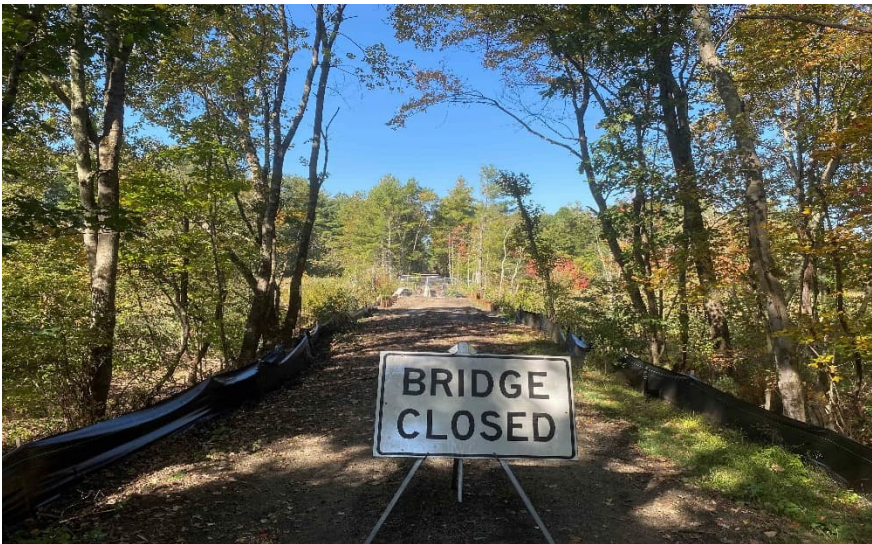
| Photo No.: 5 | Date: 10-4-23 | | |

| Description: Work area within segment 8, bridge 128 area, looking westward. | | | |

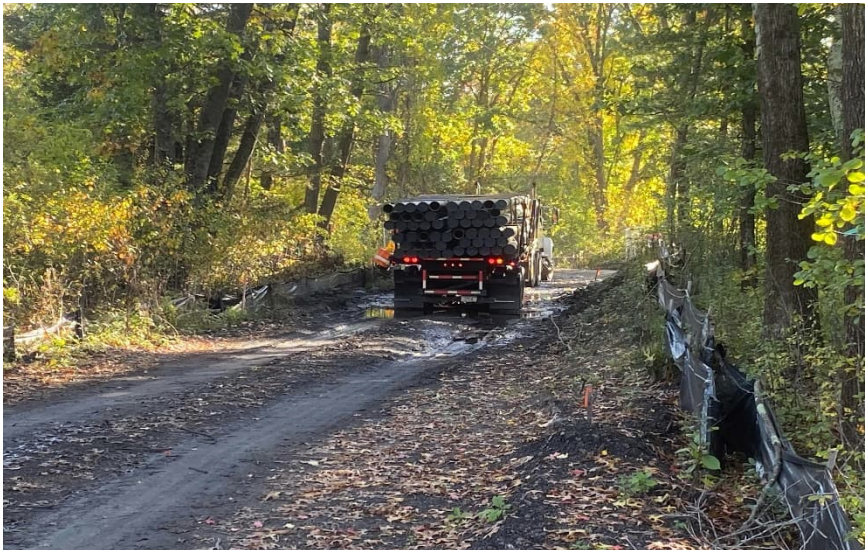
| Photo No.: 8 | Date: 10-4-23 | | |

| Description: Work area within segment 14, bringing in new conduit, looking eastward. | | | |

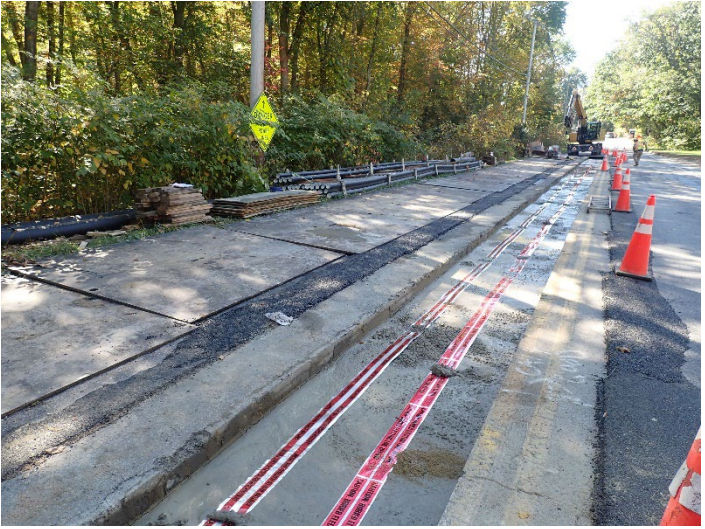
| Photo No.: 2 | Date: 10/05/2023 | | |

| Description: View of Oscar's Crew (Bond) working on Forest Ave. Facing south. | | | |

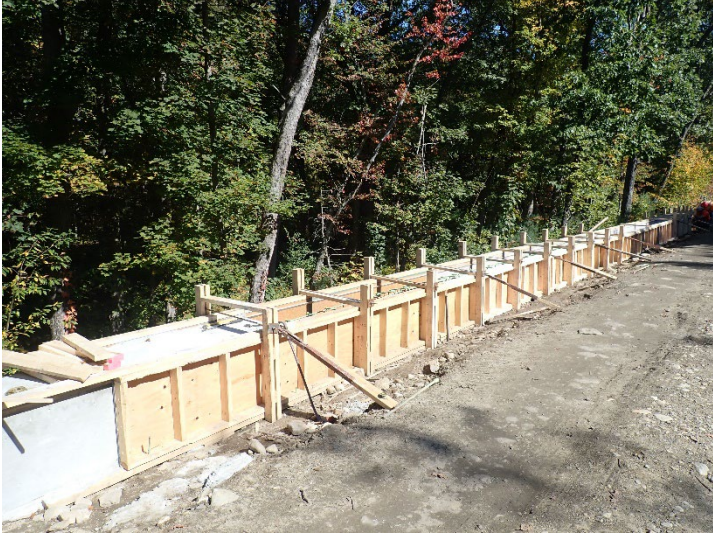
| Photo No.: 3 | Date: 10/05/2023 | | |

| Description: View of ET&L working on walls in segment 1. Facing east. | | | |

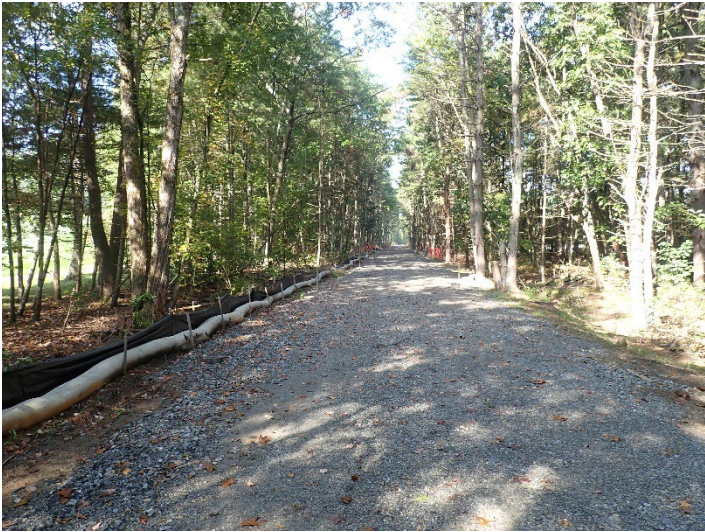
| Photo No.: 6 | Date: 10/05/2023 | | |

| Description: View of E&S controls in segment 4. Facing west. | | | |

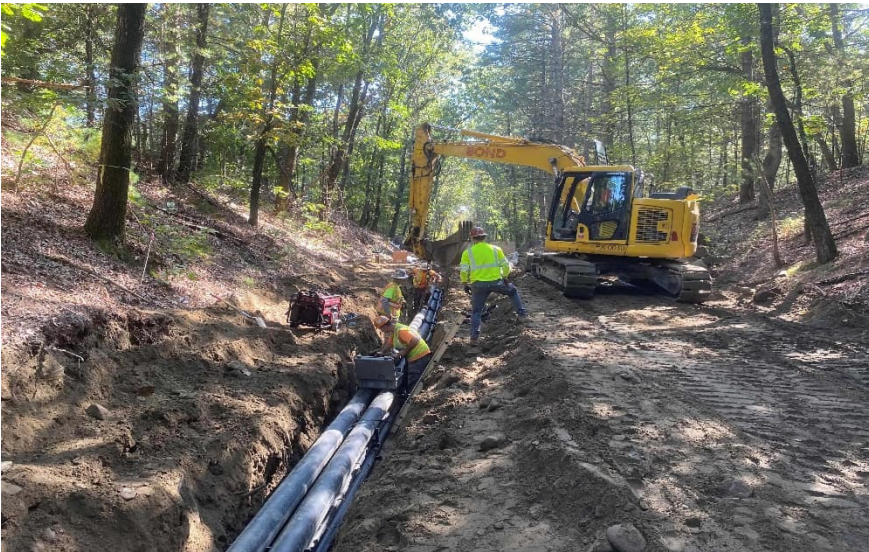
| Photo No.: 1 Date: 10-5-23 | | Town: Sudbury | |

| Description: Conduit work area within segment 9, looking eastward. | | | |

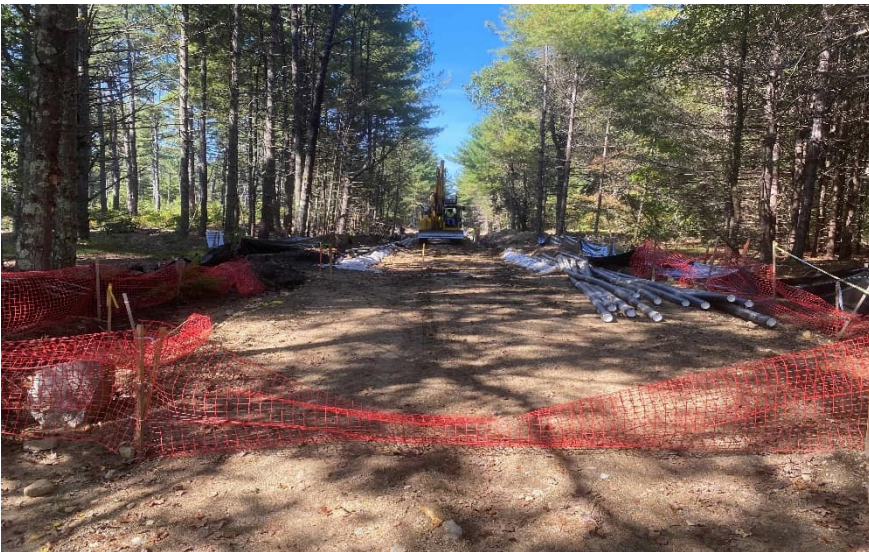
| Photo No.: 2 Date: 10-5-23 | | Town: Sudbury | |

| Description: Work area within segment 7, existing erosion control/cattle guard, looking westward. | | | |

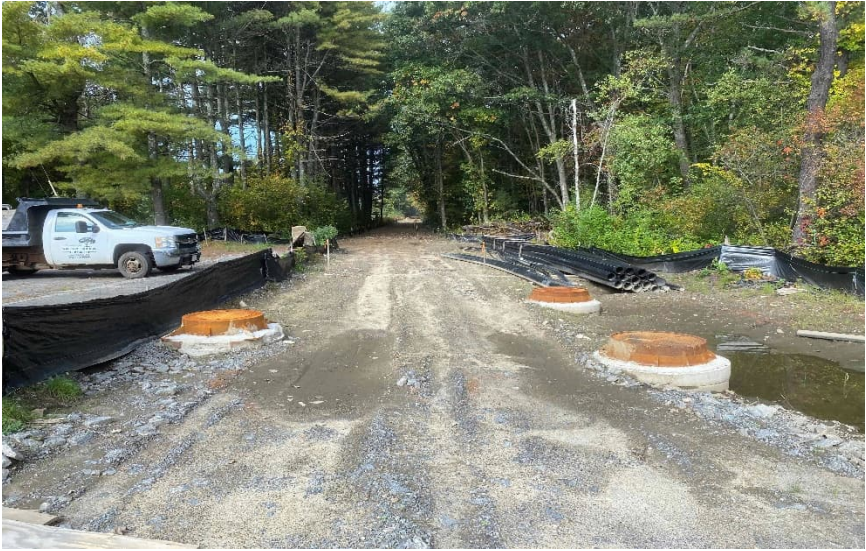
| Photo No.: 3 | Date: 10-5-23 | | |

| Description: Work area within segment 11, existing erosion control, looking westward. | | | |

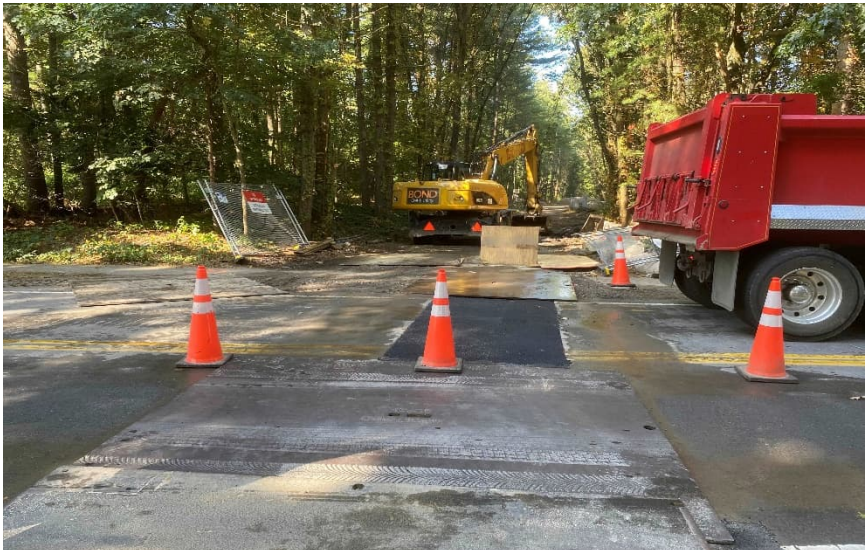
| Photo No.: 4 | Date: 10-5-23 | | |

| Description: Work area within Horse Pond Road, black topping (west side of road), looking westward. | | | |

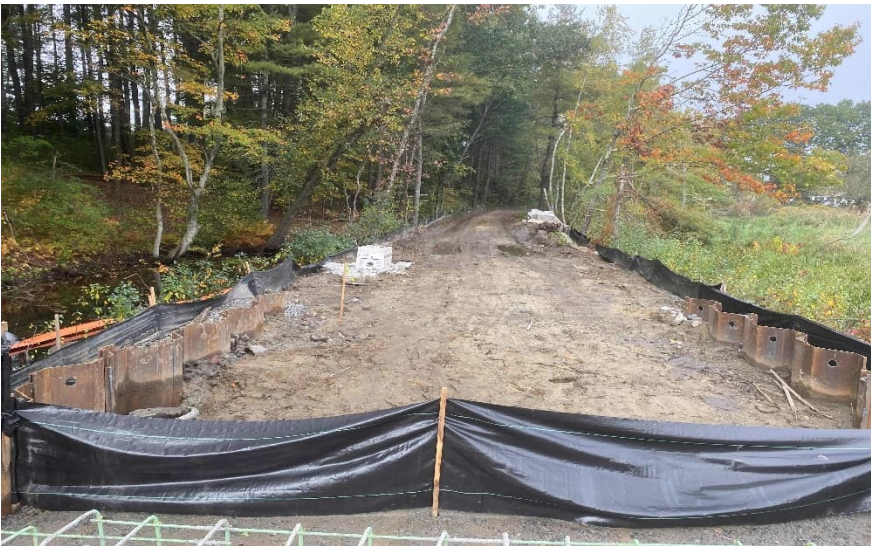
| Photo No.: 5 Date: 10-5-23 | | Town: Sudbury | |

| Description: Work area within segment 13, existing erosion control, looking westward. | | | |

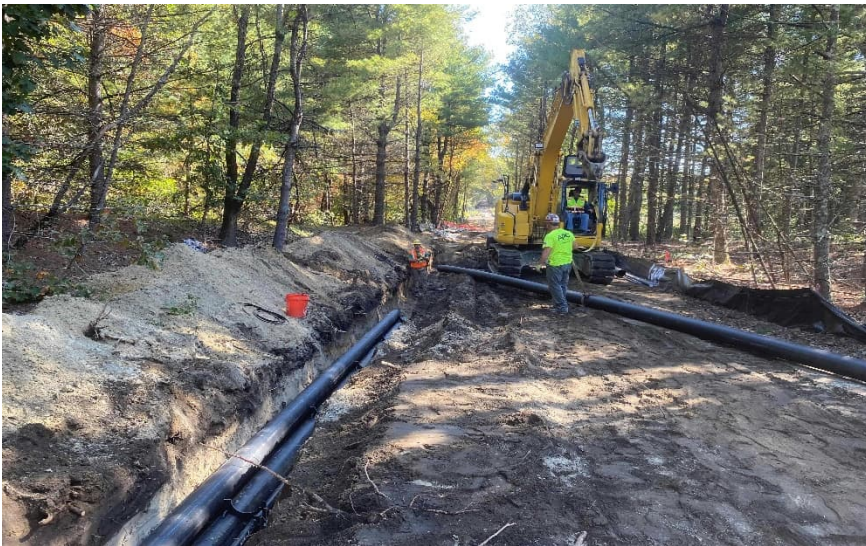
| Photo No.: 6 Date: 10-5-23 | | Town: Sudbury | |

| Description: Work area within segment 7, conduit work, looking westward. | | | |

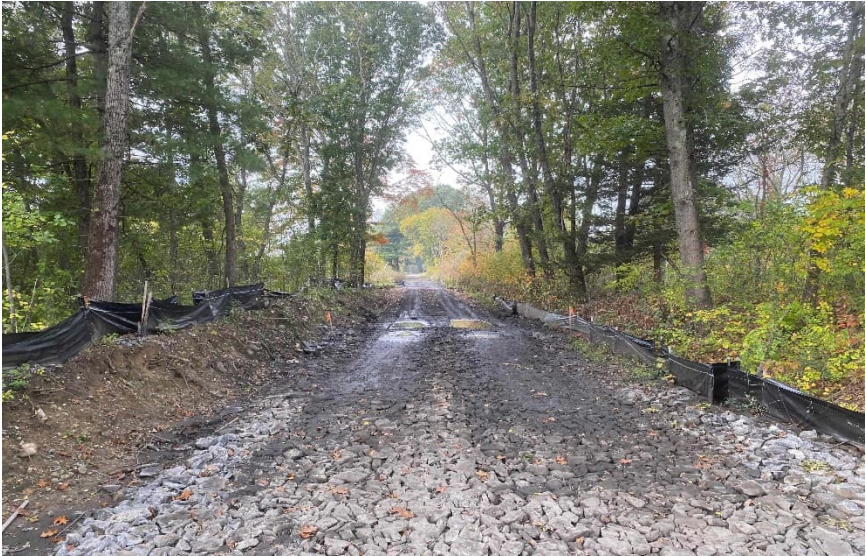
| Photo No.: 7 | Date: 10-5-23 | | |

| Description: Work area within segment 14, existing erosion control, looking westward. | | | |

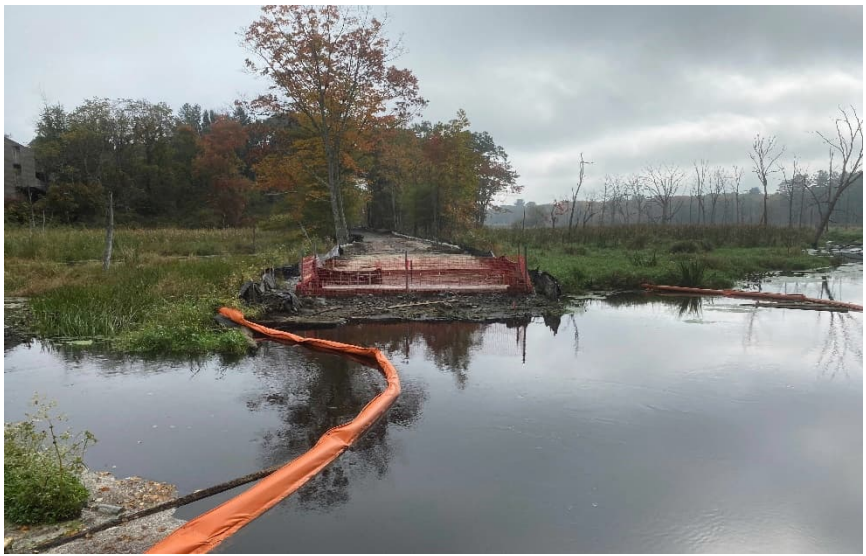
| Photo No.: 8 | Date: 10-5-23 | | |

| Description: Hop Brook looking from segment 13 -> segment 14, looking eastward. | | | |

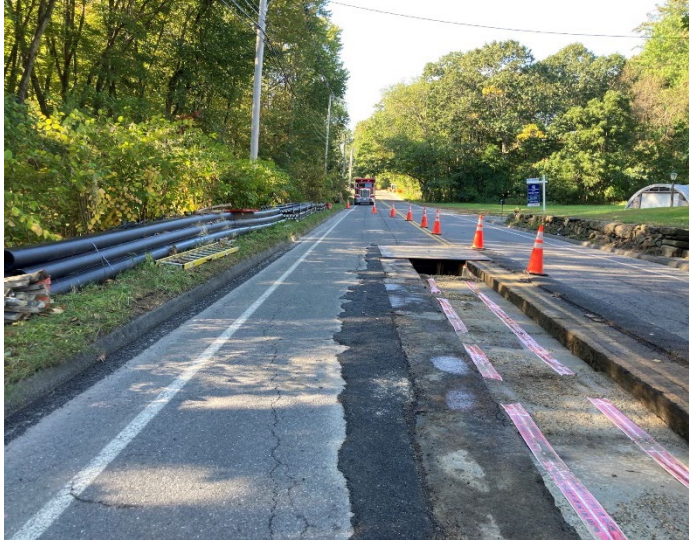
| Photo No.: 1 | Date: 10-02-2023 | | |

| Description: View of Bond working near MH #4 on Forest Ave. Facing south. | | | |

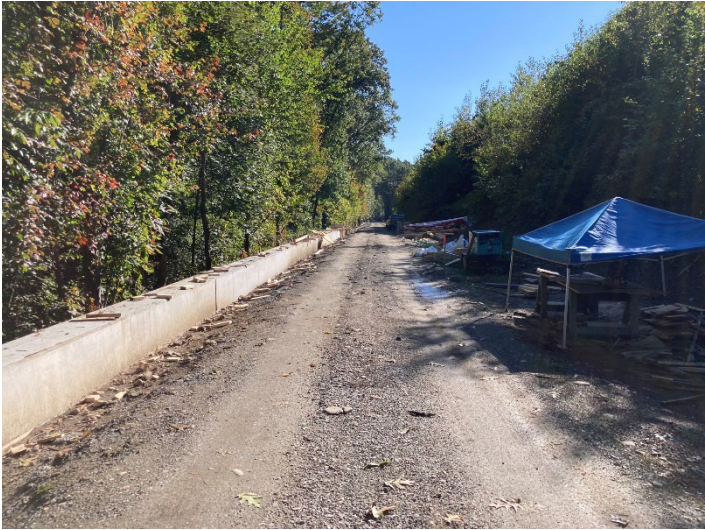
| Photo No.: 3 | Date: 10-02-2023 | | |

| Description: View of ET&L working at walls 1 and 2 in segment 1. Facing west. | | | |

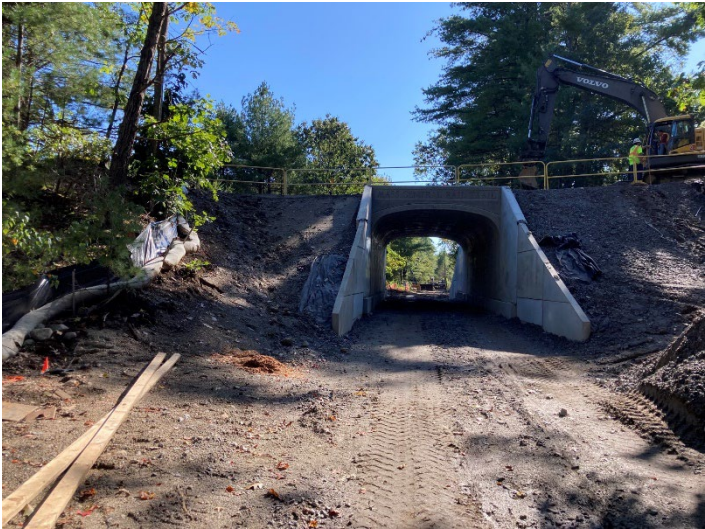
| Photo No.: 4 | Date: 10-02-2023 | | |

| Description: View of ET&L working at Chestnut St bridge. Facing east. | | | |

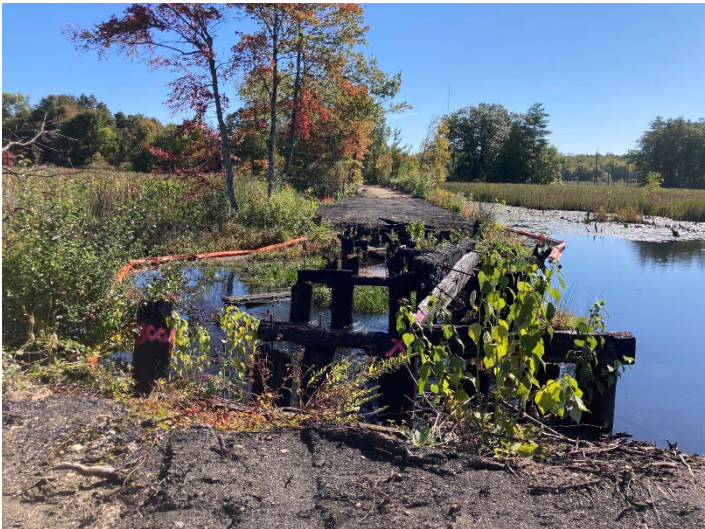
| Photo No.: 5 | Date: 10-02-2023 | | |

| Description: View of bridge 130. No active work at time of inspection. Facing east. | | | |

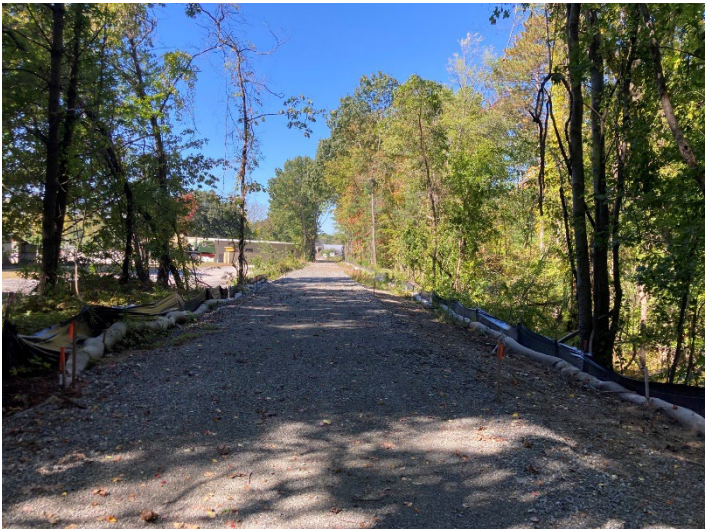
| Photo No.: 6 | Date: 10-02-2023 | | |

| Description: View of east end of segment 3. Facing west. | | | |

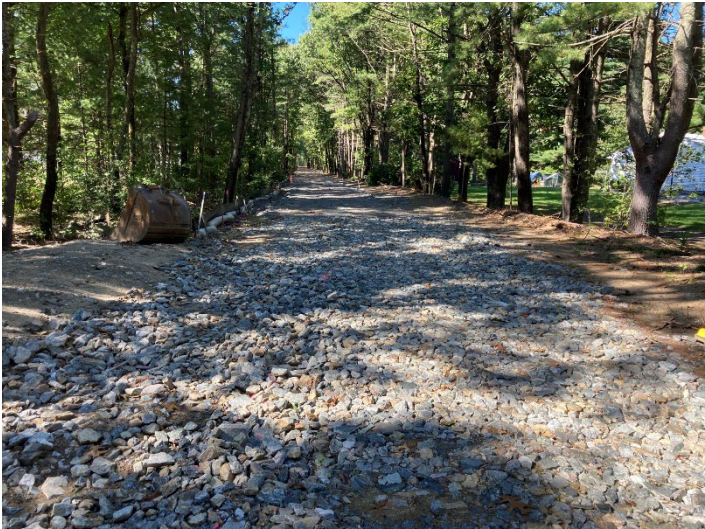
| Photo No.: 7 | Date: 10-02-2023 | | |

| Description: View of entrance to segment 4 off Parmenter. Facing west. | | | |

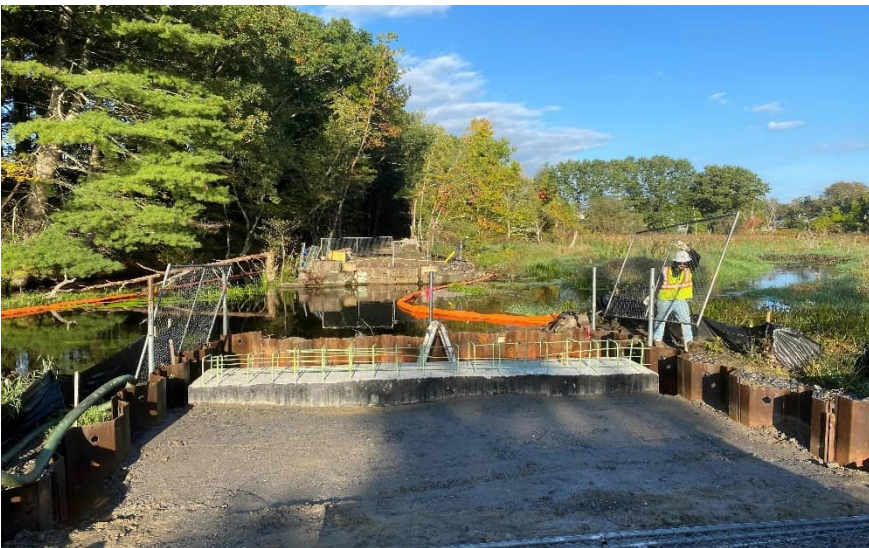
| Photo No.: 1 Date: 10-2-23 | | Town: Sudbury | |

| Description: Work area from segment 14, looking westward. | | | |

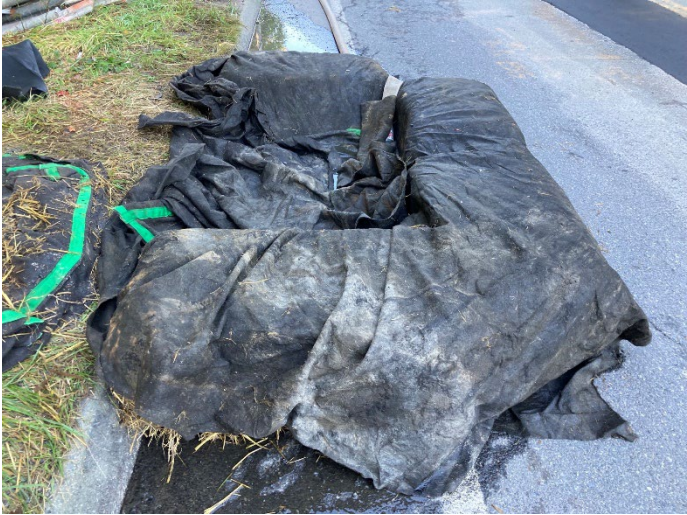
| Photo No.: 3 | Date: 10/03/2023 | | |

| Description: View of dewatering controls (straw bale corral with filter fabric and silt bag). Facing south. | | | |

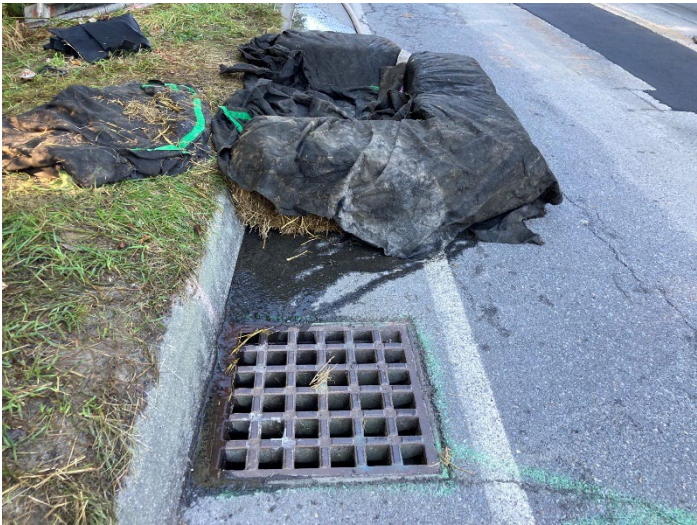
| Photo No.: 4 | Date: 10/03/2023 | | |

| Description: View dewatering controls (straw bale corral with filter fabric and silt bag) and discharge point from project (catch basin below hay bale corral on Forest Ave). Discharge appeared slightly turbid. Turbidity reading was above 50 NTUs. Facing north. | | | |

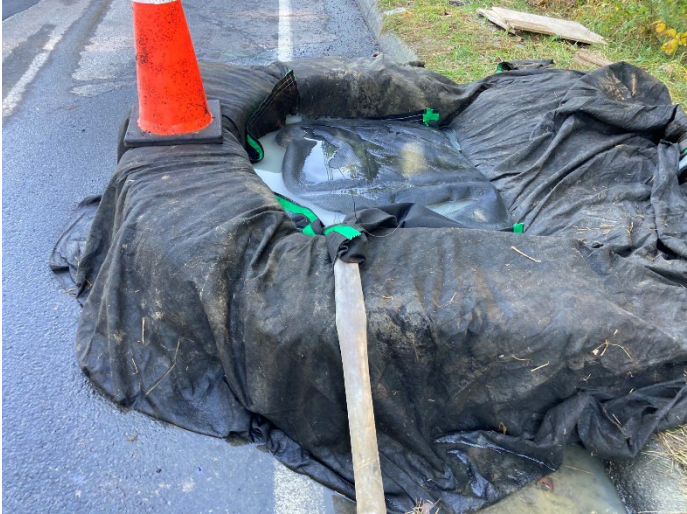
| Photo No.: 3 | Date: 10/04/2023 | | |

| Description: View of initial dewatering controls (straw bale corral with filter fabric and silt bag). Facing north. | | | |

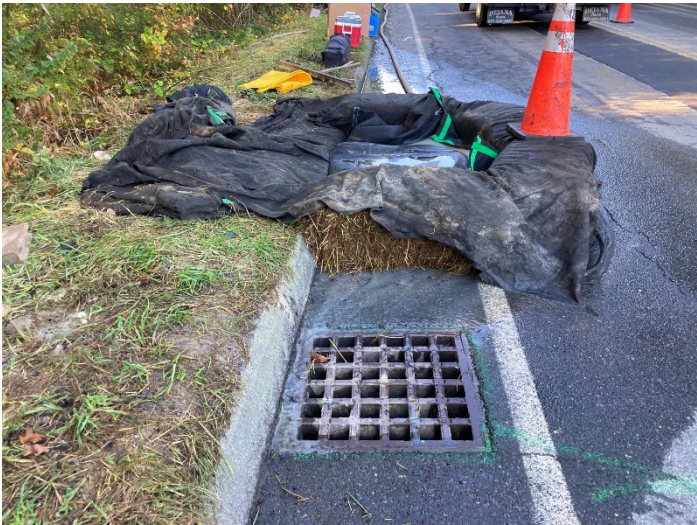
| Photo No.: 4 | Date: 10/04/2023 | | |

| Description: View dewatering controls (straw bale corral with filter fabric and silt bag) and discharge point from project (catch basin below straw bale corral on Forest Ave). Discharge appeared turbid and chalk colored. Initial turbidity reading was above 355 NTUs. Pump was subsequently turned off. Facing south. | | | |

| Section A – Individual Completing this Log | |
|---|--|
| Provide a description of the specific condition that triggered the need for corrective action and the cause (if identifiable): Initial turbidity reading for 10/04/2023 exceeded 355 NTUs and discharge appeared turbid and chalk colored. This is believed to have been caused by stone added to the trench. | |

- ☒ Immediately took all reasonable steps to minimize or prevent the discharge of pollutants until a solution could be implemented, including shutting off the dewatering discharge as soon as possible depending on the severity of the condition taking safety considerations into account.
- ☒ Determined whether the dewatering controls were operating effectively and whether they were causing the conditions.
- ☒ Made any necessary adjustments, repairs, or replacements to the dewatering controls to lower the turbidity levels below the benchmark or remove the visible plume or sheen.

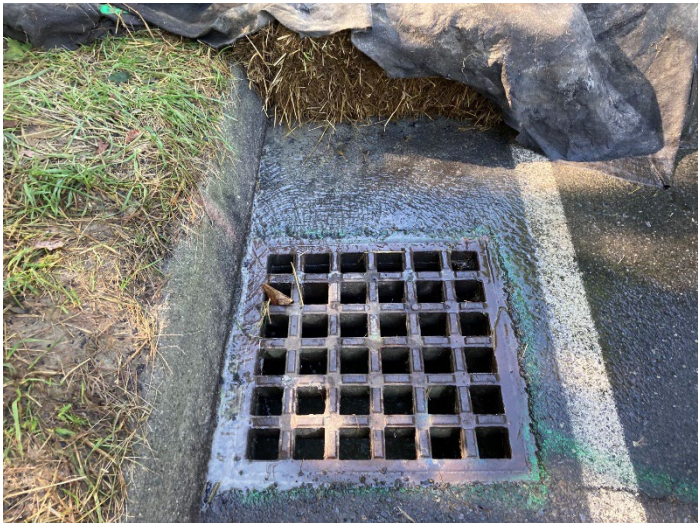
| Photo No.: 6 | Date: 10/04/2023 | | |

Turbidity sampling conducted. Dewatering set up to discharge to straw bale corral above Town of Hudson catch basin along Forest Avenue north of the area dewatered. Catch basins appear to discharge into stream below culvert at Forest Ave/Glendale Rd. Water appeared turbid and chalk colored. This is believed to have been caused by stone added to the trench. First turbidity sample was collected at 9:00am and was above 355 NTUs. Pump was turned off at 9:30am per requirements in Section 5.2.2 of the 2022 EPA CGP. Filter system was added, and pumping resumed at 10:35am. Additional turbidity sample was collected at 11:00am. This sample was above 50 NTUs, but less than 355 NTUs. See additional corrective action log.

| Description: View of discharge from project (catch basin below hay bale corral on Forest Ave) with added filter system. Discharge appeared slightly turbid. Turbidity reading was above 50 NTUs, but less than 355 NTUs. Facing south. | | | |
