**Weekly Environmental Compliance Summary**

**Sudbury to Hudson Transmission Reliability Project (USEPA Tracking # MAR1003UW)**

Week of: November 6, 2023 to November 10, 2023

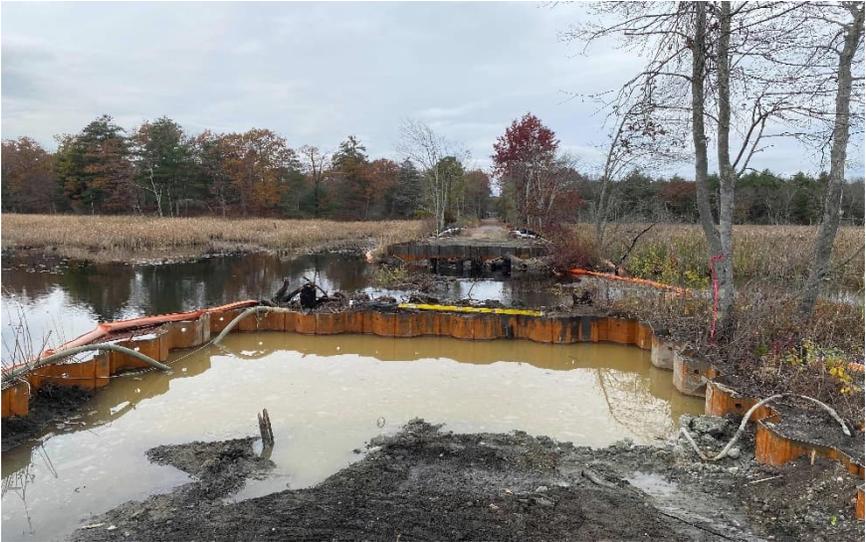
<p>PHOTOGRAPHIC LOG</p>	
<p>Client Name: Eversource</p>		<p>Site Location: Sudbury to Hudson Transmission Reliability Project</p>	<p>Town: Hudson</p>
<p>Photo No.: 1</p>	<p>Date: 11-6-23</p>

<p>Description:</p> <p>Work area within segment 3 looking toward segment 2, bridge 130, looking westward.</p>

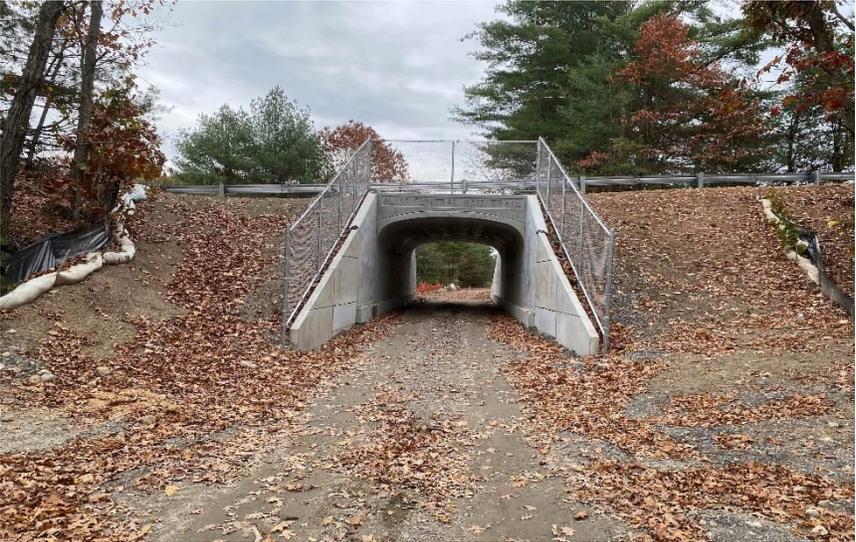
<p>PHOTOGRAPHIC LOG</p>	
<p>Client Name: Eversource</p>		<p>Site Location: Sudbury to Hudson Transmission Reliability Project</p>	<p>Town: Hudson</p>
<p>Photo No.: 2</p>	<p>Date: 11-6-23</p>

<p>Description:</p> <p>Work area within Segment 1, Chestnut Street Crossing, looking eastward.</p>

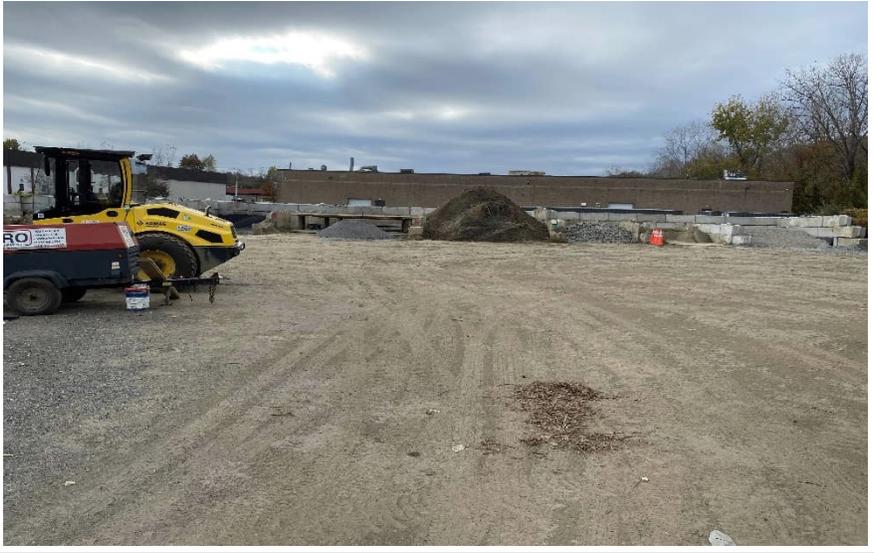
<p>PHOTOGRAPHIC LOG</p>	
<p>Client Name: Eversource</p>		<p>Site Location: Sudbury to Hudson Transmission Reliability Project</p>	<p>Town: Hudson</p>
<p>Photo No.: 3</p>	<p>Date: 11-6-23</p>

<p>Description: Bonazzoli laydown yard, looking westward.</p>

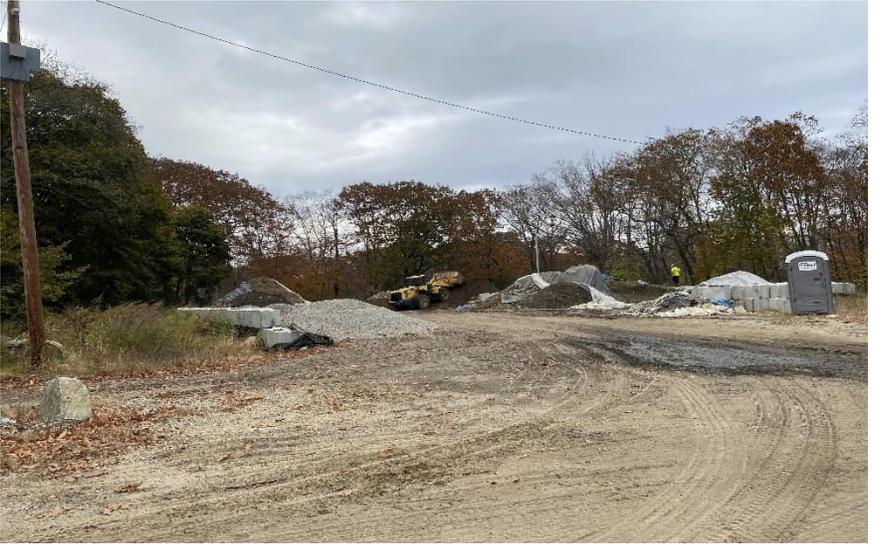
<p>PHOTOGRAPHIC LOG</p>	
<p>Client Name: Eversource</p>		<p>Site Location: Sudbury to Hudson Transmission Reliability Project</p>	<p>Town: Hudson</p>
<p>Photo No.: 4</p>	<p>Date: 11-6-23</p>

<p>Description: Stowe Court laydown yard, soil deliveries, looking southward.</p>

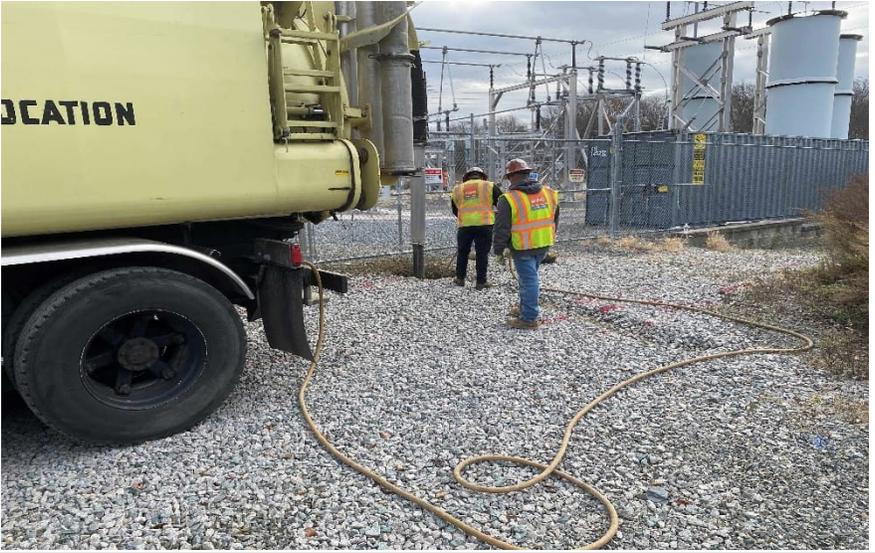
<p>PHOTOGRAPHIC LOG</p>	
<p>Client Name: Eversource</p>		<p>Site Location: Sudbury to Hudson Transmission Reliability Project</p>	<p>Town: Sudbury</p>
<p>Photo No.: 5</p>	<p>Date: 11-6-23</p>

<p>Description:</p> <p>Work area near substation, test pitting prior to conduit work, looking eastward.</p>

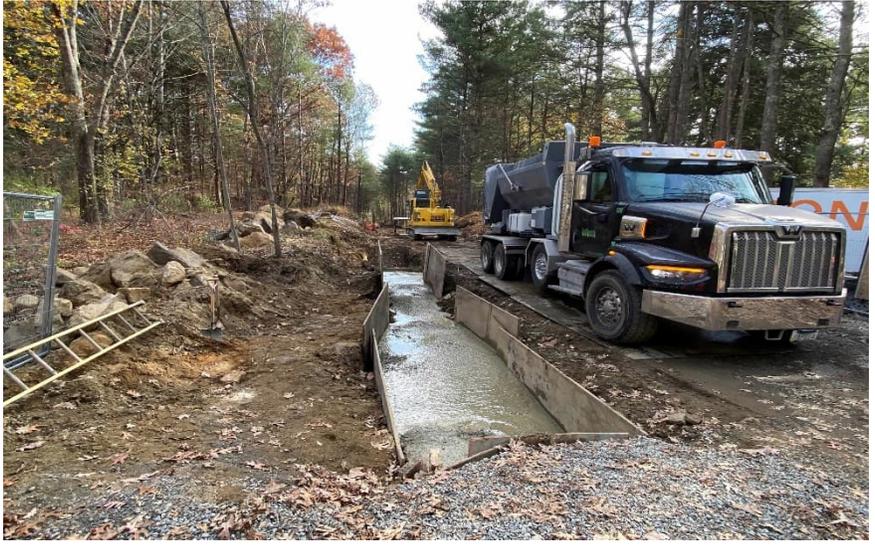
<p>PHOTOGRAPHIC LOG</p>	
<p>Client Name: Eversource</p>		<p>Site Location: Sudbury to Hudson Transmission Reliability Project</p>	<p>Town: Sudbury</p>
<p>Photo No.: 6</p>	<p>Date: 11-6-23</p>

<p>Description:</p> <p>Work area within Segment 10, conduit work, existing erosion control, looking eastward.</p>

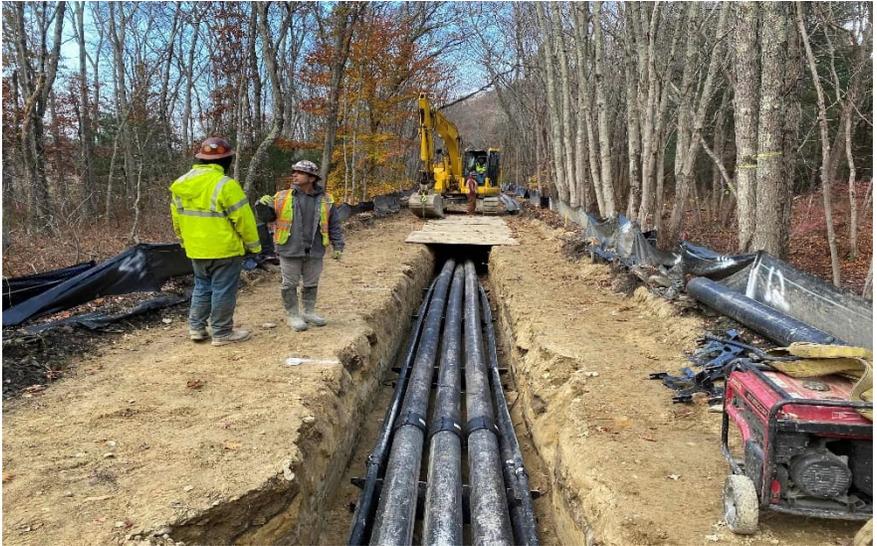
<p>PHOTOGRAPHIC LOG</p>	
<p>Client Name: Eversource</p>		<p>Site Location: Sudbury to Hudson Transmission Reliability Project</p>	<p>Town: Sudbury</p>
<p>Photo No.: 7</p>	<p>Date: 11-6-23</p>

<p>Description:</p> <p>Work area within Segment 14, conduit work – placement of conduit pipe, existing erosion control, looking westward.</p>

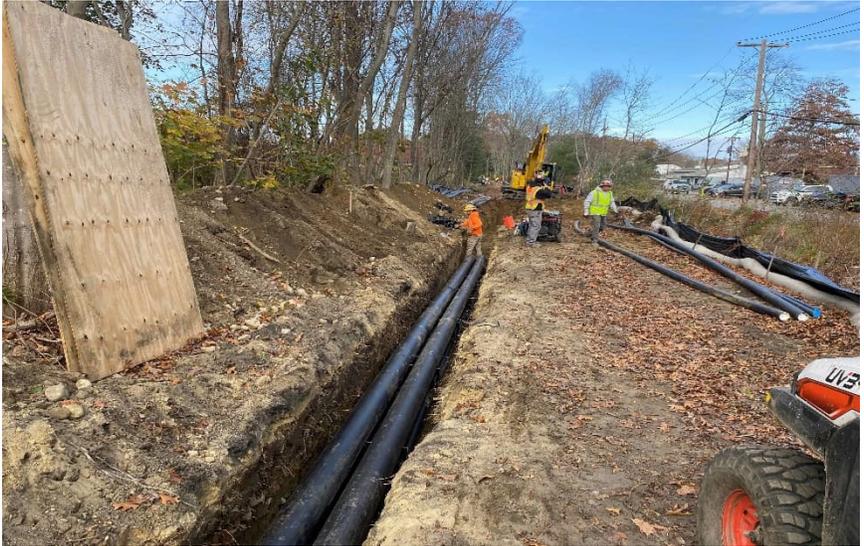
<p>PHOTOGRAPHIC LOG</p>	
<p>Client Name: Eversource</p>		<p>Site Location: Sudbury to Hudson Transmission Reliability Project</p>	<p>Town: Sudbury</p>
<p>Photo No.: 8</p>	<p>Date: 11-6-23</p>

<p>Description:</p> <p>Work area within Segment 12, conduit work – placement of conduit pipe, existing erosion control, looking westward.</p>

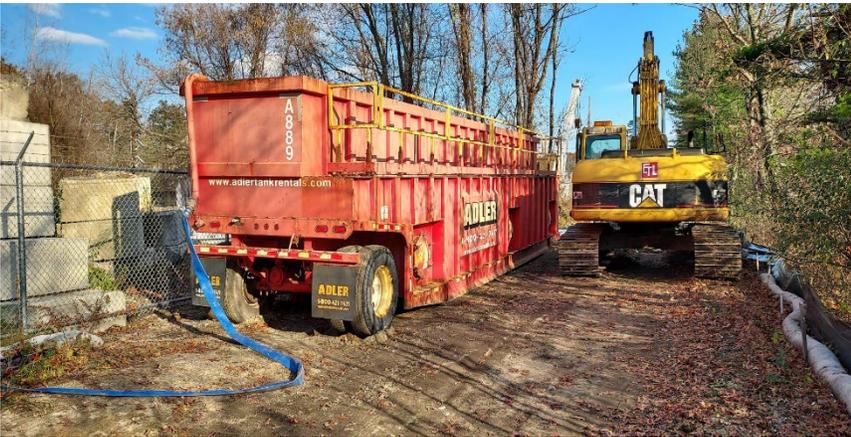
<b>PHOTOGRAPHIC LOG</b>	
<b>Client Name:</b> Eversource		<b>Site Location:</b> Sudbury to Hudson Transmission Reliability Project	<b>Town:</b> Hudson
<b>Photo No.:</b> 2	<b>Date:</b> 11-7-23

<b>Description:</b>  Frac tank set up within Segment 3, looking westward.

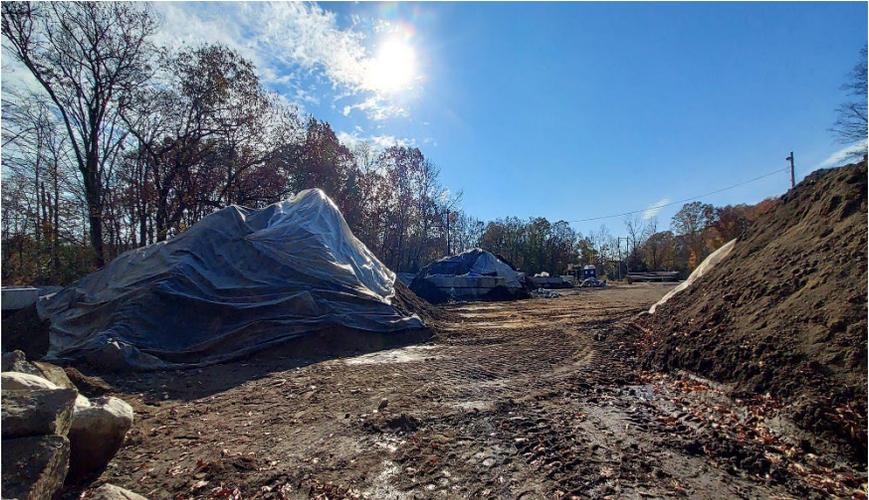
<b>PHOTOGRAPHIC LOG</b>	
Client Name: Eversource		Site Location: Sudbury to Hudson Transmission Reliability Project	Town: Hudson
Photo No.: 3	Date: 11-7-23

<b>Description:</b>  Stowe Court laydown yard, soil deliveries, looking northward.

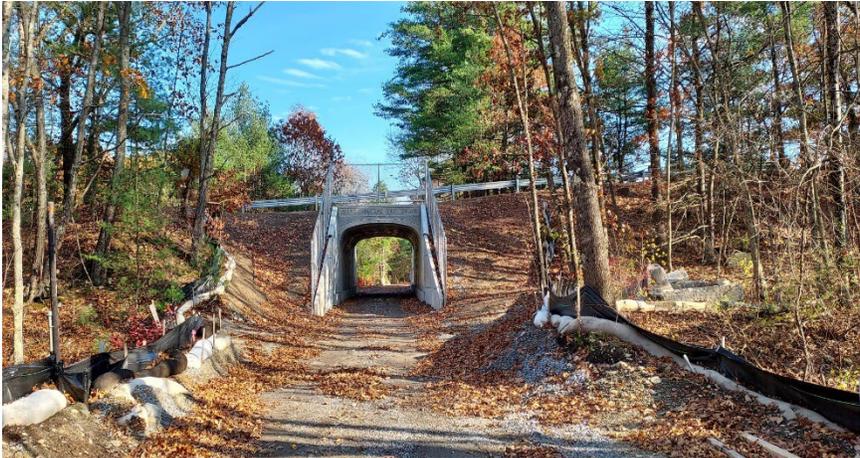
<b>PHOTOGRAPHIC LOG</b>	
Client Name: Eversource		Site Location: Sudbury to Hudson Transmission Reliability Project	Town: Hudson
Photo No.: 4	Date: 11-7-23

<b>Description:</b>  Work area within Segment 1, Chestnut Street Crossing, looking eastward.

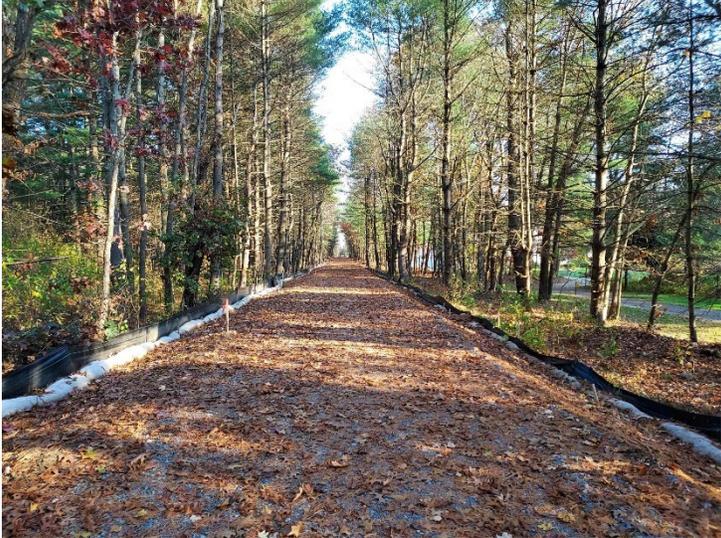
<b>PHOTOGRAPHIC LOG</b>	
<b>Client Name:</b> Eversource		<b>Site Location:</b> Sudbury to Hudson Transmission Reliability Project	<b>Town:</b> Hudson
<b>Photo No.:</b> 5	<b>Date:</b> 11-7-23

<b>Description:</b>  Erosion controls within Segment 5, looking westward.

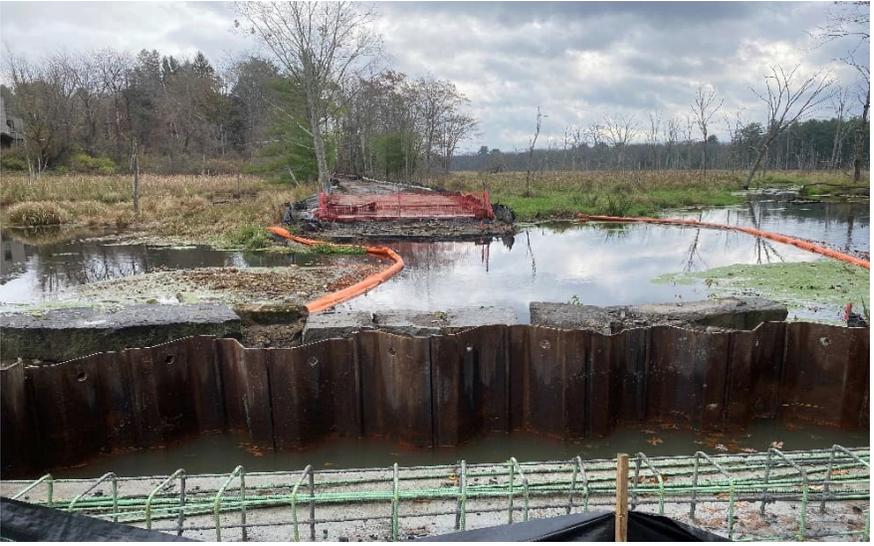
<p>PHOTOGRAPHIC LOG</p>	
<p>Client Name: Eversource</p>		<p>Site Location: Sudbury to Hudson Transmission Reliability Project</p>	<p>Town: Sudbury</p>
<p>Photo No.: 1</p>	<p>Date: 11-7-23</p>

<p>Description:</p> <p>Work area within segment 13 looking toward segment 14 over Hop Brook, bridge 127, looking eastward.</p>

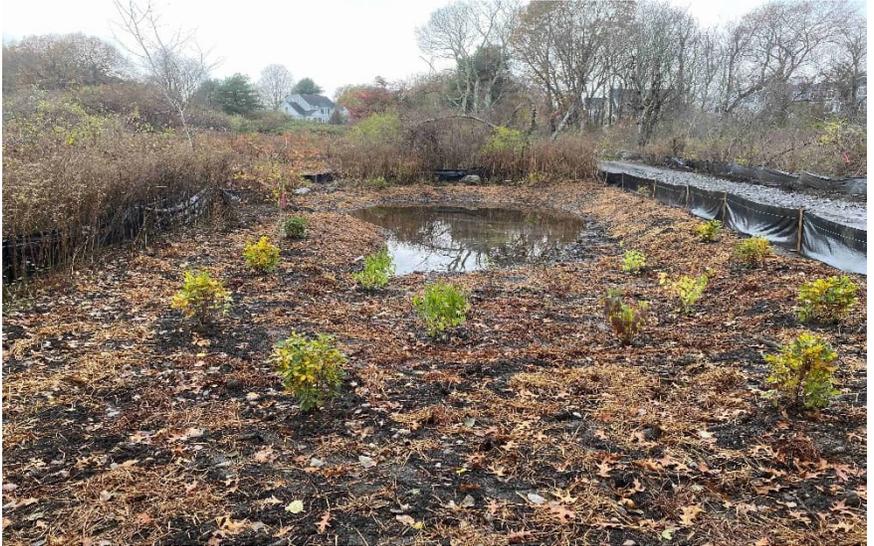
<p>PHOTOGRAPHIC LOG</p>	
<p>Client Name: Eversource</p>		<p>Site Location: Sudbury to Hudson Transmission Reliability Project</p>	<p>Town: Sudbury</p>
<p>Photo No.: 2</p>	<p>Date: 11-7-23</p>

<p>Description:</p> <p>Wetland replication area, within Segment 14, looking westward.</p>

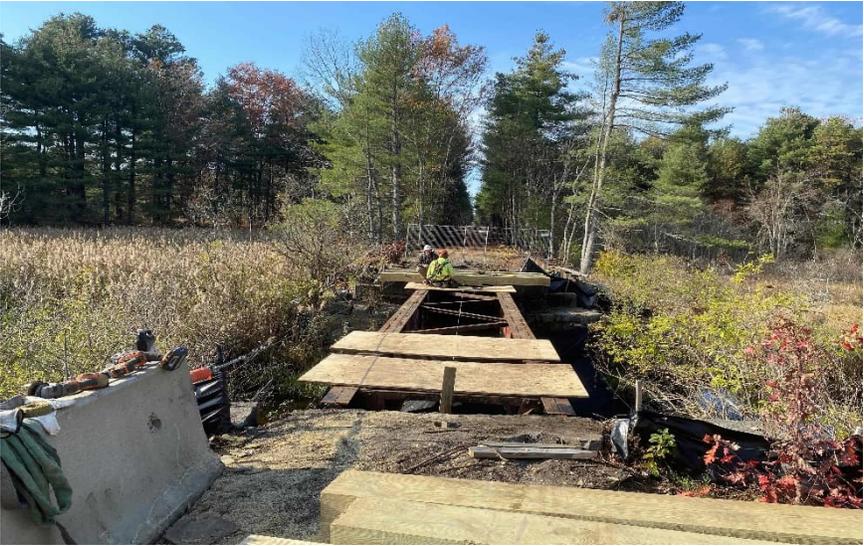
<p>PHOTOGRAPHIC LOG</p>	
<p>Client Name: Eversource</p>		<p>Site Location: Sudbury to Hudson Transmission Reliability Project</p>	<p>Town: Sudbury</p>
<p>Photo No.: 3</p>	<p>Date: 11-7-23</p>

<p>Description:                  Work area within Segment 8 toward segment 7, bridge 128 work, existing erosion control, looking westward.</p>

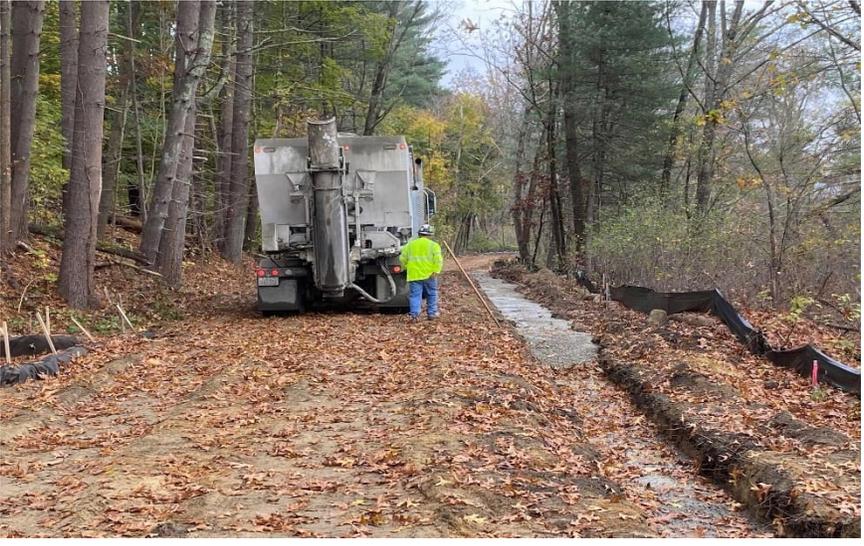
<p>PHOTOGRAPHIC LOG</p>	
<p>Client Name: Eversource</p>		<p>Site Location: Sudbury to Hudson Transmission Reliability Project</p>	<p>Town: Sudbury</p>
<p>Photo No.: 4</p>	<p>Date: 11-7-23</p>

<p>Description:                  Work area within Segment 13, conduit work, existing erosion control, looking westward.</p>

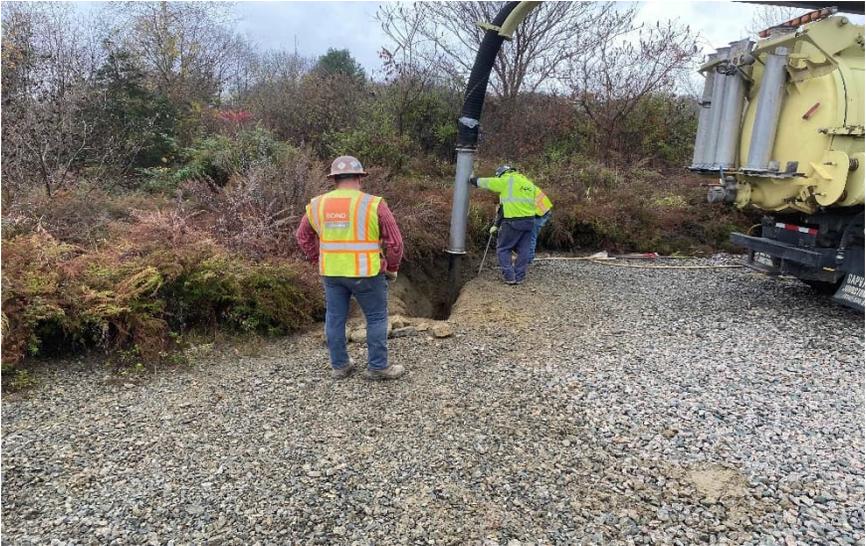
<p>PHOTOGRAPHIC LOG</p>	
<p>Client Name: Eversource</p>		<p>Site Location: Sudbury to Hudson Transmission Reliability Project</p>	<p>Town: Sudbury</p>
<p>Photo No.: 5</p>	<p>Date: 11-7-23</p>

<p>Description:                  Work area near substation, test pitting prior to conduit work, looking westward.</p>

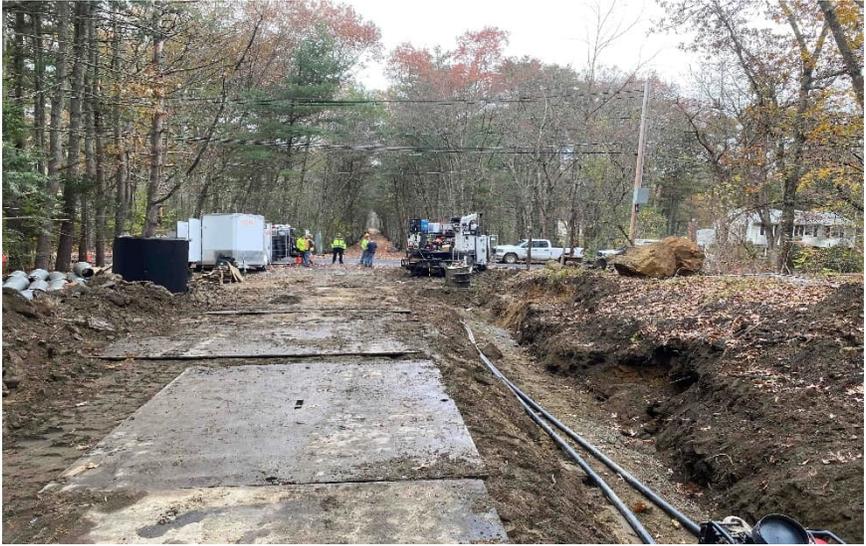
<p>PHOTOGRAPHIC LOG</p>	
<p>Client Name: Eversource</p>		<p>Site Location: Sudbury to Hudson Transmission Reliability Project</p>	<p>Town: Sudbury</p>
<p>Photo No.: 6</p>	<p>Date: 11-7-23</p>

<p>Description:                  Work area within Segment 10, conduit work, looking westward.</p>

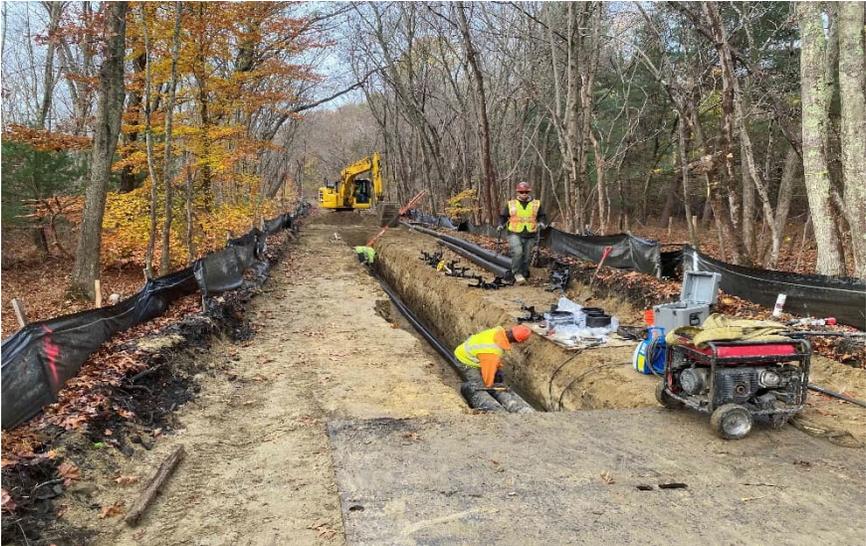
<p align="center"><b>PHOTOGRAPHIC LOG</b></p>	
<p>Client Name: Eversource</p>		<p>Site Location: Sudbury to Hudson Transmission Reliability Project</p>	<p>Town: Sudbury</p>
<p>Photo No.: 7</p>	<p>Date: 11-7-23</p>

<p>Description:</p> <p>Work area within Segment 14, conduit work – placement of conduit pipe, existing erosion control, looking westward.</p>

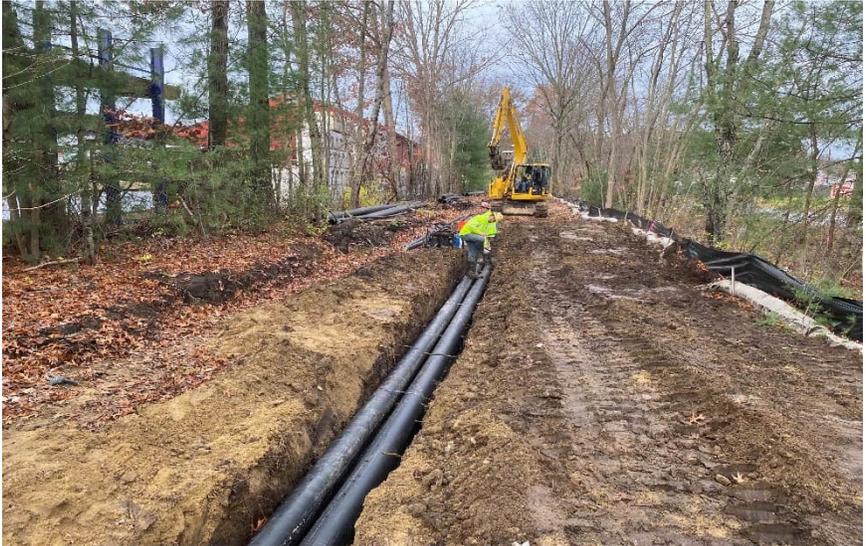
<p align="center"><b>PHOTOGRAPHIC LOG</b></p>	
<p>Client Name: Eversource</p>		<p>Site Location: Sudbury to Hudson Transmission Reliability Project</p>	<p>Town: Sudbury</p>
<p>Photo No.: 8</p>	<p>Date: 11-7-23</p>

<p>Description:</p> <p>Work area within Segment 12, conduit work – placement of conduit pipe, existing erosion control, looking westward.</p>

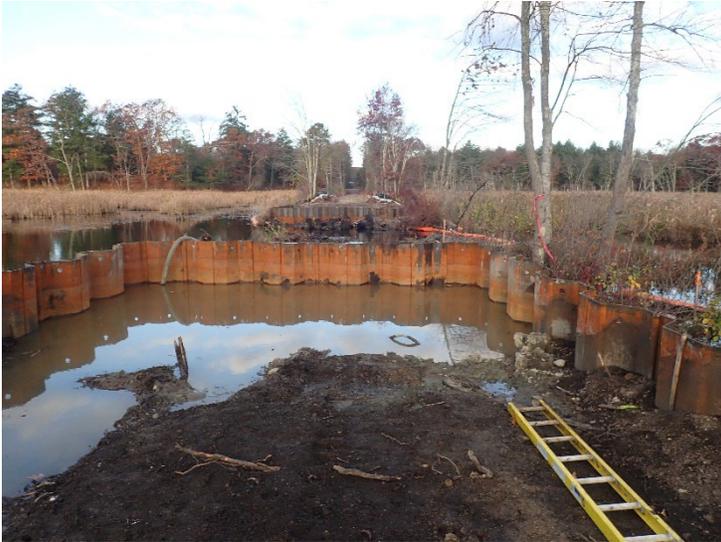
<p align="center"><b>PHOTOGRAPHIC LOG</b></p>	
<p><b>Client Name:</b> Eversource</p>		<p><b>Site Location:</b> Sudbury to Hudson Transmission Reliability Project</p>	<p><b>Town:</b> Hudson</p>
<p><b>Photo No.:</b> 1</p>	<p><b>Date:</b> 11-8-23</p>

<p><b>Description:</b></p> <p>Work area within segment 3 looking toward segment 2, bridge 130, Dewatering activities initiated. Looking westward.</p>

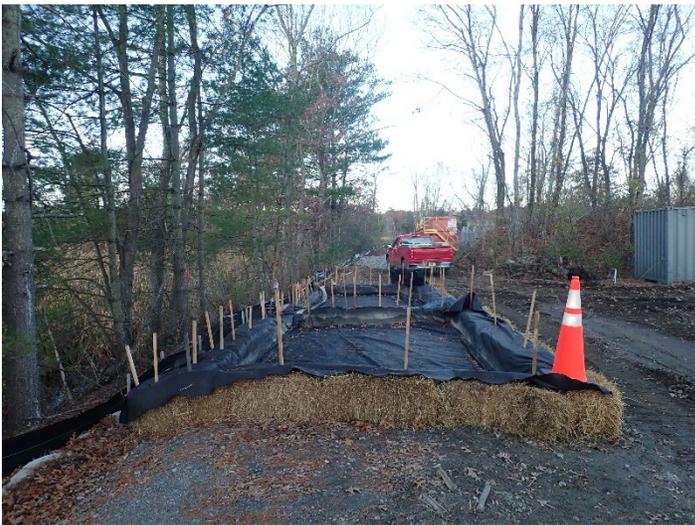
<p align="center"><b>PHOTOGRAPHIC LOG</b></p>	
<p><b>Client Name:</b> Eversource</p>		<p><b>Site Location:</b> Sudbury to Hudson Transmission Reliability Project</p>	<p><b>Town:</b> Hudson</p>
<p><b>Photo No.:</b> 2</p>	<p><b>Date:</b> 11-8-23</p>

<p><b>Description:</b></p> <p>Filter bag and corral set up within Segment 3, looking westward.</p>

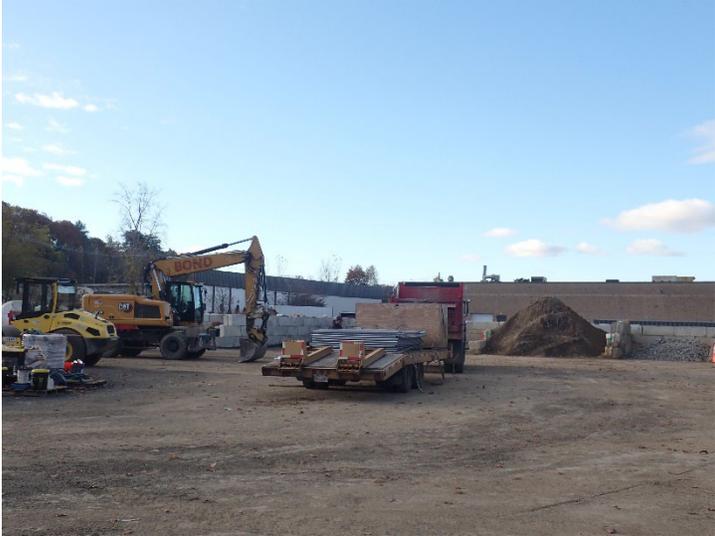
<b>PHOTOGRAPHIC LOG</b>	
Client Name: Eversource		Site Location: Sudbury to Hudson Transmission Reliability Project	Town: Hudson
Photo No.: 3	Date: 11-8-23

Description:  Bonazzoli laydown yard, looking westward.

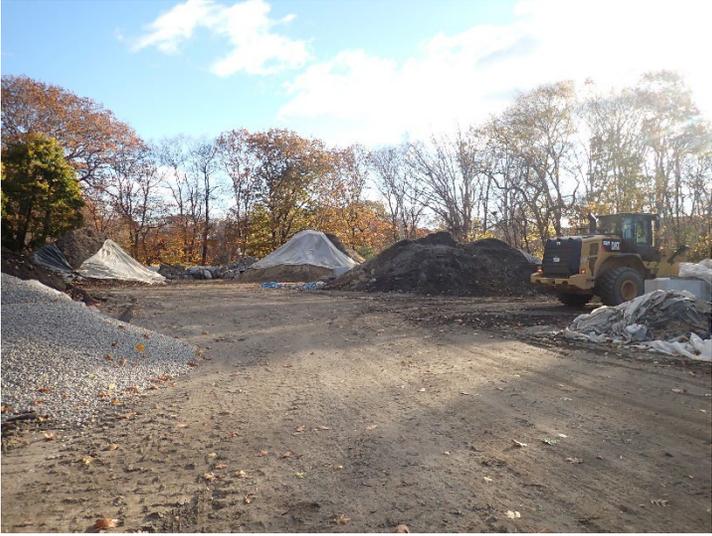
<b>PHOTOGRAPHIC LOG</b>	
Client Name: Eversource		Site Location: Sudbury to Hudson Transmission Reliability Project	Town: Hudson
Photo No.: 4	Date: 11-8-23

Description:  Stowe Court laydown yard, soil deliveries, looking southward.

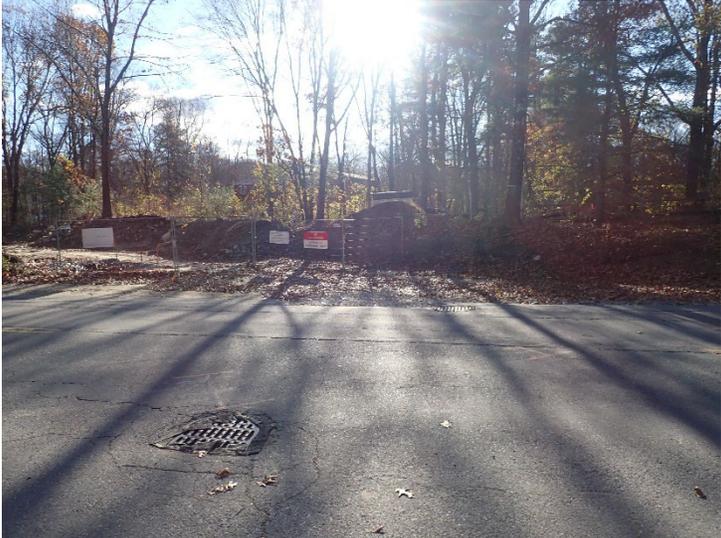
<p><b>PHOTOGRAPHIC LOG</b></p>	
<p><b>Client Name:</b> Eversource</p>		<p><b>Site Location:</b> Sudbury to Hudson Transmission Reliability Project</p>	<p><b>Town:</b> Hudson</p>
<p><b>Photo No.:</b> 6</p>	<p><b>Date:</b> 11-8-23</p>

<p><b>Description:</b>                  Silt sacks in catch basins on Wilkins St at Segment 1, looking eastward.</p>

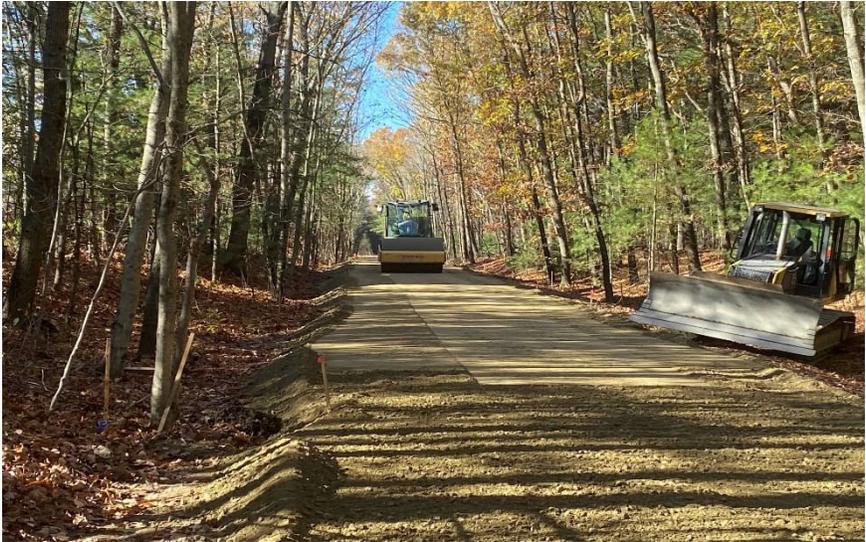
<p>PHOTOGRAPHIC LOG</p>	
<p>Client Name: Eversource</p>		<p>Site Location: Sudbury to Hudson Transmission Reliability Project</p>	<p>Town: Sudbury</p>
<p>Photo No.: 1</p>	<p>Date: 11-8-23</p>

<p>Description:</p> <p>Work area within segment 11, grading work, looking westward.</p>

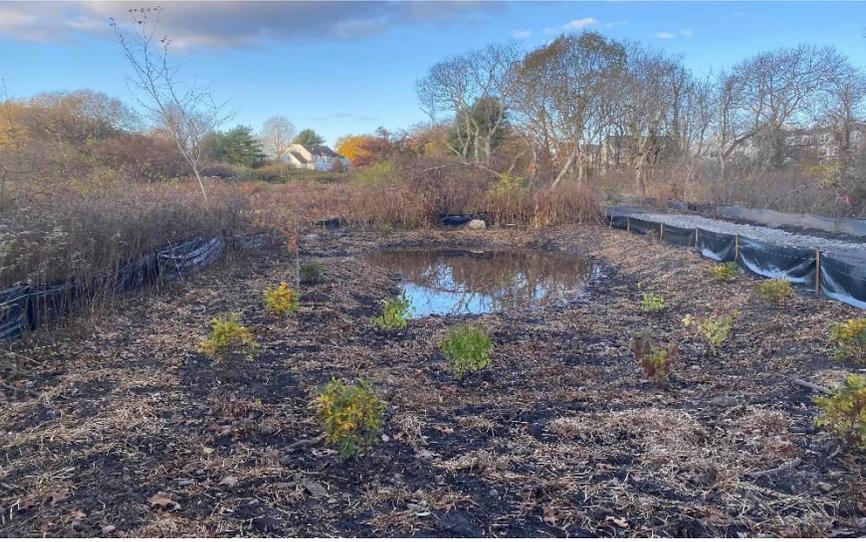
<p>PHOTOGRAPHIC LOG</p>	
<p>Client Name: Eversource</p>		<p>Site Location: Sudbury to Hudson Transmission Reliability Project</p>	<p>Town: Sudbury</p>
<p>Photo No.: 2</p>	<p>Date: 11-8-23</p>

<p>Description:</p> <p>Wetland replication area, within Segment 14, looking westward.</p>

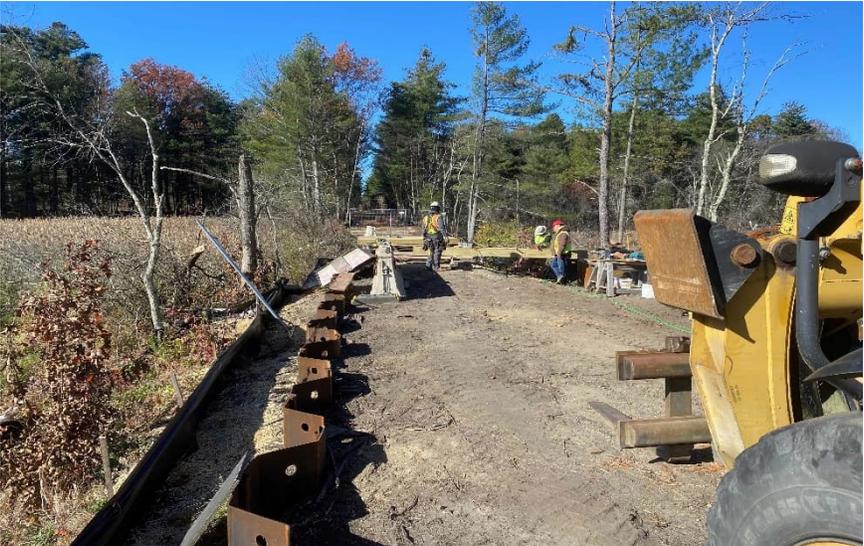
<p>PHOTOGRAPHIC LOG</p>	
<p>Client Name: Eversource</p>		<p>Site Location: Sudbury to Hudson Transmission Reliability Project</p>	<p>Town: Sudbury</p>
<p>Photo No.: 3</p>	<p>Date: 11-8-23</p>

<p>Description:</p> <p>Work area within Segment 8 toward segment 7, bridge 128 work, existing erosion control, looking westward.</p>

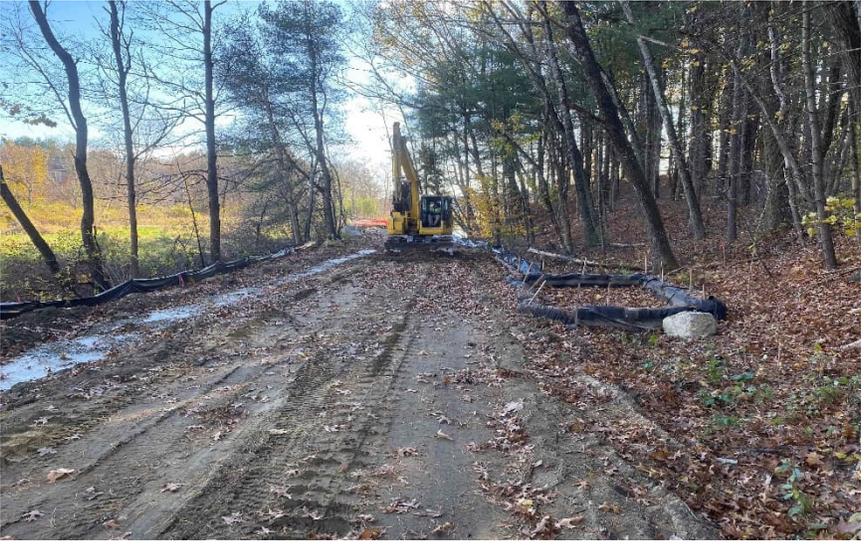
<p>PHOTOGRAPHIC LOG</p>	
<p>Client Name: Eversource</p>		<p>Site Location: Sudbury to Hudson Transmission Reliability Project</p>	<p>Town: Sudbury</p>
<p>Photo No.: 4</p>	<p>Date: 11-8-23</p>

<p>Description:</p> <p>Work area within Segment 13, conduit work, existing erosion control, looking eastward.</p>

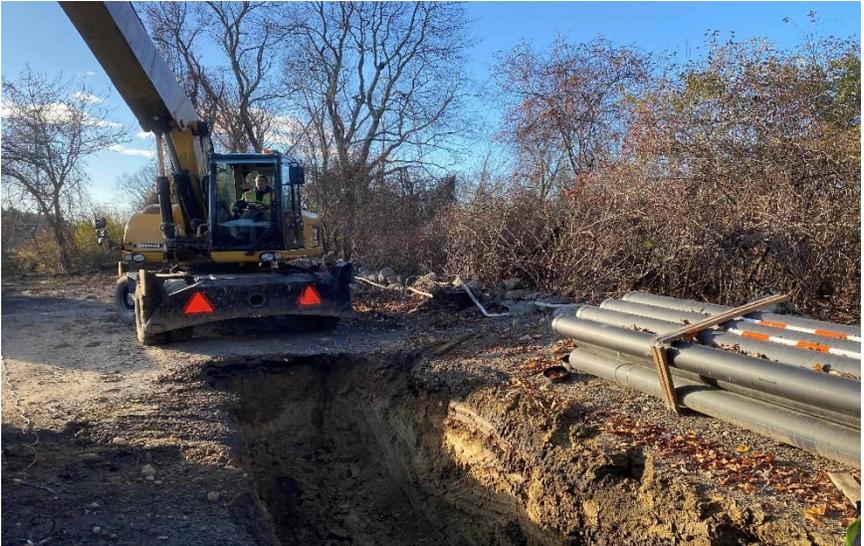
<p>PHOTOGRAPHIC LOG</p>	
<p>Client Name: Eversource</p>		<p>Site Location: Sudbury to Hudson Transmission Reliability Project</p>	<p>Town: Sudbury</p>
<p>Photo No.: 5</p>	<p>Date: 11-8-23</p>

<p>Description:                  Work area near substation, conduit work, looking southward.</p>

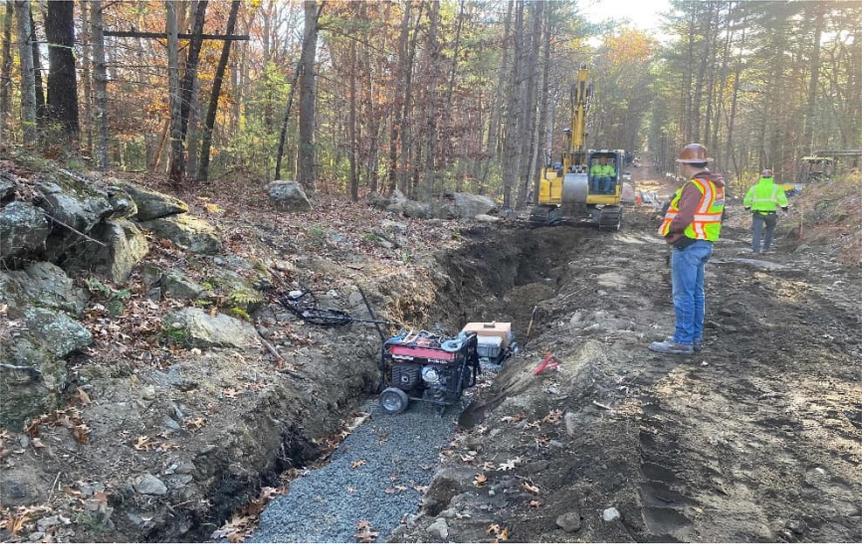
<p>PHOTOGRAPHIC LOG</p>	
<p>Client Name: Eversource</p>		<p>Site Location: Sudbury to Hudson Transmission Reliability Project</p>	<p>Town: Sudbury</p>
<p>Photo No.: 6</p>	<p>Date: 11-8-23</p>

<p>Description:                  Work area within Segment 10, conduit work, existing erosion control, looking eastward.</p>

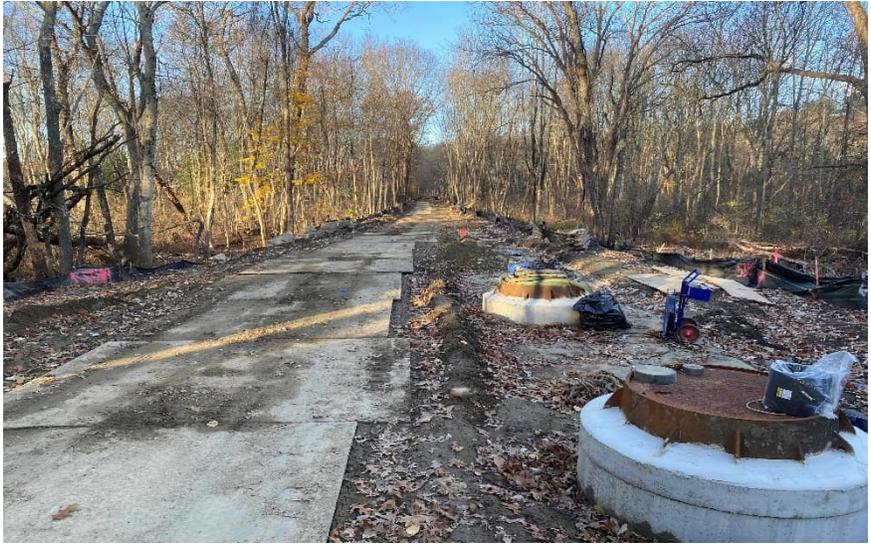
<p>PHOTOGRAPHIC LOG</p>	
<p>Client Name: Eversource</p>		<p>Site Location: Sudbury to Hudson Transmission Reliability Project</p>	<p>Town: Sudbury</p>
<p>Photo No.: 7</p>	<p>Date: 11-8-23</p>

<p>Description:</p> <p>Work area within Segment 14, conduit work area near manhole #27, existing erosion control, looking westward.</p>

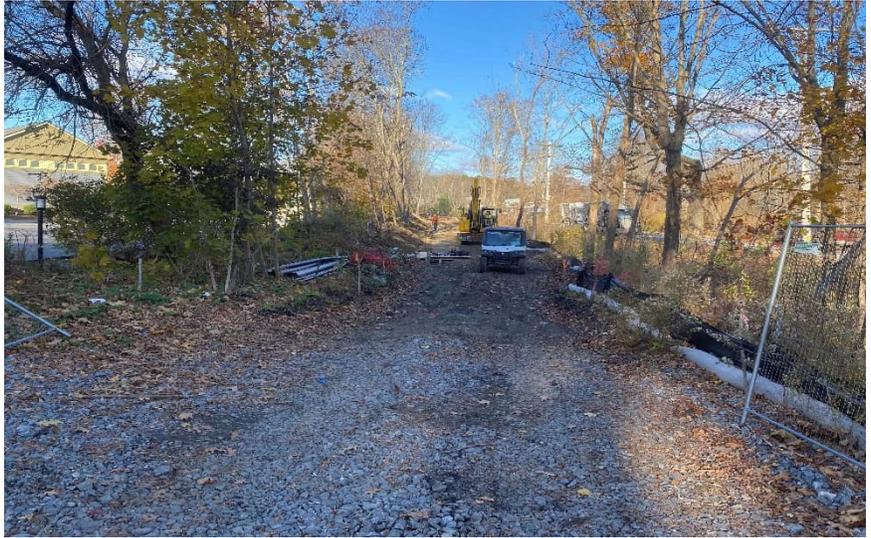
<p>PHOTOGRAPHIC LOG</p>	
<p>Client Name: Eversource</p>		<p>Site Location: Sudbury to Hudson Transmission Reliability Project</p>	<p>Town: Sudbury</p>
<p>Photo No.: 8</p>	<p>Date: 11-8-23</p>

<p>Description:</p> <p>Work area within Segment 12, conduit work – placement of conduit pipe, existing erosion control, looking westward.</p>

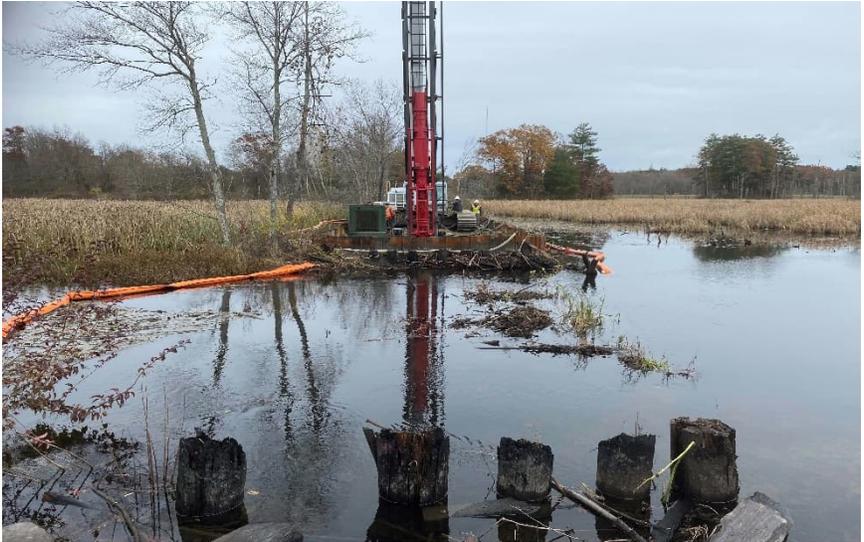
<p>PHOTOGRAPHIC LOG</p>	
<p>Client Name: Eversource</p>		<p>Site Location: Sudbury to Hudson Transmission Reliability Project</p>	<p>Town: Hudson</p>
<p>Photo No.: 1</p>	<p>Date: 11-10-23</p>

<p>Description:</p> <p>Work (pile driving) within segment 3 looking from segment 2, bridge 130, looking eastward.</p>

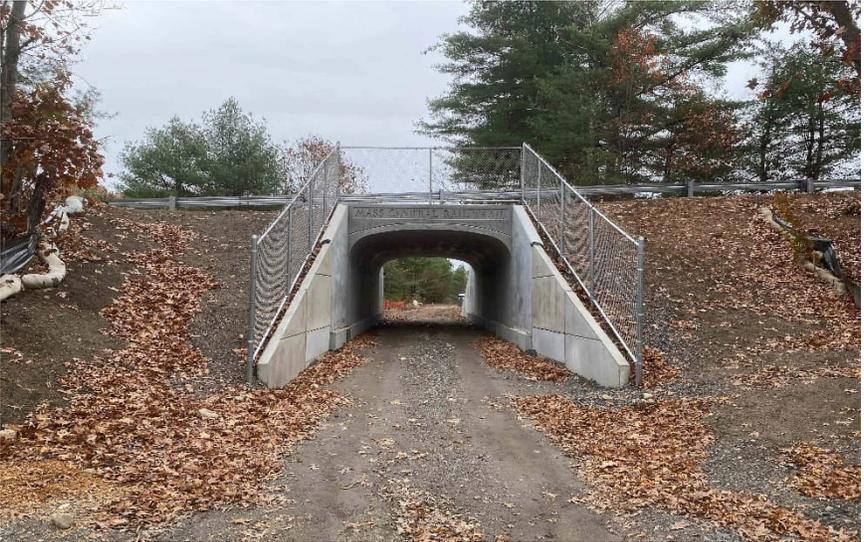
<p>PHOTOGRAPHIC LOG</p>	
<p>Client Name: Eversource</p>		<p>Site Location: Sudbury to Hudson Transmission Reliability Project</p>	<p>Town: Hudson</p>
<p>Photo No.: 2</p>	<p>Date: 11-10-23</p>

<p>Description:</p> <p>Work area within Segment 1, Chestnut Street Crossing, looking eastward.</p>

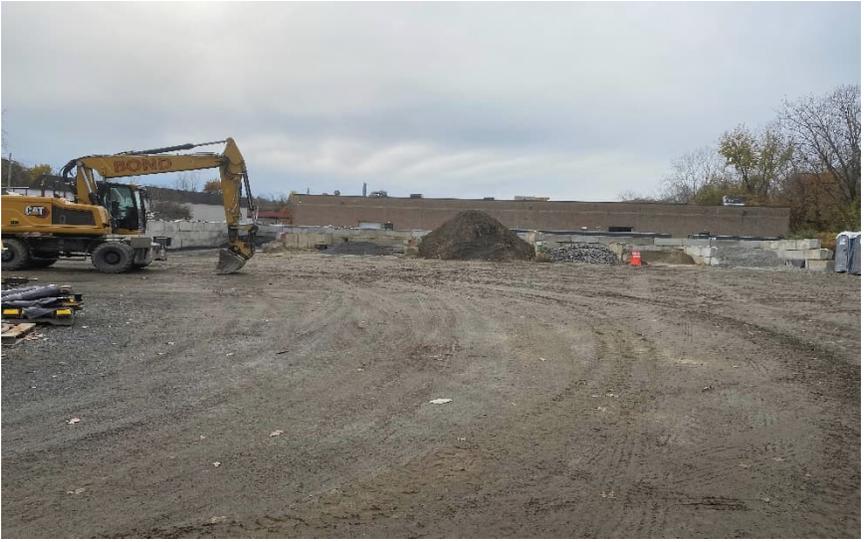
<p>PHOTOGRAPHIC LOG</p>	
<p>Client Name: Eversource</p>		<p>Site Location: Sudbury to Hudson Transmission Reliability Project</p>	<p>Town: Hudson</p>
<p>Photo No.: 3</p>	<p>Date: 11-10-23</p>

<p>Description: Bonazzoli laydown yard, looking westward.</p>

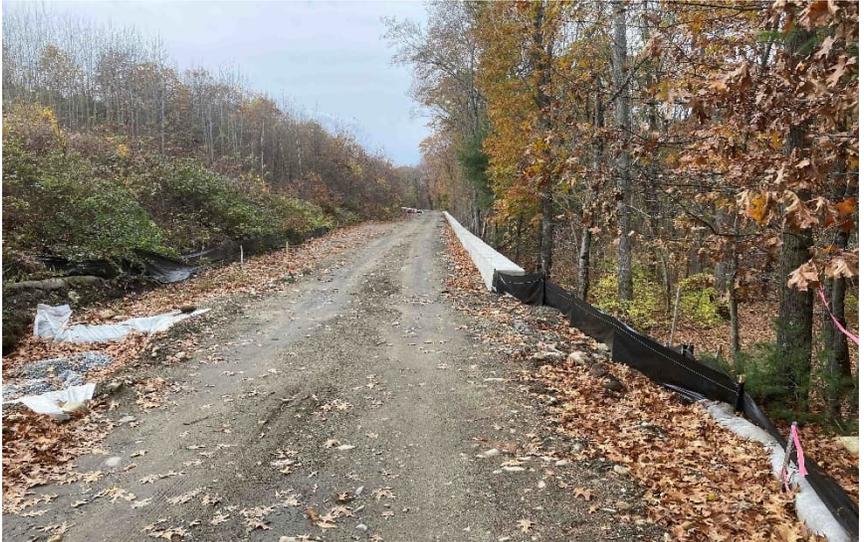
<p>PHOTOGRAPHIC LOG</p>	
<p>Client Name: Eversource</p>		<p>Site Location: Sudbury to Hudson Transmission Reliability Project</p>	<p>Town: Hudson</p>
<p>Photo No.: 4</p>	<p>Date: 11-10-23</p>

<p>Description: Concrete caps over sheeting within segment 1, existing erosion control, looking westward.</p>

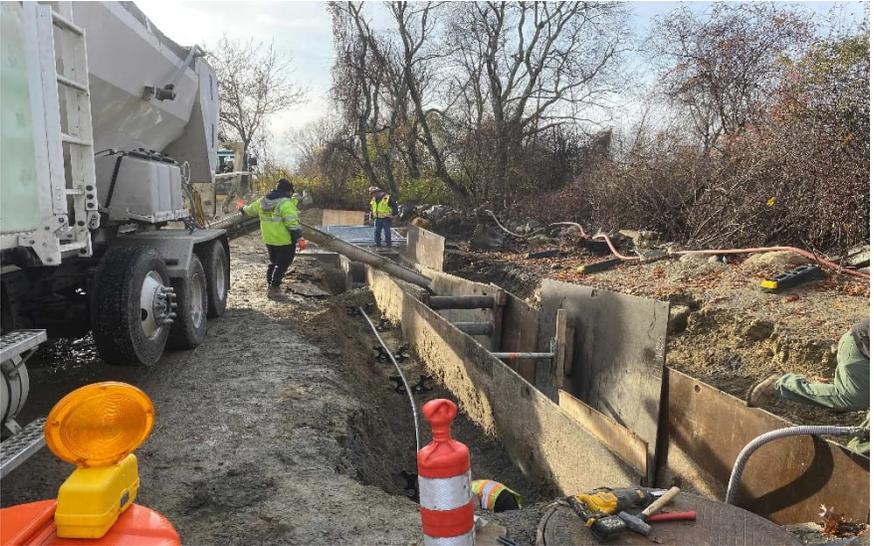
<p>PHOTOGRAPHIC LOG</p>	
<p>Client Name: Eversource</p>		<p>Site Location: Sudbury to Hudson Transmission Reliability Project</p>	<p>Town: Sudbury</p>
<p>Photo No.: 5</p>	<p>Date: 11-10-23</p>

<p>Description:</p> <p>Work area near substation, conduit work from manhole #28, looking southward.</p>

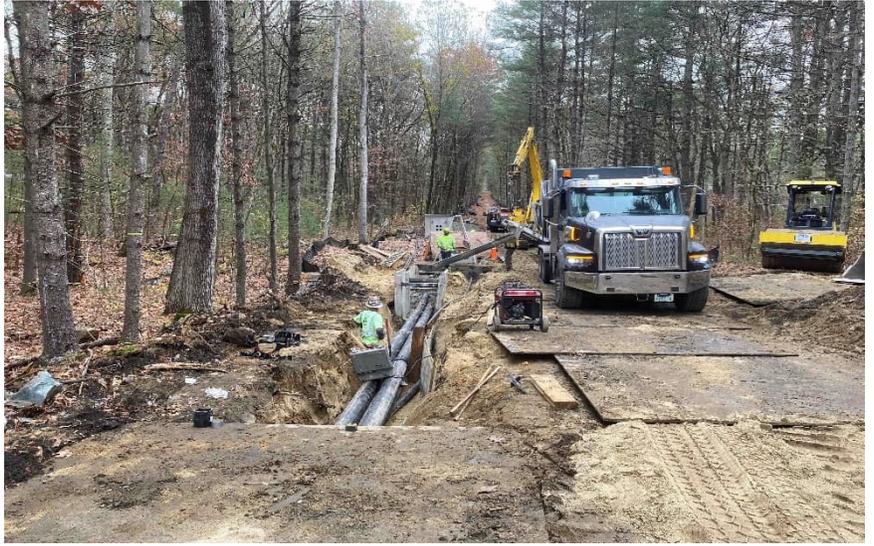
<p>PHOTOGRAPHIC LOG</p>	
<p>Client Name: Eversource</p>		<p>Site Location: Sudbury to Hudson Transmission Reliability Project</p>	<p>Town: Sudbury</p>
<p>Photo No.: 6</p>	<p>Date: 11-10-23</p>

<p>Description:</p> <p>Work area within Segment 10, conduit work, existing erosion control, looking eastward.</p>

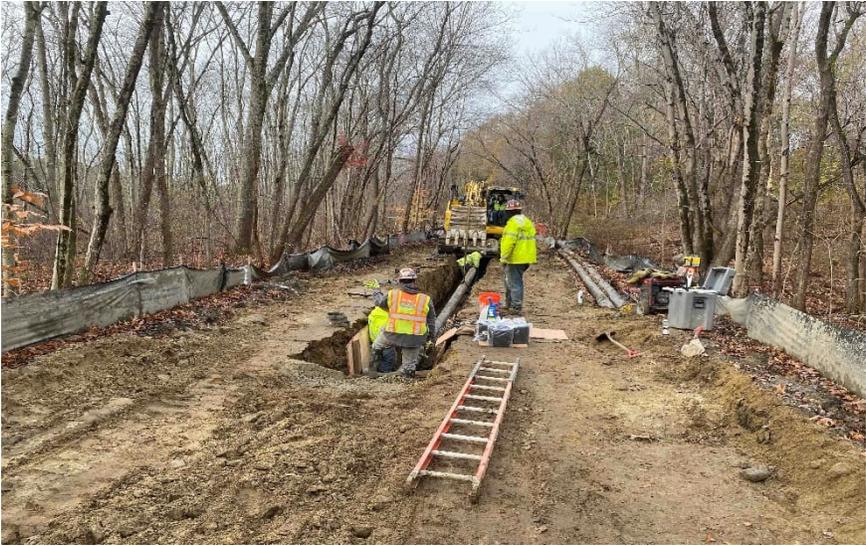
<p>PHOTOGRAPHIC LOG</p>	
<p>Client Name: Eversource</p>		<p>Site Location: Sudbury to Hudson Transmission Reliability Project</p>	<p>Town: Sudbury</p>
<p>Photo No.: 7</p>	<p>Date: 11-10-23</p>

<p>Description:</p> <p>Work area within Segment 14, conduit work – placement of conduit pipe, existing erosion control, looking westward.</p>

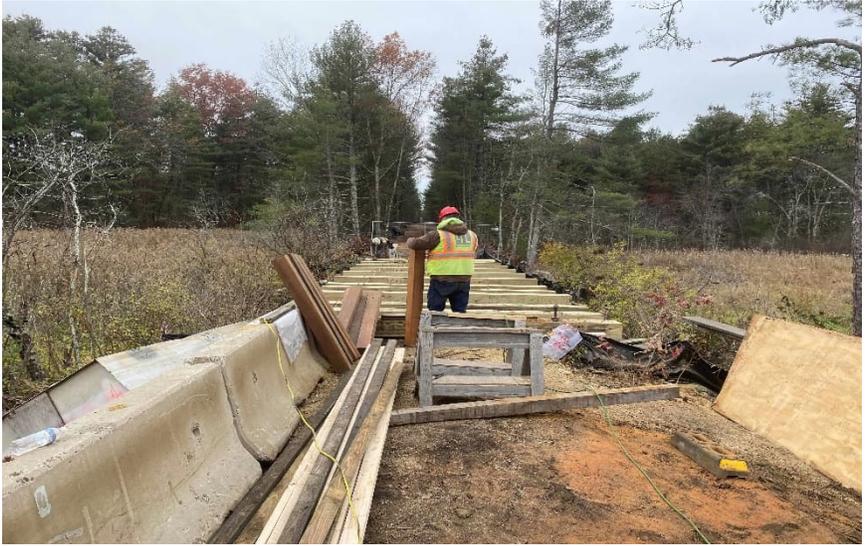
<p>PHOTOGRAPHIC LOG</p>	
<p>Client Name: Eversource</p>		<p>Site Location: Sudbury to Hudson Transmission Reliability Project</p>	<p>Town: Sudbury</p>
<p>Photo No.: 8</p>	<p>Date: 11-10-23</p>

<p>Description:</p> <p>Work area within Segment 8, rebuild of bridge 128, looking westward.</p>

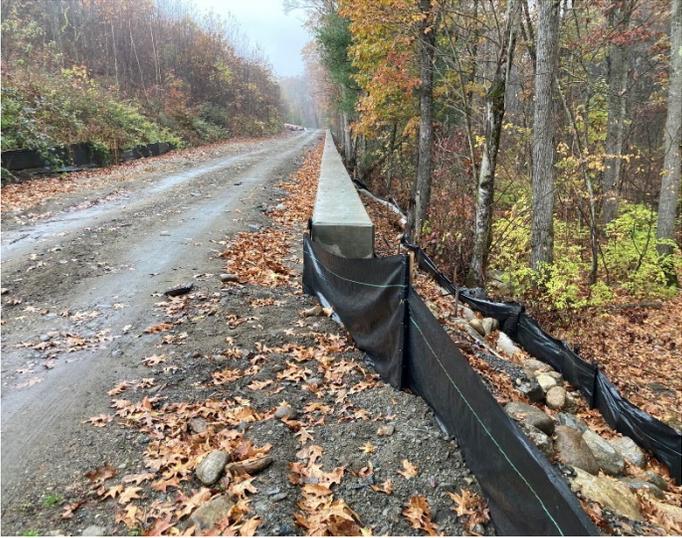
<b>PHOTOGRAPHIC LOG</b>	
<b>Client Name:</b> Eversource		<b>Site Location:</b> Sudbury to Hudson Transmission Reliability Project	<b>Town:</b> Hudson/Stow
<b>Photo No.:</b> 1	<b>Date:</b> 11-09-2023

<b>Description:</b> View of walls 1 and 2 in segment 1. Facing west.

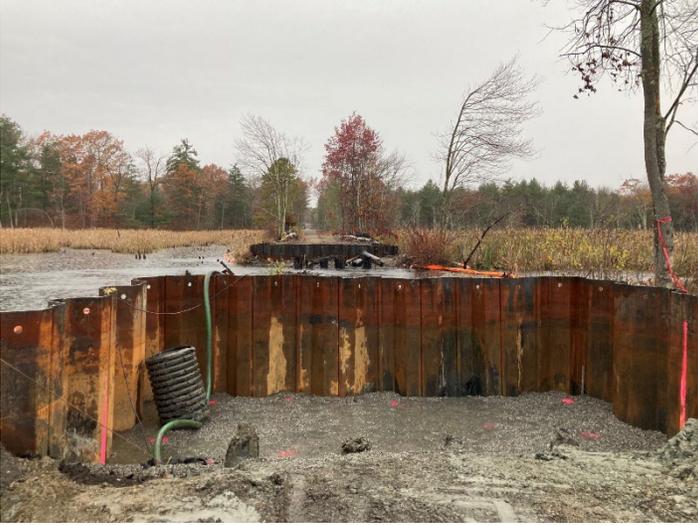
<b>PHOTOGRAPHIC LOG</b>	
<b>Client Name:</b> Eversource		<b>Site Location:</b> Sudbury to Hudson Transmission Reliability Project	<b>Town:</b> Hudson
<b>Photo No.:</b> 2	<b>Date:</b> 11-09-2023

<b>Description:</b> View of work area at bridge 130 in segment 3. See additional dewatering inspection report. Facing west.
