**Weekly Environmental Compliance Summary**

**Sudbury to Hudson Transmission Reliability Project (USEPA Tracking # MAR1003UW)**

Week of: November 6, 2023 to November 10, 2023

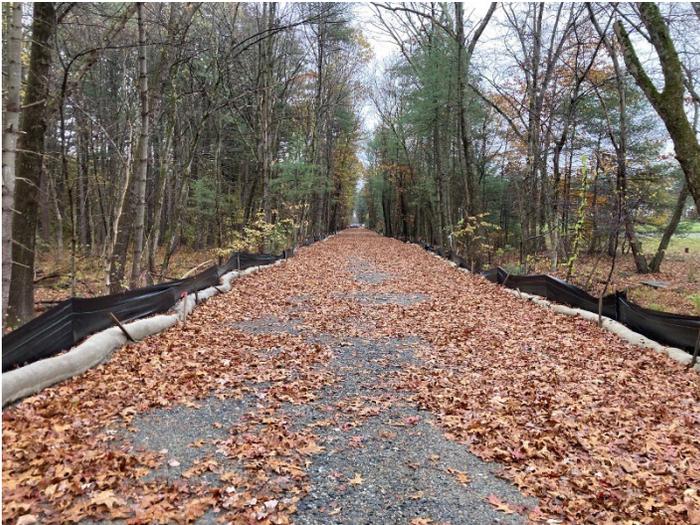
<b>Client Name:</b> Eversource		<b>Site Location:</b> Sudbury to Hudson Transmission Reliability Project	<b>Town:</b> Hudson
<b>Photo No.:</b> 5	<b>Date:</b> 11-09-2023

<b>Description:</b> View of Type B E&S controls in segment 4. Facing east.

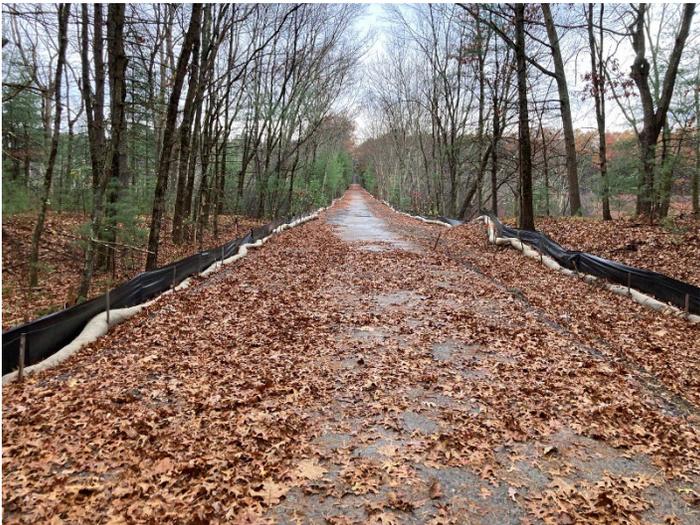
<b>Client Name:</b> Eversource		<b>Site Location:</b> Sudbury to Hudson Transmission Reliability Project	<b>Town:</b> Hudson
<b>Photo No.:</b> 6	<b>Date:</b> 11-09-2023

<b>Description:</b> View of Type B E&S controls in segment 5. Facing west.

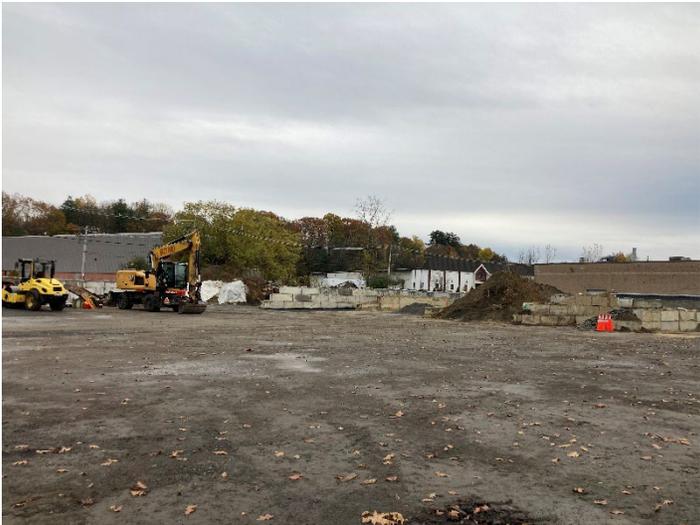
<b>Epsilon</b> ASSOCIATES INC.		<b>PHOTOGRAPHIC LOG</b>	
Client Name: Eversource		Site Location: Sudbury to Hudson Transmission Reliability Project	Town: Hudson
Photo No.: 7	Date: 11-09-2023

<b>Description:</b> View of Bonazzoli laydown yard. Facing southwest.

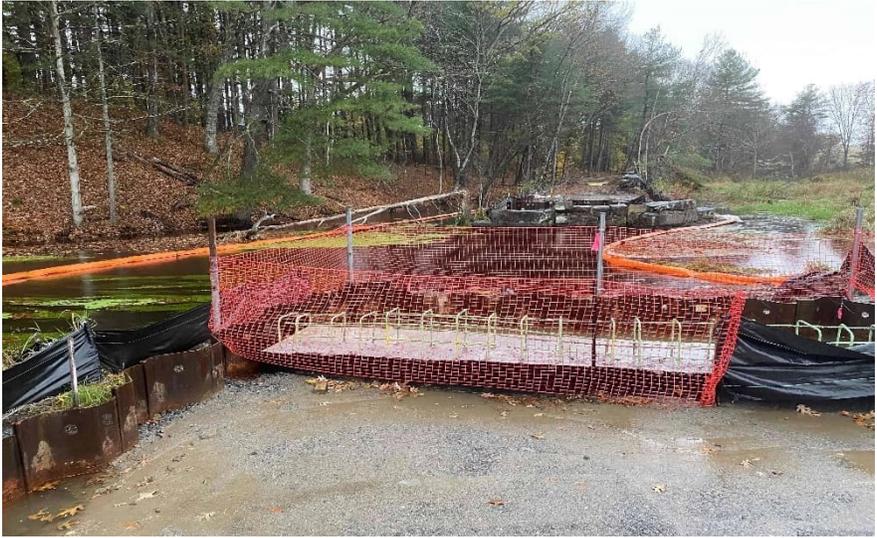
<b>PHOTOGRAPHIC LOG</b>	
Client Name: Eversource		Site Location: Sudbury to Hudson Transmission Reliability Project	Town: Sudbury
Photo No.: 1	Date: 11-9-23

Description:  Work area looking from segment 14 toward segment 13 (bridge 127 area), looking westward.

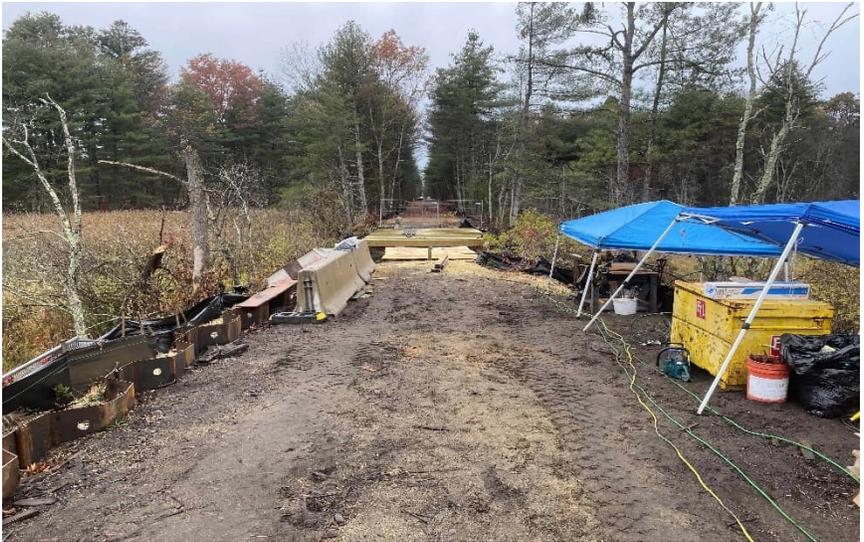
<b>PHOTOGRAPHIC LOG</b>	
Client Name: Eversource		Site Location: Sudbury to Hudson Transmission Reliability Project	Town: Sudbury
Photo No.: 2	Date: 11-9-23

Description:  Work area from segment 8 toward segment 7, existing erosion control, looking westward.

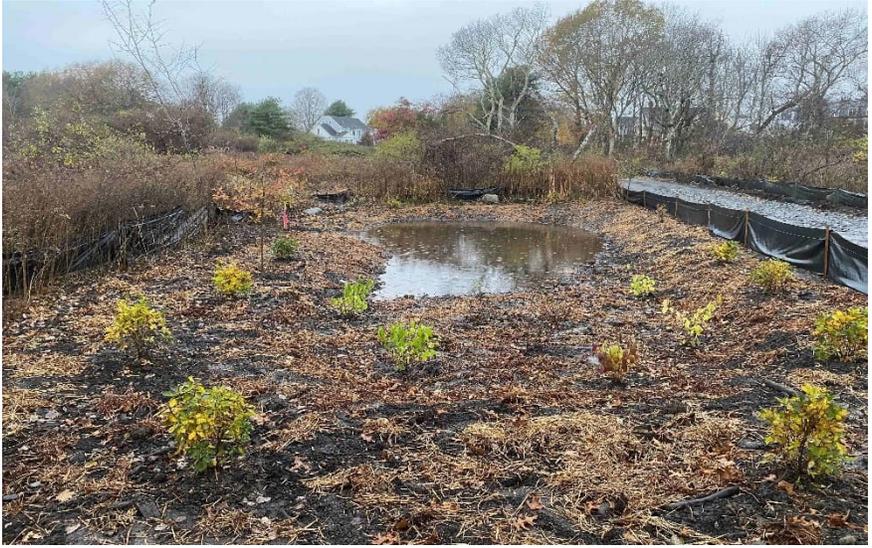
<b>PHOTOGRAPHIC LOG</b>	
Client Name: Eversource		Site Location: Sudbury to Hudson Transmission Reliability Project	Town: Sudbury
Photo No.: 3	Date: 11-9-23

Description:  Work area from segment 14, wetland replication area, looking westward.

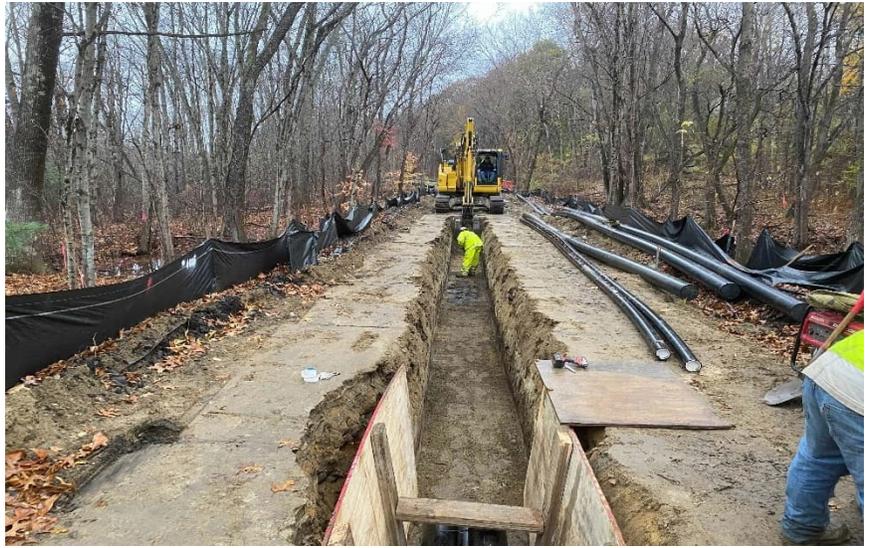
<b>PHOTOGRAPHIC LOG</b>	
Client Name: Eversource		Site Location: Sudbury to Hudson Transmission Reliability Project	Town: Sudbury
Photo No.: 4	Date: 11-9-23

Description:  Work area within segment 14, conduit work, looking westward.

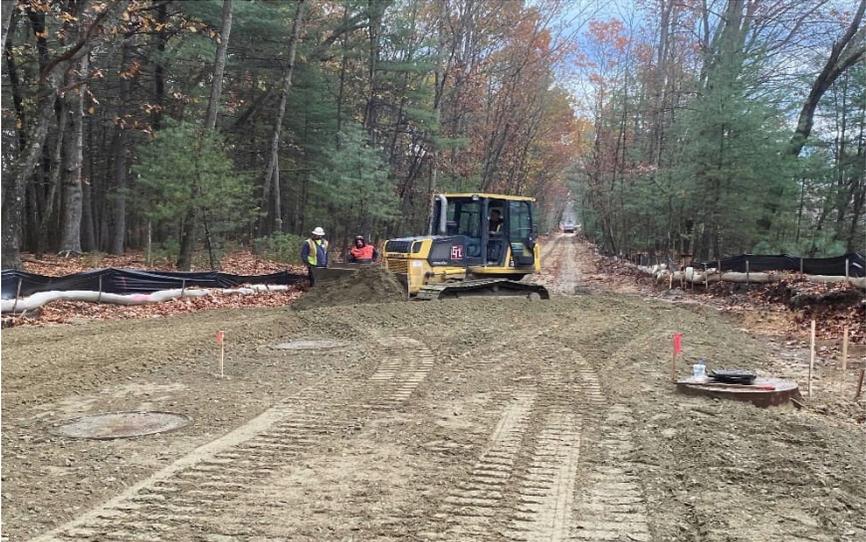
<b>PHOTOGRAPHIC LOG</b>	
Client Name: Eversource		Site Location: Sudbury to Hudson Transmission Reliability Project	
Town: Sudbury			
Photo No.: 5	Date: 11-9-23

Description:  Work area, grading work, within segment 11, existing erosion control, looking eastward.

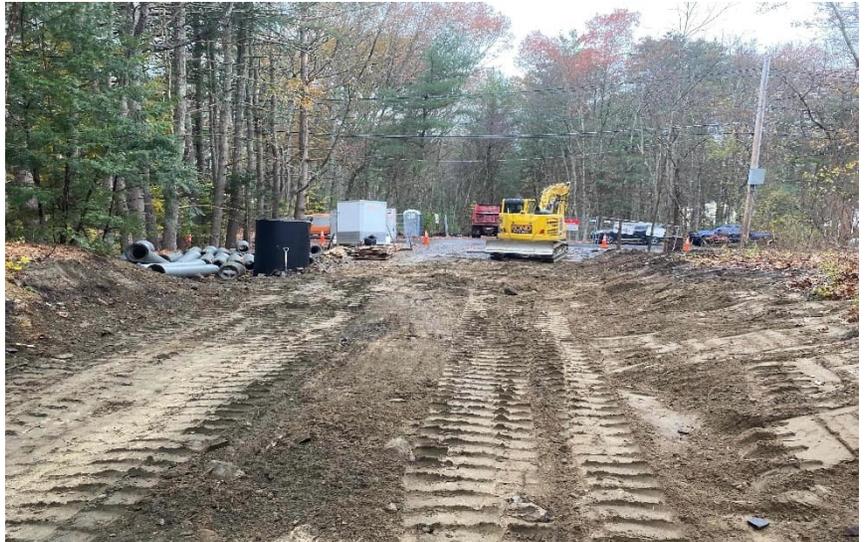
<b>PHOTOGRAPHIC LOG</b>	
Client Name: Eversource		Site Location: Sudbury to Hudson Transmission Reliability Project	
Town: Sudbury			
Photo No.: 6	Date: 11-9-23

Description:  Work area within segment 10, conduit work, looking westward.

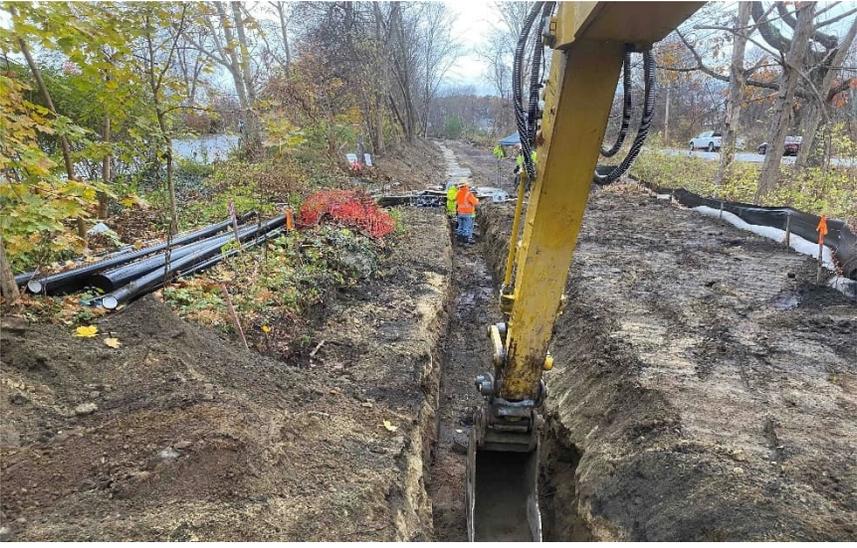
<b>PHOTOGRAPHIC LOG</b>	
Client Name: Eversource		Site Location: Sudbury to Hudson Transmission Reliability Project	Town: Sudbury
Photo No.: 7	Date: 11-9-23

Description:  Work area within segment 12, conduit work, existing erosion control, looking westward.

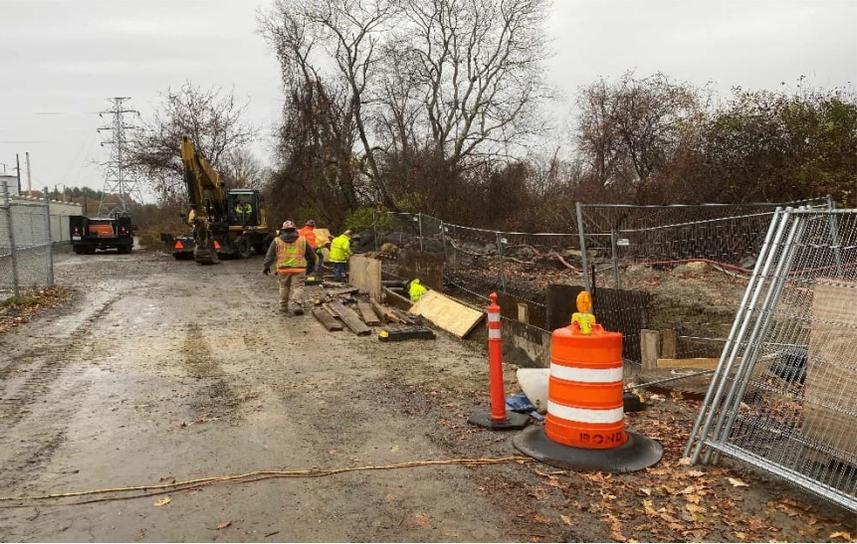
<b>PHOTOGRAPHIC LOG</b>	
Client Name: Eversource		Site Location: Sudbury to Hudson Transmission Reliability Project	Town: Sudbury
Photo No.: 8	Date: 11-9-23

Description:  Conduit work near substation & manhole #28, looking southward.

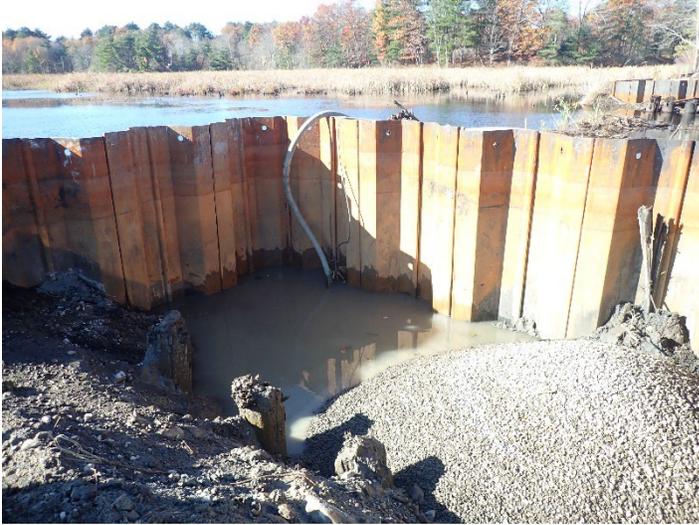
<b>PHOTOGRAPHIC LOG</b>	
<b>Client Name:</b> Eversource		<b>Site Location:</b> Sudbury to Hudson Transmission Reliability Project	<b>Town:</b> Hudson
<b>Photo No.:</b> 1	<b>Date:</b> 11/8/2023

<b>Description:</b> View of water prior to treatment at bridge 130 at Fort Meadow Brook.. Water appeared turbid. Facing west.

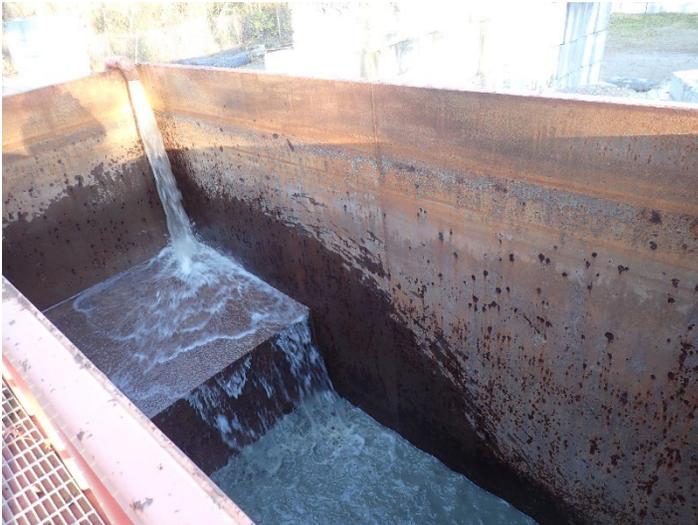
<b>PHOTOGRAPHIC LOG</b>	
<b>Client Name:</b> Eversource		<b>Site Location:</b> Sudbury to Hudson Transmission Reliability Project	<b>Town:</b> Hudson
<b>Photo No.:</b> 2	<b>Date:</b> 11/8/2023

<b>Description:</b> View of water pumping into the frac tank. Facing west.

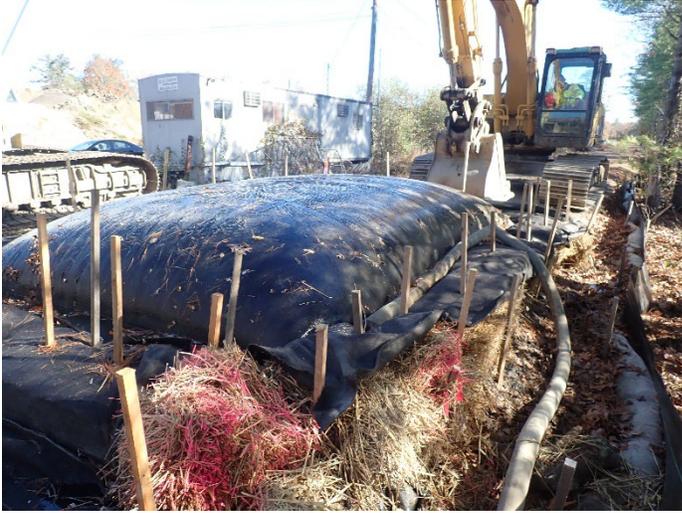
<b>PHOTOGRAPHIC LOG</b>		
<b>Client Name:</b> Eversource		<b>Site Location:</b> Sudbury to Hudson Transmission Reliability Project		<b>Town:</b> Hudson
<b>Photo No.:</b> 3	<b>Date:</b> 11/8/2023

<b>Description:</b> View of dewatering controls (straw bale corral with filter fabric, stone, and silt bag). Facing east.

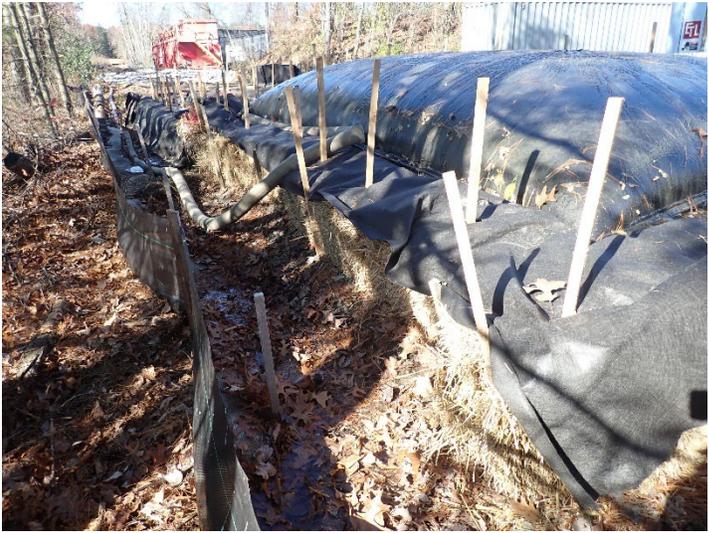
<b>PHOTOGRAPHIC LOG</b>		
<b>Client Name:</b> Eversource		<b>Site Location:</b> Sudbury to Hudson Transmission Reliability Project		<b>Town:</b> Hudson
<b>Photo No.:</b> 4	<b>Date:</b> 11/8/2023

<b>Description:</b> View of discharge from controls. Discharge appeared turbid. Turbidity reading was on average 22 NTUs at 1:30pm. Discharge did not appear to be leaving the project. Facing west.

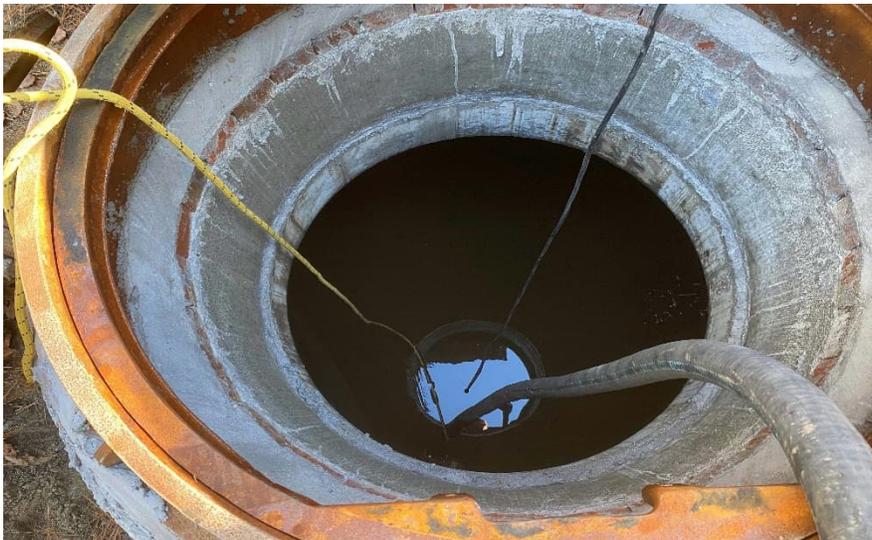
<b>PHOTOGRAPHIC LOG</b>	
Client Name: Eversource		Site Location: Sudbury to Hudson Transmission Reliability Project	Town: Sudbury
Photo No.: 1	Date: 11/8/2023

Description: View of area being pumped from manhole within segment 10.

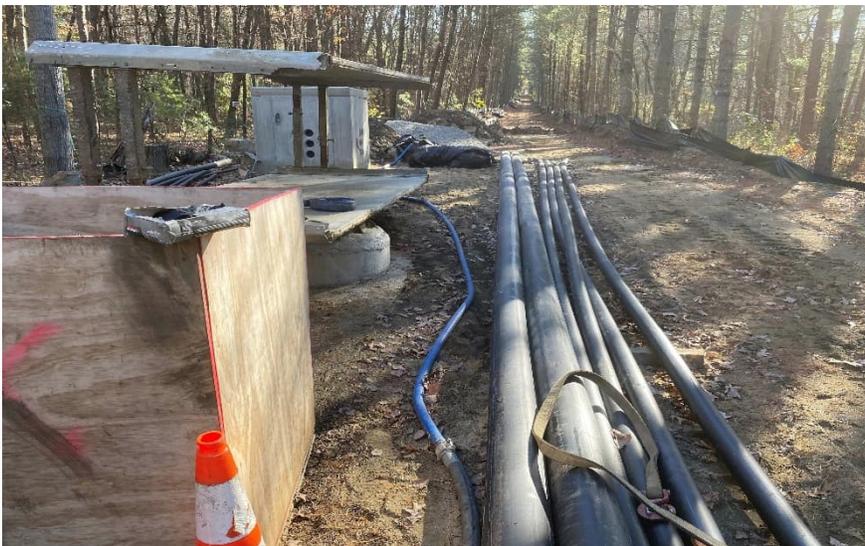
<b>PHOTOGRAPHIC LOG</b>	
Client Name: Eversource		Site Location: Sudbury to Hudson Transmission Reliability Project	Town: Sudbury
Photo No.: 2	Date: 11/8/2023

Description: Segment 10. View of dewatering operation. Looking eastward.

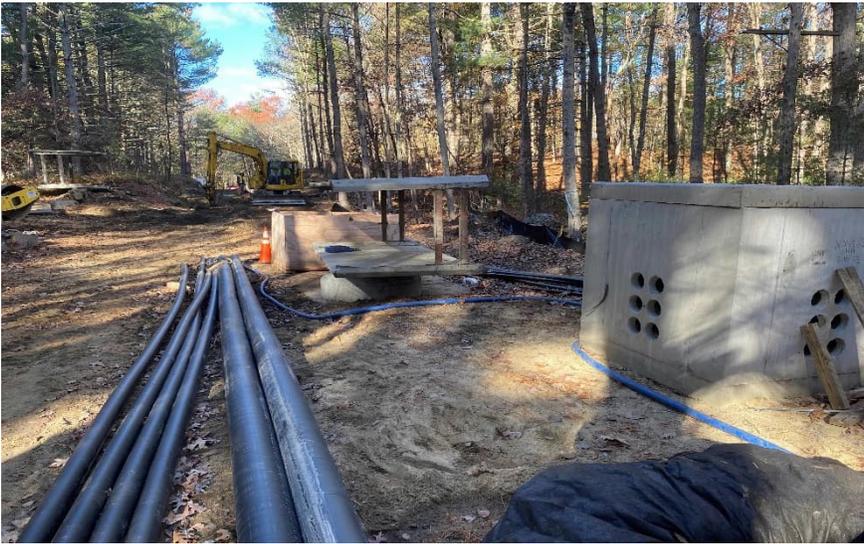
<b>PHOTOGRAPHIC LOG</b>	
Client Name: Eversource		Site Location: Sudbury to Hudson Transmission Reliability Project	Town: Sudbury
Photo No.: 3	Date: 11/8/2023

Description: Segment 10. View of dewatering operation, looking westward.

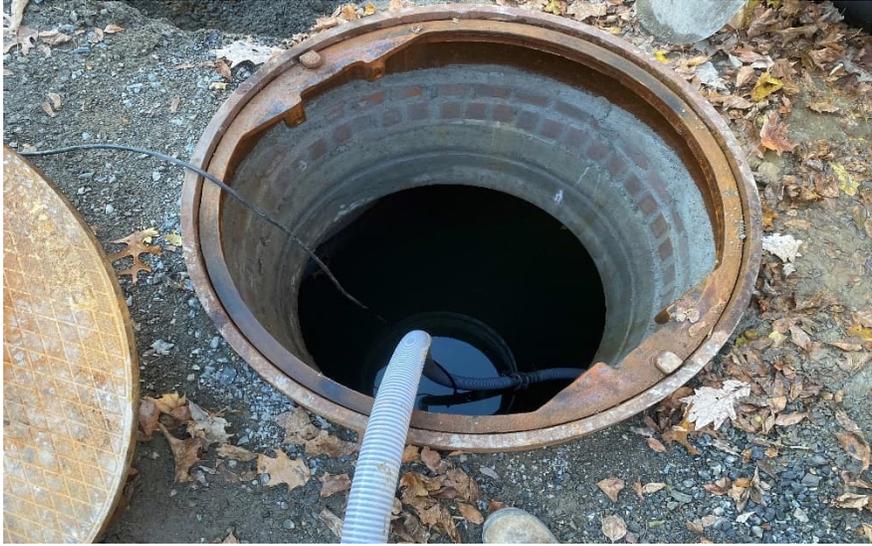
<b>PHOTOGRAPHIC LOG</b>	
Client Name: Eversource		Site Location: Sudbury to Hudson Transmission Reliability Project	Town: Sudbury
Photo No.: 1	Date: 11/8/2023

Description: View of area being pumped from manhole #28 outside substation.

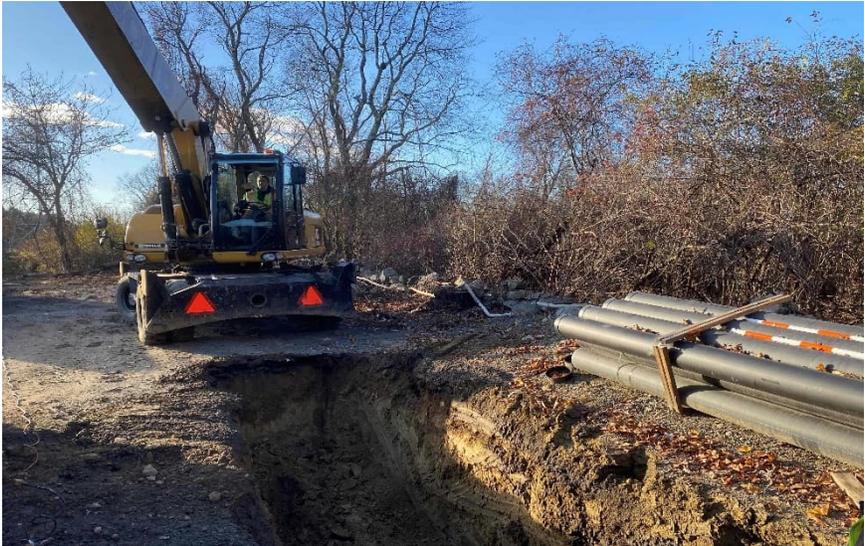
<b>PHOTOGRAPHIC LOG</b>	
Client Name: Eversource		Site Location: Sudbury to Hudson Transmission Reliability Project	Town: Sudbury
Photo No.: 2	Date: 11/8/2023

Description: Manhole #28. View of dewatering operation. Looking southward.

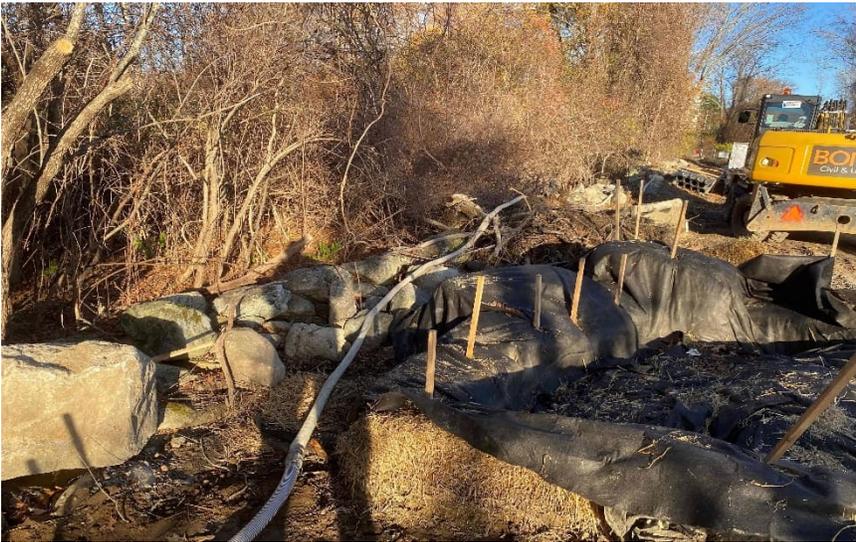
<b>PHOTOGRAPHIC LOG</b>	
Client Name: Eversource		Site Location: Sudbury to Hudson Transmission Reliability Project	Town: Sudbury
Photo No.: 3	Date: 11/8/2023

Description: Manhole #28. View of dewatering operation, looking northward.

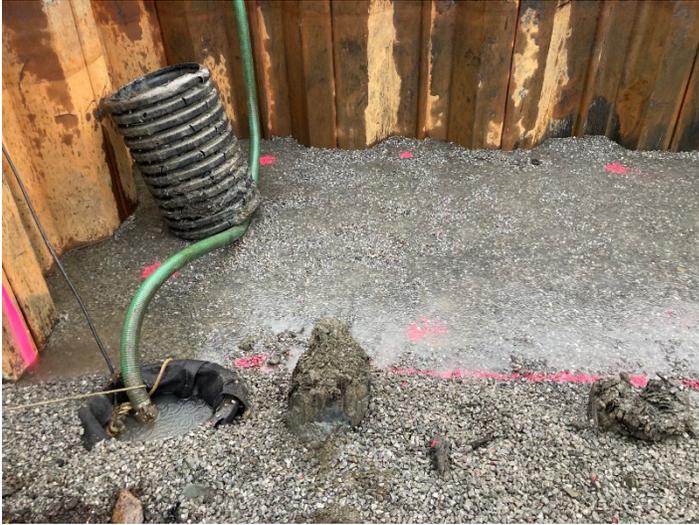
<b>PHOTOGRAPHIC LOG</b>		
<b>Client Name:</b> Eversource		<b>Site Location:</b> Sudbury to Hudson Transmission Reliability Project		<b>Town:</b> Hudson
<b>Photo No.:</b> 1	<b>Date:</b> 11/09/2023

<b>Description:</b> View of coffer dam at bridge 130 in segment 3. Water appeared slightly turbid prior to treatment. Facing west.

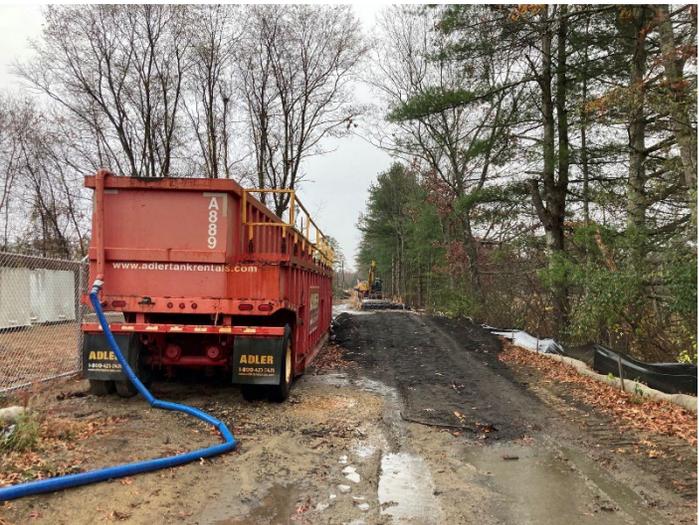
<b>PHOTOGRAPHIC LOG</b>		
<b>Client Name:</b> Eversource		<b>Site Location:</b> Sudbury to Hudson Transmission Reliability Project		<b>Town:</b> Hudson
<b>Photo No.:</b> 2	<b>Date:</b> 11/09/2023

<b>Description:</b> View of frac tank. Facing east.

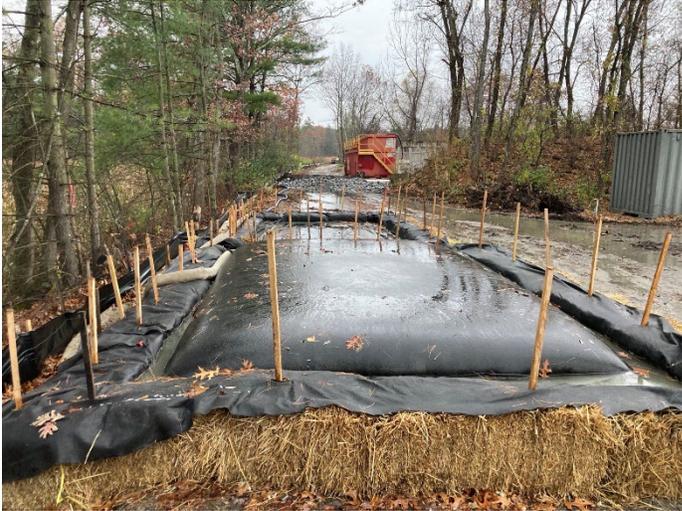
<b>PHOTOGRAPHIC LOG</b>	
<b>Client Name:</b> Eversource		<b>Site Location:</b> Sudbury to Hudson Transmission Reliability Project	<b>Town:</b> Hudson
<b>Photo No.:</b> 3	<b>Date:</b> 11/09/2023

<b>Description:</b> View of dewatering controls (frac tank and straw bale corral with filter fabric, stone, and silt bag). Facing west.

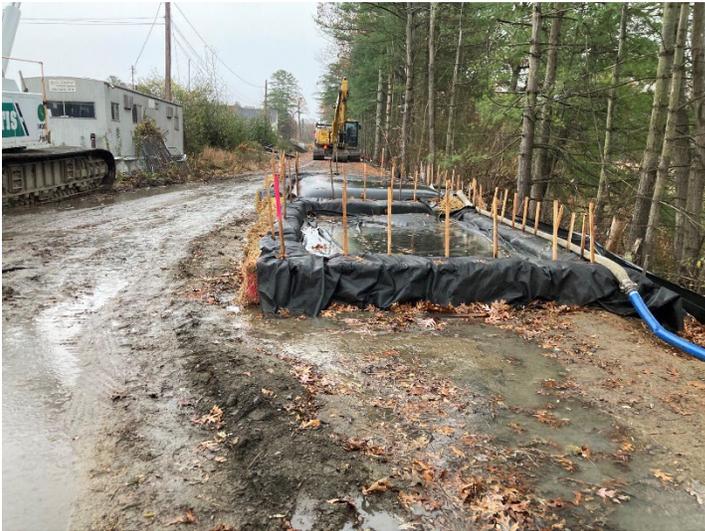
<b>PHOTOGRAPHIC LOG</b>	
<b>Client Name:</b> Eversource		<b>Site Location:</b> Sudbury to Hudson Transmission Reliability Project	<b>Town:</b> Hudson
<b>Photo No.:</b> 4	<b>Date:</b> 11/09/2023

<b>Description:</b> View of discharge from controls. Discharge appeared turbid. Turbidity reading was higher than 50 NTUs, but discharge did not appear to be leaving the project. Facing east.

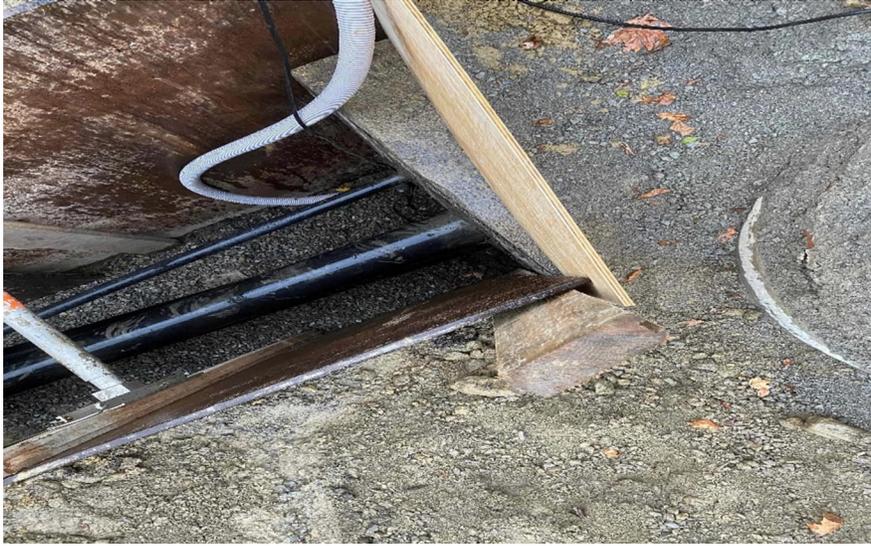
PHOTOGRAPHIC LOG	
Client Name: Eversource		Site Location: Sudbury to Hudson Transmission Reliability Project	Town: Sudbury
Photo No.: 1	Date: 11/9/2023

Description: View of area being pumped from manhole #28 outside substation.

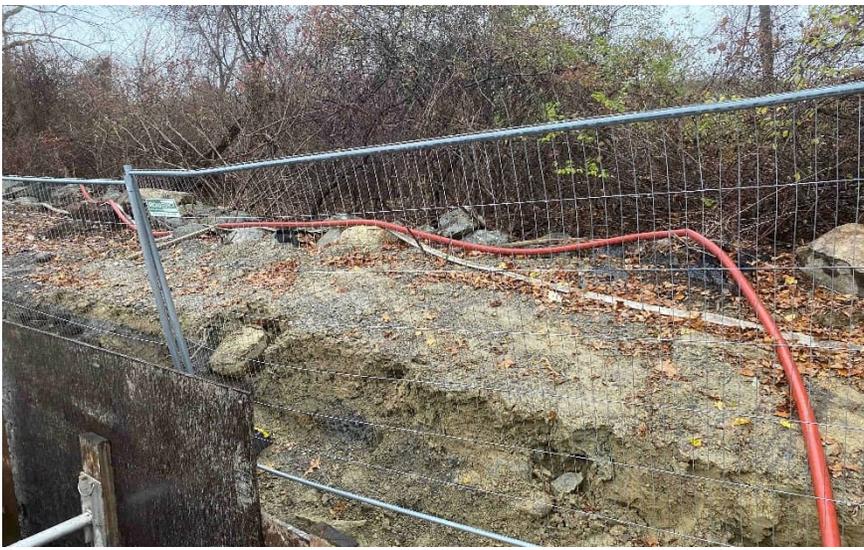
PHOTOGRAPHIC LOG	
Client Name: Eversource		Site Location: Sudbury to Hudson Transmission Reliability Project	Town: Sudbury
Photo No.: 2	Date: 11/9/2023

Description: Manhole #28. View of dewatering operation. Looking southward.

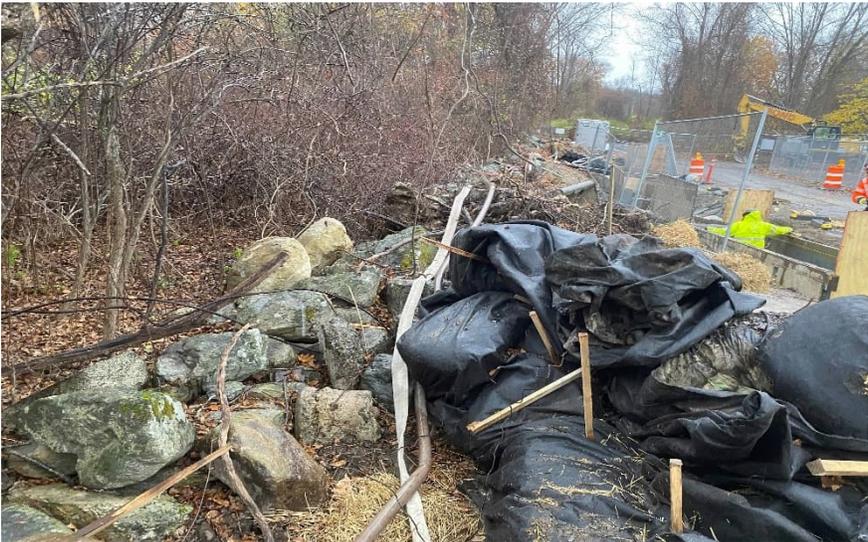
<b>PHOTOGRAPHIC LOG</b>	
Client Name: Eversource		Site Location: Sudbury to Hudson Transmission Reliability Project	Town: Sudbury
Photo No.: 3	Date: 11/9/2023

Description: Manhole #28. View of dewatering operation, looking northward.

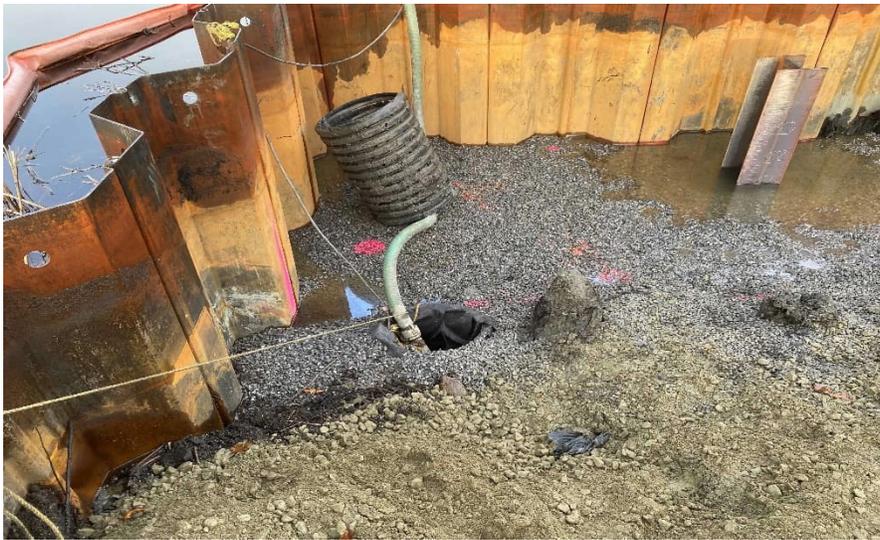
<b>PHOTOGRAPHIC LOG</b>	
Client Name: Eversource		Site Location: Sudbury to Hudson Transmission Reliability Project	Town: Hudson
Photo No.: 1	Date: 11/10/2023

Description: View of area being pumped (i.e. cofferdam within segment 3 off Fort Meadow Brook), looking eastward.

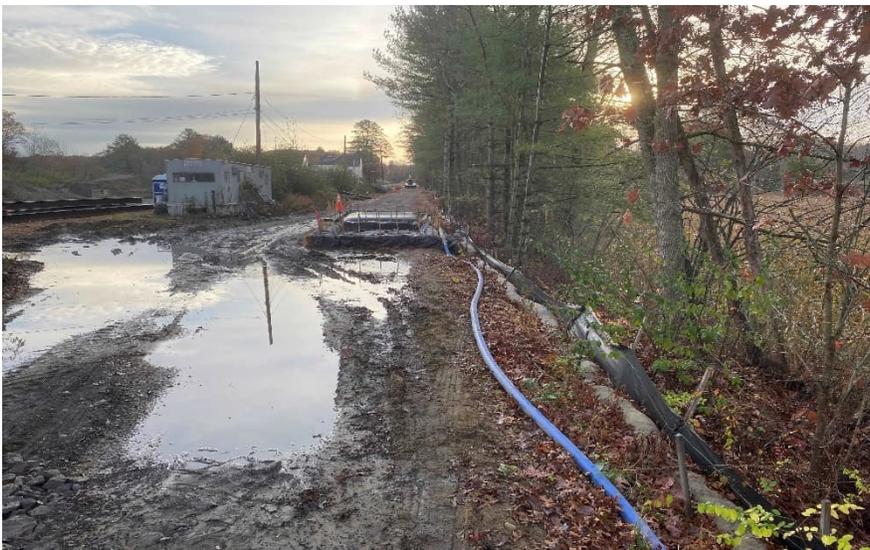
<b>PHOTOGRAPHIC LOG</b>	
Client Name: Eversource		Site Location: Sudbury to Hudson Transmission Reliability Project	Town: Hudson
Photo No.: 2	Date: 11/10/2023

Description: Segment 3. View of dewatering operation. Looking eastward.

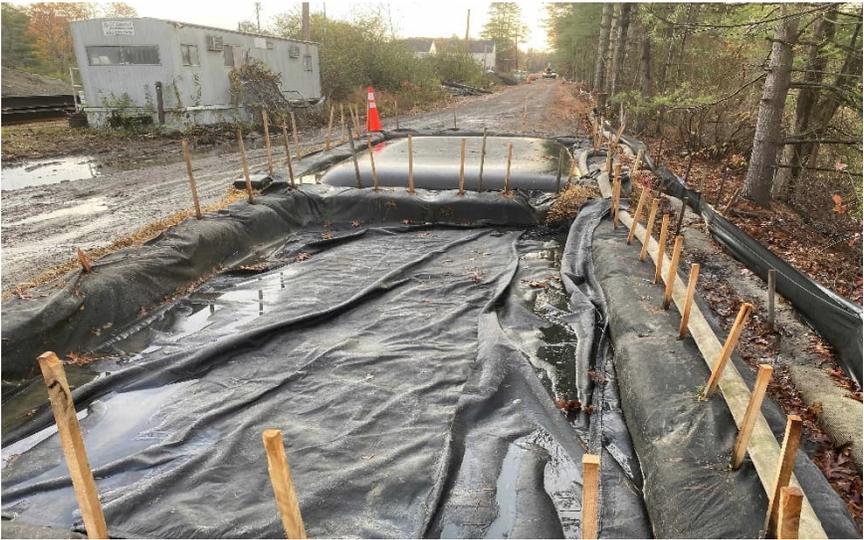
<b>PHOTOGRAPHIC LOG</b>	
Client Name: Eversource		Site Location: Sudbury to Hudson Transmission Reliability Project	
Photo No.: 3      Date: 11/10/2023

Description: Segment 3. View of discharge bag/bales dewatering operation, looking eastward.

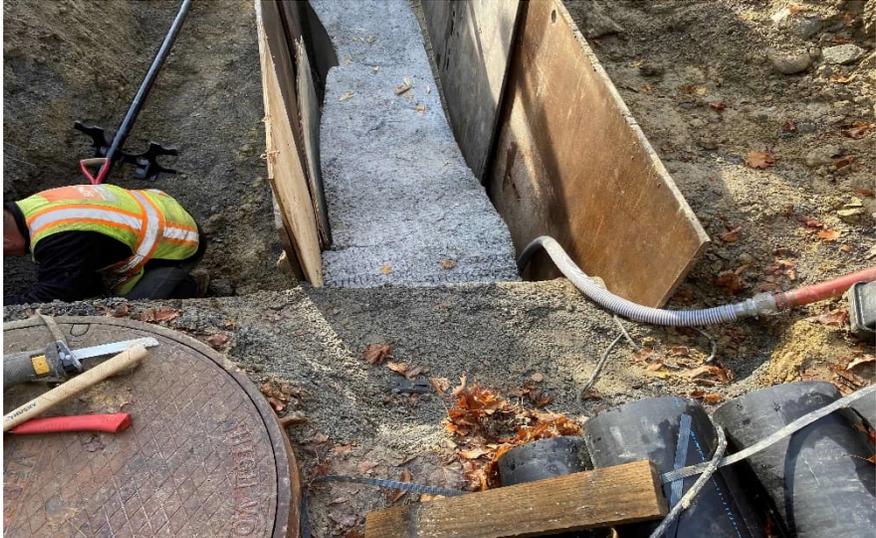
<b>PHOTOGRAPHIC LOG</b>	
Client Name: Eversource		Site Location: Sudbury to Hudson Transmission Reliability Project	Town: Sudbury
Photo No.: 1	Date: 11/10/2023

Description: View of area being pumped from trench from manhole #28 outside substation, looking southward.

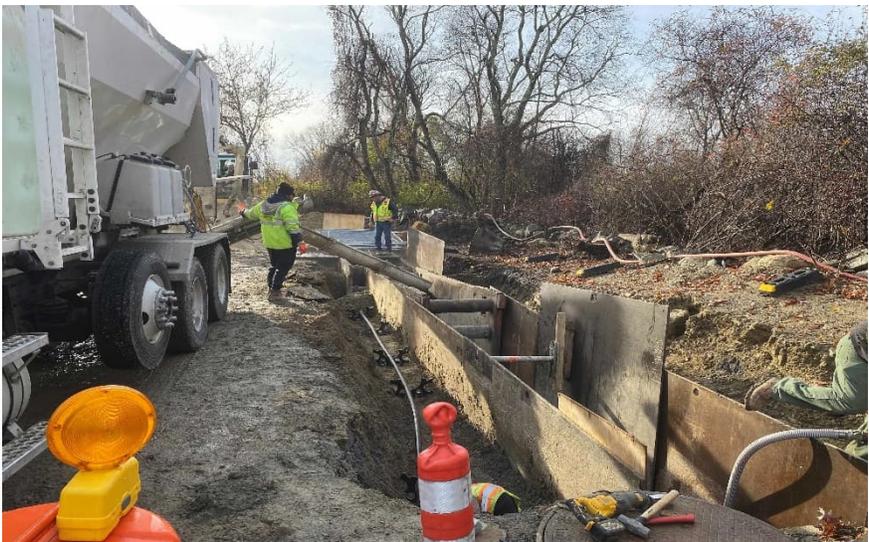
<b>PHOTOGRAPHIC LOG</b>	
Client Name: Eversource		Site Location: Sudbury to Hudson Transmission Reliability Project	Town: Sudbury
Photo No.: 2	Date: 11/10/2023

Description: Manhole #28. View of dewatering operation. Looking southward.

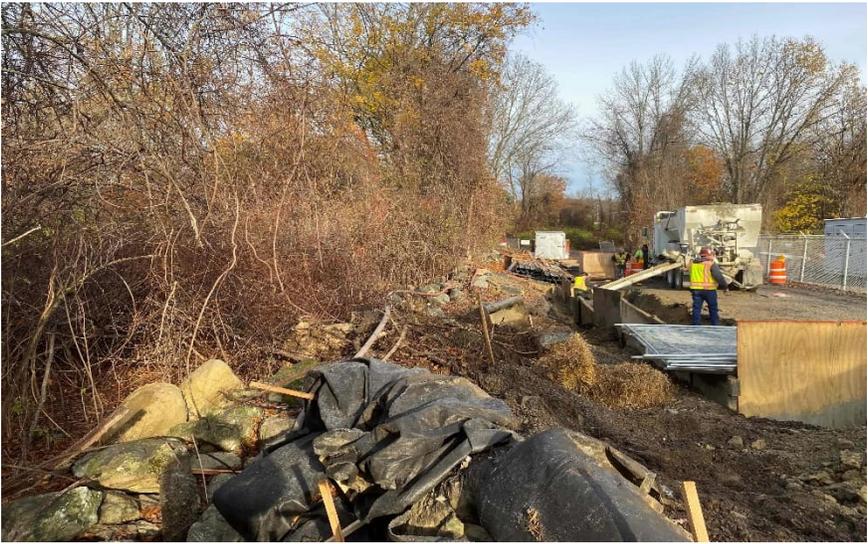
<b>PHOTOGRAPHIC LOG</b>	
Client Name: Eversource		Site Location: Sudbury to Hudson Transmission Reliability Project	Town: Sudbury
Photo No.: 3	Date: 11/10/2023

Description: Manhole #28. View of dewatering operation, looking northward.

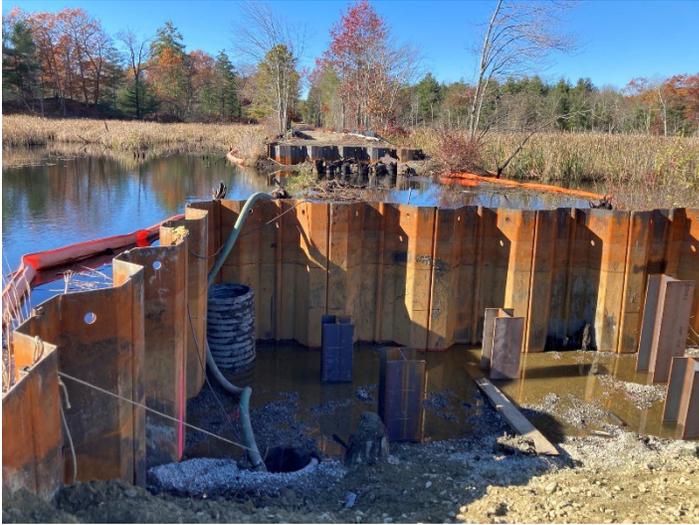
<b>PHOTOGRAPHIC LOG</b>		
<b>Client Name:</b> Eversource		<b>Site Location:</b> Sudbury to Hudson Transmission Reliability Project		<b>Town:</b> Hudson
<b>Photo No.:</b> 1	<b>Date:</b> 11/11/2023

<b>Description:</b> View of work area and pumping operation at bridge 130 in segment 3. Facing west.

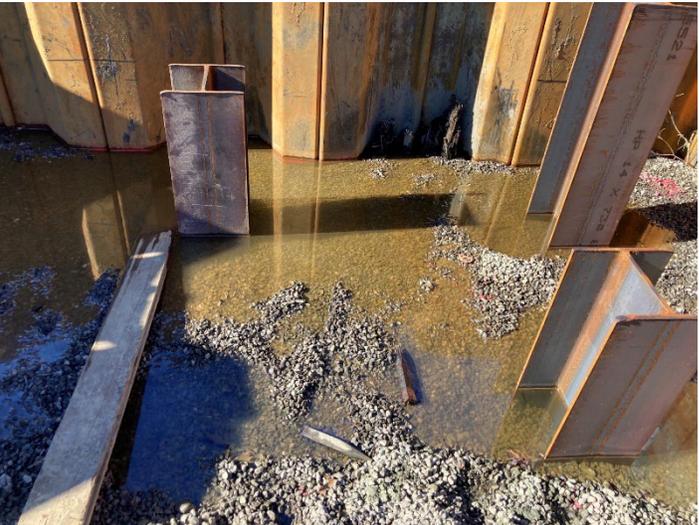
<b>PHOTOGRAPHIC LOG</b>		
<b>Client Name:</b> Eversource		<b>Site Location:</b> Sudbury to Hudson Transmission Reliability Project		<b>Town:</b> Hudson
<b>Photo No.:</b> 2	<b>Date:</b> 11/11/2023

<b>Description:</b> View of water prior to treatment. Water appeared mostly clear. Facing west.

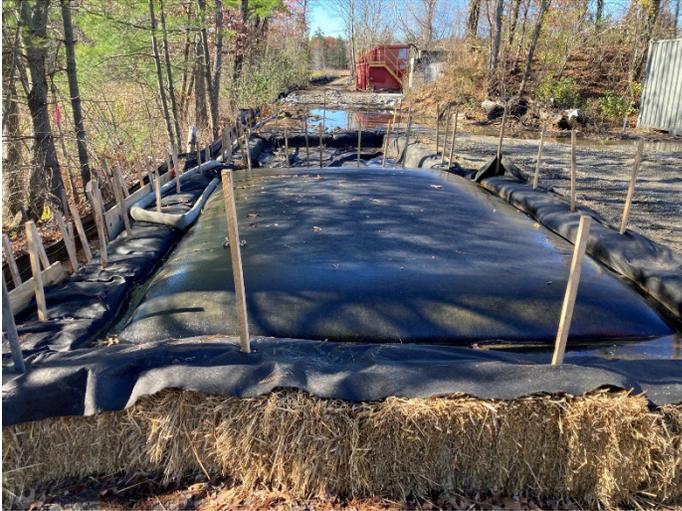
<b>PHOTOGRAPHIC LOG</b>	
<b>Client Name:</b> Eversource		<b>Site Location:</b> Sudbury to Hudson Transmission Reliability Project	<b>Town:</b> Hudson
<b>Photo No.:</b> 3	<b>Date:</b> 11/11/2023

<b>Description:</b> View of dewatering controls (straw bale corral with filter fabric, stone, and silt bag). Frac tank was not used today. Facing west.

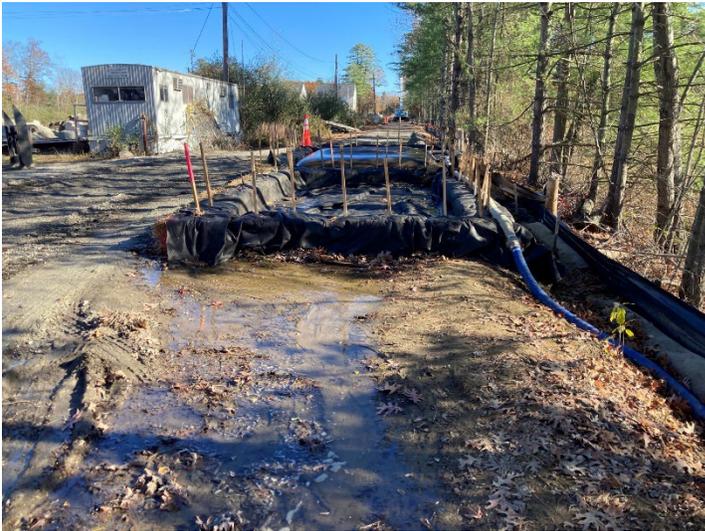
<b>PHOTOGRAPHIC LOG</b>	
<b>Client Name:</b> Eversource		<b>Site Location:</b> Sudbury to Hudson Transmission Reliability Project	<b>Town:</b> Hudson
<b>Photo No.:</b> 4	<b>Date:</b> 11/11/2023

<b>Description:</b> View of discharge from controls. Discharge appeared mostly clear. Turbidity reading was below 50 NTUs. Discharge did not appear to be leaving the project at time of inspection. Facing east.

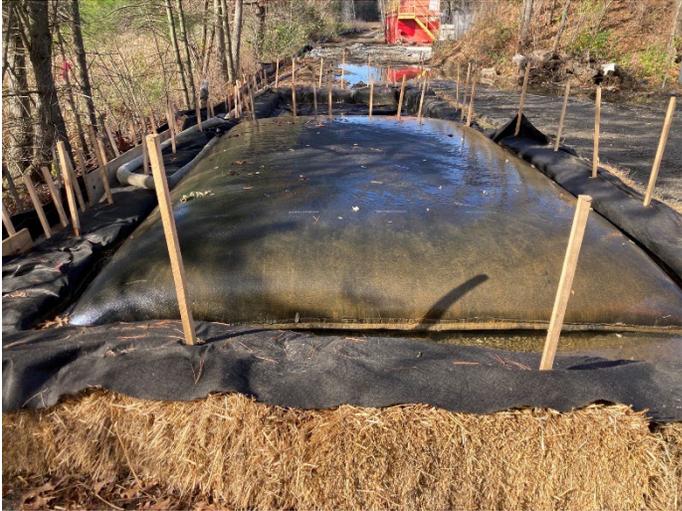
<b>PHOTOGRAPHIC LOG</b>		
<b>Client Name:</b> Eversource		<b>Site Location:</b> Sudbury to Hudson Transmission Reliability Project		<b>Town:</b> Hudson
<b>Photo No.:</b> 3	<b>Date:</b> 11/12/2023

<b>Description:</b> View of dewatering controls (straw bale corral with filter fabric, stone, and silt bag). Frac tank was not used today. Facing west.
