Weekly Environmental Compliance Summary

Sudbury to Hudson Transmission Reliability Project (USEPA Tracking # MAR1003UW)

Sudbury, Hudson, and Stow, MA

Week of: November 13, 2023 to November 17, 2023

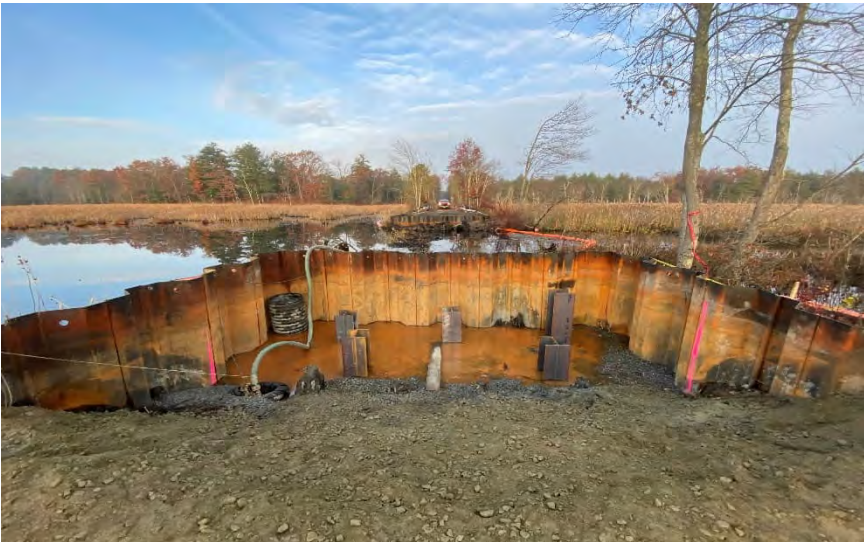
PHOTOGRAPHIC LOG	
Client Name: Eversource		Site Location: Sudbury to Hudson Transmission Reliability Project	
Photo No.: 1		Date: 11-14-23	
Description: Work area within segment 3 -> segment 2, bridge 130 work area, newly placed H-piles, looking westward.

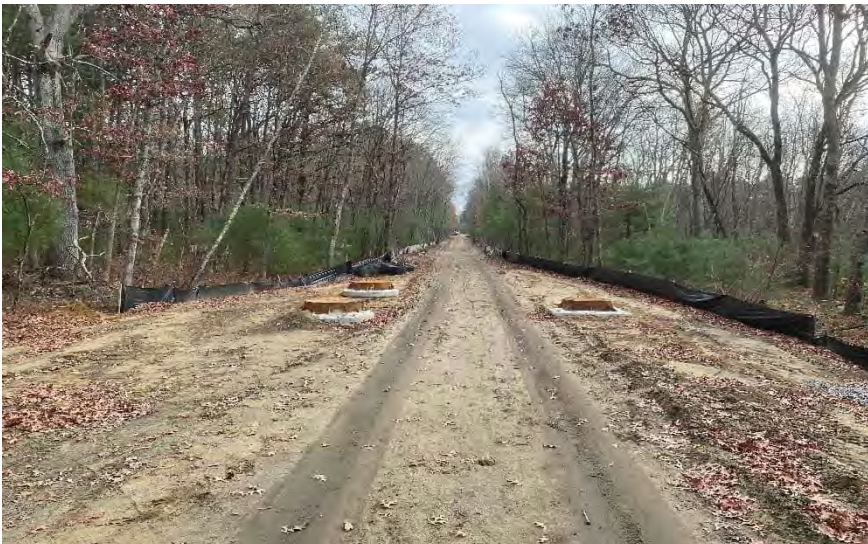
PHOTOGRAPHIC LOG	
Client Name: Eversource		Site Location: Sudbury to Hudson Transmission Reliability Project	
Photo No.: 6 Date: 11-14-23		Town: Hudson	
Description: Segment 6, Manhole #14, existing erosion control, looking eastward.

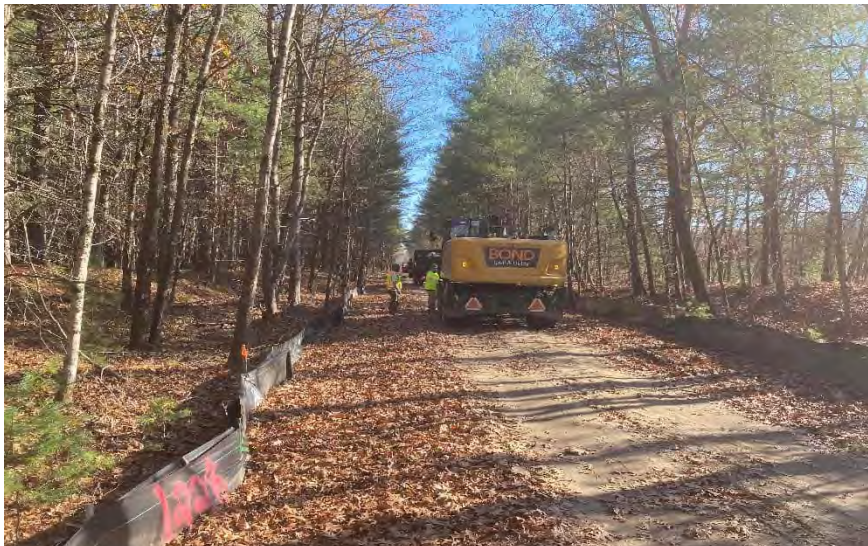
PHOTOGRAPHIC LOG	
Client Name: Eversource		Site Location: Sudbury to Hudson Transmission Reliability Project	
Photo No.: 6 Date: 11-16-23		Town: Hudson	
Description: Work area with segment 6, debris removal, existing erosion control, looking eastward.

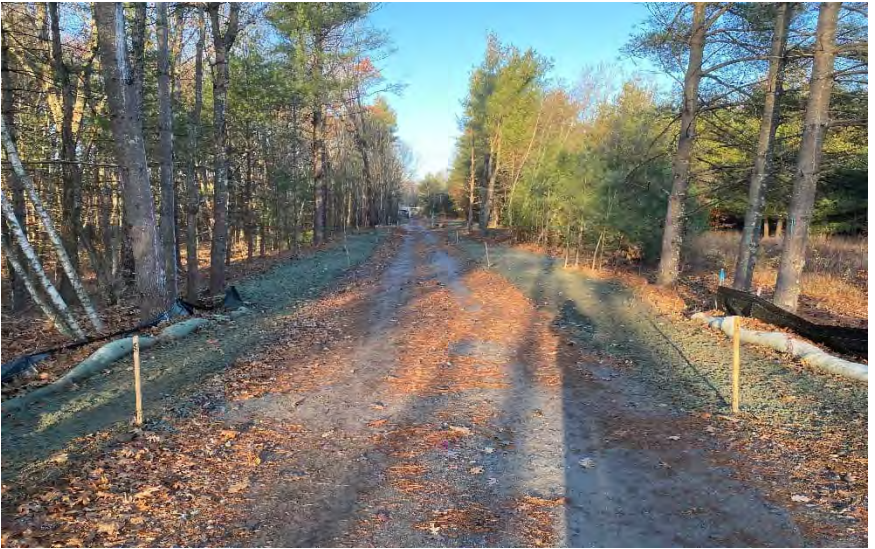
PHOTOGRAPHIC LOG	
Client Name: Eversource		Site Location: Sudbury to Hudson Transmission Reliability Project	
Town: Hudson			
Photo No.: 7	Date: 11-16-23

Description: Work area within segment 2, existing erosion control, newly placed hydroseeding, looking westward.

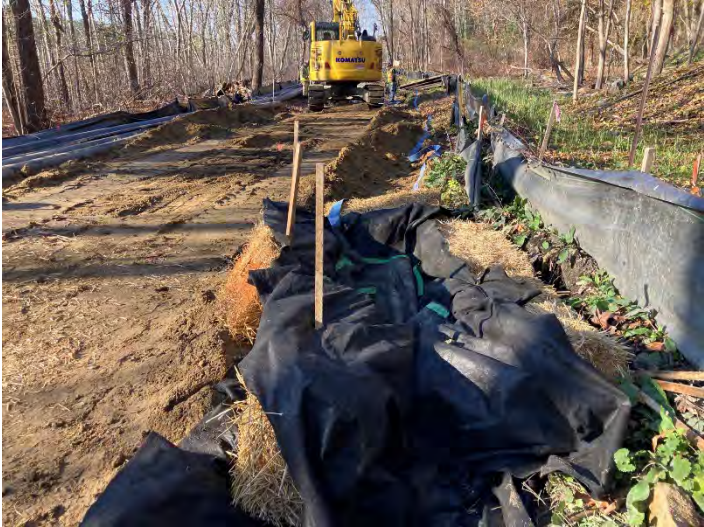
PHOTOGRAPHIC LOG	
Client Name: Eversource		Site Location: Sudbury to Hudson Transmission Reliability Project	
Photo No.: 1		Date: 11/16/2023	
Description: View of Bond's dewatering operation in segment 14. See additional dewatering inspection report. Facing west.

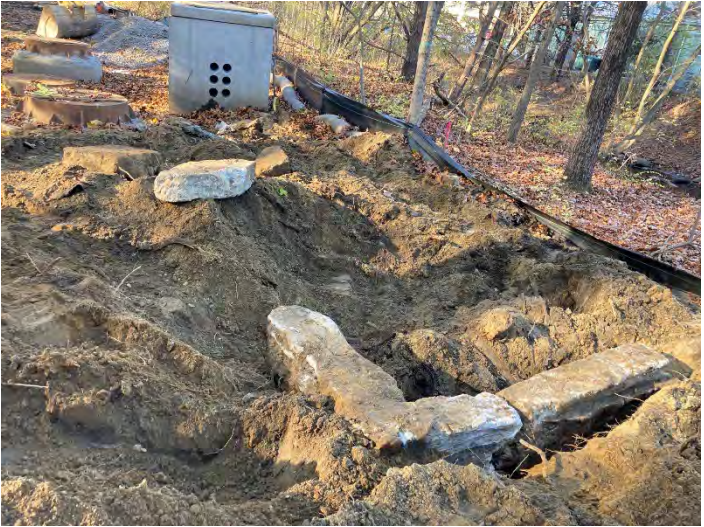
PHOTOGRAPHIC LOG	
Client Name: Eversource		Site Location: Sudbury to Hudson Transmission Reliability Project	
Photo No.: 2		Date: 11/16/2023	
Description: Historic battery box in segment 13 was accidentally dug up during conduit work on 11/16/2023. Stones will be put back into position and re-buried. David Gutbrod (Commonwealth Heritage) was notified. Facing southwest.

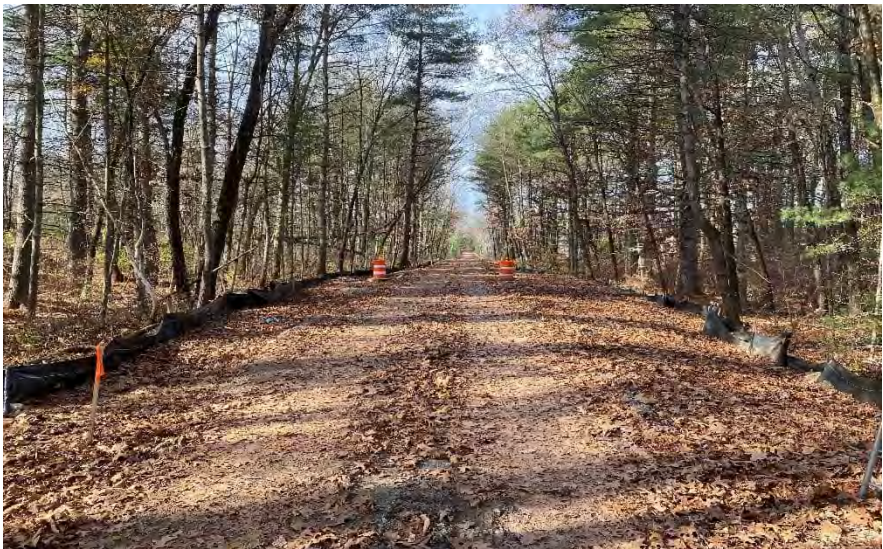
PHOTOGRAPHIC LOG	
Client Name: Eversource		Site Location: Sudbury to Hudson Transmission Reliability Project	
Photo No.: 4		Date: 11-17-23	
Description: Work area within segment 5, existing erosion control, looking westward.

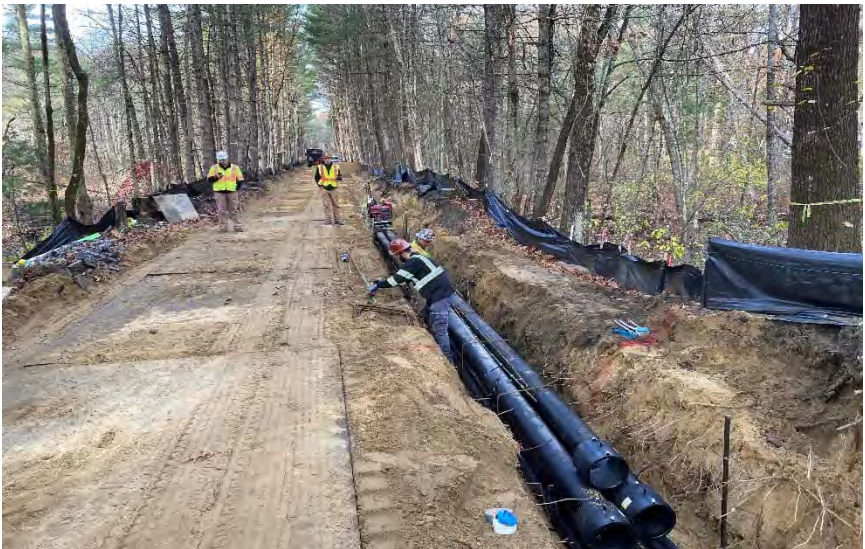
PHOTOGRAPHIC LOG	
Client Name: Eversource		Site Location: Sudbury to Hudson Transmission Reliability Project	
Photo No.: 6		Date: 11-17-23	
Description: Work area within Segment 10, conduit work over Dudley Brook, existing erosion control, looking westward.

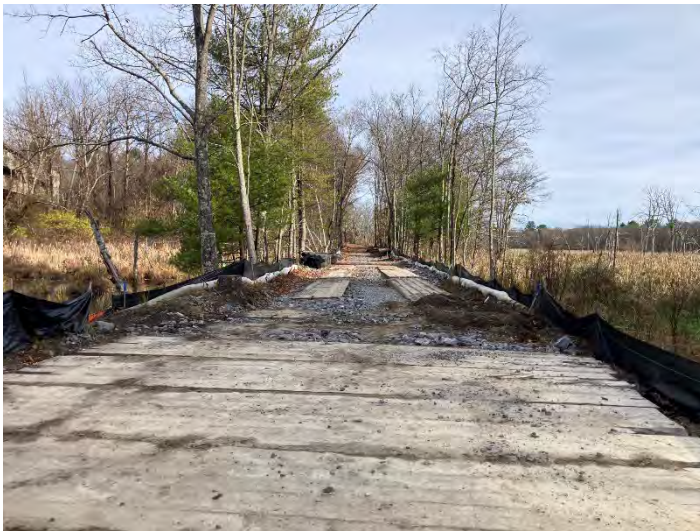
PHOTOGRAPHIC LOG	
Client Name: Eversource		Site Location: Sudbury to Hudson Transmission Reliability Project	
Photo No.: 2		Date: 11-15-2023	
Description: View of E&S controls at west end of segment 14, from bridge 127. Facing east.

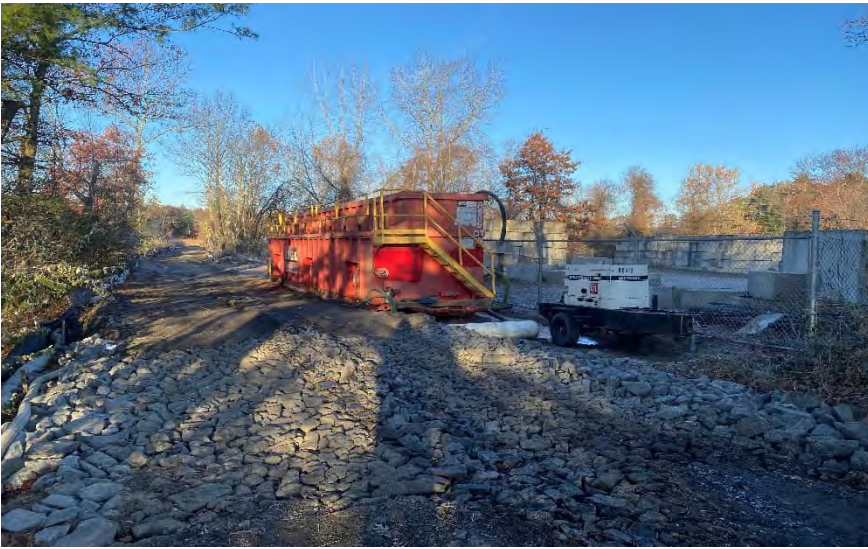
PHOTOGRAPHIC LOG	
Client Name: Eversource		Site Location: Sudbury to Hudson Transmission Reliability Project	
Photo No.: 3 Date: 11/15/2023

Description: Segment 3. View of discharge dewatering operation, looking westward.			
 		PHOTOGRAPHIC LOG	
Client Name: Eversource		Site Location: Sudbury to Hudson Transmission Reliability Project	
Photo No.: 4 Date: 11/15/2023		 	
Description: Segment 3. View of discharge from bag/bales to adjacent work area, looking eastward. Water discharge to bag intermittent and appeared to be slightly turbid. Discharge from corral to work area (foreground).

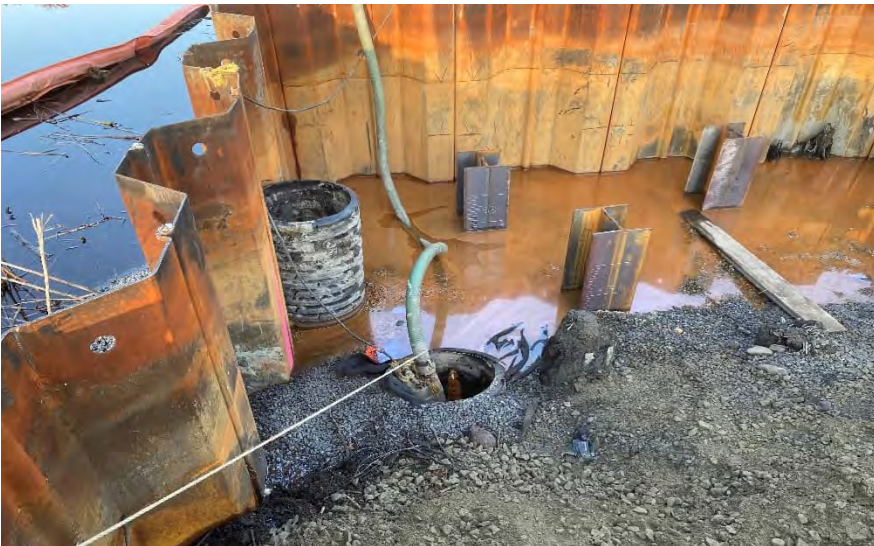
PHOTOGRAPHIC LOG	
Client Name: Eversource		Site Location: Sudbury to Hudson Transmission Reliability Project	
Photo No.: 1		Date: 11/16/2023	
Description: View of area being pumped (i.e., cofferdam within segment 3 off Fort Meadow Brook), looking westward.

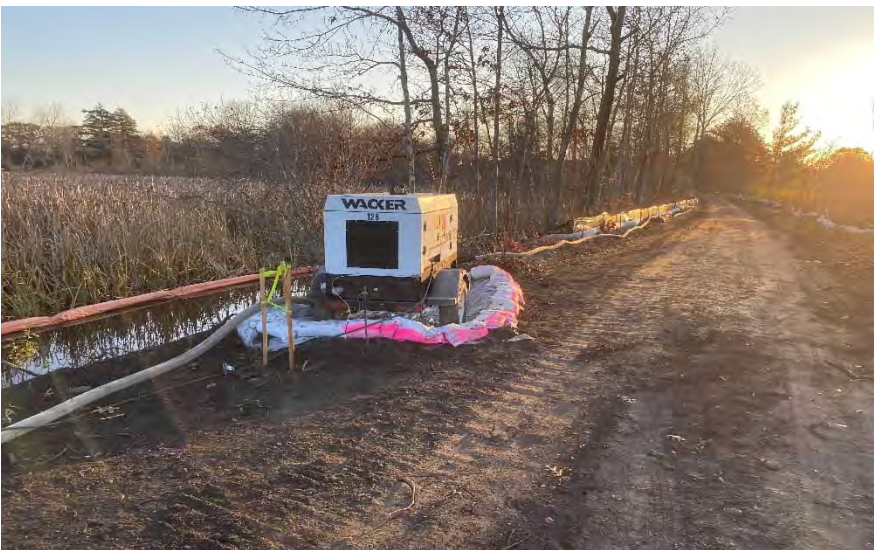
PHOTOGRAPHIC LOG	
Client Name: Eversource		Site Location: Sudbury to Hudson Transmission Reliability Project	
Photo No.: 2		Date: 11/16/2023	
Description: Segment 3. View of dewatering operation. Looking eastward.

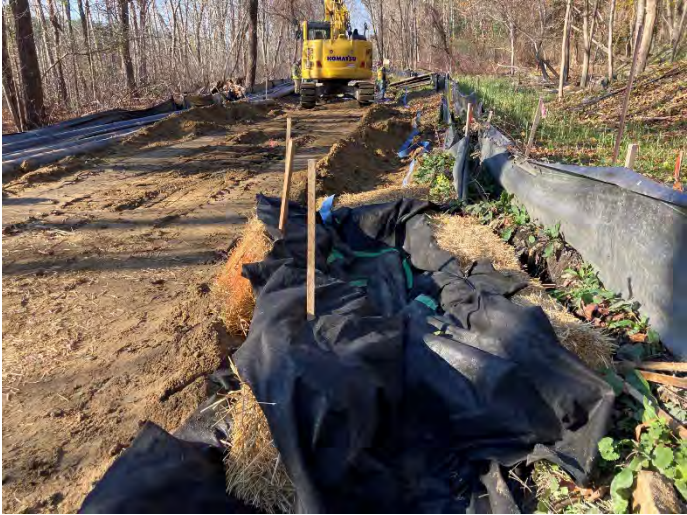
PHOTOGRAPHIC LOG	
Client Name: Eversource		Site Location: Sudbury to Hudson Transmission Reliability Project	
Photo No.: 3		Town: Sudbury	
Date: 11/16/2023

Description: View of dewatering controls (straw bale corral with filter fabric and silt bag). Facing west.

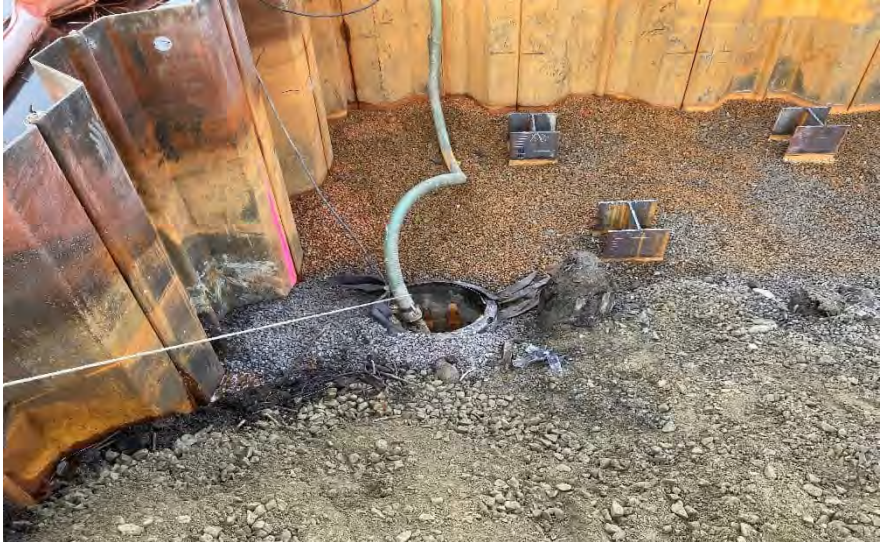
PHOTOGRAPHIC LOG	
Client Name: Eversource		Site Location: Sudbury to Hudson Transmission Reliability Project	
Photo No.: 1		Town: Hudson	
Date: 11/17/2023

Description: View of area being pumped (i.e., cofferdam within segment 3 off Fort Meadow Brook), looking westward.

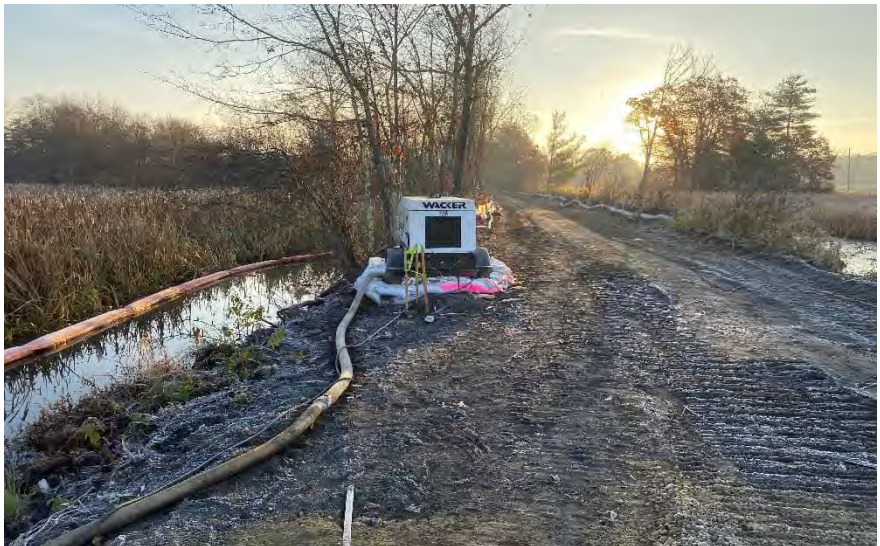
PHOTOGRAPHIC LOG	
Client Name: Eversource		Site Location: Sudbury to Hudson Transmission Reliability Project	
Photo No.: 2		Town: Hudson	
Date: 11/17/2023

Description: Segment 3. View of dewatering operation. Looking eastward.

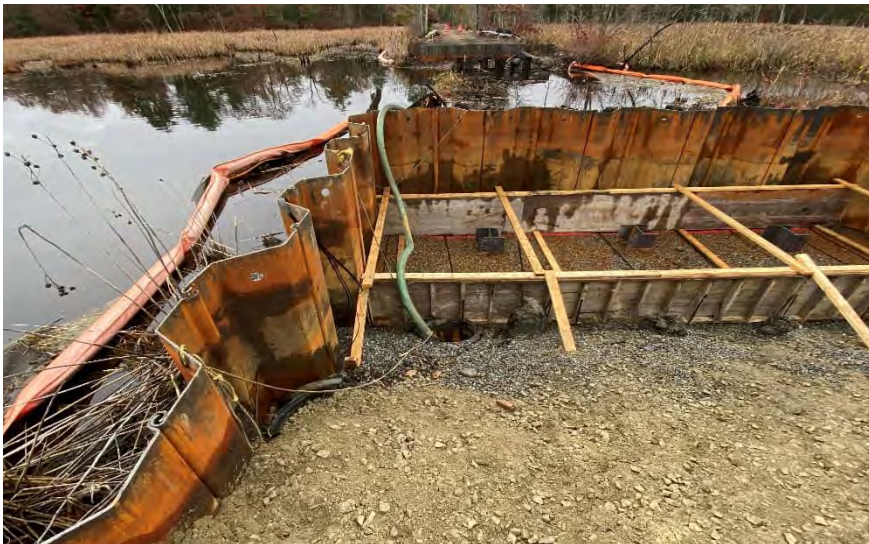
PHOTOGRAPHIC LOG	
Client Name: Eversource		Site Location: Sudbury to Hudson Transmission Reliability Project	
Photo No.: 1		Date: 11/18/2023	
Description: View of area being pumped (i.e., cofferdam within segment 3 off Fort Meadow Brook), looking westward.

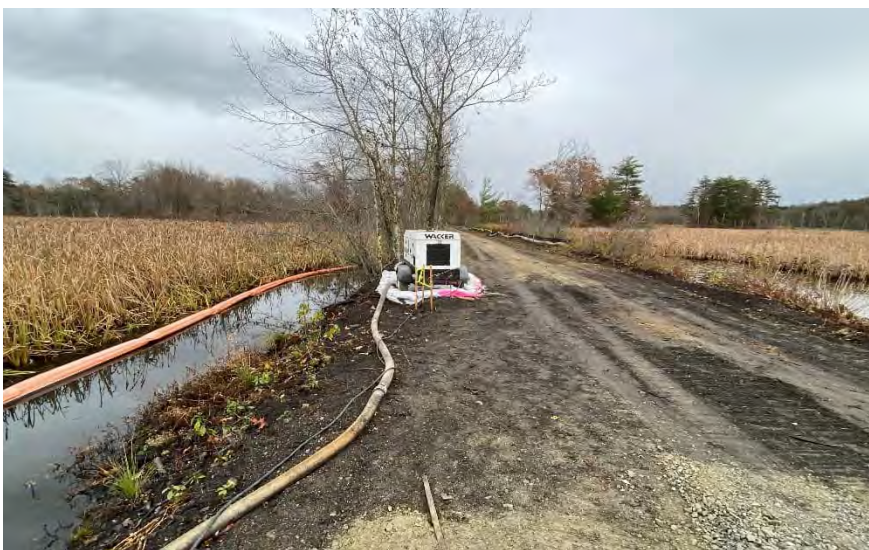
PHOTOGRAPHIC LOG	
Client Name: Eversource		Site Location: Sudbury to Hudson Transmission Reliability Project	
Photo No.: 2		Date: 11/18/2023	
Description: Segment 3. View of dewatering operation. Looking eastward.

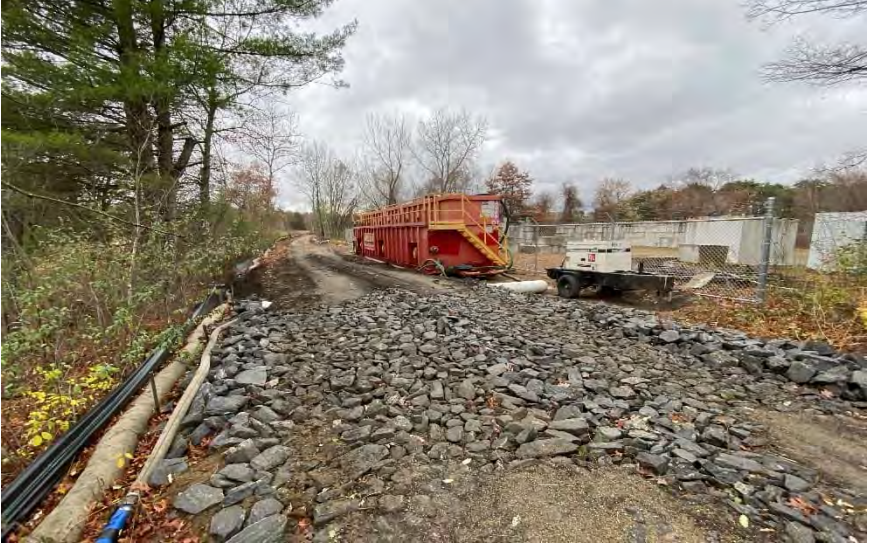
PHOTOGRAPHIC LOG	
Client Name: Eversource		Site Location: Sudbury to Hudson Transmission Reliability Project	
Photo No.: 3 Date: 11/18/2023

Description: Segment 3. View of discharge dewatering operation, looking westward.

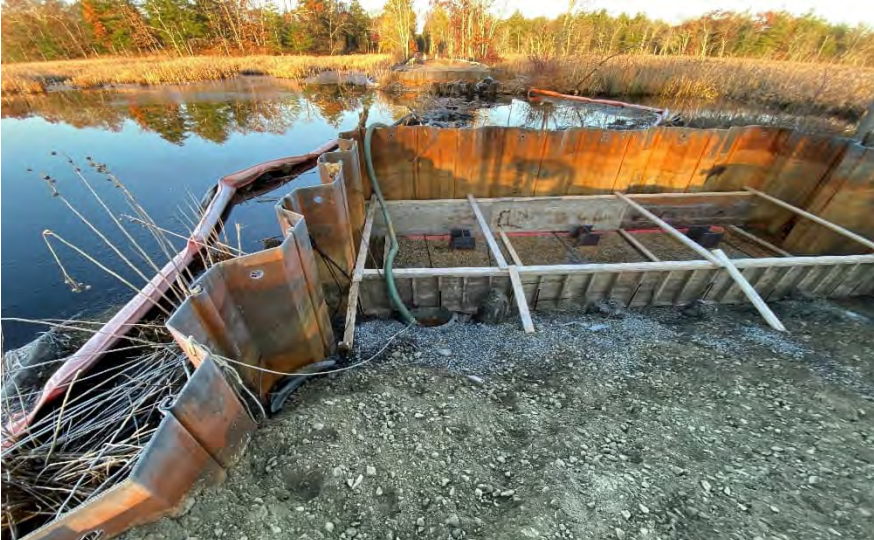
PHOTOGRAPHIC LOG	
Client Name: Eversource		Site Location: Sudbury to Hudson Transmission Reliability Project	
Town: Hudson			
Photo No.: 1	Date: 11/19/2023

Description: View of area being pumped (i.e., cofferdam within segment 3 off Fort Meadow Brook), looking westward.

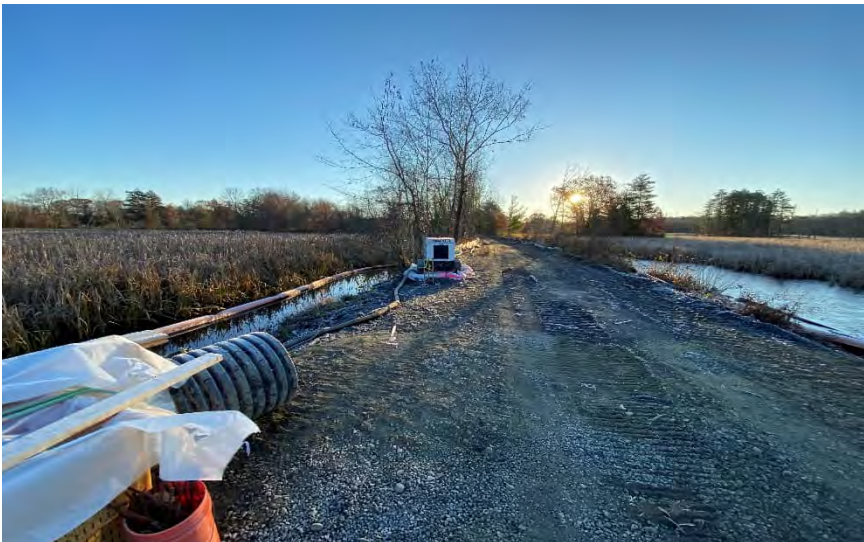
PHOTOGRAPHIC LOG	
Client Name: Eversource		Site Location: Sudbury to Hudson Transmission Reliability Project	
Town: Hudson			
Photo No.: 2	Date: 11/19/2023

Description: Segment 3. View of dewatering operation. Looking eastward.
