**Weekly Environmental Compliance Summary**

**Sudbury to Hudson Transmission Reliability Project (USEPA Tracking # MAR1003UW)**

Sudbury, Hudson, and Stow, MA

Week of: March 11, 2024 to March 15, 2024

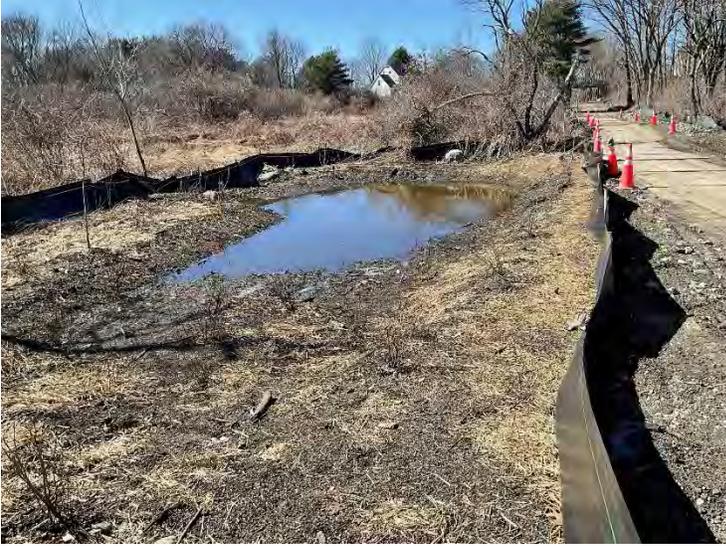
<p align="right"><b>PHOTOGRAPHIC LOG</b></p>	
<p>Client Name: Eversource</p>		<p>Site Location: Sudbury to Hudson Transmission Reliability Project</p>	<p>Town: Sudbury</p>
<p>Photo No.: 1</p>	<p>Date: 3/12/2024</p>

<p>Description: View of wetland replication area in segment 14. Facing west.</p>

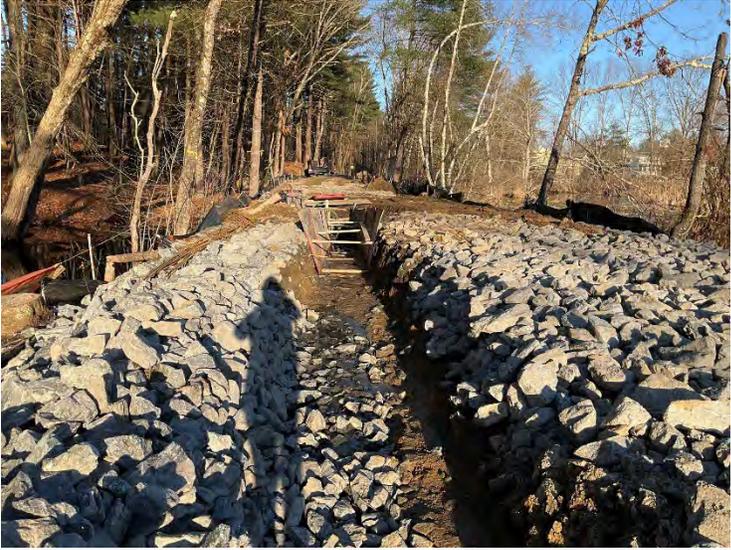
<b>PHOTOGRAPHIC LOG</b>	
Client Name: Eversource		Site Location: Sudbury to Hudson Transmission Reliability Project	Town: Sudbury
Photo No.: 3	Date: 3/12/2024

Description: View of Bond's work area in segment 13 leading to bridge 127. See additional dewatering inspection report. Facing west.

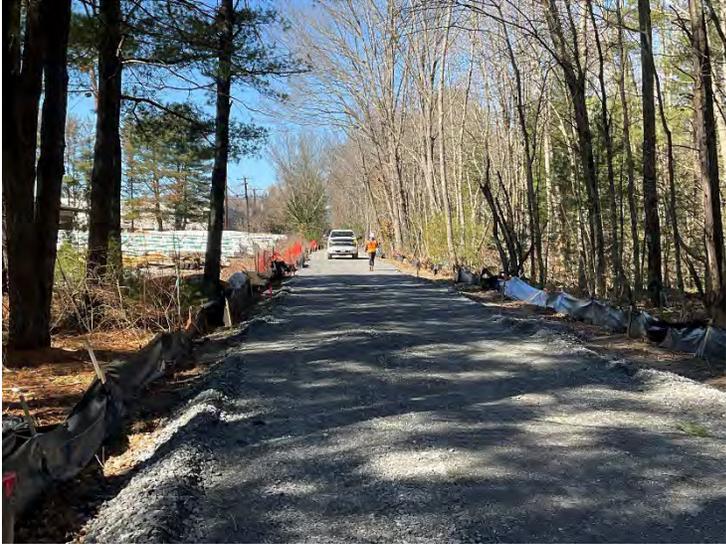
<p><b>PHOTOGRAPHIC LOG</b></p>	
<p>Client Name: Eversource</p>		<p>Site Location: Sudbury to Hudson Transmission Reliability Project</p>	<p>Town: Sudbury</p>
<p>Photo No.: 5</p>	<p>Date: 3/12/2024</p>

<p>Description: View of Emma Verville (SWCA) escorting New Wave crew through vernal pool TOY restriction zone in segment 11. Facing west.</p>

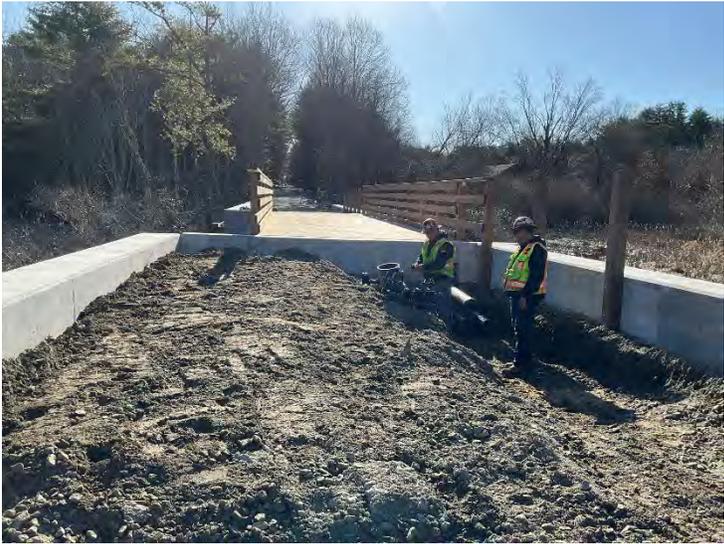
<p><b>PHOTOGRAPHIC LOG</b></p>	
<p>Client Name: Eversource</p>		<p>Site Location: Sudbury to Hudson Transmission Reliability Project</p>	<p>Town: Sudbury</p>
<p>Photo No.: 6</p>	<p>Date: 3/12/2024</p>

<p>Description: View of Bond working at bridge 128. Facing east.</p>

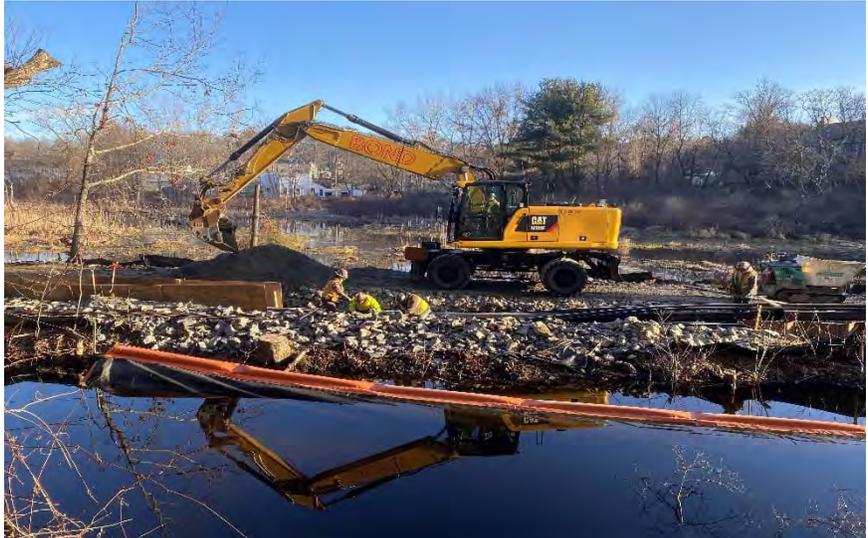
<p>PHOTOGRAPHIC LOG</p>	
<p>Client Name: Eversource</p>		<p>Site Location: Sudbury to Hudson Transmission Reliability Project</p>	<p>Town: Sudbury</p>
<p>Photo No.: 6</p>	<p>Date: 3-13-24</p>

<p>Description:</p> <p>Work area within segment 13, conduit work, existing erosion control (floating silt curtain), looking eastward.</p>

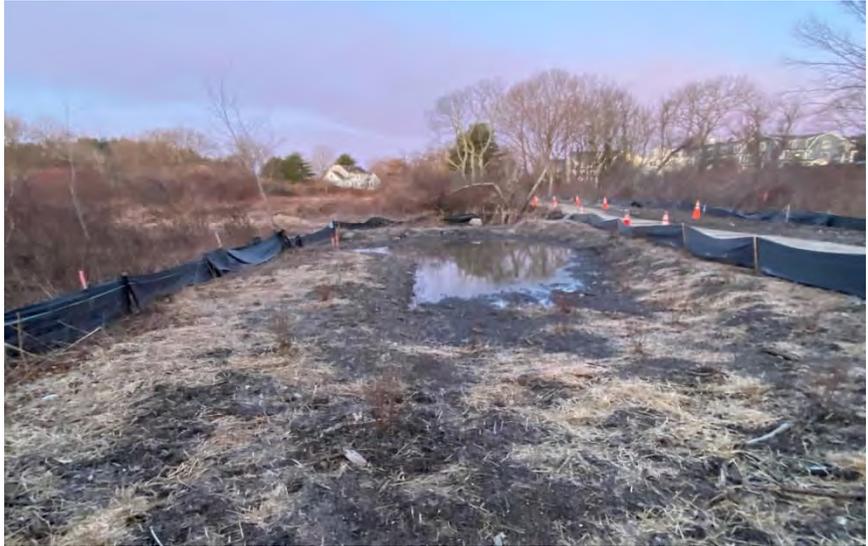
<p align="center">PHOTOGRAPHIC LOG</p>	
<p>Client Name: Eversource</p>		<p>Site Location: Sudbury to Hudson Transmission Reliability Project</p>	<p>Town: Sudbury</p>
<p>Photo No.: 8</p>	<p>Date: 3-13-24</p>

<p>Description:</p> <p>Wetland replication area within segment 14, existing erosion control, looking westward.</p>

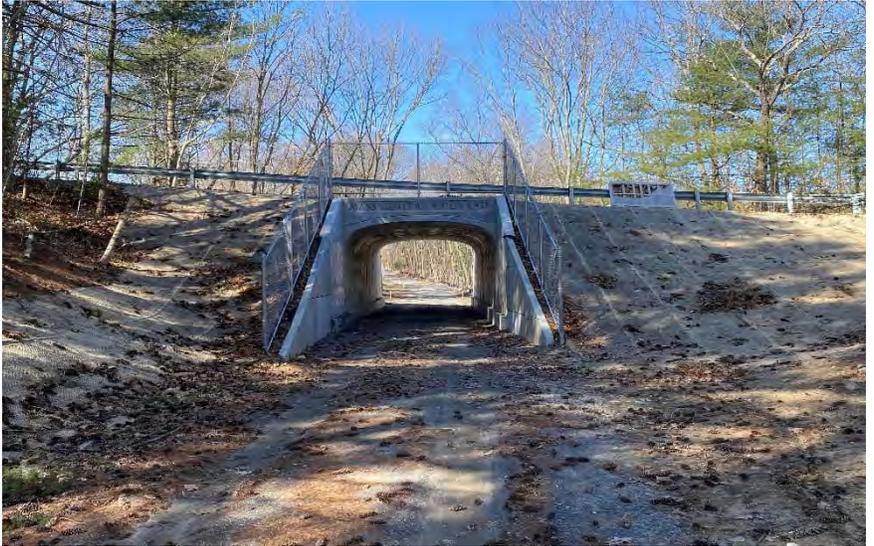
<p align="center">PHOTOGRAPHIC LOG</p>	
<p>Client Name: Eversource</p>		<p>Site Location: Sudbury to Hudson Transmission Reliability Project</p>	<p>Town: Hudson</p>
<p>Photo No.: 4</p>	<p>Date: 3-14-24</p>

<p>Description:</p> <p>Work area within segment 2, existing erosion control (hydroseeding, jute netting) at Chestnut Street crossing, looking westward.</p>

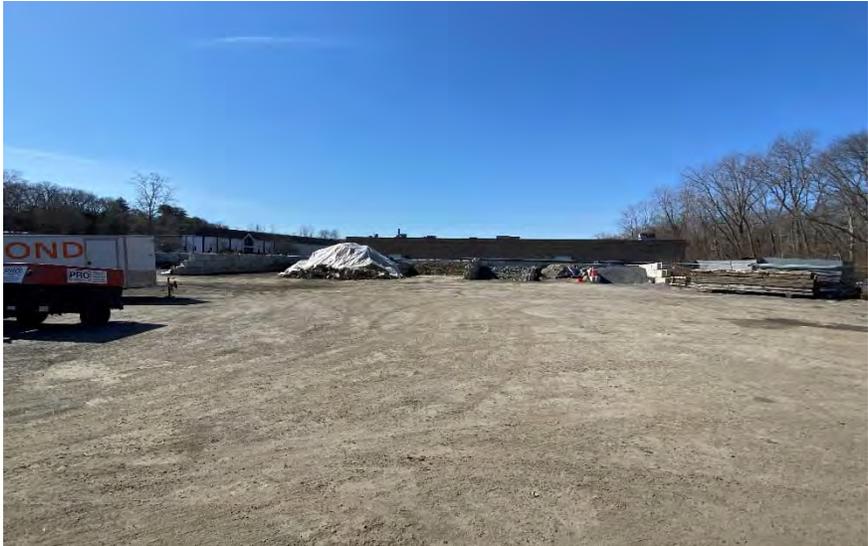
<p>PHOTOGRAPHIC LOG</p>	
<p>Client Name: Eversource</p>		<p>Site Location: Sudbury to Hudson Transmission Reliability Project</p>	<p>Town: Hudson</p>
<p>Photo No.: 5</p>	<p>Date: 3-14-24</p>

<p>Description:</p> <p>Laydown yard off Bonazzoli Avenue, covered spoil piles, looking westward.</p>

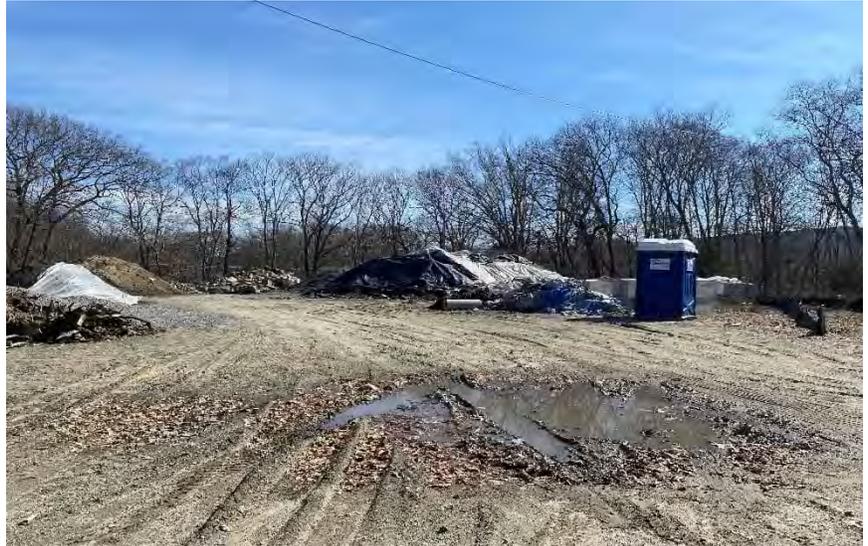
<p>PHOTOGRAPHIC LOG</p>	
<p>Client Name: Eversource</p>		<p>Site Location: Sudbury to Hudson Transmission Reliability Project</p>	<p>Town: Hudson</p>
<p>Photo No.: 6</p>	<p>Date: 3-14-24</p>

<p>Description:</p> <p>Laydown yard off Stowe Court, covered spoil piles, looking southward.</p>

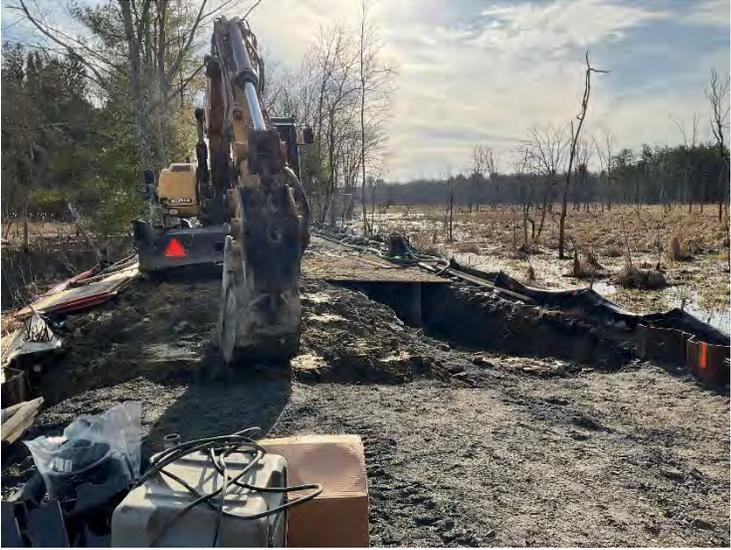
<p><b>PHOTOGRAPHIC LOG</b></p>	
<p>Client Name: Eversource</p>		<p>Site Location: Sudbury to Hudson Transmission Reliability Project</p>	<p>Town: Sudbury</p>
<p>Photo No.: 3</p>	<p>Date: 3/14/2024</p>

<p>Description: View of Bond's work area in segment 14 leading to bridge 127. See additional dewatering inspection report. Facing east.</p>

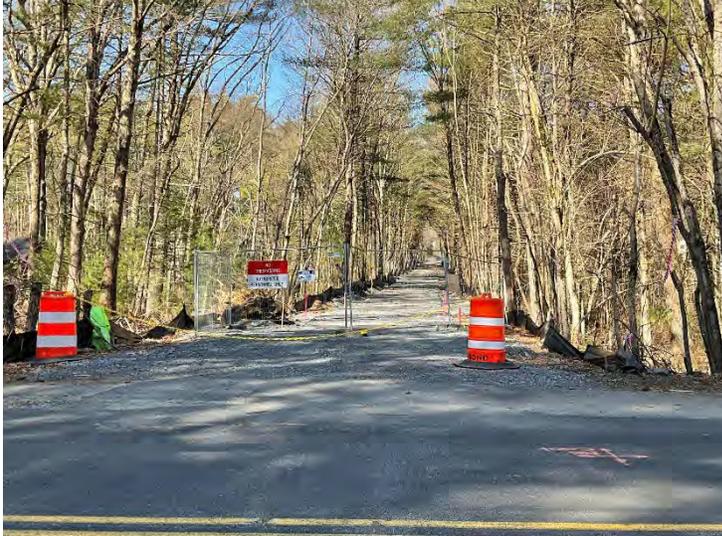
<p><b>PHOTOGRAPHIC LOG</b></p>	
<p>Client Name: Eversource</p>		<p>Site Location: Sudbury to Hudson Transmission Reliability Project</p>	<p>Town: Sudbury</p>
<p>Photo No.: 5</p>	<p>Date: 3/14/2024</p>

<p>Description: View of entrance to segment 9 from Peakham Rd. Barrels, chain, and flags are in place to demarcate vernal pool TOY restriction zone. Facing west.</p>

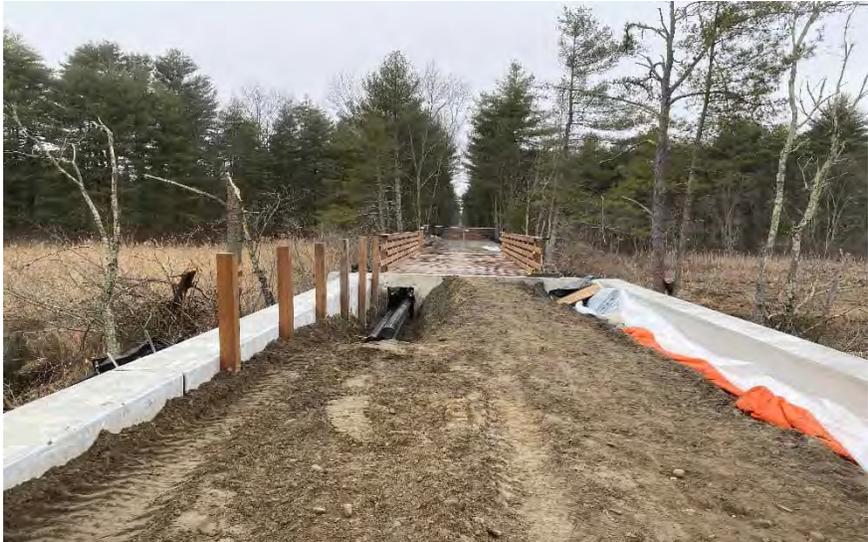
<p>PHOTOGRAPHIC LOG</p>	
<p>Client Name: Eversource</p>		<p>Site Location: Sudbury to Hudson Transmission Reliability Project</p>	<p>Town: Sudbury</p>
<p>Photo No.: 7</p>	<p>Date: 3-15-24</p>

<p>Description:</p> <p>Work area within segment 8, existing erosion control, bridge 128, looking westward.</p>

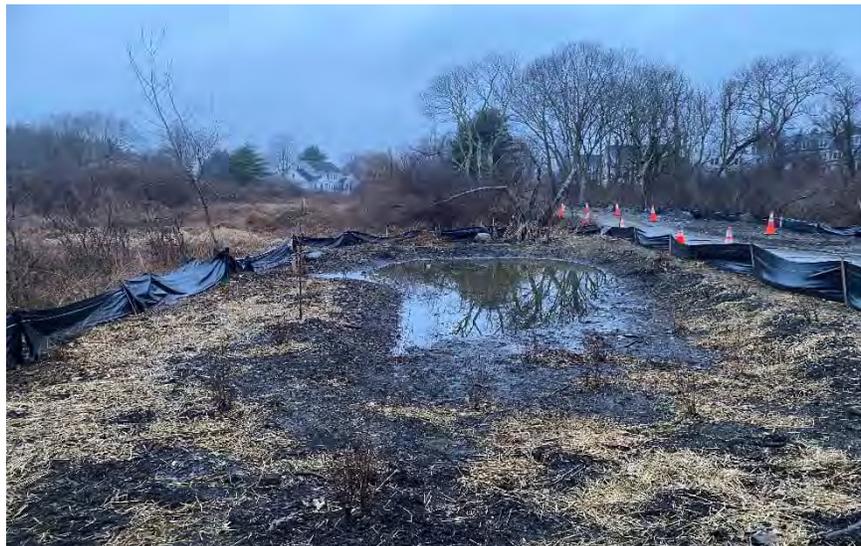
<p>PHOTOGRAPHIC LOG</p>	
<p>Client Name: Eversource</p>		<p>Site Location: Sudbury to Hudson Transmission Reliability Project</p>	<p>Town: Sudbury</p>
<p>Photo No.: 8</p>	<p>Date: 3-15-24</p>

<p>Description:</p> <p>Wetland replication area within segment 14, existing erosion control, looking westward.</p>

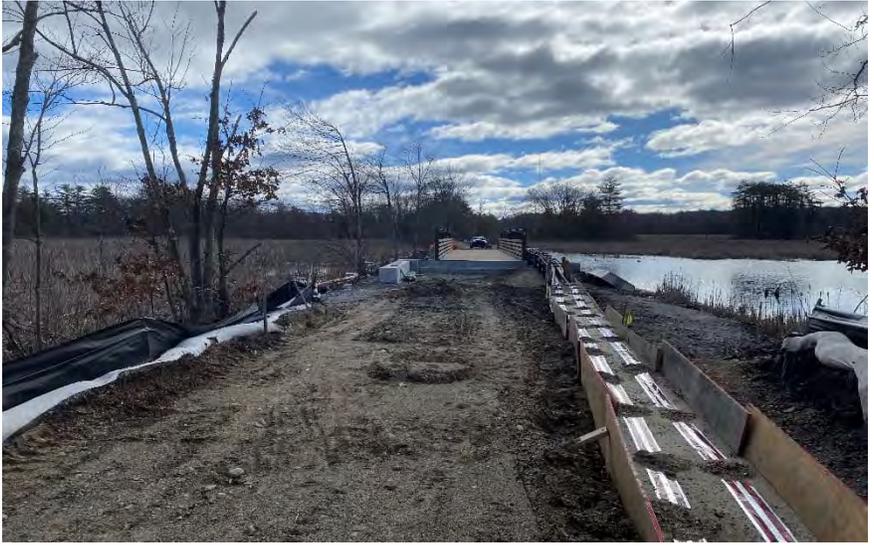
<b>PHOTOGRAPHIC LOG</b>	
Client Name: Eversource		Site Location: Sudbury to Hudson Transmission Reliability Project	Town: Hudson
Photo No.: 1	Date: 3-11-24

Description:  Work area within segment 2, recent conduit work near bridge 130, existing erosion control, looking eastward.

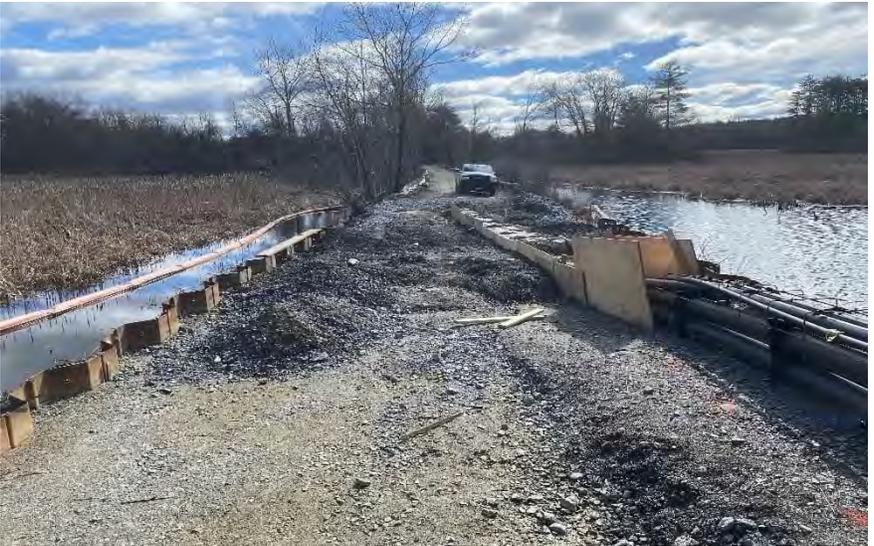
<b>PHOTOGRAPHIC LOG</b>	
Client Name: Eversource		Site Location: Sudbury to Hudson Transmission Reliability Project	Town: Hudson
Photo No.: 2	Date: 3-11-24

Description:  Work area within segment 3, recent conduit work near bridge 130, existing erosion control, looking eastward.

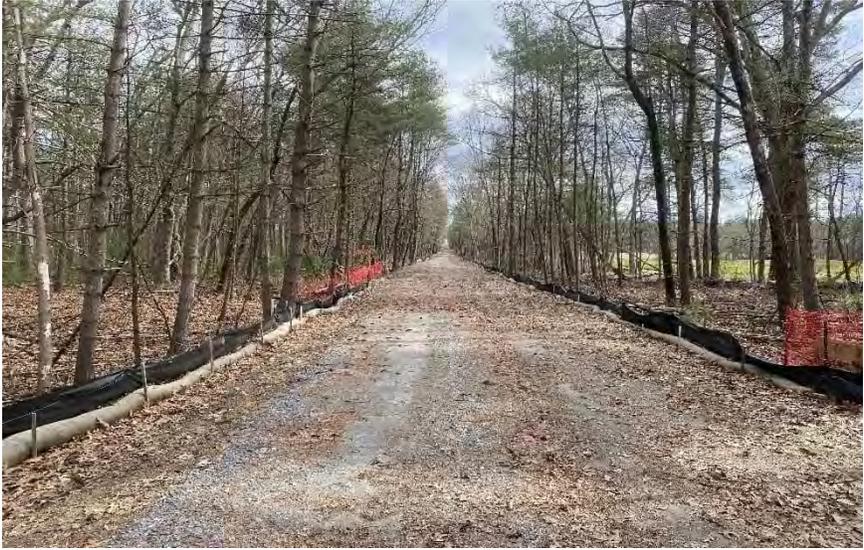
<b>PHOTOGRAPHIC LOG</b>	
Client Name: Eversource		Site Location: Sudbury to Hudson Transmission Reliability Project	Town: Hudson
Photo No.: 3	Date: 3-11-24

Description:  Work area within segment 4, existing erosion control, looking eastward.

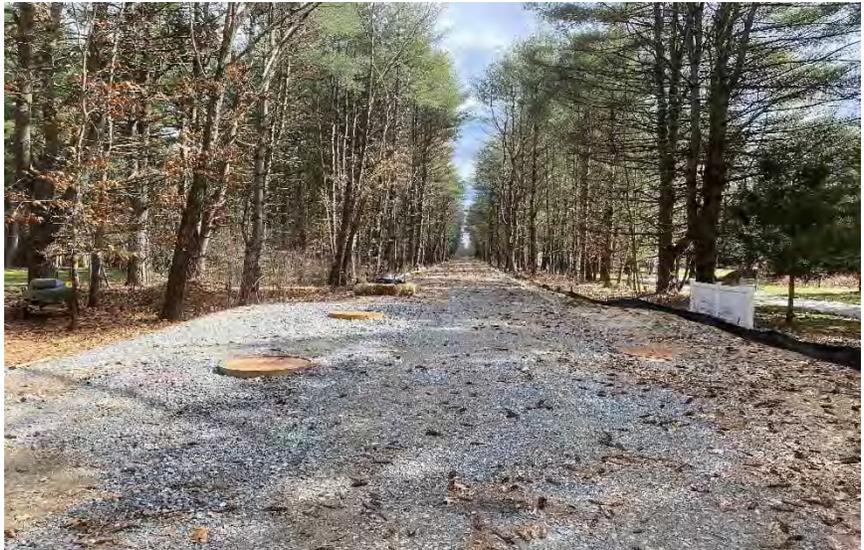
<b>PHOTOGRAPHIC LOG</b>	
Client Name: Eversource		Site Location: Sudbury to Hudson Transmission Reliability Project	Town: Hudson
Photo No.: 4	Date: 3-11-24

Description:  Work area within segment 5 at manhole #11, existing erosion control, looking eastward.

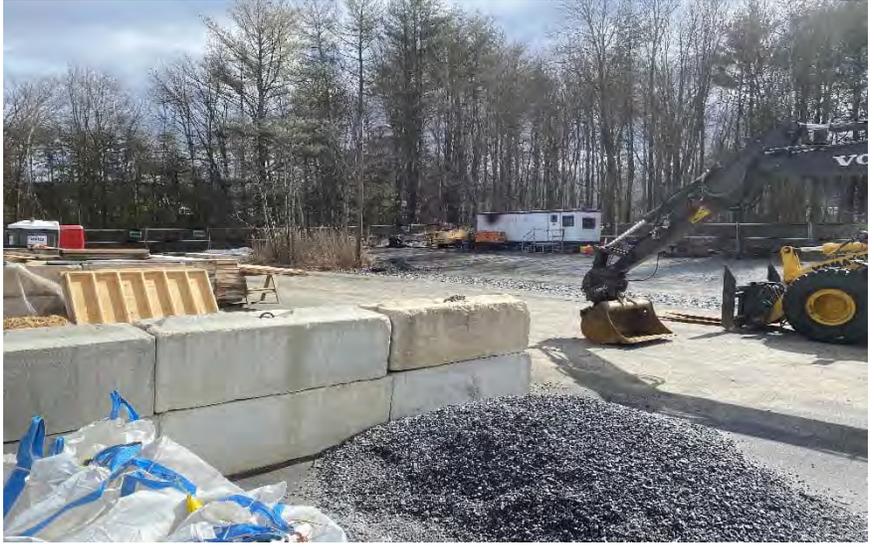
<b>PHOTOGRAPHIC LOG</b>	
Client Name: Eversource		Site Location: Sudbury to Hudson Transmission Reliability Project	Town: Hudson
Photo No.: 5	Date: 3-11-24

Description:  Laydown yard off Main Street, looking westward.

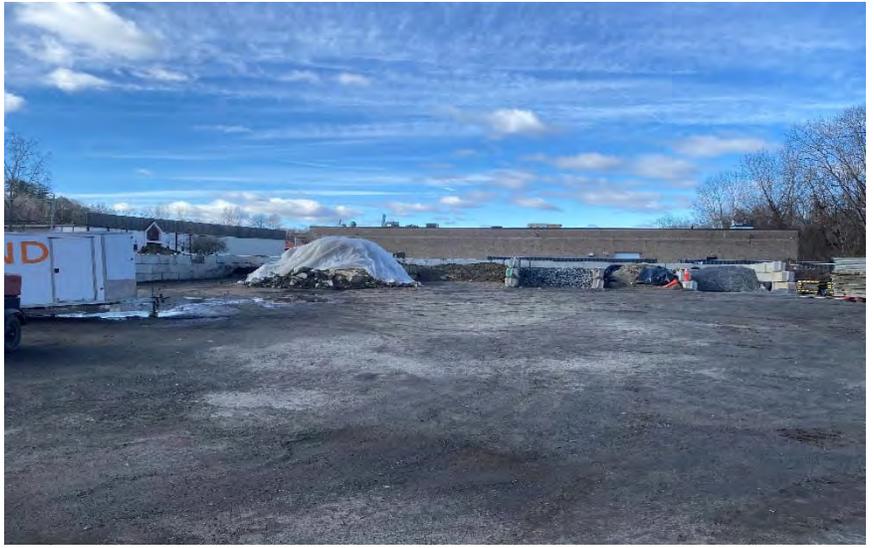
<b>PHOTOGRAPHIC LOG</b>	
Client Name: Eversource		Site Location: Sudbury to Hudson Transmission Reliability Project	Town: Hudson
Photo No.: 6	Date: 3-11-24

Description:  Laydown yard off Bonazzoli Avenue, covered spoil piles, looking westward.

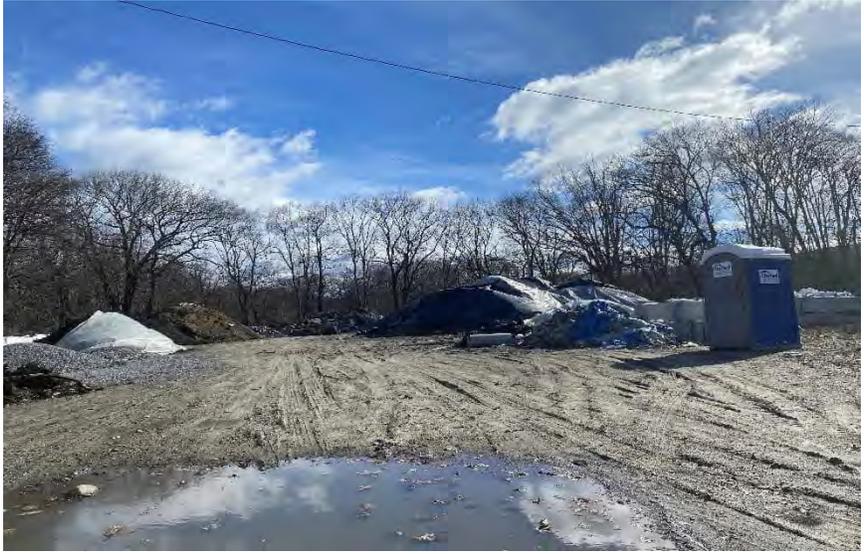
<b>PHOTOGRAPHIC LOG</b>	
Client Name: Eversource		Site Location: Sudbury to Hudson Transmission Reliability Project	Town: Hudson
Photo No.: 7	Date: 3-11-24

Description:  Laydown yard off Stowe Court, covered spoil piles, looking southward.

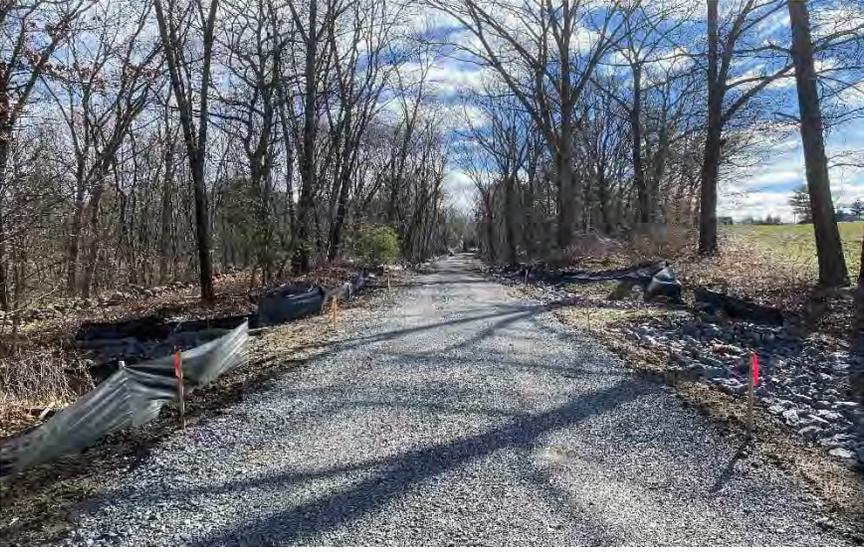
<b>PHOTOGRAPHIC LOG</b>	
Client Name: Eversource		Site Location: Sudbury to Hudson Transmission Reliability Project	Town: Stow
Photo No.: 8	Date: 3-11-24

Description:  Work area within segment 1, existing erosion control, looking eastward.

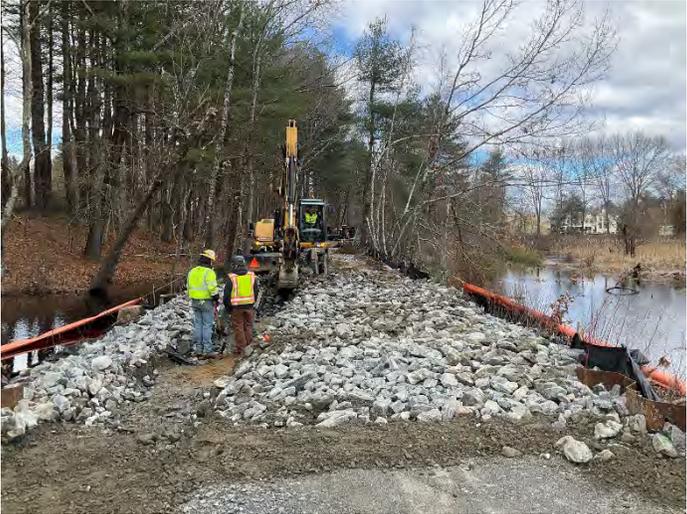
<b>Epsilon</b> ASSOCIATES INC.		<b>PHOTOGRAPHIC LOG</b>	
Client Name: Eversource		Site Location: Sudbury to Hudson Transmission Reliability Project	Town: Sudbury
Photo No.: 5	Date: 3-11-2024

Description: View of Bond working in segment 13 just before bridge 127. Facing west.

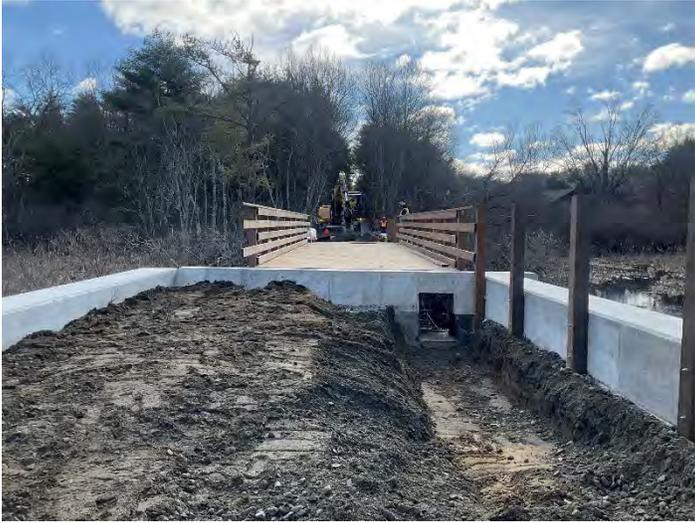
<b>Epsilon</b> ASSOCIATES INC.		<b>PHOTOGRAPHIC LOG</b>	
Client Name: Eversource		Site Location: Sudbury to Hudson Transmission Reliability Project	Town: Sudbury
Photo No.: 9	Date: 3-11-2024

Description: View of Bridge 128 from segment 7. Facing east.

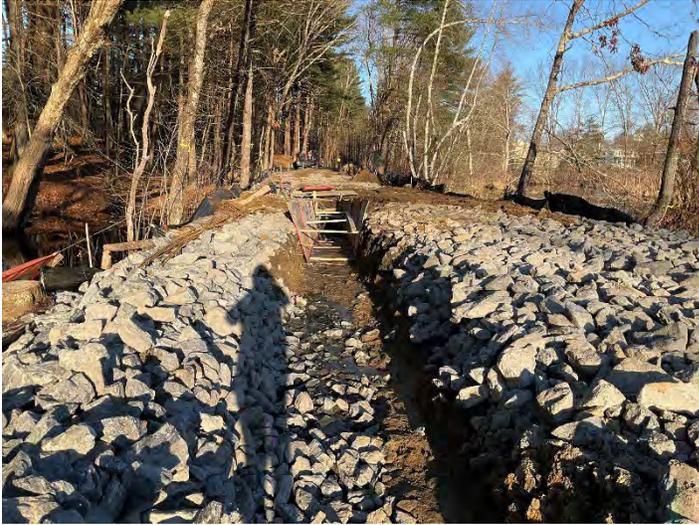
<b>PHOTOGRAPHIC LOG</b>		
Client Name: Eversource		Site Location: Sudbury to Hudson Transmission Reliability Project		Town: Sudbury
Photo No.: 1	Date: 3/12/2024

Description: View of Bond's work area in segment 13 leading to bridge 127. Facing west.

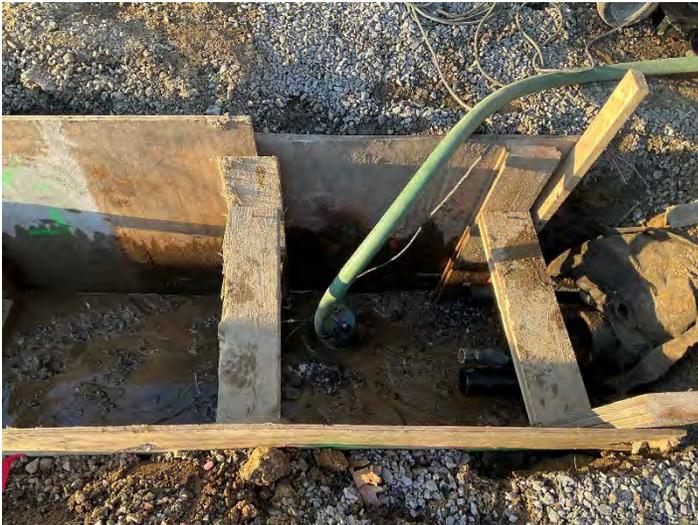
<b>PHOTOGRAPHIC LOG</b>		
Client Name: Eversource		Site Location: Sudbury to Hudson Transmission Reliability Project		Town: Sudbury
Photo No.: 2	Date: 3/12/2024

Description: View of pumping in trench in segment 13. Water prior to treatment appeared slightly turbid.

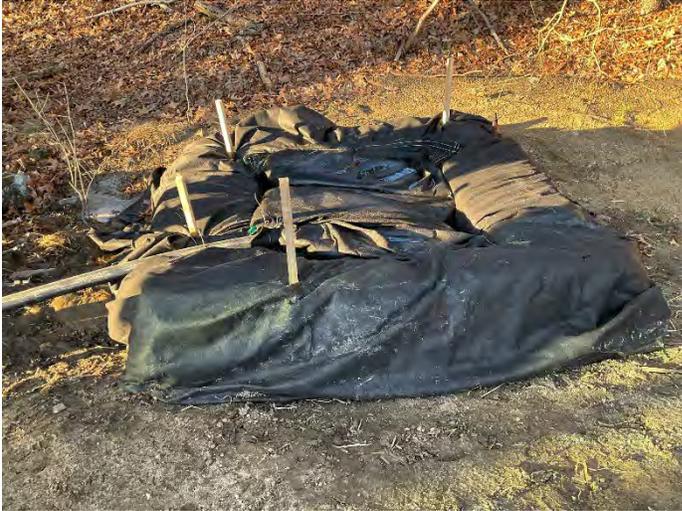
<b>PHOTOGRAPHIC LOG</b>	
Client Name: Eversource		Site Location: Sudbury to Hudson Transmission Reliability Project	
		Town: Sudbury	
Photo No.: 3	Date: 3/12/2024

Description: View of dewatering controls (straw bale corral with filter fabric and silt bag). Facing south.

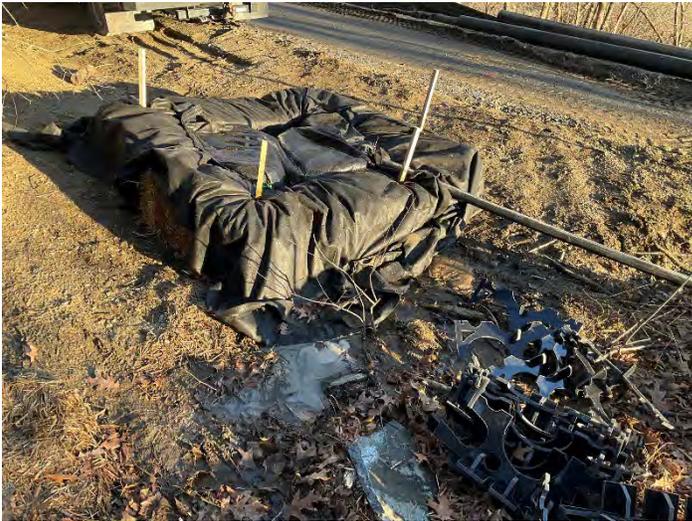
<b>PHOTOGRAPHIC LOG</b>	
Client Name: Eversource		Site Location: Sudbury to Hudson Transmission Reliability Project	
		Town: Sudbury	
Photo No.: 4	Date: 3/12/2024

Description: Additional view of dewatering controls (straw bale corral with filter fabric and silt bag) and discharge from corral. Discharge traveled east outside of the silt fence but did not reach any jurisdictional areas. Discharge appeared slightly turbid, but turbidity reading was below 50 NTUs. Facing northwest.

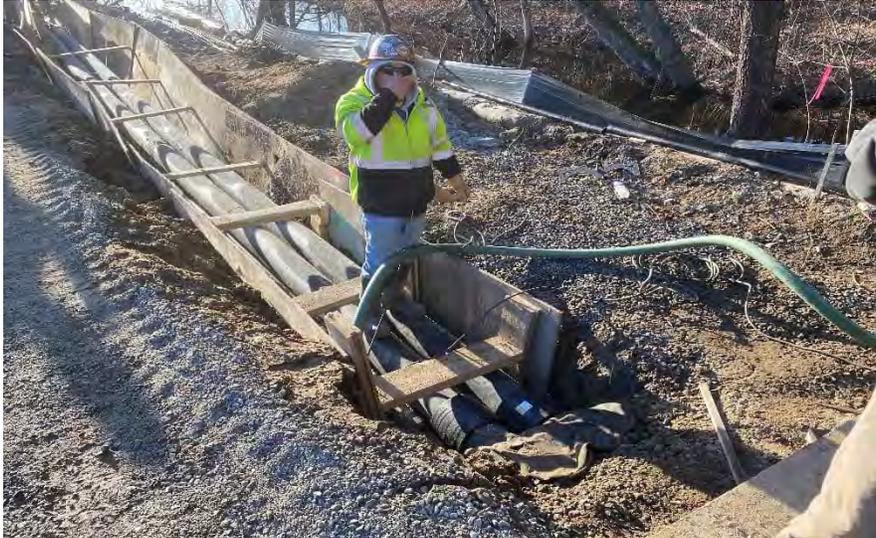
PHOTOGRAPHIC LOG	
Client Name: Eversource		Site Location: Sudbury to Hudson Transmission Reliability Project	Town: Sudbury
Photo No.: 1	Date: 3/13/2024

Description: View of area being pumped from segment 13 conduit trench near bridge 127, looking eastward.

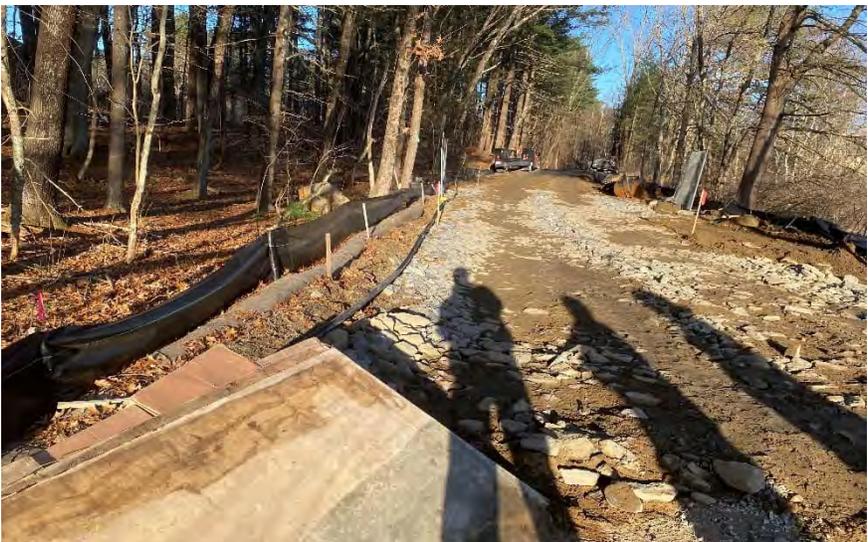
PHOTOGRAPHIC LOG	
Client Name: Eversource		Site Location: Sudbury to Hudson Transmission Reliability Project	Town: Sudbury
Photo No.: 2	Date: 3/13/2024

Description: Segment 13. View of dewatering operation. Looking westward.

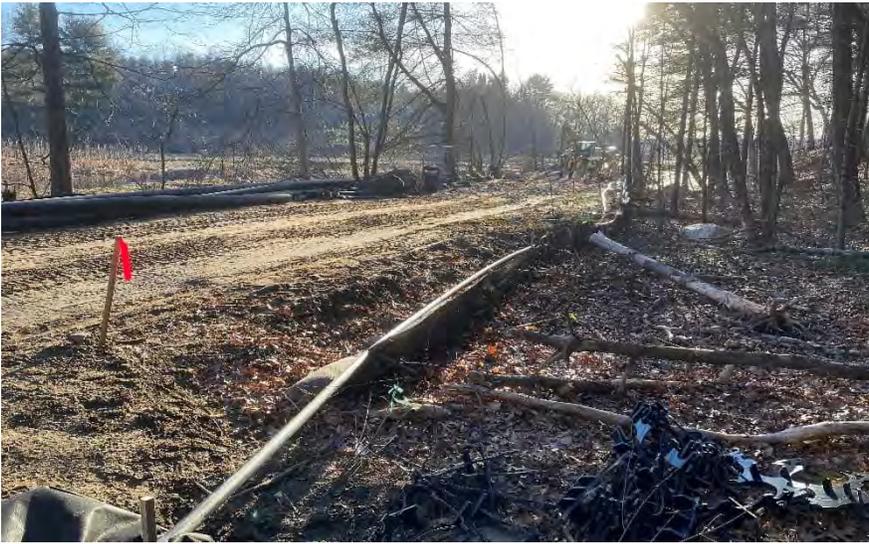
<b>PHOTOGRAPHIC LOG</b>	
Client Name: Eversource		Site Location: Sudbury to Hudson Transmission Reliability Project	Town: Sudbury
Photo No.: 3	Date: 3/13/2024

Description: Segment 13. View of dewatering operation, looking eastward.

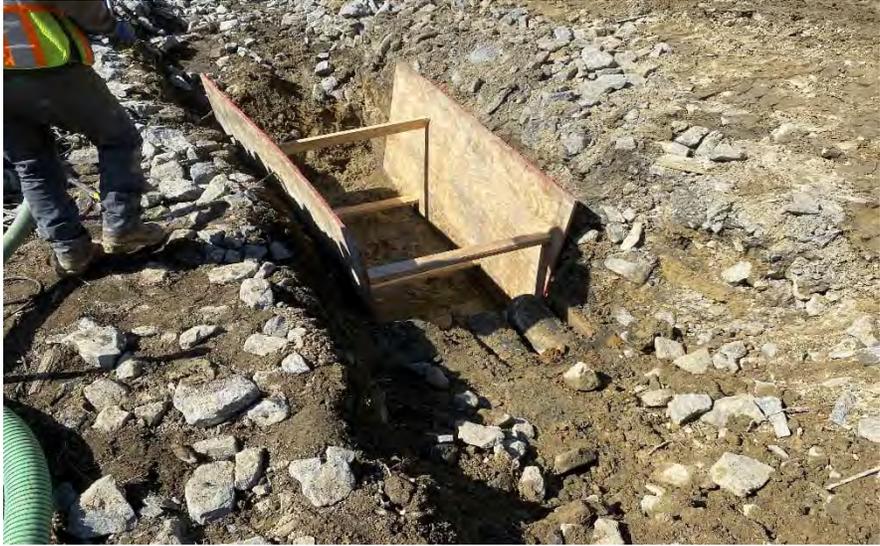
<b>PHOTOGRAPHIC LOG</b>	
Client Name: Eversource		Site Location: Sudbury to Hudson Transmission Reliability Project	Town: Sudbury
Photo No.: 1	Date: 3/13/2024

Description: View of area being pumped from conduit trench adjacent to bridge 127 - segment 14, looking eastward.

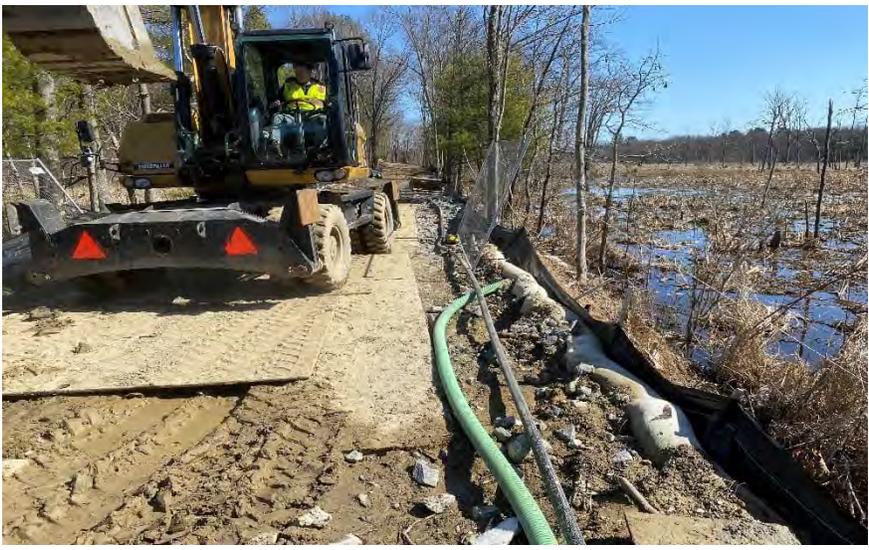
<b>PHOTOGRAPHIC LOG</b>	
Client Name: Eversource		Site Location: Sudbury to Hudson Transmission Reliability Project	Town: Sudbury
Photo No.: 2	Date: 3/13/2024

Description: Segment #14. View of dewatering operation, looking eastward.

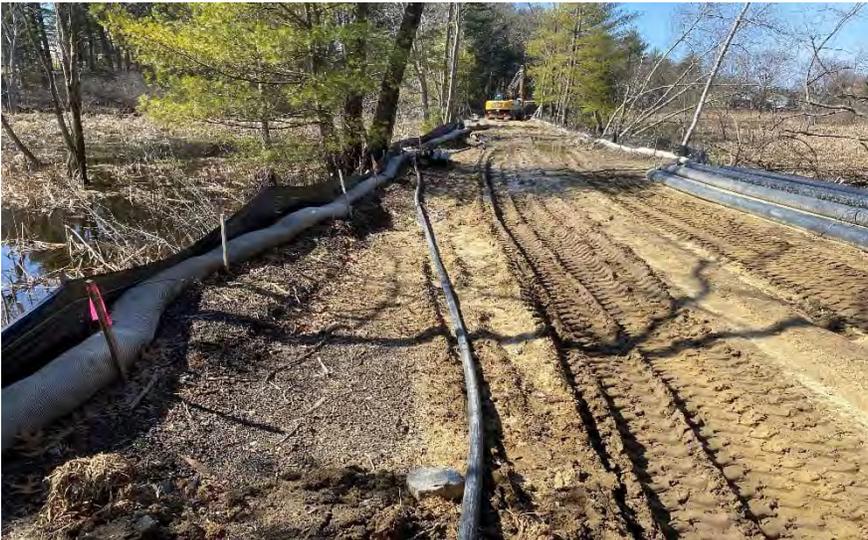
<b>PHOTOGRAPHIC LOG</b>	
Client Name: Eversource		Site Location: Sudbury to Hudson Transmission Reliability Project	Town: Sudbury
Photo No.: 3	Date: 3/13/2024

Description: Segment 14. View of dewatering operation, looking westward.

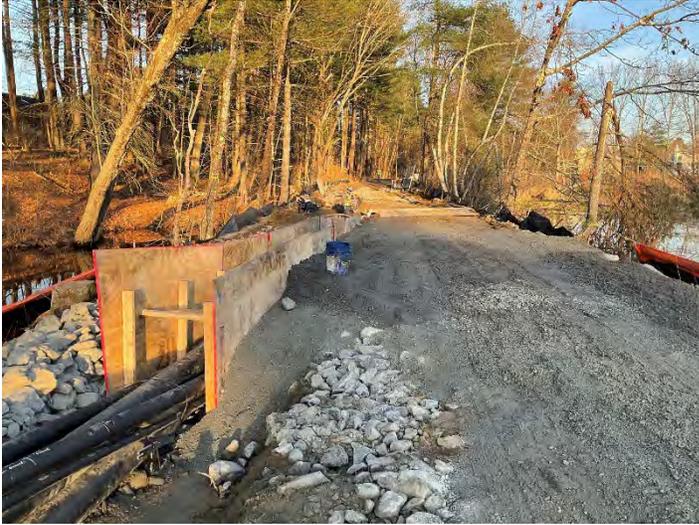
<b>PHOTOGRAPHIC LOG</b>	
Client Name: Eversource		Site Location: Sudbury to Hudson Transmission Reliability Project	Town: Sudbury
Photo No.: 1	Date: 3/14/2024

<b>Description:</b> View of Bond's work area in segment 13 leading to bridge 127. Facing west.

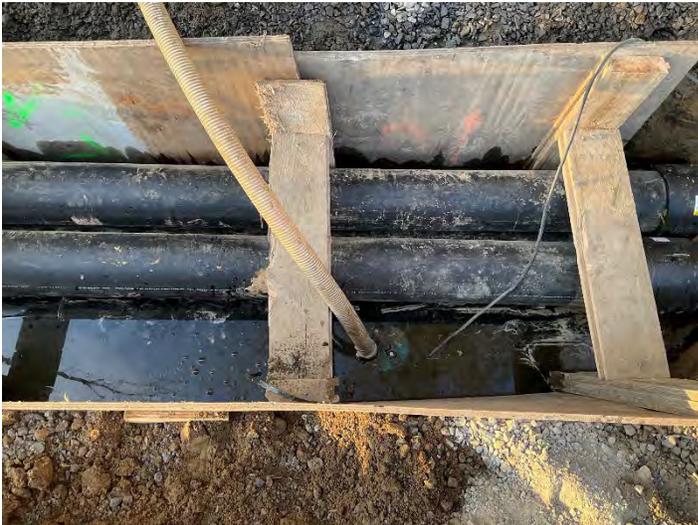
<b>PHOTOGRAPHIC LOG</b>	
Client Name: Eversource		Site Location: Sudbury to Hudson Transmission Reliability Project	Town: Sudbury
Photo No.: 2	Date: 3/14/2024

<b>Description:</b> View of pumping in trench in segment 13. Water prior to treatment appeared slightly turbid.

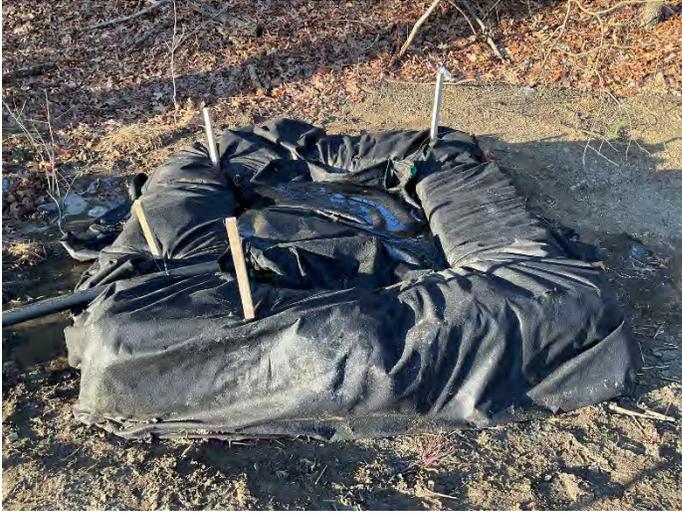
<b>PHOTOGRAPHIC LOG</b>	
Client Name: Eversource		Site Location: Sudbury to Hudson Transmission Reliability Project	Town: Sudbury
Photo No.: 3	Date: 3/14/2024

Description: View of dewatering controls (straw bale corral with filter fabric and silt bag). Facing south.

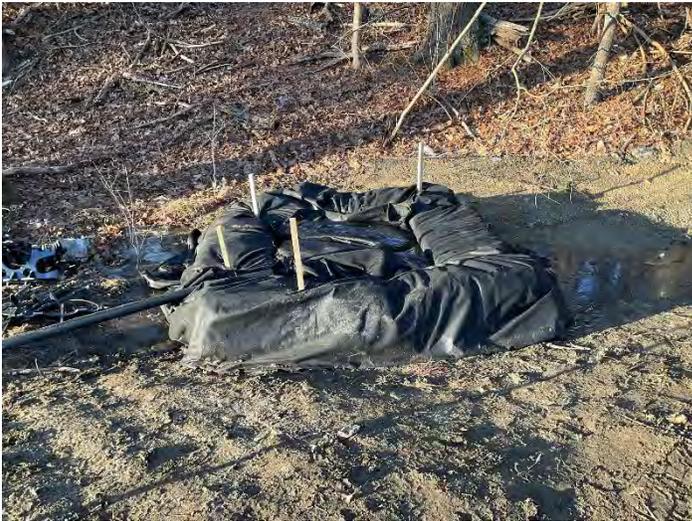
<b>PHOTOGRAPHIC LOG</b>	
Client Name: Eversource		Site Location: Sudbury to Hudson Transmission Reliability Project	Town: Sudbury
Photo No.: 4	Date: 3/14/2024

Description: Additional view of dewatering controls (straw bale corral with filter fabric and silt bag) and discharge from corral. Discharge traveled east and west outside of the silt fence but did not reach any jurisdictional areas. Discharge appeared mostly clear and turbidity reading was below 50 NTUs. Facing south.

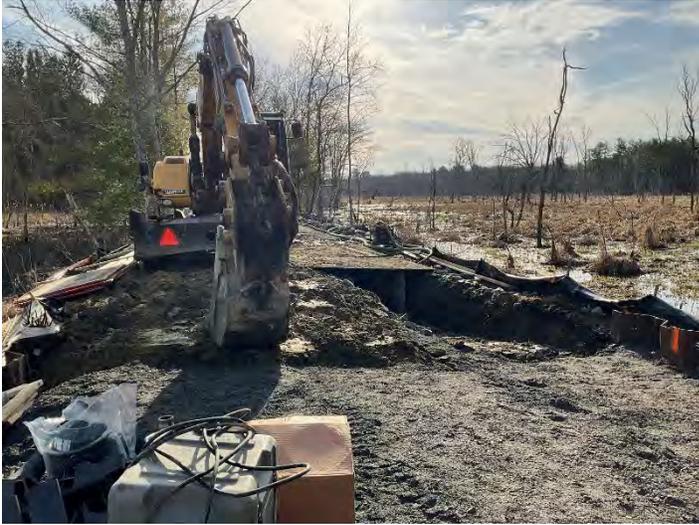
<b>PHOTOGRAPHIC LOG</b>	
Client Name: Eversource		Site Location: Sudbury to Hudson Transmission Reliability Project	
		Town: Sudbury	
Photo No.: 1	Date: 3/14/2024

Description: View of Bond's work area in segment 14 leading to bridge 127. Facing west.

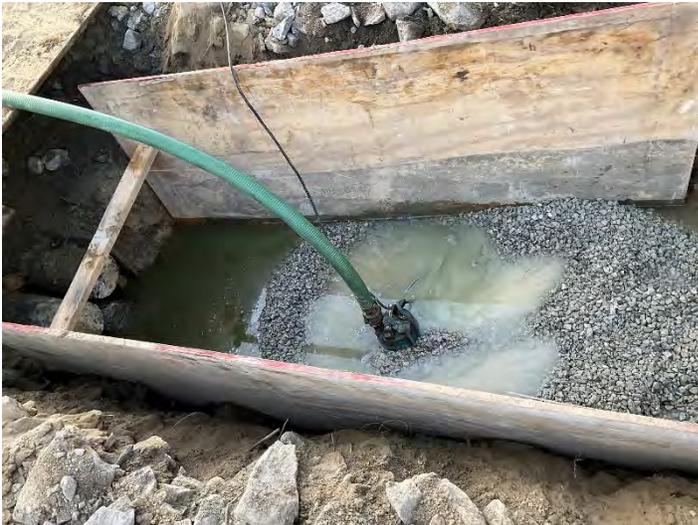
<b>PHOTOGRAPHIC LOG</b>	
Client Name: Eversource		Site Location: Sudbury to Hudson Transmission Reliability Project	
		Town: Sudbury	
Photo No.: 2	Date: 3/14/2024

Description: View of water prior to treatment. Water appeared turbid.
