**Weekly Environmental Compliance Summary**

**Sudbury to Hudson Transmission Reliability Project (USEPA Tracking # MAR1003UW)**

Sudbury, Hudson, and Stow, MA

Week of: March 18, 2024 to March 23, 2024

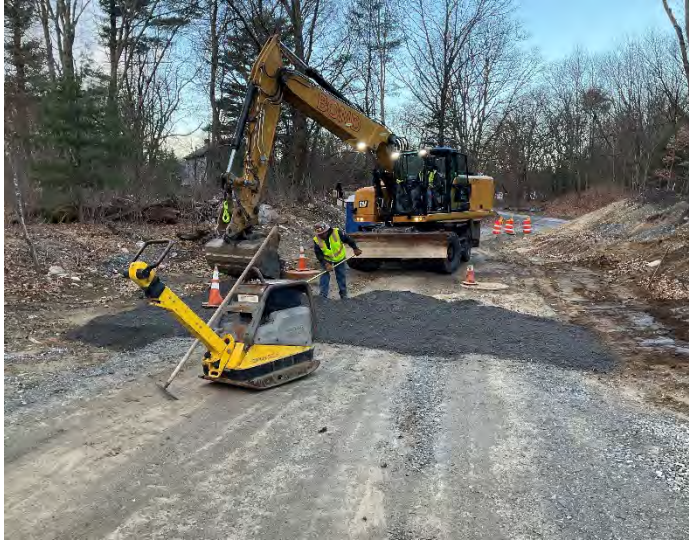
<b>PHOTOGRAPHIC LOG</b>	
Client Name: Eversource		Site Location: Sudbury to Hudson Transmission Reliability Project	Town: Hudson
Photo No.: 1	Date: 3-18-2024

Description: View of Bond working at MH # 5 in segment 1. Facing west.

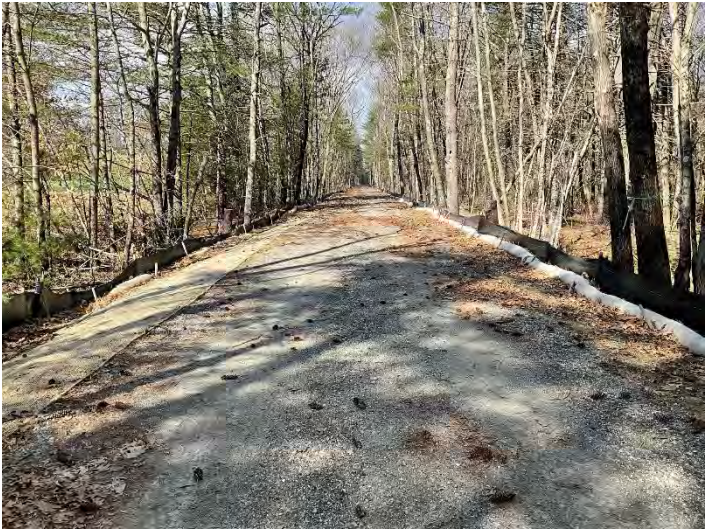
<b>PHOTOGRAPHIC LOG</b>	
Client Name: Eversource		Site Location: Sudbury to Hudson Transmission Reliability Project	Town: Hudson
Photo No.: 4	Date: 3-18-2024

Description: View of E&S controls in segment 4. Facing west.

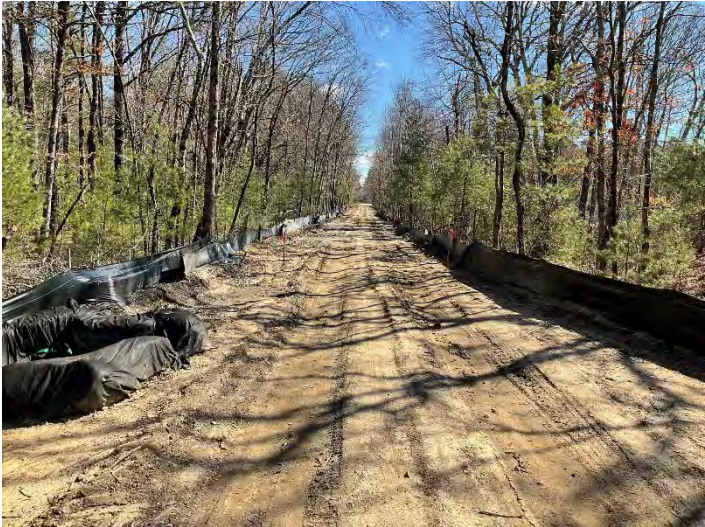
<b>Epsilon</b> ASSOCIATES INC.		<b>PHOTOGRAPHIC LOG</b>	
Client Name: Eversource		Site Location: Sudbury to Hudson Transmission Reliability Project	Town: Hudson
Photo No.: 6	Date: 3-18-2024

Description: View of E&S controls in segment 6. Facing east.

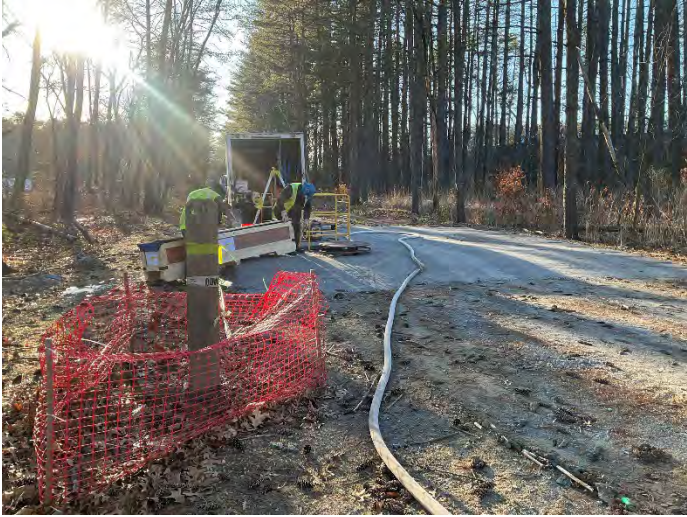
PHOTOGRAPHIC LOG	
Client Name: Eversource		Site Location: Sudbury to Hudson Transmission Reliability Project	Town: Hudson
Photo No.: 1	Date: 3/21/2024

Description: View of Haugland working at MH #10. Facing east.

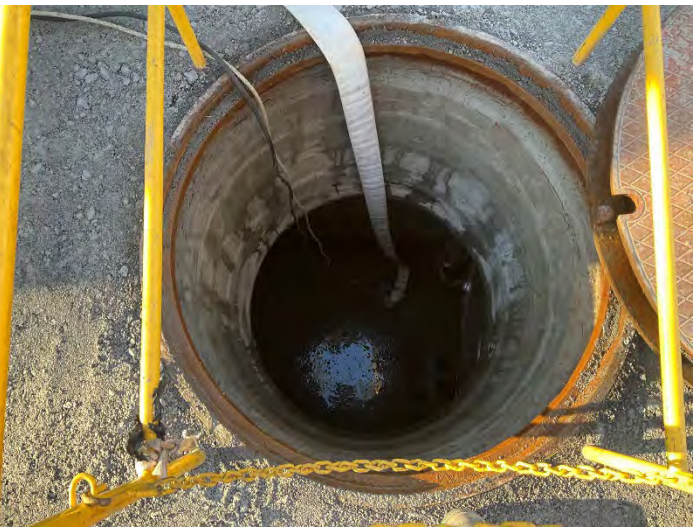
PHOTOGRAPHIC LOG	
Client Name: Eversource		Site Location: Sudbury to Hudson Transmission Reliability Project	Town: Hudson
Photo No.: 2	Date: 3/21/2024

Description: View of pump in MH #10. Water appeared mostly clear prior to treatment.

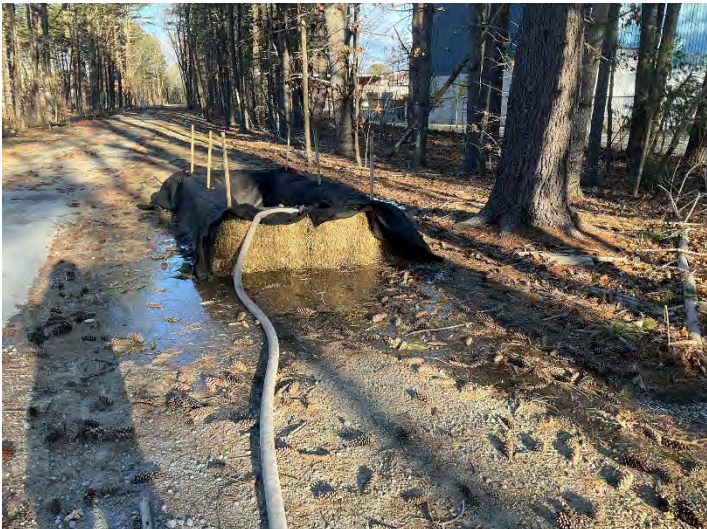
<b>PHOTOGRAPHIC LOG</b>	
Client Name: Eversource		Site Location: Sudbury to Hudson Transmission Reliability Project	Town: Hudson
Photo No.: 4	Date: 3/21/2024

<b>Description:</b> View of dewatering controls (straw bale corral with filter fabric and silt bag) and discharge from project. Discharge appeared mostly clear and turbidity reading was below 50 NTUs. Discharge did not appear to reach any jurisdictional areas. Facing west.

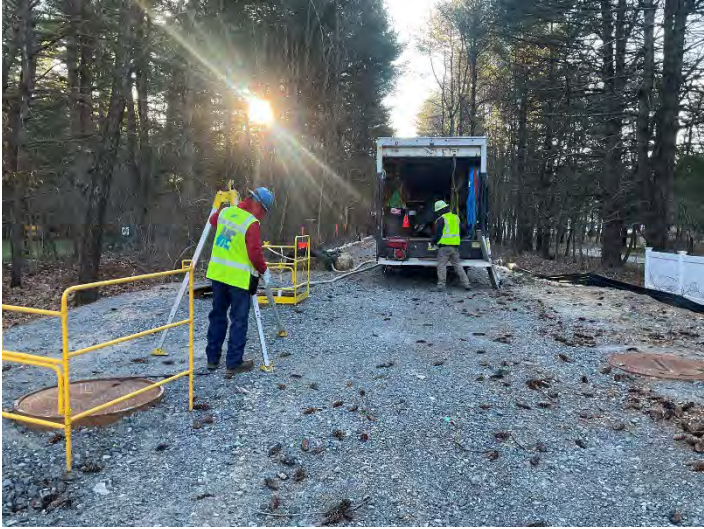
<b>PHOTOGRAPHIC LOG</b>	
Client Name: Eversource		Site Location: Sudbury to Hudson Transmission Reliability Project	Town: Hudson
Photo No.: 1	Date: 3/21/2024

<b>Description:</b> View of Haugland working at MH #11 in segment 5. Facing east.

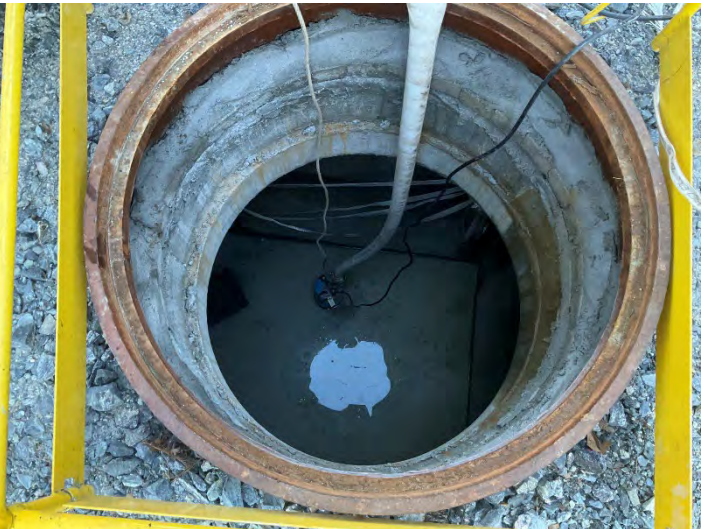
<b>PHOTOGRAPHIC LOG</b>	
Client Name: Eversource		Site Location: Sudbury to Hudson Transmission Reliability Project	Town: Hudson
Photo No.: 2	Date: 3/21/2024

<b>Description:</b> View of pump in MH #11. Water appeared mostly clear prior to treatment.

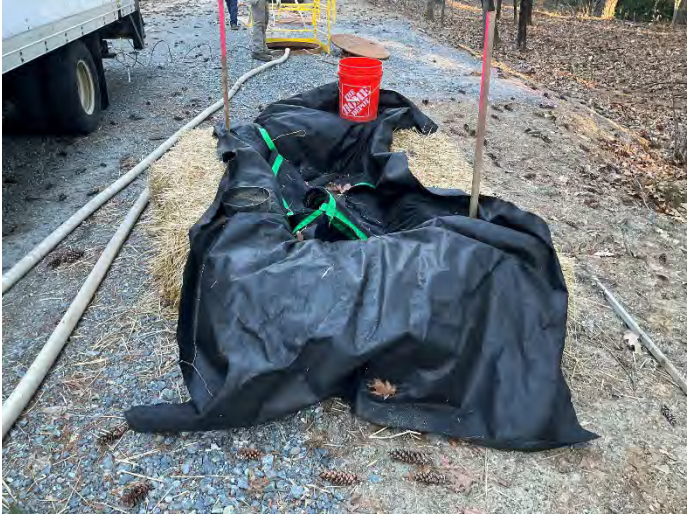
PHOTOGRAPHIC LOG	
Client Name: Eversource		Site Location: Sudbury to Hudson Transmission Reliability Project	
Town: Hudson			
Photo No.: 3	Date: 3/21/2024

<b>Description:</b> View of dewatering controls (straw bale corral with filter fabric, and silt bag). Facing west.

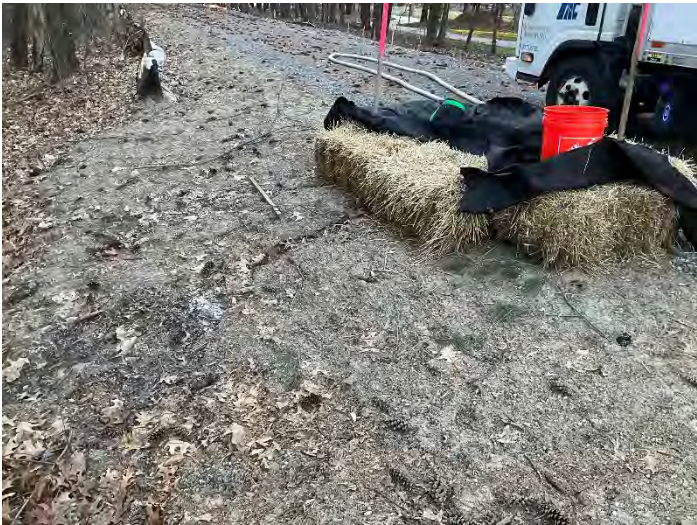
PHOTOGRAPHIC LOG	
Client Name: Eversource		Site Location: Sudbury to Hudson Transmission Reliability Project	
Town: Hudson			
Photo No.: 4	Date: 3/21/2024

<b>Description:</b> Additional view of dewatering controls and discharge. Discharge appeared mostly clear and turbidity reading was below 50 NTUs. Discharge did not appear to reach any jurisdictional areas. Facing southeast.

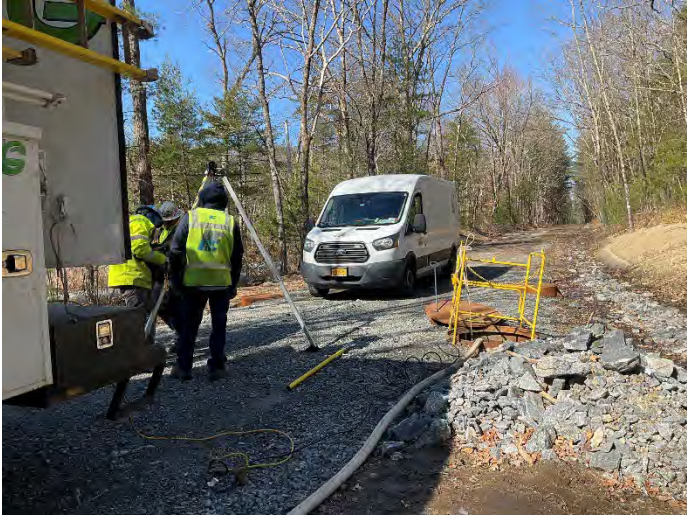
PHOTOGRAPHIC LOG	
Client Name: Eversource		Site Location: Sudbury to Hudson Transmission Reliability Project	
Town: Hudson			
Photo No.: 1	Date: 3/21/2024

<b>Description:</b> View of Haugland working at MH #12. Facing west.

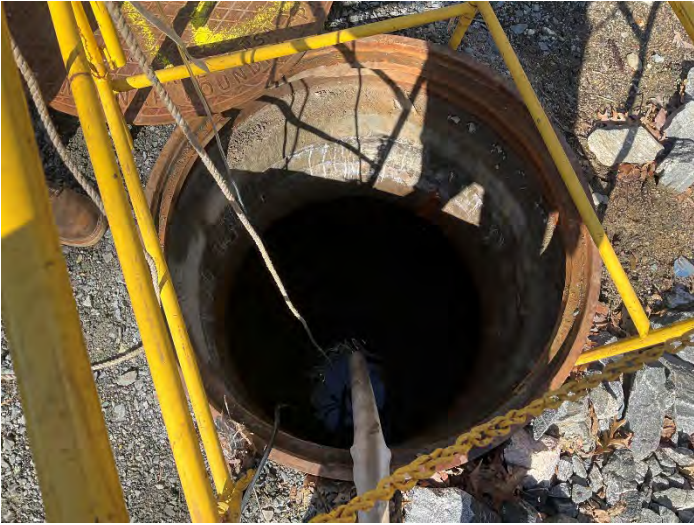
PHOTOGRAPHIC LOG	
Client Name: Eversource		Site Location: Sudbury to Hudson Transmission Reliability Project	
Town: Hudson			
Photo No.: 2	Date: 3/21/2024

<b>Description:</b> View of pump in MH #12. Water appeared mostly clear prior to treatment.

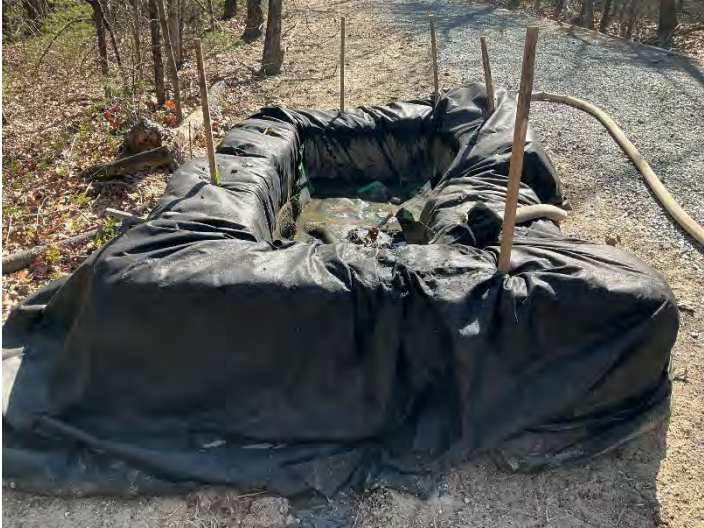
<b>PHOTOGRAPHIC LOG</b>	
Client Name: Eversource		Site Location: Sudbury to Hudson Transmission Reliability Project	
Town: Hudson			
Photo No.: 3	Date: 3/21/2024

<b>Description:</b> View of dewatering controls (straw bale corral with filter fabric and silt bag). Facing east.
