Weekly Environmental Compliance Summary

Sudbury to Hudson Transmission Reliability Project (USEPA Tracking # MAR1003UW)

Sudbury, Hudson, and Stow, MA

Week of: April 8, 2024 to April 13, 2024

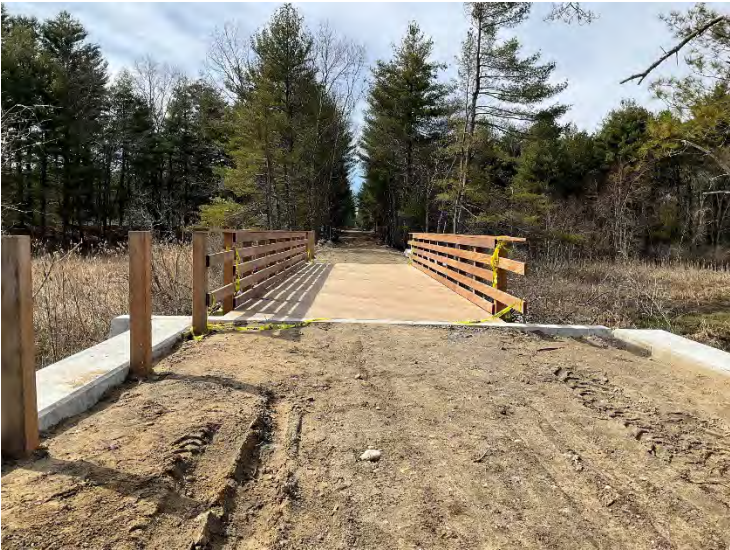
PHOTOGRAPHIC LOG	
Client Name: Eversource		Site Location: Sudbury to Hudson Transmission Reliability Project	Town: Sudbury
Photo No.: 1	Date: 4/08/2024

Description: View of bridge 128. Facing west.

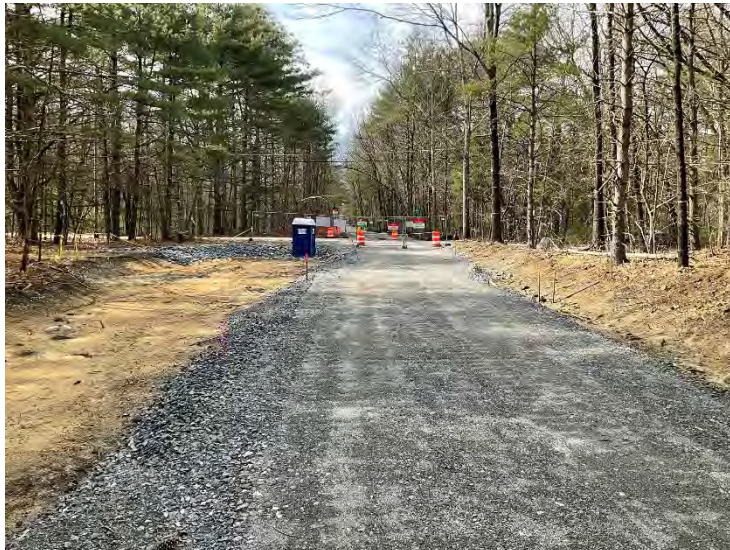
PHOTOGRAPHIC LOG	
Client Name: Eversource		Site Location: Sudbury to Hudson Transmission Reliability Project	Town: Sudbury
Photo No.: 2	Date: 4/08/2024

Description: View of west end of segment 9. Facing west.

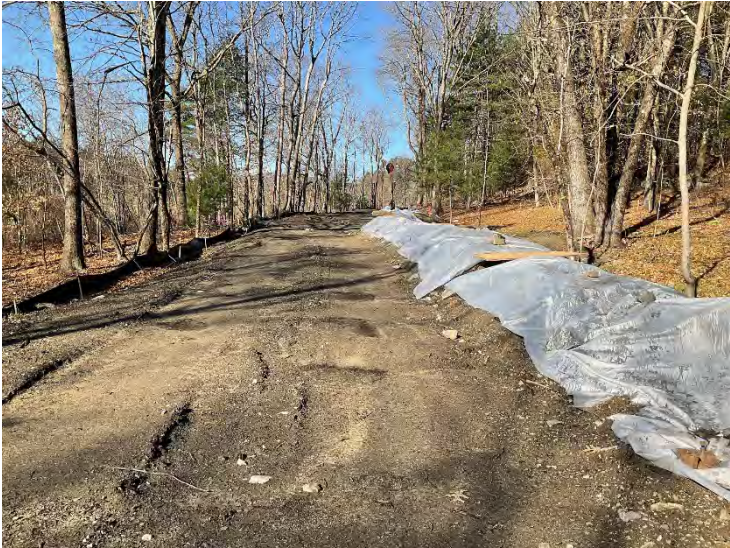
<p>PHOTOGRAPHIC LOG</p>	
<p>Client Name: Eversource</p>		<p>Site Location: Sudbury to Hudson Transmission Reliability Project</p>	<p>Town: Sudbury</p>
<p>Photo No.: 5</p>	<p>Date: 4/08/2024</p>

<p>Description: View of stockpile/spoil berm at Sta. #738 in segment 14. Facing west.</p>

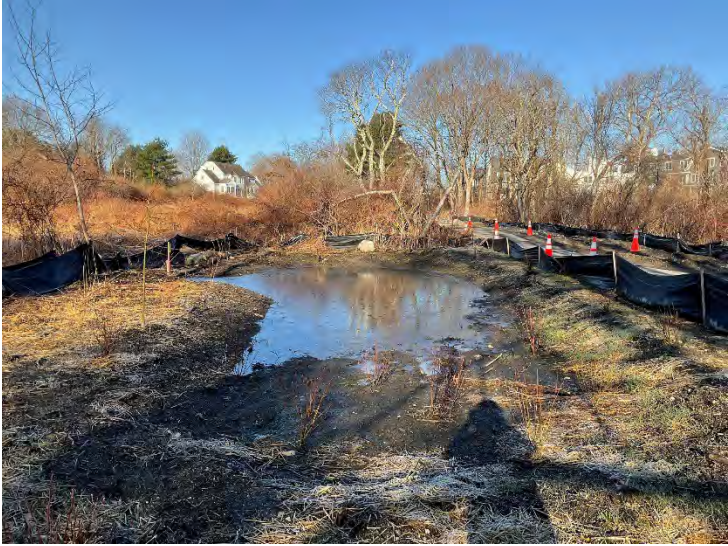
<p>PHOTOGRAPHIC LOG</p>	
<p>Client Name: Eversource</p>		<p>Site Location: Sudbury to Hudson Transmission Reliability Project</p>	<p>Town: Sudbury</p>
<p>Photo No.: 6</p>	<p>Date: 4/08/2024</p>

<p>Description: View of wetland replication area in segment 14. Facing west.</p>

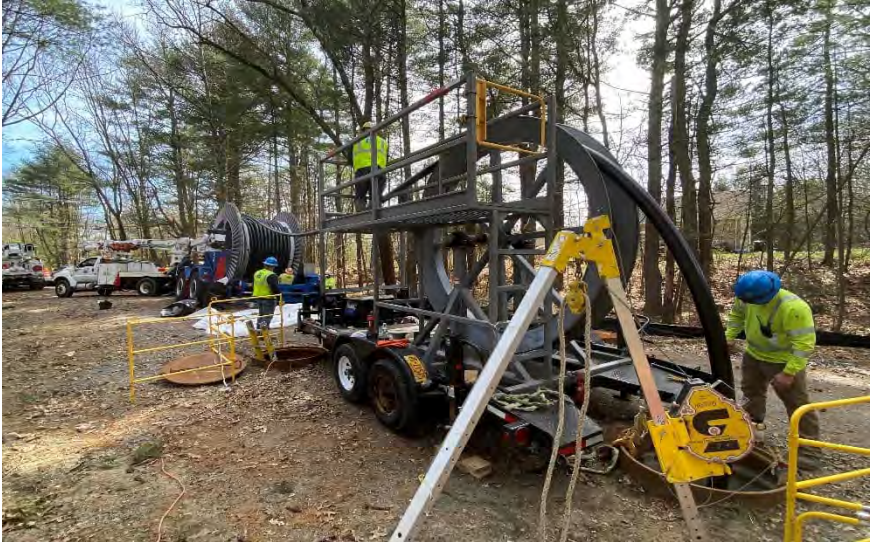
<p>PHOTOGRAPHIC LOG</p>	
<p>Client Name: Eversource</p>		<p>Site Location: Sudbury to Hudson Transmission Reliability Project</p>	<p>Town: Hudson</p>
<p>Photo No.: 2</p>	<p>Date: 4-8-24</p>

<p>Description:</p> <p>Work area within Segment 5, manhole #13, cable pulling work, looking eastward.</p>

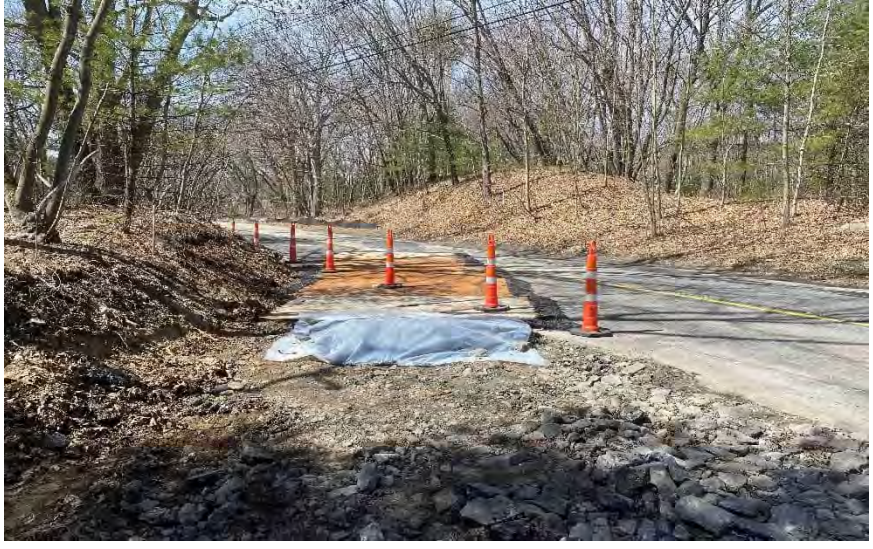
<p>PHOTOGRAPHIC LOG</p>	
<p>Client Name: Eversource</p>		<p>Site Location: Sudbury to Hudson Transmission Reliability Project</p>	<p>Town: Hudson</p>
<p>Photo No.: 4</p>	<p>Date: 4-8-24</p>

<p>Description:</p> <p>Roadway crossing of Wilkins Avenue, looking westward.</p>

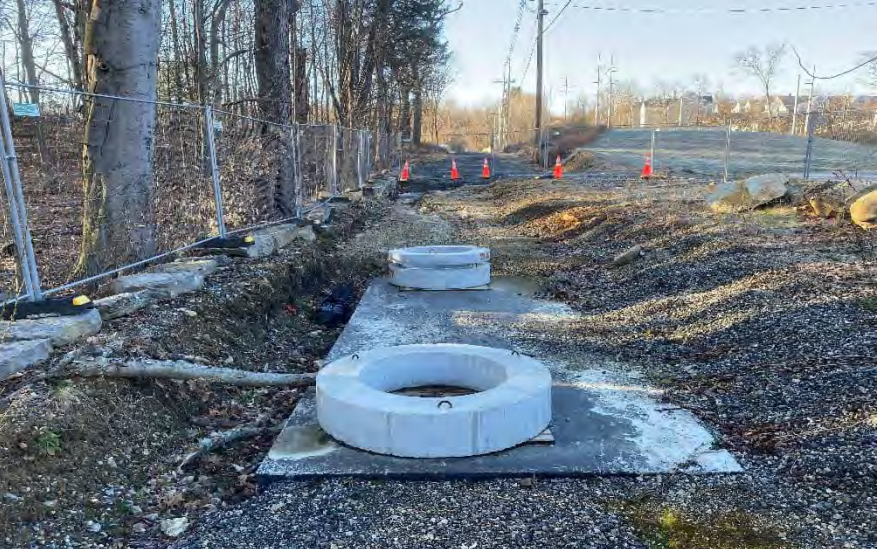
<p>PHOTOGRAPHIC LOG</p>	
<p>Client Name: Eversource</p>		<p>Site Location: Sudbury to Hudson Transmission Reliability Project</p>	<p>Town: Hudson</p>
<p>Photo No.: 6</p>	<p>Date: 4-8-24</p>

<p>Description:</p> <p>Manhole #1 area adjacent to the Hudson Power & light facility, looking eastward.</p>

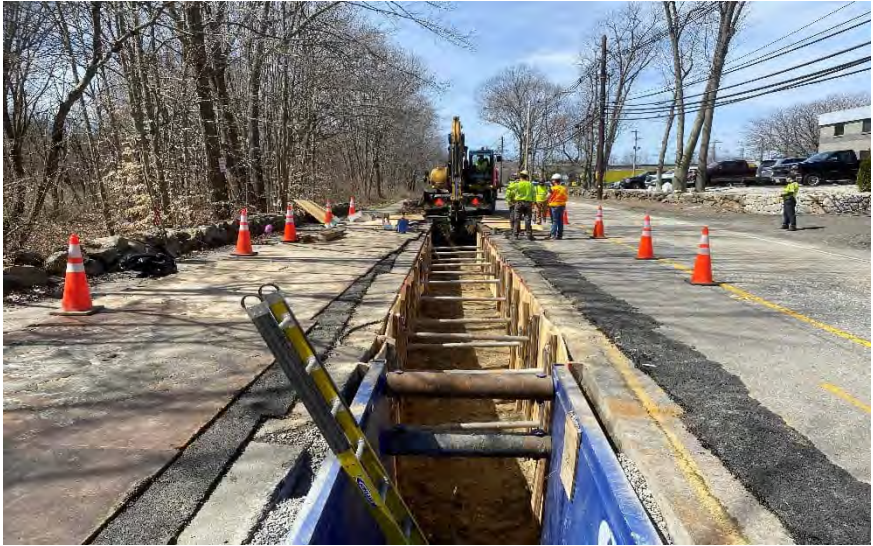
<p>PHOTOGRAPHIC LOG</p>	
<p>Client Name: Eversource</p>		<p>Site Location: Sudbury to Hudson Transmission Reliability Project</p>	<p>Town: Hudson</p>
<p>Photo No.: 7</p>	<p>Date: 4-8-24</p>

<p>Description:</p> <p>Conduit trench work within Forest Avenue, looking southward.</p>

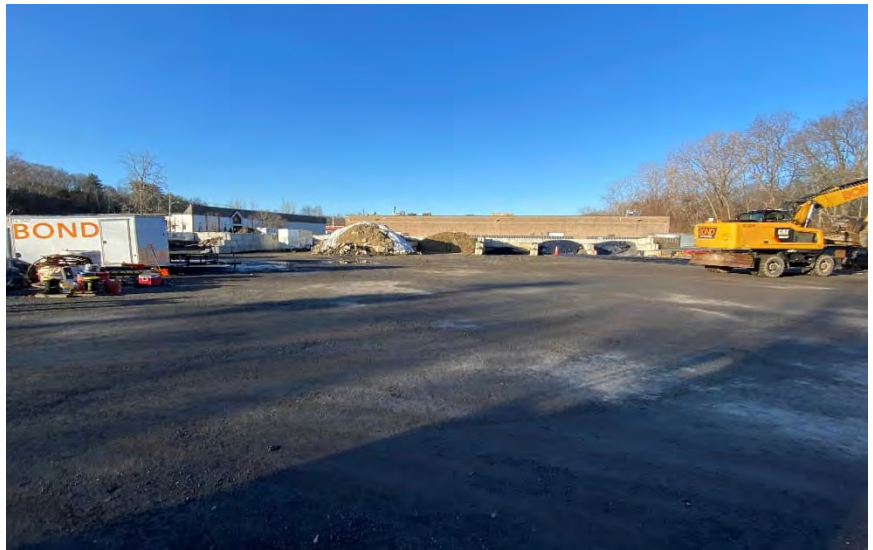
<p>PHOTOGRAPHIC LOG</p>	
<p>Client Name: Eversource</p>		<p>Site Location: Sudbury to Hudson Transmission Reliability Project</p>	<p>Town: Hudson</p>
<p>Photo No.: 8</p>	<p>Date: 4-8-24</p>

<p>Description:</p> <p>Bonazzoli laydown yard, movement of materials, looking westward.</p>

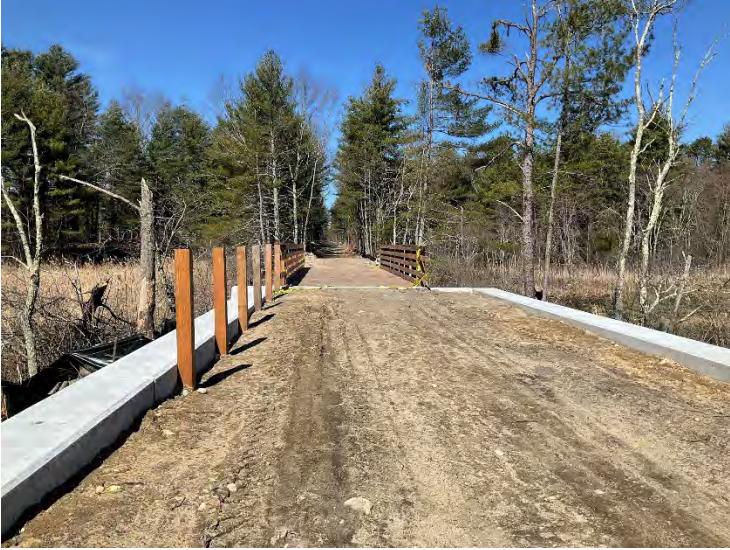
<p>PHOTOGRAPHIC LOG</p>	
<p>Client Name: Eversource</p>		<p>Site Location: Sudbury to Hudson Transmission Reliability Project</p>	<p>Town: Sudbury</p>
<p>Photo No.: 1</p>	<p>Date: 4/09/2024</p>

<p>Description: View of bridge 128. Facing west.</p>

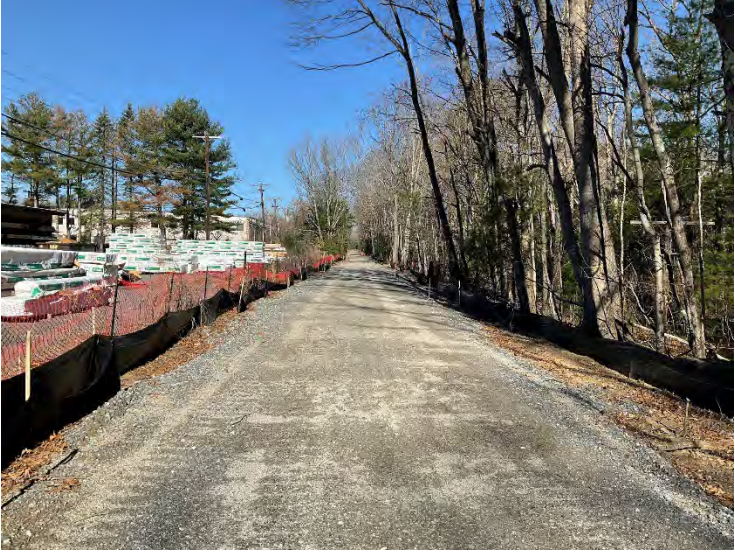
PHOTOGRAPHIC LOG	
Client Name: Eversource		Site Location: Sudbury to Hudson Transmission Reliability Project	Town: Sudbury
Photo No.: 3	Date: 4/09/2024

Description: View of E&S controls in segment 11. Facing west.

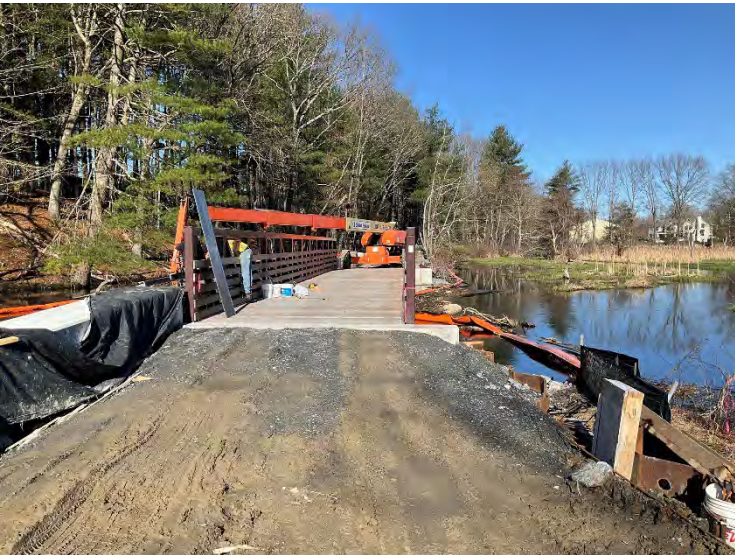
PHOTOGRAPHIC LOG	
Client Name: Eversource		Site Location: Sudbury to Hudson Transmission Reliability Project	Town: Sudbury
Photo No.: 4	Date: 4/09/2024

Description: View of Bond working at bridge 127. Facing west.

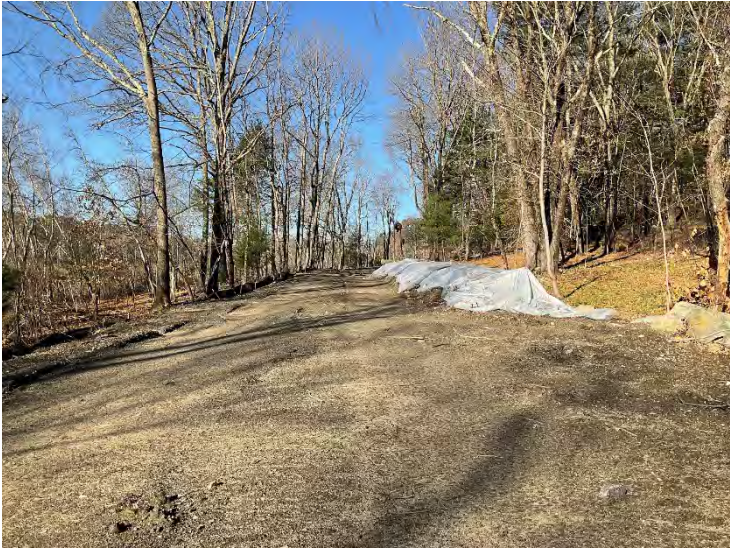
PHOTOGRAPHIC LOG	
Client Name: Eversource		Site Location: Sudbury to Hudson Transmission Reliability Project	Town: Sudbury
Photo No.: 5	Date: 4/09/2024

Description: View of stockpile/spoil berm at Sta. #738 in segment 14. Facing west.

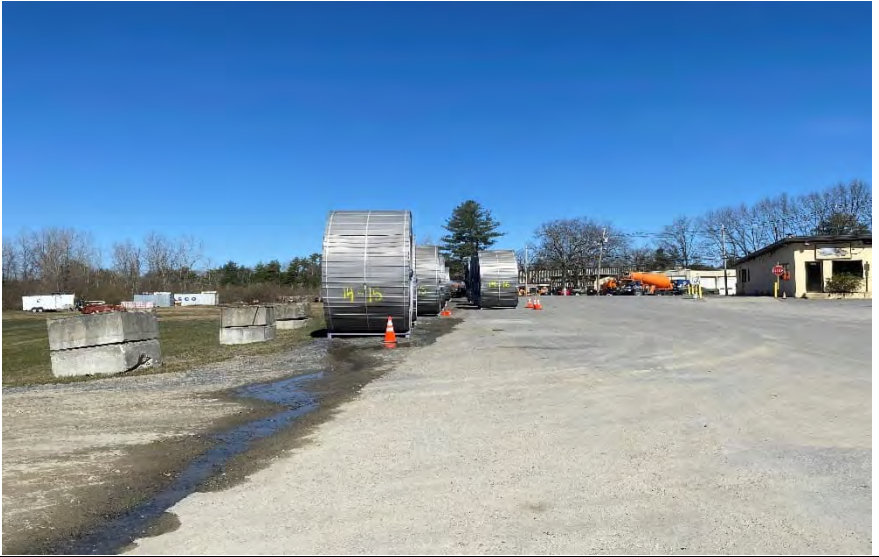
<p>PHOTOGRAPHIC LOG</p>	
<p>Client Name: Eversource</p>		<p>Site Location: Sudbury to Hudson Transmission Reliability Project</p>	<p>Town: Hudson</p>
<p>Photo No.: 1</p>	<p>Date: 4-9-24</p>

<p>Description:</p> <p>Work area within Haugland laydown yard, stored cable on reels, looking eastward.</p>

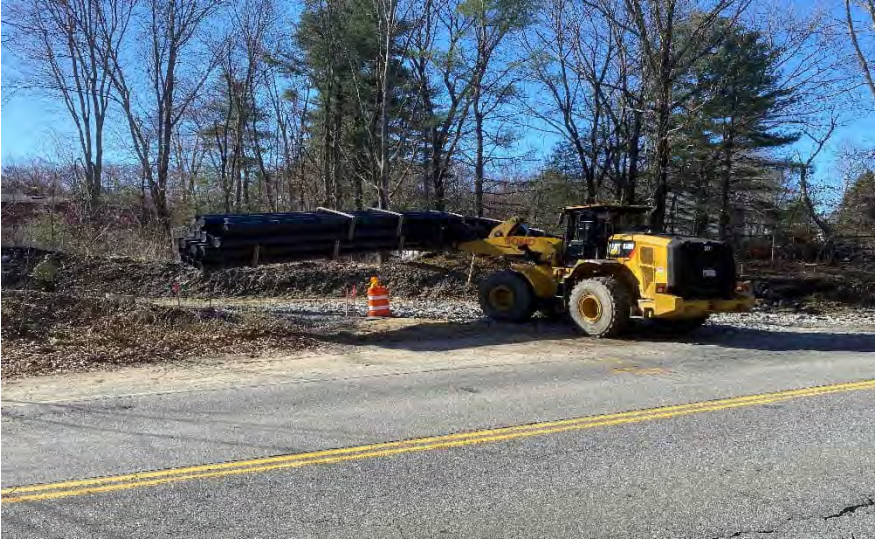
<p align="center">PHOTOGRAPHIC LOG</p>	
<p>Client Name: Eversource</p>		<p>Site Location: Sudbury to Hudson Transmission Reliability Project</p>	<p>Town: Hudson</p>
<p>Photo No.: 4</p>	<p>Date: 4-9-24</p>

<p>Description:</p> <p>Delivery of conduit for roadway crossing of Wilkins Avenue, looking eastward.</p>

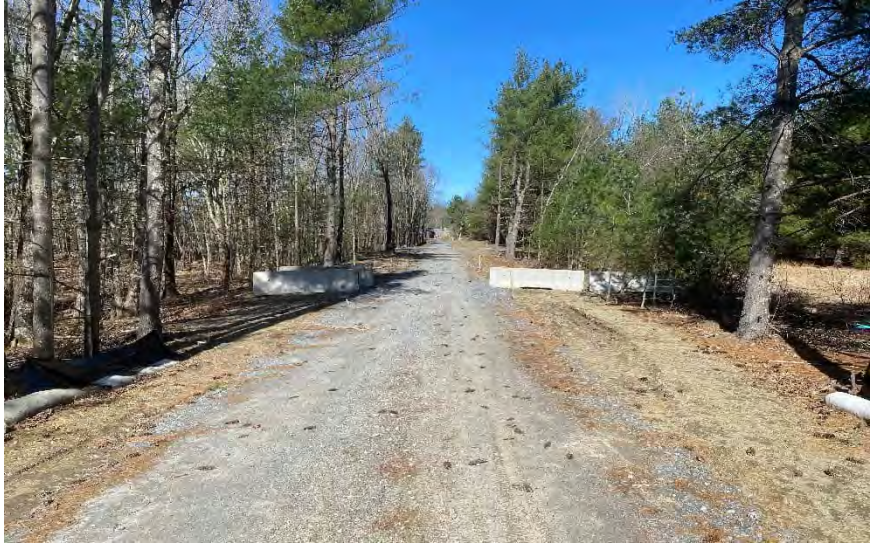
<p>PHOTOGRAPHIC LOG</p>	
<p>Client Name: Eversource</p>		<p>Site Location: Sudbury to Hudson Transmission Reliability Project</p>	<p>Town: Hudson</p>
<p>Photo No.: 6</p>	<p>Date: 4-9-24</p>

<p>Description:</p> <p>Work area within segment 2, existing erosion control, looking westward.</p>

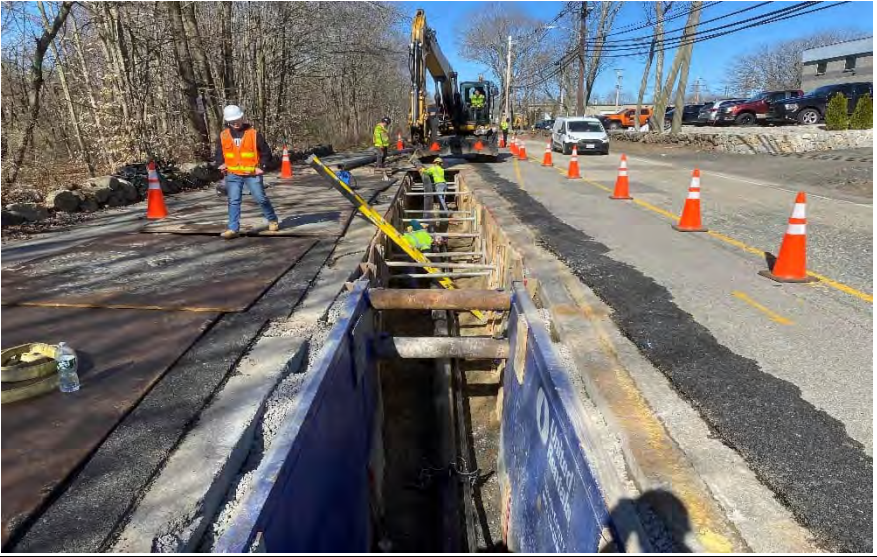
<p>PHOTOGRAPHIC LOG</p>	
<p>Client Name: Eversource</p>		<p>Site Location: Sudbury to Hudson Transmission Reliability Project</p>	<p>Town: Hudson</p>
<p>Photo No.: 7</p>	<p>Date: 4-9-24</p>

<p>Description: Conduit trench work within Forest Avenue, looking southward.</p>

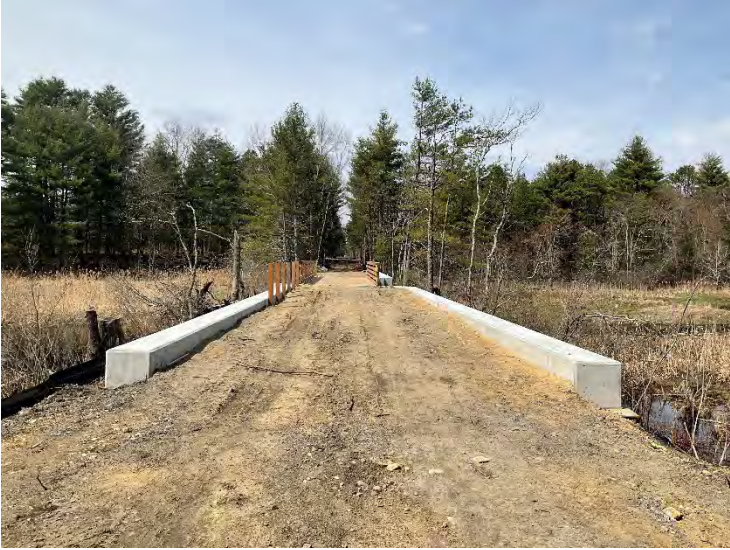
<p align="right">PHOTOGRAPHIC LOG</p>	
<p>Client Name: Eversource</p>		<p>Site Location: Sudbury to Hudson Transmission Reliability Project</p>	<p>Town: Sudbury</p>
<p>Photo No.: 1</p>	<p>Date: 4/10/2024</p>

<p>Description: View of bridge 128. Facing west.</p>

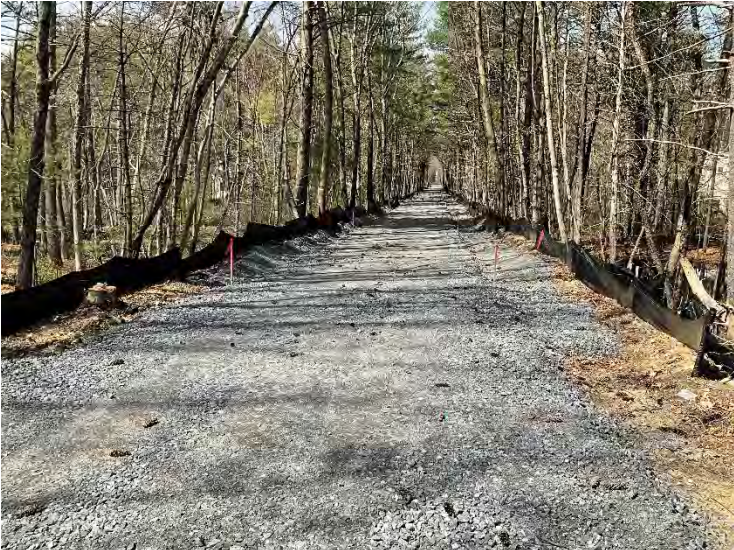
<p align="right">PHOTOGRAPHIC LOG</p>	
<p>Client Name: Eversource</p>		<p>Site Location: Sudbury to Hudson Transmission Reliability Project</p>	<p>Town: Sudbury</p>
<p>Photo No.: 2</p>	<p>Date: 4/10/2024</p>

<p>Description: View of E&S controls in segment 9. Facing west.</p>

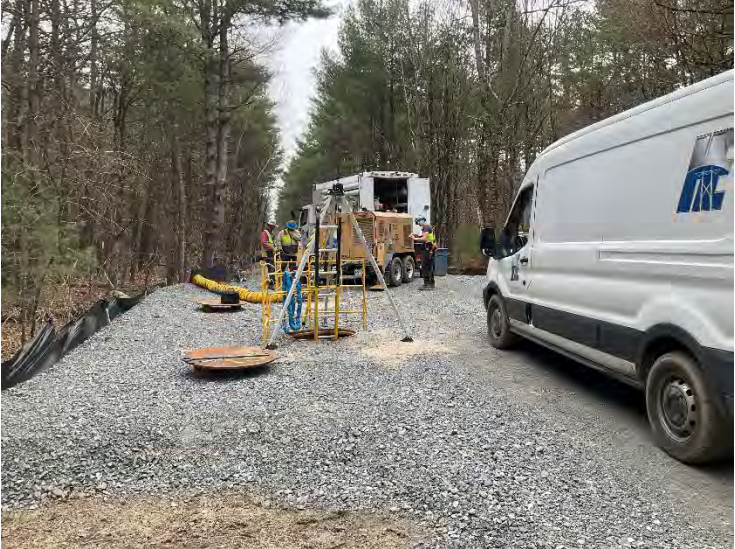
PHOTOGRAPHIC LOG	
Client Name: Eversource		Site Location: Sudbury to Hudson Transmission Reliability Project	
Town: Sudbury			
Photo No.: 3	Date: 4/10/2024

Description: View of active work. Haugland pulling cable from manhole 14 to manhole 15. Facing east.

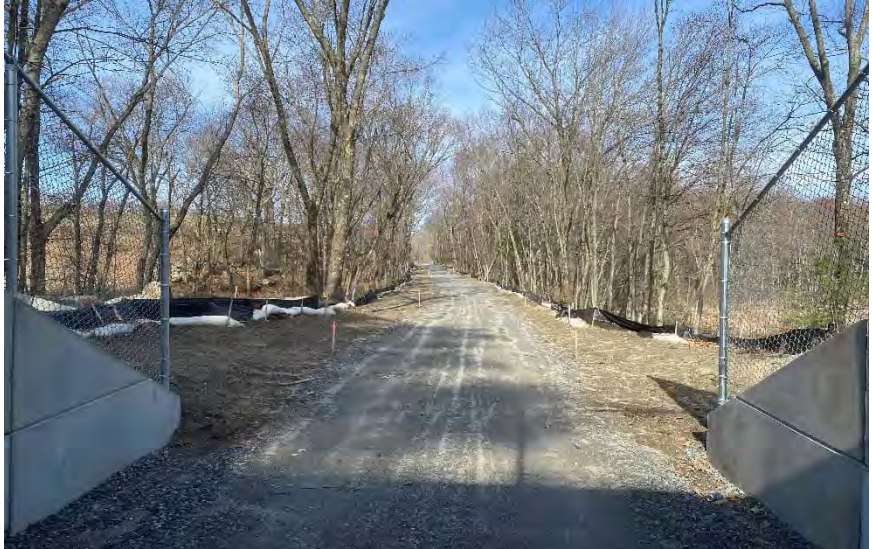
<p>PHOTOGRAPHIC LOG</p>	
<p>Client Name: Eversource</p>		<p>Site Location: Sudbury to Hudson Transmission Reliability Project</p>	<p>Town: Hudson</p>
<p>Photo No.: 2</p>	<p>Date: 4-10-24</p>

<p>Description:</p> <p>Work area within Segment 1, Chestnut Street crossing, looking westward.</p>

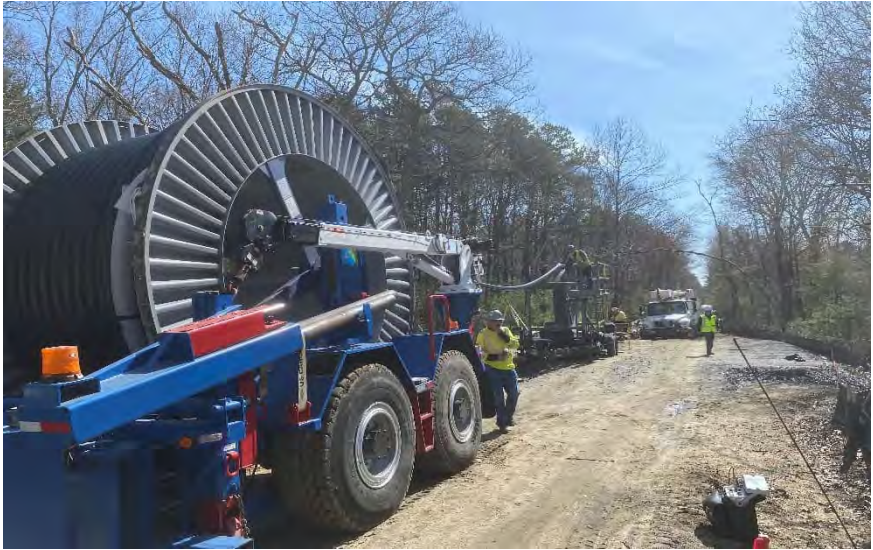
<p>PHOTOGRAPHIC LOG</p>	
<p>Client Name: Eversource</p>		<p>Site Location: Sudbury to Hudson Transmission Reliability Project</p>	<p>Town: Hudson</p>
<p>Photo No.: 3</p>	<p>Date: 4-10-24</p>

<p>Description:</p> <p>Work area within Segment 6, manhole #14, cable pulling work, looking eastward.</p>

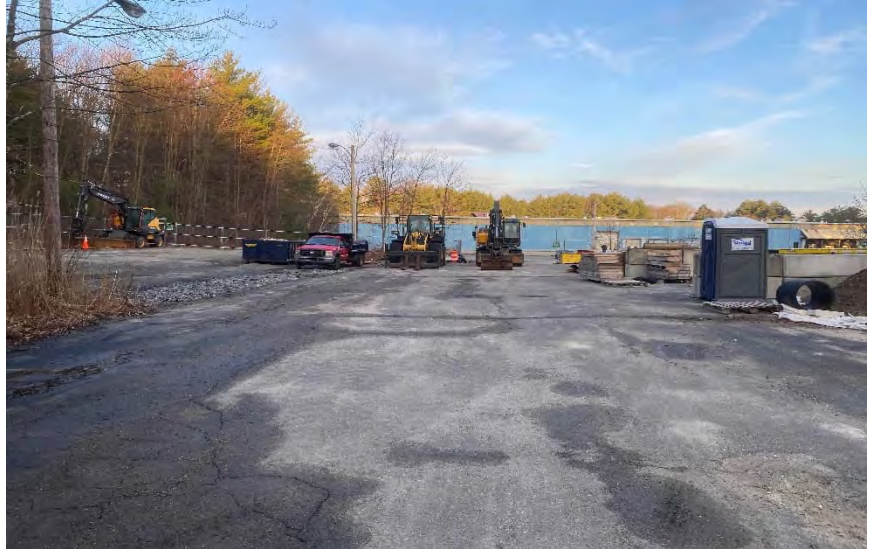
<p>PHOTOGRAPHIC LOG</p>	
<p>Client Name: Eversource</p>		<p>Site Location: Sudbury to Hudson Transmission Reliability Project</p>	<p>Town: Hudson</p>
<p>Photo No.: 4</p>	<p>Date: 4-10-24</p>

<p>Description:</p> <p>ET&L laydown yard, looking westward.</p>

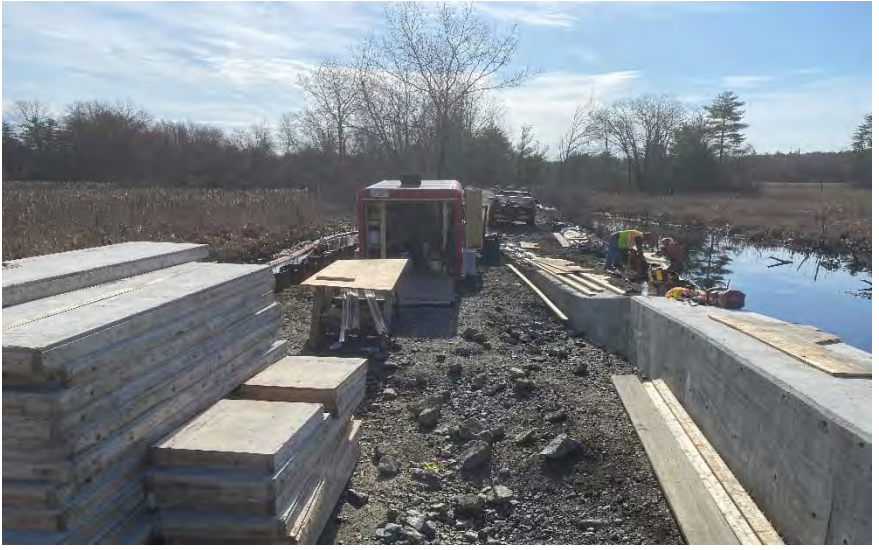
<p>PHOTOGRAPHIC LOG</p>	
<p>Client Name: Eversource</p>		<p>Site Location: Sudbury to Hudson Transmission Reliability Project</p>	<p>Town: Hudson</p>
<p>Photo No.: 5</p>	<p>Date: 4-10-24</p>

<p>Description:</p> <p>Work area within segment 3 looking across Fort Meadow Brook, Bridge 130, existing erosion control, looking eastward.</p>

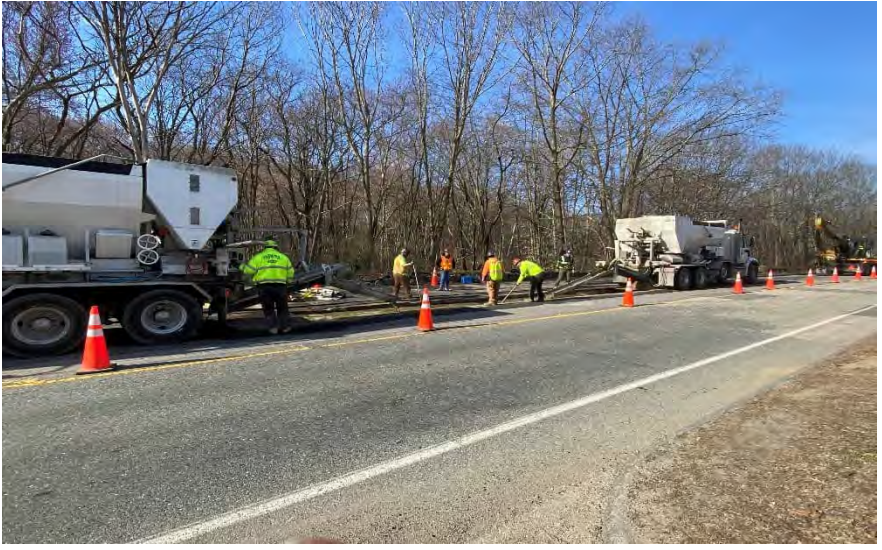
<p>PHOTOGRAPHIC LOG</p>	
<p>Client Name: Eversource</p>		<p>Site Location: Sudbury to Hudson Transmission Reliability Project</p>	<p>Town: Hudson</p>
<p>Photo No.: 7</p>	<p>Date: 4-10-24</p>

<p>Description: Conduit trench work within Forest Avenue, looking southward.</p>

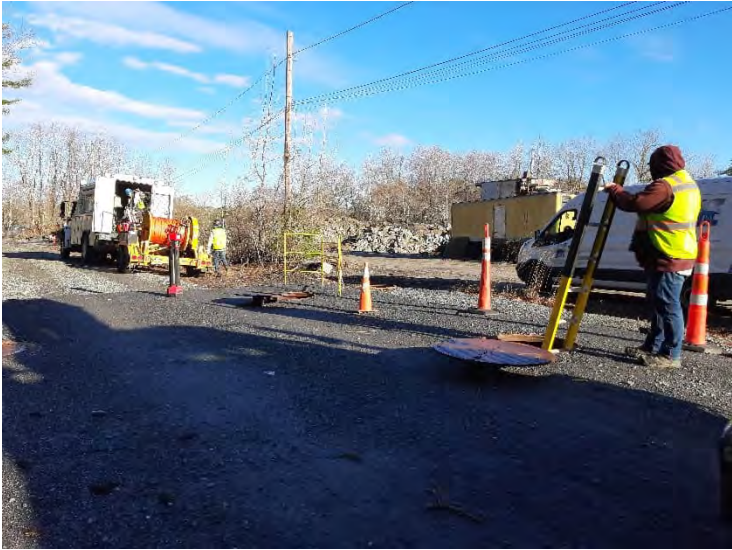
<p>PHOTOGRAPHIC LOG</p>	
<p>Client Name: Eversource</p>		<p>Site Location: Sudbury to Hudson Transmission Reliability Project</p>	<p>Town: Hudson</p>
<p>Photo No.: 1</p>	<p>Date: 4-13-24</p>

<p>Description:</p> <p>Work area within segment 3, manhole #8 work (mandrel, swab, GCC). Work crew determined no dewatering was needed at this manhole. Looking westward.</p>

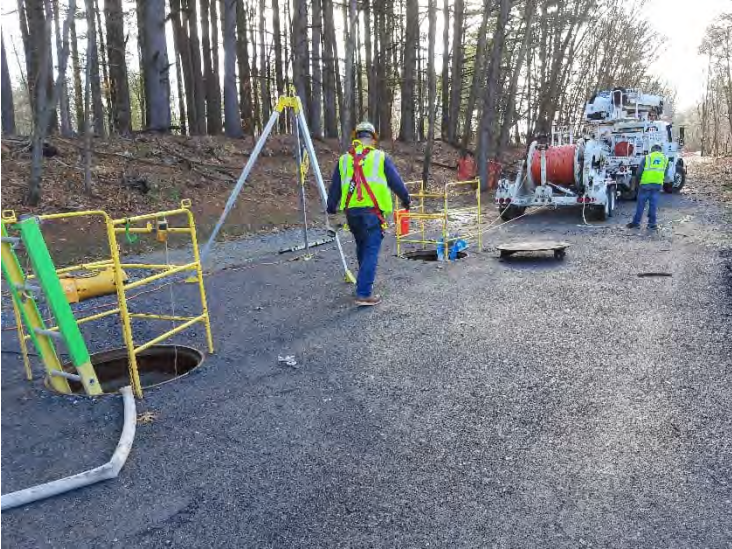
<p>PHOTOGRAPHIC LOG</p>	
<p>Client Name: Eversource</p>		<p>Site Location: Sudbury to Hudson Transmission Reliability Project</p>	<p>Town: Hudson</p>
<p>Photo No.: 2</p>	<p>Date: 4-13-24</p>

<p>Description:</p> <p>Work area within segment 3, manhole #9 work (mandrel, swab, GCC), dewatering, looking eastward.</p>

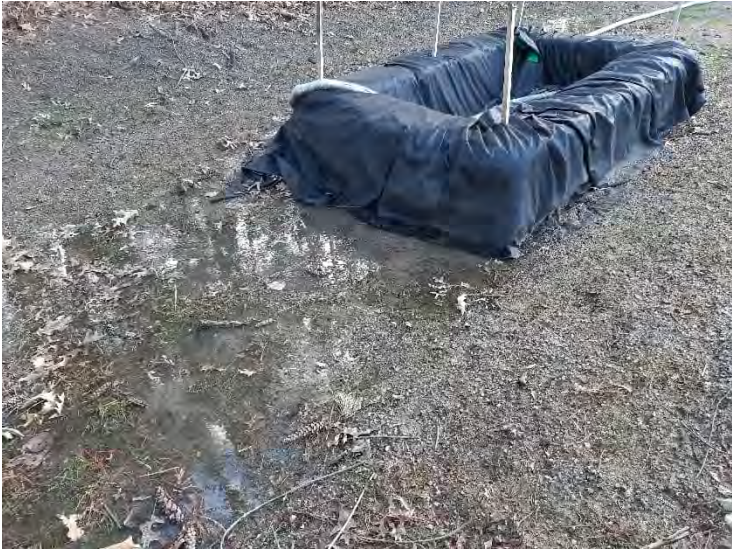
<p>PHOTOGRAPHIC LOG</p>	
<p>Client Name: Eversource</p>		<p>Site Location: Sudbury to Hudson Transmission Reliability Project</p>	<p>Town: Hudson</p>
<p>Photo No.: 3</p>	<p>Date: 4-13-24</p>

<p>Description:</p> <p>Work area within segment 3, manhole #9 dewatering bag/corral, looking westward.</p>

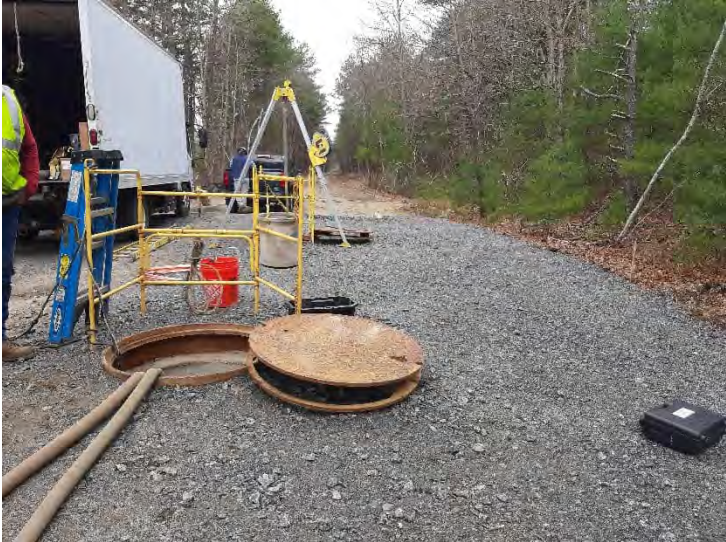
<p>PHOTOGRAPHIC LOG</p>	
<p>Client Name: Eversource</p>		<p>Site Location: Sudbury to Hudson Transmission Reliability Project</p>	<p>Town: Hudson</p>
<p>Photo No.: 4</p>	<p>Date: 4-13-24</p>

Manhole #14 had significant amounts of accumulated water inside and was dewatered with two pumps simultaneously. Replacement dewatering bags were brought in and used at this location. Additional water poured continuously from the lower conduit on the west side once the water was low enough to expose it. Dewatering was not completed by the time Haugland concluded operations for the day, and the intended work at manhole #14 (halo installation) was not conducted.

<p>Description:</p> <p>Work area within segment 6, manhole #14 work (intended halo installation), dewatering, looking westward.</p>

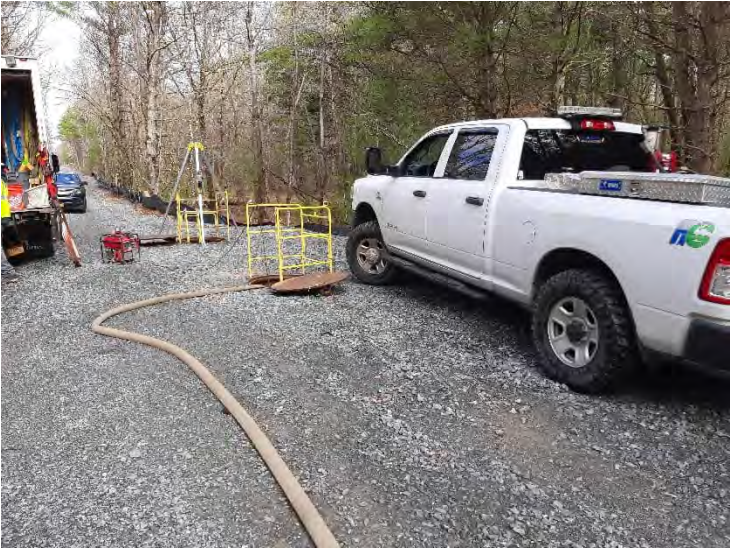
PHOTOGRAPHIC LOG	
Client Name: Eversource		Site Location: Sudbury to Hudson Transmission Reliability Project	Town: Sudbury
Photo No.: 7	Date: 4-13-24

<p>Description:</p> <p>Work area within segment 7, manhole #15 work (halo installation), dewatering, looking westward. Significantly drier than manhole #14.</p>

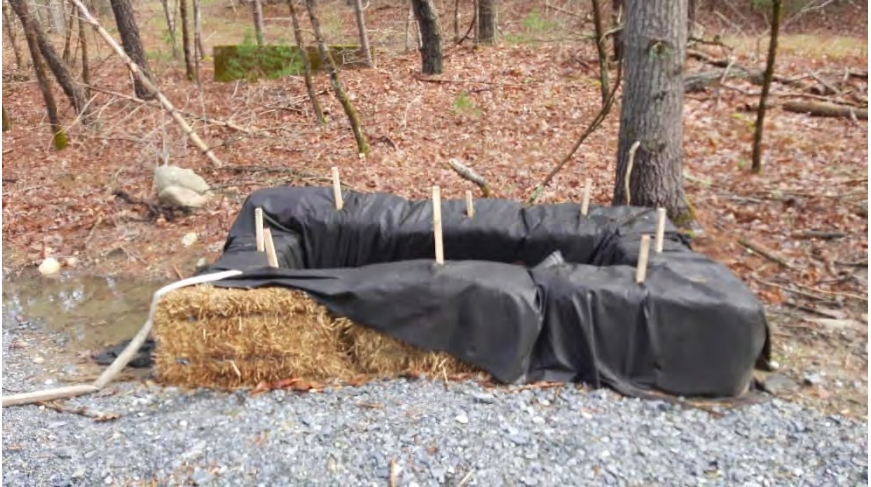
PHOTOGRAPHIC LOG	
Client Name: Eversource		Site Location: Sudbury to Hudson Transmission Reliability Project	Town: Sudbury
Photo No.: 8	Date: 4-13-24

<p>Description:</p> <p>Work area within segment 7, manhole #15 dewatering bag/corral. Looking northward.</p>

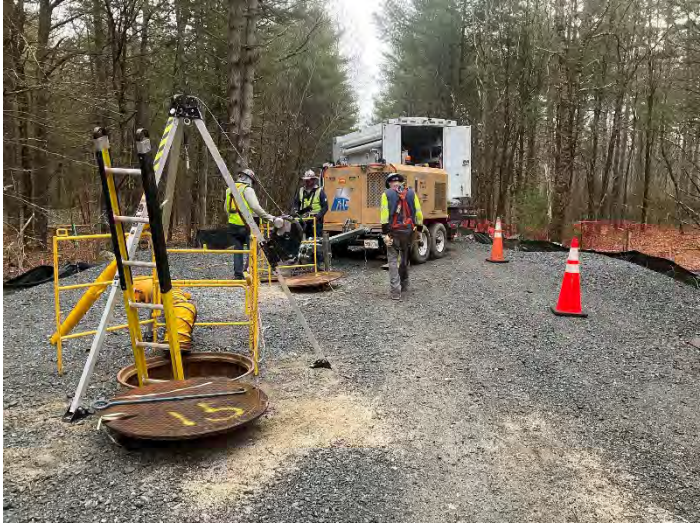
PHOTOGRAPHIC LOG	
Client Name: Eversource		Site Location: Sudbury to Hudson Transmission Reliability Project	Town: Sudbury
Photo No.: 1	Date: 4-11-2024

Description: View of Haugland working at MH #15 in segment 7. Facing east.

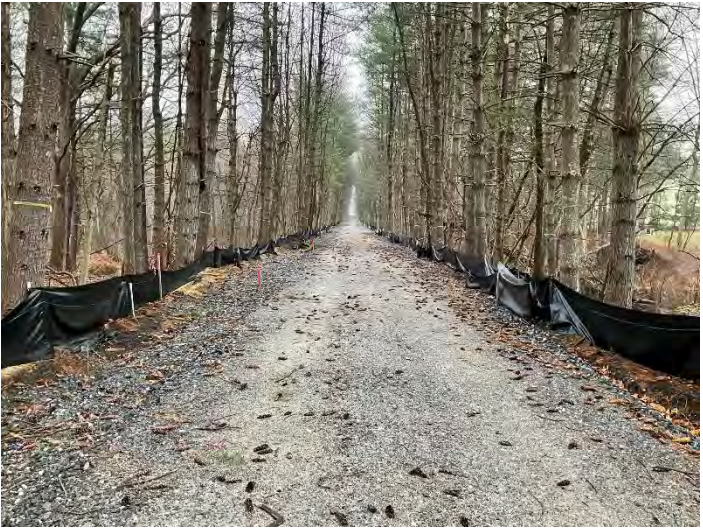
Client Name: Eversource		Site Location: Sudbury to Hudson Transmission Reliability Project	Town: Sudbury
Photo No.: 4	Date: 4-11-2024

Description: View of syncopated silt fence in segment 10. Facing west.

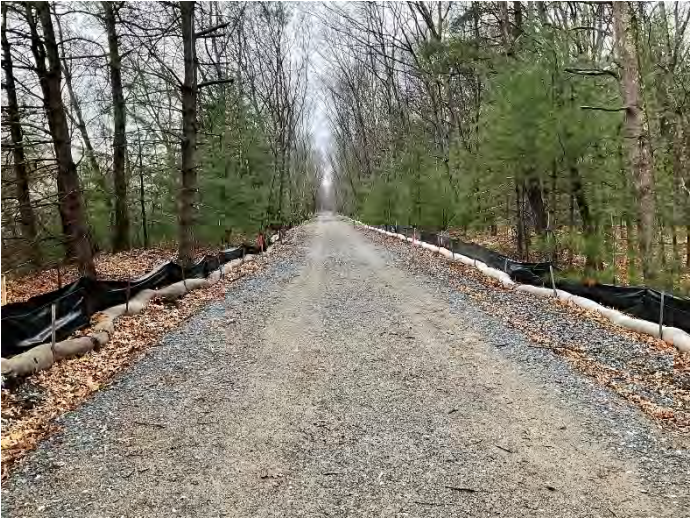
PHOTOGRAPHIC LOG	
Client Name: Eversource		Site Location: Sudbury to Hudson Transmission Reliability Project	Town: Sudbury
Photo No.: 5	Date: 4-11-2024

Description: View of E&S controls in segment 11. Facing west.

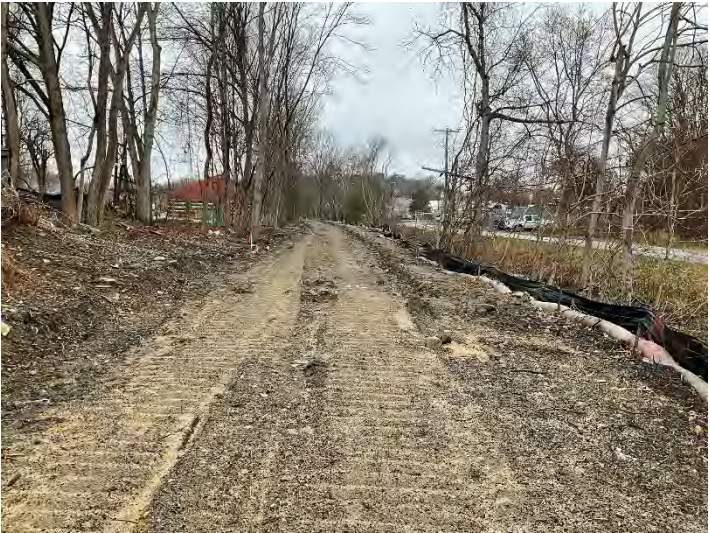
PHOTOGRAPHIC LOG	
Client Name: Eversource		Site Location: Sudbury to Hudson Transmission Reliability Project	Town: Sudbury
Photo No.: 6	Date: 4-11-2024

Description: View of E&S controls in segment 12. Facing west.

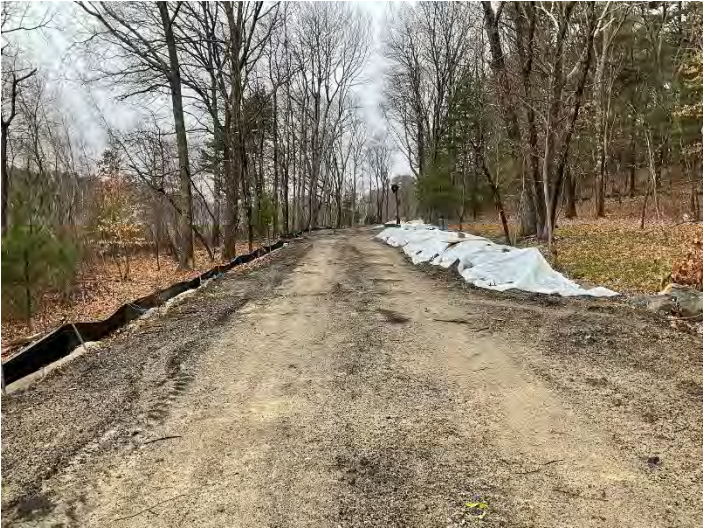
PHOTOGRAPHIC LOG	
Client Name: Eversource		Site Location: Sudbury to Hudson Transmission Reliability Project	Town: Sudbury
Photo No.: 7	Date: 4-11-2024

Description: View of stockpile/spoil berm at Sta. #738 in segment 14. Facing west.

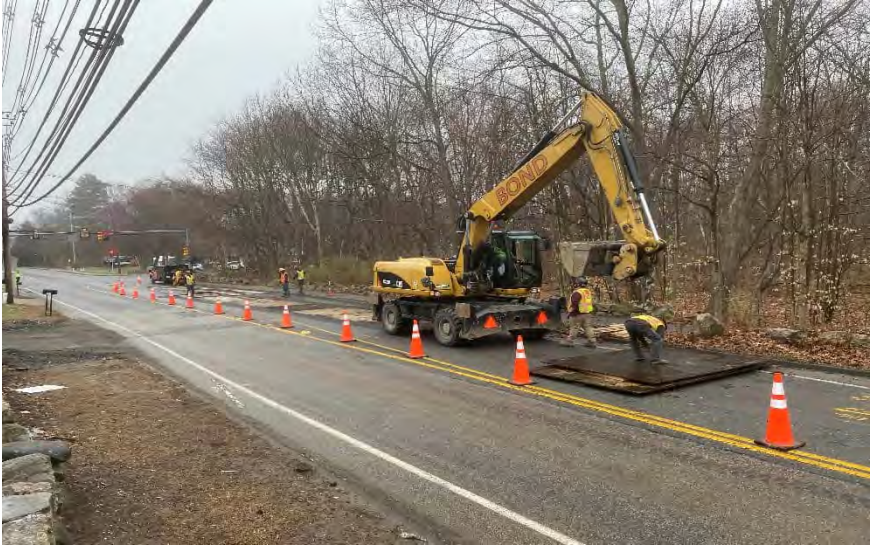
PHOTOGRAPHIC LOG	
Client Name: Eversource		Site Location: Sudbury to Hudson Transmission Reliability Project	Town: Hudson
Photo No.: 2	Date: 4-11-24

Description: Conduit work within Forest Avenue near manhole #2, looking westward.

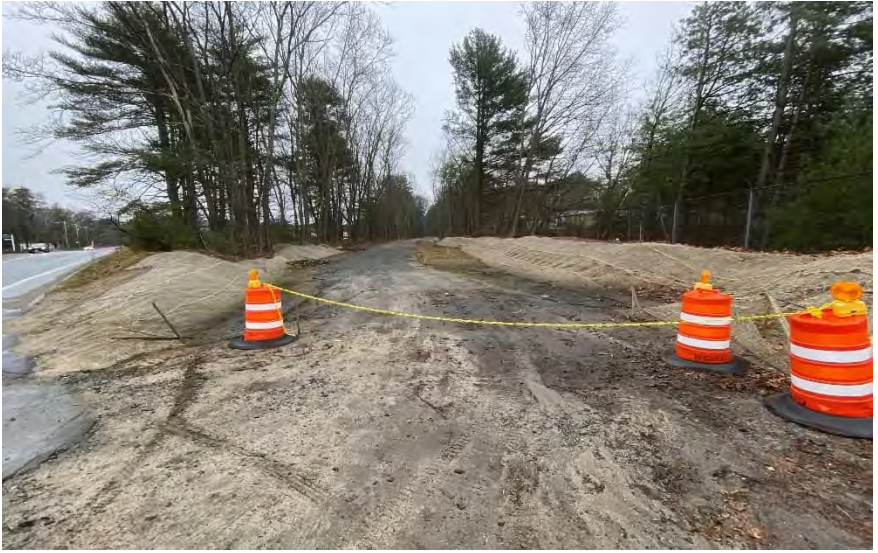
PHOTOGRAPHIC LOG	
Client Name: Eversource		Site Location: Sudbury to Hudson Transmission Reliability Project	Town: Hudson
Photo No.: 3	Date: 4-11-24

Description: Work area within segment 4, existing erosion control, looking eastward.

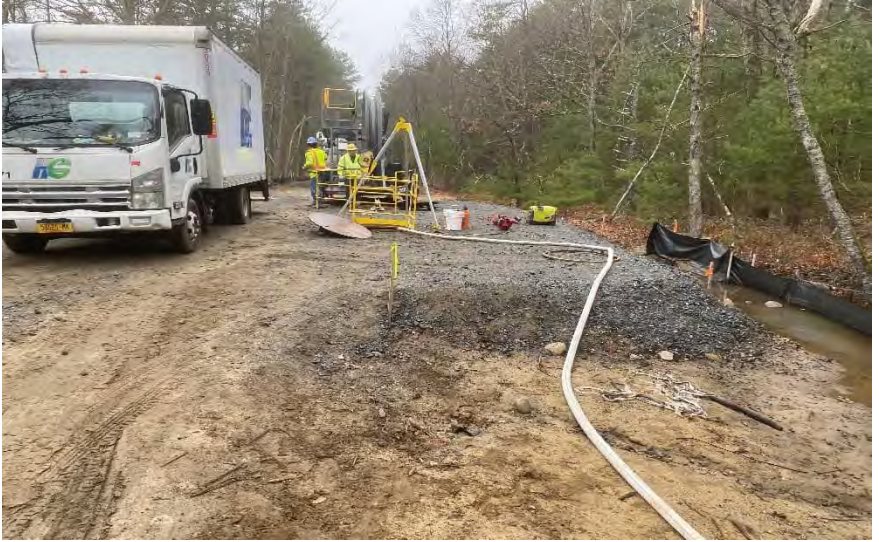
PHOTOGRAPHIC LOG	
Client Name: Eversource		Site Location: Sudbury to Hudson Transmission Reliability Project	
Town: Hudson			
Photo No.: 5	Date: 4-11-24

Description: Wire pulling work within segment 6, manhole #14, existing erosion control, looking westward.

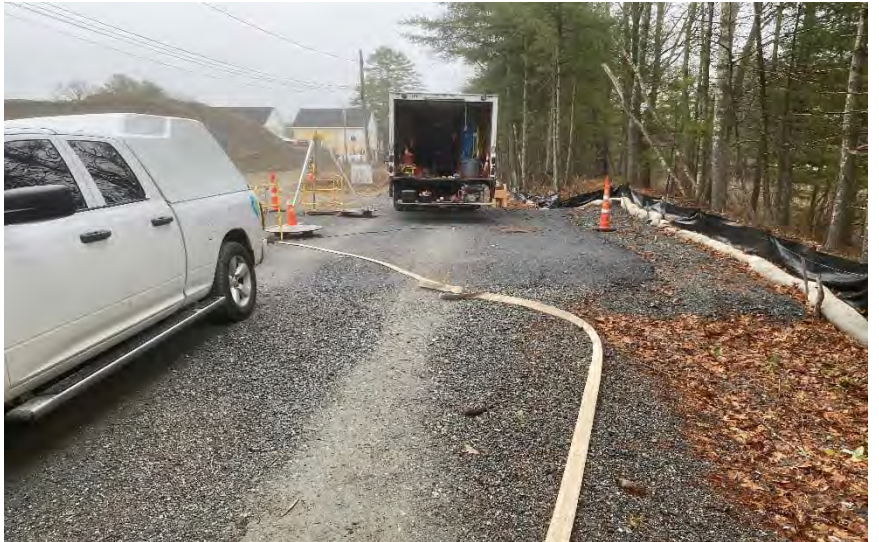
PHOTOGRAPHIC LOG	
Client Name: Eversource		Site Location: Sudbury to Hudson Transmission Reliability Project	
Town: Hudson			
Photo No.: 6	Date: 4-11-24

Description: Wire pulling work within segment 3, manhole #8, existing erosion control, looking eastward.

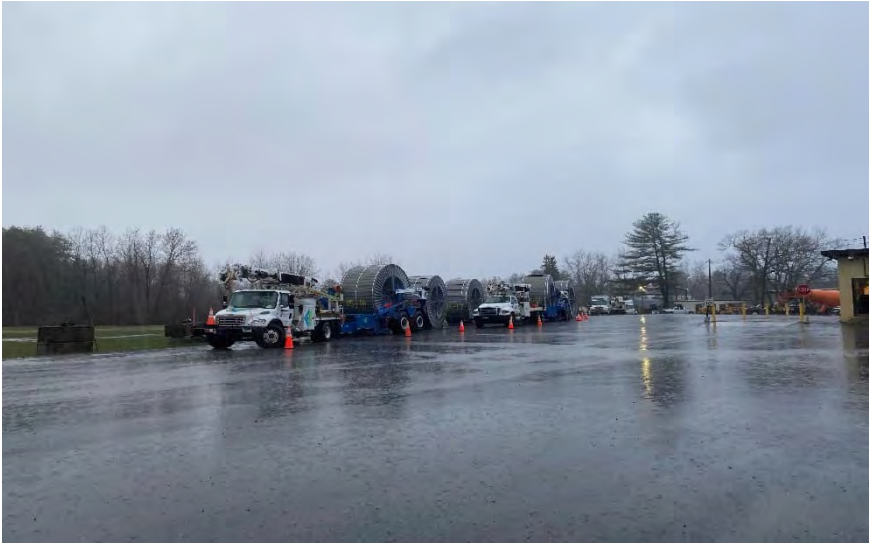
PHOTOGRAPHIC LOG	
Client Name: Eversource		Site Location: Sudbury to Hudson Transmission Reliability Project	
Photo No.: 1 Date: 4-12-24		Town: Hudson	
Description: Haugland laydown yard, stored cable, looking eastward.

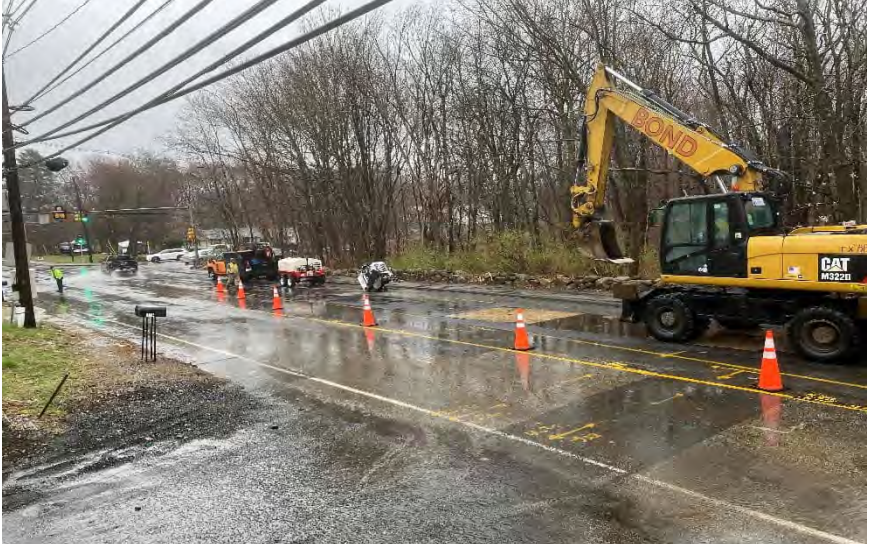
PHOTOGRAPHIC LOG	
Client Name: Eversource		Site Location: Sudbury to Hudson Transmission Reliability Project	
Photo No.: 2 Date: 4-12-24		Town: Hudson	
Description: Saw cutting work within Forest Avenue near manhole #2, looking westward.

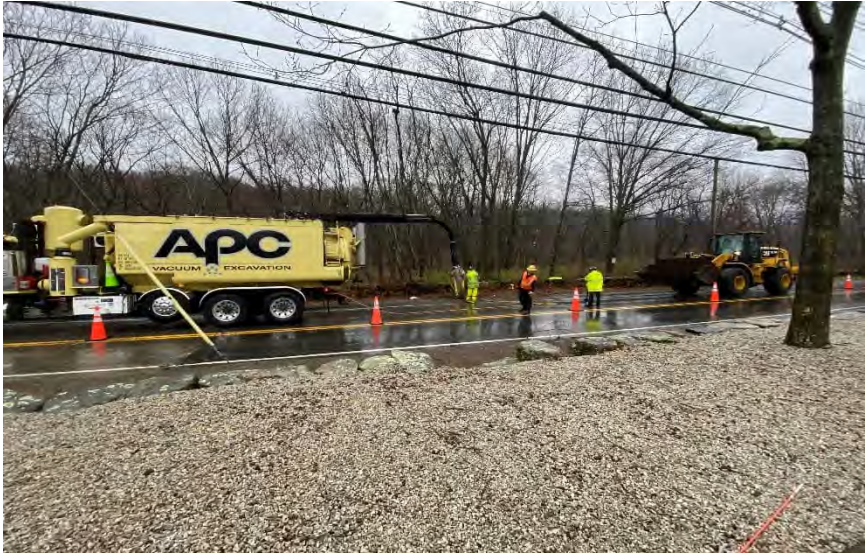
PHOTOGRAPHIC LOG	
Client Name: Eversource		Site Location: Sudbury to Hudson Transmission Reliability Project	Town: Hudson
Photo No.: 3	Date: 4-12-24

Description: Vac work within Forest Avenue near manhole #2, looking eastward.

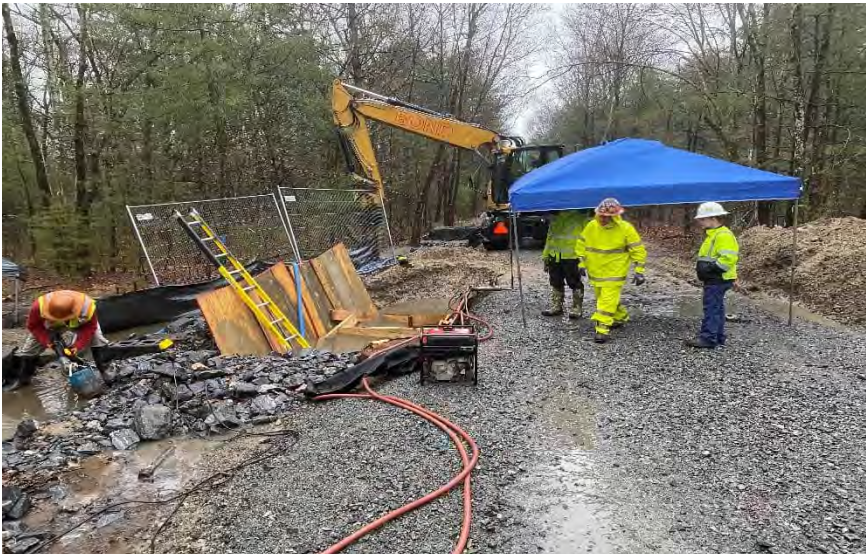
PHOTOGRAPHIC LOG	
Client Name: Eversource		Site Location: Sudbury to Hudson Transmission Reliability Project	Town: Hudson
Photo No.: 4	Date: 4-12-24

Description: Work area within segment 5 at manhole #12, conduit repairs, existing erosion control, looking eastward.
