Weekly Environmental Compliance Summary

Sudbury to Hudson Transmission Reliability Project (USEPA Tracking # MAR1003UW)

Sudbury, Hudson, and Stow, MA

Week of: April 8, 2024 to April 13, 2024

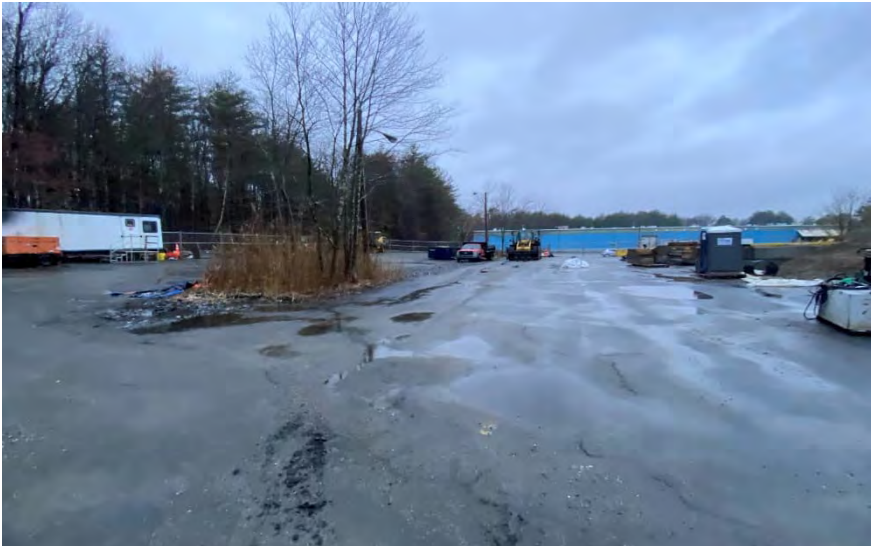
PHOTOGRAPHIC LOG	
Client Name: Eversource		Site Location: Sudbury to Hudson Transmission Reliability Project	Town: Hudson
Photo No.: 6	Date: 4-12-24

Description: ET&L laydown yard, looking westward.

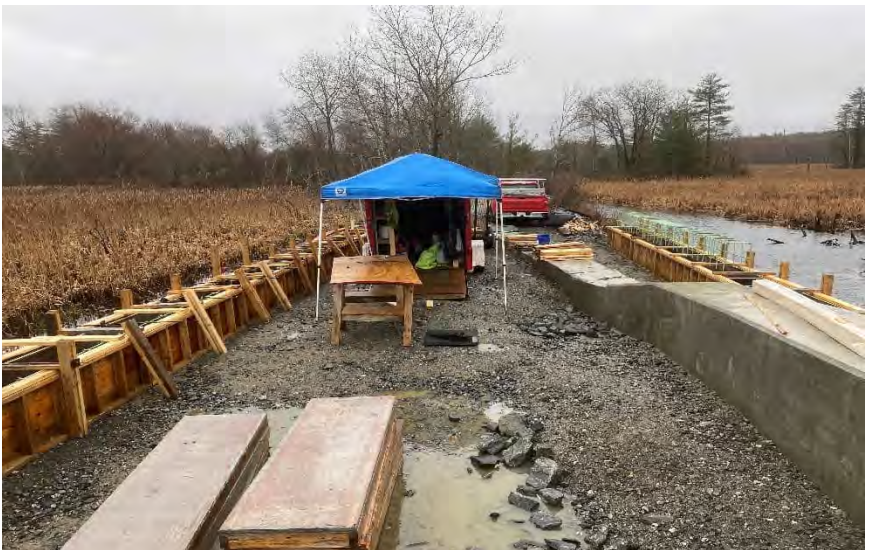
PHOTOGRAPHIC LOG	
Client Name: Eversource		Site Location: Sudbury to Hudson Transmission Reliability Project	Town: Hudson
Photo No.: 8	Date: 4-12-24

Description: Work area within segment 3, Bridge 130, concrete cap work, looking eastward.

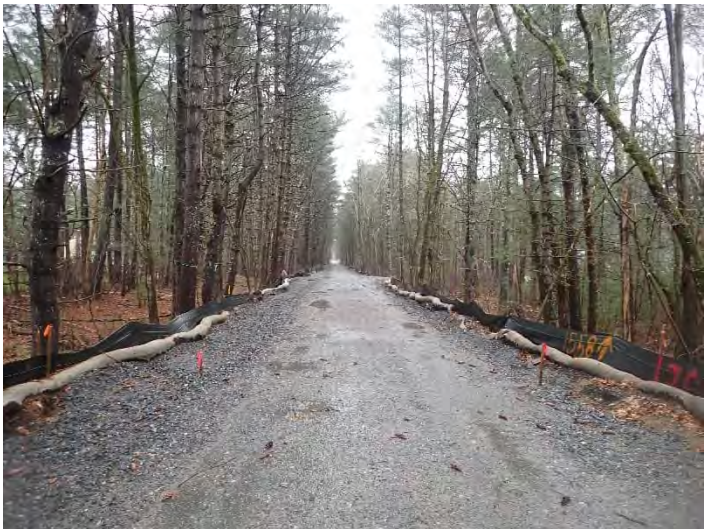
PHOTOGRAPHIC LOG	
Client Name: Eversource		Site Location: Sudbury to Hudson Transmission Reliability Project	Town: Sudbury
Photo No.: 2	Date: 4-12-2024

Description: View of E&S controls in segment 9. Facing east.

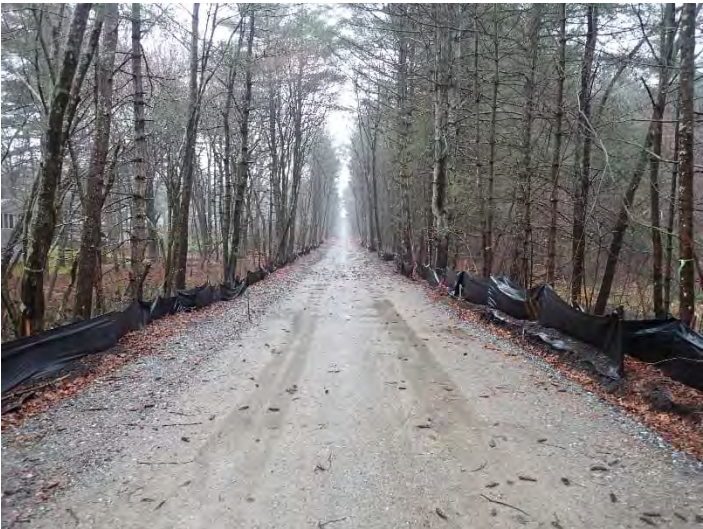
Epsilon ASSOCIATES INC.		PHOTOGRAPHIC LOG	
Client Name: Eversource		Site Location: Sudbury to Hudson Transmission Reliability Project	Town: Sudbury
Photo No.: 3	Date: 4-12-2024

Description: View of syncopated silt fence in segment 11. Facing east.

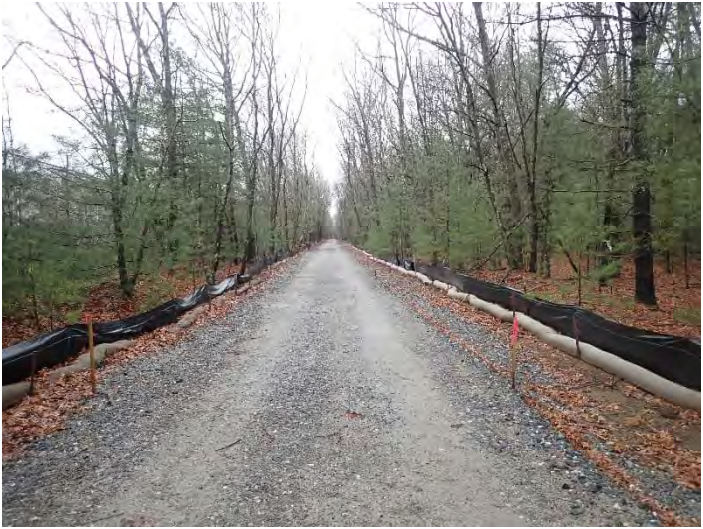
Epsilon ASSOCIATES INC.		PHOTOGRAPHIC LOG	
Client Name: Eversource		Site Location: Sudbury to Hudson Transmission Reliability Project	Town: Sudbury
Photo No.: 4	Date: 4-12-2024

Description: View of E&S controls in segment 11. Facing west.

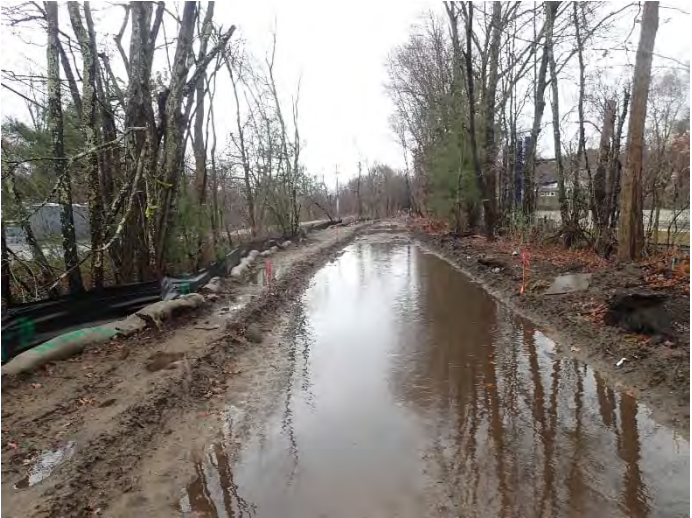
PHOTOGRAPHIC LOG	
Client Name: Eversource		Site Location: Sudbury to Hudson Transmission Reliability Project	Town: Sudbury
Photo No.: 5	Date: 4-12-2024

Description: View of E&S controls in segment 12. Facing east.

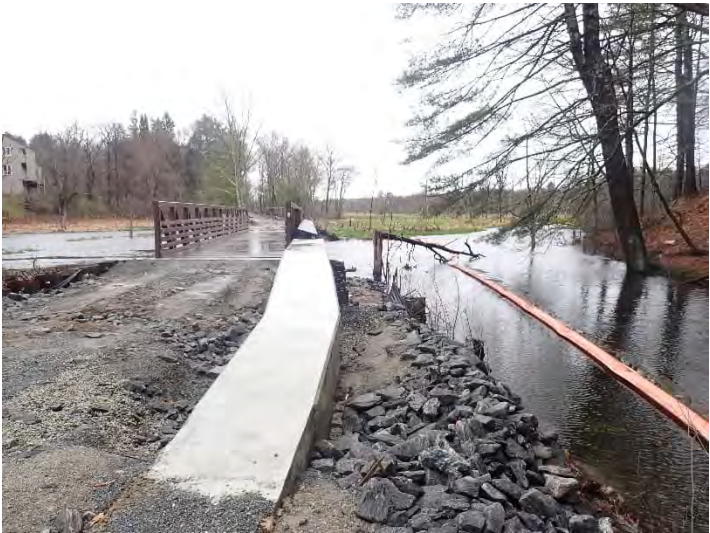
PHOTOGRAPHIC LOG	
Client Name: Eversource		Site Location: Sudbury to Hudson Transmission Reliability Project	Town: Sudbury
Photo No.: 6	Date: 4-12-2024

Description: View of bridge 127 and turbidity curtain. Facing east.

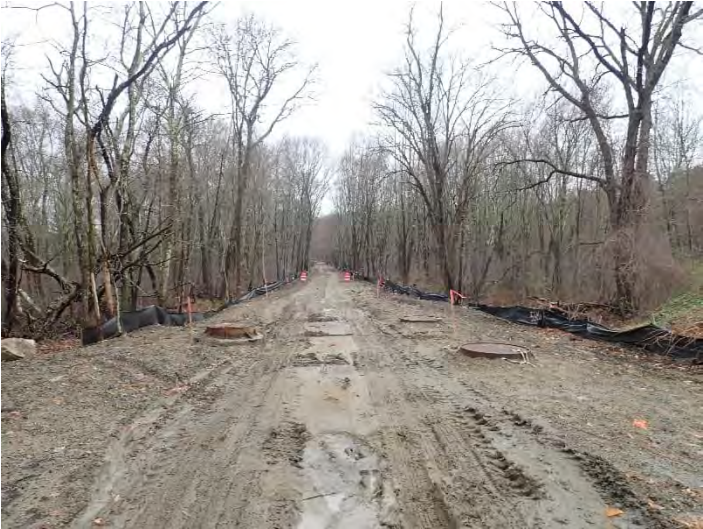
PHOTOGRAPHIC LOG	
Client Name: Eversource		Site Location: Sudbury to Hudson Transmission Reliability Project	Town: Sudbury
Photo No.: 7	Date: 4-12-2024

Description: View of E&S controls in segment 14. Steel plates were removed from this area. Facing west.

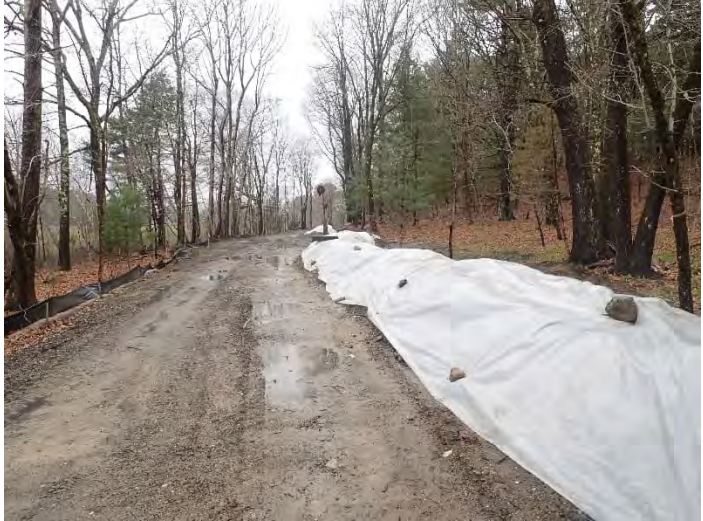
PHOTOGRAPHIC LOG	
Client Name: Eversource		Site Location: Sudbury to Hudson Transmission Reliability Project	Town: Sudbury
Photo No.: 8	Date: 4-12-2024

Description: View of stockpile/spoil berm at Sta. #738 in segment 14. Facing west.
