Weekly Environmental Compliance Summary

Sudbury to Hudson Transmission Reliability Project (USEPA Tracking # MAR1003UW)

Sudbury, Hudson, and Stow, MA

Week of: May 6, 2024 to May 11, 2024

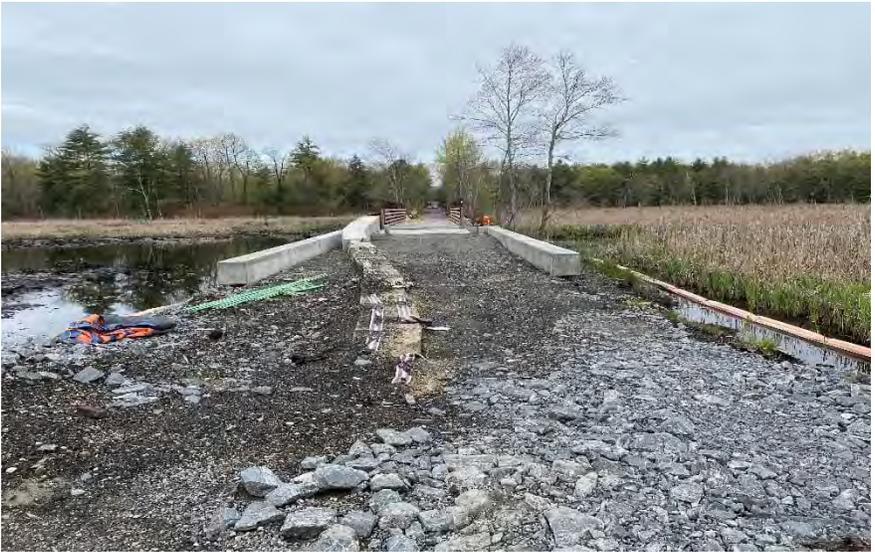
<p align="center">PHOTOGRAPHIC LOG</p>	
<p>Client Name: Eversource</p>		<p>Site Location: Sudbury to Hudson Transmission Reliability Project</p>	<p>Town: Hudson</p>
<p>Photo No.: 5</p>	<p>Date: 5-6-24</p>

<p>Description:</p> <p>Work area within segment 3 looking across Fort Meadow Brook, Bridge 130, existing erosion control, looking westward.</p>

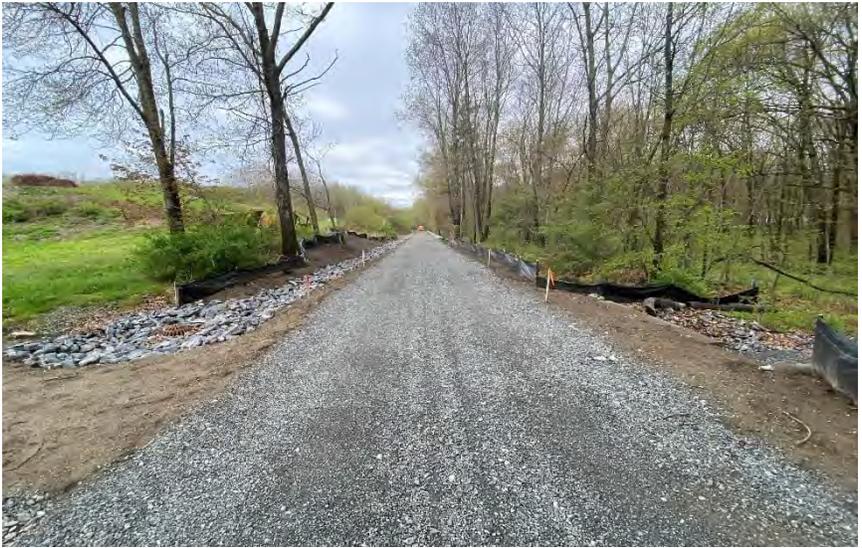
PHOTOGRAPHIC LOG	
Client Name: Eversource		Site Location: Sudbury to Hudson Transmission Reliability Project	Town: Stow
Photo No.: 8	Date: 5-6-24

Description: Work area within segment 1, existing erosion control, looking westward.

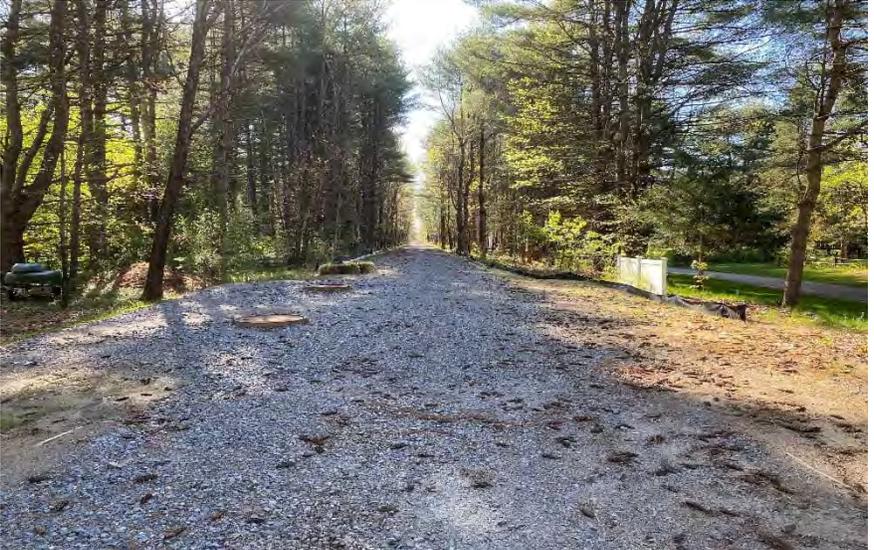
<p align="center">PHOTOGRAPHIC LOG</p>	
<p>Client Name: Eversource</p>		<p>Site Location: Sudbury to Hudson Transmission Reliability Project</p>	<p>Town: Hudson</p>
<p>Photo No.: 5</p>	<p>Date: 5-7-24</p>

<p>Description:</p> <p>Work area within segment 5, manhole #11, existing erosion control, looking eastward.</p>

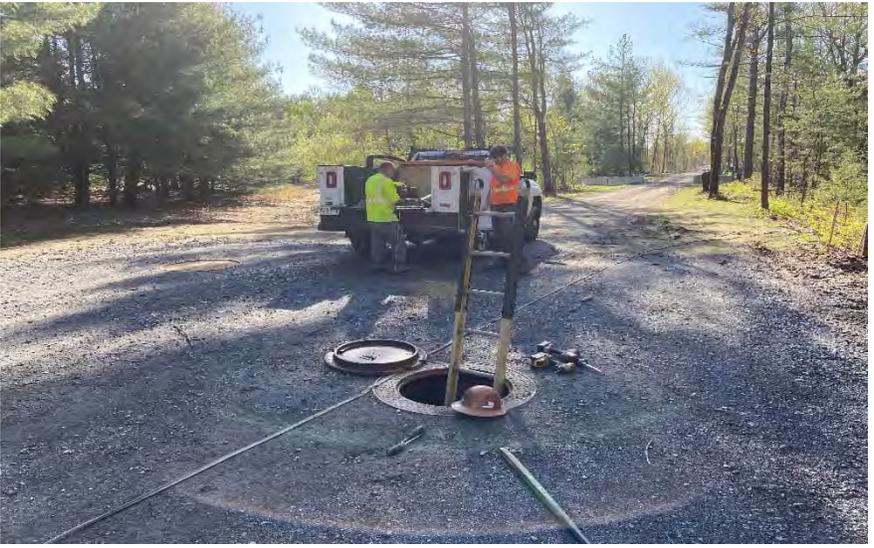
<p align="center">PHOTOGRAPHIC LOG</p>	
<p>Client Name: Eversource</p>		<p>Site Location: Sudbury to Hudson Transmission Reliability Project</p>	<p>Town: Hudson</p>
<p>Photo No.: 6</p>	<p>Date: 5-7-24</p>

<p>Description:</p> <p>Work area within Segment 2, handhole #7, repairs at handhole, looking eastward.</p>

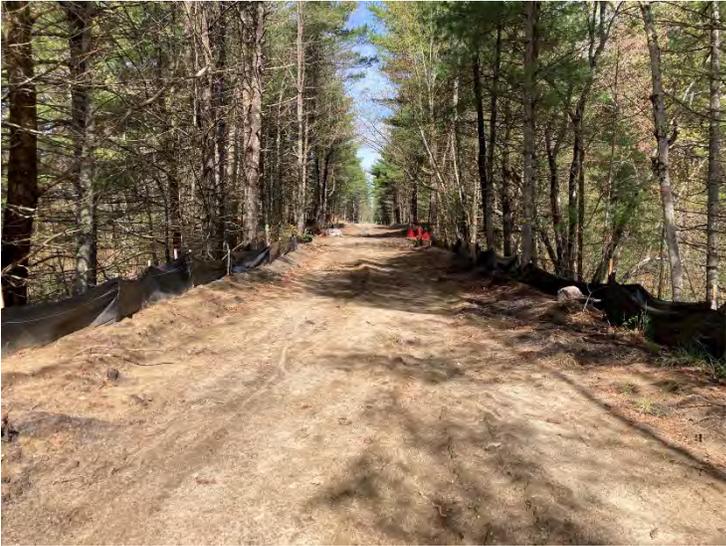
<p>PHOTOGRAPHIC LOG</p>	
<p>Client Name: Eversource</p>		<p>Site Location: Sudbury to Hudson Transmission Reliability Project</p>	<p>Town: Sudbury</p>
<p>Photo No.: 1</p>	<p>Date: 5/09/2024</p>

<p>Description: View of E&S controls in segment 7. Facing west.</p>

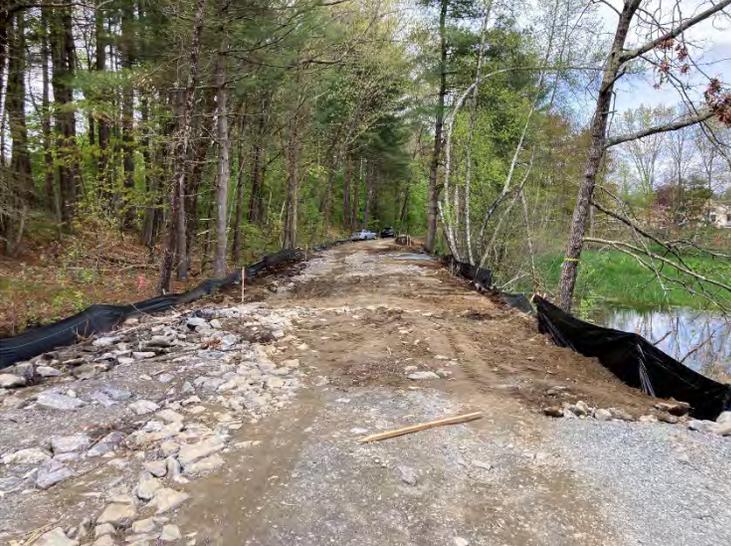
<p>PHOTOGRAPHIC LOG</p>	
<p>Client Name: Eversource</p>		<p>Site Location: Sudbury to Hudson Transmission Reliability Project</p>	<p>Town: Sudbury</p>
<p>Photo No.: 4</p>	<p>Date: 5/09/2024</p>

<p>Description: View of E&S controls in segment 13. Facing west.</p>

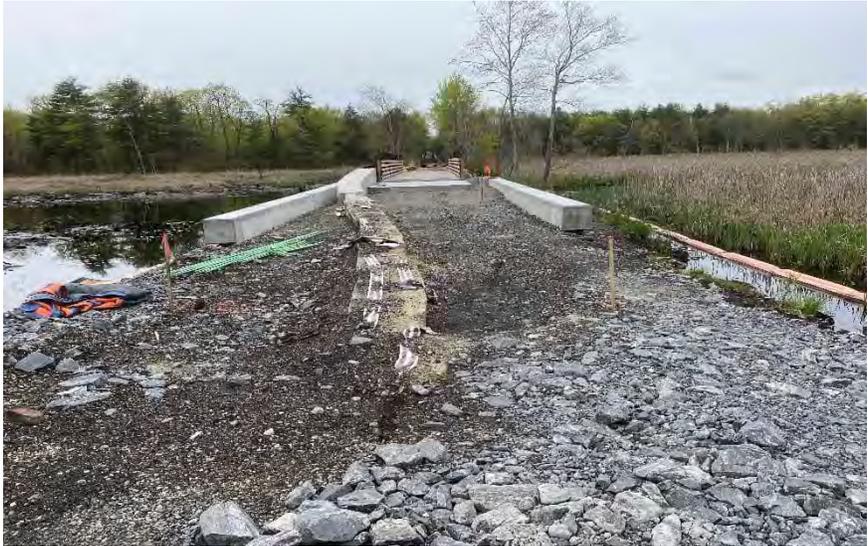
<p align="center">PHOTOGRAPHIC LOG</p>	
<p>Client Name: Eversource</p>		<p>Site Location: Sudbury to Hudson Transmission Reliability Project</p>	<p>Town: Hudson</p>
<p>Photo No.: 3</p>	<p>Date: 5-10-24</p>

<p>Description:</p> <p>Work area within segment 3 across Fort Meadow Brook along bridge 130, existing erosion control, looking westward.</p>

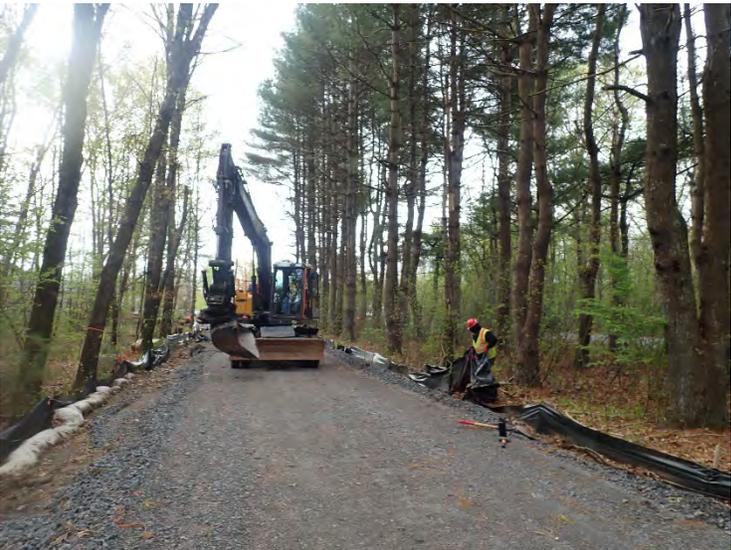
<p>PHOTOGRAPHIC LOG</p>	
<p>Client Name: Eversource</p>		<p>Site Location: Sudbury to Hudson Transmission Reliability Project</p>	<p>Town: Sudbury</p>
<p>Photo No.: 2</p>	<p>Date: 5/10/2024</p>

<p>Description: View of crews working on erosion controls in segment 11 off Union Ave. Facing east.</p>

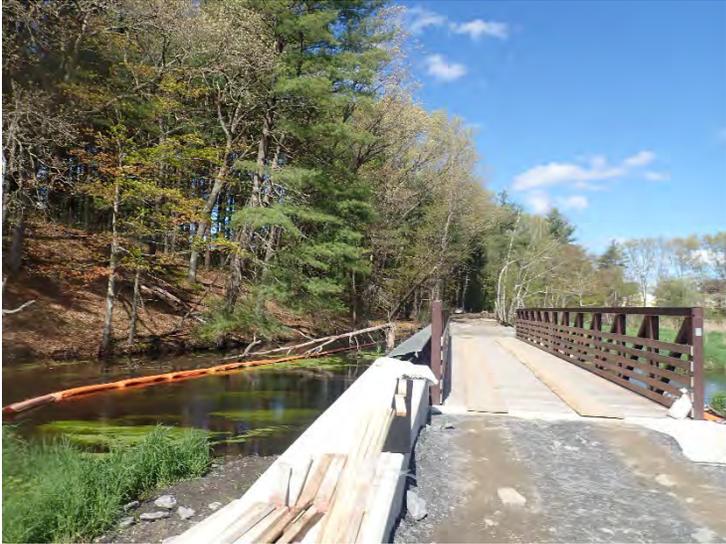
<p>PHOTOGRAPHIC LOG</p>	
<p>Client Name: Eversource</p>		<p>Site Location: Sudbury to Hudson Transmission Reliability Project</p>	<p>Town: Sudbury</p>
<p>Photo No.: 5</p>	<p>Date: 5/10/2024</p>

<p>Description: View of bridge 127 and turbidity curtain. Facing west.</p>

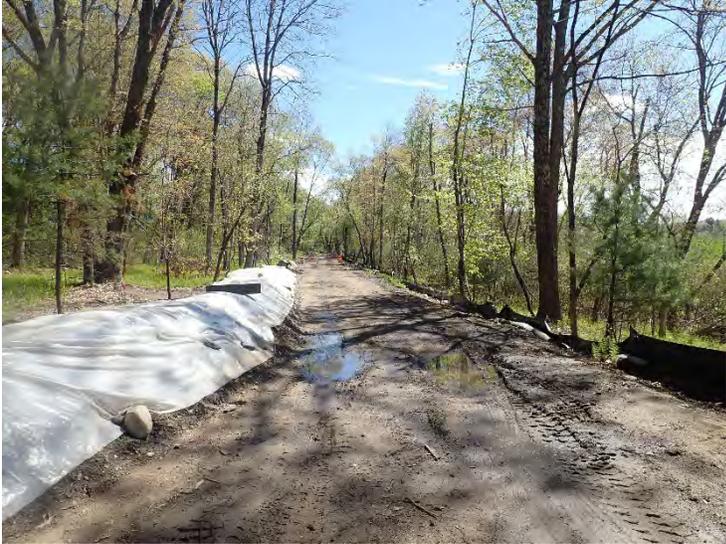
<p>PHOTOGRAPHIC LOG</p>	
<p>Client Name: Eversource</p>		<p>Site Location: Sudbury to Hudson Transmission Reliability Project</p>	<p>Town: Sudbury</p>
<p>Photo No.: 7</p>	<p>Date: 5/10/2024</p>

<p>Description: View of soil spoil berm in segment 14. Facing east.</p>

-Spoil berm is present within segment 14. Berm created 3-08-2024. Berm is covered with plastic. Stockpile/berm now active as of 5-01-2024. Stockpile noted today (5/08/2024) near MH #25 in segment 13.

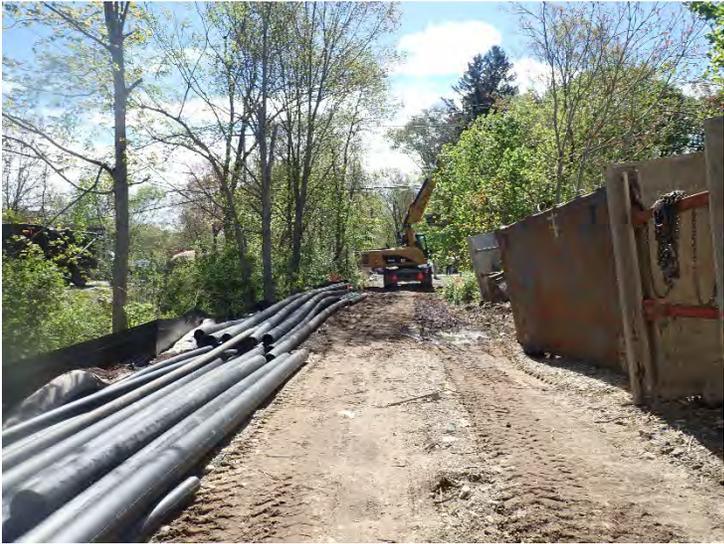
<p>PHOTOGRAPHIC LOG</p>	
<p>Client Name: Eversource</p>		<p>Site Location: Sudbury to Hudson Transmission Reliability Project</p>	<p>Town: Sudbury</p>
<p>Photo No.: 8</p>	<p>Date: 5/10/2024</p>

<p>Description: View of erosion controls in segment 12. Bond preparing entrance of segment 12 for Bostong Post Road crossing work. Facing east.</p>

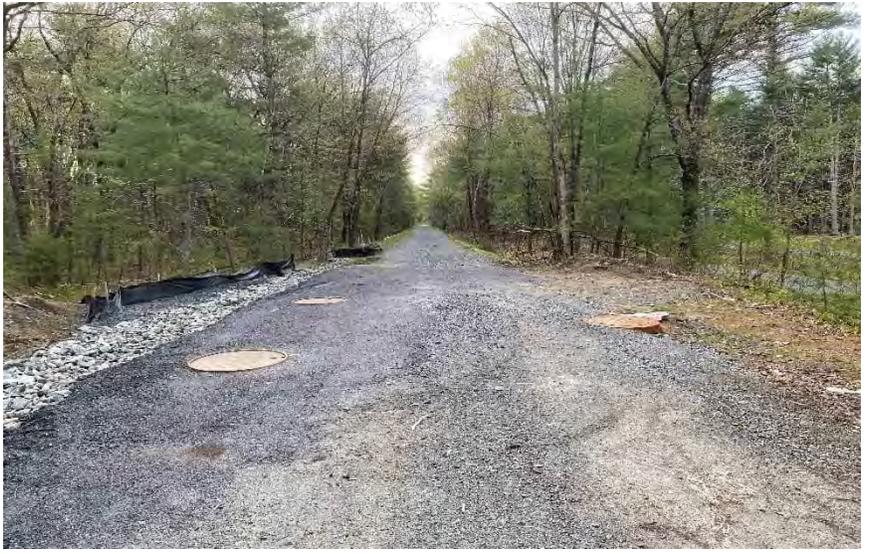
PHOTOGRAPHIC LOG	
Client Name: Eversource		Site Location: Sudbury to Hudson Transmission Reliability Project	Town: Hudson
Photo No.: 4	Date: 5-8-24

Description: Work area within segment 5 at manhole #12, existing erosion control, looking eastward.

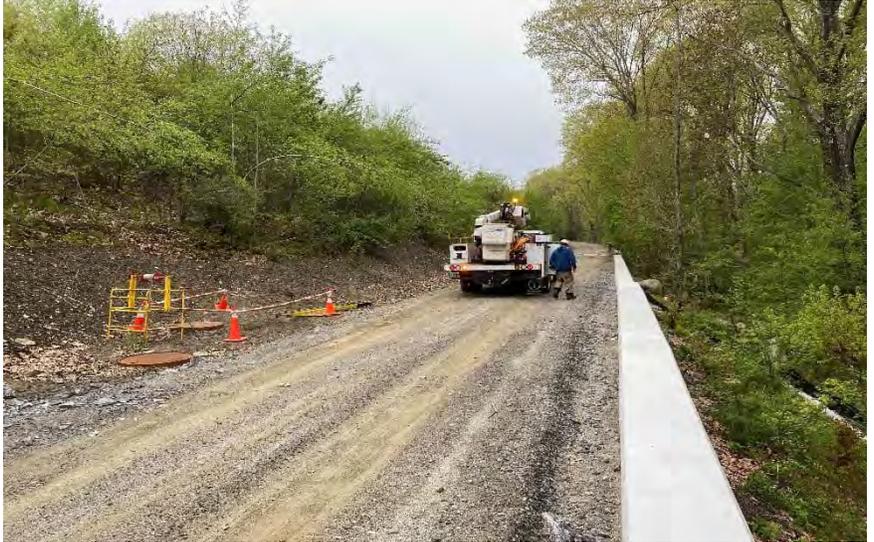
PHOTOGRAPHIC LOG	
Client Name: Eversource		Site Location: Sudbury to Hudson Transmission Reliability Project	Town: Hudson
Photo No.: 5	Date: 5-8-24

Description: Work area within segment 1, existing erosion control, fiber optics work at handhole #6, looking westward.

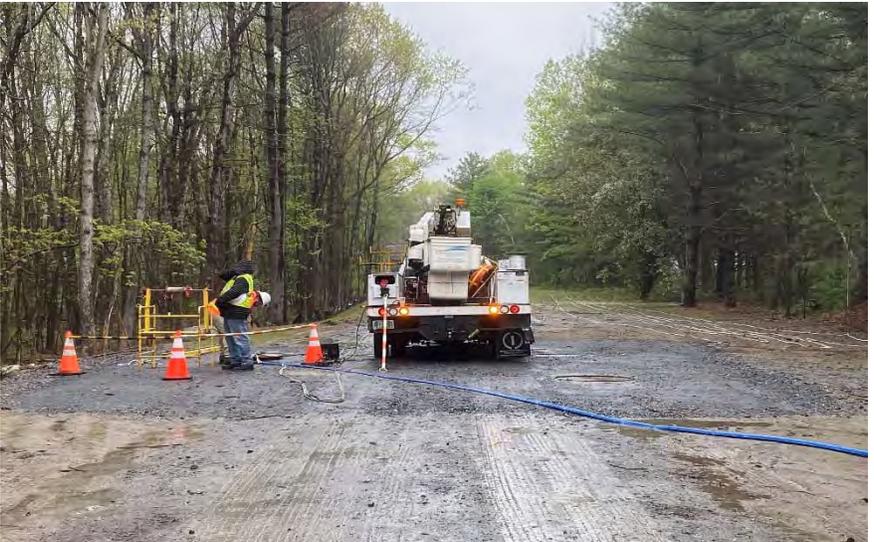
PHOTOGRAPHIC LOG	
Client Name: Eversource		Site Location: Sudbury to Hudson Transmission Reliability Project	Town: Hudson
Photo No.: 6	Date: 5-8-24

Description: Work area within segment 2, existing erosion control, fiber optics work at handhole #7, looking westward.

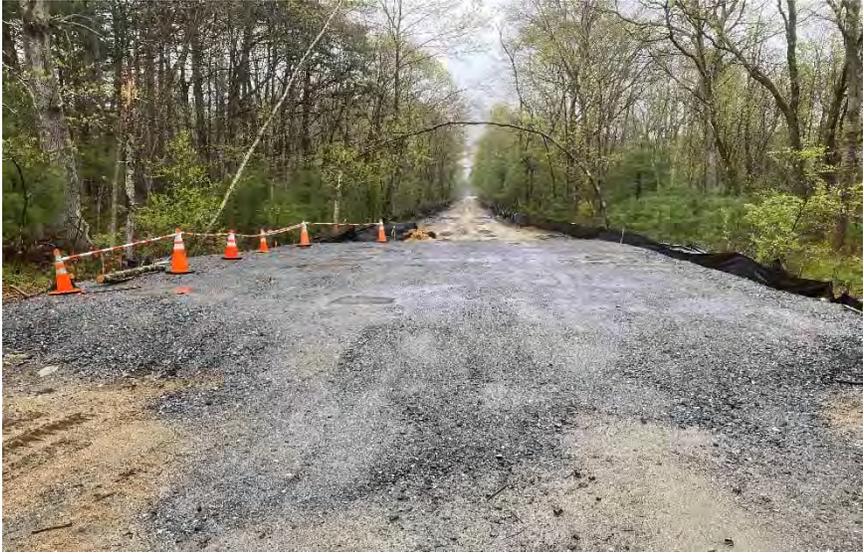
PHOTOGRAPHIC LOG	
Client Name: Eversource		Site Location: Sudbury to Hudson Transmission Reliability Project	Town: Hudson
Photo No.: 7	Date: 5-8-24

Description: Work area within segment 6, manhole #14 area, existing erosion control, looking eastward.

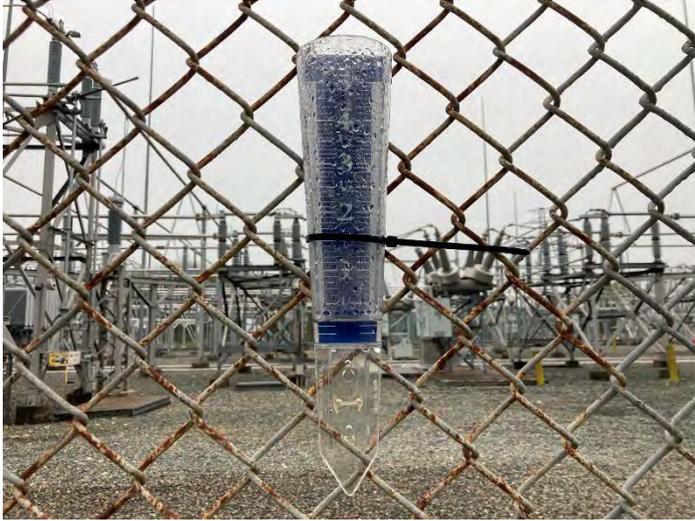
PHOTOGRAPHIC LOG	
Client Name: Eversource		Site Location: Sudbury to Hudson Transmission Reliability Project	Town: Sudbury
Photo No.: 1	Date: 5-08-2024

Description: View of rain gauge at Sudbury Substation. 0.28" observed in gauge. Facing south.

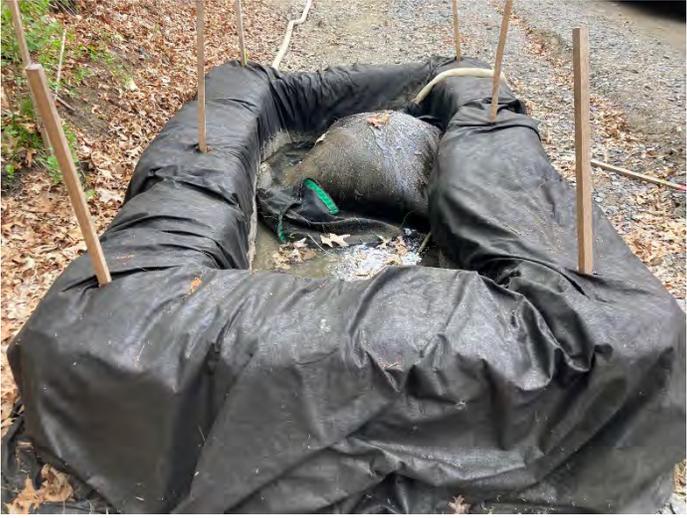
Epsilon ASSOCIATES INC.		PHOTOGRAPHIC LOG	
Client Name: Eversource		Site Location: Sudbury to Hudson Transmission Reliability Project	Town: Sudbury
Photo No.: 5	Date: 5-08-2024

Description: View of dewatering controls at MH #22 in segment 11. See additional dewatering inspection report. Facing east.

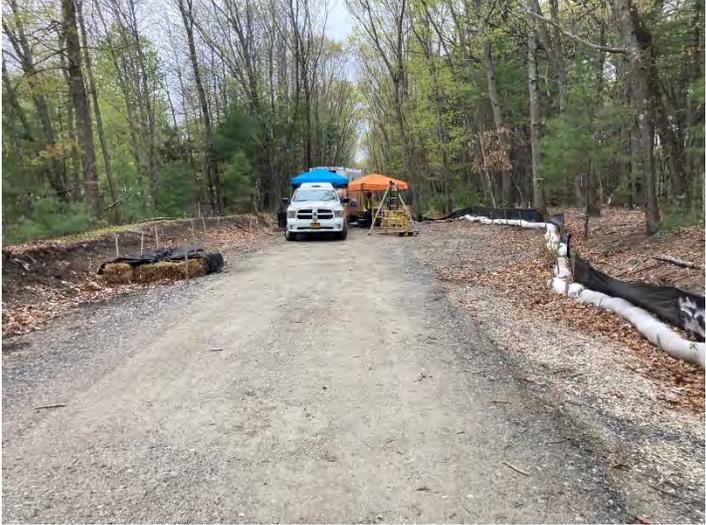
Epsilon ASSOCIATES INC.		PHOTOGRAPHIC LOG	
Client Name: Eversource		Site Location: Sudbury to Hudson Transmission Reliability Project	Town: Sudbury
Photo No.: 6	Date: 5-08-2024

Description: View of Haugland working at MH #23 and E&S controls in segment 11. Facing west.

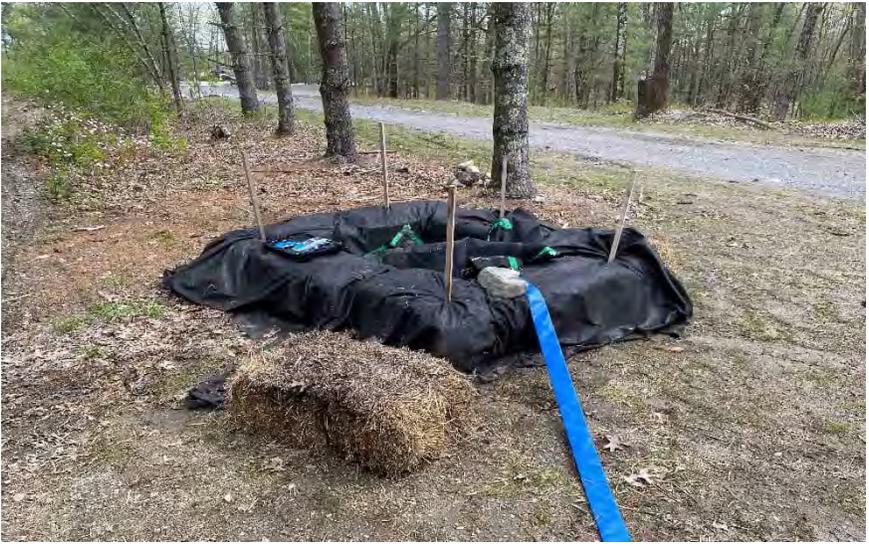
PHOTOGRAPHIC LOG	
Client Name: Eversource		Site Location: Sudbury to Hudson Transmission Reliability Project	Town: Hudson
Photo No.: 4	Date: 5/6/2024

Description: Handhole #7. View of discharge bag/corral, looking eastward. Water from bag/corral discharged to adjacent area.

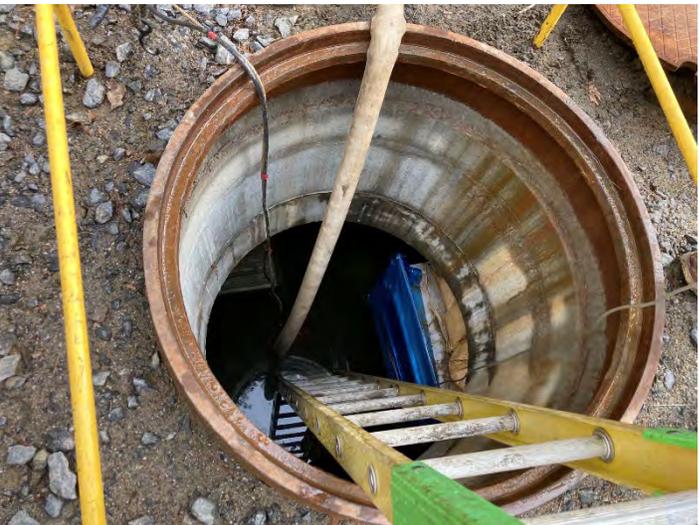
PHOTOGRAPHIC LOG	
Client Name: Eversource		Site Location: Sudbury to Hudson Transmission Reliability Project	Town: Sudbury
Photo No.: 2	Date: 5/06/2024

Description: View of pump in MH #22. Water appeared mostly clear prior to treatment.

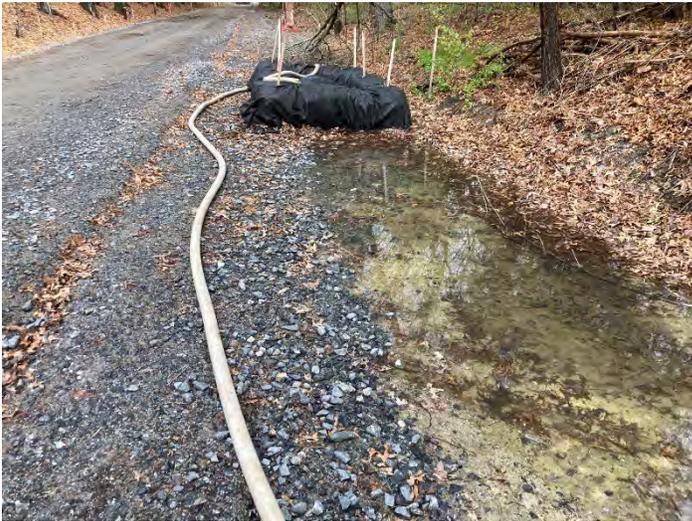
PHOTOGRAPHIC LOG	
Client Name: Eversource		Site Location: Sudbury to Hudson Transmission Reliability Project	Town: Sudbury
Photo No.: 4	Date: 5/06/2024

Description: View of dewatering controls (straw bale corral with filter fabric and silt bag) and discharge from corral. Discharge appeared clear and turbidity was below 50 NTUs. Discharge did not reach any jurisdictional resource areas. Facing west.

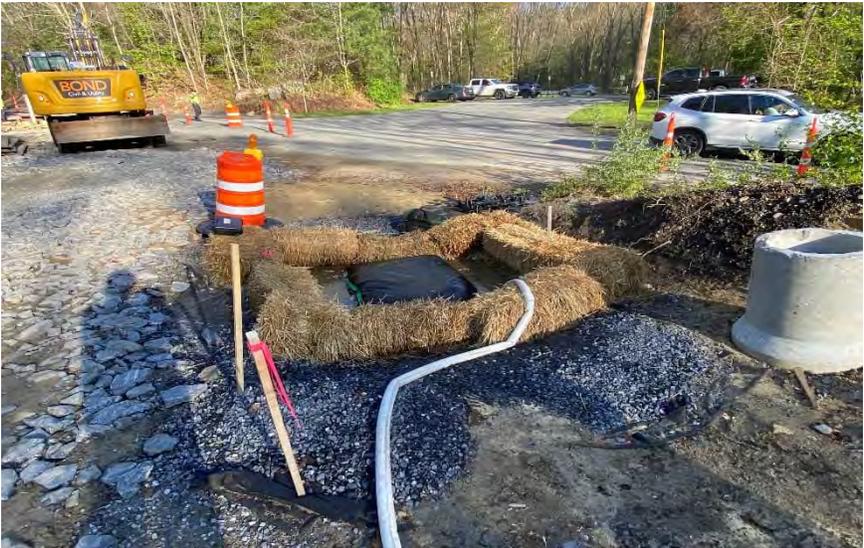
PHOTOGRAPHIC LOG	
Client Name: Eversource		Site Location: Sudbury to Hudson Transmission Reliability Project	Town: Hudson
Photo No.: 4	Date: 5/7/2024

Description: Wilkins Street trench. View of discharge bag/corral, looking westward. Water from bag/corral discharged to underlying catch basin.

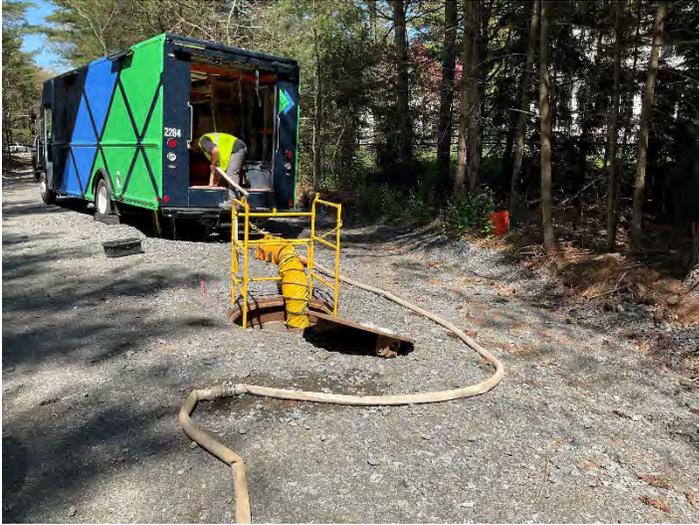
PHOTOGRAPHIC LOG	
Client Name: Eversource		Site Location: Sudbury to Hudson Transmission Reliability Project	Town: Sudbury
Photo No.: 1	Date: 5/07/2024

Description: View of Haugland working at MH #18. Facing northwest.

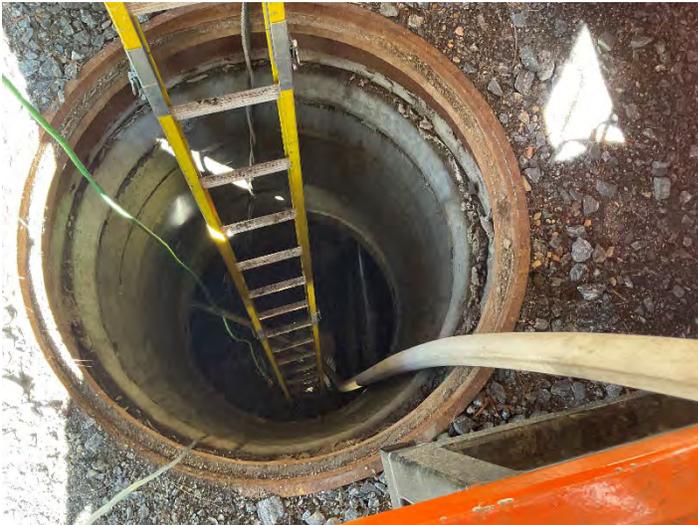
PHOTOGRAPHIC LOG	
Client Name: Eversource		Site Location: Sudbury to Hudson Transmission Reliability Project	Town: Sudbury
Photo No.: 2	Date: 5/07/2024

Description: View of pump in MH #18. Water appeared mostly clear prior to treatment.

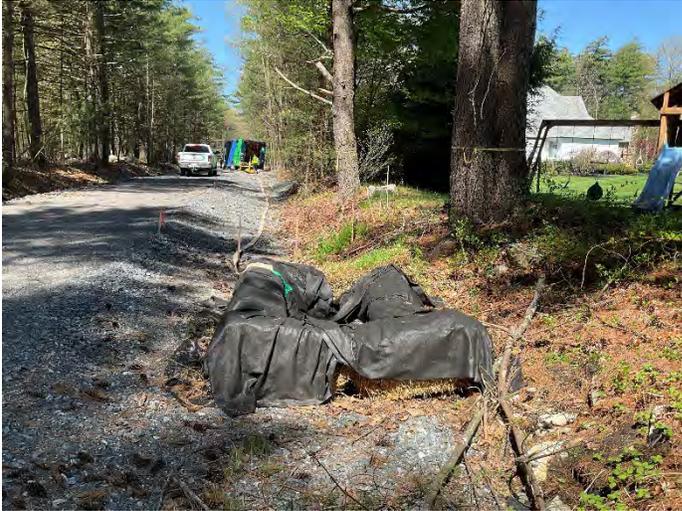
PHOTOGRAPHIC LOG	
Client Name: Eversource		Site Location: Sudbury to Hudson Transmission Reliability Project	Town: Sudbury
Photo No.: 3	Date: 5/07/2024

Description: View of dewatering controls (straw bale corral with filter fabric and silt bag). Facing west.

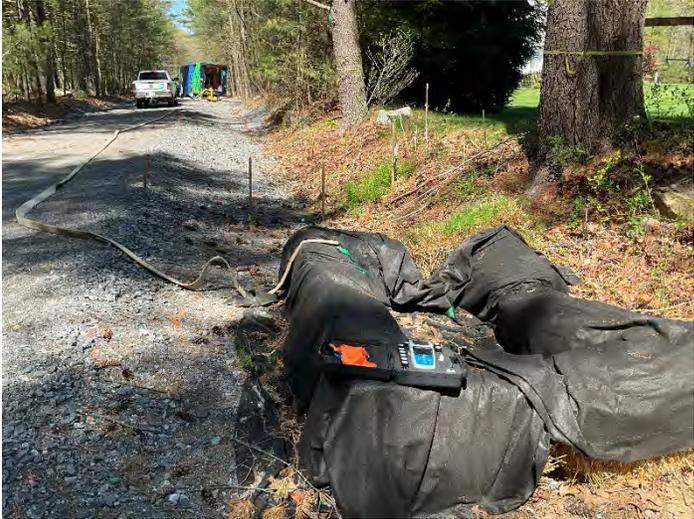
PHOTOGRAPHIC LOG	
Client Name: Eversource		Site Location: Sudbury to Hudson Transmission Reliability Project	Town: Sudbury
Photo No.: 4	Date: 5/07/2024

Description: View of dewatering controls (straw bale corral with filter fabric and silt bag). Discharge did not leave the corral and appeared to be mostly clear. No sample taken. Facing west.

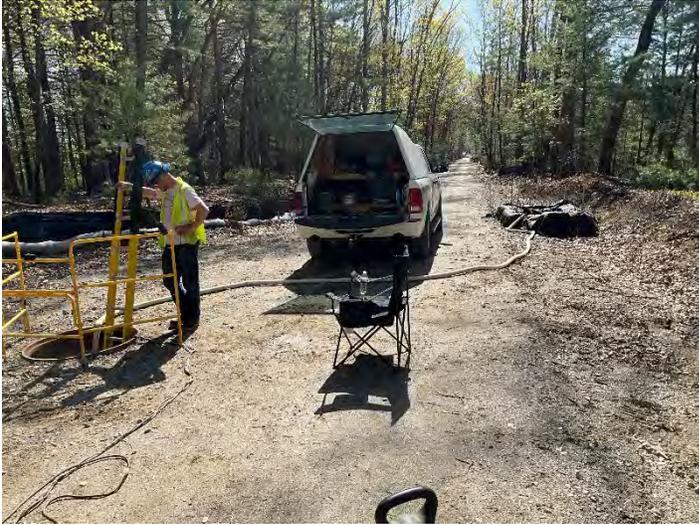
PHOTOGRAPHIC LOG	
Client Name: Eversource		Site Location: Sudbury to Hudson Transmission Reliability Project	Town: Sudbury
Photo No.: 1	Date: 5/07/2024

Description: View of Haugland working at MH #23. Facing east.

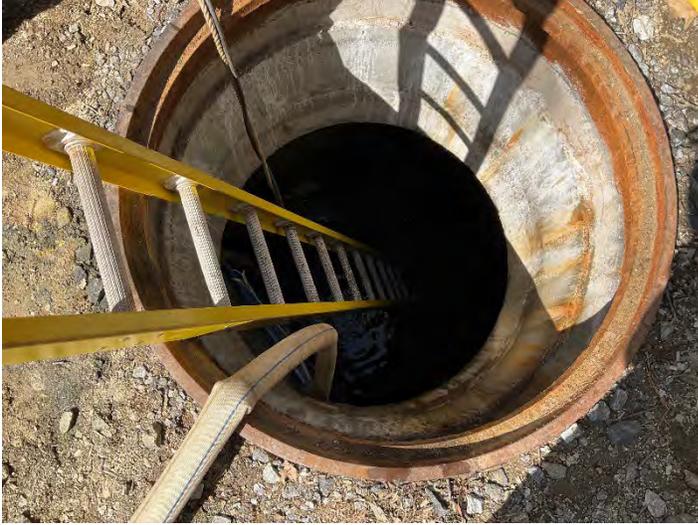
PHOTOGRAPHIC LOG	
Client Name: Eversource		Site Location: Sudbury to Hudson Transmission Reliability Project	Town: Sudbury
Photo No.: 2	Date: 5/07/2024

Description: View of pump in MH #23. Water appeared mostly clear prior to treatment.

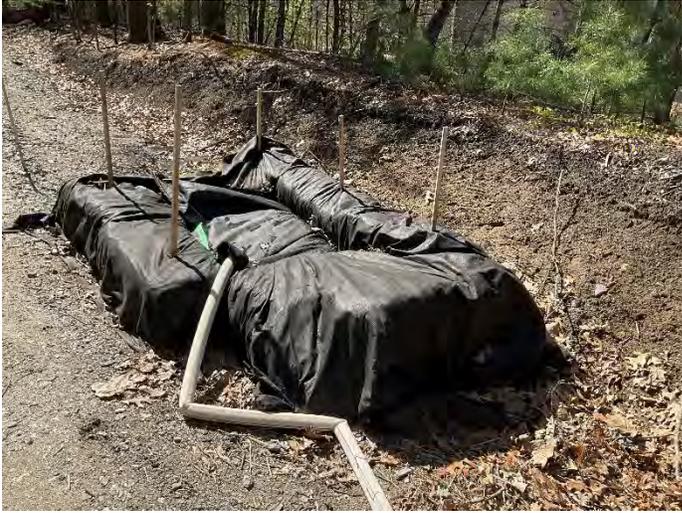
PHOTOGRAPHIC LOG	
Client Name: Eversource		Site Location: Sudbury to Hudson Transmission Reliability Project	Town: Sudbury
Photo No.: 3	Date: 5/07/2024

Description: View of dewatering controls (straw bale corral with filter fabric and silt bag). Facing southeast.

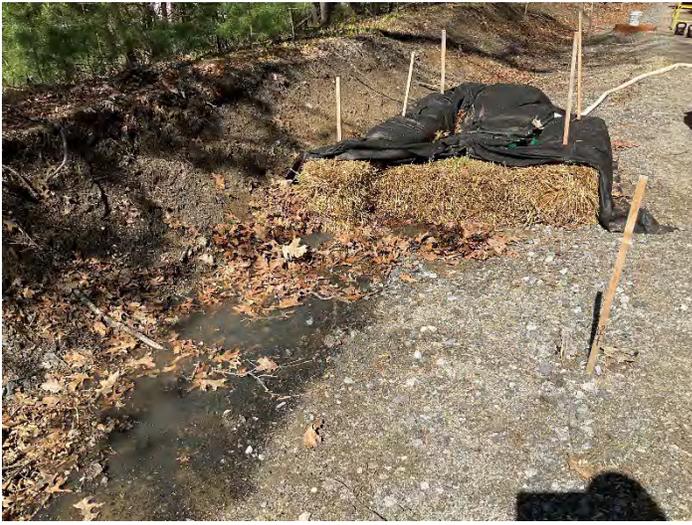
PHOTOGRAPHIC LOG	
Client Name: Eversource		Site Location: Sudbury to Hudson Transmission Reliability Project	Town: Sudbury
Photo No.: 4	Date: 5/07/2024

Description: View of dewatering controls (straw bale corral with filter fabric and silt bag) and discharge from corral. Discharge appeared slightly cloudy, but turbidity was below 50 NTUs. Discharge did not appear to reach any jurisdictional resource areas. Facing west.

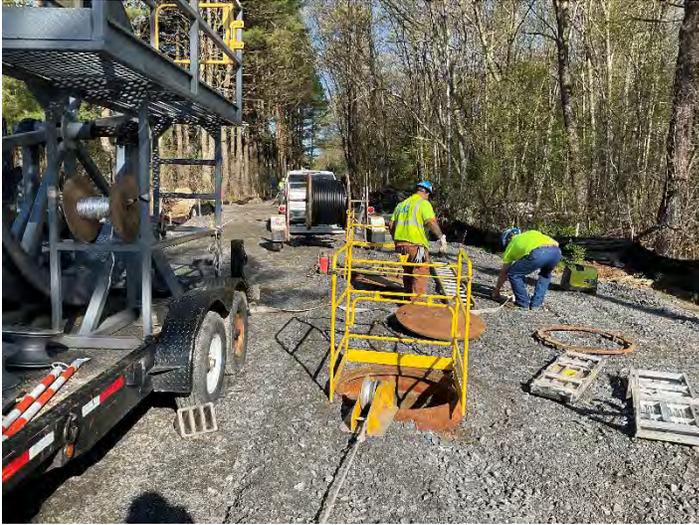
PHOTOGRAPHIC LOG	
Client Name: Eversource		Site Location: Sudbury to Hudson Transmission Reliability Project	Town: Sudbury
Photo No.: 1	Date: 5/07/2024

Description: View of Haugland working at MH #24. Facing west.

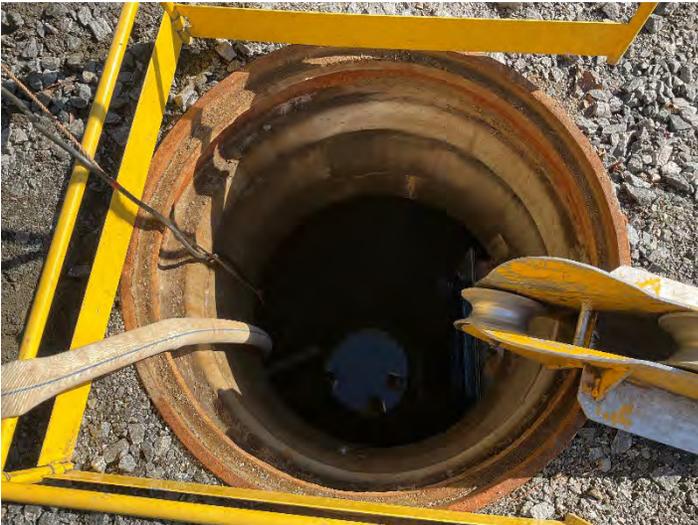
PHOTOGRAPHIC LOG	
Client Name: Eversource		Site Location: Sudbury to Hudson Transmission Reliability Project	Town: Sudbury
Photo No.: 2	Date: 5/07/2024

Description: View of pump in MH #24. Water appeared mostly clear prior to treatment.

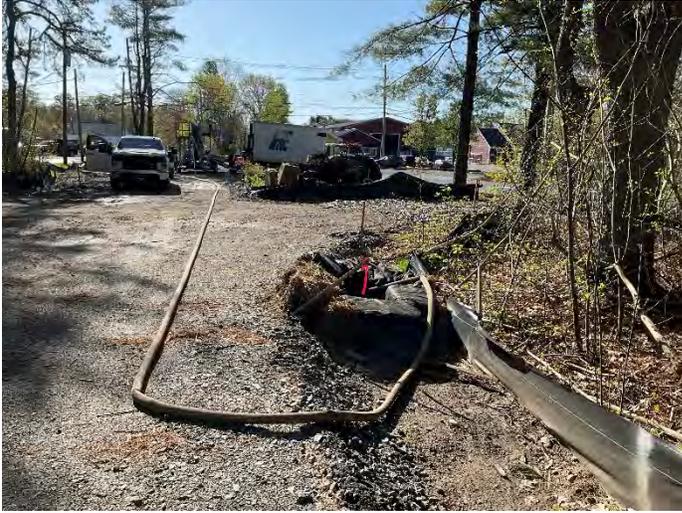
PHOTOGRAPHIC LOG	
Client Name: Eversource		Site Location: Sudbury to Hudson Transmission Reliability Project	Town: Sudbury
Photo No.: 3	Date: 5/07/2024

Description: View of dewatering controls (straw bale corral with filter fabric and silt bag). Facing east.

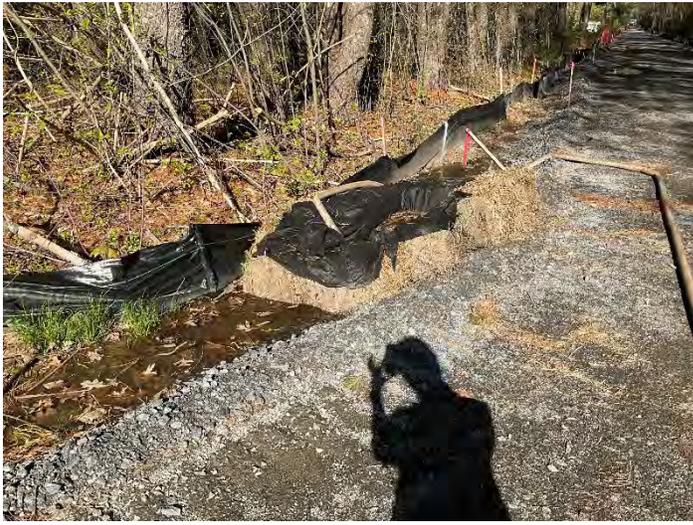
PHOTOGRAPHIC LOG	
Client Name: Eversource		Site Location: Sudbury to Hudson Transmission Reliability Project	Town: Sudbury
Photo No.: 4	Date: 5/07/2024

Description: View of dewatering controls (straw bale corral with filter fabric and silt bag) and discharge from corral. Discharge appeared clear and turbidity was below 50 NTUs. Discharge did not reach any jurisdictional resource areas. Facing southwest.

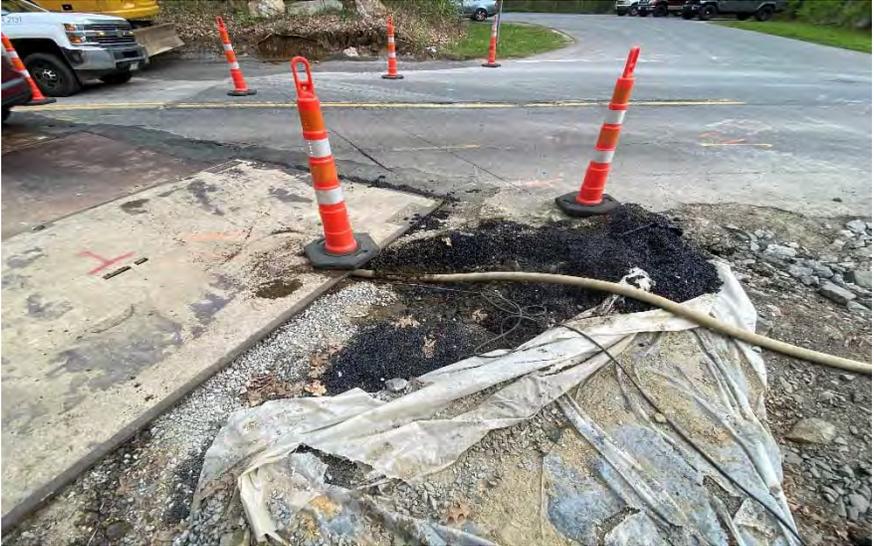
PHOTOGRAPHIC LOG	
Client Name: Eversource		Site Location: Sudbury to Hudson Transmission Reliability Project	Town: Hudson
Photo No.: 1	Date: 5/8/2024

Description: View of area being pumped from trench across Wilkins Street.

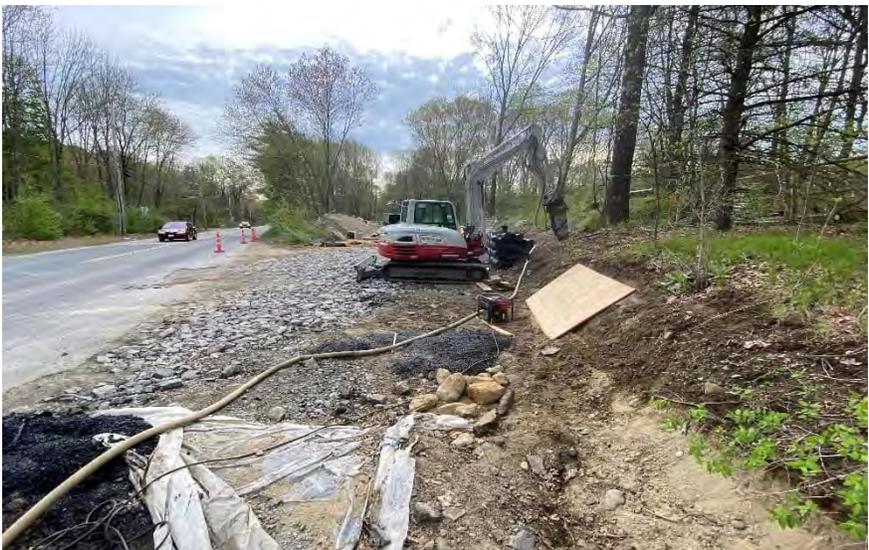
PHOTOGRAPHIC LOG	
Client Name: Eversource		Site Location: Sudbury to Hudson Transmission Reliability Project	Town: Hudson
Photo No.: 2	Date: 5/8/2024

Description: Wilkins Street trench. View of dewatering operation. Looking eastward.

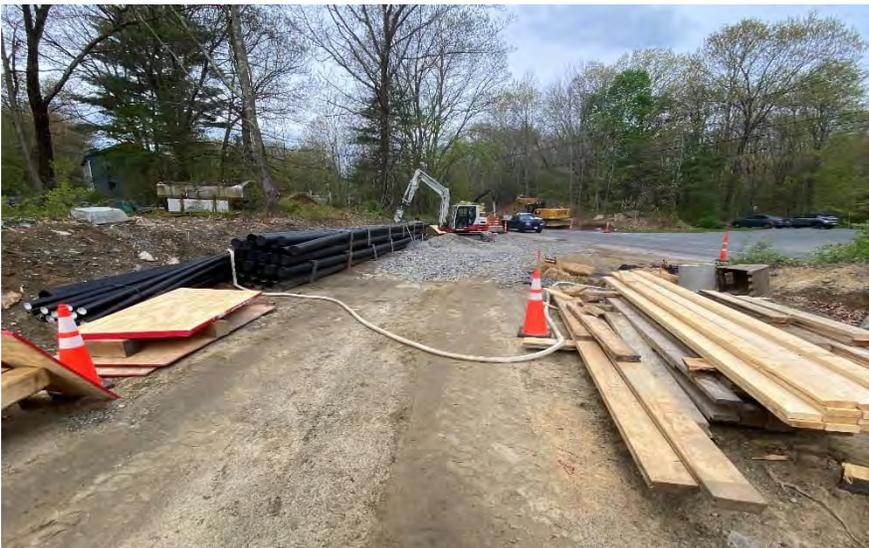
PHOTOGRAPHIC LOG	
Client Name: Eversource		Site Location: Sudbury to Hudson Transmission Reliability Project	Town: Hudson
Photo No.: 3	Date: 5/8/2024

Description: Wilkins Street trench. View of dewatering operation, looking westward.

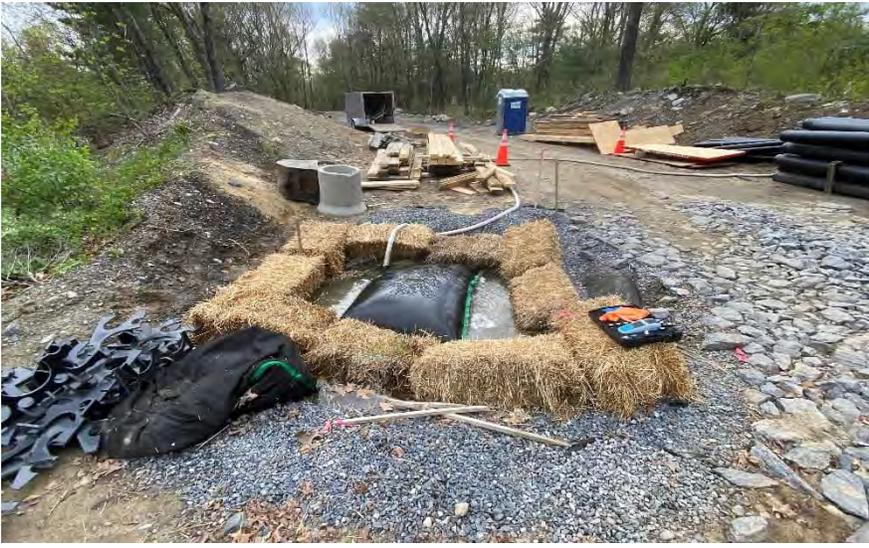
PHOTOGRAPHIC LOG	
Client Name: Eversource		Site Location: Sudbury to Hudson Transmission Reliability Project	Town: Hudson
Photo No.: 4	Date: 5/8/2024

Description: Wilkins Street trench. View of discharge bag/corral, looking westward. Water from bag/corral discharged to underlying catch basin.

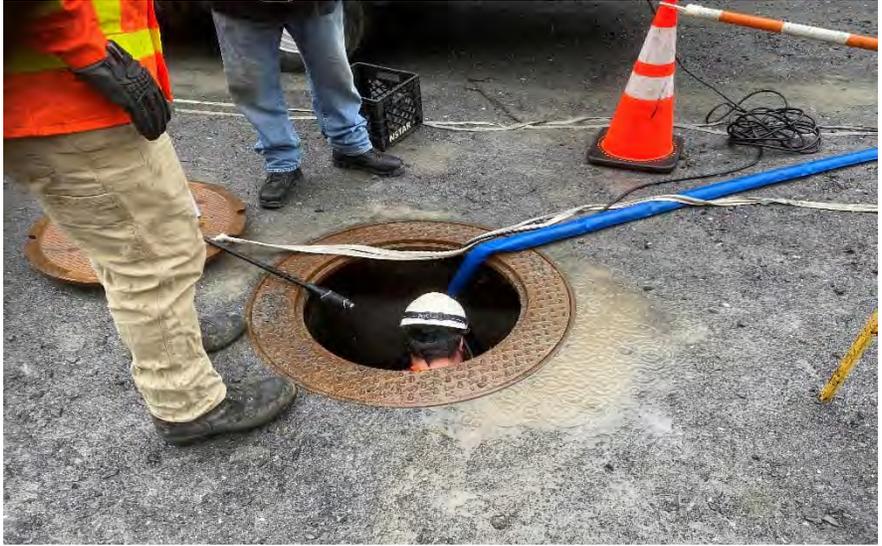
PHOTOGRAPHIC LOG	
Client Name: Eversource		Site Location: Sudbury to Hudson Transmission Reliability Project	Town: Hudson
Photo No.: 1	Date: 5/8/2024

Description: View of area being pumped from handhole #7, segment 2.

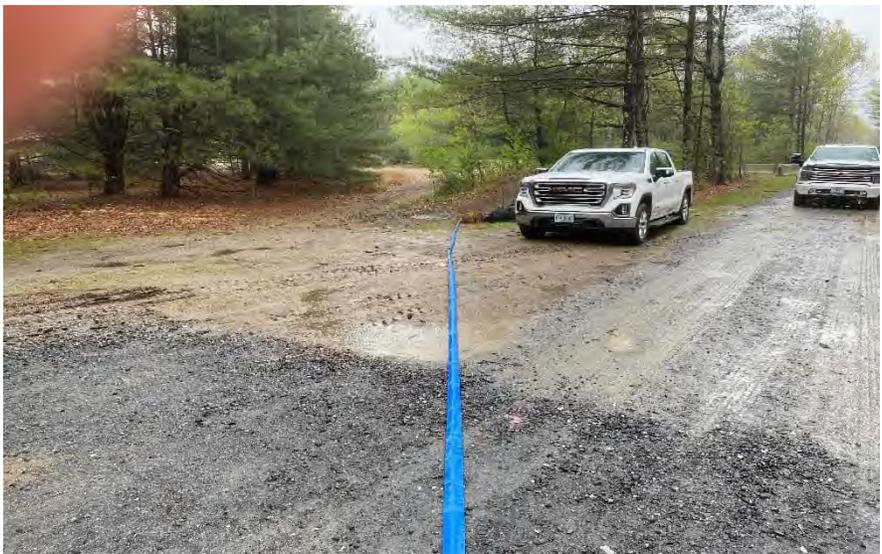
PHOTOGRAPHIC LOG	
Client Name: Eversource		Site Location: Sudbury to Hudson Transmission Reliability Project	Town: Hudson
Photo No.: 2	Date: 5/8/2024

Description: Handhole #7. View of dewatering operation. Looking eastward.

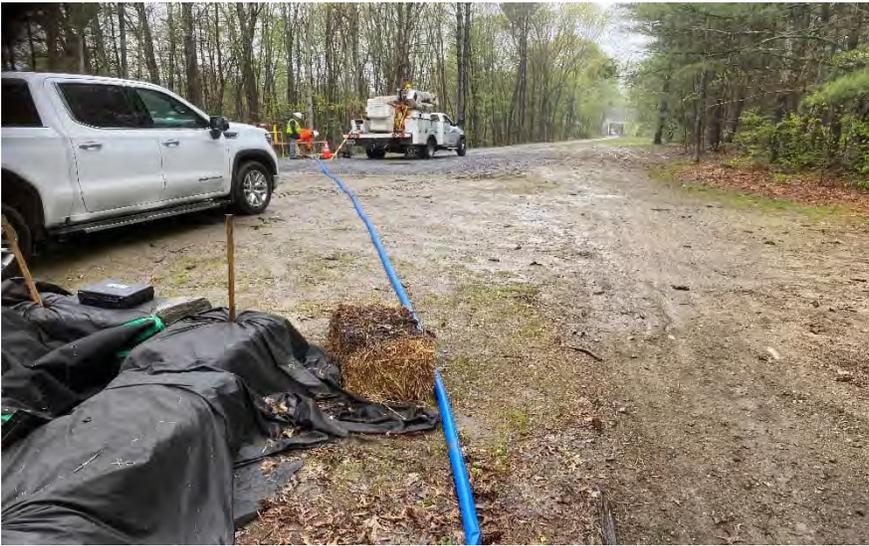
PHOTOGRAPHIC LOG	
Client Name: Eversource		Site Location: Sudbury to Hudson Transmission Reliability Project	
Town: Hudson			
Photo No.: 3	Date: 5/8/2024

Description: Handhole #7. View of dewatering operation, looking westward.

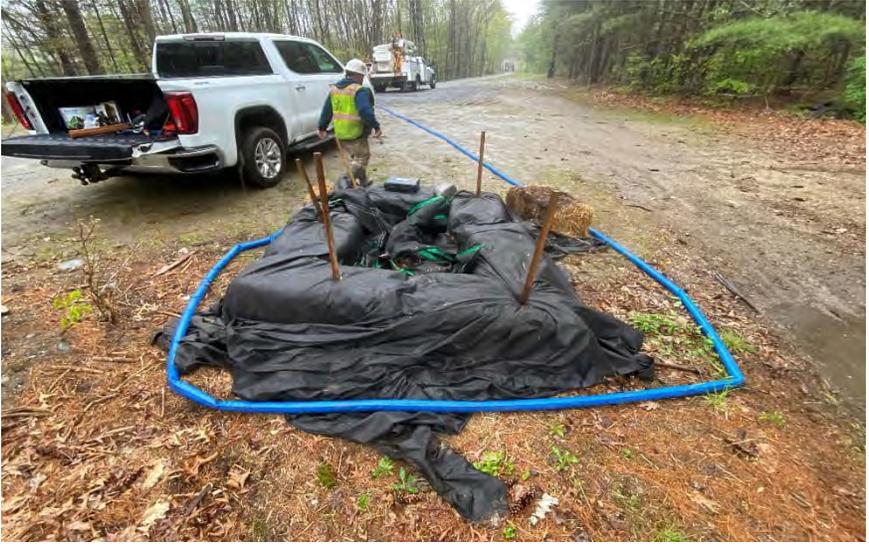
PHOTOGRAPHIC LOG	
Client Name: Eversource		Site Location: Sudbury to Hudson Transmission Reliability Project	
Town: Hudson			
Photo No.: 4	Date: 5/8/2024

Description: Handhole #7. View of discharge bag/corral, looking westward. Water from bag/corral discharged to adjacent area.

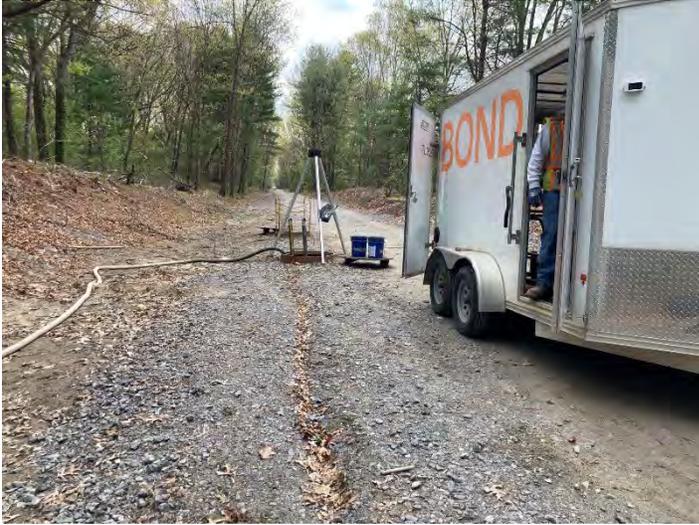
PHOTOGRAPHIC LOG	
Client Name: Eversource		Site Location: Sudbury to Hudson Transmission Reliability Project	
Town: Sudbury			
Photo No.: 1	Date: 5/08/2024

Description: View of Bond working at MH #22. Facing east.

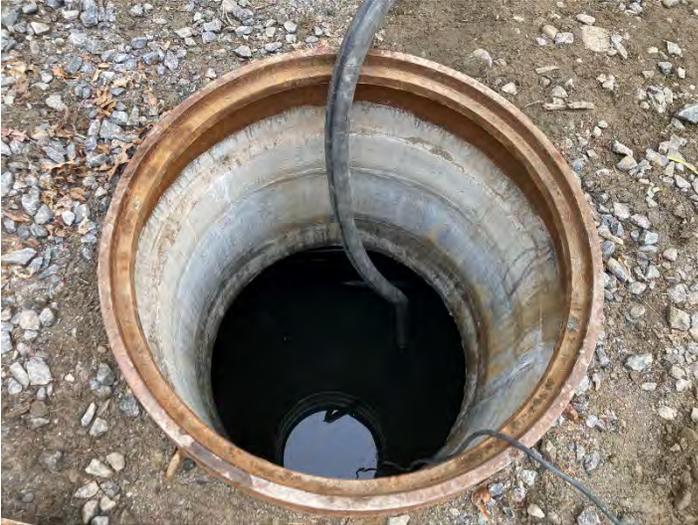
PHOTOGRAPHIC LOG	
Client Name: Eversource		Site Location: Sudbury to Hudson Transmission Reliability Project	
Town: Sudbury			
Photo No.: 2	Date: 5/08/2024

Description: View of pump in MH #22. Water appeared mostly clear prior to treatment.

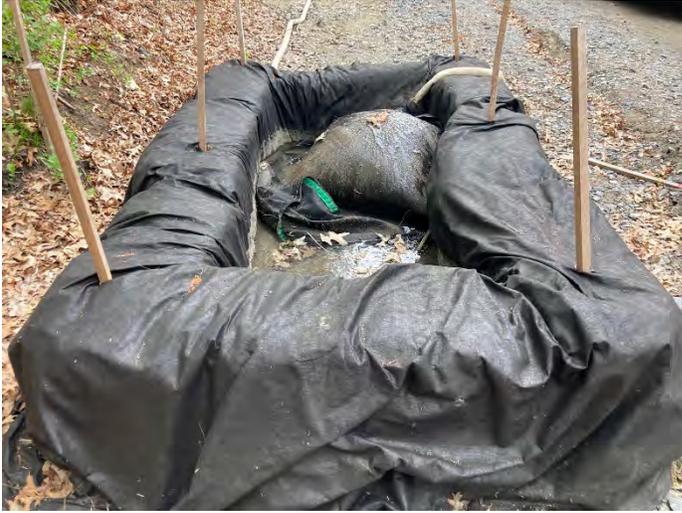
PHOTOGRAPHIC LOG	
Client Name: Eversource		Site Location: Sudbury to Hudson Transmission Reliability Project	
Town: Sudbury			
Photo No.: 3	Date: 5/08/2024

Description: View of dewatering controls (straw bale corral with filter fabric and silt bag). Facing east.

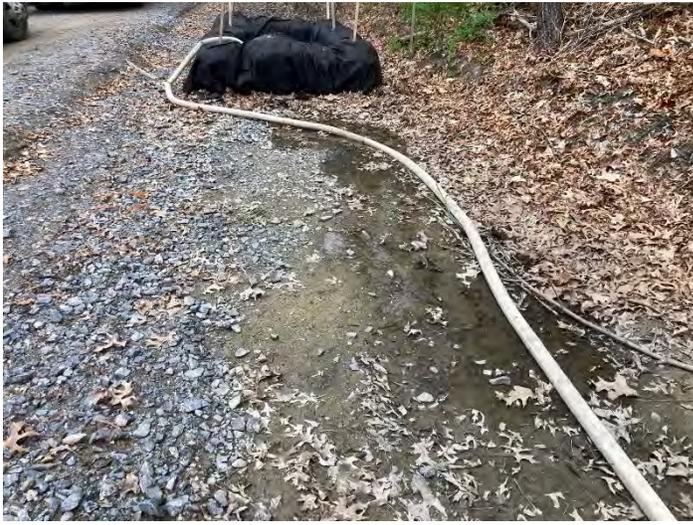
PHOTOGRAPHIC LOG	
Client Name: Eversource		Site Location: Sudbury to Hudson Transmission Reliability Project	
Town: Sudbury			
Photo No.: 4	Date: 5/08/2024

Description: View of dewatering controls (straw bale corral with filter fabric and silt bag) and discharge from corral. Discharge appeared clear and turbidity was below 50 NTUs. Discharge did not reach any jurisdictional resource areas. Facing west.
