Weekly Environmental Compliance Summary

Sudbury to Hudson Transmission Reliability Project (USEPA Tracking # MAR1003UW)

Sudbury, Hudson, and Stow, MA

Week of: May 6, 2024 to May 11, 2024

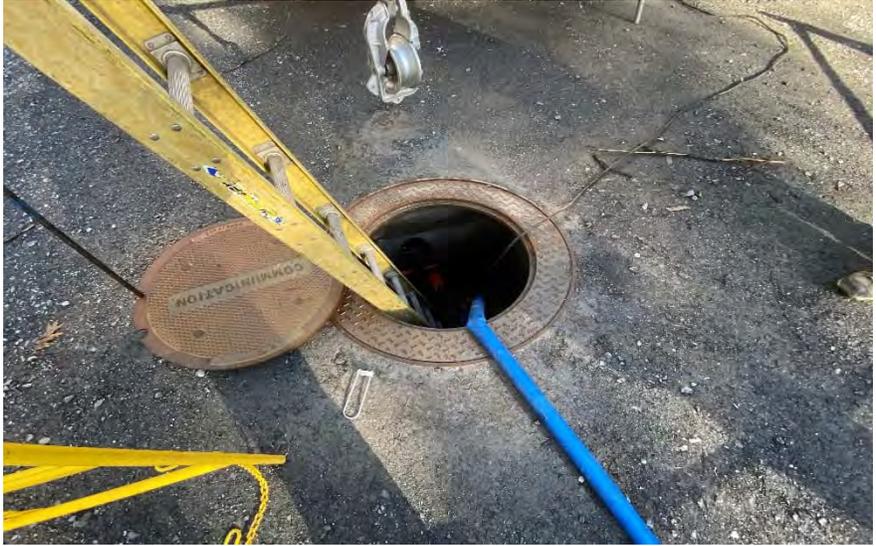
PHOTOGRAPHIC LOG	
Client Name: Eversource		Site Location: Sudbury to Hudson Transmission Reliability Project	Town: Hudson
Photo No.: 1	Date: 5/9/2024

Description: View of area being pumped from handhole #7, segment 2.

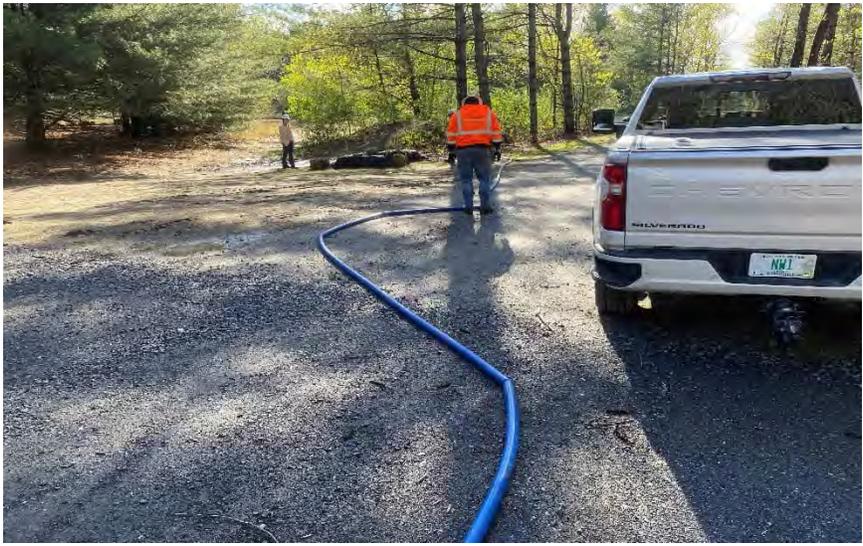
PHOTOGRAPHIC LOG	
Client Name: Eversource		Site Location: Sudbury to Hudson Transmission Reliability Project	Town: Hudson
Photo No.: 2	Date: 5/9/2024

Description: Handhole #7. View of dewatering operation. Looking eastward.

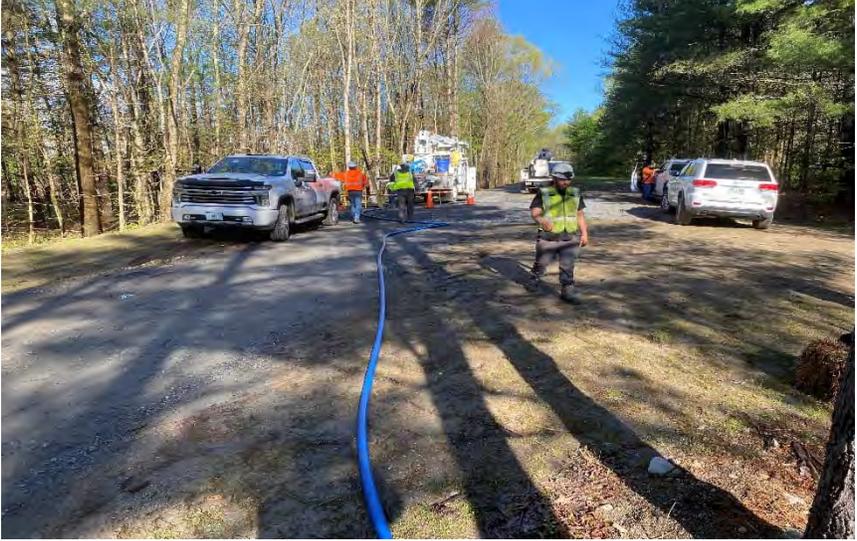
PHOTOGRAPHIC LOG	
Client Name: Eversource		Site Location: Sudbury to Hudson Transmission Reliability Project	Town: Hudson
Photo No.: 3	Date: 5/9/2024

Description: Handhole #7. View of dewatering operation, looking westward.

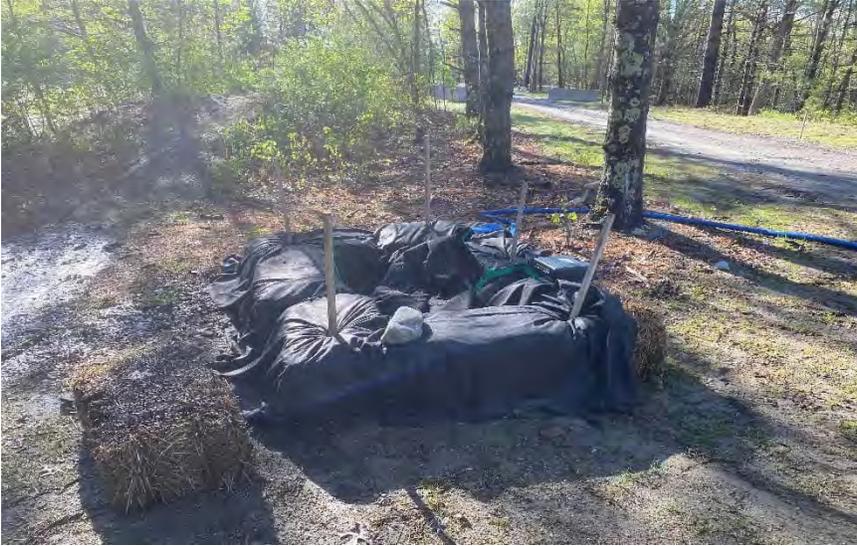
PHOTOGRAPHIC LOG	
Client Name: Eversource		Site Location: Sudbury to Hudson Transmission Reliability Project	Town: Hudson
Photo No.: 4	Date: 5/9/2024

Description: Handhole #7. View of discharge bag/corral, looking eastward. Water from bag/corral discharged to adjacent area.

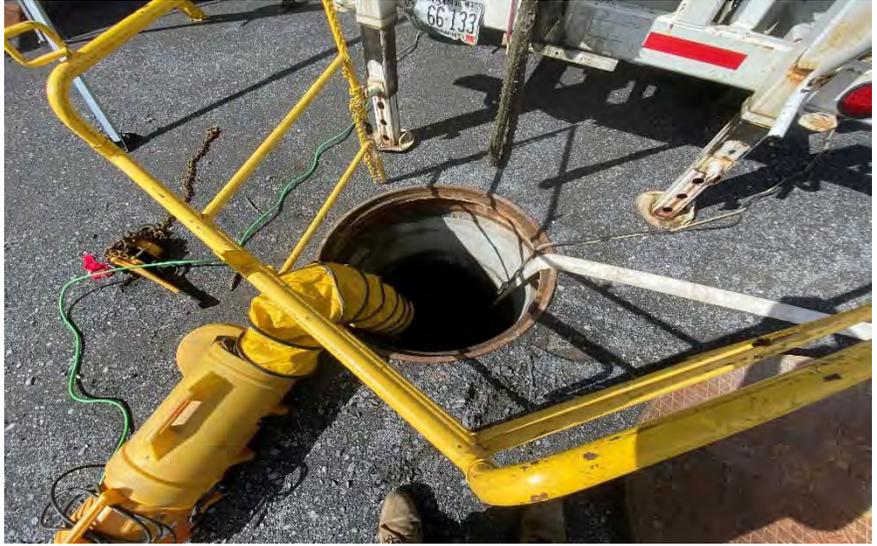
PHOTOGRAPHIC LOG	
Client Name: Eversource		Site Location: Sudbury to Hudson Transmission Reliability Project	Town: Hudson
Photo No.: 1	Date: 5/9/2024

Description: View of area being pumped from manhole #8, segment 3.

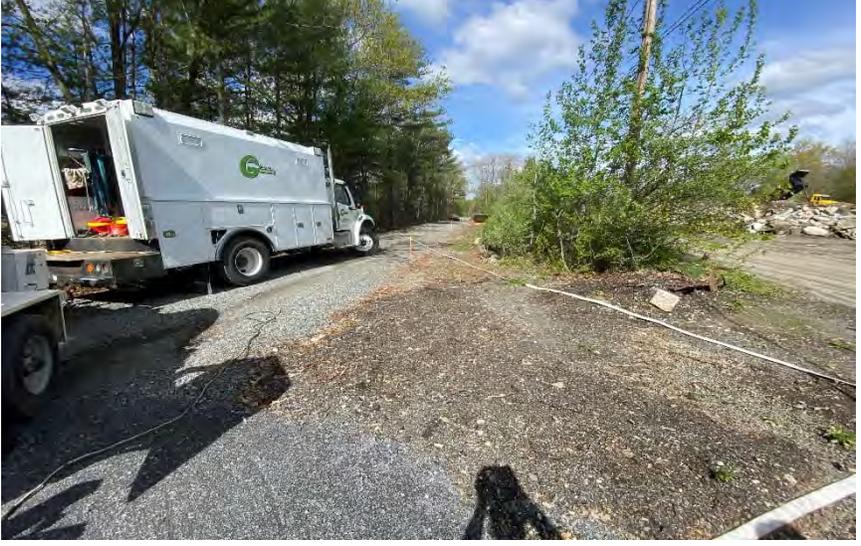
PHOTOGRAPHIC LOG	
Client Name: Eversource		Site Location: Sudbury to Hudson Transmission Reliability Project	Town: Hudson
Photo No.: 2	Date: 5/9/2024

Description: manhole #8. View of dewatering operation. Looking westward.

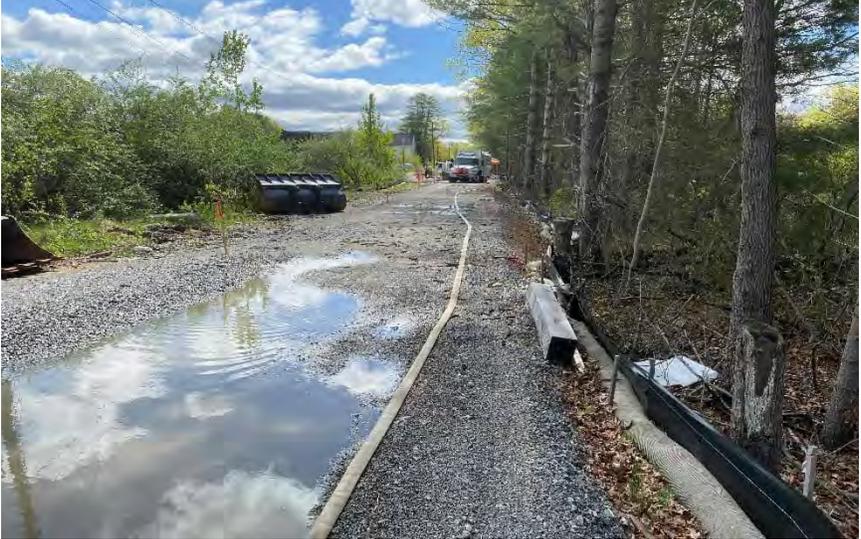
PHOTOGRAPHIC LOG	
Client Name: Eversource		Site Location: Sudbury to Hudson Transmission Reliability Project	Town: Hudson
Photo No.: 3	Date: 5/9/2024

Description: Manhole #8. View of dewatering operation, looking eastward.

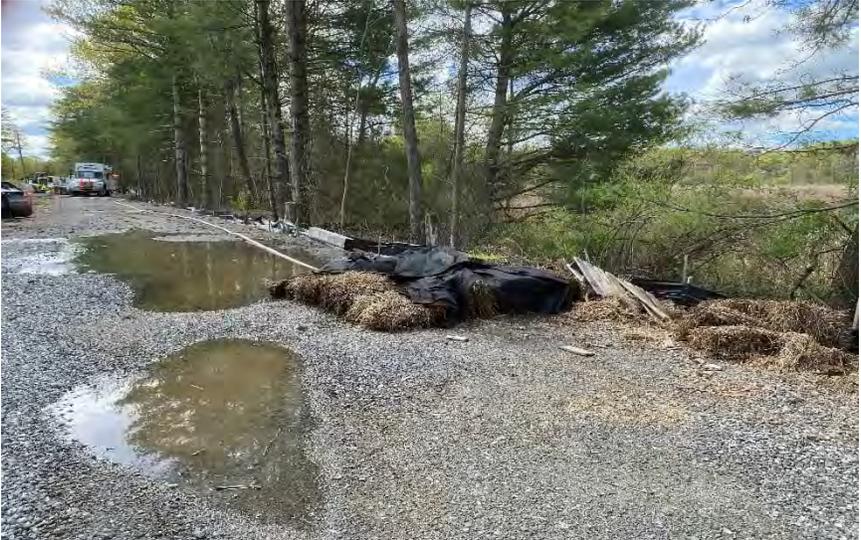
PHOTOGRAPHIC LOG	
Client Name: Eversource		Site Location: Sudbury to Hudson Transmission Reliability Project	Town: Hudson
Photo No.: 4	Date: 5/9/2024

Description: Manhole #8. View of discharge bag/corral, looking eastward. Water from bag/corral discharged to adjacent area.

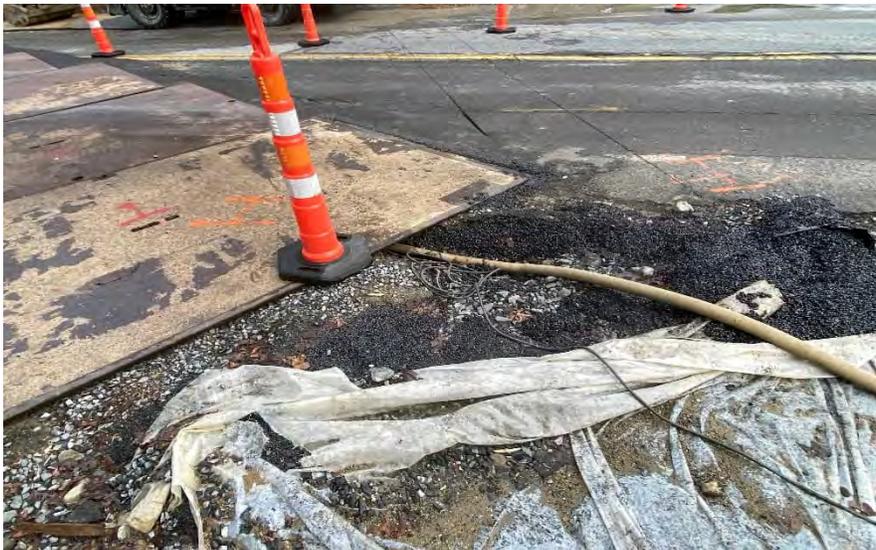
PHOTOGRAPHIC LOG	
Client Name: Eversource		Site Location: Sudbury to Hudson Transmission Reliability Project	Town: Hudson
Photo No.: 1	Date: 5/9/2024

Description: View of area being pumped from trench across Wilkins Street.

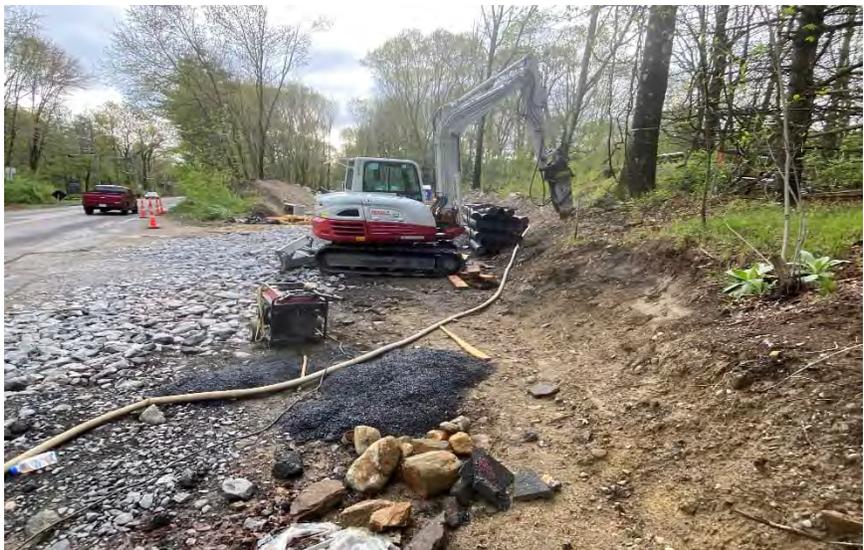
PHOTOGRAPHIC LOG	
Client Name: Eversource		Site Location: Sudbury to Hudson Transmission Reliability Project	Town: Hudson
Photo No.: 2	Date: 5/9/2024

Description: Wilkins Street trench. View of dewatering operation. Looking eastward.

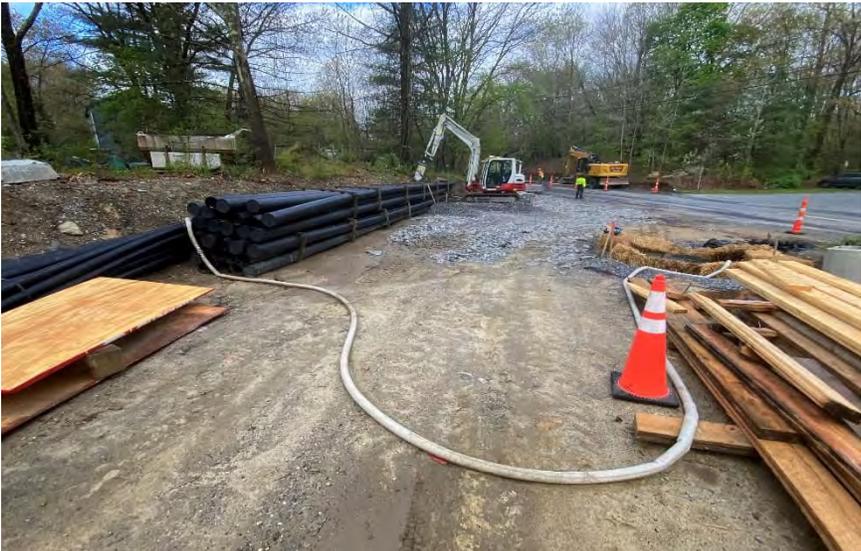
PHOTOGRAPHIC LOG	
Client Name: Eversource		Site Location: Sudbury to Hudson Transmission Reliability Project	Town: Hudson
Photo No.: 3	Date: 5/9/2024

Description: Wilkins Street trench. View of dewatering operation, looking westward.

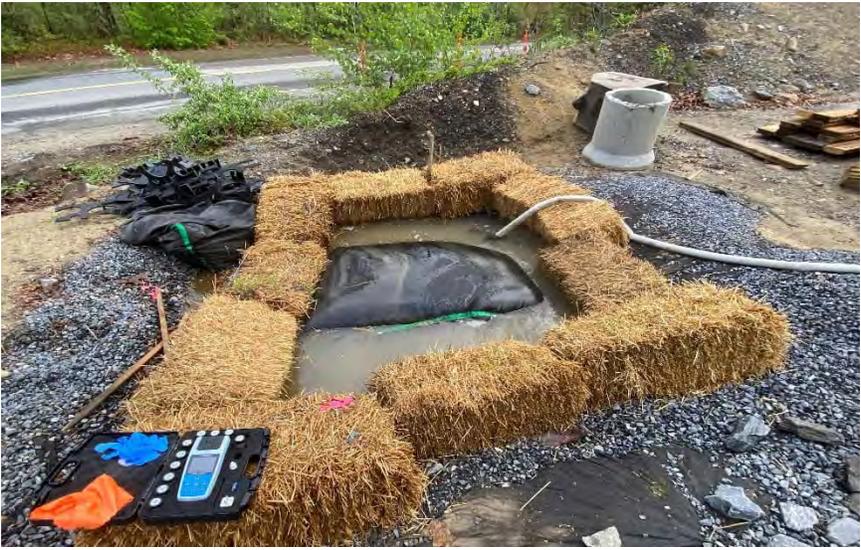
PHOTOGRAPHIC LOG	
Client Name: Eversource		Site Location: Sudbury to Hudson Transmission Reliability Project	Town: Hudson
Photo No.: 4	Date: 5/9/2024

Description: Wilkins Street trench. View of discharge bag/corral, looking westward. Water from bag/corral discharged to underlying catch basin.

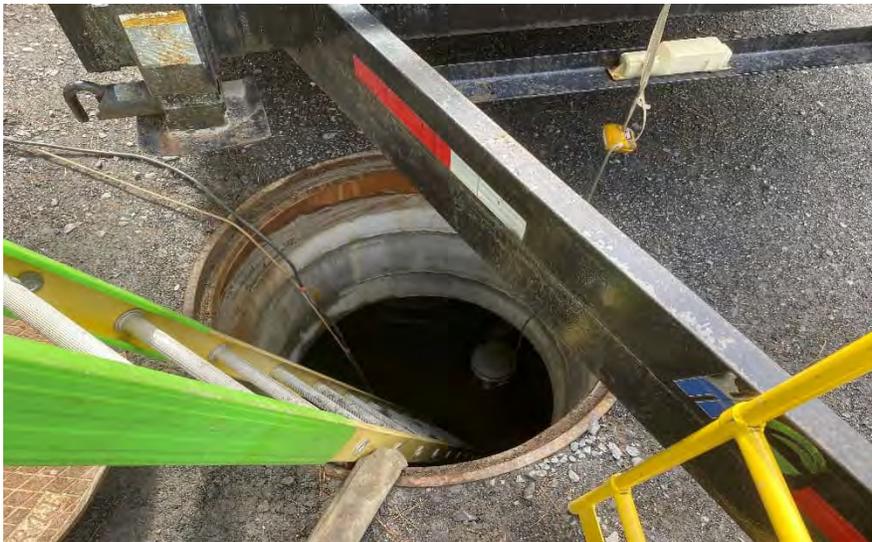
PHOTOGRAPHIC LOG	
Client Name: Eversource		Site Location: Sudbury to Hudson Transmission Reliability Project	Town: Hudson
Photo No.: 1	Date: 5/9/2024

Description: View of area being pumped from manhole #9, segment 3.

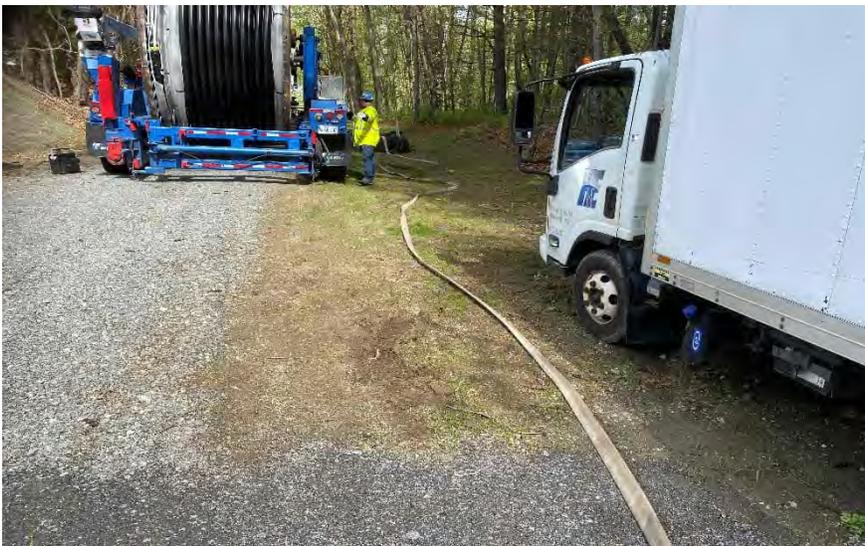
PHOTOGRAPHIC LOG	
Client Name: Eversource		Site Location: Sudbury to Hudson Transmission Reliability Project	Town: Hudson
Photo No.: 2	Date: 5/9/2024

Description: Manhole #9. View of dewatering operation. Looking eastward.

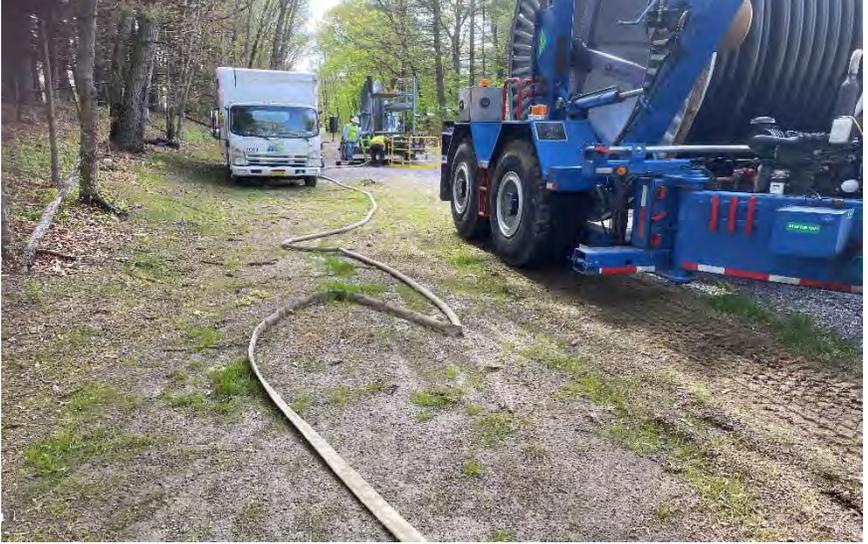
PHOTOGRAPHIC LOG	
Client Name: Eversource		Site Location: Sudbury to Hudson Transmission Reliability Project	
Photo No.: 3 Date: 5/9/2024

Description: Manhole #9. View of dewatering operation, looking westward.

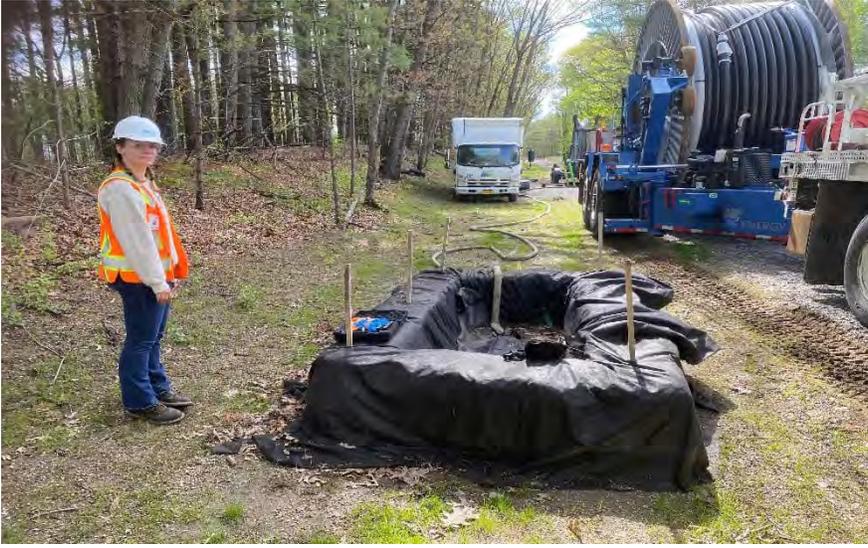
PHOTOGRAPHIC LOG	
Client Name: Eversource		Site Location: Sudbury to Hudson Transmission Reliability Project	
Photo No.: 4 Date: 5/9/2024

Description: Manhole #9. View of discharge bag/corral, looking westward. Water from bag/corral discharged to adjacent area.

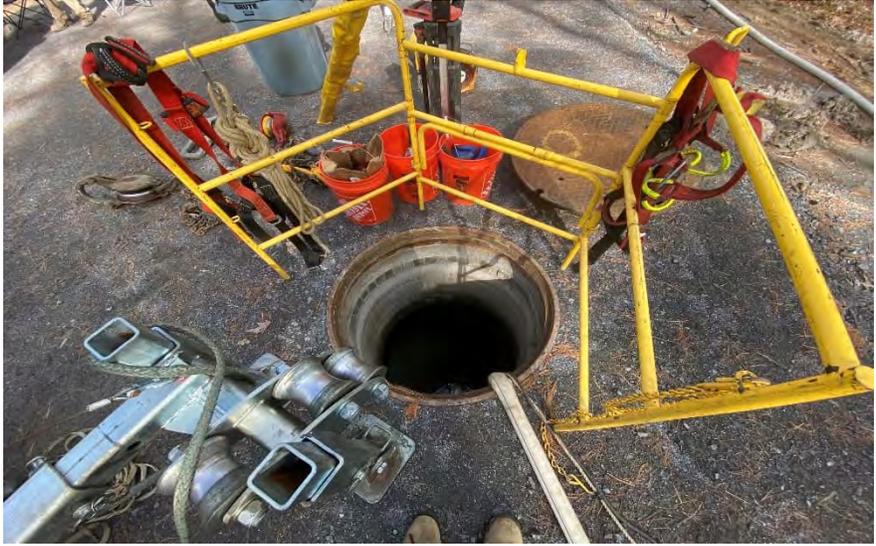
PHOTOGRAPHIC LOG	
Client Name: Eversource		Site Location: Sudbury to Hudson Transmission Reliability Project	
Town: Hudson			
Photo No.: 1	Date: 5/10/2024

Description: View of area being pumped from manhole #10, segment 4.

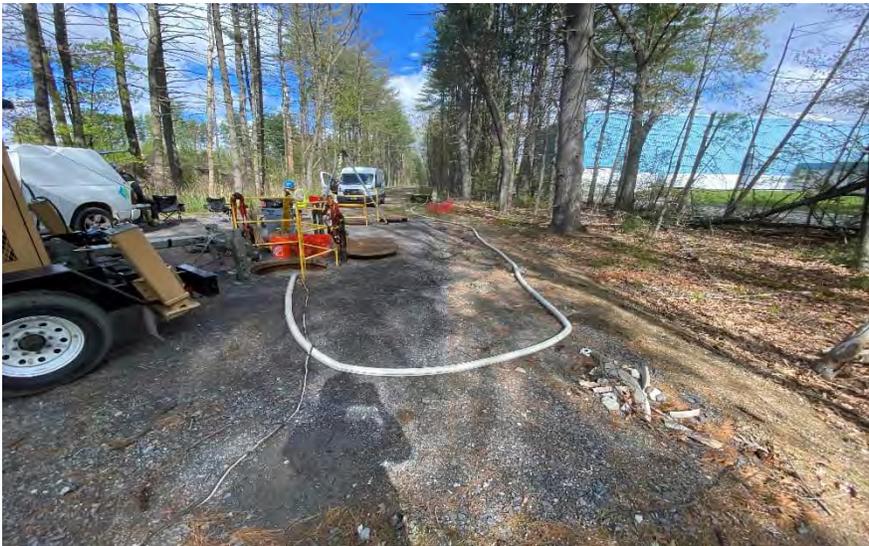
PHOTOGRAPHIC LOG	
Client Name: Eversource		Site Location: Sudbury to Hudson Transmission Reliability Project	
Town: Hudson			
Photo No.: 2	Date: 5/10/2024

Description: Manhole #10. View of dewatering operation. Looking eastward.

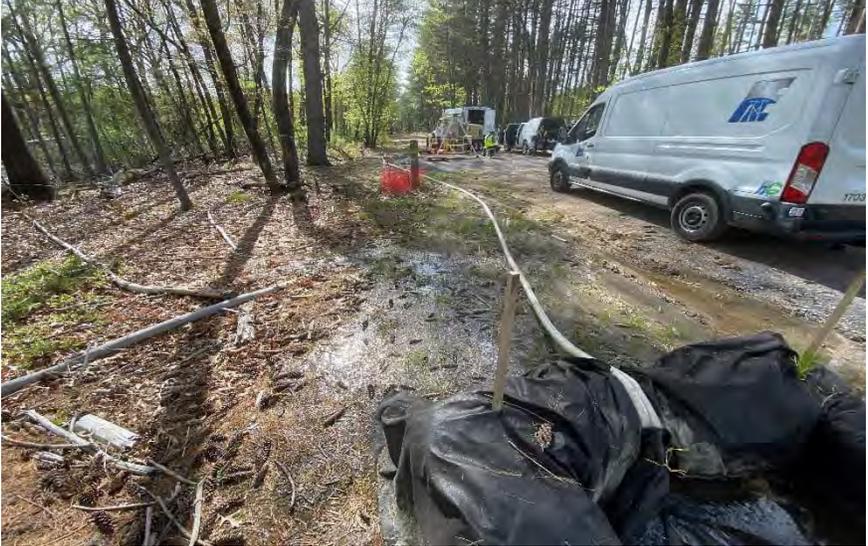
PHOTOGRAPHIC LOG	
Client Name: Eversource		Site Location: Sudbury to Hudson Transmission Reliability Project	Town: Hudson
Photo No.: 3	Date: 5/10/2024

Description: Manhole #10. View of dewatering operation, looking eastward.

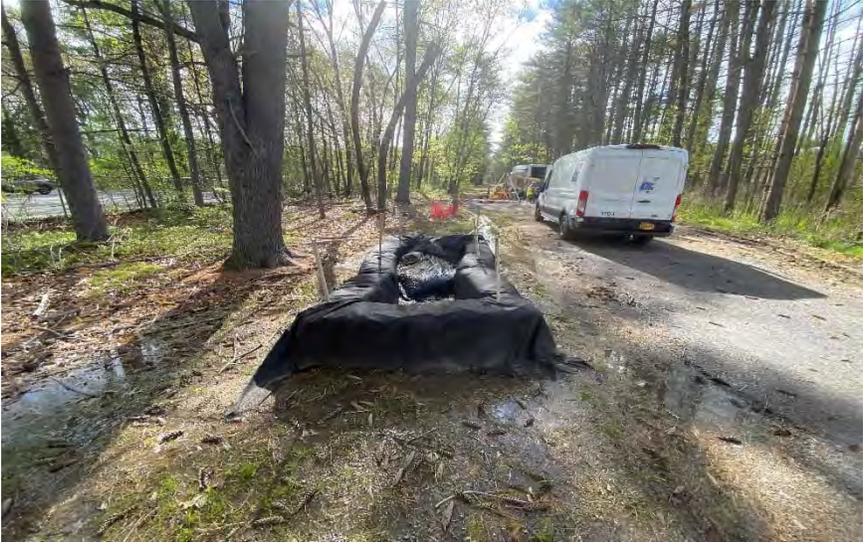
PHOTOGRAPHIC LOG	
Client Name: Eversource		Site Location: Sudbury to Hudson Transmission Reliability Project	Town: Hudson
Photo No.: 4	Date: 5/10/2024

Description: Manhole #10. View of discharge bag/corral, looking westward. Water from bag/corral discharged to adjacent area.

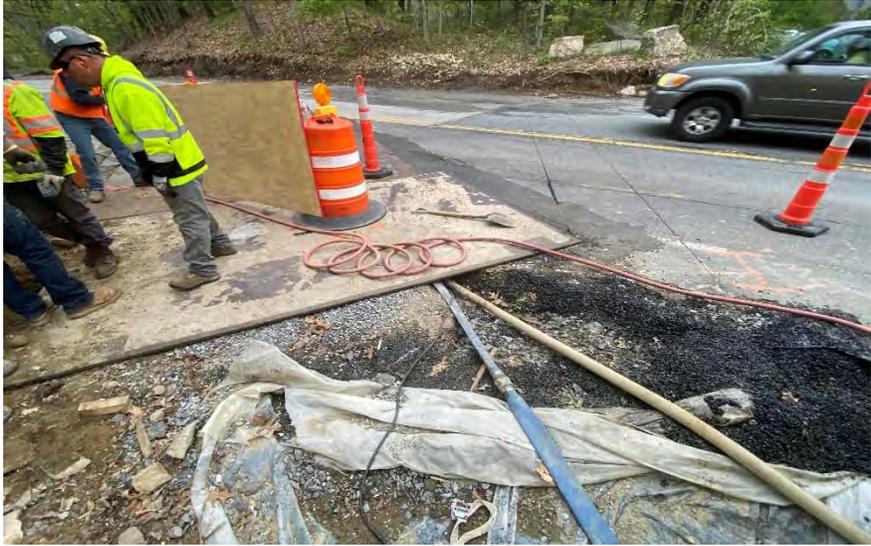
PHOTOGRAPHIC LOG	
Client Name: Eversource		Site Location: Sudbury to Hudson Transmission Reliability Project	Town: Hudson
Photo No.: 1	Date: 5/10/2024

Description: View of area being pumped from trench across Wilkins Street.

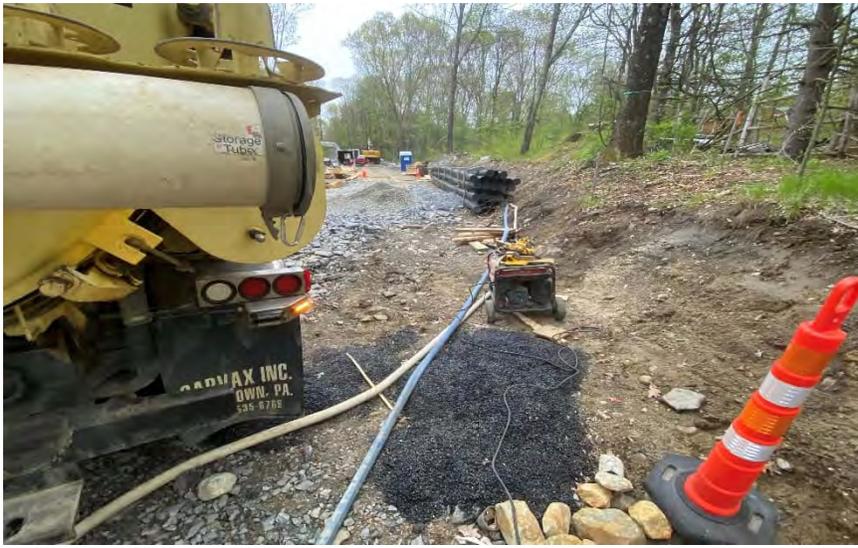
PHOTOGRAPHIC LOG	
Client Name: Eversource		Site Location: Sudbury to Hudson Transmission Reliability Project	Town: Hudson
Photo No.: 2	Date: 5/10/2024

Description: Wilkins Street trench. View of dewatering operation. Looking eastward.

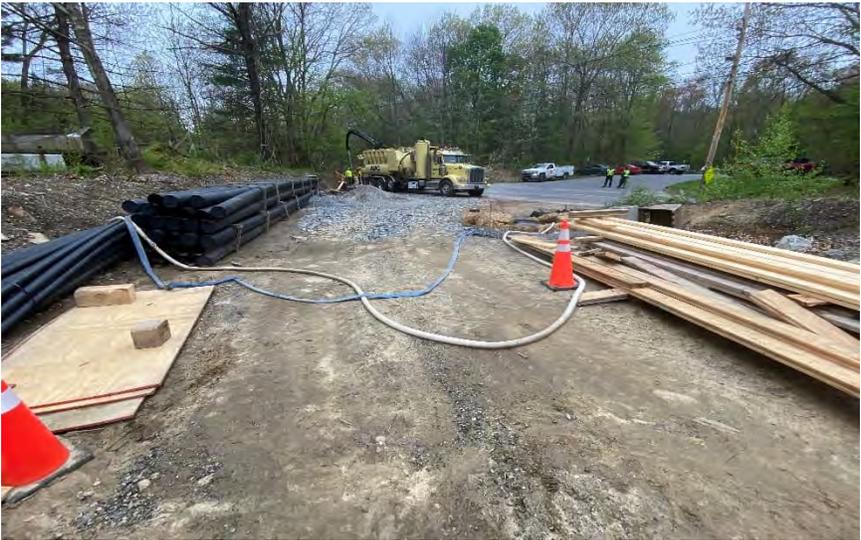
PHOTOGRAPHIC LOG	
Client Name: Eversource		Site Location: Sudbury to Hudson Transmission Reliability Project	
Town: Hudson			
Photo No.: 3	Date: 5/10/2024

Description: Wilkins Street trench. View of dewatering operation, looking westward.

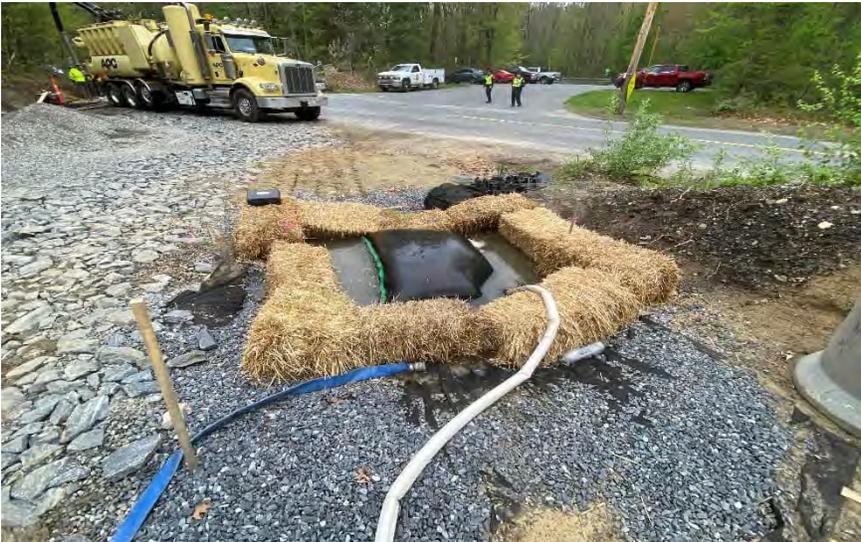
PHOTOGRAPHIC LOG	
Client Name: Eversource		Site Location: Sudbury to Hudson Transmission Reliability Project	
Town: Hudson			
Photo No.: 4	Date: 5/10/2024

Description: Wilkins Street trench. View of discharge bag/corral, looking westward. Water from bag/corral discharged to underlying catch basin.

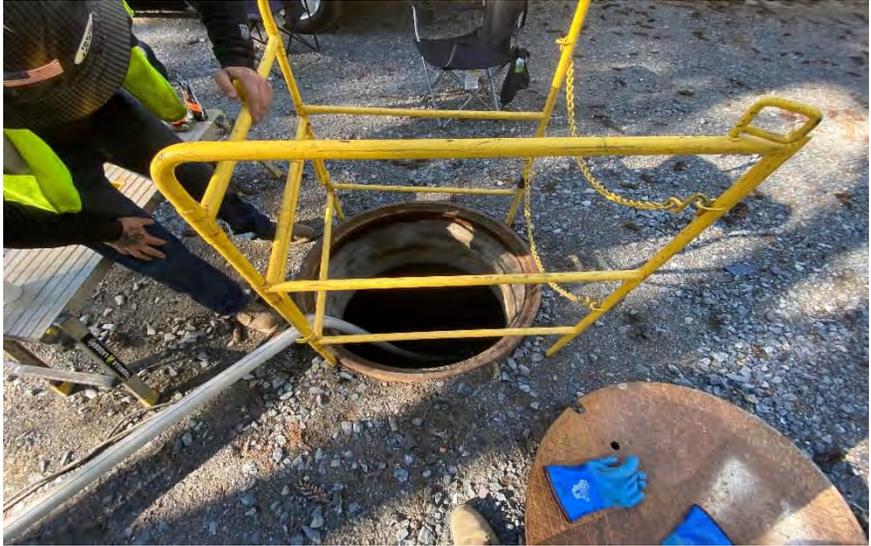
PHOTOGRAPHIC LOG	
Client Name: Eversource		Site Location: Sudbury to Hudson Transmission Reliability Project	Town: Hudson
Photo No.: 1	Date: 5/11/2024

Description: View of area being pumped from manhole #11, segment 5.

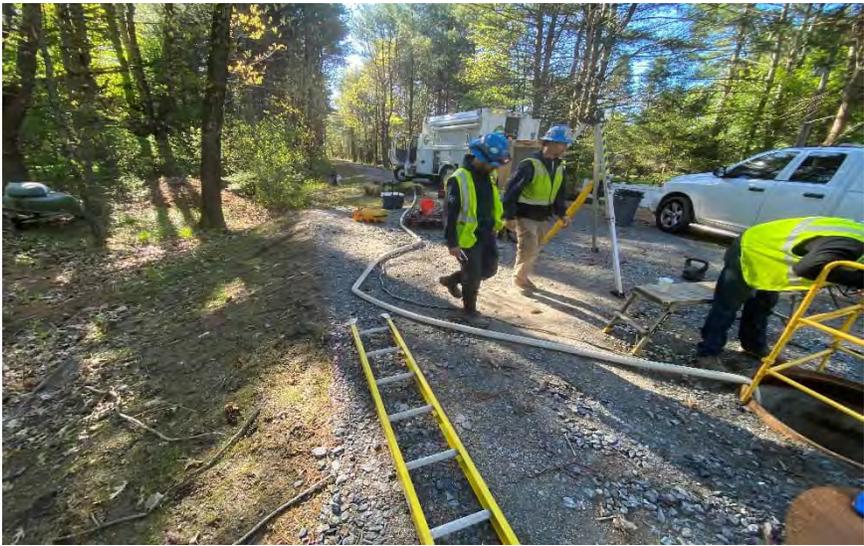
PHOTOGRAPHIC LOG	
Client Name: Eversource		Site Location: Sudbury to Hudson Transmission Reliability Project	Town: Hudson
Photo No.: 2	Date: 5/11/2024

Description: Manhole #11. View of dewatering operation. Looking eastward.

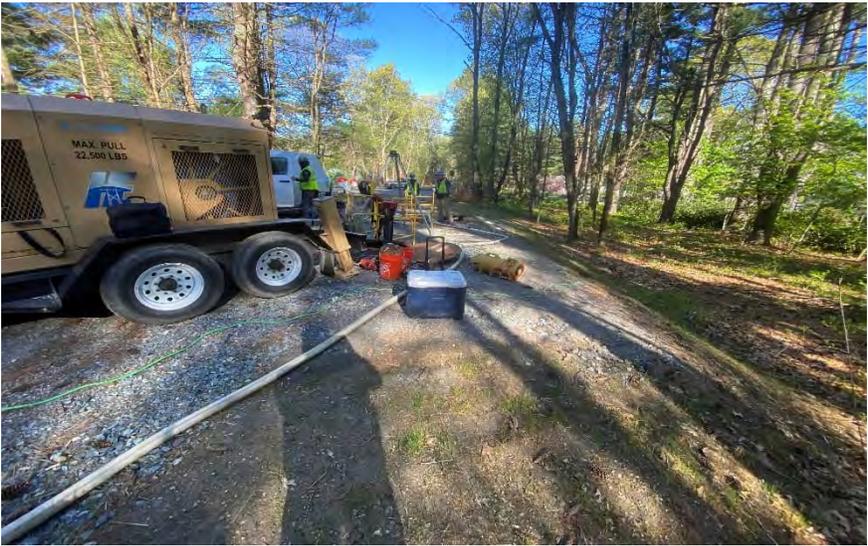
PHOTOGRAPHIC LOG	
Client Name: Eversource		Site Location: Sudbury to Hudson Transmission Reliability Project	Town: Hudson
Photo No.: 3	Date: 5/11/2024

Description: Manhole #11. View of dewatering operation, looking westward.

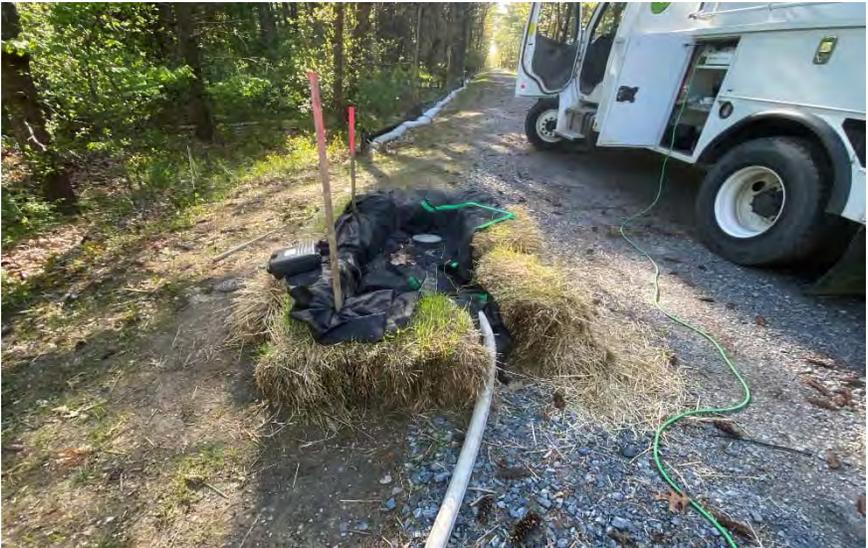
PHOTOGRAPHIC LOG	
Client Name: Eversource		Site Location: Sudbury to Hudson Transmission Reliability Project	Town: Hudson
Photo No.: 4	Date: 5/11/2024

Description: Manhole #11. View of discharge bag/corral, looking eastward. Water from bag/corral discharged to adjacent area.
