**Weekly Environmental Compliance Summary**

**Sudbury to Hudson Transmission Reliability Project (USEPA Tracking # MAR1003UW)**

Sudbury, Hudson, and Stow, MA

Week of: May 20, 2024 to May 24, 2024

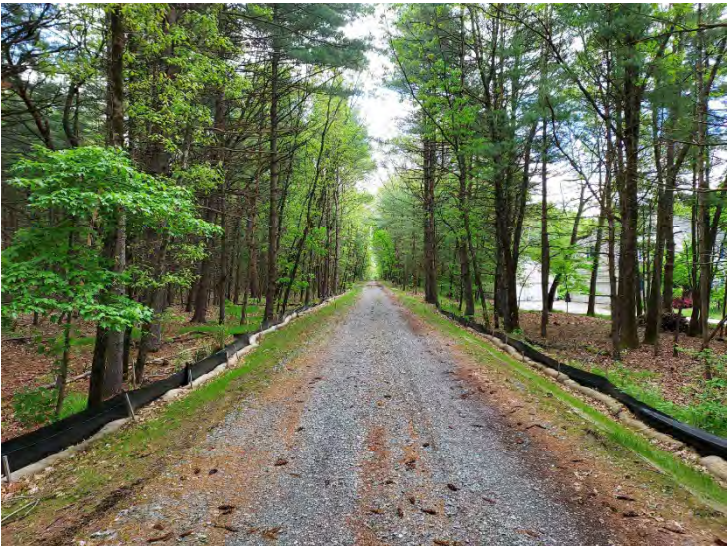
<b>PHOTOGRAPHIC LOG</b>	
Client Name: Eversource		Site Location: Sudbury to Hudson Transmission Reliability Project	Town: Hudson
Photo No.: 6	Date: 5/20/2024

Description: View of E&S controls in segment 5 off Parmenter Rd. Facing east.

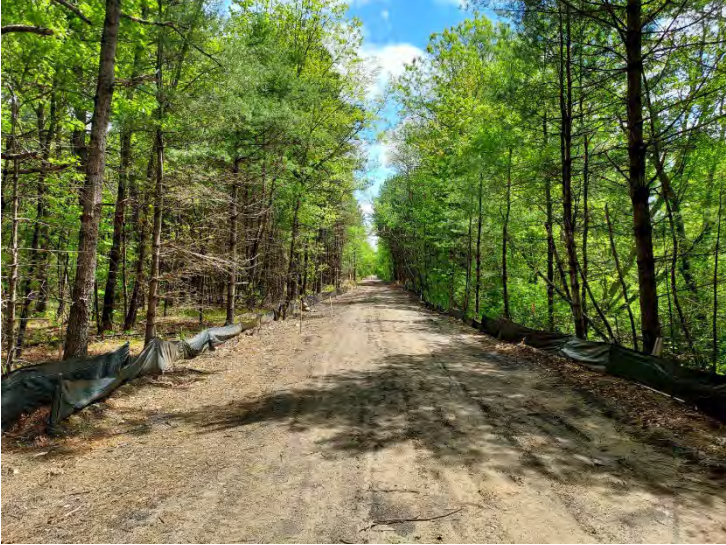
<b>PHOTOGRAPHIC LOG</b>	
Client Name: Eversource		Site Location: Sudbury to Hudson Transmission Reliability Project	Town: Hudson
Photo No.: 7	Date: 5/20/2024

Description: View of E&S controls in segment 6. Facing east.

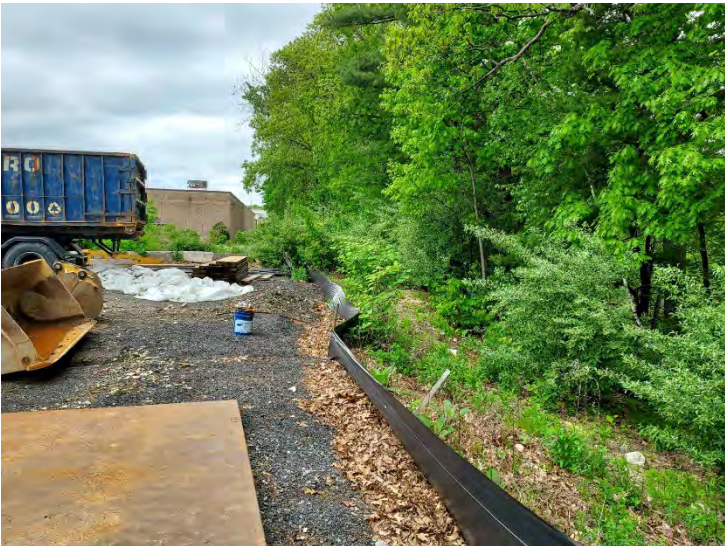
<b>PHOTOGRAPHIC LOG</b>	
Client Name: Eversource		Site Location: Sudbury to Hudson Transmission Reliability Project	Town: Hudson
Photo No.: 8	Date: 5/20/2024

Description: View of silt fence along Bonazzoli laydown yard. Facing southwest.

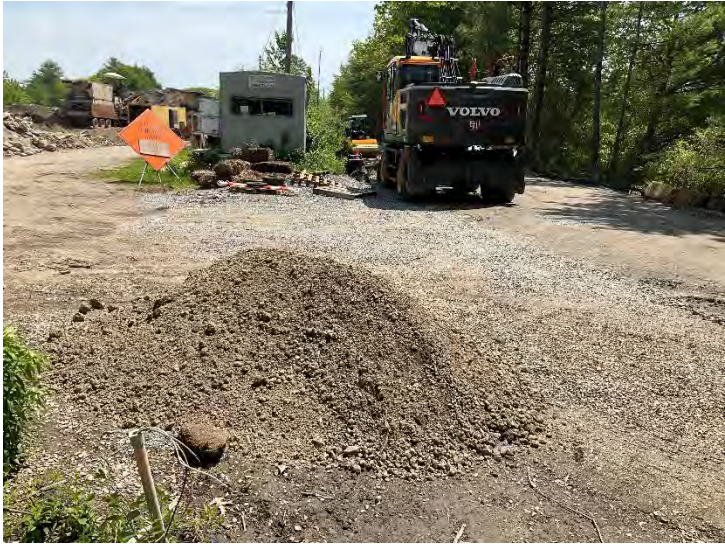
<p align="center"><b>PHOTOGRAPHIC LOG</b></p>	
<p>Client Name: Eversource</p>		<p>Site Location: Sudbury to Hudson Transmission Reliability Project</p>	<p>Town: Hudson</p>
<p>Photo No.: 7</p>	<p>Date: 5-21-24</p>

<p><b>Description:</b></p> <p>View of ET&amp;L equipment staging and spoil stockpile in segment 3. Spoil stockpile active as of 5-21-24. Facing east.</p>

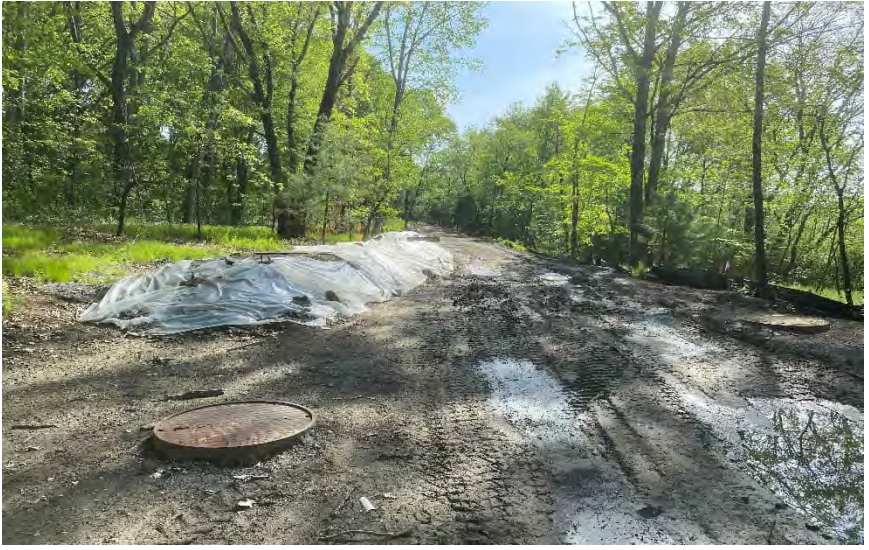
<p>PHOTOGRAPHIC LOG</p>	
<p>Client Name: Eversource</p>		<p>Site Location: Sudbury to Hudson Transmission Reliability Project</p>	<p>Town: Sudbury</p>
<p>Photo No.: 8</p>	<p>Date: 5-21-24</p>

Identify presence of stockpiles and document when placed and when removed (week maximum for stockpiles)    Yes    No  
Spoil Berm noted within segment 14, berm created 3-8-24. See photo 8.

<p>Description:</p> <p>Work area within Segment 14, covered spoil berm, existing erosion control, looking eastward.</p>

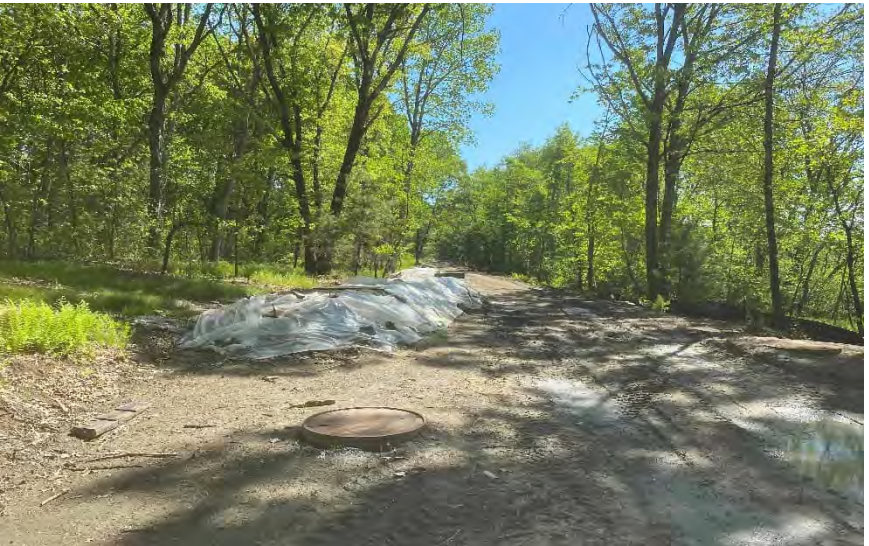
<p align="center">PHOTOGRAPHIC LOG</p>	
<p>Client Name: Eversource</p>		<p>Site Location: Sudbury to Hudson Transmission Reliability Project</p>	<p>Town: Sudbury</p>
<p>Photo No.: 8</p>	<p>Date: 5-22-24</p>

<p>Description:</p> <p>Work area within Segment 14, covered spoil berm, existing erosion control, looking eastward.</p>

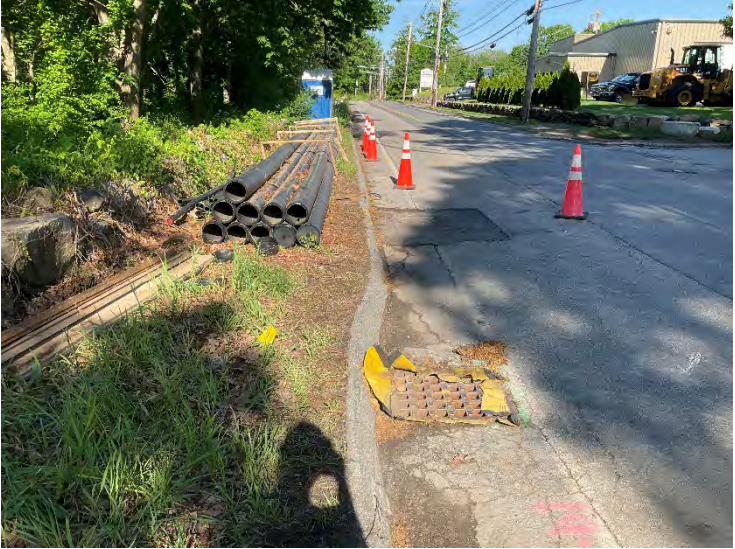
<p><b>PHOTOGRAPHIC LOG</b></p>	
<p>Client Name: Eversource</p>		<p>Site Location: Sudbury to Hudson Transmission Reliability Project</p>	<p>Town: Hudson</p>
<p>Photo No.: 1</p>	<p>Date: 5-24-24</p>

<p>Description:</p> <p>View of installed silt sack inlet protection along Forest Ave by active road work and equipment staging. Facing east.</p>

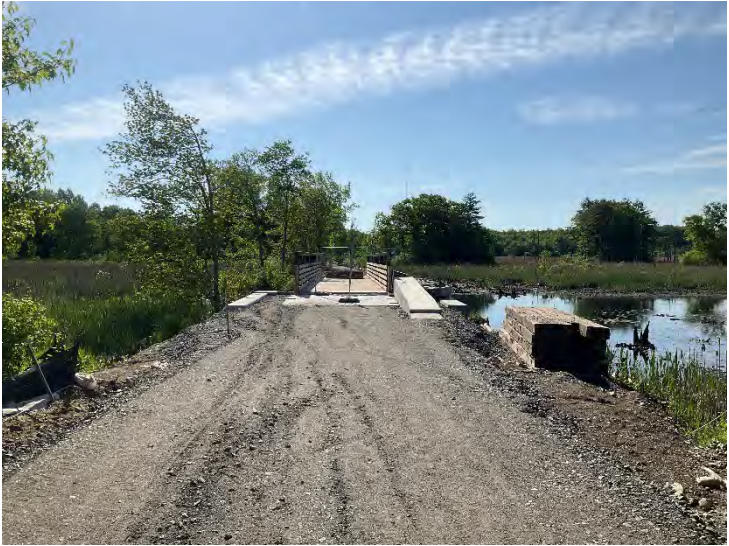
<p><b>PHOTOGRAPHIC LOG</b></p>	
<p>Client Name: Eversource</p>		<p>Site Location: Sudbury to Hudson Transmission Reliability Project</p>	<p>Town: Hudson</p>
<p>Photo No.: 5</p>	<p>Date: 5-24-24</p>

<p>Description:</p> <p>View of Bridge 130 from segment 2. Northern slope from the access road to the wetland to be monitored closely for erosion or risk of erosion. Area appears stable. Facing west.</p>

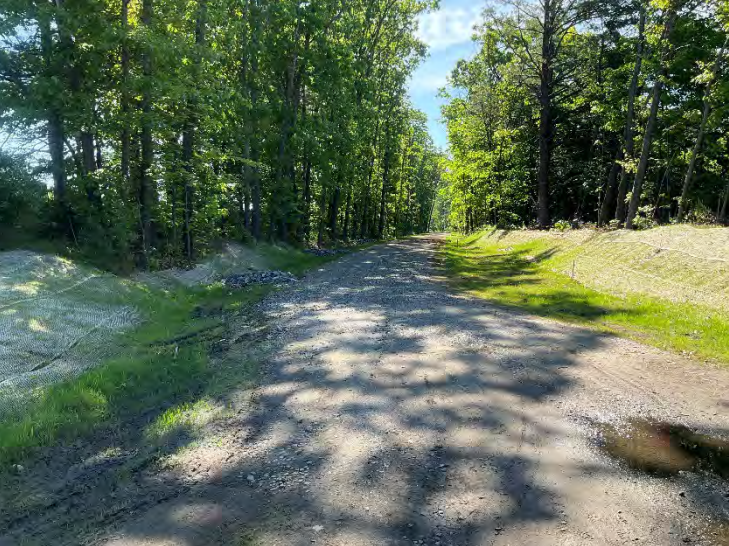
<p><b>PHOTOGRAPHIC LOG</b></p>	
<p>Client Name: Eversource</p>		<p>Site Location: Sudbury to Hudson Transmission Reliability Project</p>	<p>Town: Hudson</p>
<p>Photo No.: 6</p>	<p>Date: 5-24-24</p>

<p>Description:</p> <p>View of hydroseed matting at construction entrance to segment 4. Facing south.</p>

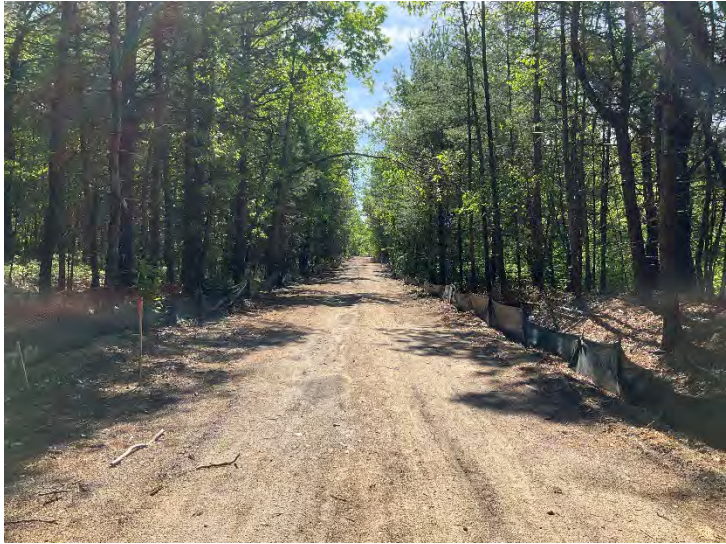
<b>PHOTOGRAPHIC LOG</b>	
Client Name: Eversource		Site Location: Sudbury to Hudson Transmission Reliability Project	Town: Hudson
Photo No.: 7	Date: 5-24-24

<b>Description:</b> View of E&S controls within segment 6. Facing east.

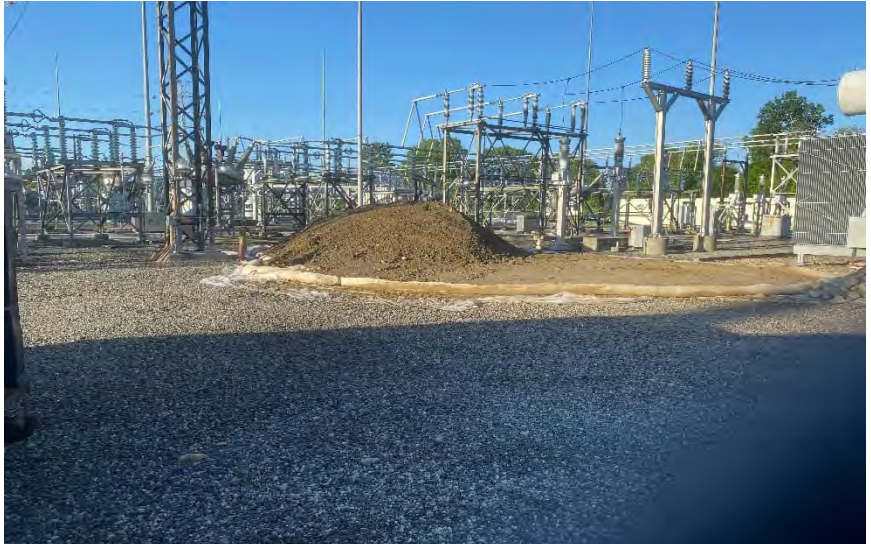
<b>PHOTOGRAPHIC LOG</b>	
Client Name: Eversource		Site Location: Sudbury to Hudson Transmission Reliability Project	Town: Sudbury
Photo No.: 6	Date: 5-24-24

<b>Description:</b>  Work area within substation, newly placed spoil pile, existing erosion control (compost tubing), looking southward.

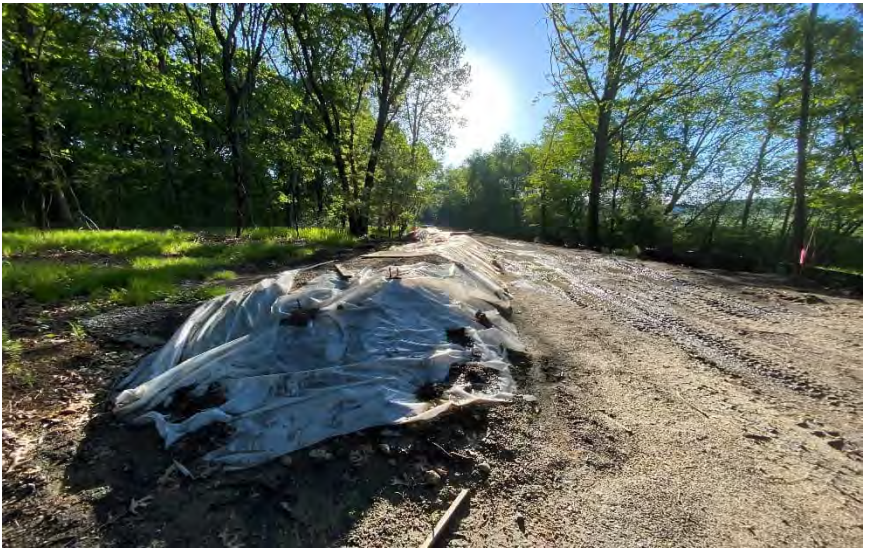
<p>PHOTOGRAPHIC LOG</p>	
<p>Client Name: Eversource</p>		<p>Site Location: Sudbury to Hudson Transmission Reliability Project</p>	<p>Town: Sudbury</p>
<p>Photo No.: 8</p>	<p>Date: 5-24-24</p>

Identify presence of stockpiles and document when placed and when removed (week maximum for stockpiles)    Yes    No  
Spoil Berm noted within segment 14, berm created 3-8-24. See photo 8.

<p>Description:</p> <p>Work area within Segment 14, covered spoil berm, existing erosion control, looking eastward.</p>

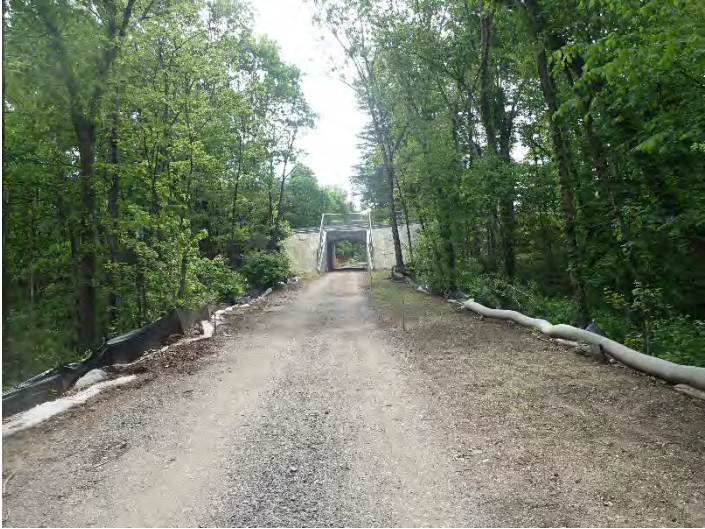
<b>PHOTOGRAPHIC LOG</b>	
Client Name: Eversource		Site Location: Sudbury to Hudson Transmission Reliability Project	Town: Hudson
Photo No.: 2	Date: 5-23-2024

-Sections of silt fence require repair in Segment 1, MON is anticipated to continue silt fence repair next week.

Description: View of E&S controls in segment 1. Facing east.

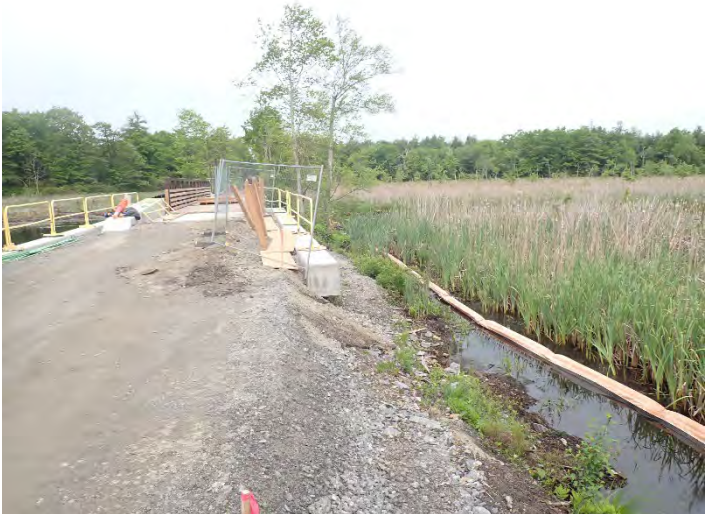
<b>Epsilon</b> ASSOCIATES INC.		<b>PHOTOGRAPHIC LOG</b>	
Client Name: Eversource		Site Location: Sudbury to Hudson Transmission Reliability Project	Town: Hudson
Photo No.: 4	Date: 5-23-2024

Description: View of turbidity curtain and northern slope at Bridge 130. Facing west.

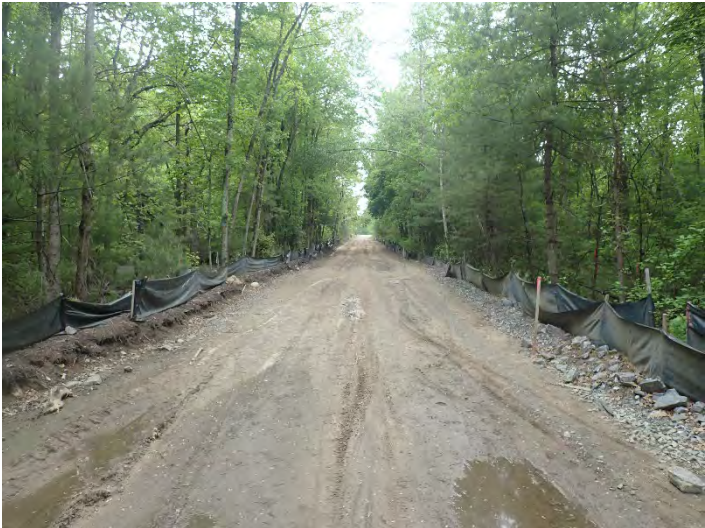
<b>Epsilon</b> ASSOCIATES INC.		<b>PHOTOGRAPHIC LOG</b>	
Client Name: Eversource		Site Location: Sudbury to Hudson Transmission Reliability Project	Town: Hudson
Photo No.: 8	Date: 5-23-2024

-Previously observed section of the silt fence, on the northern side of entrance to Segment 6, was repaired. Silt fence appeared to have been damaged by bicycles. May need to continue to review the area and repair as needed.

Description: View of E&S controls in segment 6. Facing east.

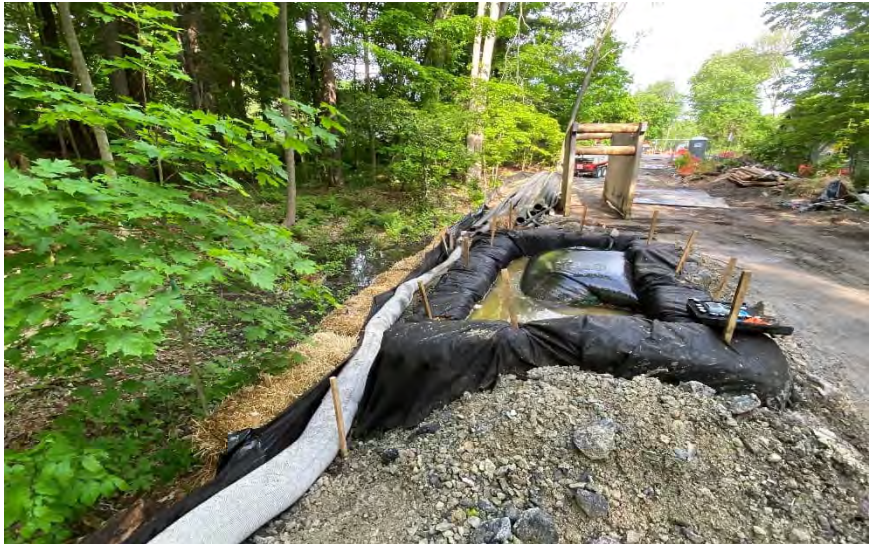
<b>PHOTOGRAPHIC LOG</b>	
Client Name: Eversource		Site Location: Sudbury to Hudson Transmission Reliability Project	Town: Sudbury
Photo No.: 6	Date: 5-23-24

Description:  Work area within segment 13, dewatering operation for conduit work across Boston Post Road, existing erosion control, looking westward.

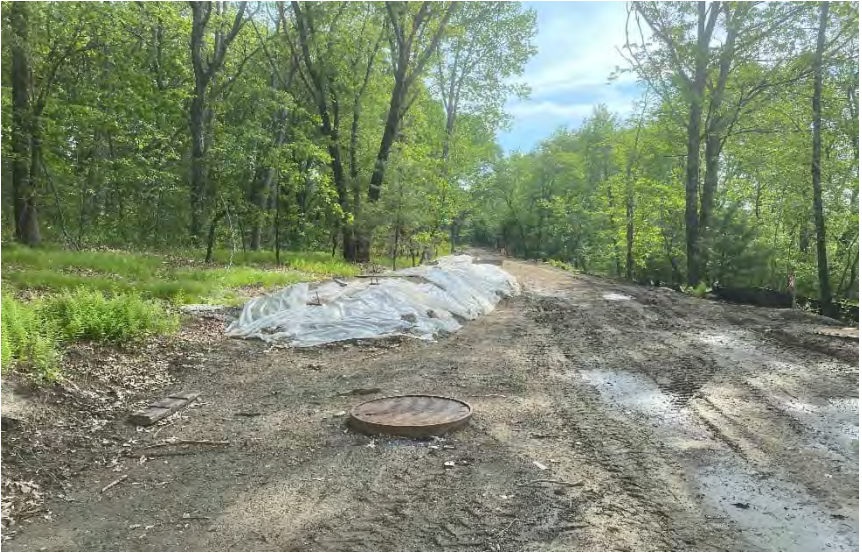
<b>PHOTOGRAPHIC LOG</b>	
<b>Client Name:</b> Eversource		<b>Site Location:</b> Sudbury to Hudson Transmission Reliability Project	<b>Town:</b> Sudbury
<b>Photo No.:</b> 7	<b>Date:</b> 5-23-24

Spoil Berm noted within segment 14, berm created 3-8-24. See photo #7.

<b>Description:</b>  Work area within segment 14, covered spoil pile, existing erosion control, looking eastward.

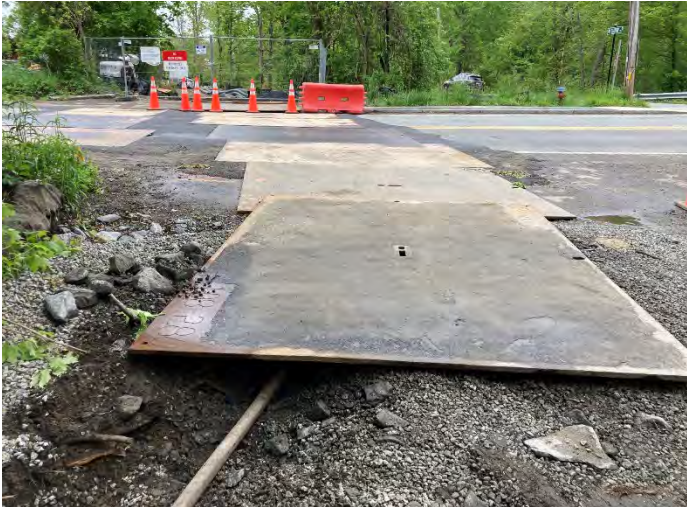
<b>PHOTOGRAPHIC LOG</b>		
Client Name: Eversource		Site Location: Sudbury to Hudson Transmission Reliability Project		Town: Sudbury
Photo No.: 1	Date: 5/19/2024

<b>Description:</b> View of Boston Post Road work area. Steel plates are placed over pump and trench. Unable to visualize water prior to treatment. Facing east.

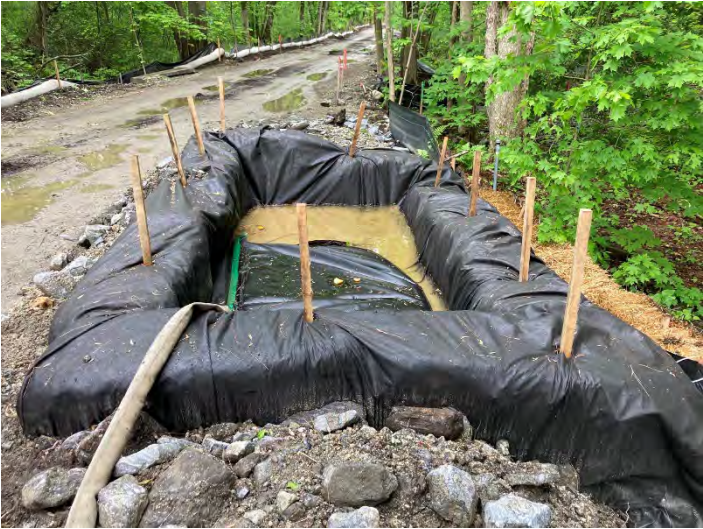
<b>PHOTOGRAPHIC LOG</b>		
Client Name: Eversource		Site Location: Sudbury to Hudson Transmission Reliability Project		Town: Sudbury
Photo No.: 2	Date: 5/19/2024

<b>Description:</b> View of dewatering controls (straw bale corral with filter fabric and silt bag) in segment 13. Facing east.

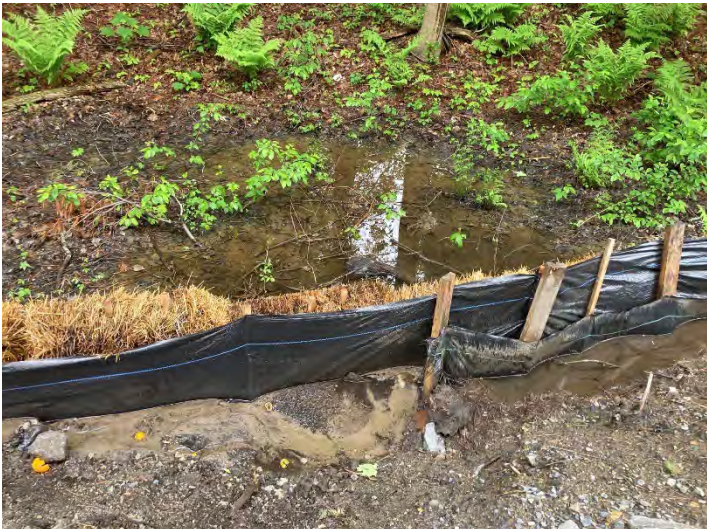
<b>PHOTOGRAPHIC LOG</b>	
Client Name: Eversource		Site Location: Sudbury to Hudson Transmission Reliability Project	
		Town: Sudbury	
Photo No.: 4	Date: 5/19/2024

<b>Description:</b> View of water discharging from site. Discharge appeared clear and turbidity reading was below 50 NTUs. Discharge did not appear to reach any jurisdictional resource areas. Facing south.

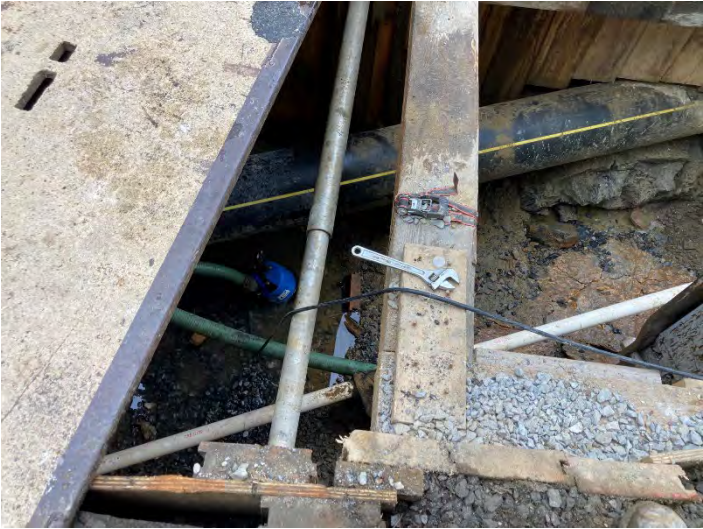
<b>PHOTOGRAPHIC LOG</b>	
Client Name: Eversource		Site Location: Sudbury to Hudson Transmission Reliability Project	
Town: Hudson			
Photo No.: 2	Date: 5/20/2024

<b>Description:</b> View of water in trench within Wilkins Street. Water appeared slightly turbid prior to treatment.

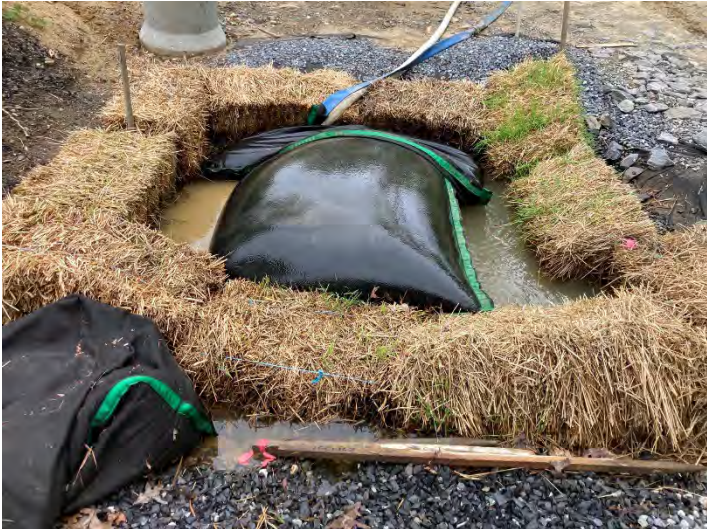
PHOTOGRAPHIC LOG	
Client Name: Eversource		Site Location: Sudbury to Hudson Transmission Reliability Project	
Town: Hudson			
Photo No.: 4	Date: 5/20/2024

<b>Description:</b> Additional view of dewatering controls and discharge. Discharge appeared slightly turbid, but turbidity reading was below 50 NTUs. Facing east.

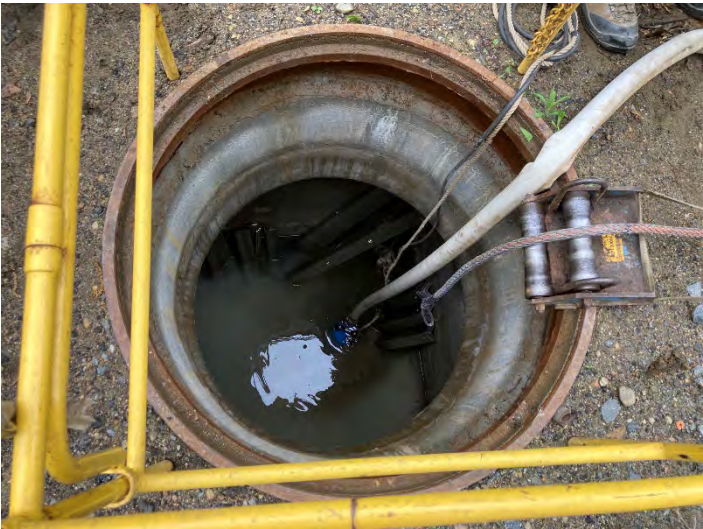
PHOTOGRAPHIC LOG	
Client Name: Eversource		Site Location: Sudbury to Hudson Transmission Reliability Project	
Town: Hudson			
Photo No.: 2	Date: 5/20/2024

<b>Description:</b> View of pump in MH #6. Water appeared slightly turbid prior to treatment. This is likely due to sediment/dirt present in manhole.

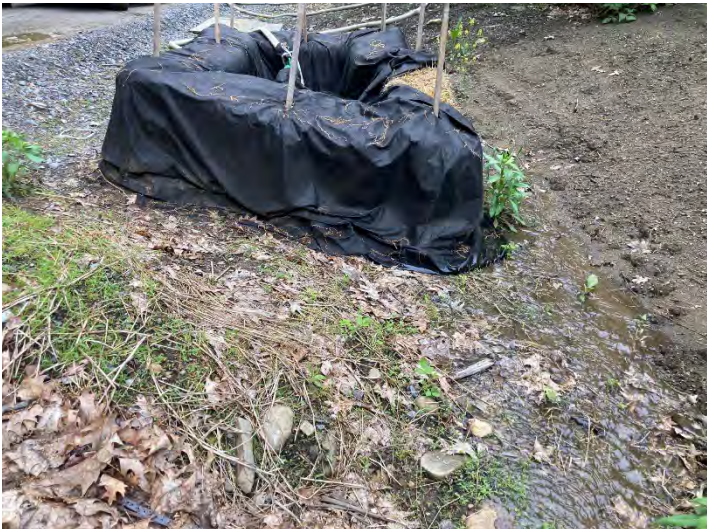
<b>PHOTOGRAPHIC LOG</b>	
Client Name: Eversource		Site Location: Sudbury to Hudson Transmission Reliability Project	
Town: Hudson			
Photo No.: 4	Date: 5/20/2024

<b>Description:</b> View of water discharging from corral. Discharge appeared mostly clear and turbidity reading was below 50 NTUs. Discharge did not appear to reach any jurisdictional resource areas. Facing east.

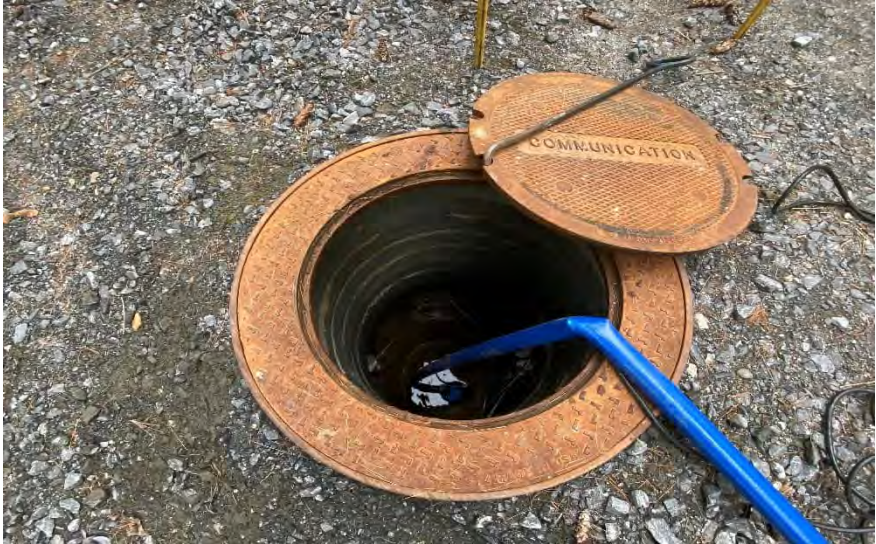
<b>PHOTOGRAPHIC LOG</b>	
Client Name: Eversource		Site Location: Sudbury to Hudson Transmission Reliability Project	Town: Sudbury
Photo No.: 1	Date: 5/20/2024

Description: View of area being pumped from handhole #18, segment 9.

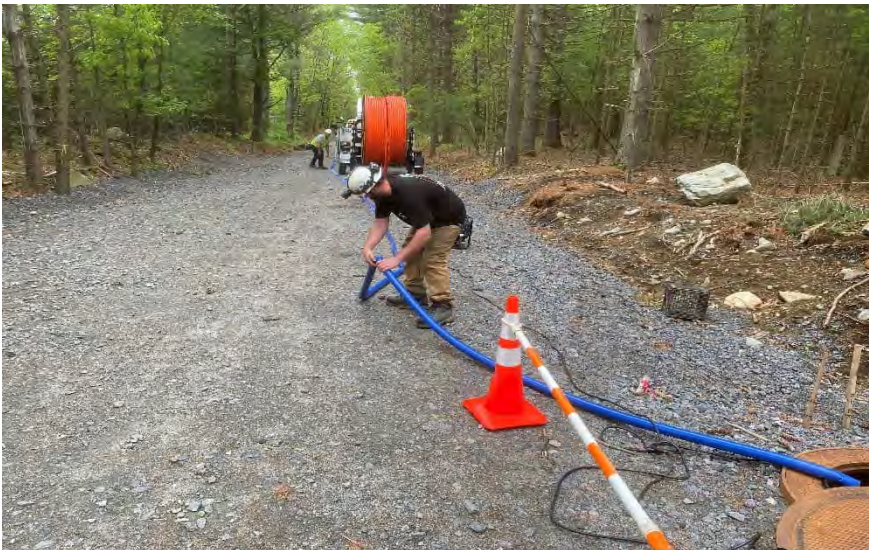
<b>PHOTOGRAPHIC LOG</b>	
Client Name: Eversource		Site Location: Sudbury to Hudson Transmission Reliability Project	Town: Sudbury
Photo No.: 2	Date: 5/20/2024

Description: Handhole #18. View of dewatering operation. Looking eastward.

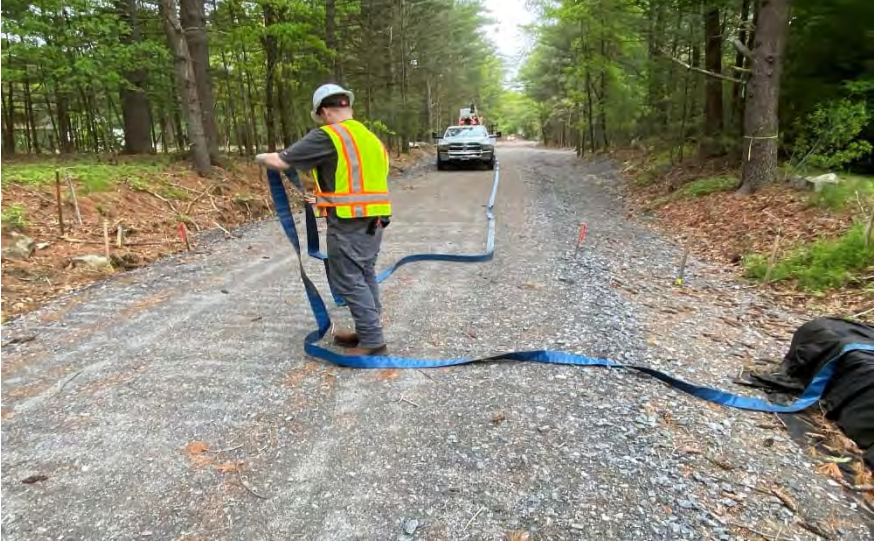
<b>PHOTOGRAPHIC LOG</b>	
Client Name: Eversource		Site Location: Sudbury to Hudson Transmission Reliability Project	Town: Sudbury
Photo No.: 3	Date: 5/20/2024

<b>Description:</b> Handhole #18. View of dewatering operation, looking westward.

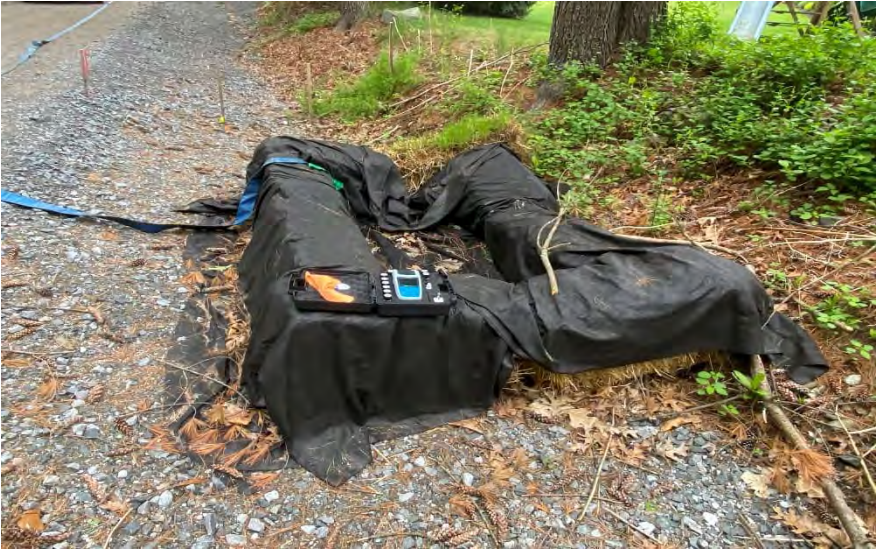
<b>PHOTOGRAPHIC LOG</b>	
Client Name: Eversource		Site Location: Sudbury to Hudson Transmission Reliability Project	Town: Sudbury
Photo No.: 4	Date: 5/20/2024

<b>Description:</b> Handhole #18. View of discharge bag/corral, looking westward. Water from bag/corral discharged to adjacent area.

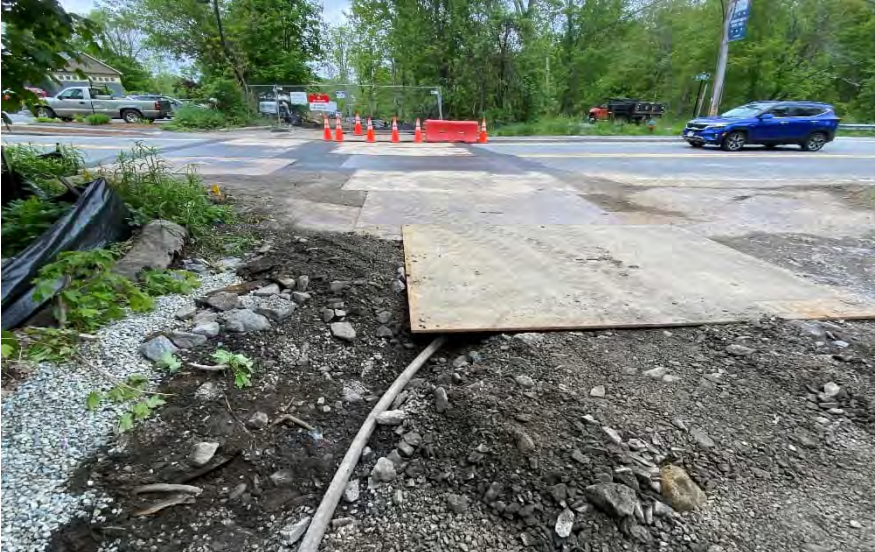
<b>PHOTOGRAPHIC LOG</b>	
<b>Client Name:</b> Eversource		<b>Site Location:</b> Sudbury to Hudson Transmission Reliability Project	<b>Town:</b> Sudbury
<b>Photo No.:</b> 1	<b>Date:</b> 5/20/2024

<b>Description:</b> View of area being pumped from trench across Boston Post Road.

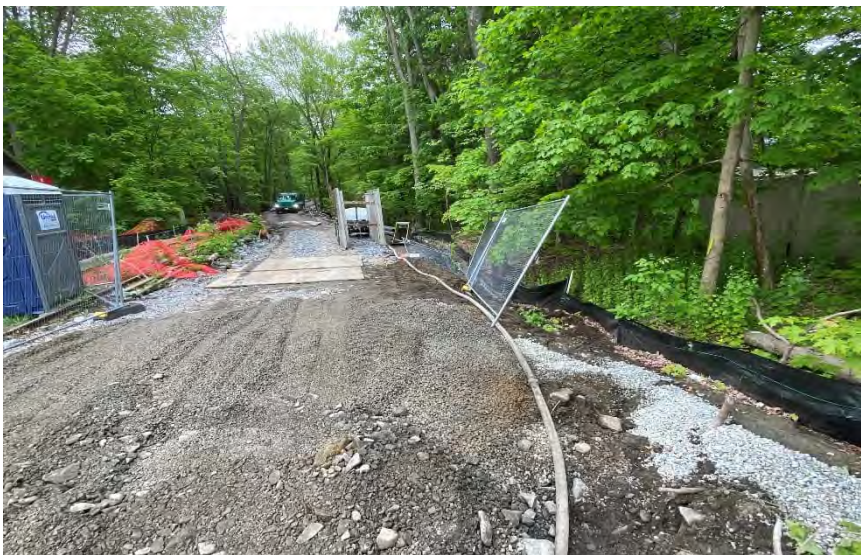
<b>PHOTOGRAPHIC LOG</b>	
<b>Client Name:</b> Eversource		<b>Site Location:</b> Sudbury to Hudson Transmission Reliability Project	<b>Town:</b> Sudbury
<b>Photo No.:</b> 2	<b>Date:</b> 5/20/2024

<b>Description:</b> Boston Post Road trench. View of dewatering operation. Looking eastward.

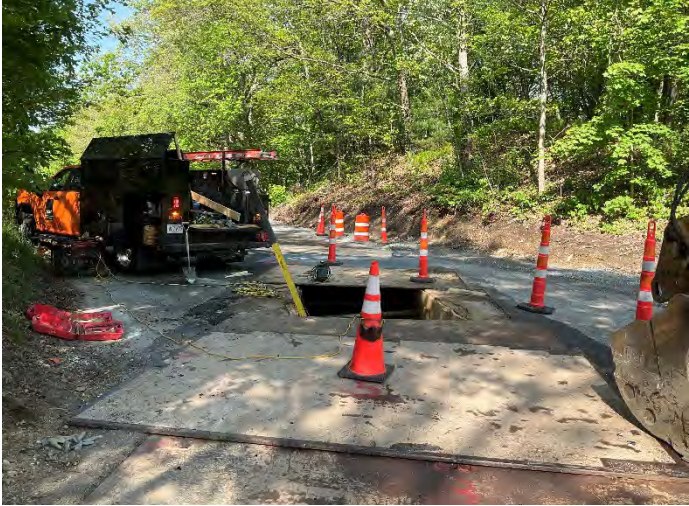
<b>PHOTOGRAPHIC LOG</b>	
Client Name: Eversource		Site Location: Sudbury to Hudson Transmission Reliability Project	
Town: Hudson			
Photo No.: 1	Date: 5/21/2024

<b>Description:</b> View of Bond working on Wilkins Street trenching. Facing west.

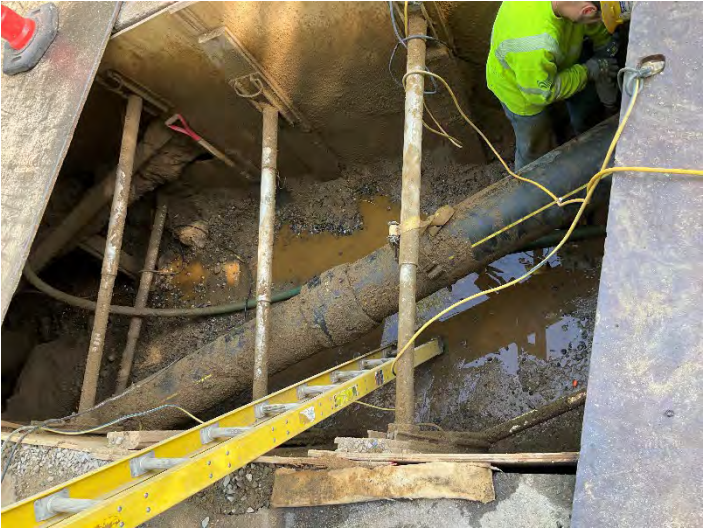
<b>PHOTOGRAPHIC LOG</b>	
Client Name: Eversource		Site Location: Sudbury to Hudson Transmission Reliability Project	
Town: Hudson			
Photo No.: 2	Date: 5/21/2024

<b>Description:</b> View of pump in trench within Wilkins Street. Water appeared cloudy prior to treatment.

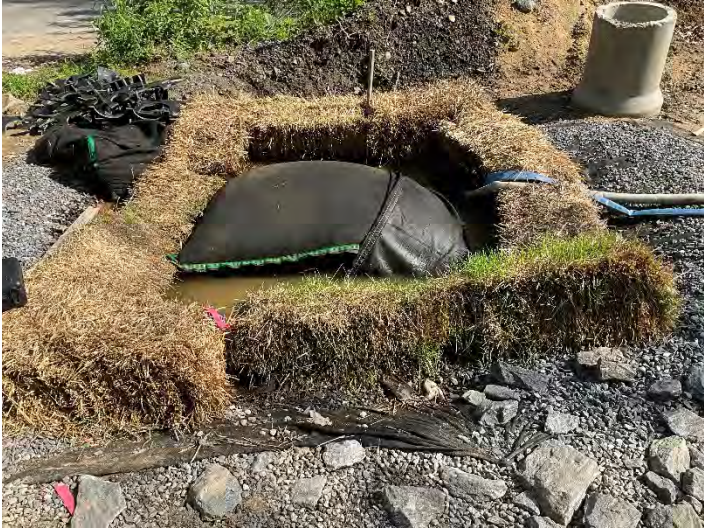
<b>PHOTOGRAPHIC LOG</b>	
Client Name: Eversource		Site Location: Sudbury to Hudson Transmission Reliability Project	Town: Hudson
Photo No.: 3	Date: 5/21/2024

<b>Description:</b> View of dewatering controls (straw bale corral with filter fabric and silt bag). Facing east.

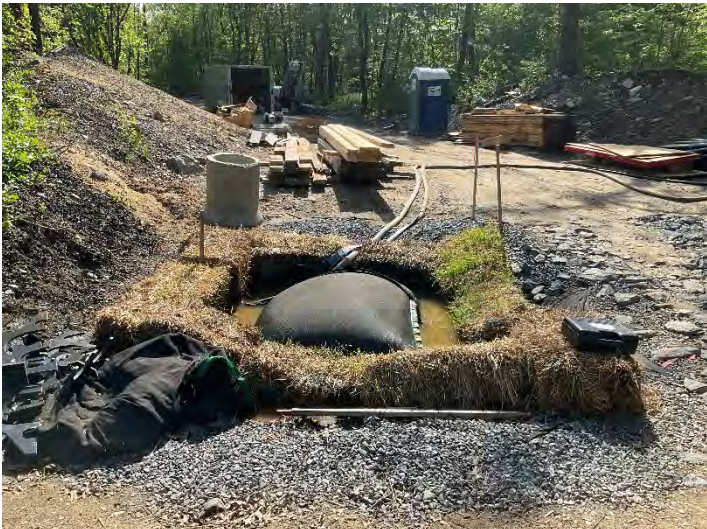
<b>PHOTOGRAPHIC LOG</b>	
Client Name: Eversource		Site Location: Sudbury to Hudson Transmission Reliability Project	Town: Hudson
Photo No.: 4	Date: 5/21/2024

<b>Description:</b> View of discharging water from corral. Discharge appeared turbid but turbidity reading was below 50 NTUs. Water was being discharged to catch basin underneath filter fabric. Facing east.

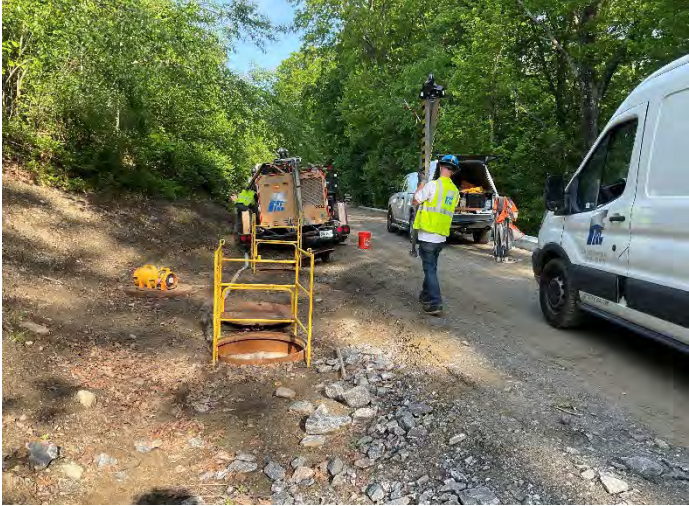
<b>PHOTOGRAPHIC LOG</b>	
Client Name: Eversource		Site Location: Sudbury to Hudson Transmission Reliability Project	
Town: Hudson		Photo No.: 1      Date: 5/21/2024	
<b>Description:</b> View of Haugland workspace in segment 1 at MH #6. Facing west.

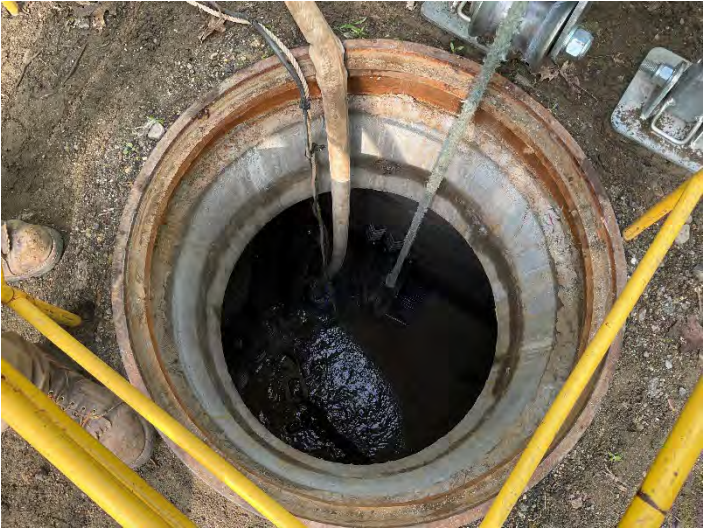
<b>PHOTOGRAPHIC LOG</b>	
Client Name: Eversource		Site Location: Sudbury to Hudson Transmission Reliability Project	
Town: Hudson		Photo No.: 2      Date: 5/21/2024	
<b>Description:</b> View of pump in MH #6. Water appeared mostly clear prior to treatment.

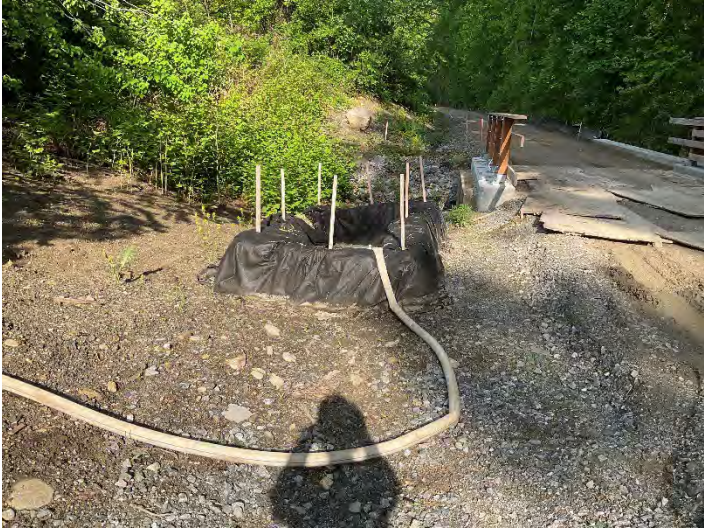
<b>PHOTOGRAPHIC LOG</b>	
Client Name: Eversource		Site Location: Sudbury to Hudson Transmission Reliability Project	
Town: Hudson			
Photo No.: 3	Date: 5/21/2024

<b>Description:</b> View of dewatering controls (straw bale corral with filter fabric and silt bag). Facing west.

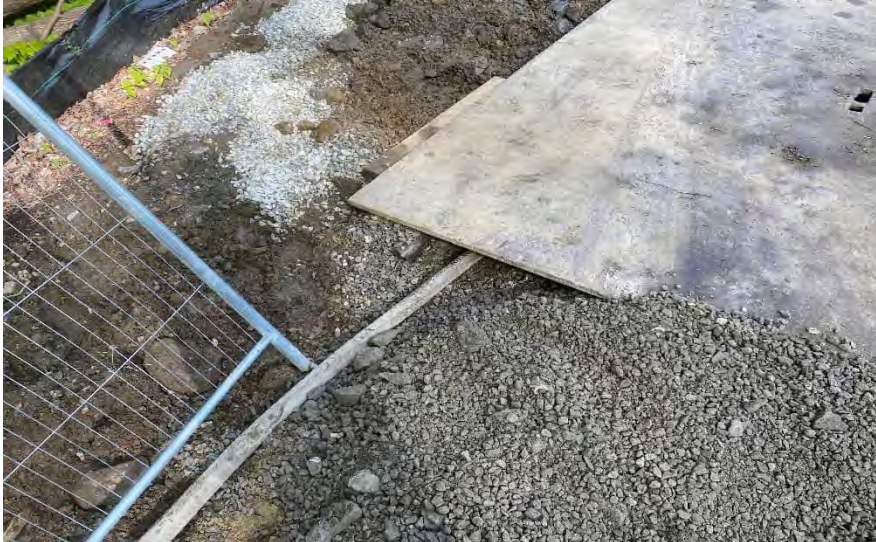
<b>PHOTOGRAPHIC LOG</b>	
<b>Client Name:</b> Eversource		<b>Site Location:</b> Sudbury to Hudson Transmission Reliability Project	
<b>Town:</b> Sudbury			
<b>Photo No.:</b> 1	<b>Date:</b> 5/21/2024

<b>Description:</b> View of area being pumped from trench across Boston Post Road.

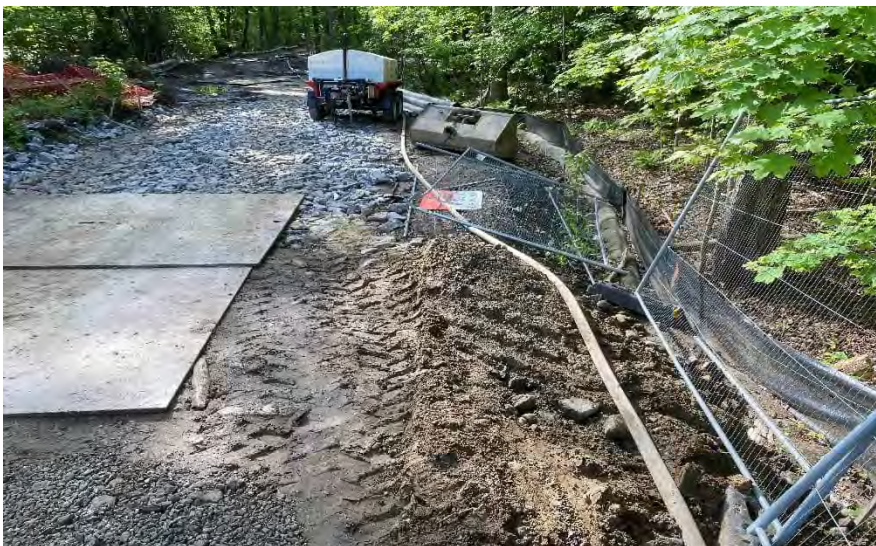
<b>PHOTOGRAPHIC LOG</b>	
<b>Client Name:</b> Eversource		<b>Site Location:</b> Sudbury to Hudson Transmission Reliability Project	
<b>Town:</b> Sudbury			
<b>Photo No.:</b> 2	<b>Date:</b> 5/21/2024

<b>Description:</b> Boston Post Road trench. View of dewatering operation. Looking eastward.

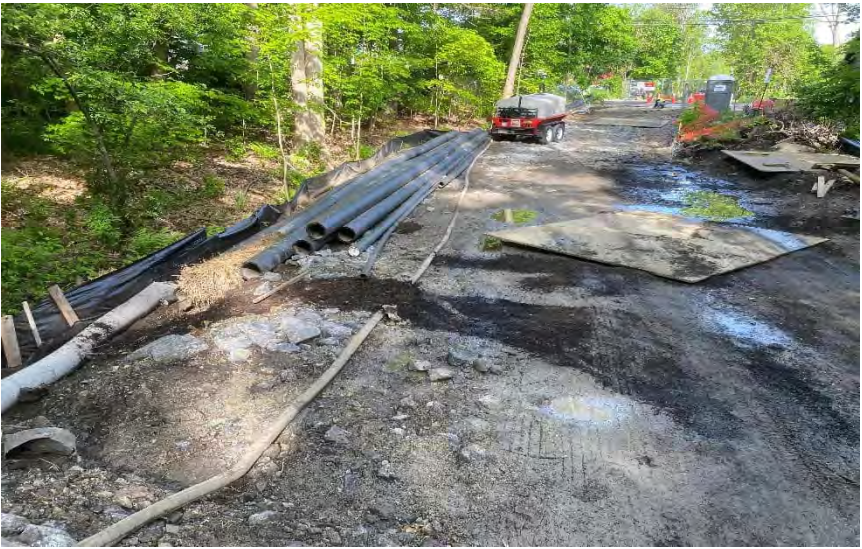
<b>PHOTOGRAPHIC LOG</b>	
Client Name: Eversource		Site Location: Sudbury to Hudson Transmission Reliability Project	Town: Sudbury
Photo No.: 3	Date: 5/21/2024

<b>Description:</b> Boston Post Road trench. View of dewatering operation, looking westward.

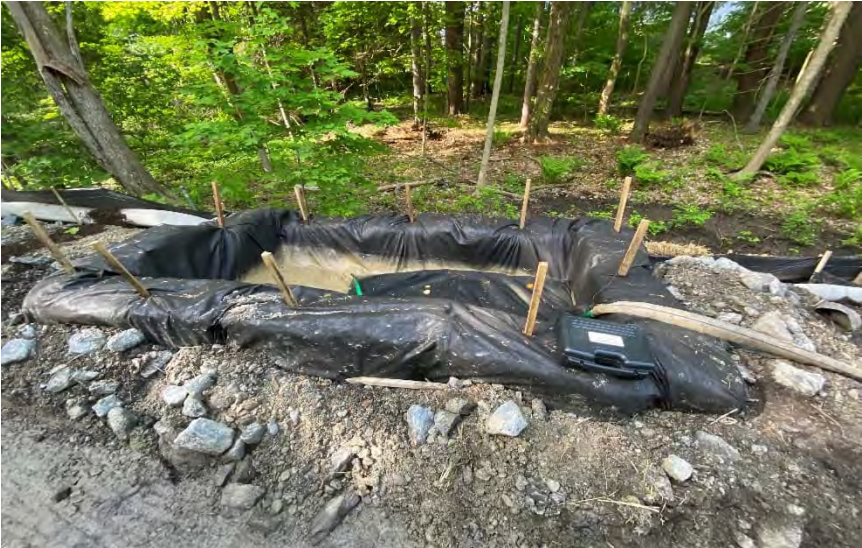
<b>PHOTOGRAPHIC LOG</b>	
Client Name: Eversource		Site Location: Sudbury to Hudson Transmission Reliability Project	Town: Sudbury
Photo No.: 4	Date: 5/21/2024

<b>Description:</b> Boston Post Road trench. View of discharge bag/corral, looking eastward. Water from bag/corral previously discharged to adjacent area down slope.

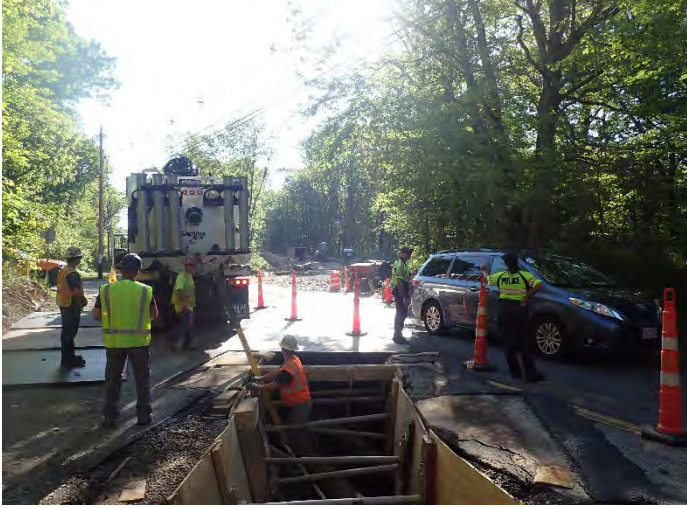
<b>PHOTOGRAPHIC LOG</b>	
Client Name: Eversource		Site Location: Sudbury to Hudson Transmission Reliability Project	
Town: Hudson			
Photo No.: 1	Date: 5/22/2024

<b>Description:</b> View of Bond working on Wilkins Street. Facing northeast.

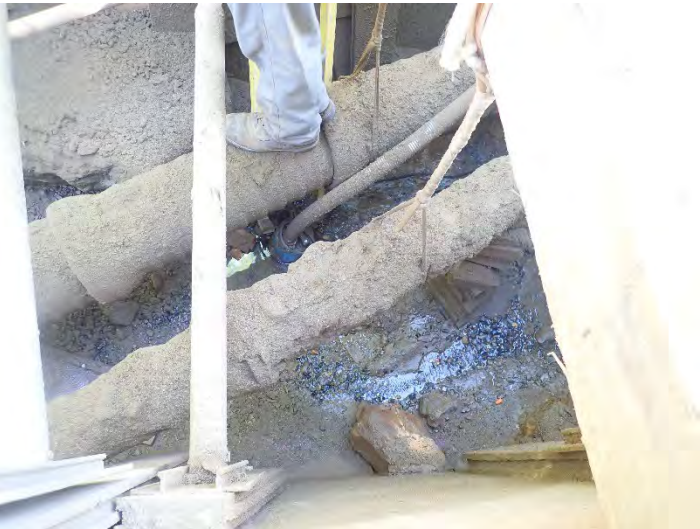
<b>PHOTOGRAPHIC LOG</b>	
Client Name: Eversource		Site Location: Sudbury to Hudson Transmission Reliability Project	
Town: Hudson			
Photo No.: 2	Date: 5/22/2024

<b>Description:</b> View of water in trench within Wilkins Street. Water appeared slightly turbid prior to treatment.

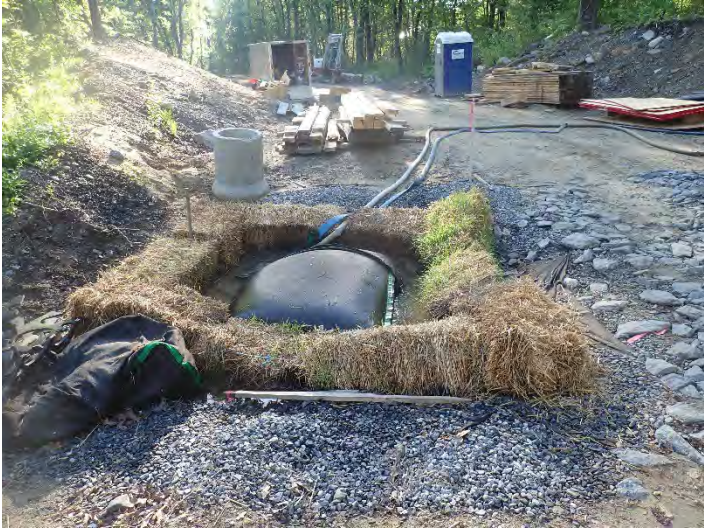
<b>PHOTOGRAPHIC LOG</b>		
Client Name: Eversource		Site Location: Sudbury to Hudson Transmission Reliability Project		Town: Hudson
Photo No.: 3	Date: 5/22/2024

<b>Description:</b> View of dewatering controls (straw bale corral with filter fabric and silt bag). Facing east.

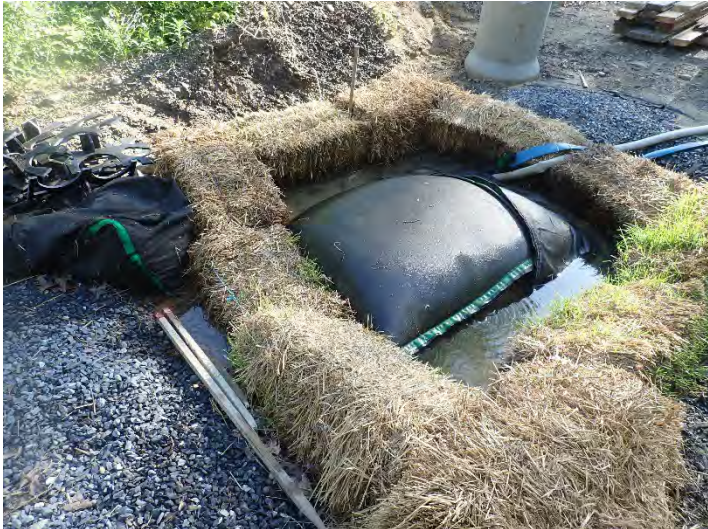
<b>PHOTOGRAPHIC LOG</b>		
Client Name: Eversource		Site Location: Sudbury to Hudson Transmission Reliability Project		Town: Hudson
Photo No.: 4	Date: 5/22/2024

<b>Description:</b> Additional view of dewatering controls and discharge. Discharge appeared clear. Turbidity reading was below 50 NTUs. Facing east.

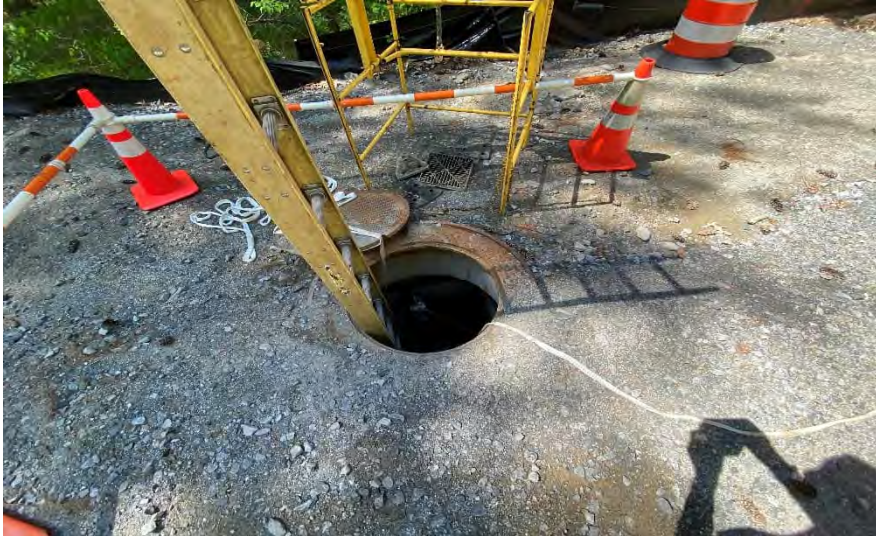
<b>PHOTOGRAPHIC LOG</b>	
Client Name: Eversource		Site Location: Sudbury to Hudson Transmission Reliability Project	Town: Sudbury
Photo No.: 1	Date: 5/22/2024

Description: View of area being pumped from handhole #20, segment 10.
