**Weekly Environmental Compliance Summary**

**Sudbury to Hudson Transmission Reliability Project (USEPA Tracking # MAR1003UW)**

Sudbury, Hudson, and Stow, MA

Week of: May 20, 2024 to May 24, 2024

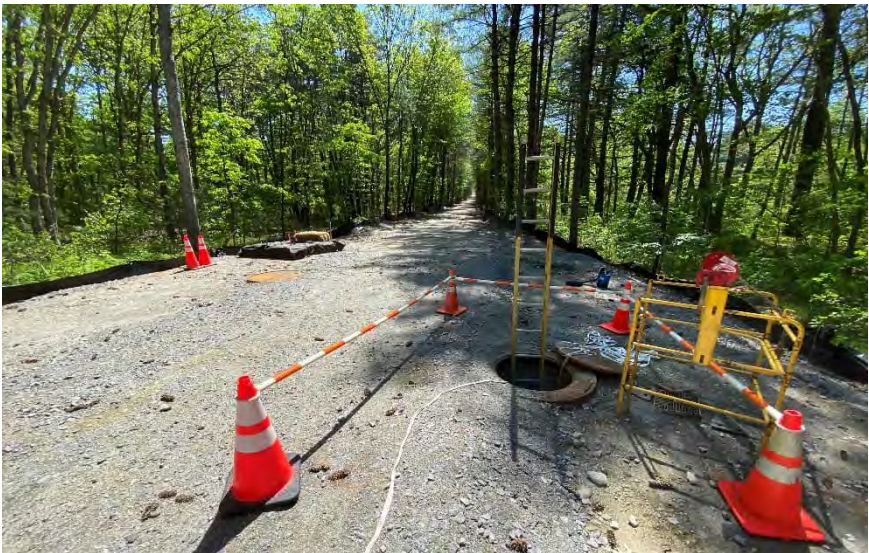
<b>PHOTOGRAPHIC LOG</b>	
Client Name: Eversource		Site Location: Sudbury to Hudson Transmission Reliability Project	Town: Sudbury
Photo No.: 2	Date: 5/22/2024

Description: Handhole #20. View of dewatering operation. Looking eastward.

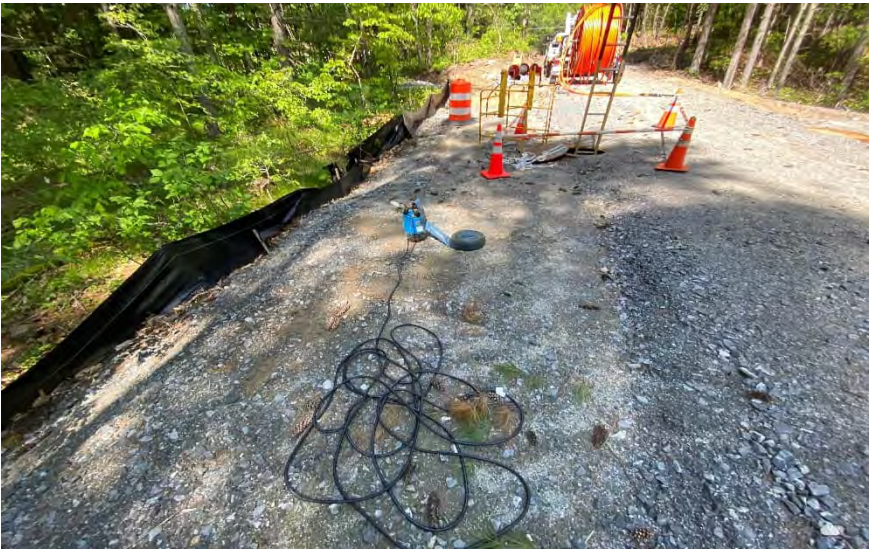
PHOTOGRAPHIC LOG	
Client Name: Eversource		Site Location: Sudbury to Hudson Transmission Reliability Project	Town: Sudbury
Photo No.: 3	Date: 5/22/2024

Description: Handhole #20. View of dewatering operation, looking eastward.

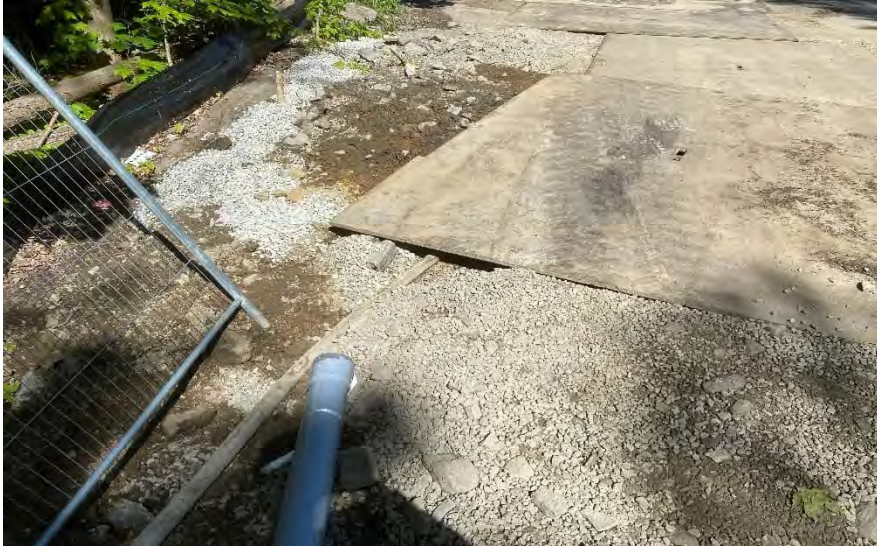
<b>PHOTOGRAPHIC LOG</b>	
<b>Client Name:</b> Eversource		<b>Site Location:</b> Sudbury to Hudson Transmission Reliability Project	<b>Town:</b> Sudbury
<b>Photo No.:</b> 1	<b>Date:</b> 5/22/2024

<b>Description:</b> View of area being pumped from trench across Boston Post Road.

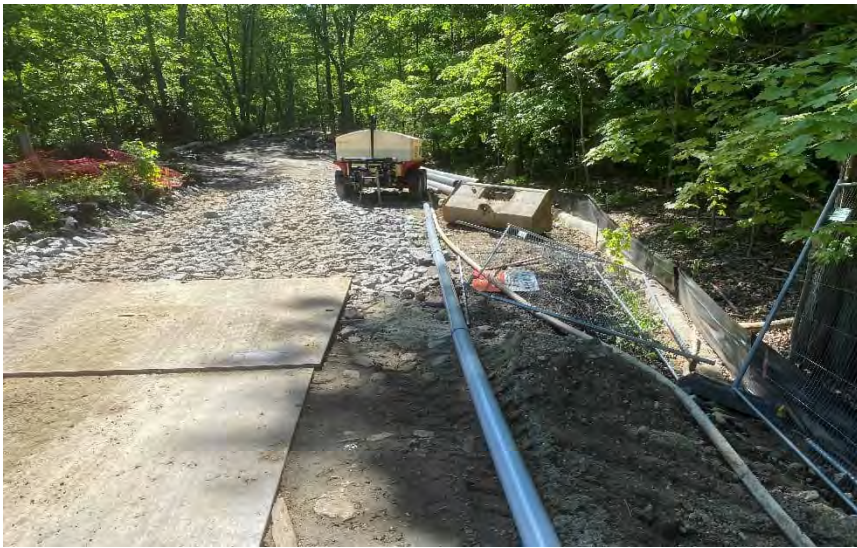
<b>PHOTOGRAPHIC LOG</b>	
<b>Client Name:</b> Eversource		<b>Site Location:</b> Sudbury to Hudson Transmission Reliability Project	<b>Town:</b> Sudbury
<b>Photo No.:</b> 2	<b>Date:</b> 5/22/2024

<b>Description:</b> Boston Post Road trench. View of dewatering operation. Looking eastward.

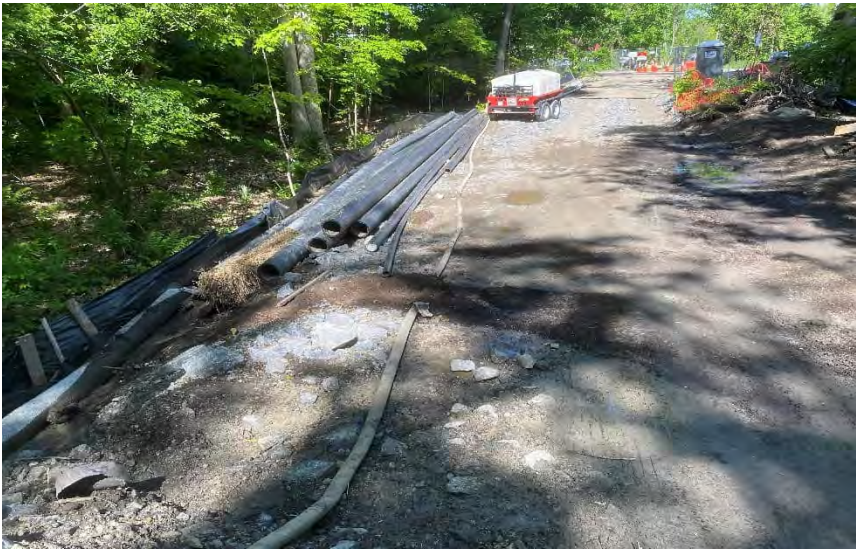
<b>PHOTOGRAPHIC LOG</b>	
<b>Client Name:</b> Eversource		<b>Site Location:</b> Sudbury to Hudson Transmission Reliability Project	<b>Town:</b> Sudbury
<b>Photo No.:</b> 3	<b>Date:</b> 5/22/2024

<b>Description:</b> Boston Post Road trench. View of dewatering operation, looking westward.

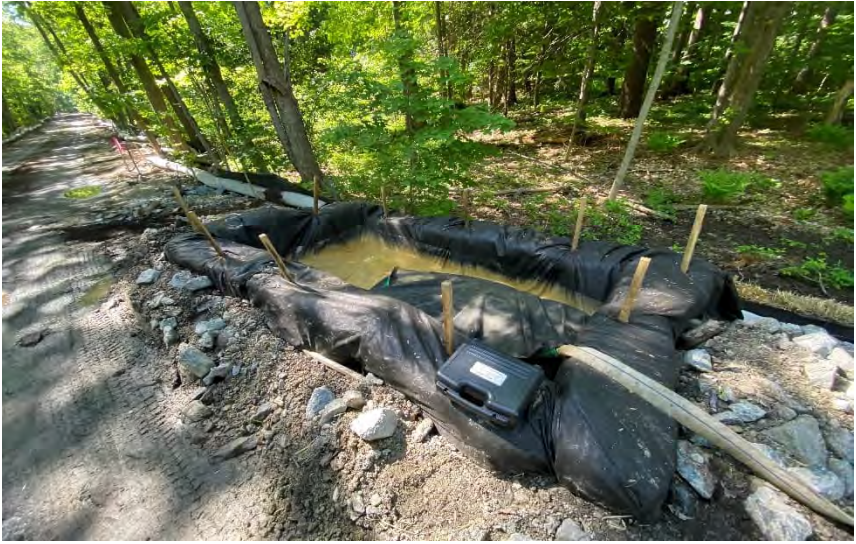
<b>PHOTOGRAPHIC LOG</b>	
<b>Client Name:</b> Eversource		<b>Site Location:</b> Sudbury to Hudson Transmission Reliability Project	<b>Town:</b> Sudbury
<b>Photo No.:</b> 4	<b>Date:</b> 5/22/2024

<b>Description:</b> Boston Post Road trench. View of discharge bag/corral, looking eastward. Water from bag/corral previously discharged to adjacent area down slope.

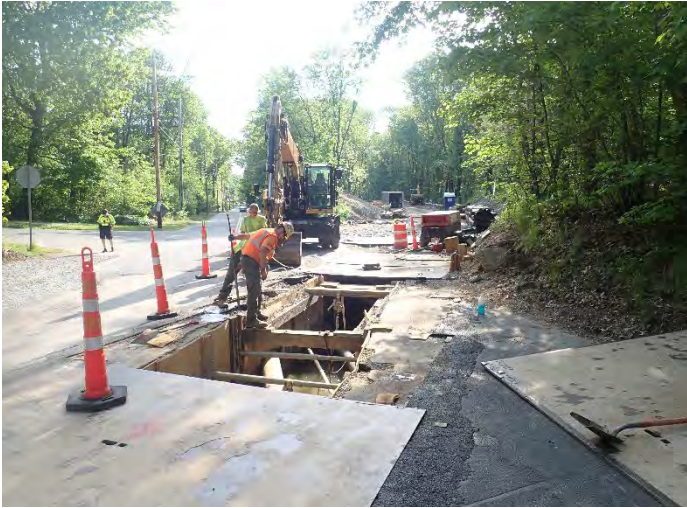
<b>PHOTOGRAPHIC LOG</b>		
Client Name: Eversource		Site Location: Sudbury to Hudson Transmission Reliability Project		Town: Hudson
Photo No.: 1	Date: 5/23/2024

Description: View of Bond working on Wilkins Street. Facing northeast.

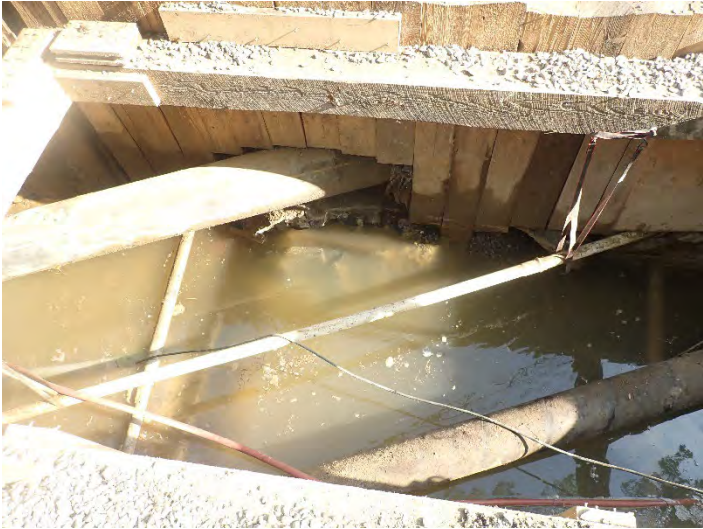
<b>PHOTOGRAPHIC LOG</b>		
Client Name: Eversource		Site Location: Sudbury to Hudson Transmission Reliability Project		Town: Hudson
Photo No.: 2	Date: 5/23/2024

Description: View of water in trench within Wilkins Street. Water appeared turbid prior to treatment.

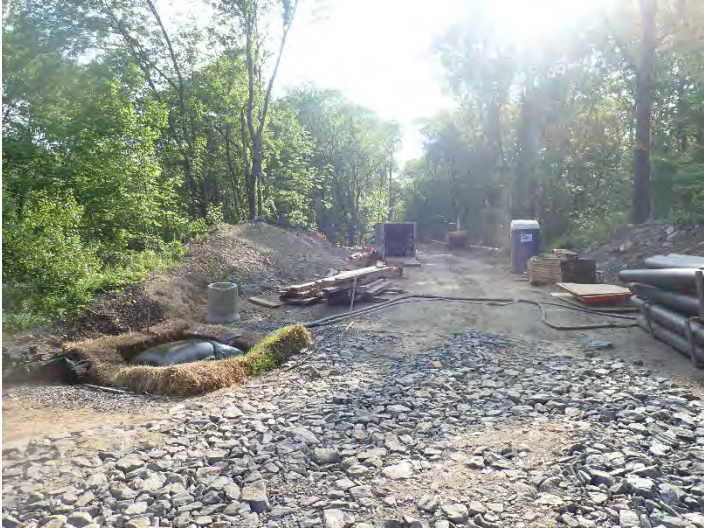
<b>PHOTOGRAPHIC LOG</b>	
Client Name: Eversource		Site Location: Sudbury to Hudson Transmission Reliability Project	
		Town: Hudson	
Photo No.: 3	Date: 5/23/2024

<b>Description:</b> View of dewatering controls (straw bale corral with filter fabric and silt bag). Facing east.

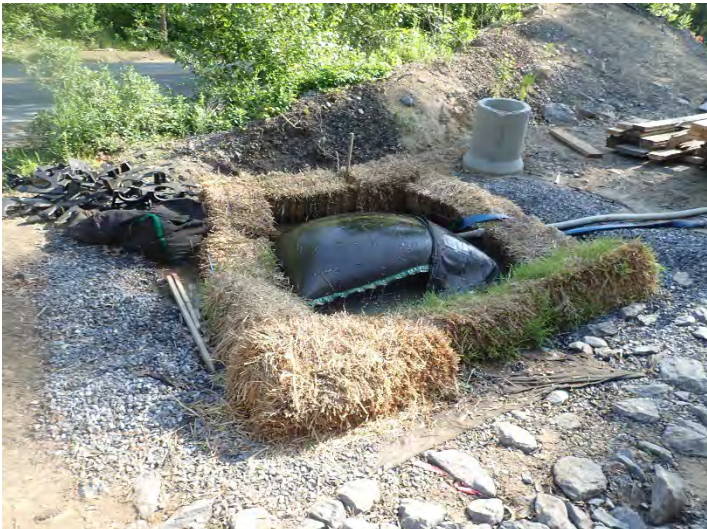
<b>PHOTOGRAPHIC LOG</b>	
Client Name: Eversource		Site Location: Sudbury to Hudson Transmission Reliability Project	
		Town: Hudson	
Photo No.: 4	Date: 5/23/2024

<b>Description:</b> Additional view of dewatering controls and discharge. Discharge appeared clear. Turbidity reading was below 50 NTUs. Facing northeast.

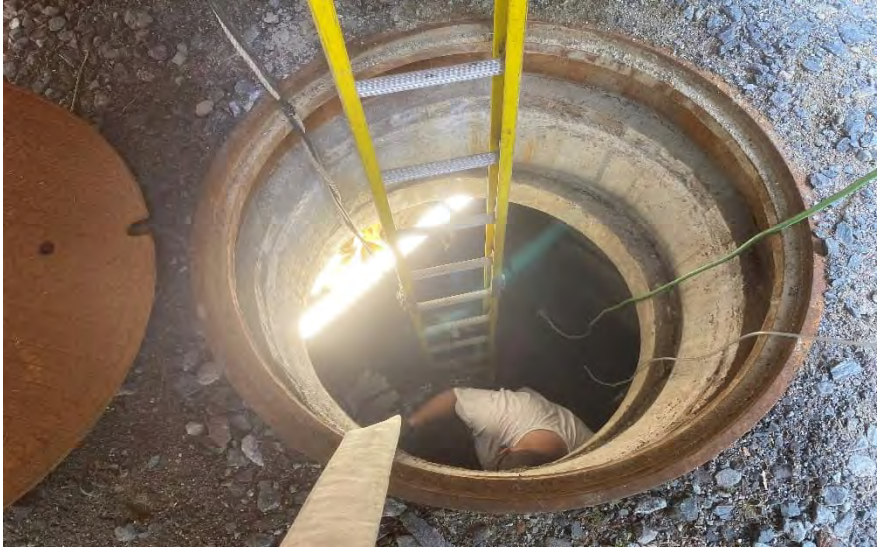
<b>PHOTOGRAPHIC LOG</b>	
Client Name: Eversource		Site Location: Sudbury to Hudson Transmission Reliability Project	Town: Sudbury
Photo No.: 1	Date: 5/23/2024

Description: View of area being pumped from handhole #20, segment 10.

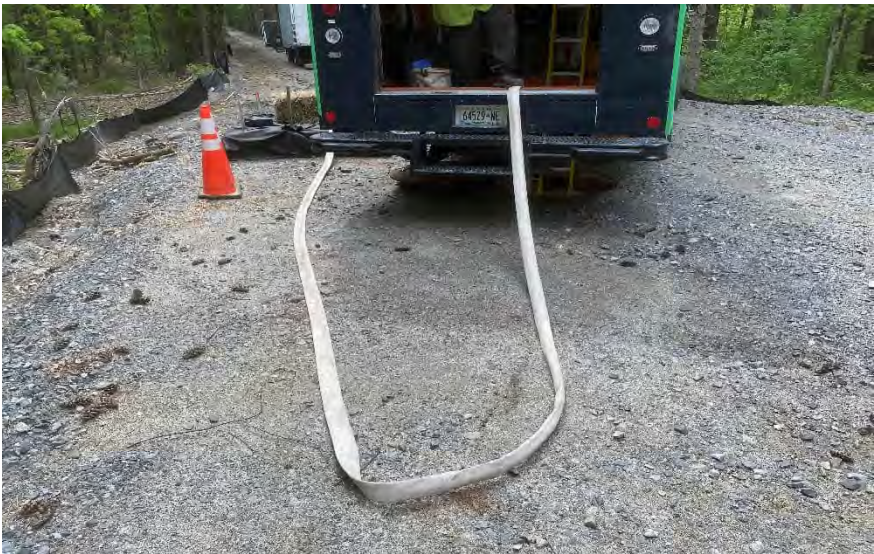
<b>PHOTOGRAPHIC LOG</b>	
Client Name: Eversource		Site Location: Sudbury to Hudson Transmission Reliability Project	Town: Sudbury
Photo No.: 2	Date: 5/23/2024

Description: Handhole #20. View of dewatering operation. Looking eastward.

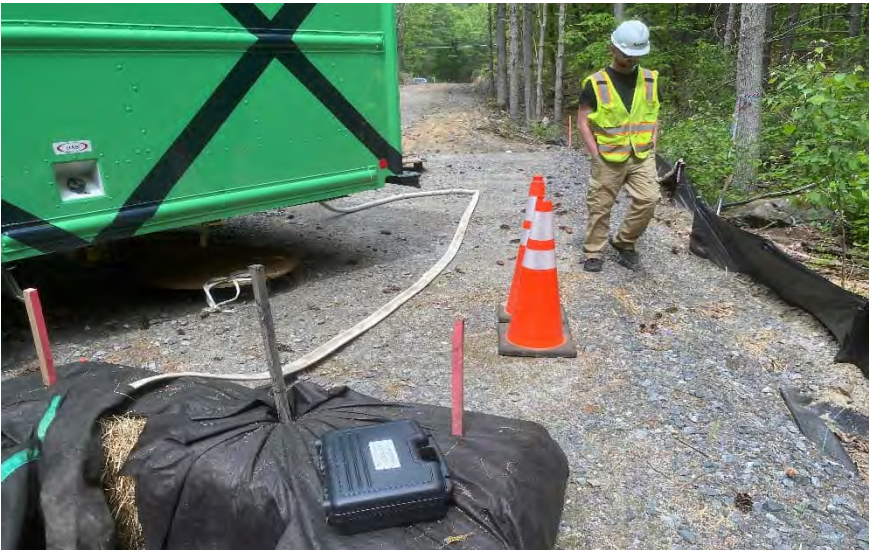
<b>PHOTOGRAPHIC LOG</b>	
Client Name: Eversource		Site Location: Sudbury to Hudson Transmission Reliability Project	
Town: Sudbury			
Photo No.: 3	Date: 5/23/2024

<b>Description:</b> Handhole #20. View of dewatering operation, looking westward.

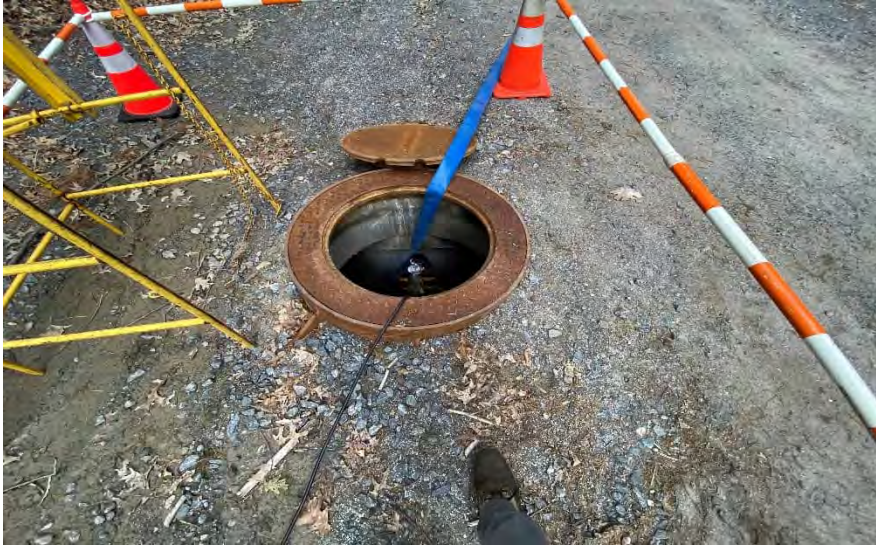
PHOTOGRAPHIC LOG	
Client Name: Eversource		Site Location: Sudbury to Hudson Transmission Reliability Project	Town: Sudbury
Photo No.: 1	Date: 5/23/2024

Description: View of area being pumped from handhole #22, segment 11.

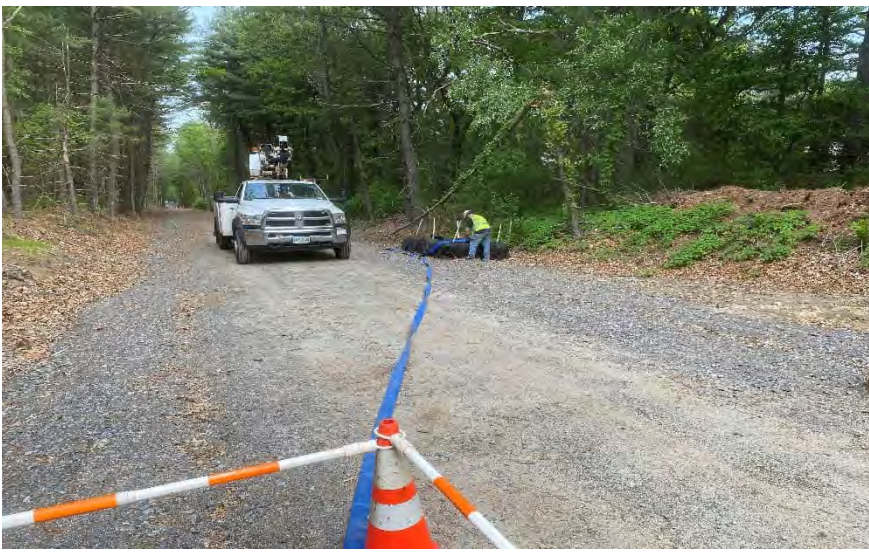
PHOTOGRAPHIC LOG	
Client Name: Eversource		Site Location: Sudbury to Hudson Transmission Reliability Project	Town: Sudbury
Photo No.: 2	Date: 5/23/2024

Description: Handhole #22. View of dewatering operation. Looking westward.

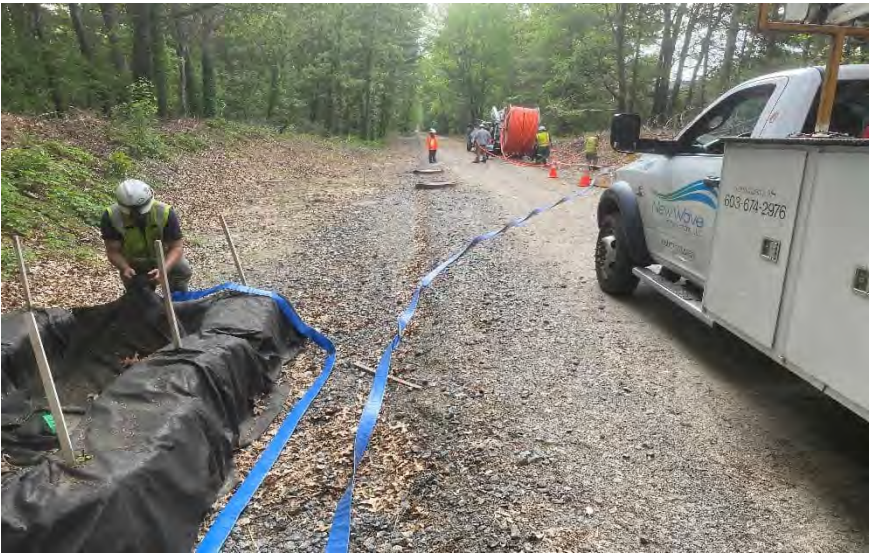
<b>PHOTOGRAPHIC LOG</b>	
Client Name: Eversource		Site Location: Sudbury to Hudson Transmission Reliability Project	Town: Sudbury
Photo No.: 3	Date: 5/23/2024

<b>Description:</b> Handhole #22. View of dewatering operation, looking westward.

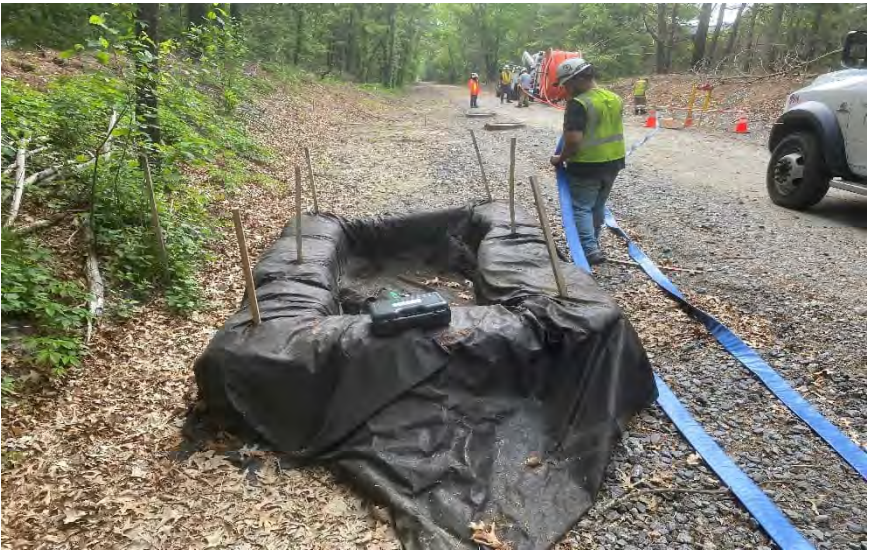
<b>PHOTOGRAPHIC LOG</b>	
Client Name: Eversource		Site Location: Sudbury to Hudson Transmission Reliability Project	Town: Sudbury
Photo No.: 4	Date: 5/23/2024

<b>Description:</b> Handhole #22. View of discharge bag/corral, looking westward. Water from bag/corral discharged to adjacent area.

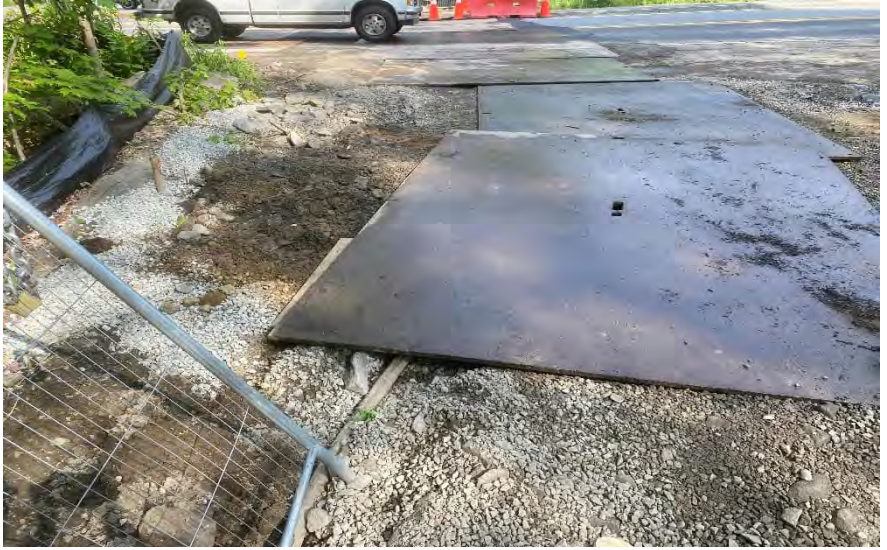
<b>PHOTOGRAPHIC LOG</b>	
Client Name: Eversource		Site Location: Sudbury to Hudson Transmission Reliability Project	Town: Sudbury
Photo No.: 1	Date: 5/23/2024

Description: View of area being pumped from trench across Boston Post Road.

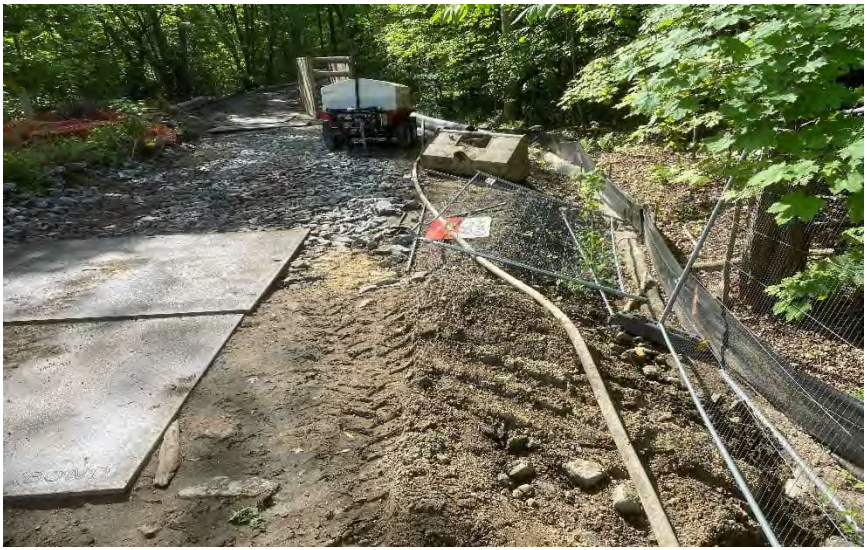
<b>PHOTOGRAPHIC LOG</b>	
Client Name: Eversource		Site Location: Sudbury to Hudson Transmission Reliability Project	Town: Sudbury
Photo No.: 2	Date: 5/23/2024

Description: Boston Post Road trench. View of dewatering operation. Looking eastward.

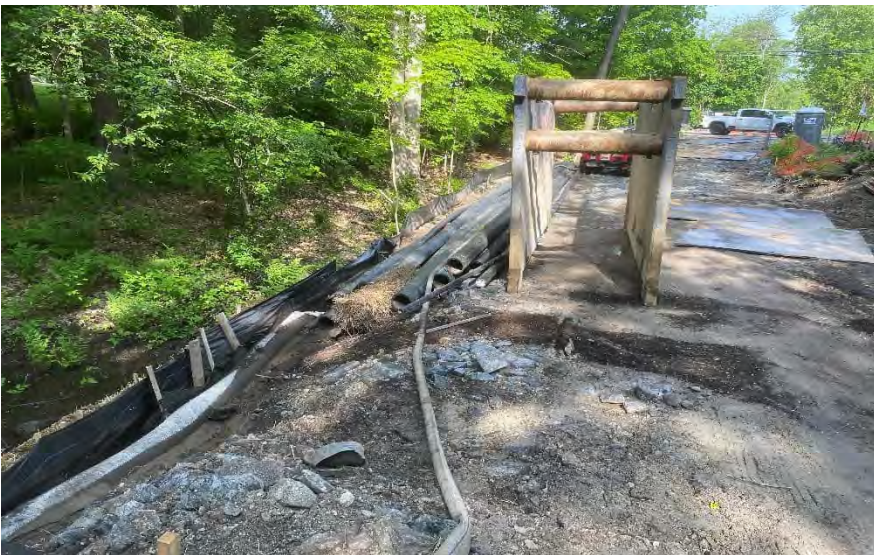
<b>PHOTOGRAPHIC LOG</b>	
Client Name: Eversource		Site Location: Sudbury to Hudson Transmission Reliability Project	Town: Sudbury
Photo No.: 3	Date: 5/23/2024

<b>Description:</b> Boston Post Road trench. View of dewatering operation, looking westward.

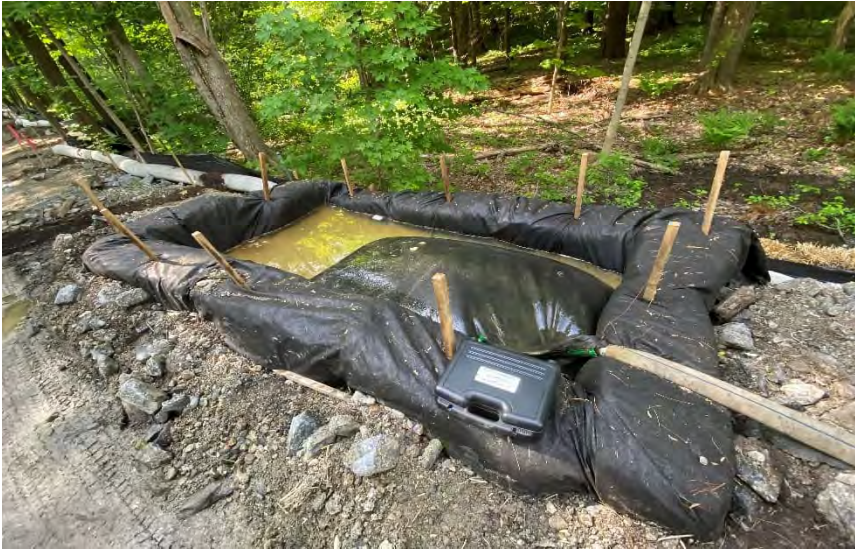
<b>PHOTOGRAPHIC LOG</b>	
Client Name: Eversource		Site Location: Sudbury to Hudson Transmission Reliability Project	Town: Sudbury
Photo No.: 4	Date: 5/23/2024

<b>Description:</b> Boston Post Road trench. View of discharge bag/corral, looking eastward. Water from bag/corral previously discharged to adjacent area down slope.

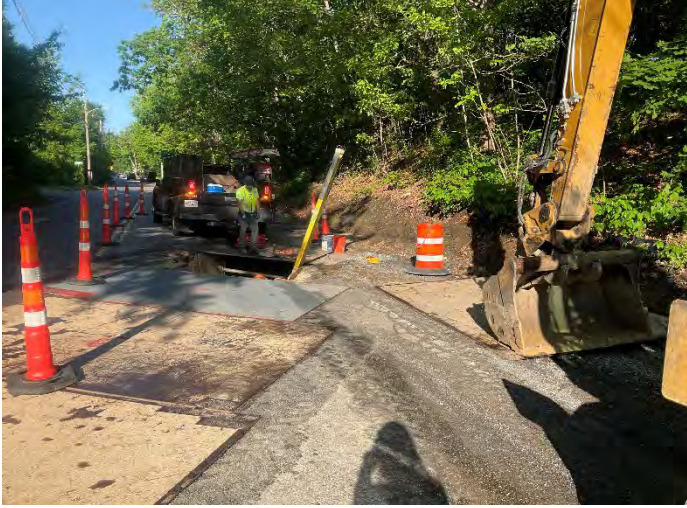
<b>PHOTOGRAPHIC LOG</b>	
Client Name: Eversource		Site Location: Sudbury to Hudson Transmission Reliability Project	Town: Hudson
Photo No.: 1	Date: 5/24/2024

<b>Description:</b> View of Bond working on Wilkins Street. Facing west.

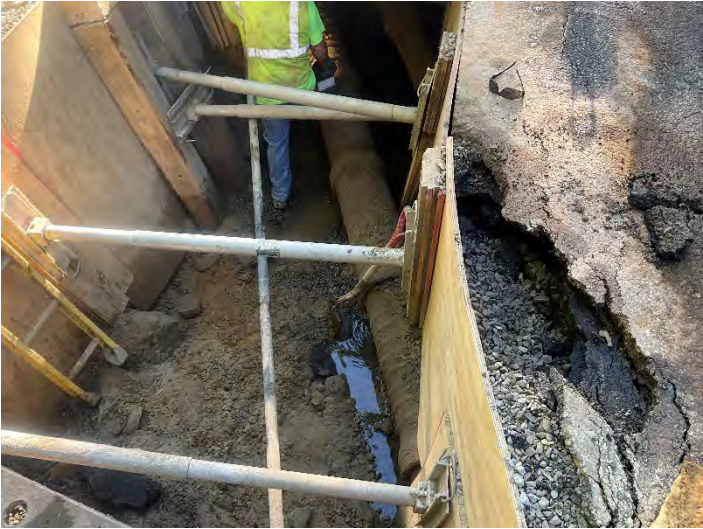
<b>PHOTOGRAPHIC LOG</b>	
Client Name: Eversource		Site Location: Sudbury to Hudson Transmission Reliability Project	Town: Hudson
Photo No.: 2	Date: 5/24/2024

<b>Description:</b> View of pump in trench within Wilkins Street. Water appeared clear prior to treatment.

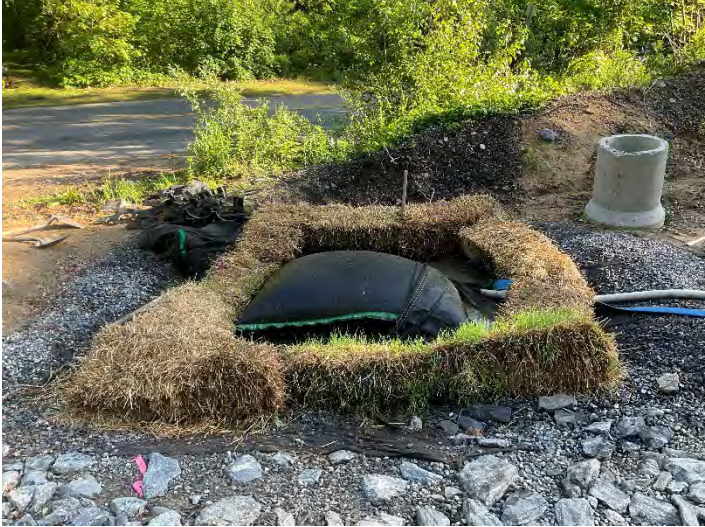
<b>PHOTOGRAPHIC LOG</b>	
Client Name: Eversource		Site Location: Sudbury to Hudson Transmission Reliability Project	
Town: Hudson			
Photo No.: 3	Date: 5/24/2024

<b>Description:</b> View of dewatering controls (straw bale corral with filter fabric and silt bag). Facing east.

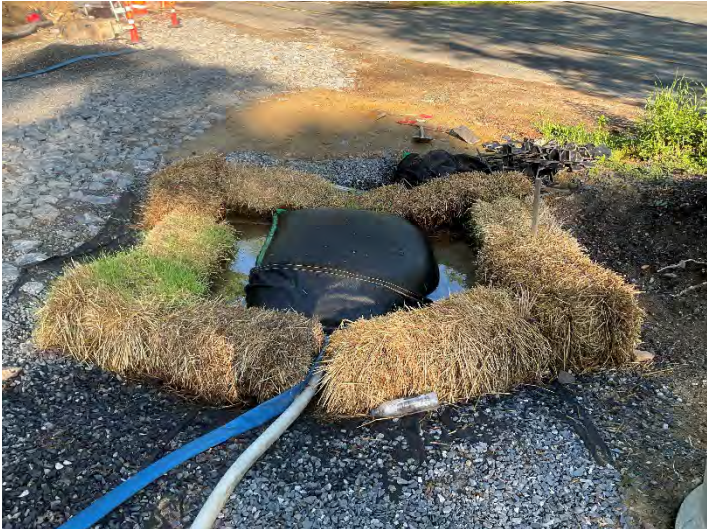
<b>PHOTOGRAPHIC LOG</b>	
Client Name: Eversource		Site Location: Sudbury to Hudson Transmission Reliability Project	
Town: Hudson			
Photo No.: 4	Date: 5/24/2024

<b>Description:</b> View of discharging water from corral. Discharge appeared clear and turbidity reading was below 50 NTUs. Water was being discharged to catch basin underneath filter fabric. Facing west.
