Weekly Environmental Compliance Summary

Sudbury to Hudson Transmission Reliability Project (USEPA Tracking # MAR1003UW)

Sudbury, Hudson, and Stow, MA

Week of: July 29, 2024 to August 3, 2024

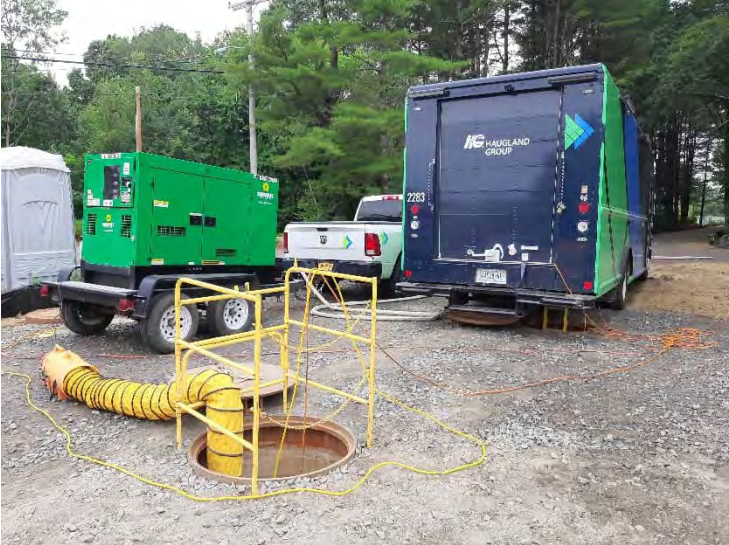
| <p>Photo No.: 1</p> | <p>Date: 7-29-24</p> | | |

| <p>Description:</p> <p>Work area at manhole 24 (Segment 11), crimping and splicing, looking westward.</p> | | | |

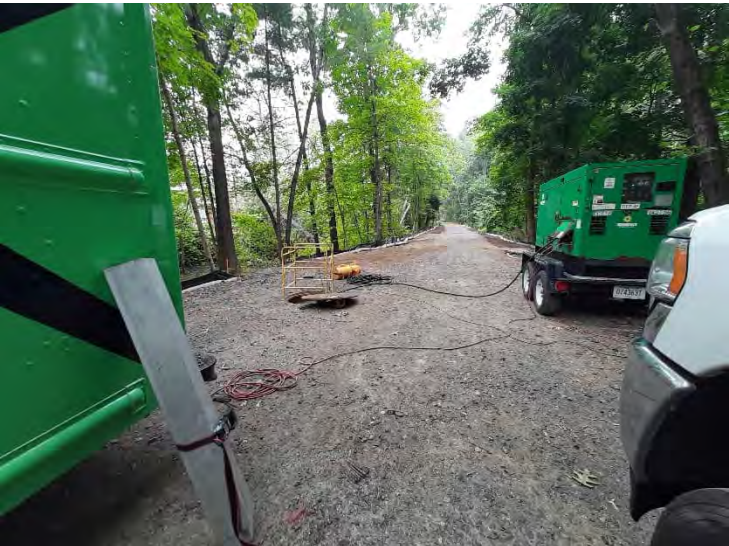
| <p>Photo No.: 2</p> | <p>Date: 7-29-24</p> | | |

| <p>Description:</p> <p>Work area at manhole 25 (Segment 13), crimping and splicing, looking eastward.</p> | | | |

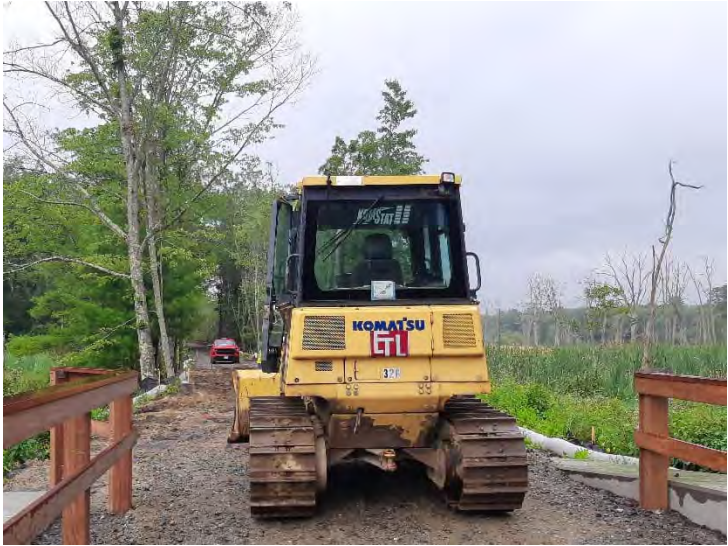
| <p>Photo No.: 3</p> | <p>Date: 7-29-24</p> | | |

| <p>Description:</p> <p>Work area near Bridge 127, Segment 14 side, grading ROW, looking eastward.</p> | | | |

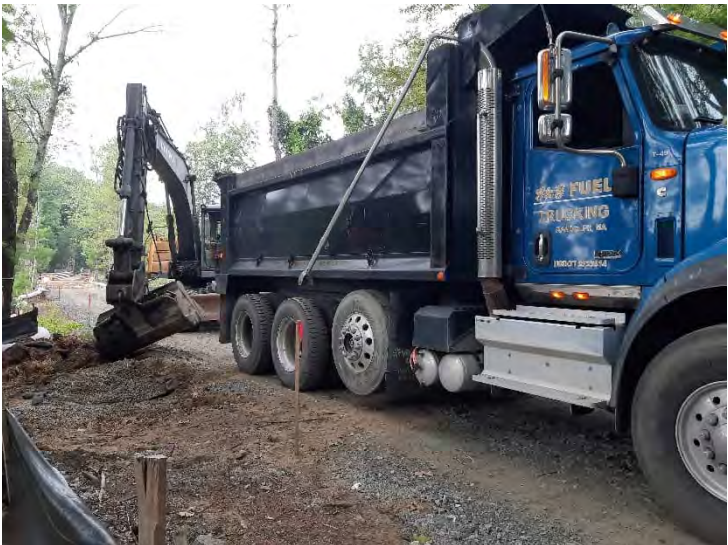
| <p>Photo No.: 4</p> | <p>Date: 7-29-24</p> | | |

| <p>Description:</p> <p>Work area in Segment 14, disposing of construction debris throughout segment, looking westward.</p> | | | |

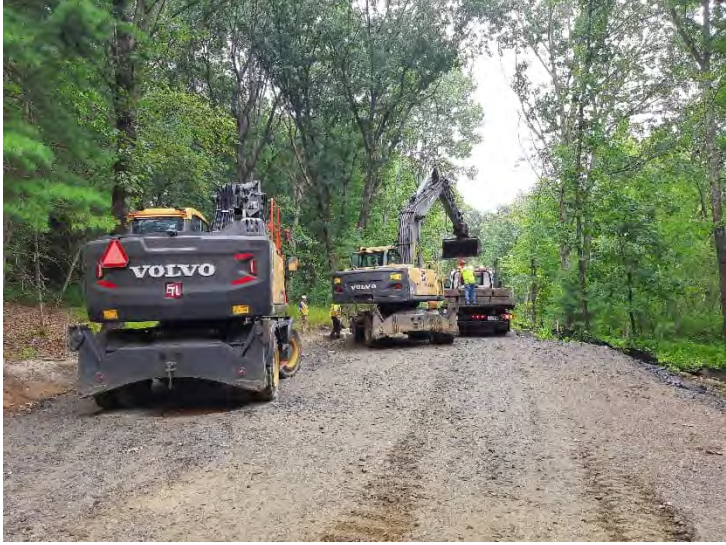
| <p>Photo No.: 5</p> | <p>Date: 7-29-24</p> | | |

| <p>Description:</p> <p>Work area in Segment 14, removing crane mats, looking eastward.</p> | | | |

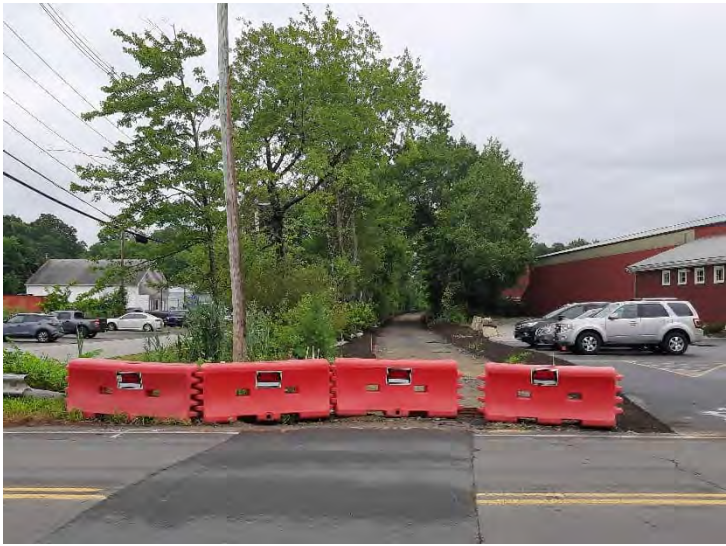
| <p>Photo No.: 6</p> | <p>Date: 7-29-24</p> | | |

| <p>Description:</p> <p>Previous work area in Segment 12, no work in this segment today, existing erosion controls and barricade, looking eastward.</p> | | | |

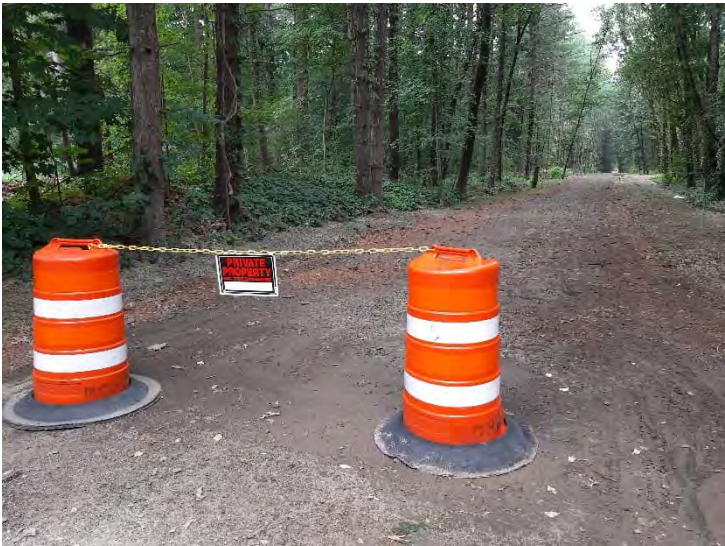
| Photo No.: 8 | Date: 7-29-24 | | |

| Description: Previous work area within Segment 10, no work in this segment today, existing hydroseeding, looking eastward. | | | |

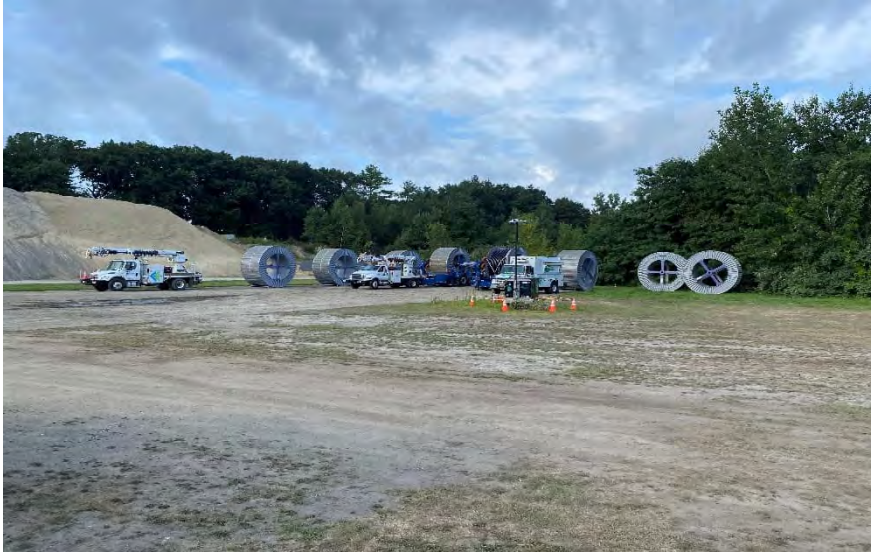
| <p>Photo No.: 1</p> | <p>Date: 7-31-24</p> | | |

| <p>Description:</p> <p>Haugland laydown yard, stored wire on reels, looking westward.</p> | | | |

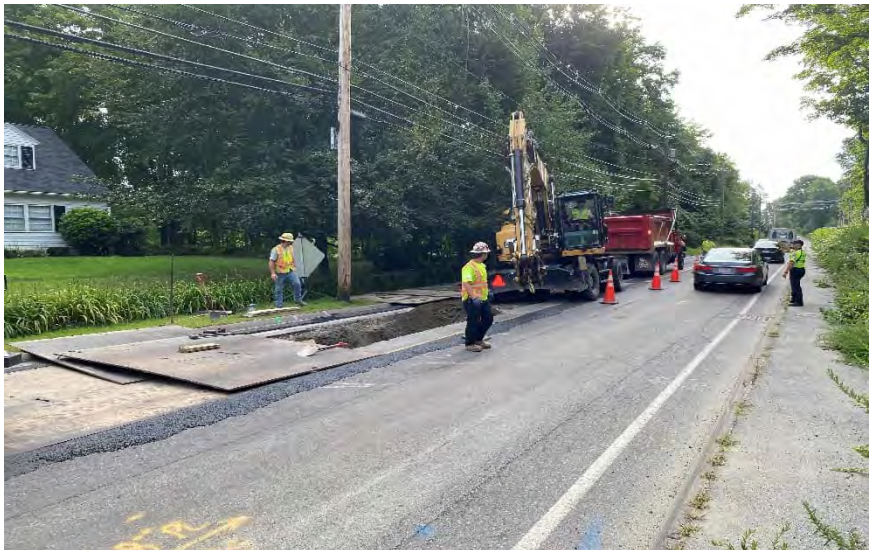
| <p>Photo No.: 4</p> | <p>Date: 7-31-24</p> | | |

| <p>Description:</p> <p>Conduit work near manhole #1, near Hudson Power & Light facility, looking northward.</p> | | | |

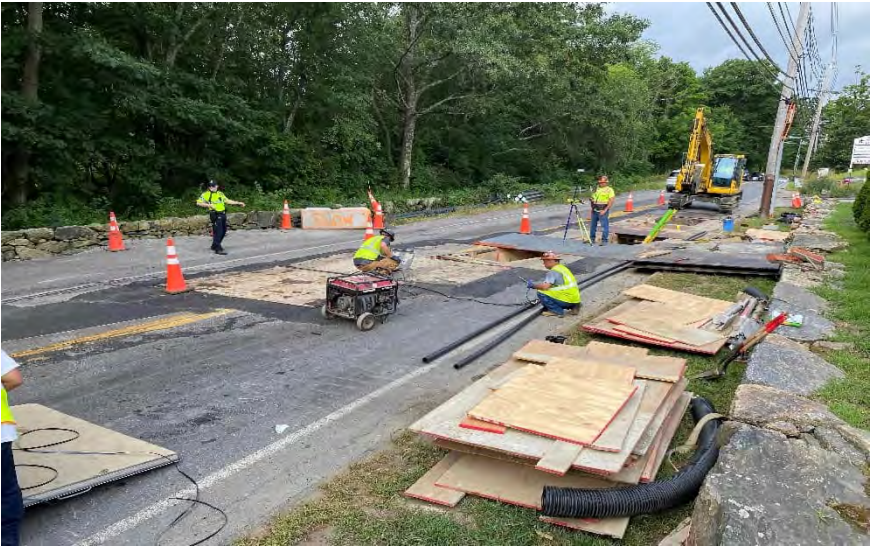
| Photo No.: 5 Date: 7-31-24 | | Town: Hudson | |

| Description: Conduit work near manhole #2, near Bonazolli Avenue intersection with Forest Ave., looking southward. | | | |

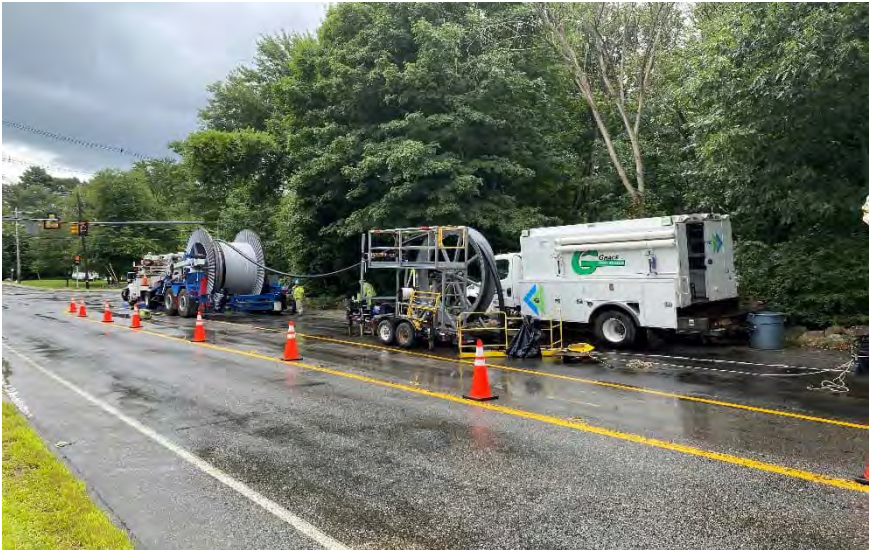
| <p>Photo No.: 7</p> | <p>Date: 7-31-24</p> | | |

| <p>Description:</p> <p>Wire pulling work within Forest Avenue, Manhole #2, Forest Avenue, looking northward.</p> | | | |

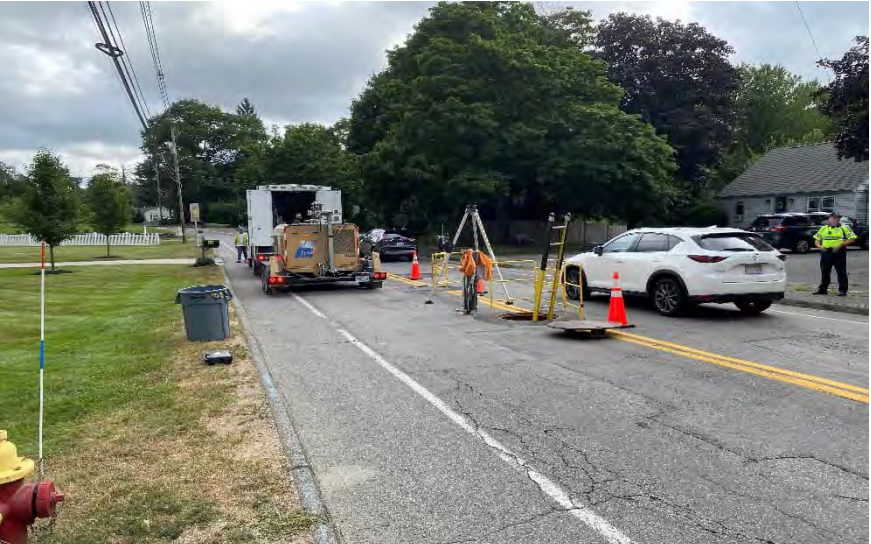
| <p>Photo No.: 8</p> | <p>Date: 7-31-24</p> | | |

| <p>Description:</p> <p>Wire pulling work within Forest Avenue, Manhole #3, Forest Avenue, looking northward.</p> | | | |

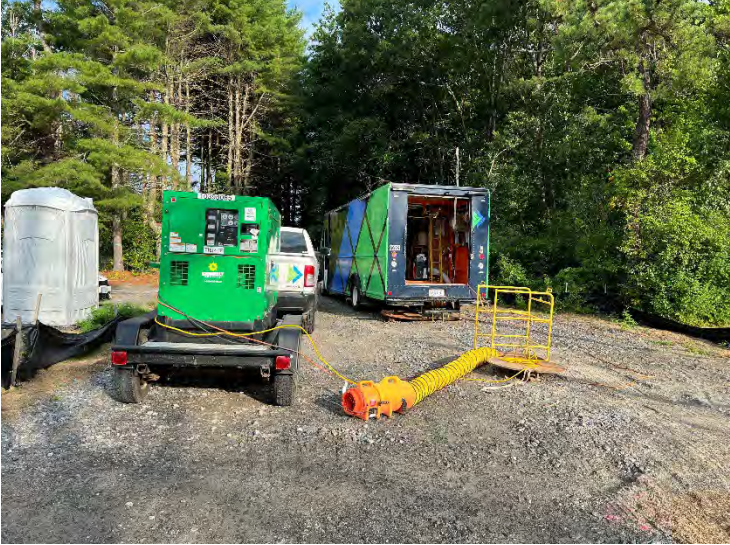
| <p>Photo No.: 1</p> | <p>Date: 7/31/2024</p> | | |

| <p>Description: View of Haugland splicers at MH #24 in segment 11. Facing northwest.</p> | | | |

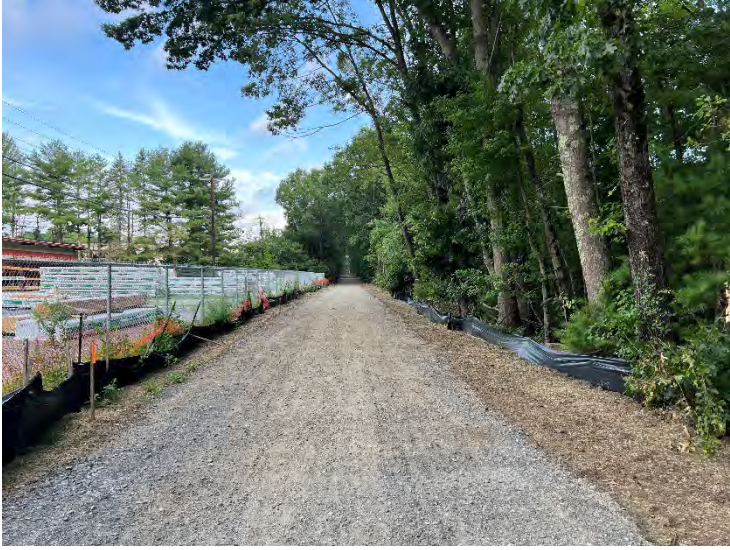
| <p>Photo No.: 5</p> | <p>Date: 7/31/2024</p> | | |

| <p>Description: View of E&S controls in segment 11. Facing west.</p> | | | |

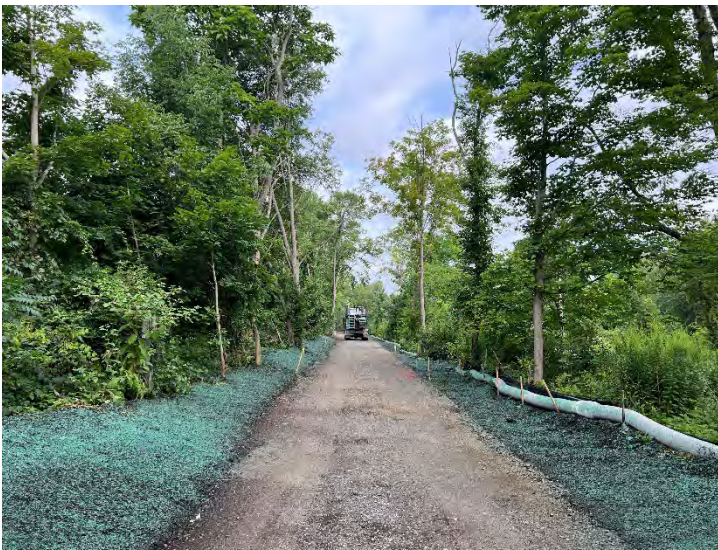
| <p>Photo No.: 8</p> | <p>Date: 7/31/2024</p> | | |

| <p>Description: View of MON applying hydroseed in segment 12. Facing northwest.</p> | | | |

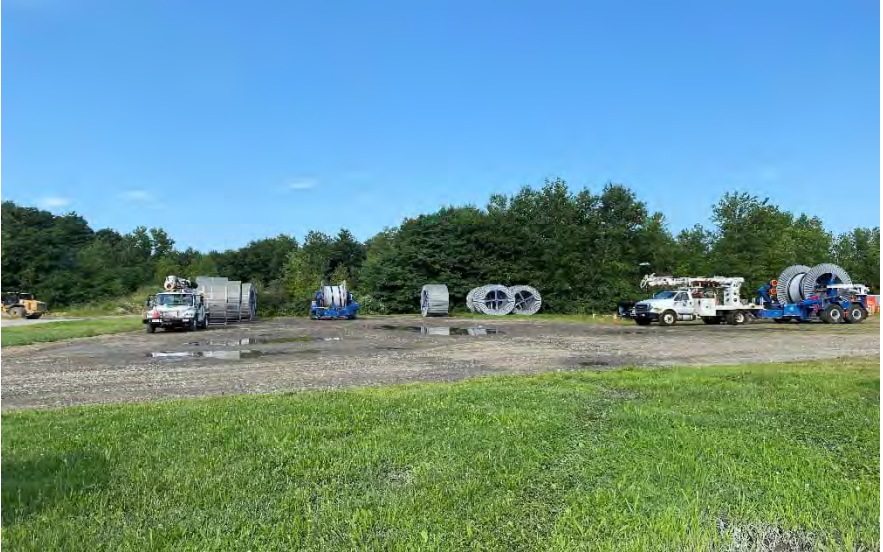
| <p>Photo No.: 1</p> | <p>Date: 8-1-24</p> | | |

| <p>Description:</p> <p>Haugland laydown yard, stored wire on reels, looking northward.</p> | | | |

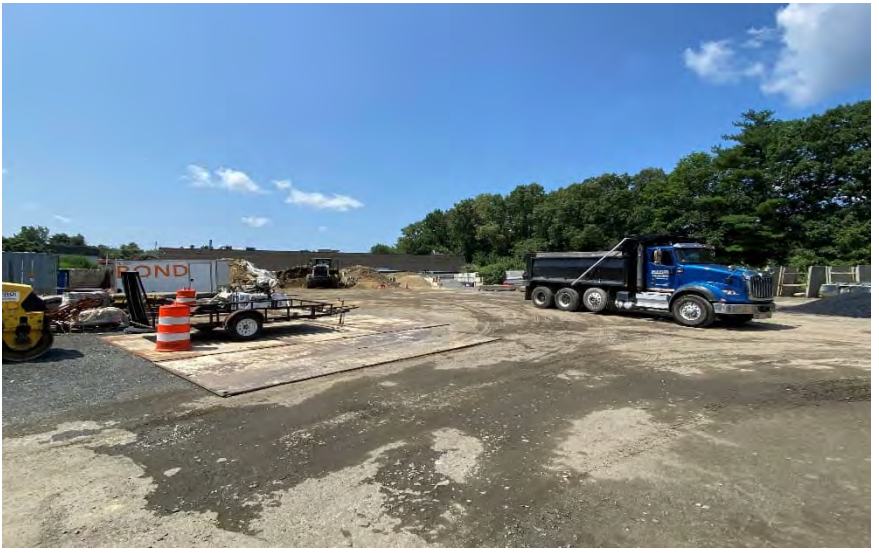
| <p>Photo No.: 2</p> | <p>Date: 8-1-24</p> | | |

| <p>Description:</p> <p>Bonazzoli laydown yard, spoil loading/unloading, looking westward.</p> | | | |

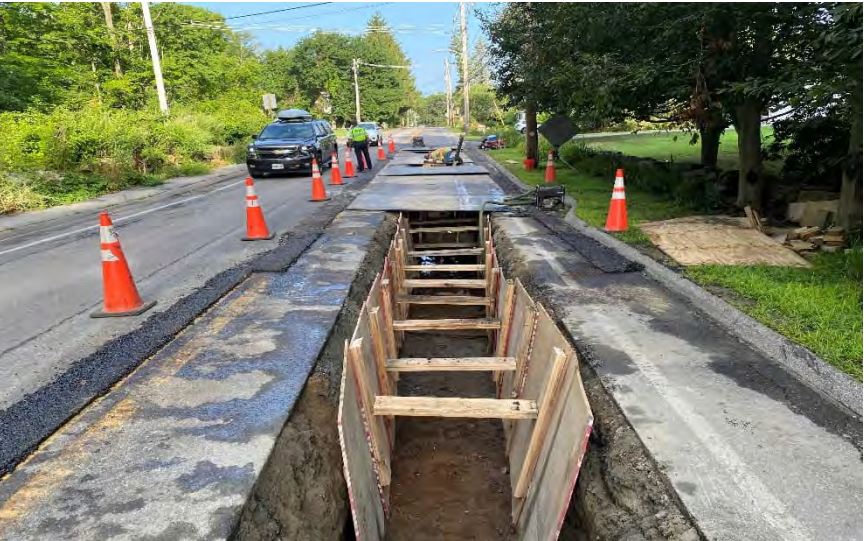
| <p>Photo No.: 4</p> | <p>Date: 8-1-24</p> | | |

| <p>Description:</p> <p>Conduit work near manhole #1, near Hudson Power & Light facility, looking southward.</p> | | | |

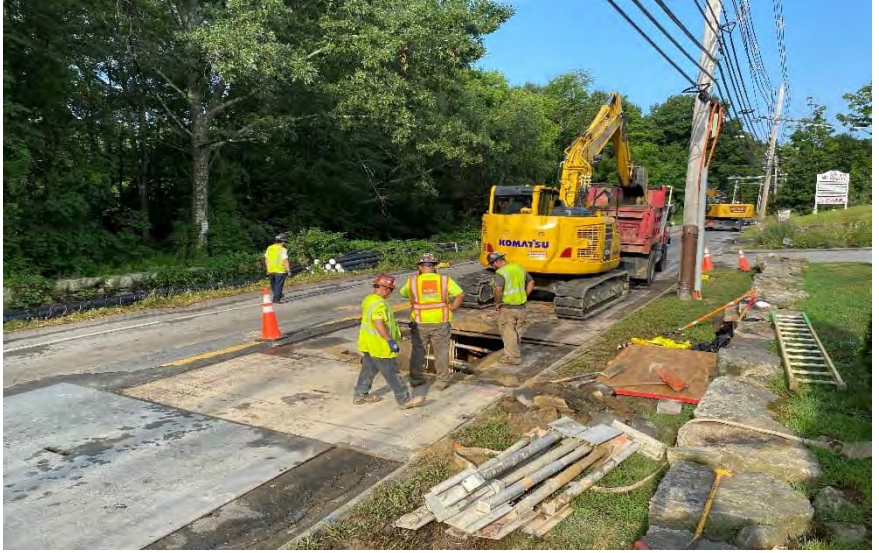
| <p>Photo No.: 5</p> | <p>Date: 8-1-24</p> | | |

| <p>Description:</p> <p>Conduit work near manhole #2, near Bonazolli Avenue intersection with Forest Ave., looking southward.</p> | | | |

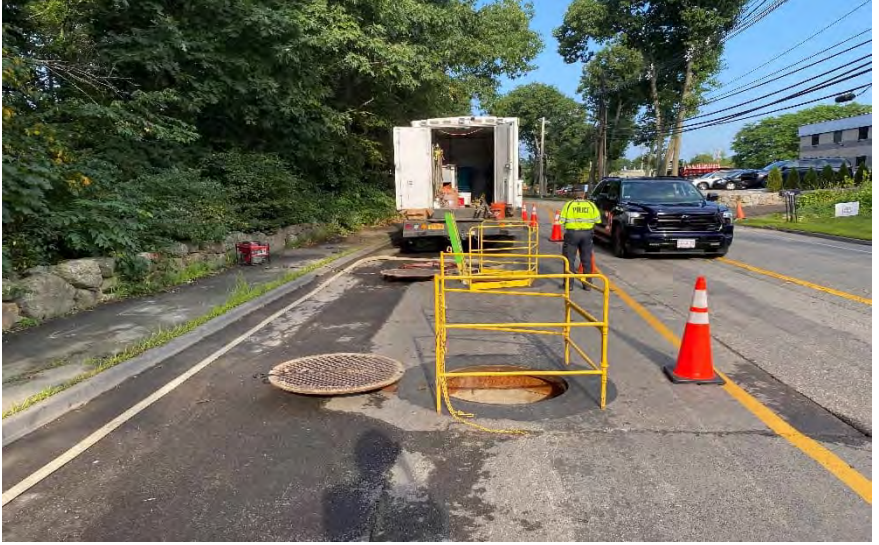
| Photo No.: 7 | Date: 8-1-24 | | |

| Description: Wire pulling work within Forest Avenue, Manhole #2, Forest Avenue, looking southward. | | | |

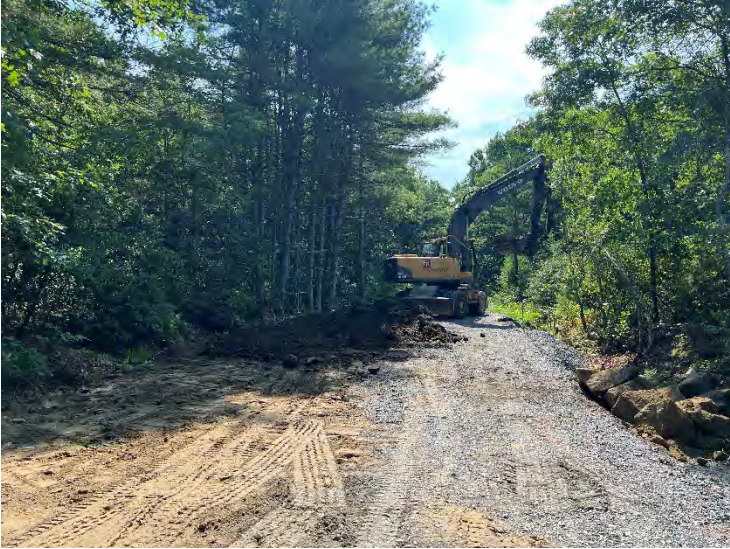
| Photo No.: 1 | Date: 8/1/2024 | | |

| Description: View of ET&L widening segment 7. Facing east. | | | |

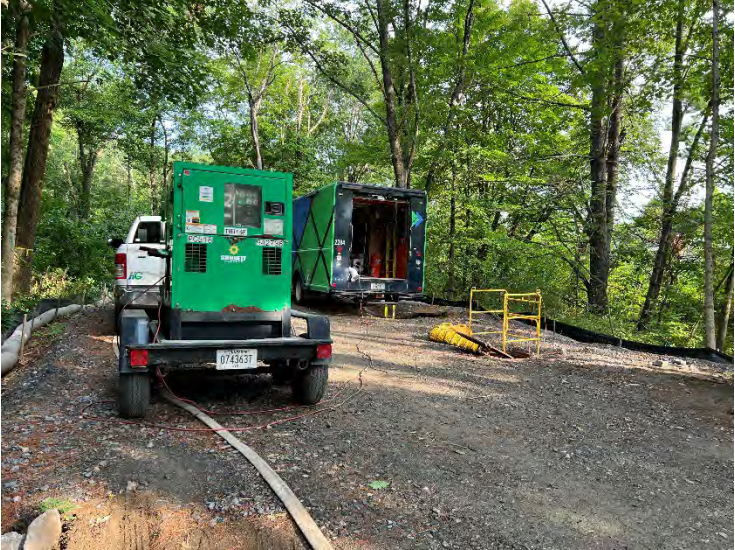
| Photo No.: 3 | Date: 8/1/2024 | | |

| Description: View of Haugland splicers at MH #25 in segment 13. Facing northwest. | | | |

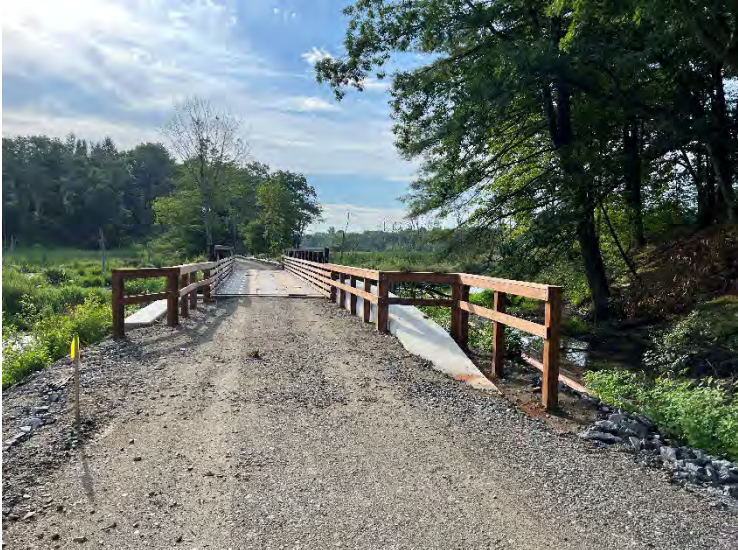
| Photo No.: 4 | Date: 8/1/2024 | | |

| Description: View of Bridge 127. Facing east. | | | |

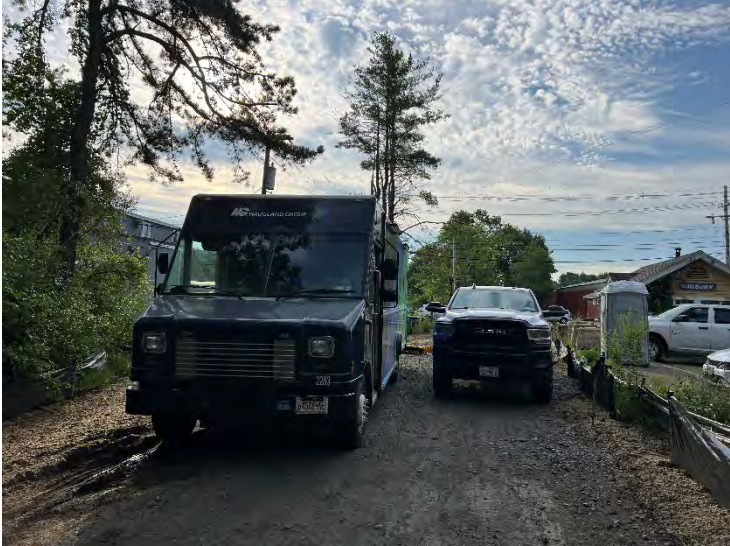
| Photo No.: 5 | Date: 8/1/2024 | | |

| Description: View of Haugland work area at MH#24 in segment 11. Facing east. | | | |

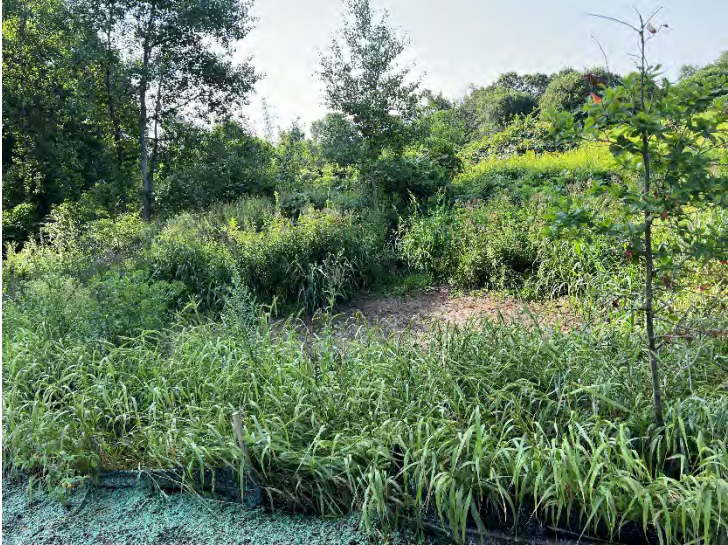
| Photo No.: 6 | Date: 8/1/2024 | | |

| Description: View of the wetland replication area in segment 14. Facing south. | | | |

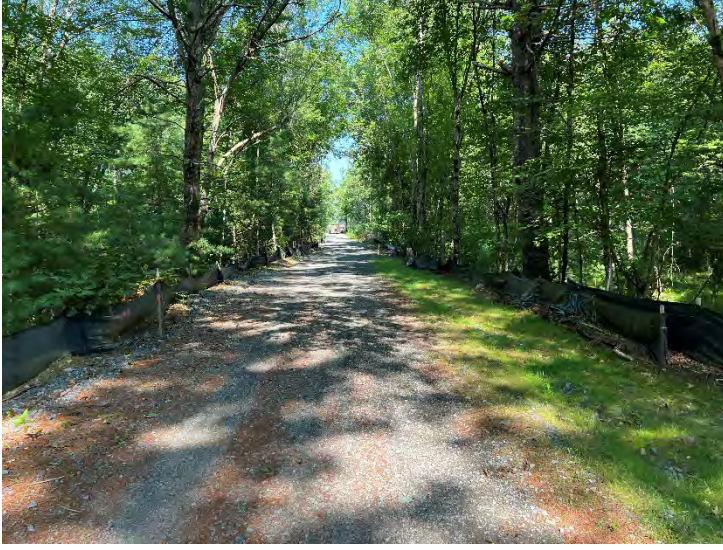
| <p>Photo No.: 8</p> | <p>Date: 8/1/2024</p> | | |

| <p>Description: View of E&S controls in segment 7. Facing west.</p> | | | |

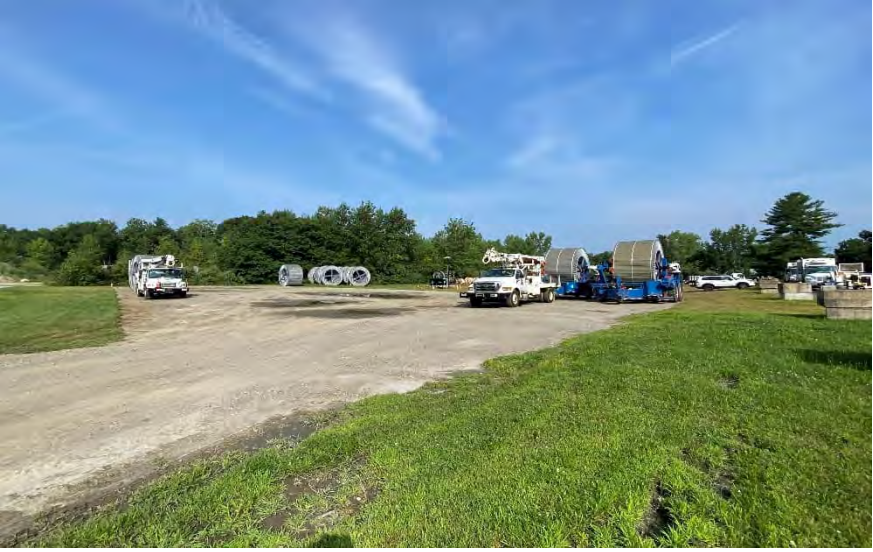
| Photo No.: 1 | Date: 8-2-24 | | |

| Description: Haugland laydown yard, stored wire on reels, looking northward. | | | |

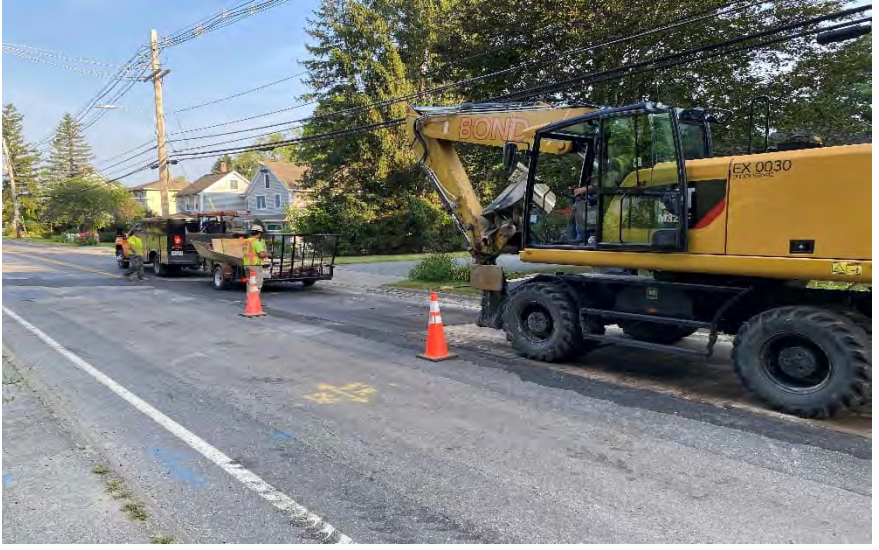
| <p>Photo No.: 4</p> | <p>Date: 8-2-24</p> | | |

| <p>Description:</p> <p>Conduit work near manhole #1, near Hudson Power & Light facility, looking northward.</p> | | | |

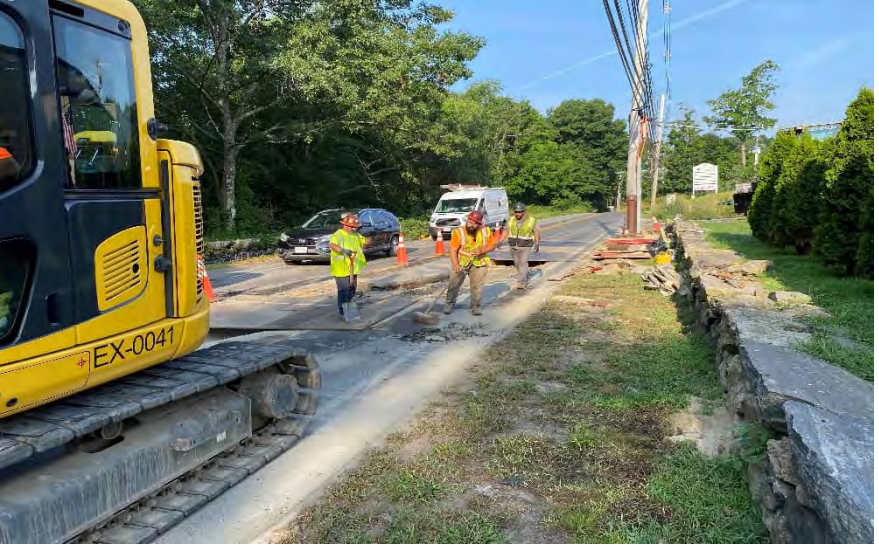
| <p>Photo No.: 5</p> | <p>Date: 8-2-24</p> | | |

| <p>Description:</p> <p>Conduit work near manhole #2, near Bonazolli Avenue intersection with Forest Ave., looking southward.</p> | | | |

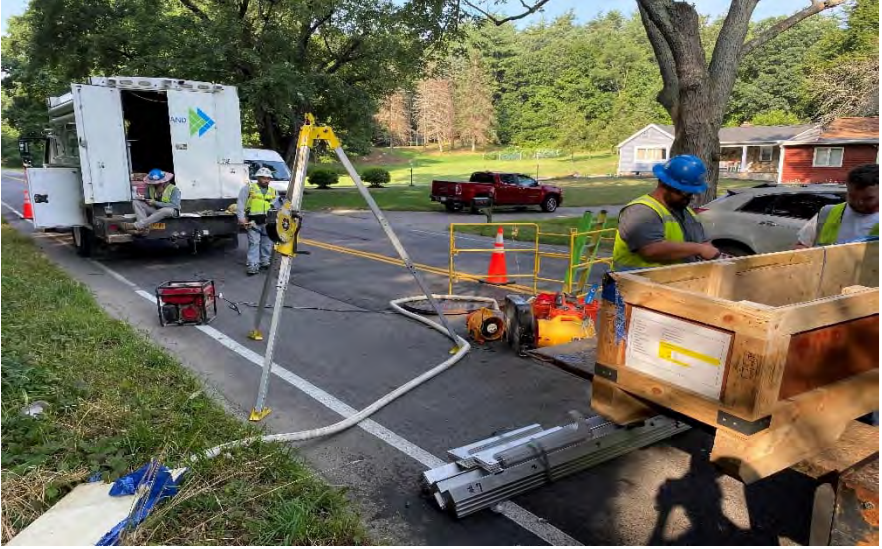
| <p>Photo No.: 7</p> | <p>Date: 8-2-24</p> | | |

| <p>Description:</p> <p>Wire pulling work within Forest Avenue, Manhole #4, Forest Avenue, looking southward.</p> | | | |

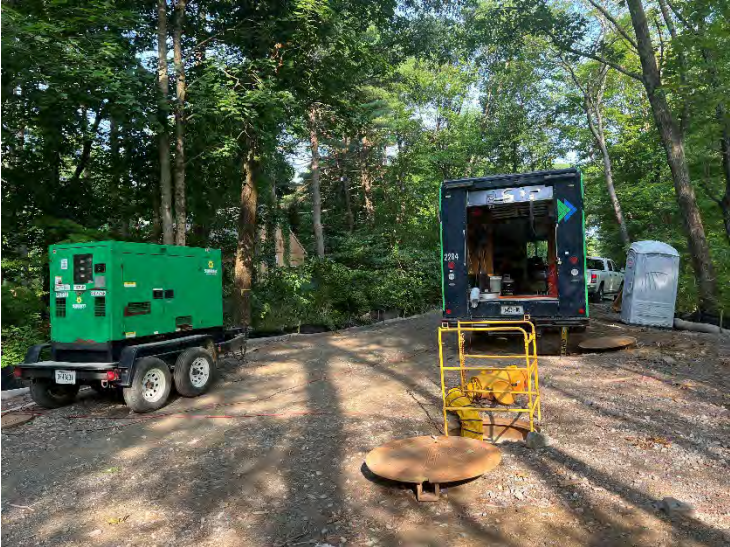
| <p>Photo No.: 1</p> | <p>Date: 8/2/2024</p> | | |

| <p>Description: View of Haugland splicers at MH #25 in segment 13. Facing west.</p> | | | |

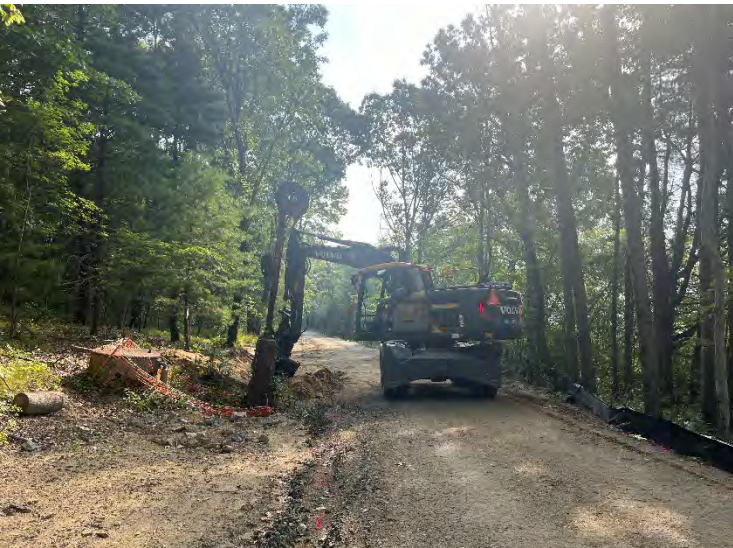
| <p>Photo No.: 2</p> | <p>Date: 8/2/2024</p> | | |

| <p>Description: View of ET&L working on making the swale in segment 14. Concrete wash out area has been cleaned up. Facing east.</p> | | | |

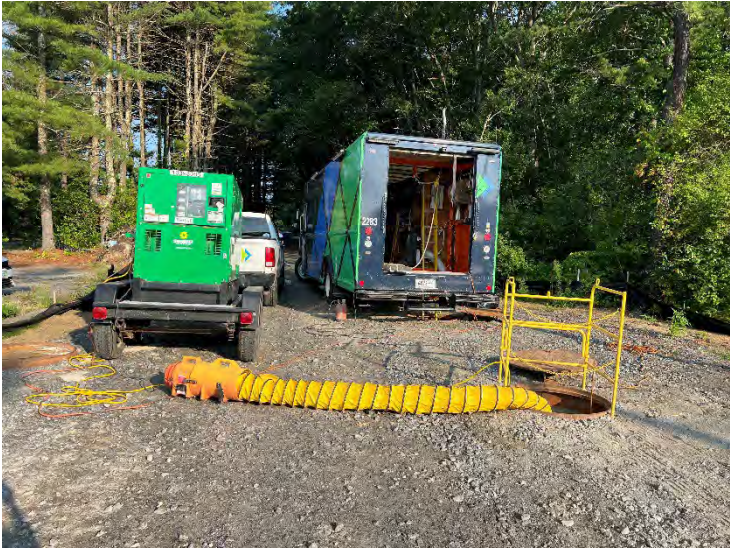
| <p>Photo No.: 5</p> | <p>Date: 8/2/2024</p> | | |

| <p>Description: View of Haugland splicers at MH#24 in segment 11. See additional dewatering report. Facing west.</p> | | | |

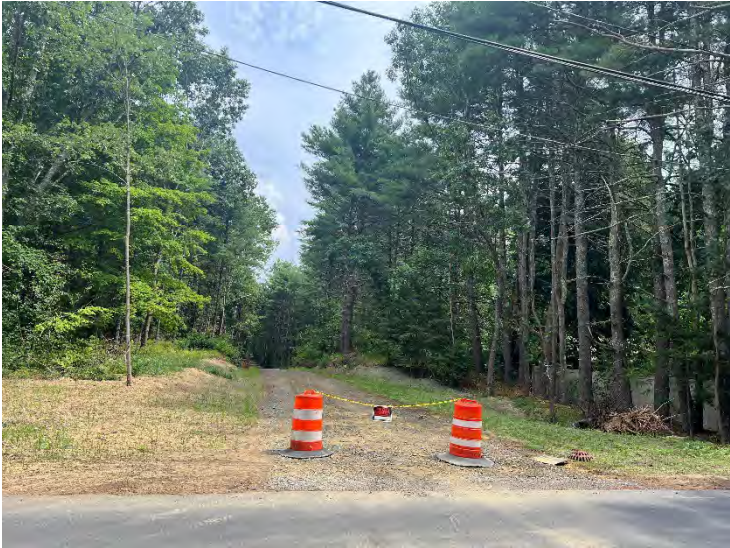
| Photo No.: 7 | Date: 8/2/2024 | | |

| Description: View construction entrance to segment 10. Facing east. | | | |

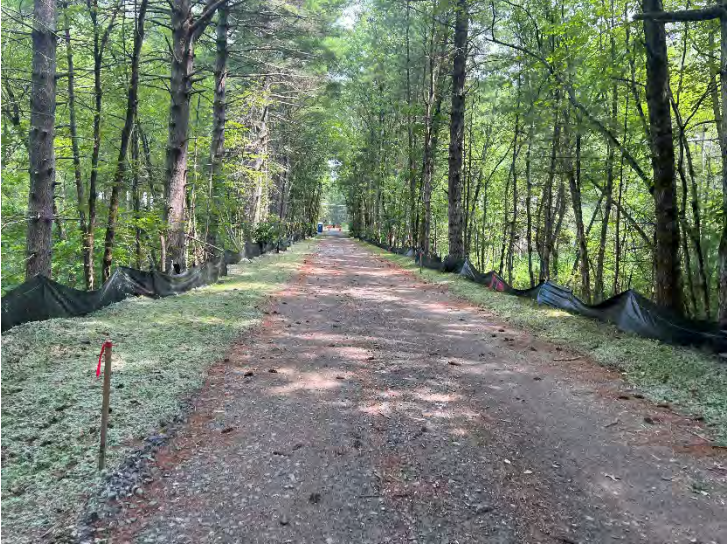
| Photo No.: 8 | Date: 8/2/2024 | | |

- Repairs needed to silt fencing and tubing in segment 9 at Sta. # 518+00. Contractors are aware of the needed repairs and will address next week (week of 8/5/24).

| Description: View of E&S controls in segment 9. Facing west. | | | |

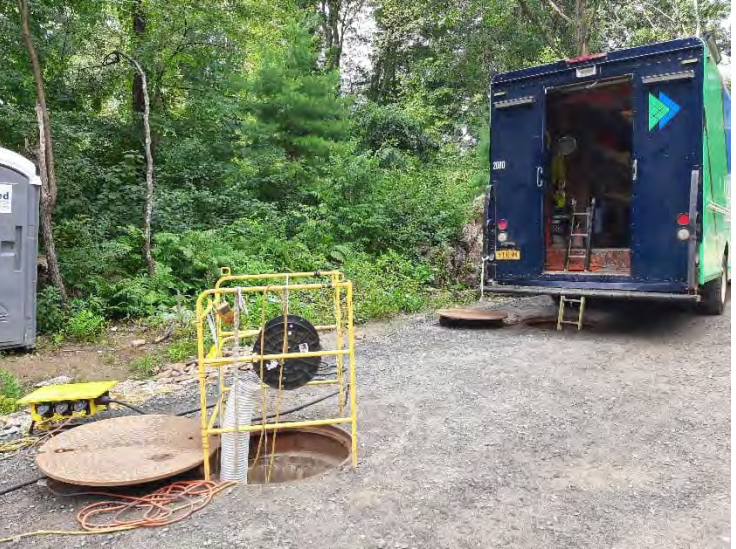
| <p>Photo No.: 2</p> | <p>Date: 8-3-24</p> | | |

| <p>Description:</p> <p>Work area at manhole #5 (segment 1), crimping and splicing, looking westward.</p> | | | |

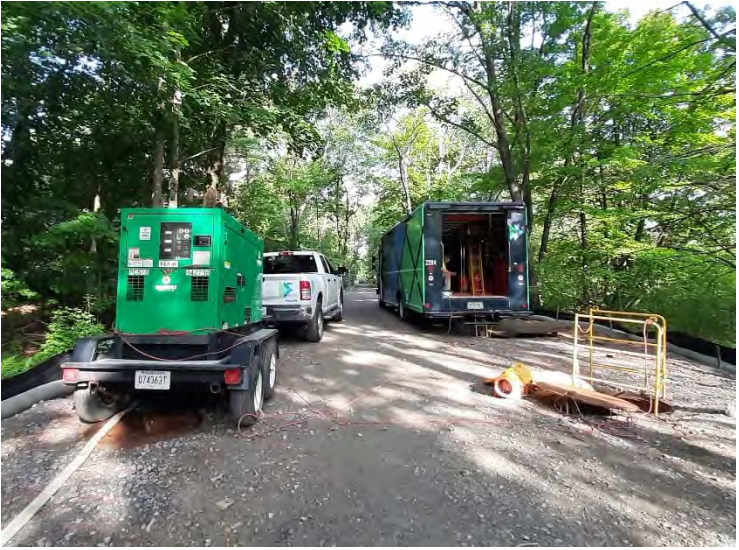
| <p>Photo No.: 3</p> | <p>Date: 8-3-24</p> | | |

| <p>Description:</p> <p>Work area at manhole #25 (segment 13) with existing erosion controls, crimping and splicing, looking westward.</p> | | | |

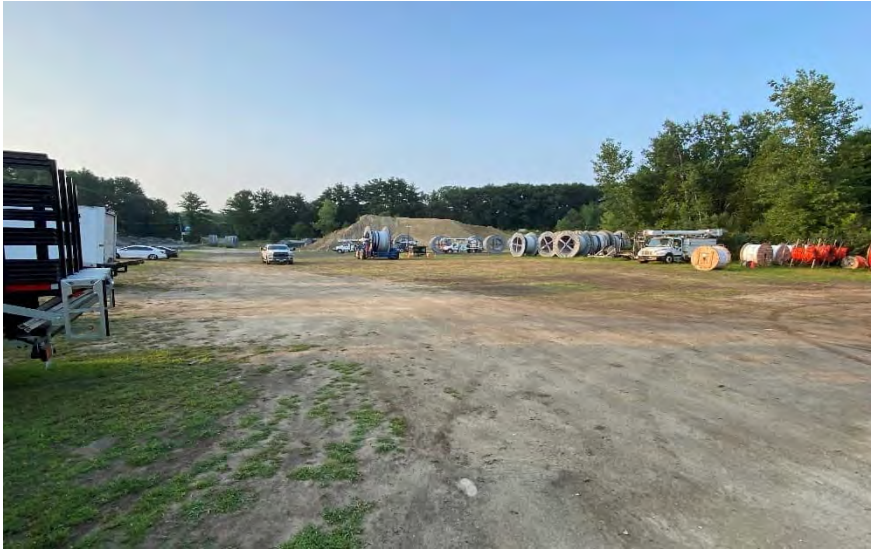
| Photo No.: 1 | Date: 7-30-24 | | |

| Description: Haugland laydown yard, stored wire on reels, looking westward. | | | |

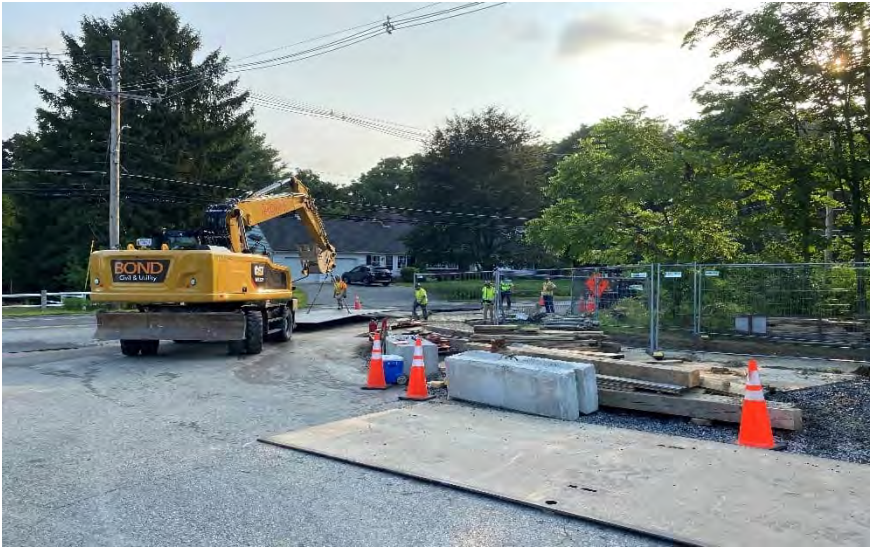
| Photo No.: 2 | Date: 7-30-24 | | |

| Description: Bond conducting conduit work within Forest Avenue near manhole #1, looking westward. | | | |

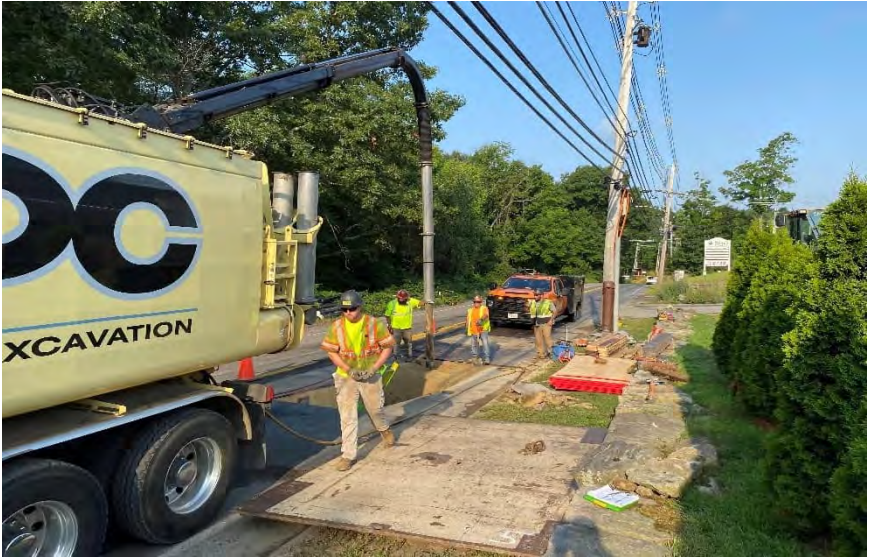
| Photo No.: 3 | Date: 7-30-24 | | |

| Description: Bond conducting conduit work within Forest Avenue near manhole #2, looking southward. | | | |

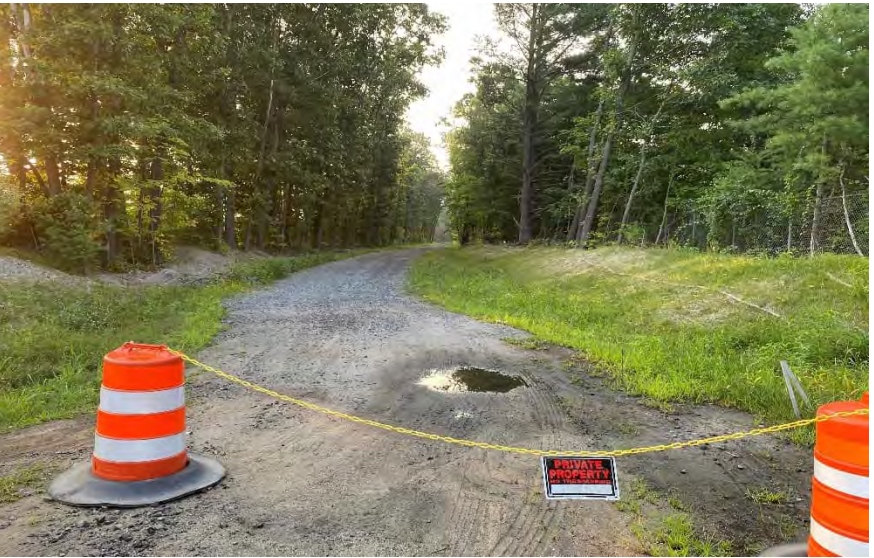
| Photo No.: 4 | Date: 7-30-24 | | |

| Description: Work area within segment 4, sides vegetated, looking eastward. | | | |

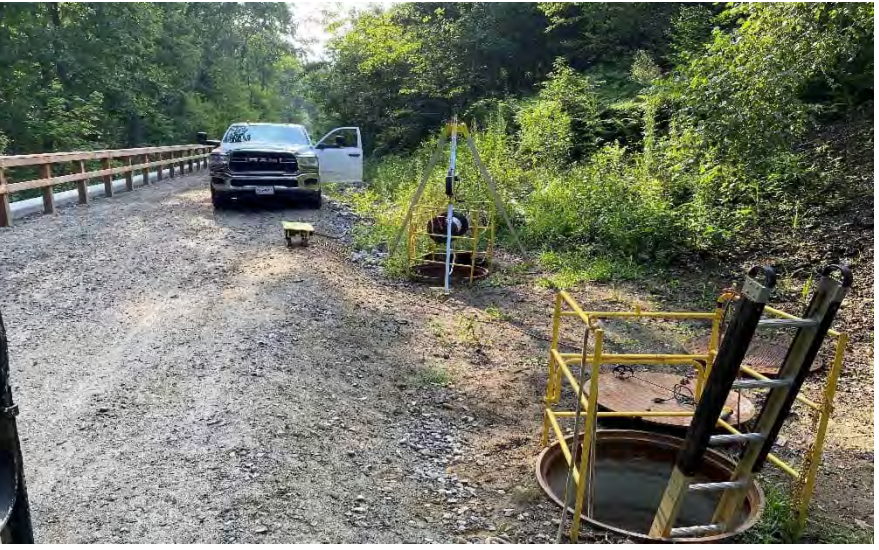
| Photo No.: 6 | Date: 7-30-24 | | |

| Description: Haugland splicing at manhole #6, segment 1, looking eastward. | | | |

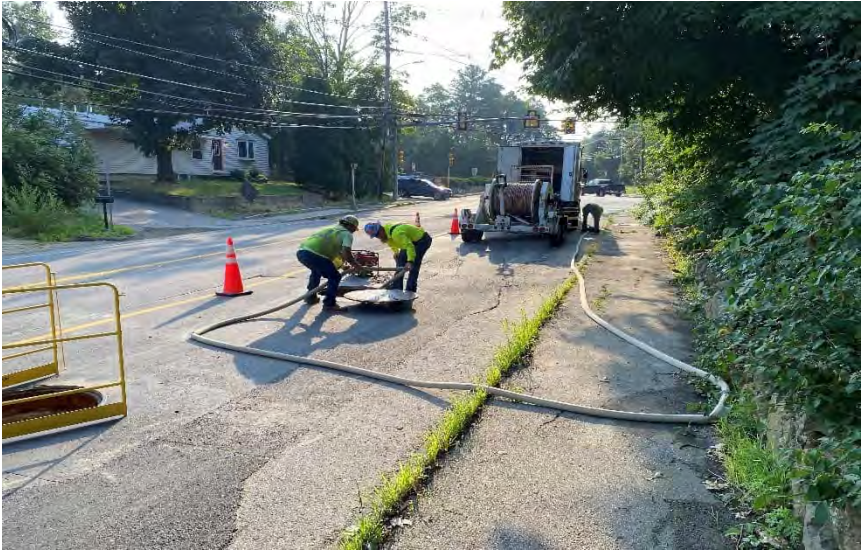
| Photo No.: 7 | Date: 7-30-24 | | |

| Description: Haugland swab/mandrel at manhole #2, Forest Avenue, looking westward. | | | |

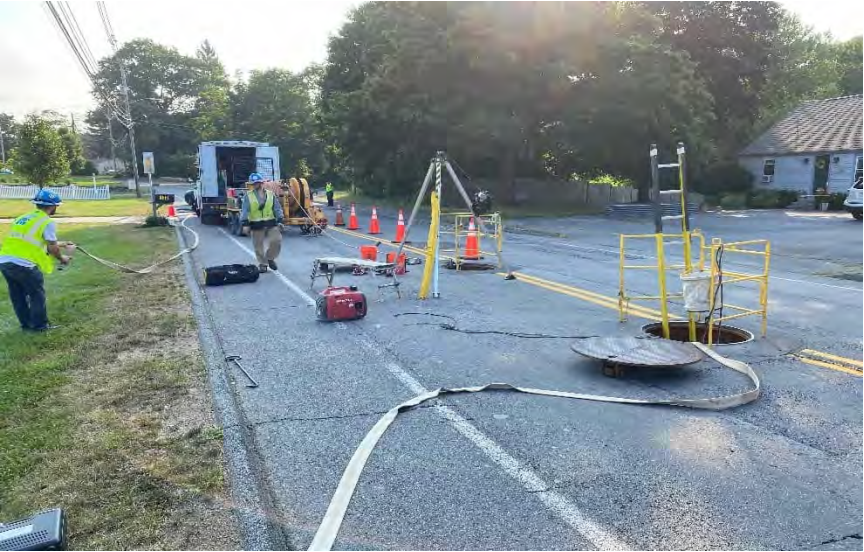
| Photo No.: 8 | Date: 7-30-24 | | |

| Description: Haugland swab/mandrel at manhole #3, Forest Avenue, looking northward. | | | |

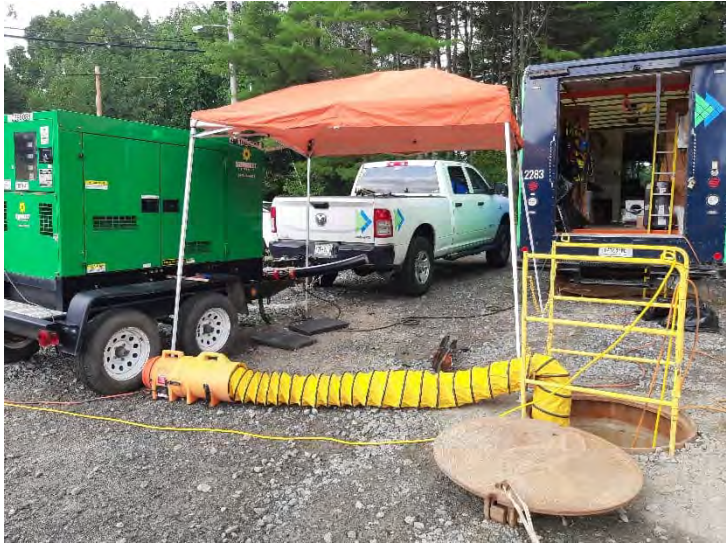
| Photo No.: 1 | Date: 7-30-24 | | |

| Description: Work area at manhole 24 (Segment 11), crimping and splicing, looking westward. | | | |

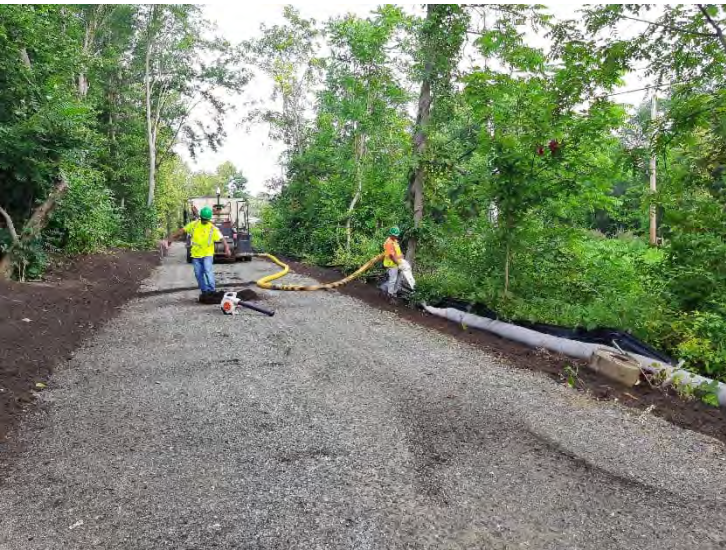
| Photo No.: 2 | Date: 7-30-24 | | |

| Description: Work area within Segment 12, replacing filter tube, looking westward. | | | |

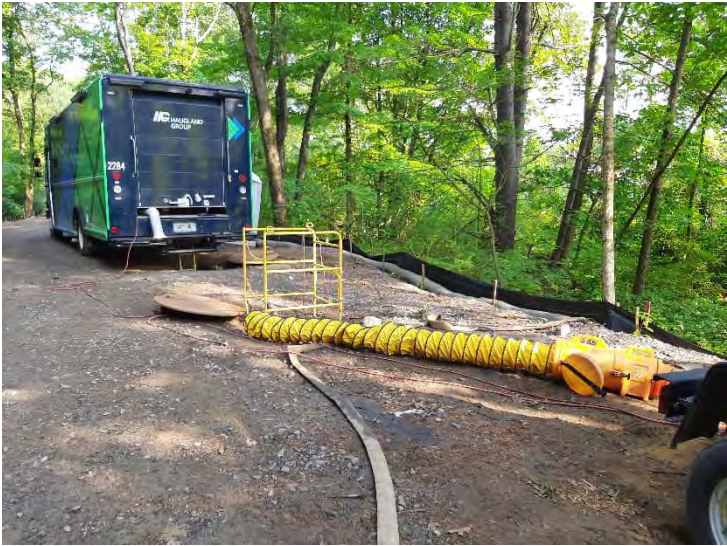
| Photo No.: 3 | Date: 7-30-24 | | |

| Description: Work area at manhole 25 (Segment 13), crimping and splicing, existing erosion controls, looking westward. | | | |

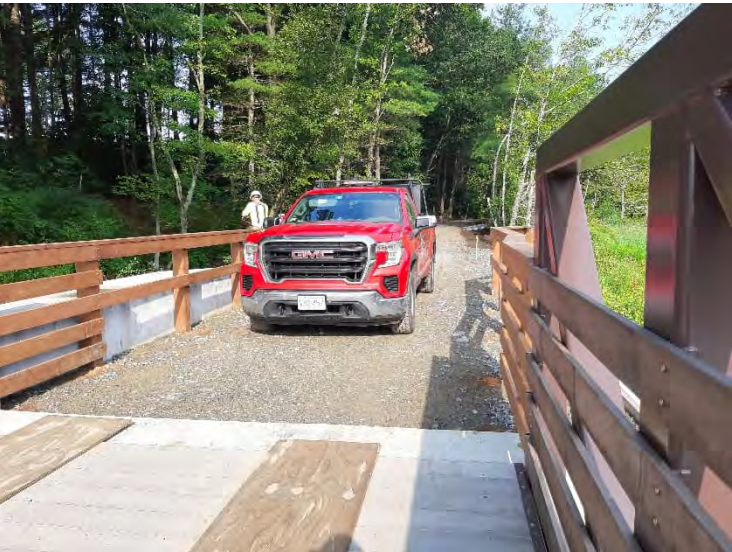
| Photo No.: 4 | Date: 7-30-24 | | |

| Description: Work area at Bridge 127, carpentry work, looking westward. | | | |
