Weekly Environmental Compliance Summary

Sudbury to Hudson Transmission Reliability Project (USEPA Tracking # MAR1003UW)

Sudbury, Hudson, and Stow, MA

Week of: July 29, 2024 to August 3, 2024

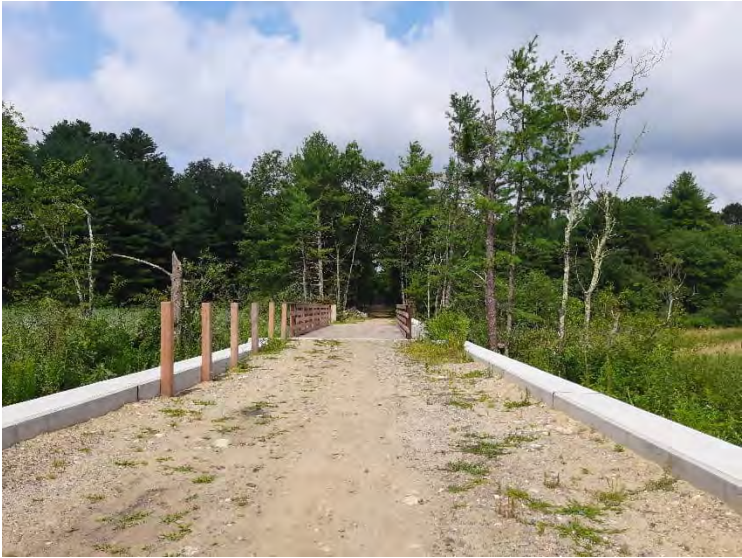
| Photo No.: 7 | Date: 7-30-24 | | |

| Description: Bridge 128, Segment 8 towards Segment 7, no work in these segments today, looking westward. | | | |

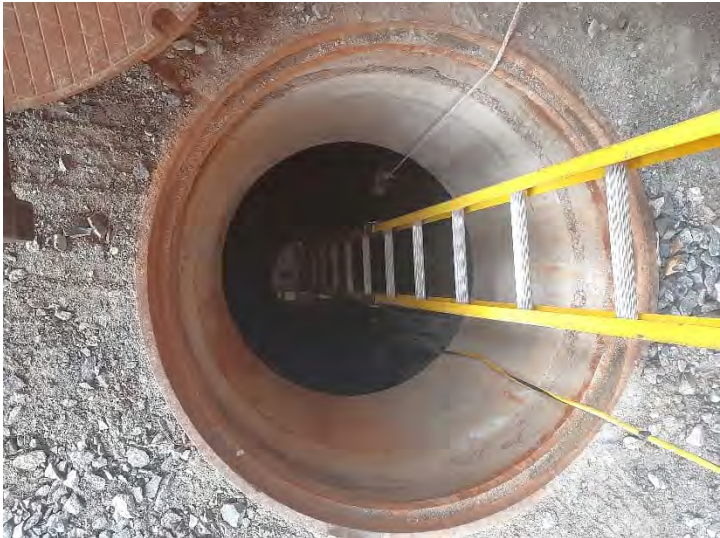
| Photo No.: 1 | Date: 7/29/2024 | | |

| Description: View of manhole #24, area being pumped, facing westward and looking down. | | | |

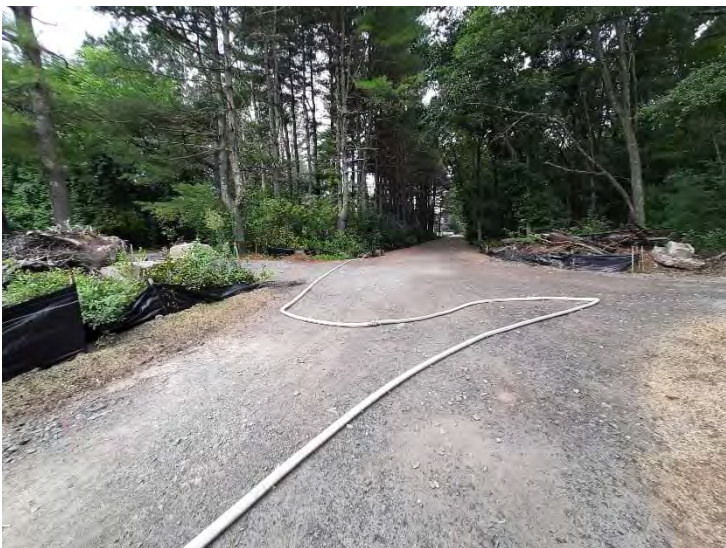
| Photo No.: 2 | Date: 7/29/2024 | | |

| Description: Manhole #24. View of dewatering operation, looking westward. | | | |

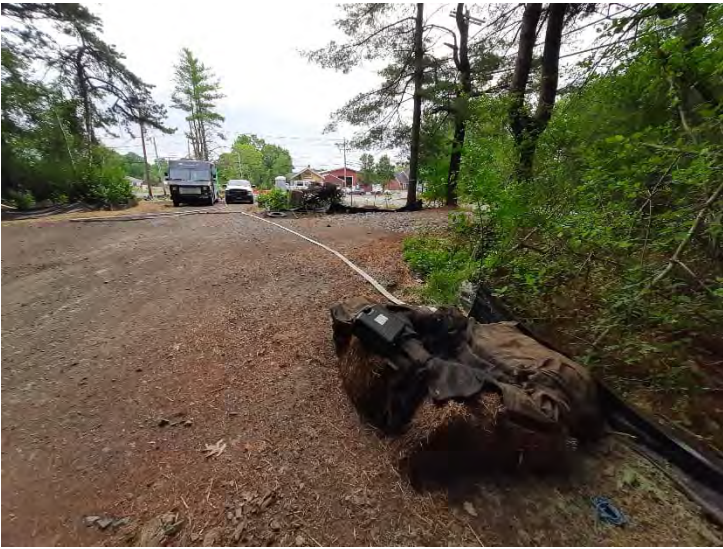
| Photo No.: 3 | Date: 7/29/2024 | | |

| Description: View of dewatering operation for manhole #24, looking eastward. | | | |

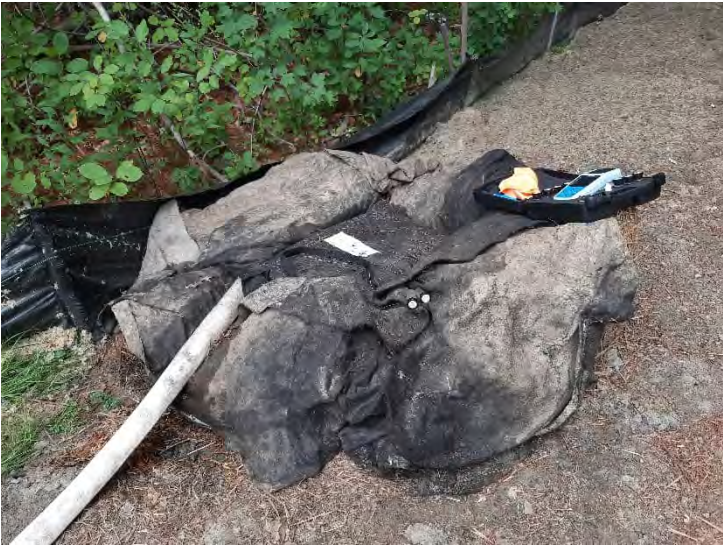
| Photo No.: 4 | Date: 7/29/2024 | | |

| Description: Manhole #24. View of discharge bag/corral, looking westward. | | | |

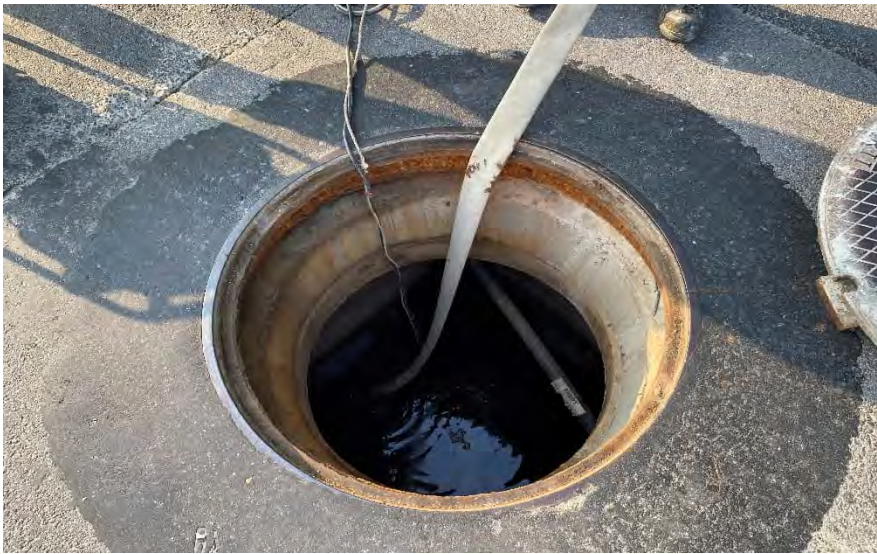
| Photo No.: 1 | Date: 7/30/2024 | | |

| Description: View of area being pumped from manhole #2 within Forest Ave. | | | |

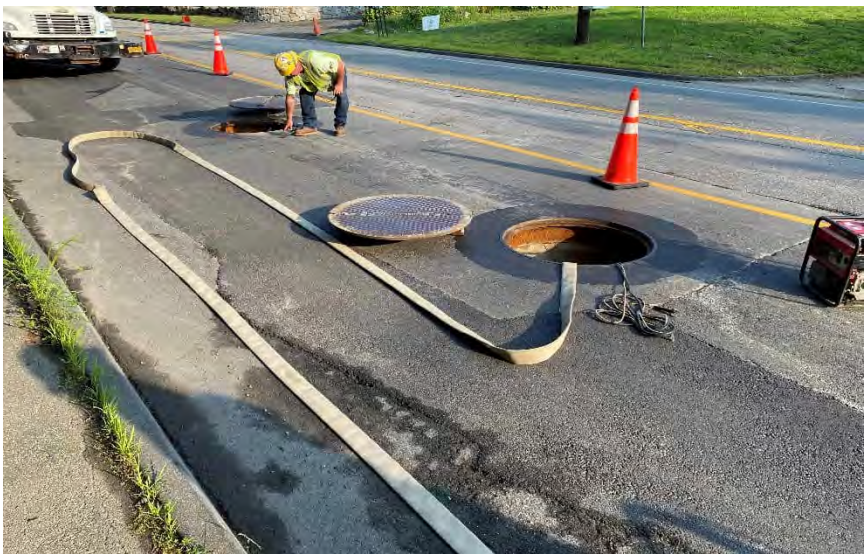
| Photo No.: 2 | Date: 7/30/2024 | | |

| Description: Manhole #2. View of dewatering operation. Looking southward. | | | |

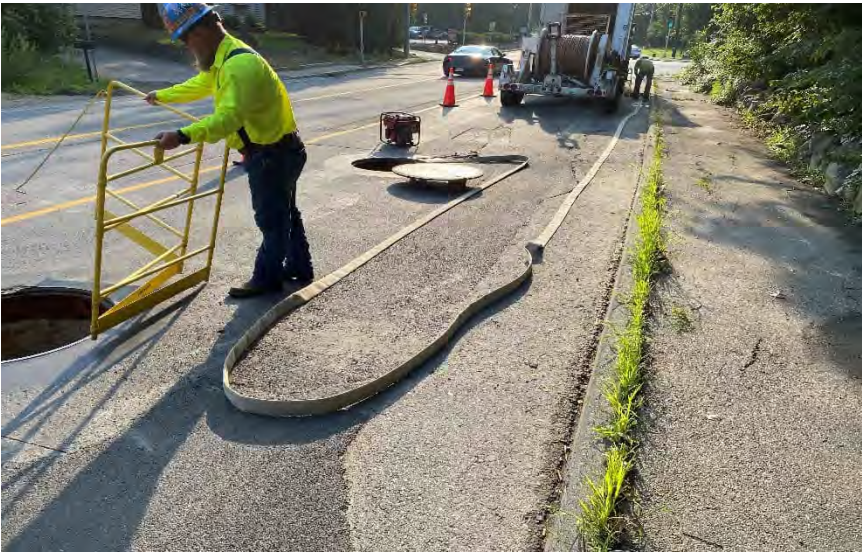
| Photo No.: 3 | Date: 7/30/2024 | | |

| Description: Manhole #2. View of dewatering operation, looking northward. | | | |

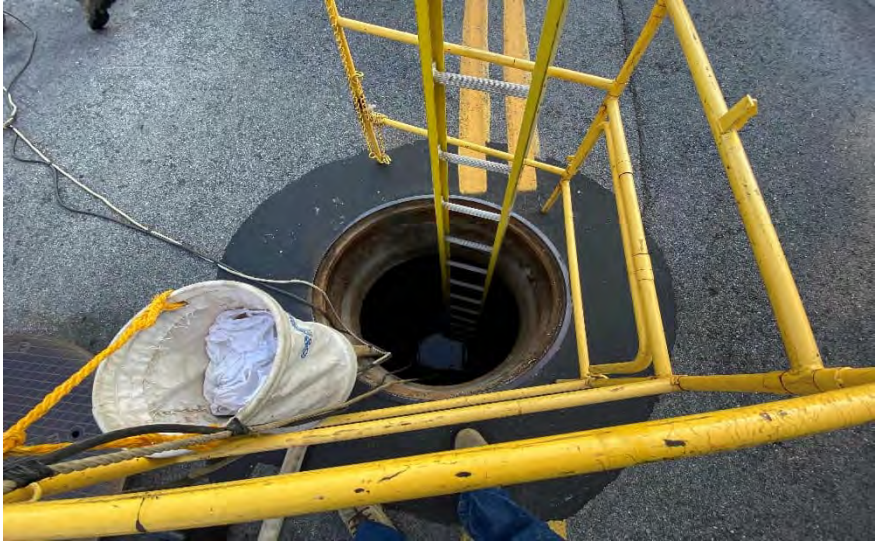
| Photo No.: 1 | Date: 7/30/2024 | | |

| Description: View of area being pumped from manhole #3 within Forest Ave. | | | |

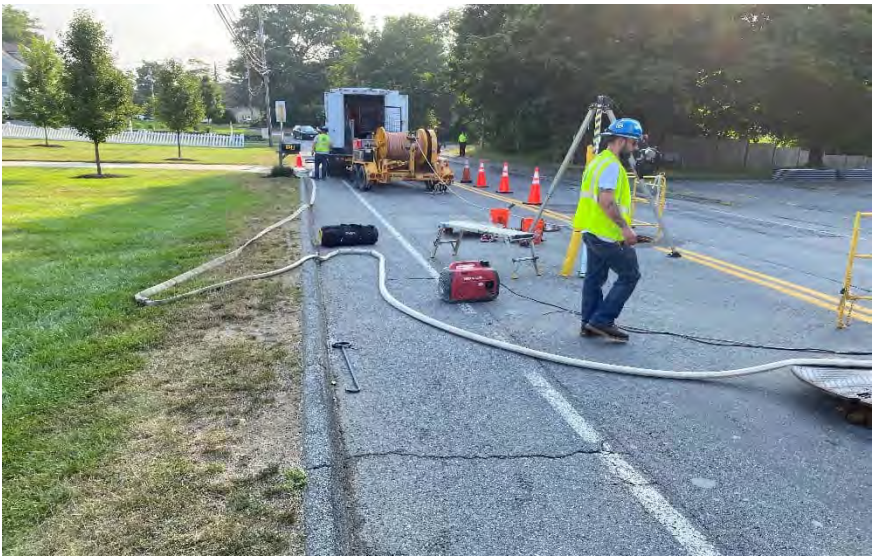
| Photo No.: 2 | Date: 7/30/2024 | | |

| Description: Manhole #3. View of dewatering operation. Looking northward. | | | |

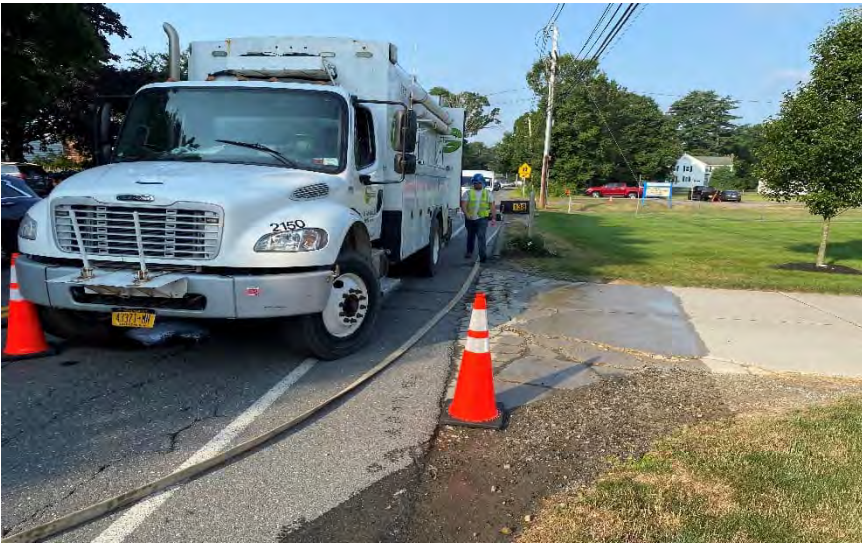
| Photo No.: 3 | Date: 7/30/2024 | | |

| Description: Manhole #3. View of dewatering operation, looking southward. | | | |

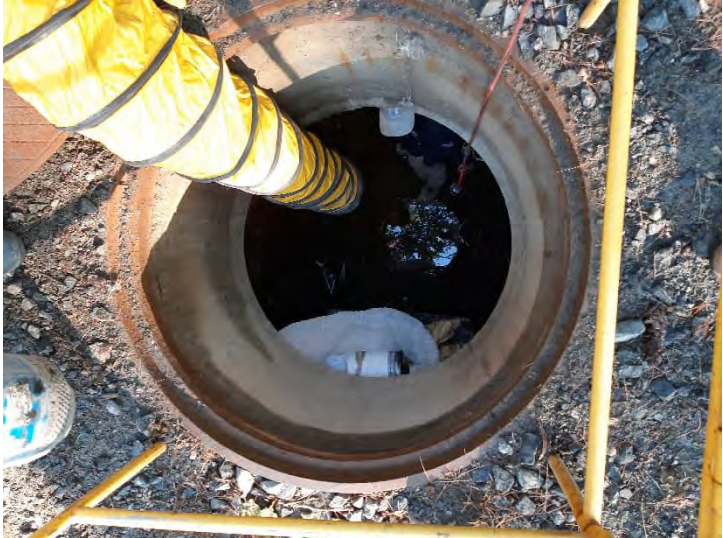
| Photo No.: 1 | Date: 7/30/2024 | | |

| Description: View of manhole #25, area being pumped, facing westward and looking down. | | | |

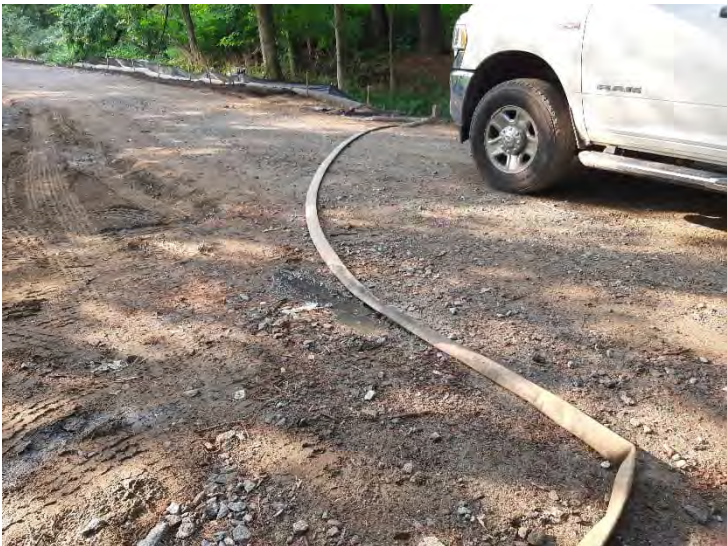
| Photo No.: 2 | Date: 7/30/2024 | | |

| Description: Manhole #25. View of dewatering operation, looking eastward. | | | |

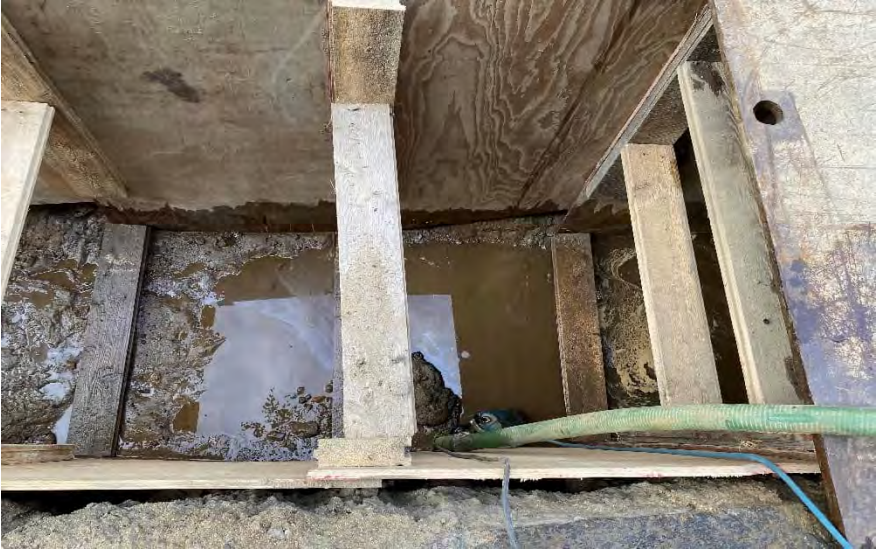
| Photo No.: 1 | Date: 8/1/2024 | | |

| Description: View of area being pumped from trench close to manhole #1 near Hudson Power & Light facility off Forest Avenue. | | | |

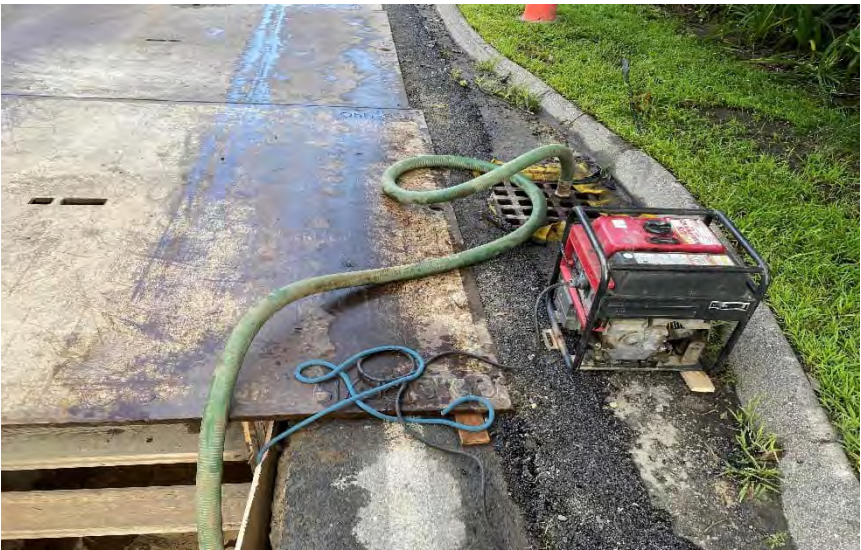
| Photo No.: 2 | Date: 8/1/2024 | | |

| Description: Near manhole #1. View of dewatering operation. Looking northward. | | | |

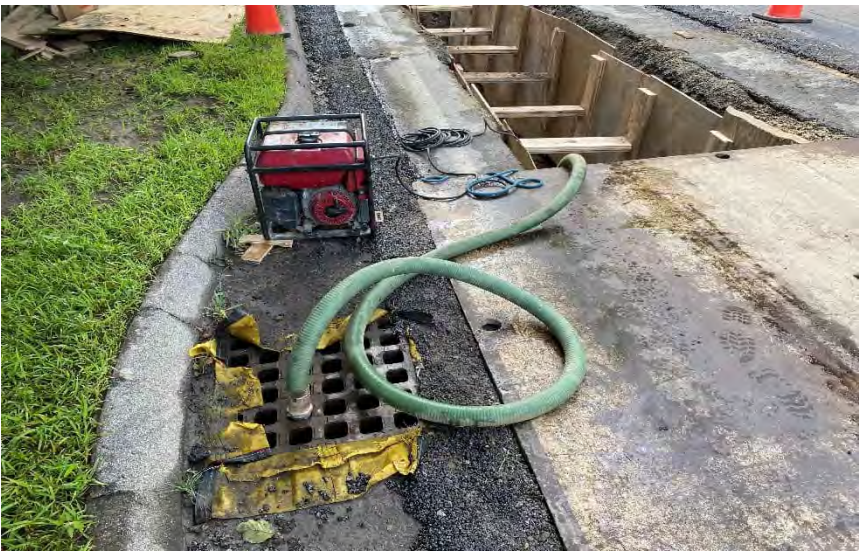
| Photo No.: 3 | Date: 8/1/2024 | | |

| Description: Near manhole #1. View of dewatering operation, looking northward. | | | |

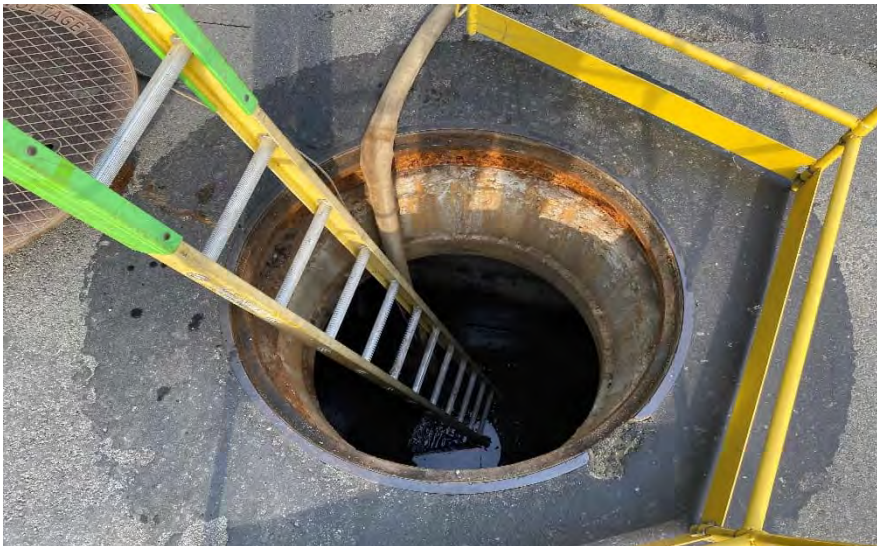
| Photo No.: 1 | Date: 8/1/2024 | | |

| Description: View of area being pumped from manhole #2 within Forest Ave. | | | |

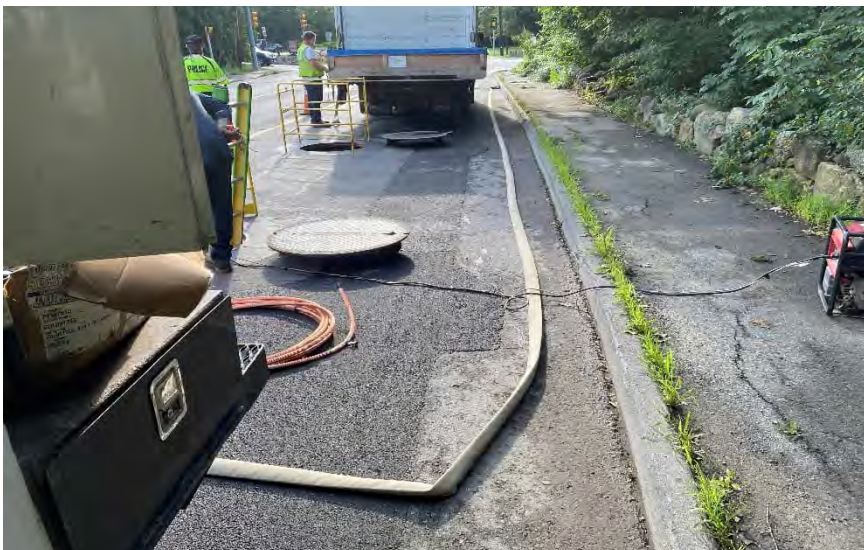
| Photo No.: 2 | Date: 8/1/2024 | | |

| Description: Manhole #2. View of dewatering operation. Looking northward. | | | |

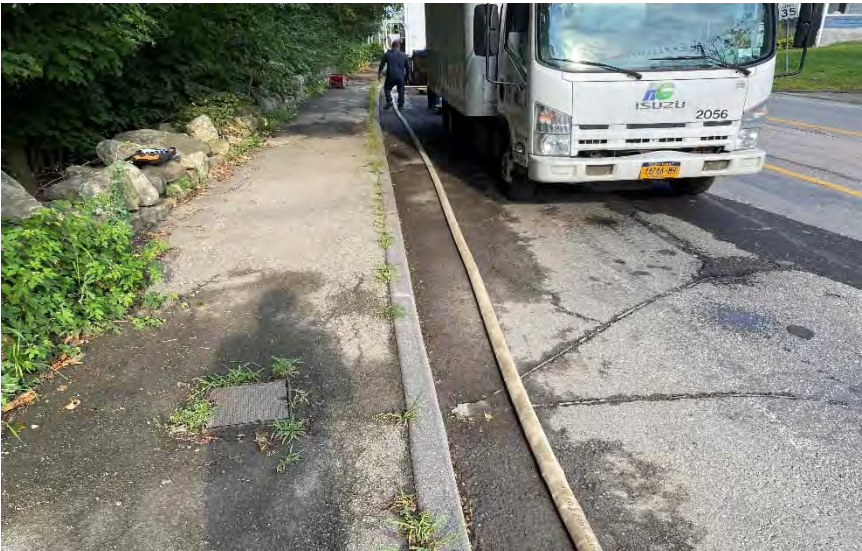
| Photo No.: 3 | Date: 8/1/2024 | | |

| Description: Manhole #2. View of dewatering operation, looking southward. | | | |

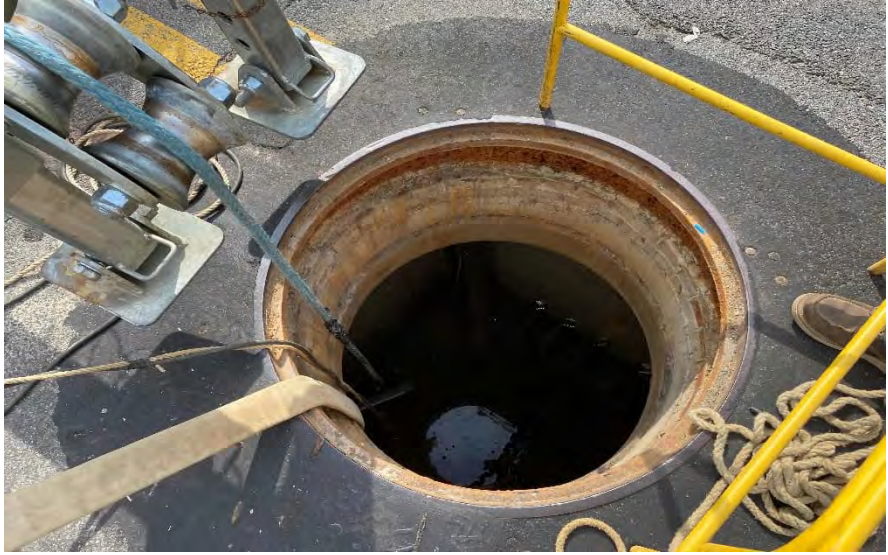
| Photo No.: 1 | Date: 7/31/2024 | | | |

| Description: View of area being pumped from manhole #3 within Forest Ave. | | | | |

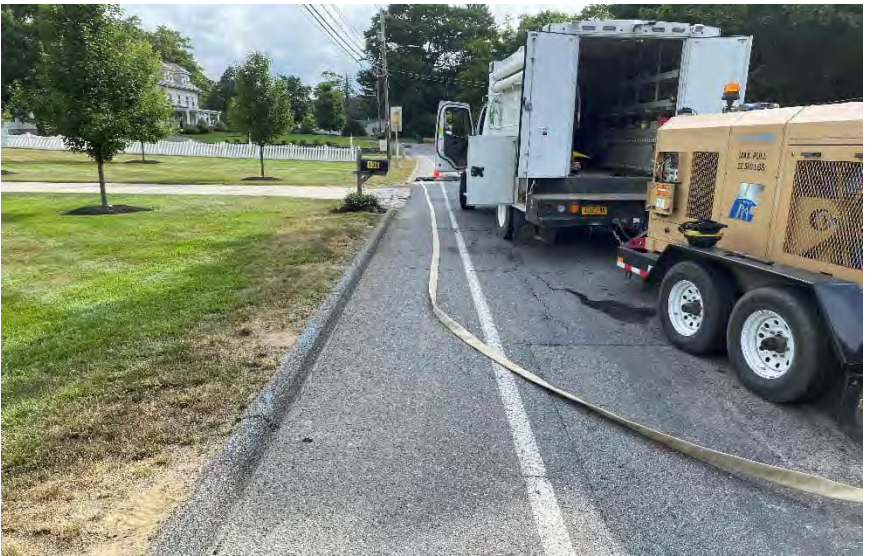
| Photo No.: 2 | Date: 7/31/2024 | | | |

| Description: Manhole #3. View of dewatering operation. Looking northward. | | | | |

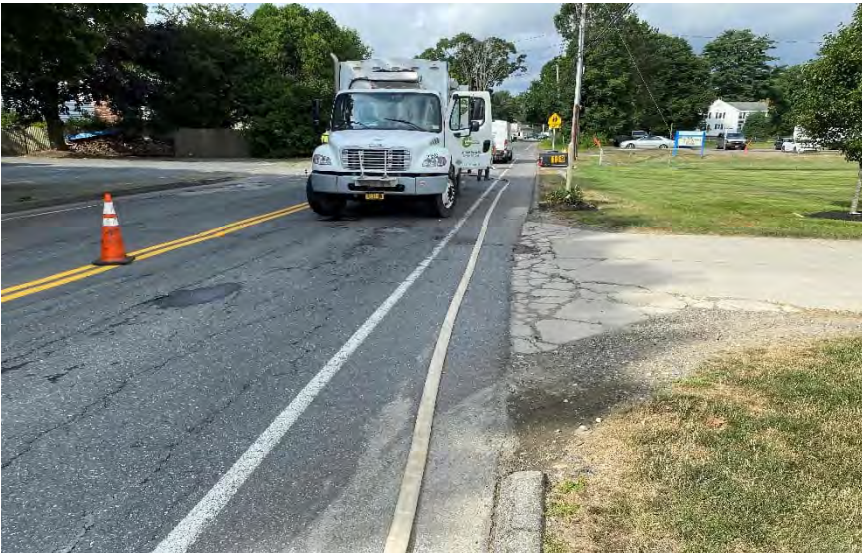
| Photo No.: 3 | Date: 7/31/2024 | | |

| Description: Manhole #3. View of dewatering operation, looking southward. | | | |

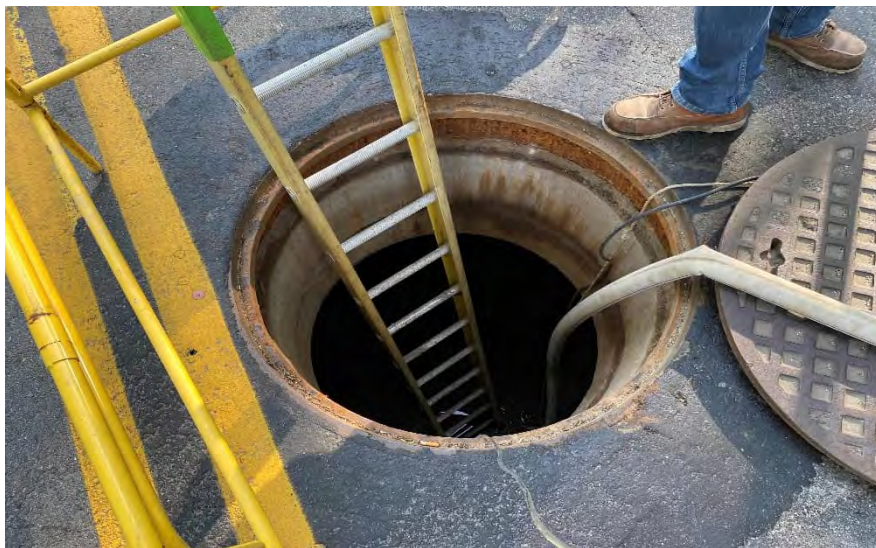
Photo No.: 1
Date: 8/2/2024

Description:
View of area being pumped from manhole #4 within Forest Ave.

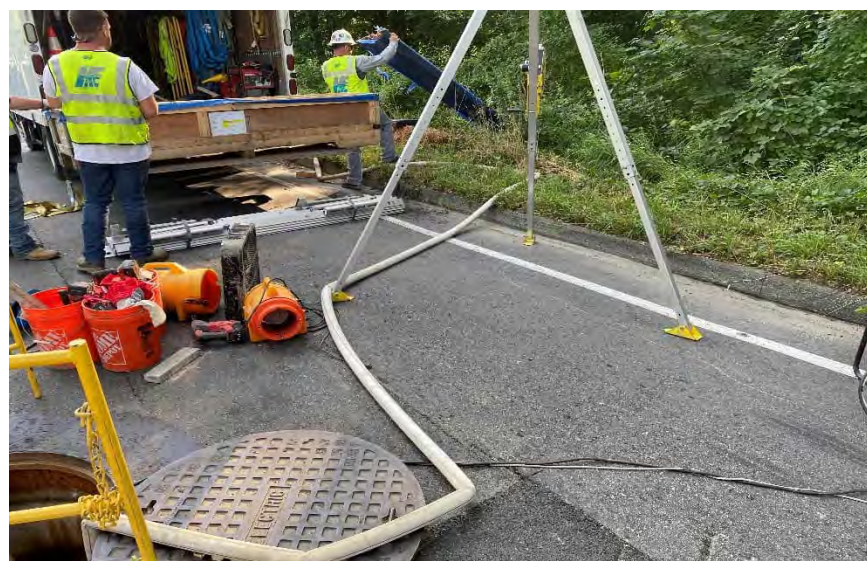
Photo No.: 2
Date: 8/2/2024

Description:
Manhole #4. View of dewatering operation. Looking northward.

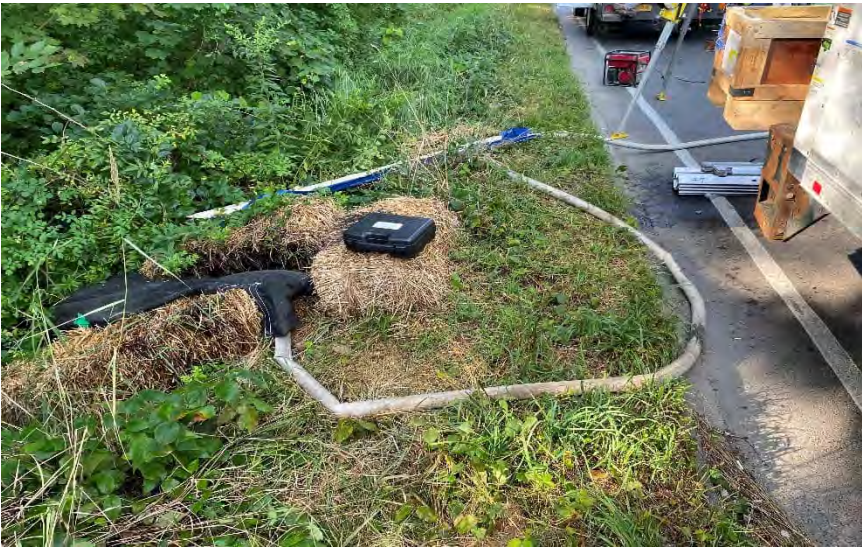
| Photo No.: 3 | Date: 8/2/2024 | | |

| Description: Manhole #4. View of dewatering operation, looking southward. | | | |

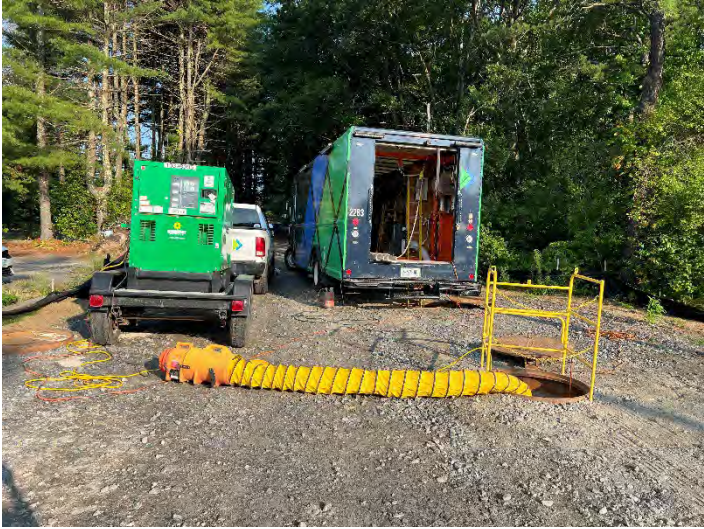
| Photo No.: 1 | Date: 8/2/2024 | | | |

| Description: View of Haugland cable splicers working at MH #24. Facing west. | | | | |

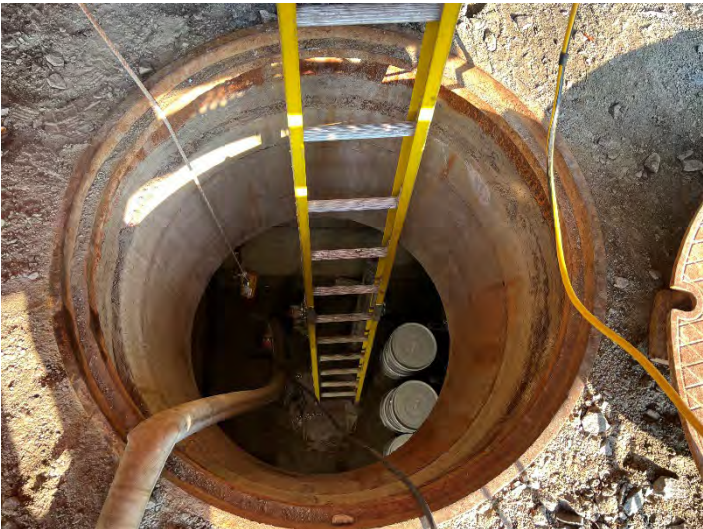
| Photo No.: 2 | Date: 8/2/2024 | | | |

| Description: View of pump in MH #24. Water appeared to be clear prior to treatment. | | | | |

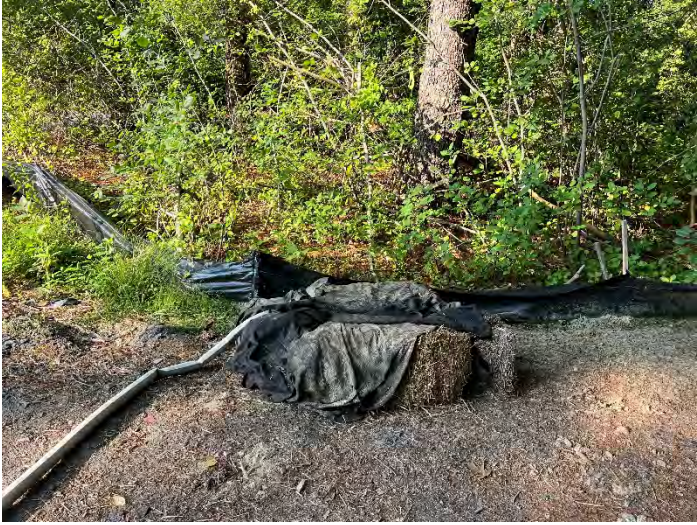
| Photo No.: 3 | Date: 8/2/2024 | | |

| Description: View of dewatering controls (straw bale corral with filter fabric and silt bag). Facing south. | | | |

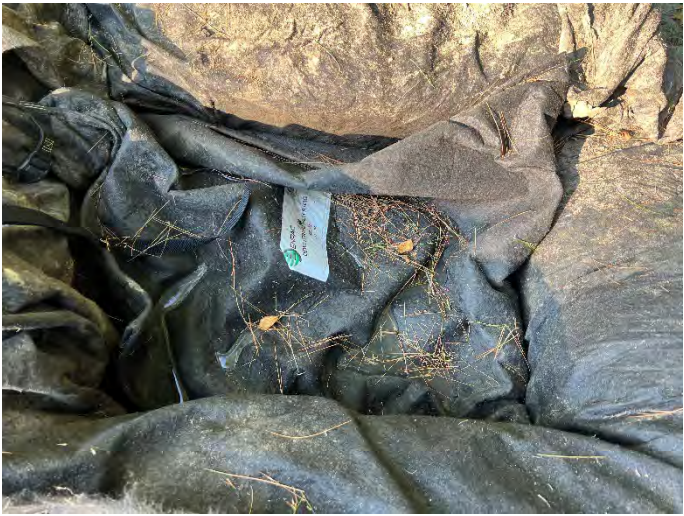
| Photo No.: 4 | Date: 8/2/2024 | | |

| Description: Another view of dewatering controls (straw bale corral with filter fabric and silt bag) and discharge within the corral. Discharge did not leave the corral. No sample collected. Discharge did not reach any jurisdictional areas. | | | |

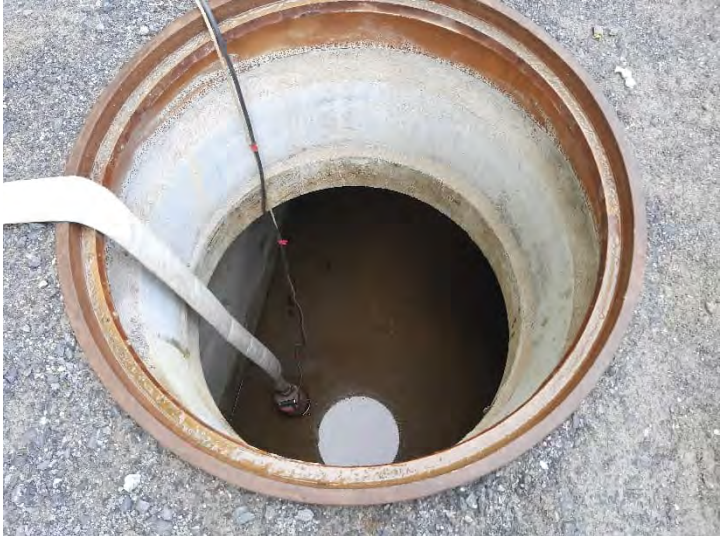
| Photo No.: 1 | Date: 8/3/2024 | | |

| Description: View of manhole #1 (near Hudson Light & Power), area being pumped, looking down. | | | |

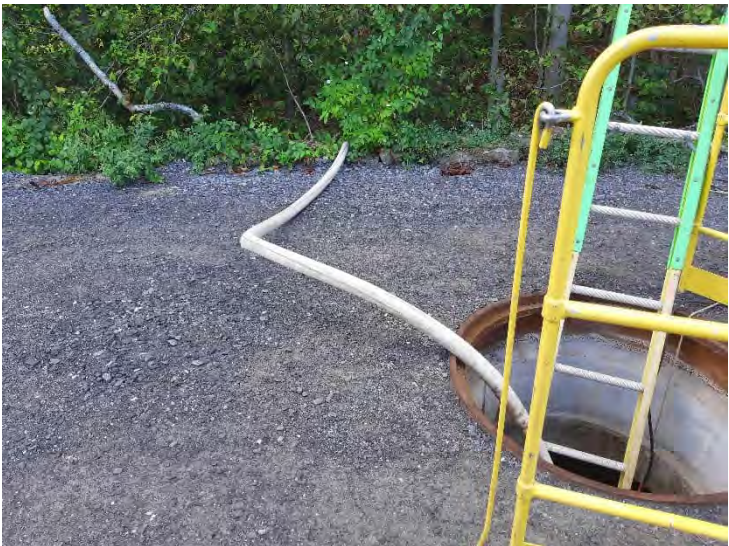
| Photo No.: 2 | Date: 8/3/2024 | | |

| Description: Manhole #1. View of dewatering operation, looking westward. | | | |

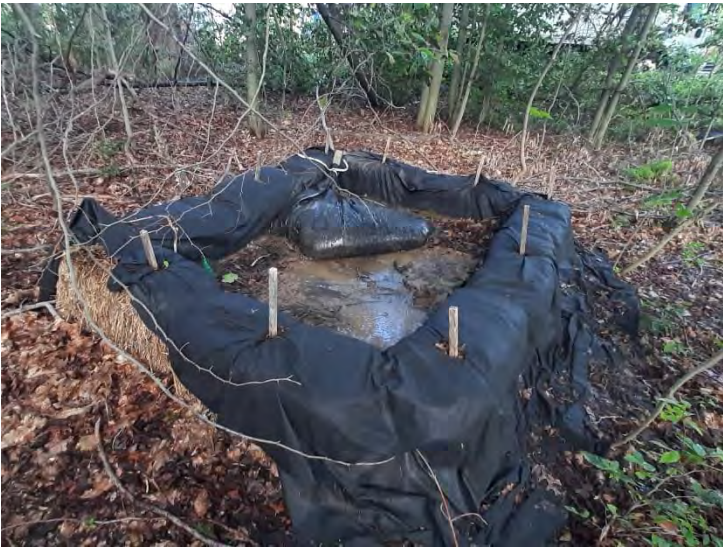
| Photo No.: 3 | Date: 8/3/2024 | | |

| Description: View of dewatering operation for manhole #1, looking westward. | | | |

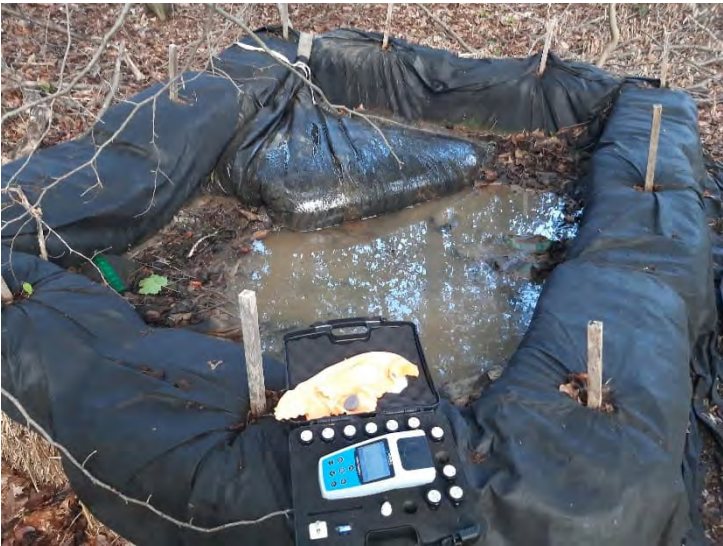
| Photo No.: 4 | Date: 8/3/2024 | | |

| Description: Manhole #1. View of filter bag/corral, looking westward. No visible discharge exiting corral. | | | |

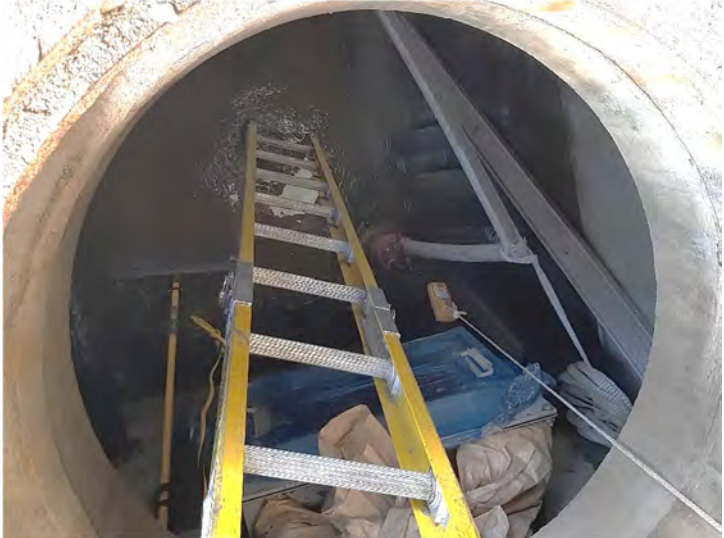
| Photo No.: 1 | Date: 8/3/2024 | | | |

| Description: View of manhole #26 (segment 14), area being pumped, facing down. | | | | |

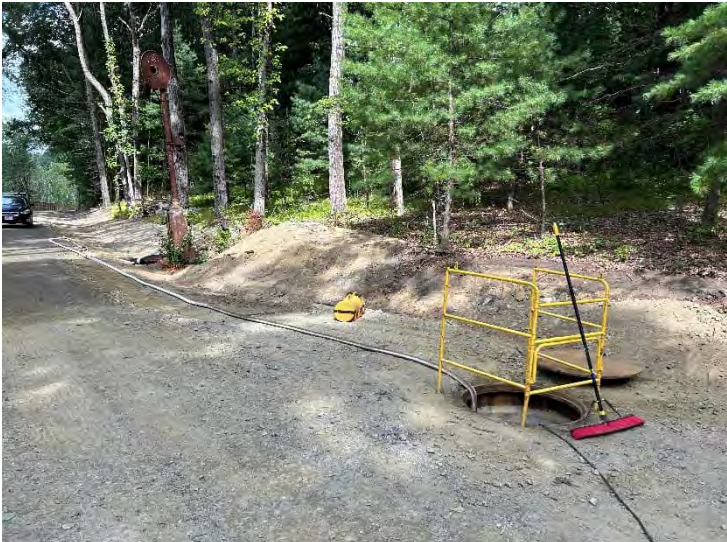
| Photo No.: 2 | Date: 8/3/2024 | | | |

| Description: Manhole #26. View of dewatering operation, looking westward. | | | | |

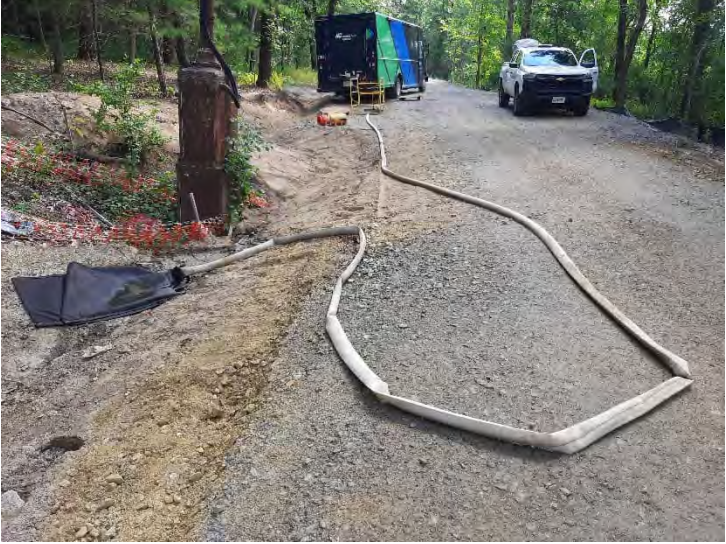
| Photo No.: 3 | Date: 8/3/2024 | | |

| Description: View of dewatering operation for manhole #26, looking eastward. | | | |

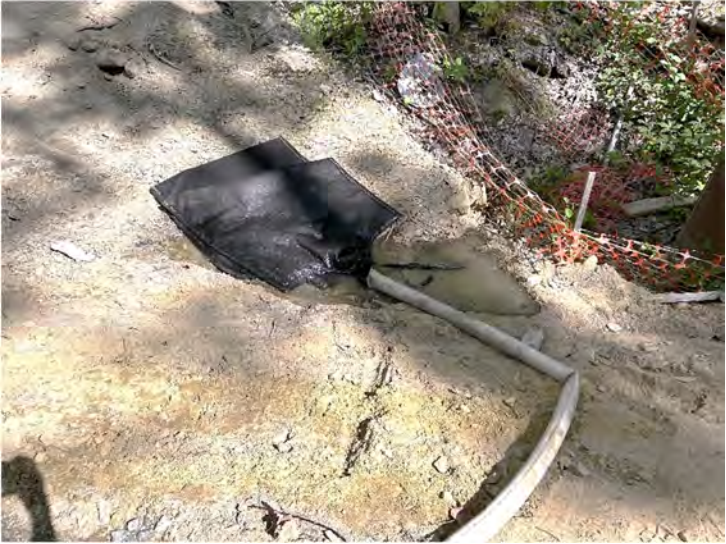
| Photo No.: 4 | Date: 8/3/2024 | | |

| Description: Manhole #26. View of discharge bag on top second filter bag, looking northward. Filter bag discharging to the surrounding area. | | | |
