Weekly Environmental Compliance Summary

Sudbury to Hudson Transmission Reliability Project (USEPA Tracking # MAR1003UW)

Sudbury, Hudson, and Stow, MA

Week of: August 5, 2024 to August 10, 2024

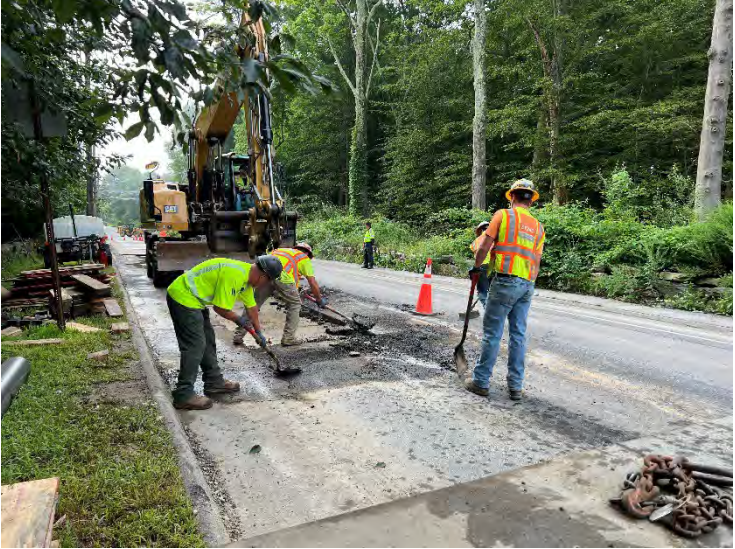
<p>PHOTOGRAPHIC LOG</p>	
<p>Client Name: Eversource</p>		<p>Site Location: Sudbury to Hudson Transmission Reliability Project</p>	<p>Town: Hudson</p>
<p>Photo No.: 1</p>	<p>Date: 8-8-24</p>

<p>Description: View of Bond removing steel plates for paving on Forest Ave by MH#1. Facing east.</p>

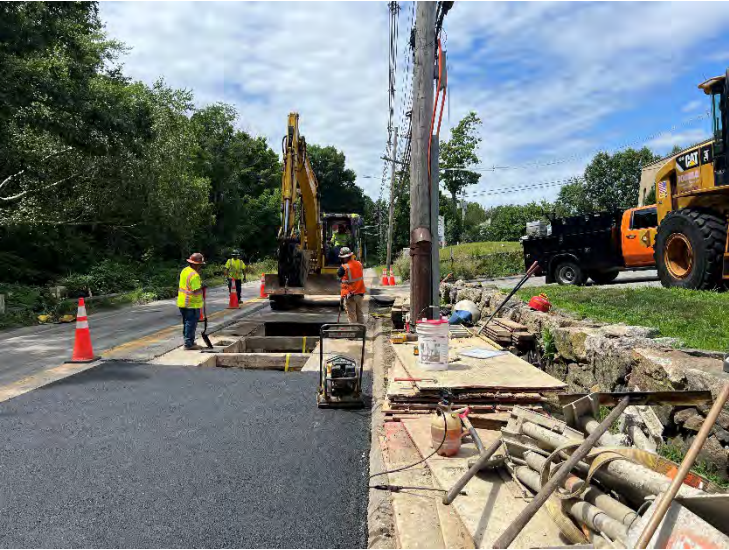
<p>PHOTOGRAPHIC LOG</p>	
<p>Client Name: Eversource</p>		<p>Site Location: Sudbury to Hudson Transmission Reliability Project</p>	<p>Town: Hudson</p>
<p>Photo No.: 3</p>	<p>Date: 8-8-24</p>

<p>Description:</p> <p>View of Bond work area on Forest Ave by MH #2. Facing west.</p>

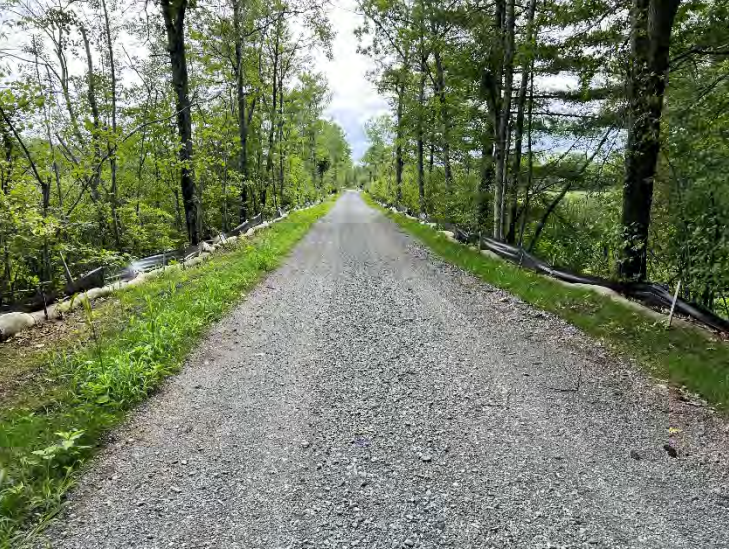
<p>PHOTOGRAPHIC LOG</p>	
<p>Client Name: Eversource</p>		<p>Site Location: Sudbury to Hudson Transmission Reliability Project</p>	<p>Town: Hudson</p>
<p>Photo No.: 4</p>	<p>Date: 8-8-24</p>

<p>Description:</p> <p>View of E&S controls in segment 2. Facing west.</p>

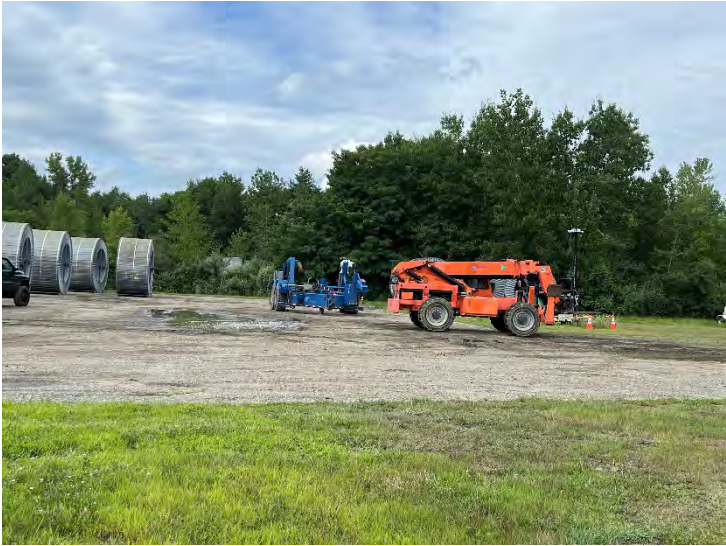
<p>PHOTOGRAPHIC LOG</p>	
<p>Client Name: Eversource</p>		<p>Site Location: Sudbury to Hudson Transmission Reliability Project</p>	<p>Town: Hudson</p>
<p>Photo No.: 5</p>	<p>Date: 8-8-24</p>

<p>Description: View of stored cable reels within Haugland laydown yard. Facing southwest.</p>

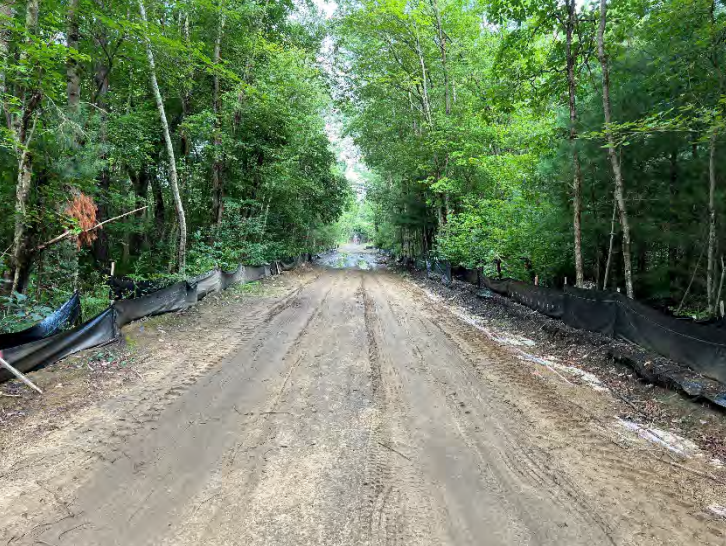
<p>PHOTOGRAPHIC LOG</p>	
<p>Client Name: Eversource</p>		<p>Site Location: Sudbury to Hudson Transmission Reliability Project</p>	<p>Town: Hudson</p>
<p>Photo No.: 6</p>	<p>Date: 8-8-24</p>

<p>Description: View of E&S controls in segment 6. Facing west.</p>

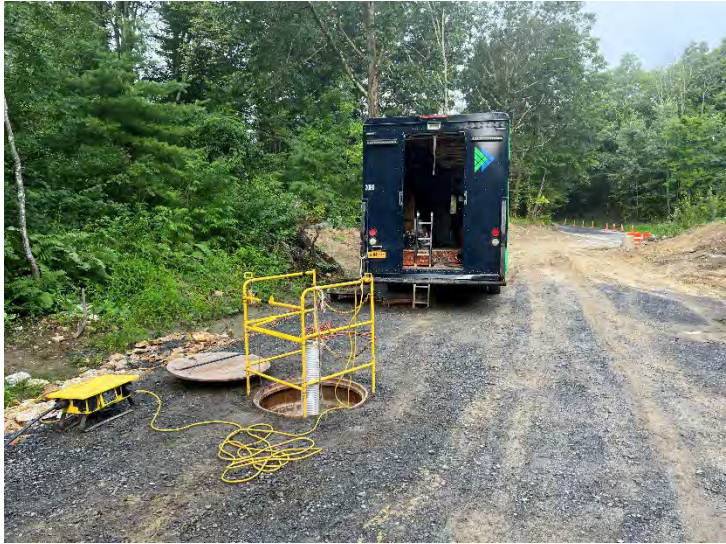
<p>PHOTOGRAPHIC LOG</p>	
<p>Client Name: Eversource</p>		<p>Site Location: Sudbury to Hudson Transmission Reliability Project</p>	<p>Town: Hudson</p>
<p>Photo No.: 7</p>	<p>Date: 8-8-24</p>

<p>Description:</p> <p>View of Haugland work area splicing at MH #5 in segment 1. Facing west.</p>

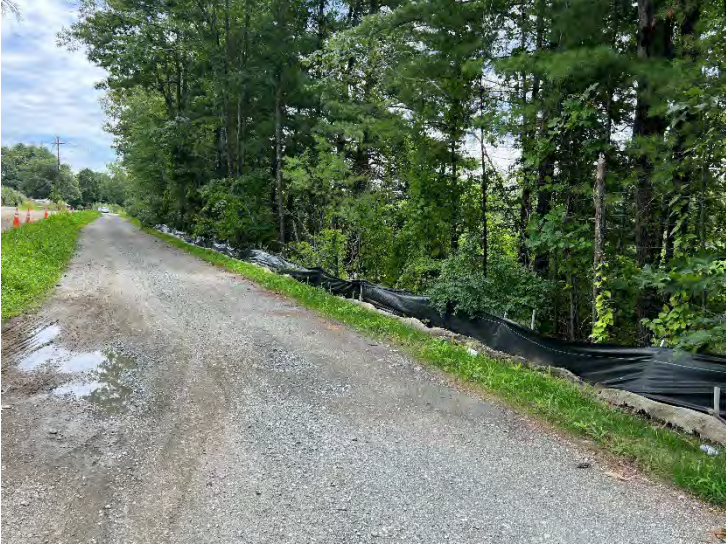
<p>PHOTOGRAPHIC LOG</p>	
<p>Client Name: Eversource</p>		<p>Site Location: Sudbury to Hudson Transmission Reliability Project</p>	<p>Town: Hudson</p>
<p>Photo No.: 8</p>	<p>Date: 8-8-24</p>

<p>Description:</p> <p>View of E&S controls in segment 3. Facing east.</p>

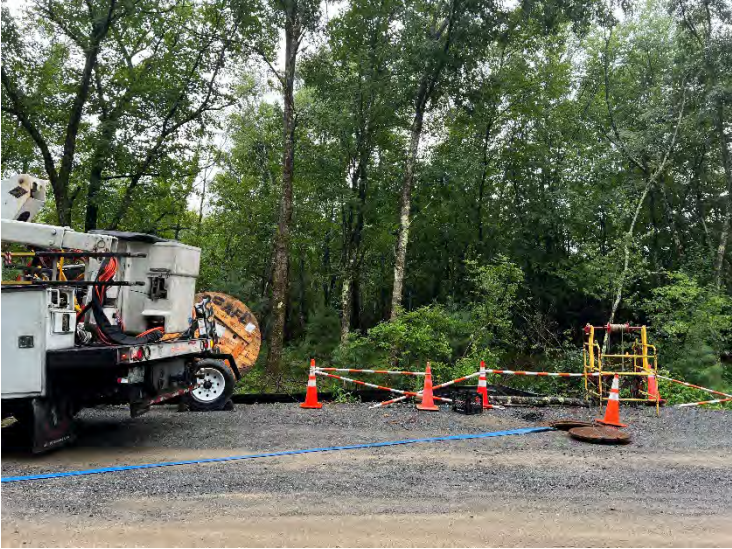
<p>PHOTOGRAPHIC LOG</p>	
<p>Client Name: Eversource</p>		<p>Site Location: Sudbury to Hudson Transmission Reliability Project</p>	<p>Town: Hudson</p>
<p>Photo No.: 1</p>	<p>Date: 8-9-24</p>

<p>Description:</p> <p>View of New Wave at handhole #14 in segment 6. See additional dewatering report. Facing south.</p>

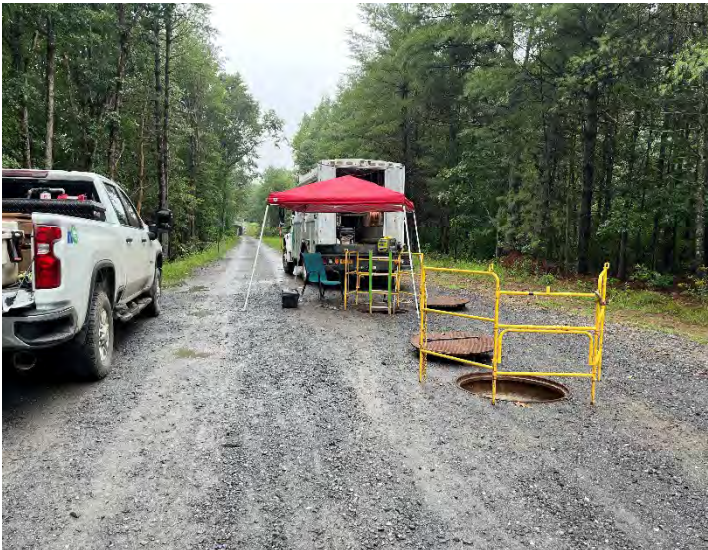
<p>PHOTOGRAPHIC LOG</p>	
<p>Client Name: Eversource</p>		<p>Site Location: Sudbury to Hudson Transmission Reliability Project</p>	<p>Town: Hudson</p>
<p>Photo No.: 2</p>	<p>Date: 8-9-24</p>

<p>Description:</p> <p>View of Haugland cable splicers at MH#7 in segment 2. Facing west.</p>

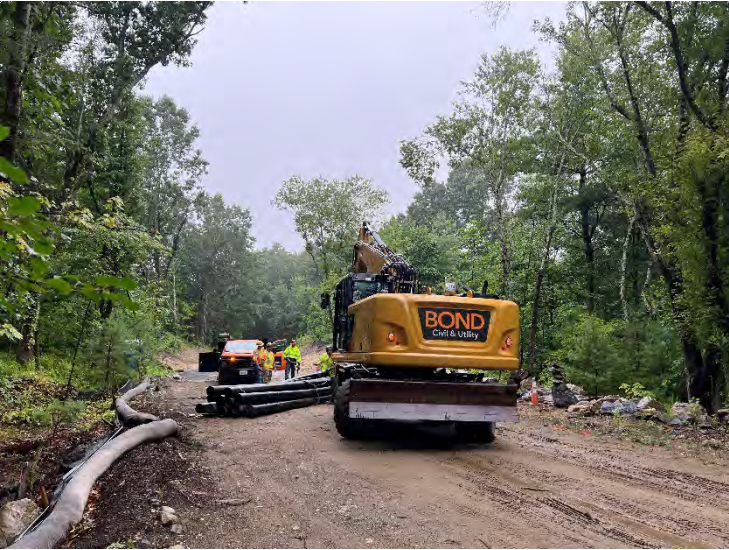
<p>PHOTOGRAPHIC LOG</p>	
<p>Client Name: Eversource</p>		<p>Site Location: Sudbury to Hudson Transmission Reliability Project</p>	<p>Town: Hudson</p>
<p>Photo No.: 3</p>	<p>Date: 8-9-24</p>

<p>Description:</p> <p>View of Bond removing staged materials at entrance to segment 1. Facing west.</p>

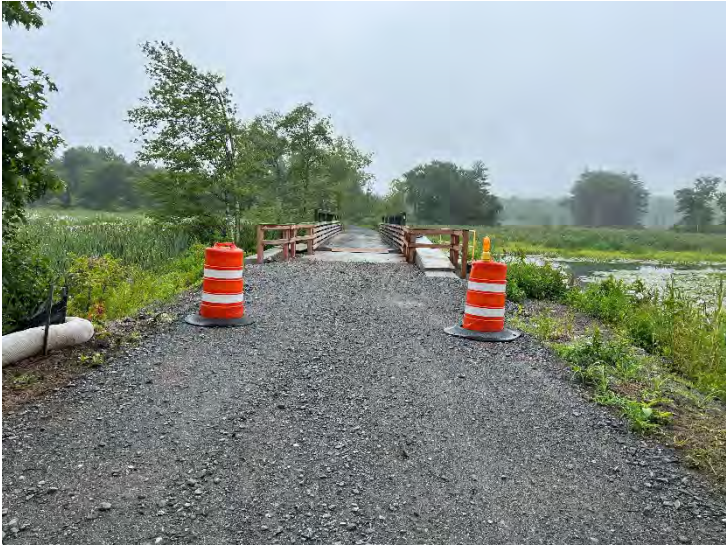
<p align="center">PHOTOGRAPHIC LOG</p>	
<p>Client Name: Eversource</p>		<p>Site Location: Sudbury to Hudson Transmission Reliability Project</p>	<p>Town: Hudson</p>
<p>Photo No.: 5</p>	<p>Date: 8-9-24</p>

<p>Description: View of Bridge 130. Facing east.</p>

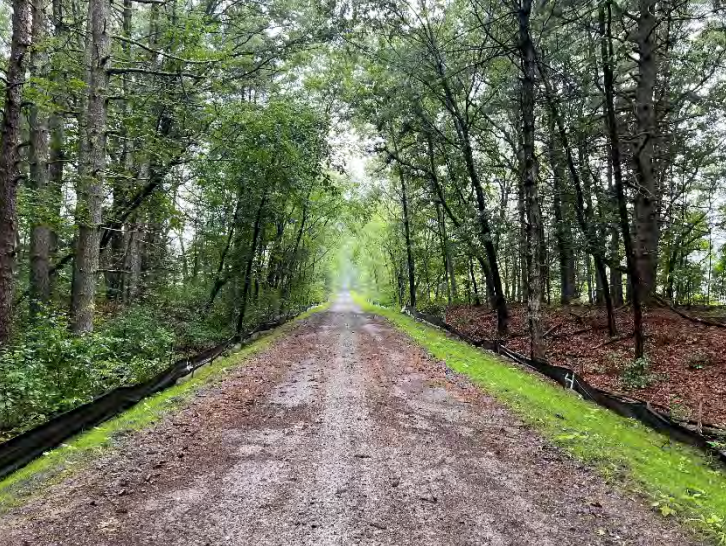
<p align="center">PHOTOGRAPHIC LOG</p>	
<p>Client Name: Eversource</p>		<p>Site Location: Sudbury to Hudson Transmission Reliability Project</p>	<p>Town: Hudson</p>
<p>Photo No.: 6</p>	<p>Date: 8-9-24</p>

<p>Description: View of E&S controls in segment 5. Facing west.</p>

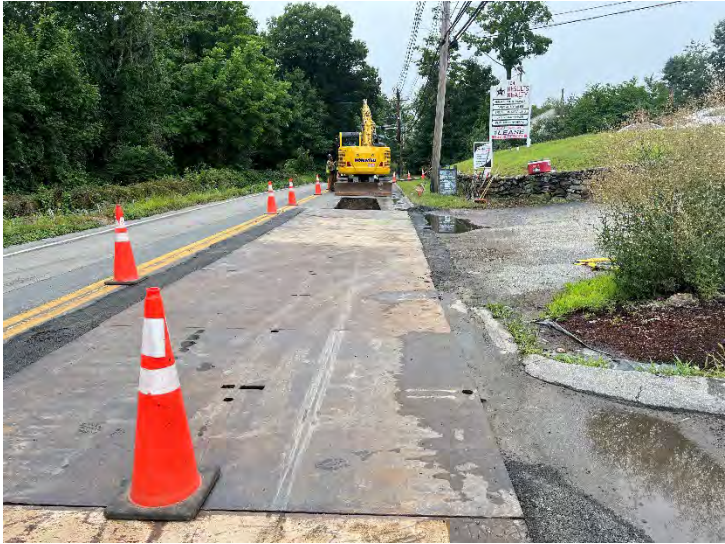
<p>PHOTOGRAPHIC LOG</p>	
<p>Client Name: Eversource</p>		<p>Site Location: Sudbury to Hudson Transmission Reliability Project</p>	<p>Town: Hudson</p>
<p>Photo No.: 7</p>	<p>Date: 8-9-24</p>

<p>Description: View of Bond removing asphalt in preparation for conduit installation west of MH#2 in Forest Ave. Facing west.</p>

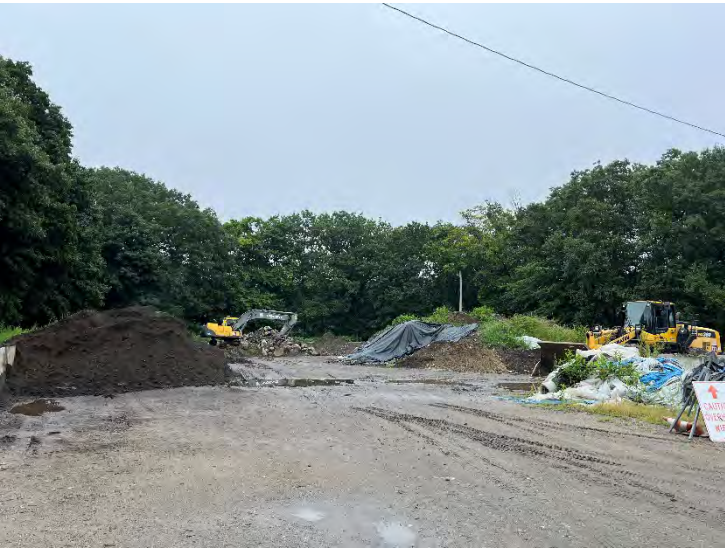
<p>PHOTOGRAPHIC LOG</p>	
<p>Client Name: Eversource</p>		<p>Site Location: Sudbury to Hudson Transmission Reliability Project</p>	<p>Town: Hudson</p>
<p>Photo No.: 8</p>	<p>Date: 8-9-24</p>

<p>Description: View of Stowe Court laydown yard. Facing east.</p>

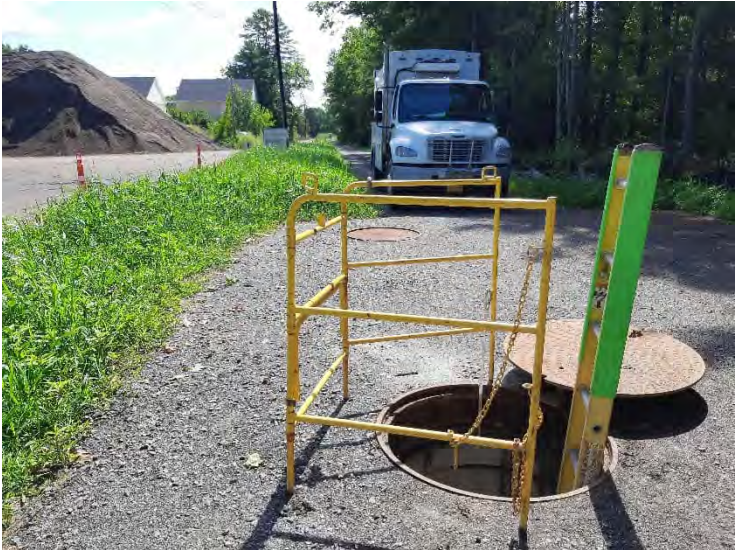
<p>PHOTOGRAPHIC LOG</p>	
<p>Client Name: Eversource</p>		<p>Site Location: Sudbury to Hudson Transmission Reliability Project</p>	<p>Town: Hudson</p>
<p>Photo No.: 1</p>	<p>Date: 8-10-24</p>

<p>Description:</p> <p>Work area at manhole #8 (segment 3), Haugland modifying manhole, looking eastward.</p>

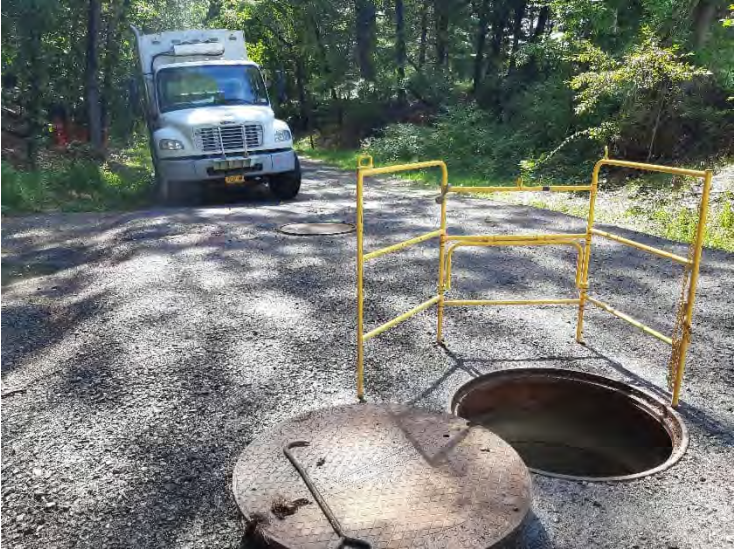
<p>PHOTOGRAPHIC LOG</p>	
<p>Client Name: Eversource</p>		<p>Site Location: Sudbury to Hudson Transmission Reliability Project</p>	<p>Town: Hudson</p>
<p>Photo No.: 2</p>	<p>Date: 8-10-24</p>

<p>Description:</p> <p>Work area at manhole #9 (segment 3), Haugland modifying manholes, looking eastward.</p>

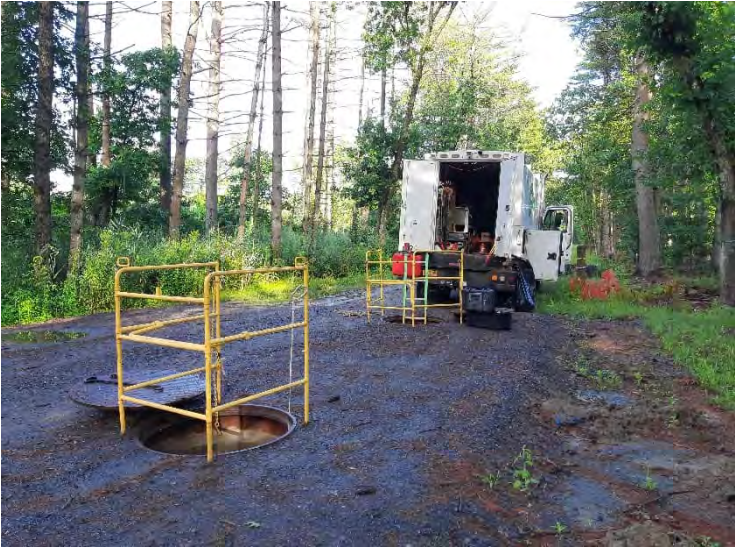
<p>PHOTOGRAPHIC LOG</p>	
<p>Client Name: Eversource</p>		<p>Site Location: Sudbury to Hudson Transmission Reliability Project</p>	<p>Town: Hudson</p>
<p>Photo No.: 3</p>	<p>Date: 8-10-24</p>

<p>Description:</p> <p>Work area at manhole #10 (segment 4), Haugland modifying manhole, looking westward.</p>

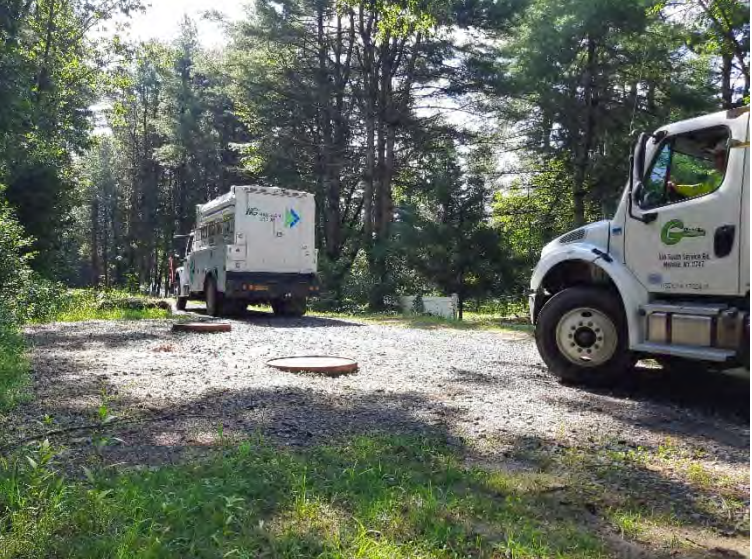
<p>PHOTOGRAPHIC LOG</p>	
<p>Client Name: Eversource</p>		<p>Site Location: Sudbury to Hudson Transmission Reliability Project</p>	<p>Town: Hudson</p>
<p>Photo No.: 4</p>	<p>Date: 8-10-24</p>

<p>Description:</p> <p>Work area at manhole #11 (segment 5), Haugland modifying manholes, looking eastward.</p>

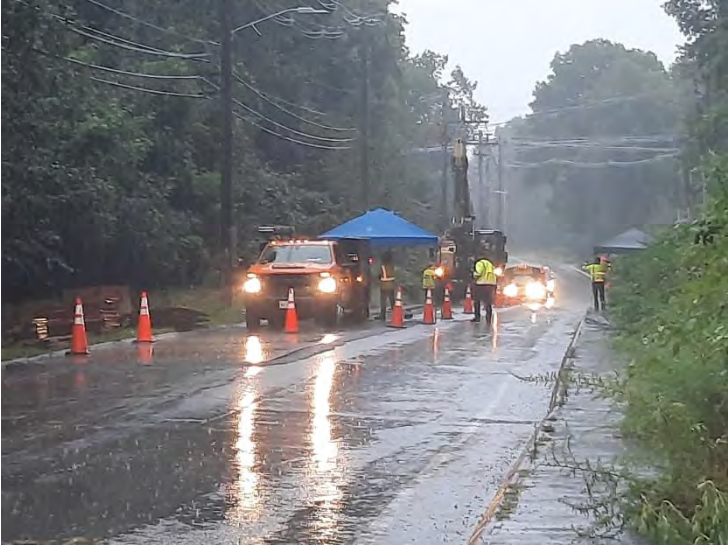
PHOTOGRAPHIC LOG	
Client Name: Eversource		Site Location: Sudbury to Hudson Transmission Reliability Project	Town: Hudson
Photo No.: 2	Date: 8-6-24

Description: Bond conducting conduit work within Forest Avenue near Hudson Light & Power, looking southward.

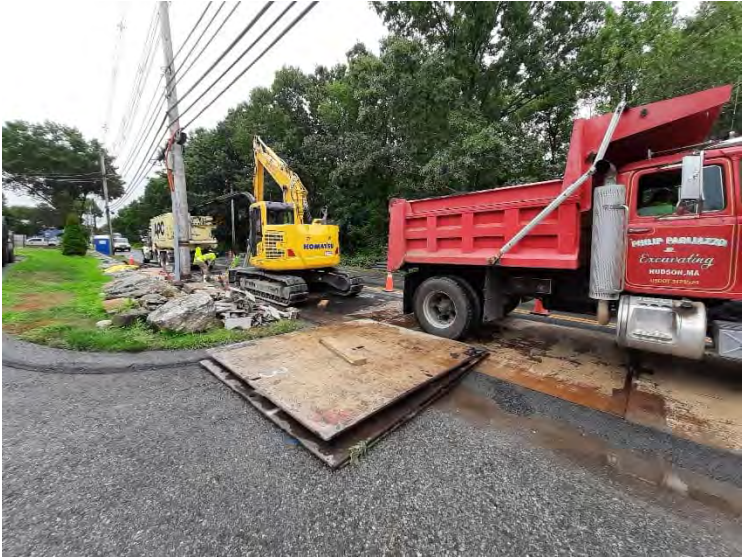
PHOTOGRAPHIC LOG	
Client Name: Eversource		Site Location: Sudbury to Hudson Transmission Reliability Project	Town: Hudson
Photo No.: 3	Date: 8-6-24

Description: Bond conducting conduit work within Forest Avenue near manhole #2 and Bonazzoli Ave, looking eastward.

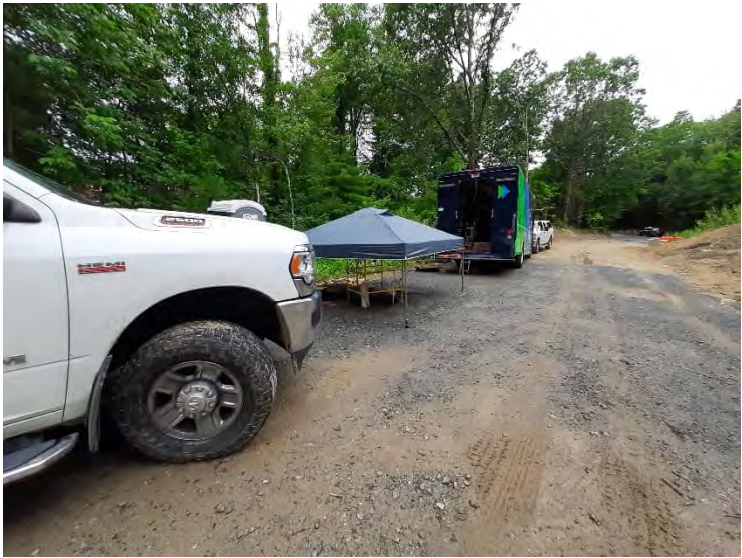
PHOTOGRAPHIC LOG	
Client Name: Eversource		Site Location: Sudbury to Hudson Transmission Reliability Project	Town: Hudson
Photo No.: 4	Date: 8-6-24

Description: Work area at manhole #5, within segment 1, Haugland crimping and splicing, looking westward.

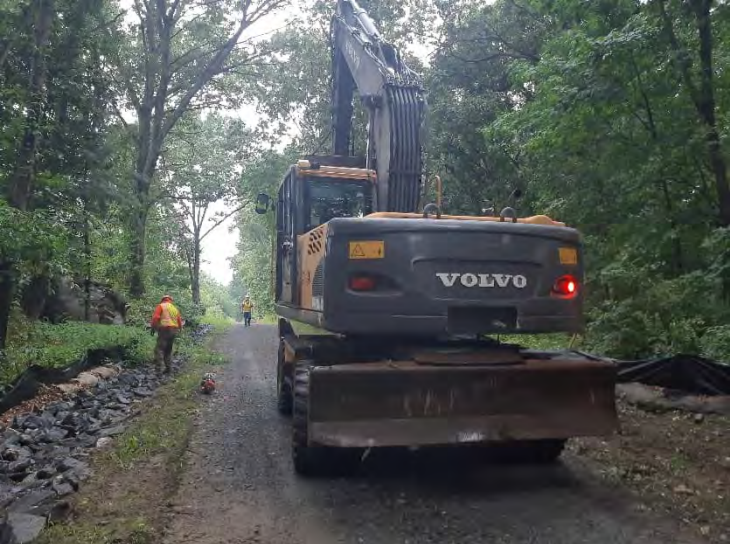
PHOTOGRAPHIC LOG	
Client Name: Eversource		Site Location: Sudbury to Hudson Transmission Reliability Project	Town: Hudson
Photo No.: 5	Date: 8-6-24

Description: Work area within segment 1, ET&L cleanup and weeding along shoulders, existing erosion controls, looking westward.

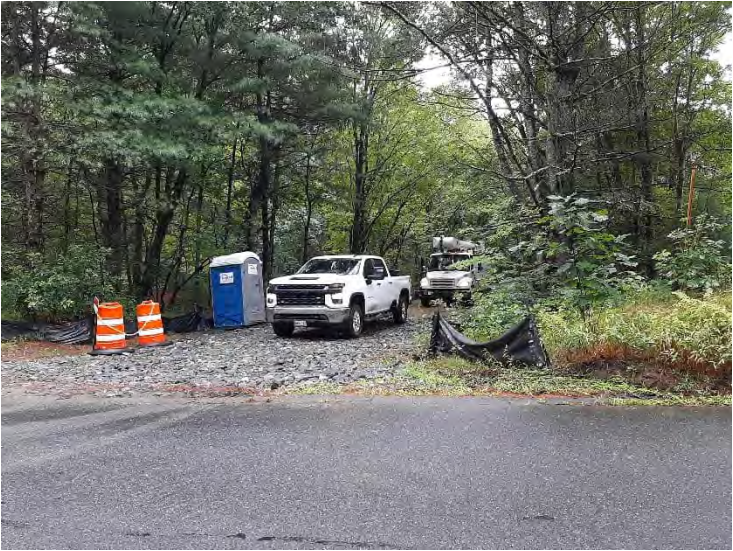
PHOTOGRAPHIC LOG	
Client Name: Eversource		Site Location: Sudbury to Hudson Transmission Reliability Project	Town: Hudson
Photo No.: 7	Date: 8-6-24

Description: Haugland exiting segment 6, after cable pulling in Sudbury, existing erosion controls, looking eastward.

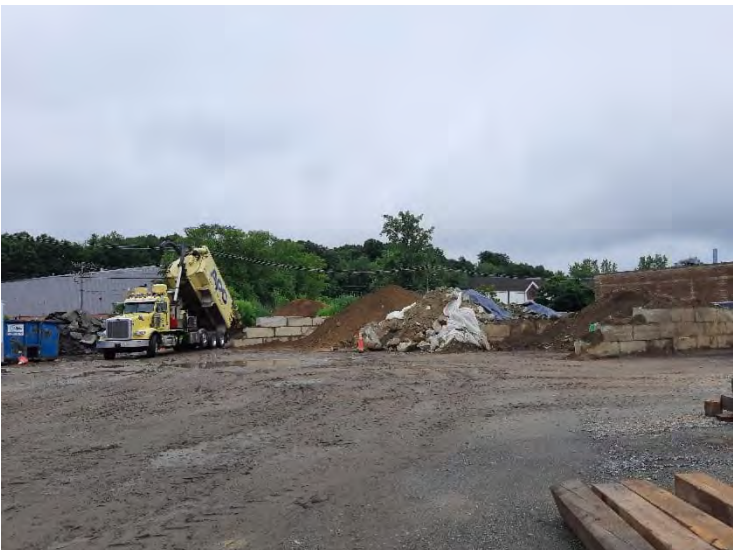
PHOTOGRAPHIC LOG	
Client Name: Eversource		Site Location: Sudbury to Hudson Transmission Reliability Project	Town: Hudson
Photo No.: 8	Date: 8-6-24

Description: Bonazzoli laydown yard, adding material to stockpile from Forest Ave work near manhole #2, existing stockpiles, looking westward.

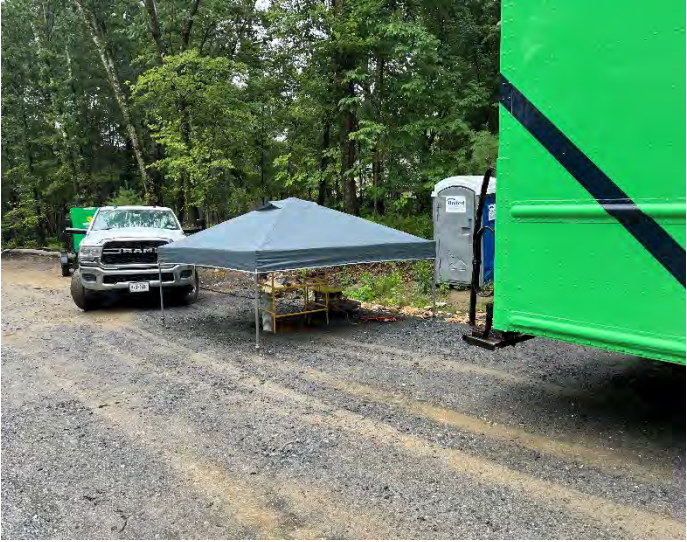
PHOTOGRAPHIC LOG	
Client Name: Eversource		Site Location: Sudbury to Hudson Transmission Reliability Project	Town: Hudson
Photo No.: 1	Date: 8-7-2024

Description: View of Haugland cable splicers working at MH #5 in segment 1. Facing east.

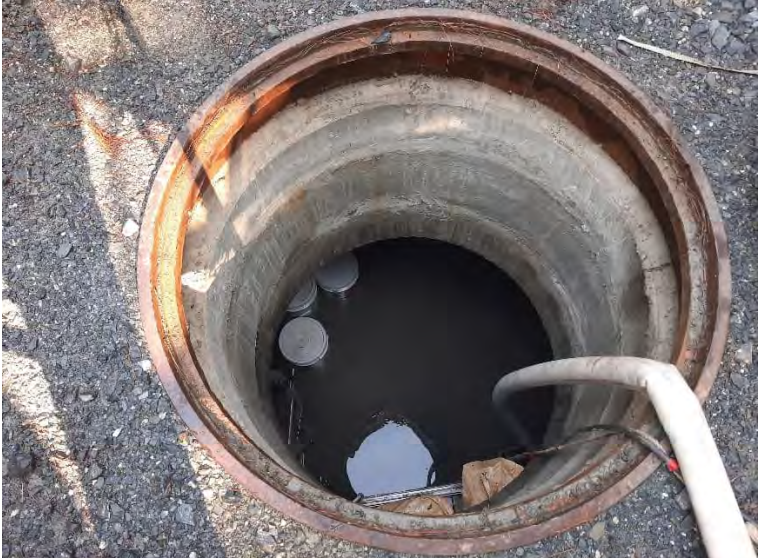
PHOTOGRAPHIC LOG	
Client Name: Eversource		Site Location: Sudbury to Hudson Transmission Reliability Project	Town: Sudbury
Photo No.: 1	Date: 8/5/2024

Description: View of manhole #15 (segment 7), area being pumped, looking down.

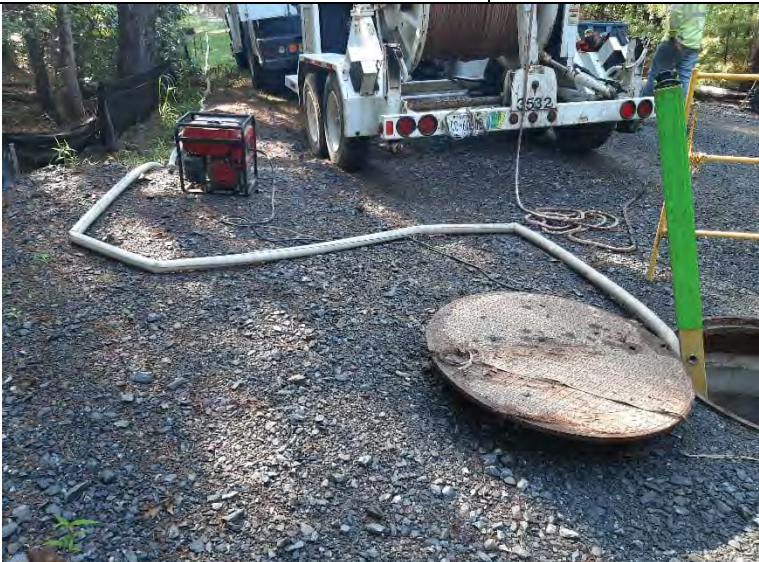
PHOTOGRAPHIC LOG	
Client Name: Eversource		Site Location: Sudbury to Hudson Transmission Reliability Project	Town: Sudbury
Photo No.: 2	Date: 8/5/2024

Description: Manhole #15. View of dewatering operation, looking eastward.

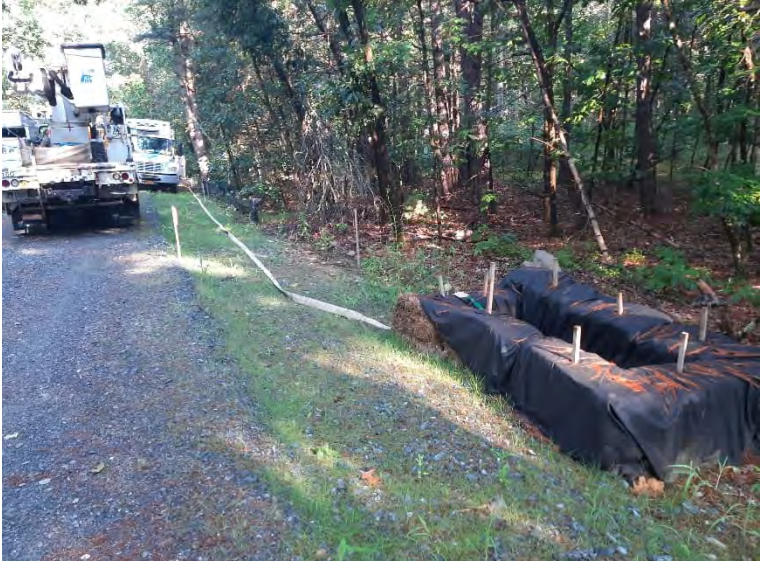
PHOTOGRAPHIC LOG	
Client Name: Eversource		Site Location: Sudbury to Hudson Transmission Reliability Project	Town: Sudbury
Photo No.: 3	Date: 8/5/2024

Description: View of dewatering operation for manhole #15, looking westward.

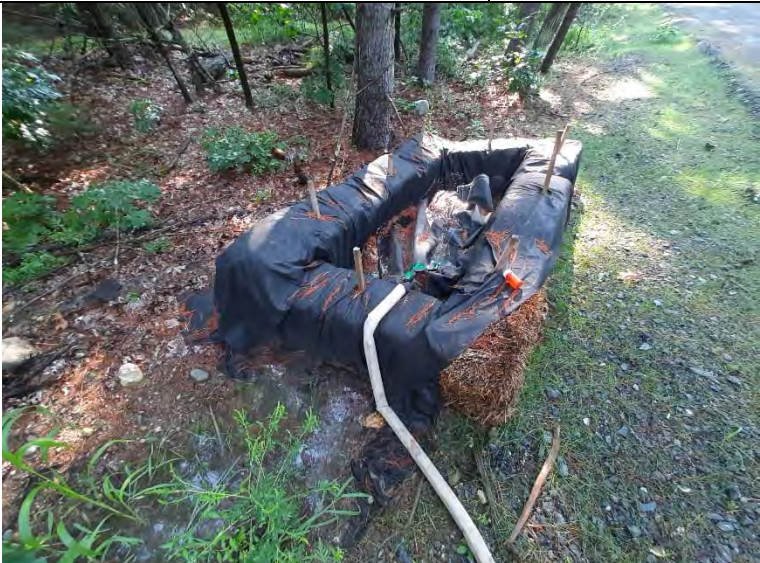
PHOTOGRAPHIC LOG	
Client Name: Eversource		Site Location: Sudbury to Hudson Transmission Reliability Project	Town: Sudbury
Photo No.: 4	Date: 8/5/2024

Description: Manhole #15. View of discharge bag/corral, looking eastward, corral discharging to the surrounding area.

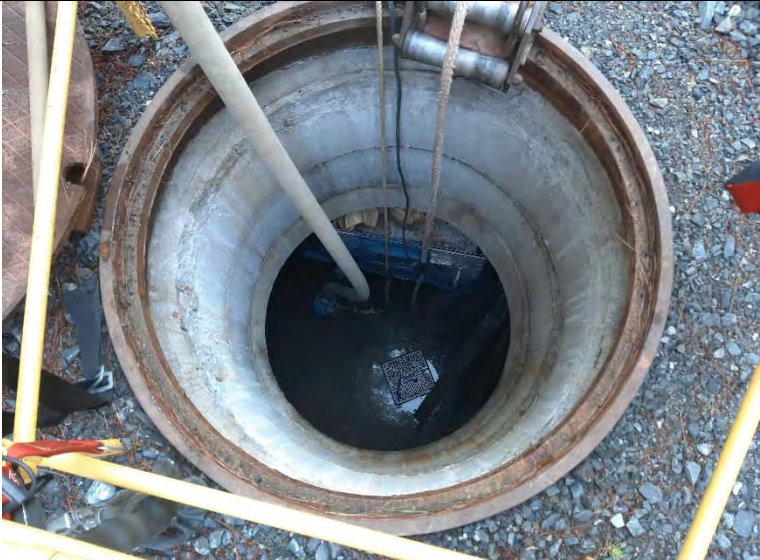
PHOTOGRAPHIC LOG	
Client Name: Eversource		Site Location: Sudbury to Hudson Transmission Reliability Project	Town: Sudbury
Photo No.: 1	Date: 8/5/2024

Description: View of manhole #16 (segment 7), area being pumped, looking down.

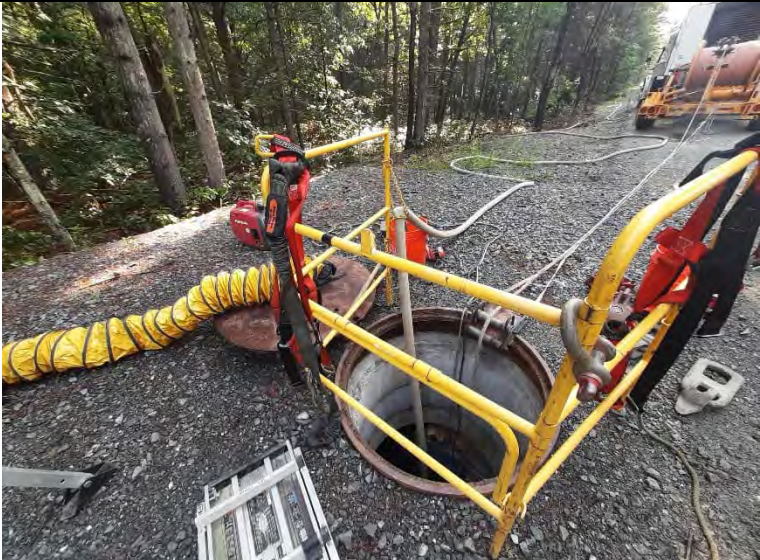
PHOTOGRAPHIC LOG	
Client Name: Eversource		Site Location: Sudbury to Hudson Transmission Reliability Project	Town: Sudbury
Photo No.: 2	Date: 8/5/2024

Description: Manhole #16. View of dewatering operation, looking eastward.

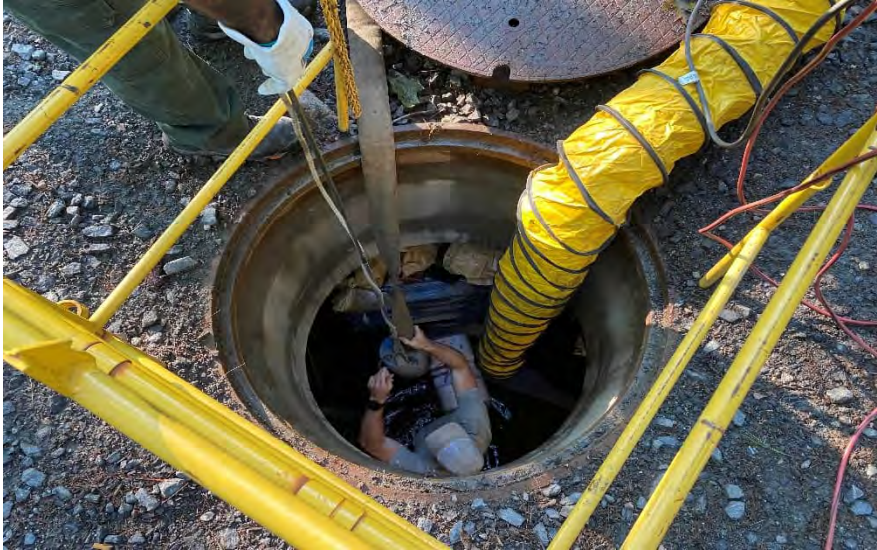
PHOTOGRAPHIC LOG	
Client Name: Eversource		Site Location: Sudbury to Hudson Transmission Reliability Project	Town: Sudbury
Photo No.: 1	Date: 8/5/2024

Description: View of area being pumped from manhole #25, Segment 13.

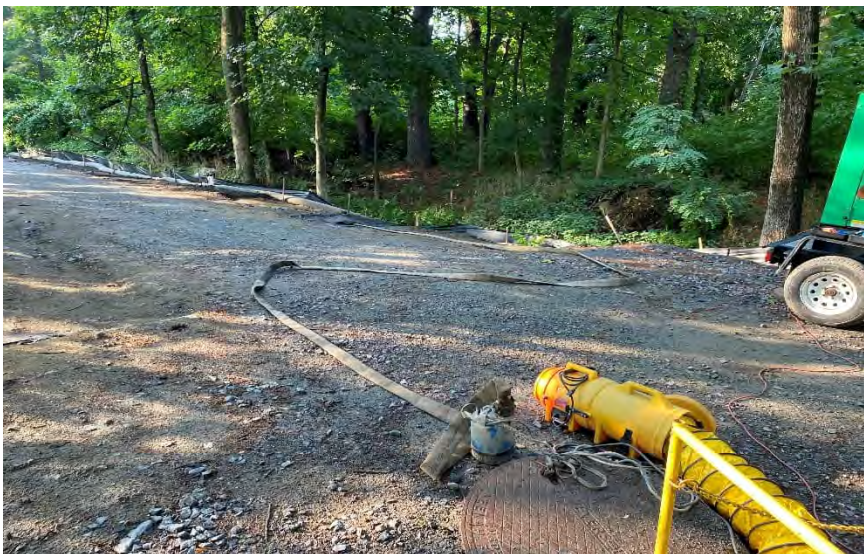
PHOTOGRAPHIC LOG	
Client Name: Eversource		Site Location: Sudbury to Hudson Transmission Reliability Project	Town: Sudbury
Photo No.: 2	Date: 8/5/2024

Description: Manhole #25. View of dewatering operation. Looking westward.

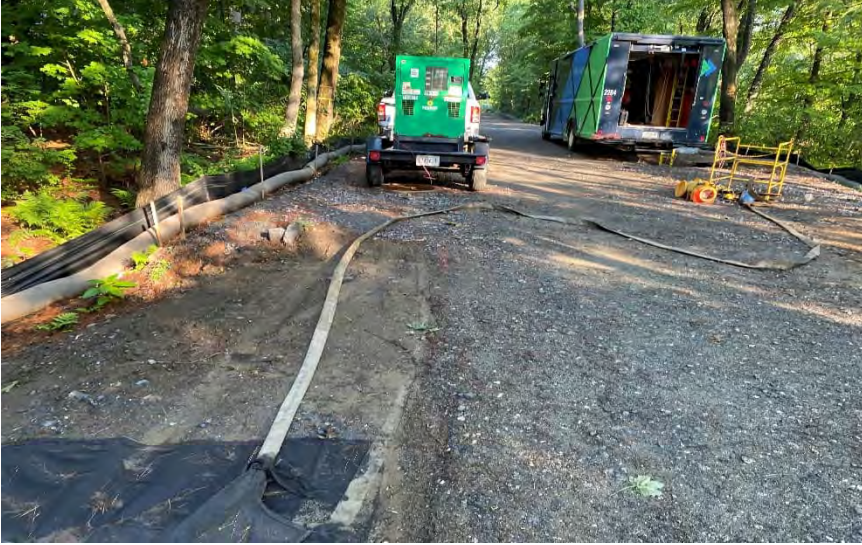
PHOTOGRAPHIC LOG	
Client Name: Eversource		Site Location: Sudbury to Hudson Transmission Reliability Project	Town: Sudbury
Photo No.: 3	Date: 8/5/2024

Description: Manhole #25. View of dewatering operation, looking westward.

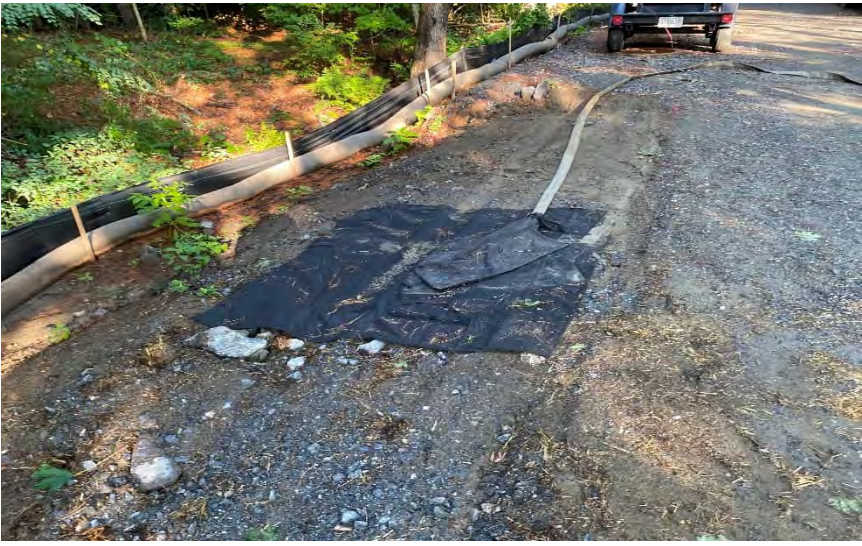
PHOTOGRAPHIC LOG	
Client Name: Eversource		Site Location: Sudbury to Hudson Transmission Reliability Project	Town: Sudbury
Photo No.: 4	Date: 8/5/2024

Description: Manhole #25. View of discharge bag. Water from bag discharged to adjacent area within segment 13.

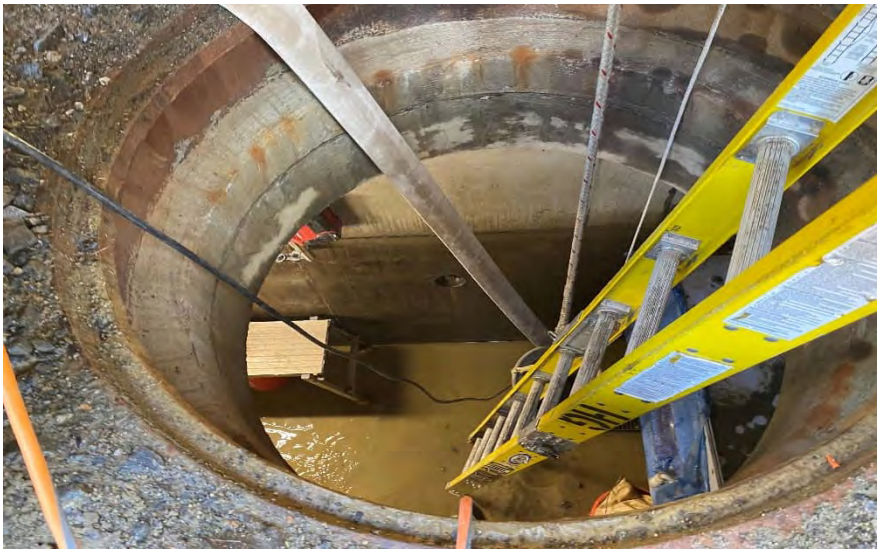
PHOTOGRAPHIC LOG	
Client Name: Eversource		Site Location: Sudbury to Hudson Transmission Reliability Project	Town: Sudbury
Photo No.: 1	Date: 8/5/2024

Description: View of area being pumped from manhole #26 within Segment 14.

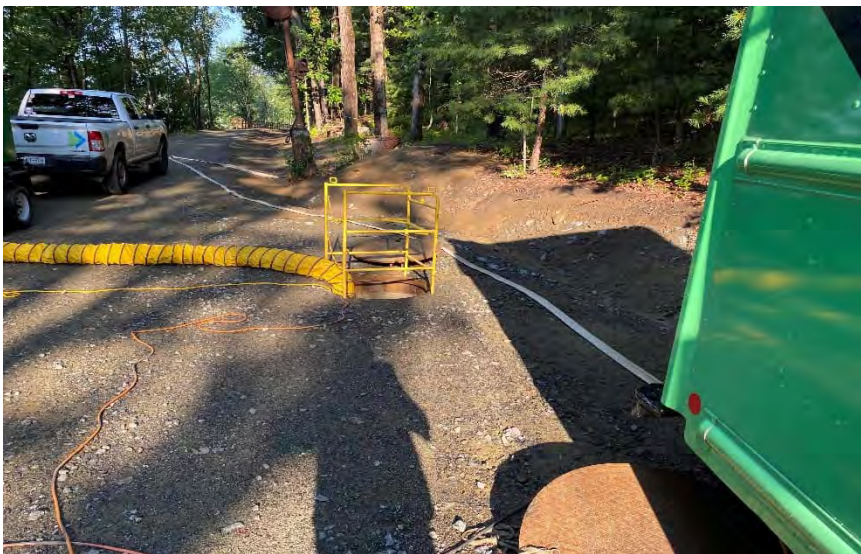
PHOTOGRAPHIC LOG	
Client Name: Eversource		Site Location: Sudbury to Hudson Transmission Reliability Project	Town: Sudbury
Photo No.: 2	Date: 8/5/2024

Description: Manhole #26. View of dewatering operation. Looking westward.

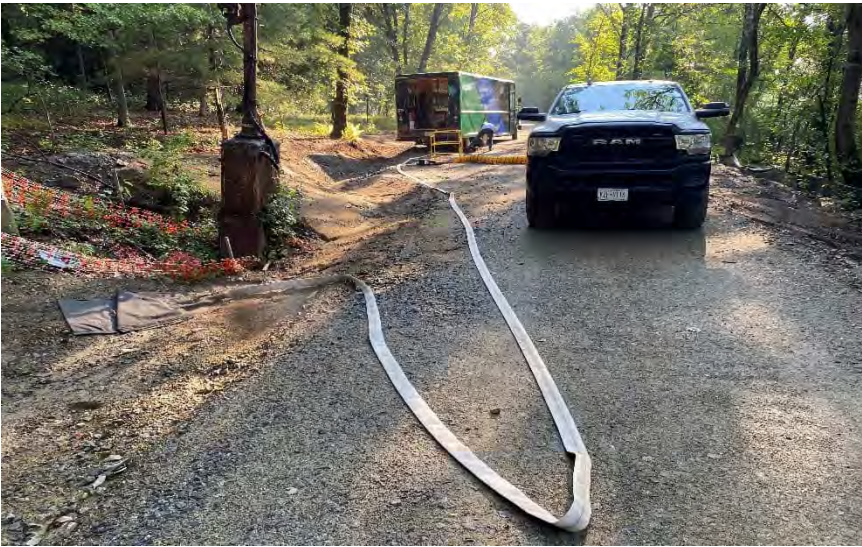
PHOTOGRAPHIC LOG	
Client Name: Eversource		Site Location: Sudbury to Hudson Transmission Reliability Project	Town: Sudbury
Photo No.: 3	Date: 8/5/2024

Description: Manhole #26 View of dewatering operation, looking eastward.

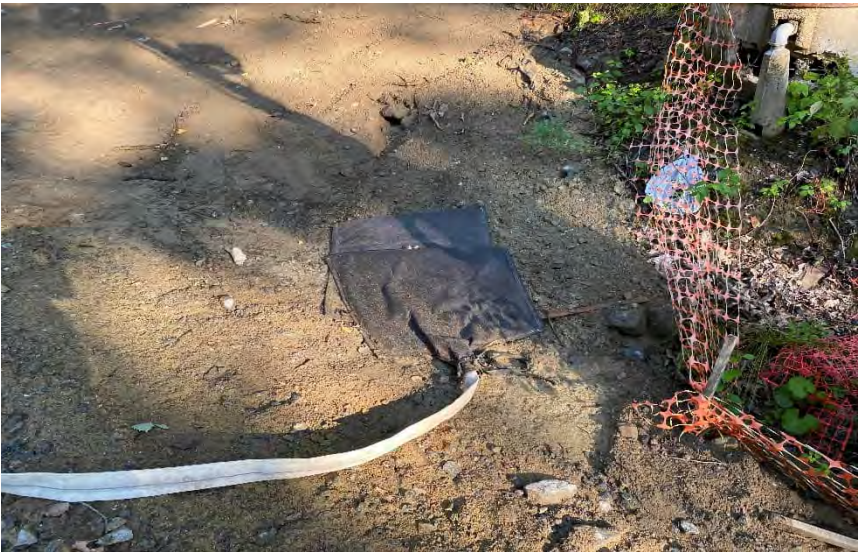
PHOTOGRAPHIC LOG	
Client Name: Eversource		Site Location: Sudbury to Hudson Transmission Reliability Project	Town: Sudbury
Photo No.: 4	Date: 8/5/2024

Description: Manhole #26. View of discharge bag. Water from bag discharged to adjacent area within segment 14.

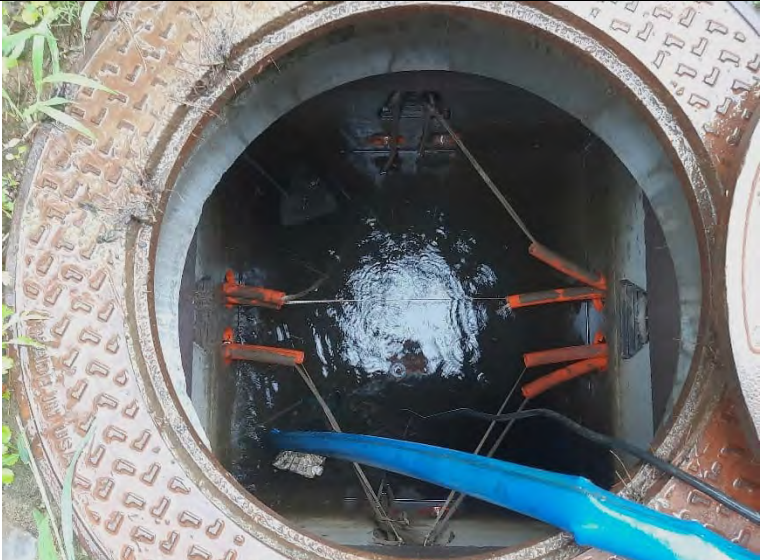
PHOTOGRAPHIC LOG	
Client Name: Eversource		Site Location: Sudbury to Hudson Transmission Reliability Project	Town: Hudson
Photo No.: 1	Date: 8/6/2024

Description: View of handhole #9 (segment 3), area being pumped, looking down.

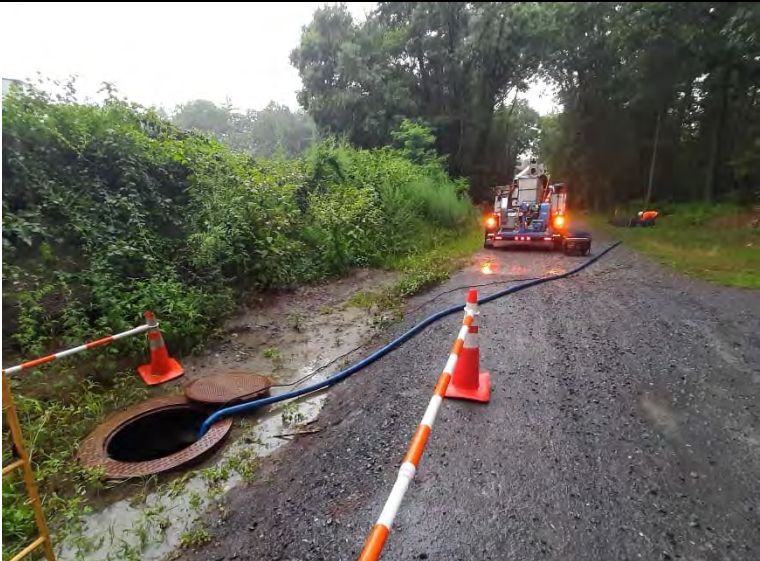
PHOTOGRAPHIC LOG	
Client Name: Eversource		Site Location: Sudbury to Hudson Transmission Reliability Project	Town: Hudson
Photo No.: 2	Date: 8/6/2024

Description: Manhole #9. View of dewatering operation, looking westward.

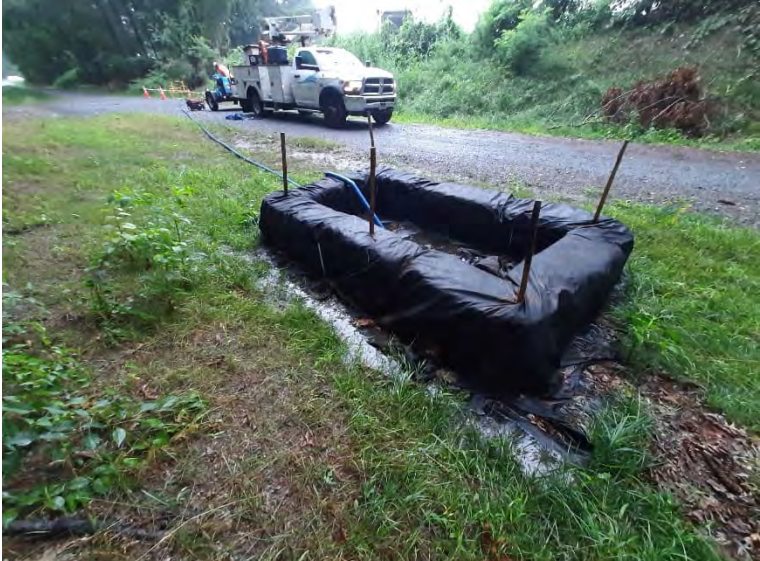
PHOTOGRAPHIC LOG	
Client Name: Eversource		Site Location: Sudbury to Hudson Transmission Reliability Project	Town: Hudson
Photo No.: 3	Date: 8/6/2024

Description: View of dewatering operation for manhole #9, looking eastward.

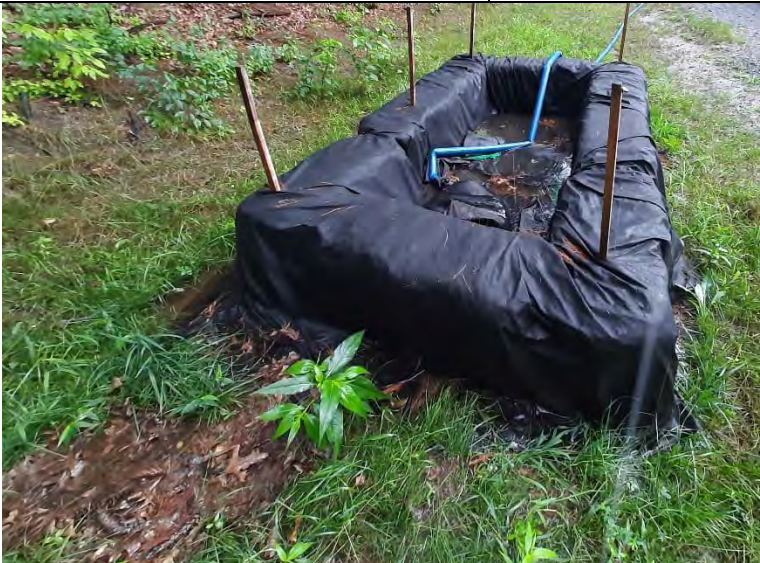
PHOTOGRAPHIC LOG	
Client Name: Eversource		Site Location: Sudbury to Hudson Transmission Reliability Project	Town: Hudson
Photo No.: 4	Date: 8/6/2024

Description: Manhole #9. View of discharge bag/corral, looking eastward, corral discharging to the surrounding area.

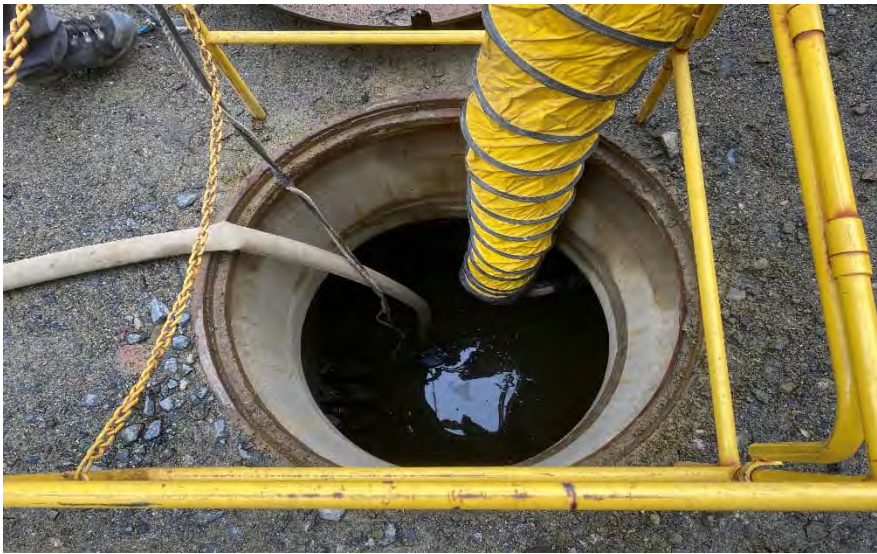
PHOTOGRAPHIC LOG	
Client Name: Eversource		Site Location: Sudbury to Hudson Transmission Reliability Project	Town: Sudbury
Photo No.: 1	Date: 8/6/2024

Description: View of area being pumped from manhole #27 within Segment 14.

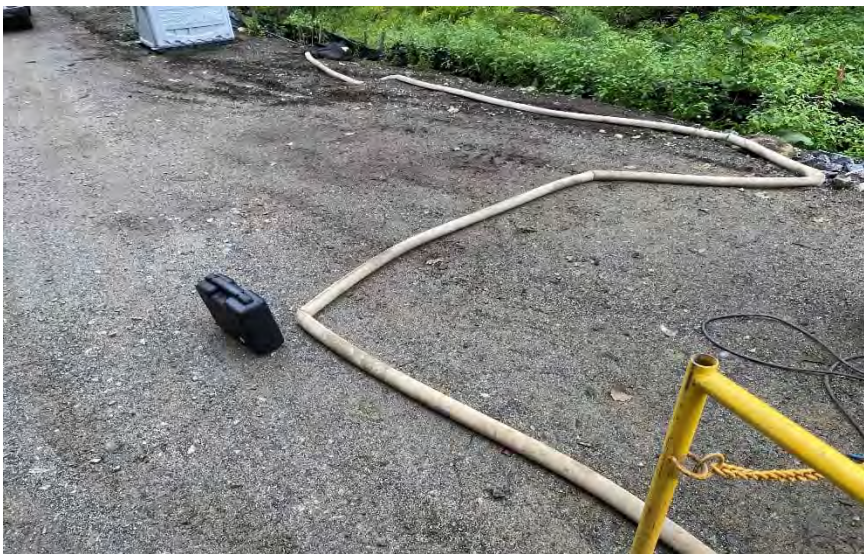
PHOTOGRAPHIC LOG	
Client Name: Eversource		Site Location: Sudbury to Hudson Transmission Reliability Project	Town: Sudbury
Photo No.: 2	Date: 8/6/2024

Description: Manhole #27. View of dewatering operation. Looking westward.

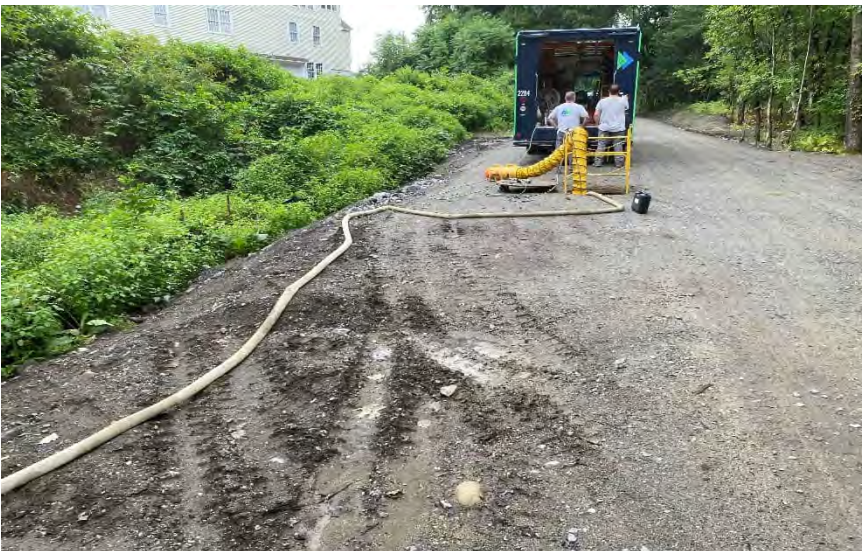
PHOTOGRAPHIC LOG	
Client Name: Eversource		Site Location: Sudbury to Hudson Transmission Reliability Project	Town: Sudbury
Photo No.: 3	Date: 8/6/2024

Description: Manhole #27 View of dewatering operation, looking eastward.
