Weekly Environmental Compliance Summary

Sudbury to Hudson Transmission Reliability Project (USEPA Tracking # MAR1003UW)

Sudbury, Hudson, and Stow, MA

Week of: August 5, 2024 to August 10, 2024

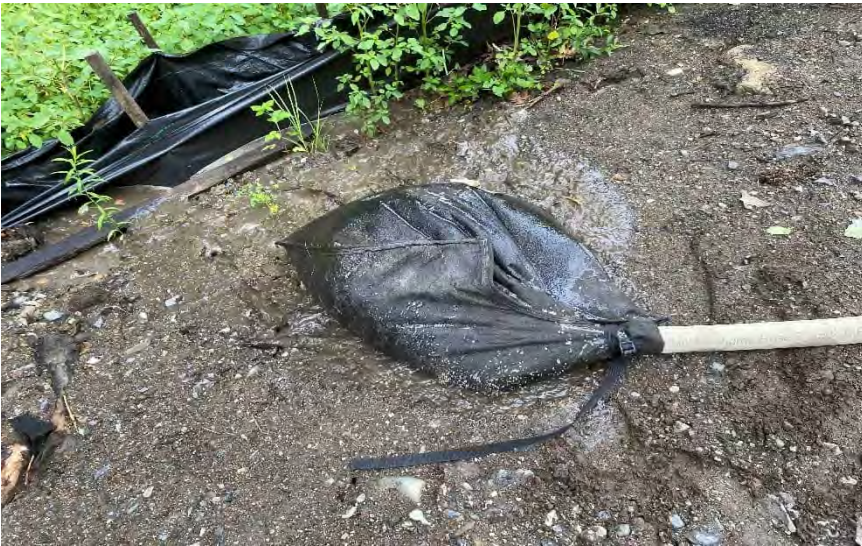
PHOTOGRAPHIC LOG	
Client Name: Eversource		Site Location: Sudbury to Hudson Transmission Reliability Project	Town: Sudbury
Photo No.: 4	Date: 8/6/2024

Description: Manhole #27. View of discharge bag. Water from bag discharged to adjacent vegetated area within segment 14.

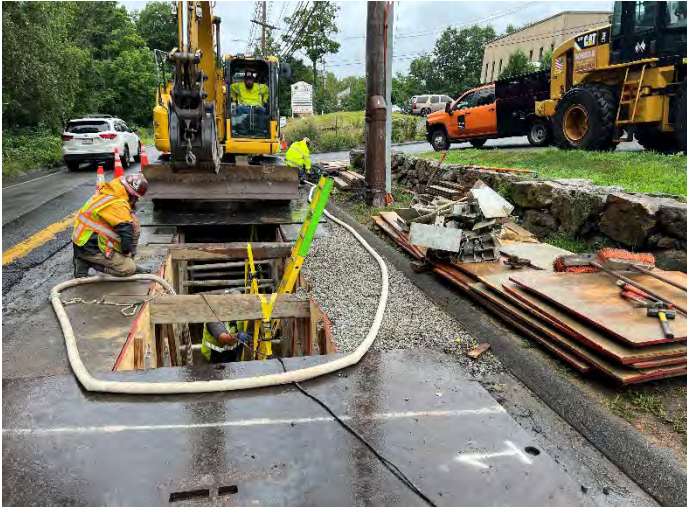
PHOTOGRAPHIC LOG	
Client Name: Eversource		Site Location: Sudbury to Hudson Transmission Reliability Project	Town: Hudson
Photo No.: 1	Date: 8/7/2024

Description: View of Bond workspace west of MH#2 within Forest Ave. Facing west.

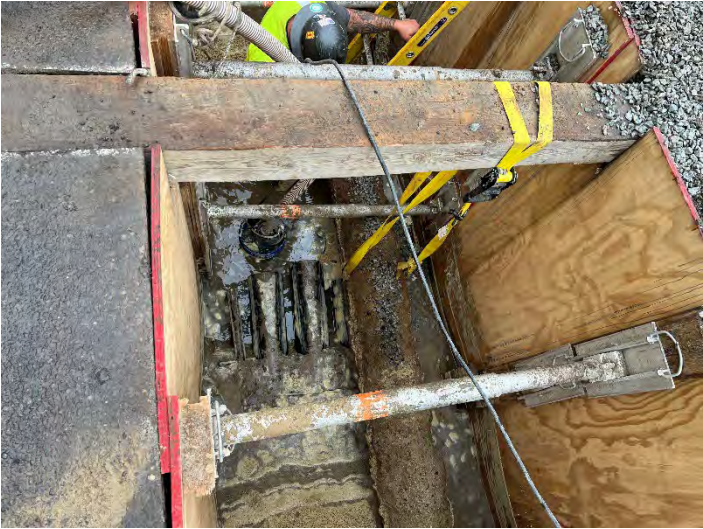
PHOTOGRAPHIC LOG	
Client Name: Eversource		Site Location: Sudbury to Hudson Transmission Reliability Project	Town: Hudson
Photo No.: 2	Date: 8/7/2024

Description: View of pump in trench. Sand from trench walls visibly mixing in with storm water within trench.

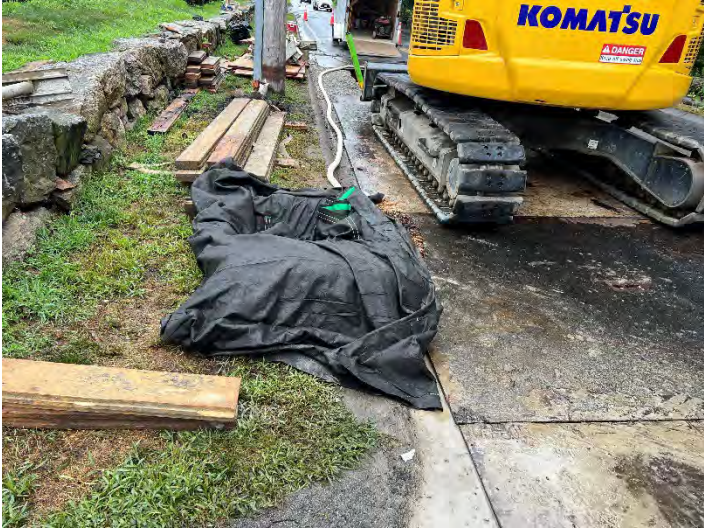
PHOTOGRAPHIC LOG	
Client Name: Eversource		Site Location: Sudbury to Hudson Transmission Reliability Project	Town: Hudson
Photo No.: 3	Date: 8/7/2024

Description: View of dewatering controls (straw bale corral with filter fabric and silt bag). Facing east.

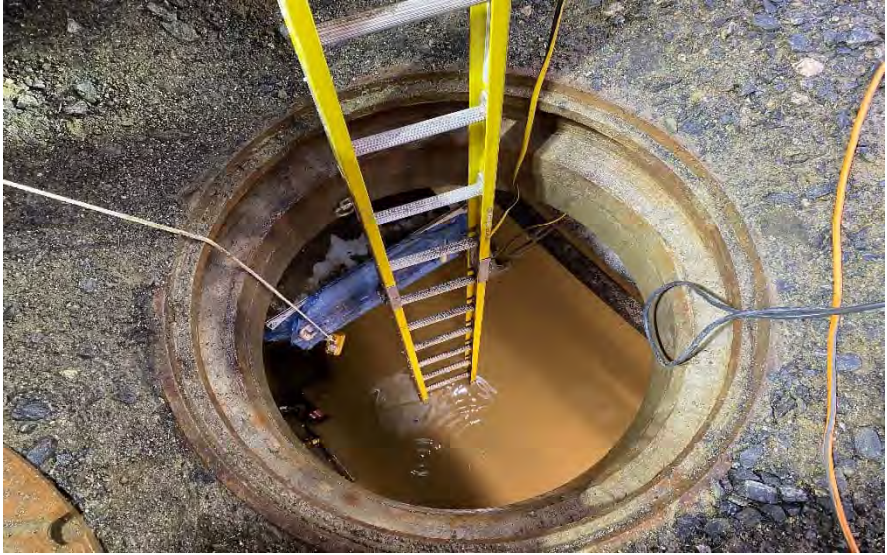
PHOTOGRAPHIC LOG	
Client Name: Eversource		Site Location: Sudbury to Hudson Transmission Reliability Project	Town: Sudbury
Photo No.: 1	Date: 8/7/2024

Description: View of area being pumped from manhole #26 within Segment 14.

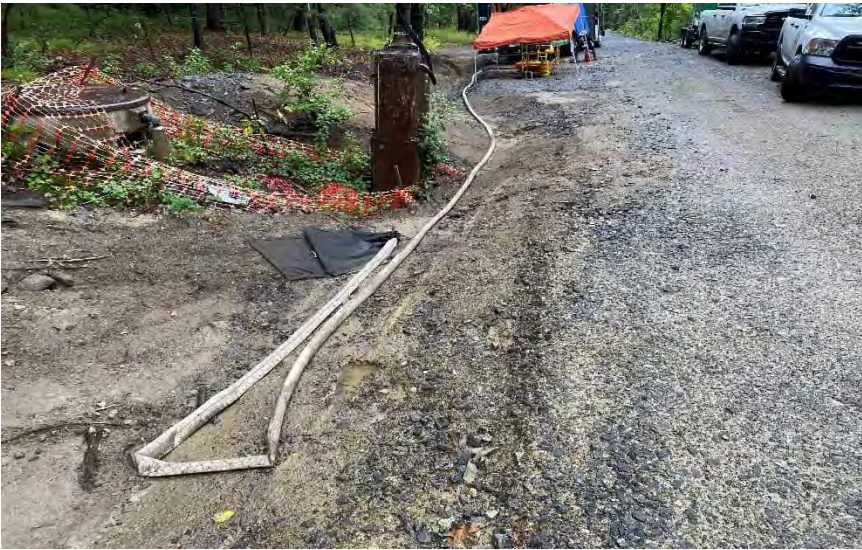
PHOTOGRAPHIC LOG	
Client Name: Eversource		Site Location: Sudbury to Hudson Transmission Reliability Project	Town: Sudbury
Photo No.: 3	Date: 8/7/2024

Description: Manhole #26 View of dewatering operation, looking eastward.

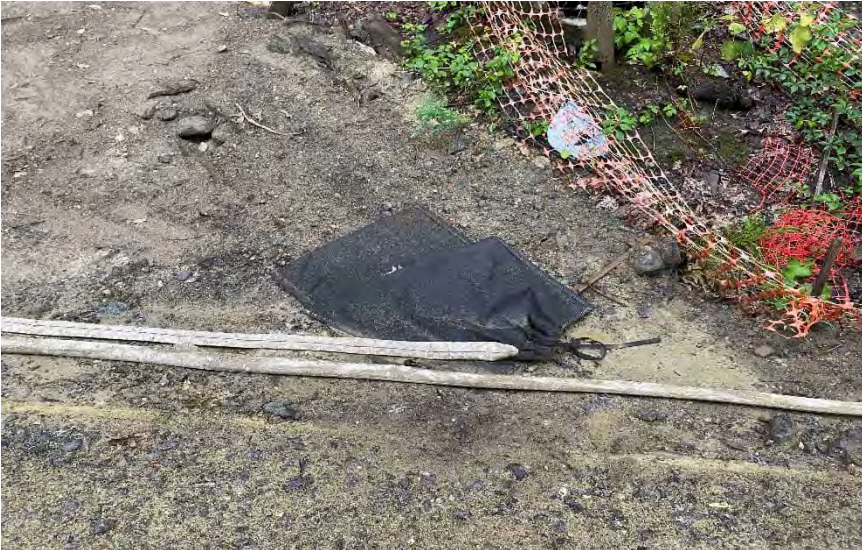
PHOTOGRAPHIC LOG	
Client Name: Eversource		Site Location: Sudbury to Hudson Transmission Reliability Project	Town: Sudbury
Photo No.: 4	Date: 8/7/2024

Description: Manhole #26. View of discharge bag. Water from bag discharged to adjacent area within segment 14.

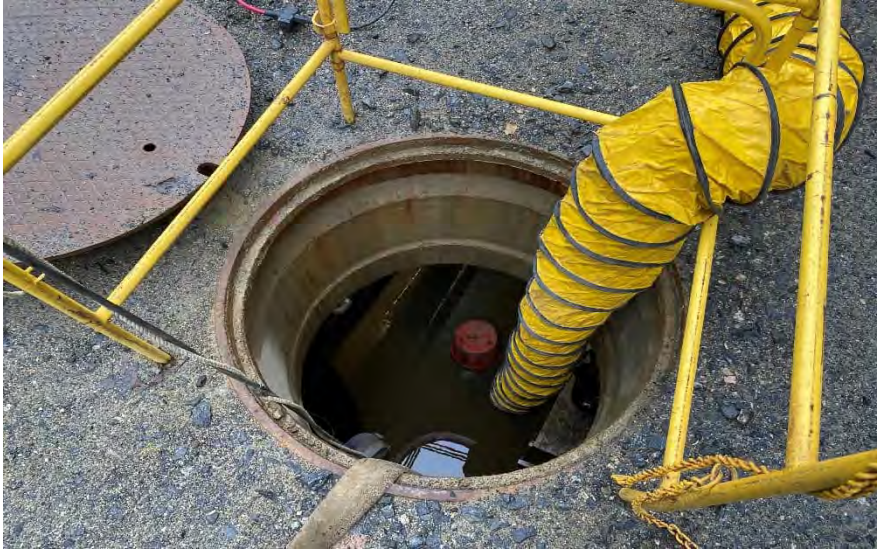
PHOTOGRAPHIC LOG	
Client Name: Eversource		Site Location: Sudbury to Hudson Transmission Reliability Project	Town: Sudbury
Photo No.: 1	Date: 8/7/2024

Description: View of area being pumped from manhole #27 within Segment 14.

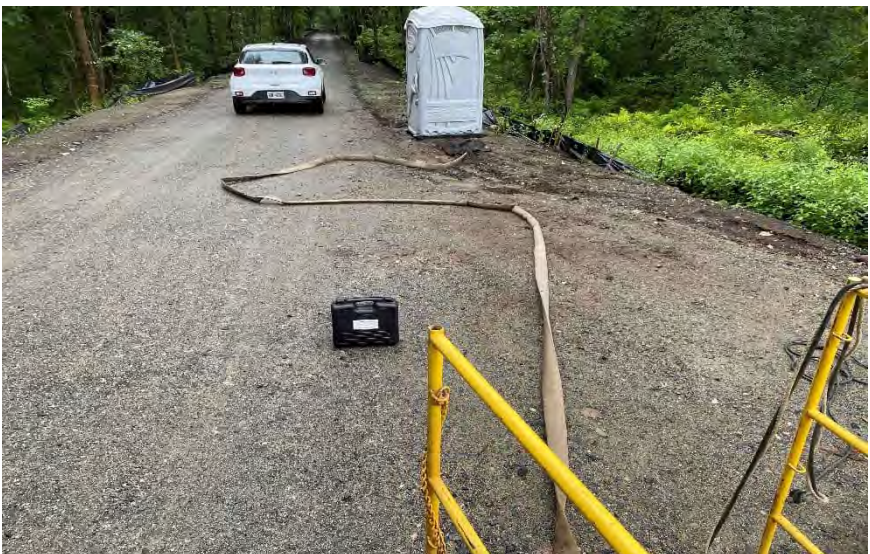
PHOTOGRAPHIC LOG	
Client Name: Eversource		Site Location: Sudbury to Hudson Transmission Reliability Project	Town: Sudbury
Photo No.: 2	Date: 8/7/2024

Description: Manhole #27. View of dewatering operation. Looking westward.

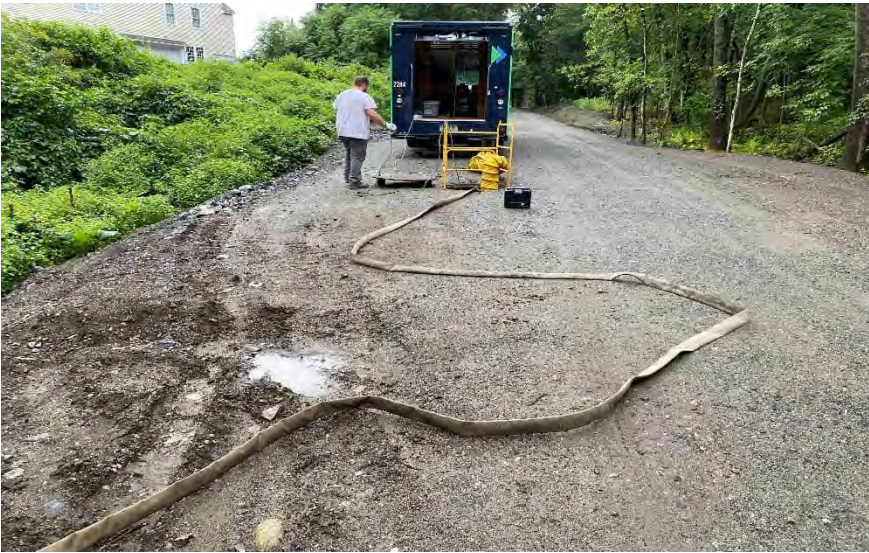
<h2 style="margin: 0;">PHOTOGRAPHIC LOG</h2>	
Client Name: Eversource		Site Location: Sudbury to Hudson Transmission Reliability Project	Town: Sudbury
Photo No.: 3	Date: 8/7/2024

Description: Manhole #27 View of dewatering operation, looking eastward.

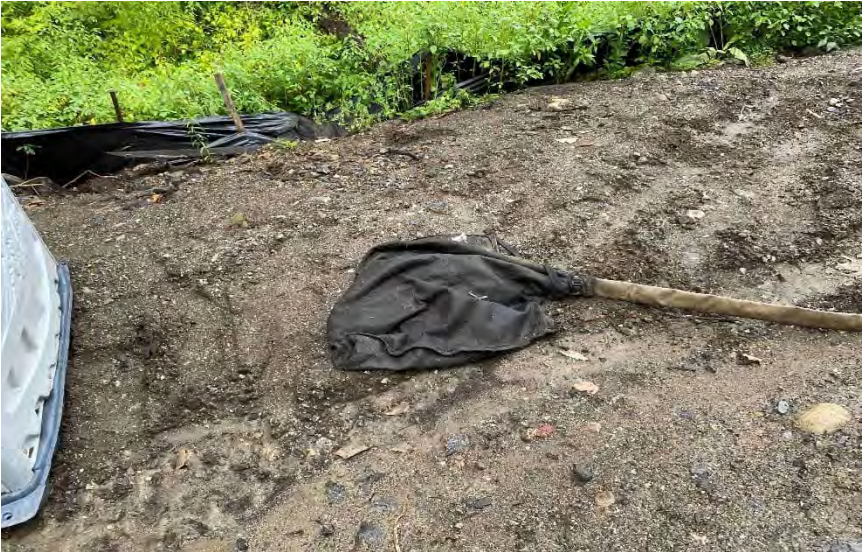
<h2 style="margin: 0;">PHOTOGRAPHIC LOG</h2>	
Client Name: Eversource		Site Location: Sudbury to Hudson Transmission Reliability Project	Town: Sudbury
Photo No.: 4	Date: 8/7/2024

Description: Manhole #27. View of discharge bag. Water from bag discharged to adjacent vegetated area within segment 14.

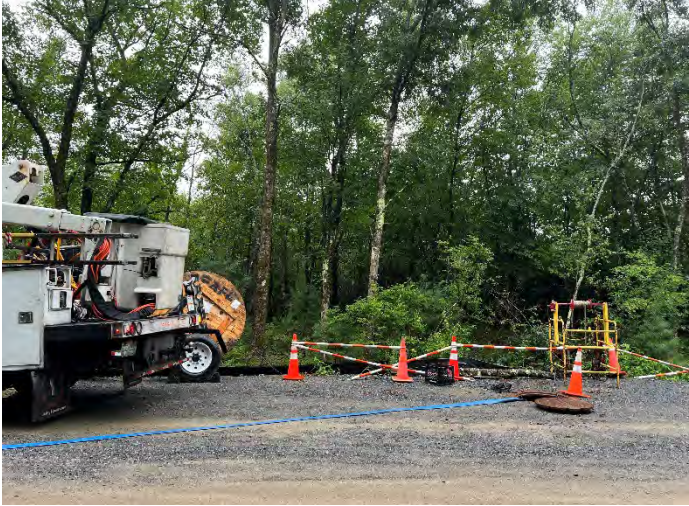
PHOTOGRAPHIC LOG	
Client Name: Eversource		Site Location: Sudbury to Hudson Transmission Reliability Project	Town: Hudson
Photo No.: 1	Date: 8/9/2024

Description: View of New Wave at HH #14 in segment 6. Facing south.

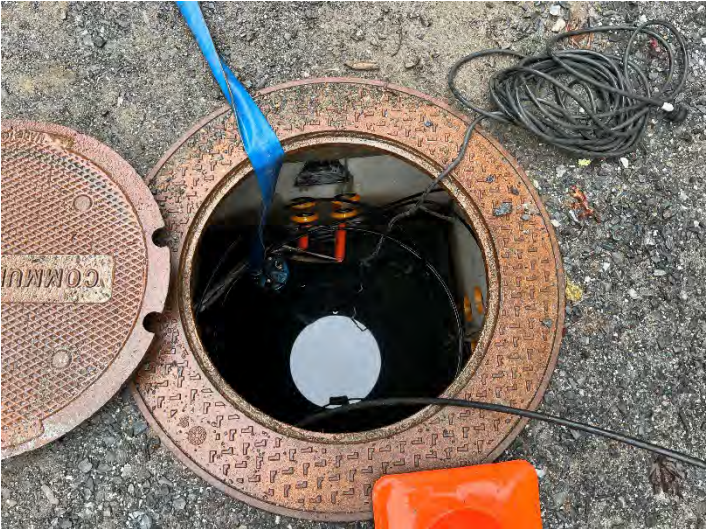
PHOTOGRAPHIC LOG	
Client Name: Eversource		Site Location: Sudbury to Hudson Transmission Reliability Project	Town: Hudson
Photo No.: 2	Date: 8/9/2024

Description: View of pump in HH #14. Water appeared clear prior to treatment.

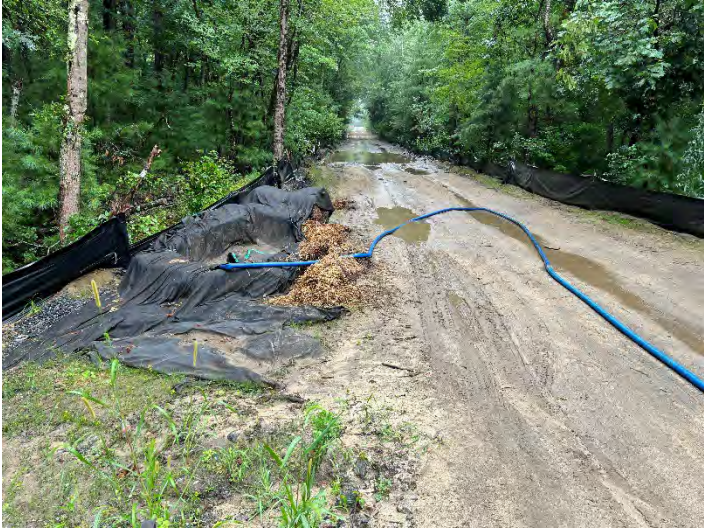
PHOTOGRAPHIC LOG	
Client Name: Eversource		Site Location: Sudbury to Hudson Transmission Reliability Project	Town: Hudson
Photo No.: 3	Date: 8/9/2024

Description: View of dewatering controls (straw bale corral with filter fabric and silt bag). Facing east.

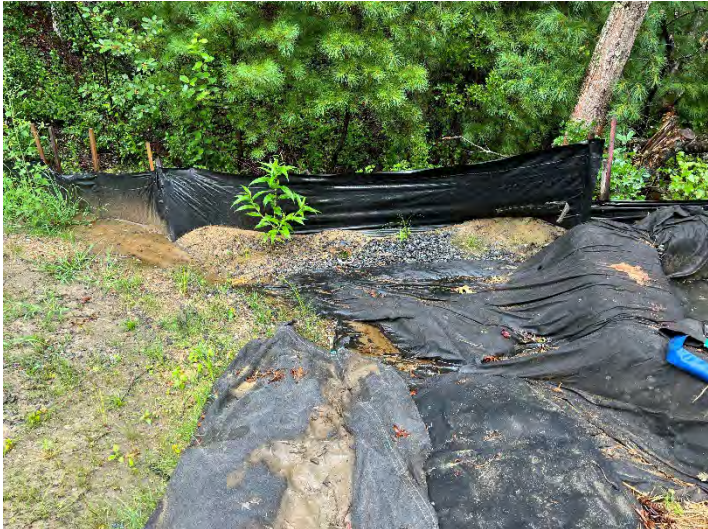
PHOTOGRAPHIC LOG	
Client Name: Eversource		Site Location: Sudbury to Hudson Transmission Reliability Project	Town: Hudson
Photo No.: 4	Date: 8/9/2024

Description: View of discharging water from corral. Discharge appeared clear and turbidity reading was below 50 NTUs. Facing north.

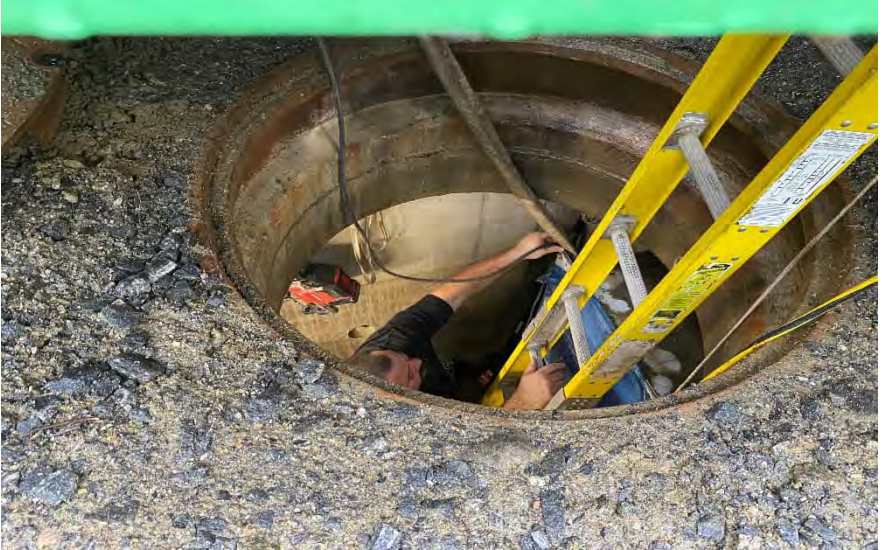
PHOTOGRAPHIC LOG	
Client Name: Eversource		Site Location: Sudbury to Hudson Transmission Reliability Project	
		Town: Sudbury	
Photo No.: 1	Date: 8/9/2024

Description: View of area being pumped from manhole #26 within Segment 14.

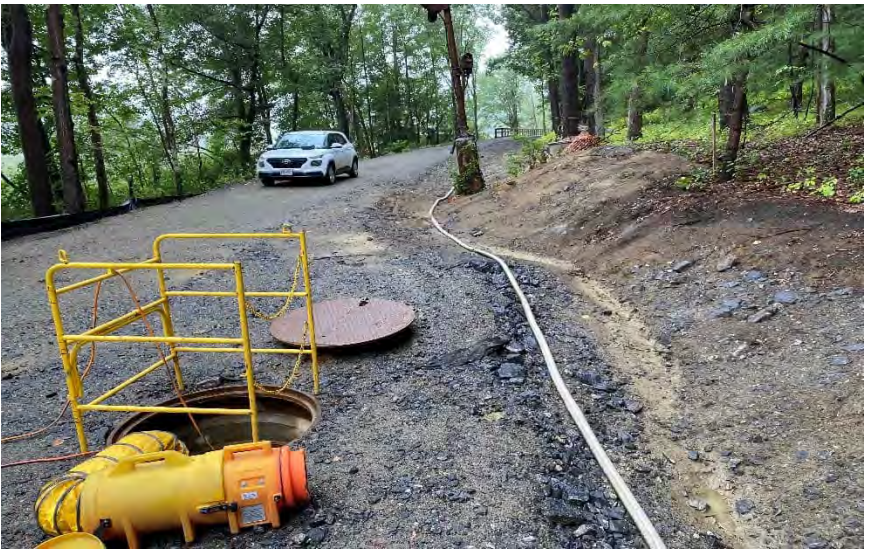
PHOTOGRAPHIC LOG	
Client Name: Eversource		Site Location: Sudbury to Hudson Transmission Reliability Project	
		Town: Sudbury	
Photo No.: 2	Date: 8/9/2024

Description: Manhole #26. View of dewatering operation. Looking westward.

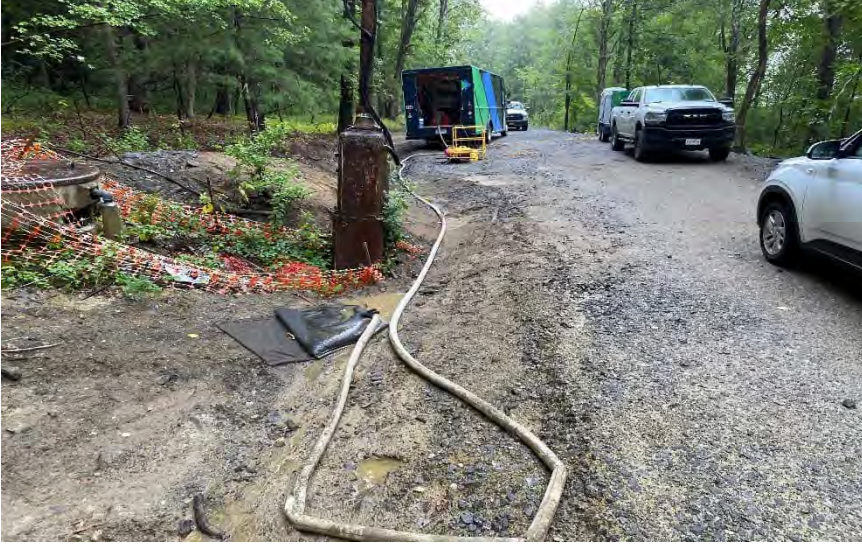
PHOTOGRAPHIC LOG	
Client Name: Eversource		Site Location: Sudbury to Hudson Transmission Reliability Project	Town: Sudbury
Photo No.: 3	Date: 8/9/2024

Description: Manhole #26 View of dewatering operation, looking eastward.

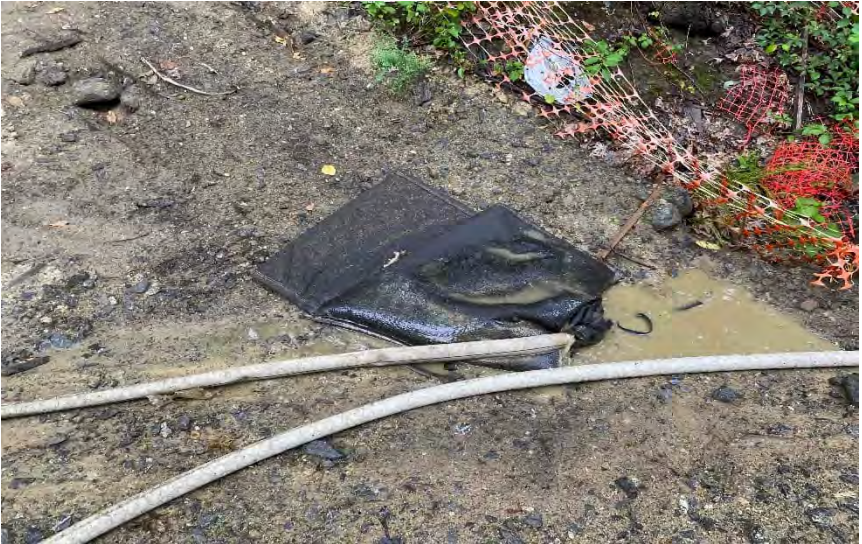
PHOTOGRAPHIC LOG	
Client Name: Eversource		Site Location: Sudbury to Hudson Transmission Reliability Project	Town: Sudbury
Photo No.: 4	Date: 8/9/2024

Description: Manhole #26. View of discharge bag. Water from bag discharged to adjacent area within segment 14.

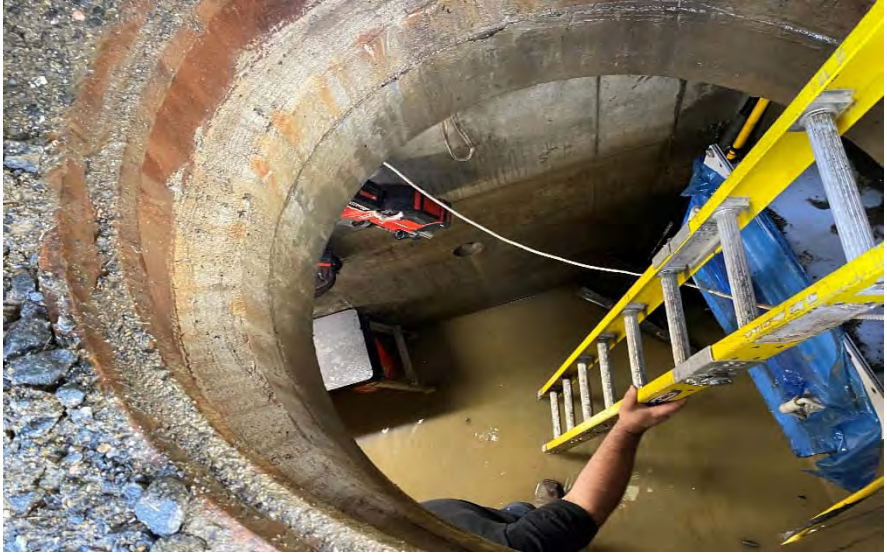
PHOTOGRAPHIC LOG	
Client Name: Eversource		Site Location: Sudbury to Hudson Transmission Reliability Project	Town: Sudbury
Photo No.: 1	Date: 8/10/2024

Description: View of area being pumped from manhole #26 within Segment 14.

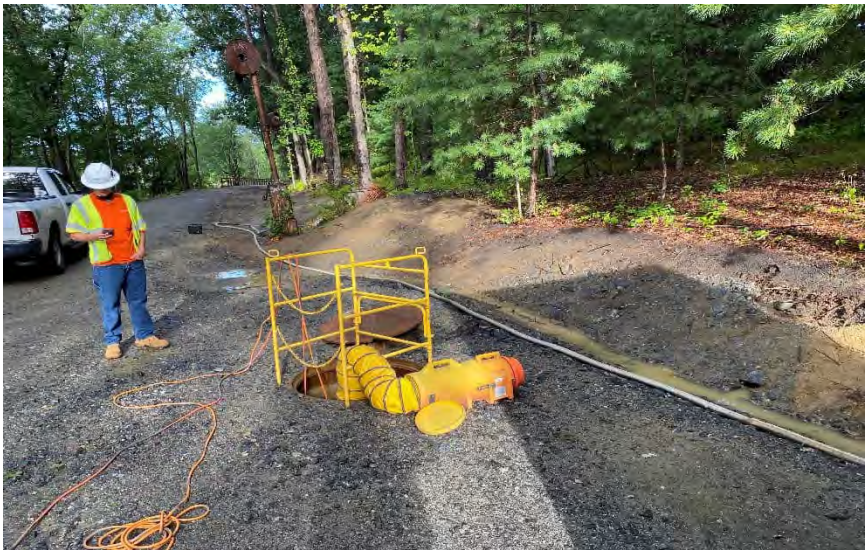
PHOTOGRAPHIC LOG	
Client Name: Eversource		Site Location: Sudbury to Hudson Transmission Reliability Project	Town: Sudbury
Photo No.: 2	Date: 8/10/2024

Description: Manhole #26. View of dewatering operation. Looking westward.

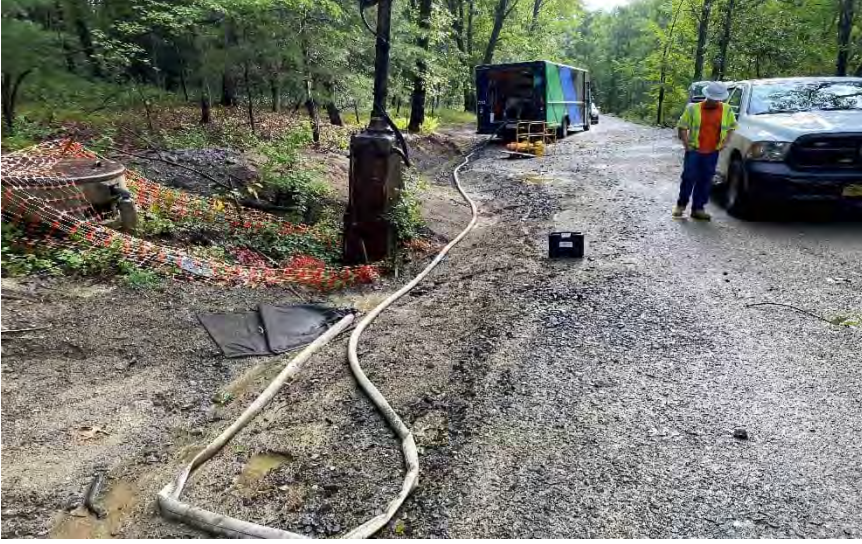
PHOTOGRAPHIC LOG	
Client Name: Eversource		Site Location: Sudbury to Hudson Transmission Reliability Project	Town: Sudbury
Photo No.: 3	Date: 8/10/2024

Description: Manhole #26 View of dewatering operation, looking eastward.

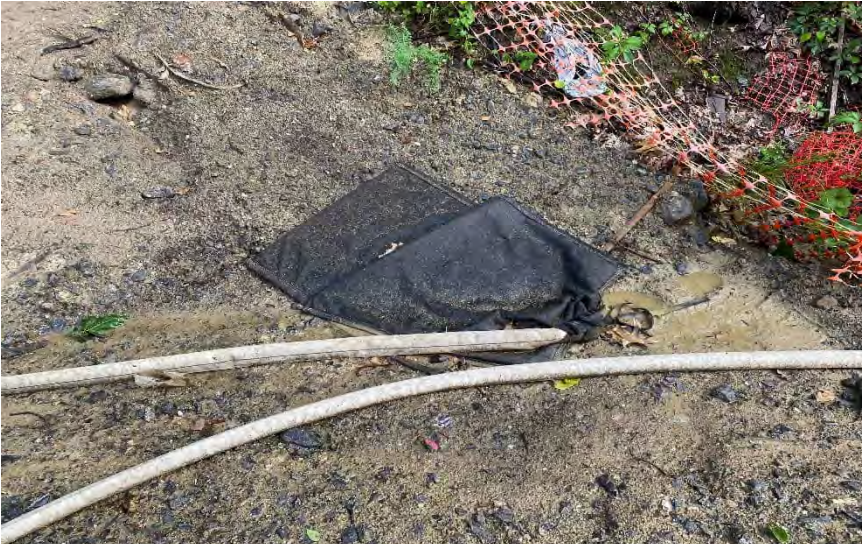
PHOTOGRAPHIC LOG	
Client Name: Eversource		Site Location: Sudbury to Hudson Transmission Reliability Project	Town: Sudbury
Photo No.: 4	Date: 8/10/2024

Description: Manhole #26. View of discharge bag. Water from bag discharged to adjacent area within segment 14.
