Weekly Environmental Compliance Summary

Sudbury to Hudson Transmission Reliability Project (USEPA Tracking # MAR1003UW)

Sudbury, Hudson, and Stow, MA

Week of: August 26, 2024 to August 30, 2024

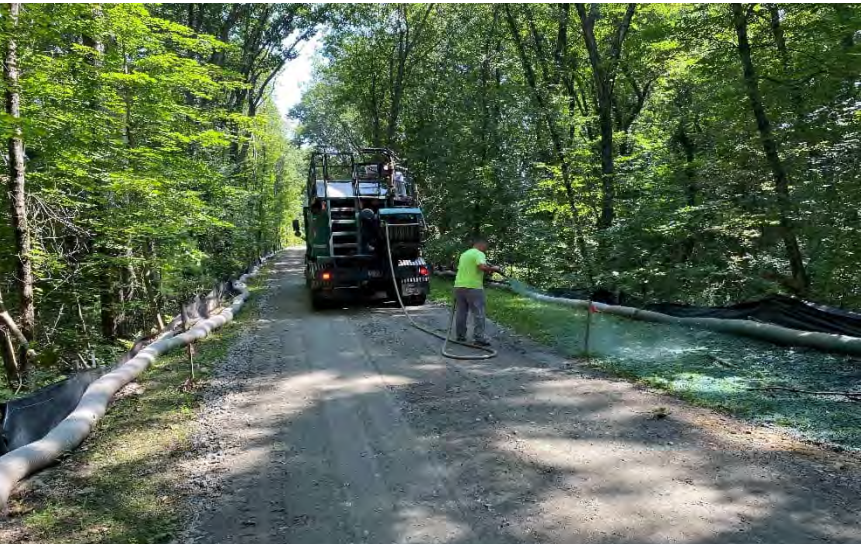
| <p>Photo No.: 2</p> | <p>Date: 8-26-24</p> | | |

| <p>Description:</p> <p>Work area within segment 1, MON hydroseeding, existing erosion control, looking eastward.</p> | | | |

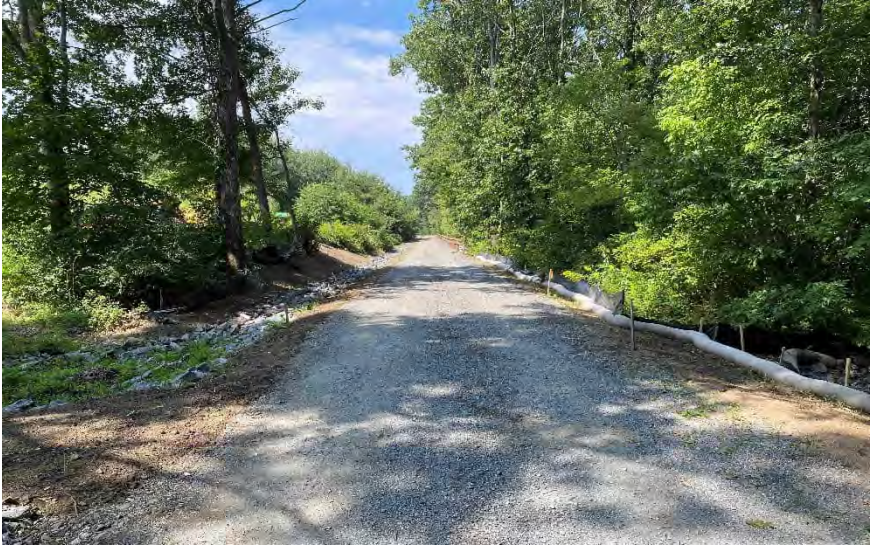
| <p>Photo No.: 4</p> | <p>Date: 8-26-24</p> | | |

| <p>Description: Work area within segment 1, existing erosion control, looking westward.</p> | | | |

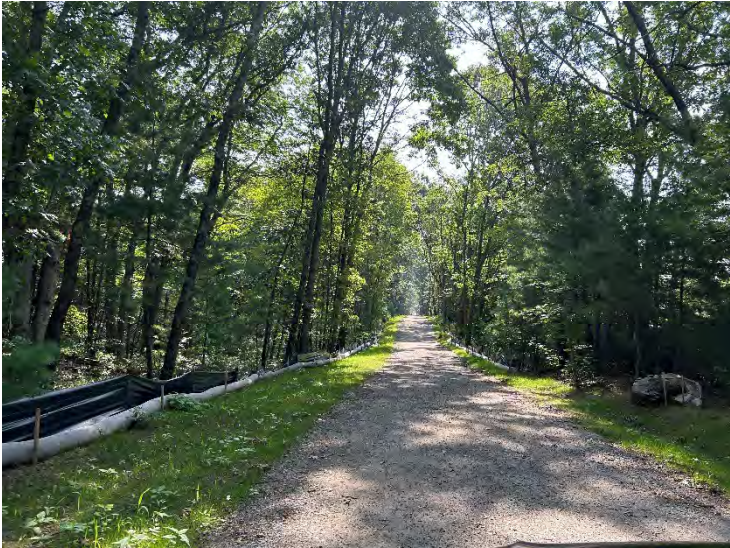
| Photo No.: 7 | Date: 8/26/2024 | | |

| Description: View of E&S controls in segment 11. Facing east. | | | |

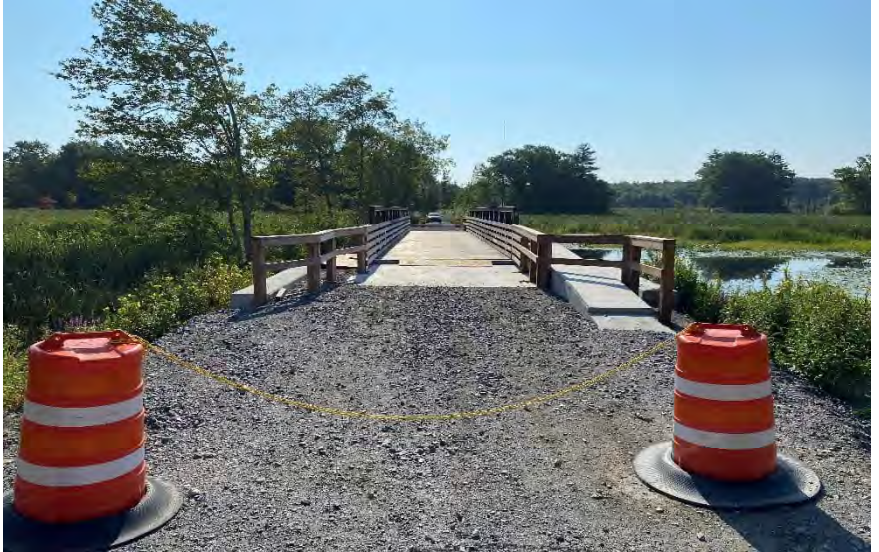
| <p>Photo No.: 1</p> | <p>Date: 8-27-24</p> | | |

| <p>Description:</p> <p>Bridge 130, over Fort Meadow Brook, existing erosion control, looking eastward.</p> | | | |

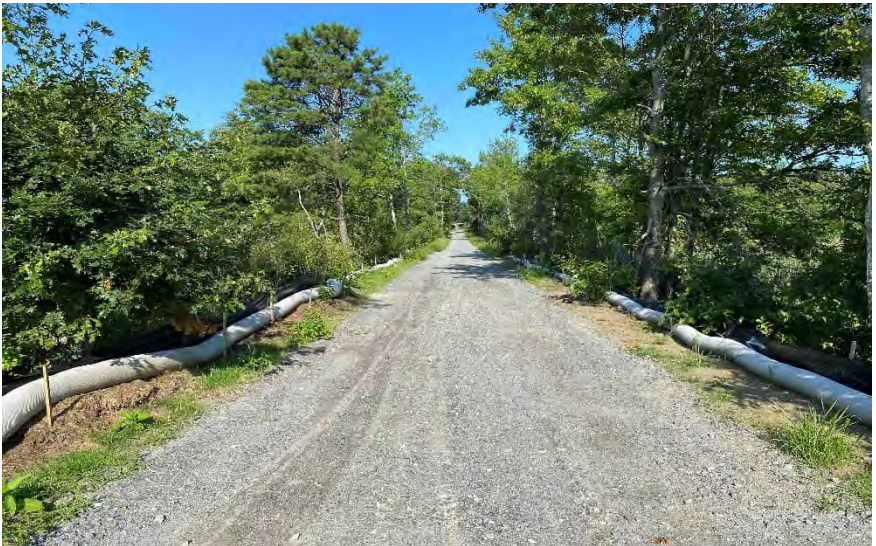
| <p>Photo No.: 6</p> | <p>Date: 8-27-24</p> | | |

| <p>Description:</p> <p>Work area within segment 2, existing erosion control, looking westward.</p> | | | |

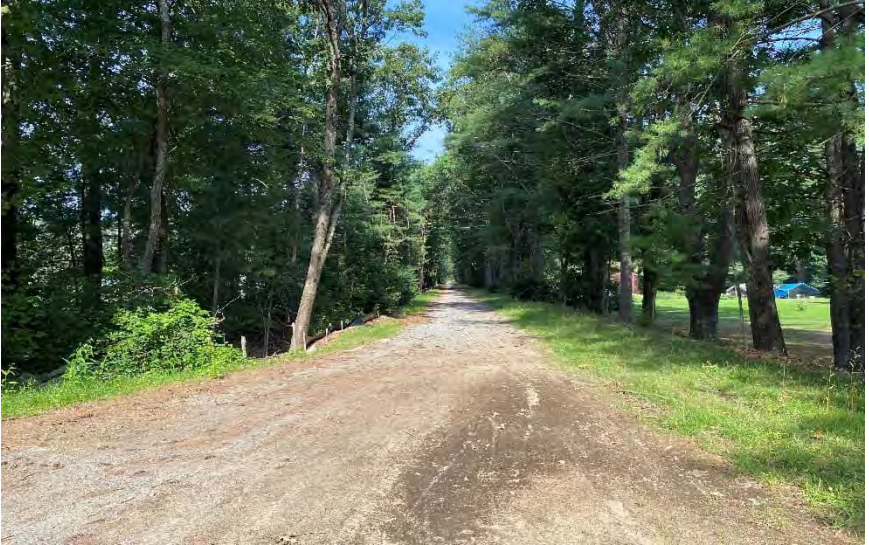
| Photo No.: 1 | Date: 8-28-24 | | |

| Description: Work area within segment 4, existing erosion control, looking westward. | | | |

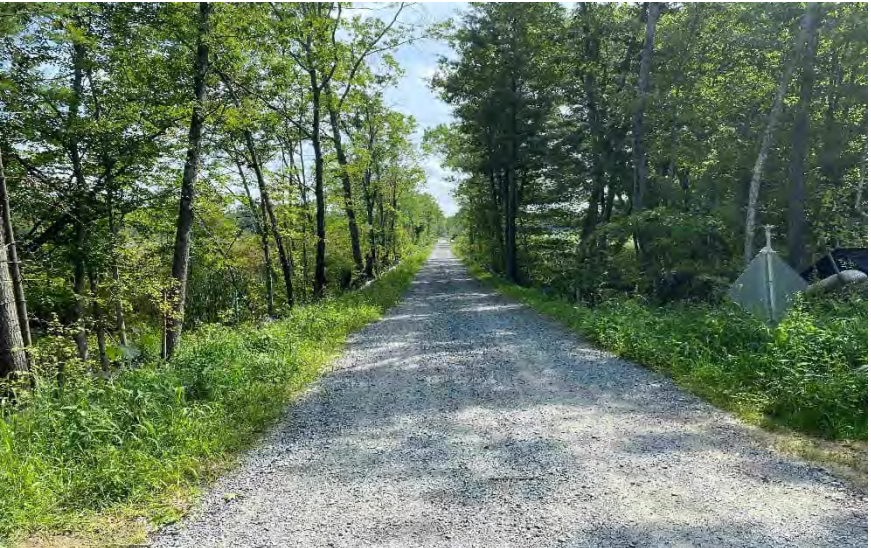
| <p>Photo No.: 4</p> | <p>Date: 8-28-24</p> | | |

| <p>Description: Work area within segment 3, existing erosion control, looking eastward.</p> | | | |

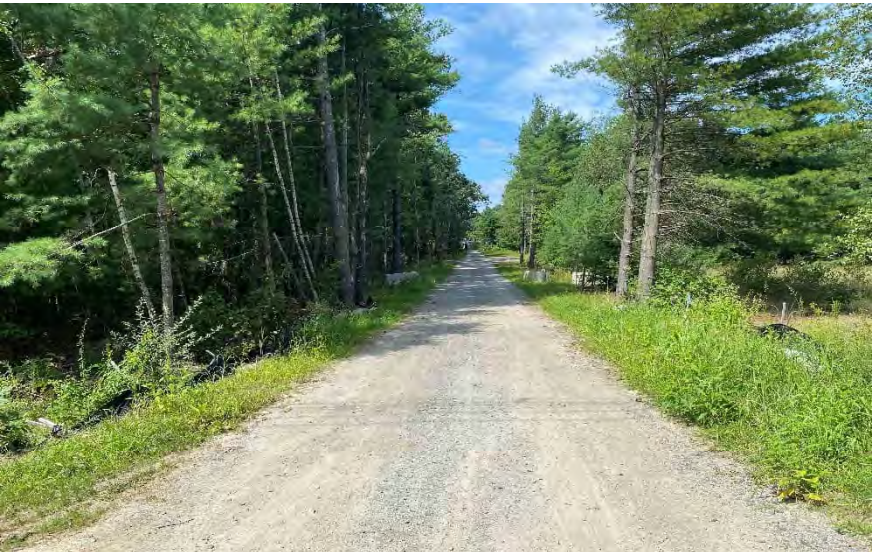
| <p>Photo No.: 6</p> | <p>Date: 8-28-24</p> | | |

| <p>Description:</p> <p>Work area within segment 2, existing erosion control, looking westward.</p> | | | |

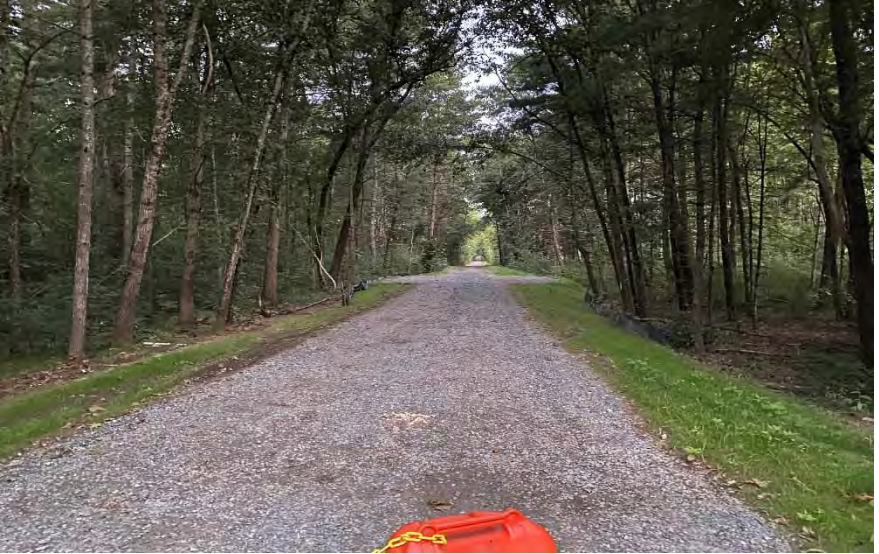
| <p>Photo No.: 1</p> | <p>Date: 8-30-24</p> | | |

| <p>Description:</p> <p>Work area within segment 5, manhole #13, existing erosion control, looking westward.</p> | | | |

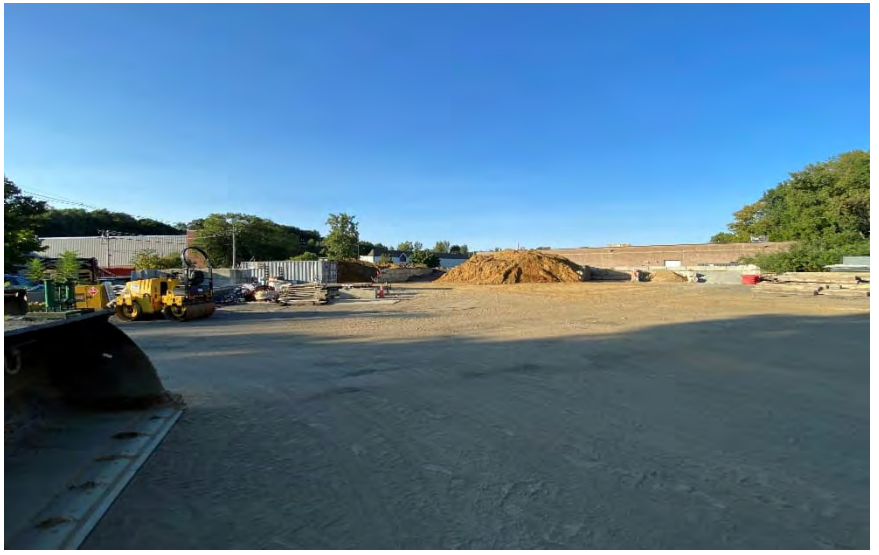
| <p>Photo No.: 2</p> | <p>Date: 8-30-24</p> | | |

| <p>Description:</p> <p>Bonazzoli laydown yard, stockpiled materials, looking westward.</p> | | | |

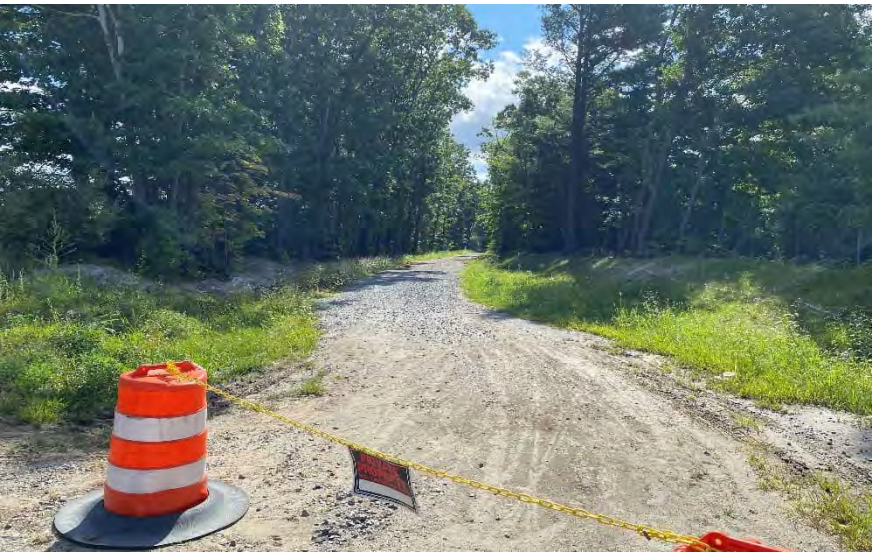
| <p>Photo No.: 4</p> | <p>Date: 8-30-24</p> | | |

| <p>Description:</p> <p>Work area within segment 4, existing erosion control, looking eastward.</p> | | | |

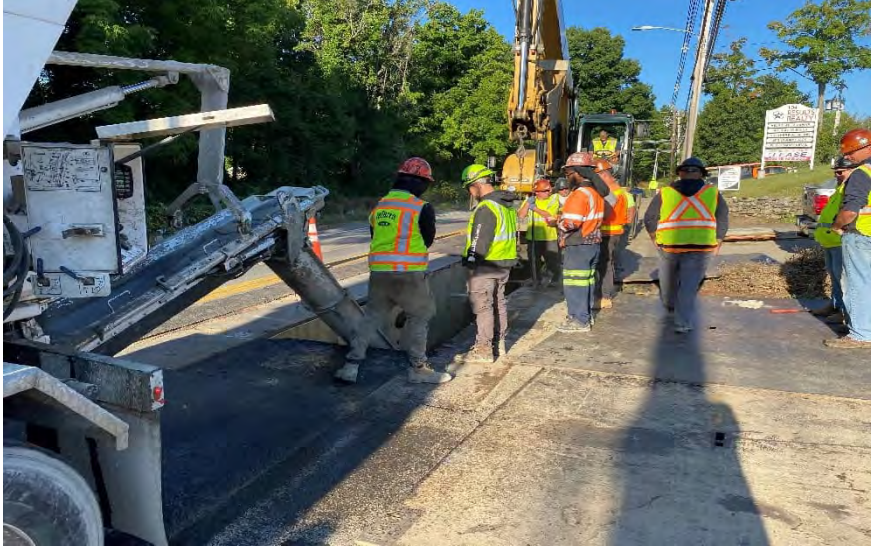
| <p>Photo No.: 5</p> | <p>Date: 8-30-24</p> | | |

| <p>Description:</p> <p>Conduit work near 106 Forest, near Bonazolli Avenue intersection with Forest Ave., looking southward.</p> | | | |

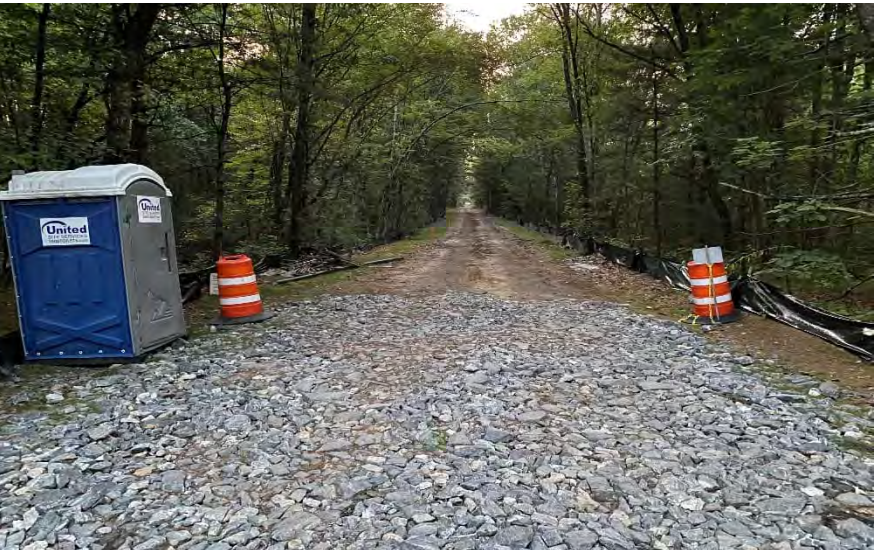
| <p>Photo No.: 6</p> | <p>Date: 8-30-24</p> | | |

| <p>Description:</p> <p>Work area within segment 6, existing erosion control, looking eastward.</p> | | | |

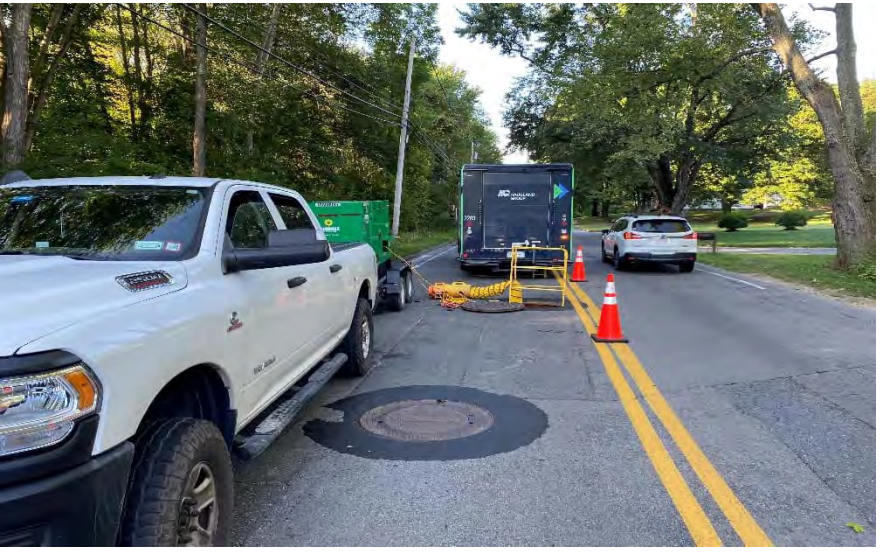
| <p>Photo No.: 8</p> | <p>Date: 8-30-24</p> | | |

| <p>Description: Haugland conducting splicing work in Forest Avenue near manhole #4, looking southward.</p> | | | |

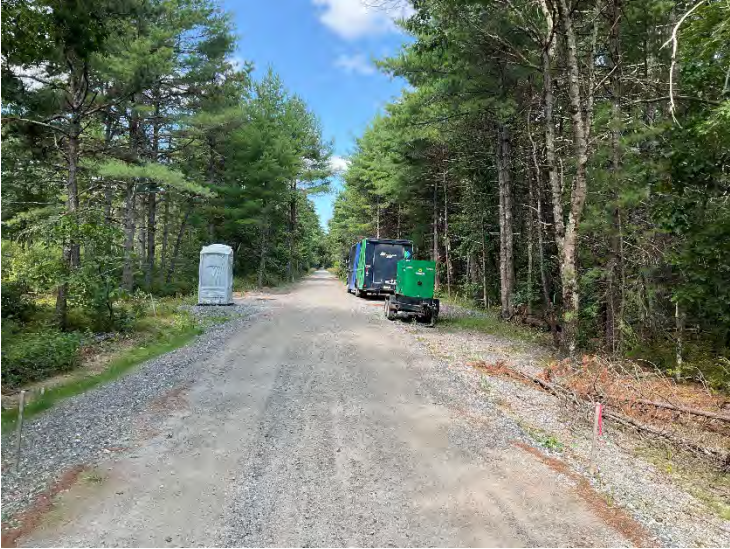
| Photo No.: 1 | Date: 8/30/2024 | | |

| Description: View of Haugland splicers at MH #16. Facing west. | | | |

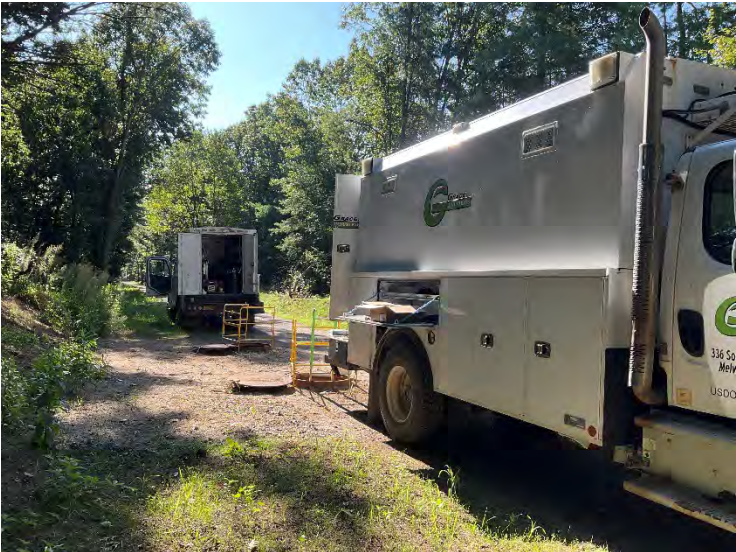
| Photo No.: 2 | Date: 8/30/2024 | | |

| Description: View of Haugland MOD racking crew at MH #22. Facing east. | | | |

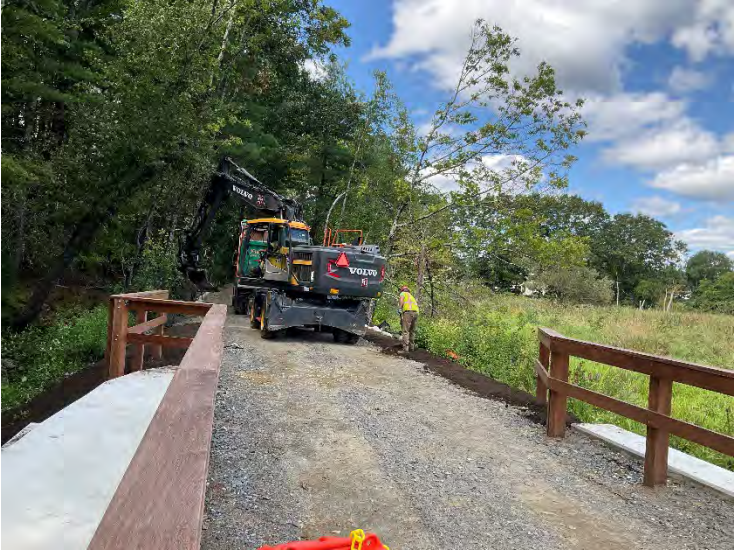
| <p>Photo No.: 3</p> | <p>Date: 8/30/2024</p> | | |

| <p>Description: View of ET&L applying planting soil to ROW shoulders in segment 13. Facing west.</p> | | | |

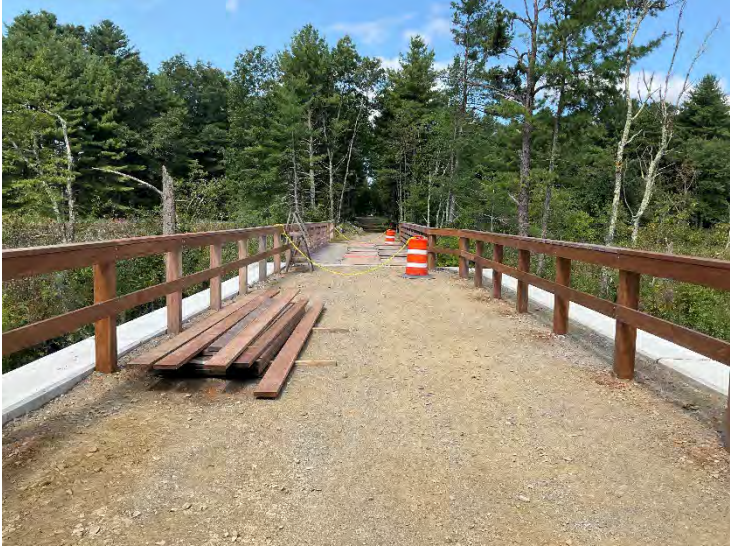
| Photo No.: 5 | Date: 8/30/2024 | | |

| Description: View of Bridge 128. Facing west. | | | |

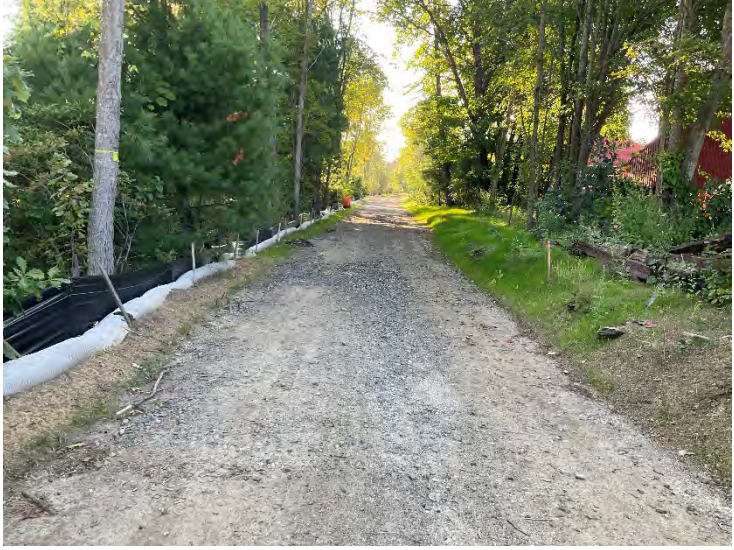
| <p>Photo No.: 7</p> | <p>Date: 8/30/2024</p> | | |

| <p>Description: View of E&S controls in segment 12. Facing east.</p> | | | |

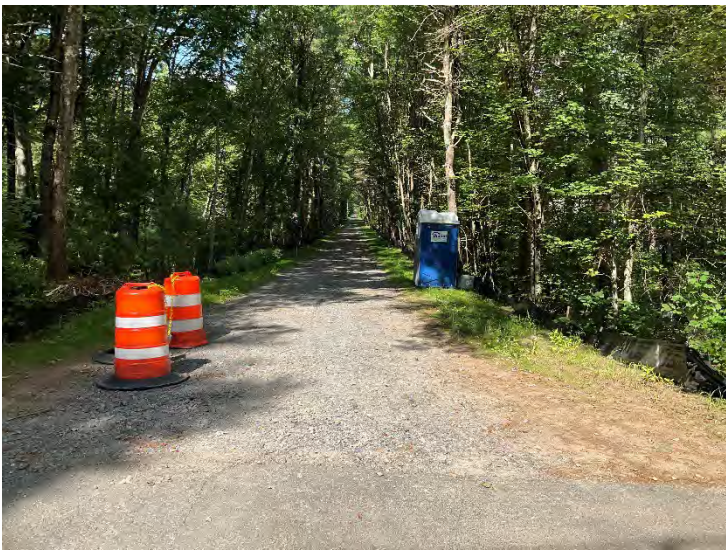
| <p>Photo No.: 8</p> | <p>Date: 8/30/2024</p> | | |

| <p>Description: View of construction entrance to segment 9. Facing west.</p> | | | |

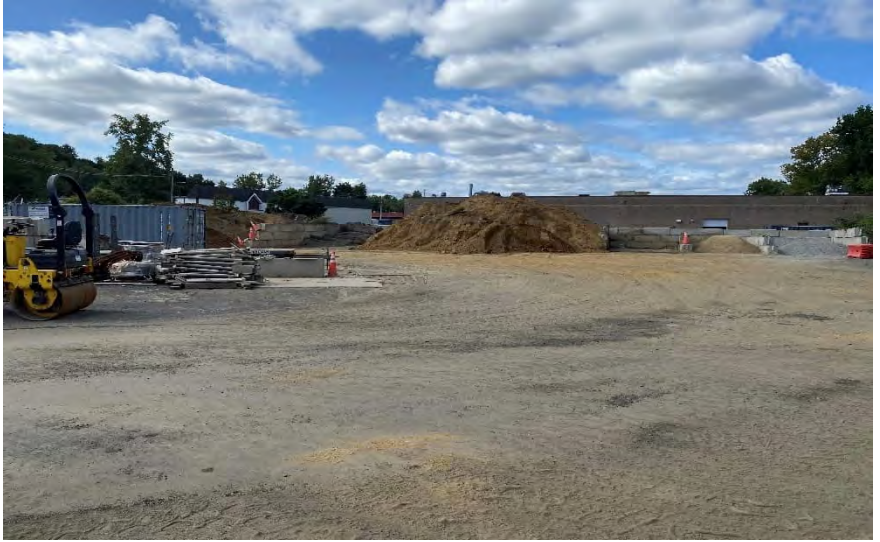
| Photo No.: 2 | Date: 8-29-24 | | |

| Description: Laydown yard at Bonazzoli, stockpiled spoils, looking westward. | | | |

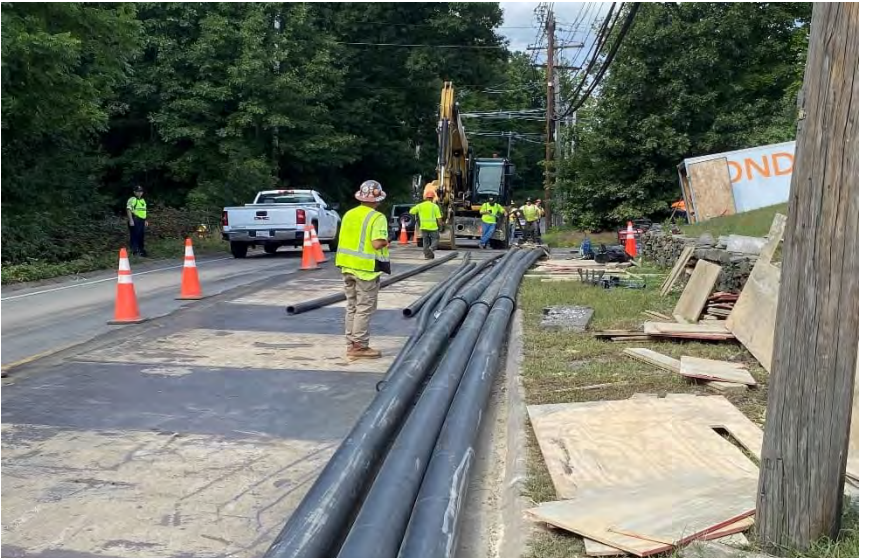
| Photo No.: 3 | Date: 8-29-24 | | |

| Description: Bond conducting conduit work within Forest Avenue near 106 Forest, looking southward. | | | |

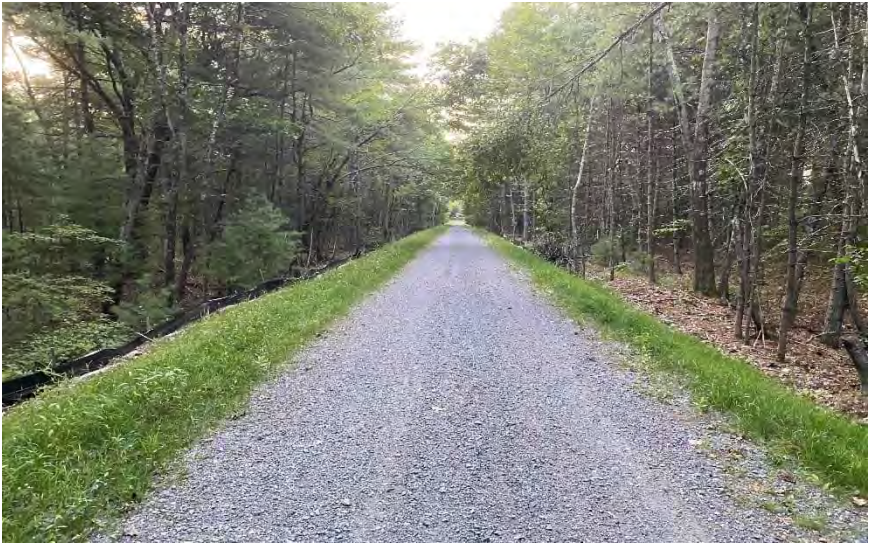
| Photo No.: 6 | Date: 8-29-24 | | |

| Description: Work area within segment 5, existing erosion control, looking eastward. | | | |

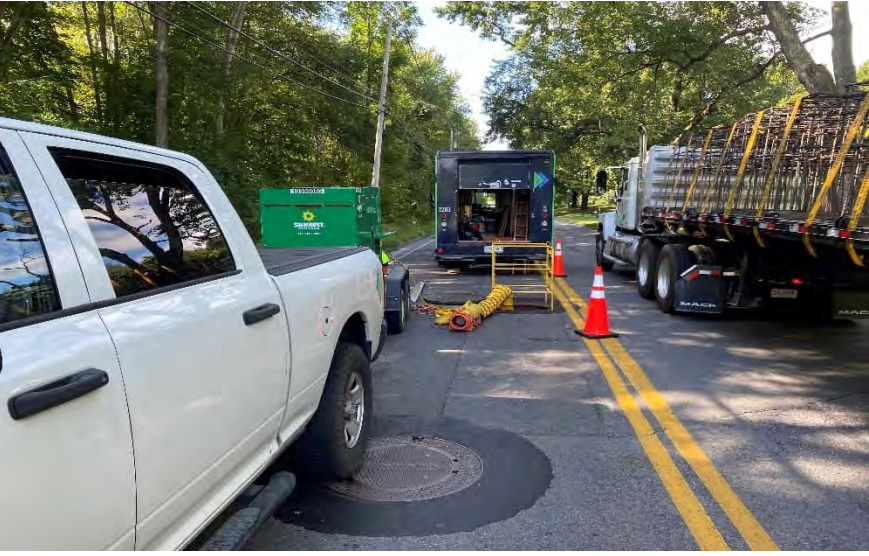
| Photo No.: 8 | Date: 8-29-24 | | |

| Description: Haugland splicing work at manhole #4, Forest Avenue, looking southward. | | | |

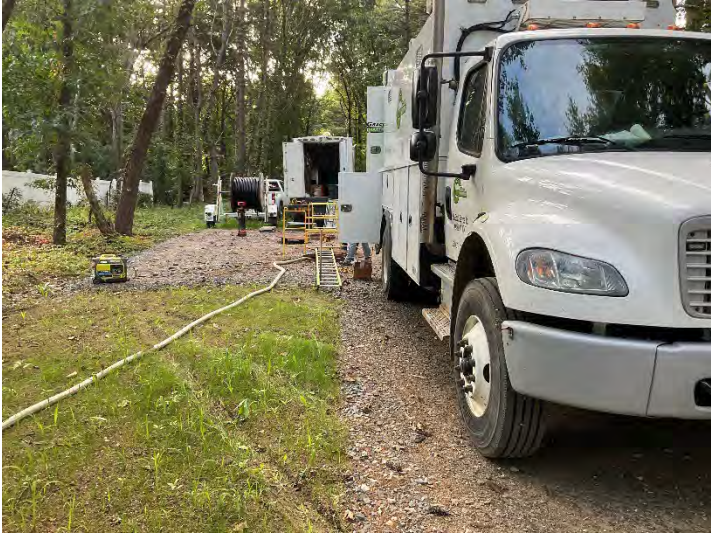
| Photo No.: 1 | Date: 8-29-24 | | |

| Description: View of Haugland work area at MH #21. Facing east | | | |

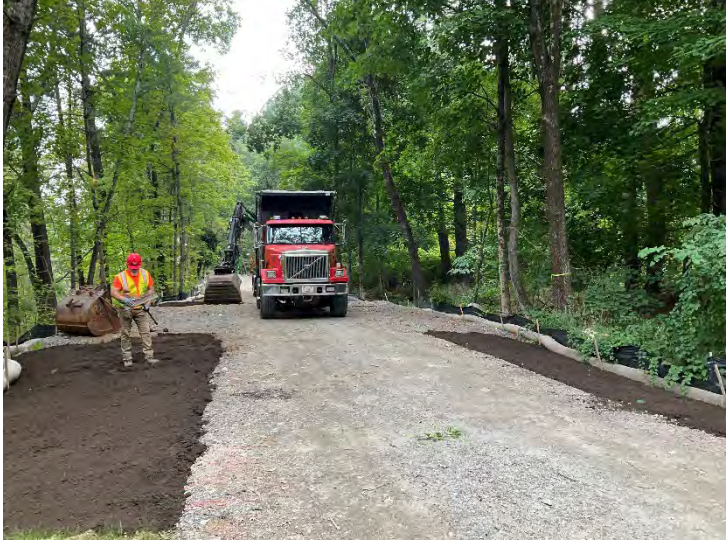
| Photo No.: 2 | Date: 8-29-24 | | |

| Description: View of ET&L applying planting soil in segment 13. Facing east. | | | |

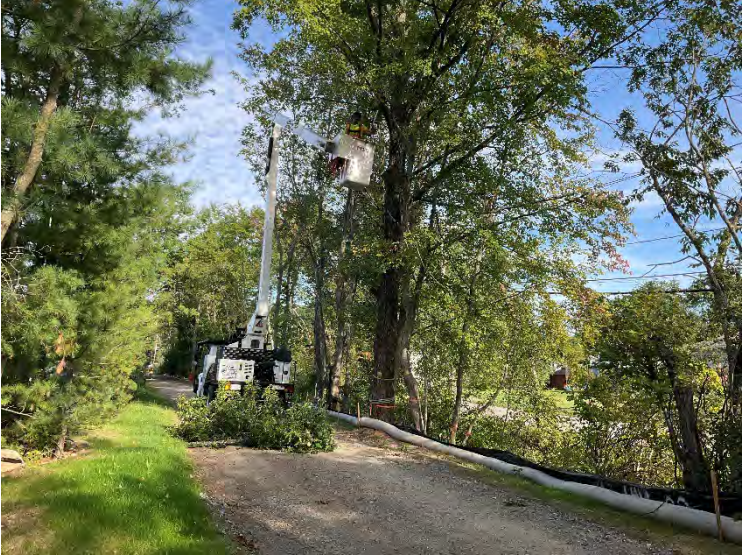
| Photo No.: 3 | Date: 8-29-24 | | |

| Description: View of Moosehead clearing trees in segment 12. Facing west. | | | |

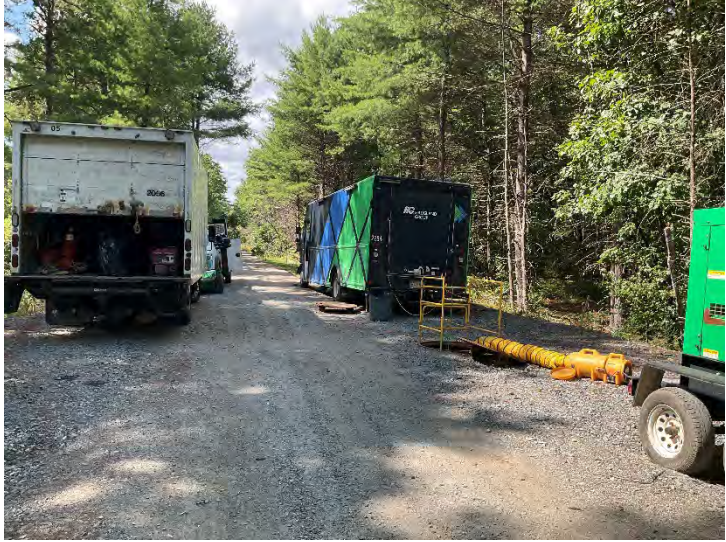
| Photo No.: 5 | Date: 8-29-24 | | |

| Description: View of Haugland cable splicers at MH#16 in segment 7. Facing west. | | | |

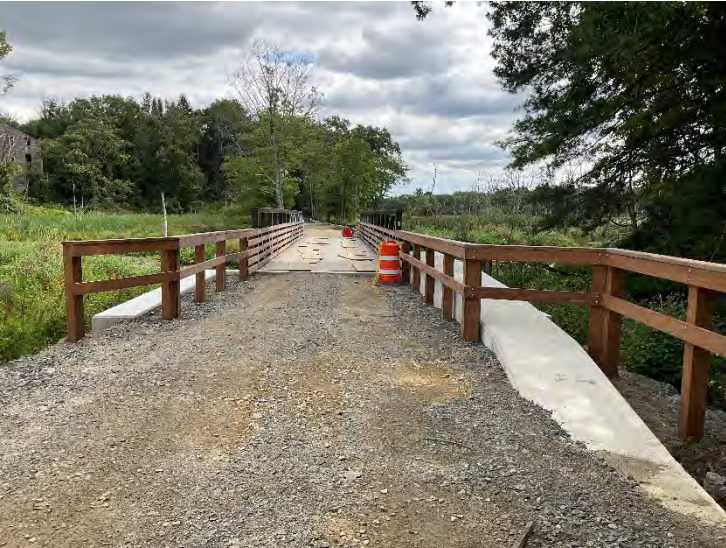
| Photo No.: 6 | Date: 8-29-24 | | |

| Description: View of Bridge 127. Facing east. | | | |

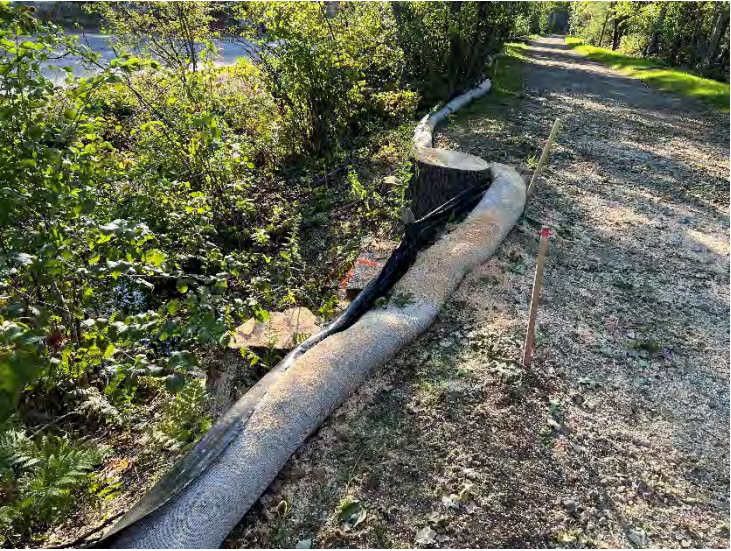
| Photo No.: 7 | Date: 8-29-24 | | |

| Description: View of cleared trees in segment 12 by the culvert. Facing east. | | | |

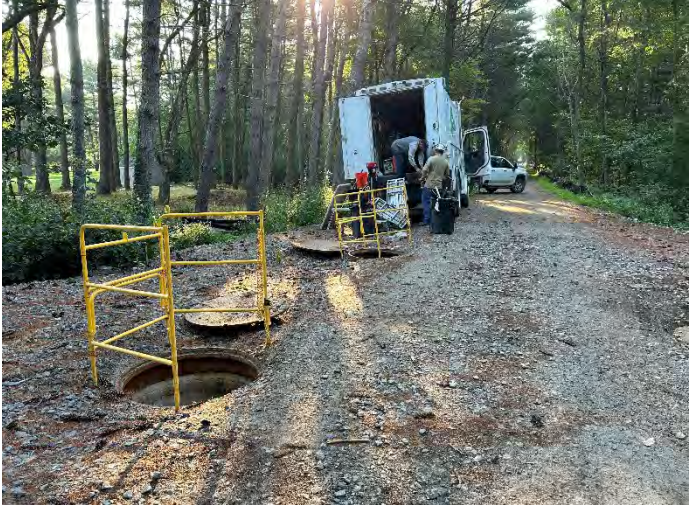
| | | PHOTOGRAPHIC LOG | |
|---|---|--|---|
| Photo No.: 1 | Date: 8/27/2024 | | |

| | | PHOTOGRAPHIC LOG | |
|---|---|--|---|
| Description: View of Haugland working at MH #19 within segment 9. Facing east. | | | |

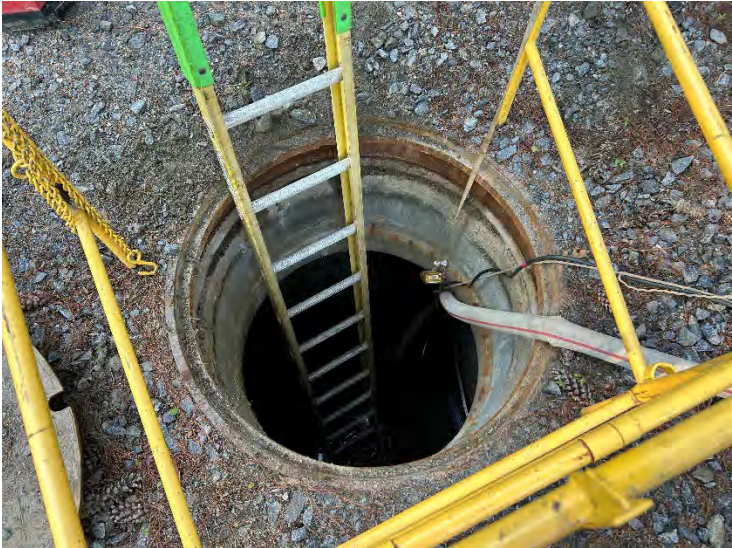
| | | PHOTOGRAPHIC LOG | |
|---|---|--|---|
| Photo No.: 2 | Date: 8/27/2024 | | |

| | | PHOTOGRAPHIC LOG | |
|---|---|--|---|
| Description: View of pump in MH #19. | | | |

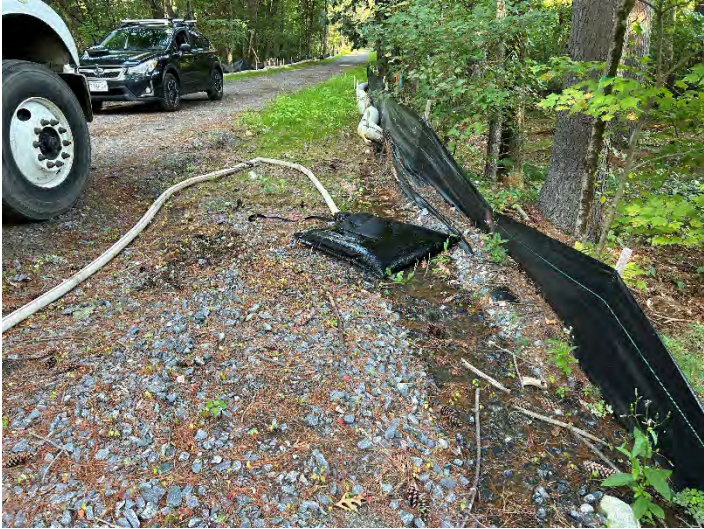
| Photo No.: 3 | Date: 8/27/2024 | | |

| Description: View of dewatering discharge. Facing west. | | | |

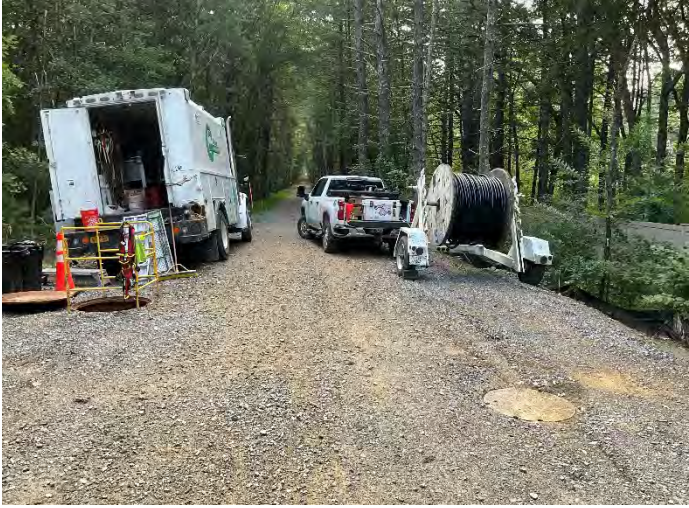
| | | PHOTOGRAPHIC LOG | |
|--|---|--|---|
| Photo No.: 1 | Date: 8/28/2024 | | |

| | | PHOTOGRAPHIC LOG | |
|--|---|--|---|
| Description: View of Haugland working at MH #20 within segment 10. Facing east. | | | |

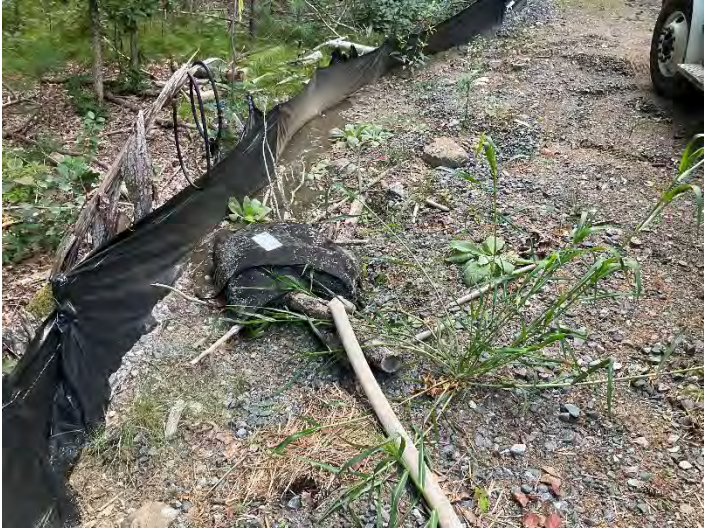
| | | PHOTOGRAPHIC LOG | |
|---|---|--|---|
| Photo No.: 3 | Date: 8/28/2024 | | |

| | | PHOTOGRAPHIC LOG | |
|---|---|--|---|
| Description: View of dewatering from manhole to filter bag. Facing east. | | | |

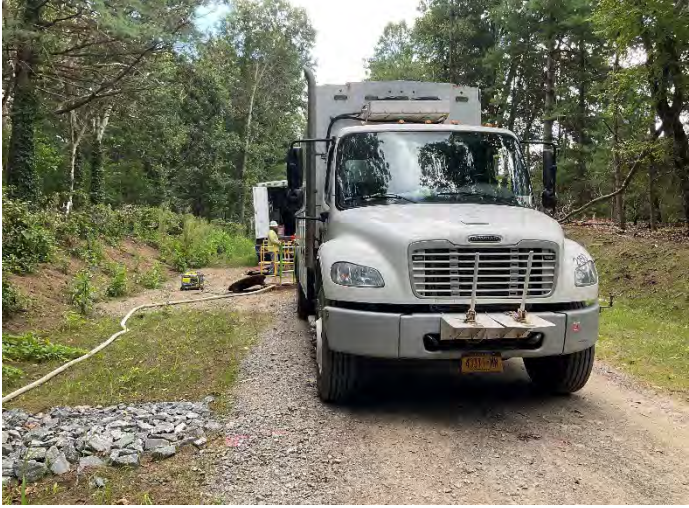
| | | PHOTOGRAPHIC LOG | |
|--|---|--|---|
| Photo No.: 1 | Date: 8/29/2024 | | |

| | | PHOTOGRAPHIC LOG | |
|--|---|--|---|
| Description: View of Haugland working at MH #22 within segment 11. Facing east. | | | |

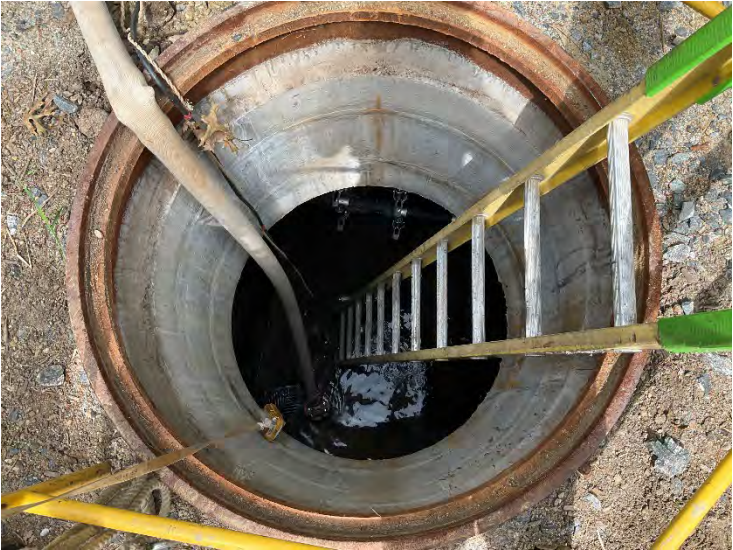
| | | PHOTOGRAPHIC LOG | |
|---|---|--|---|
| Photo No.: 2 | Date: 8/29/2024 | | |

| | | PHOTOGRAPHIC LOG | |
|---|---|--|---|
| Description: View of pump in MH #22. | | | |

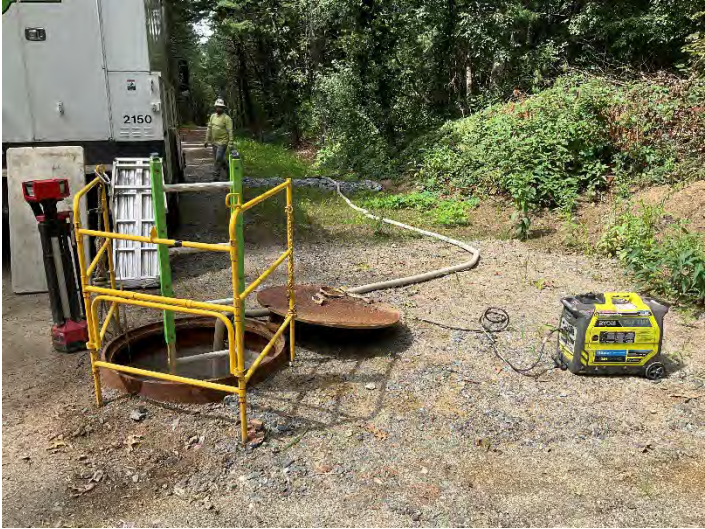
| Photo No.: 3 | Date: 8/29/2024 | | |

| Description: View of dewatering setup from manhole to filter bag. Facing west. | | | |

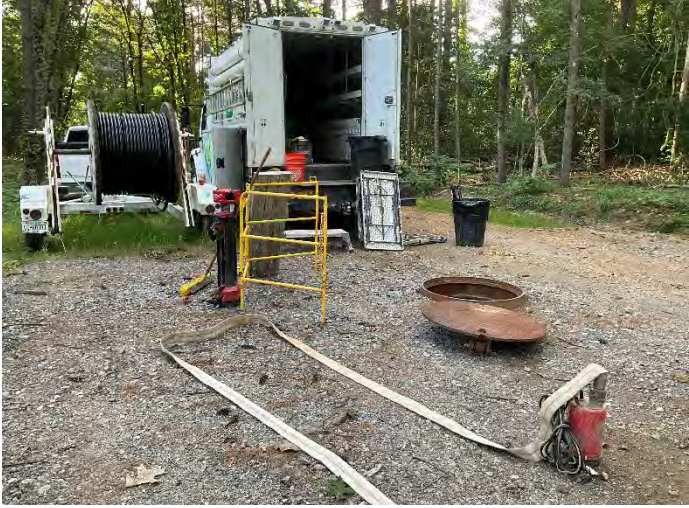
| Photo No.: 1 | Date: 8/29/2024 | | |

| Description: View of Haugland working at MH #21 within segment 10. Facing east. | | | |

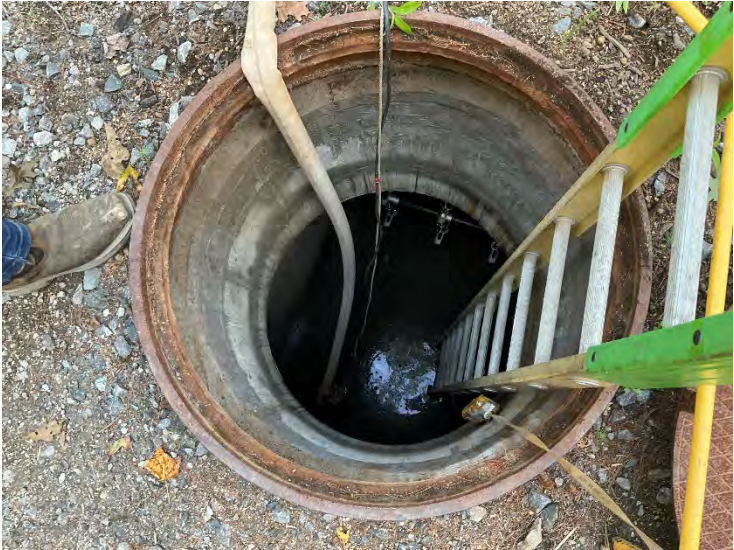
| Photo No.: 2 | Date: 8/29/2024 | | |

| Description: View of pump in MH #20. | | | |

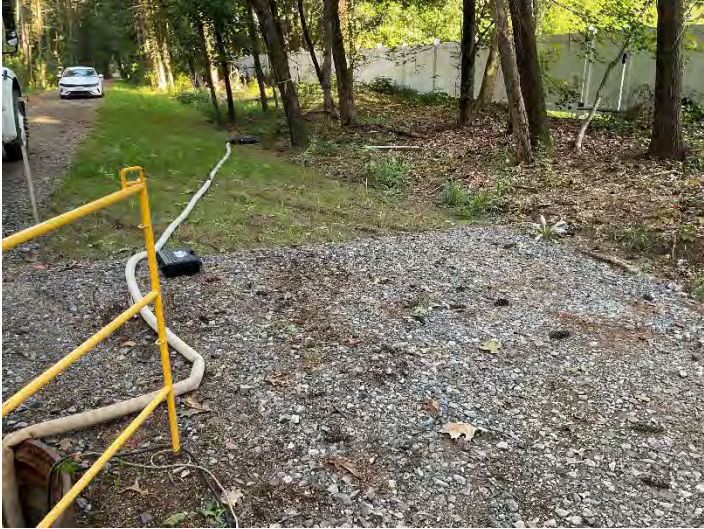
| Photo No.: 3 | Date: 8/29/2024 | | |

| Description: View of dewatering setup from manhole to filter bag. Facing west. | | | |

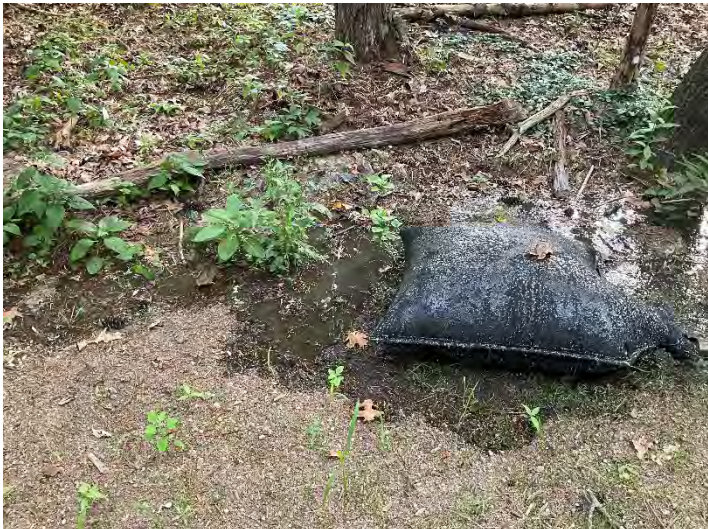
| Photo No.: 4 | Date: 8/29/2024 | | |

| Description: View of discharge from filter bag. Discharge appeared to be clear and turbidity reading was below 50 NTUs. Facing north. | | | |
