**Environmental Monitor Construction Site Inspection Report**  
**MassDOT Project #608164 Construction Contract # 119678**  
**EM Report #21**

Project Description: Bruce Freeman Rail Trail Right-of-Way  
 Permit Description(s): Order of Conditions (MGL Chapter 131, Section 40 and 310 CMR 10.00, Mass DEP File No. 301-1362); 2022 EPA NPDES General Permit for Discharges from Construction Areas; U.S. Army Corps of Engineers Permit No NAE-2021-01975.

Project Name:	Bruce Freeman Rail Trail - Phase 2d - Sudbury
Date of Inspections:	9/3/2024
Bi Weekly/ Monthly Period Covered:	September Weekly Inspection #1
Inspector's Name(s):	Anna Haznar
Inspectors' Contact Information:	ahaznar@beta-inc.com

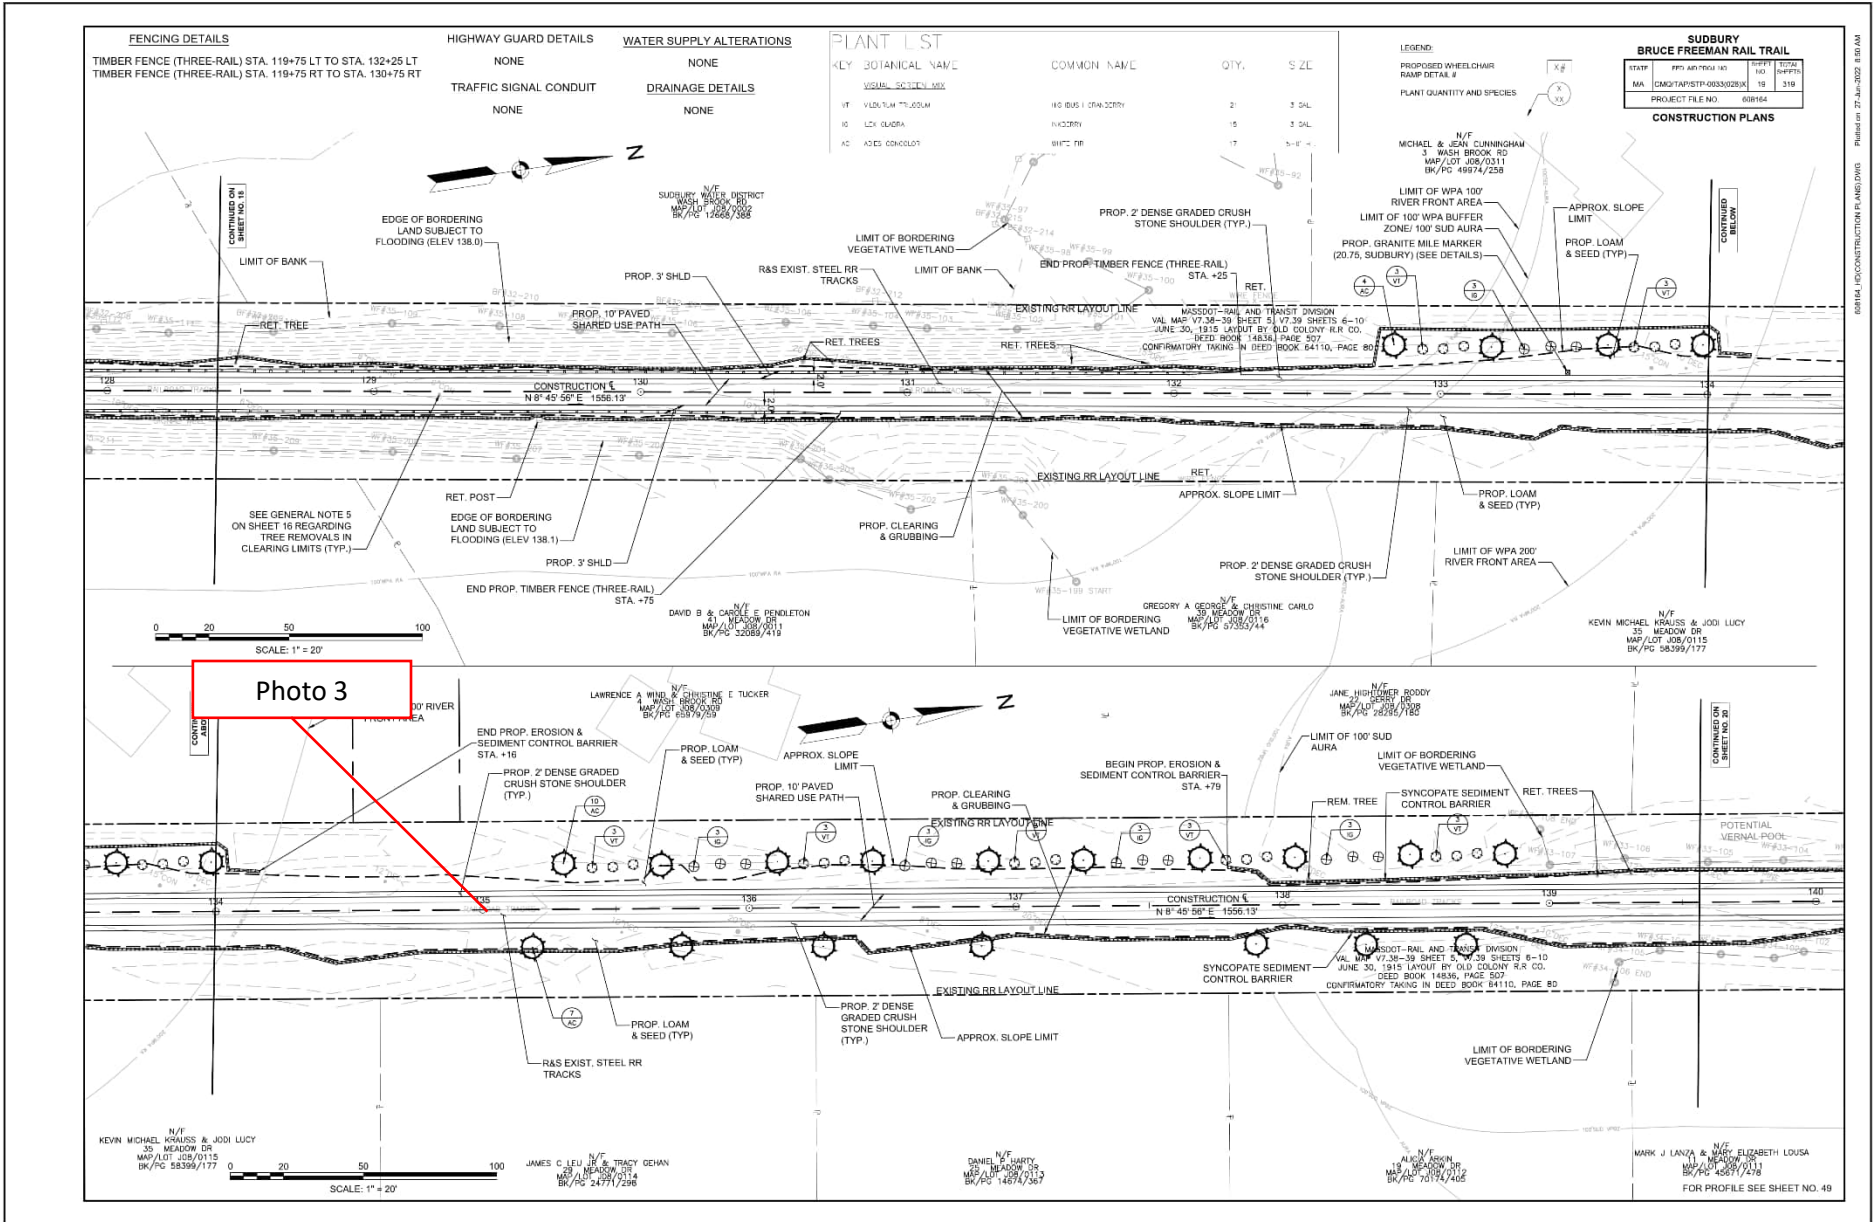
Photo 3

57	Japanese hops ( <i>Humulus japonicus</i> ) has been observed throughout the Project and requires removal <b>Priority: High</b>	8/5/2024	8/12/2024	The Contractor should perform varying removal approaches including herbicide treatment and hand pulling to remove the vegetation throughout the Project and reseed areas that are no longer stabilized due to herbicide application.	8/5/2024 - Removal methods, including herbicide work and hand pulling have been observed to remove the plant throughout the Project. 8/7/2024 - Japanese hops and other invasives appear to be wilting due to herbicide application. Multiple areas along the trail appear to have not been treated and seed heads have appeared on some of the plants that were not treated. A second application of herbicide and pulling of plants with seedheads is recommended to ensure spreading does not continue. 8/12/2024 - Herbicide application on the Japanese hops and other invasives was occurring at the time of the inspection. Plants that have been previously treated appear to be dead or wilting. 8/16/2024 - A majority of the Japanese hops were observed as wilting, while some plants do not appear to have been treated (i.e., near Station 1003+00). 8/20/2024 - Multiple areas throughout the Project where herbicide application was performed have been observed as no longer stable due to herbicide killing grass and other vegetation. These areas include but are not limited to Station 137+00 to Station 145+00 and Station 223+00 to Station 240+00. These areas should be reseeded to ensure stabilization. 8/27/2024 - Observation remains. Areas that are no longer stabilized due to herbicide application should be reseeded. There are multiple locations along the path where hops are present with seed heads and should be retreated. 9/3/2024 - Observation remains. Japanese hops that were treated with herbicide appear to be dead. Japanese hops are still present along the path in varying amounts, with a large population with seed heads present near Station 1002+00. Areas that are no longer stabilized due to herbicide application are further discussed in Long Term Compliance Action Item 59.

<b>Photo No. 3</b>	<b>Date:</b> 9/3/2024	 
<b>Direction Photo Taken:</b>  Toward the North		
<b>Description:</b> View of an area that is no longer stabilized due to herbicide application and Japanese hops with seed heads that require removal at Station 135+00 per Long Term Compliance Action Item 59 and 57.
