Weekly Environmental Compliance Summary

Sudbury to Hudson Transmission Reliability Project (USEPA Tracking # MAR1003UW)

Week of: September 23, 2024 to September 27, 2024

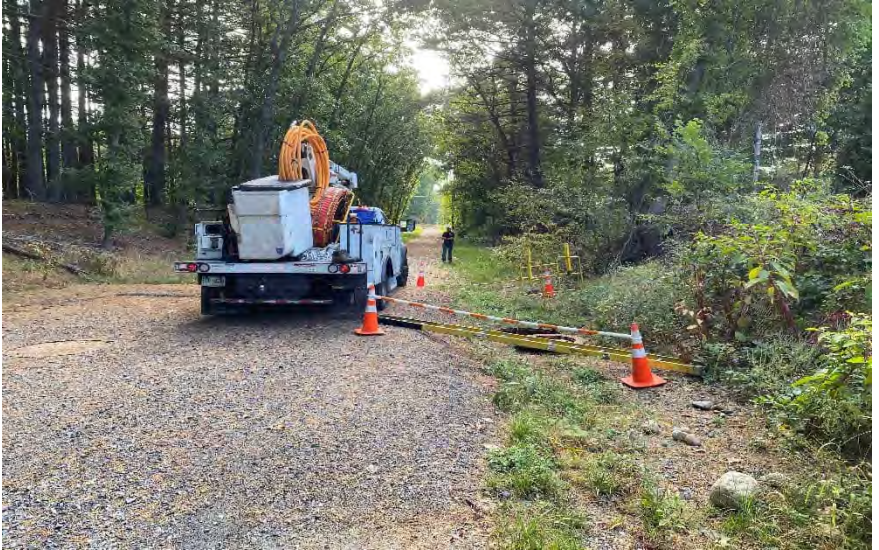
PHOTOGRAPHIC LOG	
Client Name: Eversource		Site Location: Sudbury to Hudson Transmission Reliability Project	Town: Hudson
Photo No.: 2	Date: 9-24-24

Description: Work area within segment 3, New Wave conducting fiber optic work, handhole #9, existing erosion control, looking westward.

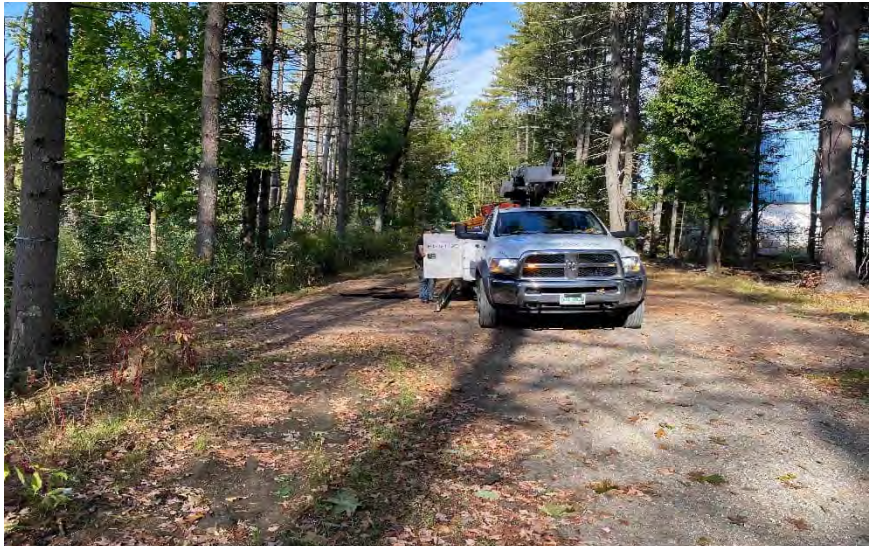
<p>PHOTOGRAPHIC LOG</p>	
<p>Client Name: Eversource</p>		<p>Site Location: Sudbury to Hudson Transmission Reliability Project</p>	<p>Town: Hudson</p>
<p>Photo No.: 4</p>	<p>Date: 9-24-24</p>

<p>Description: Work area within segment 4, New Wave conducting fiber optic work, handhole #10, existing erosion control, looking westward.</p>

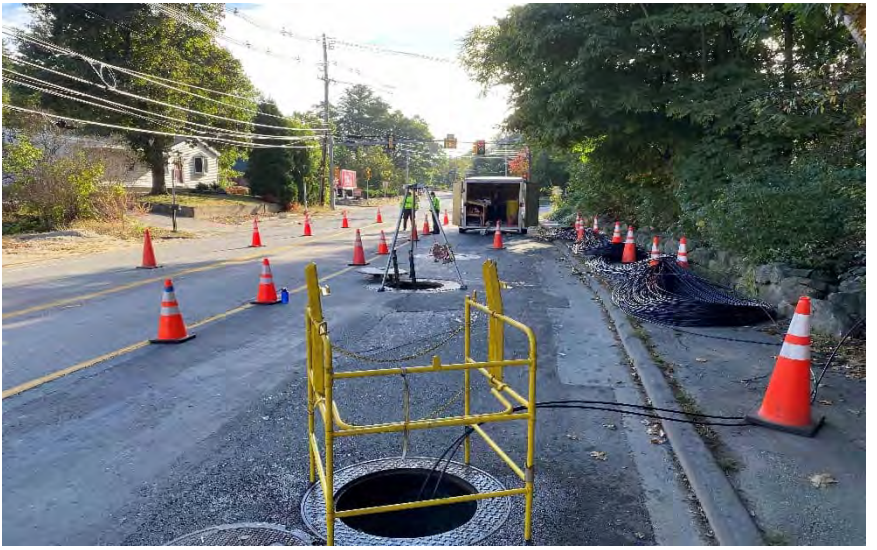
<p align="right">PHOTOGRAPHIC LOG</p>	
<p>Client Name: Eversource</p>		<p>Site Location: Sudbury to Hudson Transmission Reliability Project</p>	<p>Town: Hudson</p>
<p>Photo No.: 6</p>	<p>Date: 9-24-24</p>

<p>Description:</p> <p>Bond conducting proofing work at manhole #2, looking northward.</p>

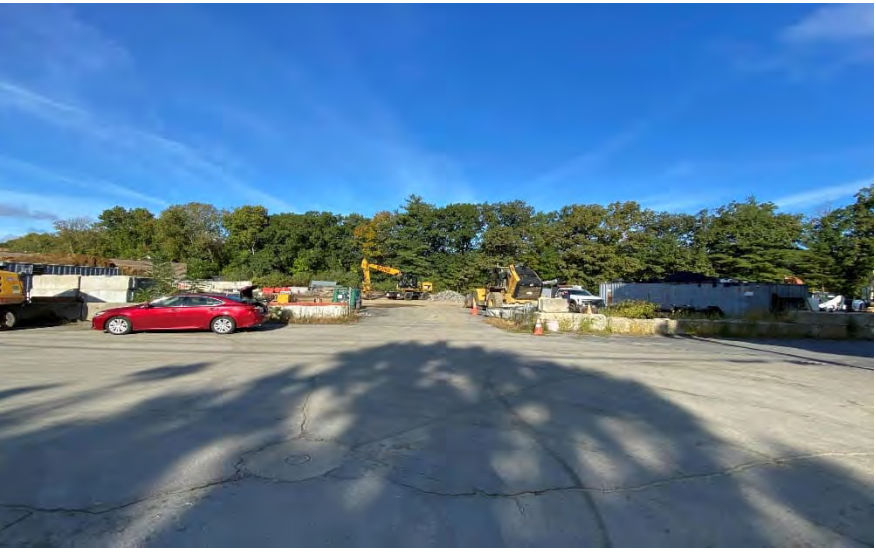
<p align="center">PHOTOGRAPHIC LOG</p>	
<p>Client Name: Eversource</p>		<p>Site Location: Sudbury to Hudson Transmission Reliability Project</p>	<p>Town: Hudson</p>
<p>Photo No.: 8</p>	<p>Date: 9-24-24</p>

<p>Description: Bonazzoli laydown yard, Bond working here with spoil management, looking northward.</p>

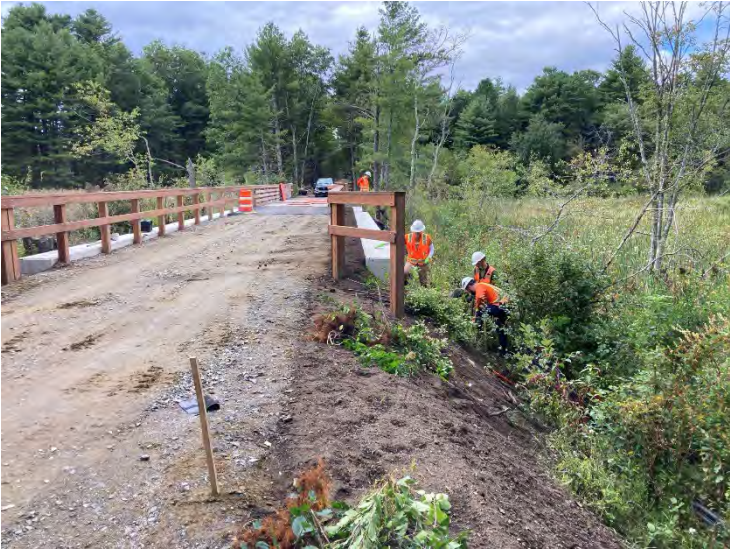
PHOTOGRAPHIC LOG	
Client Name: Eversource		Site Location: Sudbury to Hudson Transmission Reliability Project	
Town: Sudbury			
Photo No.: 1	Date: 9/24/2024

Description: View of SWCA removing invasive vegetation in segment 8 at bridge 128. Facing west.

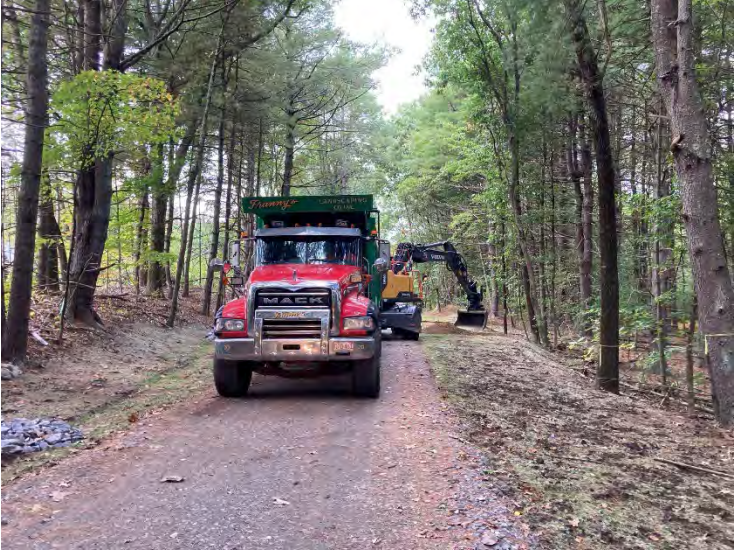
<p>PHOTOGRAPHIC LOG</p>	
<p>Client Name: Eversource</p>		<p>Site Location: Sudbury to Hudson Transmission Reliability Project</p>	<p>Town: Sudbury</p>
<p>Photo No.: 3</p>	<p>Date: 9/24/2024</p>

<p>Description: View of ET&L spreading loam in segment 8. Facing west.</p>

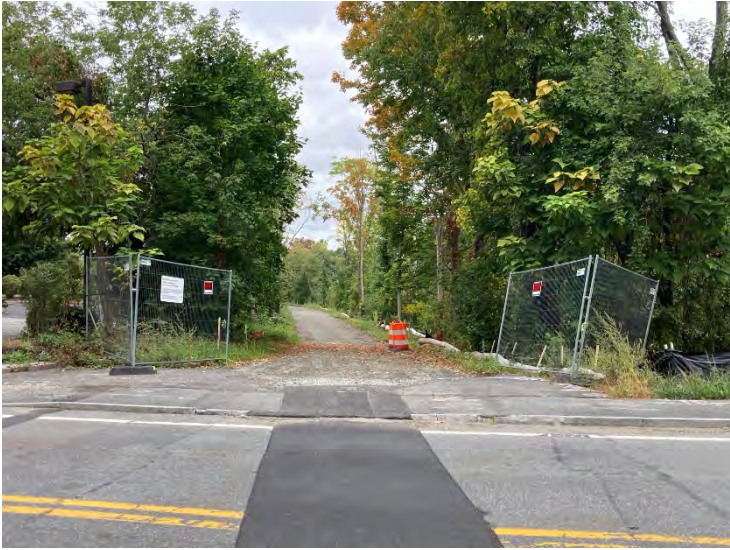
<p>PHOTOGRAPHIC LOG</p>	
<p>Client Name: Eversource</p>		<p>Site Location: Sudbury to Hudson Transmission Reliability Project</p>	<p>Town: Sudbury</p>
<p>Photo No.: 5</p>	<p>Date: 9/24/2024</p>

<p>Description: View of entrance to segment 12 off Boston Post Rd. Facing west.</p>

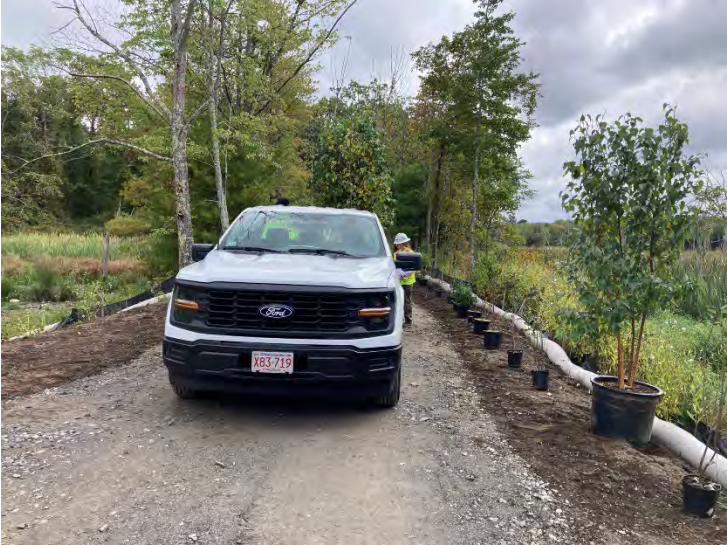
<p>PHOTOGRAPHIC LOG</p>	
<p>Client Name: Eversource</p>		<p>Site Location: Sudbury to Hudson Transmission Reliability Project</p>	<p>Town: Sudbury</p>
<p>Photo No.: 6</p>	<p>Date: 9/24/2024</p>

<p>Description: View of MON conducting restoration planting in segment 14. See additional planting reports. Facing east.</p>

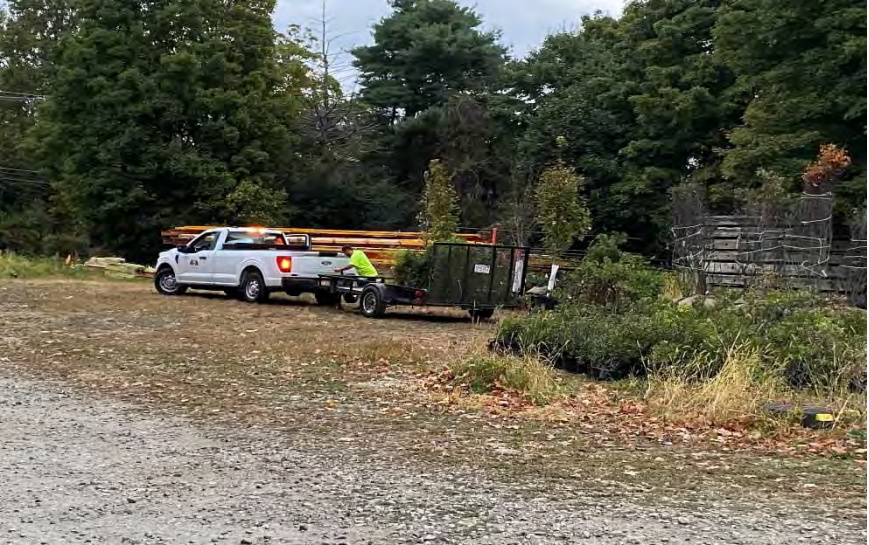
<p align="center">PHOTOGRAPHIC LOG</p>	
<p>Client Name: Eversource</p>		<p>Site Location: Sudbury to Hudson Transmission Reliability Project</p>	<p>Town: Hudson</p>
<p>Photo No.: 1</p>	<p>Date: 9-25-24</p>

<p>Description:</p> <p>MON loading plants at Bond office for use in the field (segment 14), looking eastward.</p>

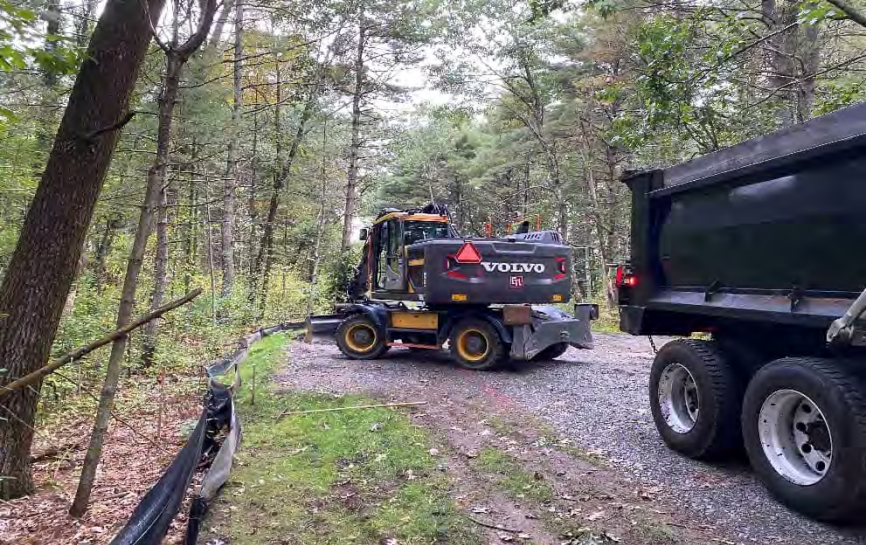
<p align="center">PHOTOGRAPHIC LOG</p>	
<p>Client Name: Eversource</p>		<p>Site Location: Sudbury to Hudson Transmission Reliability Project</p>	<p>Town: Hudson</p>
<p>Photo No.: 2</p>	<p>Date: 9-25-24</p>

<p>Description:</p> <p>Work area within segment 5, ET&L conducting pad removal work, manhole #13, existing erosion control, looking westward.</p>

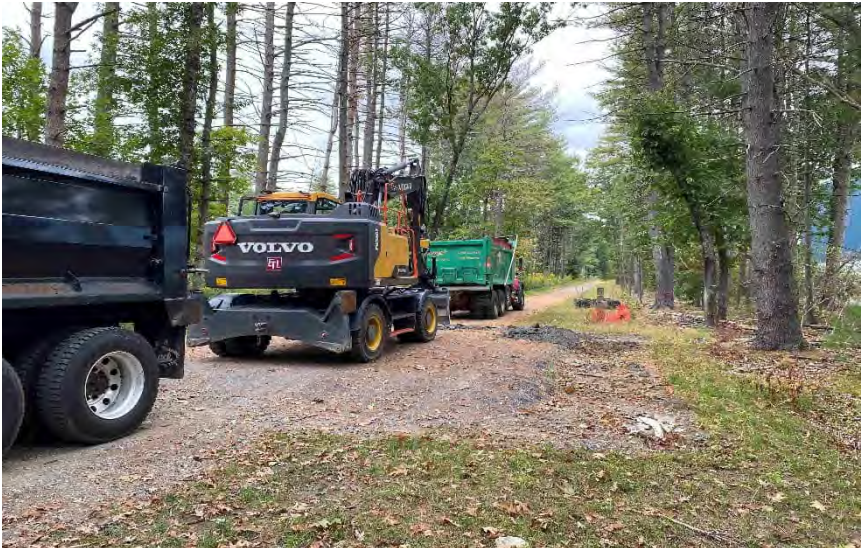
<p align="center">PHOTOGRAPHIC LOG</p>	
<p>Client Name: Eversource</p>		<p>Site Location: Sudbury to Hudson Transmission Reliability Project</p>	<p>Town: Hudson</p>
<p>Photo No.: 4</p>	<p>Date: 9-25-24</p>

<p>Description:</p> <p>Work area within segment 4, ET&L conducting pad removal work, manhole #10, existing erosion control, looking westward.</p>

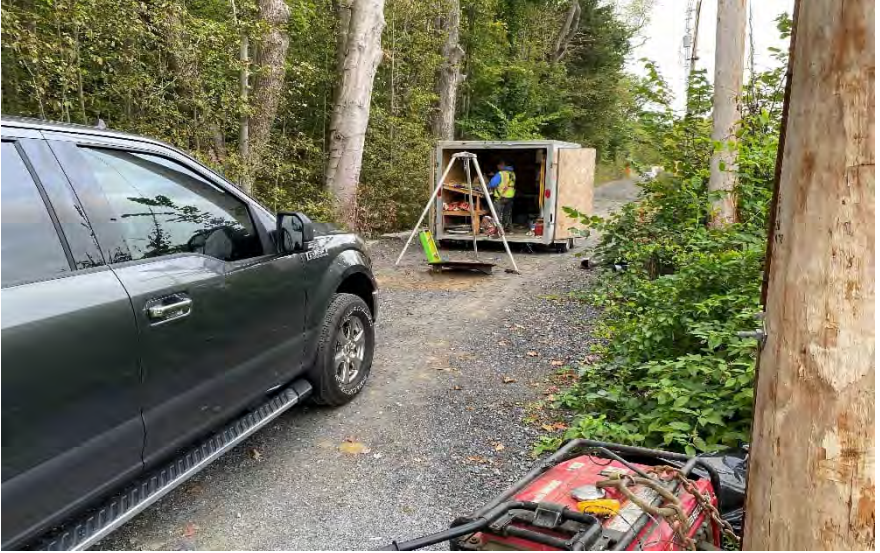
<p>PHOTOGRAPHIC LOG</p>	
<p>Client Name: Eversource</p>		<p>Site Location: Sudbury to Hudson Transmission Reliability Project</p>	<p>Town: Hudson</p>
<p>Photo No.: 5</p>	<p>Date: 9-25-24</p>

<p>Description:</p> <p>Bond conducting proofing work at manhole #1, looking eastward.</p>

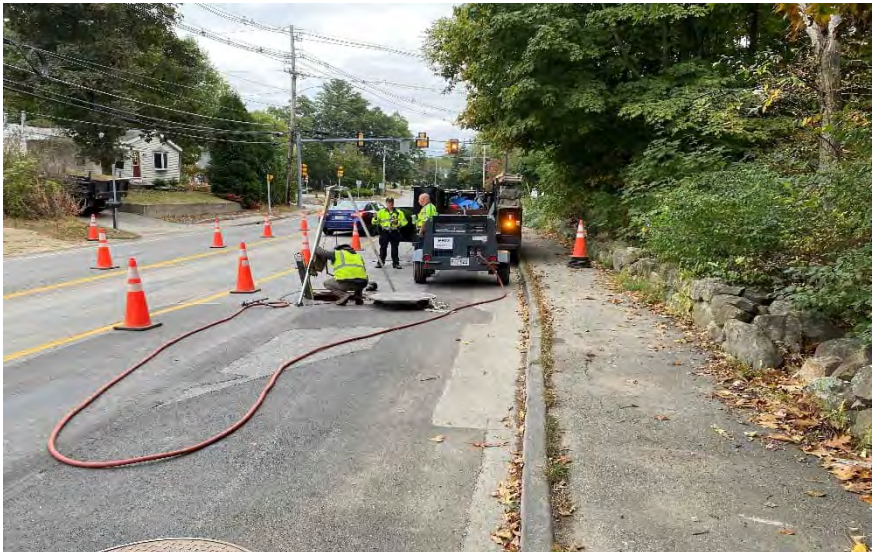
<p>PHOTOGRAPHIC LOG</p>	
<p>Client Name: Eversource</p>		<p>Site Location: Sudbury to Hudson Transmission Reliability Project</p>	<p>Town: Hudson</p>
<p>Photo No.: 6</p>	<p>Date: 9-25-24</p>

<p>Description:</p> <p>Bond conducting proofing work at manhole #2, looking northward.</p>

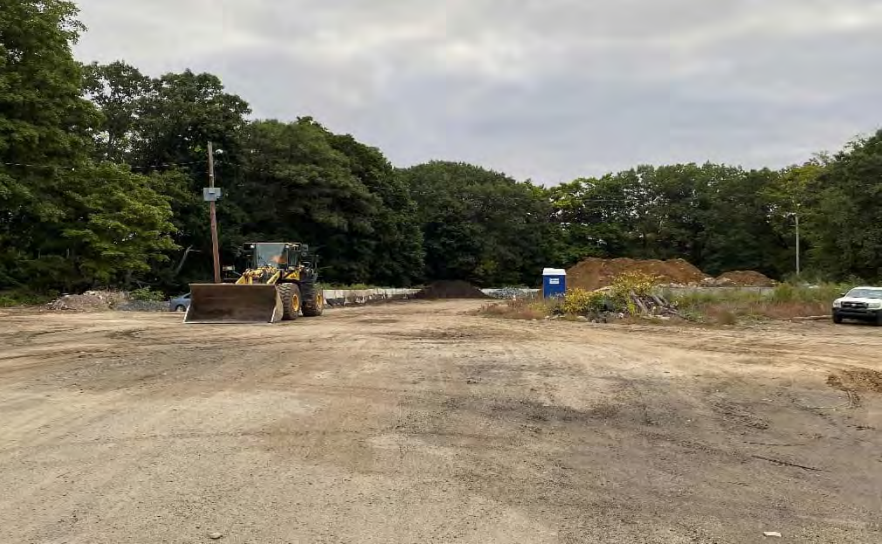
<p>PHOTOGRAPHIC LOG</p>	
<p>Client Name: Eversource</p>		<p>Site Location: Sudbury to Hudson Transmission Reliability Project</p>	<p>Town: Hudson</p>
<p>Photo No.: 7</p>	<p>Date: 9-25-24</p>

<p>Description: Stowe Court laydown yard, spoil management, looking southward.</p>

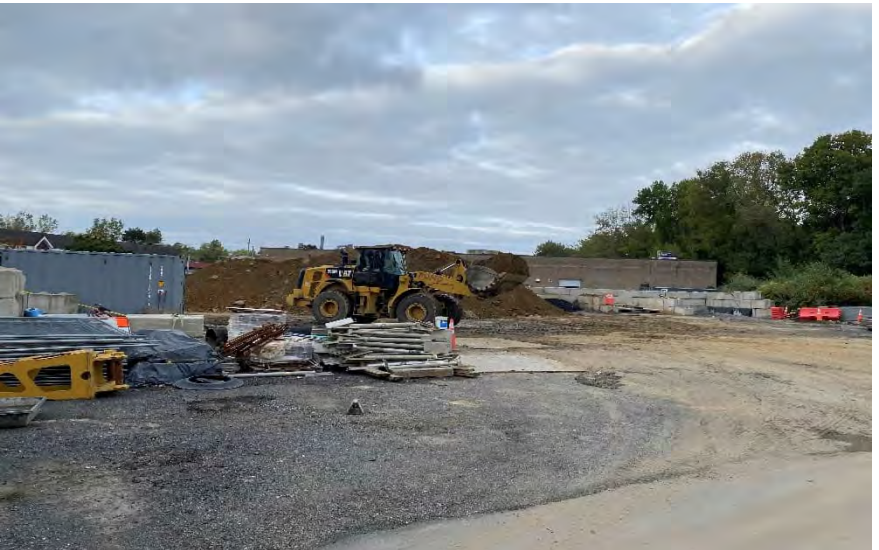
<p>PHOTOGRAPHIC LOG</p>	
<p>Client Name: Eversource</p>		<p>Site Location: Sudbury to Hudson Transmission Reliability Project</p>	<p>Town: Hudson</p>
<p>Photo No.: 8</p>	<p>Date: 9-25-24</p>

<p>Description: Bonazzoli laydown yard, Bond working here with spoil management, looking westward.</p>

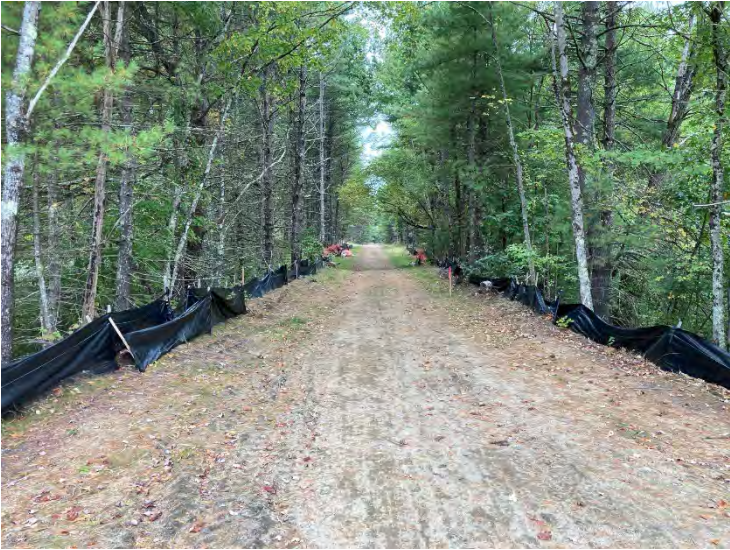
PHOTOGRAPHIC LOG	
Client Name: Eversource		Site Location: Sudbury to Hudson Transmission Reliability Project	Town: Sudbury
Photo No.: 1	Date: 9/25/2024

Description: View of E&S controls at east end of segment 7. Facing west.

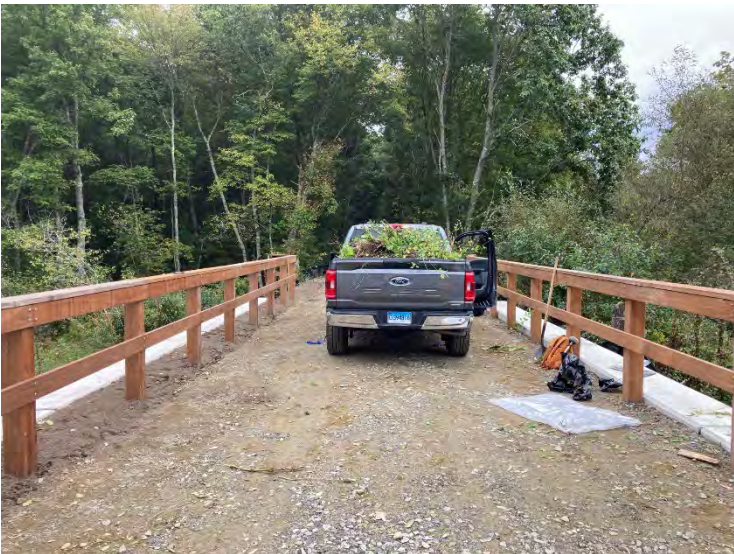
PHOTOGRAPHIC LOG	
Client Name: Eversource		Site Location: Sudbury to Hudson Transmission Reliability Project	Town: Sudbury
Photo No.: 2	Date: 9/25/2024

Description: View of SWCA removing invasive vegetation in segment 8 at bridge 128. Facing east.

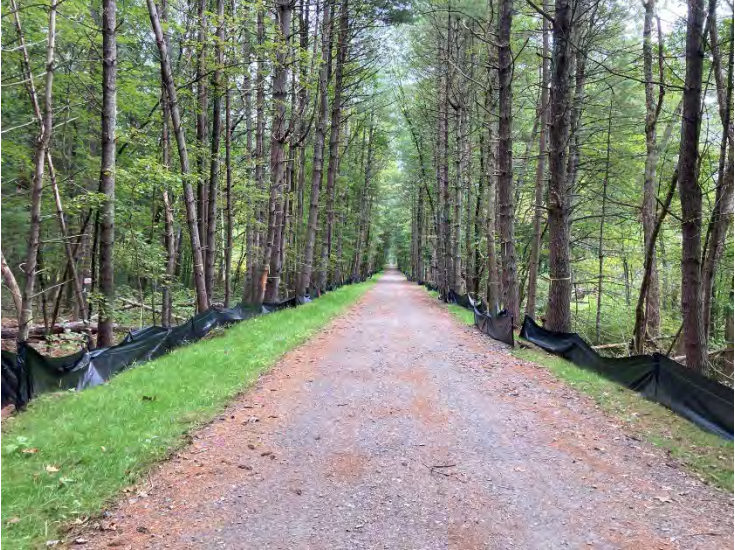
PHOTOGRAPHIC LOG	
Client Name: Eversource		Site Location: Sudbury to Hudson Transmission Reliability Project	Town: Sudbury
Photo No.: 3	Date: 9/25/2024

Description: View of E&S controls in segment 10. Facing east.

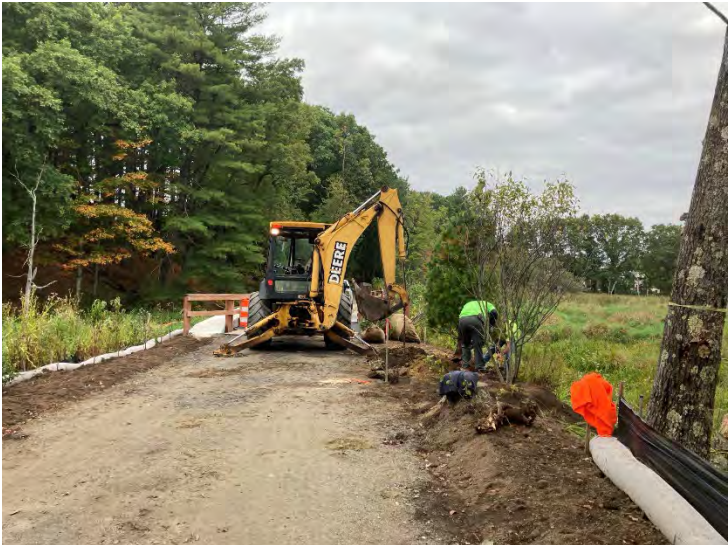
<p>PHOTOGRAPHIC LOG</p>	
<p>Client Name: Eversource</p>		<p>Site Location: Sudbury to Hudson Transmission Reliability Project</p>	<p>Town: Sudbury</p>
<p>Photo No.: 6</p>	<p>Date: 9/25/2024</p>

<p>Description: View of MON conducting restoration planting in segment 14. See additional planting reports. Facing west.</p>

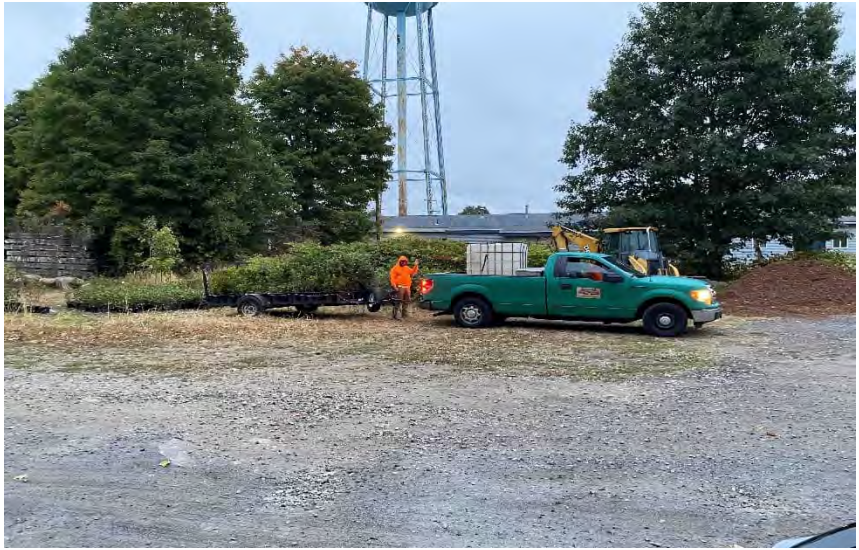
<p>PHOTOGRAPHIC LOG</p>	
<p>Client Name: Eversource</p>		<p>Site Location: Sudbury to Hudson Transmission Reliability Project</p>	<p>Town: Hudson</p>
<p>Photo No.: 1</p>	<p>Date: 9-26-24</p>

<p>Description: MON loading plants at Bond office for use in the field (segments 13/14), looking southward.</p>

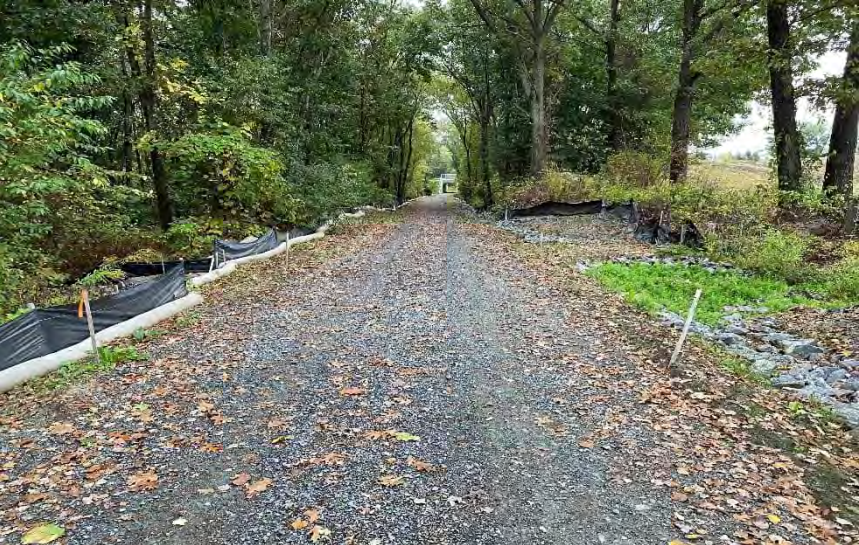
<p>PHOTOGRAPHIC LOG</p>	
<p>Client Name: Eversource</p>		<p>Site Location: Sudbury to Hudson Transmission Reliability Project</p>	<p>Town: Stow</p>
<p>Photo No.: 2</p>	<p>Date: 9-26-24</p>

<p>Description: Work area within segment 1, recently loamed & hydro seeded areas, existing erosion control, looking eastward.</p>

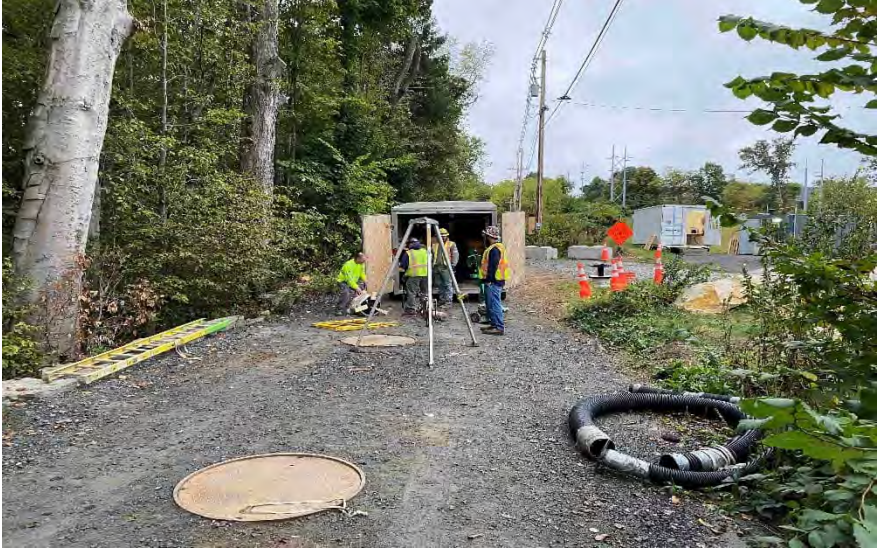
<p align="center">PHOTOGRAPHIC LOG</p>	
<p>Client Name: Eversource</p>		<p>Site Location: Sudbury to Hudson Transmission Reliability Project</p>	<p>Town: Hudson</p>
<p>Photo No.: 5</p>	<p>Date: 9-26-24</p>

<p>Description:</p> <p>Bond conducting proofing work at manhole #1, looking eastward.</p>

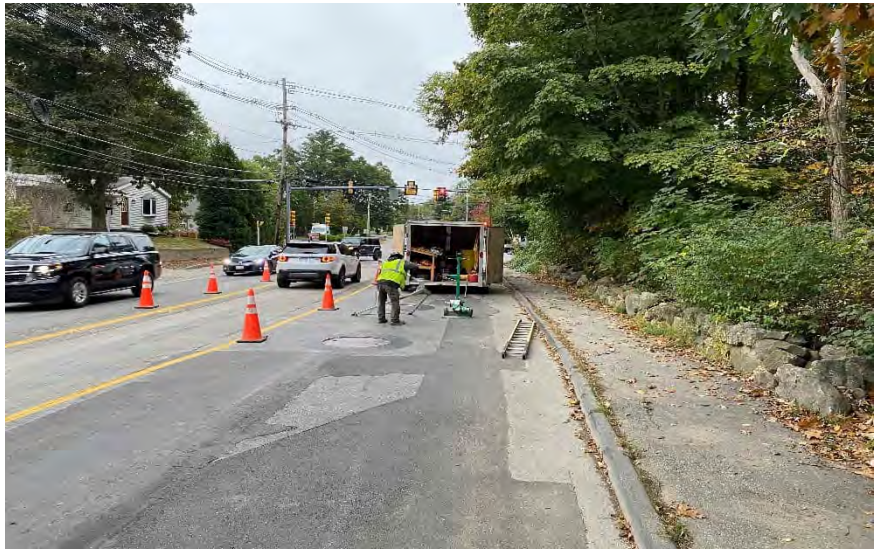
<p align="center">PHOTOGRAPHIC LOG</p>	
<p>Client Name: Eversource</p>		<p>Site Location: Sudbury to Hudson Transmission Reliability Project</p>	<p>Town: Hudson</p>
<p>Photo No.: 6</p>	<p>Date: 9-26-24</p>

<p>Description:</p> <p>Bond conducting proofing work at manhole #2, looking northward.</p>

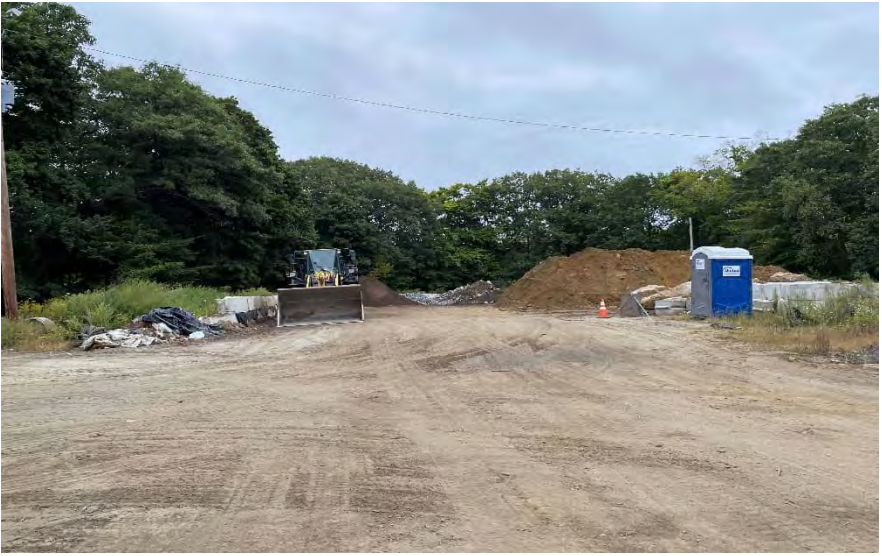
PHOTOGRAPHIC LOG	
Client Name: Eversource		Site Location: Sudbury to Hudson Transmission Reliability Project	Town: Hudson
Photo No.: 7	Date: 9-26-24

Description: Stowe Court laydown yard, spoil management, looking southward.

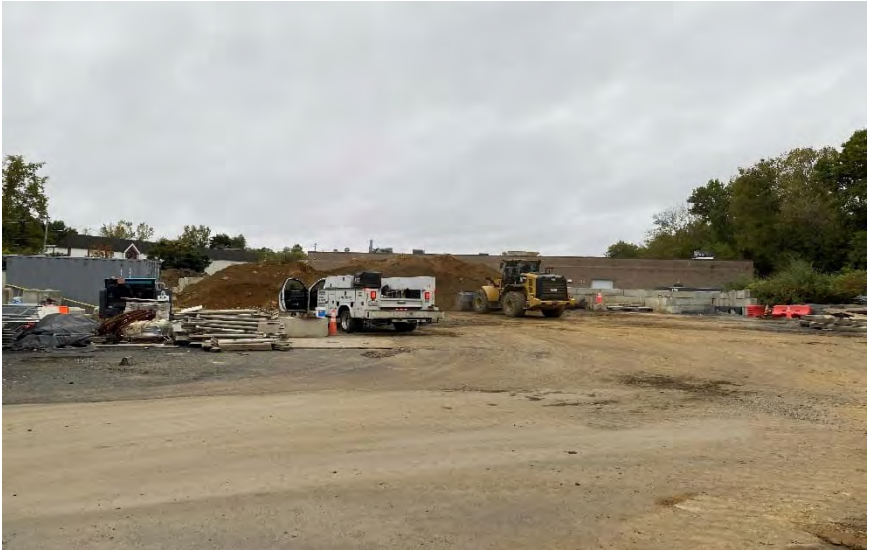
PHOTOGRAPHIC LOG	
Client Name: Eversource		Site Location: Sudbury to Hudson Transmission Reliability Project	Town: Hudson
Photo No.: 8	Date: 9-26-24

Description: Bonazzoli laydown yard, Bond working here with spoil management, looking westward.

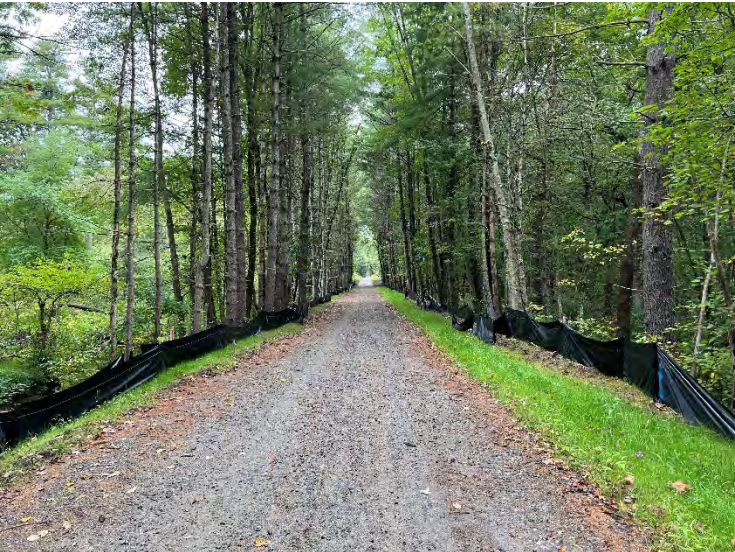
PHOTOGRAPHIC LOG	
Client Name: Eversource		Site Location: Sudbury to Hudson Transmission Reliability Project	Town: Sudbury
Photo No.: 2	Date: 9/26/2024

Description: View of E&S controls in segment 10. Facing west.

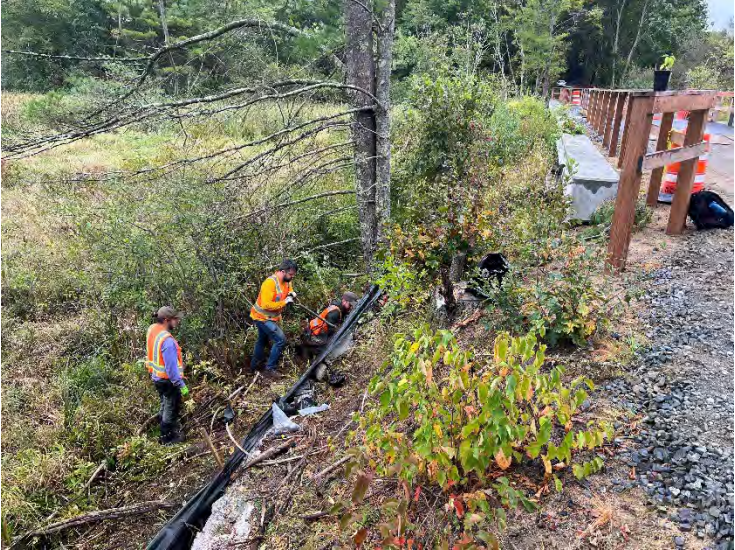
<p>PHOTOGRAPHIC LOG</p>	
<p>Client Name: Eversource</p>		<p>Site Location: Sudbury to Hudson Transmission Reliability Project</p>	<p>Town: Sudbury</p>
<p>Photo No.: 3</p>	<p>Date: 9/26/2024</p>

<p>Description: View of SWCA team removing invasive plant species from segment 7 by Bridge 128. Facing east.</p>

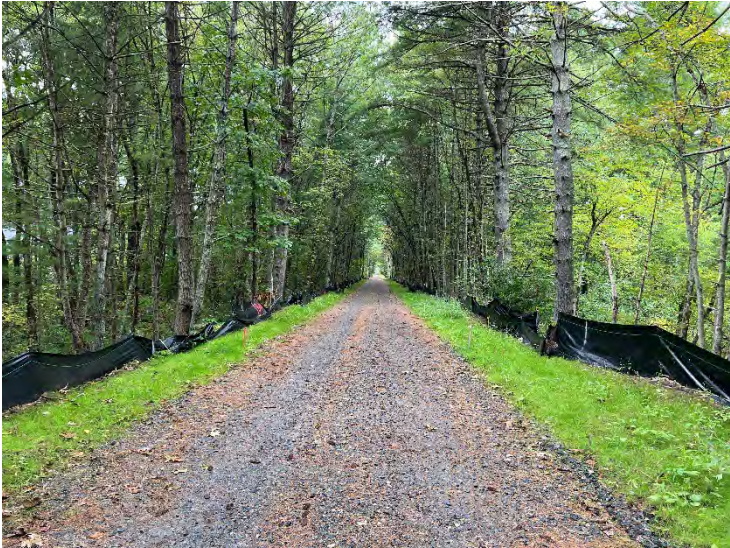
<p>PHOTOGRAPHIC LOG</p>	
<p>Client Name: Eversource</p>		<p>Site Location: Sudbury to Hudson Transmission Reliability Project</p>	<p>Town: Sudbury</p>
<p>Photo No.: 5</p>	<p>Date: 9/26/2024</p>

<p>Description: View of E&S controls in segment 9. Facing west.</p>

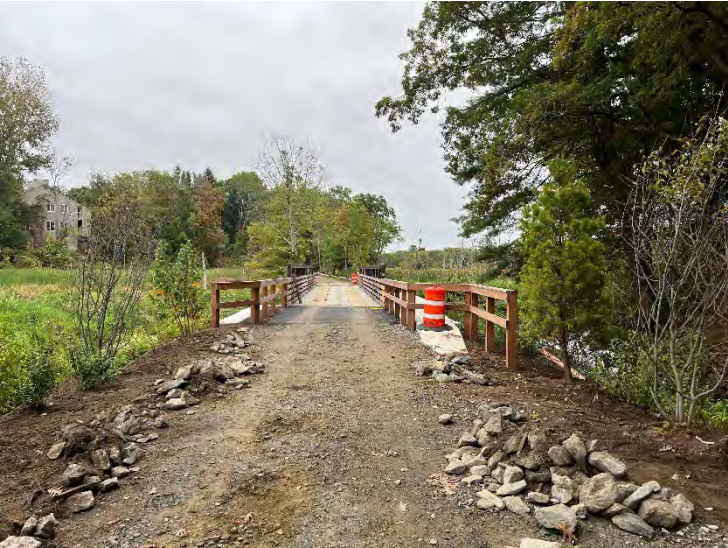
<p>PHOTOGRAPHIC LOG</p>	
<p>Client Name: Eversource</p>		<p>Site Location: Sudbury to Hudson Transmission Reliability Project</p>	<p>Town: Sudbury</p>
<p>Photo No.: 7</p>	<p>Date: 9/26/2024</p>

<p>Description: View of Bridge 127. Removed rip rap on ROW edges to be removed once work is completed in this segment. Facing east.</p>

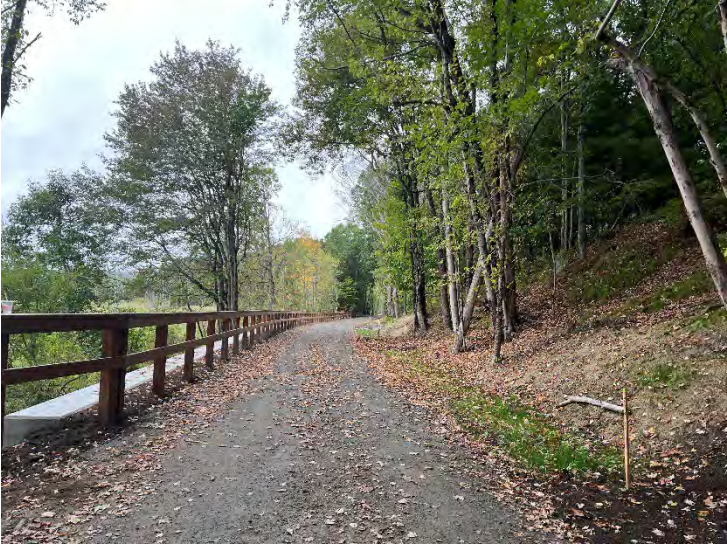
<p>PHOTOGRAPHIC LOG</p>	
<p>Client Name: Eversource</p>		<p>Site Location: Sudbury to Hudson Transmission Reliability Project</p>	<p>Town: Sudbury</p>
<p>Photo No.: 8</p>	<p>Date: 9/26/2024</p>

<p>Description: View of Wall 14 in segment 14. Facing west.</p>

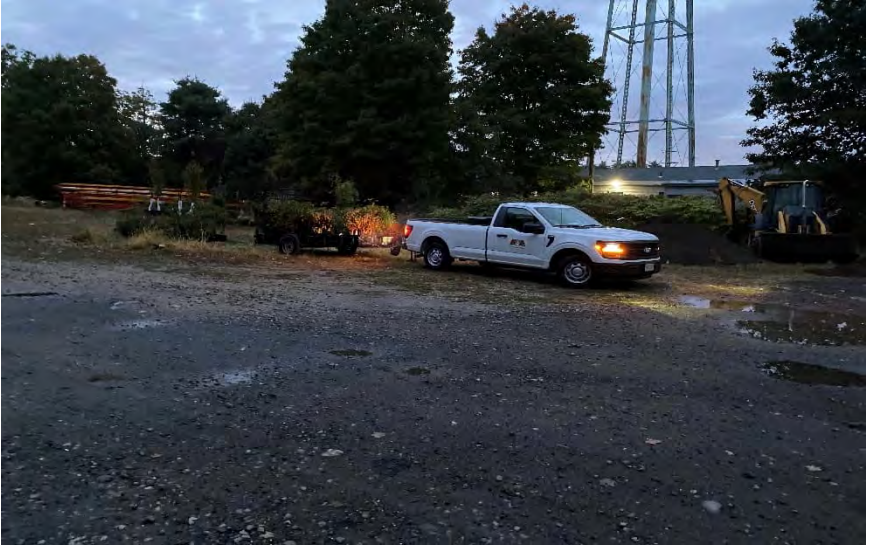
PHOTOGRAPHIC LOG	
Client Name: Eversource		Site Location: Sudbury to Hudson Transmission Reliability Project	Town: Hudson
Photo No.: 1	Date: 9-27-24

Description: MON loading plants at Bond office for use in the field (segment 13), looking southward.

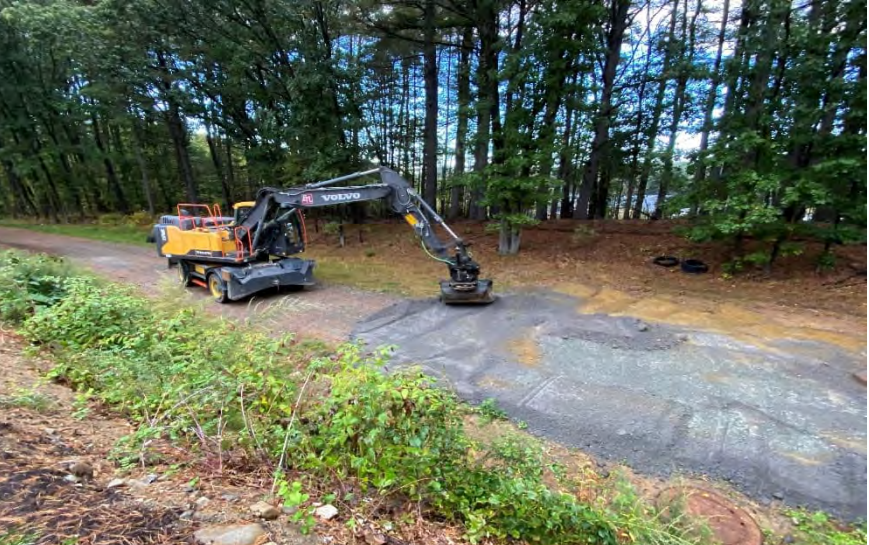
PHOTOGRAPHIC LOG	
Client Name: Eversource		Site Location: Sudbury to Hudson Transmission Reliability Project	Town: Hudson
Photo No.: 2	Date: 9-27-24

Description: Work area within segment 3, ET&L removing gravel pad at manhole #9, looking southward.

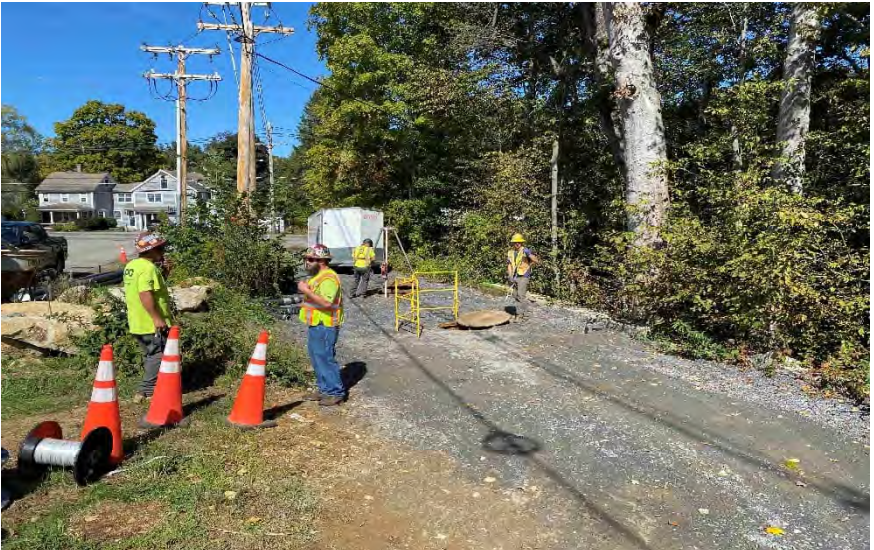
<p>PHOTOGRAPHIC LOG</p>	
<p>Client Name: Eversource</p>		<p>Site Location: Sudbury to Hudson Transmission Reliability Project</p>	<p>Town: Hudson</p>
<p>Photo No.: 5</p>	<p>Date: 9-27-24</p>

<p>Description:</p> <p>Bond conducting proofing work at manhole #1, looking westward.</p>

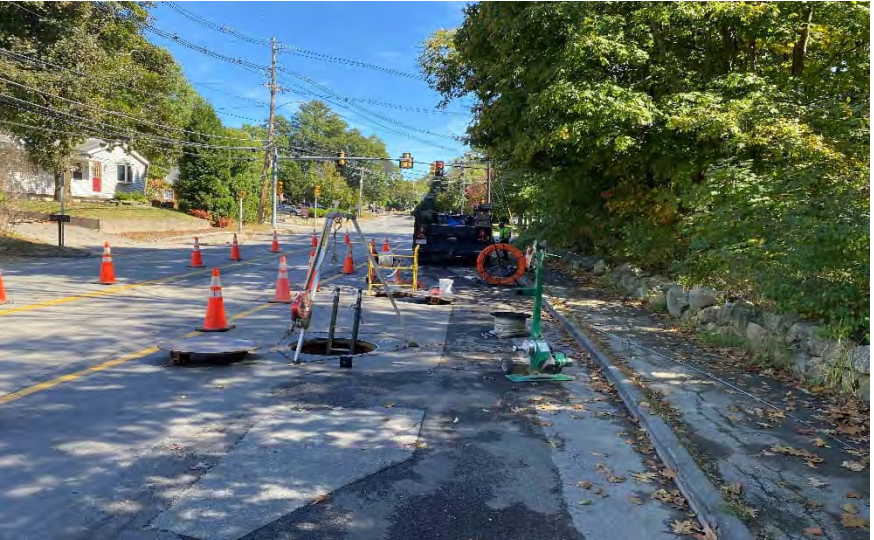
<p>PHOTOGRAPHIC LOG</p>	
<p>Client Name: Eversource</p>		<p>Site Location: Sudbury to Hudson Transmission Reliability Project</p>	<p>Town: Hudson</p>
<p>Photo No.: 6</p>	<p>Date: 9-27-24</p>

<p>Description:</p> <p>Bond conducting proofing work at manhole #2, looking northward.</p>

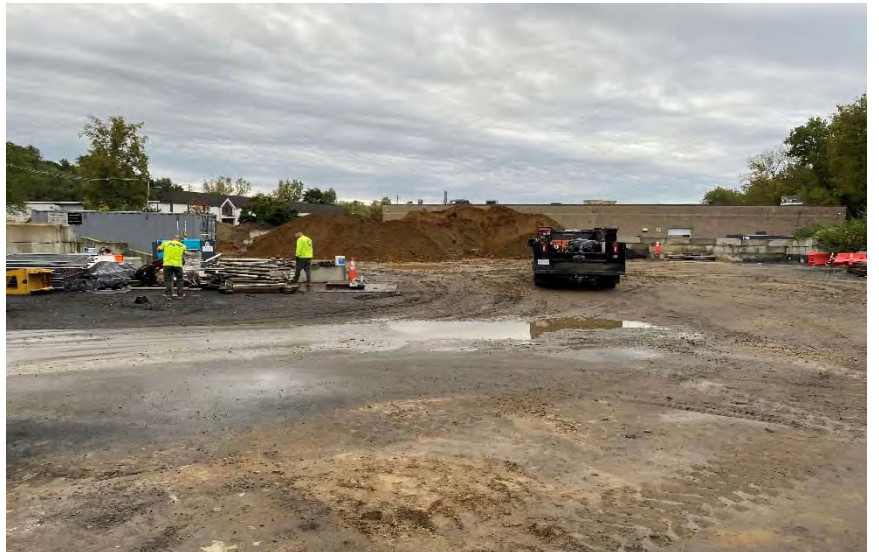
<p>PHOTOGRAPHIC LOG</p>	
<p>Client Name: Eversource</p>		<p>Site Location: Sudbury to Hudson Transmission Reliability Project</p>	<p>Town: Hudson</p>
<p>Photo No.: 8</p>	<p>Date: 9-27-24</p>

<p>Description:</p> <p>Bonazzoli laydown yard, Bond working here with cleanup work, looking westward.</p>

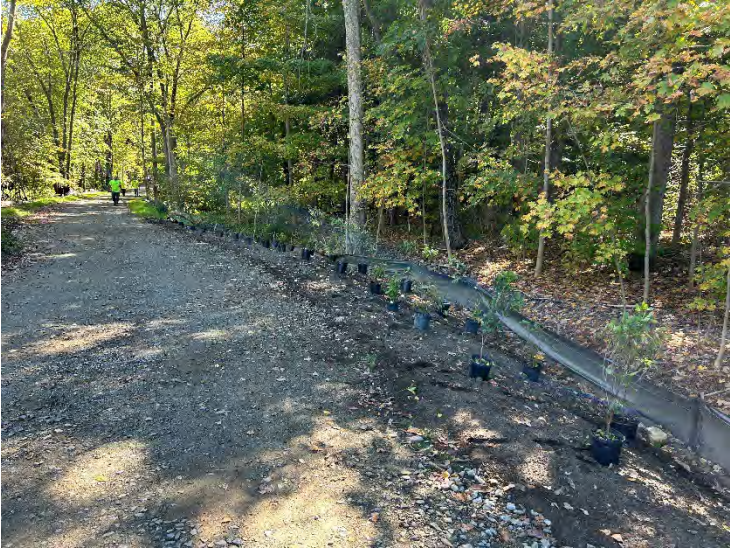
PHOTOGRAPHIC LOG	
Client Name: Eversource		Site Location: Sudbury to Hudson Transmission Reliability Project	Town: Sudbury
Photo No.: 1	Date: 9/27/2024

Description: View of plants laid out according to planting scheme. MON planting in segment 13 with oversight from environmental monitors from AECOM & SWCA. Facing southeast.

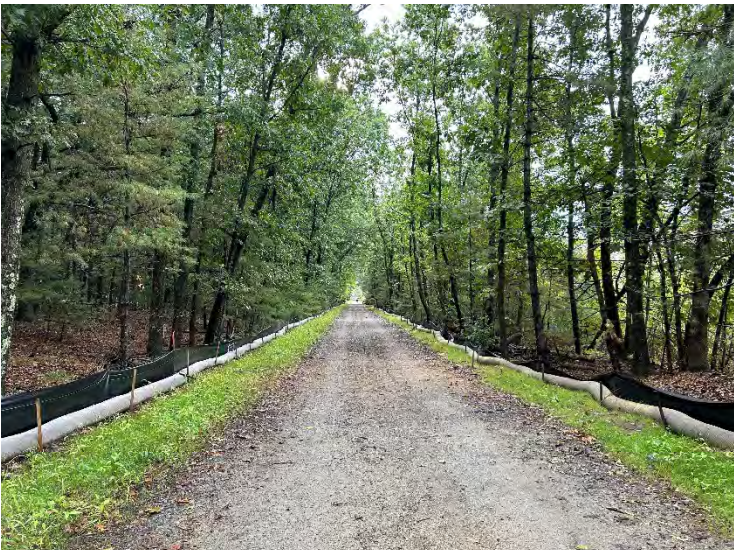
PHOTOGRAPHIC LOG	
Client Name: Eversource		Site Location: Sudbury to Hudson Transmission Reliability Project	Town: Sudbury
Photo No.: 2	Date: 9/27/2024

Description: View of E&S controls in segment 11. Facing east.

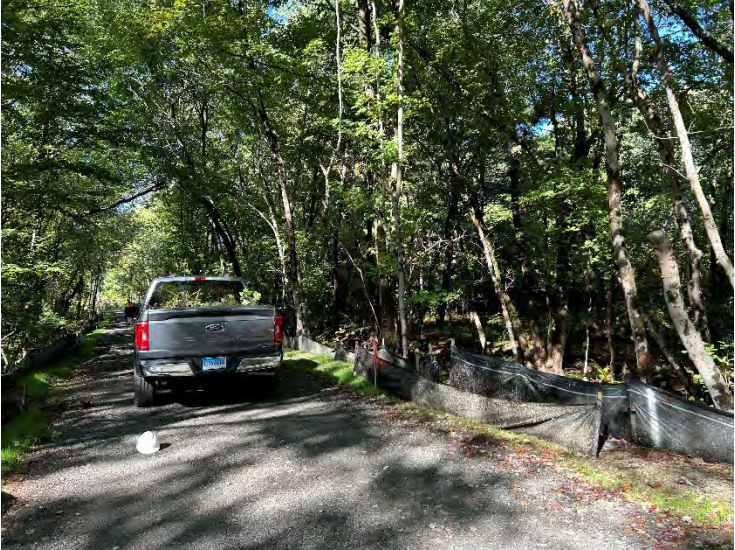
<p>PHOTOGRAPHIC LOG</p>	
<p>Client Name: Eversource</p>		<p>Site Location: Sudbury to Hudson Transmission Reliability Project</p>	<p>Town: Sudbury</p>
<p>Photo No.: 3</p>	<p>Date: 9/27/2024</p>

<p>Description: View of SWCA team removing invasive plant species from segment 14. Facing west.</p>

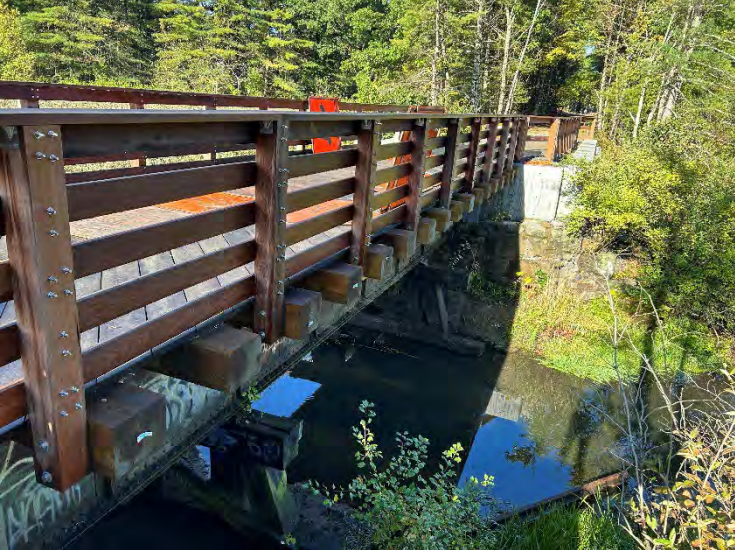
<p>PHOTOGRAPHIC LOG</p>	
<p>Client Name: Eversource</p>		<p>Site Location: Sudbury to Hudson Transmission Reliability Project</p>	<p>Town: Sudbury</p>
<p>Photo No.: 4</p>	<p>Date: 9/27/2024</p>

<p>Description: View of bridge 128. Netting has been removed from under the bridge. Facing southwest.</p>

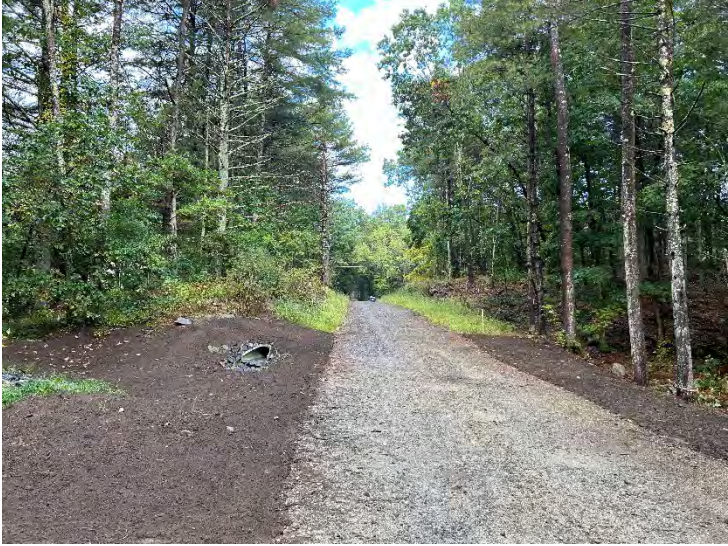
PHOTOGRAPHIC LOG	
Client Name: Eversource		Site Location: Sudbury to Hudson Transmission Reliability Project	Town: Sudbury
Photo No.: 8	Date: 9/27/2024

Description: View of loam applied to ROW shoulders in segment 10. Facing west.

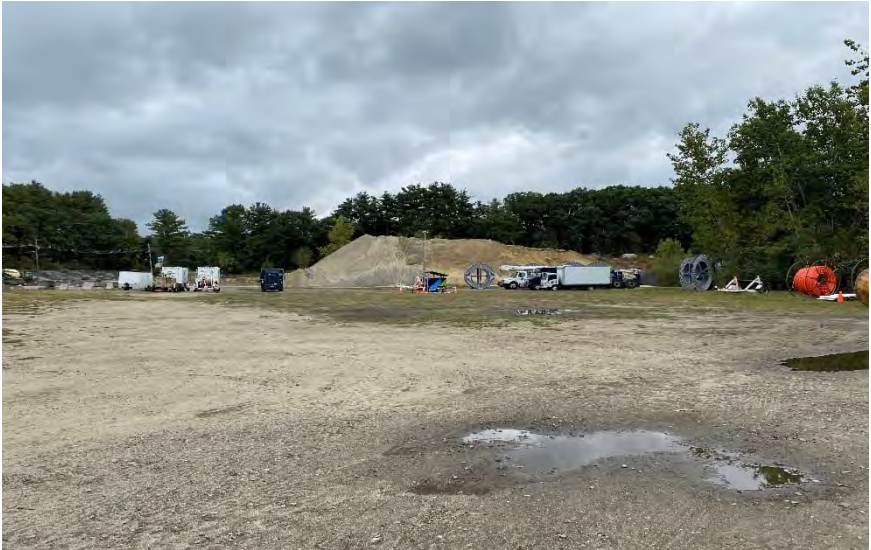
PHOTOGRAPHIC LOG	
Client Name: Eversource		Site Location: Sudbury to Hudson Transmission Reliability Project	Town: Hudson
Photo No.: 1	Date: 9-23-24

Description: Haugland laydown yard, stored wire on reels, looking westward.

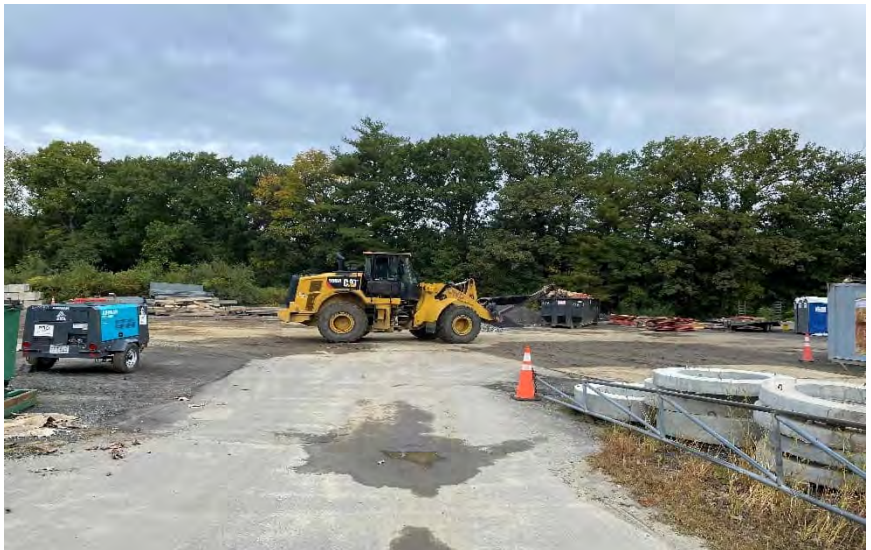
PHOTOGRAPHIC LOG	
Client Name: Eversource		Site Location: Sudbury to Hudson Transmission Reliability Project	Town: Hudson
Photo No.: 2	Date: 9-23-24

Description: Laydown yard at Bonazzoli, Bond working with the stockpiled spoils, looking northward.

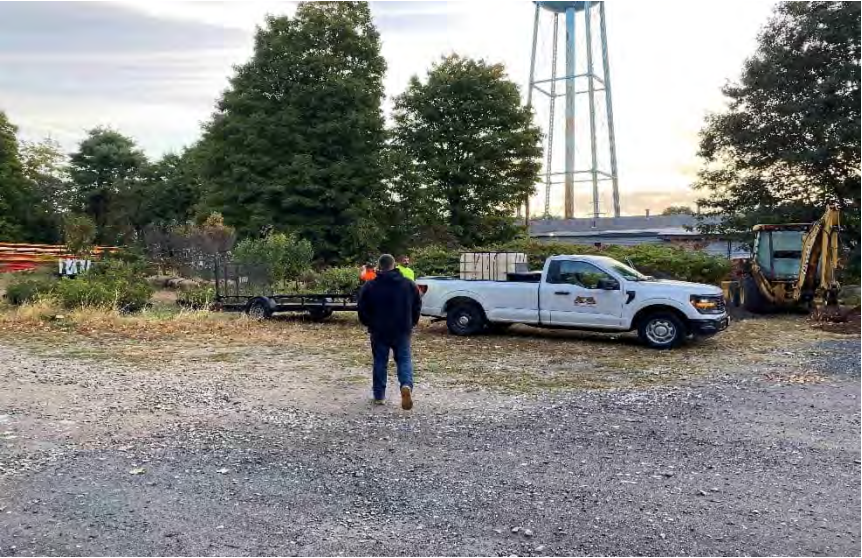
PHOTOGRAPHIC LOG	
Client Name: Eversource		Site Location: Sudbury to Hudson Transmission Reliability Project	Town: Hudson
Photo No.: 3	Date: 9-23-24

Description: Bond storage area for plants, MON loading plants for field work (segment 14), looking southward.
