Weekly Environmental Compliance Summary

Sudbury to Hudson Transmission Reliability Project (USEPA Tracking # MAR1003UW)

Week of: September 23, 2024 to September 27, 2024

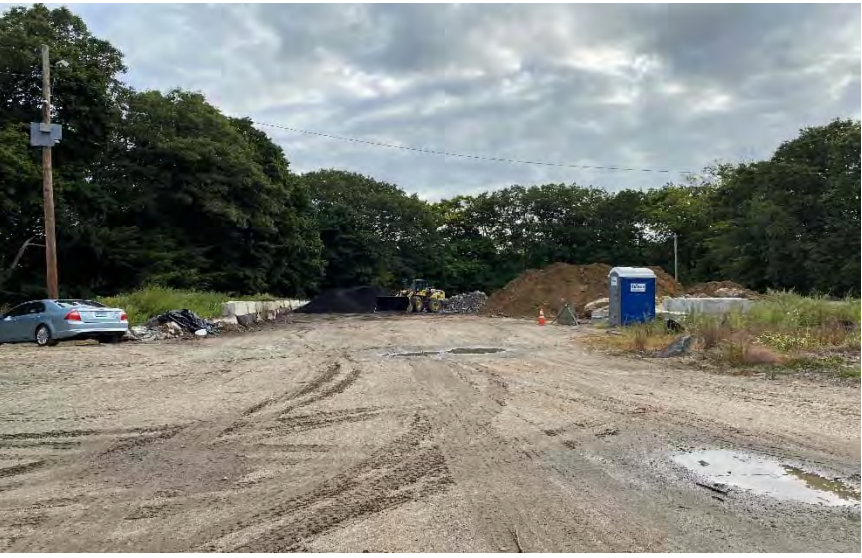
PHOTOGRAPHIC LOG	
Client Name: Eversource		Site Location: Sudbury to Hudson Transmission Reliability Project	Town: Hudson
Photo No.: 4	Date: 9-23-24

Description: ET&L working within laydown yard at Stowe Court, looking southward.

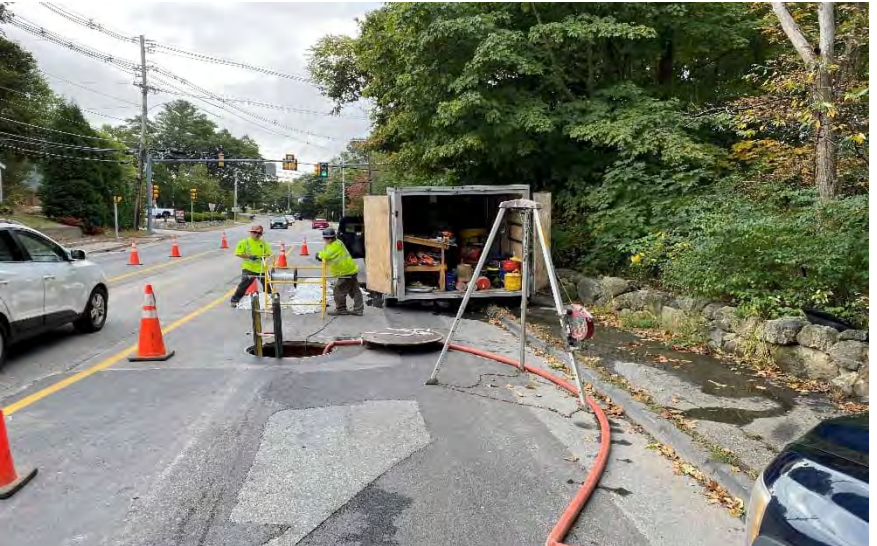
PHOTOGRAPHIC LOG	
Client Name: Eversource		Site Location: Sudbury to Hudson Transmission Reliability Project	Town: Hudson
Photo No.: 6	Date: 9-23-24

Description: Bond working at manhole #2 proofing conduit, looking northward.

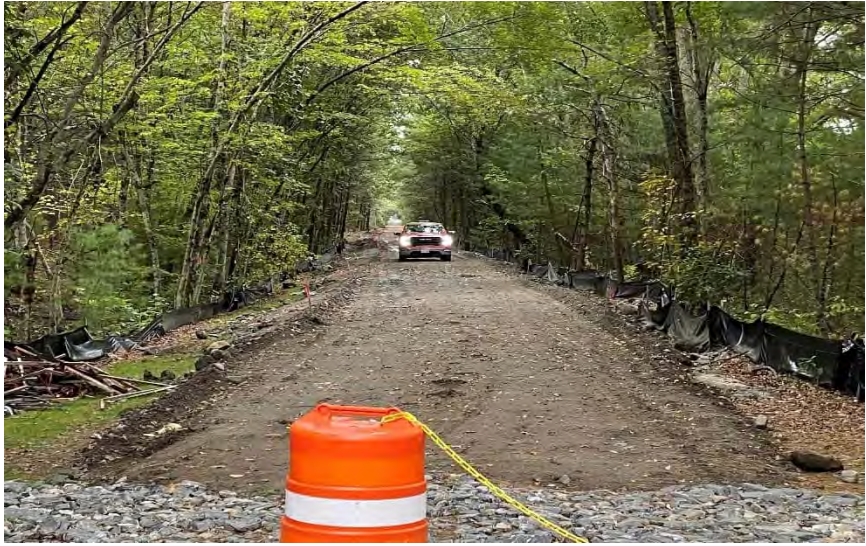
PHOTOGRAPHIC LOG	
Client Name: Eversource		Site Location: Sudbury to Hudson Transmission Reliability Project	Town: Hudson
Photo No.: 8	Date: 9-23-24

Description: Work area within segment 6, ET&L reviewing area prior to grading, existing erosion control, looking eastward.

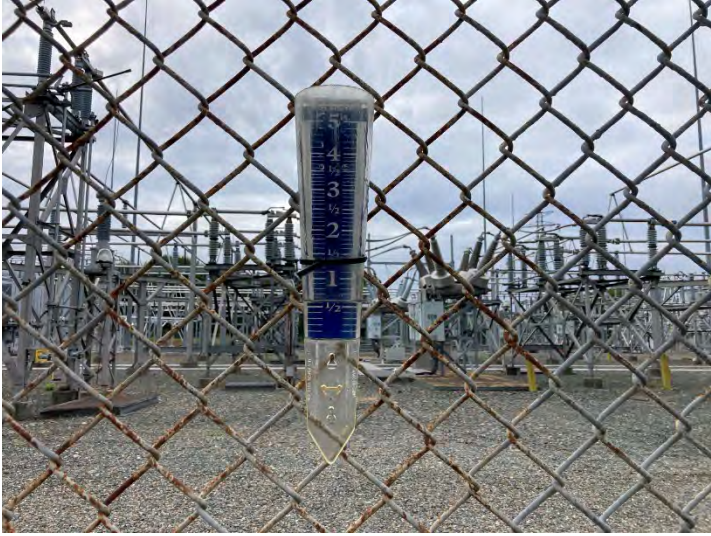
PHOTOGRAPHIC LOG	
Client Name: Eversource		Site Location: Sudbury to Hudson Transmission Reliability Project	Town: Sudbury
Photo No.: 1	Date: 9-23-24

Description: View of rain gauge at Sudbury Substation. 0.60" observed in gauge at 8:00am on 9-23-2024. Facing south.

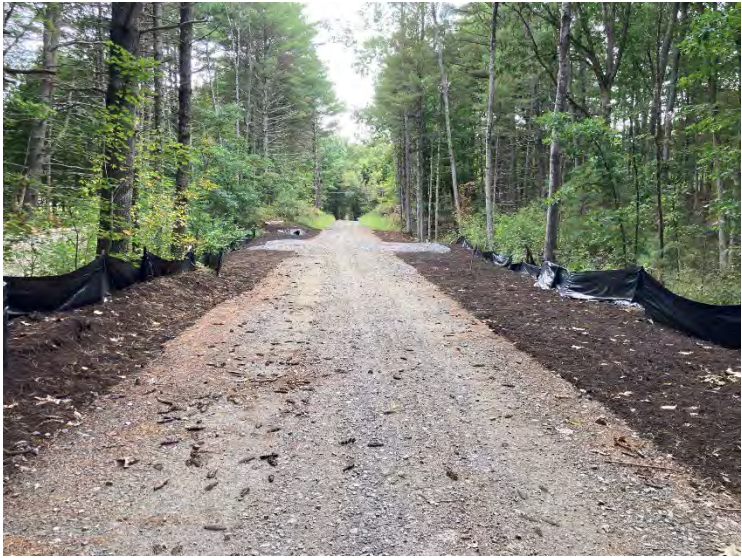
Epsilon ASSOCIATES INC.		PHOTOGRAPHIC LOG	
Client Name: Eversource		Site Location: Sudbury to Hudson Transmission Reliability Project	Town: Sudbury
Photo No.: 4	Date: 9-23-24

Description: View of E&S controls at west end of segment 10. Facing west.

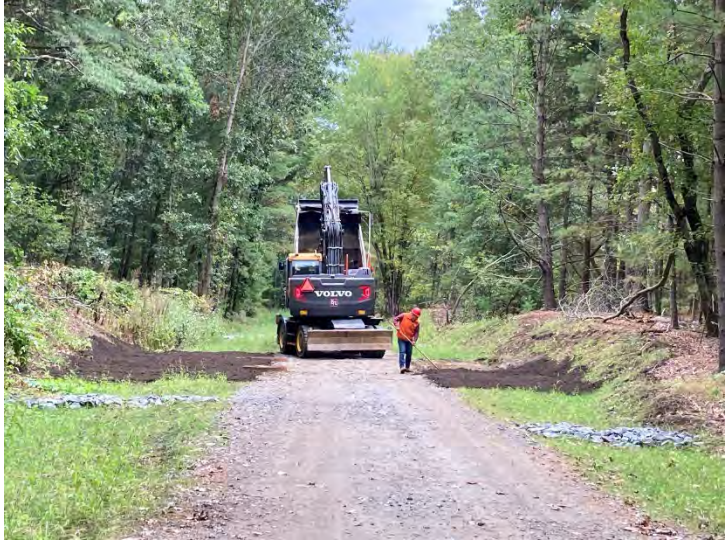
PHOTOGRAPHIC LOG	
Client Name: Eversource		Site Location: Sudbury to Hudson Transmission Reliability Project	Town: Sudbury
Photo No.: 5	Date: 9-23-24

Description: View of ET&L applying loam in segment 11. Facing west.

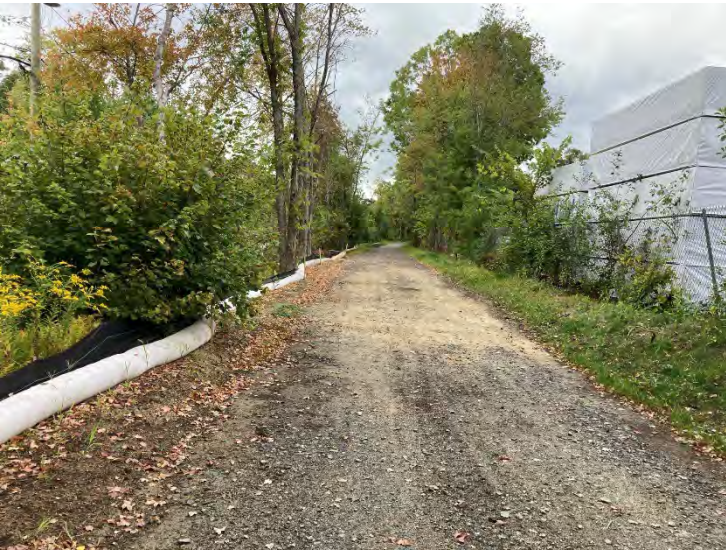
PHOTOGRAPHIC LOG	
Client Name: Eversource		Site Location: Sudbury to Hudson Transmission Reliability Project	Town: Sudbury
Photo No.: 6	Date: 9-23-24

Description: View of E&S controls in segment 12. Facing east.

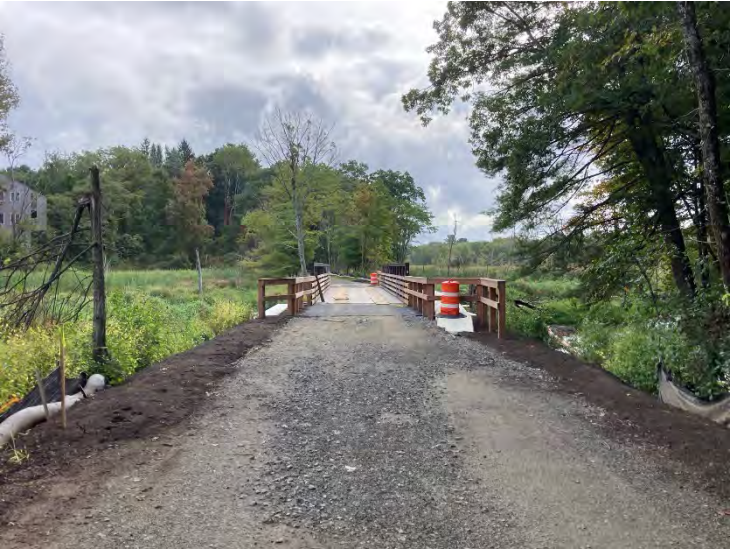
Epsilon ASSOCIATES INC.		PHOTOGRAPHIC LOG	
Client Name: Eversource		Site Location: Sudbury to Hudson Transmission Reliability Project	Town: Sudbury
Photo No.: 7	Date: 9-23-24

Description: View of bridge 127. Facing east.

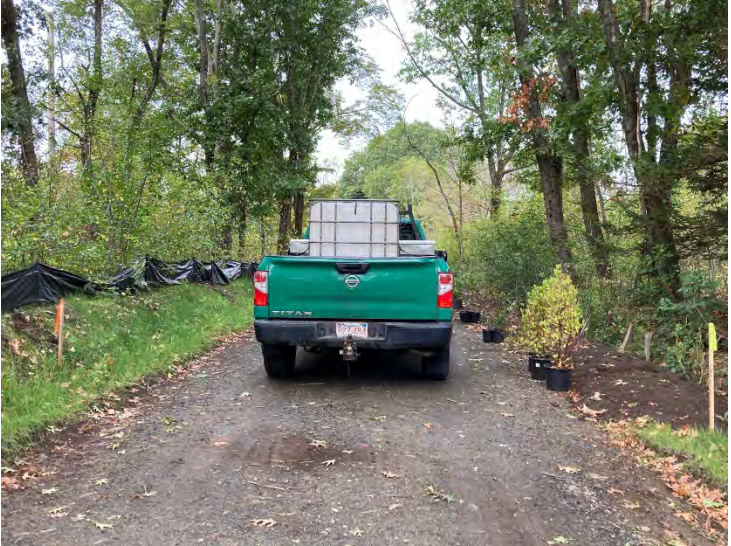
Epsilon ASSOCIATES INC.		PHOTOGRAPHIC LOG	
Client Name: Eversource		Site Location: Sudbury to Hudson Transmission Reliability Project	Town: Sudbury
Photo No.: 8	Date: 9-23-24

Description: View of MON conducting restoration planting in segment 14. See additional planting reports. Facing west.

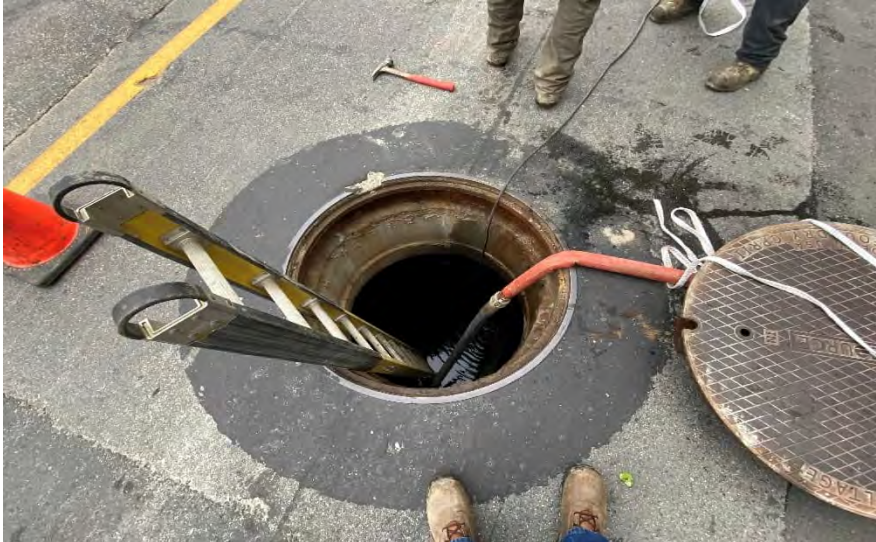
PHOTOGRAPHIC LOG	
Client Name: Eversource		Site Location: Sudbury to Hudson Transmission Reliability Project	Town: Hudson
Photo No.: 1	Date: 9/23/2024

Description: View of area being pumped from Manhole #2 within Forest Avenue.

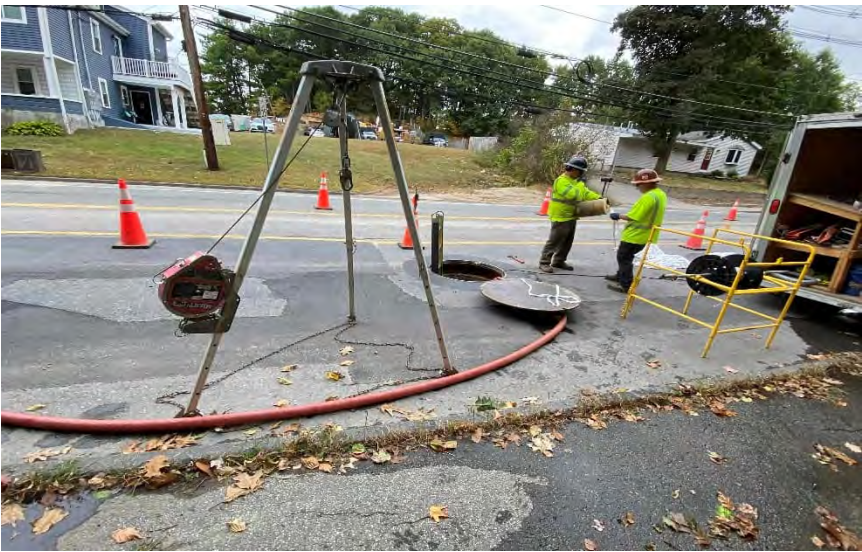
<h2 style="margin: 0;">PHOTOGRAPHIC LOG</h2>	
Client Name: Eversource		Site Location: Sudbury to Hudson Transmission Reliability Project	
Town: Hudson			
Photo No.: 3	Date: 9/23/2024

Description: Manhole #2 Forest Avenue. View of dewatering operation, looking westward.

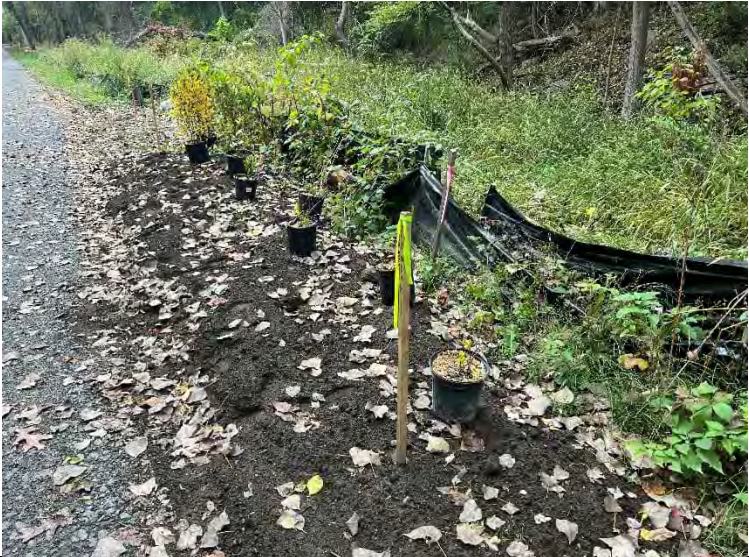
<p>PHOTOGRAPHIC LOG</p>	
<p>Client Name: Eversource</p>		<p>Site Location: Sudbury to Hudson Transmission Reliability Project</p>	<p>Town: Sudbury</p>
<p>Photo No.: 3</p>	<p>Date: 9/23/24</p>

<p>Description: View of plants laid out to planting scheme at sta#742+20 to 742+40. Facing west.</p>

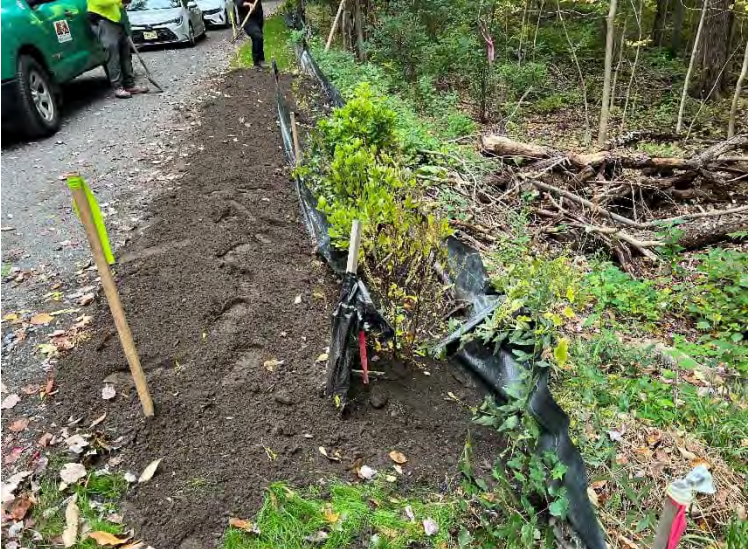
<p>PHOTOGRAPHIC LOG</p>	
<p>Client Name: Eversource</p>		<p>Site Location: Sudbury to Hudson Transmission Reliability Project</p>	<p>Town: Sudbury</p>
<p>Photo No.: 4</p>	<p>Date: 9/23/24</p>

<p>Description: View of installed plants between sta#743+00 and #744+00. Space between syncopated silt fencing was used for planting, cut/downed trees behind the work area did not allow for planting beyond the fencing. Facing east.</p>

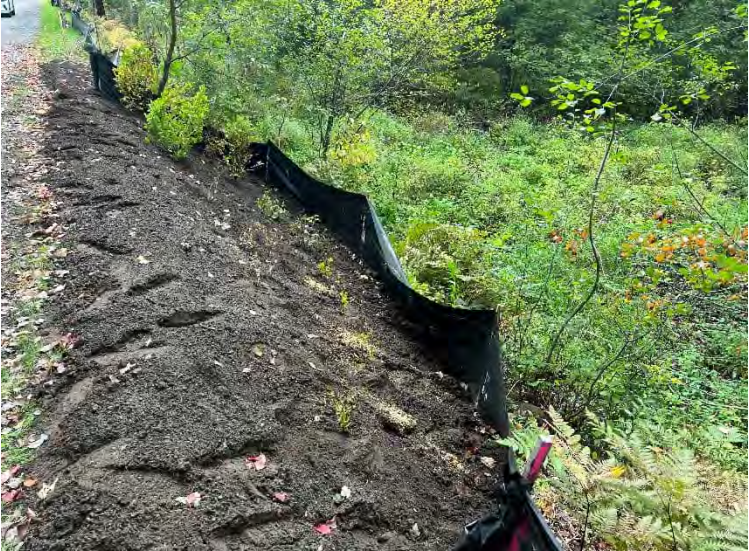
<p>PHOTOGRAPHIC LOG</p>	
<p>Client Name: Eversource</p>		<p>Site Location: Sudbury to Hudson Transmission Reliability Project</p>	<p>Town: Sudbury</p>
<p>Photo No.: 2</p>	<p>Date: 9/23/24</p>

<p>Description: View of installed plants in station #746+80 to 747+20. One CA shifted westward from plans to fill the middle of the planting bed. Facing east.</p>

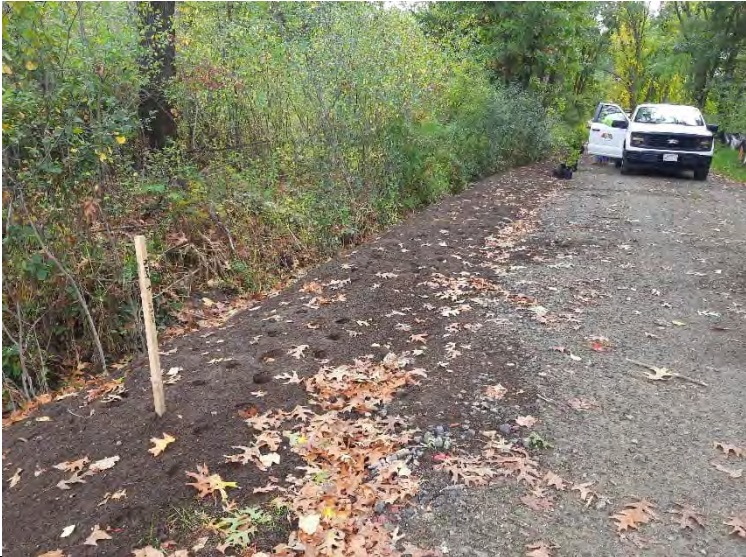
PHOTOGRAPHIC LOG	
Client Name: Eversource		Site Location: Sudbury to Hudson Transmission Reliability Project	Town: Sudbury
Photo No.: 1	Date: 9/23/24

Description: Segment 14, north side, near STA 765+00. MON organizing plantings from east to west. Looking eastward.

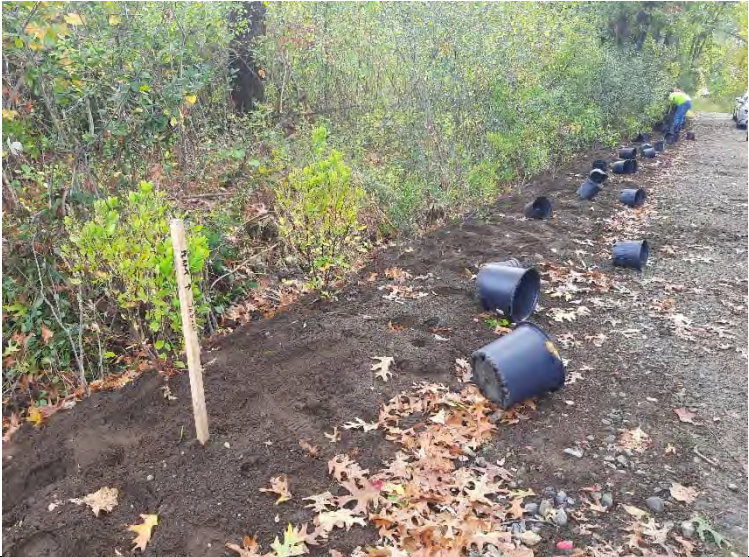
<p>PHOTOGRAPHIC LOG</p>	
<p>Client Name: Eversource</p>		<p>Site Location: Sudbury to Hudson Transmission Reliability Project</p>	<p>Town: Sudbury</p>
<p>Photo No.: 3</p>	<p>Date: 9/23/24</p>

<p>Description: Segment 14, north side, near STA 765 + 00. Newly installed plantings. Looking eastward.</p>

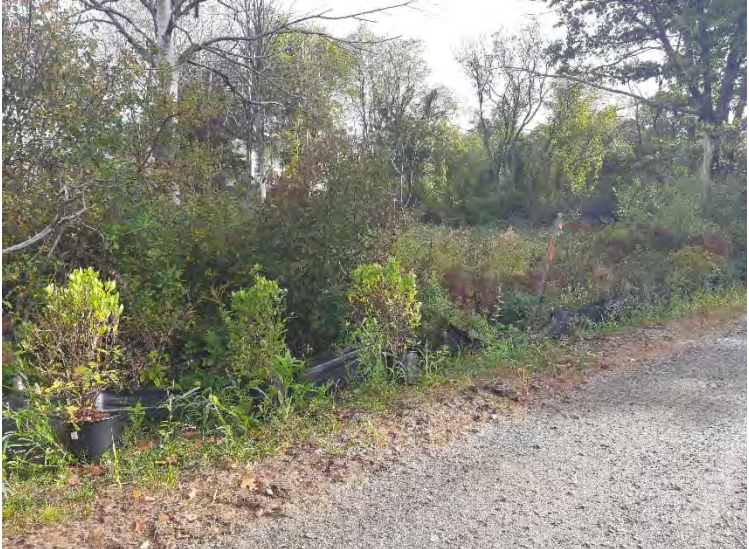
<p>PHOTOGRAPHIC LOG</p>	
<p>Client Name: Eversource</p>		<p>Site Location: Sudbury to Hudson Transmission Reliability Project</p>	<p>Town: Sudbury</p>
<p>Photo No.: 4</p>	<p>Date: 9/23/24</p>

<p>Description: Segment 14, north side, opposite west end of replication area. Three pepperbushes (CA) moved from east side of culvert to west side. Looking eastward.</p>

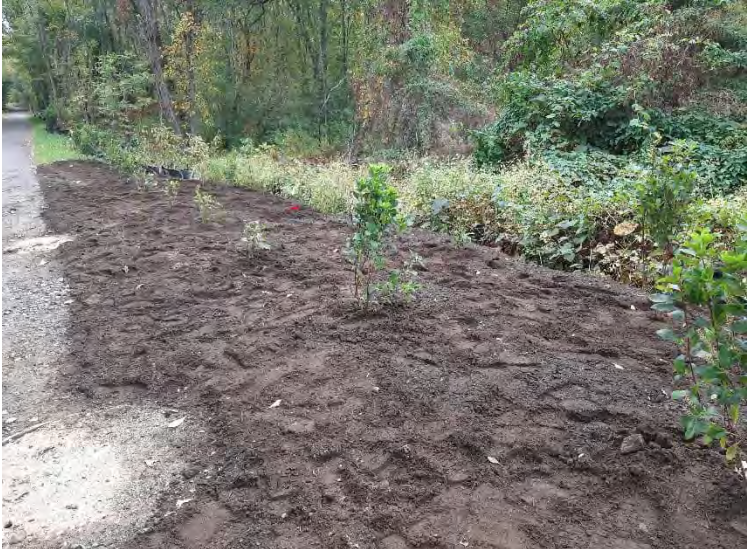
<p>PHOTOGRAPHIC LOG</p>	
<p>Client Name: Eversource</p>		<p>Site Location: Sudbury to Hudson Transmission Reliability Project</p>	<p>Town: Sudbury</p>
<p>Photo No.: 2</p>	<p>Date: 9/23/24</p>

<p>Description:</p> <p>Segment 14, north side, near MH 27. Installed plantings. Planned location for absent dogwood (SD) marked with white flag and annotated in red. Looking westward.</p>

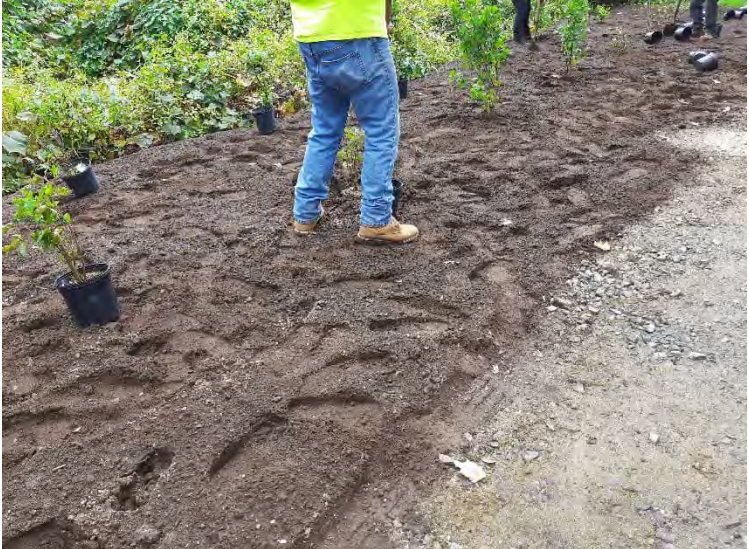
<p>PHOTOGRAPHIC LOG</p>	
<p>Client Name: Eversource</p>		<p>Site Location: Sudbury to Hudson Transmission Reliability Project</p>	<p>Town: Sudbury</p>
<p>Photo No.: 4</p>	<p>Date: 9/23/24</p>

<p>Description: Segment 14, north side, near MH 27. MON installing plantings. Looking eastward.</p>

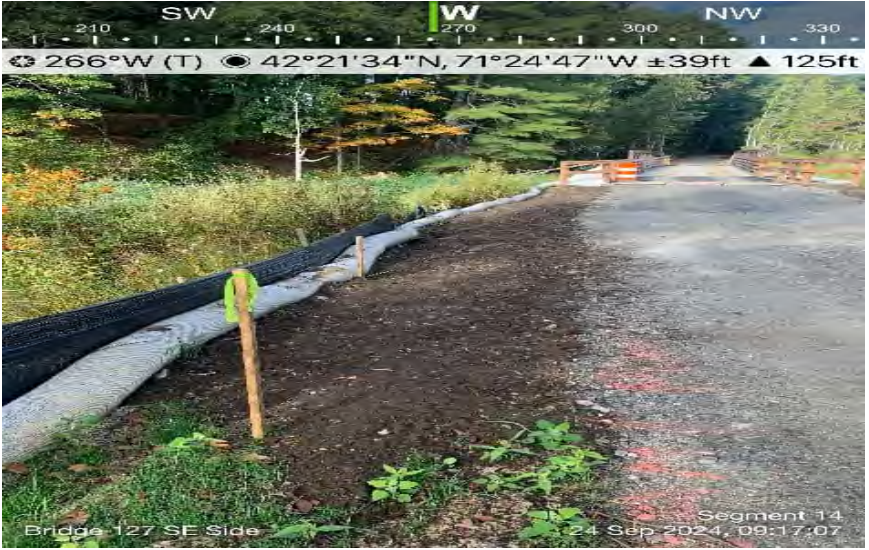
<p>PHOTOGRAPHIC LOG</p>	
<p>Client Name: Eversource</p>		<p>Site Location: Sudbury to Hudson Transmission Reliability Project</p>	<p>Town: Sudbury</p>
<p>Photo No.: 1</p>	<p>Date: 9/24/2024</p>

<p>Description: Bed prior to planting at Bridge 127 in Segment 14. The bed is on the southern side of the work area and the eastern side of Bridge 127, approximately between Stations 725+75 and 726+40.</p>		<p>Bridge 127 SE Side Segment 14 24 Sep 2024, 09:17:07</p>

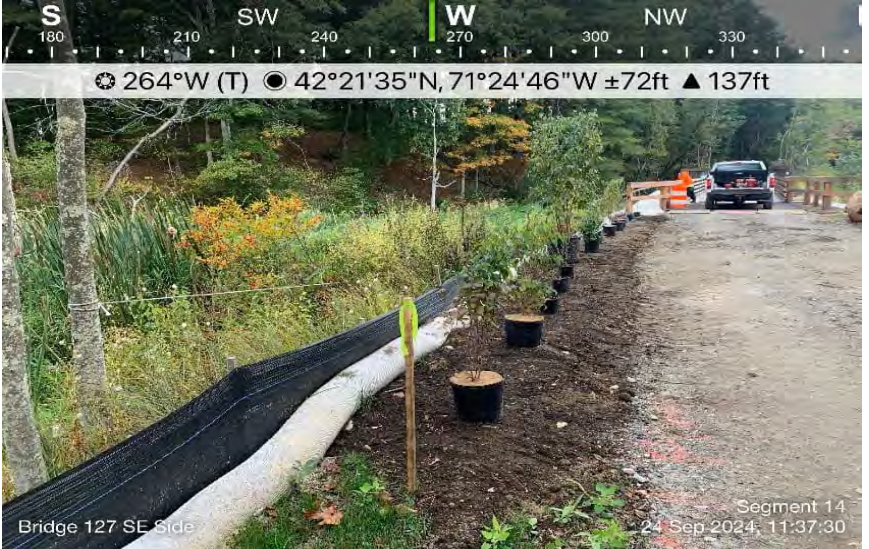
<p>PHOTOGRAPHIC LOG</p>	
<p>Client Name: Eversource</p>		<p>Site Location: Sudbury to Hudson Transmission Reliability Project</p>	<p>Town: Sudbury</p>
<p>Photo No.: 2</p>	<p>Date: 9/24/2024</p>

<p>Description: Bed with plants staged at Bridge 127 in Segment 14. The bed is on the southern side of the work area and the eastern side of Bridge 127, approximately between Stations 725+75 and 726+40.</p>		<p>Bridge 127 SE Side Segment 14 24 Sep 2024, 11:37:30</p>

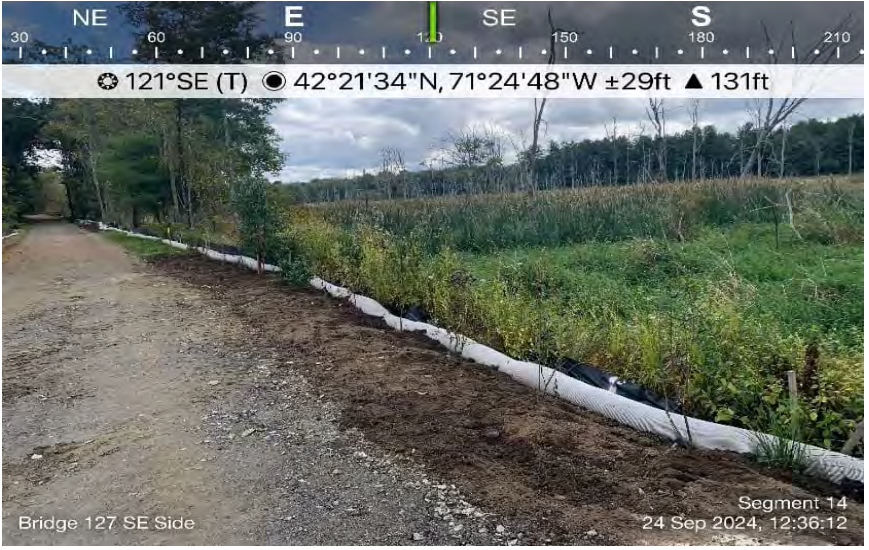
<p>PHOTOGRAPHIC LOG</p>	
<p>Client Name: Eversource</p>		<p>Site Location: Sudbury to Hudson Transmission Reliability Project</p>	<p>Town: Sudbury</p>
<p>Photo No.: 3</p>	<p>Date: 9/24/2024</p>

<p>Description: Bed after planting was completed at Bridge 127 in Segment 14. The bed is on the southern side of the work area and the eastern side of Bridge 127, approximately between Stations 725+75 and 726+40.</p>		<p>Bridge 127 SE Side</p> <p>Segment 14 24 Sep 2024, 12:36:12</p>

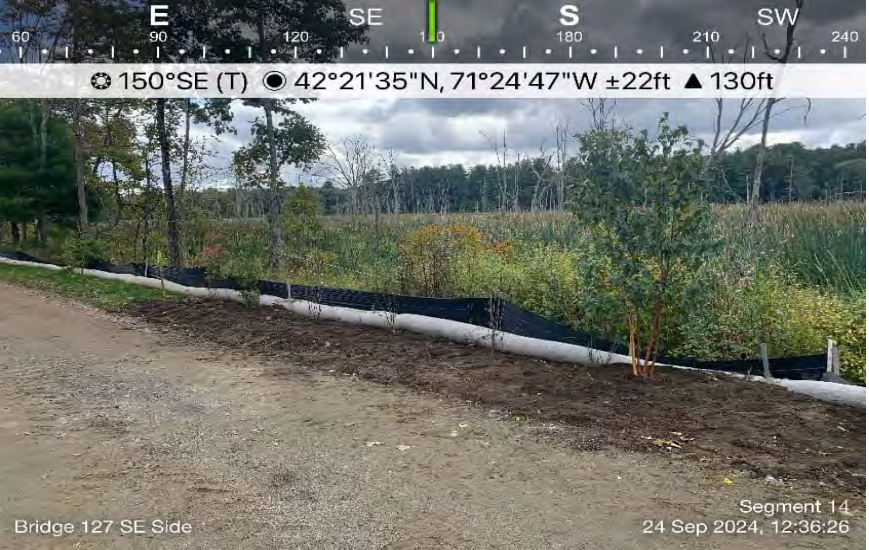
<p>PHOTOGRAPHIC LOG</p>	
<p>Client Name: Eversource</p>		<p>Site Location: Sudbury to Hudson Transmission Reliability Project</p>	<p>Town: Sudbury</p>
<p>Photo No.: 4</p>	<p>Date: 9/24/2024</p>

<p>Description: Bed after planting was completed at Bridge 127 in Segment 14. The bed is on the southern side of the work area and the eastern side of Bridge 127, approximately between Stations 725+75 and 726+40. Pictured is the eastern side of the bed and the final location of the gray birch tree. From left to right are 2 silky dogwood plants, 3 winterberry plants, and then the 1 gray birch tree.</p>		<p>Bridge 127 SE Side</p> <p>Segment 14 24 Sep 2024, 12:36:26</p>

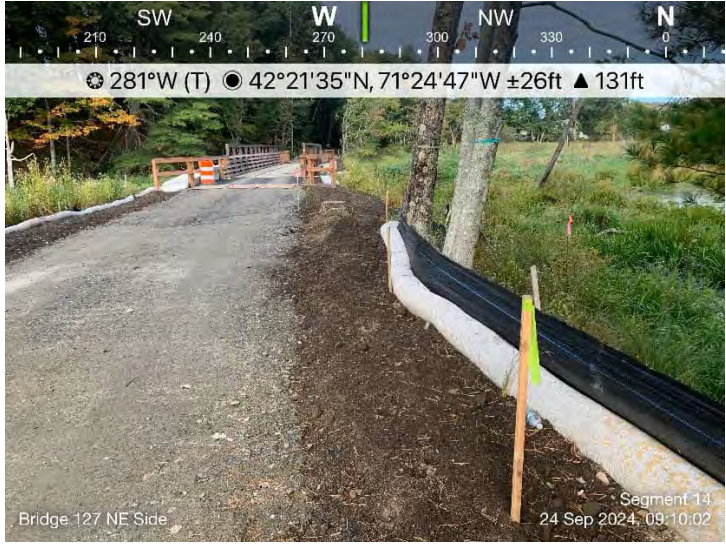
<p>PHOTOGRAPHIC LOG</p>	
<p>Client Name: Eversource</p>		<p>Site Location: Sudbury to Hudson Transmission Reliability Project</p>	<p>Town: Sudbury</p>
<p>Photo No.: 1</p>	<p>Date: 9/24/2024</p>

<p>Description: Bed prior to planting at Bridge 127 in Segment 14. The bed is on the northern side of the work area and the eastern side of Bridge 127, approximately between Stations 725+75 and 726+40.</p>		<p>Bridge 127 NE Side Segment 14 24 Sep 2024, 09:10:02</p>

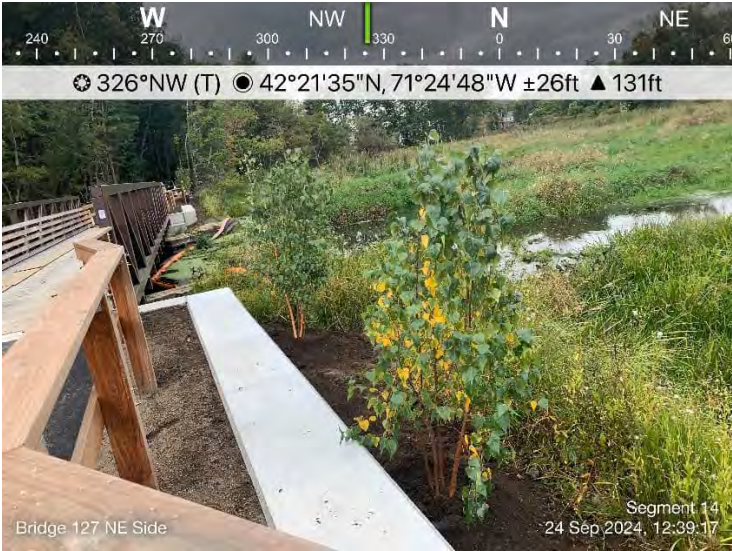
<p>PHOTOGRAPHIC LOG</p>	
<p>Client Name: Eversource</p>		<p>Site Location: Sudbury to Hudson Transmission Reliability Project</p>	<p>Town: Sudbury</p>
<p>Photo No.: 3</p>	<p>Date: 9/24/2024</p>

<p>Description: Bed with 2 gray birch (BP) trees planted at Bridge 127 in Segment 14. The trees are on the western end of the bed. The bed is on the northern side of the work area and the eastern side of Bridge 127, approximately between Stations 725+75 and 726+40.</p>

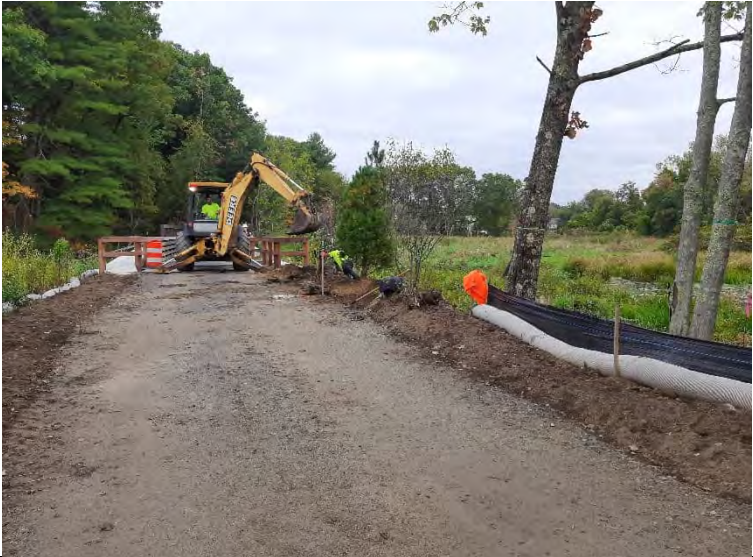
<p>PHOTOGRAPHIC LOG</p>	
<p>Client Name: Eversource</p>		<p>Site Location: Sudbury to Hudson Transmission Reliability Project</p>	<p>Town: Sudbury</p>
<p>Photo No.: 1</p>	<p>Date: 9/25/24</p>

<p>Description: Segment 14, north side, east of Bridge 127. MON installing tree plantings. One serviceberry (AC) moved to opp. side of ROW and westward, to bed behind photo vantage point, due to space restrictions. Looking westward.</p>

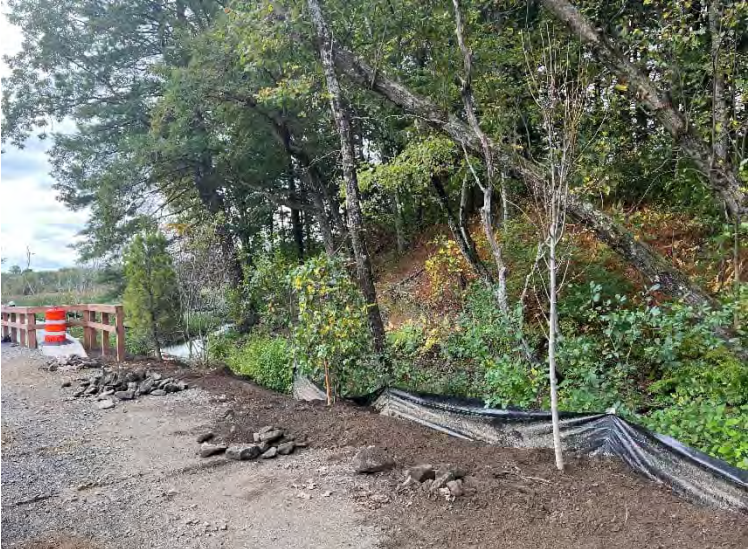
<p>PHOTOGRAPHIC LOG</p>	
<p>Client Name: Eversource</p>		<p>Site Location: Sudbury to Hudson Transmission Reliability Project</p>	<p>Town: Sudbury</p>
<p>Photo No.: 2</p>	<p>Date: 9/25/24</p>

<p>Description: View of installed trees on southern side of the work area west of Bridge 127. Facing southeast.</p>

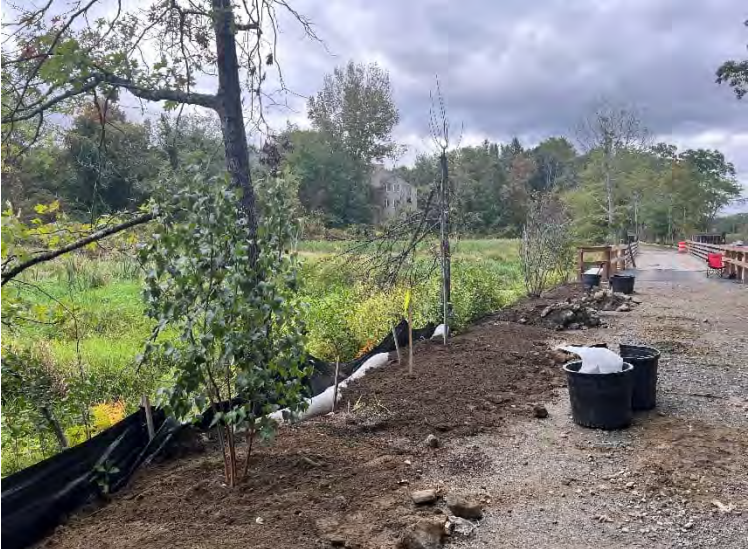
<p>PHOTOGRAPHIC LOG</p>	
<p>Client Name: Eversource</p>		<p>Site Location: Sudbury to Hudson Transmission Reliability Project</p>	<p>Town: Sudbury</p>
<p>Photo No.: 2</p>	<p>Date: 9/25/24</p>

<p>Description: View of installed trees on northern side of the work area west of Bridge 127. Facing east.</p>

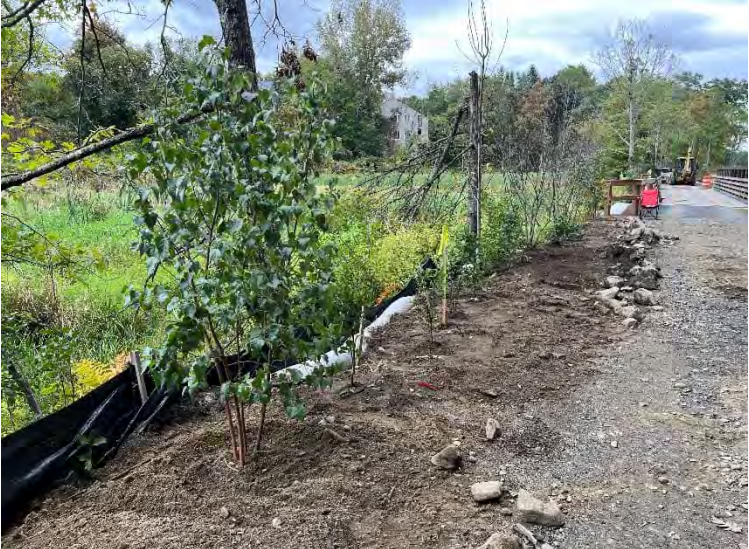
<p>PHOTOGRAPHIC LOG</p>	
<p>Client Name: Eversource</p>		<p>Site Location: Sudbury to Hudson Transmission Reliability Project</p>	<p>Town: Sudbury</p>
<p>Photo No.: 4</p>	<p>Date: 9/25/24</p>

<p>Description: View of installed plants. Stones left on ROW edge to be removed by ET&L after work is finished in this area. <i>Facing east.</i></p>

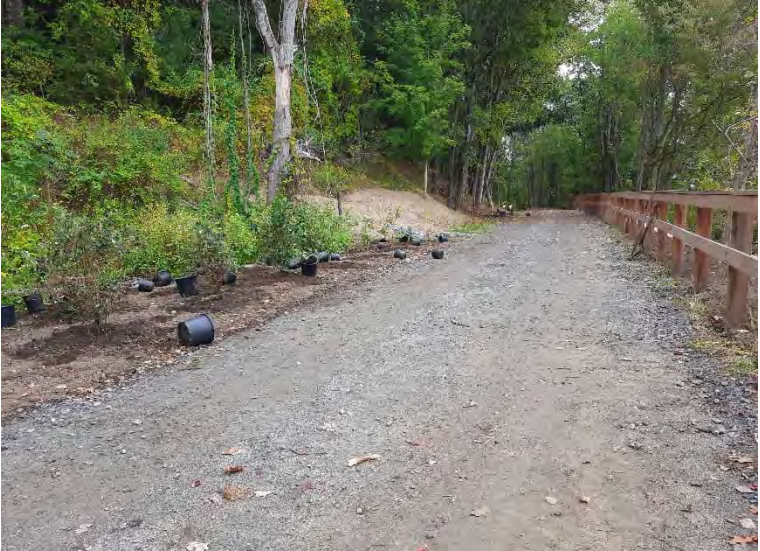
<p>PHOTOGRAPHIC LOG</p>	
<p>Client Name: Eversource</p>		<p>Site Location: Sudbury to Hudson Transmission Reliability Project</p>	<p>Town: Sudbury</p>
<p>Photo No.: 2</p>	<p>Date: 9/26/24</p>

<p>Description: Segment 14, north side, near STA 732+ ~25. Plantings in progress. Looking eastward.</p>

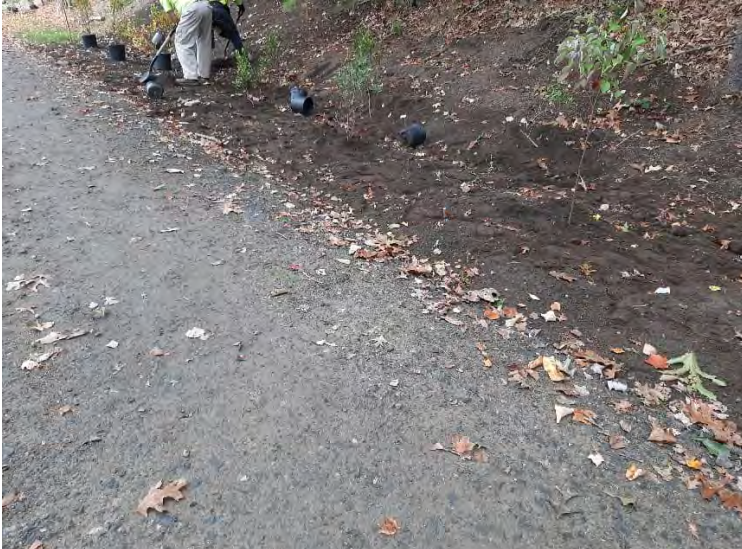
<p>PHOTOGRAPHIC LOG</p>	
<p>Client Name: Eversource</p>		<p>Site Location: Sudbury to Hudson Transmission Reliability Project</p>	<p>Town: Sudbury</p>
<p>Photo No.: 2</p>	<p>Date: 9/26/24</p>

<p>Description: Segment 14, north side, near STA 734 + ~75. MON installing shrubs. Looking westward.</p>

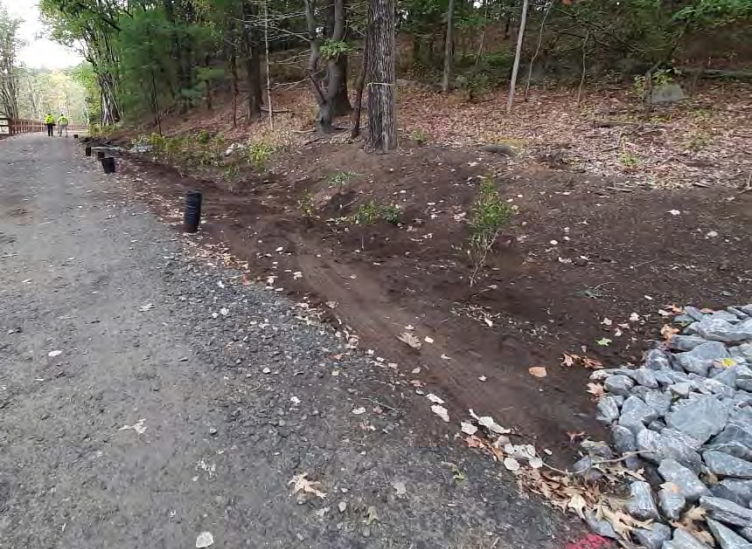
<p>PHOTOGRAPHIC LOG</p>	
<p>Client Name: Eversource</p>		<p>Site Location: Sudbury to Hudson Transmission Reliability Project</p>	<p>Town: Sudbury</p>
<p>Photo No.: 4</p>	<p>Date: 9/26/24</p>

<p>Description: Segment 14, north side, near STA 735 + ~55. Installed plantings. Looking westward.</p>

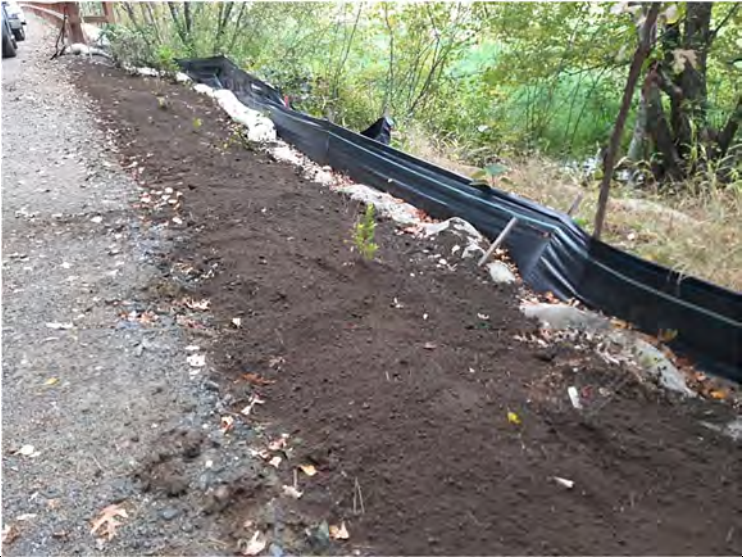
<p>PHOTOGRAPHIC LOG</p>	
<p>Client Name: Eversource</p>		<p>Site Location: Sudbury to Hudson Transmission Reliability Project</p>	<p>Town: Sudbury</p>
<p>Photo No.: 1</p>	<p>Date: 9/26/24</p>

<p>Description: Segment 14, south shoulder, west of Wall 13. Installed plants. Looking eastward.</p>

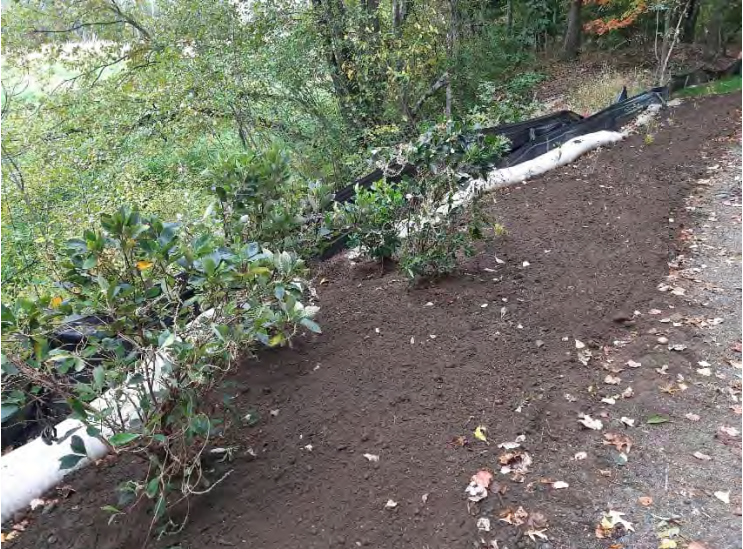
<p>PHOTOGRAPHIC LOG</p>	
<p>Client Name: Eversource</p>		<p>Site Location: Sudbury to Hudson Transmission Reliability Project</p>	<p>Town: Sudbury</p>
<p>Photo No.: 2</p>	<p>Date: 9/26/24</p>

<p>Description: Segment 14, south shoulder, west of Wall 13. Installed plants. Looking westward.</p>

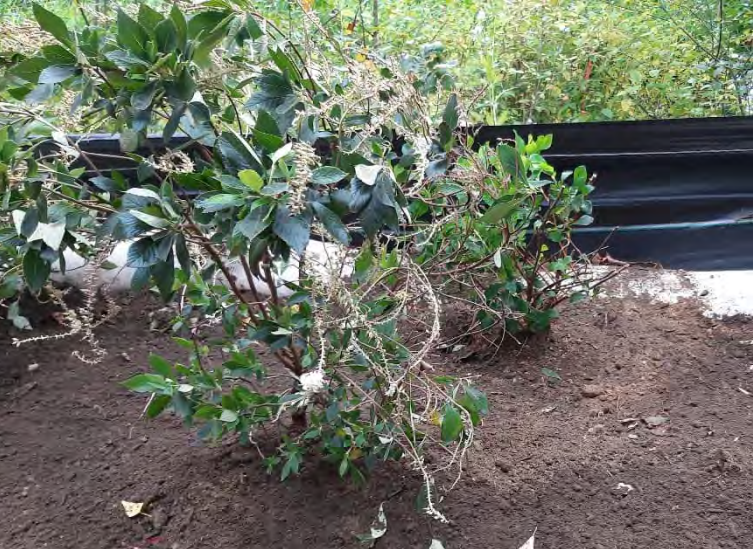
<p>PHOTOGRAPHIC LOG</p>	
<p>Client Name: Eversource</p>		<p>Site Location: Sudbury to Hudson Transmission Reliability Project</p>	<p>Town: Sudbury</p>
<p>Photo No.: 4</p>	<p>Date: 9/26/24</p>

<p>Description:</p> <p>Segment 14, south shoulder, west of Wall 13. Example of pepperbush (CA) condition, including flowering. Looking south.</p>

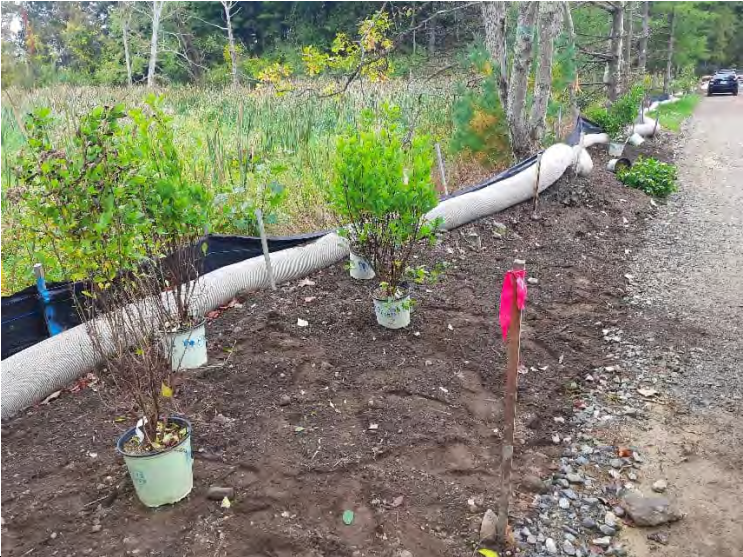
PHOTOGRAPHIC LOG	
Client Name: Eversource		Site Location: Sudbury to Hudson Transmission Reliability Project	Town: Sudbury
Photo No.: 3	Date: 9/26/24

<p>Description:</p> <p>Segment 14, south side, near STA -728 + 00. MON laying out planting distribution, three pepperbushes (CA) shifted westward due to pre-existing trees/root systems. Looking westward.</p>

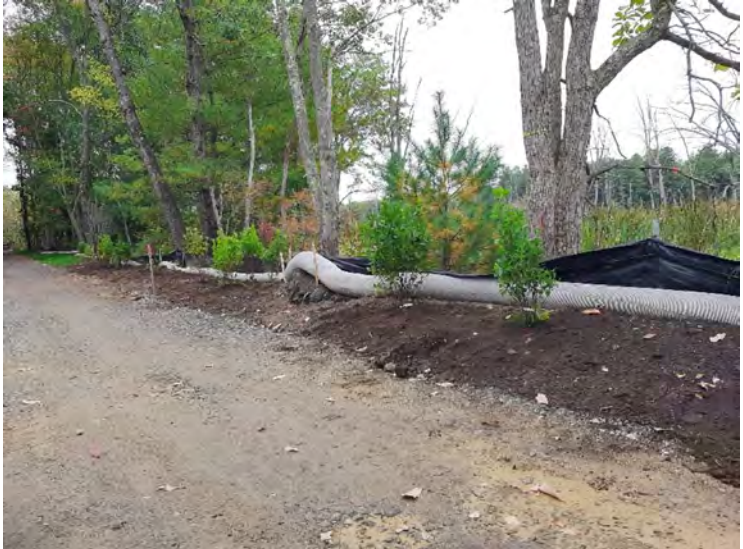
PHOTOGRAPHIC LOG	
Client Name: Eversource		Site Location: Sudbury to Hudson Transmission Reliability Project	Town: Sudbury
Photo No.: 4	Date: 9/26/24

<p>Description:</p> <p>Segment 14, south side, near STA 727 + ~70. Installed plantings. Looking eastward.</p>

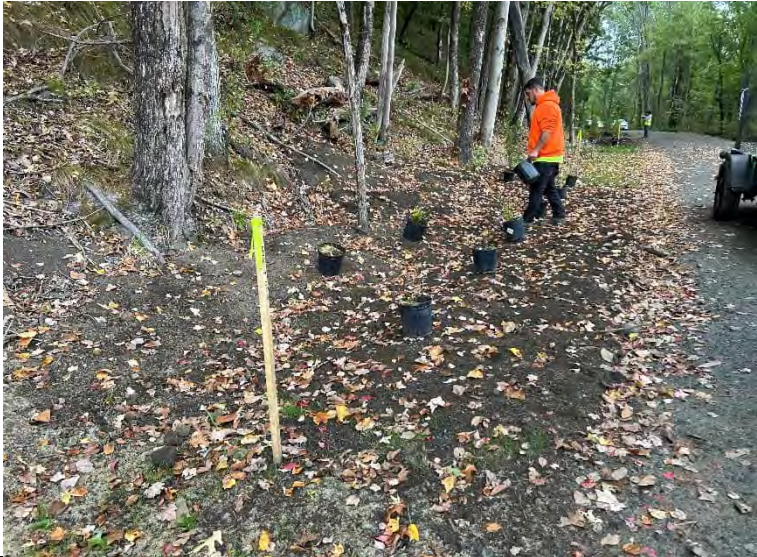
<p>PHOTOGRAPHIC LOG</p>	
<p>Client Name: Eversource</p>		<p>Site Location: Sudbury to Hudson Transmission Reliability Project</p>	<p>Town: Sudbury</p>
<p>Photo No.: 1</p>	<p>Date: 9/26/24</p>

<p>Description: View of plants being arranged. <i>Facing east.</i></p>

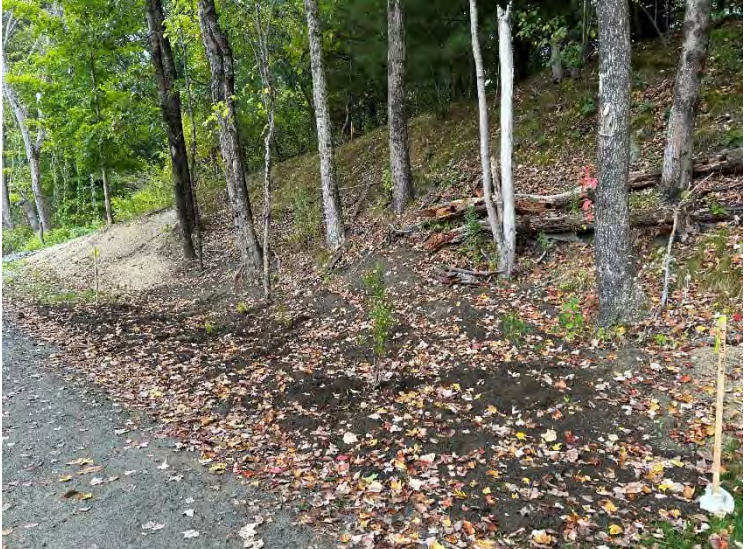
<p>PHOTOGRAPHIC LOG</p>	
<p>Client Name: Eversource</p>		<p>Site Location: Sudbury to Hudson Transmission Reliability Project</p>	<p>Town: Sudbury</p>
<p>Photo No.: 2</p>	<p>Date: 9/26/24</p>

<p>Description: View of completed plantings. <i>Facing northwest.</i></p>

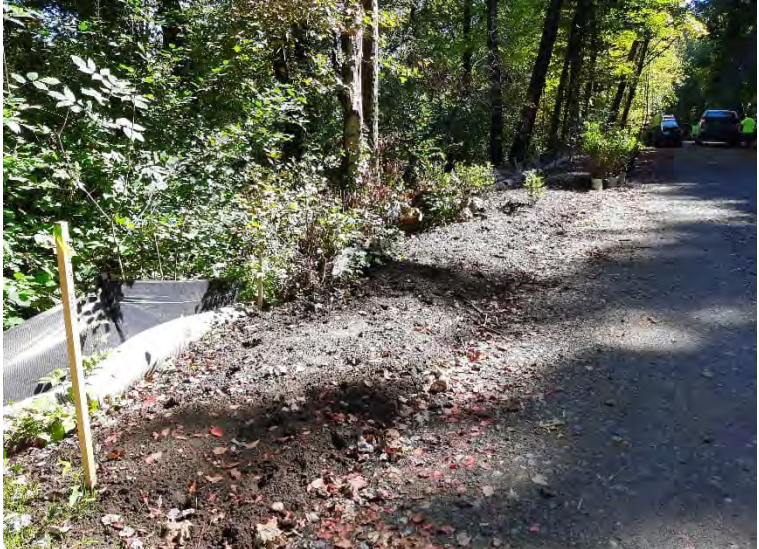
PHOTOGRAPHIC LOG	
Client Name: Eversource		Site Location: Sudbury to Hudson Transmission Reliability Project	Town: Sudbury
Photo No.: 2	Date: 9/27/24

Description: Segment 13, north side, near STA 715 + ~80. Bed prior to plantings, including pre-existing stumps. Looking eastward.

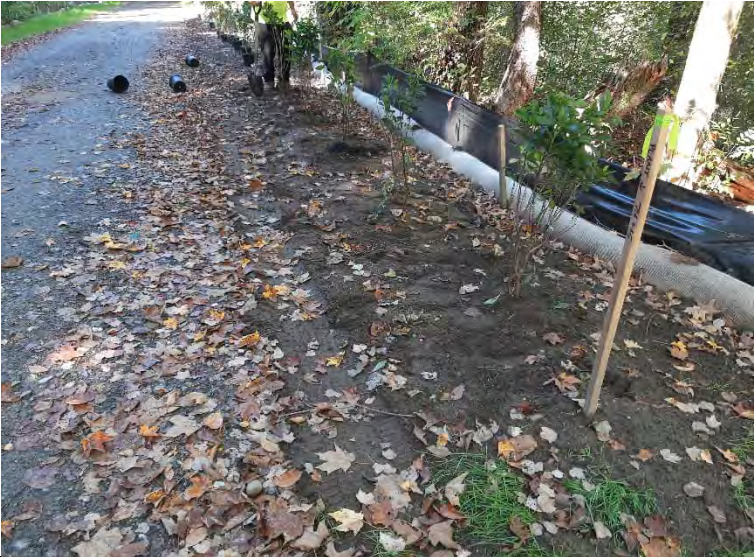
PHOTOGRAPHIC LOG	
Client Name: Eversource		Site Location: Sudbury to Hudson Transmission Reliability Project	Town: Sudbury
Photo No.: 3	Date: 9/27/24

Description: Segment 13, north shoulder, near STA 716 + 65. MON installing plantings. Looking westward.

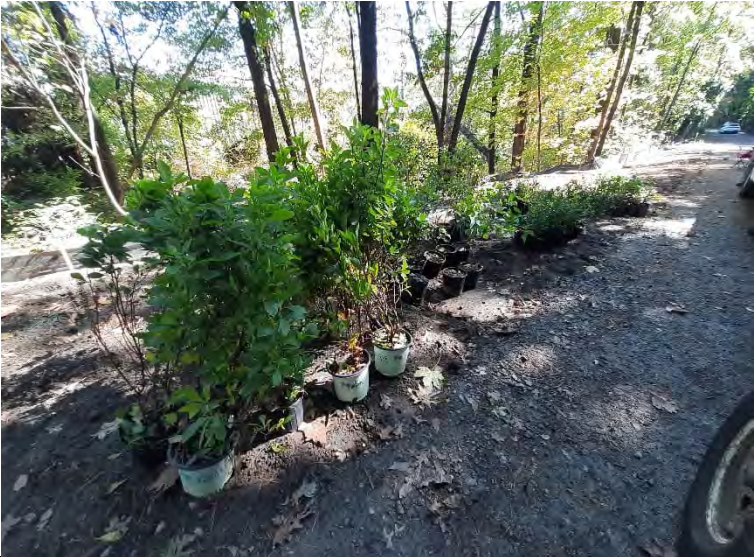
PHOTOGRAPHIC LOG	
Client Name: Eversource		Site Location: Sudbury to Hudson Transmission Reliability Project	Town: Sudbury
Photo No.: 1	Date: 9/27/24

Description: Segment 13, north side, near STA 718 + ~00 (MH 27). Shrubs assembled for planting, bed prior to planting. Looking northeastward.

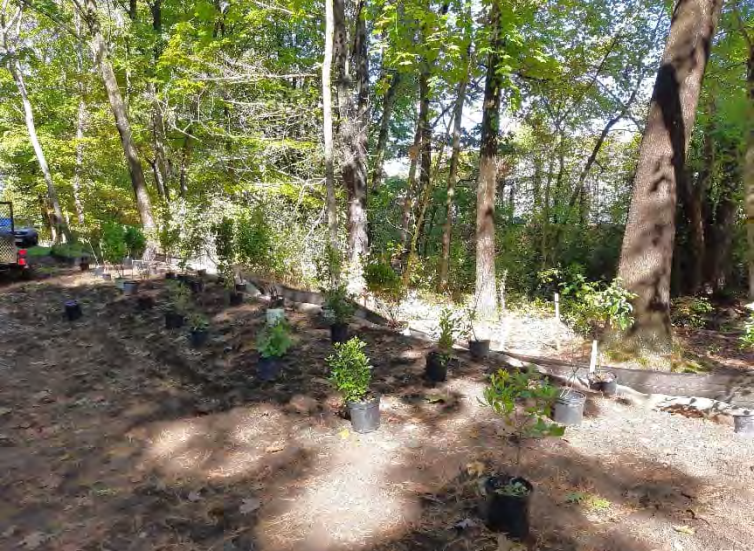
PHOTOGRAPHIC LOG	
Client Name: Eversource		Site Location: Sudbury to Hudson Transmission Reliability Project	Town: Sudbury
Photo No.: 2	Date: 9/27/24

Description: Segment 13, north side, near STA 718 + ~00. MON laying out plantings prior to installation. Looking westward.

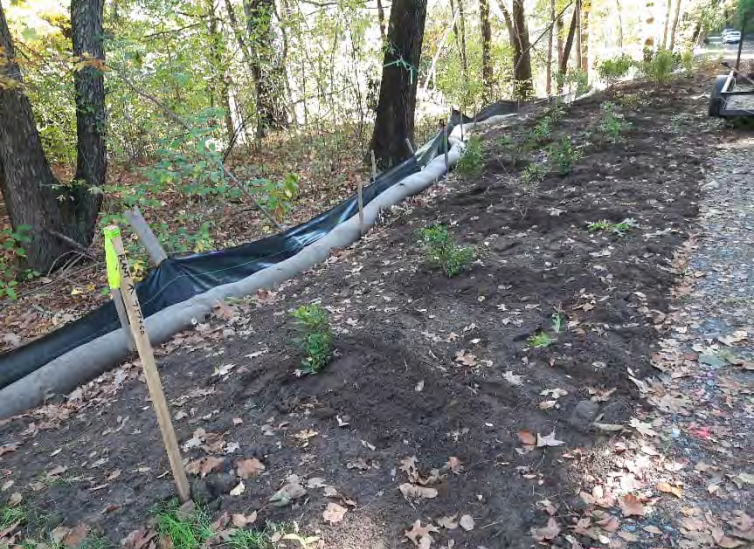
<p>PHOTOGRAPHIC LOG</p>	
<p>Client Name: Eversource</p>		<p>Site Location: Sudbury to Hudson Transmission Reliability Project</p>	<p>Town: Sudbury</p>
<p>Photo No.: 4</p>	<p>Date: 9/27/24</p>

<p>Description: Segment 13, north shoulder, near STA 717 + 50. Installed plantings. Looking eastward.</p>
