Weekly Environmental Compliance Summary

Sudbury to Hudson Transmission Reliability Project (USEPA Tracking # MAR1003UW)

Week of: September 23, 2024 to September 27, 2024

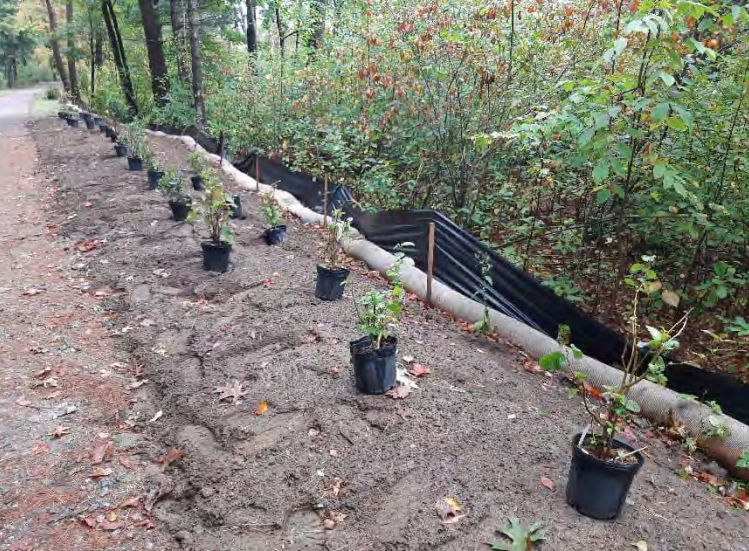
<p>PHOTOGRAPHIC LOG</p>	
<p>Client Name: Eversource</p>		<p>Site Location: Sudbury to Hudson Transmission Reliability Project</p>	<p>Town: Sudbury</p>
<p>Photo No.: 2</p>	<p>Date: 9/27/24</p>

<p>Description: Segment 13, north side, near STA 721 + ~80. MON laying out plantings prior to installation. Looking westward.</p>

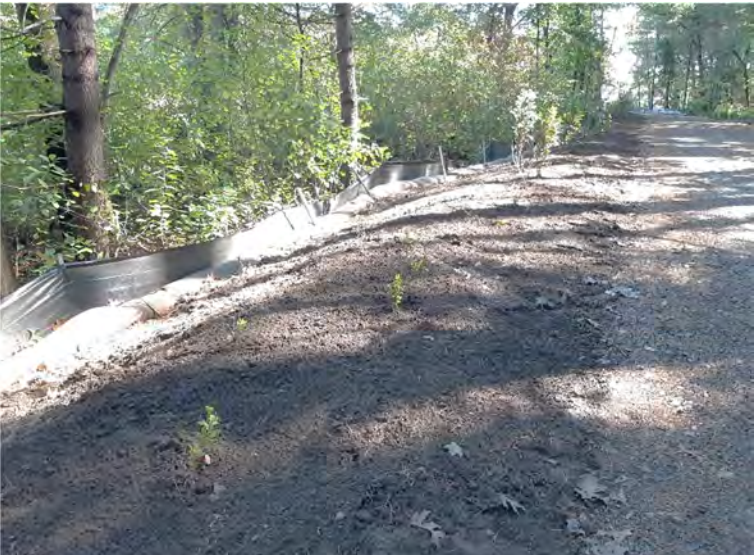
PHOTOGRAPHIC LOG	
Client Name: Eversource		Site Location: Sudbury to Hudson Transmission Reliability Project	Town: Sudbury
Photo No.: 4	Date: 9/27/24

Description: Segment 13, north shoulder, near STA 721 + ~00. Installed plantings. Looking eastward.

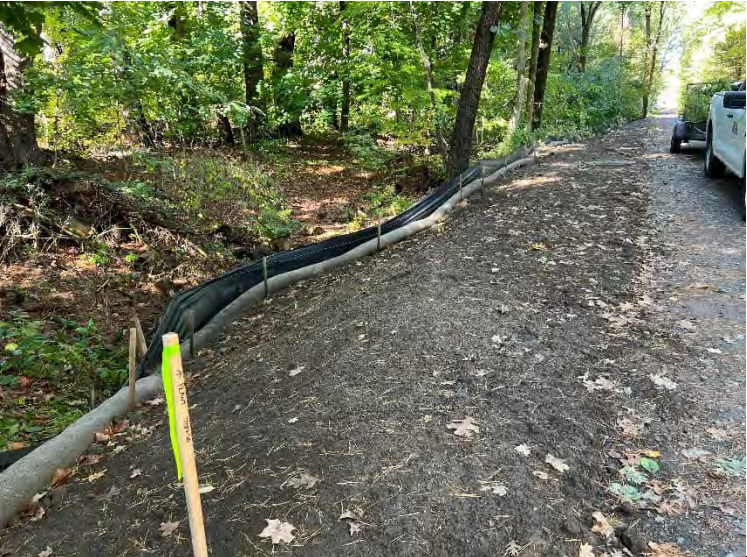
<p>PHOTOGRAPHIC LOG</p>	
<p>Client Name: Eversource</p>		<p>Site Location: Sudbury to Hudson Transmission Reliability Project</p>	<p>Town: Sudbury</p>
<p>Photo No.: 1</p>	<p>Date: 9/27/24</p>

<p>Description: View of planting bed at manhole #25 prior to installation. <i>Facing west.</i></p>

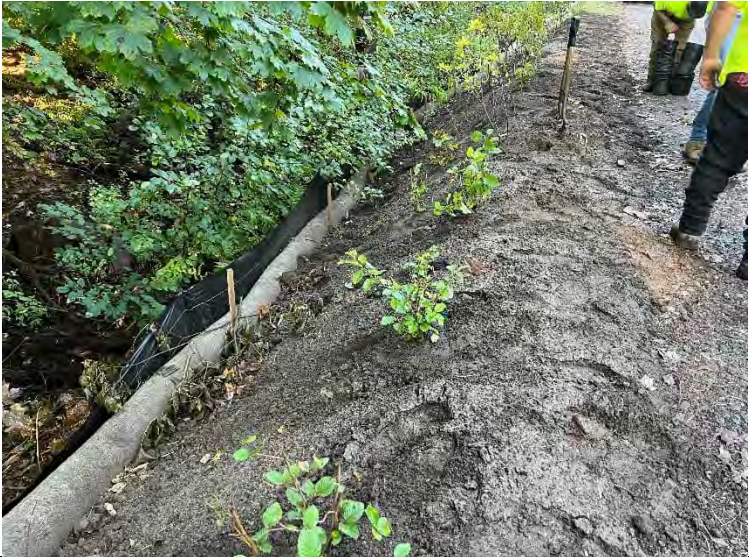
<p>PHOTOGRAPHIC LOG</p>	
<p>Client Name: Eversource</p>		<p>Site Location: Sudbury to Hudson Transmission Reliability Project</p>	<p>Town: Sudbury</p>
<p>Photo No.: 3</p>	<p>Date: 9/27/24</p>

Alders (CH) trimmed to ≤ 2' before arriving at site (less than plan spec); otherwise generally "fair" condition.

<p>Description: View of installed CH (Alders). Alders cut back prior to being brought to site. <i>Facing west.</i></p>

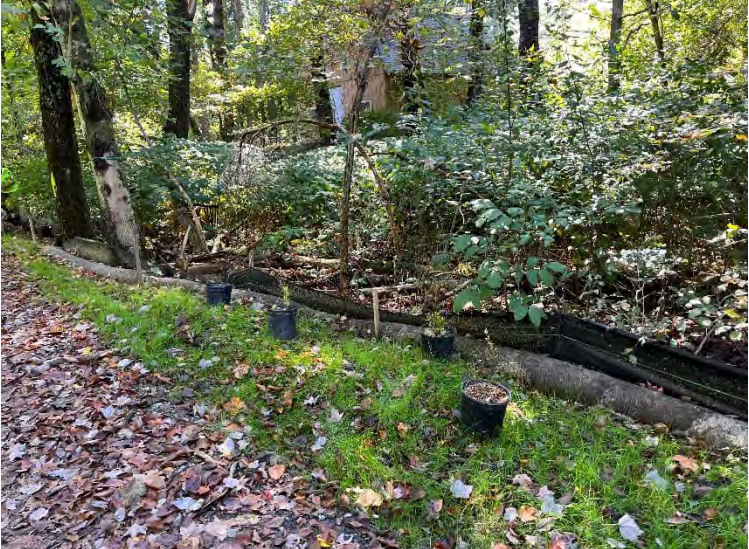
<p>PHOTOGRAPHIC LOG</p>	
<p>Client Name: Eversource</p>		<p>Site Location: Sudbury to Hudson Transmission Reliability Project</p>	<p>Town: Sudbury</p>
<p>Photo No.: 4</p>	<p>Date: 9/27/24</p>

<p>Description: View of GB staged within hydroseeded area. <i>Facing southeast.</i></p>

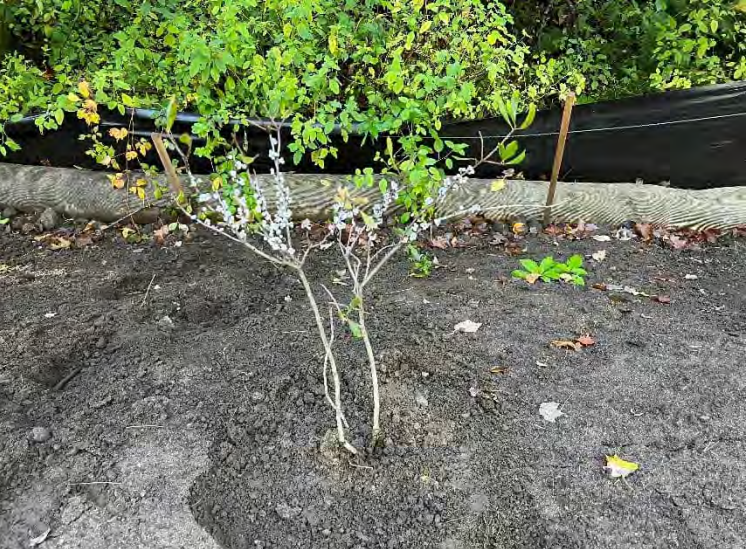
<p>PHOTOGRAPHIC LOG</p>	
<p>Client Name: Eversource</p>		<p>Site Location: Sudbury to Hudson Transmission Reliability Project</p>	<p>Town: Sudbury</p>
<p>Photo No.: 4</p>	<p>Date: 9/27/24</p>

<p>Description: View of fruiting MP. <i>Facing south.</i></p>

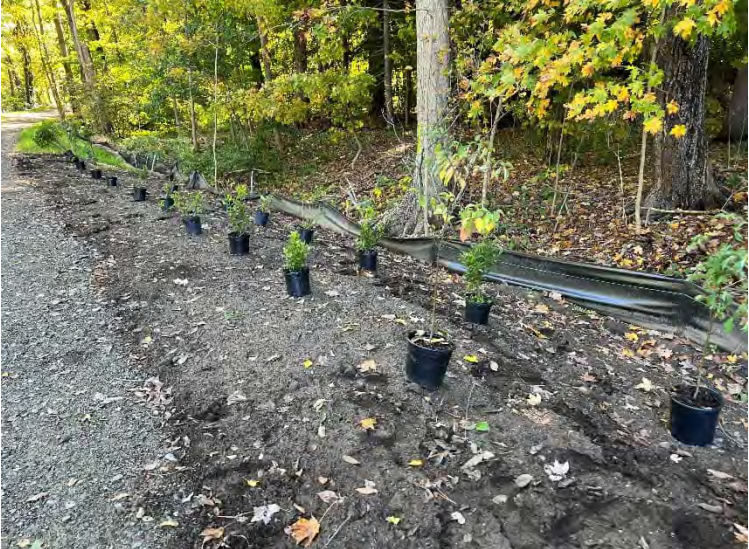
<p>PHOTOGRAPHIC LOG</p>	
<p>Client Name: Eversource</p>		<p>Site Location: Sudbury to Hudson Transmission Reliability Project</p>	<p>Town: Sudbury</p>
<p>Photo No.: 2</p>	<p>Date: 9/27/24</p>

<p>Description: View of plants laid out according to plans. <i>Facing east.</i></p>
