**Weekly Environmental Compliance Summary**

**Sudbury to Hudson Transmission Reliability Project (USEPA Tracking # MAR1003UW)**

Sudbury, Hudson, and Stow, MA

Week of: October 7, 2024 to October 11, 2024

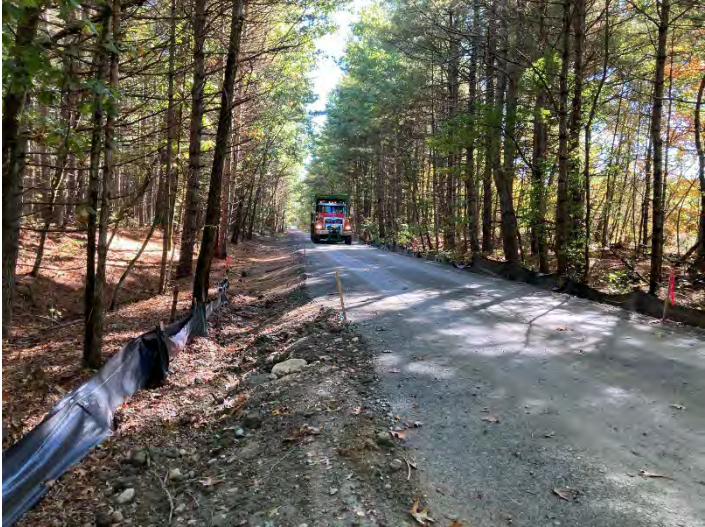
<b>PHOTOGRAPHIC LOG</b>	
Client Name: Eversource		Site Location: Sudbury to Hudson Transmission Reliability Project	Town: Hudson
Photo No.: 7	Date: 10-08-2024

Description: View of E&S controls and truck delivery through segment 6 for ET&L's work in segment 7. Facing east.

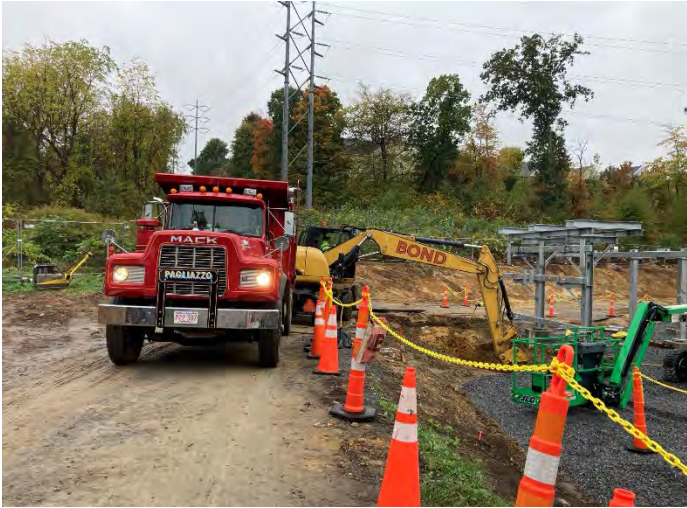
<b>PHOTOGRAPHIC LOG</b>	
Client Name: Eversource		Site Location: Sudbury to Hudson Transmission Reliability Project	Town: Hudson
Photo No.: 1	Date: 10/07/2024

<b>Description:</b> View of Bond working between MH #1 and Hudson Light & Power substation. Facing south.

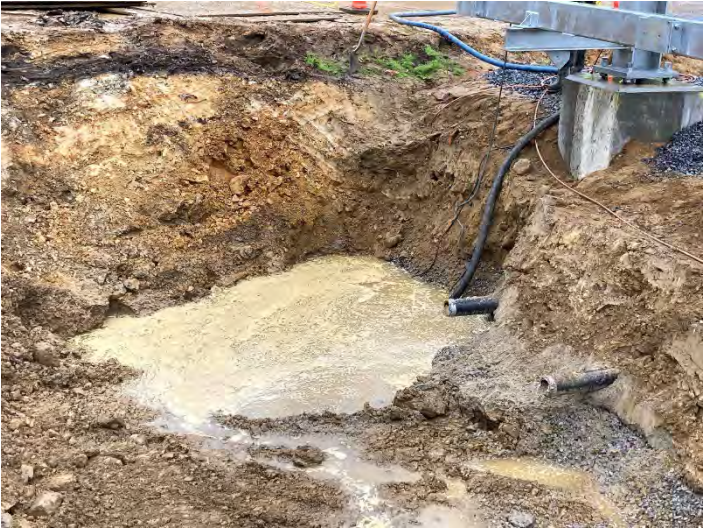
<b>PHOTOGRAPHIC LOG</b>	
Client Name: Eversource		Site Location: Sudbury to Hudson Transmission Reliability Project	Town: Hudson
Photo No.: 2	Date: 10/07/2024

<b>Description:</b> View of pump in trench. Water appeared turbid prior to treatment. Facing south.

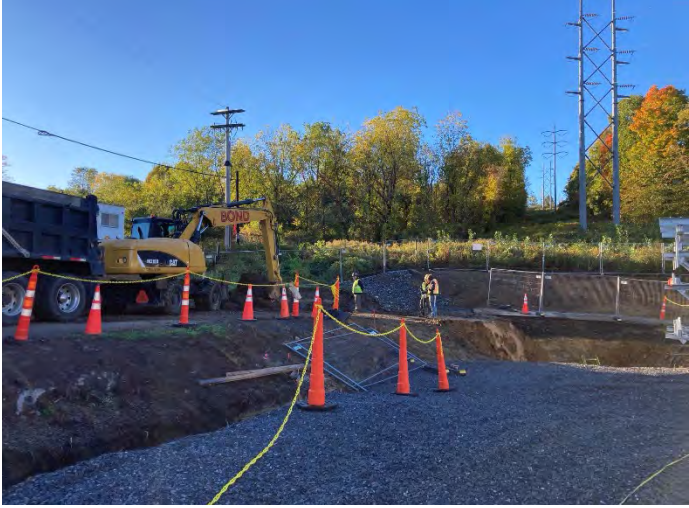
<b>PHOTOGRAPHIC LOG</b>	
Client Name: Eversource		Site Location: Sudbury to Hudson Transmission Reliability Project	Town: Hudson
Photo No.: 1	Date: 10/08/2024

<b>Description:</b> View of Bond working between MH #1 and Hudson Light & Power substation. Facing southeast.

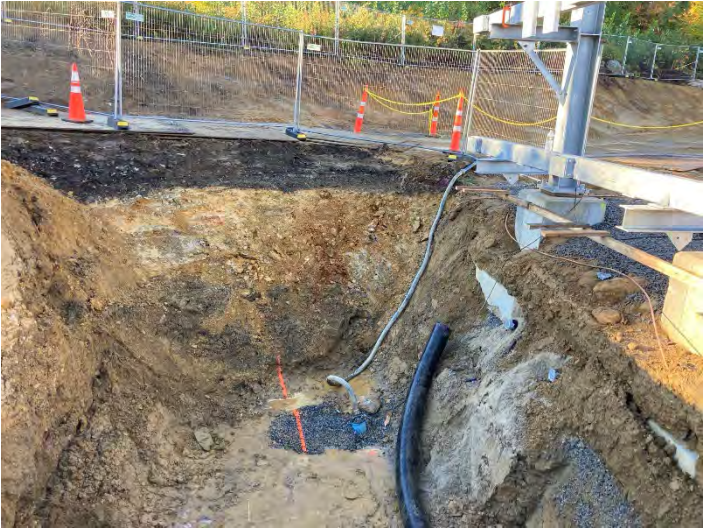
<b>PHOTOGRAPHIC LOG</b>	
Client Name: Eversource		Site Location: Sudbury to Hudson Transmission Reliability Project	Town: Hudson
Photo No.: 2	Date: 10/08/2024

<b>Description:</b> View of pump in trench. Water appeared turbid prior to treatment. Facing south.

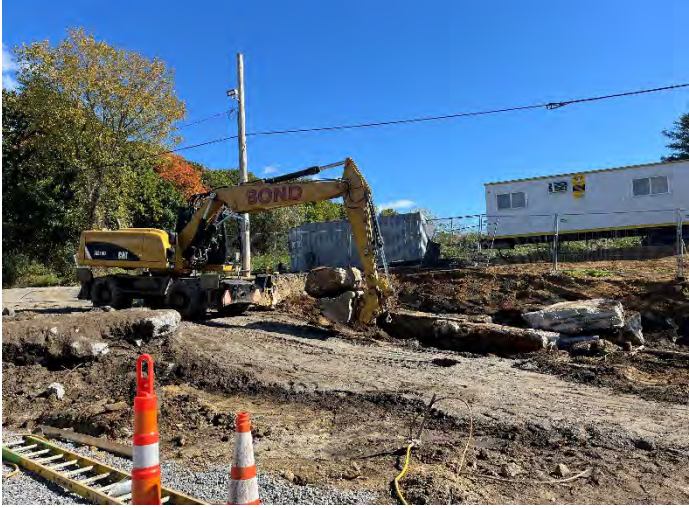
<b>PHOTOGRAPHIC LOG</b>	
Client Name: Eversource		Site Location: Sudbury to Hudson Transmission Reliability Project	Town: Hudson
Photo No.: 1	Date: 10/09/2024

<b>Description:</b> View of Bond working between MH #1 and Hudson Light & Power substation. Facing east.

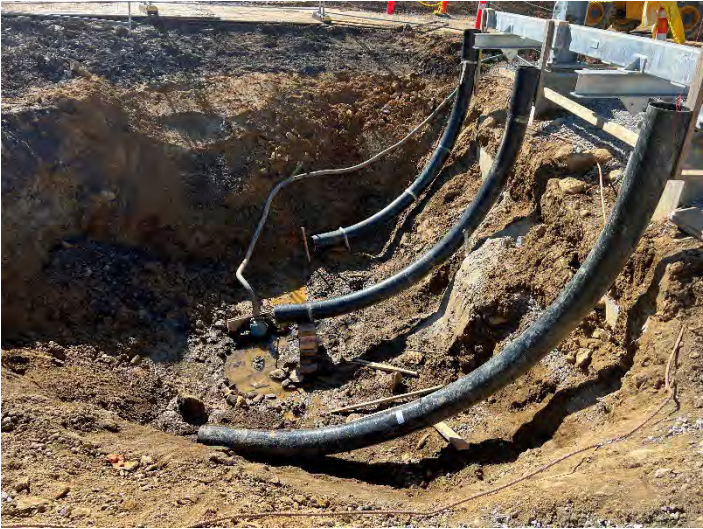
<b>PHOTOGRAPHIC LOG</b>	
Client Name: Eversource		Site Location: Sudbury to Hudson Transmission Reliability Project	Town: Hudson
Photo No.: 2	Date: 10/09/2024

<b>Description:</b> View of pump in trench. Water appeared turbid prior to treatment. Facing south.

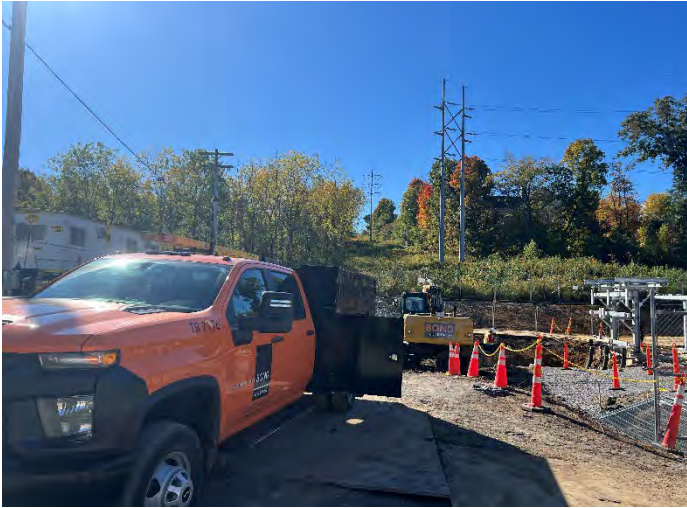
<b>PHOTOGRAPHIC LOG</b>	
Client Name: Eversource		Site Location: Sudbury to Hudson Transmission Reliability Project	Town: Hudson
Photo No.: 1	Date: 10/11/2024

Description: View of Bond working between MH #1 and Hudson Light & Power substation. Facing south.
