**Weekly Environmental Compliance Summary**

**Sudbury to Hudson Transmission Reliability Project (USEPA Tracking # MAR1003UW)**

Week of: October 14, 2024 to October 19, 2024

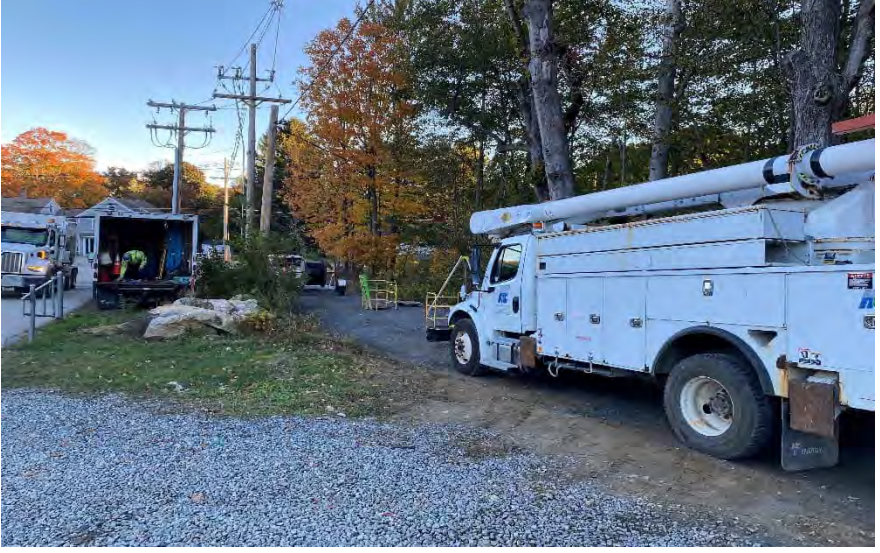
<p>PHOTOGRAPHIC LOG</p>	
<p>Client Name: Eversource</p>		<p>Site Location: Sudbury to Hudson Transmission Reliability Project</p>	<p>Town: Hudson</p>
<p>Photo No.: 5</p>	<p>Date: 10-16-24</p>

<p>Description: Haugland conducting wire work at manhole #1, looking westward.</p>

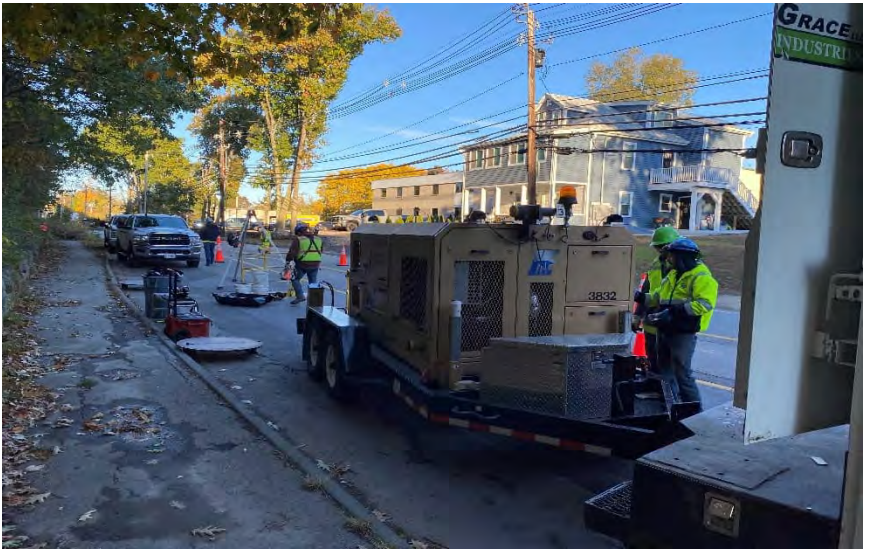
<p>PHOTOGRAPHIC LOG</p>	
<p>Client Name: Eversource</p>		<p>Site Location: Sudbury to Hudson Transmission Reliability Project</p>	<p>Town: Hudson</p>
<p>Photo No.: 6</p>	<p>Date: 10-16-24</p>

<p>Description: Haugland conducting wire work at manhole #2, looking southward.</p>

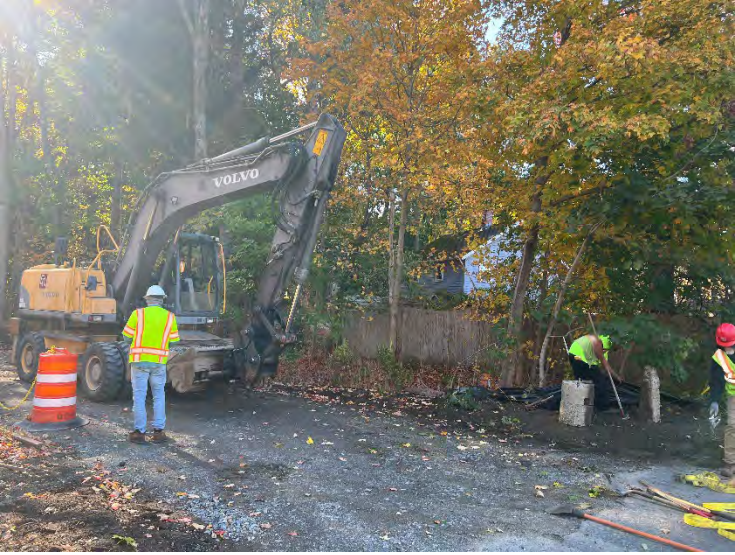
<p><b>PHOTOGRAPHIC LOG</b></p>	
<p>Client Name: Eversource</p>		<p>Site Location: Sudbury to Hudson Transmission Reliability Project</p>	<p>Town: Sudbury</p>
<p>Photo No.: 2</p>	<p>Date: 10/16/2024</p>

<p>Description: View of ET&amp;L resetting historical artifacts at entrance to segment 13 off of Boston Post Road. Facing southeast.</p>

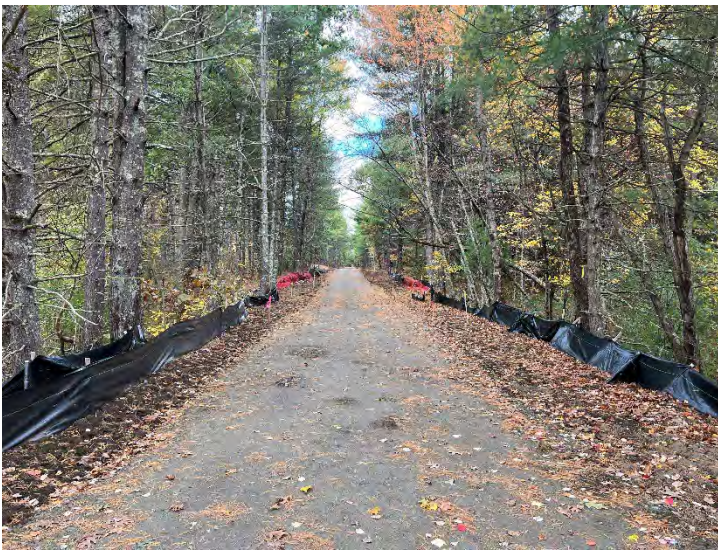
<p><b>PHOTOGRAPHIC LOG</b></p>	
<p>Client Name: Eversource</p>		<p>Site Location: Sudbury to Hudson Transmission Reliability Project</p>	<p>Town: Sudbury</p>
<p>Photo No.: 8</p>	<p>Date: 10/16/2024</p>

<p>Description: View of E&amp;S controls and installed planting loam in segment 7. Facing west.</p>

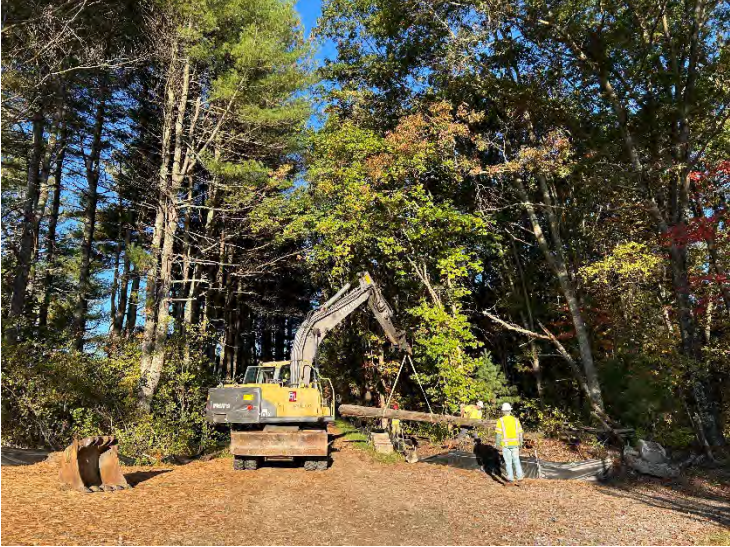
<p><b>PHOTOGRAPHIC LOG</b></p>	
<p>Client Name: Eversource</p>		<p>Site Location: Sudbury to Hudson Transmission Reliability Project</p>	<p>Town: Sudbury</p>
<p>Photo No.: 1</p>	<p>Date: 10/17/2024</p>

<p>Description: View of ET&amp;L resetting artifacts and removing debris within segment 11. Facing west.</p>

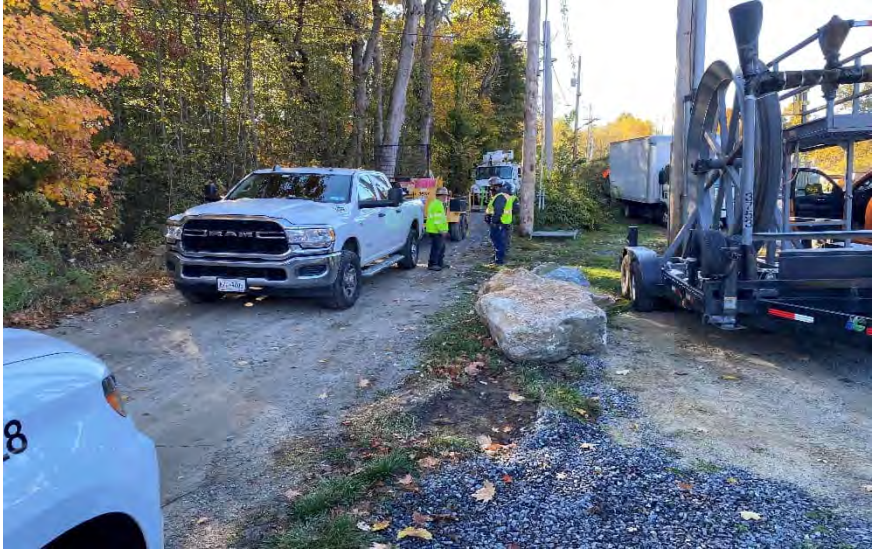
<p align="center"><b>PHOTOGRAPHIC LOG</b></p>	
<p>Client Name: Eversource</p>		<p>Site Location: Sudbury to Hudson Transmission Reliability Project</p>	<p>Town: Hudson</p>
<p>Photo No.: 1</p>	<p>Date: 10-18-24</p>

<p>Description:</p> <p>Work area at manhole #1, Bond conducting exploratory work to repair conduit &amp; Haugland conducting wire work to Hudson Substation, looking eastward.</p>

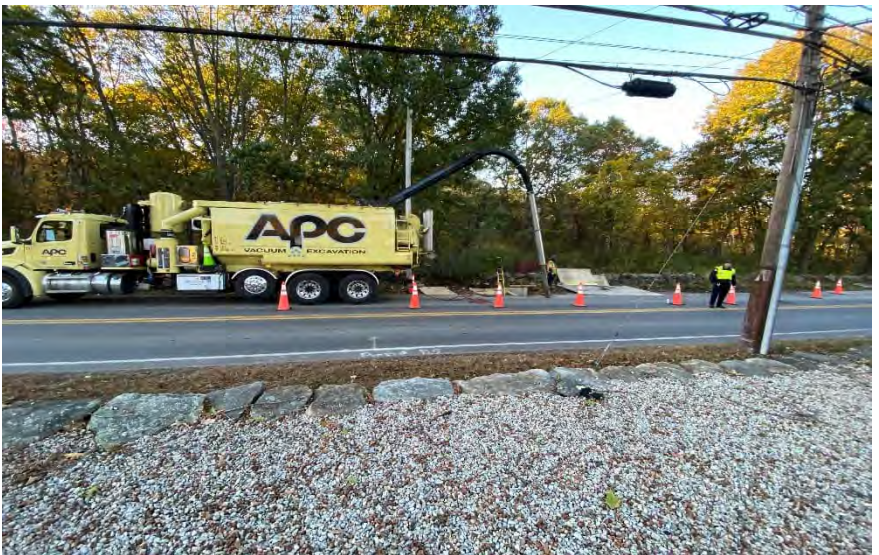
<p align="center"><b>PHOTOGRAPHIC LOG</b></p>	
<p>Client Name: Eversource</p>		<p>Site Location: Sudbury to Hudson Transmission Reliability Project</p>	<p>Town: Hudson</p>
<p>Photo No.: 2</p>	<p>Date: 10-18-24</p>

<p>Description:</p> <p>Work area within Forest Avenue, Bond excavating to repair conduit, looking eastward.</p>

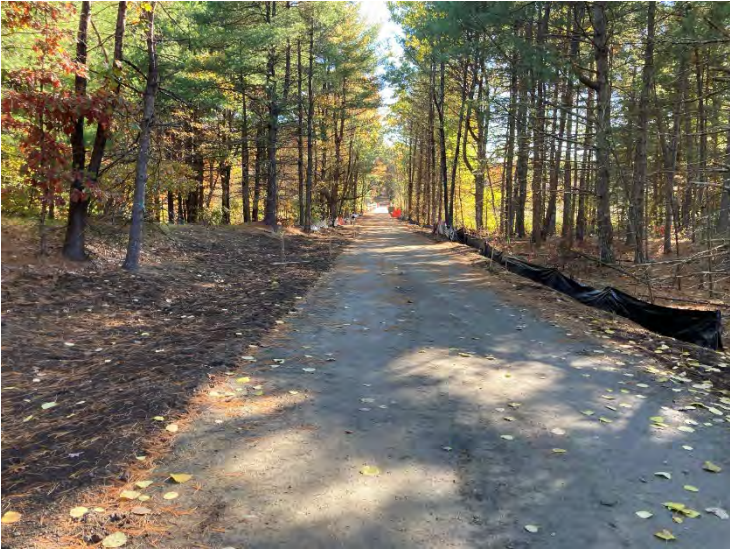
<p><b>PHOTOGRAPHIC LOG</b></p>	
<p>Client Name: Eversource</p>		<p>Site Location: Sudbury to Hudson Transmission Reliability Project</p>	<p>Town: Sudbury</p>
<p>Photo No.: 1</p>	<p>Date: 10/18/2024</p>

<p>Description: View of loam and E&amp;S controls at east end of segment 7. Facing east.</p>

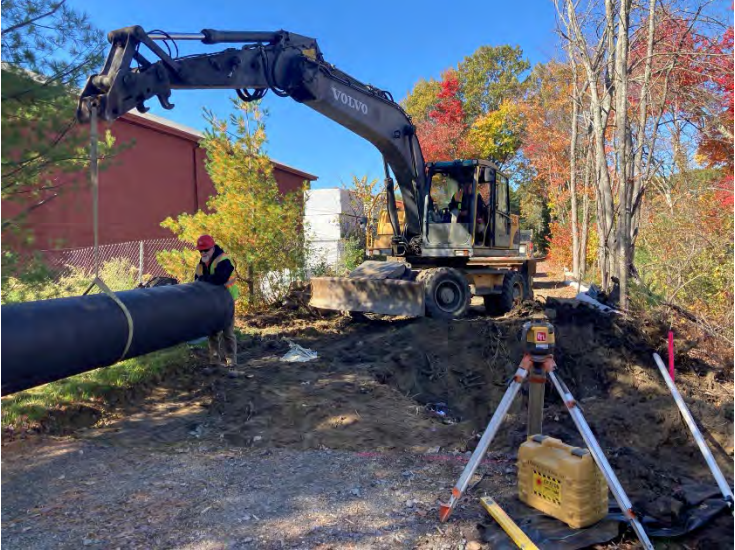
<p><b>PHOTOGRAPHIC LOG</b></p>	
<p>Client Name: Eversource</p>		<p>Site Location: Sudbury to Hudson Transmission Reliability Project</p>	<p>Town: Sudbury</p>
<p>Photo No.: 3</p>	<p>Date: 10/18/2024</p>

<p>Description: View of ET&amp;L performing culvert extension in segment 12. Facing west.</p>

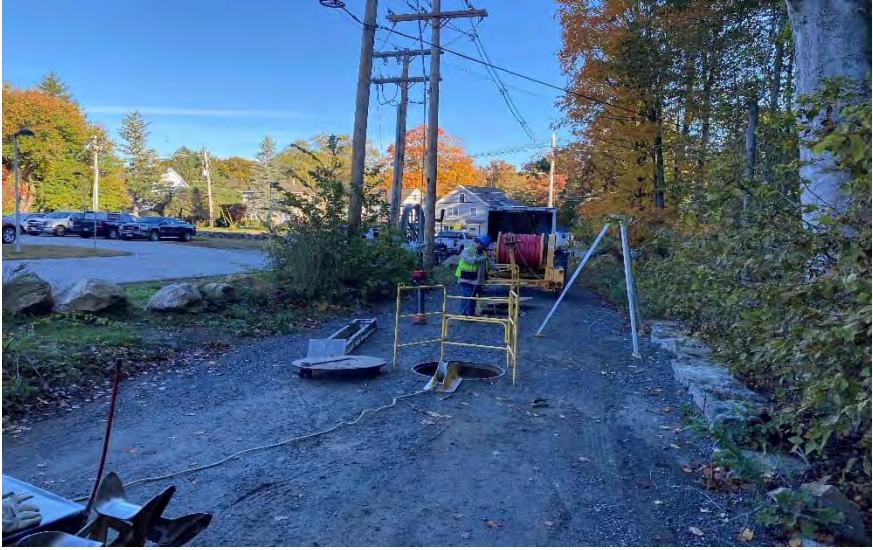
<b>PHOTOGRAPHIC LOG</b>	
Client Name: Eversource		Site Location: Sudbury to Hudson Transmission Reliability Project	Town: Hudson
Photo No.: 5	Date: 10-15-24

Description:  Haugland conducting swab/mandrel work at manhole #1, looking westward.

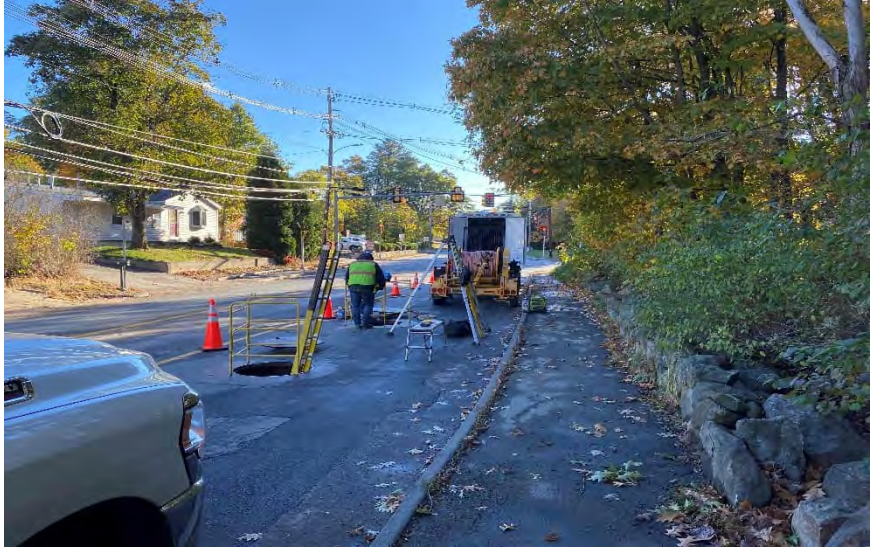
<b>PHOTOGRAPHIC LOG</b>	
Client Name: Eversource		Site Location: Sudbury to Hudson Transmission Reliability Project	Town: Hudson
Photo No.: 6	Date: 10-15-24

Description:  Haugland conducting swab/mandrel work at manhole #2, looking northward.

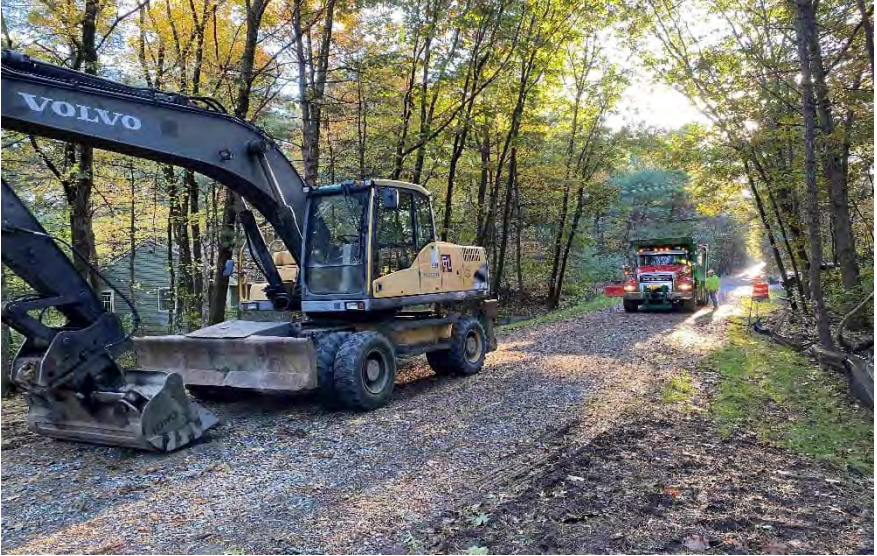
<b>PHOTOGRAPHIC LOG</b>	
Client Name: Eversource		Site Location: Sudbury to Hudson Transmission Reliability Project	Town: Hudson
Photo No.: 7	Date: 10-15-24

Description:  Work area within segment 5, manhole #13, ET&L equipment for grading work within segment 6, existing erosion control, looking eastward.

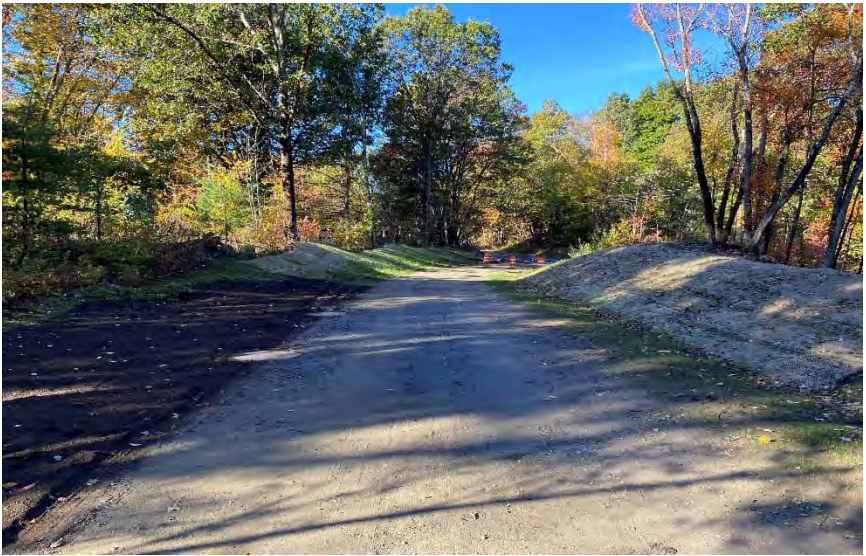
<b>PHOTOGRAPHIC LOG</b>	
Client Name: Eversource		Site Location: Sudbury to Hudson Transmission Reliability Project	Town: Hudson
Photo No.: 8	Date: 10-15-24

Description:  Work area within segment 1, recently loamed areas prior to hydro seeding, existing erosion control, looking westward.

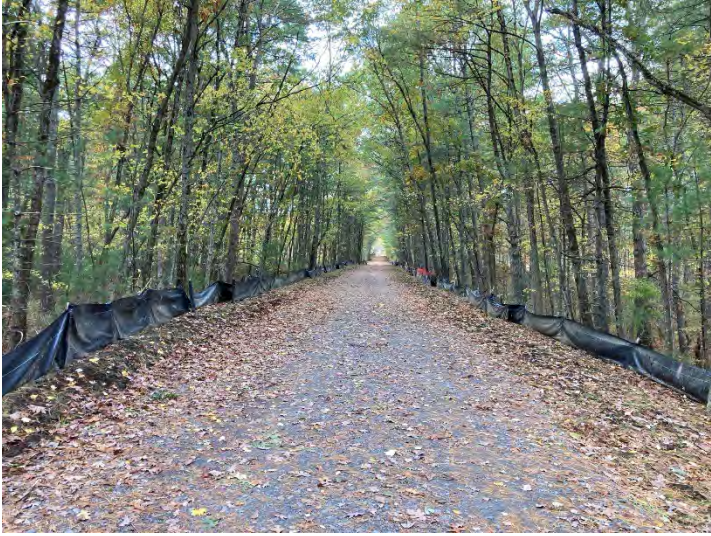
<b>PHOTOGRAPHIC LOG</b>	
Client Name: Eversource		Site Location: Sudbury to Hudson Transmission Reliability Project	Town: Sudbury
Photo No.: 1	Date: 10-15-24

Description: View of E&S controls at east end of segment 8. Facing west.

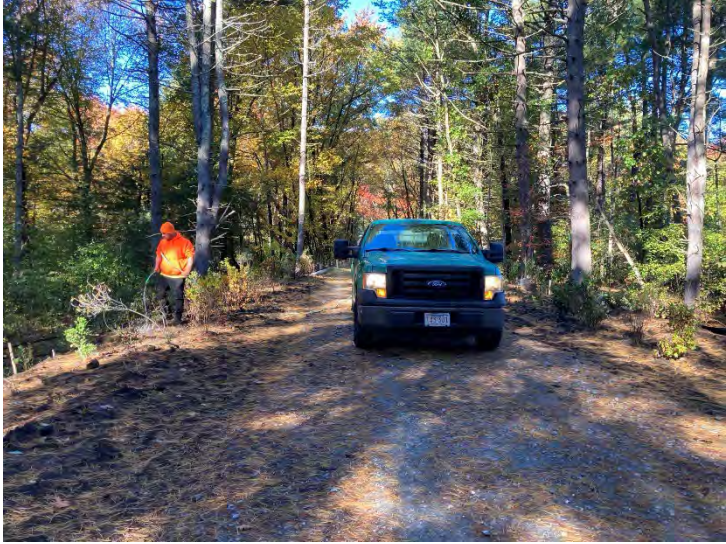
<b>PHOTOGRAPHIC LOG</b>	
Client Name: Eversource		Site Location: Sudbury to Hudson Transmission Reliability Project	Town: Sudbury
Photo No.: 2	Date: 10-15-24

Description: View of MON watering plants in segment 9. Facing west.

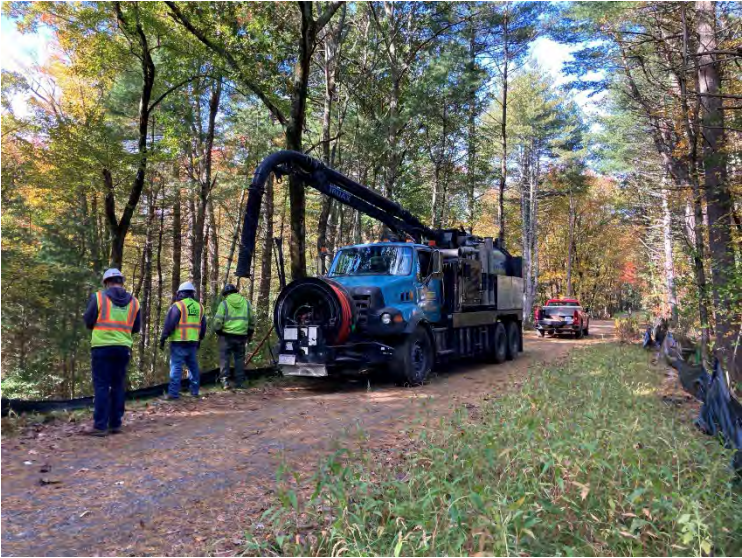
<b>PHOTOGRAPHIC LOG</b>	
Client Name: Eversource		Site Location: Sudbury to Hudson Transmission Reliability Project	Town: Sudbury
Photo No.: 3	Date: 10-15-24

Description: View of ET&L performing culvert cleanout in segment 9. Facing southwest.

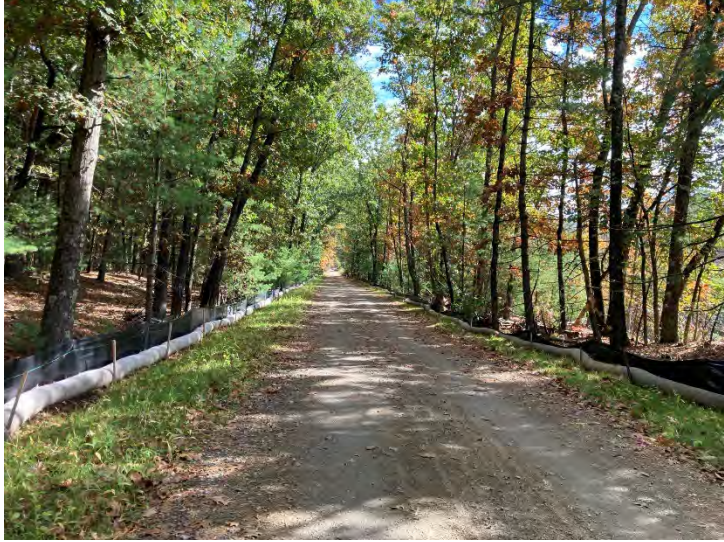
<b>PHOTOGRAPHIC LOG</b>	
Client Name: Eversource		Site Location: Sudbury to Hudson Transmission Reliability Project	Town: Sudbury
Photo No.: 5	Date: 10-15-24

Description: View of E&S controls in segment 11. Facing east.

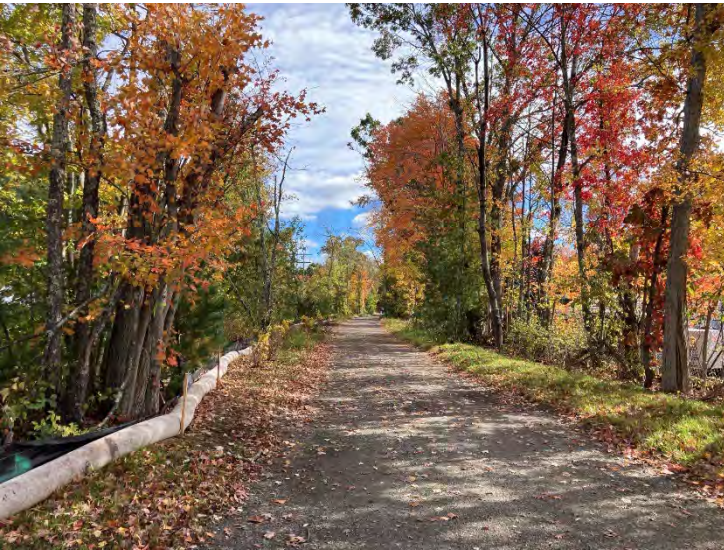
<b>PHOTOGRAPHIC LOG</b>	
Client Name: Eversource		Site Location: Sudbury to Hudson Transmission Reliability Project	Town: Sudbury
Photo No.: 6	Date: 10-15-24

Description: View of E&S controls in segment 12. Facing east.

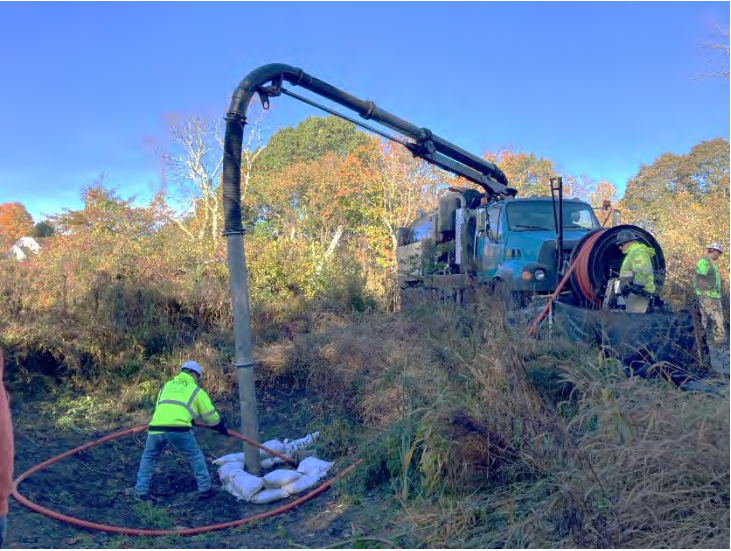
<b>Epsilon</b> ASSOCIATES INC.		<b>PHOTOGRAPHIC LOG</b>	
Client Name: Eversource		Site Location: Sudbury to Hudson Transmission Reliability Project	Town: Sudbury
Photo No.: 7	Date: 10-15-24

Description: View of ET&L performing culvert cleanout at wetland replication area in segment 14. Facing west.

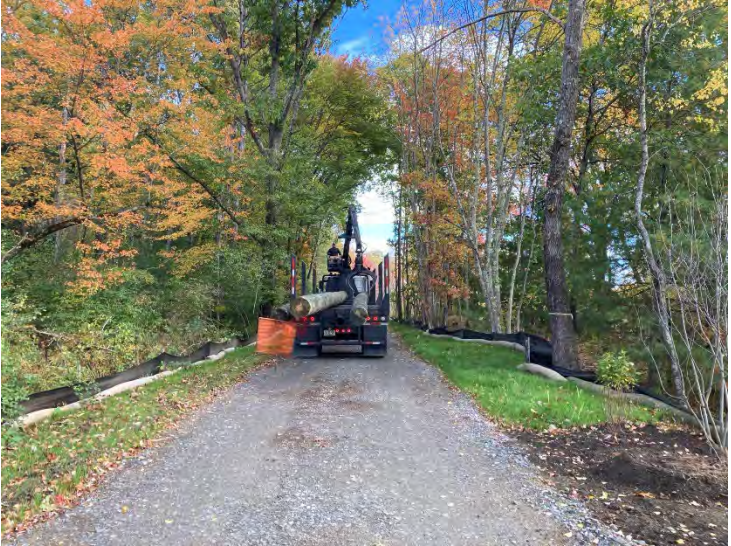
<b>Epsilon</b> ASSOCIATES INC.		<b>PHOTOGRAPHIC LOG</b>	
Client Name: Eversource		Site Location: Sudbury to Hudson Transmission Reliability Project	Town: Sudbury
Photo No.: 8	Date: 10-15-24

Description: View of delivery of osprey nest poles and E&S controls in segment 14. Facing east.

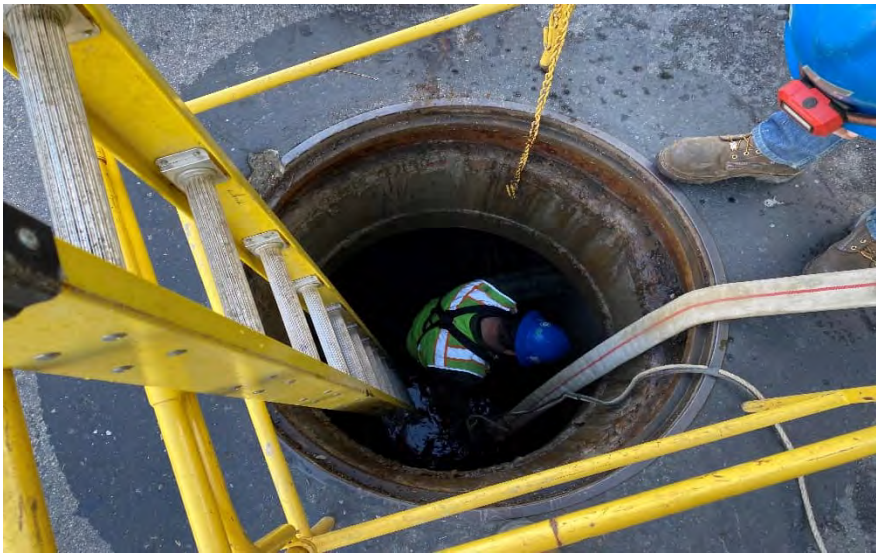
<b>PHOTOGRAPHIC LOG</b>	
Client Name: Eversource		Site Location: Sudbury to Hudson Transmission Reliability Project	Town: Hudson
Photo No.: 1	Date: 10/15/2024

Description: View of area being pumped from manhole #2 Forest Avenue.

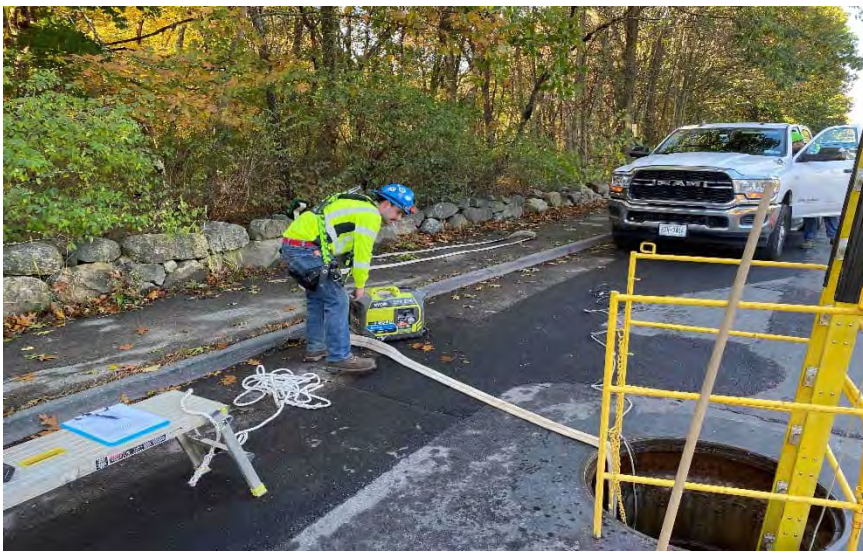
<b>PHOTOGRAPHIC LOG</b>	
Client Name: Eversource		Site Location: Sudbury to Hudson Transmission Reliability Project	Town: Hudson
Photo No.: 2	Date: 10/15/2024

Description: Manhole #2. View of dewatering operation. Looking southward.

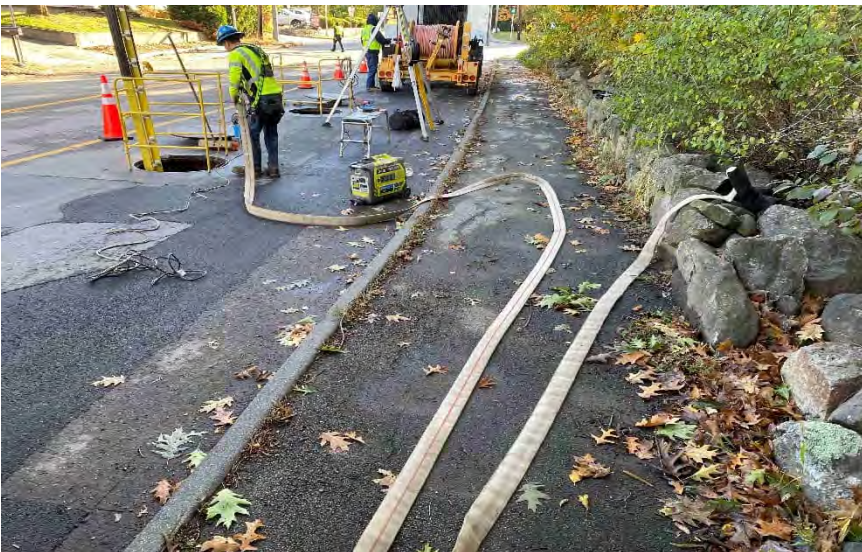
<h2 style="margin: 0;">PHOTOGRAPHIC LOG</h2>	
Client Name: Eversource		Site Location: Sudbury to Hudson Transmission Reliability Project	Town: Hudson
Photo No.: 3	Date: 10/15/2024

Description: Manhole #2. View of dewatering operation, looking northward.

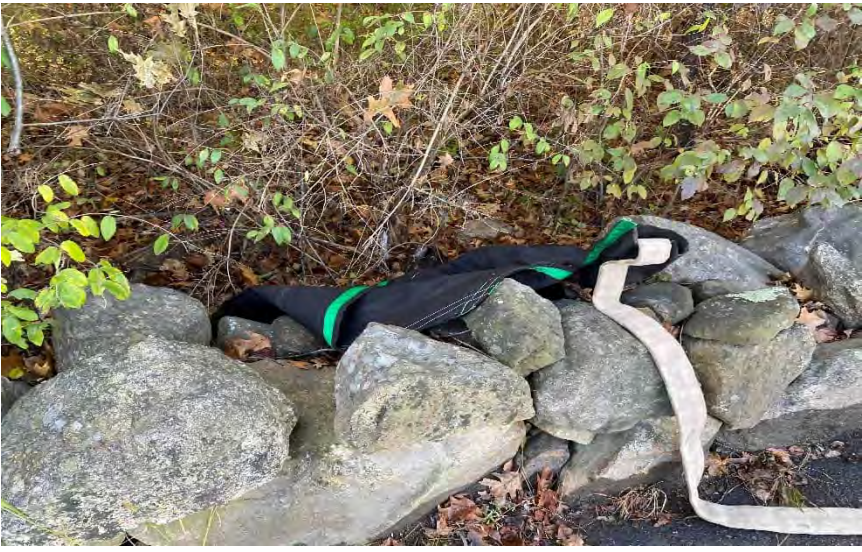
<h2 style="margin: 0;">PHOTOGRAPHIC LOG</h2>	
Client Name: Eversource		Site Location: Sudbury to Hudson Transmission Reliability Project	Town: Hudson
Photo No.: 4	Date: 10/15/2024

Description: Manhole #2. View of discharge bag. Water from bag discharged to adjacent area.

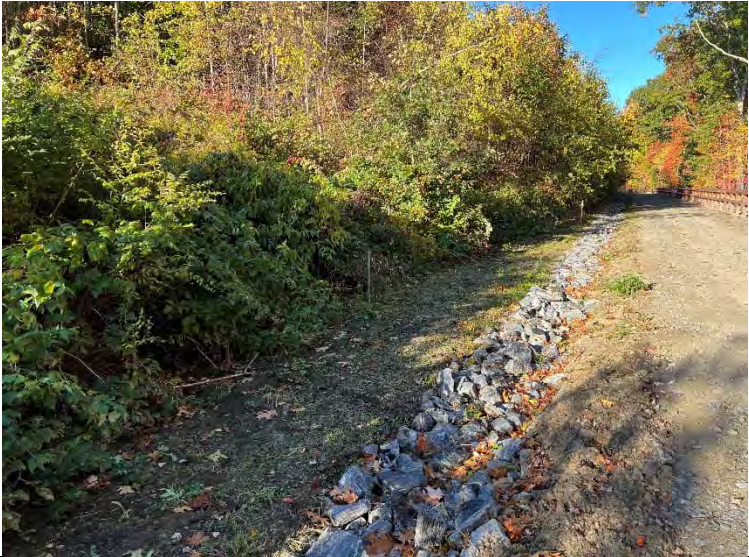
<p>PHOTOGRAPHIC LOG</p>	
<p>Client Name: Eversource</p>		<p>Site Location: Sudbury to Hudson Transmission Reliability Project</p>	<p>Town: Hudson</p>
<p>Photo No.: 1</p>	<p>Date: 10/17/24</p>

<p>Description: View of planting bed prior to installation. <i>Facing west.</i></p>

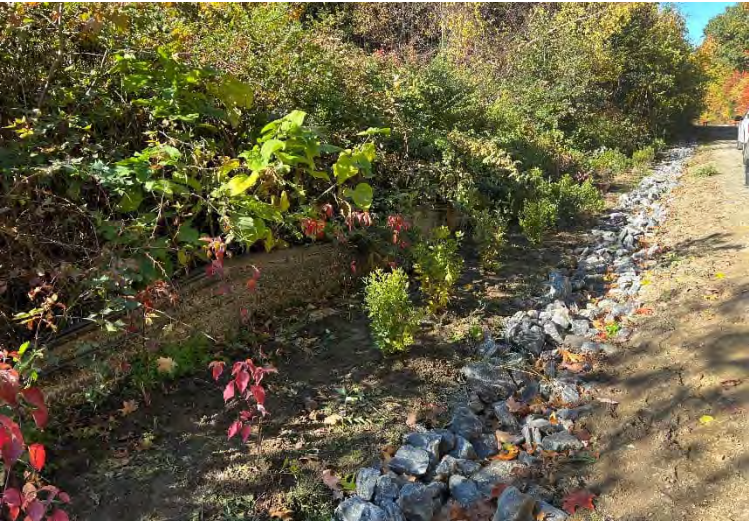
<p>PHOTOGRAPHIC LOG</p>	
<p>Client Name: Eversource</p>		<p>Site Location: Sudbury to Hudson Transmission Reliability Project</p>	<p>Town: Hudson</p>
<p>Photo No.: 4</p>	<p>Date: 10/17/24</p>

<p>Description: View of installed plants. <i>Facing west.</i></p>

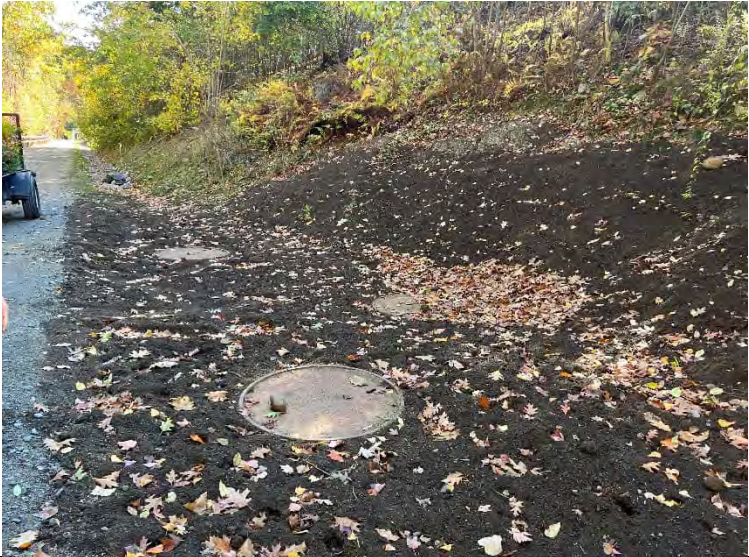
PHOTOGRAPHIC LOG	
Client Name: Eversource		Site Location: Sudbury to Hudson Transmission Reliability Project	Town: Hudson
Photo No.: 1	Date: 10/17/24

Description: View of planting bed prior to installation. <i>Facing east.</i>

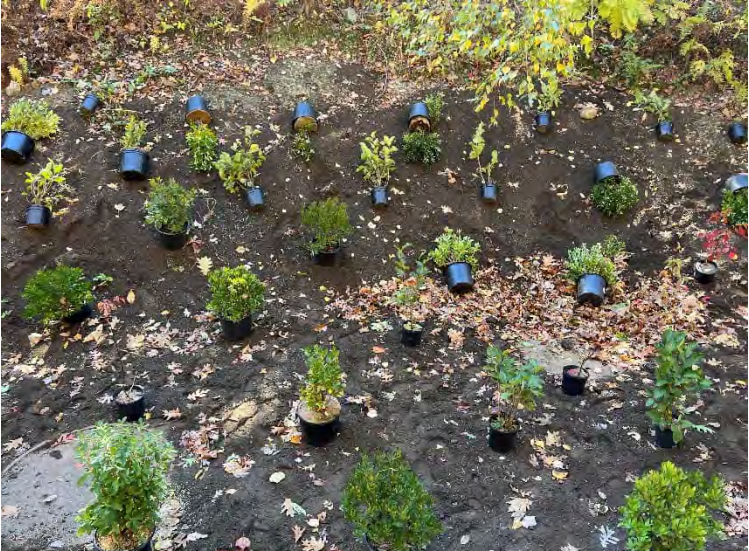
PHOTOGRAPHIC LOG	
Client Name: Eversource		Site Location: Sudbury to Hudson Transmission Reliability Project	Town: Hudson
Photo No.: 2	Date: 10/17/24

Description: View of plants laid out prior to installation. The fourth row of plants was extended to a fifth row to fill loamed slope of the planting bed. <i>Facing south.</i>

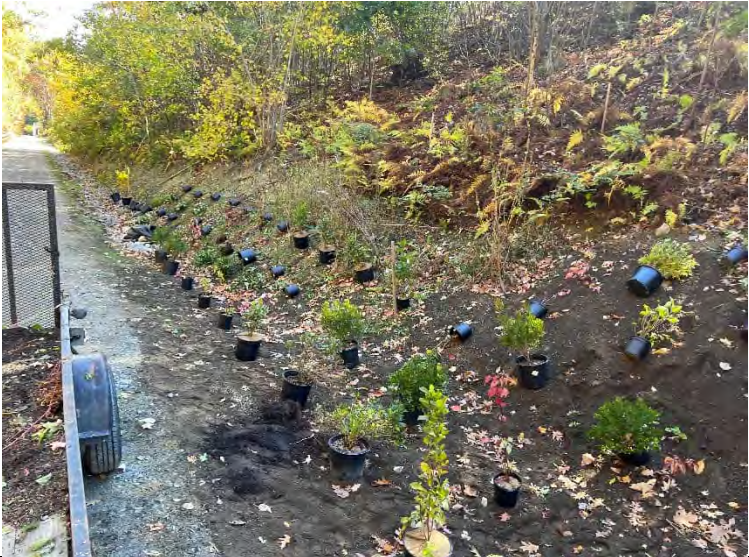
<p>PHOTOGRAPHIC LOG</p>	
<p>Client Name: Eversource</p>		<p>Site Location: Sudbury to Hudson Transmission Reliability Project</p>	<p>Town: Hudson</p>
<p>Photo No.: 3</p>	<p>Date: 10/17/24</p>

<p>Description: View of the eastern end of planting bed. Fourth row started within loamed area due to existing natural plants on the slope. <i>Facing east.</i></p>

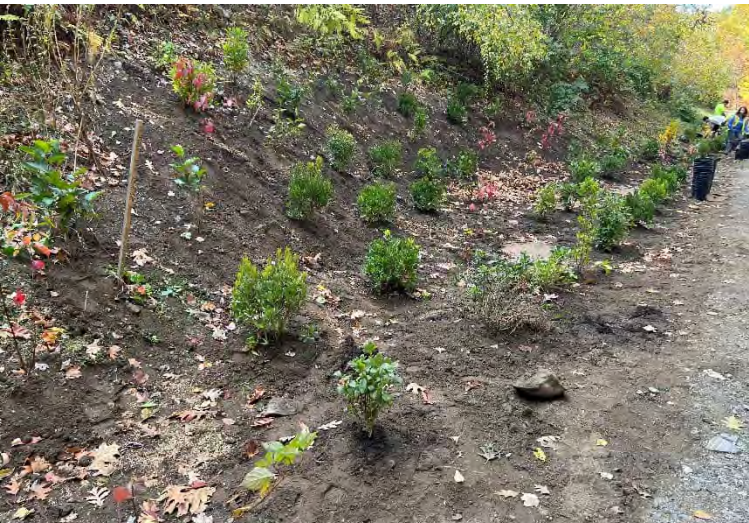
<p>PHOTOGRAPHIC LOG</p>	
<p>Client Name: Eversource</p>		<p>Site Location: Sudbury to Hudson Transmission Reliability Project</p>	<p>Town: Hudson</p>
<p>Photo No.: 4</p>	<p>Date: 10/17/24</p>

<p>Description: View of installed plants. <i>Facing west.</i></p>

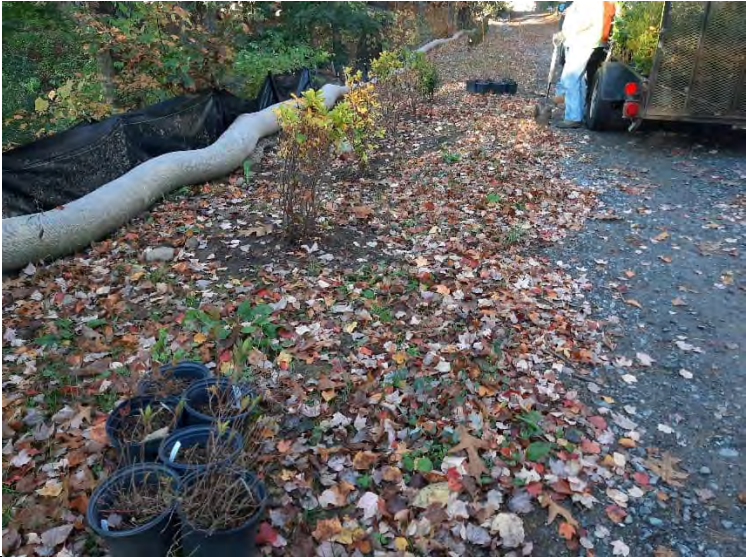
<p>PHOTOGRAPHIC LOG</p>	
<p>Client Name: Eversource</p>		<p>Site Location: Sudbury to Hudson Transmission Reliability Project</p>	<p>Town: Hudson</p>
<p>Photo No.: 1</p>	<p>Date: 10/17/24</p>

<p>Description: Segment 1, south side, ~STA 129 + 70 to ~STA 130 + 50. Bed prior to installation of huckleberry plants (GB); all other plants in this bed previously installed. Looking westward.</p>

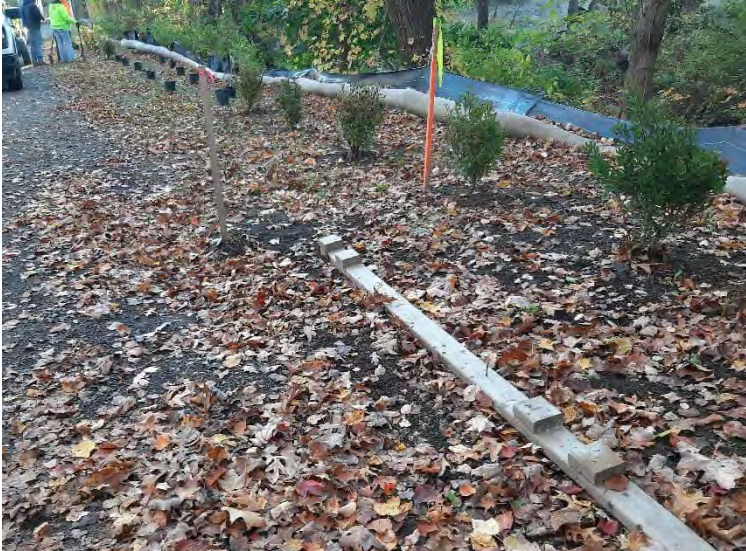
<p>PHOTOGRAPHIC LOG</p>	
<p>Client Name: Eversource</p>		<p>Site Location: Sudbury to Hudson Transmission Reliability Project</p>	<p>Town: Hudson</p>
<p>Photo No.: 2</p>	<p>Date: 10/17/24</p>

<p>Description: Segment 1, south side, ~STA 129 + 70 to ~STA 130 + 50. MON staging GB at mapped location around previous plantings. No GBs available during previous plantings. Looking eastward.</p>

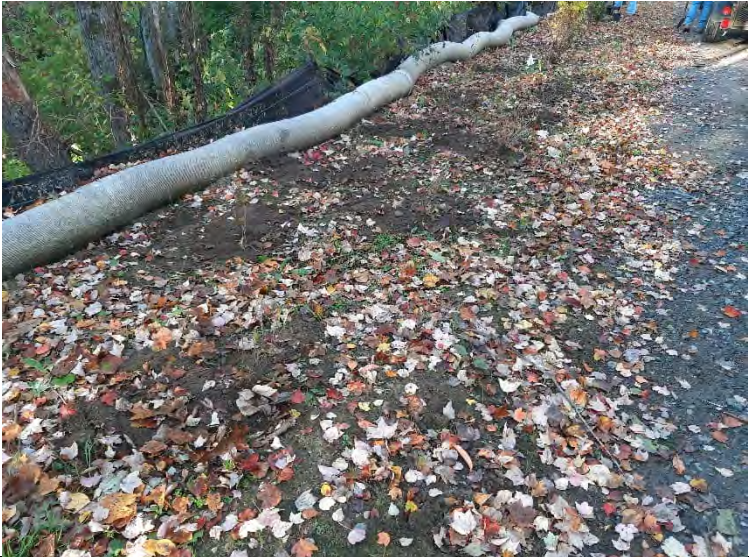
<p>PHOTOGRAPHIC LOG</p>	
<p>Client Name: Eversource</p>		<p>Site Location: Sudbury to Hudson Transmission Reliability Project</p>	<p>Town: Hudson</p>
<p>Photo No.: 3</p>	<p>Date: 10/17/24</p>

<p>Description: Segment 1, south side, ~STA 129 + 70 to ~STA 130 + 50. Installed GBs at east end of bed. Looking westward.</p>

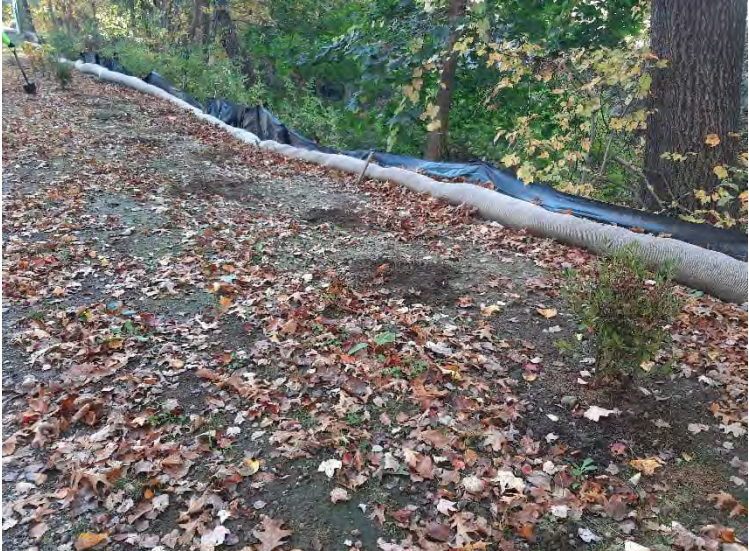
<p>PHOTOGRAPHIC LOG</p>	
<p>Client Name: Eversource</p>		<p>Site Location: Sudbury to Hudson Transmission Reliability Project</p>	<p>Town: Hudson</p>
<p>Photo No.: 4</p>	<p>Date: 10/17/24</p>

<p>Description: Segment 1, south side, ~STA 129 + 70 to ~STA 130 + 50. Installed GBs near middle of bed. Looking eastward.</p>

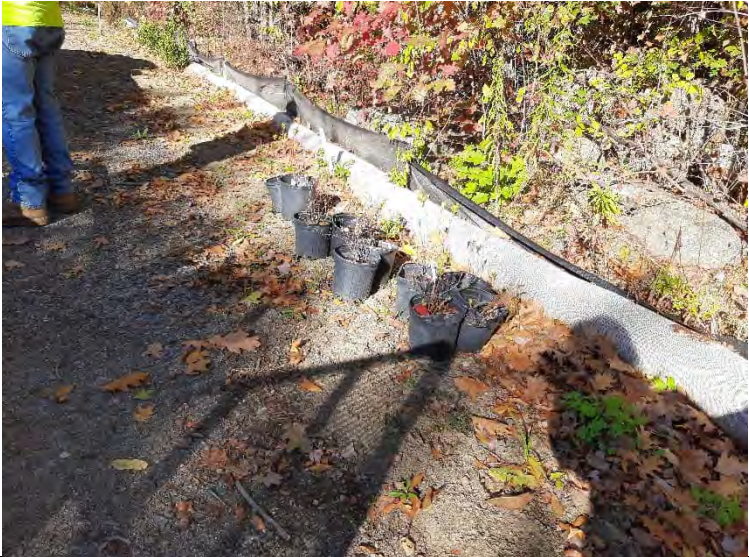
PHOTOGRAPHIC LOG	
Client Name: Eversource		Site Location: Sudbury to Hudson Transmission Reliability Project	Town: Hudson
Photo No.: 1	Date: 10/17/24

Description:  Segment 1, north side, near STA 118+00. MON preparing to stage huckleberries (GB) at marked areas around existing plantings. Looking westward.

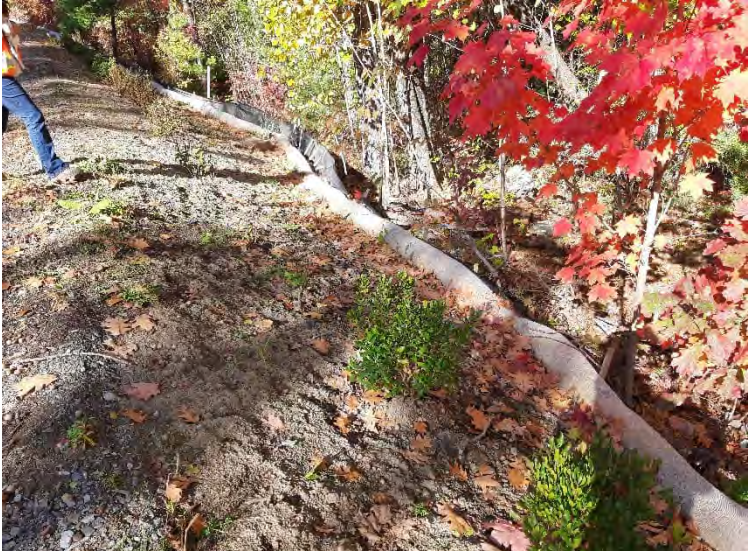
PHOTOGRAPHIC LOG	
Client Name: Eversource		Site Location: Sudbury to Hudson Transmission Reliability Project	Town: Hudson
Photo No.: 2	Date: 10/17/24

Description:  Segment 1, north side, near STA 116+50. Widest part of bed prior to today's installations. Looking westward.

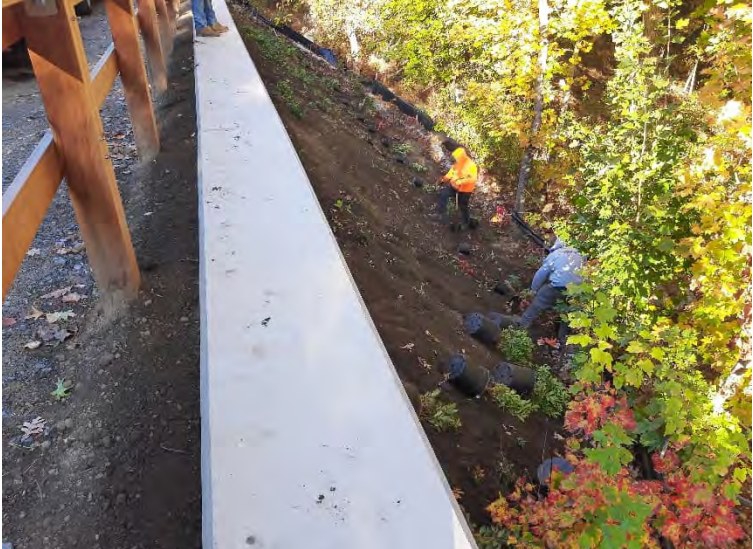
<p>PHOTOGRAPHIC LOG</p>	
<p>Client Name: Eversource</p>		<p>Site Location: Sudbury to Hudson Transmission Reliability Project</p>	<p>Town: Hudson</p>
<p>Photo No.: 2</p>	<p>Date: 10/18/24</p>

<p>Description: Segment 1, north side, near MH6. MON staging and installing plants on steeply sloped bed. Looking westward.</p>

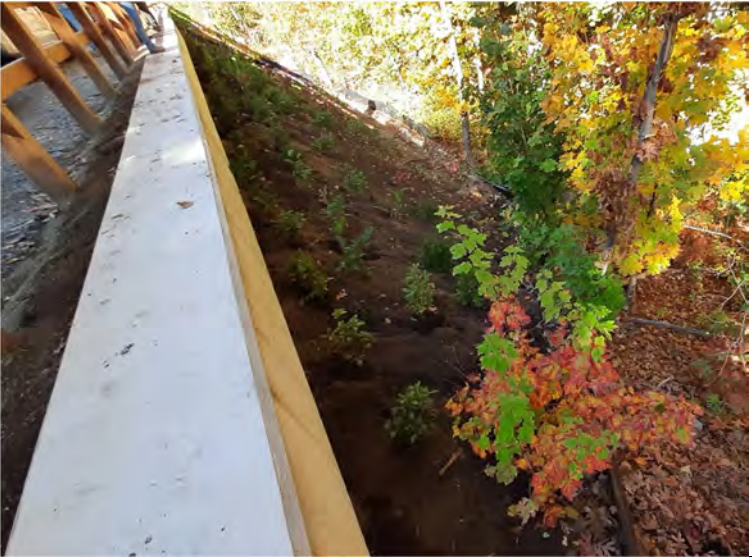
<p>PHOTOGRAPHIC LOG</p>	
<p>Client Name: Eversource</p>		<p>Site Location: Sudbury to Hudson Transmission Reliability Project</p>	<p>Town: Hudson</p>
<p>Photo No.: 3</p>	<p>Date: 10/18/24</p>

<p>Description: Segment 1, north side, near MH6. Steeply sloped bed after MON installed plants. Looking westward.</p>
