Weekly Environmental Compliance Summary

Sudbury to Hudson Transmission Reliability Project (USEPA Tracking # MAR1003UW)

Week of: October 21, 2024 to October 26, 2024

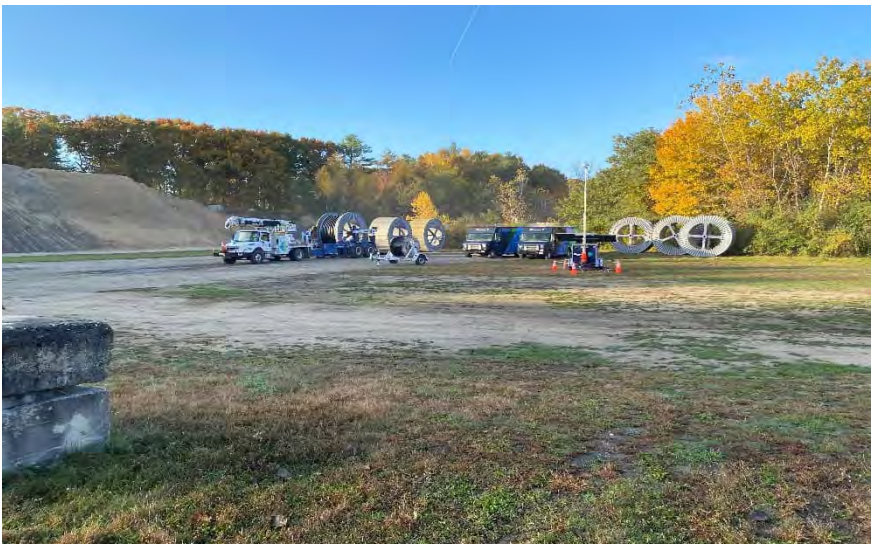
PHOTOGRAPHIC LOG	
Client Name: Eversource		Site Location: Sudbury to Hudson Transmission Reliability Project	Town: Hudson
Photo No.: 2	Date: 10-21-24

Description: Haugland laydown yard, mirk ready to deploy to the field, looking northward.

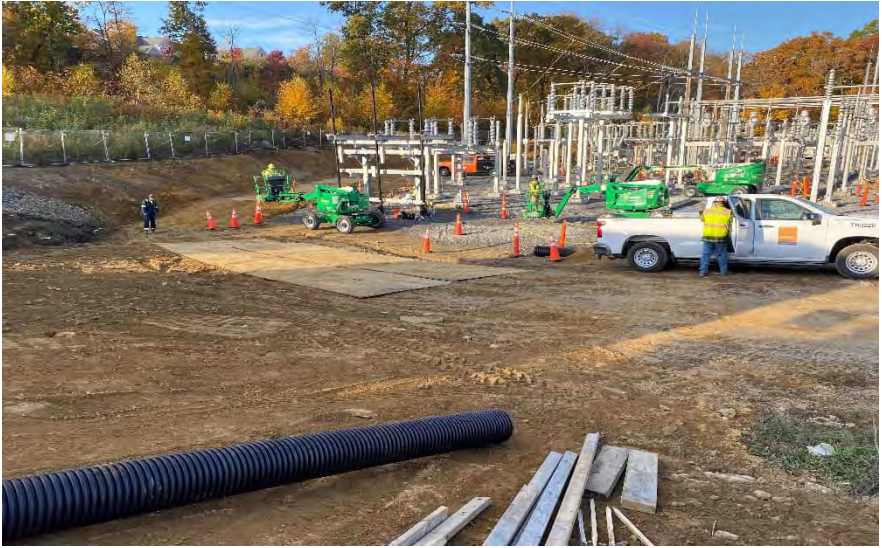
<p align="center">PHOTOGRAPHIC LOG</p>	
<p>Client Name: Eversource</p>		<p>Site Location: Sudbury to Hudson Transmission Reliability Project</p>	<p>Town: Hudson</p>
<p>Photo No.: 3</p>	<p>Date: 10-21-24</p>

<p>Description:</p> <p>Haugland conducting work within the Hudson Power & Light substation, looking southward.</p>

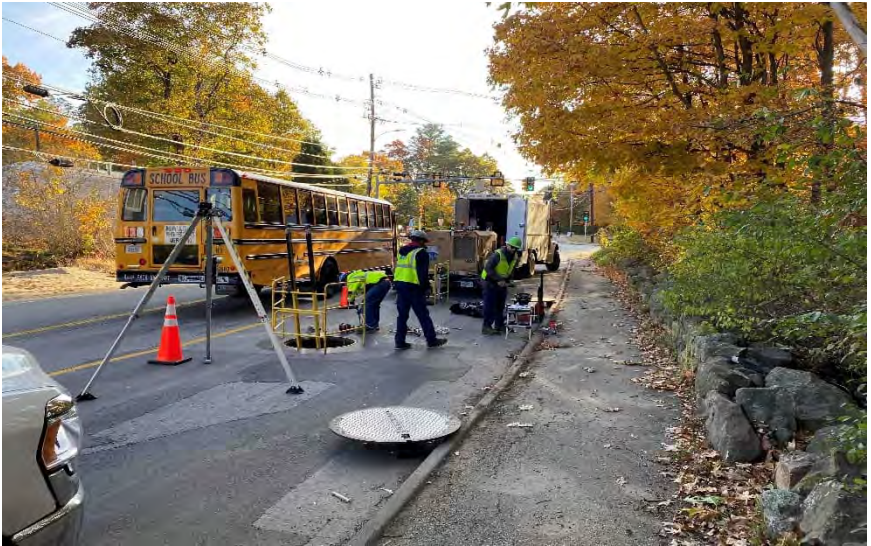
<p align="center">PHOTOGRAPHIC LOG</p>	
<p>Client Name: Eversource</p>		<p>Site Location: Sudbury to Hudson Transmission Reliability Project</p>	<p>Town: Hudson</p>
<p>Photo No.: 4</p>	<p>Date: 10-21-24</p>

<p>Description:</p> <p>Haugland working at manhole #2 to conduct wire pulling, looking northward.</p>

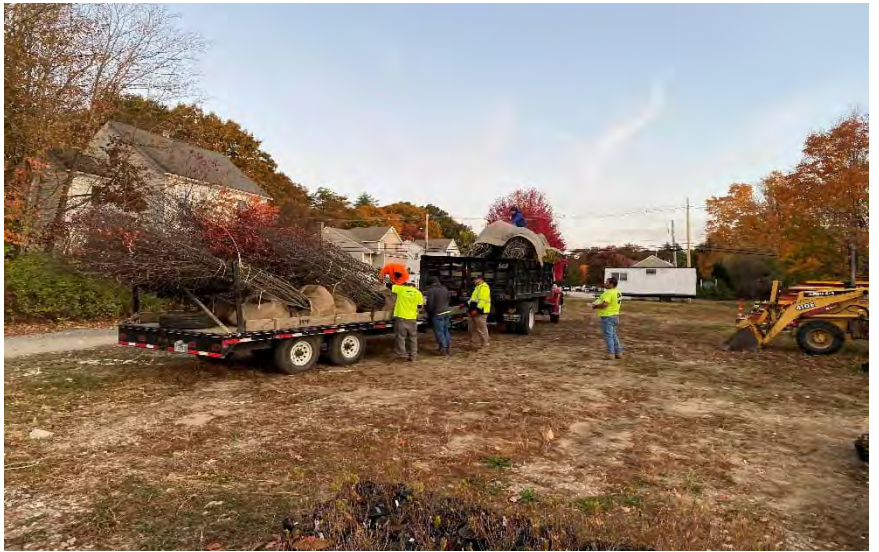
<p>PHOTOGRAPHIC LOG</p>	
<p>Client Name: Eversource</p>		<p>Site Location: Sudbury to Hudson Transmission Reliability Project</p>	<p>Town: Hudson</p>
<p>Photo No.: 6</p>	<p>Date: 10-21-24</p>

<p>Description:</p> <p>MON receiving plant order, to place within segment 8 today, looking eastward.</p>

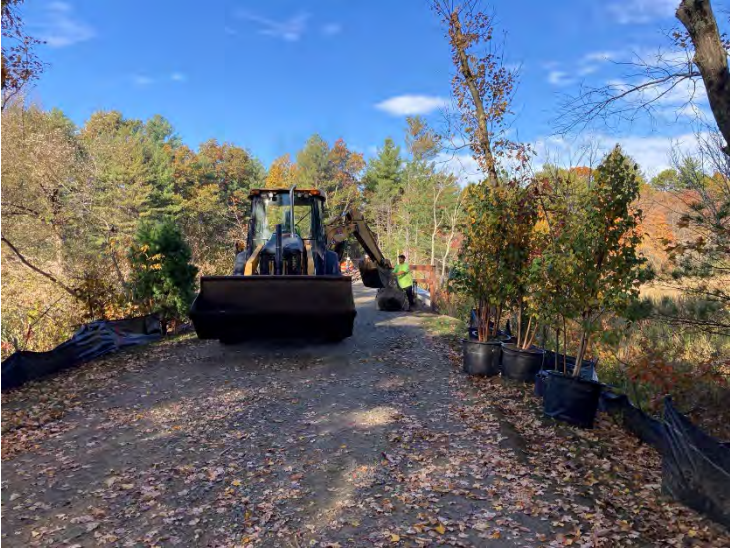
PHOTOGRAPHIC LOG	
Client Name: Eversource		Site Location: Sudbury to Hudson Transmission Reliability Project	Town: Sudbury
Photo No.: 1	Date: 10/21/2024

Description: View of MON's planting activities at bridge 128 in segment 8. Facing west.

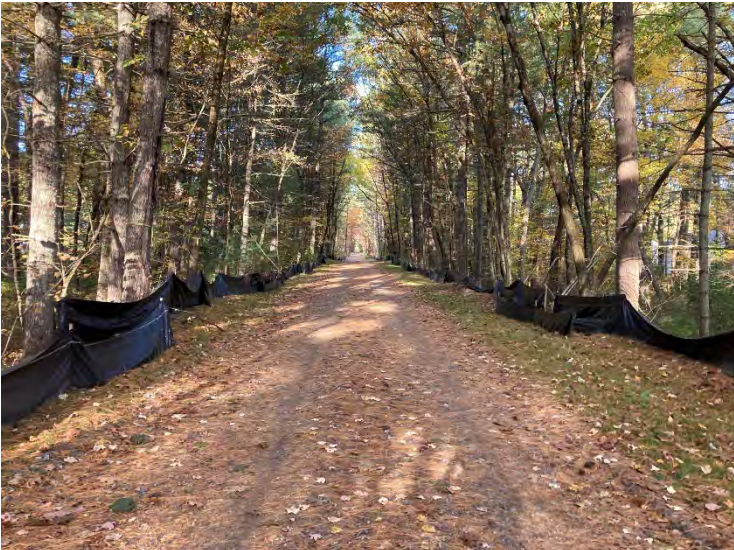
PHOTOGRAPHIC LOG	
Client Name: Eversource		Site Location: Sudbury to Hudson Transmission Reliability Project	Town: Sudbury
Photo No.: 2	Date: 10/21/2024

Description: View of E&S controls in segment 9. Facing west.

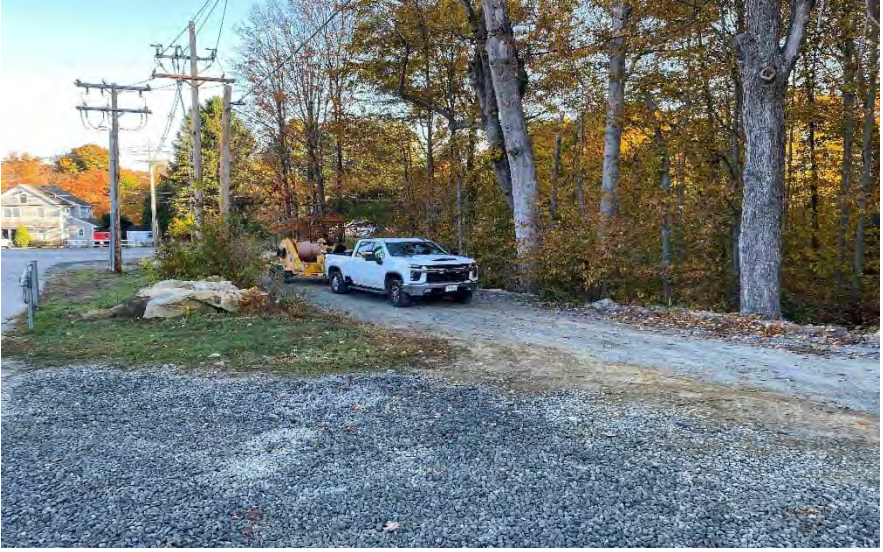
PHOTOGRAPHIC LOG	
Client Name: Eversource		Site Location: Sudbury to Hudson Transmission Reliability Project	Town: Hudson
Photo No.: 1	Date: 10-23-24

Description: Work area at manhole #1, Haugland conducting work to the Hudson substation, looking westward.

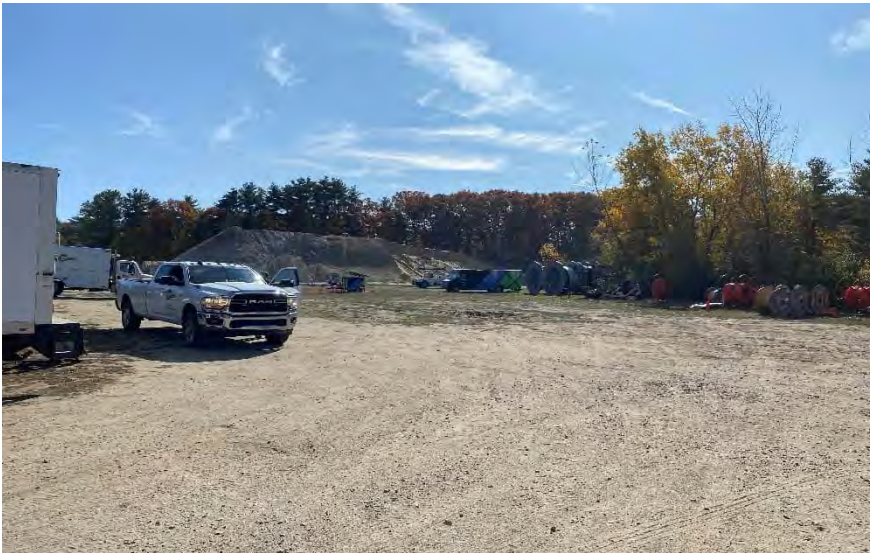
PHOTOGRAPHIC LOG	
Client Name: Eversource		Site Location: Sudbury to Hudson Transmission Reliability Project	Town: Hudson
Photo No.: 2	Date: 10-23-24

Description: Haugland laydown yard, mirk ready to deploy to the field, looking westward.

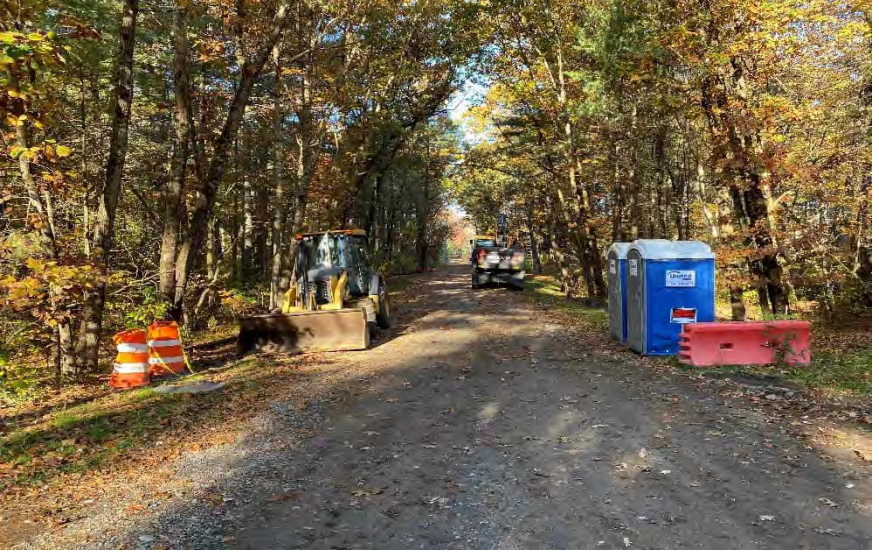
PHOTOGRAPHIC LOG	
Client Name: Eversource		Site Location: Sudbury to Hudson Transmission Reliability Project	Town: Hudson
Photo No.: 5	Date: 10-23-24

Description: Work area within segment 5, ET&L staging for work within segment 7, existing erosion control, looking westward.

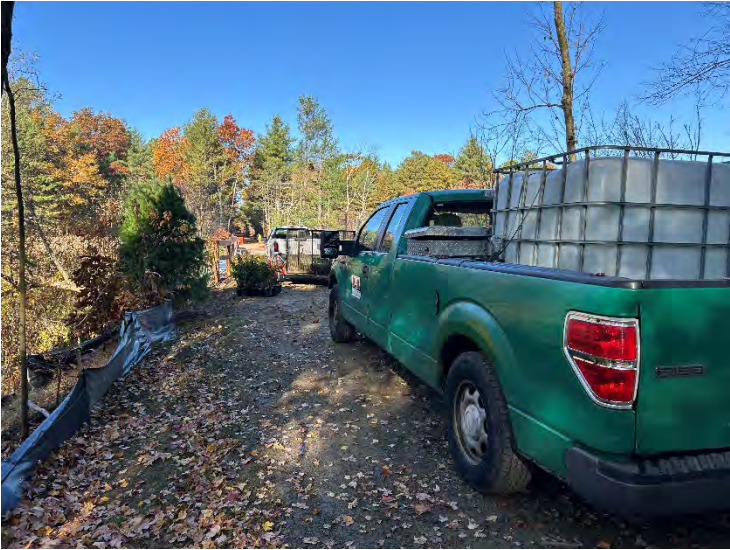
<p>PHOTOGRAPHIC LOG</p>	
<p>Client Name: Eversource</p>		<p>Site Location: Sudbury to Hudson Transmission Reliability Project</p>	<p>Town: Sudbury</p>
<p>Photo No.: 1</p>	<p>Date: 10/23/2024</p>

<p>Description: View of MON's planting activities at bridge 128 in segment 8. Facing west.</p>

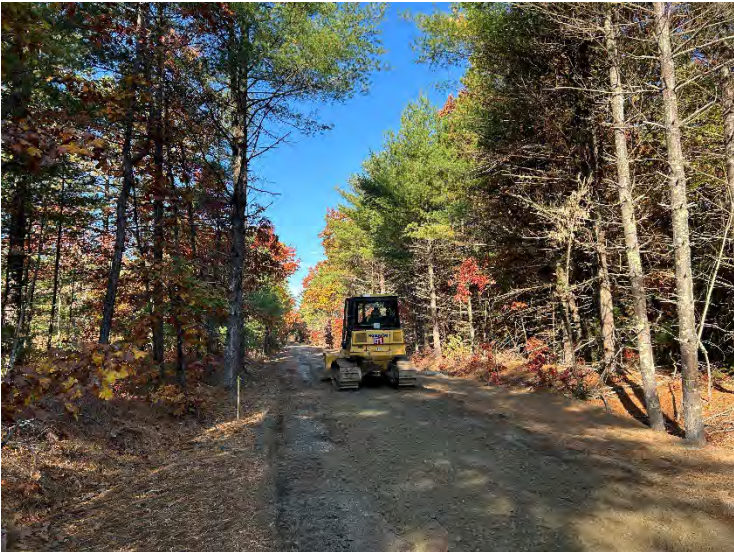
<p>PHOTOGRAPHIC LOG</p>	
<p>Client Name: Eversource</p>		<p>Site Location: Sudbury to Hudson Transmission Reliability Project</p>	<p>Town: Sudbury</p>
<p>Photo No.: 2</p>	<p>Date: 10/23/2024</p>

<p>Description: View of ET&L working on road surface in segment 7. Facing west.</p>

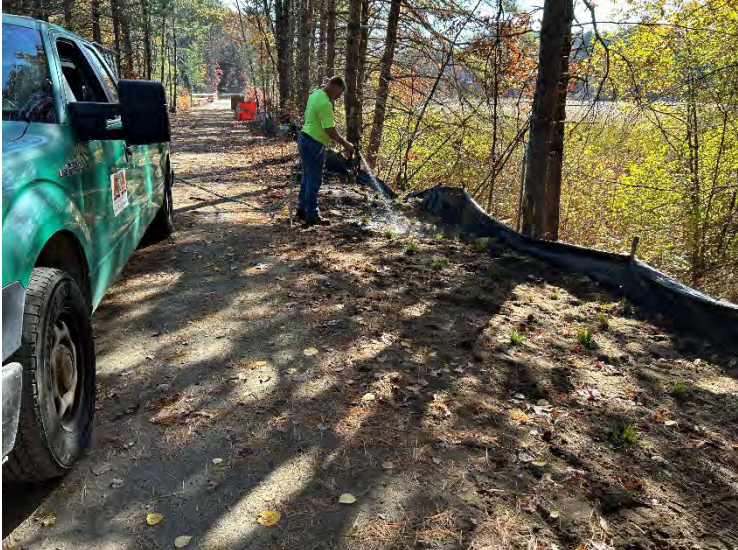
<p>PHOTOGRAPHIC LOG</p>	
<p>Client Name: Eversource</p>		<p>Site Location: Sudbury to Hudson Transmission Reliability Project</p>	<p>Town: Sudbury</p>
<p>Photo No.: 4</p>	<p>Date: 10/23/2024</p>

<p>Description: View of MON watering newly installed plants. Facing east.</p>

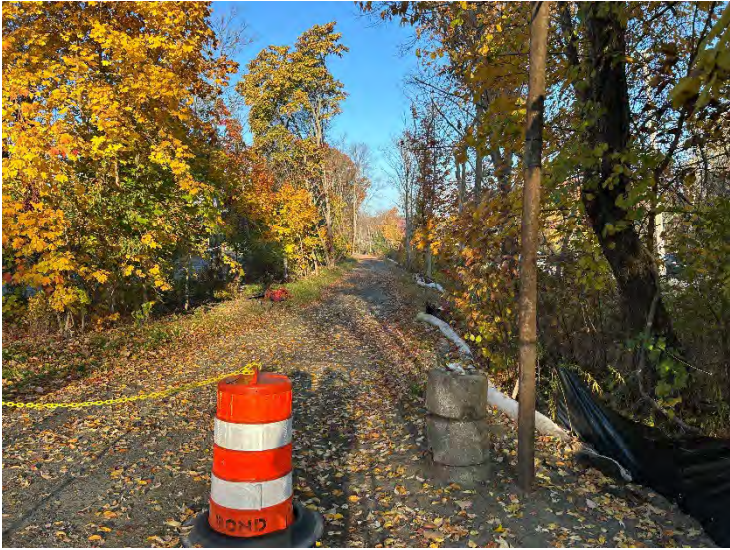
<p>PHOTOGRAPHIC LOG</p>	
<p>Client Name: Eversource</p>		<p>Site Location: Sudbury to Hudson Transmission Reliability Project</p>	<p>Town: Sudbury</p>
<p>Photo No.: 5</p>	<p>Date: 10/23/2024</p>

<p>Description: View of erosion controls and reset historical artifacts at the eastern entrance to segment 12. Facing west.</p>

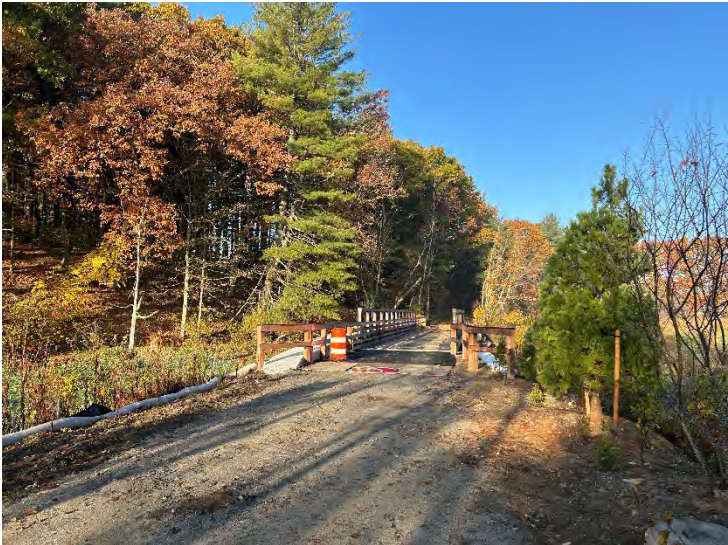
<p>PHOTOGRAPHIC LOG</p>	
<p>Client Name: Eversource</p>		<p>Site Location: Sudbury to Hudson Transmission Reliability Project</p>	<p>Town: Sudbury</p>
<p>Photo No.: 6</p>	<p>Date: 10/23/2024</p>

<p>Description: View of bridge 127 from segment 14. Facing west.</p>

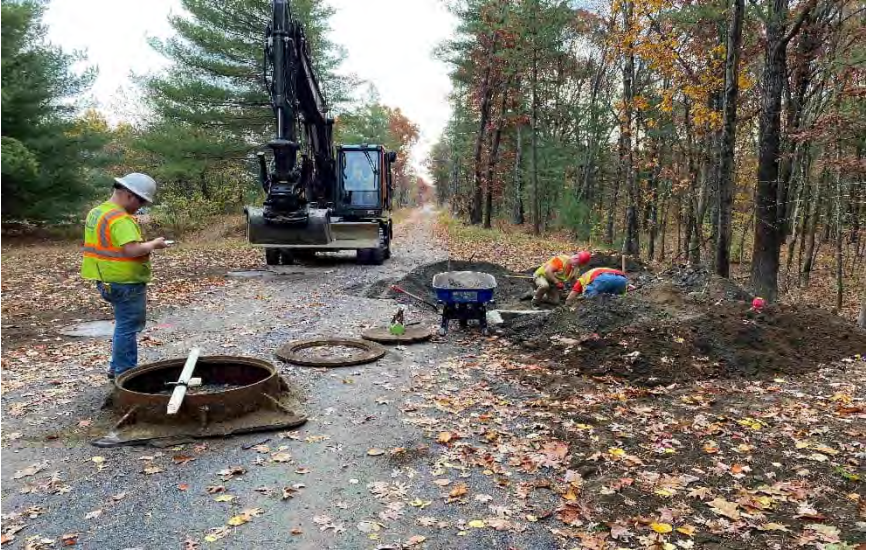
<p align="right">PHOTOGRAPHIC LOG</p>	
<p>Client Name: Eversource</p>		<p>Site Location: Sudbury to Hudson Transmission Reliability Project</p>	<p>Town: Hudson</p>
<p>Photo No.: 1</p>	<p>Date: 10-24-24</p>

<p>Description:</p> <p>Work area at handhole #7, ET&L conducting work on frames & covers, looking eastward.</p>

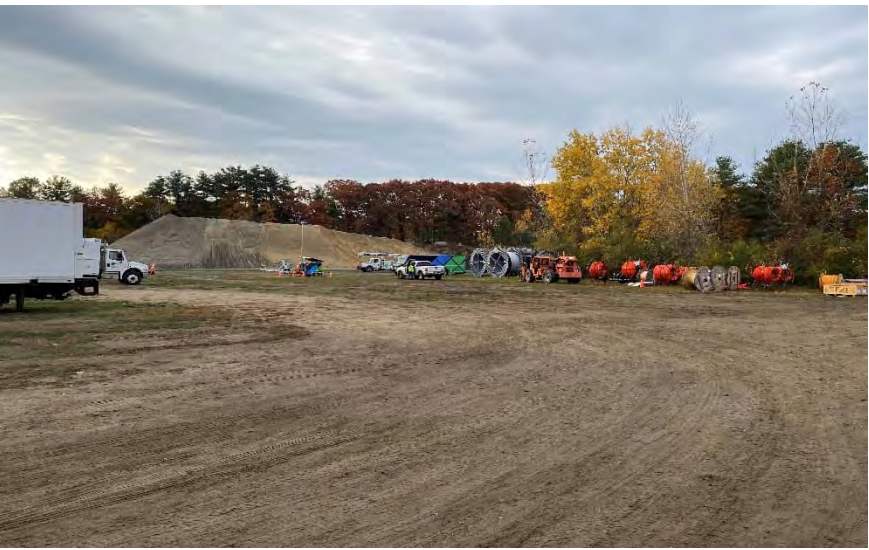
<p align="right">PHOTOGRAPHIC LOG</p>	
<p>Client Name: Eversource</p>		<p>Site Location: Sudbury to Hudson Transmission Reliability Project</p>	<p>Town: Hudson</p>
<p>Photo No.: 2</p>	<p>Date: 10-24-24</p>

<p>Description:</p> <p>Haugland laydown yard, looking westward.</p>

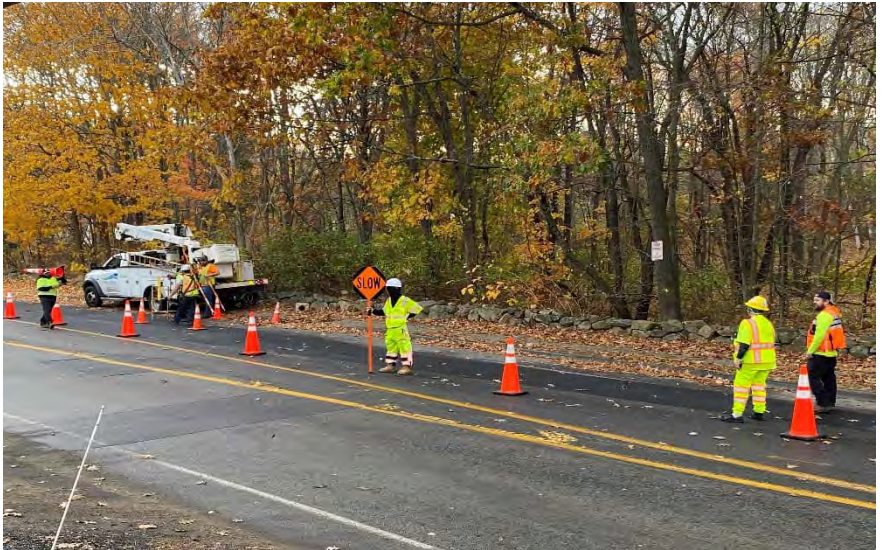
<p>PHOTOGRAPHIC LOG</p>	
<p>Client Name: Eversource</p>		<p>Site Location: Sudbury to Hudson Transmission Reliability Project</p>	<p>Town: Hudson</p>
<p>Photo No.: 4</p>	<p>Date: 10-24-24</p>

<p>Description:</p> <p>New Wave working at handhole #2 to conduct fiber optic work, looking southward.</p>

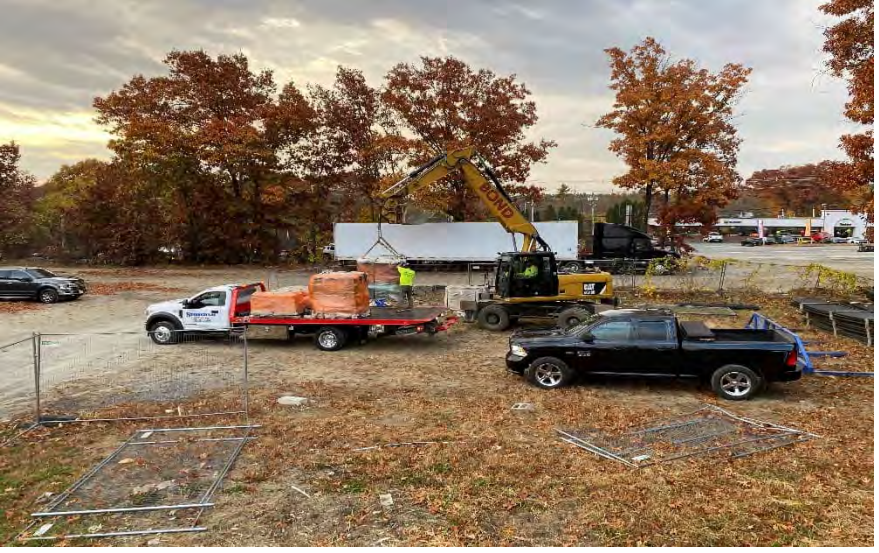
<p align="right">PHOTOGRAPHIC LOG</p>	
<p>Client Name: Eversource</p>		<p>Site Location: Sudbury to Hudson Transmission Reliability Project</p>	<p>Town: Hudson</p>
<p>Photo No.: 5</p>	<p>Date: 10-24-24</p>

<p>Description:</p> <p>Bond working at their laydown area, looking westward.</p>

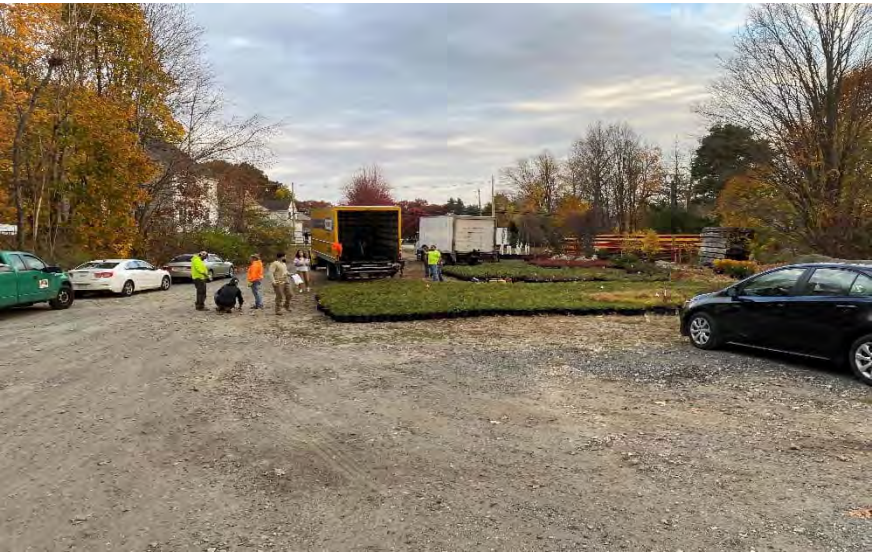
<p align="right">PHOTOGRAPHIC LOG</p>	
<p>Client Name: Eversource</p>		<p>Site Location: Sudbury to Hudson Transmission Reliability Project</p>	<p>Town: Hudson</p>
<p>Photo No.: 6</p>	<p>Date: 10-24-24</p>

<p>Description:</p> <p>MON receiving plant order, to place within segment 8 today, looking eastward.</p>

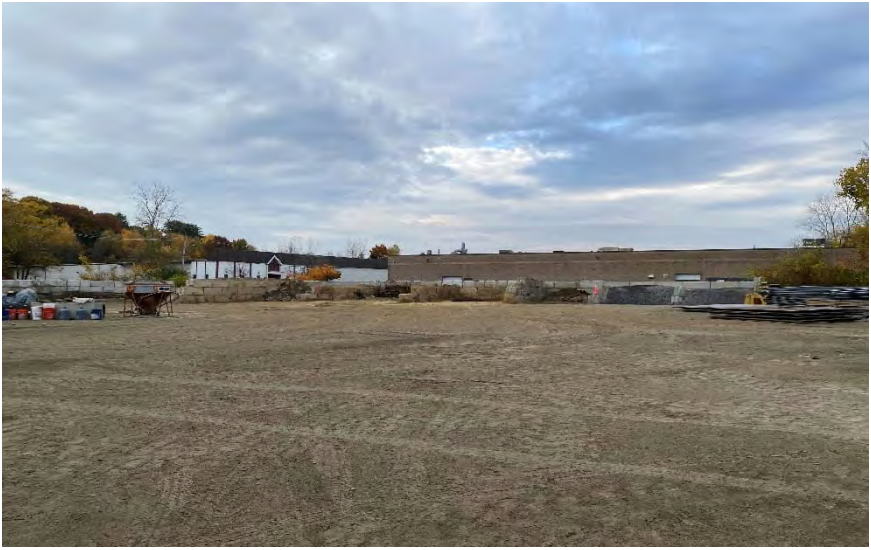
<p>PHOTOGRAPHIC LOG</p>	
<p>Client Name: Eversource</p>		<p>Site Location: Sudbury to Hudson Transmission Reliability Project</p>	<p>Town: Hudson</p>
<p>Photo No.: 7</p>	<p>Date: 10-24-24</p>

<p>Description:</p> <p>Bonazzoli laydown yard, looking westward.</p>

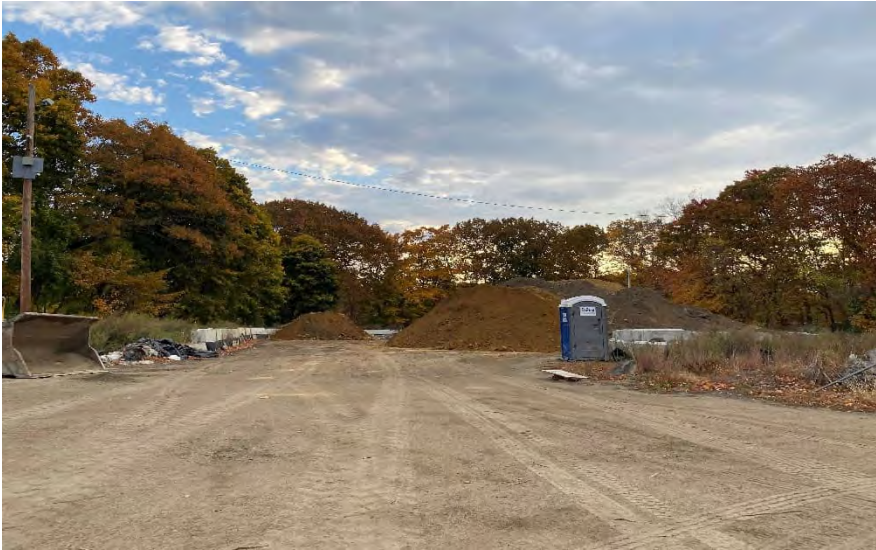
<p>PHOTOGRAPHIC LOG</p>	
<p>Client Name: Eversource</p>		<p>Site Location: Sudbury to Hudson Transmission Reliability Project</p>	<p>Town: Hudson</p>
<p>Photo No.: 8</p>	<p>Date: 10-24-24</p>

<p>Description:</p> <p>Stowe Court laydown yard, looking southward.</p>

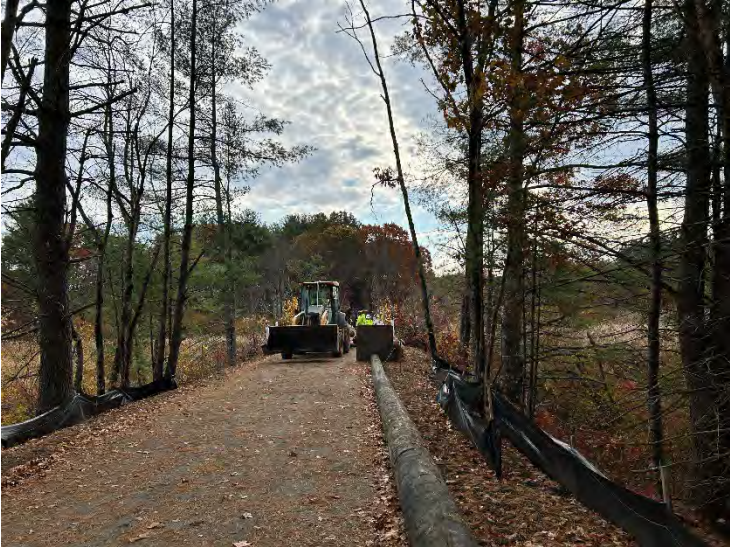
PHOTOGRAPHIC LOG	
Client Name: Eversource		Site Location: Sudbury to Hudson Transmission Reliability Project	Town: Sudbury
Photo No.: 1	Date: 10/24/2024

Description: View of MON's planting activities at bridge 128 in segment 7. Facing east.

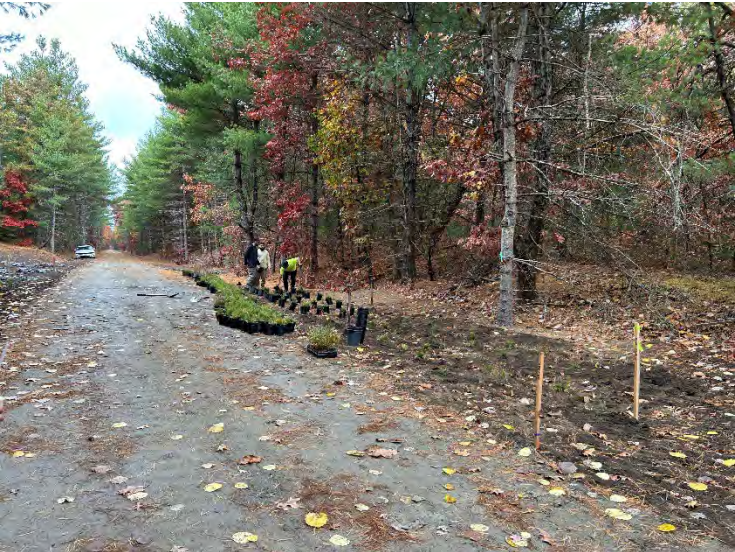
PHOTOGRAPHIC LOG	
Client Name: Eversource		Site Location: Sudbury to Hudson Transmission Reliability Project	Town: Sudbury
Photo No.: 2	Date: 10/24/2024

Description: View MON's planting activities in segment 7. Facing west.

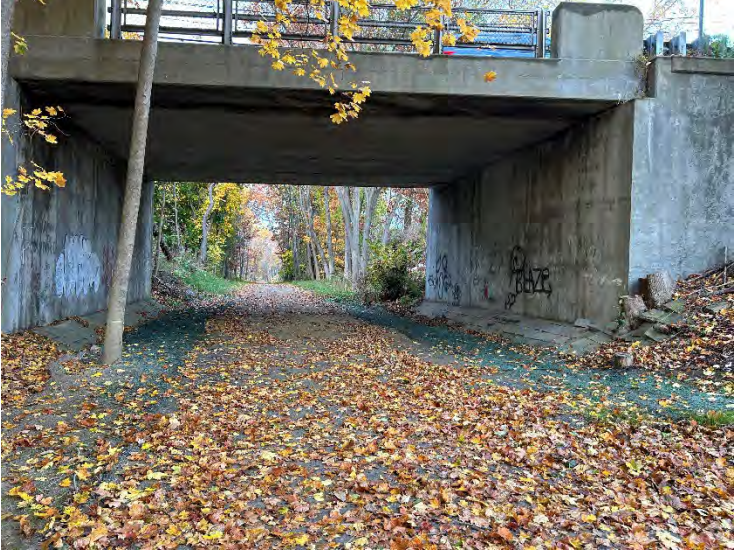
PHOTOGRAPHIC LOG	
Client Name: Eversource		Site Location: Sudbury to Hudson Transmission Reliability Project	Town: Sudbury
Photo No.: 3	Date: 10/24/2024

Description: View of hydroseeded shoulders under Landham Road overpass in segment 14. Facing west.

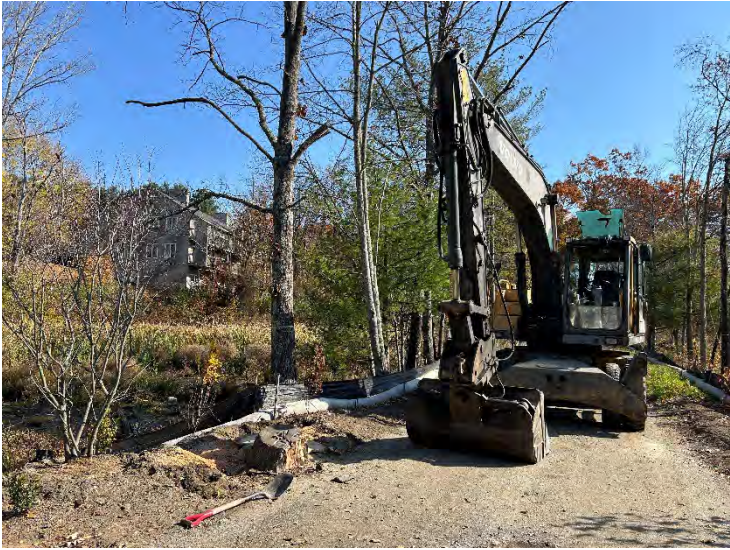
<p>PHOTOGRAPHIC LOG</p>	
<p>Client Name: Eversource</p>		<p>Site Location: Sudbury to Hudson Transmission Reliability Project</p>	<p>Town: Sudbury</p>
<p>Photo No.: 5</p>	<p>Date: 10/24/2024</p>

<p>Description: View ET&L removing a stump in segment 14 near bridge 127. Facing northeast.</p>

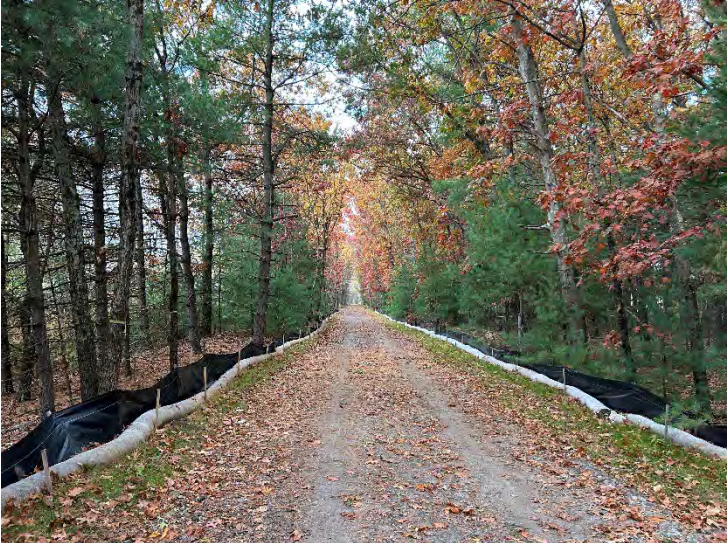
<p>PHOTOGRAPHIC LOG</p>	
<p>Client Name: Eversource</p>		<p>Site Location: Sudbury to Hudson Transmission Reliability Project</p>	<p>Town: Sudbury</p>
<p>Photo No.: 6</p>	<p>Date: 10/24/2024</p>

<p>Description: View of E&S controls within segment 11. Facing west.</p>

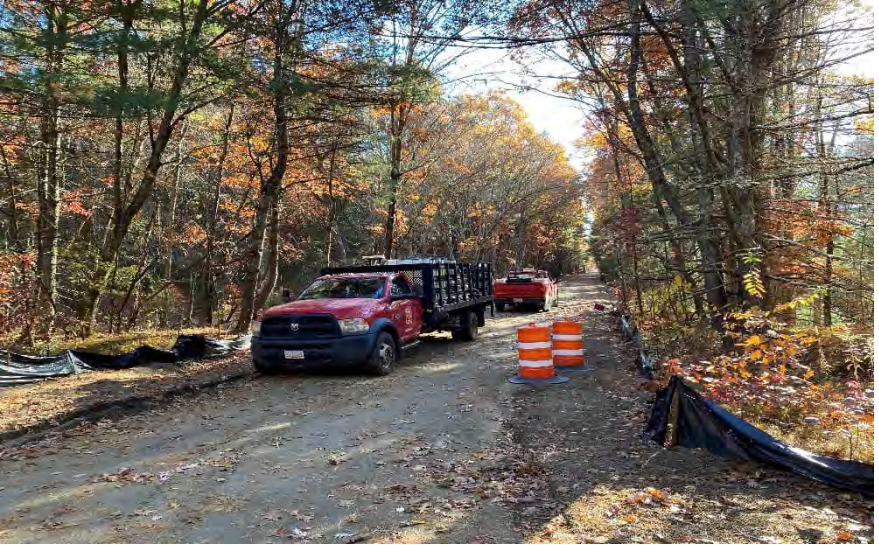
PHOTOGRAPHIC LOG	
Client Name: Eversource		Site Location: Sudbury to Hudson Transmission Reliability Project	Town: Hudson
Photo No.: 1	Date: 10-25-24

Description: Work area within segment 6, ET&L conducting work, existing erosion control, looking eastward.

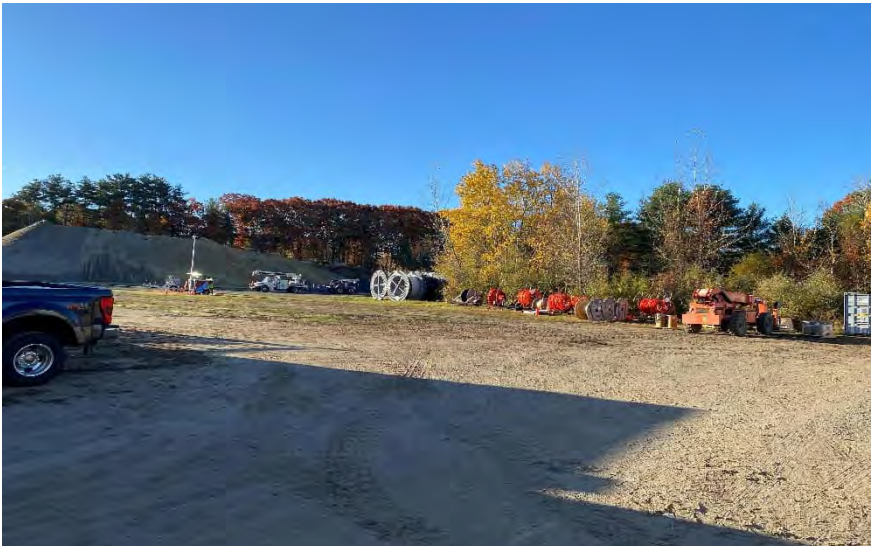
PHOTOGRAPHIC LOG	
Client Name: Eversource		Site Location: Sudbury to Hudson Transmission Reliability Project	Town: Hudson
Photo No.: 2	Date: 10-25-24

Description: Haugland laydown yard, mirk ready to deploy to the field, looking westward.

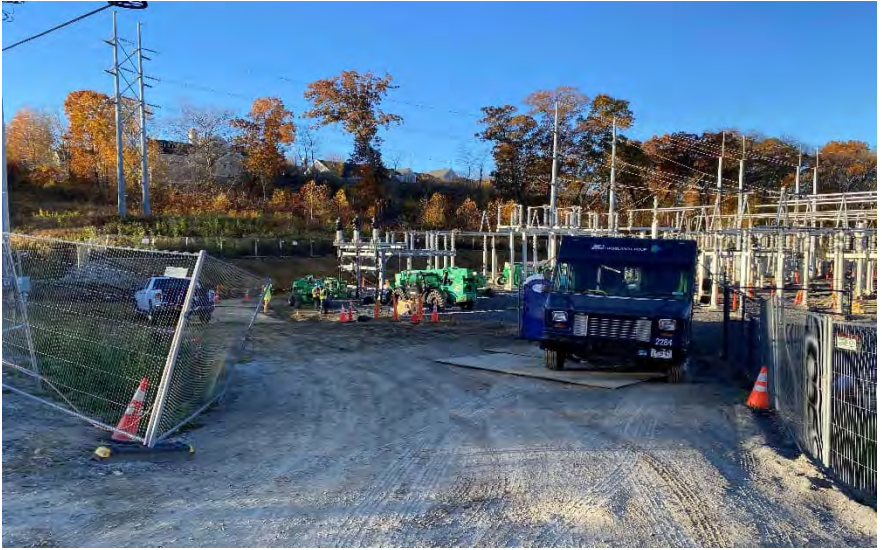
<p>PHOTOGRAPHIC LOG</p>	
<p>Client Name: Eversource</p>		<p>Site Location: Sudbury to Hudson Transmission Reliability Project</p>	<p>Town: Hudson</p>
<p>Photo No.: 3</p>	<p>Date: 10-25-24</p>

<p>Description:</p> <p>Haugland conducting work within the Hudson Power & Light substation, looking southward.</p>

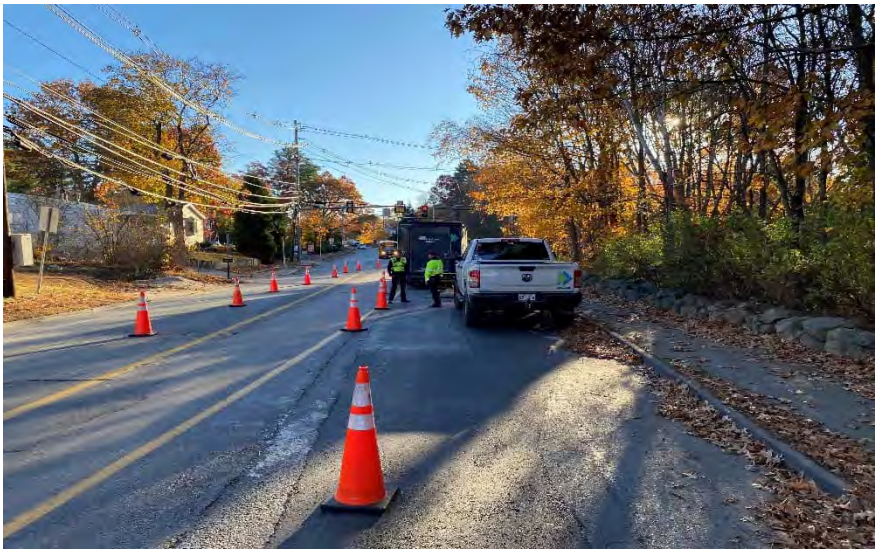
<p>PHOTOGRAPHIC LOG</p>	
<p>Client Name: Eversource</p>		<p>Site Location: Sudbury to Hudson Transmission Reliability Project</p>	<p>Town: Hudson</p>
<p>Photo No.: 4</p>	<p>Date: 10-25-24</p>

<p>Description:</p> <p>Haugland working at manhole #2 to conduct splicing work, looking northward.</p>

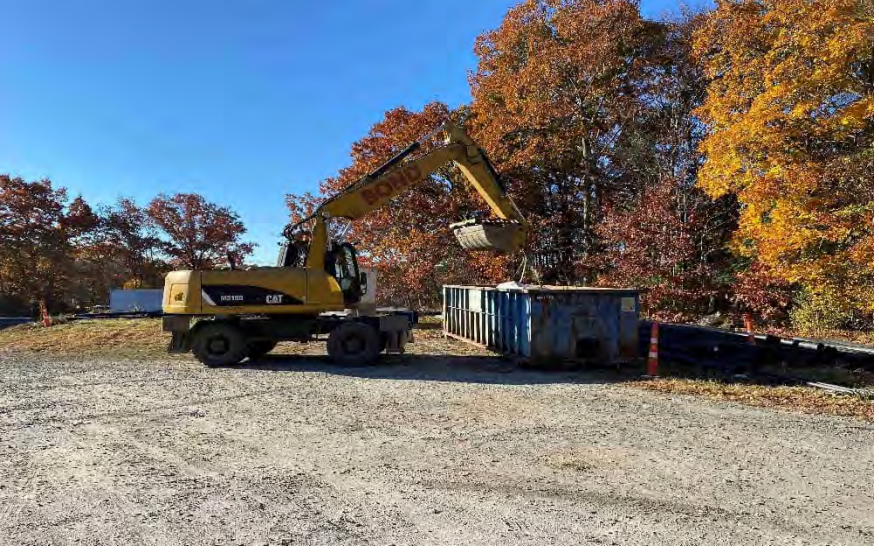
PHOTOGRAPHIC LOG	
Client Name: Eversource		Site Location: Sudbury to Hudson Transmission Reliability Project	Town: Hudson
Photo No.: 5	Date: 10-25-24

Description: Bond working at their laydown area, looking westward.

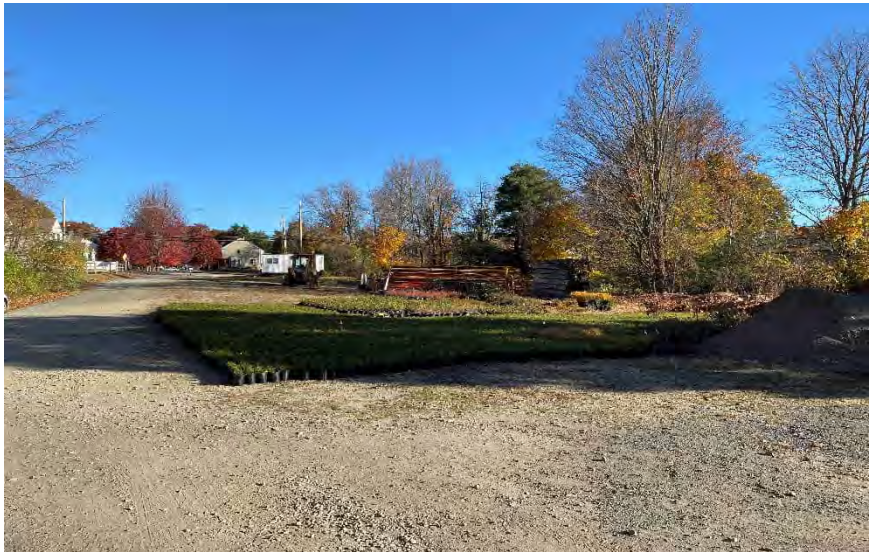
PHOTOGRAPHIC LOG	
Client Name: Eversource		Site Location: Sudbury to Hudson Transmission Reliability Project	Town: Hudson
Photo No.: 6	Date: 10-25-24

Description: MON plant storage area at Bond laydown yard, planting to take place within segment 7 today, looking eastward.

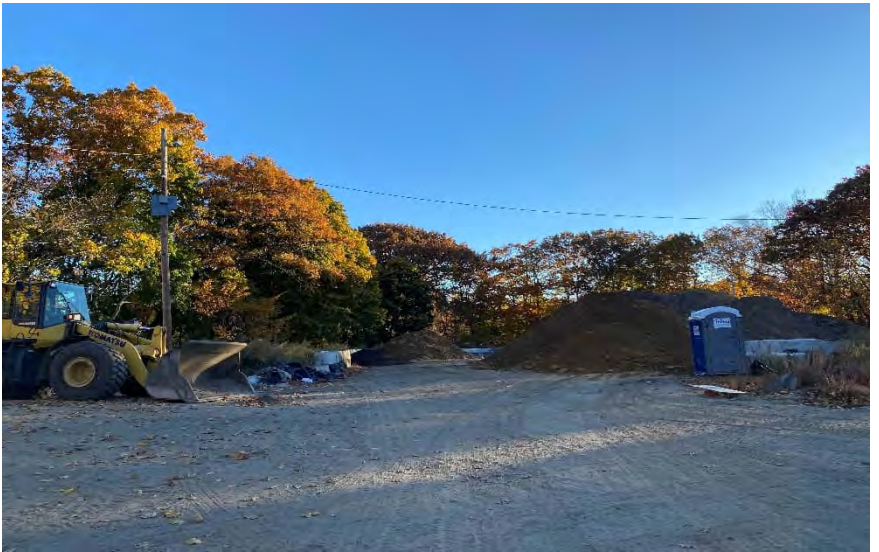
<p align="center">PHOTOGRAPHIC LOG</p>	
<p>Client Name: Eversource</p>		<p>Site Location: Sudbury to Hudson Transmission Reliability Project</p>	<p>Town: Hudson</p>
<p>Photo No.: 8</p>	<p>Date: 10-25-24</p>

<p>Description:</p> <p>Stowe Court laydown yard, looking southward.</p>

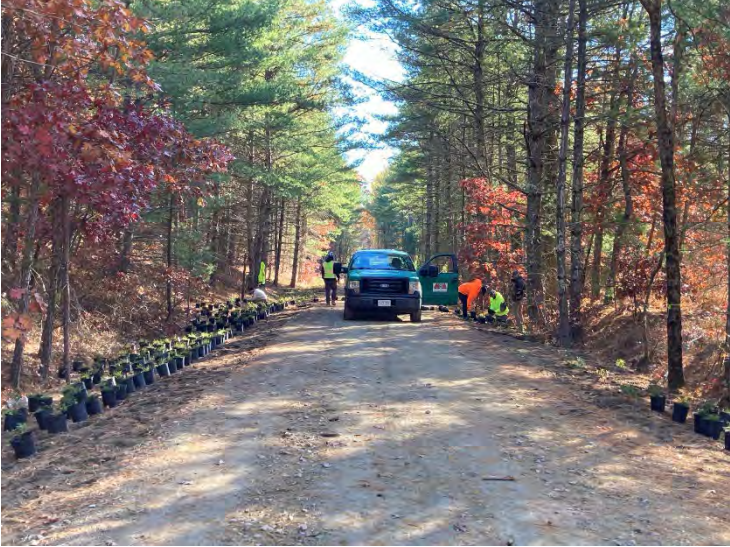
PHOTOGRAPHIC LOG	
Client Name: Eversource		Site Location: Sudbury to Hudson Transmission Reliability Project	Town: Sudbury
Photo No.: 1	Date: 10/25/2024

Description: View of MON's planting activities in segment 7. Facing east.

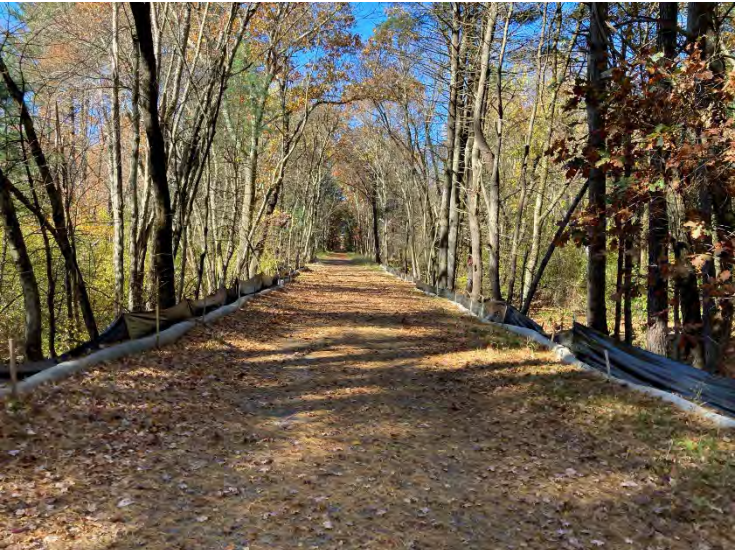
PHOTOGRAPHIC LOG	
Client Name: Eversource		Site Location: Sudbury to Hudson Transmission Reliability Project	Town: Sudbury
Photo No.: 2	Date: 10/25/2024

Description: View of E&S controls in segment 9. Facing west.

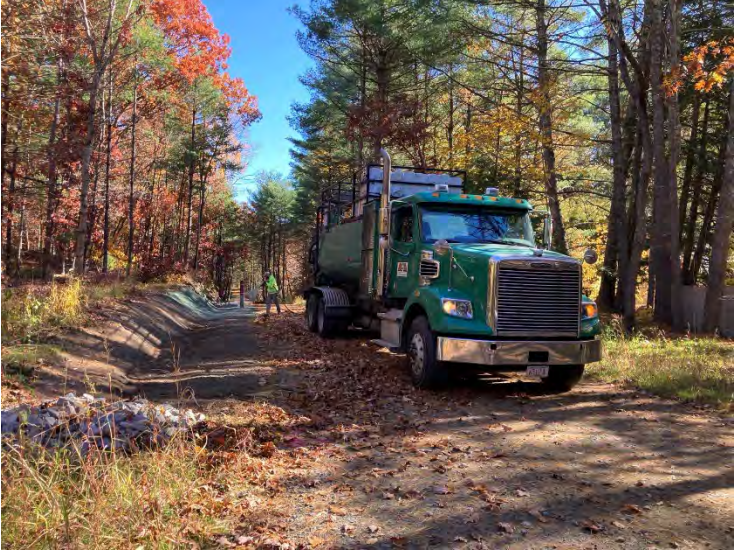
<p>PHOTOGRAPHIC LOG</p>	
<p>Client Name: Eversource</p>		<p>Site Location: Sudbury to Hudson Transmission Reliability Project</p>	<p>Town: Sudbury</p>
<p>Photo No.: 3</p>	<p>Date: 10/25/2024</p>

<p>Description: View of MON hydroseeding newly installed swale at the west end of segment 10. Facing east.</p>

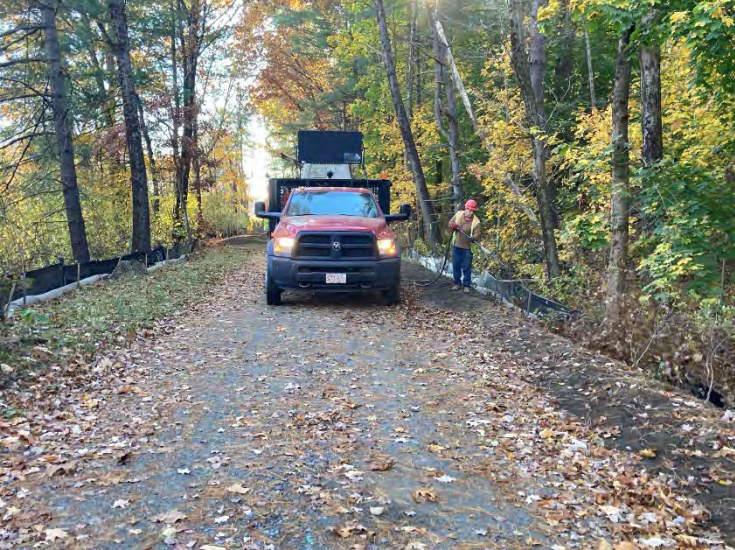
<p>PHOTOGRAPHIC LOG</p>	
<p>Client Name: Eversource</p>		<p>Site Location: Sudbury to Hudson Transmission Reliability Project</p>	<p>Town: Sudbury</p>
<p>Photo No.: 4</p>	<p>Date: 10/25/2024</p>

<p>Description: View of ET&L leave blowing ahead of MON's hydroseeding crew in segment 13. Facing east.</p>

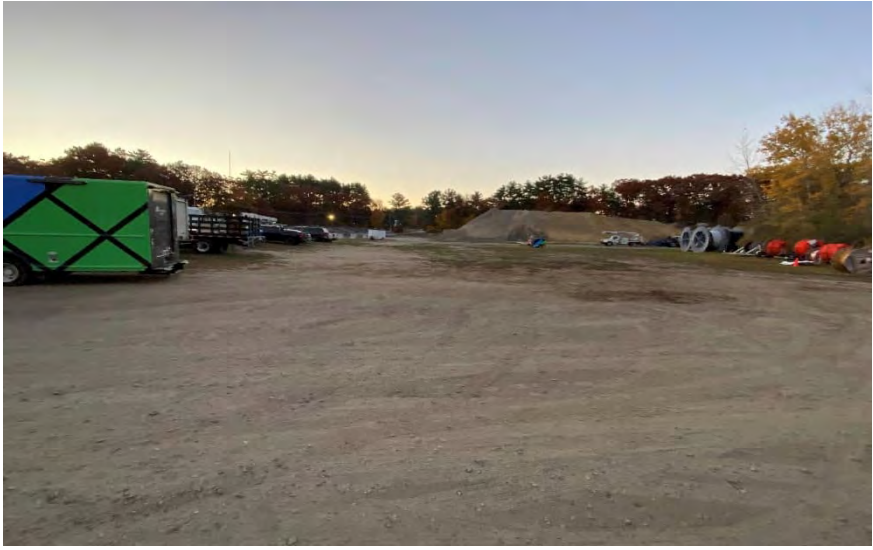
<p>PHOTOGRAPHIC LOG</p>	
<p>Client Name: Eversource</p>		<p>Site Location: Sudbury to Hudson Transmission Reliability Project</p>	<p>Town: Hudson</p>
<p>Photo No.: 1</p>	<p>Date: 10-26-24</p>

<p>Description: Haugland laydown yard, looking westward.</p>

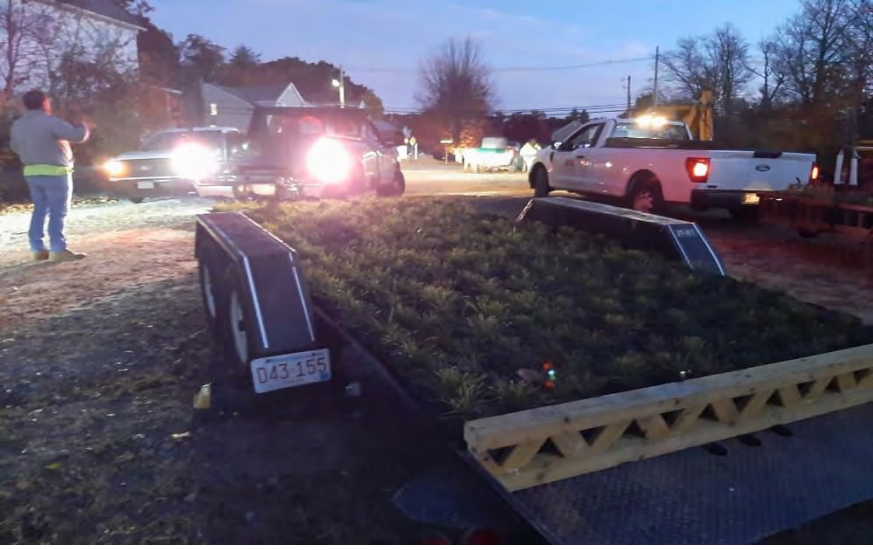
<p>PHOTOGRAPHIC LOG</p>	
<p>Client Name: Eversource</p>		<p>Site Location: Sudbury to Hudson Transmission Reliability Project</p>	<p>Town: Hudson</p>
<p>Photo No.: 2</p>	<p>Date: 10-26-24</p>

<p>Description: MON loading at Bond laydown yard, for planting within segment 7, looking eastward.</p>

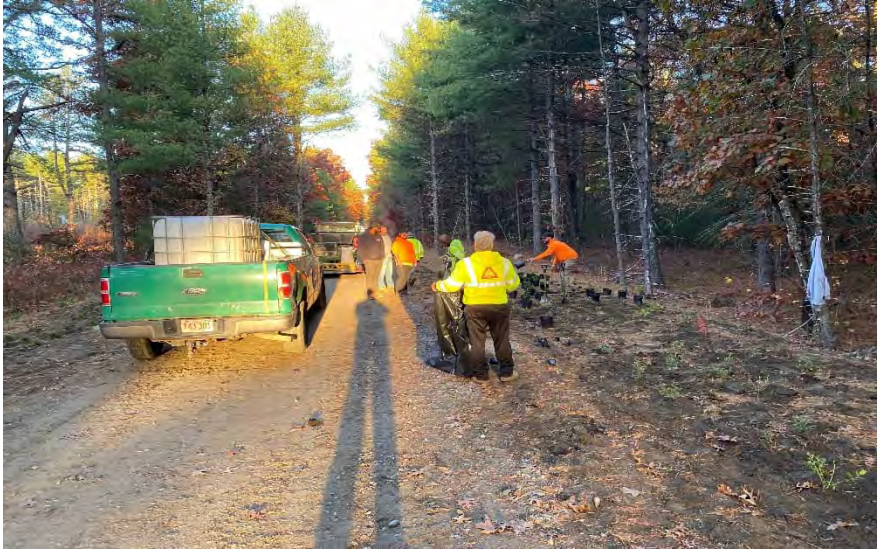
<p>PHOTOGRAPHIC LOG</p>	
<p>Client Name: Eversource</p>		<p>Site Location: Sudbury to Hudson Transmission Reliability Project</p>	<p>Town: Sudbury</p>
<p>Photo No.: 4</p>	<p>Date: 10-26-24</p>

<p>Description:</p> <p>MON conducting planting work within segment 7, looking westward.</p>

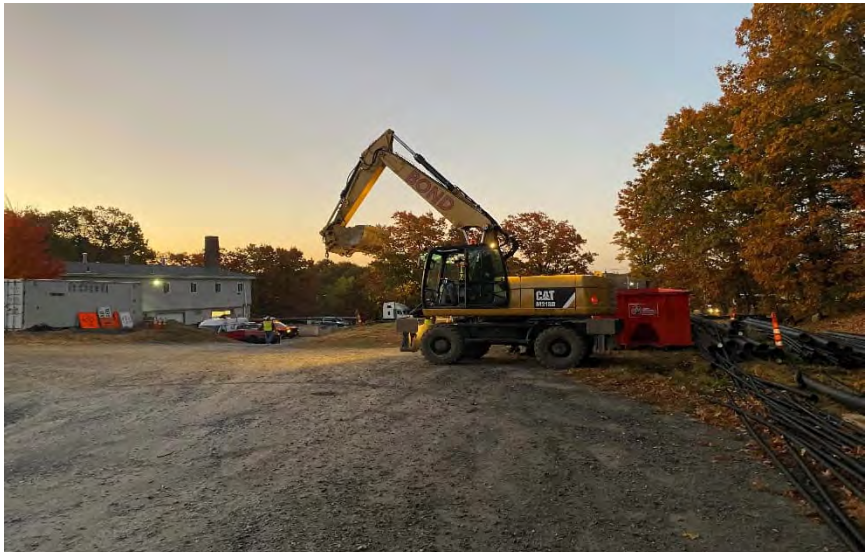
PHOTOGRAPHIC LOG	
Client Name: Eversource		Site Location: Sudbury to Hudson Transmission Reliability Project	Town: Hudson
Photo No.: 4	Date: 10-22-24

Description: Bond working at their laydown yard, looking westward.

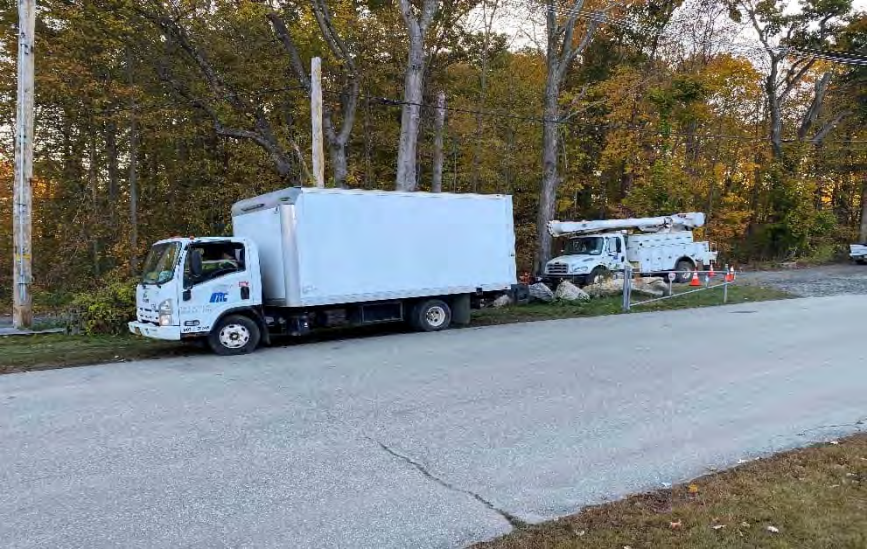
PHOTOGRAPHIC LOG	
Client Name: Eversource		Site Location: Sudbury to Hudson Transmission Reliability Project	Town: Hudson
Photo No.: 5	Date: 10-22-24

Description: Haugland conducting wire work at manhole #1, looking westward.

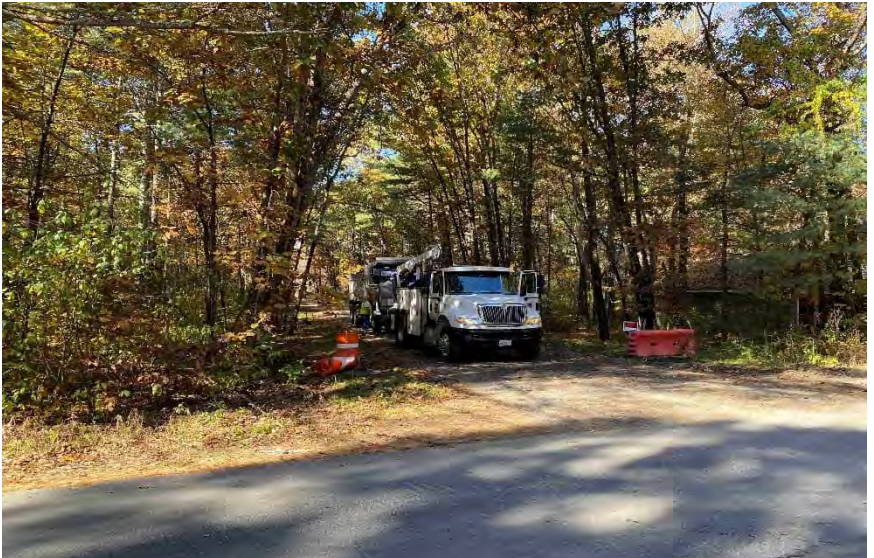
PHOTOGRAPHIC LOG	
Client Name: Eversource		Site Location: Sudbury to Hudson Transmission Reliability Project	Town: Hudson
Photo No.: 7	Date: 10-22-24

Description: Work area within segment 5, manhole #13, ET&L equipment for grading work within segment 6, existing erosion control, looking westward.
