Weekly Environmental Compliance Summary

Sudbury to Hudson Transmission Reliability Project (USEPA Tracking # MAR1003UW)

Week of: October 21, 2024 to October 26, 2024

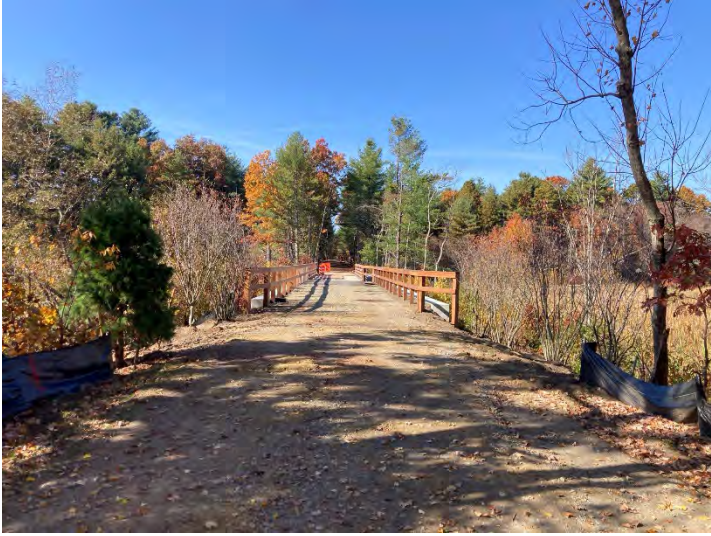
PHOTOGRAPHIC LOG	
Client Name: Eversource		Site Location: Sudbury to Hudson Transmission Reliability Project	Town: Sudbury
Photo No.: 1	Date: 10-22-24

Description: View of bridge 128. Facing west.

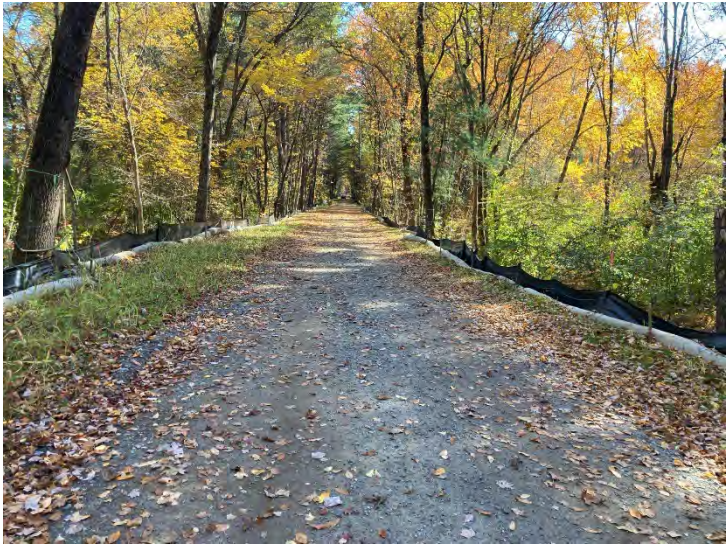
PHOTOGRAPHIC LOG	
Client Name: Eversource		Site Location: Sudbury to Hudson Transmission Reliability Project	Town: Sudbury
Photo No.: 2	Date: 10-22-24

Description: View of E&S controls in segment 9. Facing east.

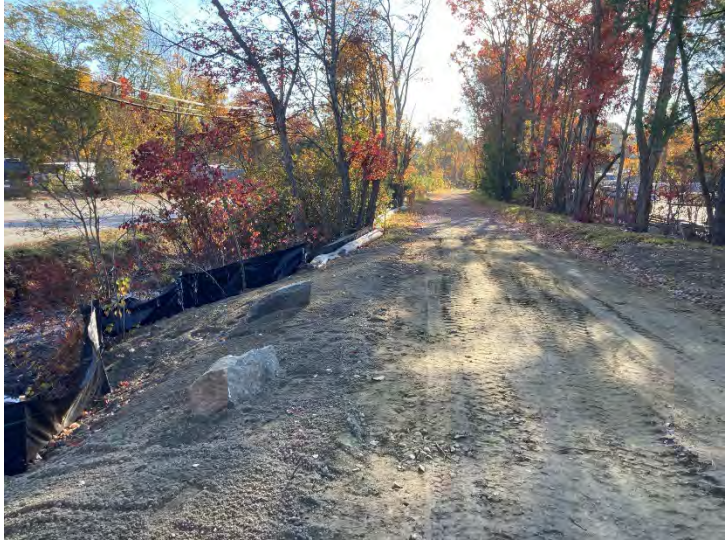
PHOTOGRAPHIC LOG	
Client Name: Eversource		Site Location: Sudbury to Hudson Transmission Reliability Project	Town: Sudbury
Photo No.: 5	Date: 10-22-24

Description: View of culvert extension area in segment 12. Facing east.

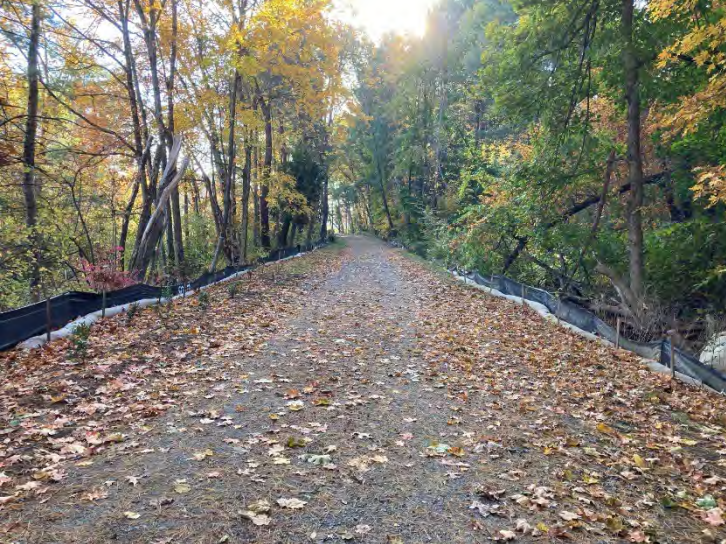
PHOTOGRAPHIC LOG	
Client Name: Eversource		Site Location: Sudbury to Hudson Transmission Reliability Project	Town: Sudbury
Photo No.: 6	Date: 10-22-24

Description: View of E&S controls in segment 13. Facing east.

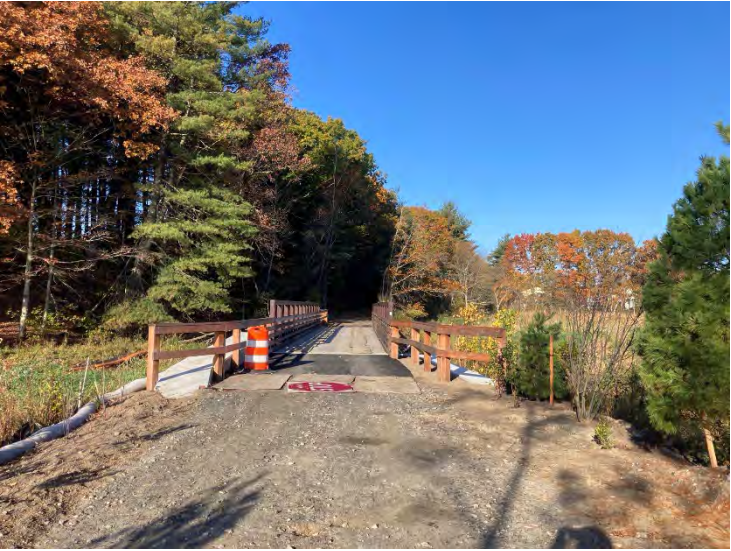
PHOTOGRAPHIC LOG	
Client Name: Eversource		Site Location: Sudbury to Hudson Transmission Reliability Project	Town: Sudbury
Photo No.: 7	Date: 10-22-24

Description: View of bridge 127. Facing west.

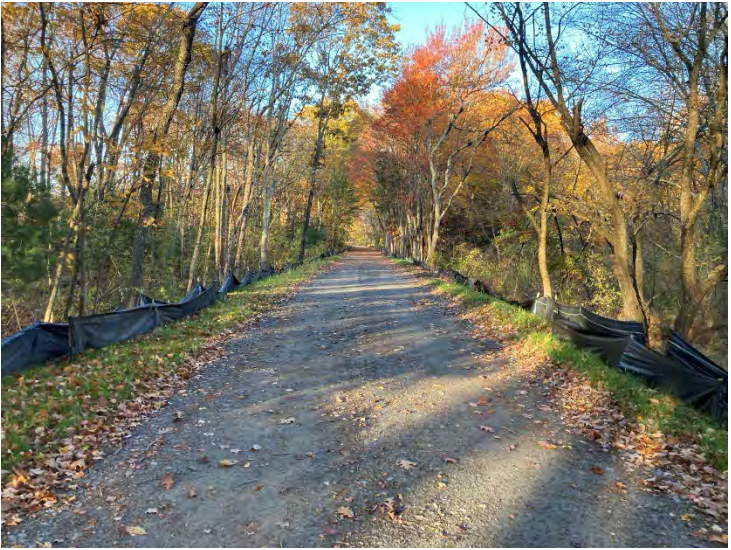
PHOTOGRAPHIC LOG	
Client Name: Eversource		Site Location: Sudbury to Hudson Transmission Reliability Project	Town: Sudbury
Photo No.: 8	Date: 10-22-24

Description: View of E&S controls in segment 14. Facing west.

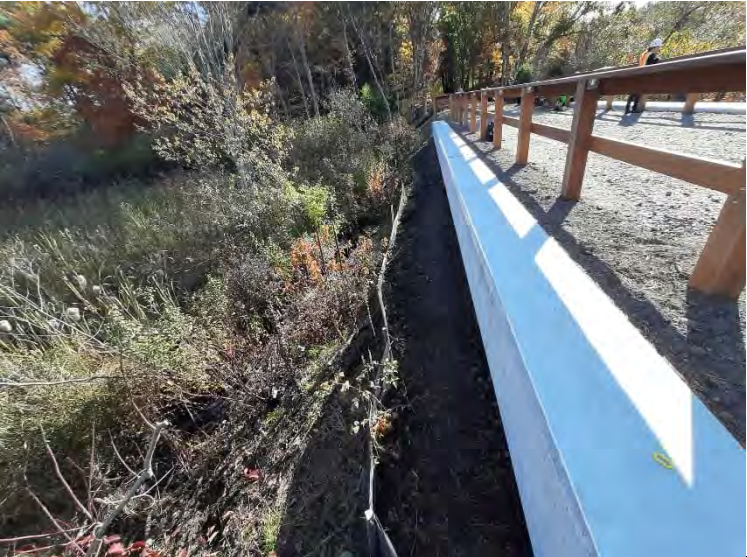
<p>PHOTOGRAPHIC LOG</p>	
<p>Client Name: Eversource</p>		<p>Site Location: Sudbury to Hudson Transmission Reliability Project</p>	<p>Town: Sudbury</p>
<p>Photo No.: 1</p>	<p>Date: 10/21/24</p>

<p>Description: Segment 8, north side, near Bridge 128, prior to plantings. Looking eastward.</p>

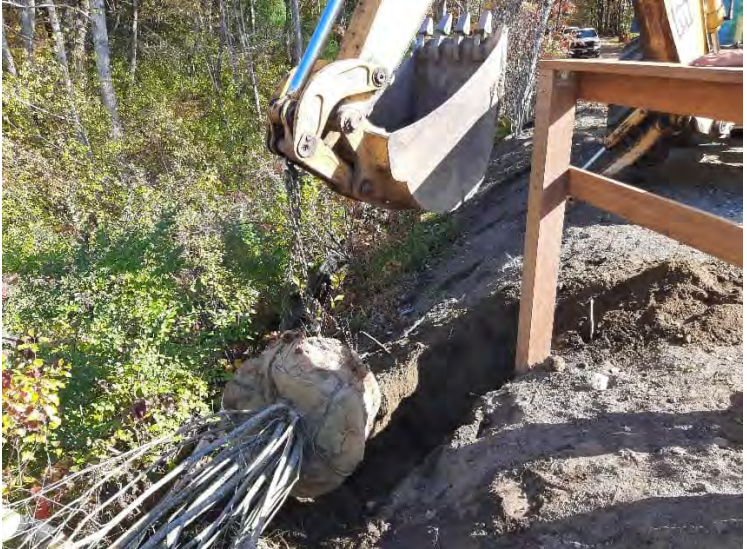
<p>PHOTOGRAPHIC LOG</p>	
<p>Client Name: Eversource</p>		<p>Site Location: Sudbury to Hudson Transmission Reliability Project</p>	<p>Town: Sudbury</p>
<p>Photo No.: 2</p>	<p>Date: 10/21/24</p>

<p>Description: Segment 8, north side, near Bridge 128. MON installing serviceberry (AC) near Bridge 128 railing. Looking eastward.</p>

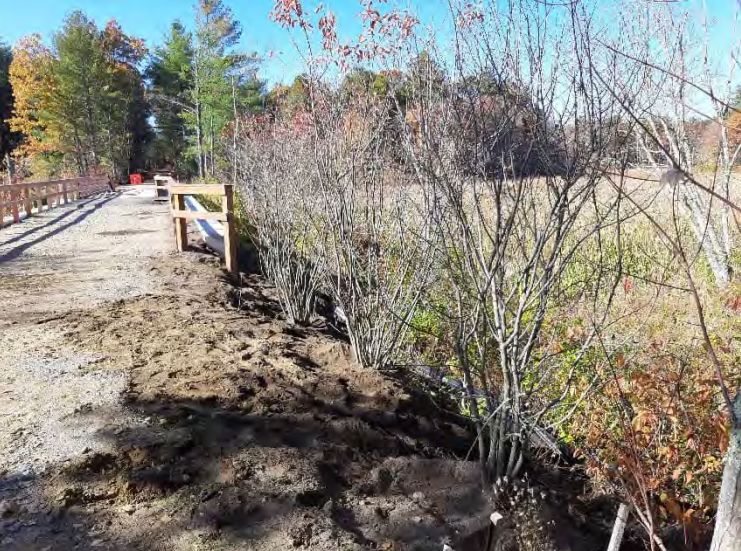
PHOTOGRAPHIC LOG	
Client Name: Eversource		Site Location: Sudbury to Hudson Transmission Reliability Project	Town: Sudbury
Photo No.: 4	Date: 10/21/24

Description: Segment 8, north side, near Bridge 128. Plantings installed by MON today (deciduous trees). Looking westward.

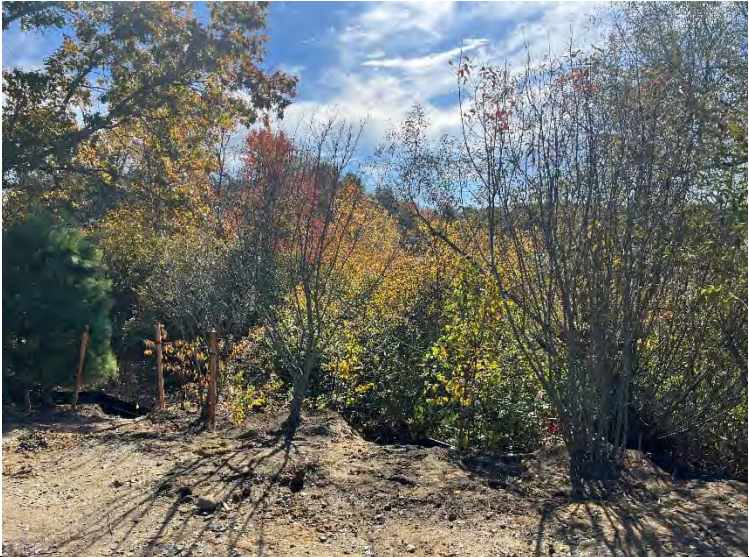
<p>PHOTOGRAPHIC LOG</p>	
<p>Client Name: Eversource</p>		<p>Site Location: Sudbury to Hudson Transmission Reliability Project</p>	<p>Town: Sudbury</p>
<p>Photo No.: 3</p>	<p>Date: 10/21/24</p>

- Only trees planted in the bed today. Missing 1 AR and 1 PS, waiting for remaining trees to be delivered.
- Tree locations shifted; AC's planted on eastern side of the bed to fit large root ball of the plant. Smaller trees shifted westward accordingly.

<p>Description: View of installed trees in eastern portion of bed. Shrubs to be planted at a later date. <i>Facing south.</i></p>

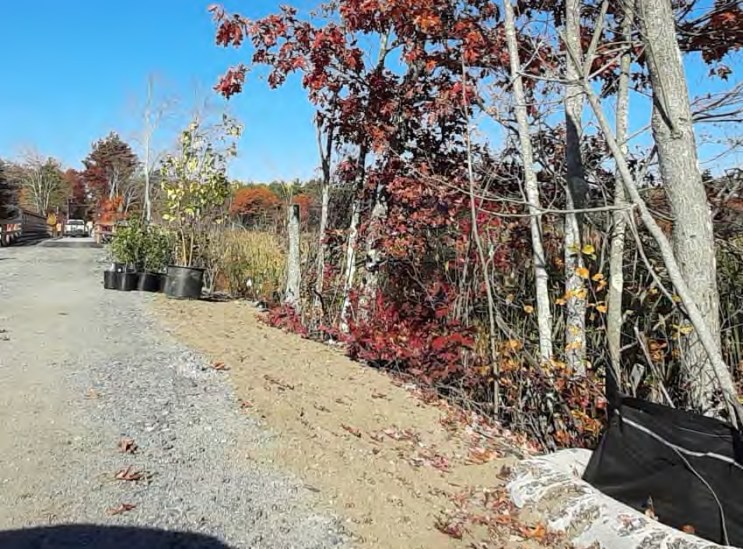
<p>PHOTOGRAPHIC LOG</p>	
<p>Client Name: Eversource</p>		<p>Site Location: Sudbury to Hudson Transmission Reliability Project</p>	<p>Town: Hudson</p>
<p>Photo No.: 2</p>	<p>Date: 10/22/24</p>

<p>Description: Segment 3, east side of Bridge 130. North side prior to plantings. Looking westward.</p>

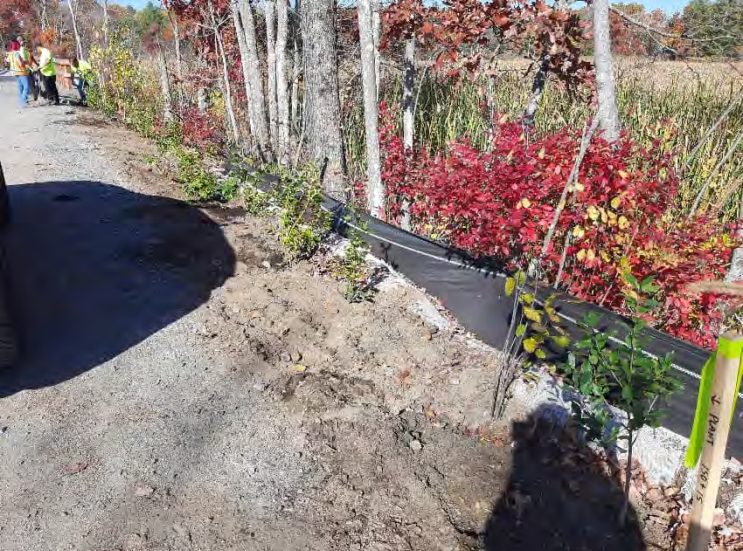
PHOTOGRAPHIC LOG	
Client Name: Eversource		Site Location: Sudbury to Hudson Transmission Reliability Project	Town: Hudson
Photo No.: 4	Date: 10/22/24

Description: Segment 3, east side of Bridge 130. South side after plantings. Looking westward.

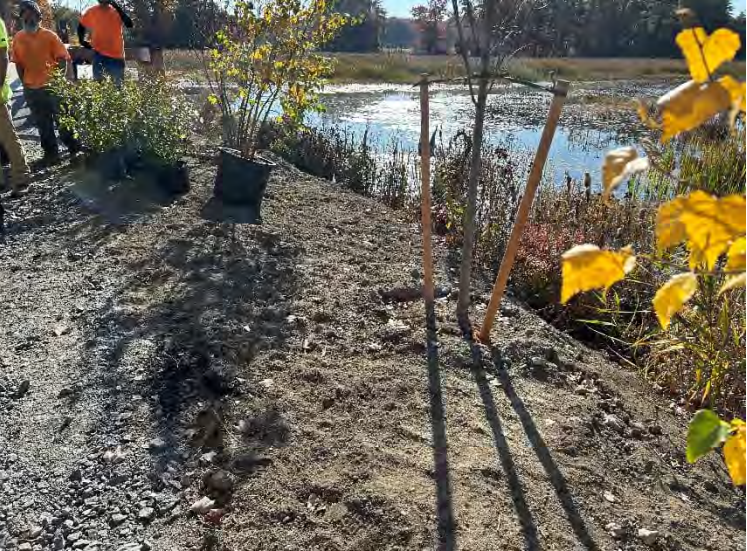
<p>PHOTOGRAPHIC LOG</p>	
<p>Client Name: Eversource</p>		<p>Site Location: Sudbury to Hudson Transmission Reliability Project</p>	<p>Town: Hudson</p>
<p>Photo No.: 2</p>	<p>Date: 10/22/24</p>

<p>Description: View of southern planting bed, previously partially planted with trees. Facing east.</p>

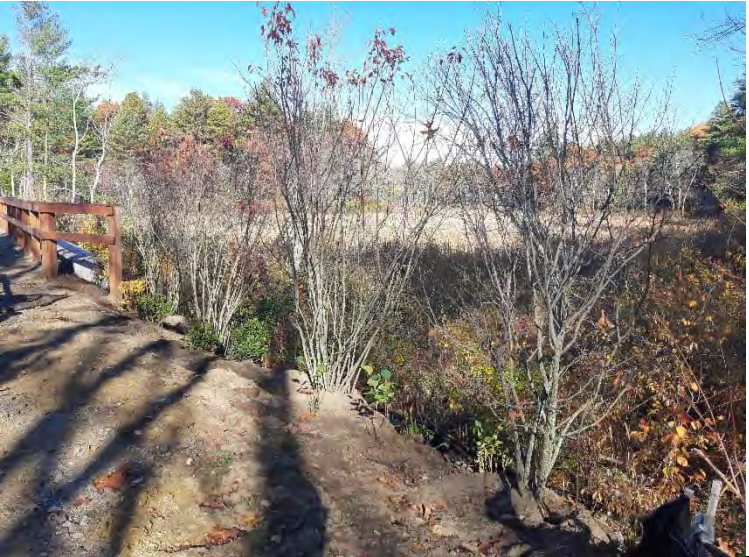
<p>PHOTOGRAPHIC LOG</p>	
<p>Client Name: Eversource</p>		<p>Site Location: Sudbury to Hudson Transmission Reliability Project</p>	<p>Town: Sudbury</p>
<p>Photo No.: 3</p>	<p>Date: 10/23/24</p>

<p>Description: Segment 8, north side, near Bridge 128. Plantings along north side of ROW after shrubs installed. Looking westward.</p>

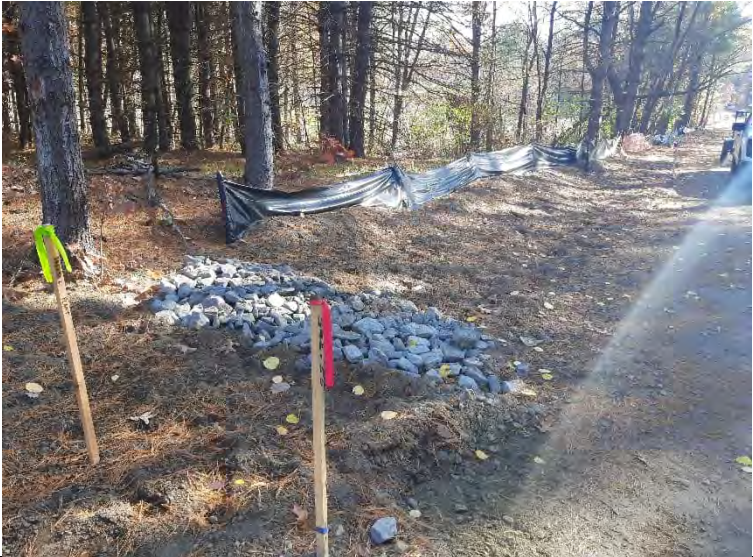
<p>PHOTOGRAPHIC LOG</p>	
<p>Client Name: Eversource</p>		<p>Site Location: Sudbury to Hudson Transmission Reliability Project</p>	<p>Town: Sudbury</p>
<p>Photo No.: 1</p>	<p>Date: 10/23/24</p>

<p>Description: Segment 8, north side, STAs 396 + ~75 to ~398 + 00. Bed prior to planting. Looking eastward.</p>

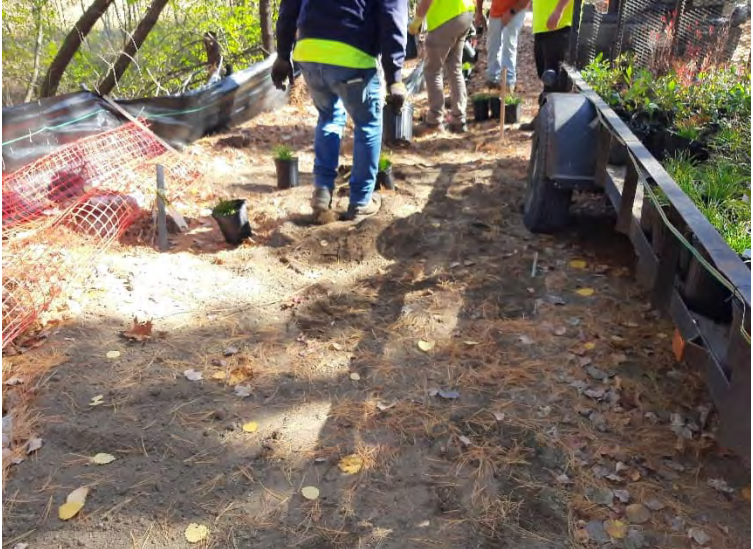
<p>PHOTOGRAPHIC LOG</p>	
<p>Client Name: Eversource</p>		<p>Site Location: Sudbury to Hudson Transmission Reliability Project</p>	<p>Town: Sudbury</p>
<p>Photo No.: 2</p>	<p>Date: 10/23/24</p>

<p>Description: Segment 8, north side, STAs 396 + ~75 to ~398 + 00. MON . Looking eastward</p>

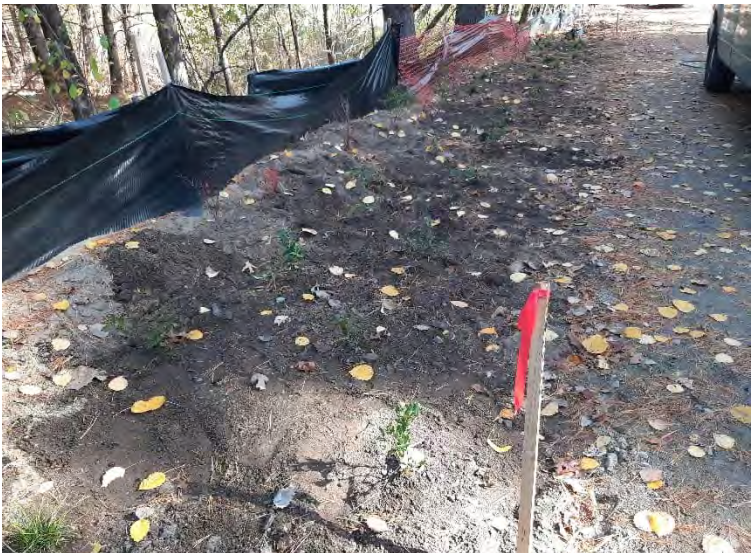
PHOTOGRAPHIC LOG	
Client Name: Eversource		Site Location: Sudbury to Hudson Transmission Reliability Project	Town: Sudbury
Photo No.: 4	Date: 10/23/24

Description: Segment 8, north side, STAs 396 + ~75 to ~398 + 00. Plantings after installation. Looking eastward.

- Missing 1 AR and 1 PS to finish planting bed. Tree locations are flagged out.
- Plants watered after installation.

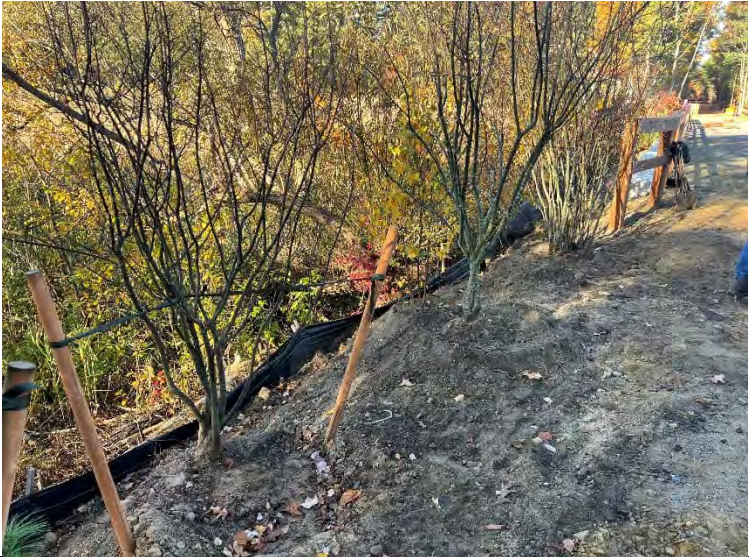
<p>PHOTOGRAPHIC LOG</p>	
<p>Client Name: Eversource</p>		<p>Site Location: Sudbury to Hudson Transmission Reliability Project</p>	<p>Town: Sudbury</p>
<p>Photo No.: 1</p>	<p>Date: 10/23/24</p>

<p>Description: View of eastern portion of the planting bed prior to shrub installation. <i>Facing southwest.</i></p>

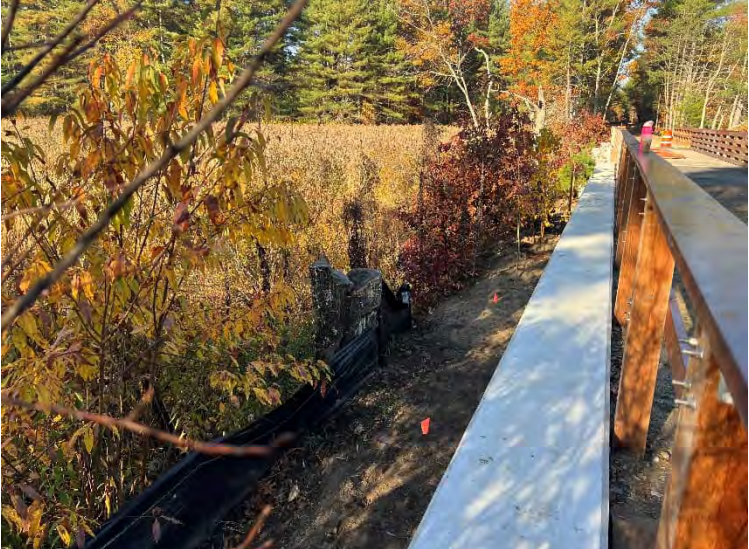
<p>PHOTOGRAPHIC LOG</p>	
<p>Client Name: Eversource</p>		<p>Site Location: Sudbury to Hudson Transmission Reliability Project</p>	<p>Town: Sudbury</p>
<p>Photo No.: 2</p>	<p>Date: 10/23/24</p>

<p>Description: View of western portion of planting bed prior to shrub installation. <i>Facing west.</i></p>

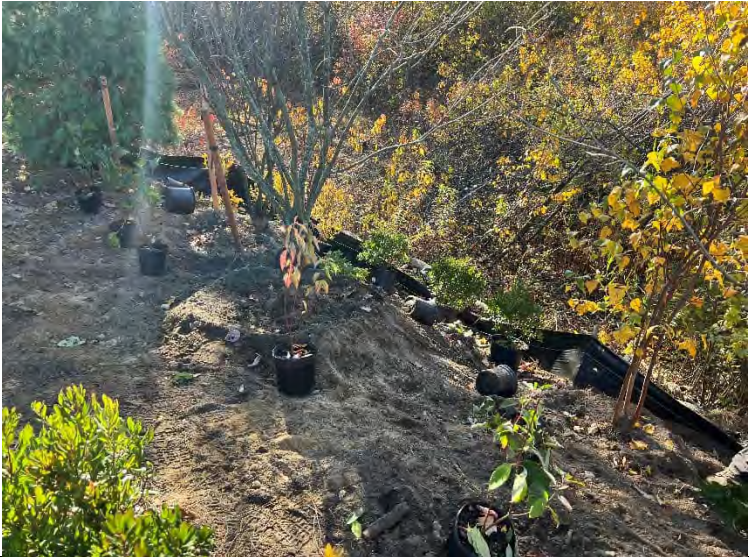
<p>PHOTOGRAPHIC LOG</p>	
<p>Client Name: Eversource</p>		<p>Site Location: Sudbury to Hudson Transmission Reliability Project</p>	<p>Town: Sudbury</p>
<p>Photo No.: 3</p>	<p>Date: 10/23/24</p>

<p>Description: View of plants laid out according to plans. <i>Facing southeast.</i></p>

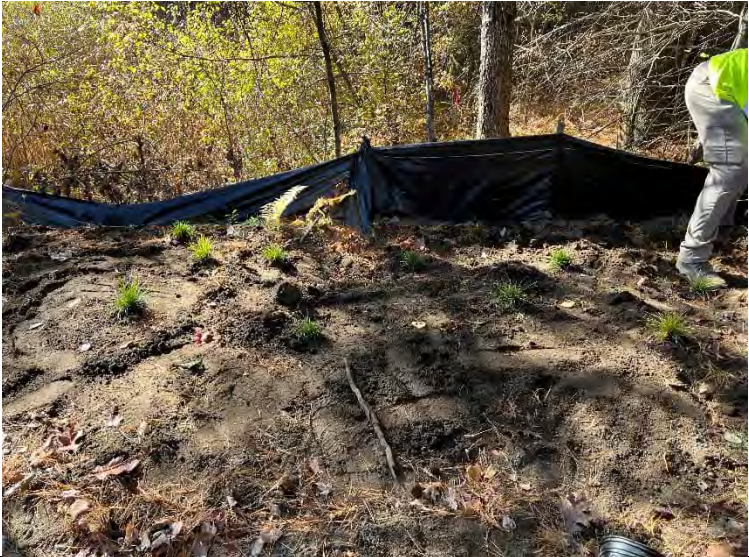
<p>PHOTOGRAPHIC LOG</p>	
<p>Client Name: Eversource</p>		<p>Site Location: Sudbury to Hudson Transmission Reliability Project</p>	<p>Town: Sudbury</p>
<p>Photo No.: 3</p>	<p>Date: 10/23/24</p>

<p>Description: View of installed plants according to plans. Facing south.</p>

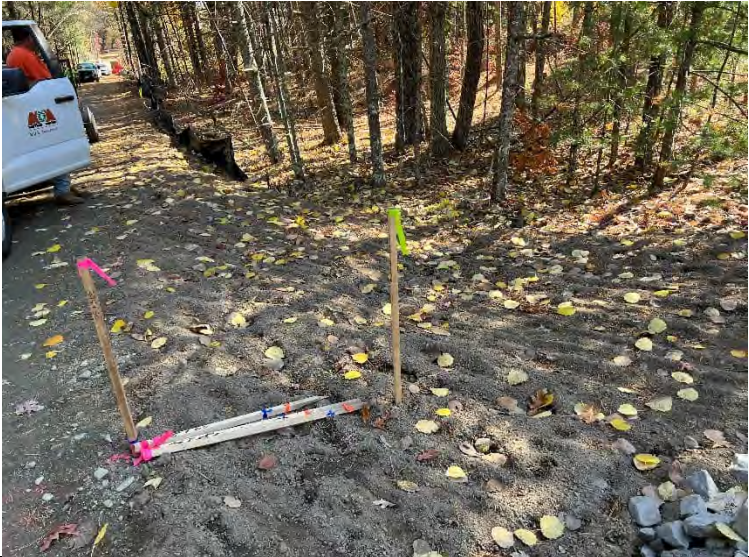
<p>PHOTOGRAPHIC LOG</p>	
<p>Client Name: Eversource</p>		<p>Site Location: Sudbury to Hudson Transmission Reliability Project</p>	<p>Town: Sudbury</p>
<p>Photo No.: 1</p>	<p>Date: 10/23/24</p>

<p>Description: View of planting bed prior to installation. <i>Facing east.</i></p>

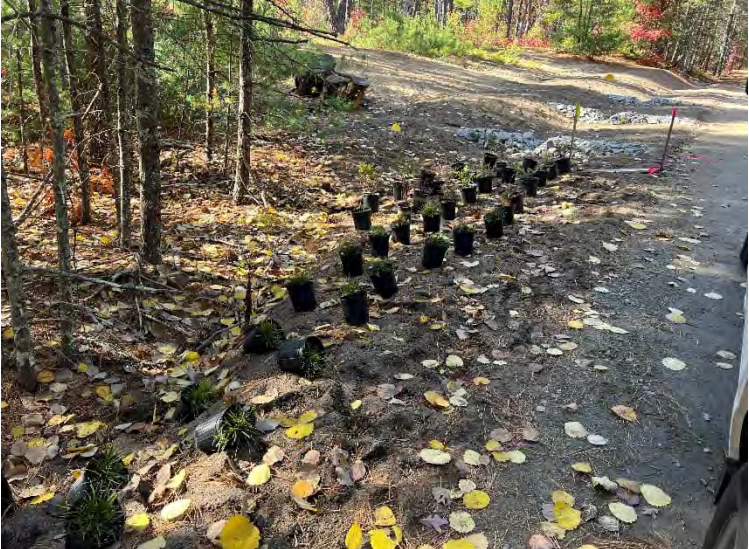
<p>PHOTOGRAPHIC LOG</p>	
<p>Client Name: Eversource</p>		<p>Site Location: Sudbury to Hudson Transmission Reliability Project</p>	<p>Town: Sudbury</p>
<p>Photo No.: 2</p>	<p>Date: 10/23/24</p>

<p>Description: View of plants laid out prior to installation. <i>Facing southwest.</i></p>

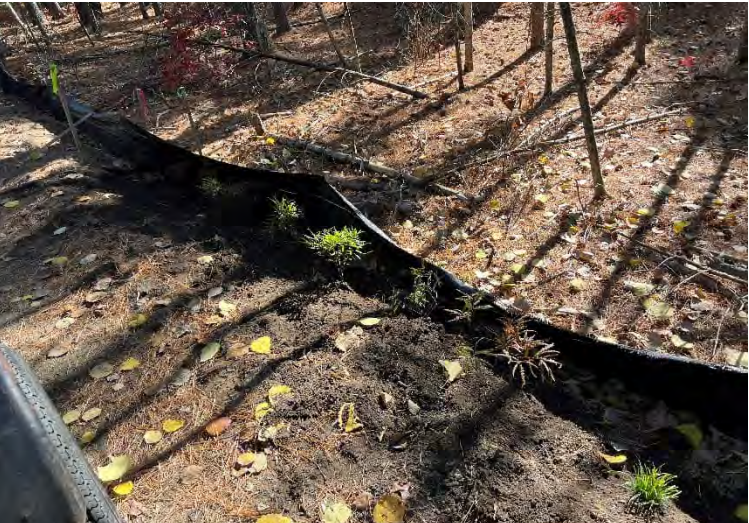
PHOTOGRAPHIC LOG	
Client Name: Eversource		Site Location: Sudbury to Hudson Transmission Reliability Project	Town: Sudbury
Photo No.: 4	Date: 10/23/24

Description: Another view of installed plants. <i>Facing south.</i>

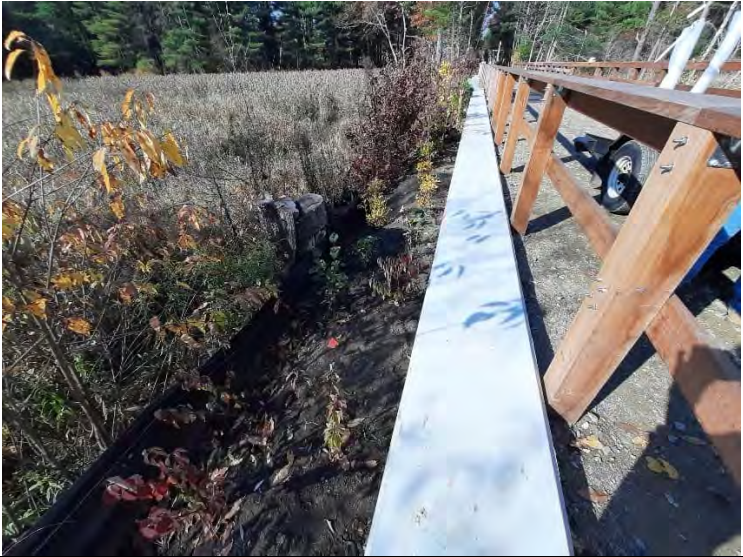
PHOTOGRAPHIC LOG	
Client Name: Eversource		Site Location: Sudbury to Hudson Transmission Reliability Project	Town: Sudbury
Photo No.: 1	Date: 10/24/24

Description: Segment 8, south side, near Bridge 128. Flagged location for red maple (AR) prior to installation. Looking westward.

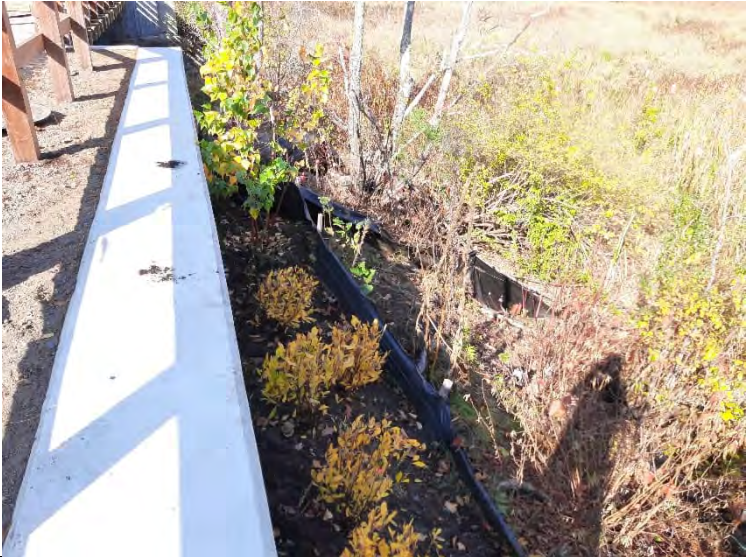
<p>PHOTOGRAPHIC LOG</p>	
<p>Client Name: Eversource</p>		<p>Site Location: Sudbury to Hudson Transmission Reliability Project</p>	<p>Town: Sudbury</p>
<p>Photo No.: 3</p>	<p>Date: 10/24/24</p>

<p>Description: Segment 8, north side, near Bridge 128. Flagged location for AR prior to installation. Looking westward.</p>

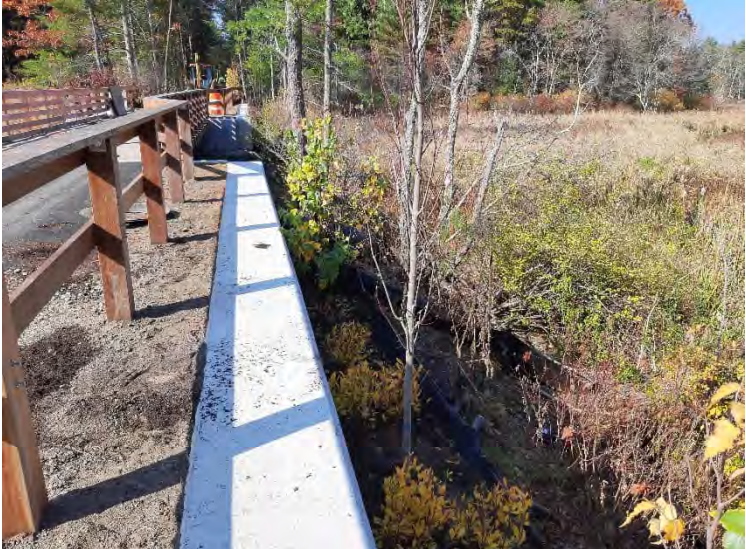
<p>PHOTOGRAPHIC LOG</p>	
<p>Client Name: Eversource</p>		<p>Site Location: Sudbury to Hudson Transmission Reliability Project</p>	<p>Town: Sudbury</p>
<p>Photo No.: 4</p>	<p>Date: 10/24/24</p>

<p>Description: Segment 8, south side, near Bridge 128. AR after installation. Looking westward.</p>

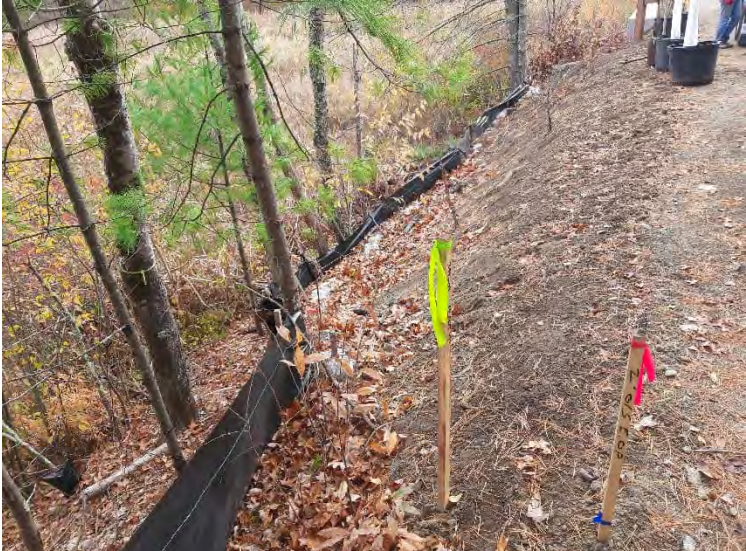
<p>PHOTOGRAPHIC LOG</p>	
<p>Client Name: Eversource</p>		<p>Site Location: Sudbury to Hudson Transmission Reliability Project</p>	<p>Town: Sudbury</p>
<p>Photo No.: 2</p>	<p>Date: 10/24/24</p>

<p>Description</p> <p>Segment 7, north side, near Bridge 128. north side planting area prior to tree installation, trees for planting visible in background. Looking eastward.</p>

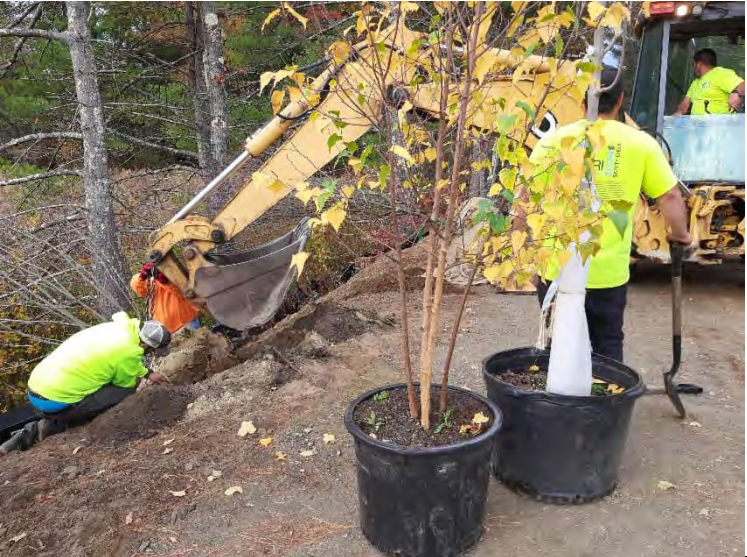
PHOTOGRAPHIC LOG	
Client Name: Eversource		Site Location: Sudbury to Hudson Transmission Reliability Project	Town: Sudbury
Photo No.: 3	Date: 10/24/24

Description: Segment 7, south side, near Bridge 128. MON installing serviceberry (AC) on shoulder, gray birch (BP) and red maple (AR) staged for planting after ACs. Looking westward.

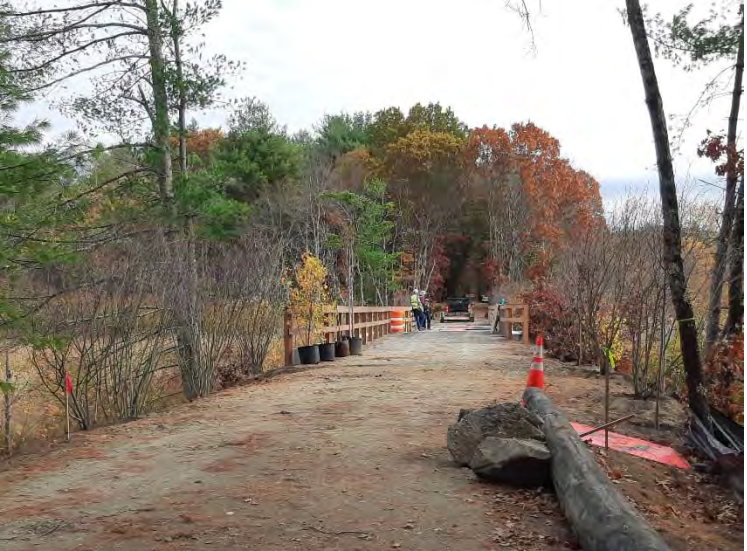
PHOTOGRAPHIC LOG	
Client Name: Eversource		Site Location: Sudbury to Hudson Transmission Reliability Project	Town: Sudbury
Photo No.: 4	Date: 10/24/24

Description: Segment 7, west side of Bridge 128. Shoulders following tree installation on north and south side. 1 BP, 2 AR, and 2 red oak (QV) staged along north rail for planting on following day. Looking eastward.

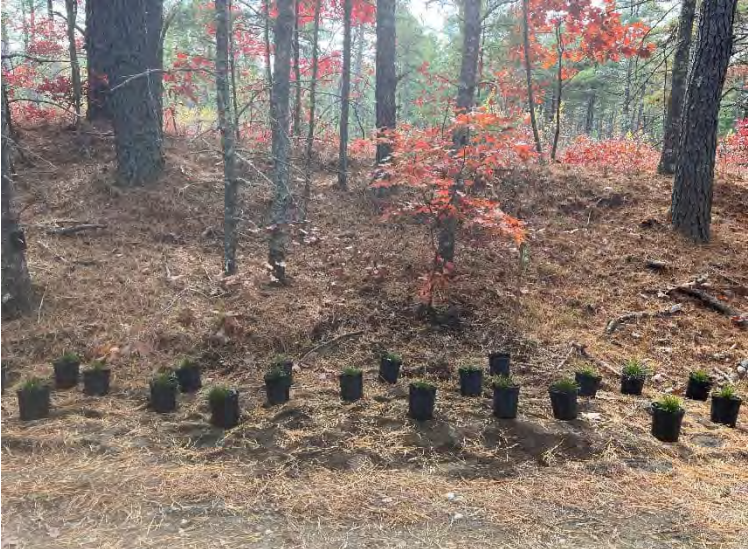
<p>PHOTOGRAPHIC LOG</p>	
<p>Client Name: Eversource</p>		<p>Site Location: Sudbury to Hudson Transmission Reliability Project</p>	<p>Town: Sudbury</p>
<p>Photo No.: 2</p>	<p>Date: 10/24/24</p>

<p>Description: View of plants laid out prior to installation. <i>Facing south.</i></p>

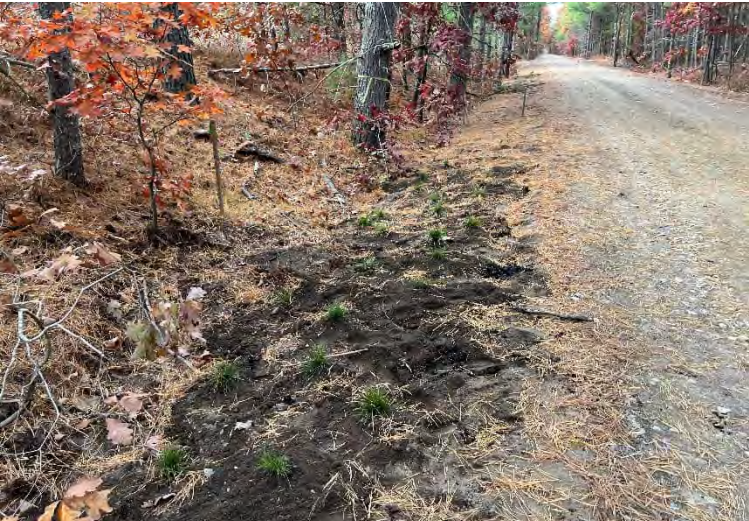
<p>PHOTOGRAPHIC LOG</p>	
<p>Client Name: Eversource</p>		<p>Site Location: Sudbury to Hudson Transmission Reliability Project</p>	<p>Town: Sudbury</p>
<p>Photo No.: 4</p>	<p>Date: 10/24/24</p>

<p>Description: View of installed plants. Facing west.</p>

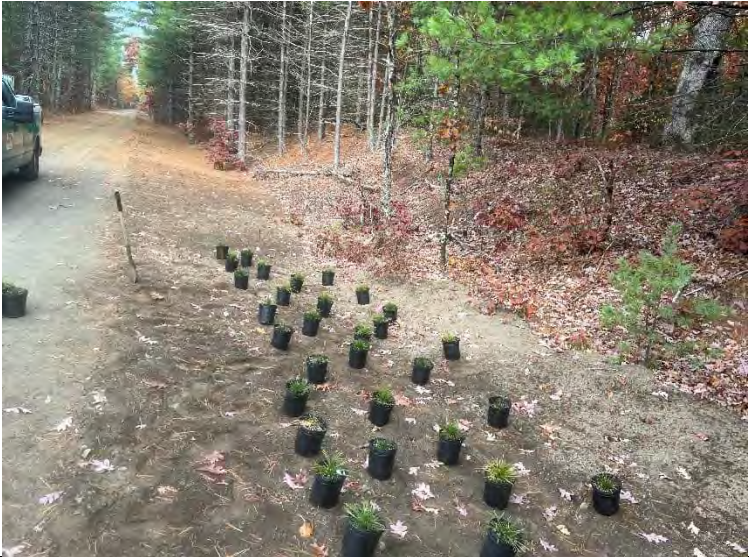
<p>PHOTOGRAPHIC LOG</p>	
<p>Client Name: Eversource</p>		<p>Site Location: Sudbury to Hudson Transmission Reliability Project</p>	<p>Town: Sudbury</p>
<p>Photo No.: 1</p>	<p>Date: 10/24/24</p>

<p>Description: View of planting bed prior to installation. <i>Facing west.</i></p>

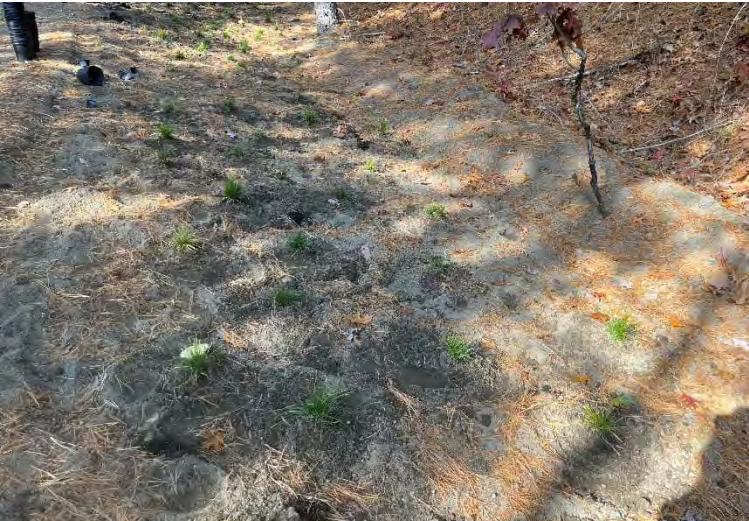
PHOTOGRAPHIC LOG	
Client Name: Eversource		Site Location: Sudbury to Hudson Transmission Reliability Project	Town: Sudbury
Photo No.: 4	Date: 10/24/24

Description: View of installed plants according to plans in the western portion of the bed. <i>Facing west.</i>

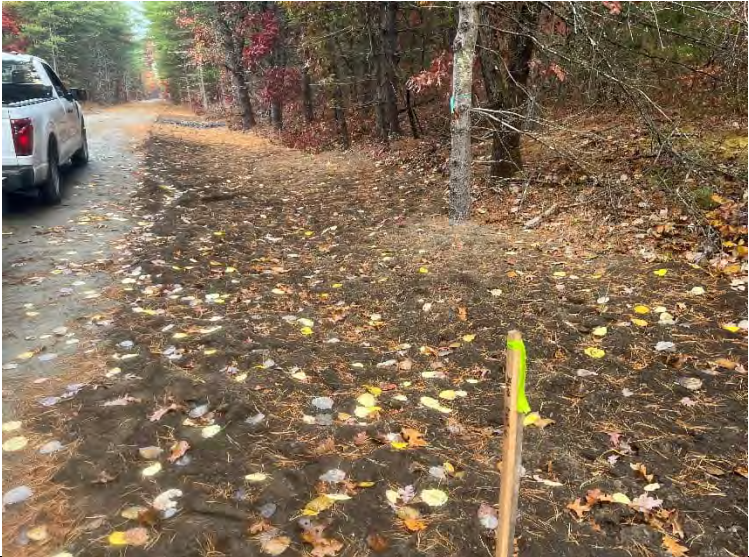
<p>PHOTOGRAPHIC LOG</p>	
<p>Client Name: Eversource</p>		<p>Site Location: Sudbury to Hudson Transmission Reliability Project</p>	<p>Town: Sudbury</p>
<p>Photo No.: 1</p>	<p>Date: 10/24/24</p>

<p>Description: View of planting bed prior to installation. <i>Facing west.</i></p>

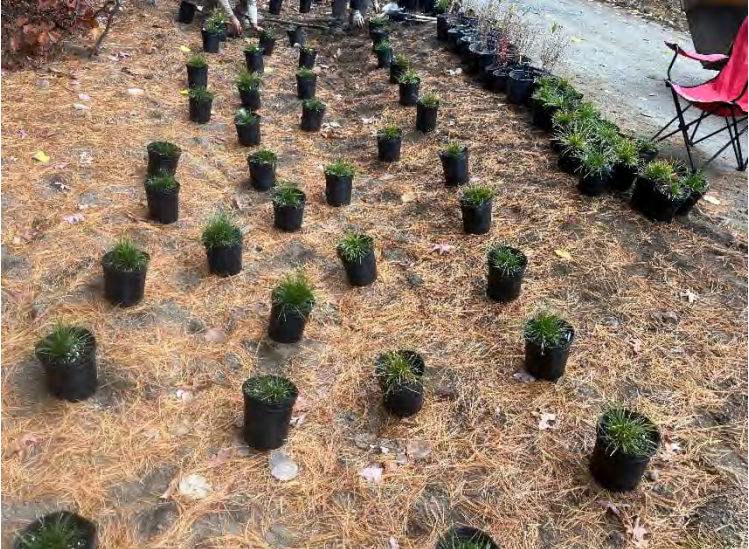
<p>PHOTOGRAPHIC LOG</p>	
<p>Client Name: Eversource</p>		<p>Site Location: Sudbury to Hudson Transmission Reliability Project</p>	<p>Town: Sudbury</p>
<p>Photo No.: 2</p>	<p>Date: 10/24/24</p>

<p>Description: View of plants laid out prior to installation. <i>Facing east.</i></p>

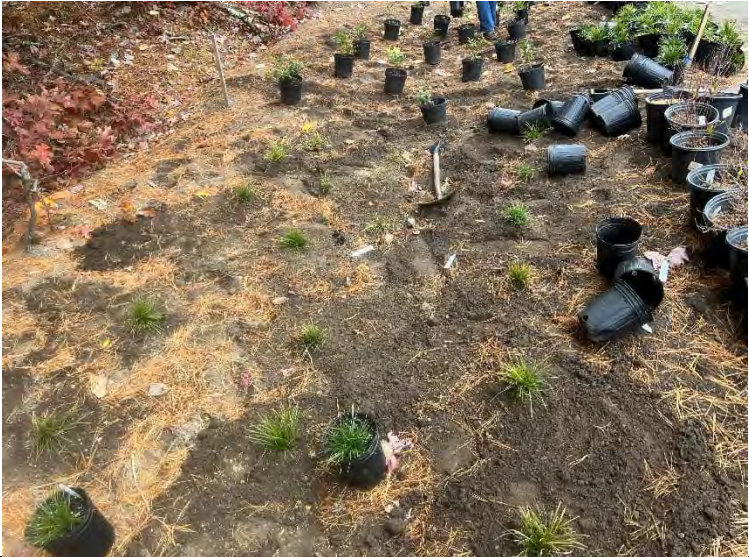
<p>PHOTOGRAPHIC LOG</p>	
<p>Client Name: Eversource</p>		<p>Site Location: Sudbury to Hudson Transmission Reliability Project</p>	<p>Town: Sudbury</p>
<p>Photo No.: 3</p>	<p>Date: 10/24/24</p>

<p>Description: View of plants being installed. Facing east.</p>

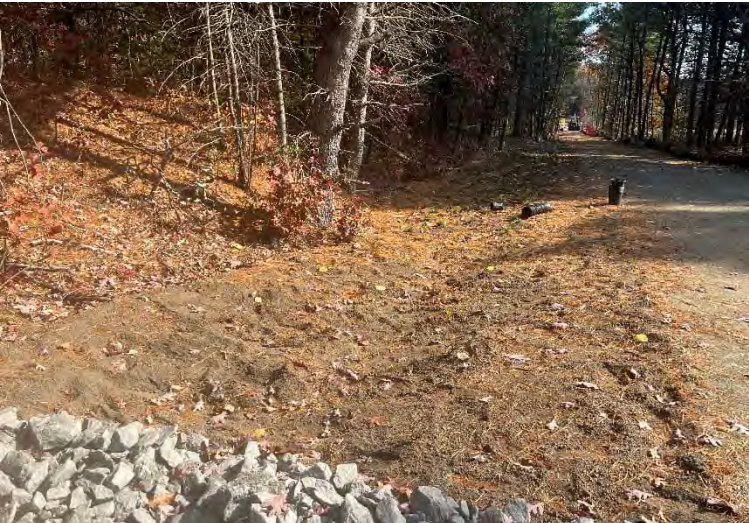
<p>PHOTOGRAPHIC LOG</p>	
<p>Client Name: Eversource</p>		<p>Site Location: Sudbury to Hudson Transmission Reliability Project</p>	<p>Town: Sudbury</p>
<p>Photo No.: 4</p>	<p>Date: 10/24/24</p>

<p>Description: View of installed plants according to plans. Facing east.</p>

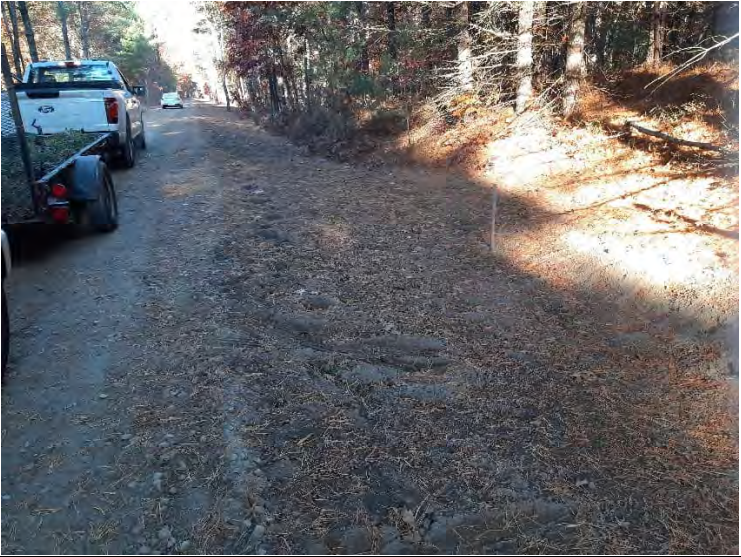
<p>PHOTOGRAPHIC LOG</p>	
<p>Client Name: Eversource</p>		<p>Site Location: Sudbury to Hudson Transmission Reliability Project</p>	<p>Town: Sudbury</p>
<p>Photo No.: 1</p>	<p>Date: 10/25/24</p>

<p>Description: Segment 7, north side, STA 392 + ~95. Loamed shoulder prior to planting. Looking westward.</p>

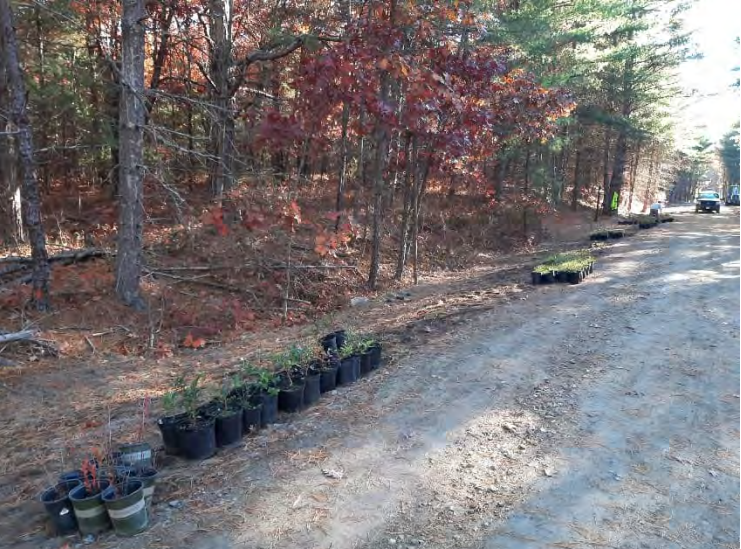
<p>PHOTOGRAPHIC LOG</p>	
<p>Client Name: Eversource</p>		<p>Site Location: Sudbury to Hudson Transmission Reliability Project</p>	<p>Town: Sudbury</p>
<p>Photo No.: 2</p>	<p>Date: 10/25/24</p>

<p>Description: Segment 7, north side, STA 391 + ~60. MON laying out and installing plants. Looking eastward.</p>

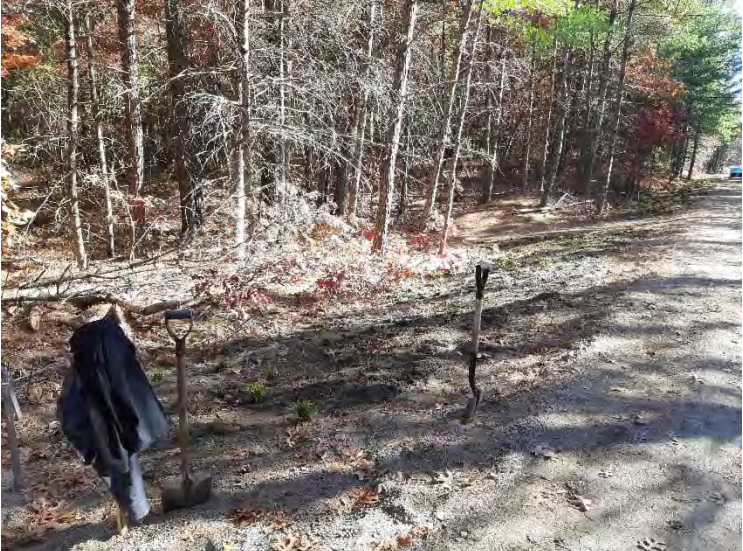
PHOTOGRAPHIC LOG	
Client Name: Eversource		Site Location: Sudbury to Hudson Transmission Reliability Project	Town: Sudbury
Photo No.: 4	Date: 10/25/24

Description: Segment 7, north side, STA 391 + ~00. Plants following installation. Gap left for trailhead visible in the sunlit area to the right side of the image. Looking eastward.

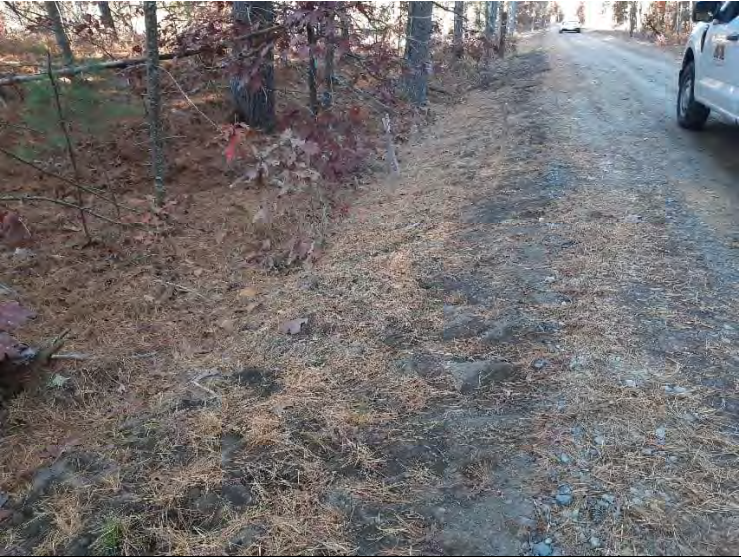
<p>PHOTOGRAPHIC LOG</p>	
<p>Client Name: Eversource</p>		<p>Site Location: Sudbury to Hudson Transmission Reliability Project</p>	<p>Town: Sudbury</p>
<p>Photo No.: 1</p>	<p>Date: 10/25/24</p>

<p>Description: Segment 7, south side, STA 392 + -50. Shoulder prior to today's plantings, yesterday's plantings visible in foreground and midground. Looking westward.</p>

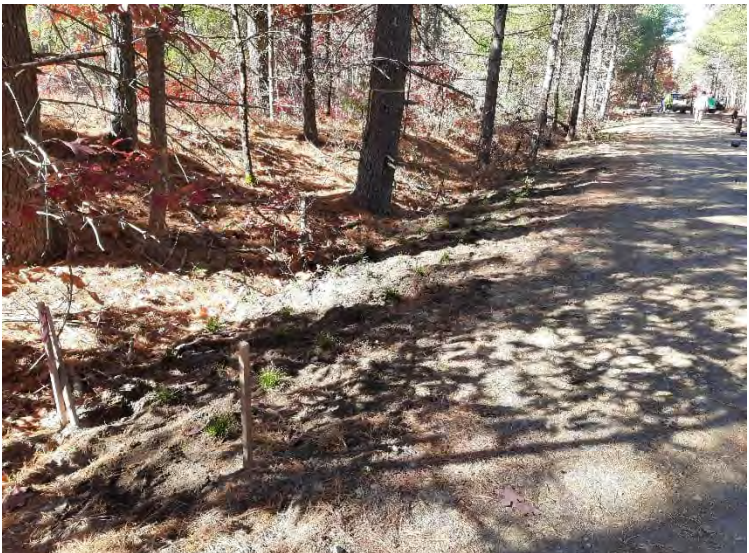
PHOTOGRAPHIC LOG	
Client Name: Eversource		Site Location: Sudbury to Hudson Transmission Reliability Project	Town: Sudbury
Photo No.: 4	Date: 10/25/24

Description: Segment 7, south side, STA 392 + ~55. Installed plantings between existing plantings. Looking eastward.

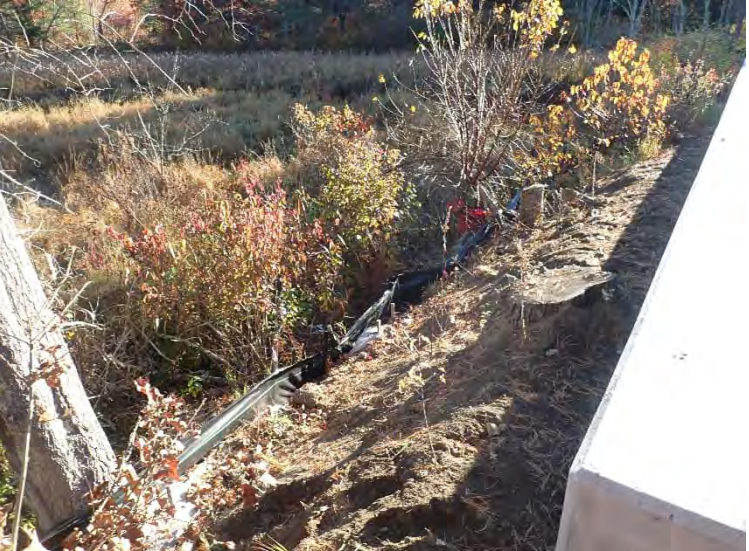
<p>PHOTOGRAPHIC LOG</p>	
<p>Client Name: Eversource</p>		<p>Site Location: Sudbury to Hudson Transmission Reliability Project</p>	<p>Town: Sudbury</p>
<p>Photo No.: 2</p>	<p>Date: 10/25/24</p>

<p>Description: View of northwestern side of Bridge 128 prior to installation. Facing northeast.</p>

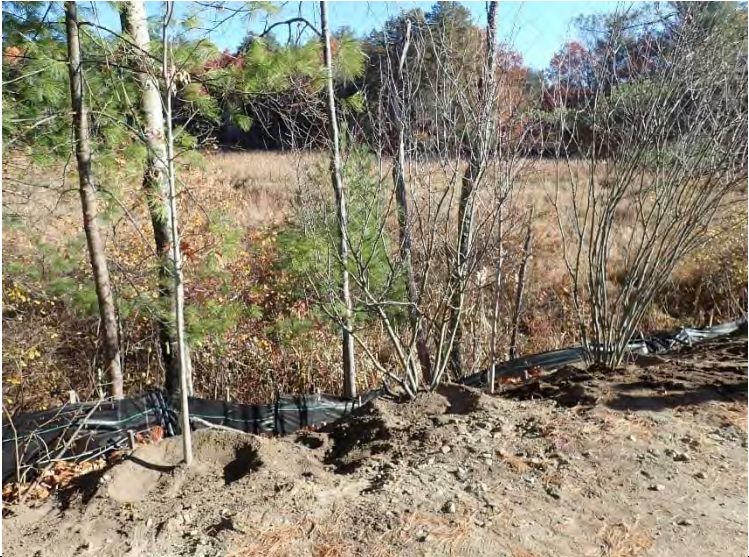
<p>PHOTOGRAPHIC LOG</p>	
<p>Client Name: Eversource</p>		<p>Site Location: Sudbury to Hudson Transmission Reliability Project</p>	<p>Town: Sudbury</p>
<p>Photo No.: 3</p>	<p>Date: 10/25/24</p>

<p>Description: View of installed plants. <i>Facing east.</i></p>

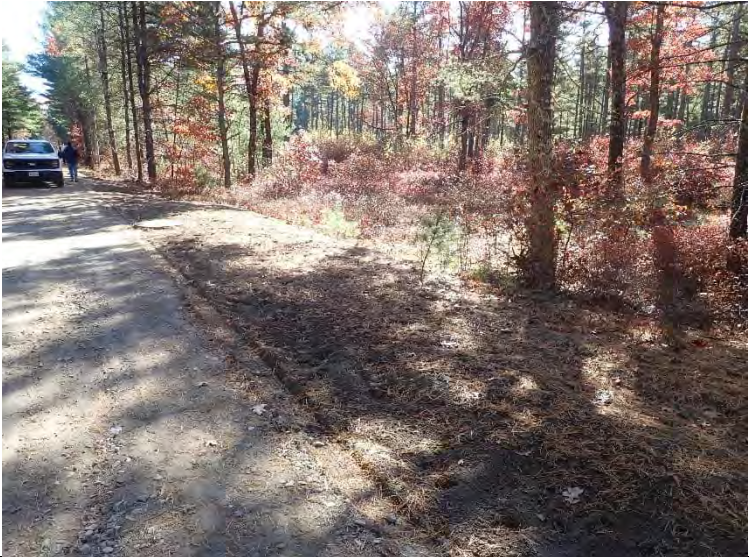
<p>PHOTOGRAPHIC LOG</p>	
<p>Client Name: Eversource</p>		<p>Site Location: Sudbury to Hudson Transmission Reliability Project</p>	<p>Town: Sudbury</p>
<p>Photo No.: 1</p>	<p>Date: 10/25/24</p>

<p>Description: View of southern planting bed prior to installation. <i>Facing east.</i></p>
