Weekly Environmental Compliance Summary

Sudbury to Hudson Transmission Reliability Project (USEPA Tracking # MAR1003UW)

Week of: October 21, 2024 to October 26, 2024

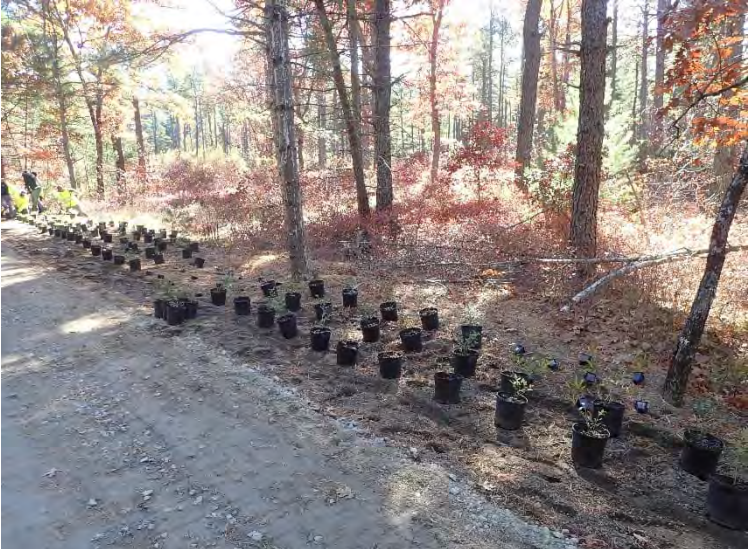
<p>PHOTOGRAPHIC LOG</p>	
<p>Client Name: Eversource</p>		<p>Site Location: Sudbury to Hudson Transmission Reliability Project</p>	<p>Town: Sudbury</p>
<p>Photo No.: 2</p>	<p>Date: 10/25/24</p>

<p>Description: View of plants laid out prior to installation. <i>Facing southeast.</i></p>

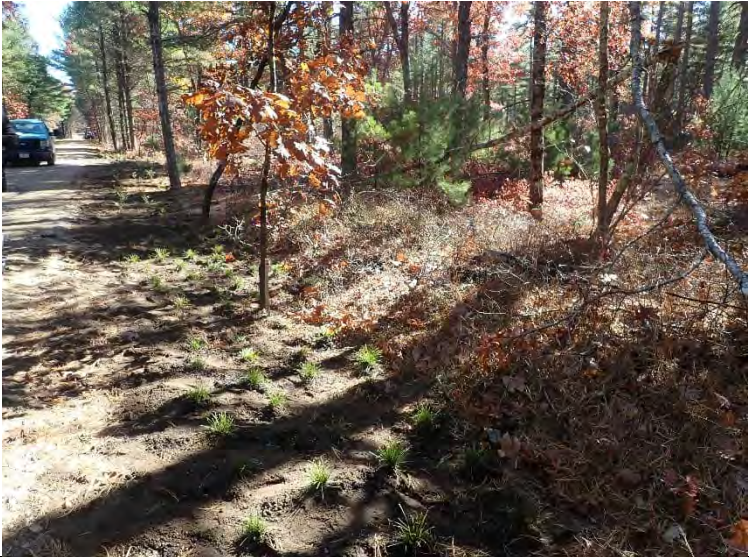
PHOTOGRAPHIC LOG	
Client Name: Eversource		Site Location: Sudbury to Hudson Transmission Reliability Project	Town: Sudbury
Photo No.: 3	Date: 10/25/24

Description: View of installed plants. <i>Facing east.</i>

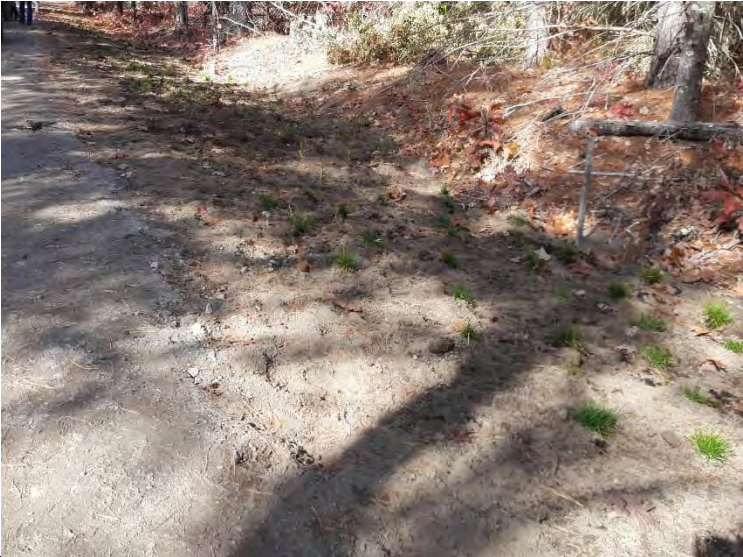
<p>PHOTOGRAPHIC LOG</p>	
<p>Client Name: Eversource</p>		<p>Site Location: Sudbury to Hudson Transmission Reliability Project</p>	<p>Town: Sudbury</p>
<p>Photo No.: 3</p>	<p>Date: 10/26/24</p>

<p>Description: Segment 7, north side, ~STA 388 + 50. Completed plantings. Looking westward.</p>

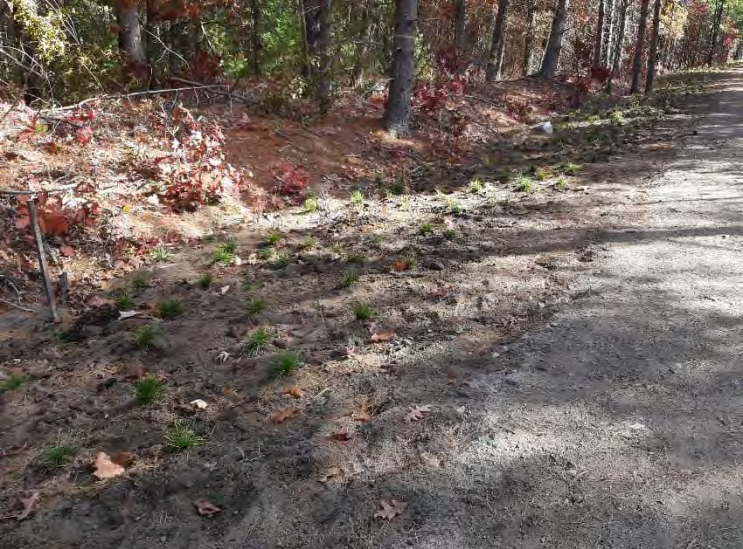
<p>PHOTOGRAPHIC LOG</p>	
<p>Client Name: Eversource</p>		<p>Site Location: Sudbury to Hudson Transmission Reliability Project</p>	<p>Town: Sudbury</p>
<p>Photo No.: 4</p>	<p>Date: 10/26/24</p>

<p>Description: Segment 7, north side, ~STA 388 + 50. Completed plantings. Looking eastward.</p>

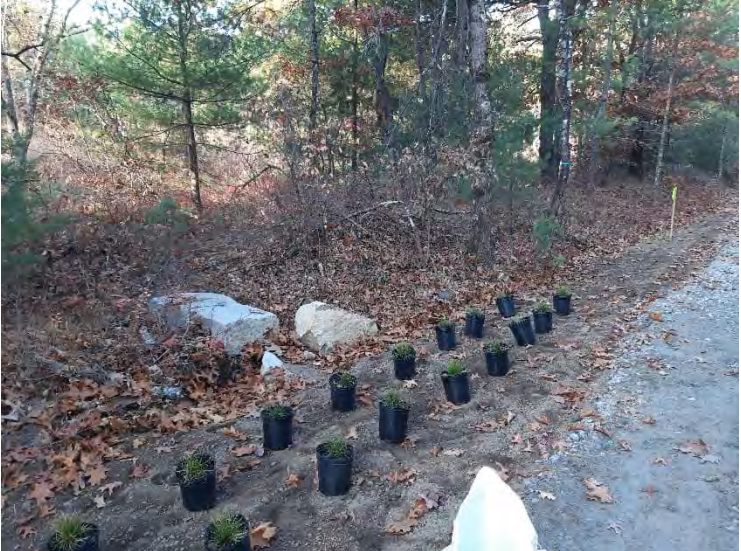
<p>PHOTOGRAPHIC LOG</p>	
<p>Client Name: Eversource</p>		<p>Site Location: Sudbury to Hudson Transmission Reliability Project</p>	<p>Town: Sudbury</p>
<p>Photo No.: 2</p>	<p>Date: 10/26/24</p>

<p>Description: Segment 7, south side, near -STA 388 + 00. MON laying plantings to approx -25 ft east of end-of-bed stake, based off bed dimensions on plans. Looking westward.</p>

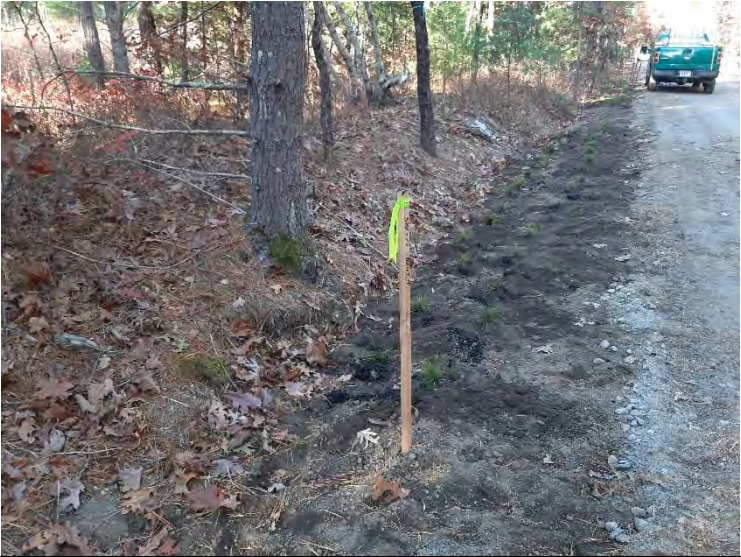
<p>PHOTOGRAPHIC LOG</p>	
<p>Client Name: Eversource</p>		<p>Site Location: Sudbury to Hudson Transmission Reliability Project</p>	<p>Town: Sudbury</p>
<p>Photo No.: 3</p>	<p>Date: 10/26/24</p>

<p>Description: Segment 7, south side, near STA 388 + ~75. Plantings after installation, bed completed. Lighter areas of soil are previously completed plantings. Looking westward.</p>

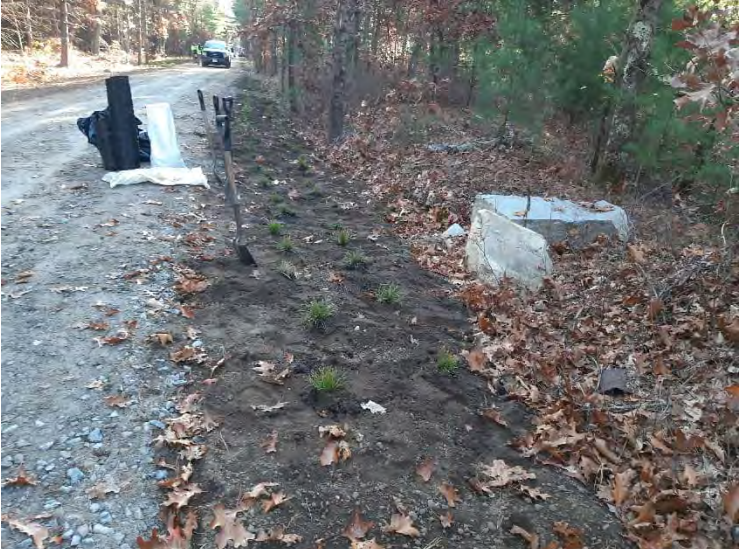
<p>PHOTOGRAPHIC LOG</p>	
<p>Client Name: Eversource</p>		<p>Site Location: Sudbury to Hudson Transmission Reliability Project</p>	<p>Town: Sudbury</p>
<p>Photo No.: 4</p>	<p>Date: 10/26/24</p>

<p>Description: Segment 7, south side, near STA 388 + ~75. Plantings after installation, bed completed. Lighter areas of soil are previously completed plantings. Looking eastward.</p>
