Weekly Environmental Compliance Summary

Sudbury to Hudson Transmission Reliability Project (USEPA Tracking # MAR1003UW)

Week of: October 28, 2024 to November 2, 2024

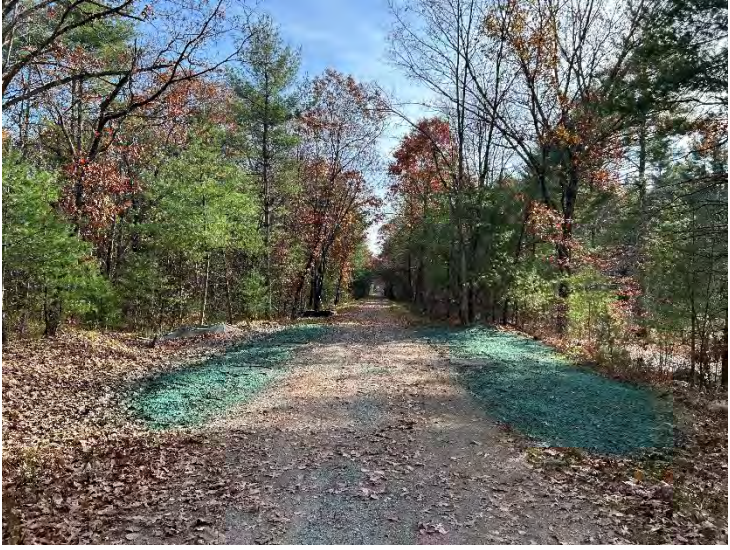
PHOTOGRAPHIC LOG	
Client Name: Eversource		Site Location: Sudbury to Hudson Transmission Reliability Project	Town: Hudson
Photo No.: 6	Date: 10/31/2024

Description: View of hydroseeded area in segment 5. Portions of segment 5 have been hydroseeded. Facing east.

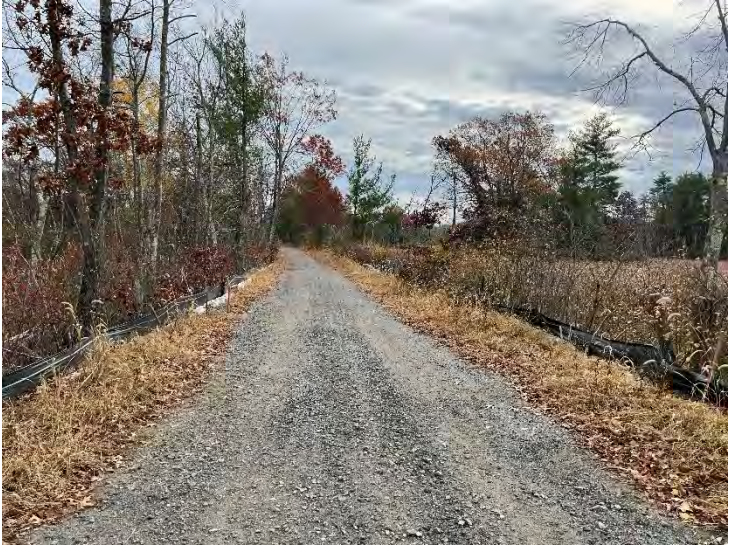
PHOTOGRAPHIC LOG	
Client Name: Eversource		Site Location: Sudbury to Hudson Transmission Reliability Project	Town: Hudson
Photo No.: 6	Date: 11/1/2024

Description: View of E&S controls in segment 3. Facing east.

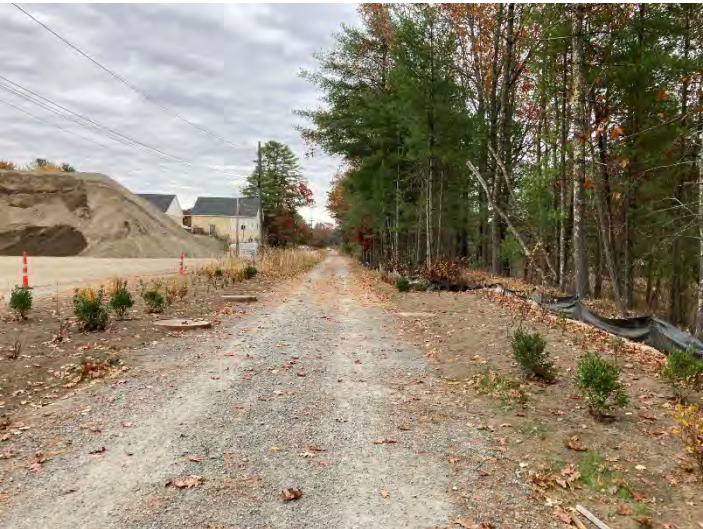
PHOTOGRAPHIC LOG	
Client Name: Eversource		Site Location: Sudbury to Hudson Transmission Reliability Project	Town: Hudson
Photo No.: 4	Date: 10-29-2024

Description: View of E&S controls and plantings at MH #8 in segment 3. Facing east.

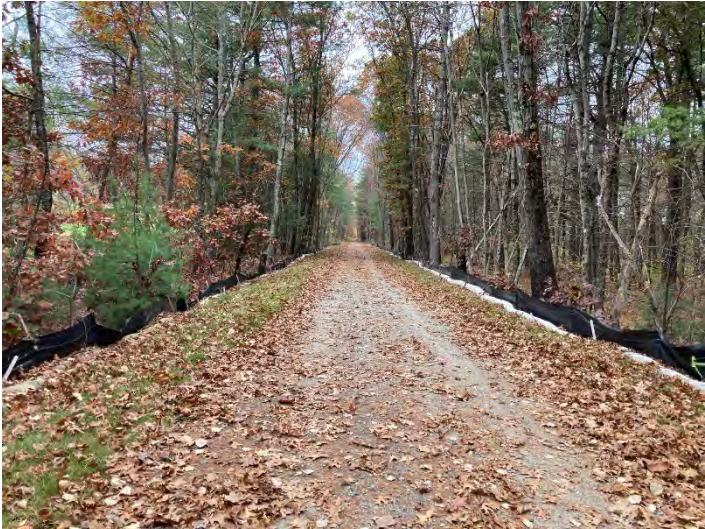
PHOTOGRAPHIC LOG	
Client Name: Eversource		Site Location: Sudbury to Hudson Transmission Reliability Project	Town: Hudson
Photo No.: 5	Date: 10-29-2024

Description: View of E&S controls in segment 4. Facing east.

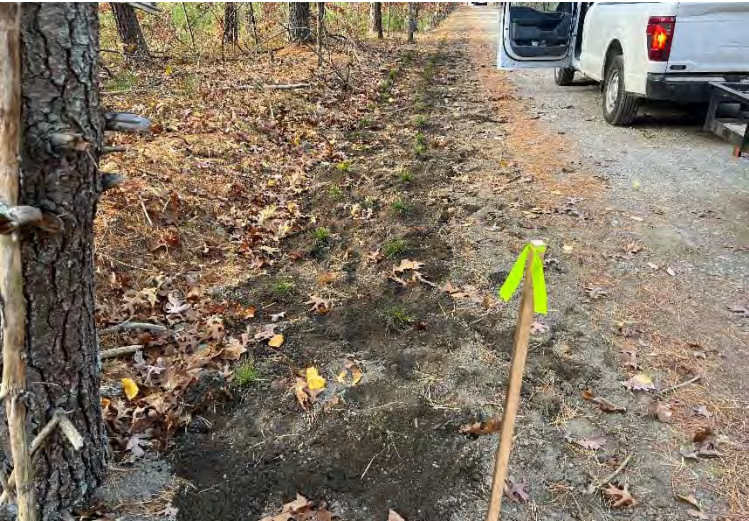
<p>PHOTOGRAPHIC LOG</p>	
<p>Client Name: Eversource</p>		<p>Site Location: Sudbury to Hudson Transmission Reliability Project</p>	<p>Town: Sudbury</p>
<p>Photo No.: 4</p>	<p>Date: 10/28/24</p>

<p>Description: View of installed sedges at station #374+25 to #374+00. Planting bed to be continued with other species tomorrow. Facing west.</p>

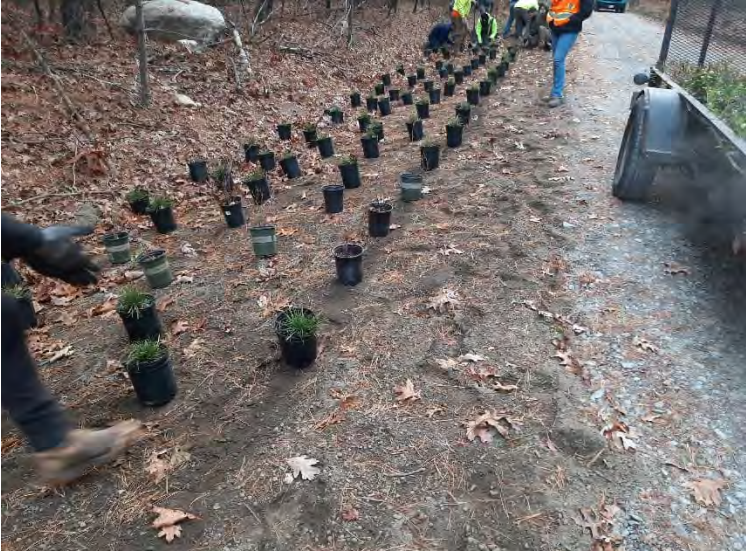
<p>PHOTOGRAPHIC LOG</p>	
<p>Client Name: Eversource</p>		<p>Site Location: Sudbury to Hudson Transmission Reliability Project</p>	<p>Town: Sudbury</p>
<p>Photo No.: 2</p>	<p>Date: 10/29/24</p>

<p>Description: Segment 7, north side, ~STA 378 + 75 to ~STA 381 + 00. MON installing plantings. Looking eastward.</p>

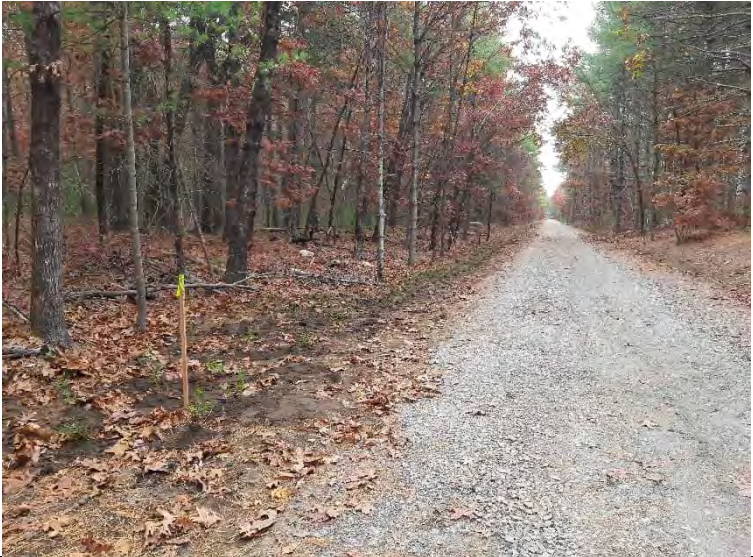
<p>PHOTOGRAPHIC LOG</p>	
<p>Client Name: Eversource</p>		<p>Site Location: Sudbury to Hudson Transmission Reliability Project</p>	<p>Town: Sudbury</p>
<p>Photo No.: 3</p>	<p>Date: 10/29/24</p>

<p>Description: Segment 7, north side, ~STA 378 + 75. Planting area after plant installation. Looking eastward.</p>

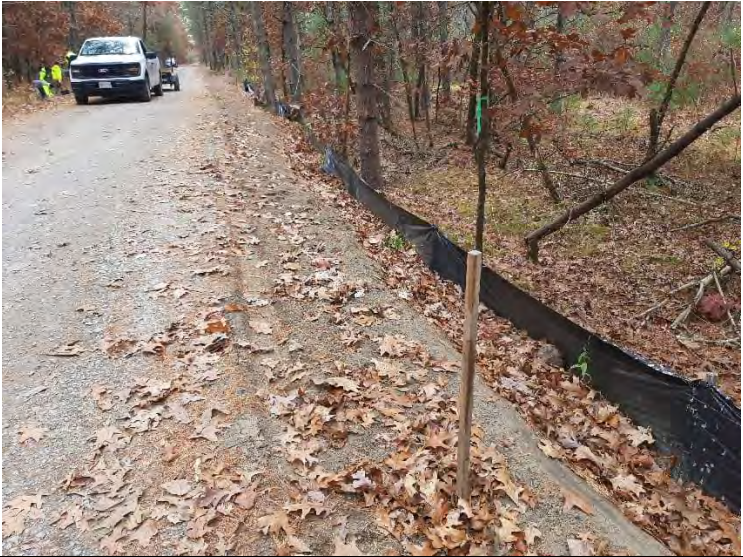
<p>PHOTOGRAPHIC LOG</p>	
<p>Client Name: Eversource</p>		<p>Site Location: Sudbury to Hudson Transmission Reliability Project</p>	<p>Town: Sudbury</p>
<p>Photo No.: 1</p>	<p>Date: 10/29/24</p>

<p>Description:</p> <p>Segment 7, south side, ~374 + 00. Planting area prior to plant installation. Looking eastward.</p>

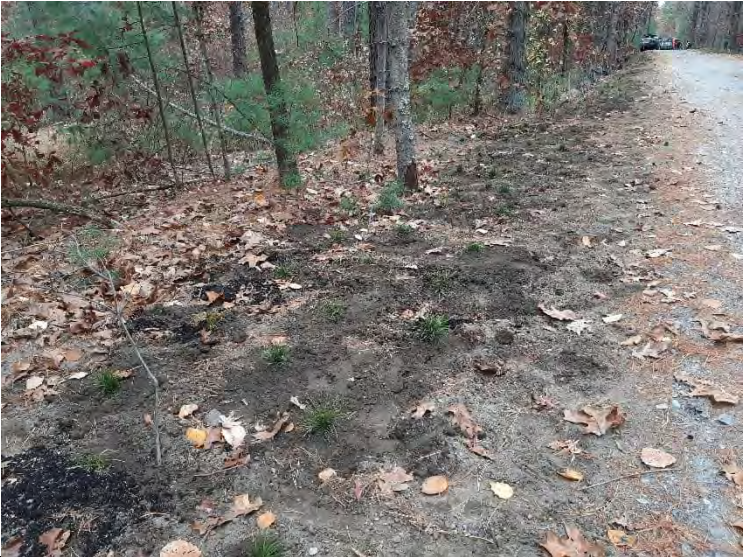
PHOTOGRAPHIC LOG	
Client Name: Eversource		Site Location: Sudbury to Hudson Transmission Reliability Project	Town: Sudbury
Photo No.: 3	Date: 10/29/24

Description: Segment 7, south side, ~STA 374 + 00. Planting area following plant installation. Looking westward.

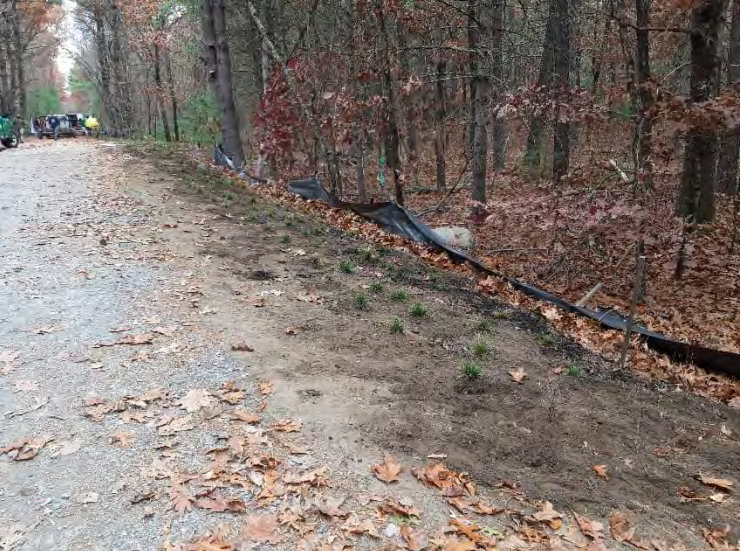
PHOTOGRAPHIC LOG	
Client Name: Eversource		Site Location: Sudbury to Hudson Transmission Reliability Project	Town: Sudbury
Photo No.: 2	Date: 10/29/24

Description: Segment 7, north side, ~STA 372 + 00. MON installing plantings. Looking westward.

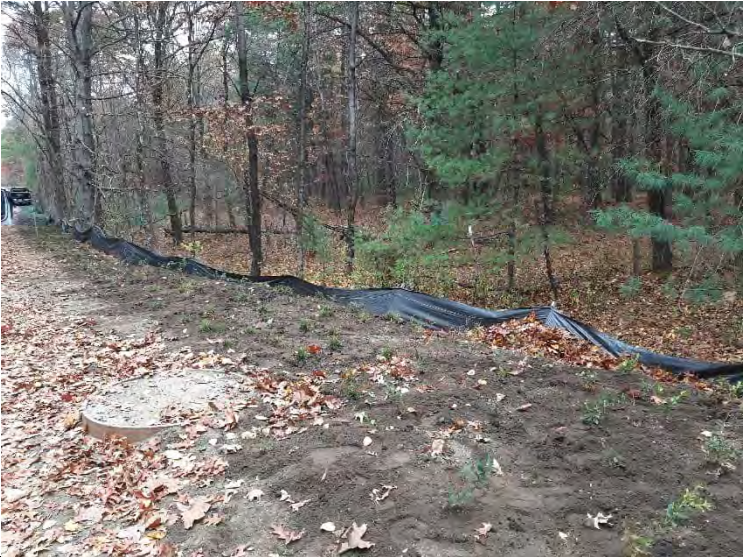
PHOTOGRAPHIC LOG	
Client Name: Eversource		Site Location: Sudbury to Hudson Transmission Reliability Project	Town: Sudbury
Photo No.: 3	Date: 10/29/24

Description: Segment 7, north side, manhole 15 (MH15). Planting area following plant installation. Planting extends into area hydroseeded this week. Looking westward.

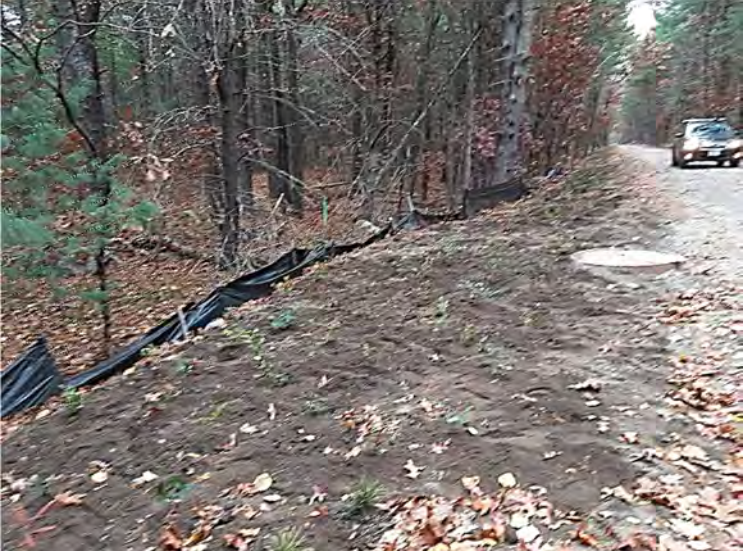
PHOTOGRAPHIC LOG	
Client Name: Eversource		Site Location: Sudbury to Hudson Transmission Reliability Project	Town: Sudbury
Photo No.: 4	Date: 10/29/24

Description: Segment 7, north side, MH15. Planting area following plant installation. Planting extends into area hydroseeded this week. Looking eastward.

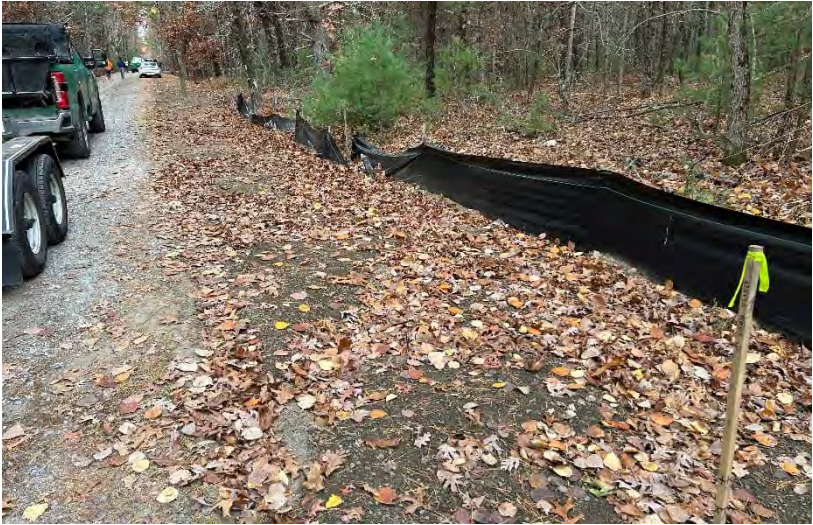
PHOTOGRAPHIC LOG	
Client Name: Eversource		Site Location: Sudbury to Hudson Transmission Reliability Project	Town: Sudbury
Photo No.: 1	Date: 10/29/24

Description: View of area prior to planting. Facing west.

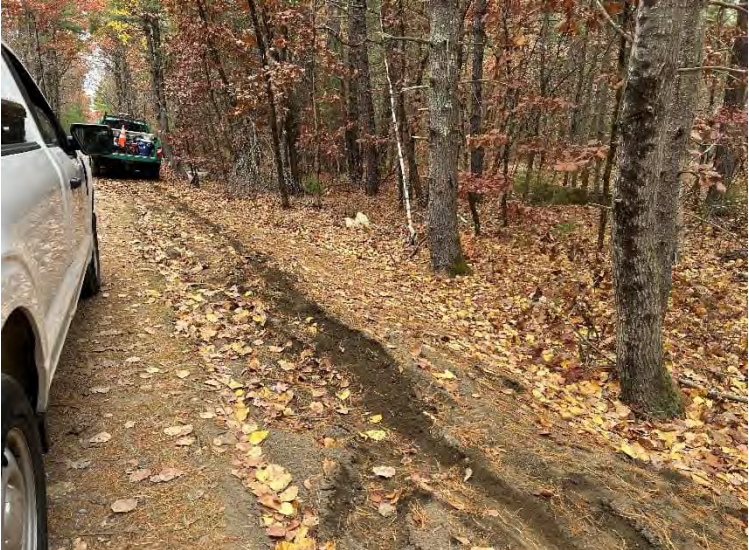
PHOTOGRAPHIC LOG	
Client Name: Eversource		Site Location: Sudbury to Hudson Transmission Reliability Project	Town: Sudbury
Photo No.: 2	Date: 10/29/24

Description: View of area prior to planting. Facing west.

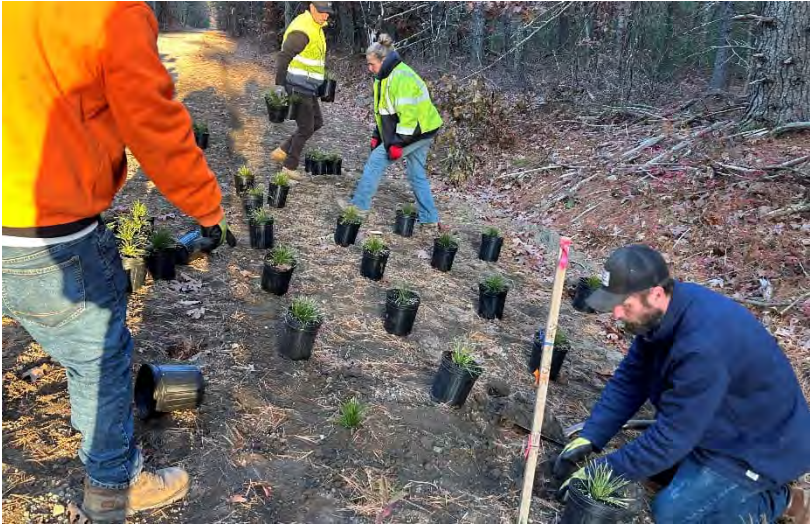
<p>PHOTOGRAPHIC LOG</p>	
<p>Client Name: Eversource</p>		<p>Site Location: Sudbury to Hudson Transmission Reliability Project</p>	<p>Town: Sudbury</p>
<p>Photo No.: 1</p>	<p>Date: 10/29/24</p>

<p>Description: View of MON placing plants according to planting scheme. Facing west.</p>

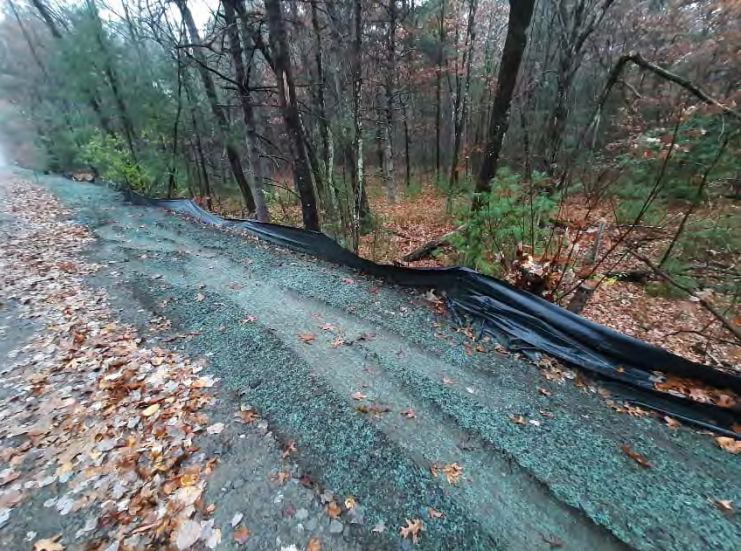
<p>PHOTOGRAPHIC LOG</p>	
<p>Client Name: Eversource</p>		<p>Site Location: Sudbury to Hudson Transmission Reliability Project</p>	<p>Town: Sudbury</p>
<p>Photo No.: 2</p>	<p>Date: 10/30/24</p>

<p>Description: Segment 7, north side, ~STA 369 + 00. Planting area prior to plant installation, area recently hydroseeded. Looking westward.</p>

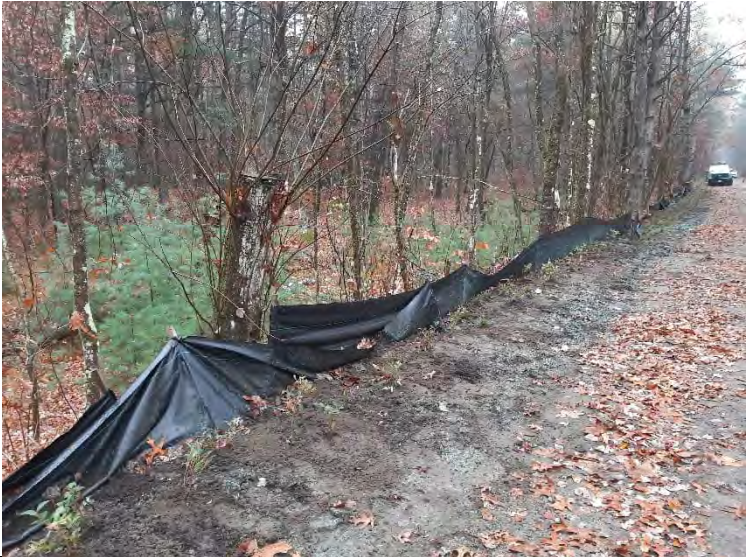
PHOTOGRAPHIC LOG	
Client Name: Eversource		Site Location: Sudbury to Hudson Transmission Reliability Project	Town: Sudbury
Photo No.: 3	Date: 10/30/24

Description: Segment 7, north side, ~STA 369 + 00. Planting area after plant installation, area recently hydroseeded. Looking eastward.

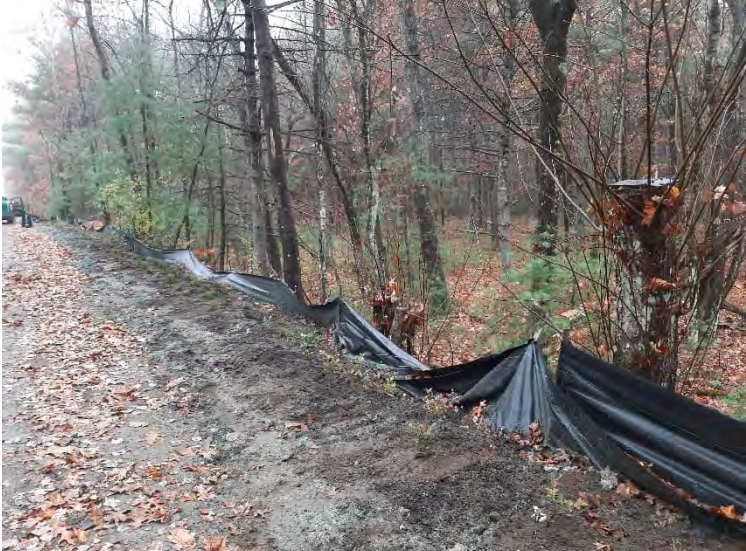
PHOTOGRAPHIC LOG	
Client Name: Eversource		Site Location: Sudbury to Hudson Transmission Reliability Project	Town: Sudbury
Photo No.: 4	Date: 10/30/24

Description: Segment 7, north side, ~STA 369 + 00. Planting area after plant installation, area recently hydroseeded. Looking westward.

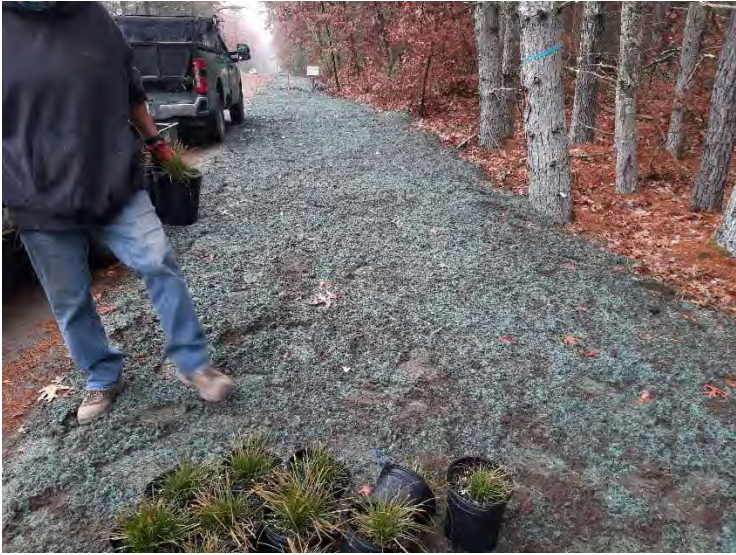
<p>PHOTOGRAPHIC LOG</p>	
<p>Client Name: Eversource</p>		<p>Site Location: Sudbury to Hudson Transmission Reliability Project</p>	<p>Town: Sudbury</p>
<p>Photo No.: 1</p>	<p>Date: 10/30/24</p>

<p>Description:</p> <p>Segment 7, north side, ~STA 366 + 00. Planting area prior to plant installation, MON staging plants for planting. Looking westward.</p>

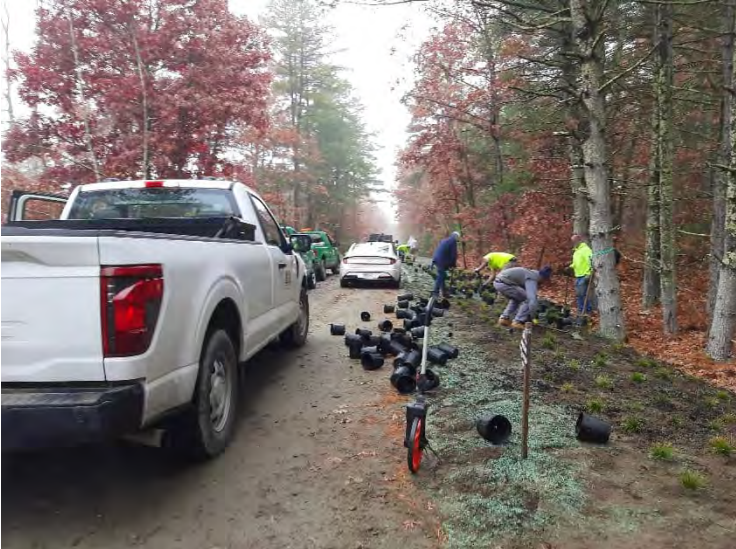
<p>PHOTOGRAPHIC LOG</p>	
<p>Client Name: Eversource</p>		<p>Site Location: Sudbury to Hudson Transmission Reliability Project</p>	<p>Town: Sudbury</p>
<p>Photo No.: 2</p>	<p>Date: 10/30/24</p>

<p>Description:</p> <p>Segment 7, north side, ~STA 366 + 00. MON staging and installing plantings. Looking westward.</p>

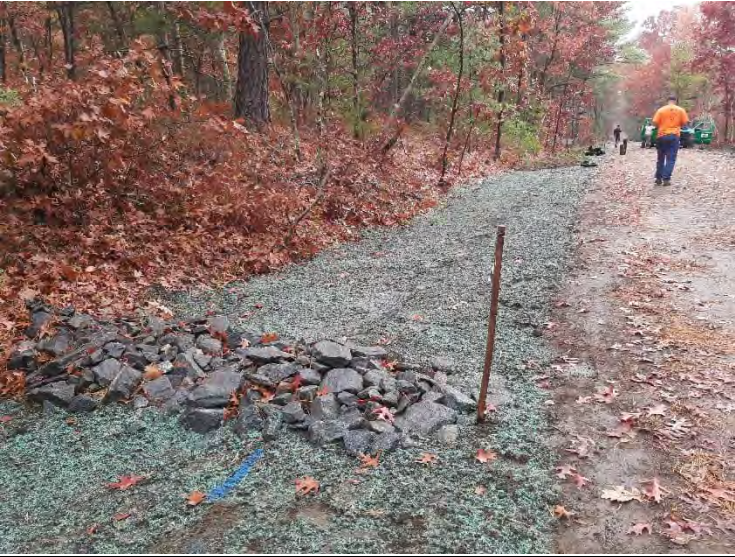
PHOTOGRAPHIC LOG	
Client Name: Eversource		Site Location: Sudbury to Hudson Transmission Reliability Project	Town: Sudbury
Photo No.: 3	Date: 10/30/24

Description: Segment 7, north side, ~STA 364 + 00. Plantings after installation. Gap between check dam and plantings filled with sedges (CS) from next "section". Looking eastward.

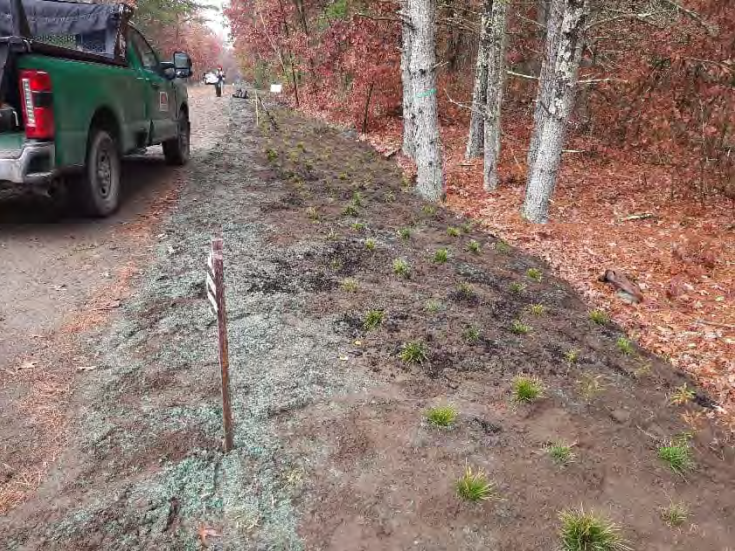
PHOTOGRAPHIC LOG	
Client Name: Eversource		Site Location: Sudbury to Hudson Transmission Reliability Project	Town: Sudbury
Photo No.: 4	Date: 10/30/24

Description: Segment 7, north side, ~STA 366 + 00. Planting area following plant installation. Looking westward.

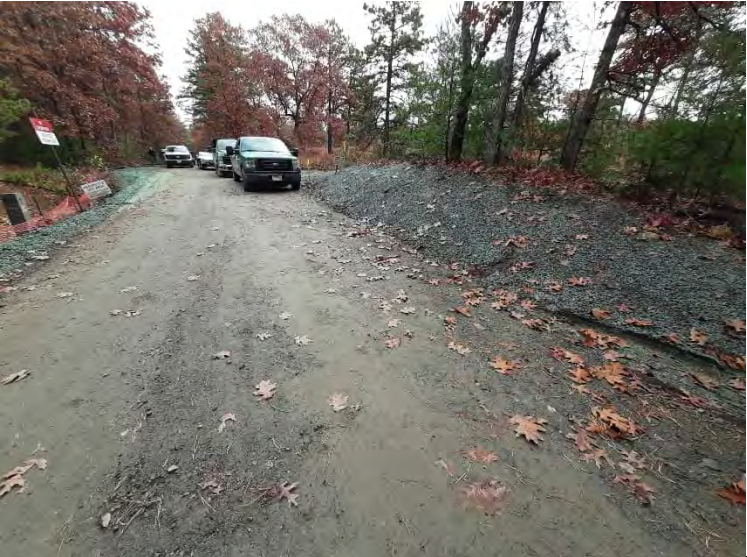
<p>PHOTOGRAPHIC LOG</p>	
<p>Client Name: Eversource</p>		<p>Site Location: Sudbury to Hudson Transmission Reliability Project</p>	<p>Town: Marlborough</p>
<p>Photo No.: 1</p>	<p>Date: 10/30/24</p>

<p>Description: Segment 6, south side, near town line. Planting area prior to plant installation. Looking eastward.</p>

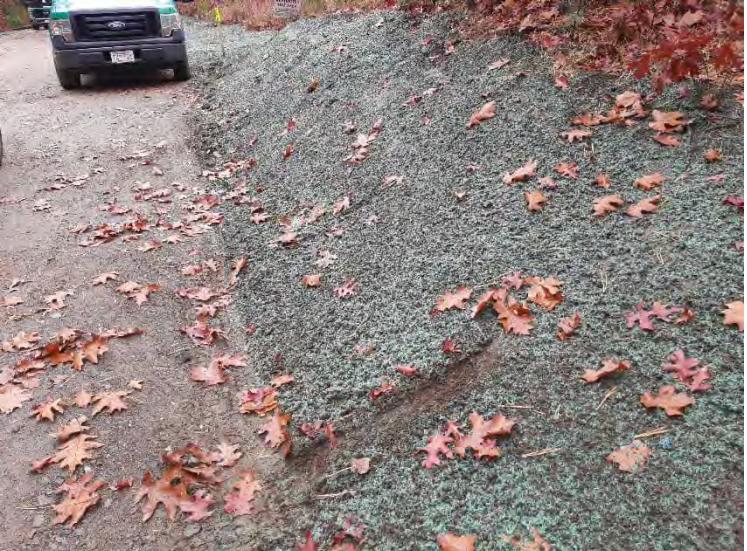
<p>PHOTOGRAPHIC LOG</p>	
<p>Client Name: Eversource</p>		<p>Site Location: Sudbury to Hudson Transmission Reliability Project</p>	<p>Town: Marlborough</p>
<p>Photo No.: 2</p>	<p>Date: 10/30/24</p>

<p>Description: Segment 6, south side, near town line. Planting area prior to plant installation. Looking eastward.</p>

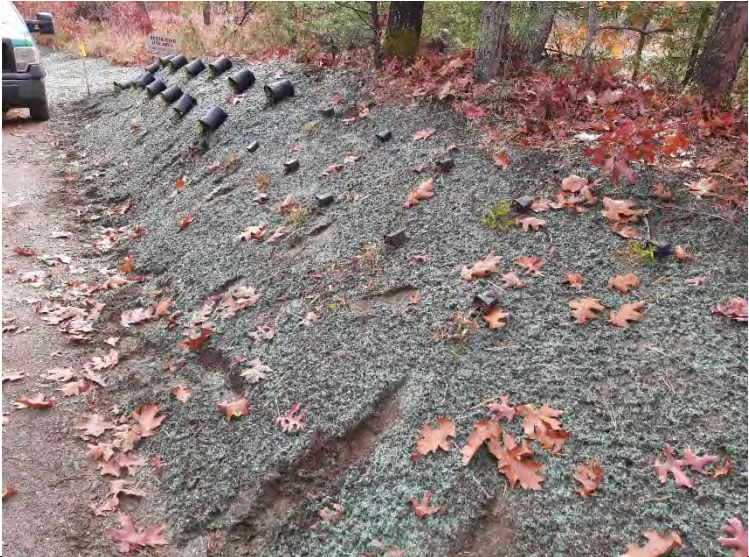
<p>PHOTOGRAPHIC LOG</p>	
<p>Client Name: Eversource</p>		<p>Site Location: Sudbury to Hudson Transmission Reliability Project</p>	<p>Town: Marlborough</p>
<p>Photo No.: 3</p>	<p>Date: 10/30/24</p>

<p>Description: Segment 6, south side, near town line. MON staging plantings. Looking eastward.</p>

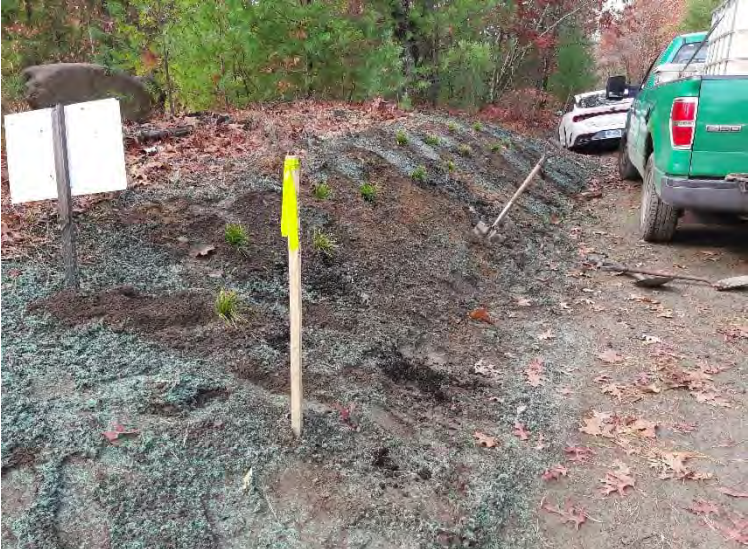
<p>PHOTOGRAPHIC LOG</p>	
<p>Client Name: Eversource</p>		<p>Site Location: Sudbury to Hudson Transmission Reliability Project</p>	<p>Town: Marlborough</p>
<p>Photo No.: 4</p>	<p>Date: 10/30/24</p>

<p>Description: Segment 6, south side, near town line. Plants following installation. Looking westward.</p>

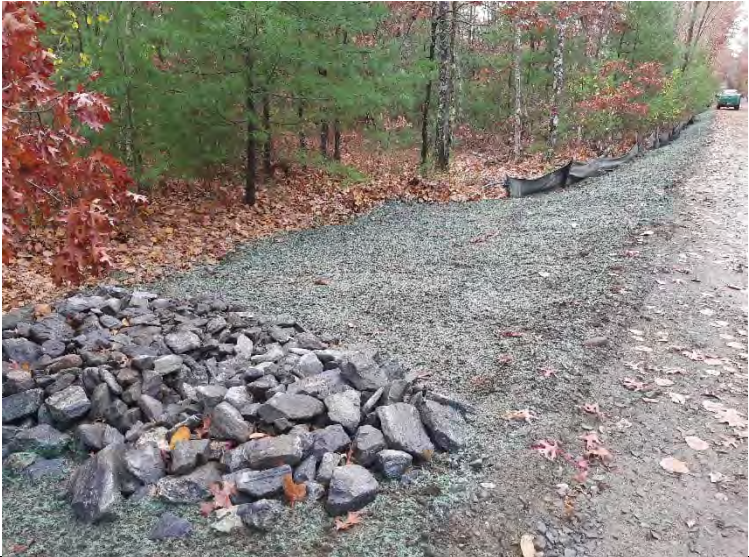
<p>PHOTOGRAPHIC LOG</p>	
<p>Client Name: Eversource</p>		<p>Site Location: Sudbury to Hudson Transmission Reliability Project</p>	<p>Town: Hudson</p>
<p>Photo No.: 1</p>	<p>Date: 10/30/24</p>

<p>Description: Segment 6, south side, ~STA 360 + 50. Planting area prior to plant installation. Looking westward.</p>

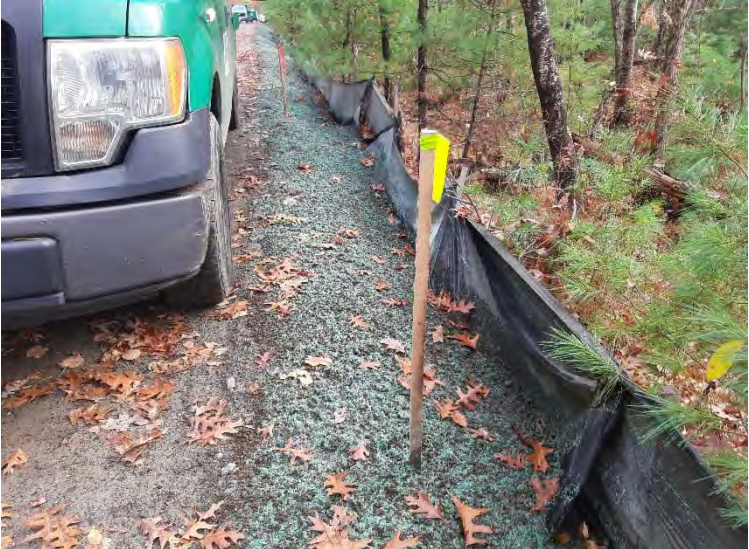
<p>PHOTOGRAPHIC LOG</p>	
<p>Client Name: Eversource</p>		<p>Site Location: Sudbury to Hudson Transmission Reliability Project</p>	<p>Town: Hudson</p>
<p>Photo No.: 2</p>	<p>Date: 10/30/24</p>

<p>Description: Segment 6, south side, ~357 + 80. Planting area prior to plant installation. Looking eastward.</p>

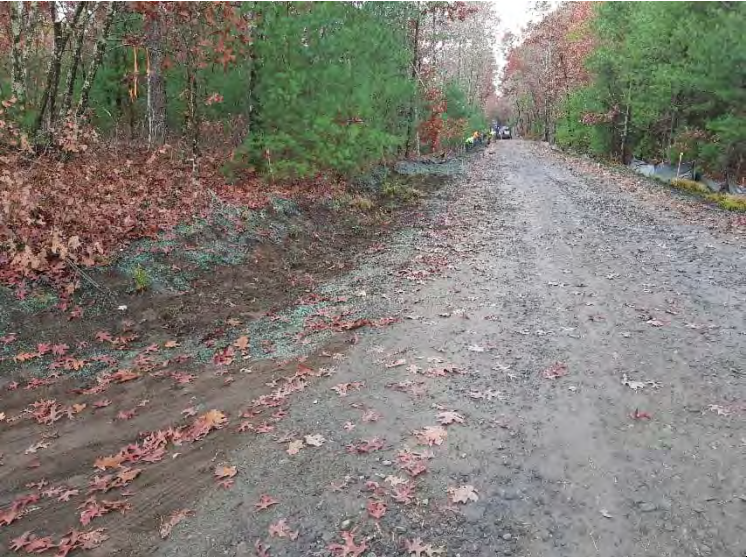
PHOTOGRAPHIC LOG	
Client Name: Eversource		Site Location: Sudbury to Hudson Transmission Reliability Project	Town: Hudson
Photo No.: 3	Date: 10/30/24

Description: Segment 6, south side, ~STA 358 + 50. Installed plantings, and MON installing plantings. Looking westward.

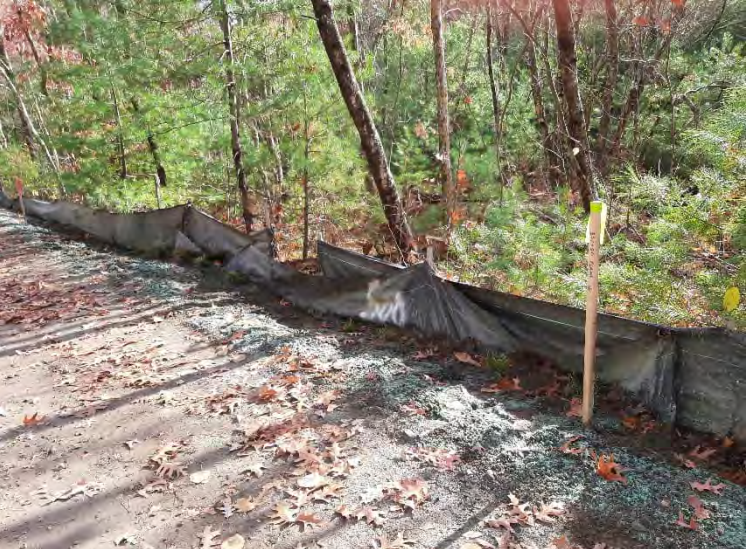
PHOTOGRAPHIC LOG	
Client Name: Eversource		Site Location: Sudbury to Hudson Transmission Reliability Project	Town: Hudson
Photo No.: 4	Date: 10/30/24

Description: Segment 6, south side, near STA 357 + ~80. Plants following installation. Looking southeastward.

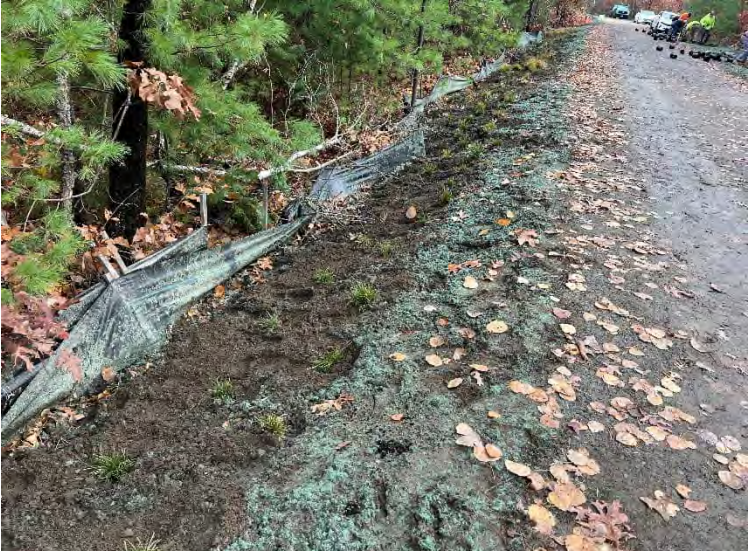
PHOTOGRAPHIC LOG	
Client Name: Eversource		Site Location: Sudbury to Hudson Transmission Reliability Project	Town: Hudson
Photo No.: 2	Date: 10/30/24

Description: View of installed plants continuing the northern planting bed. <i>Facing east.</i>

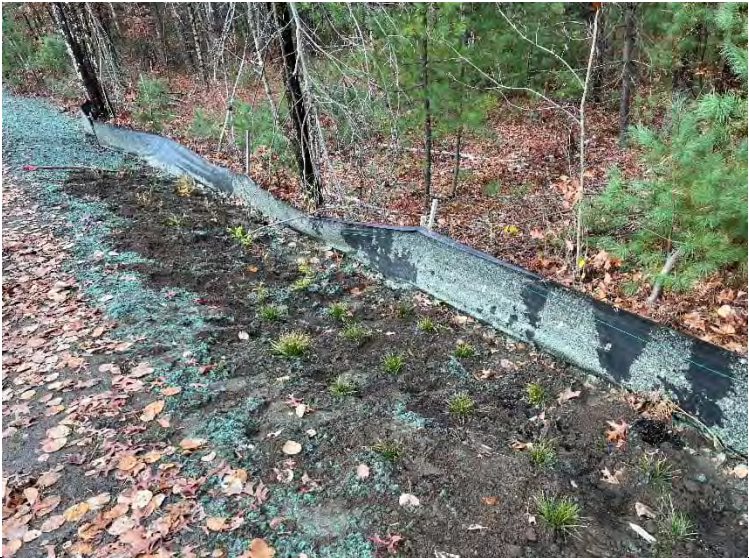
PHOTOGRAPHIC LOG	
Client Name: Eversource		Site Location: Sudbury to Hudson Transmission Reliability Project	Town: Hudson
Photo No.: 3	Date: 10/30/24

Description: Another view of installed plants. <i>Facing west.</i>

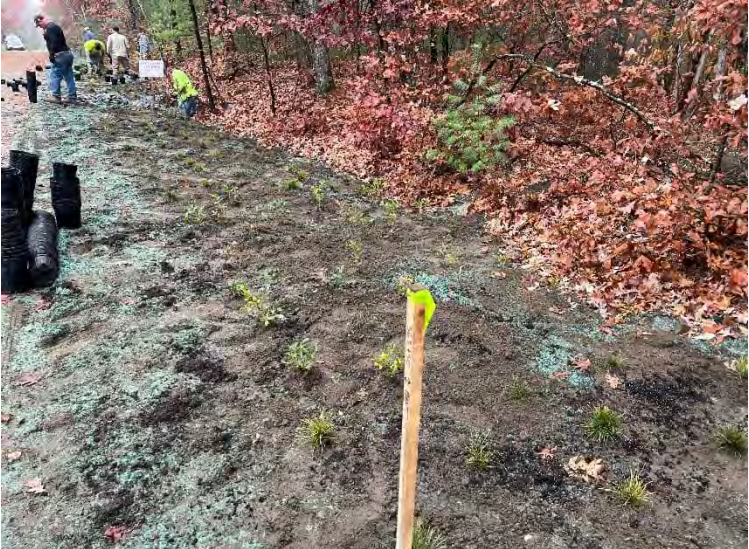
<p>PHOTOGRAPHIC LOG</p>	
<p>Client Name: Eversource</p>		<p>Site Location: Sudbury to Hudson Transmission Reliability Project</p>	<p>Town: Sudbury</p>
<p>Photo No.: 2</p>	<p>Date: 10/30/24</p>

<p>Description: View of CS installed east of rock check dam at Sta#364+00. Facing west.</p>

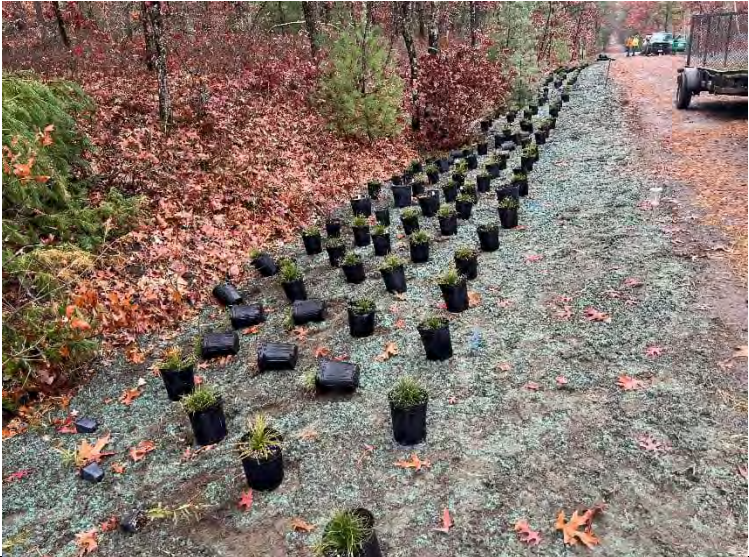
PHOTOGRAPHIC LOG	
Client Name: Eversource		Site Location: Sudbury to Hudson Transmission Reliability Project	Town: Sudbury
Photo No.: 3	Date: 10/30/24

Description: View of plants laid out prior to installation. <i>Facing east.</i>

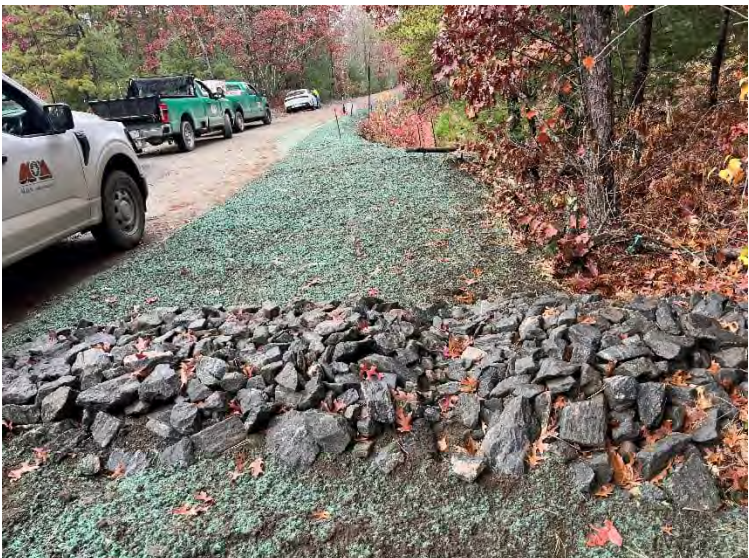
PHOTOGRAPHIC LOG	
Client Name: Eversource		Site Location: Sudbury to Hudson Transmission Reliability Project	Town: Sudbury
Photo No.: 4	Date: 10/30/24

Description: View of planting bed rock check dam at Sta#362+40 to the town line. <i>Facing west.</i>

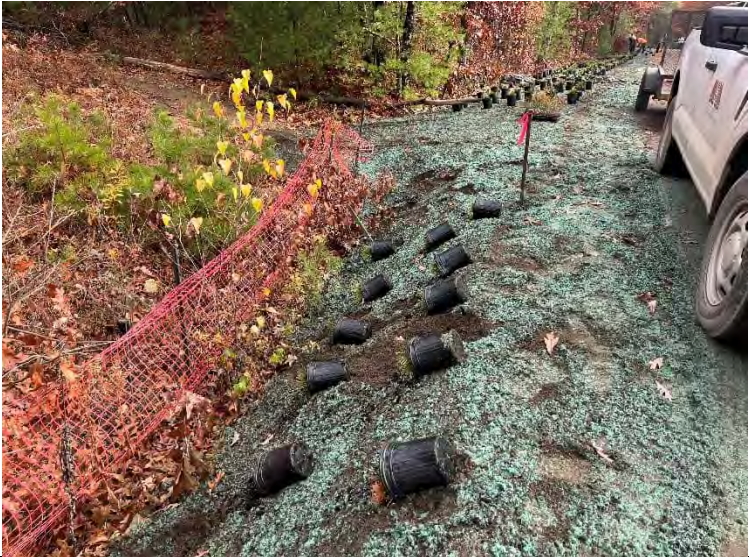
PHOTOGRAPHIC LOG	
Client Name: Eversource		Site Location: Sudbury to Hudson Transmission Reliability Project	Town: Sudbury
Photo No.: 5	Date: 10/30/24

Description: View of plant laid out prior to installation. Gap left for trail head. Facing east.

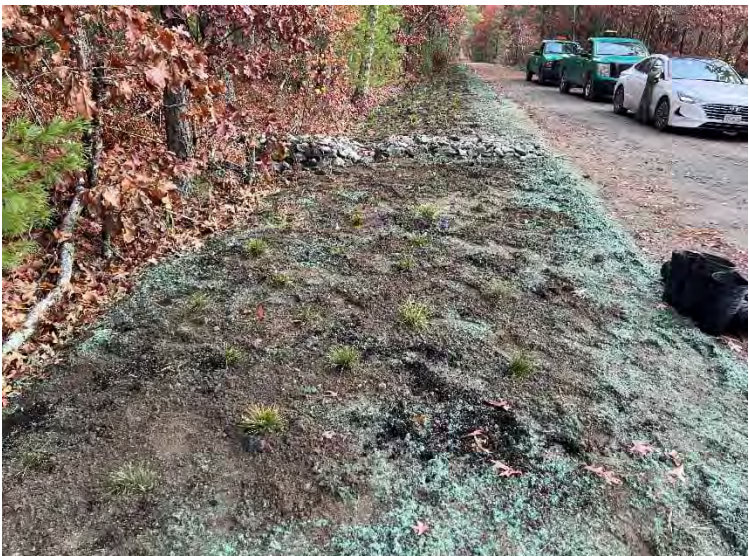
PHOTOGRAPHIC LOG	
Client Name: Eversource		Site Location: Sudbury to Hudson Transmission Reliability Project	Town: Sudbury
Photo No.: 6	Date: 10/30/24

Description: View of installed plants. Facing east.

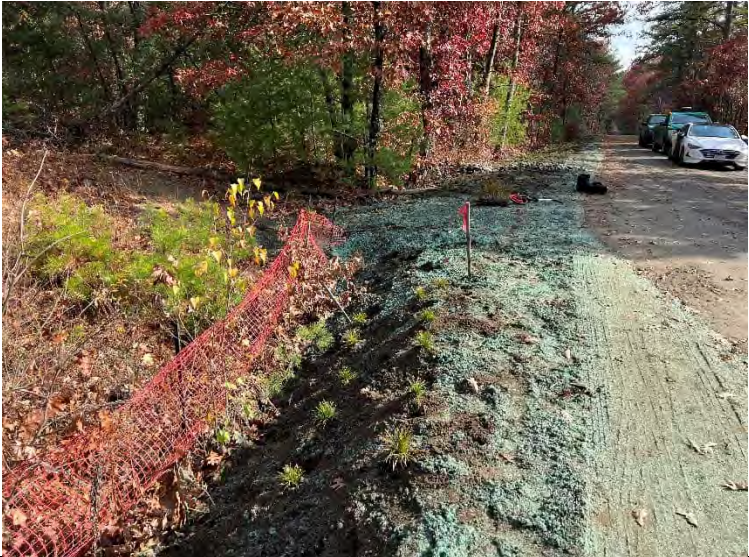
PHOTOGRAPHIC LOG	
Client Name: Eversource		Site Location: Sudbury to Hudson Transmission Reliability Project	Town: Sudbury
Photo No.: 7	Date: 10/30/24

Description: View of installed plants by the town line with gap left at the trail head. <i>Facing east.</i>

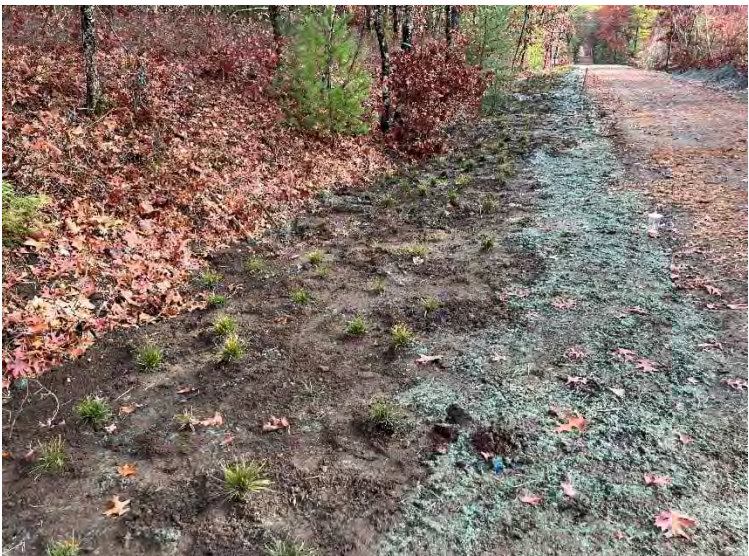
PHOTOGRAPHIC LOG	
Client Name: Eversource		Site Location: Sudbury to Hudson Transmission Reliability Project	Town: Sudbury
Photo No.: 8	Date: 10/30/24

Description: Another view of installed plants. <i>Facing east.</i>

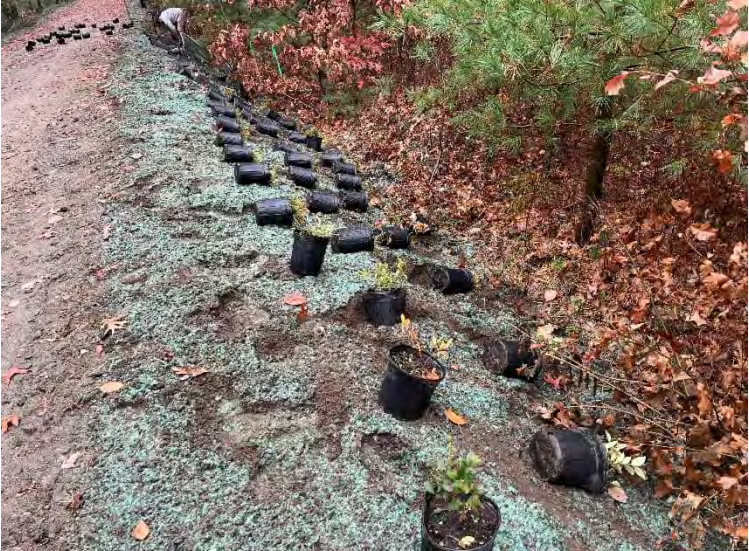
PHOTOGRAPHIC LOG	
Client Name: Eversource		Site Location: Sudbury to Hudson Transmission Reliability Project	Town: Sudbury
Photo No.: 2	Date: 10/30/24

Description: View of plants laid out according to plans. <i>Facing east.</i>

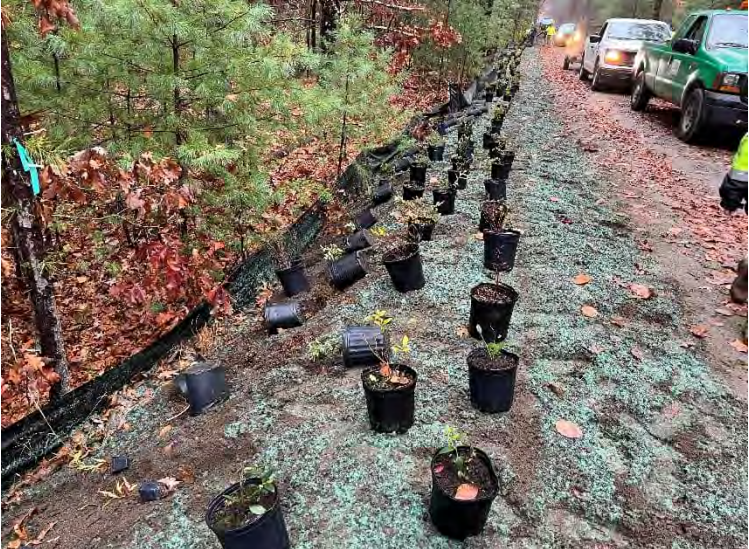
<p>PHOTOGRAPHIC LOG</p>	
<p>Client Name: Eversource</p>		<p>Site Location: Sudbury to Hudson Transmission Reliability Project</p>	<p>Town: Sudbury</p>
<p>Photo No.: 2</p>	<p>Date: 10/30/24</p>

<p>Description: View of plants laid out according to plans. <i>Facing east.</i></p>

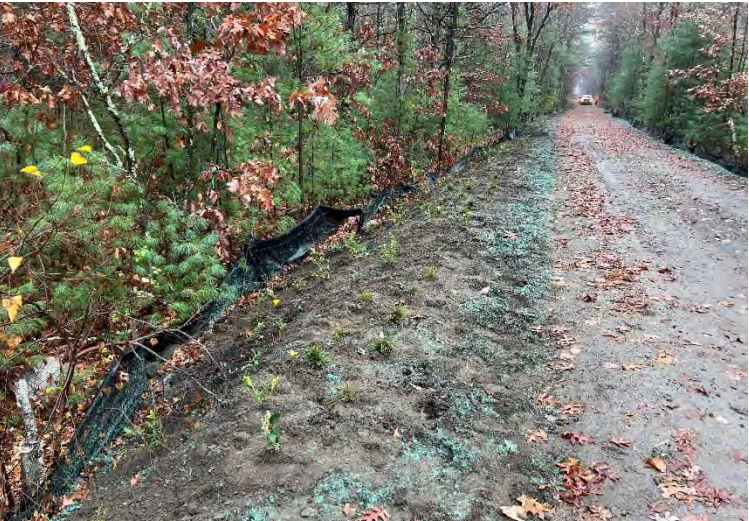
PHOTOGRAPHIC LOG	
Client Name: Eversource		Site Location: Sudbury to Hudson Transmission Reliability Project	Town: Sudbury
Photo No.: 4	Date: 10/30/24

Description: View of installed plants. <i>Facing east.</i>

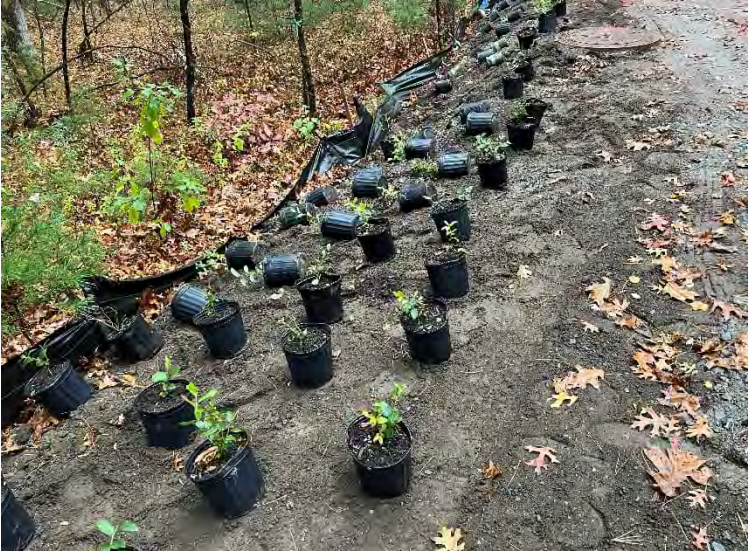
PHOTOGRAPHIC LOG	
Client Name: Eversource		Site Location: Sudbury to Hudson Transmission Reliability Project	Town: Sudbury
Photo No.: 2	Date: 10/30/24

Description: View of plants laid out according to plans. <i>Facing east.</i>

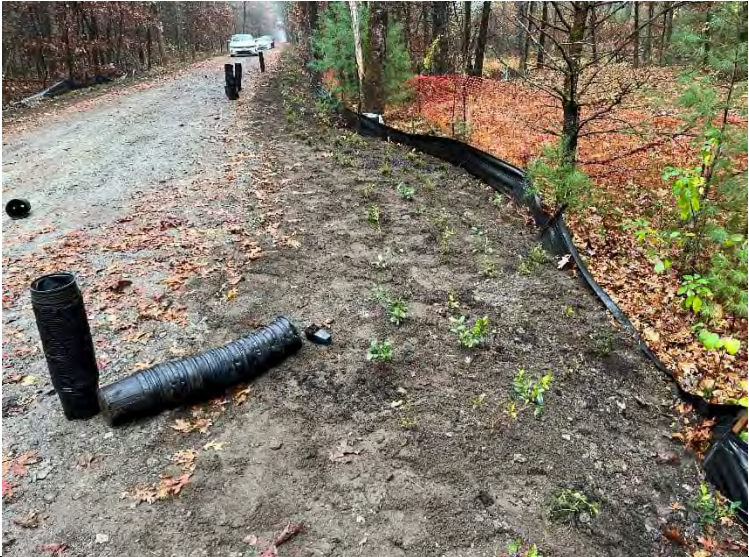
PHOTOGRAPHIC LOG	
Client Name: Eversource		Site Location: Sudbury to Hudson Transmission Reliability Project	Town: Sudbury
Photo No.: 3	Date: 10/30/24

Description: View of installed plants within eastern portion of planting bed. Facing east.

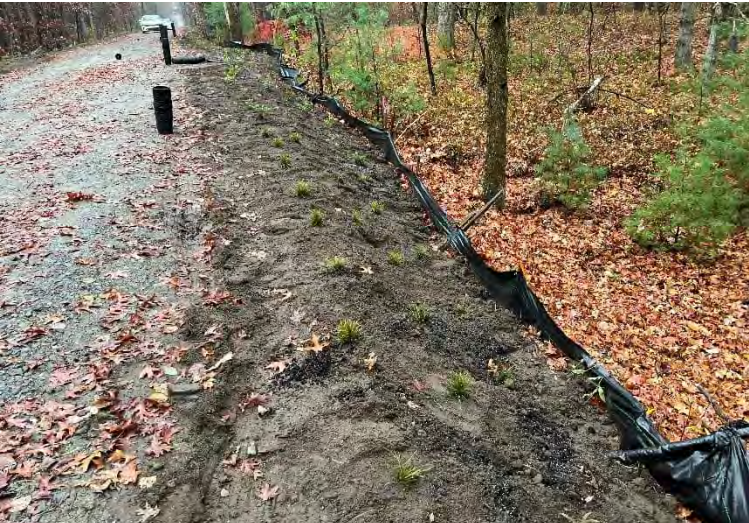
PHOTOGRAPHIC LOG	
Client Name: Eversource		Site Location: Sudbury to Hudson Transmission Reliability Project	Town: Sudbury
Photo No.: 4	Date: 10/30/24

Description: View of installed plants within western portion of planting bed. Facing east.

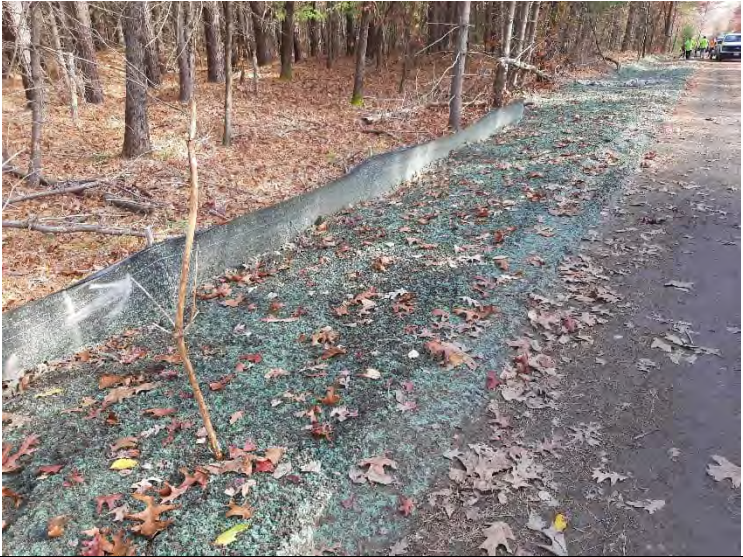
PHOTOGRAPHIC LOG	
Client Name: Eversource		Site Location: Sudbury to Hudson Transmission Reliability Project	Town: Hudson
Photo No.: 1	Date: 10/31/24

Description: Segment 6, north side, ~STA 348 + 00. North side planting area prior to installation. Looking eastward.

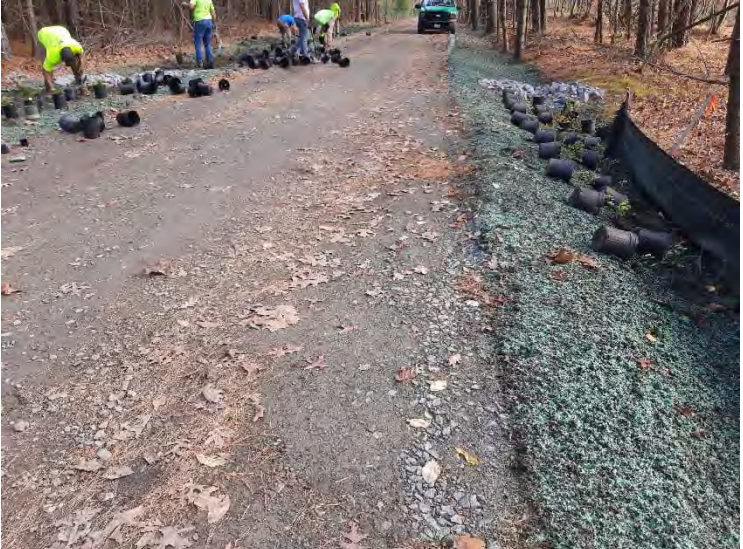
PHOTOGRAPHIC LOG	
Client Name: Eversource		Site Location: Sudbury to Hudson Transmission Reliability Project	Town: Hudson
Photo No.: 2	Date: 10/31/24

Description: Segment 6, north and south sides, STA 348 + ~50. MON staging and installing plantings. Blueberries (VA) on right side of image are the only plantings on the south side of the ROW in this section. Looking eastward.
