Weekly Environmental Compliance Summary

Sudbury to Hudson Transmission Reliability Project (USEPA Tracking # MAR1003UW)

Week of: October 28, 2024 to November 2, 2024

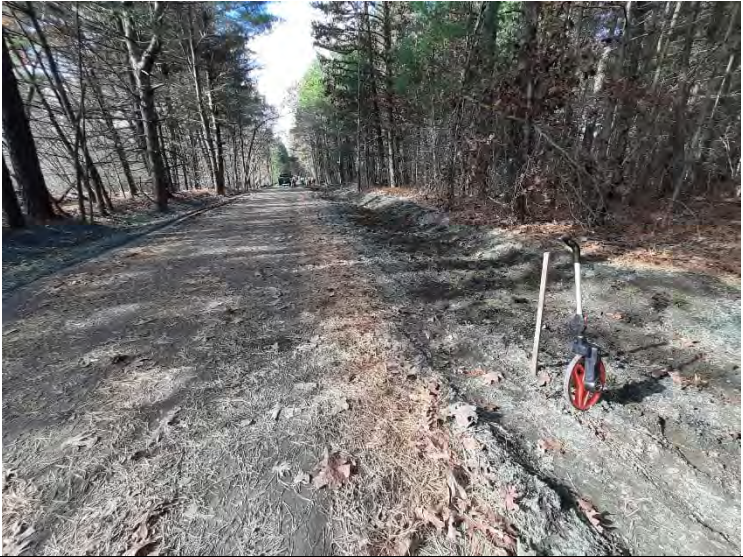
PHOTOGRAPHIC LOG	
Client Name: Eversource		Site Location: Sudbury to Hudson Transmission Reliability Project	Town: Hudson
Photo No.: 3	Date: 10/31/24

Description: Segment 6, north and side, STA ~348 + 00 to ~350 + 00. Installed plantings and MON installing plantings. Looking westward.

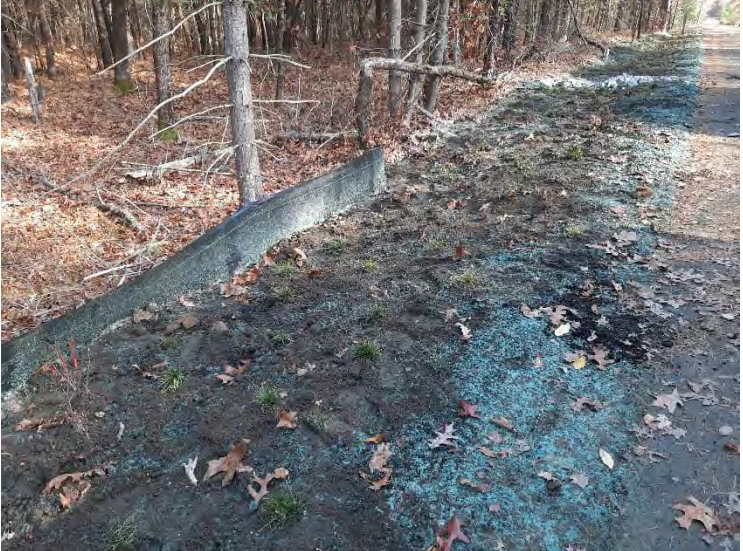
PHOTOGRAPHIC LOG	
Client Name: Eversource		Site Location: Sudbury to Hudson Transmission Reliability Project	Town: Hudson
Photo No.: 4	Date: 10/31/24

Description: Segment 6, north side, STA ~348 + 00 to ~350 + 00. Installed plantings on north side. Looking eastward.

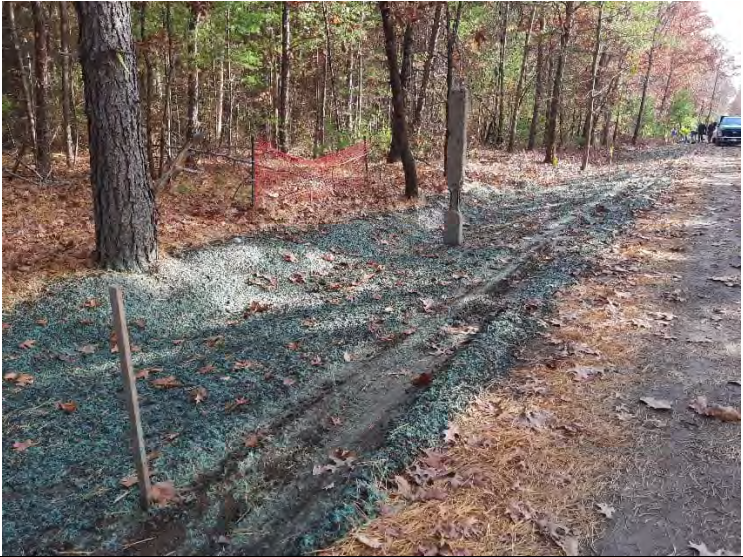
<p>PHOTOGRAPHIC LOG</p>	
<p>Client Name: Eversource</p>		<p>Site Location: Sudbury to Hudson Transmission Reliability Project</p>	<p>Town: Hudson</p>
<p>Photo No.: 1</p>	<p>Date: 10/31/24</p>

<p>Description:</p> <p>Segment 6, north side, STA ~350 + 00 to ~352 + 00. Planting area prior to installation. Archeological feature in bed, planting adjusted around it. Looking eastward.</p>

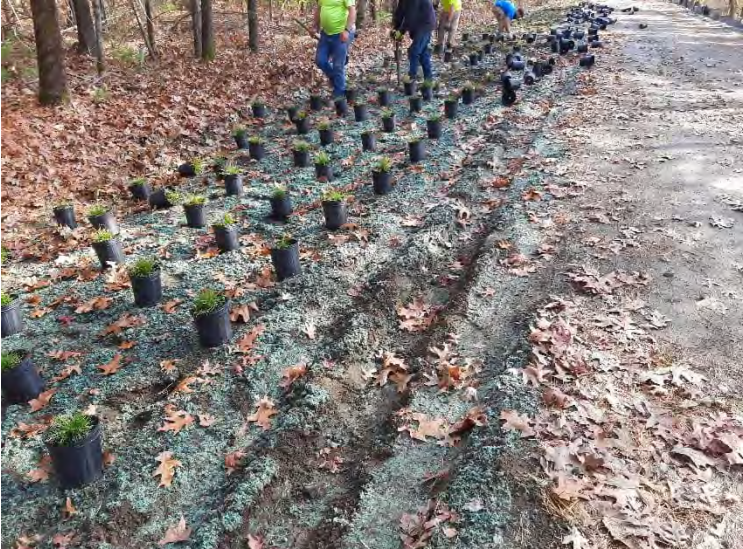
<p>PHOTOGRAPHIC LOG</p>	
<p>Client Name: Eversource</p>		<p>Site Location: Sudbury to Hudson Transmission Reliability Project</p>	<p>Town: Hudson</p>
<p>Photo No.: 2</p>	<p>Date: 10/31/24</p>

<p>Description:</p> <p>Segment 6, north side, STA ~350 + 00 to 352 + 00. MON installing plantings. Looking eastward.</p>

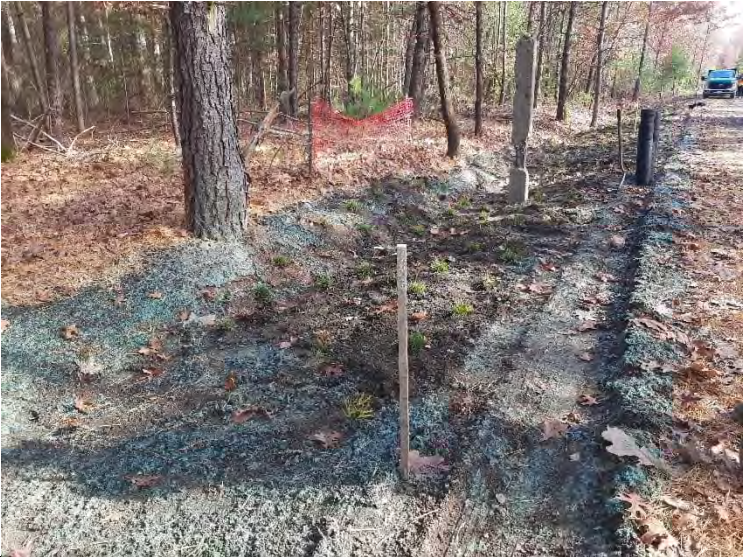
<p>PHOTOGRAPHIC LOG</p>	
<p>Client Name: Eversource</p>		<p>Site Location: Sudbury to Hudson Transmission Reliability Project</p>	<p>Town: Hudson</p>
<p>Photo No.: 3</p>	<p>Date: 10/31/24</p>

<p>Description: Segment 6, north side, ~STA 350 + 00 to 352 + 00. Installed plantings. Looking eastward.</p>

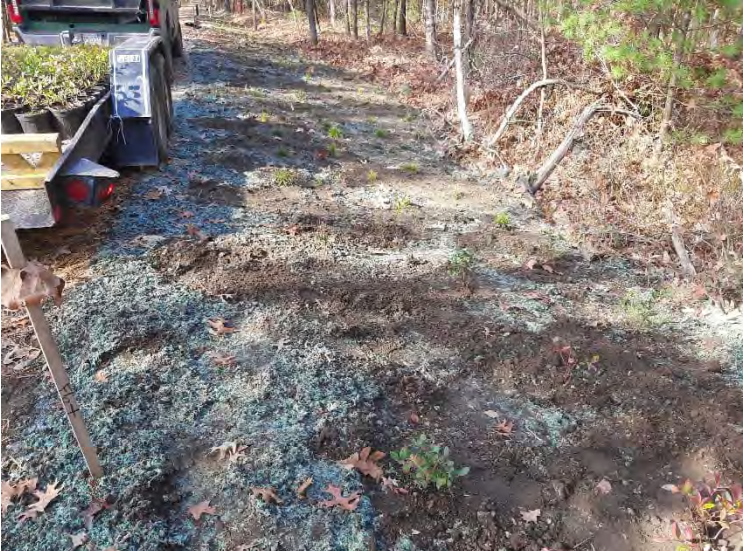
<p>PHOTOGRAPHIC LOG</p>	
<p>Client Name: Eversource</p>		<p>Site Location: Sudbury to Hudson Transmission Reliability Project</p>	<p>Town: Hudson</p>
<p>Photo No.: 4</p>	<p>Date: 10/31/24</p>

<p>Description: Segment 6, north side, ~STA 350 + 00 to 352 + 00. Installed plantings. Looking westward.</p>

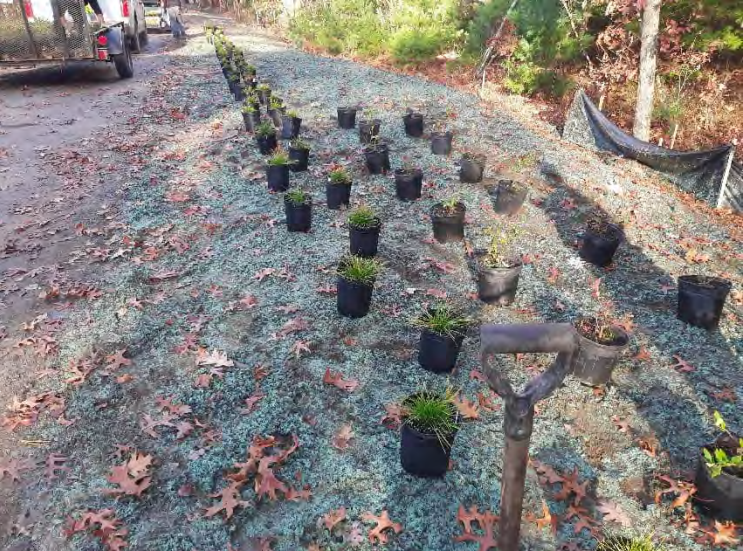
<p>PHOTOGRAPHIC LOG</p>	
<p>Client Name: Eversource</p>		<p>Site Location: Sudbury to Hudson Transmission Reliability Project</p>	<p>Town: Hudson</p>
<p>Photo No.: 2</p>	<p>Date: 10/31/24</p>

<p>Description:</p> <p>Segment 6, north side, MH 14. MON staging plantings. Looking westward.</p>

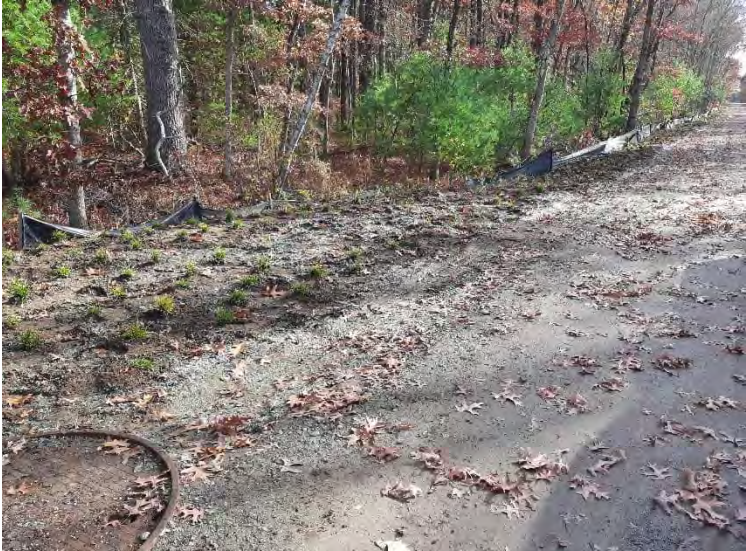
PHOTOGRAPHIC LOG	
Client Name: Eversource		Site Location: Sudbury to Hudson Transmission Reliability Project	Town: Hudson
Photo No.: 4	Date: 10/31/24

Description: Segment 6, north side, MH 14. Installed plantings. Looking eastward.

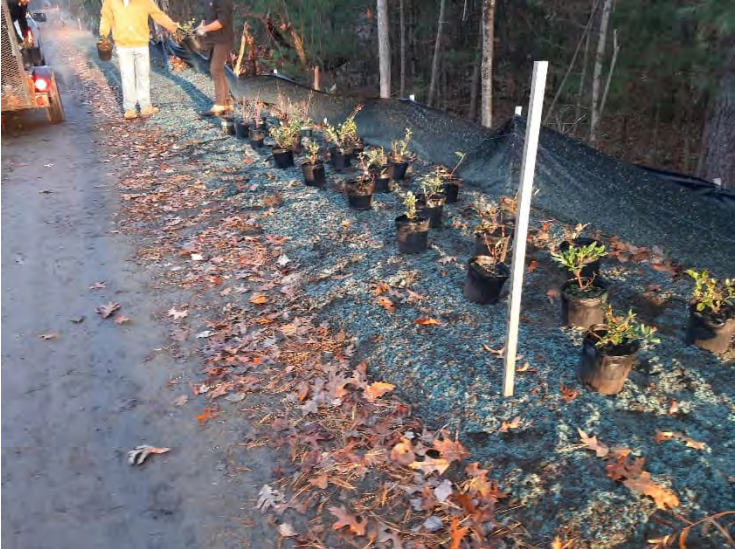
<p>PHOTOGRAPHIC LOG</p>	
<p>Client Name: Eversource</p>		<p>Site Location: Sudbury to Hudson Transmission Reliability Project</p>	<p>Town: Hudson</p>
<p>Photo No.: 2</p>	<p>Date: 10/31/24</p>

<p>Description:</p> <p>Segment 6, north side, ~STA 355 + 00 to ~357 + 00. MON staging plants for planting. Looking westward.</p>

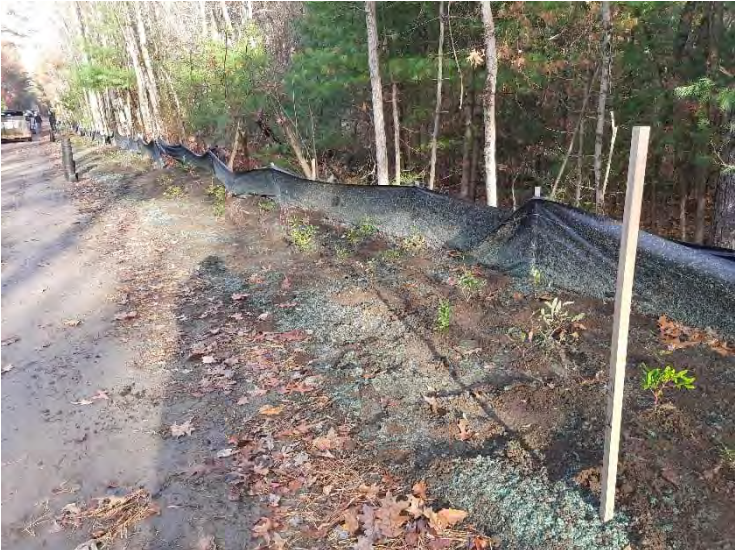
PHOTOGRAPHIC LOG	
Client Name: Eversource		Site Location: Sudbury to Hudson Transmission Reliability Project	Town: Hudson
Photo No.: 3	Date: 10/31/24

Description: Segment 6, north side, ~STA 355 + 00 to ~357 + 00. Installed plantings. Looking westward.

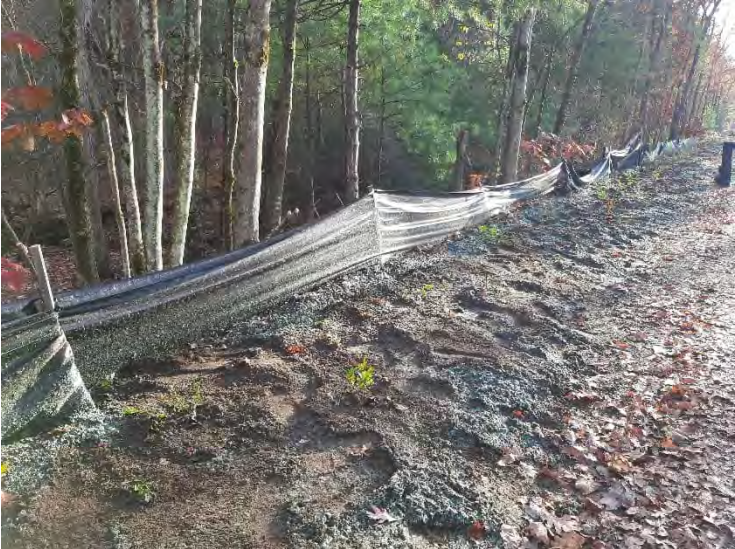
PHOTOGRAPHIC LOG	
Client Name: Eversource		Site Location: Sudbury to Hudson Transmission Reliability Project	Town: Hudson
Photo No.: 4	Date: 10/31/24

Description: Segment 6, north side, ~STA 355 + 00 to ~357 + 00. Installed plantings. Looking eastward.

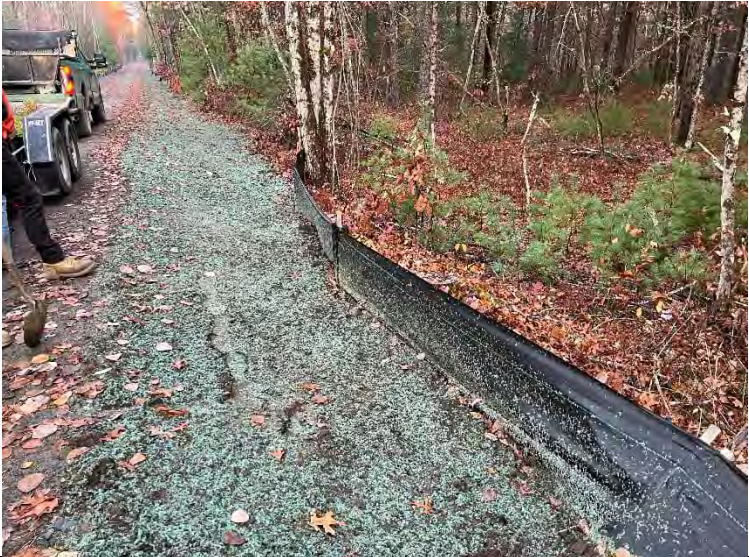
PHOTOGRAPHIC LOG	
Client Name: Eversource		Site Location: Sudbury to Hudson Transmission Reliability Project	Town: Hudson
Photo No.: 1	Date: 10/31/24

Description: View of planting bed prior to installation. <i>Facing west.</i>

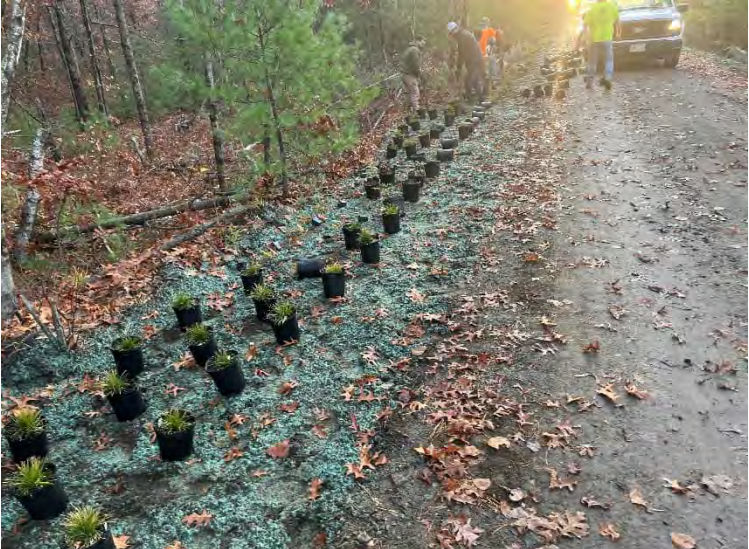
PHOTOGRAPHIC LOG	
Client Name: Eversource		Site Location: Sudbury to Hudson Transmission Reliability Project	Town: Hudson
Photo No.: 2	Date: 10/31/24

Description: View of plants laid out according to plans. <i>Facing east.</i>

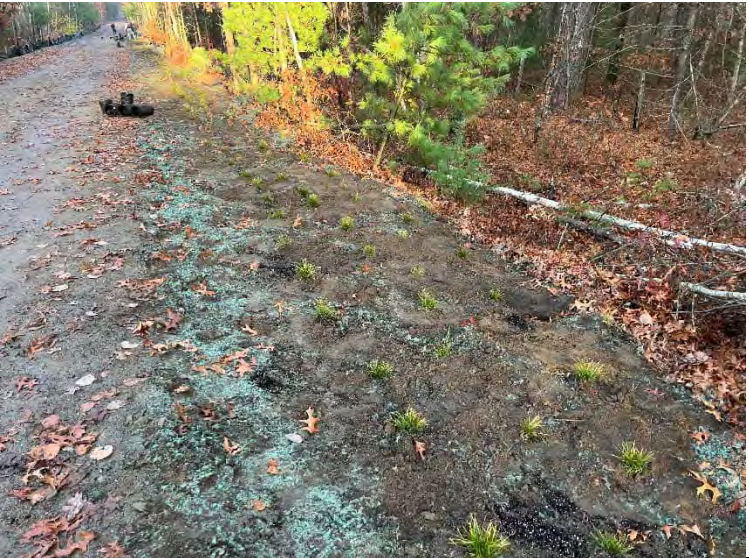
PHOTOGRAPHIC LOG	
Client Name: Eversource		Site Location: Sudbury to Hudson Transmission Reliability Project	Town: Hudson
Photo No.: 3	Date: 10/31/24

Description: View of installed plants. Facing east.

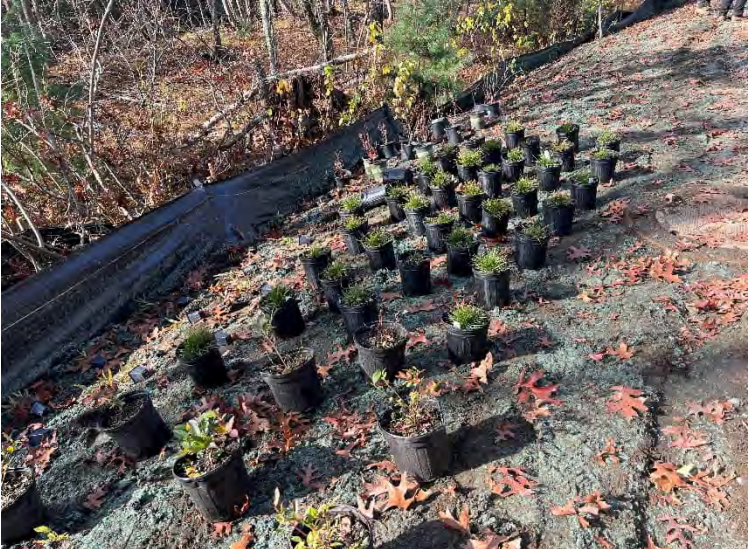
PHOTOGRAPHIC LOG	
Client Name: Eversource		Site Location: Sudbury to Hudson Transmission Reliability Project	Town: Hudson
Photo No.: 2	Date: 10/31/24

Description: View of plants being laid out for spacing prior to installation. <i>Facing southwest.</i>

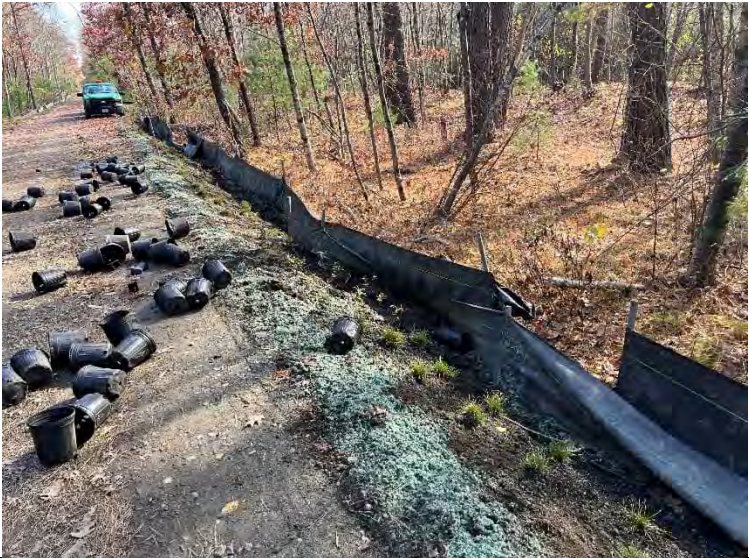
PHOTOGRAPHIC LOG	
Client Name: Eversource		Site Location: Sudbury to Hudson Transmission Reliability Project	Town: Hudson
Photo No.: 3	Date: 10/31/24

Description: View of installed plants. Facing east.

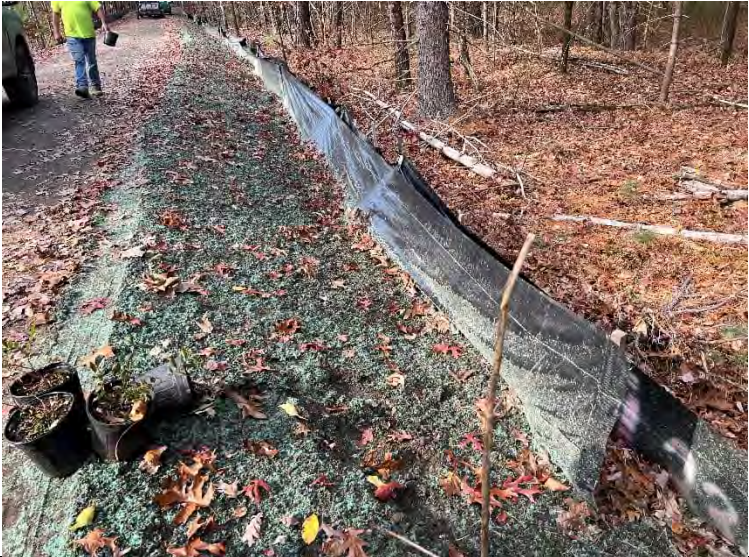
PHOTOGRAPHIC LOG	
Client Name: Eversource		Site Location: Sudbury to Hudson Transmission Reliability Project	Town: Hudson
Photo No.: 1	Date: 10/31/24

Description: View of planting bed prior to installation. <i>Facing west.</i>

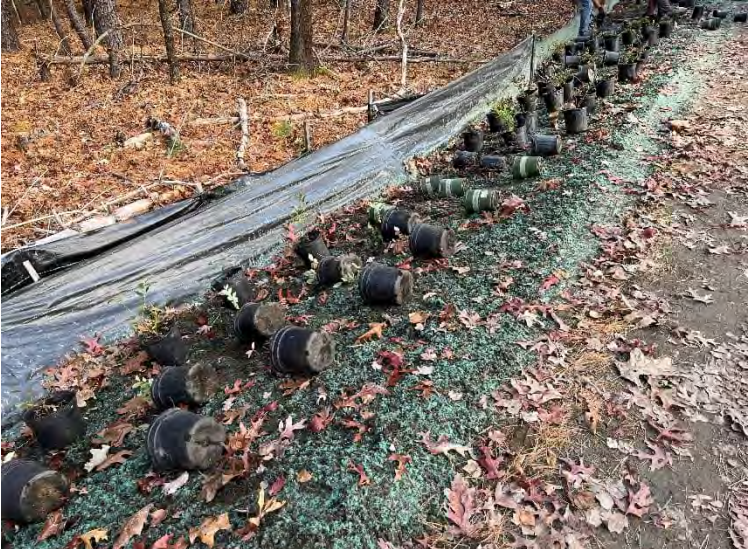
PHOTOGRAPHIC LOG	
Client Name: Eversource		Site Location: Sudbury to Hudson Transmission Reliability Project	Town: Hudson
Photo No.: 2	Date: 10/31/24

Description: View of plants laid out prior to installation. <i>Facing northeast.</i>

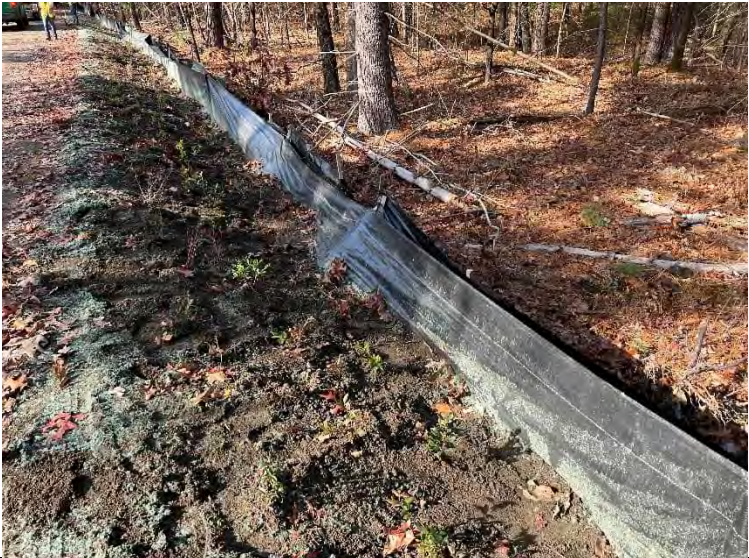
PHOTOGRAPHIC LOG	
Client Name: Eversource		Site Location: Sudbury to Hudson Transmission Reliability Project	Town: Hudson
Photo No.: 3	Date: 10/31/24

Description: View of installed plants. Facing west.

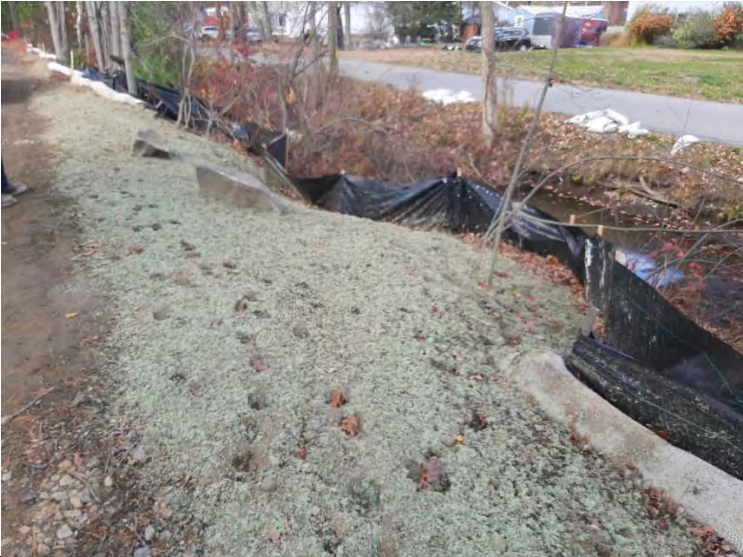
<p>PHOTOGRAPHIC LOG</p>	
<p>Client Name: Eversource</p>		<p>Site Location: Sudbury to Hudson Transmission Reliability Project</p>	<p>Town: Sudbury</p>
<p>Photo No.: 1</p>	<p>Date: 11/01/24</p>

<p>Description: Segment 12, north side, culvert extension area. Hydroseeded area prior to jute netting installation. Looking westward.</p>

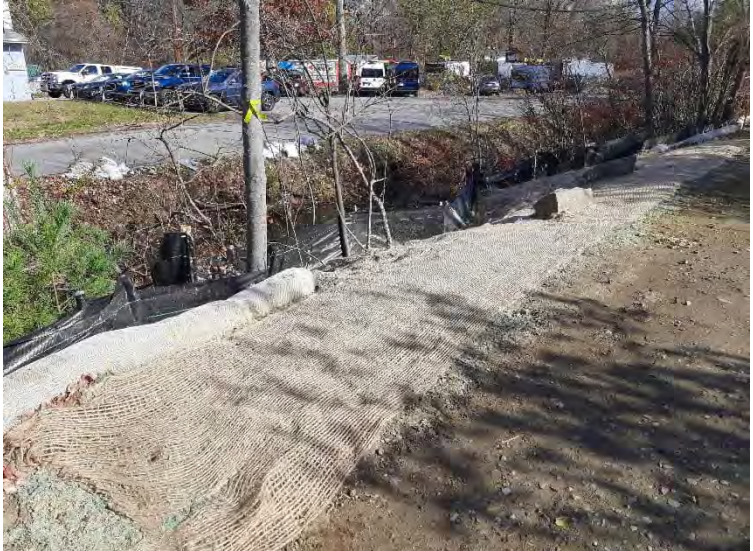
PHOTOGRAPHIC LOG	
Client Name: Eversource		Site Location: Sudbury to Hudson Transmission Reliability Project	Town: Sudbury
Photo No.: 4	Date: 11/01/24

Description: Segment 12, north side, culvert extension area. Installed jute netting. Looking eastward.

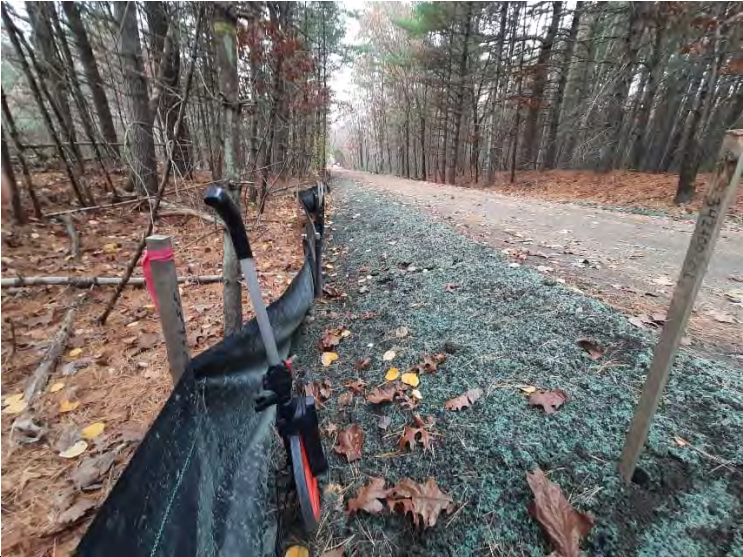
<p>PHOTOGRAPHIC LOG</p>	
<p>Client Name: Eversource</p>		<p>Site Location: Sudbury to Hudson Transmission Reliability Project</p>	<p>Town: Hudson</p>
<p>Photo No.: 1</p>	<p>Date: 11/01/24</p>

<p>Description: Segment 6, south side, STA -342 + 00. Planting area before plant installation. Looking westward.</p>

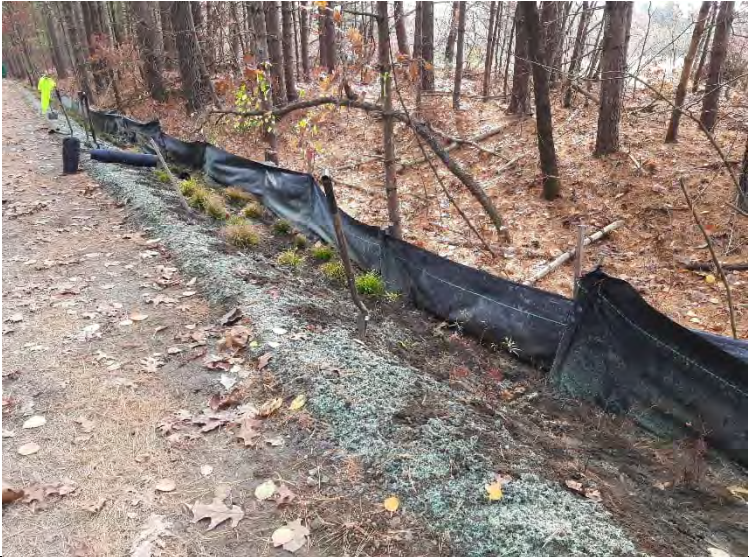
PHOTOGRAPHIC LOG	
Client Name: Eversource		Site Location: Sudbury to Hudson Transmission Reliability Project	Town: Hudson
Photo No.: 3	Date: 11/01/24

Description: Segment 6, south side, STA -342 + 00. MON installing plantings. Looking eastward.

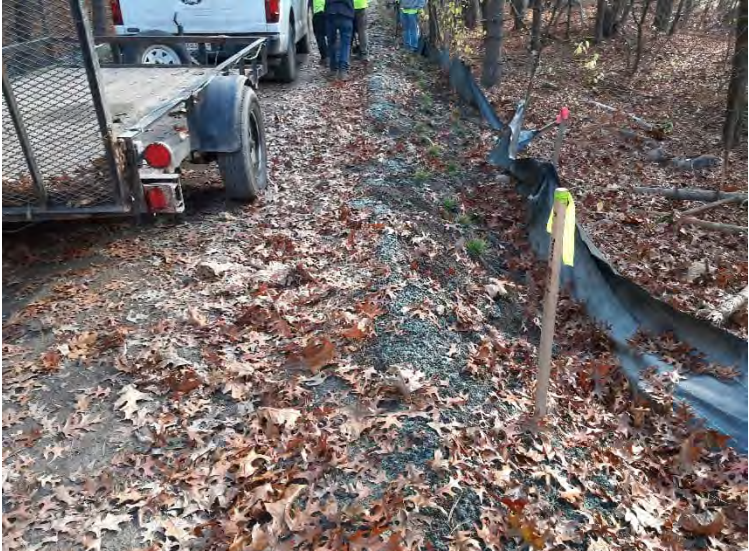
PHOTOGRAPHIC LOG	
Client Name: Eversource		Site Location: Sudbury to Hudson Transmission Reliability Project	Town: Hudson
Photo No.: 4	Date: 11/01/24

Description: Segment 6, south side, STA -341 + 75 to 342 + 00. MON installing plantings. Looking eastward.

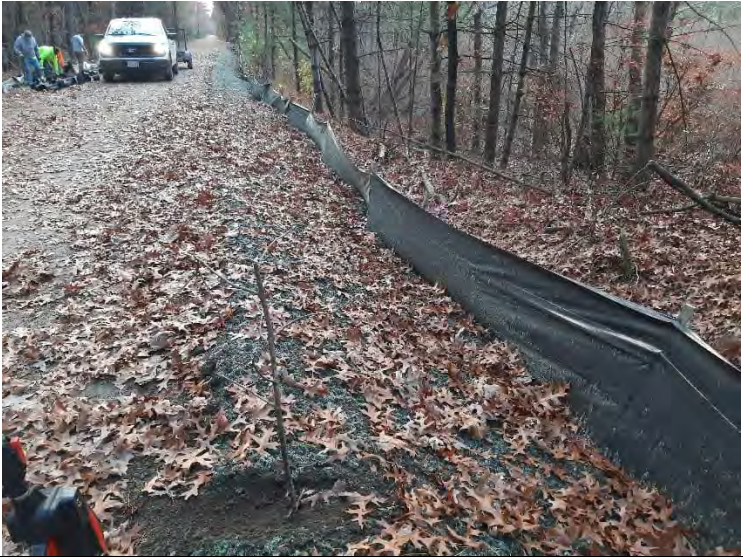
PHOTOGRAPHIC LOG	
Client Name: Eversource		Site Location: Sudbury to Hudson Transmission Reliability Project	Town: Hudson
Photo No.: 1	Date: 11/01/24

Description: Segment 6, south side, STA -346 + 00. Planting area prior to plant installation. Looking eastward.

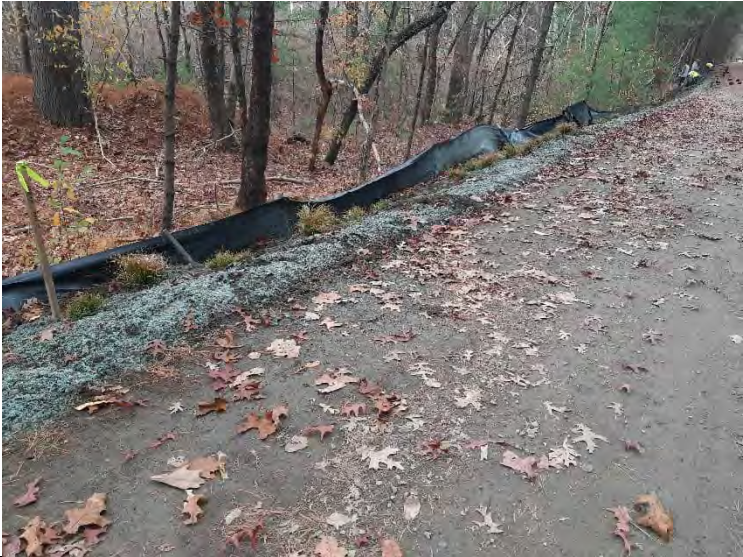
PHOTOGRAPHIC LOG	
Client Name: Eversource		Site Location: Sudbury to Hudson Transmission Reliability Project	Town: Hudson
Photo No.: 3	Date: 11/01/24

Description: Segment 6, south side, STA -348 + 00. Installed plantings, and MON installing plantings. Looking westward.

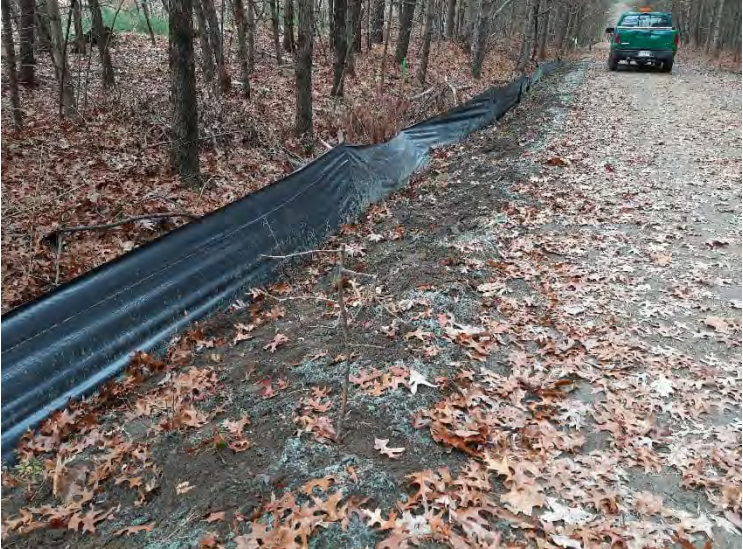
PHOTOGRAPHIC LOG	
Client Name: Eversource		Site Location: Sudbury to Hudson Transmission Reliability Project	Town: Hudson
Photo No.: 4	Date: 11/01/24

Description: Segment 6, south side, STA -346 + 00. Planting area after plant installation. Looking westward.

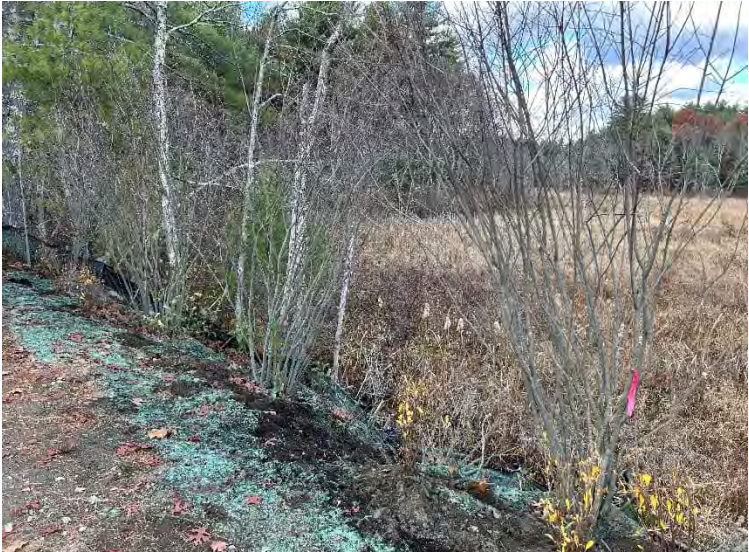
PHOTOGRAPHIC LOG	
Client Name: Eversource		Site Location: Sudbury to Hudson Transmission Reliability Project	Town: Sudbury
Photo No.: 2	Date: 11/01/24

Description: View of plantings on northern side of work area. <i>Facing northwest.</i>

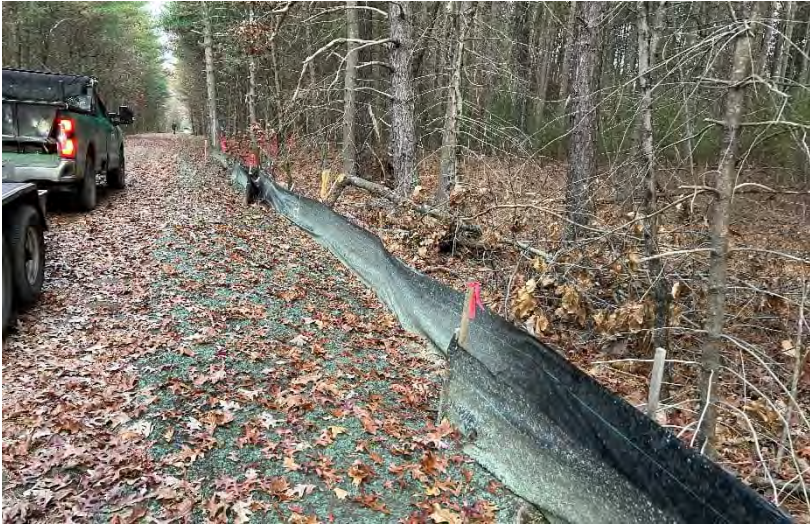
<p>PHOTOGRAPHIC LOG</p>	
<p>Client Name: Eversource</p>		<p>Site Location: Sudbury to Hudson Transmission Reliability Project</p>	<p>Town: Hudson</p>
<p>Photo No.: 1</p>	<p>Date: 11/01/24</p>

<p>Description: View of area prior to planting. Facing west.</p>

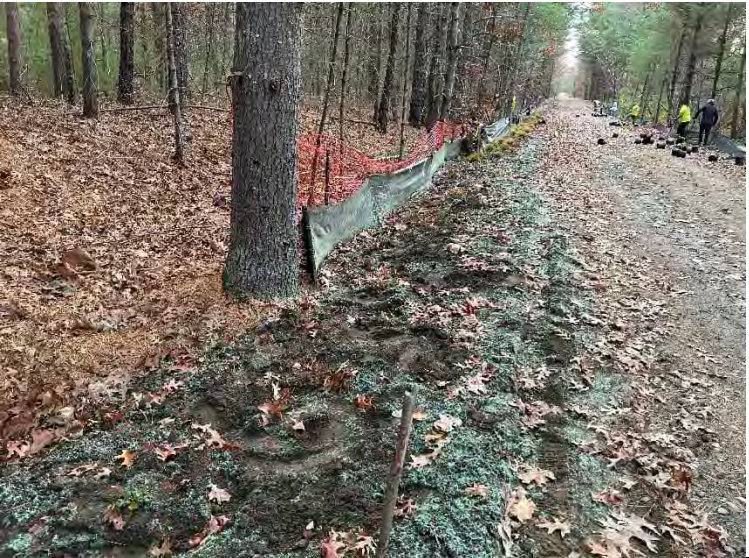
PHOTOGRAPHIC LOG	
Client Name: Eversource		Site Location: Sudbury to Hudson Transmission Reliability Project	Town: Hudson
Photo No.: 3	Date: 11/01/24

Description: View of completed plantings. Facing east.

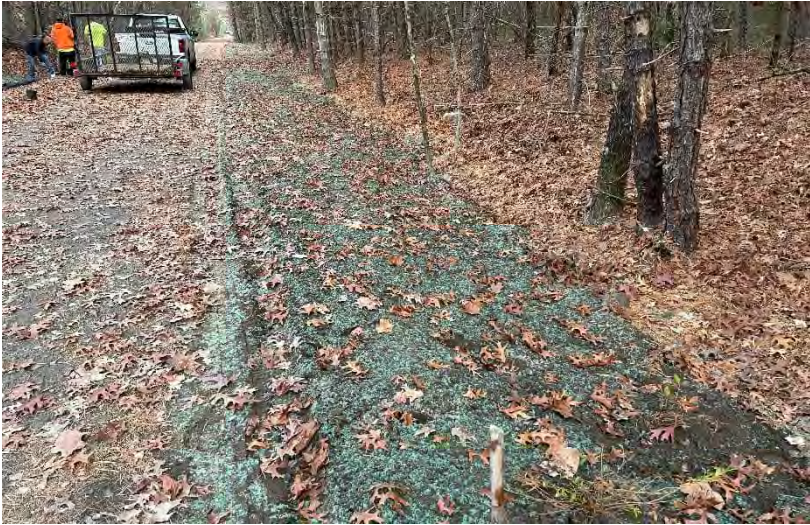
<p>PHOTOGRAPHIC LOG</p>	
<p>Client Name: Eversource</p>		<p>Site Location: Sudbury to Hudson Transmission Reliability Project</p>	<p>Town: Hudson</p>
<p>Photo No.: 1</p>	<p>Date: 11/01/24</p>

<p>Description: View of area prior to planting. Facing west.</p>

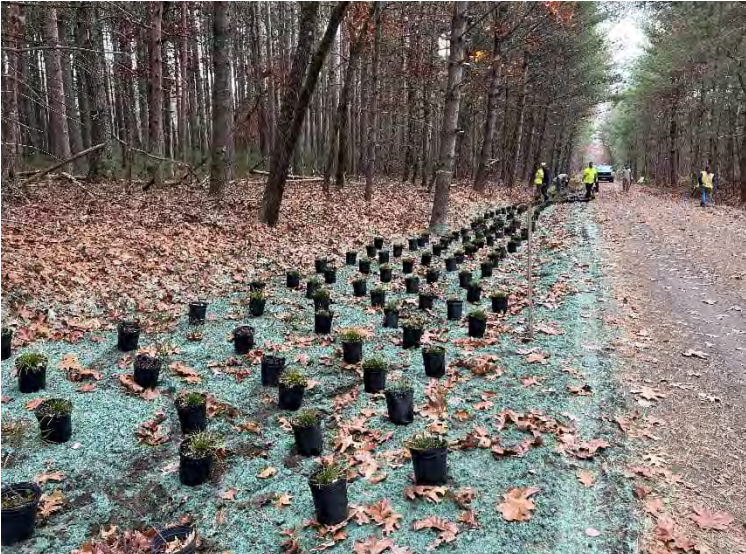
<p>PHOTOGRAPHIC LOG</p>	
<p>Client Name: Eversource</p>		<p>Site Location: Sudbury to Hudson Transmission Reliability Project</p>	<p>Town: Hudson</p>
<p>Photo No.: 2</p>	<p>Date: 11/01/24</p>

<p>Description: View of MON placing plants according to planting scheme. Facing east.</p>

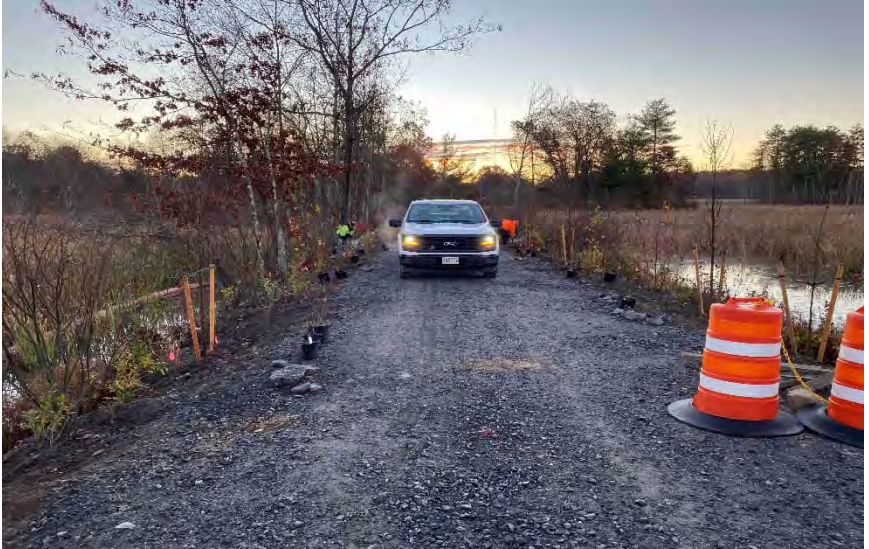
PHOTOGRAPHIC LOG	
Client Name: Eversource		Site Location: Sudbury to Hudson Transmission Reliability Project	Town: Hudson
Photo No.: 2	Date: 11-02-2024

Description: Bridge 130, segment 3. MON planting dogwoods (SA/SD), eleven (11) on the south side & nine (9) on the north side. Looking eastward.

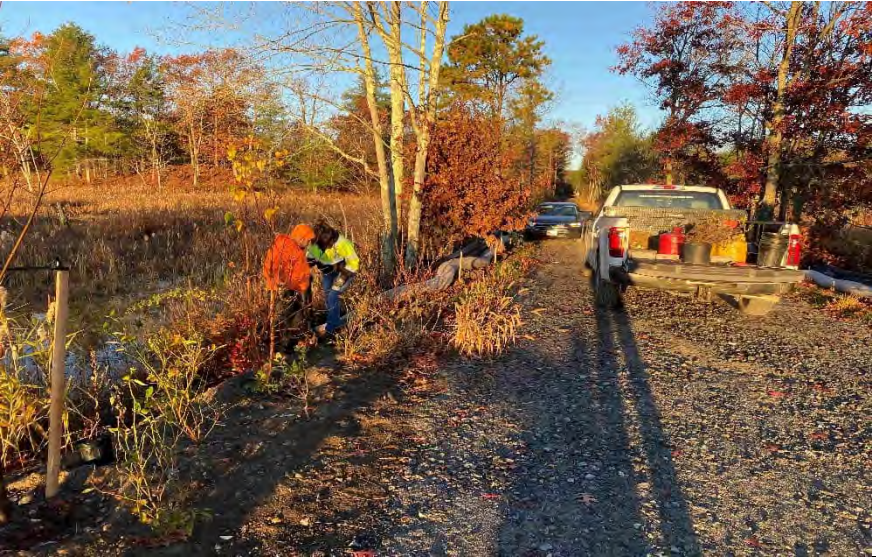
PHOTOGRAPHIC LOG	
Client Name: Eversource		Site Location: Sudbury to Hudson Transmission Reliability Project	Town: Hudson
Photo No.: 3	Date: 11-02-2024

Description: Bridge 130, segment 2. MON planting dogwoods (SA/SD), two (2) on the south side & two (2) on the north side. Looking westward.

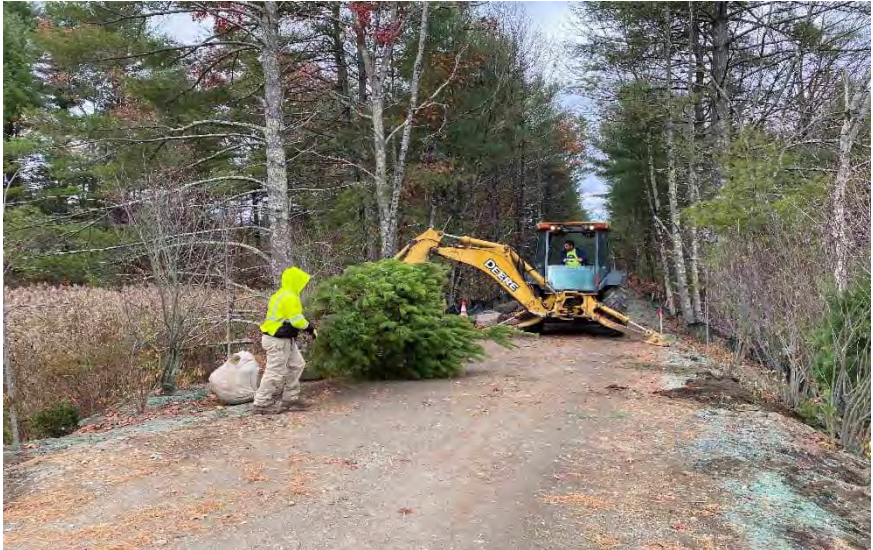
<p>PHOTOGRAPHIC LOG</p>	
<p>Client Name: Eversource</p>		<p>Site Location: Sudbury to Hudson Transmission Reliability Project</p>	<p>Town: Sudbury</p>
<p>Photo No.: 1</p>	<p>Date: 11-02-2024</p>

<p>Description:</p> <p>Bridge 128, segment 7. MON planting White pine on south side. Three (3) planted. Looking westward.</p>

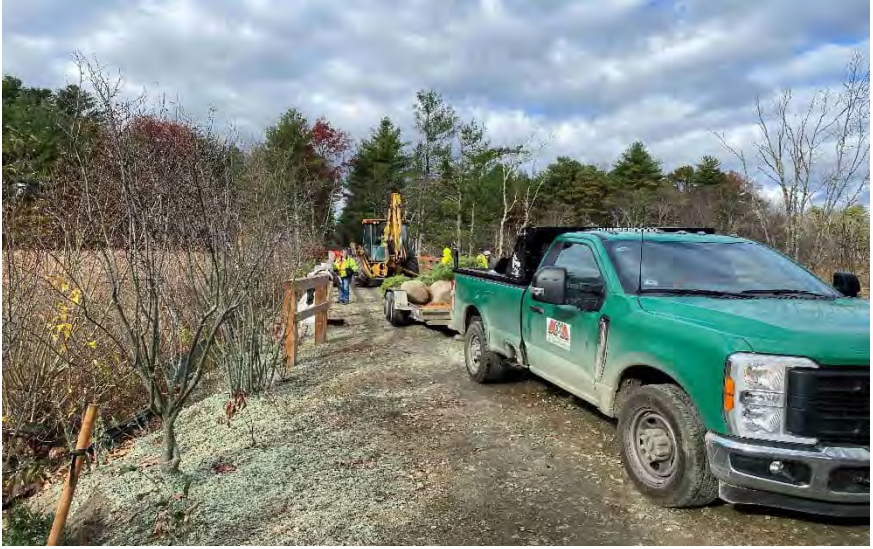
<p>PHOTOGRAPHIC LOG</p>	
<p>Client Name: Eversource</p>		<p>Site Location: Sudbury to Hudson Transmission Reliability Project</p>	<p>Town:</p>
<p>Photo No.: 2</p>	<p>Date: 11-02-2024</p>

<p>Description:</p> <p>Bridge 128, segment 7. MON planting White pine on north side. Three (3) planted. Looking westward.</p>

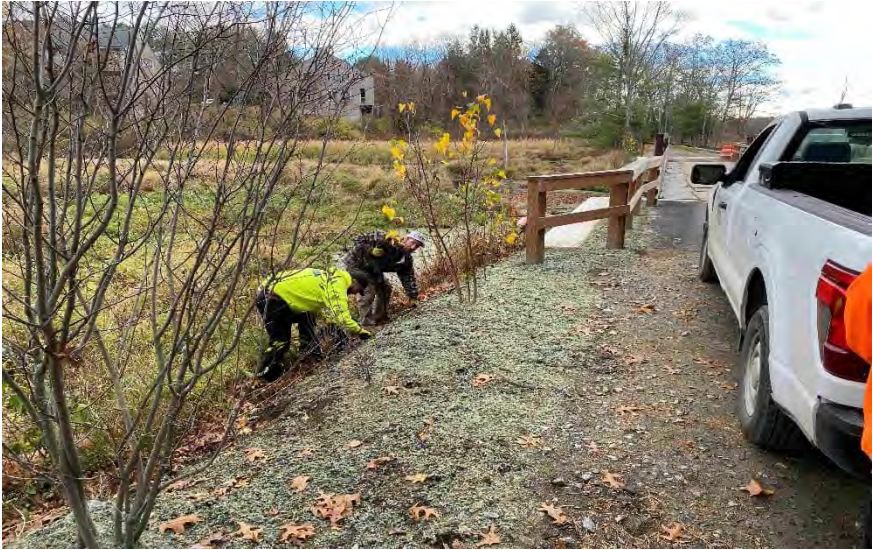
<p>PHOTOGRAPHIC LOG</p>	
<p>Client Name: Eversource</p>		<p>Site Location: Sudbury to Hudson Transmission Reliability Project</p>	<p>Town: Sudbury</p>
<p>Photo No.: 1</p>	<p>Date: 11-02-2024</p>

<p>Description:</p> <p>Bridge 127, segment 13. MON placing wetland plugs on south side. Thirty-nine (39) plugs planted. Looking eastward.</p>

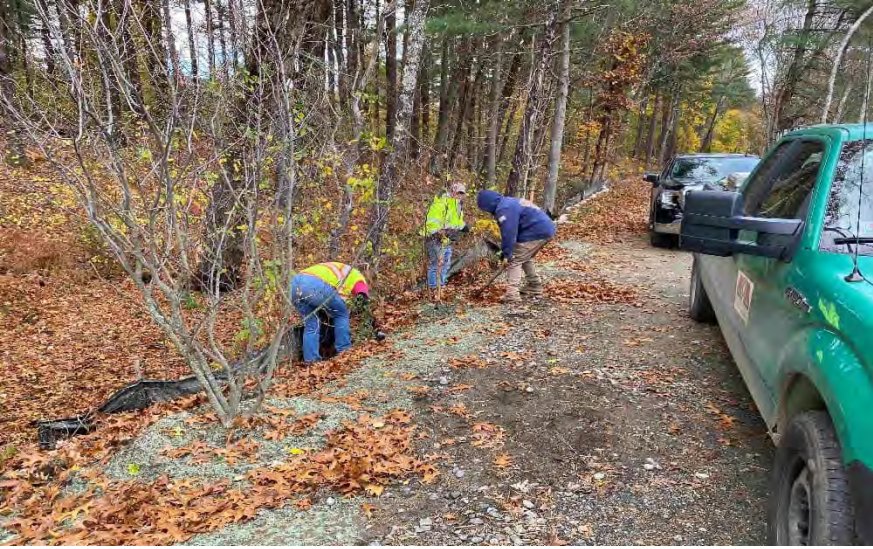
<p>PHOTOGRAPHIC LOG</p>	
<p>Client Name: Eversource</p>		<p>Site Location: Sudbury to Hudson Transmission Reliability Project</p>	<p>Town: Sudbury</p>
<p>Photo No.: 2</p>	<p>Date: 11-02-2024</p>

<p>Description:</p> <p>Bridge 127, segment 13. MON placing wetland plugs on north side. Thirty-one (31) plugs planted. Looking westward.</p>
