Environmental Monitor Construction Site Inspection Report
MassDOT Project #608164 Construction Contract # 119678
EM Report #32

Project Description: Bruce Freeman Rail Trail Right-of-Way
 Permit Description(s): Order of Conditions (MGL Chapter 131, Section 40 and 310 CMR 10.00, Mass DEP File No. 301-1362); 2022 EPA NPDES General Permit for Discharges from Construction Areas; U.S. Army Corps of Engineers Permit No NAE-2021-01975.

Project Name:	Bruce Freeman Rail Trail - Phase 2d - Sudbury
Date of Inspections:	11/19/2024
Bi Weekly/ Monthly Period Covered:	November Weekly Inspection #3
Inspector's Name(s):	Anna Haznar
Inspectors' Contact Information:	ahaznar@beta-inc.com

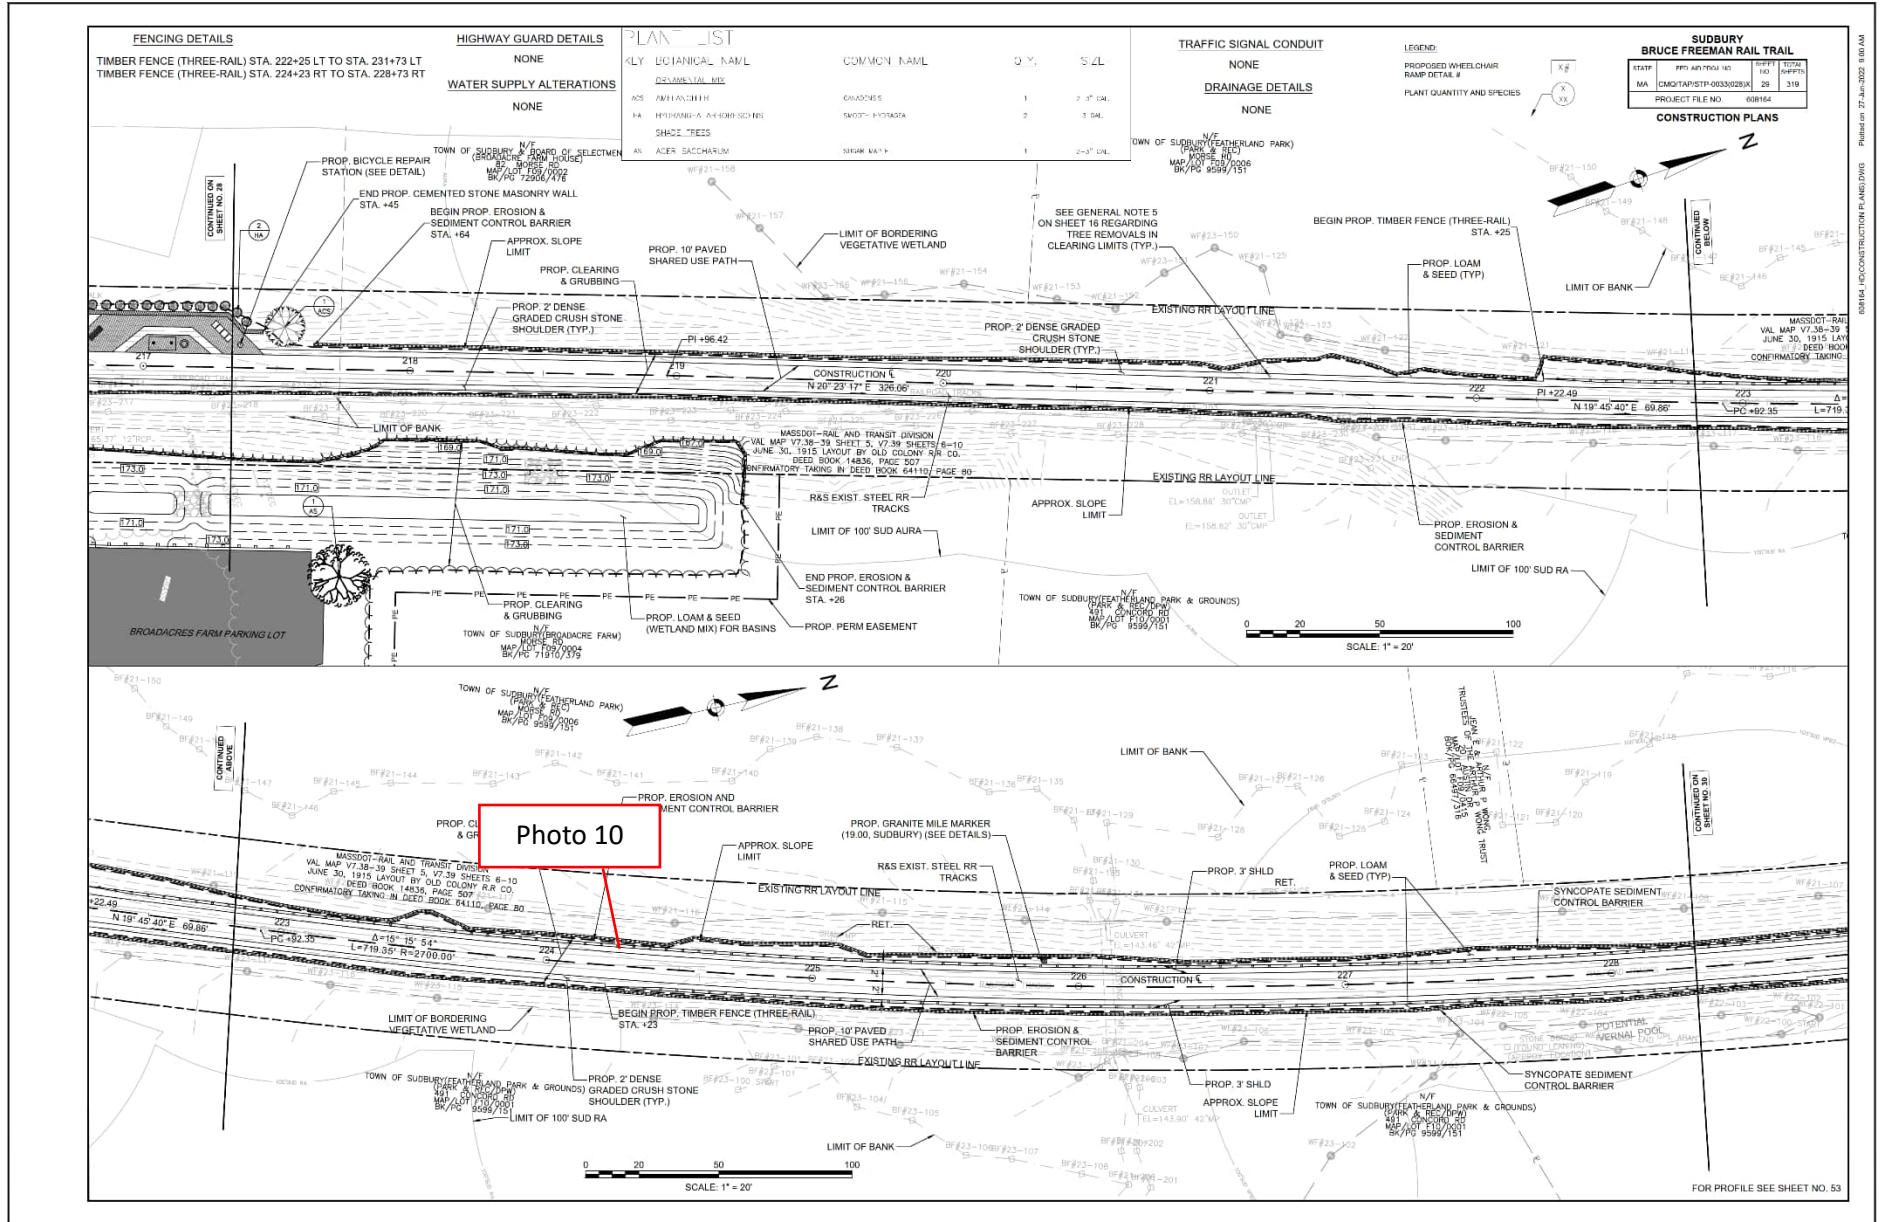
Photo 10

Direction Photo Taken: Toward the Northwest		
Description: View of the installation of interpretive signposts at the Morse Road parking lot near Station 216+75.		
Photo No. 10	Date: 11/19/2024
